**FIRNTEC**  
BUILDING COMPLIANCE

VISUAL STRUCTURAL APPRAISAL

Holly Court  
Acacia Avenue  
West Brom  
WS5 4HB

24<sup>th</sup> June 2025

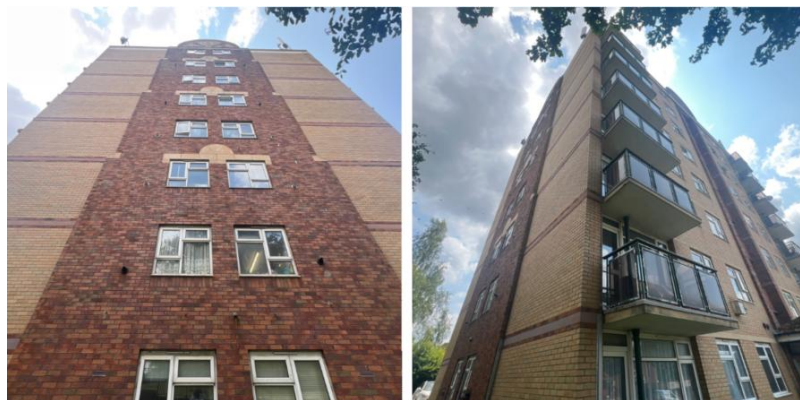
Figure 9 and 10: Building Elevations

The exterior elevations were generally in ok condition and no significant structural defects were noted to the infill panels. There were no significant cracks or tell-tale signs of any significant structural movement noted at the time of our inspection.

The exterior panels were noted to be plumb with no signs of significant bowing, bulging or leaning noted to the panels indicating failed fixings however their presence and condition cannot be confirmed.

The gable elevations have what appears to be an additional layer of brickwork external to the outer leaf. It is not clear if it is original or built after. It is in ok condition and provides some protection to slab edge and is therefore not considered a risk.

There are balconies at each level which are formed of cantilevered RC slabs tied into the main frame. The balconies would benefit from a refurbishment. The cantilevered slabs should be checked for internal corrosion potential at the benchmark inspections.

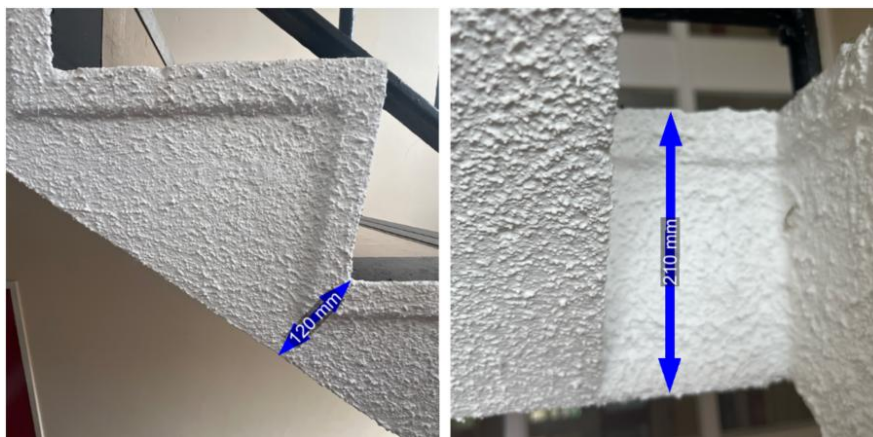
Figure 14 and 15: Stair Stringer and Landing

The stair stringer was noted to be 120mm thick which seems slim, certainly short of modern standards. A cover test is required to check the resistance of the concrete section in the event of a fire.

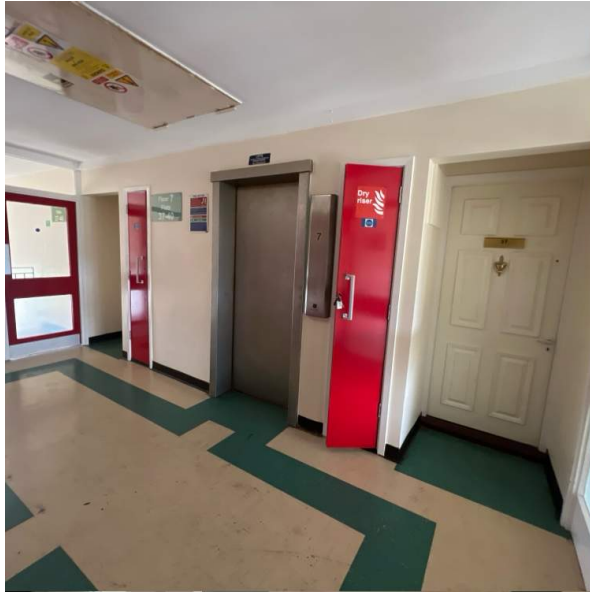
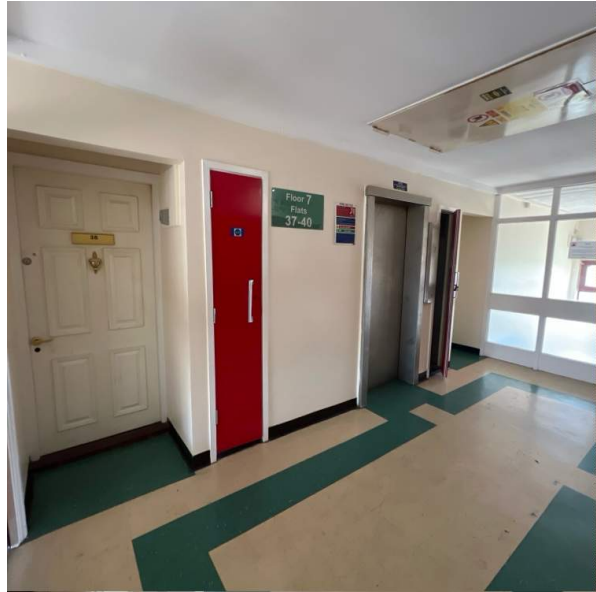
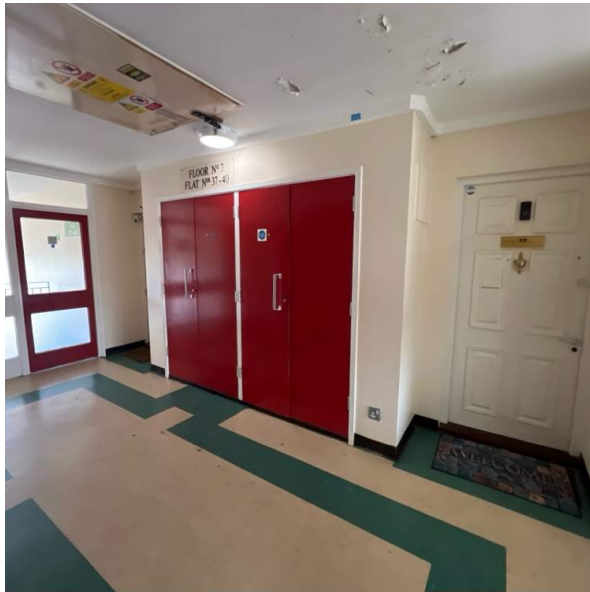
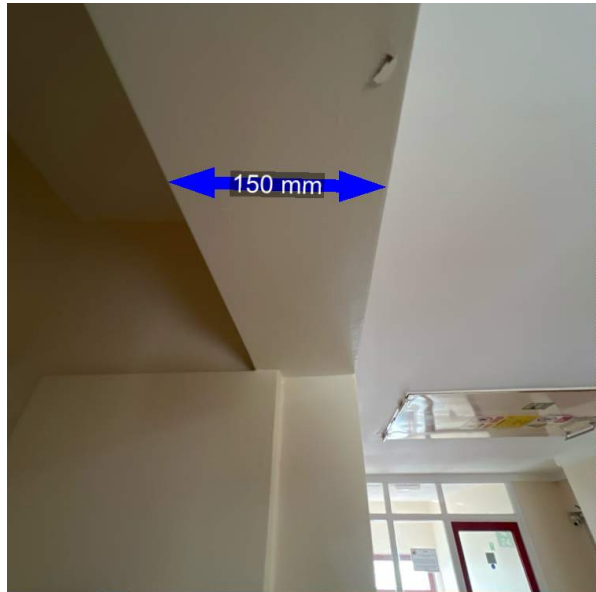
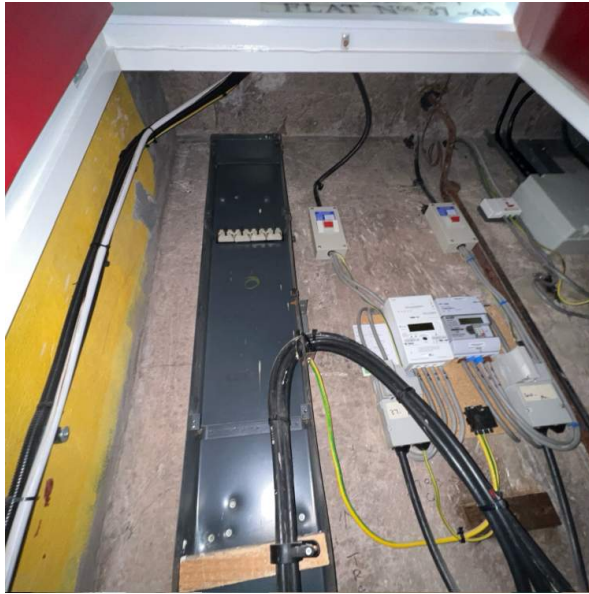
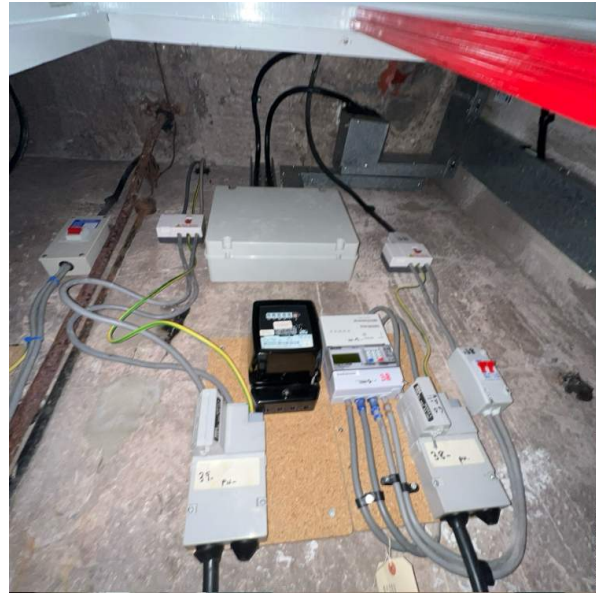
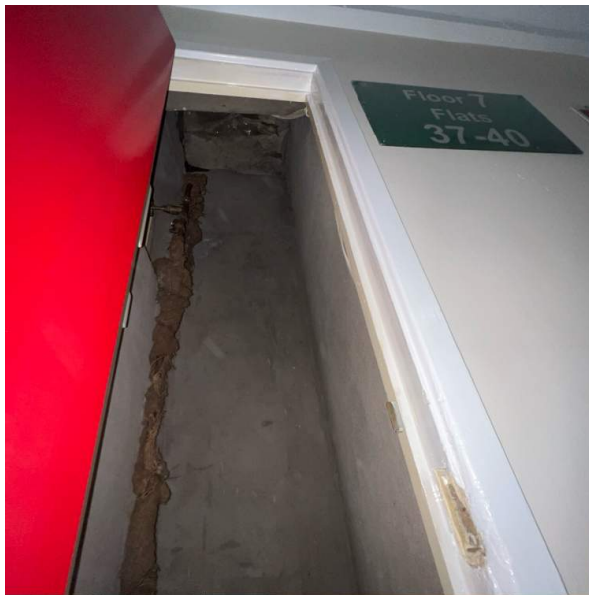
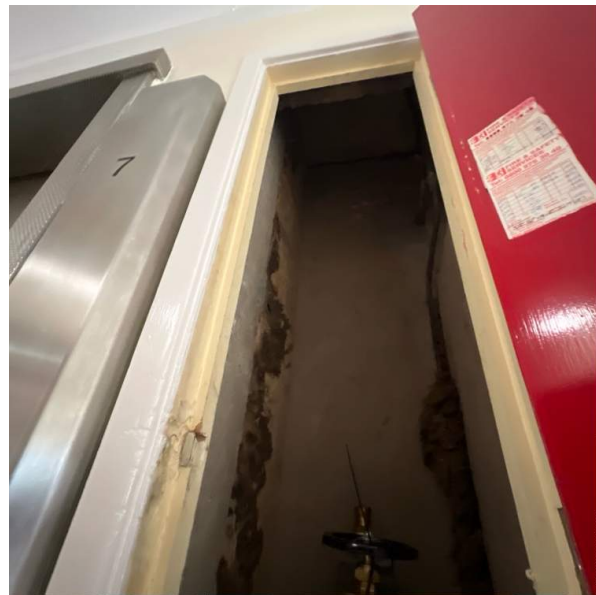
## 7th Floor Hallway

Comments: No jams or distortions noted to hallway doors to indicate any serviceability issues. Generally walls covered with finishes in hallway, likely to consist a mixture of concrete shear walls, embedded columns and masonry infill walls. Limited structure exposed. Concrete walls and infill masonry (non-load bearing) walls noted in riser cupboards.

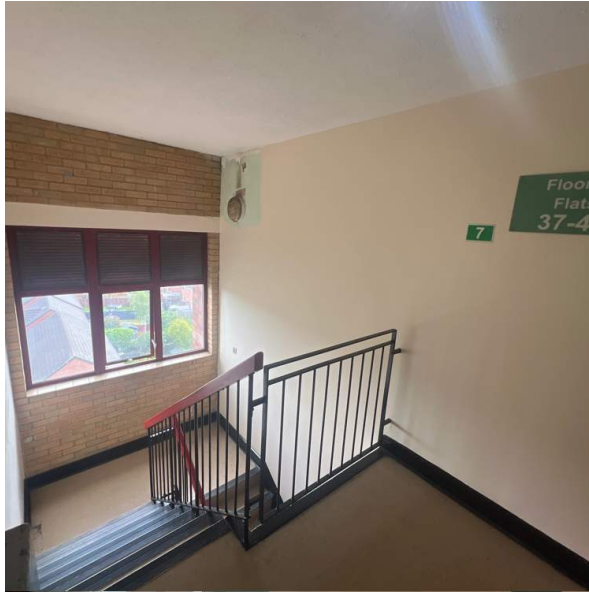
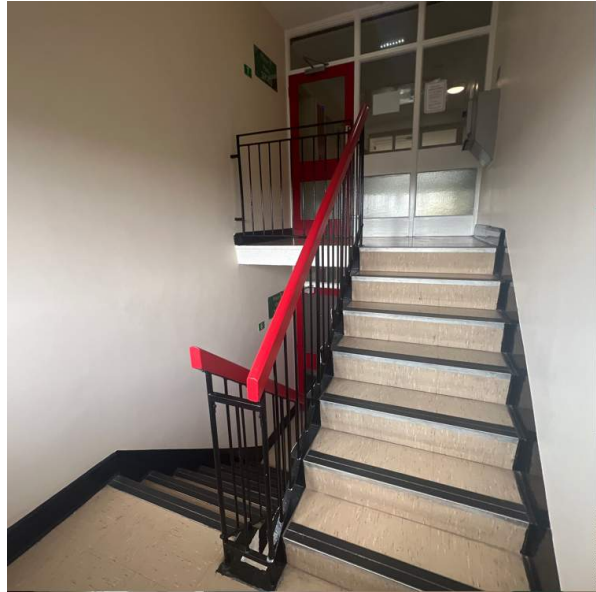
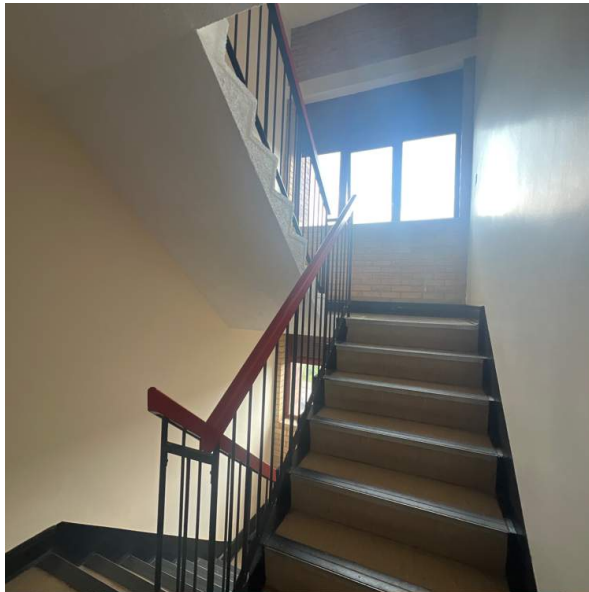
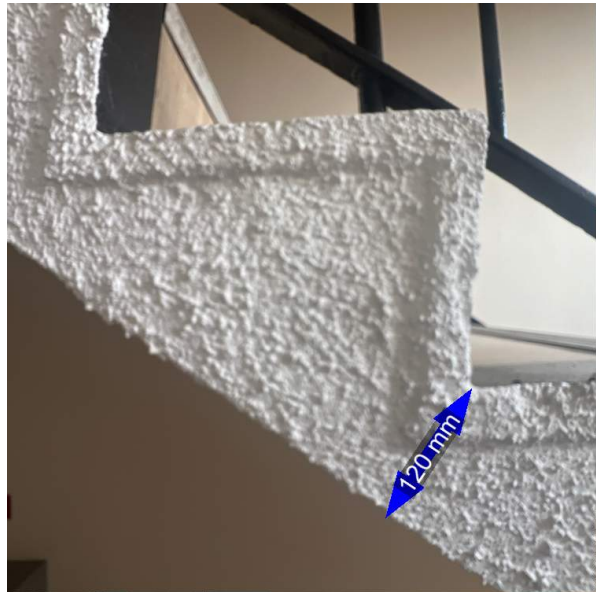
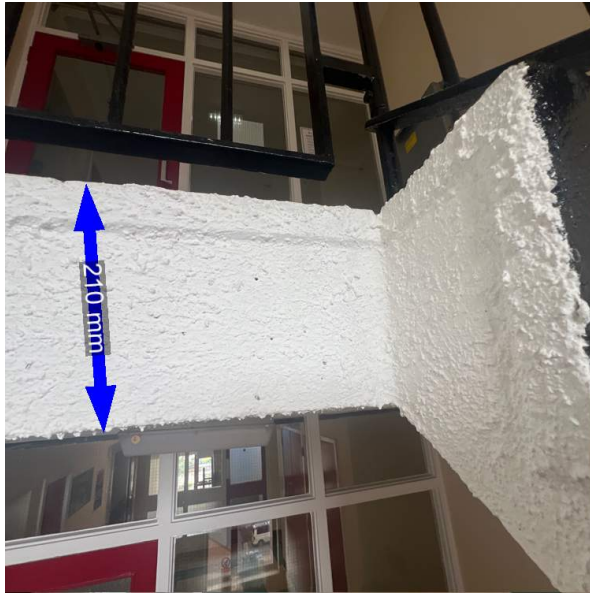
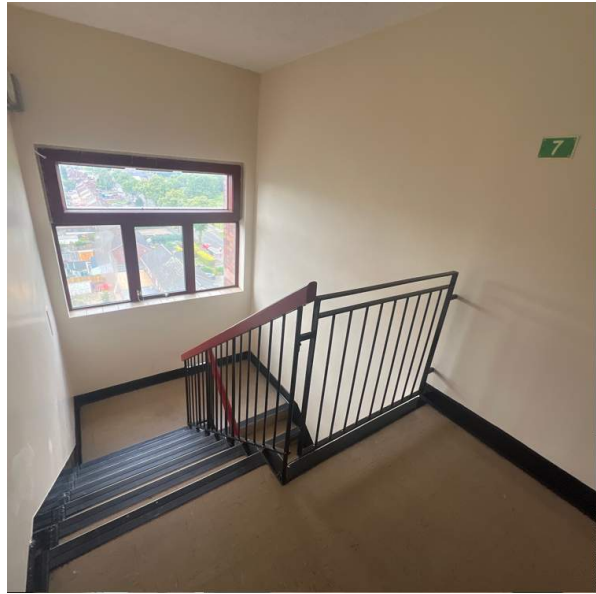
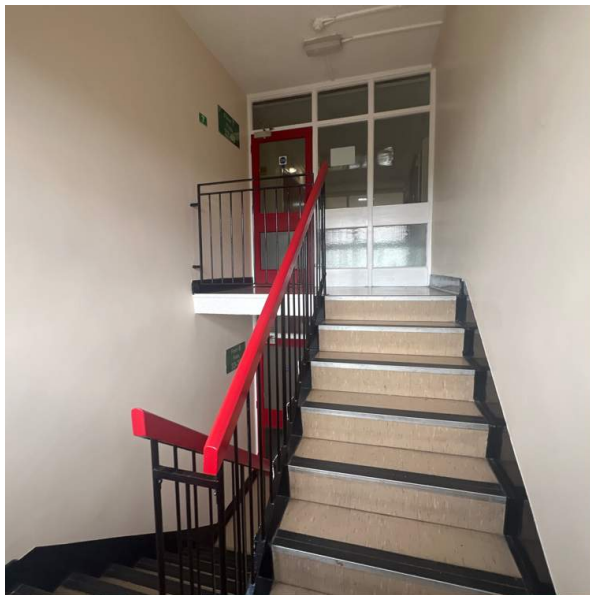
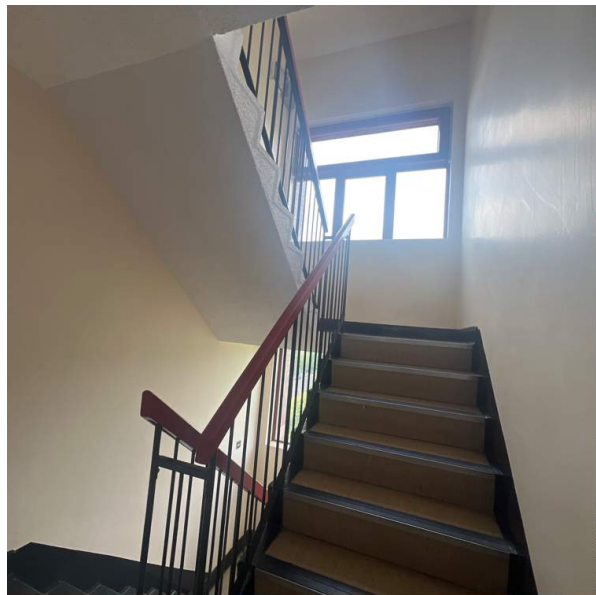
## 7th Floor Staircases

Comments: Insitu concrete stairs with steel hand railing fixed to stairs. Walls and floors appear to be fairly level.  
Stair walls covered with finishes however these would likely form the main concrete shear core walls.

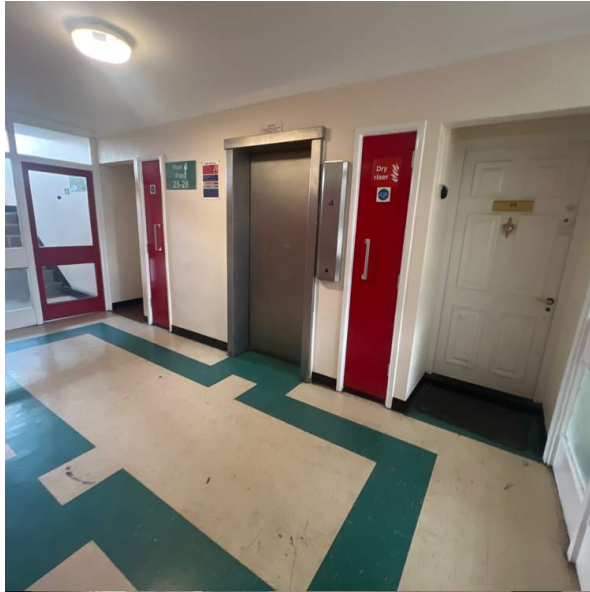
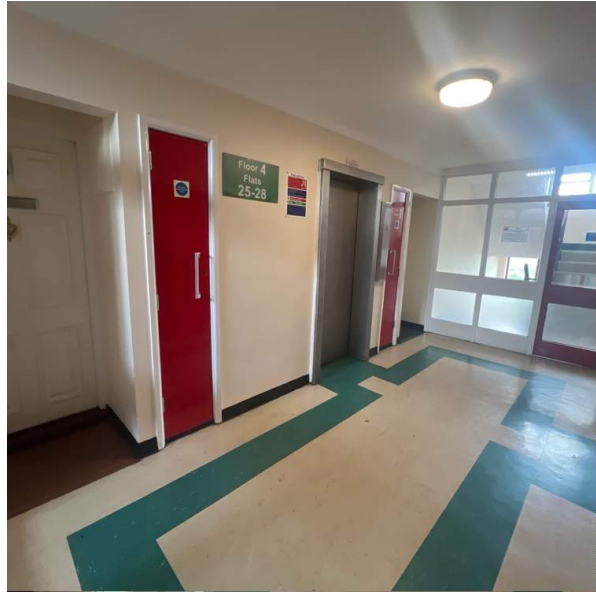
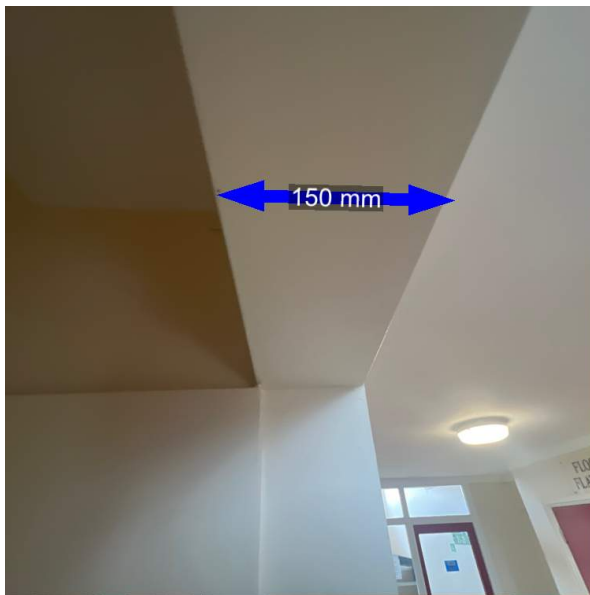
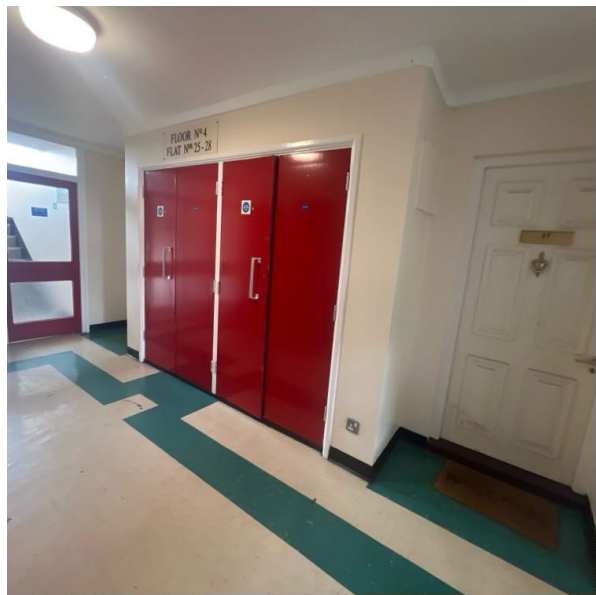
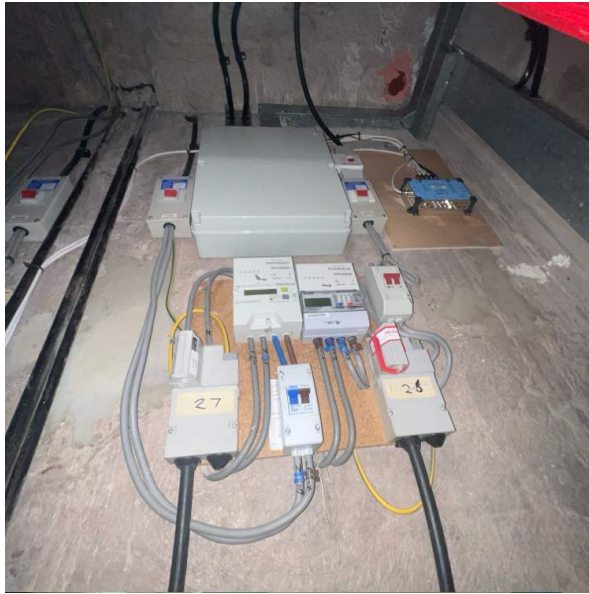
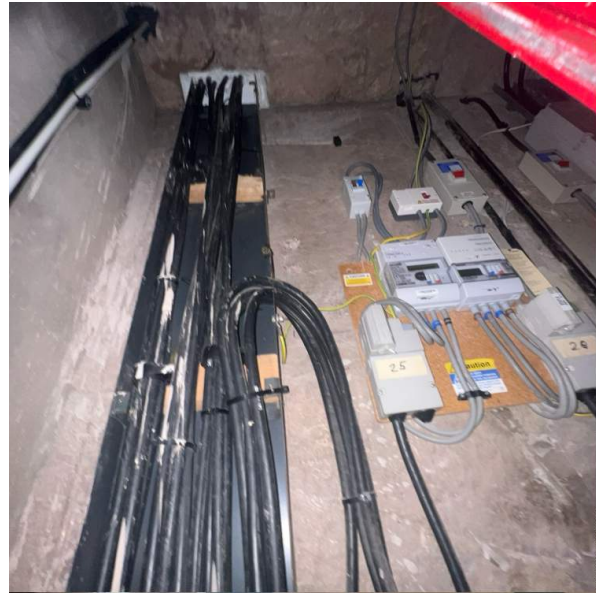
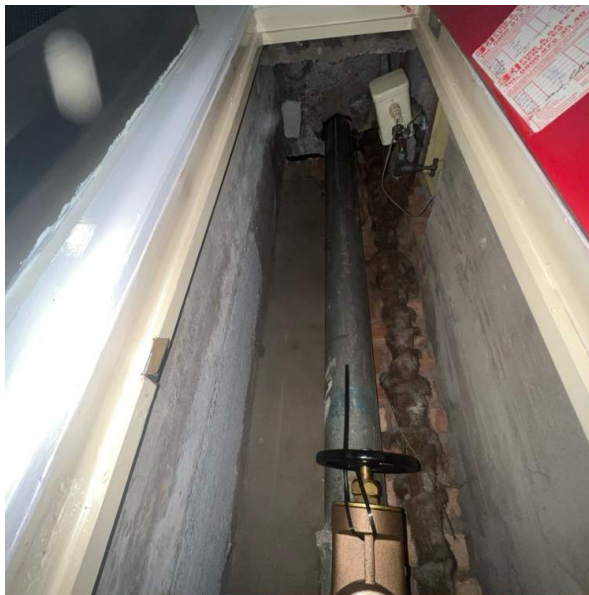
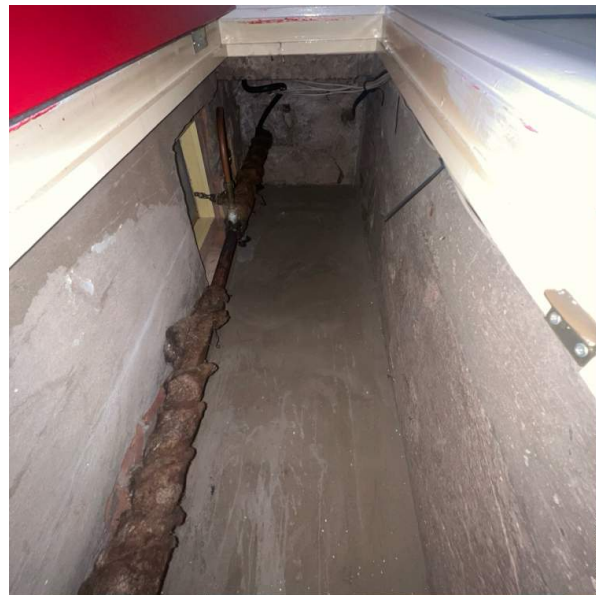
## 4th Floor Hallway

Comments: No jams or distortions noted to hallway doors to indicate any serviceability issues. Generally walls covered with finishes in hallway, likely to consist a mixture of concrete shear walls, embedded columns and masonry infill walls. Limited structure exposed. Concrete walls and infill masonry (non-load bearing) walls noted in riser cupboards.

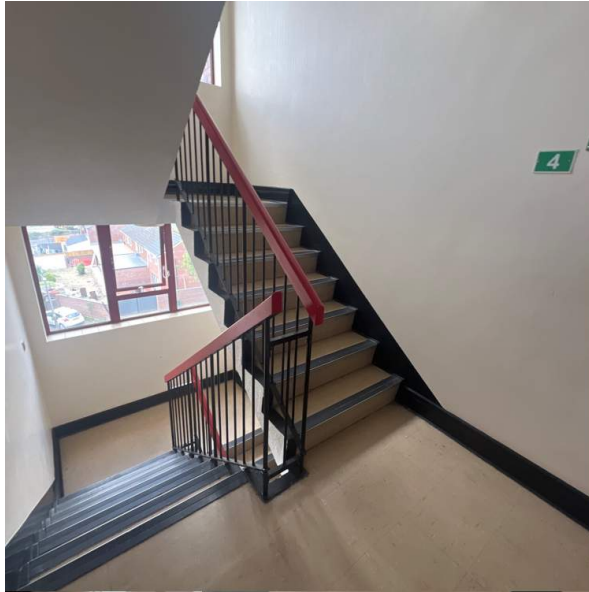
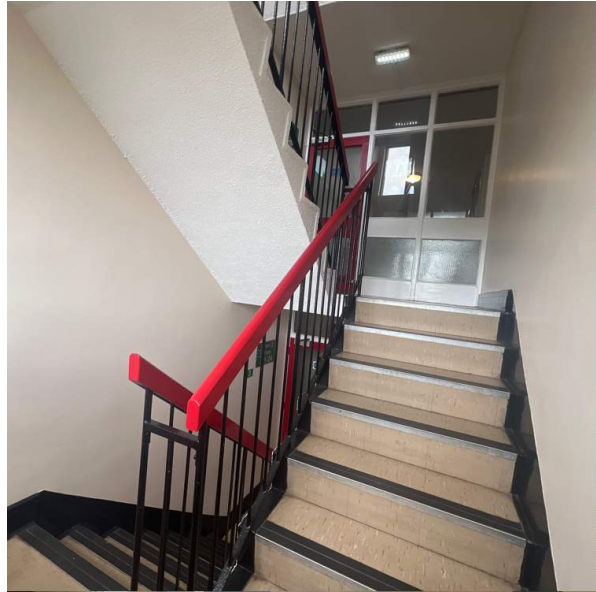
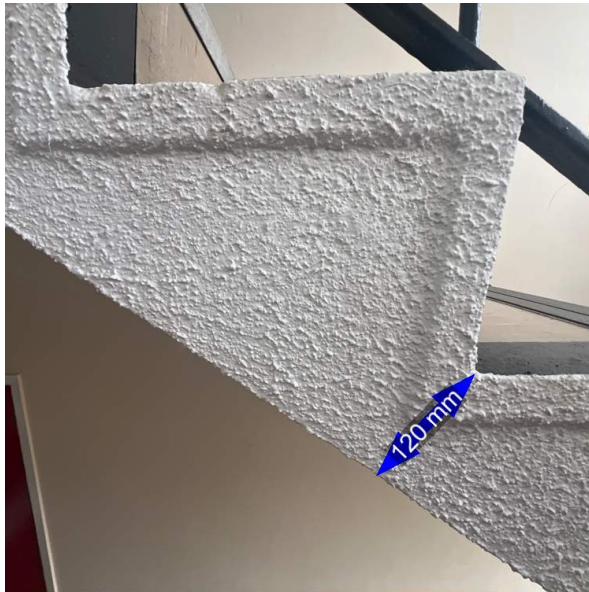
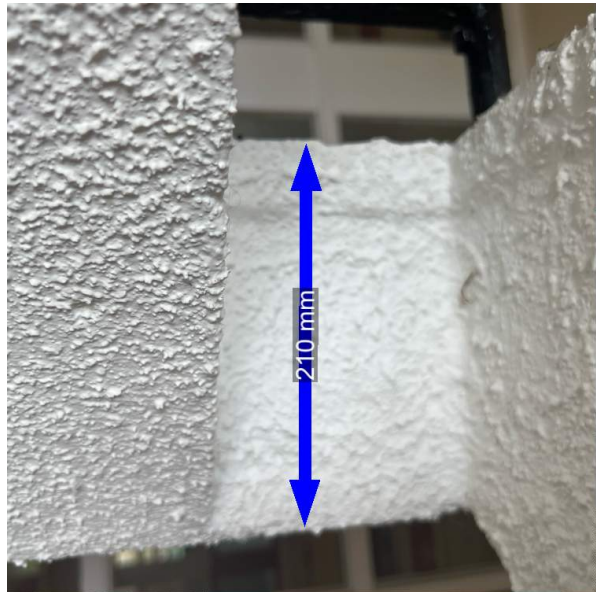
## 4th Floor Staircases

Comments: Insitu concrete stairs with steel hand railing fixed to stairs. Walls and floors appear to be fairly level.  
Stair walls covered with finishes however these would likely form the main concrete shear core walls.

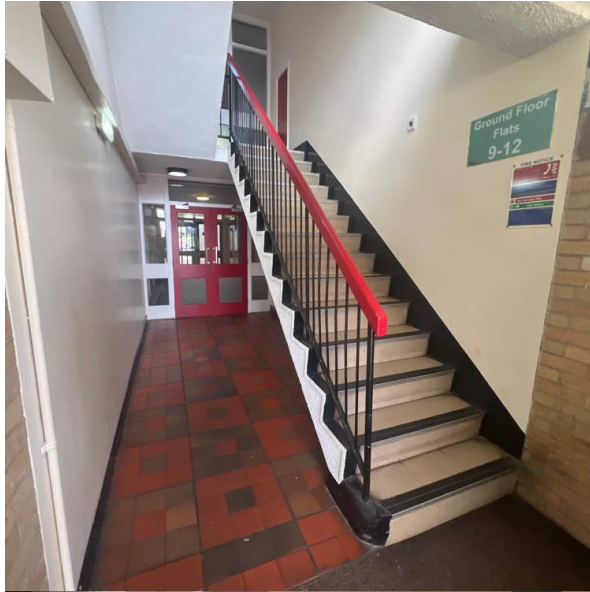
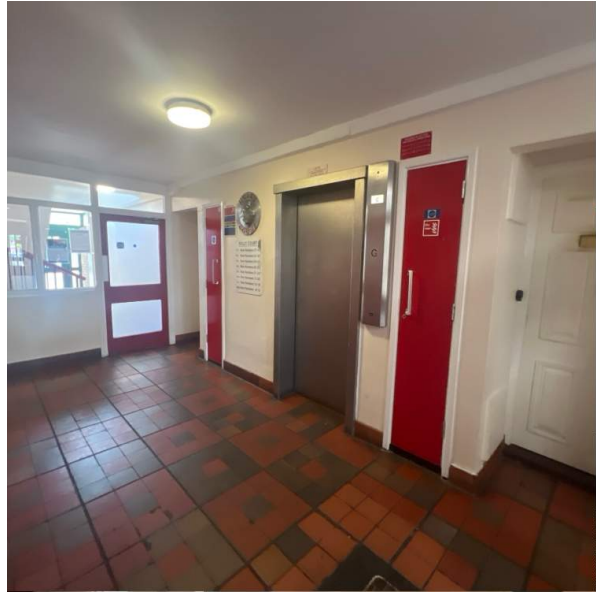
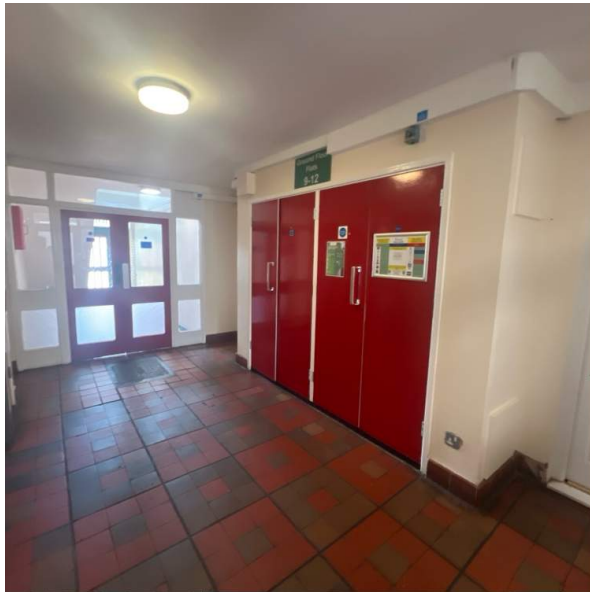
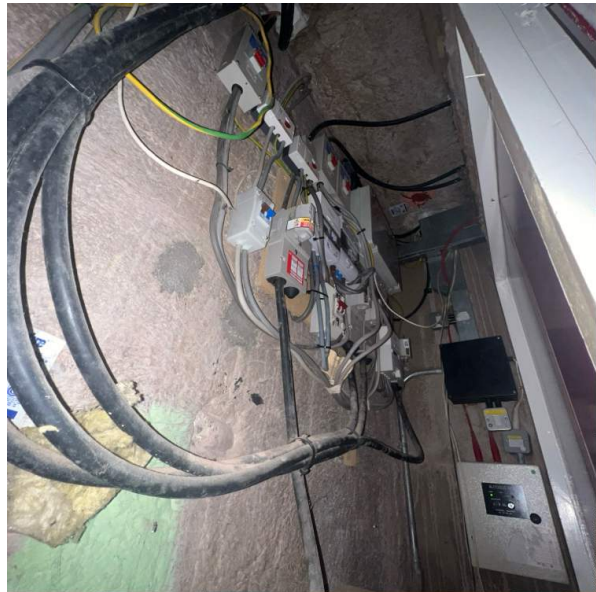
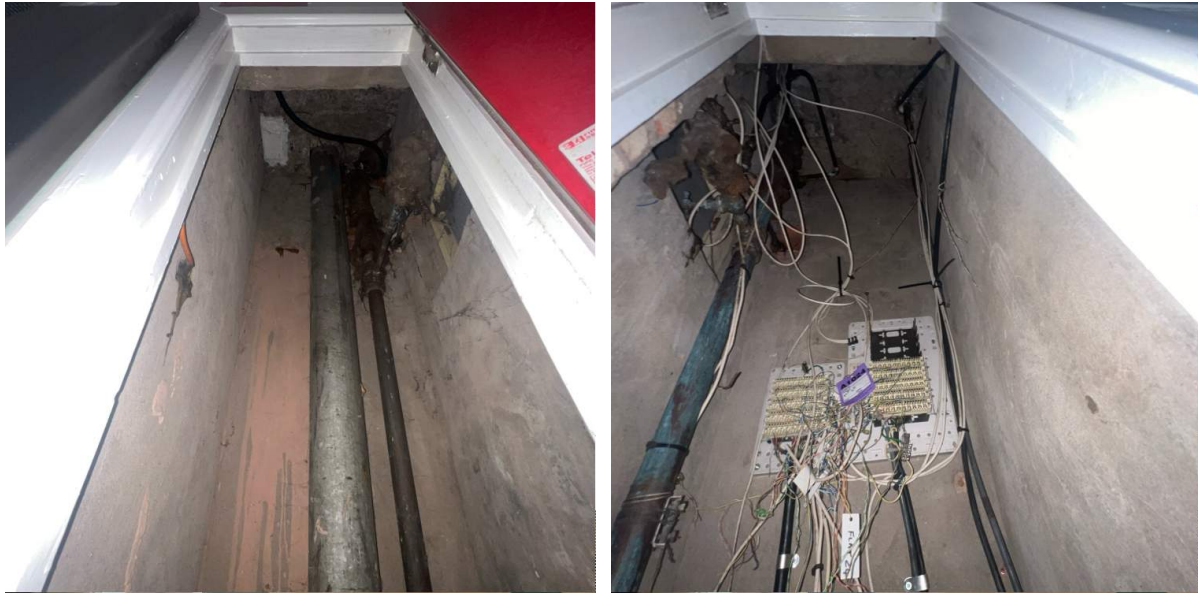
## Ground Floor Hallway

Comments: No jams or distortions noted to hallway doors to indicate any serviceability issues. Generally walls covered with finishes in hallway, likely to consist a mixture of concrete shear walls, embedded columns and masonry infill walls. Limited structure exposed. Concrete walls and infill masonry (non-load bearing) walls noted in riser cupboards.

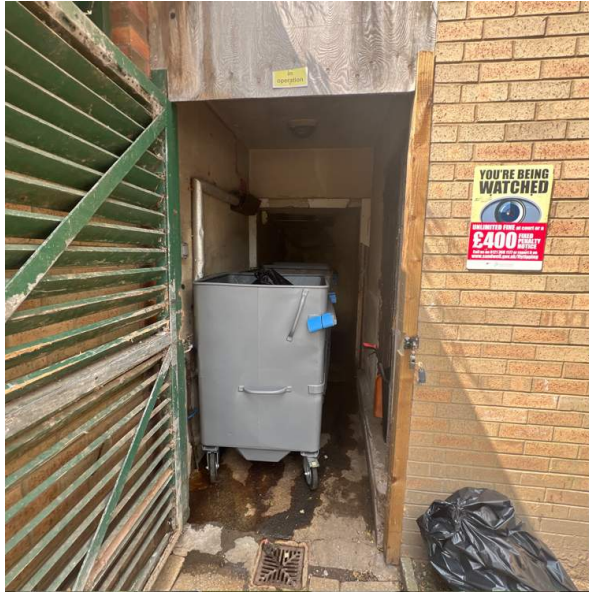
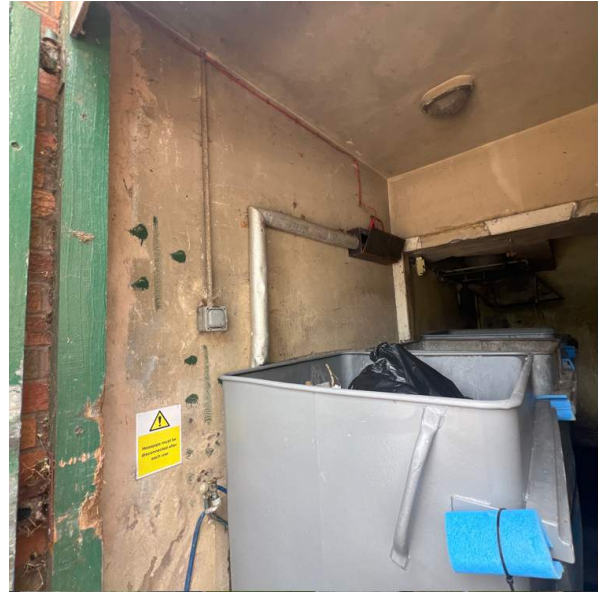
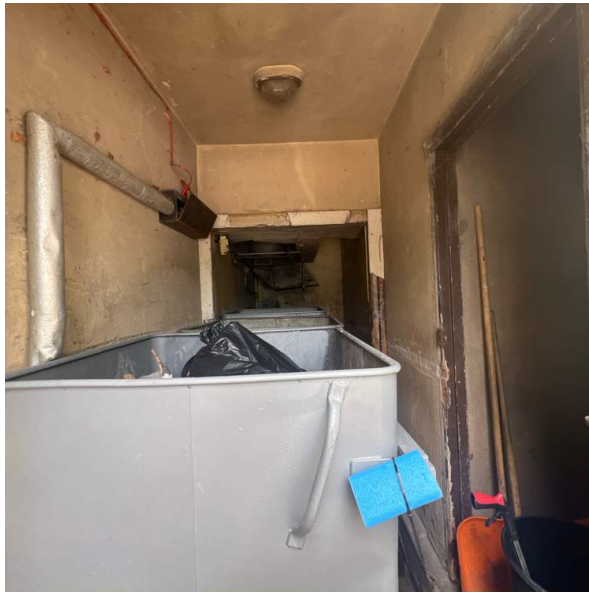
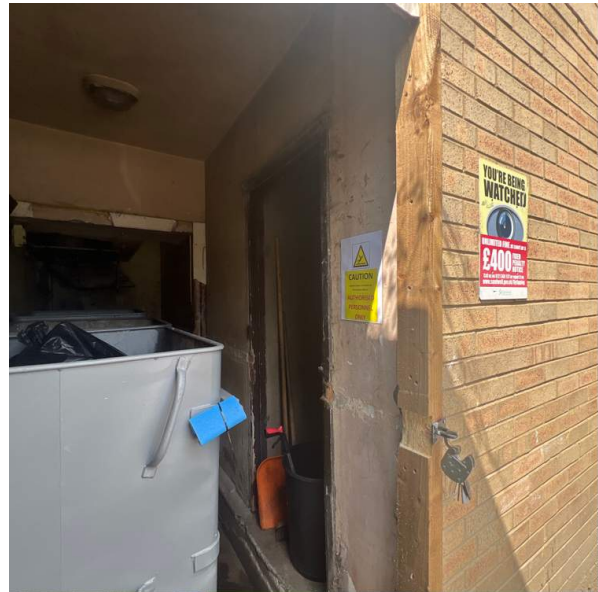
## Bin Store

Comments: RC concrete walls noted in bin store.

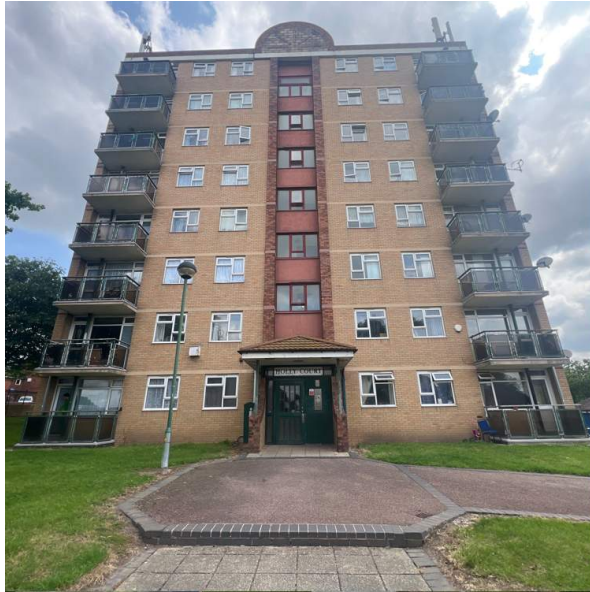
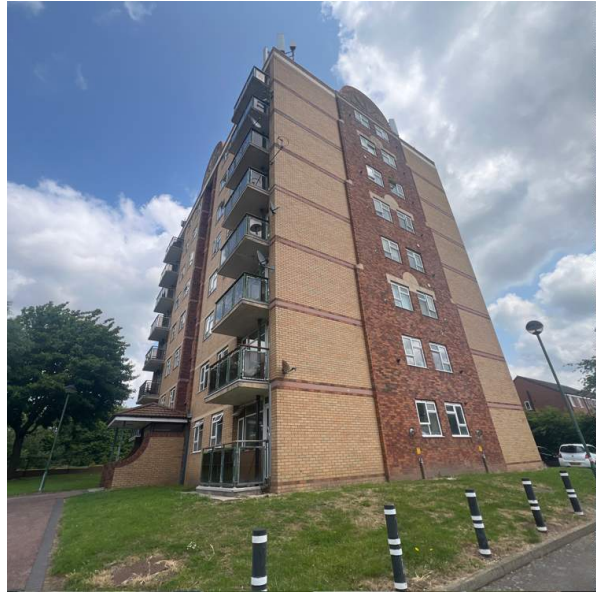
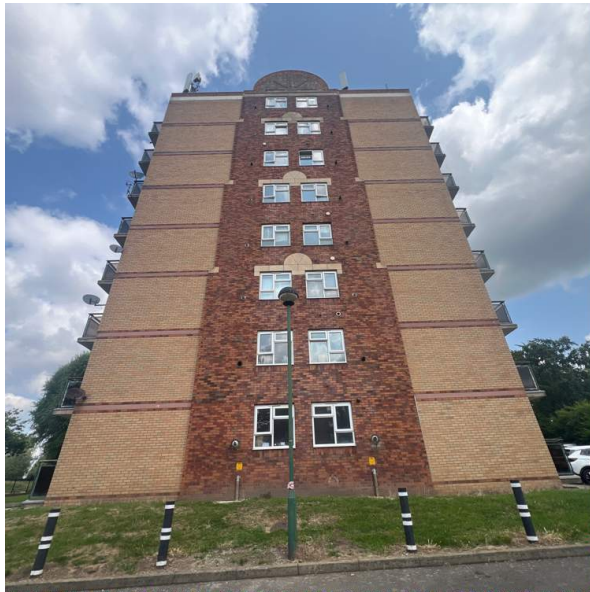
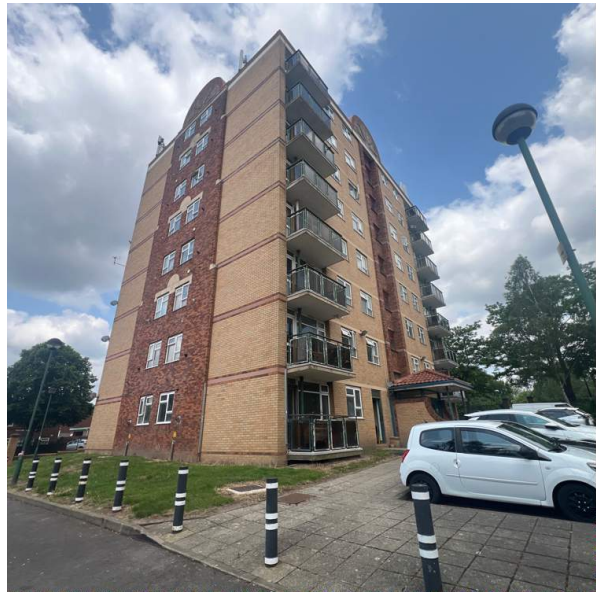
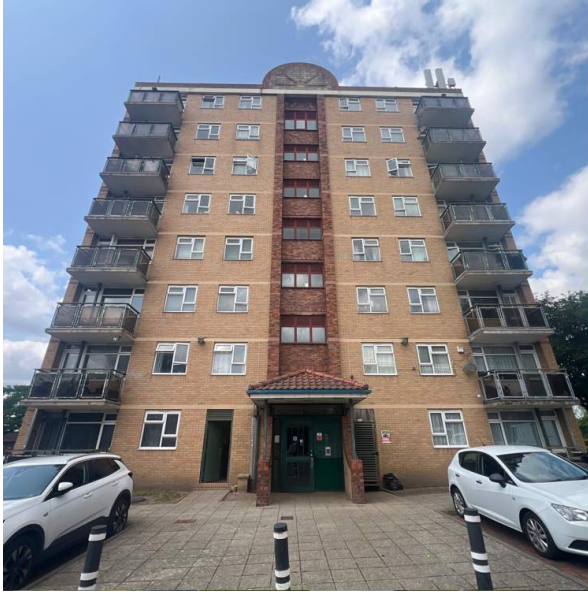
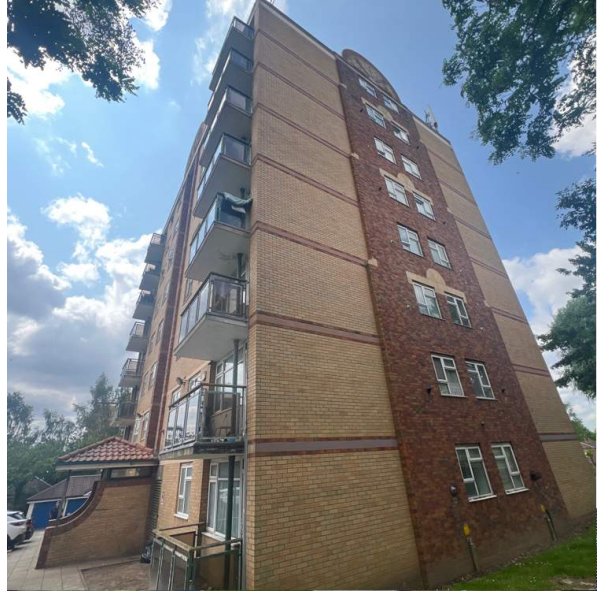
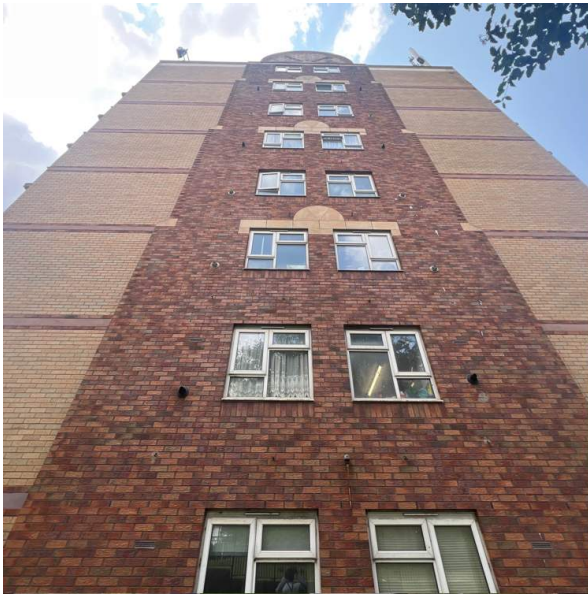
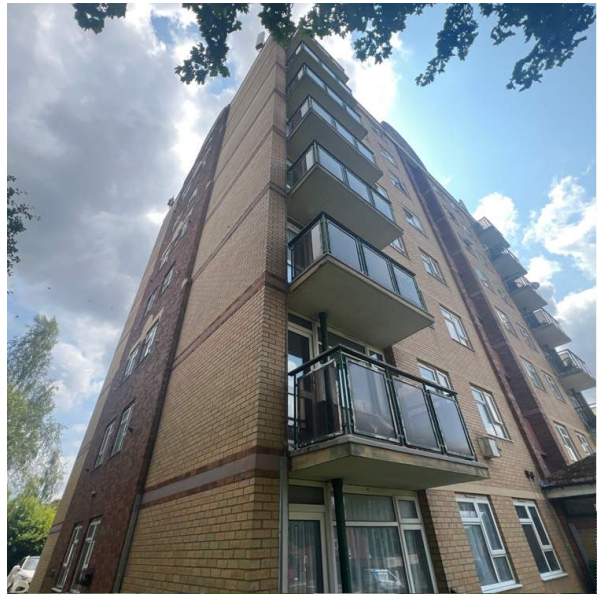
## Elevations

Comments: External facade consists of brick work on all levels to all elevations. Cantilevered balconies situated on each level.
