**FIRNTEC**  
BUILDING COMPLIANCE

VISUAL STRUCTURAL APPRAISAL

1-32 Horton Street

27<sup>th</sup> May 2025

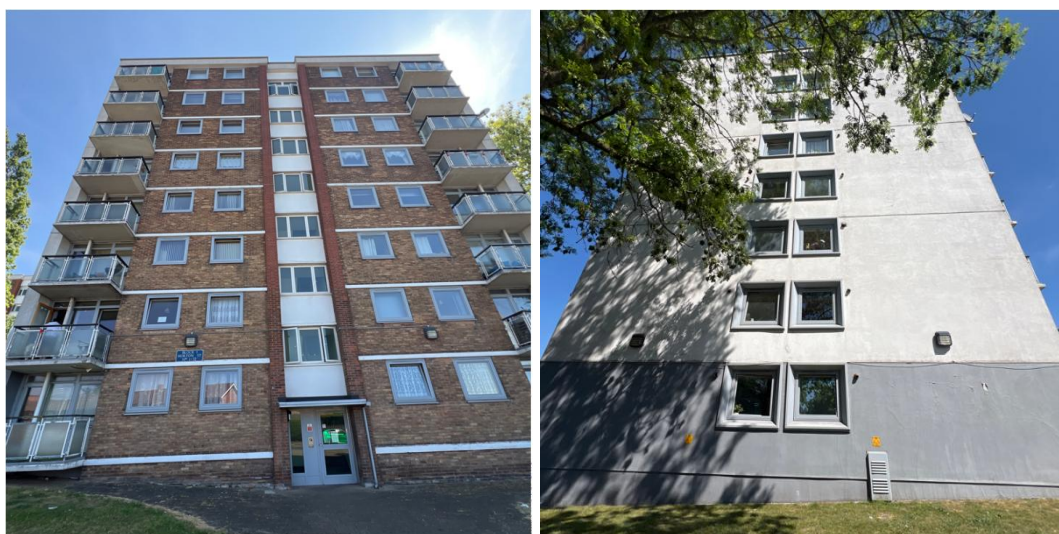
Figure 9 and 10: Building Elevations

The exterior elevations were generally in ok condition and no significant structural defects were noted to the cladding. There were no significant cracks or tell-tale signs of any significant structural movement noted at the time of our inspection.

The exterior panels were noted to be plumb with no signs of significant bowing, bulging or leaning noted to the panels indicating failed fixings however their presence and condition cannot be confirmed.

There are balconies at each level which are formed of cantilevered RC slabs tied into the main frame. The balconies have the coatings which are peeling away and the balustrades would benefit from a refurbishment. The cantilevered slabs should be checked for internal corrosion potential at the benchmark inspections.

The balconies have the coatings which are peeling away and the balustrades would benefit from a refurbishment. The cantilevered slabs should be checked for internal corrosion potential as part of the benchmark inspections above.

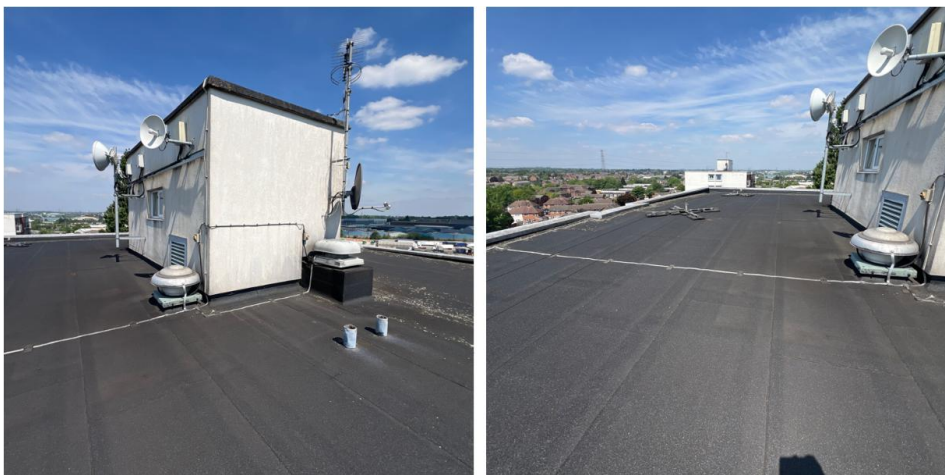
Figure 11 and 12: Roof Level

There were no tell-tale signs of any significant structural movement noted at the time of our inspection.

The roof has an asphalt finish. The exact build-up of the roof finishes were not accessible at the time of inspection. It is recommended an intrusive survey of the roof finishes is completed by a specialist surveyor to assess the condition of the roof covering.

There was moss growth and build-ups of debris noted which should be cleared as part of a normal maintenance regimen

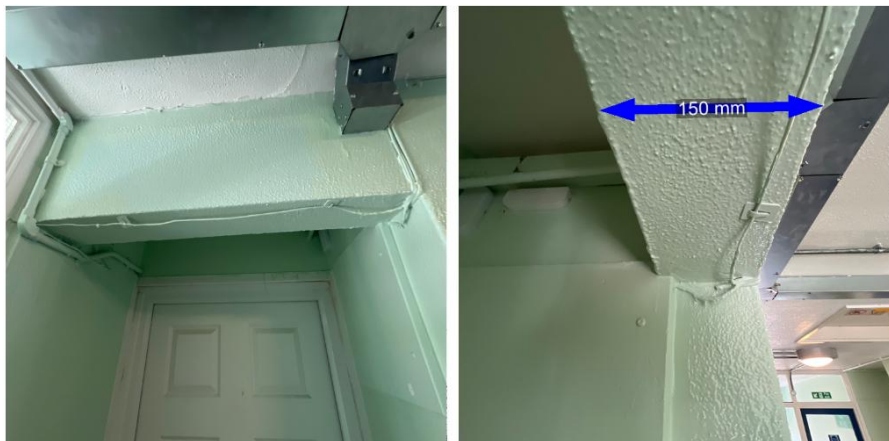
Figure 14 and 15: RC Elements within floor plan

The interior of the stair core walls were checked and were plumb and in line with observations made to the exterior – no significant signs of leaning or movement noted. The concrete appeared in fair condition with few BRE category 1 cracks but no structurally significant defects were noted.

The stair stringer was noted to be 120mm thick which seems slim, certainly short of modern standards. A cover test is required to check the resistance of the concrete section in the event of a fire.

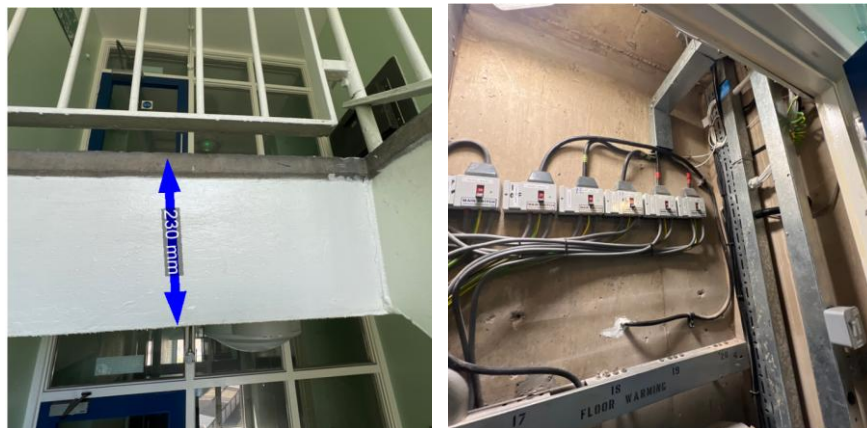
Figure 16 and 17: Slab Edge and stability wall

The floors in the communal landings were noted to be solid concrete floors. The floors were checked with a spirit level and were considered level and within tolerance. The doors and windows to the communal landings from the stair core all appeared to be level and opened and closed without difficulty. There were no signs of structural movement detected.

There were vertical concrete walls supporting the floor plates at every level. The elements visible matched the floor layout in Figure 6. The walls appear continuous from ground to roof with no transfer structure. The overall condition of the structure observed is good.

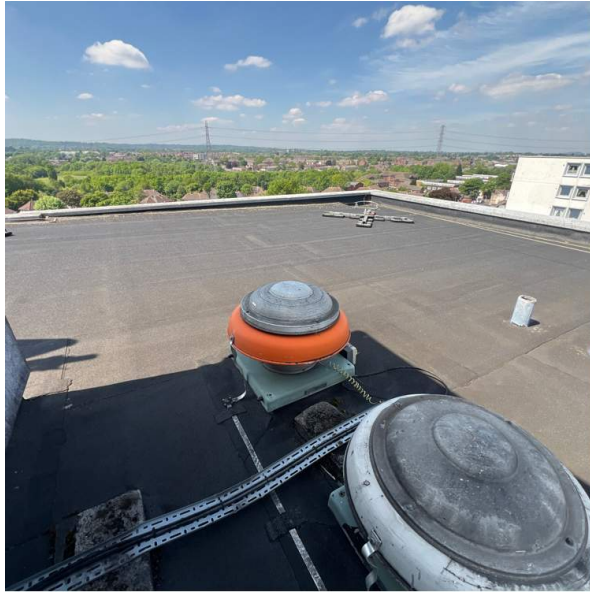
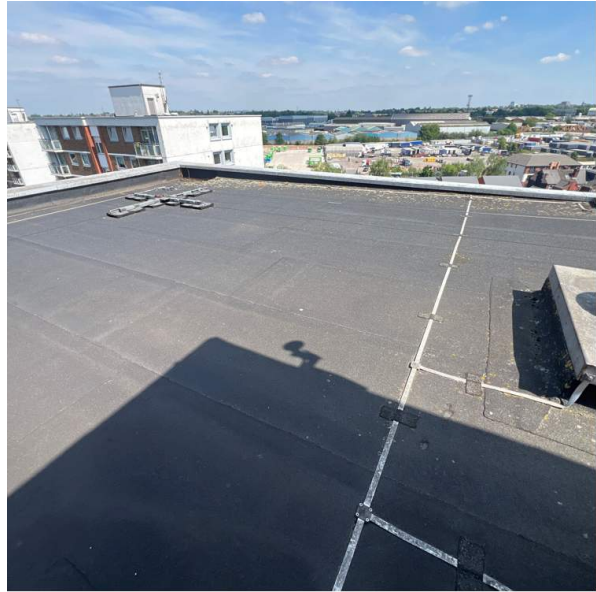
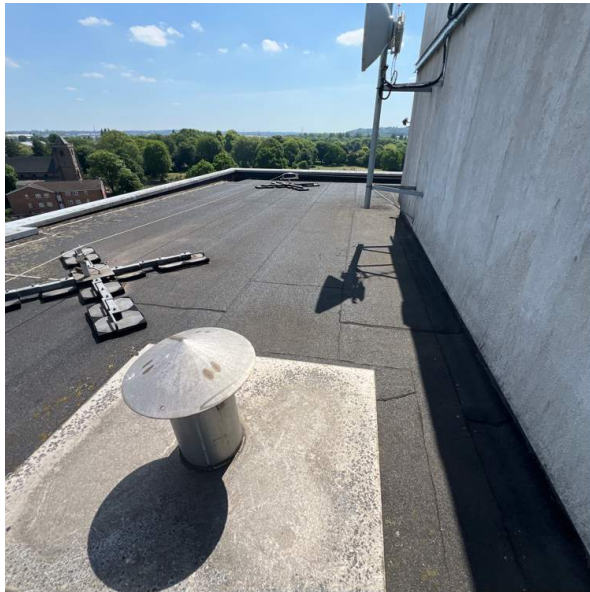
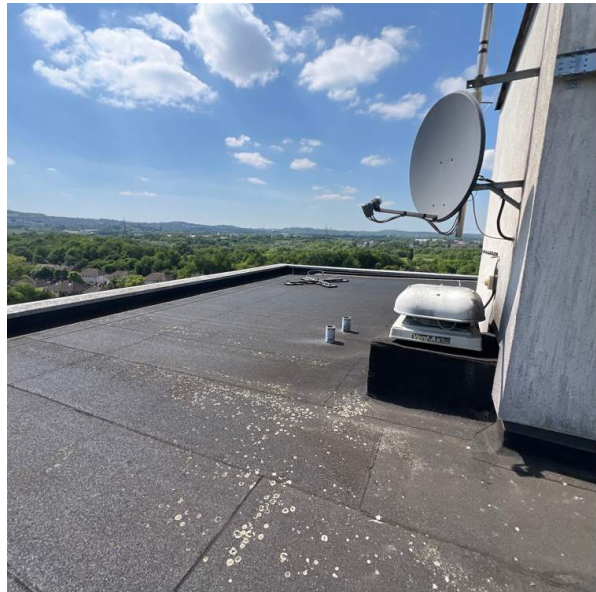
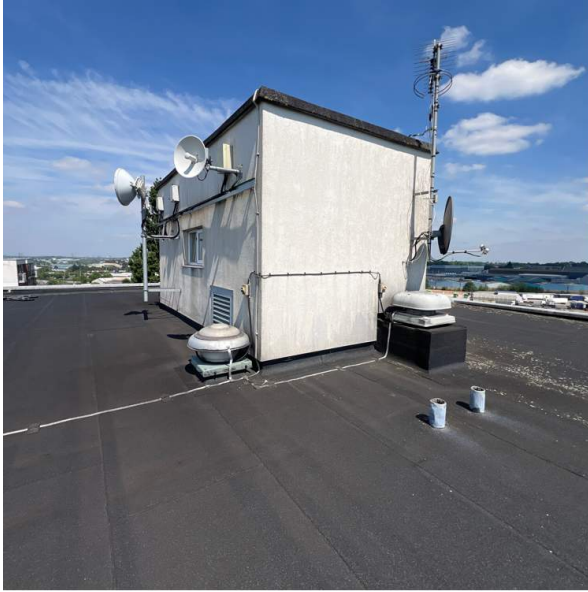
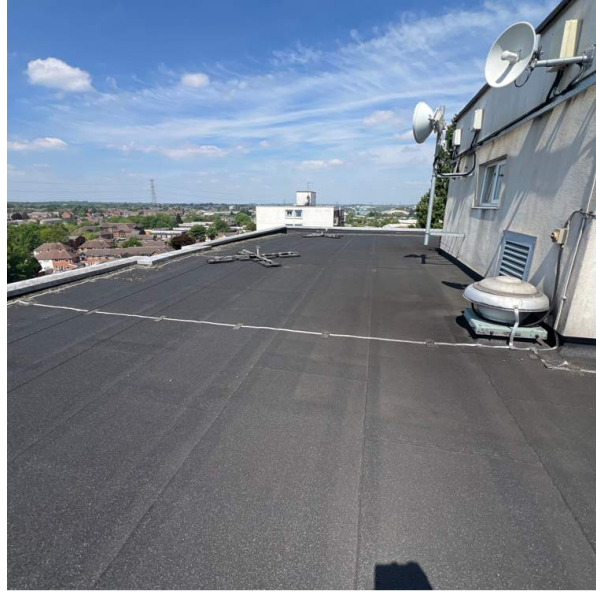
## Main Roof

Comments: Flat roof, RC concrete slab with insulated PIR board and felt coverings.

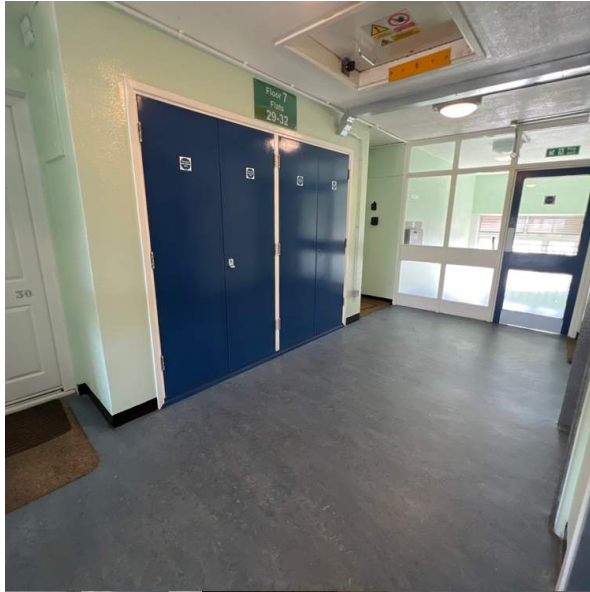
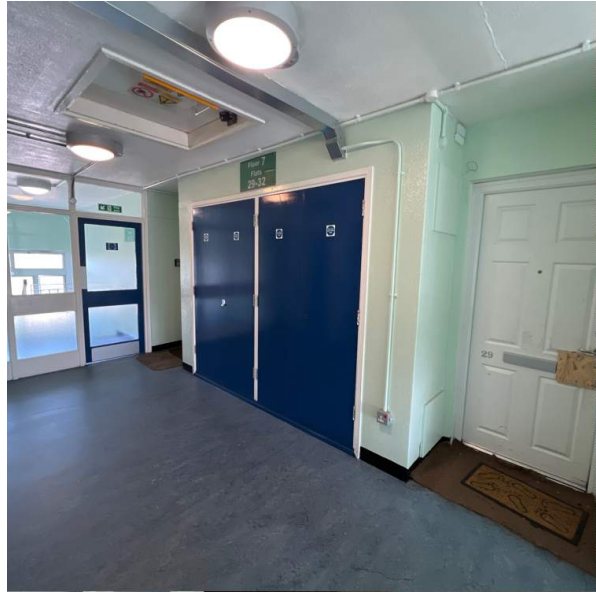
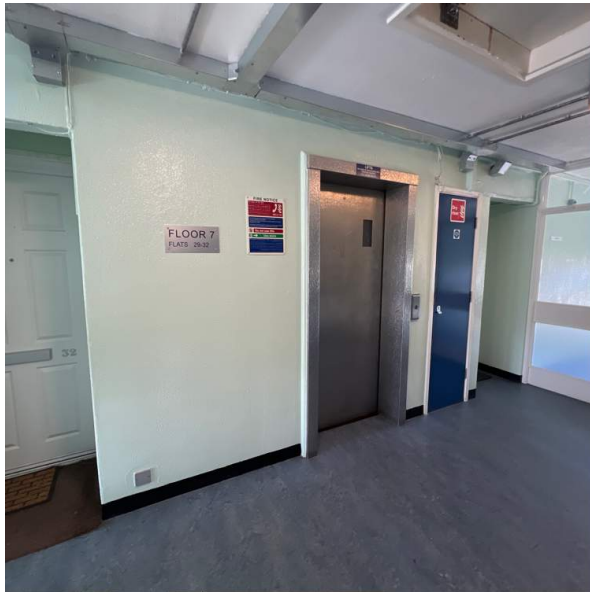
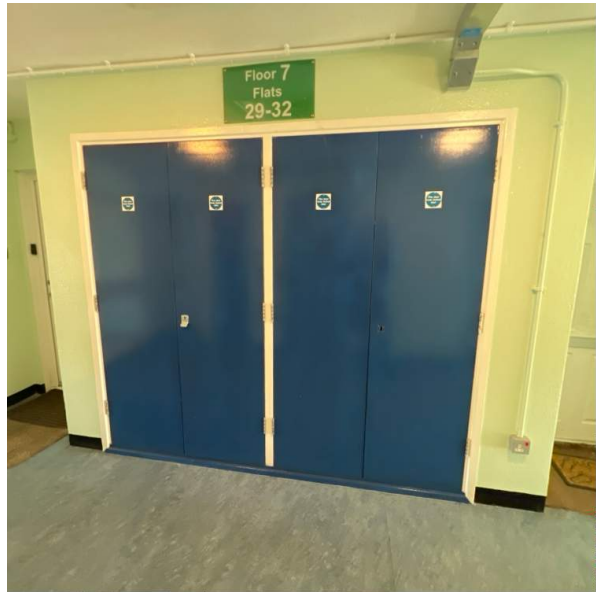
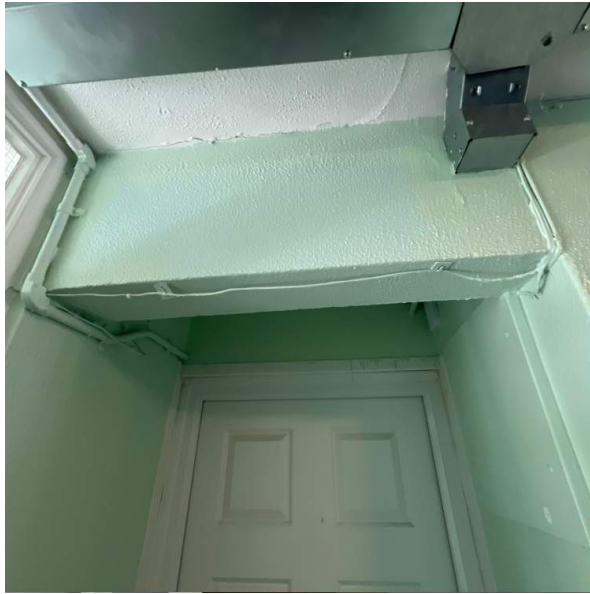
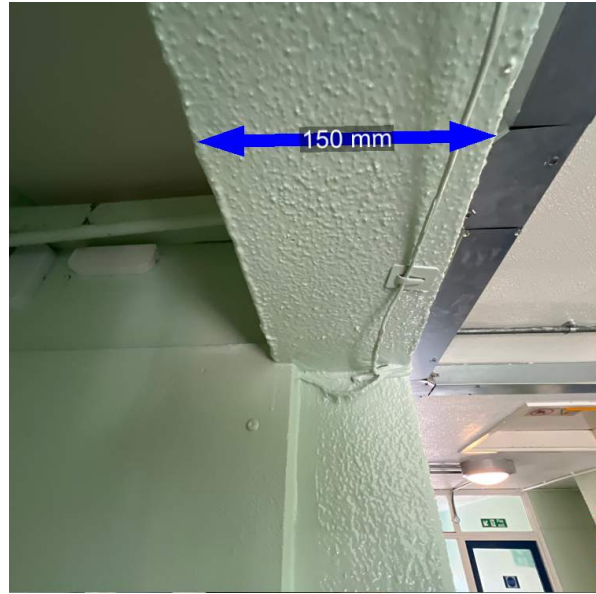
## 7th Floor Hallway

Comments: No jams or distortions noted to hallway doors to indicate any serviceability issues. Generally walls covered with finishes in hallway, likely to consist a mixture of concrete shear walls, embedded columns and masonry infill walls. Limited structure exposed. Concrete walls and infill masonry (non-load bearing) walls noted in riser cupboards.

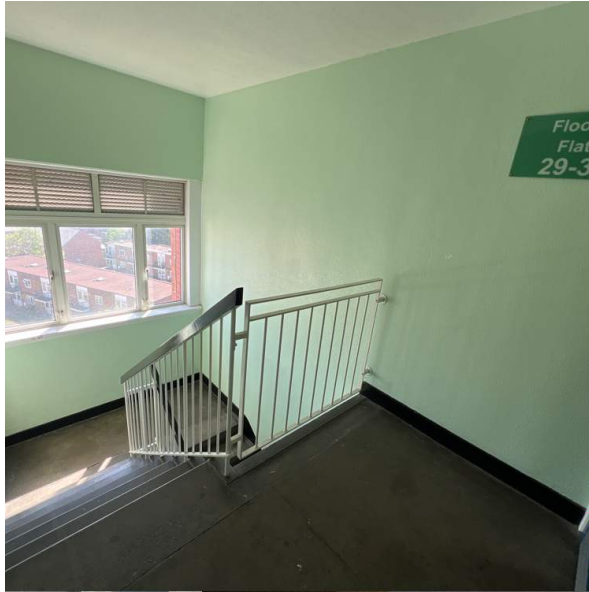
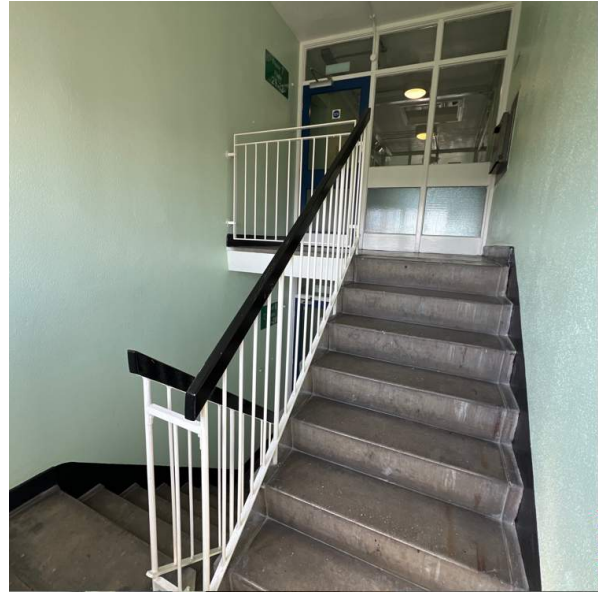
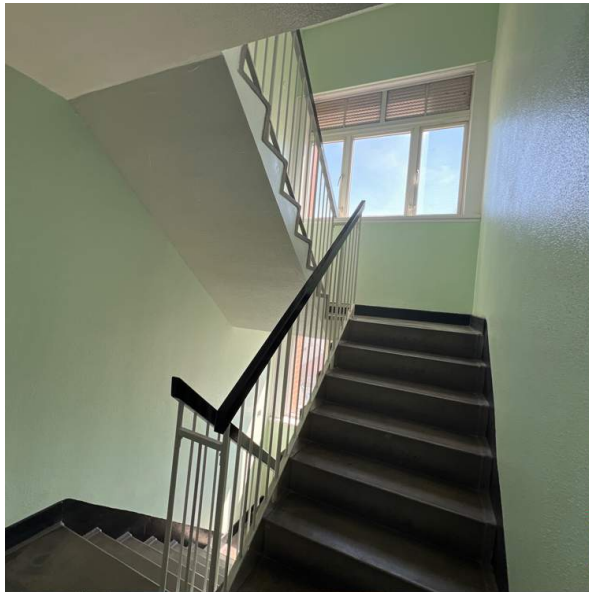
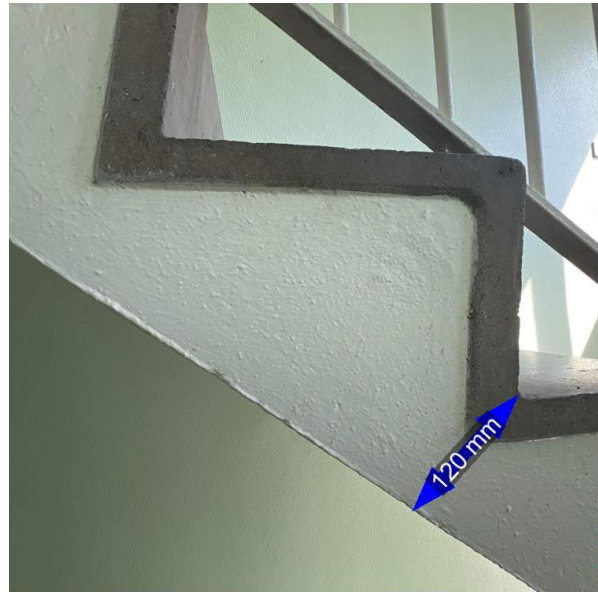
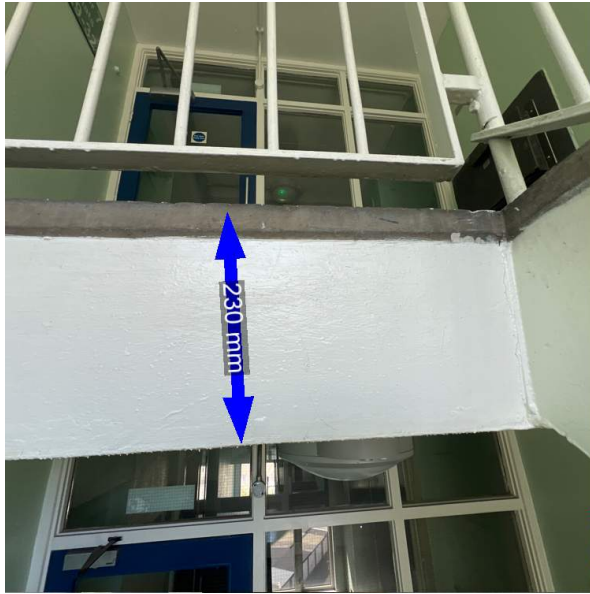
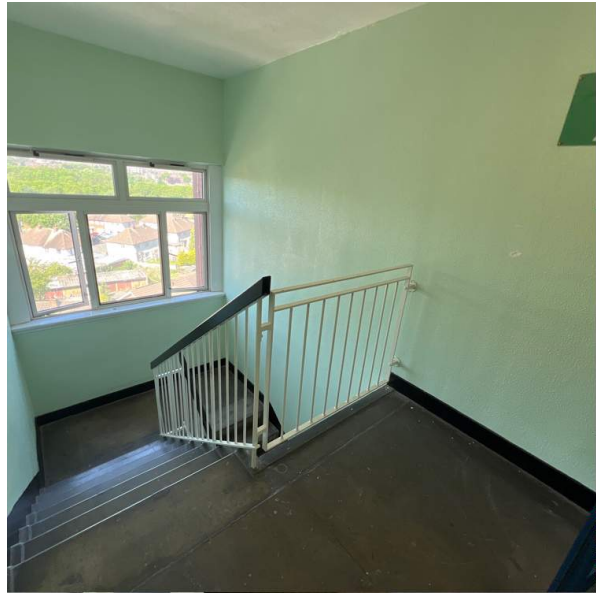
## 7th Floor Staircases

Comments: Insitu concrete stairs with steel hand railing fixed to stairs. Walls and floors appear to be fairly level.  
Stair walls covered with finishes however these would likely form the main concrete shear core walls.

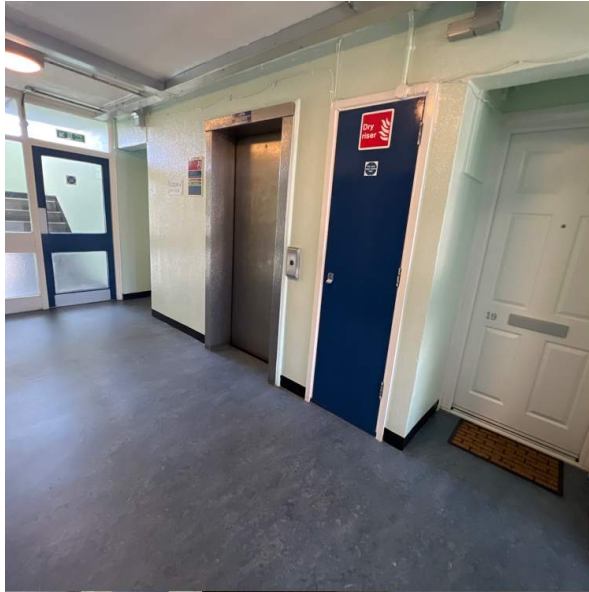
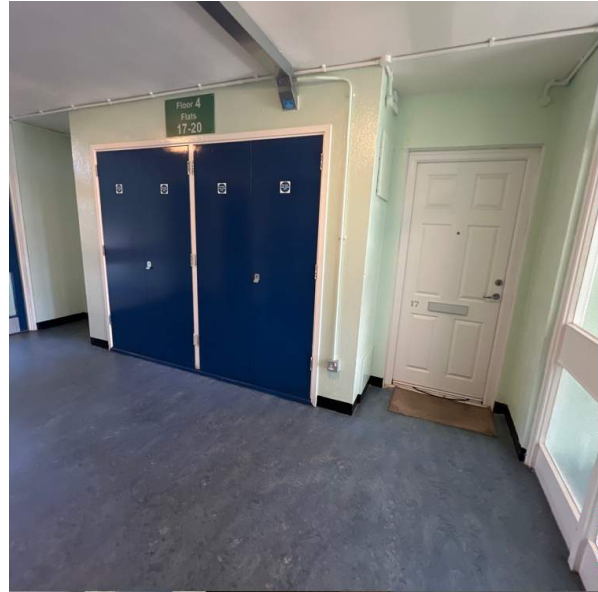
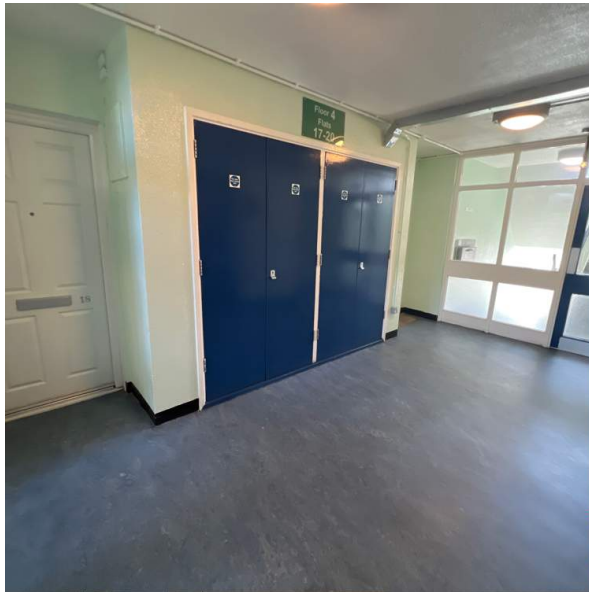
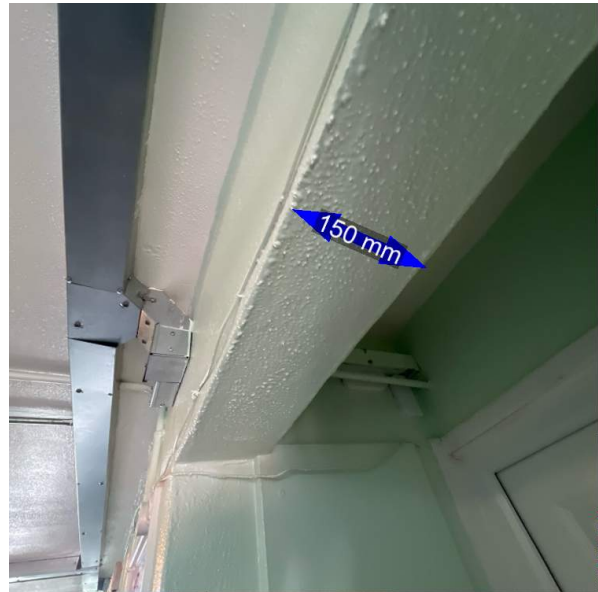
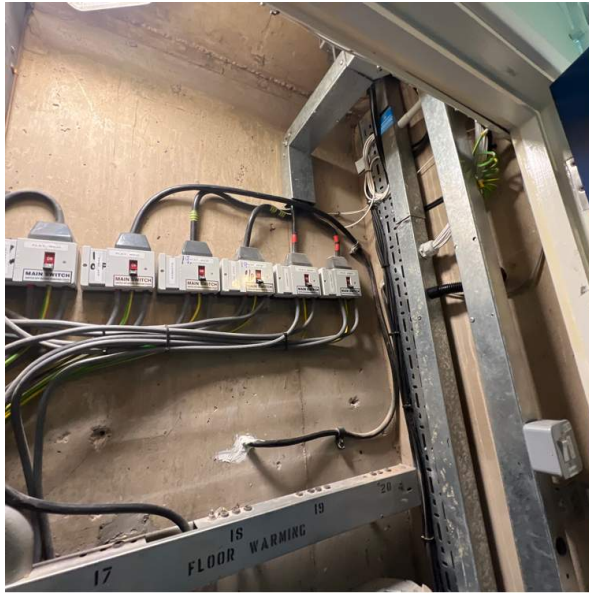
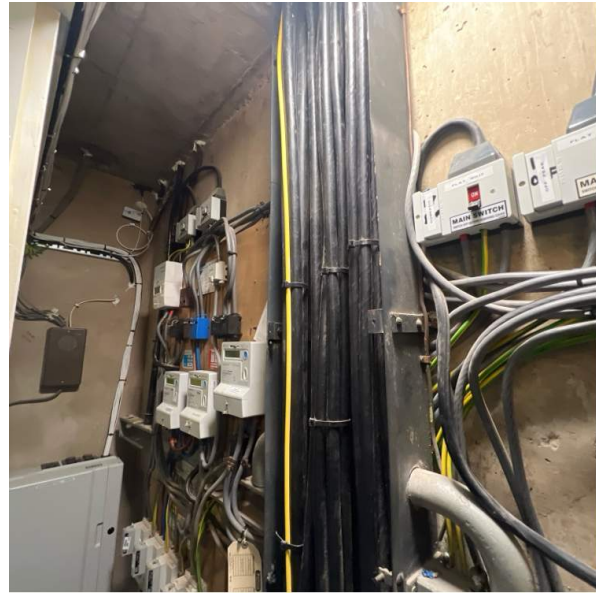
## 4th Floor Hallway

Comments: No jams or distortions noted to hallway doors to indicate any serviceability issues. Generally walls covered with finishes in hallway, likely to consist a mixture of concrete shear walls, embedded columns and masonry infill walls. Limited structure exposed. Concrete walls and infill masonry (non-load bearing) walls noted in riser cupboards.

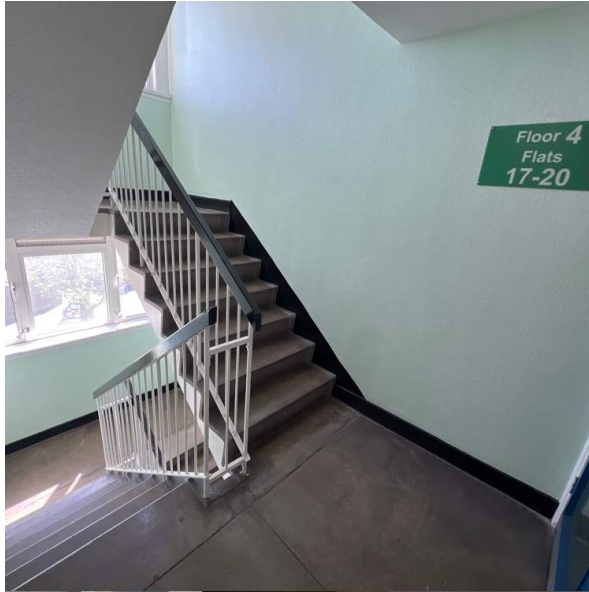
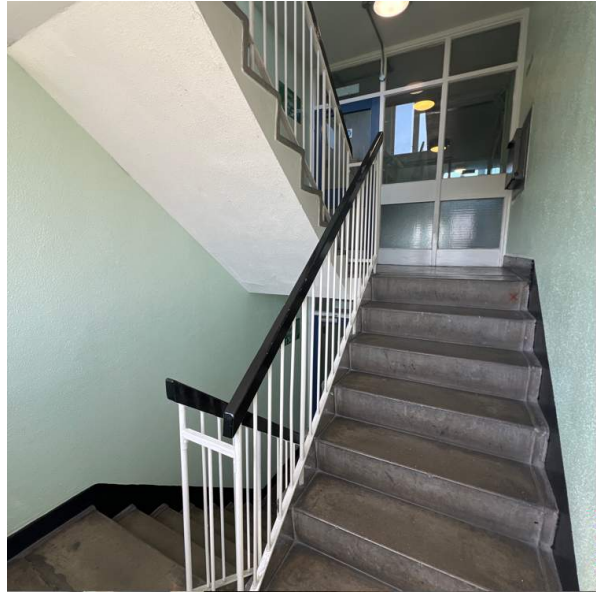
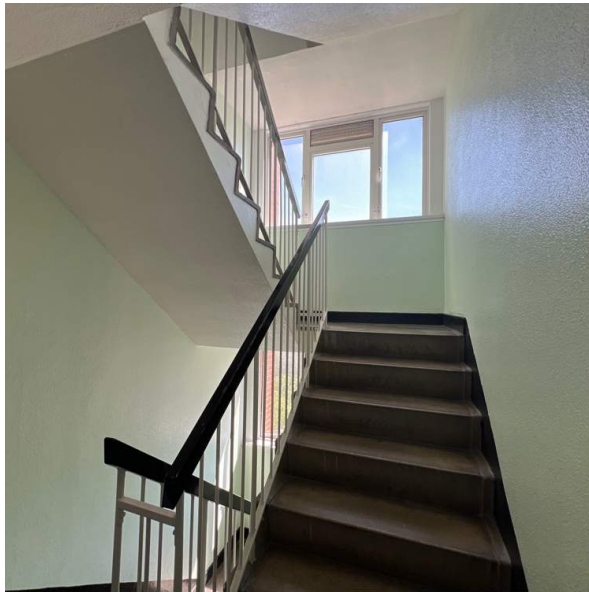
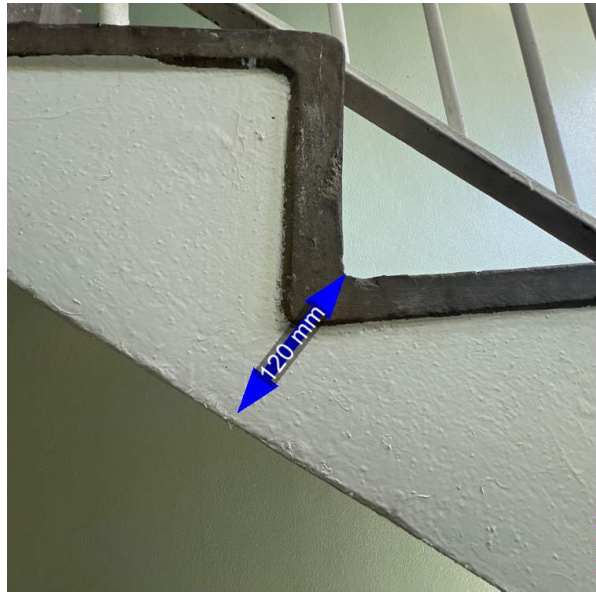
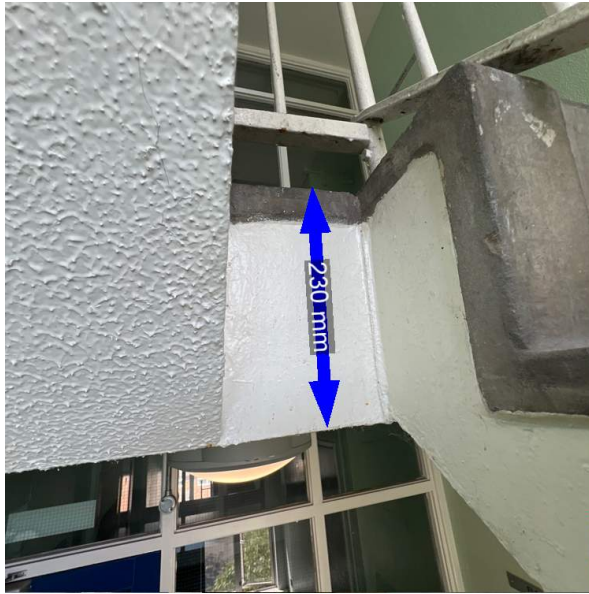
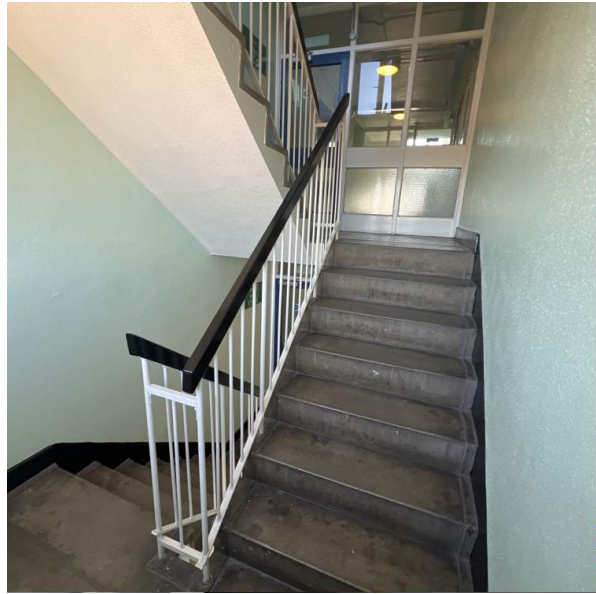
## 4th Floor Staircases

Comments: Insitu concrete stairs with steel hand railing fixed to stairs. Walls and floors appear to be fairly level.  
Stair walls covered with finishes however these would likely form the main concrete shear core walls.

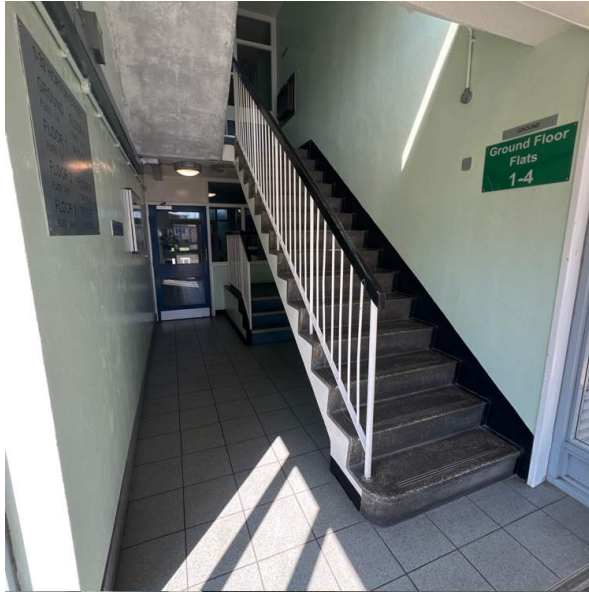
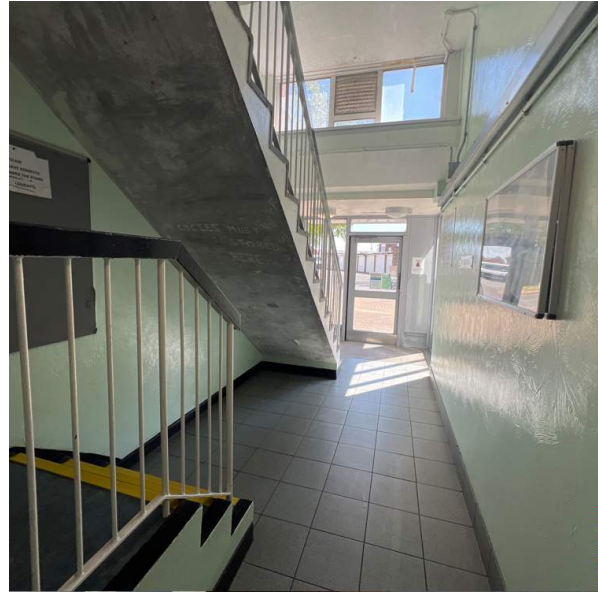
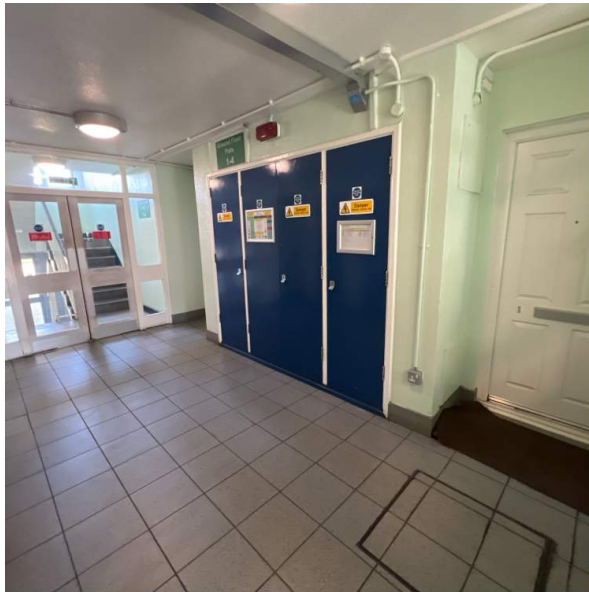
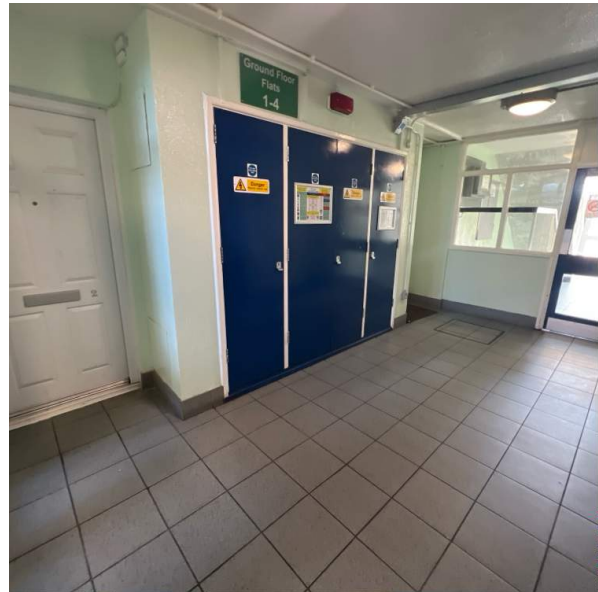
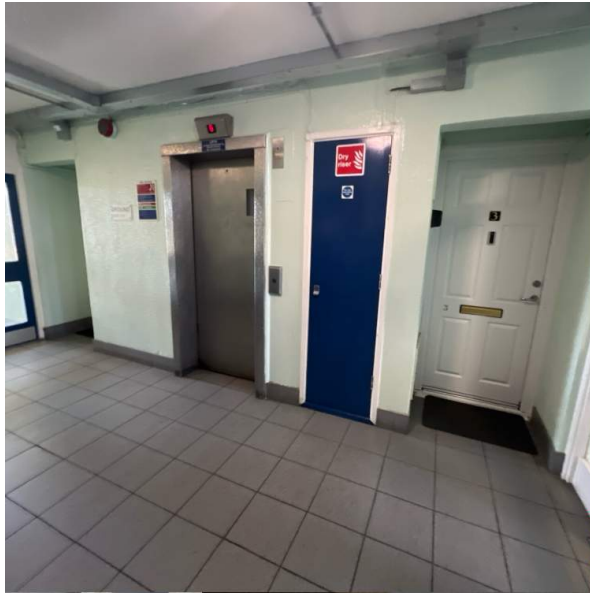
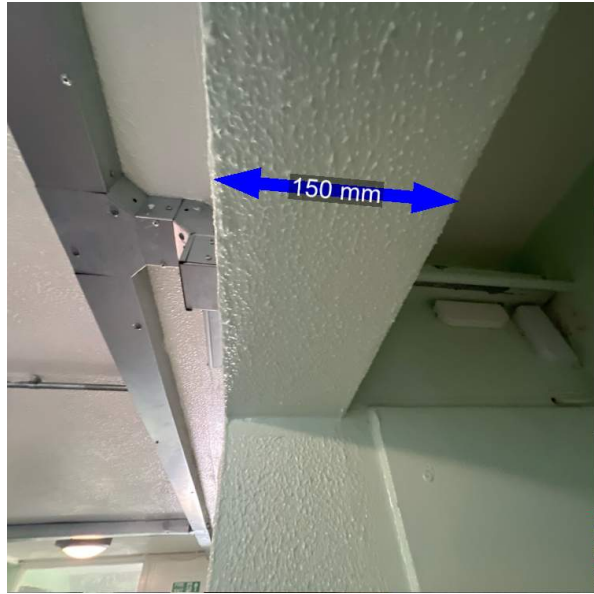
## Ground Floor Hallway

Comments: No jams or distortions noted to hallway doors to indicate any serviceability issues. Generally walls covered with finishes in hallway, likely to consist a mixture of concrete shear walls, embedded columns and masonry infill walls. Limited structure exposed. Concrete walls and infill masonry (non-load bearing) walls noted in riser cupboards.

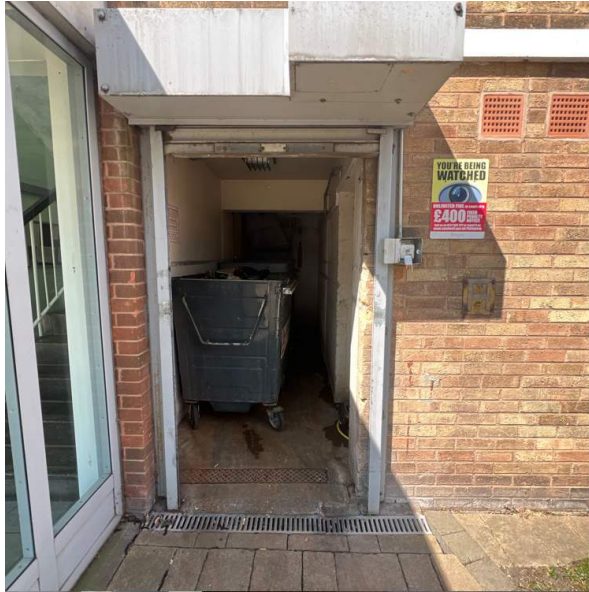
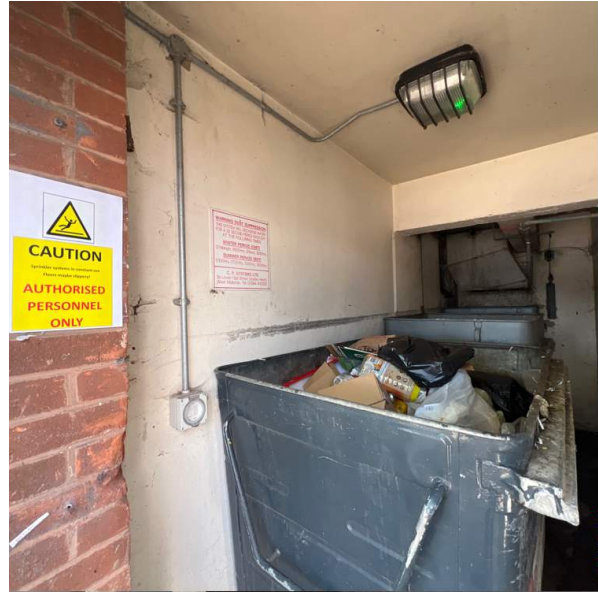
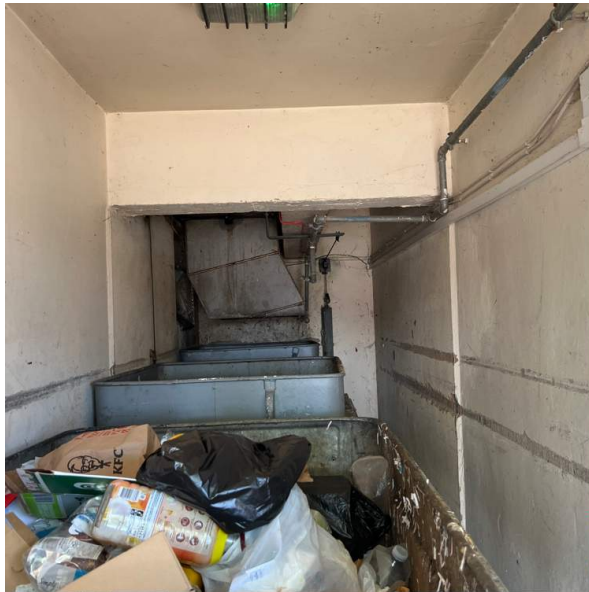
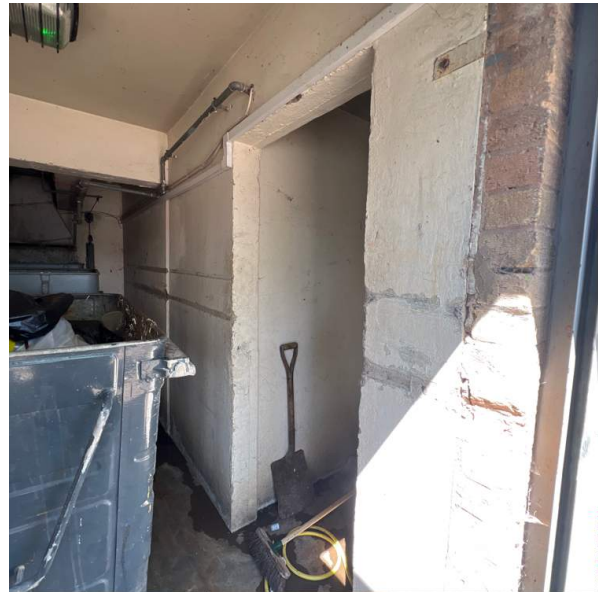
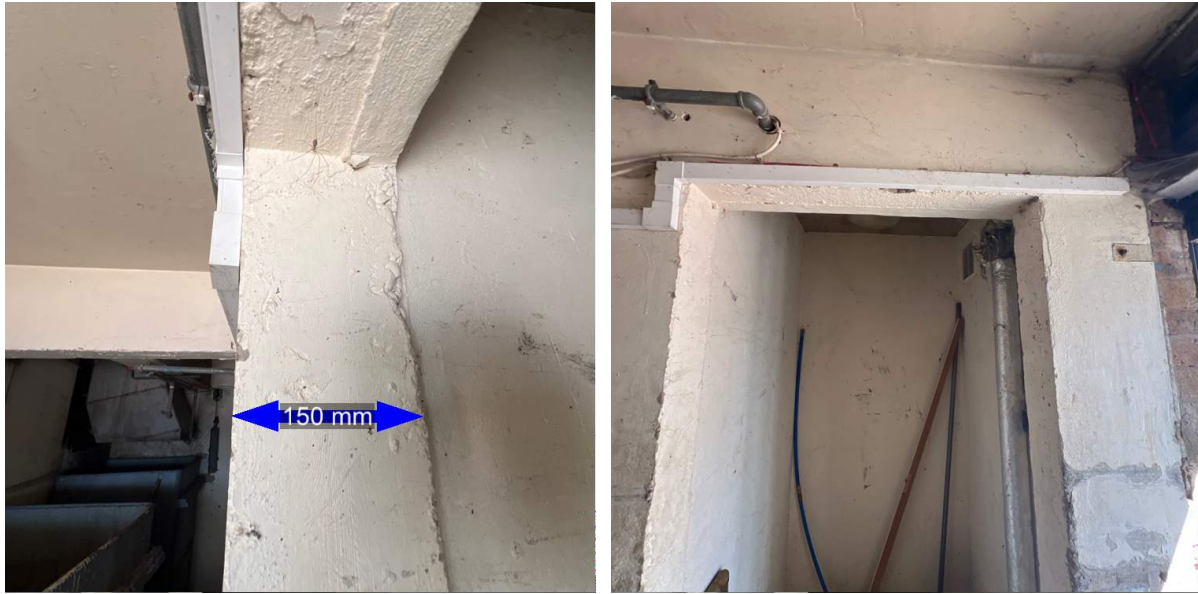
## Bin Store

Comments: RC concrete walls noted in bin store.

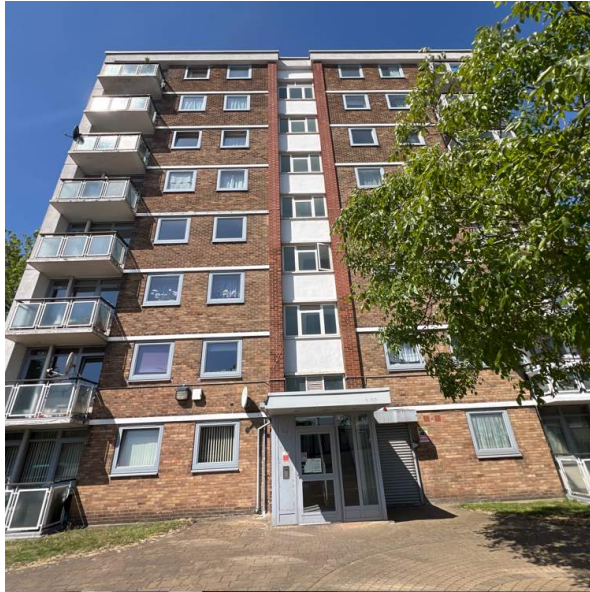
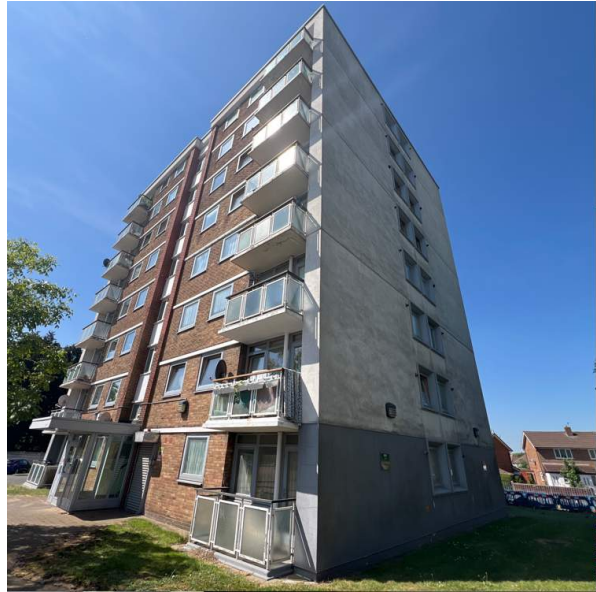
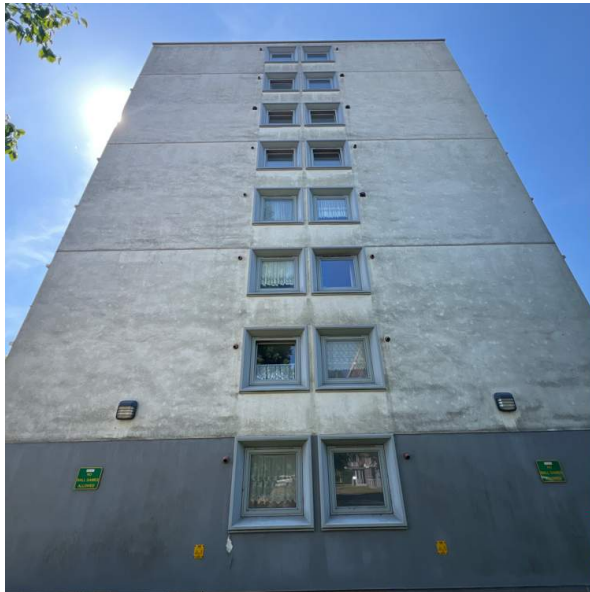
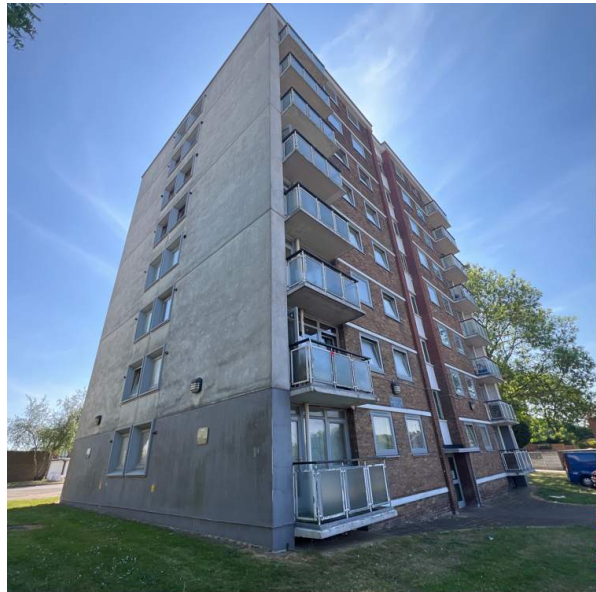
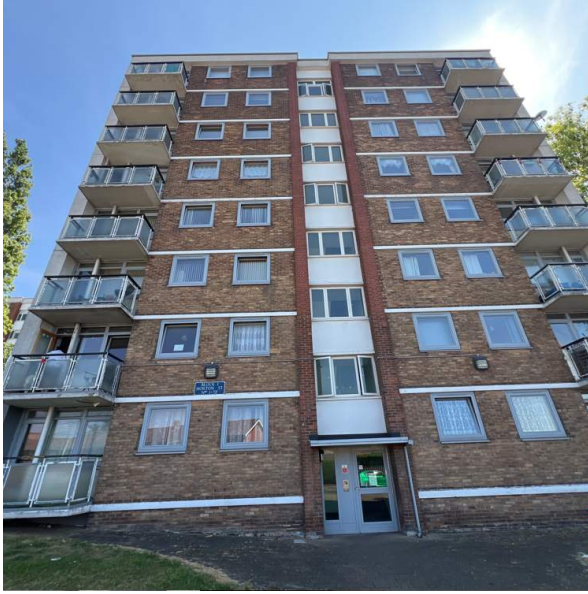
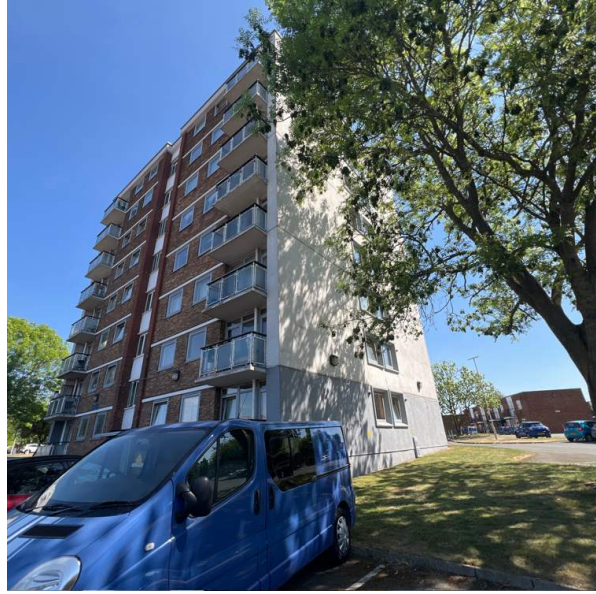
## Elevations

Comments: External facade consists of brick work on all levels to front and rear elevations with cantilevered balconies situated on corners. Side elevations consist of render to full height of walls.
