**FIRNTEC**  
BUILDING COMPLIANCE

VISUAL STRUCTURAL APPRAISAL

33-64 Horton Street

27<sup>th</sup> May 2025

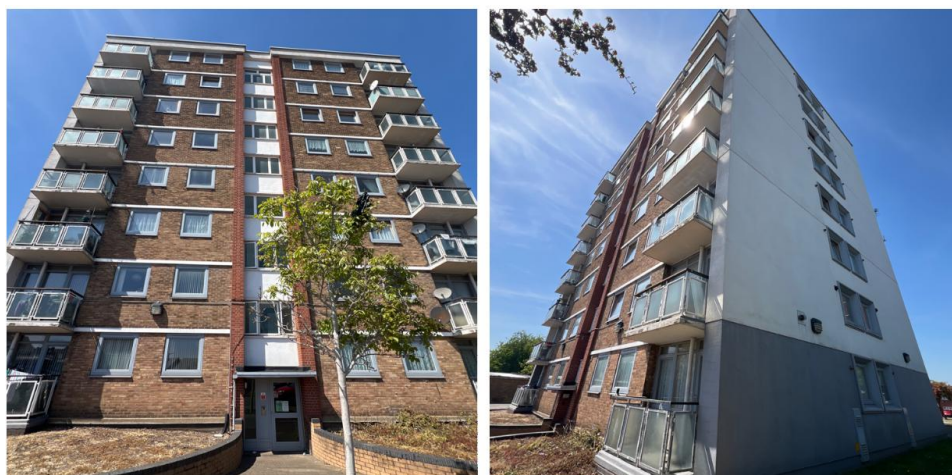
Figure 9 and 10: Building Elevations

The exterior panels were noted to be plumb with no signs of significant bowing, bulging or leaning noted to the panels indicating failed fixings however their presence and condition cannot be confirmed.

There are balconies at each level which are formed of cantilevered RC slabs tied into the main frame. The balconies have the coatings which are peeling away and the balustrades would benefit from a refurbishment. The cantilevered slabs should be checked for internal corrosion potential at the benchmark inspections.

The balconies have the coatings which are peeling away and the balustrades would benefit from a refurbishment. The cantilevered slabs should be checked for internal corrosion potential as part of the benchmark inspections above.

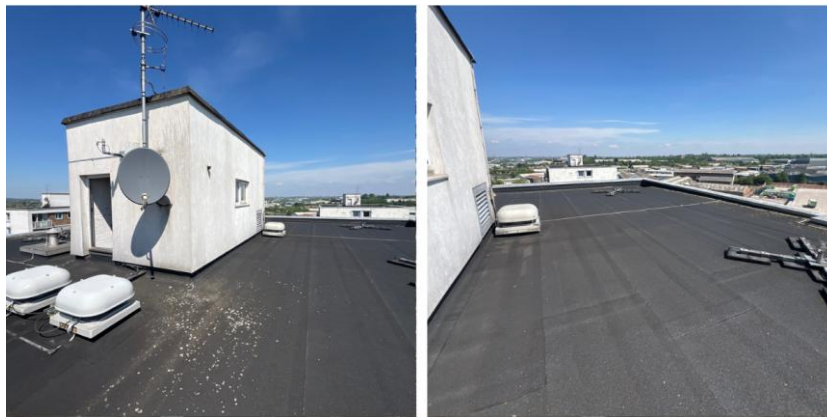
Figure 11 and 12: Roof Level

There were no tell-tale signs of any significant structural movement noted at the time of our inspection.

The roof has an asphalt finish. The exact build-up of the roof finishes were not accessible at the time of inspection. It is recommended an intrusive survey of the roof finishes is completed by a specialist surveyor to assess the condition of the roof covering.

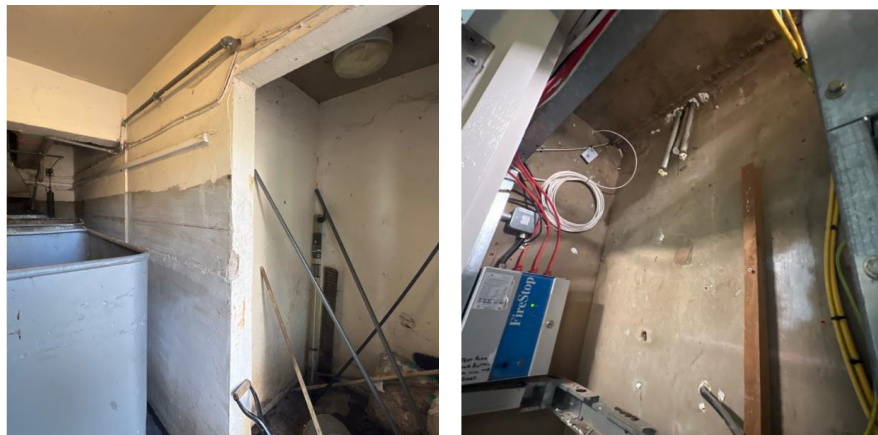
Figure 14 and 15: RC Elements within floor plan

The interior of the stair core walls were checked and were plumb and in line with observations made to the exterior – no significant signs of leaning or movement noted. The concrete appeared in fair condition with few BRE category 1 cracks but no structurally significant defects were noted.

The stair stringer was noted to be 120mm thick which seems slim, certainly short of modern standards. A cover test is required to check the resistance of the concrete section in the event of a fire.

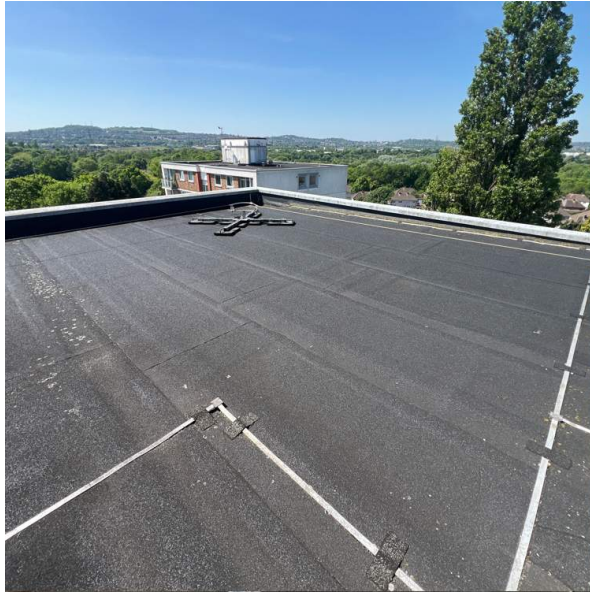
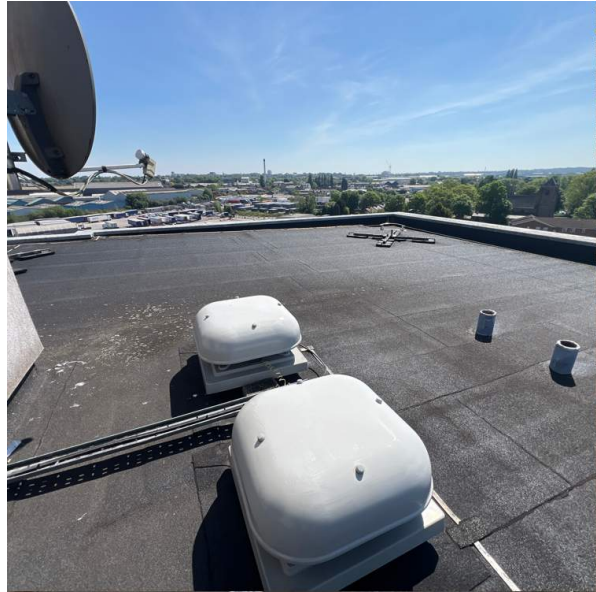
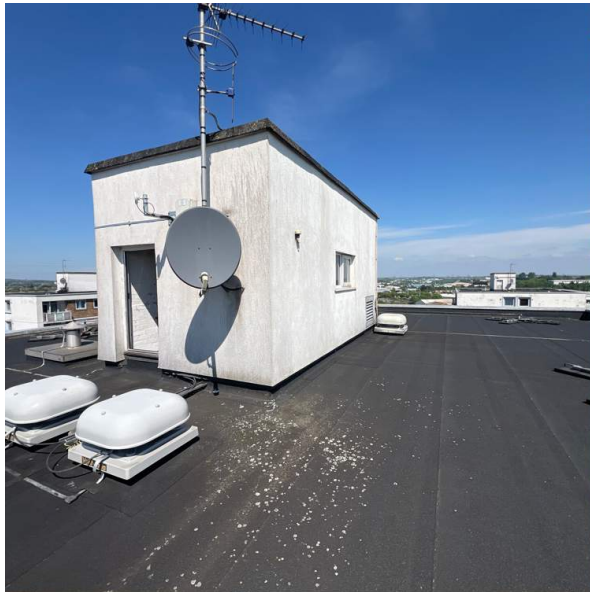
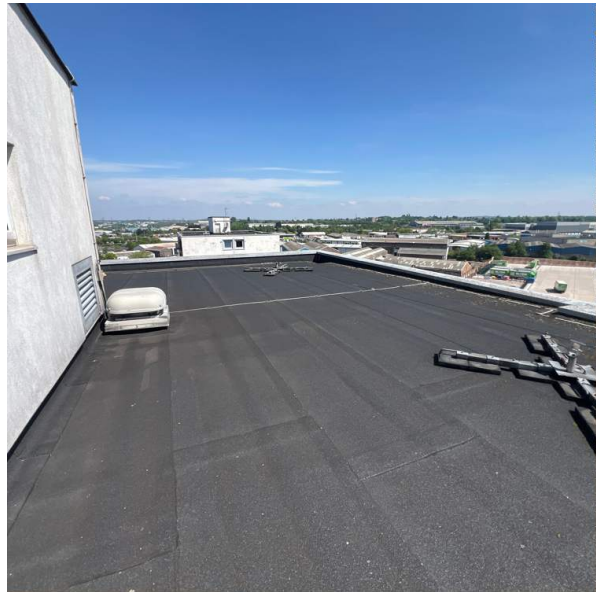
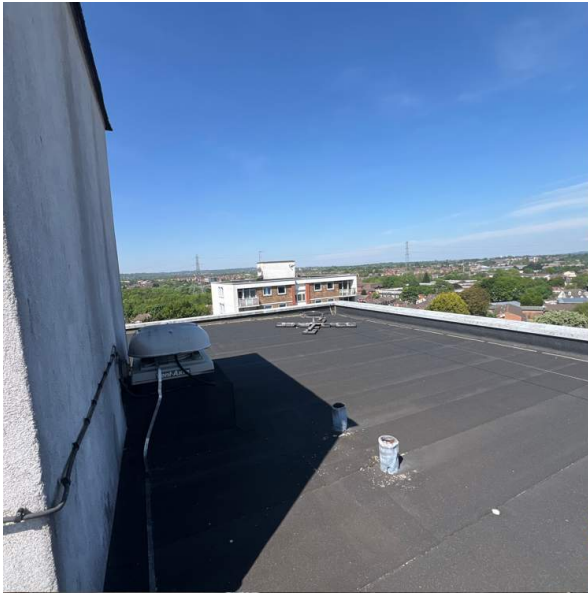
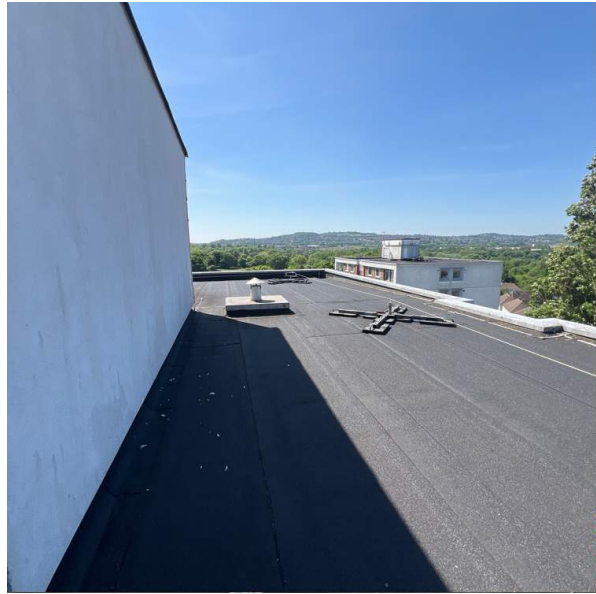
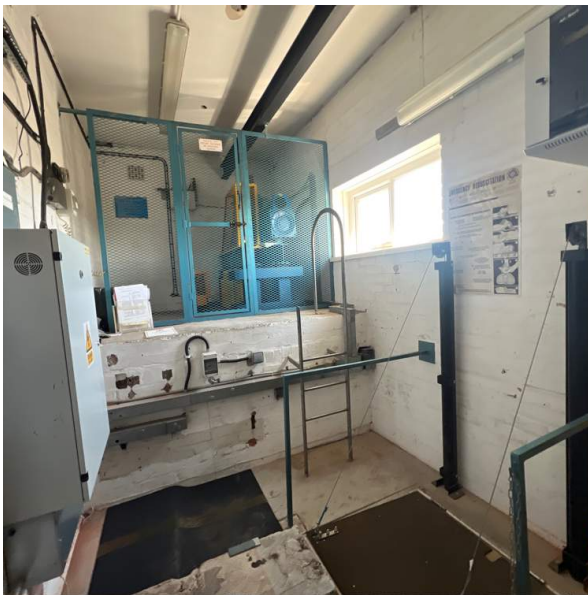
## Main Roof

Comments: Flat roof, RC concrete slab with insulated PIR board and felt coverings.

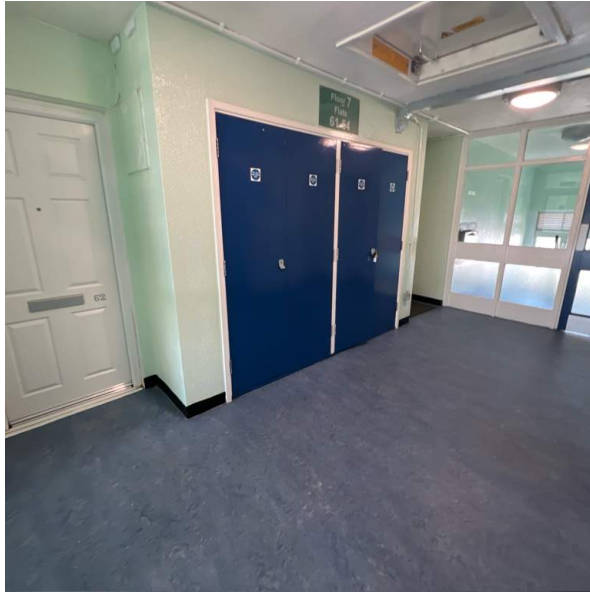
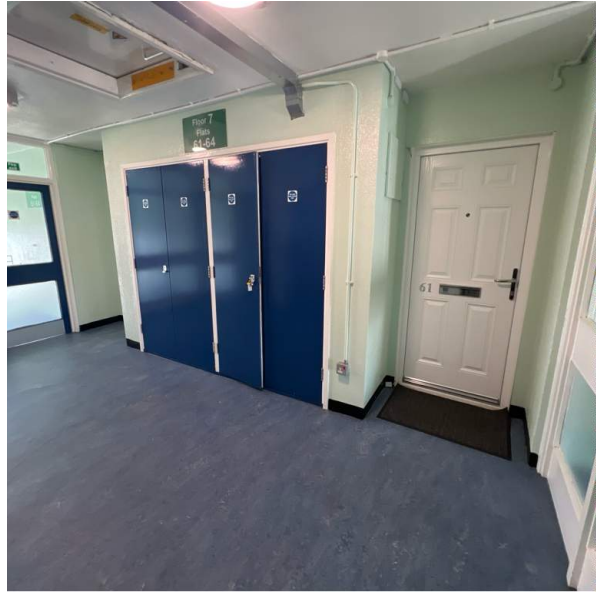
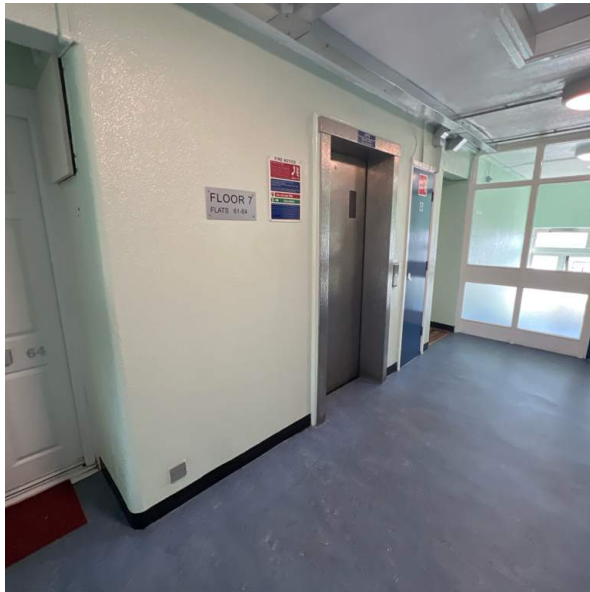
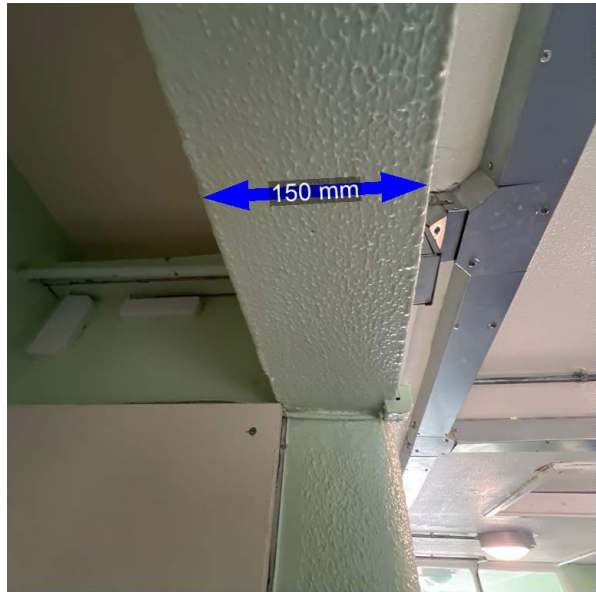
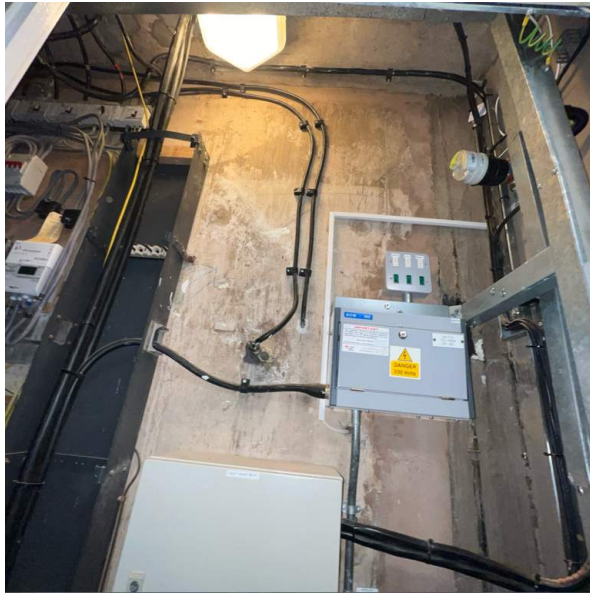
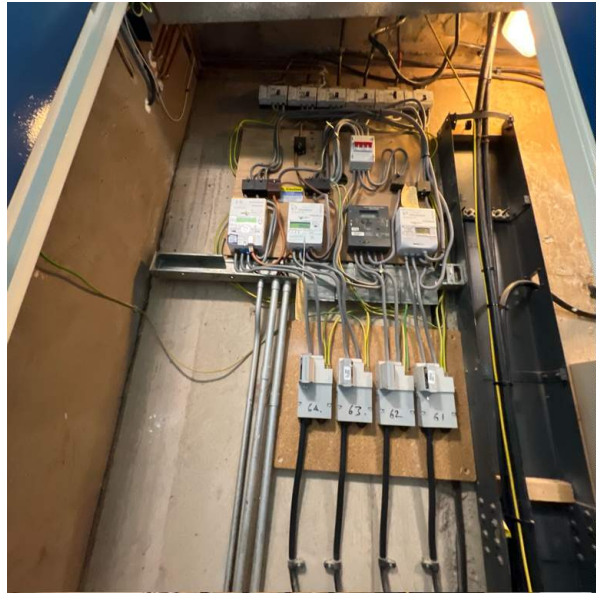
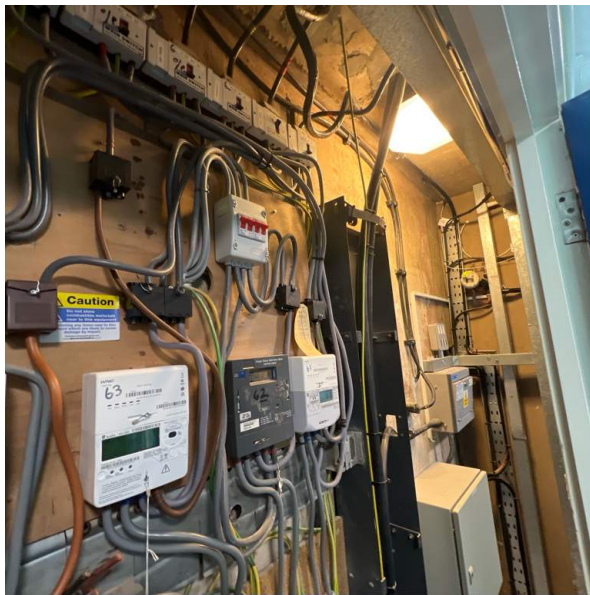
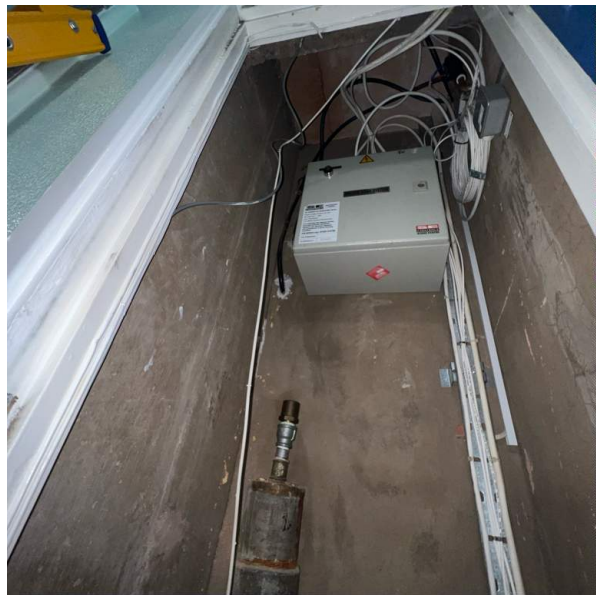
## 7th Floor Hallway

Comments: No jams or distortions noted to hallway doors to indicate any serviceability issues. Generally walls covered with finishes in hallway, likely to consist a mixture of concrete shear walls, embedded columns and masonry infill walls. Limited structure exposed. Concrete walls and infill masonry (non-load bearing) walls noted in riser cupboards.

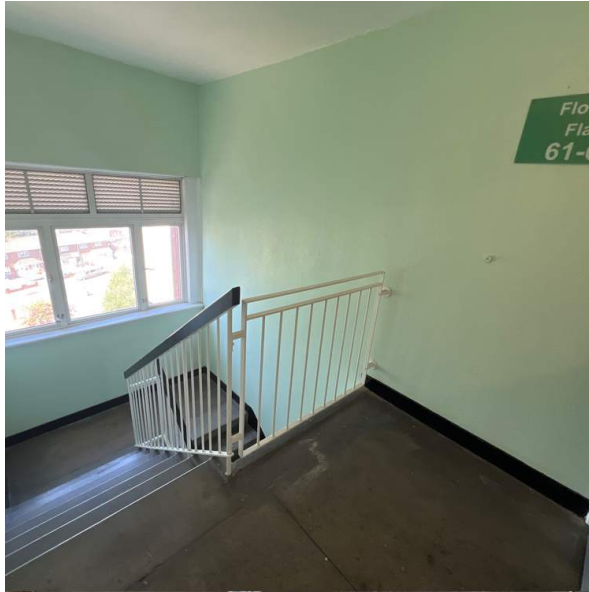
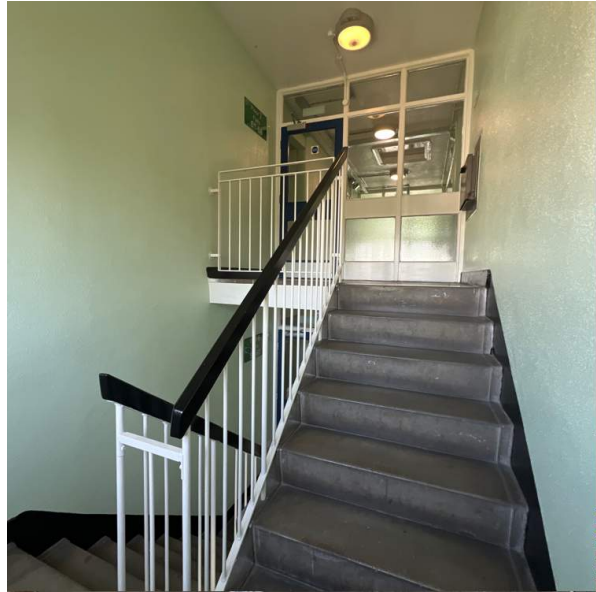
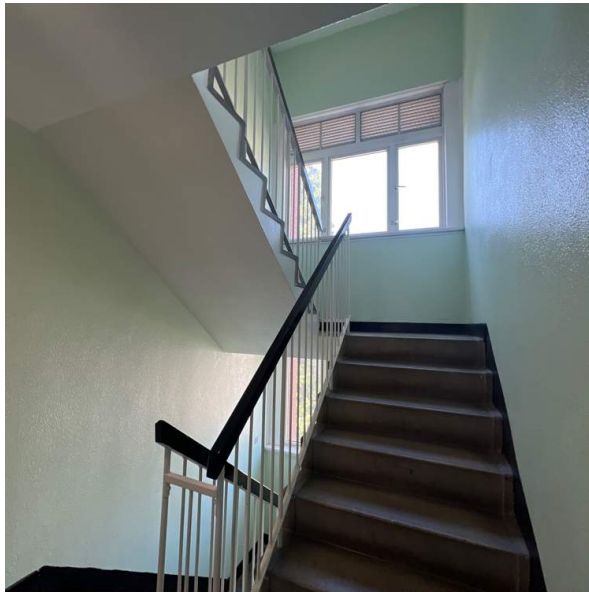
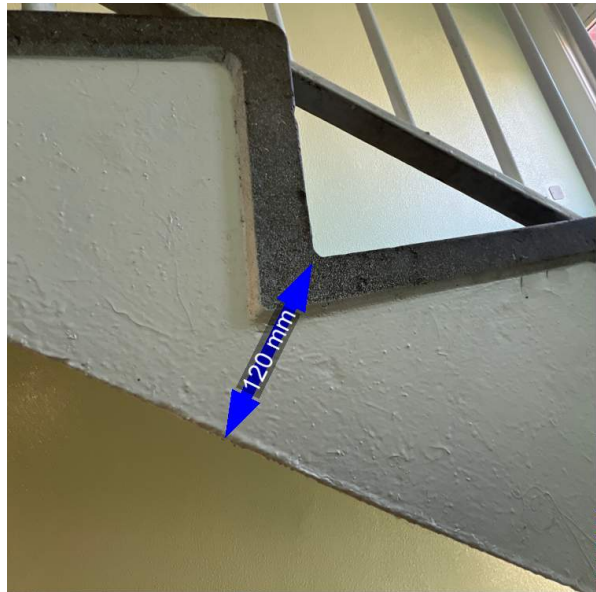
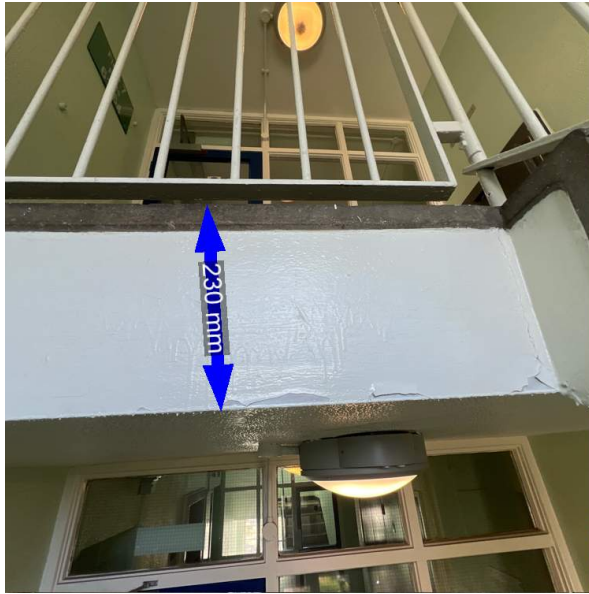
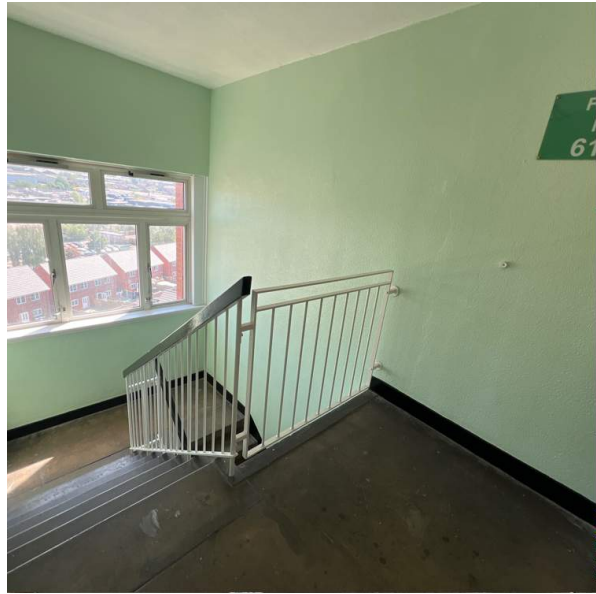
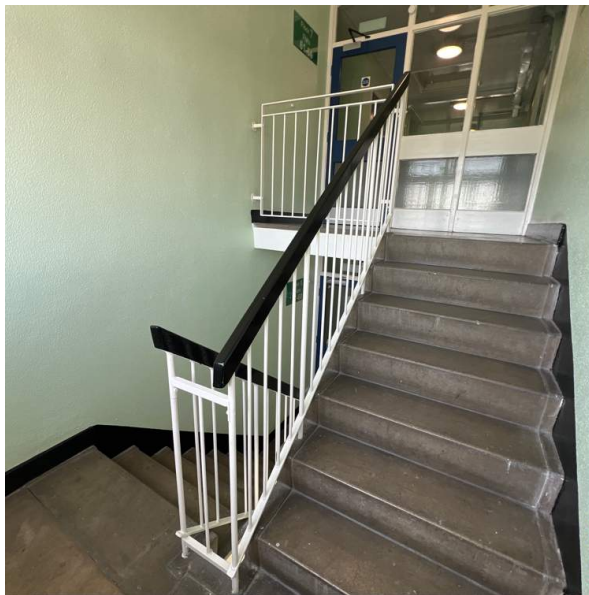
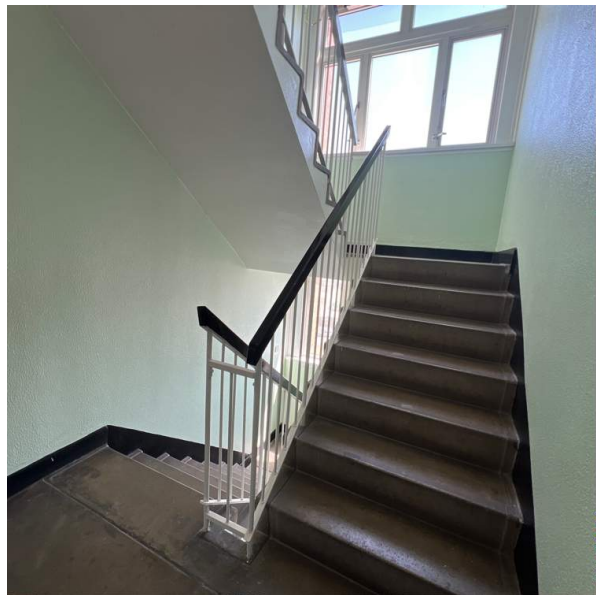
## 7th Floor Staircases

Comments: Insitu concrete stairs with steel hand railing fixed to stairs. Walls and floors appear to be fairly level.  
Stair walls covered with finishes however these would likely form the main concrete shear core walls.

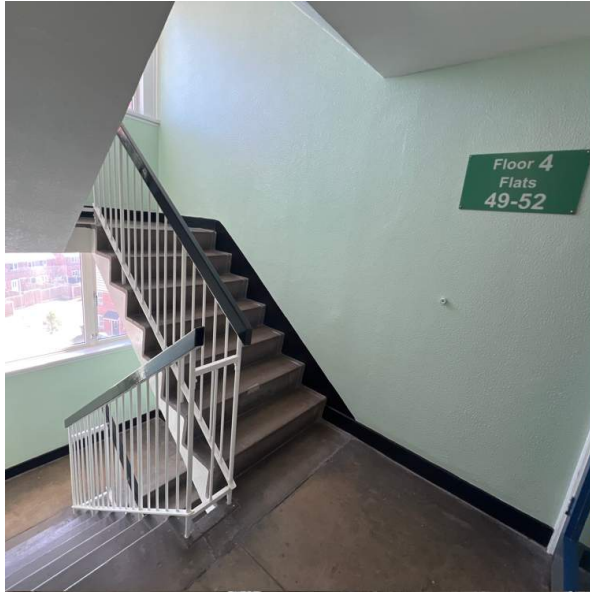
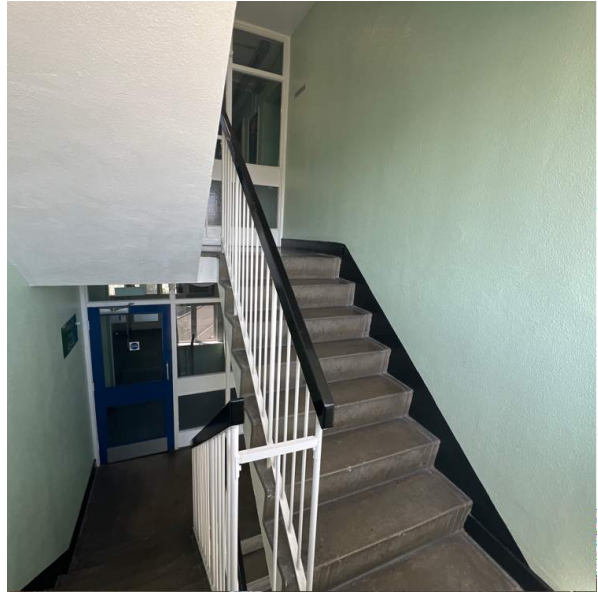
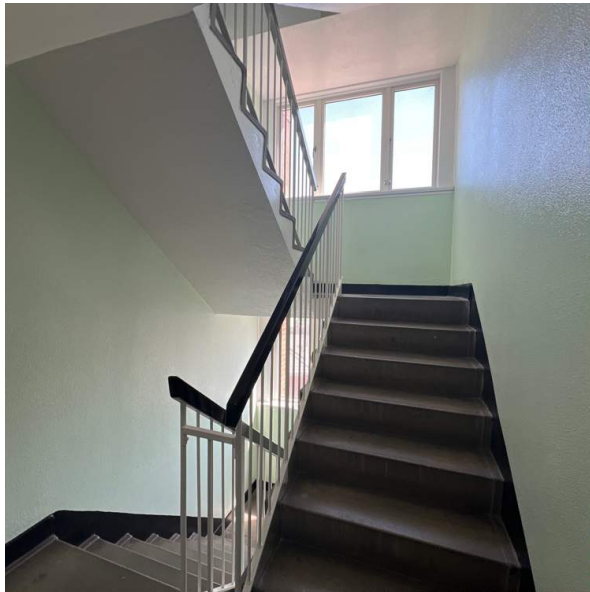
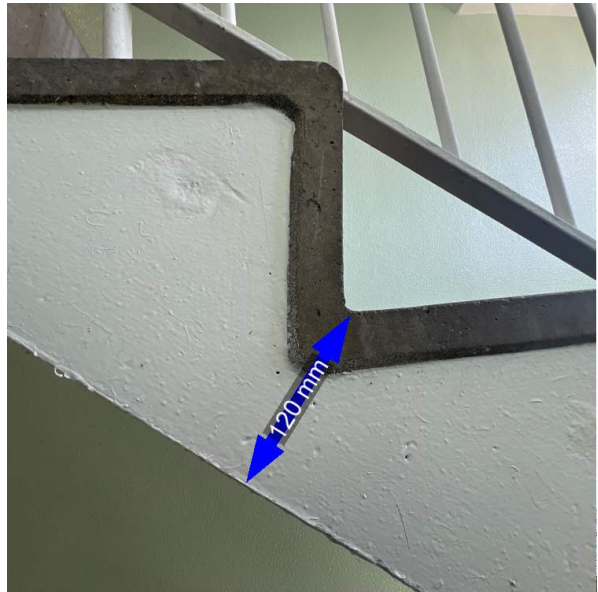
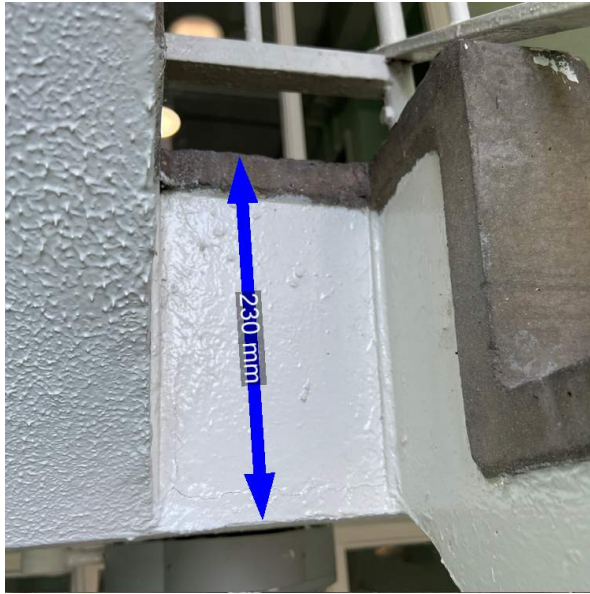
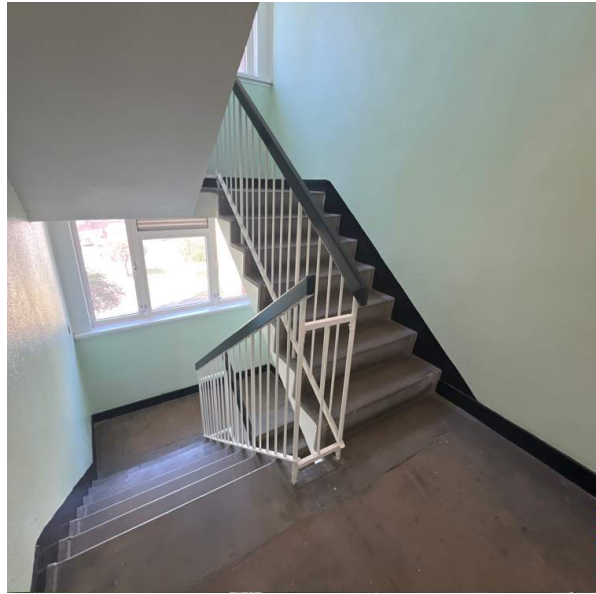
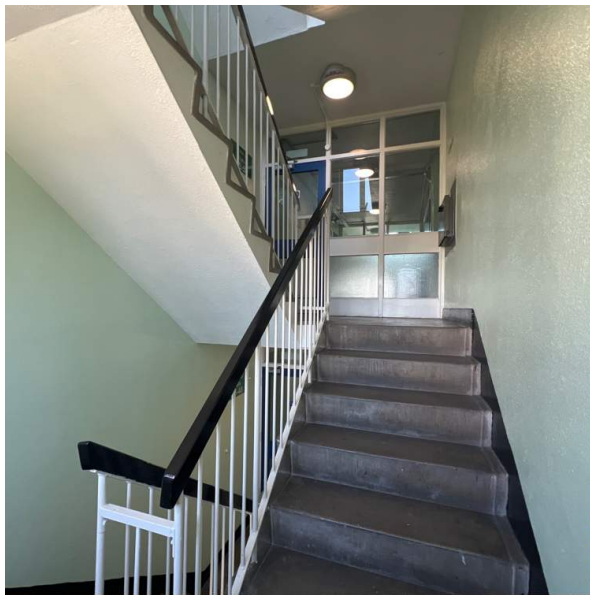
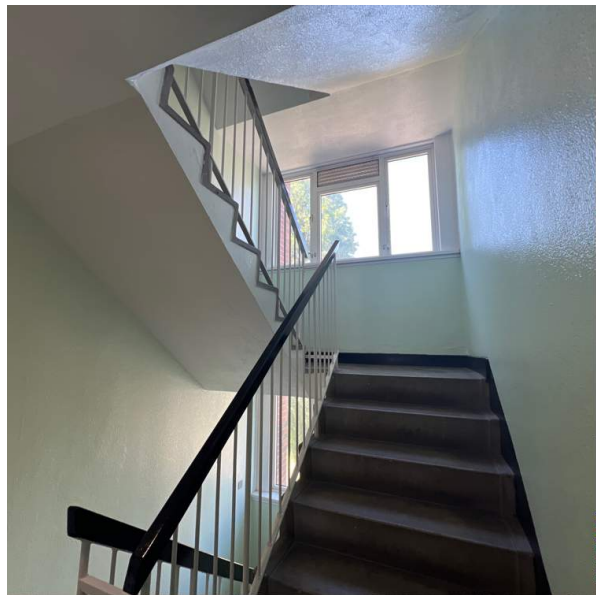
## 4th Floor Staircases

Comments: Insitu concrete stairs with steel hand railing fixed to stairs. Walls and floors appear to be fairly level.  
Stair walls covered with finishes however these would likely form the main concrete shear core walls.

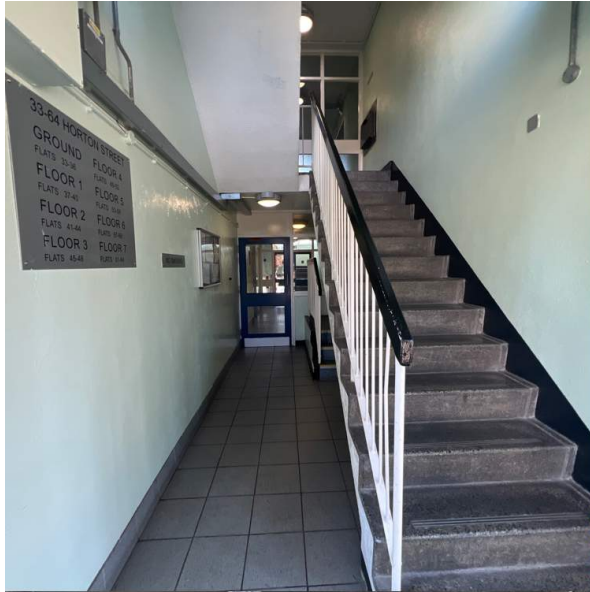
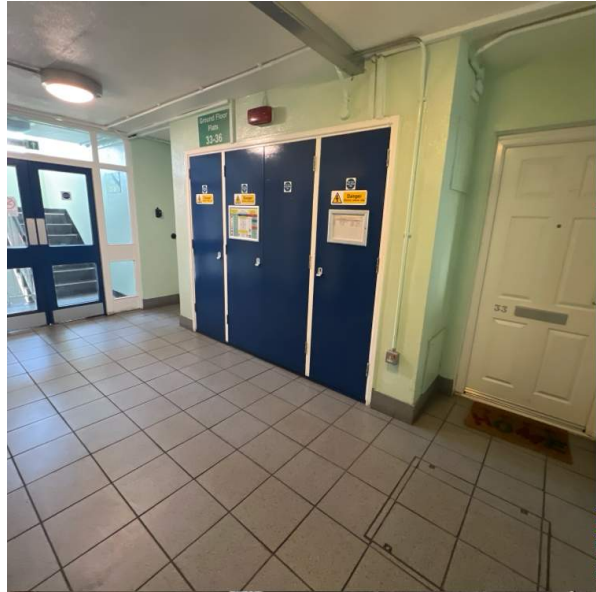
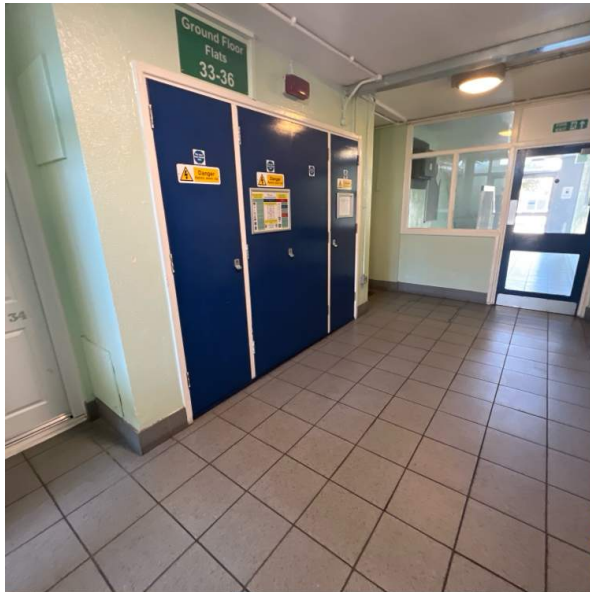
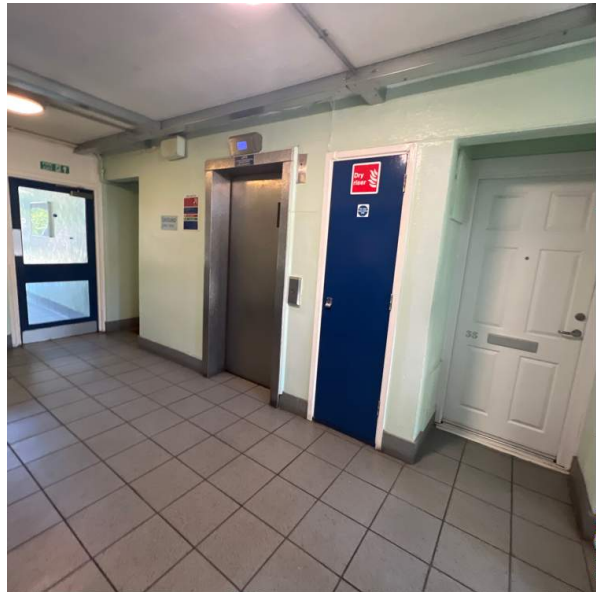
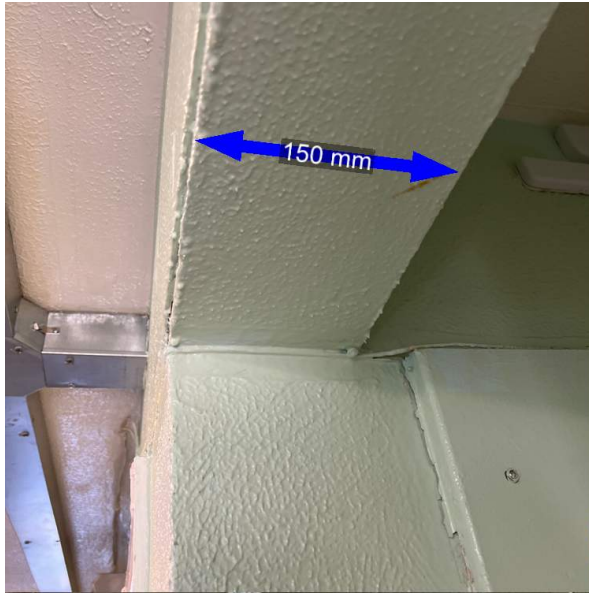
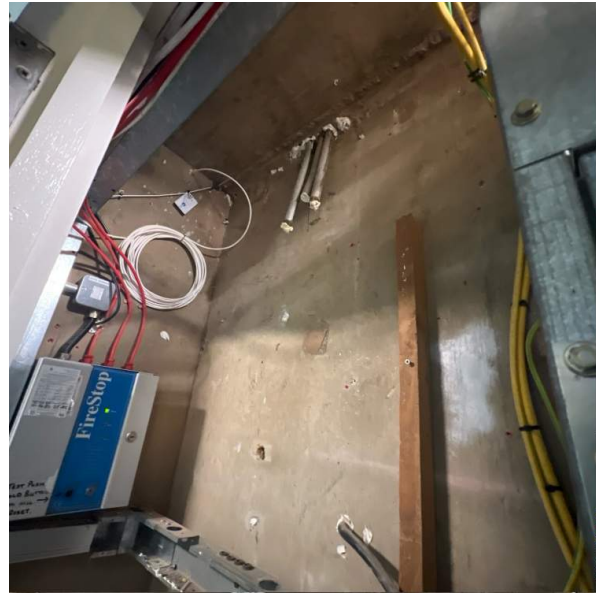
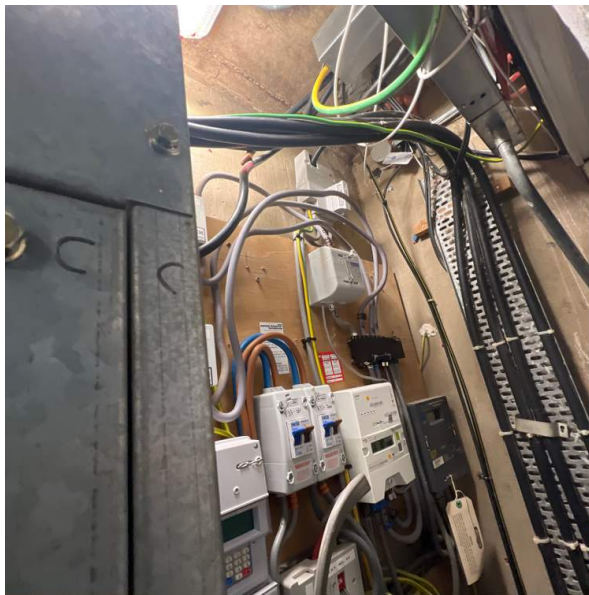
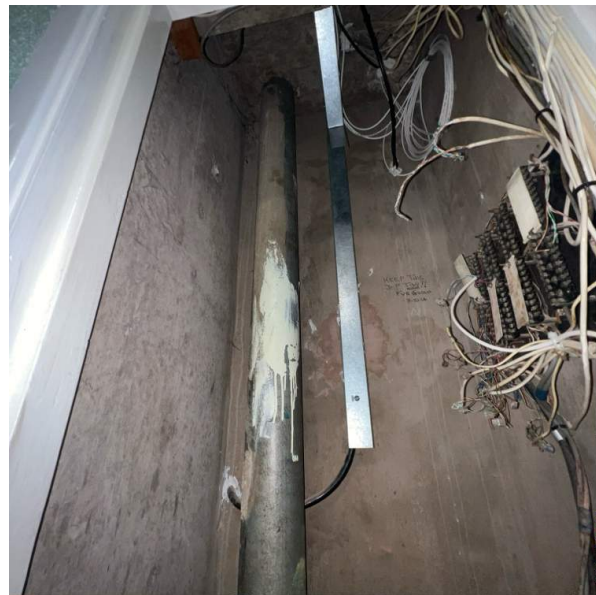
## Ground Floor Hallway

Comments: No jams or distortions noted to hallway doors to indicate any serviceability issues. Generally walls covered with finishes in hallway, likely to consist a mixture of concrete shear walls, embedded columns and masonry infill walls. Limited structure exposed. Concrete walls and infill masonry (non-load bearing) walls noted in riser cupboards.

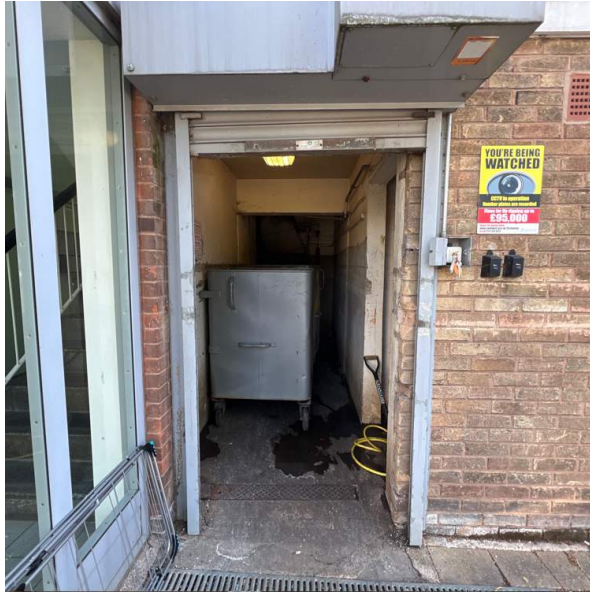
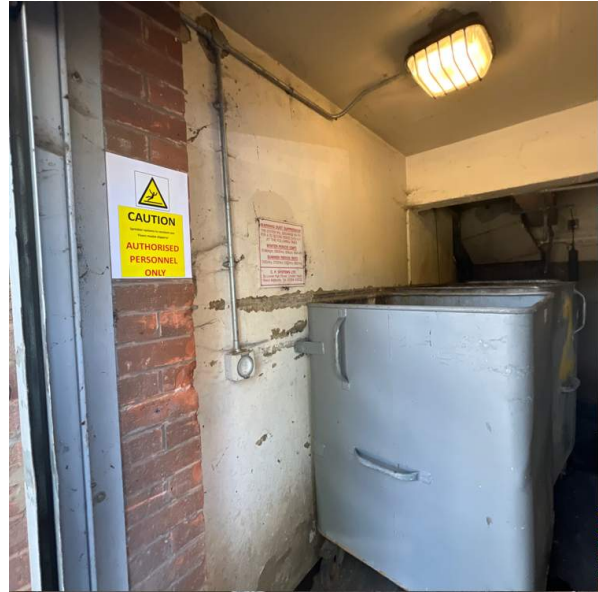
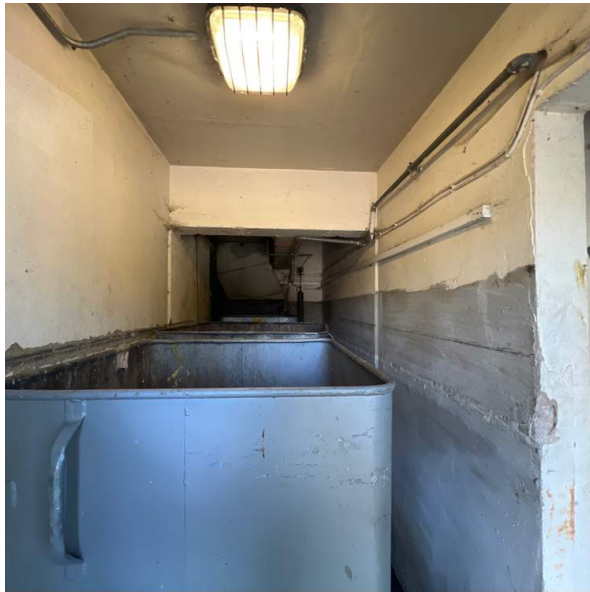
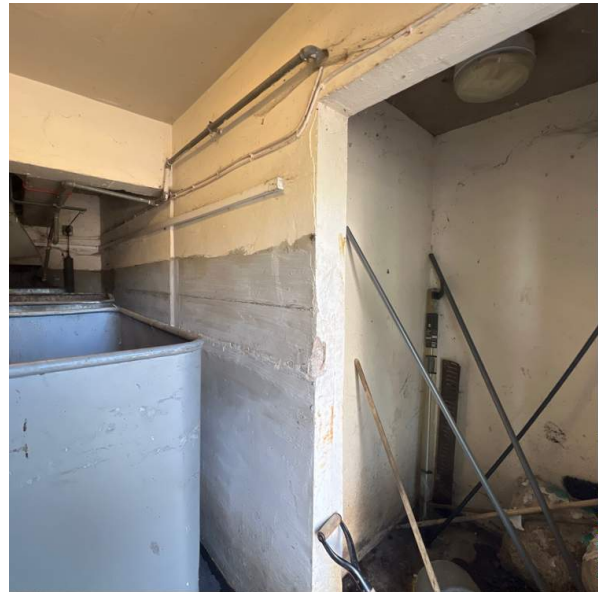
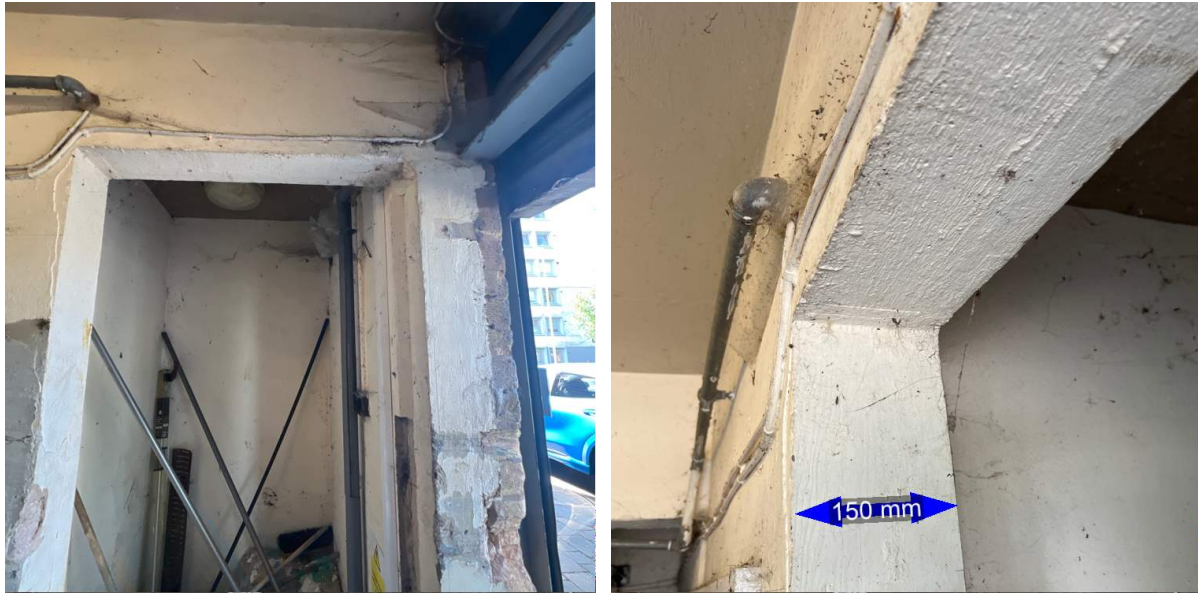
## Bin Store

Comments: RC concrete walls noted in bin store.

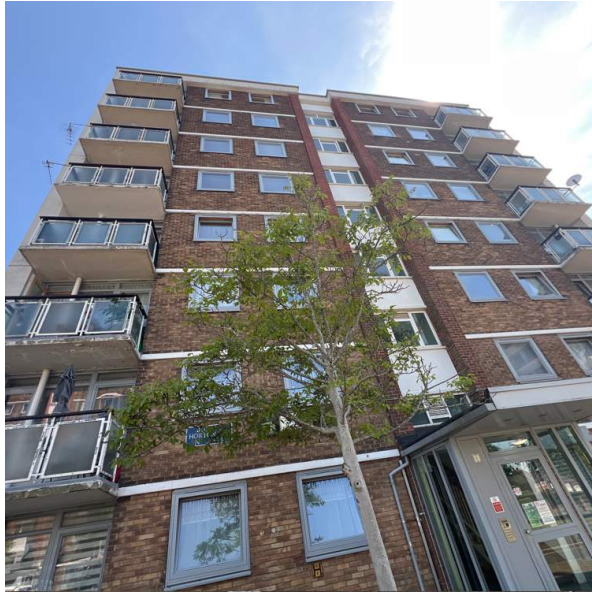
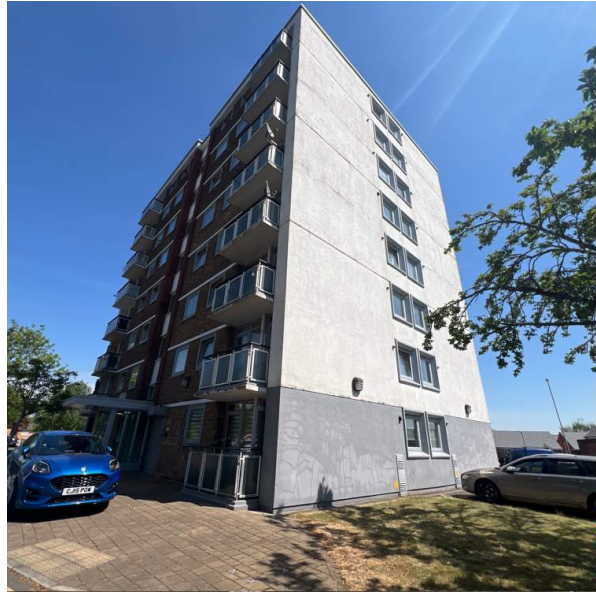
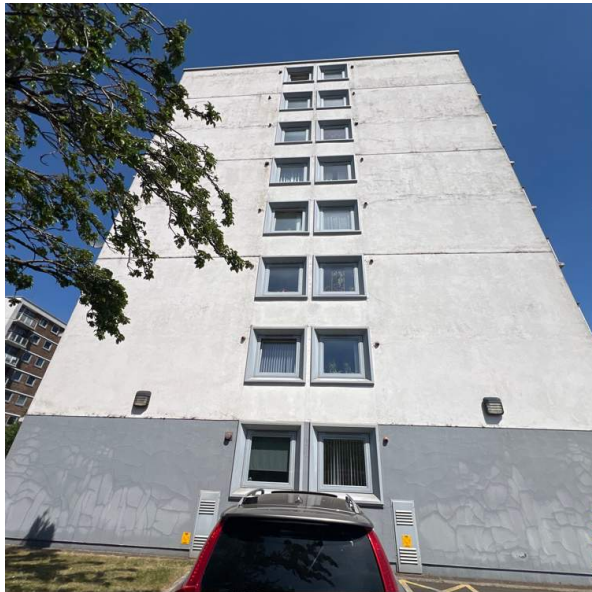
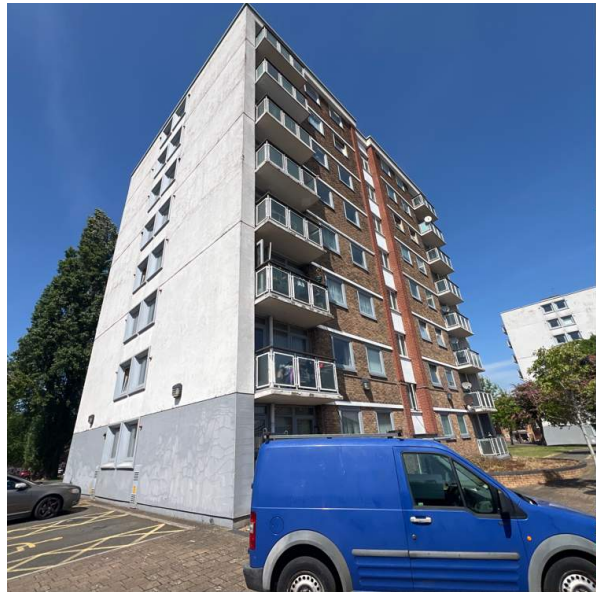
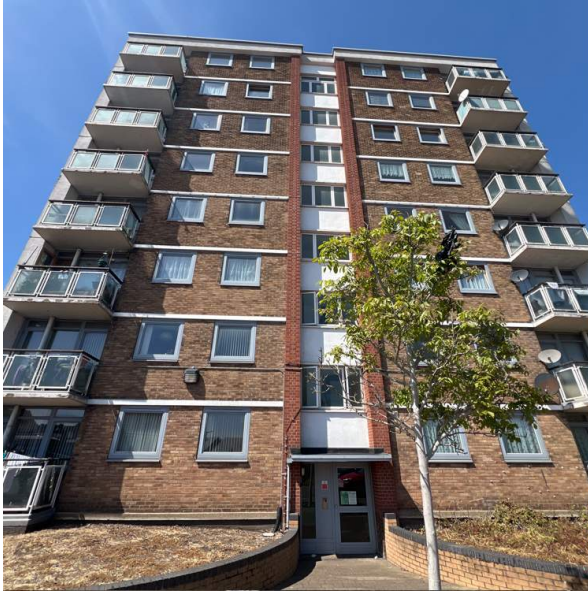
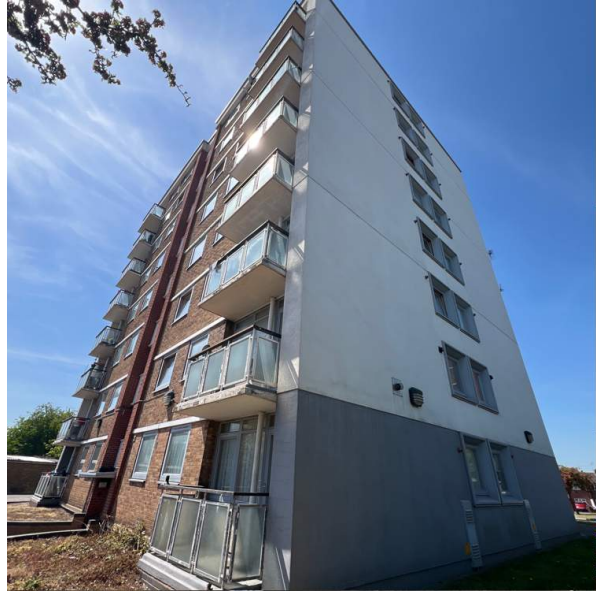
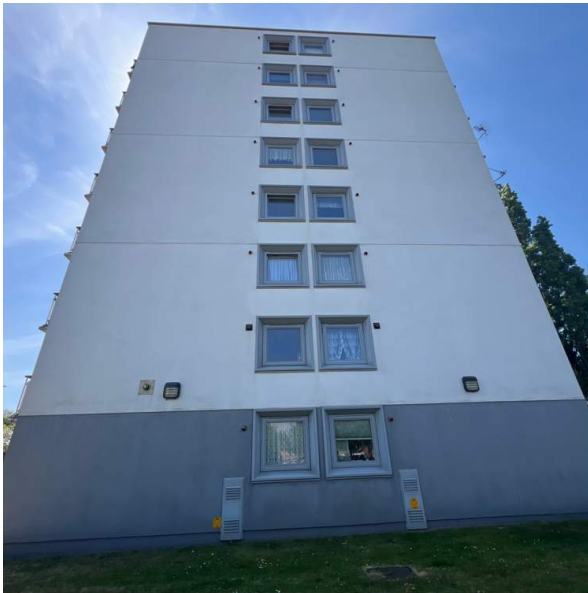
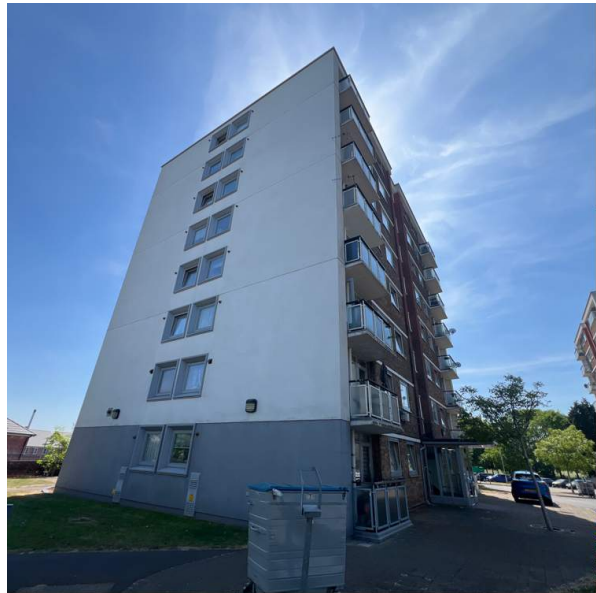
## Elevations

Comments: External facade consists of brick work on all levels to front and rear elevations with cantilevered balconies situated on corners. Side elevations consist of render to full height of walls.
