**FIRNTEC**  
BUILDING COMPLIANCE

VISUAL STRUCTURAL APPRAISAL

65-96 Horton Street

27<sup>th</sup> May 2025

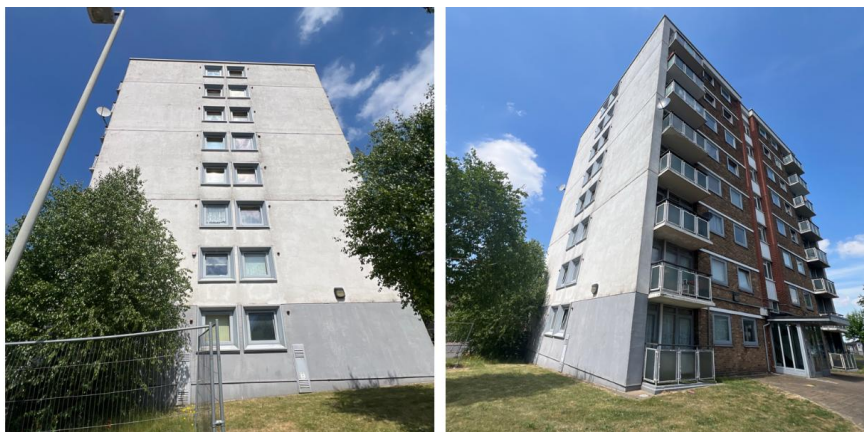
Figure 9 and 10: Building Elevations

The exterior panels were noted to be plumb with no signs of significant bowing, bulging or leaning noted to the panels indicating failed fixings however their presence and condition cannot be confirmed.

There are balconies at each level which are formed of cantilevered RC slabs tied into the main frame. The balconies have the coatings which are peeling away and the balustrades would benefit from a refurbishment. The cantilevered slabs should be checked for internal corrosion potential at the benchmark inspections.

The balconies have the coatings which are peeling away and the balustrades would benefit from a refurbishment. The cantilevered slabs should be checked for internal corrosion potential as part of the benchmark inspections above.

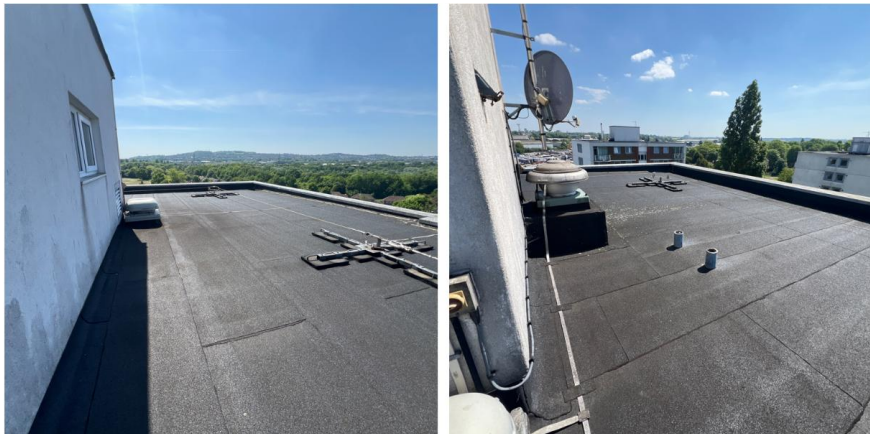
Figure 11 and 12: Roof Level

There were no tell-tale signs of any significant structural movement noted at the time of our inspection.

The roof has an asphalt finish. The exact build-up of the roof finishes were not accessible at the time of inspection. It is recommended an intrusive survey of the roof finishes is completed by a specialist surveyor to assess the condition of the roof covering although they were noted in good condition with no known water ingress issues and therefore a low risk element.

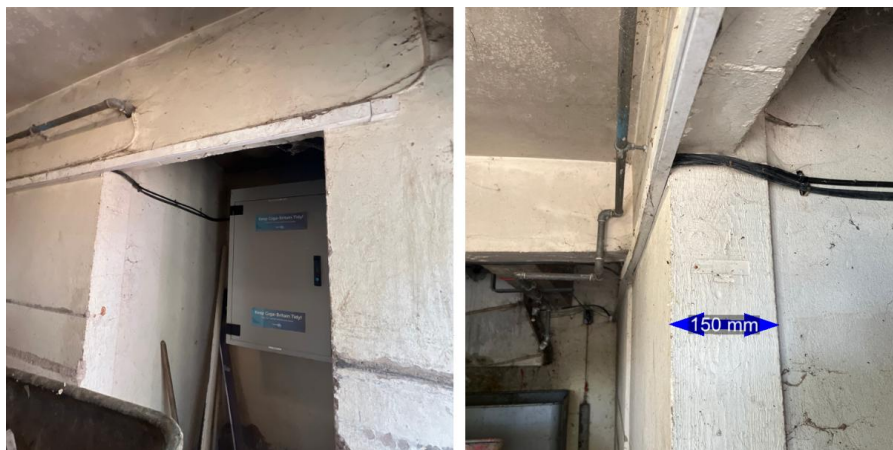
Figure 14 and 15: RC Elements within floor plan

There were vertical concrete walls supporting the floor plates at every level. The elements visible matched the floor layout in Figure 6. The walls appear continuous from ground to roof with no transfer structure. The overall condition of the structure observed is good.

The interior of the stair core walls were checked and were plumb and in line with observations made to the exterior – no significant signs of leaning or movement noted. The concrete appeared in fair condition with few BRE category 1 cracks but no structurally significant defects were noted.

The stair stringer was noted to be 120mm thick which seems slim, certainly short of modern standards. A cover test is required to check the resistance of the concrete section in the event of a fire.

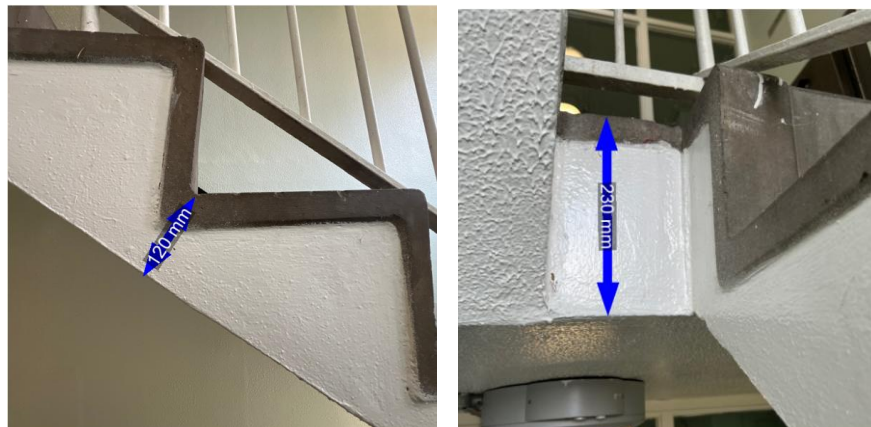
Figure 16 and 17: Slab Edge with finishes and wall thickness

The floors in the communal landings were noted to be solid concrete floors. The floors were checked with a spirit level and were considered level and within tolerance. The doors and windows to the communal landings from the stair core all appeared to be level and opened and closed without difficulty. There were no signs of structural movement detected.

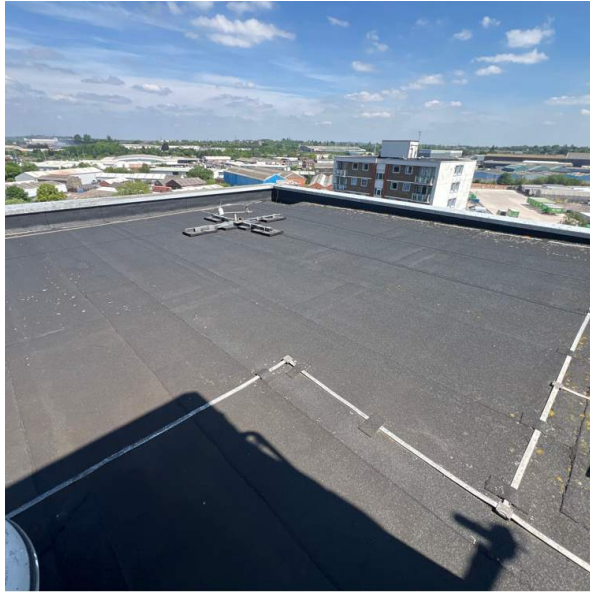
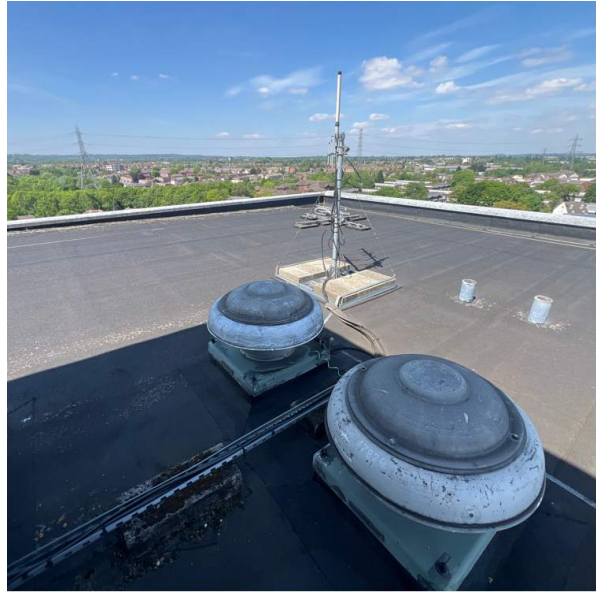
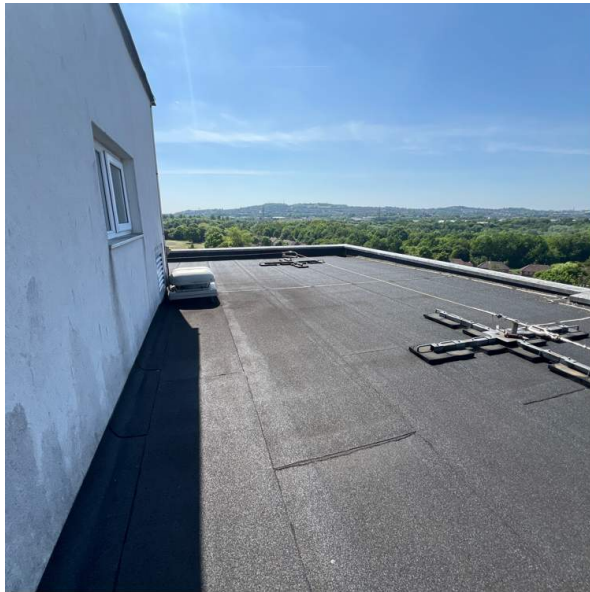
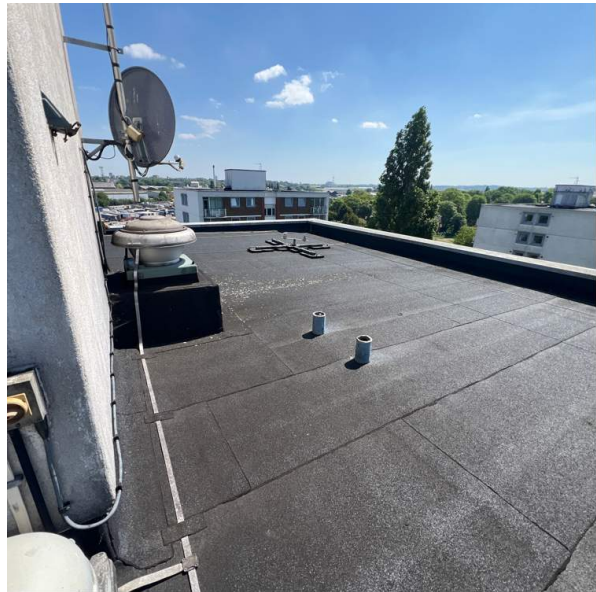
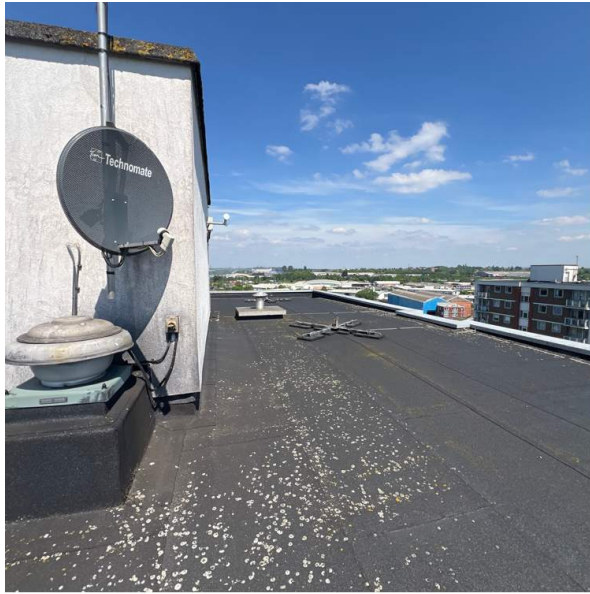
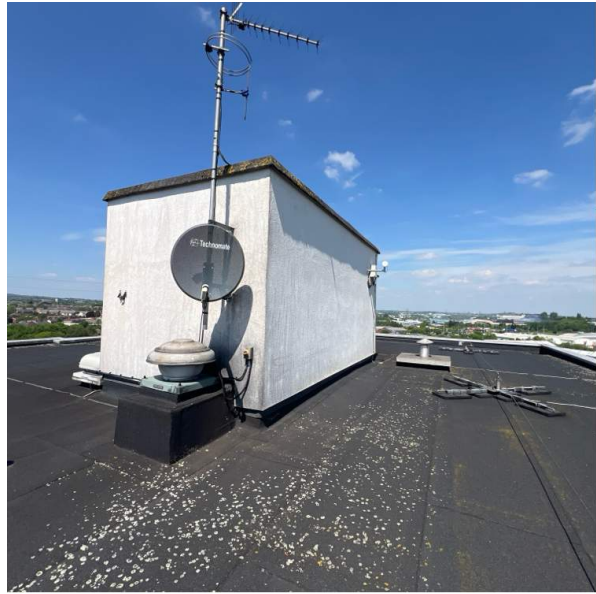
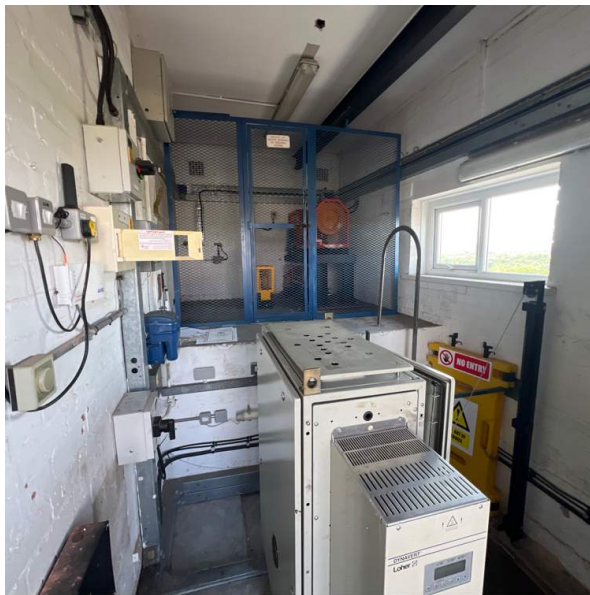
## Main Roof

Comments: Flat roof, RC concrete slab with insulated PIR board and felt coverings.

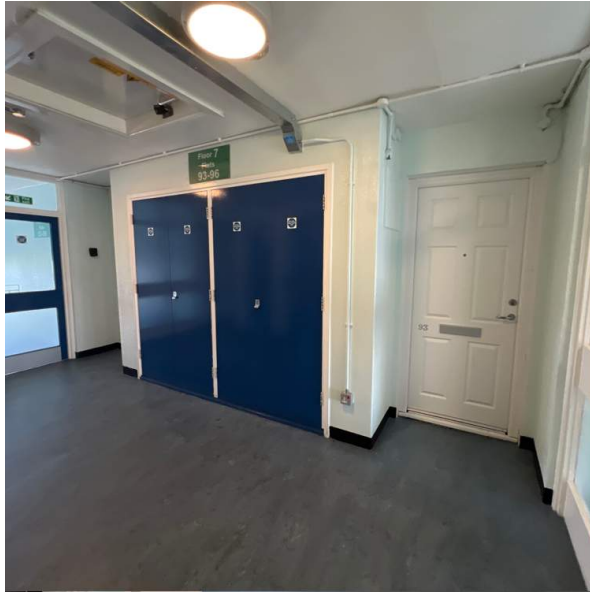
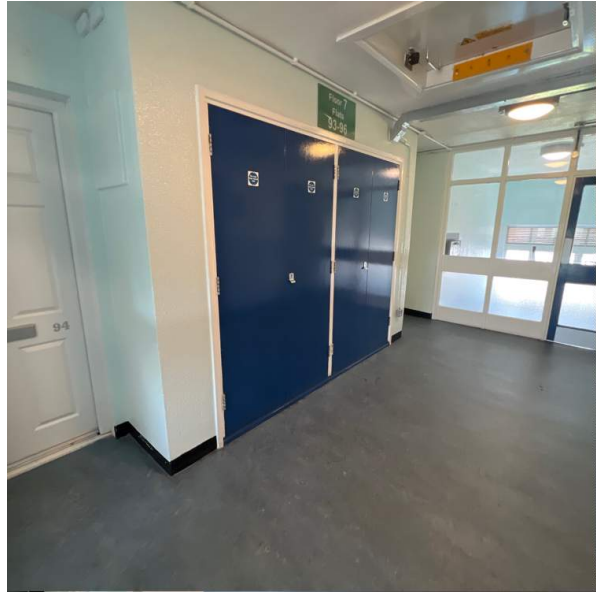
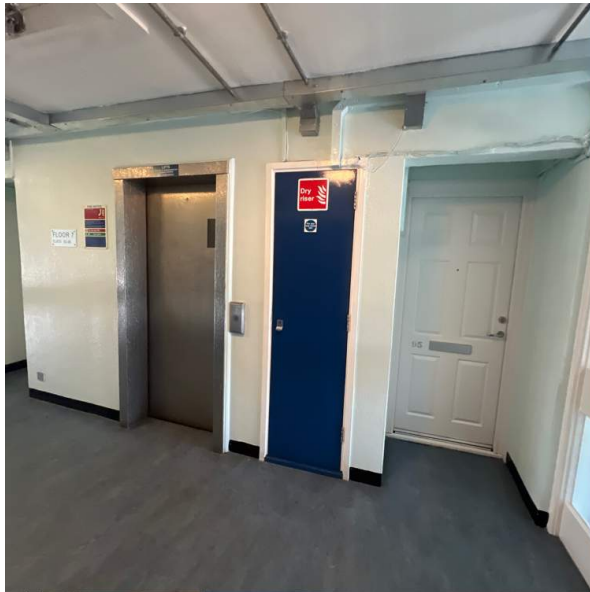
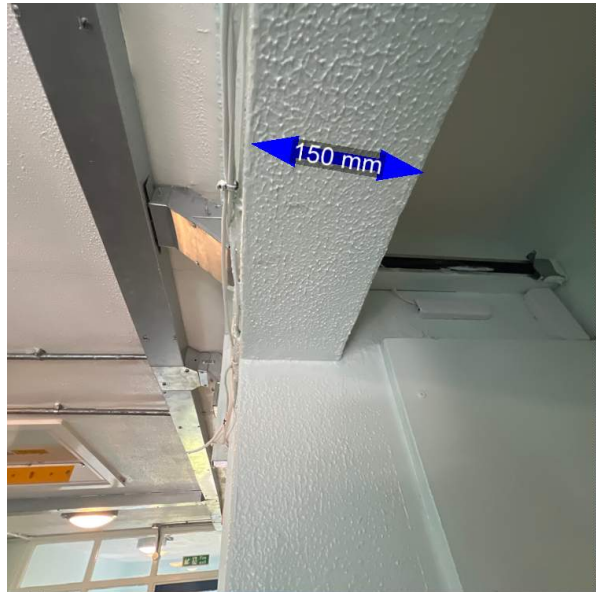
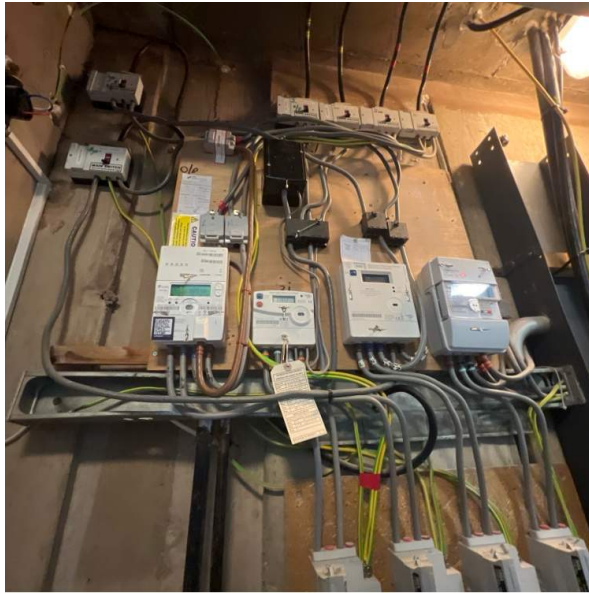
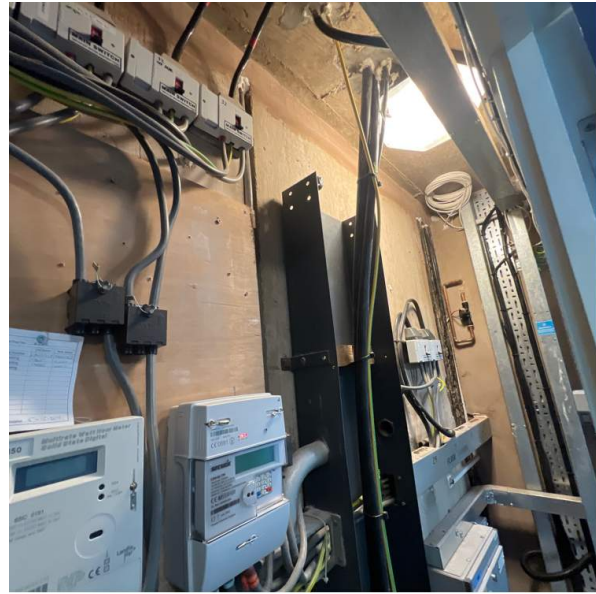
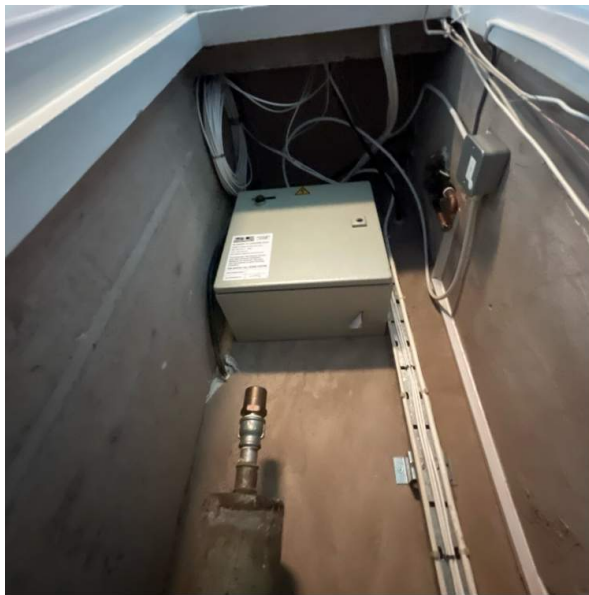
## 7th Floor Hallway

Comments: No jams or distortions noted to hallway doors to indicate any serviceability issues. Generally walls covered with finishes in hallway, likely to consist a mixture of concrete shear walls, embedded columns and masonry infill walls. Limited structure exposed. Concrete walls and infill masonry (non-load bearing) walls noted in riser cupboards.

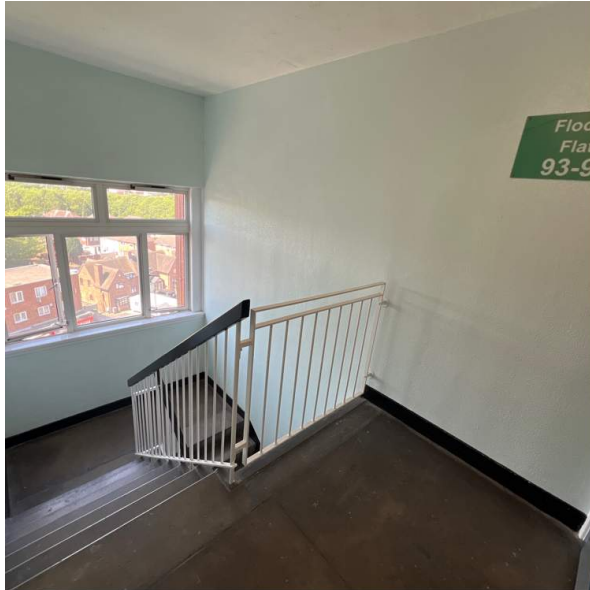
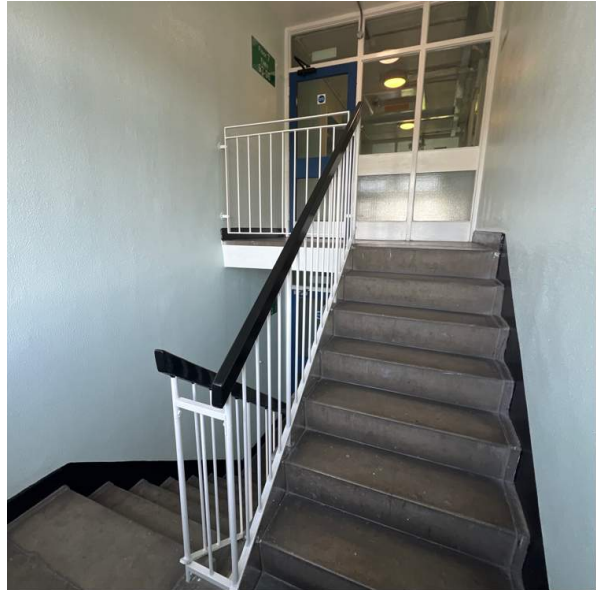
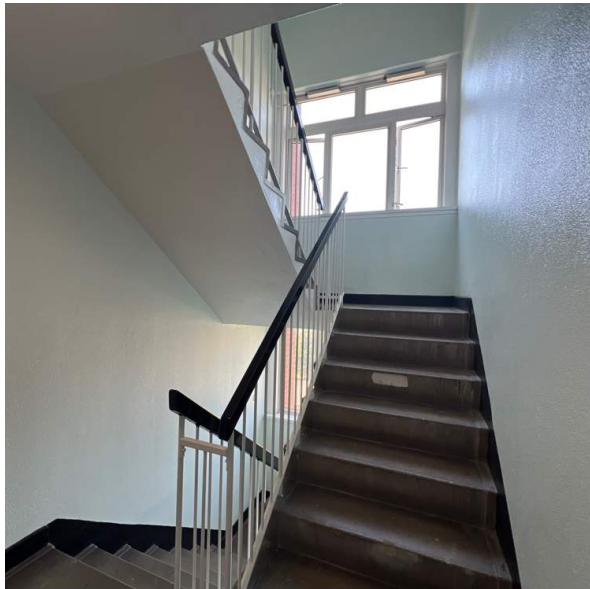
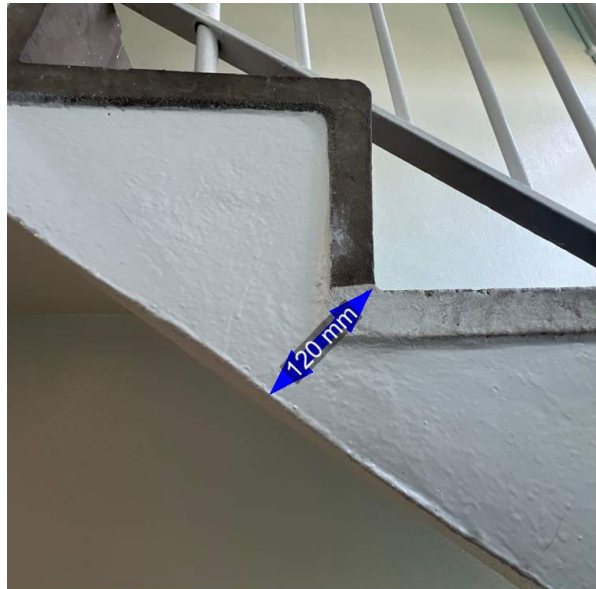
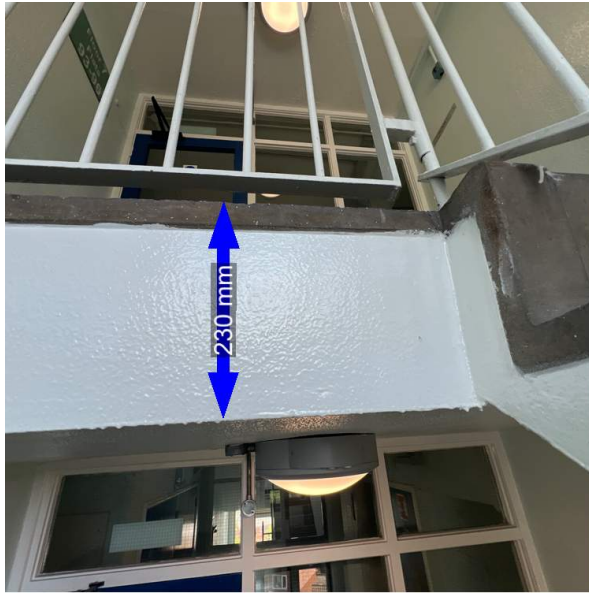
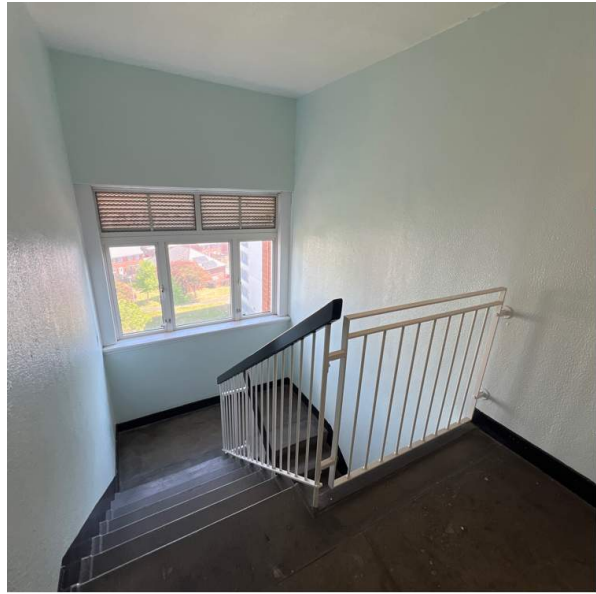
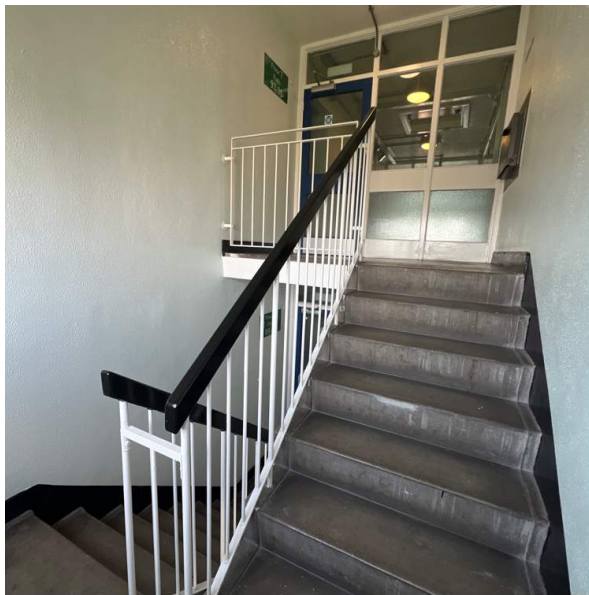
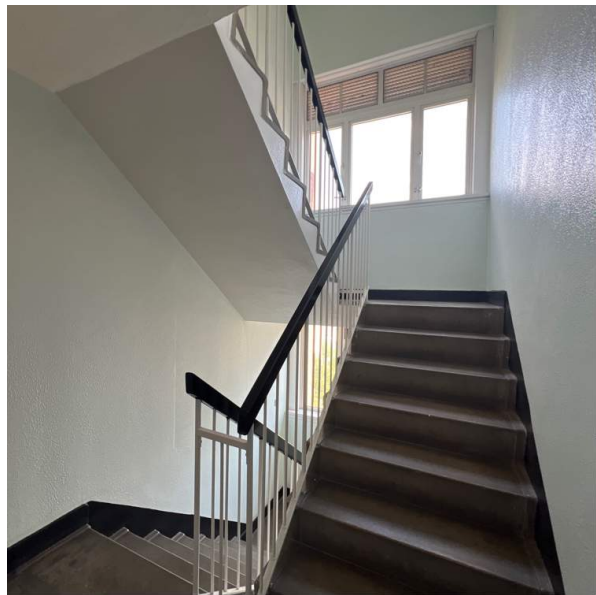
## 7th Floor Staircases

Comments: Insitu concrete stairs with steel hand railing fixed to stairs. Walls and floors appear to be fairly level.  
Stair walls covered with finishes however these would likely form the main concrete shear core walls.

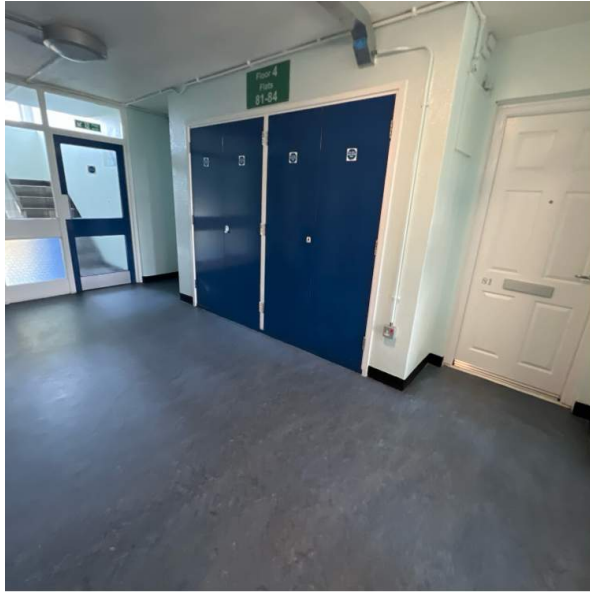
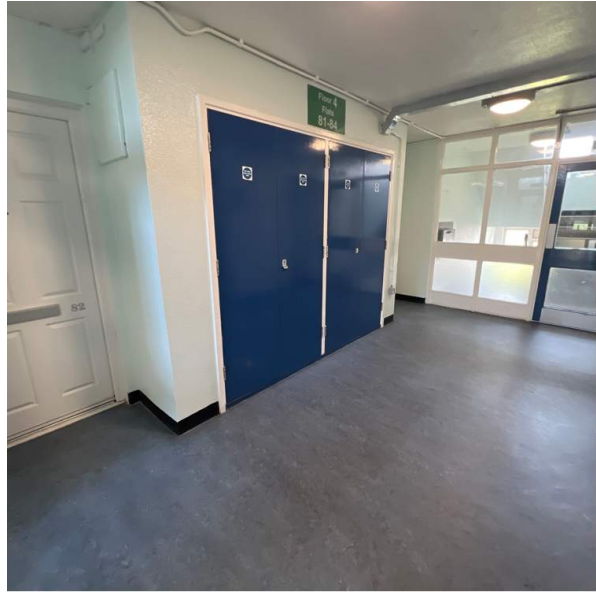
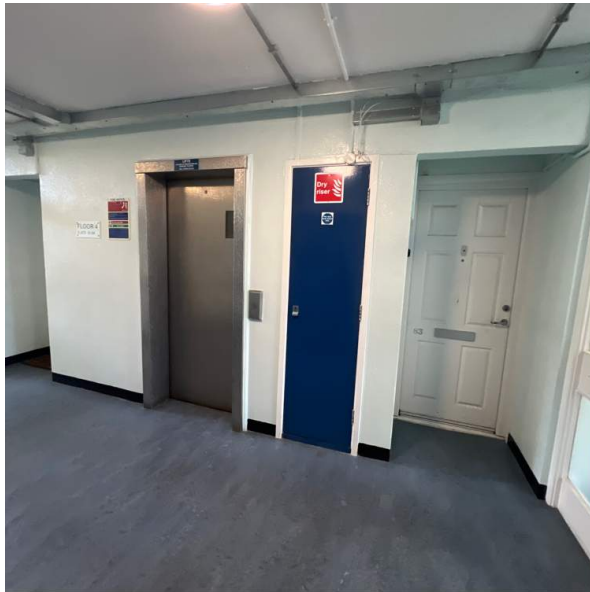
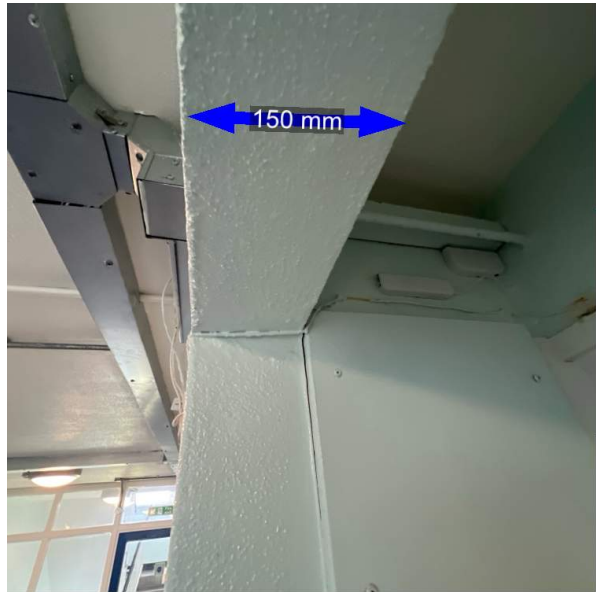
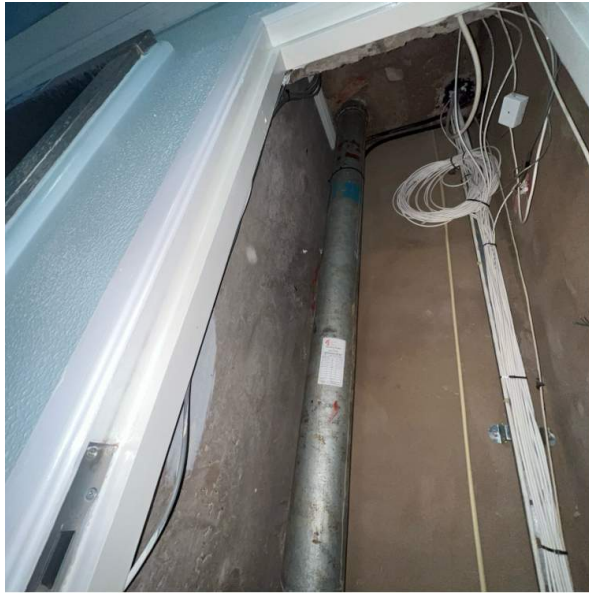
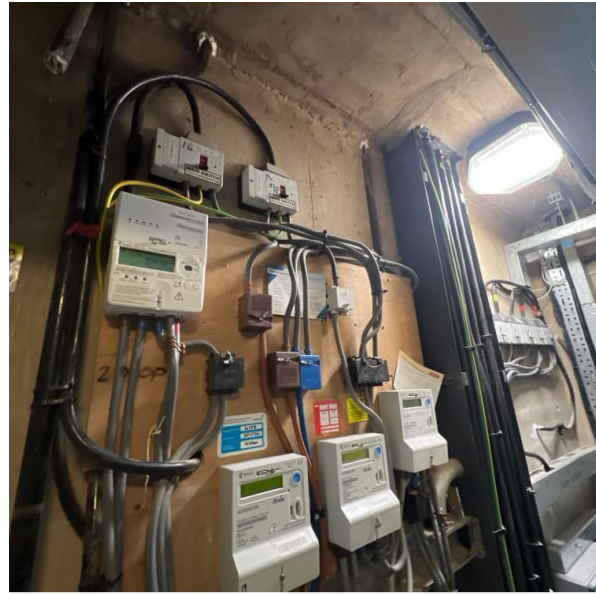
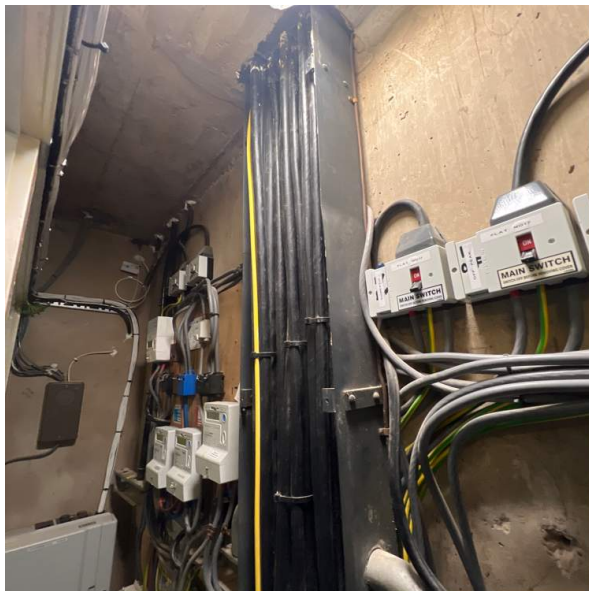
## 4th Floor Hallway

Comments: No jams or distortions noted to hallway doors to indicate any serviceability issues. Generally walls covered with finishes in hallway, likely to consist a mixture of concrete shear walls, embedded columns and masonry infill walls. Limited structure exposed. Concrete walls and infill masonry (non-load bearing) walls noted in riser cupboards.

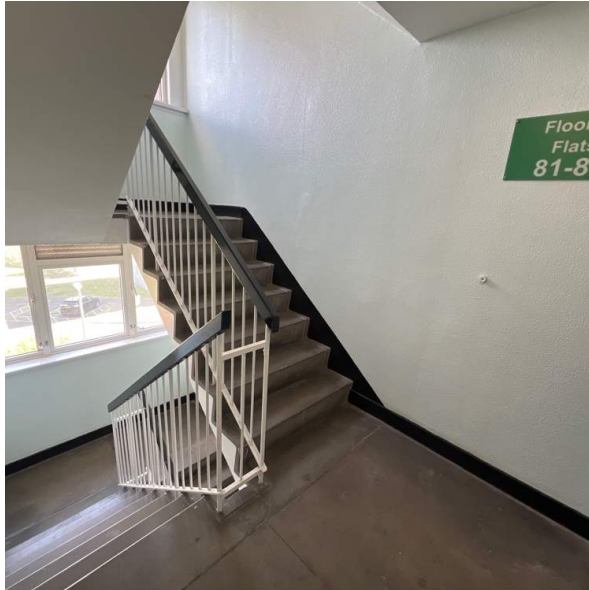
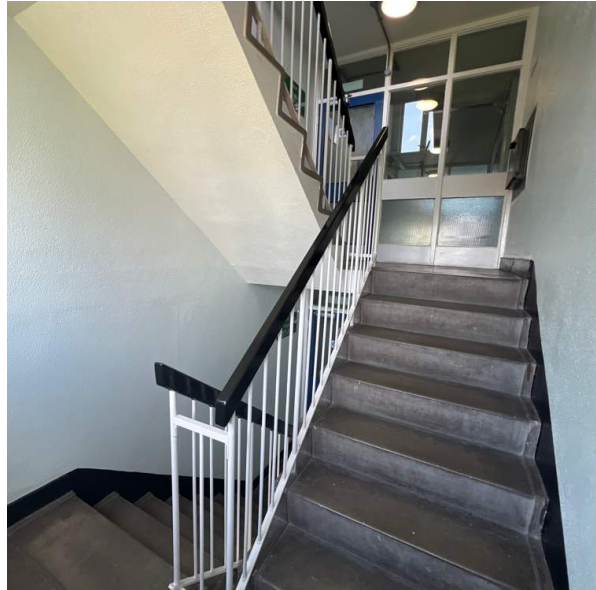
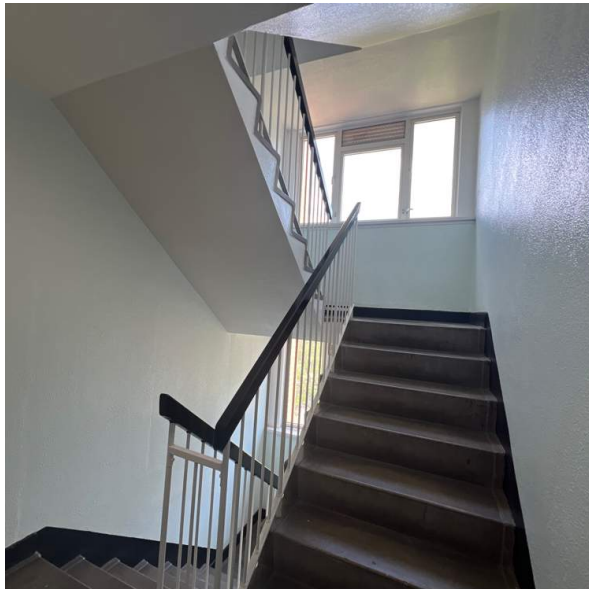
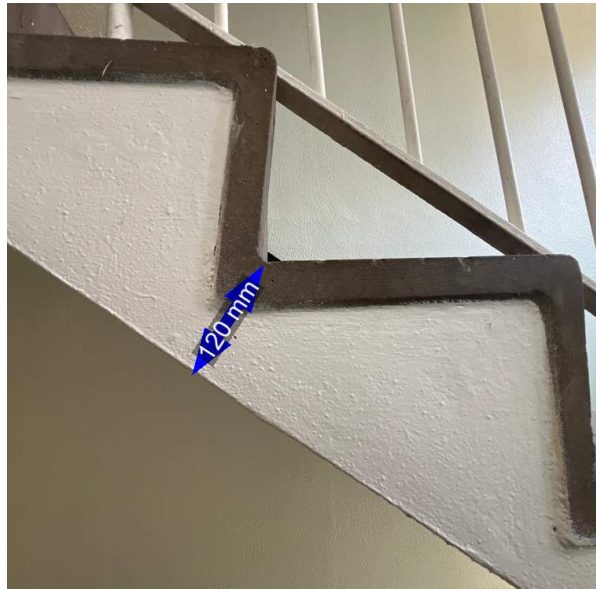
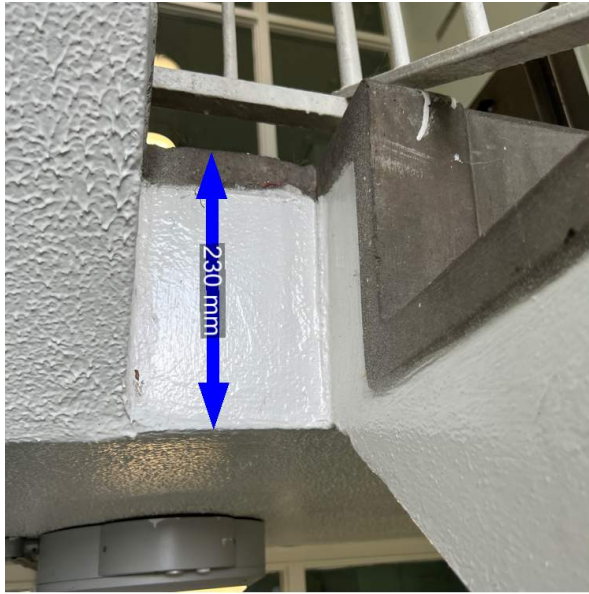
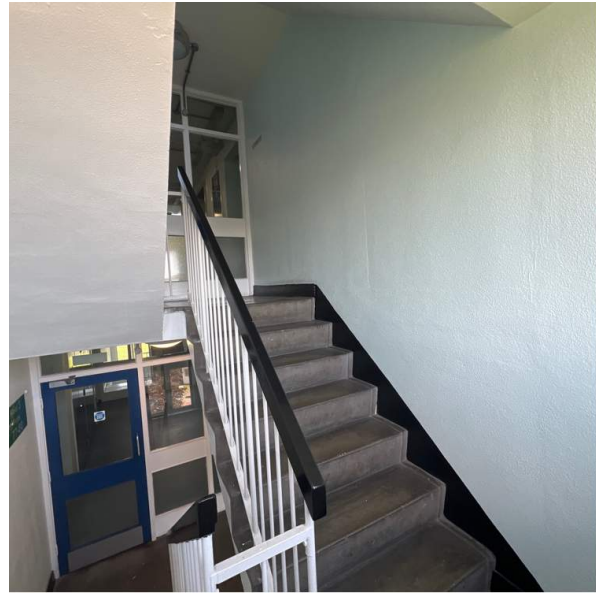
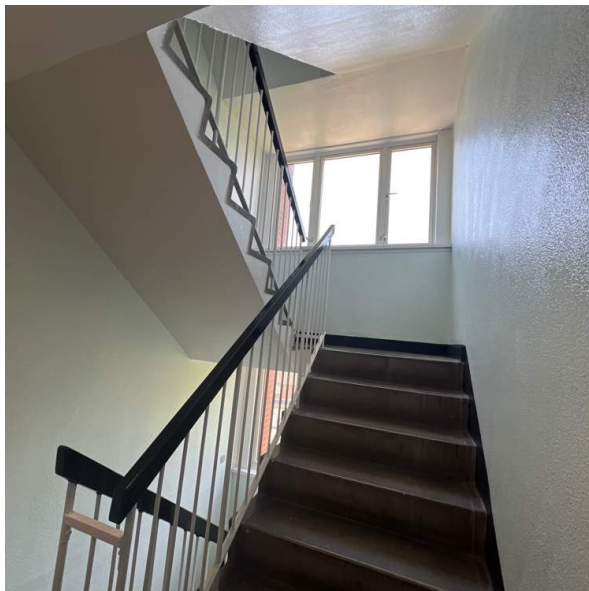
## 4th Floor Staircases

Comments: Insitu concrete stairs with steel hand railing fixed to stairs. Walls and floors appear to be fairly level.  
Stair walls covered with finishes however these would likely form the main concrete shear core walls.

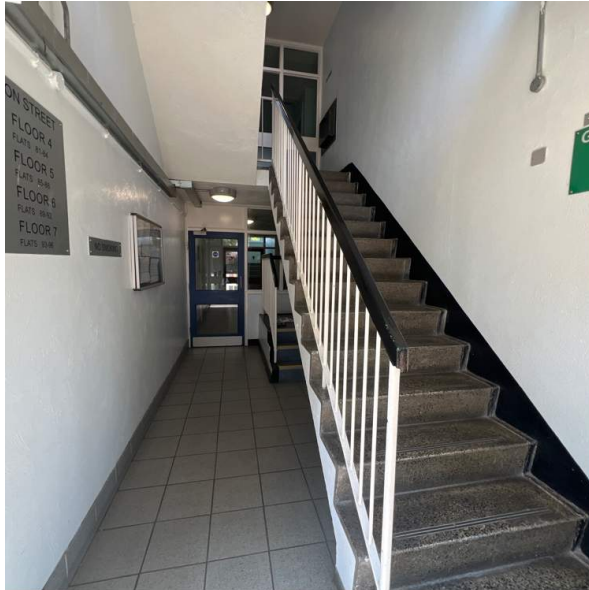
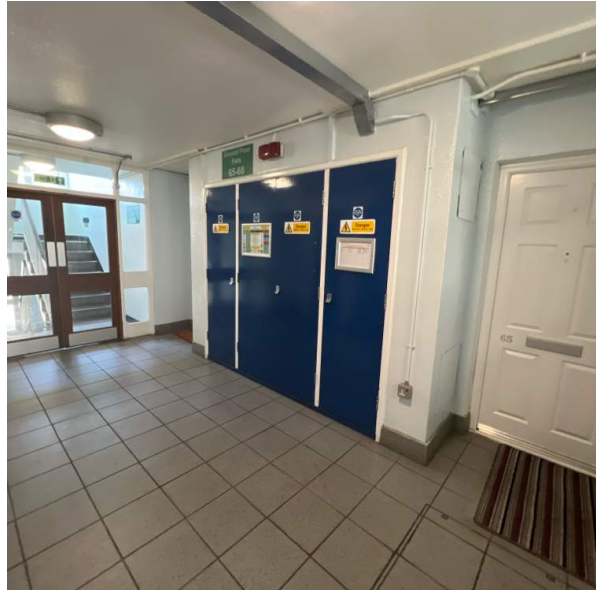
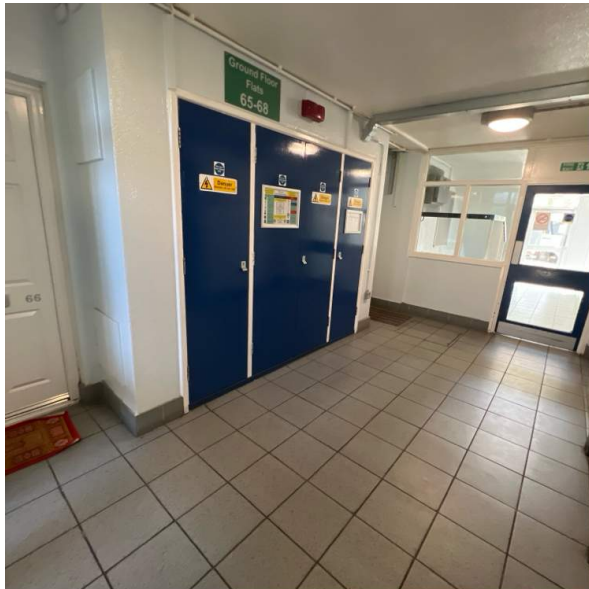
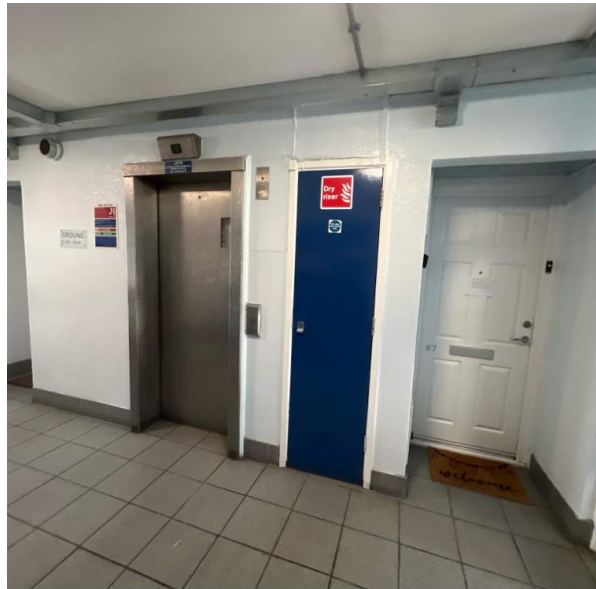
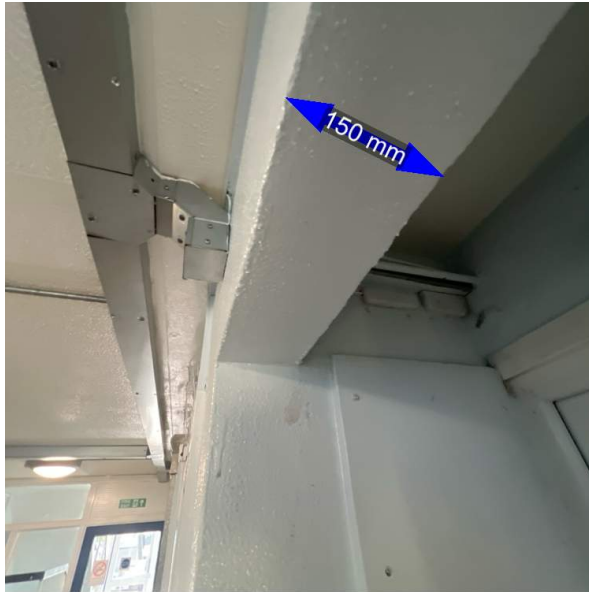
## Ground Floor Hallway

Comments: No jams or distortions noted to hallway doors to indicate any serviceability issues. Generally walls covered with finishes in hallway, likely to consist a mixture of concrete shear walls, embedded columns and masonry infill walls. Limited structure exposed. Concrete walls and infill masonry (non-load bearing) walls noted in riser cupboards.

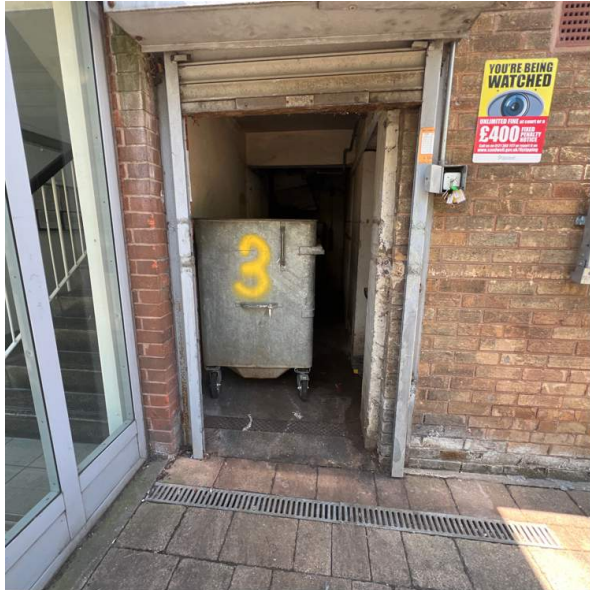
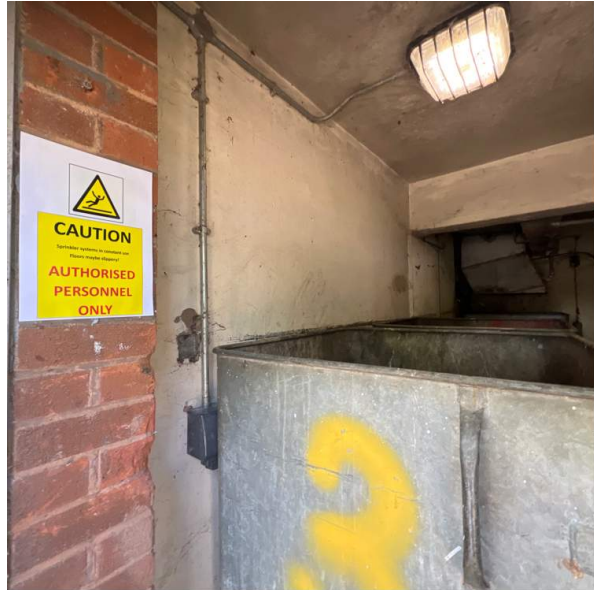
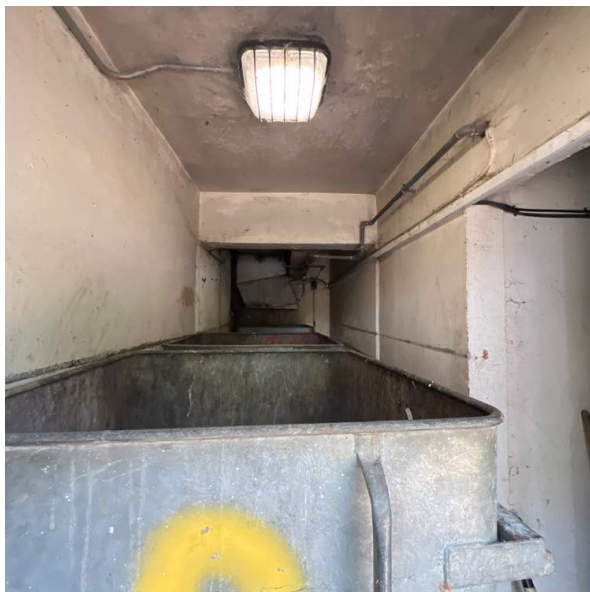
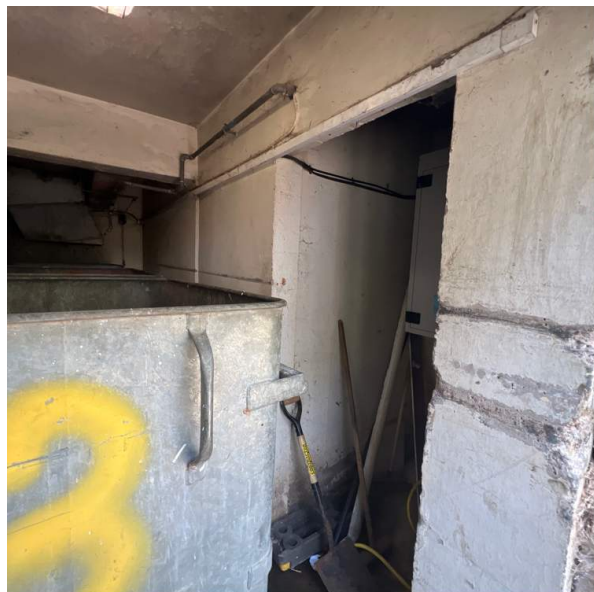
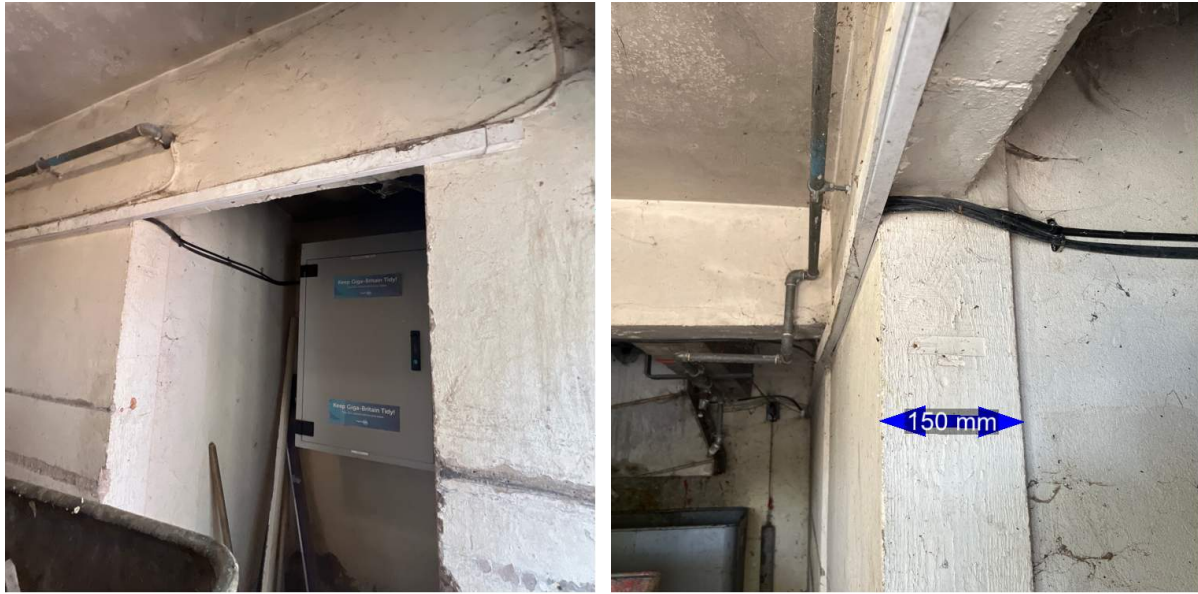
## Bin Store

Comments: RC concrete walls noted in bin store.

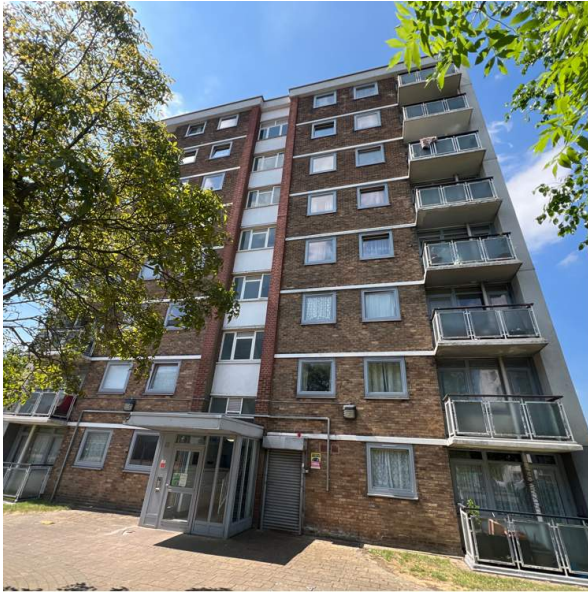
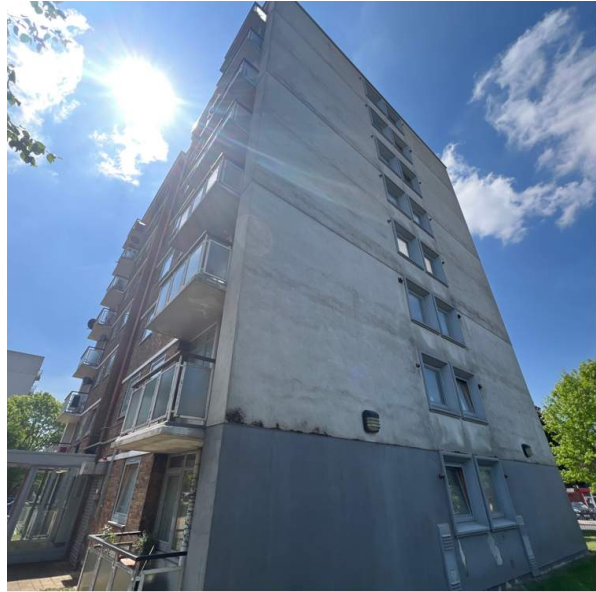
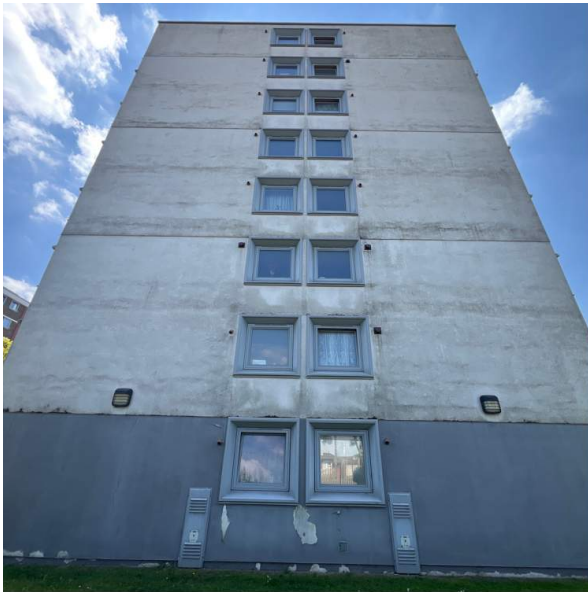
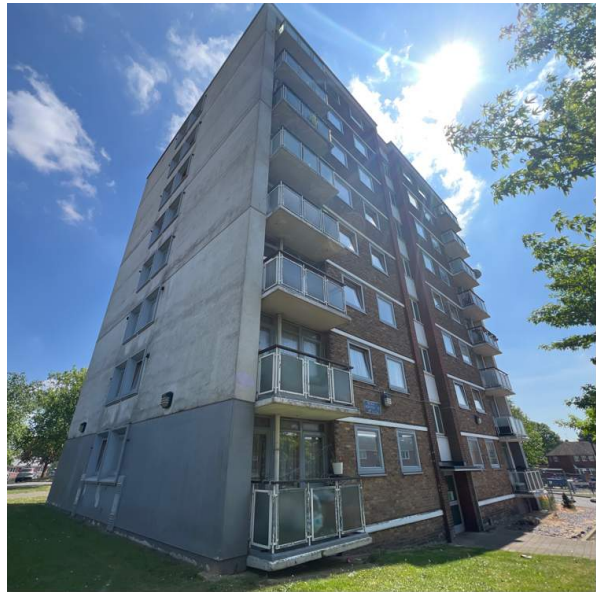
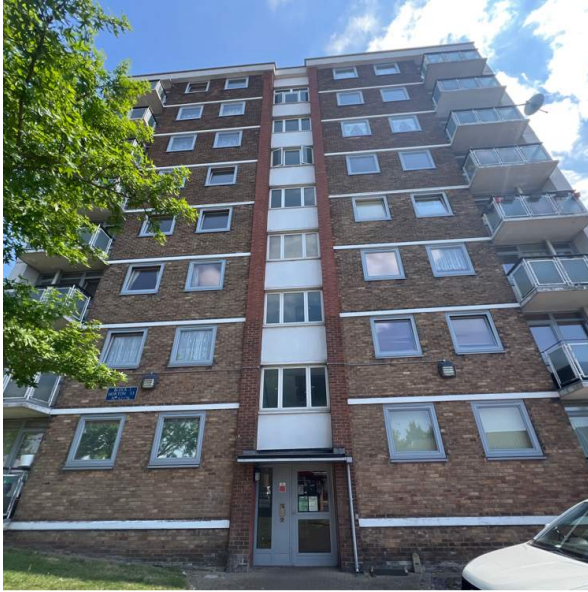
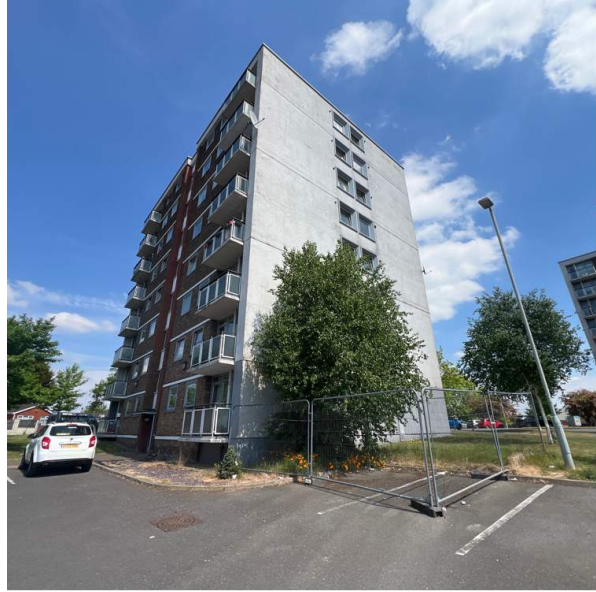
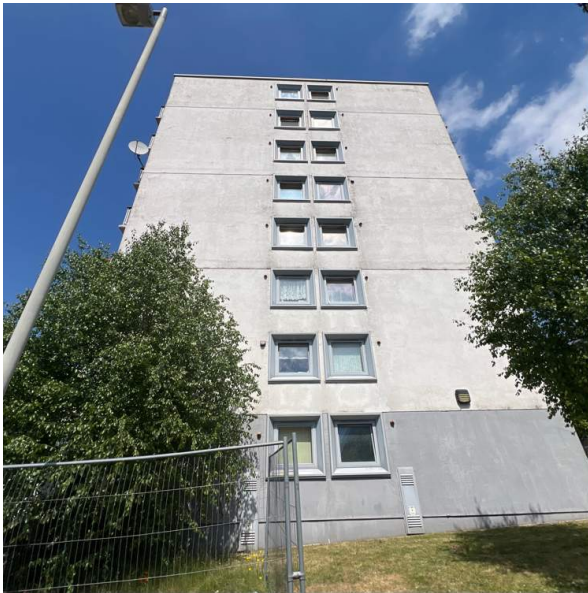
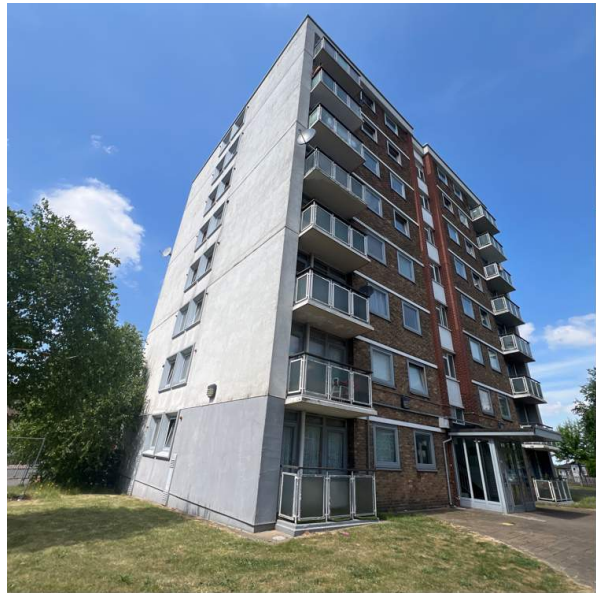
## Elevations

Comments: External facade consists of brick work on all levels to front and rear elevations with cantilevered balconies situated on corners. Side elevations consist of render to full height of walls.
