VISUAL STRUCTURAL APPRAISAL

Kenrick House

Green Street  
West Bromwich  
B70 6DW

29<sup>th</sup> November 2024

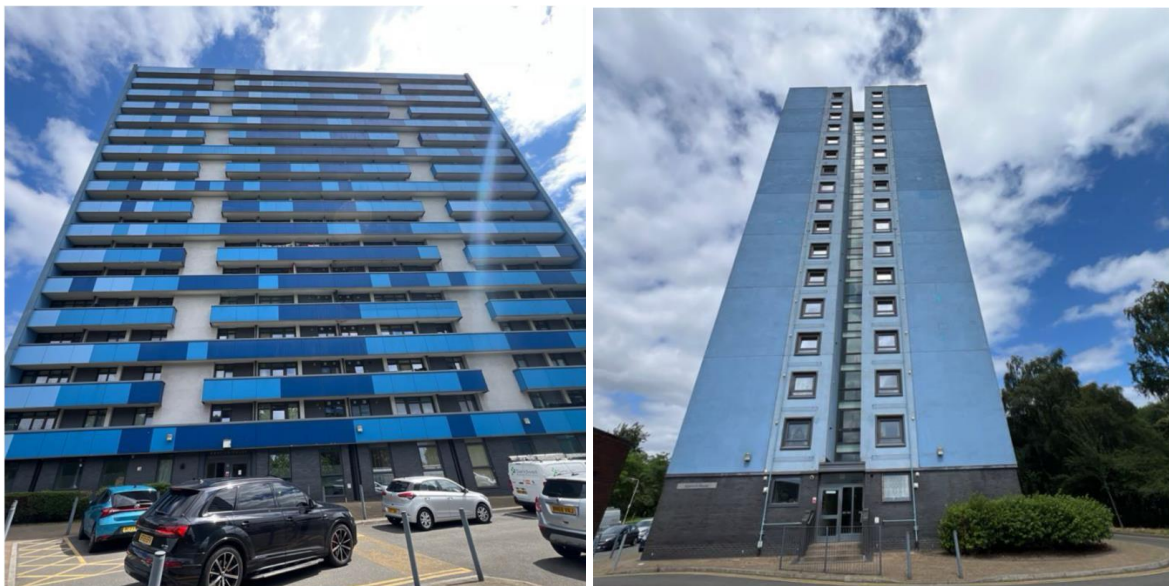
Figure 9 and 10: Front and side Elevations

The exterior elevations were generally in ok condition and no significant structural defects were noted to the cladding panels. There were no significant cracks or tell-tale signs of any significant structural movement noted at the time of our inspection.

The exterior panels were noted to be plumb with no signs of significant bowing, bulging or leaning noted to the panels indicating failed fixings however their presence and condition cannot be confirmed.

There are balconies at each level which have been clad in High Pressure Laminate panels.

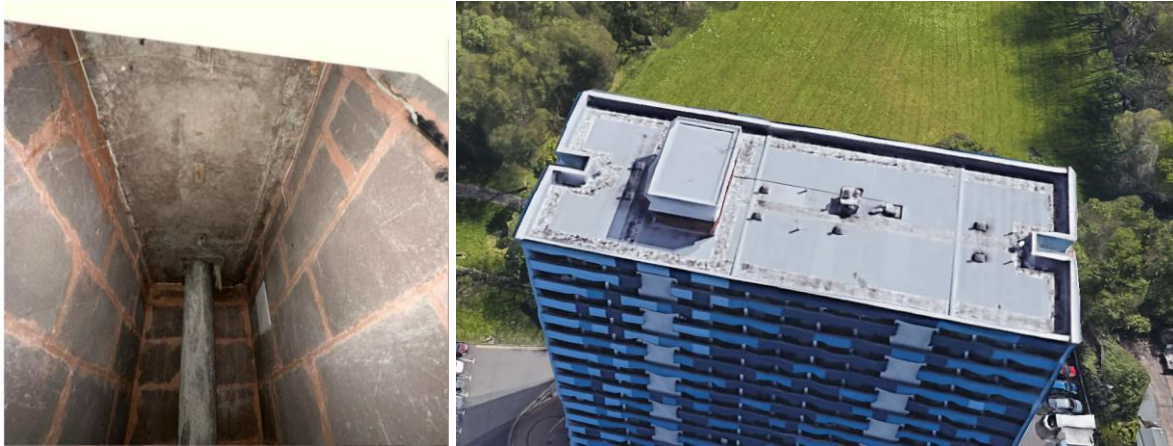
Figure 11 and 12: Underside of roof slab and satellite image

The roof was not accessible at the time of our inspection. However from satellite images it appears to be a flat roof structure with a reinforced concrete cast slab with perimeter RC parapet wall allowing safe access. There is an enclosure which partially covers the roof area likely comprising the lift plant, stair core and water tank.

The exact build-up of the roof finishes were not accessible at the time of inspection. It is recommended an intrusive survey of the roof finishes is completed by a specialist surveyor to assess the condition of the roof covering.

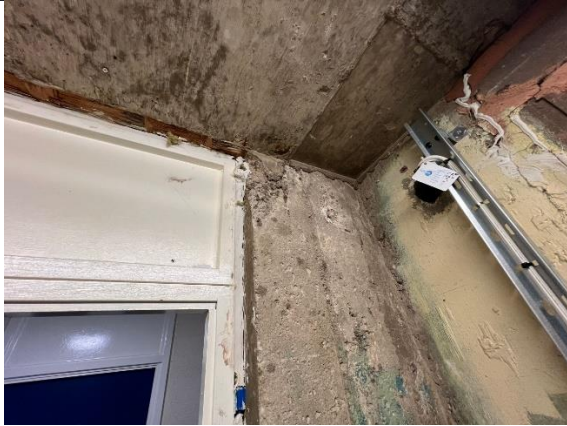
There was some localised spalling noted to a concrete elements in the electrical room at 16<sup>th</sup> floor which should be repaired by a specialist concrete repair company. It is likely that the same outfit that performs the intrusive investigations will be able to complete the repair.

Figure 13 and 14: Localised spalling and Vertical RC Structure Visible in Bin Store

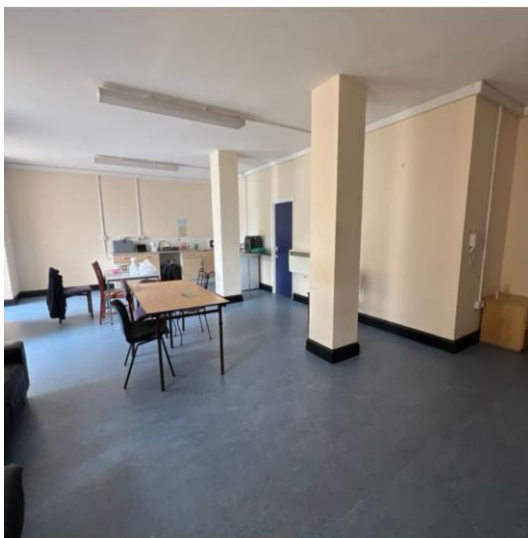
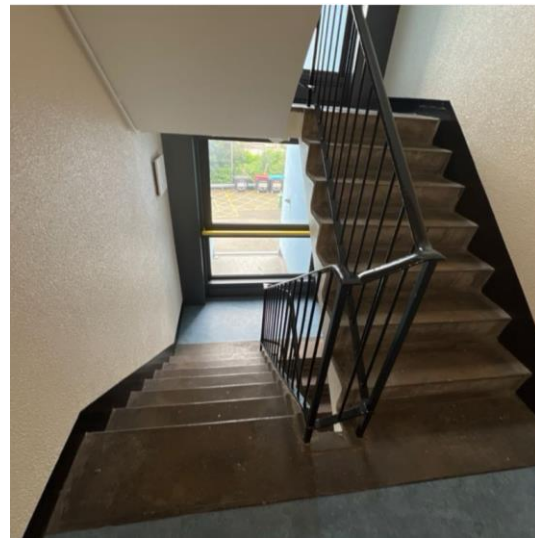
Figure 15 and 16: Internal RC Columns noted to be boarded and RC Staircase

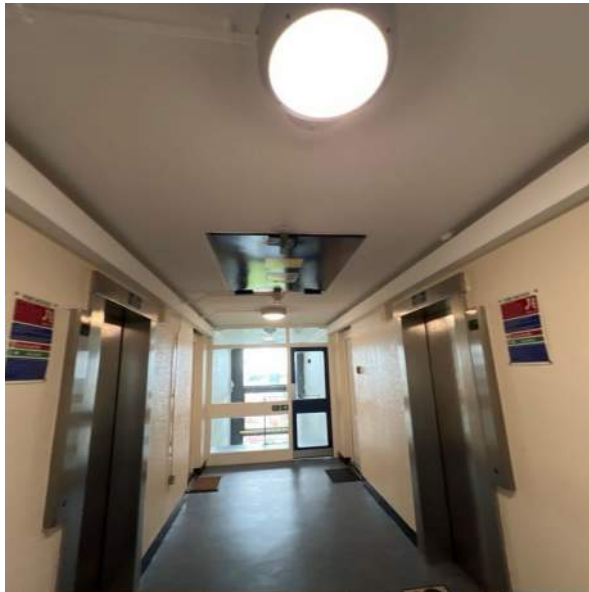
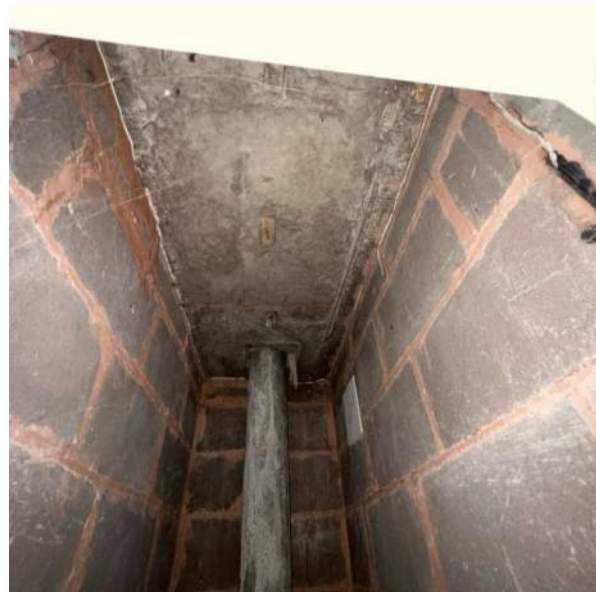
## Main Roof

Comments: No access ladder present on site to access roof.  
Insitu RC Concrete roof slab noted via dry riser cupboard.

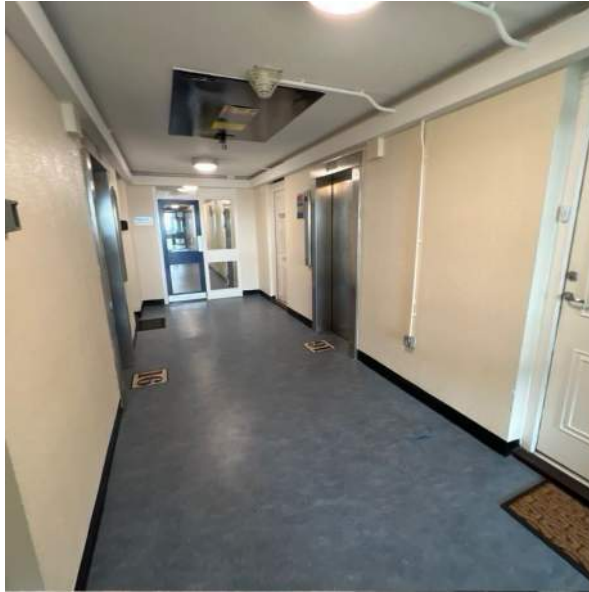
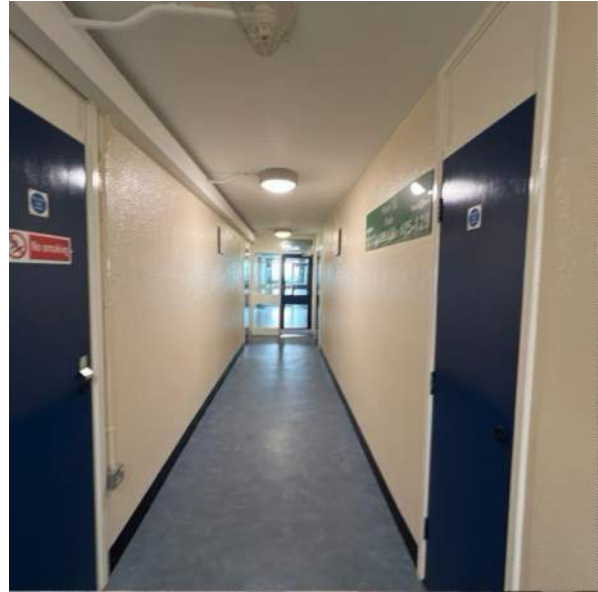
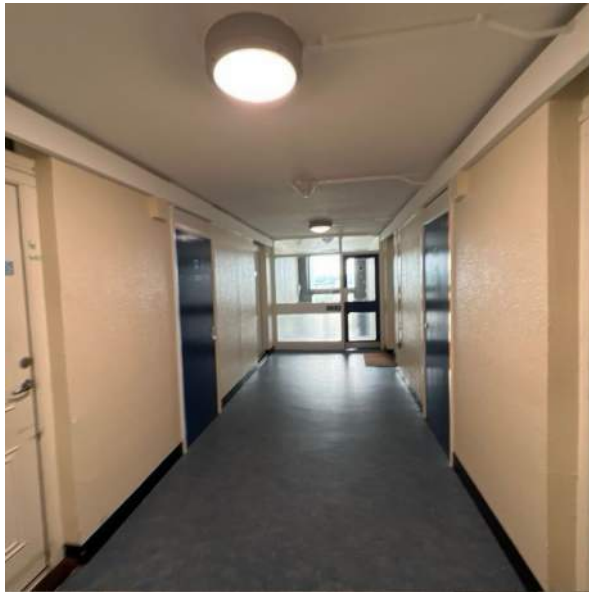
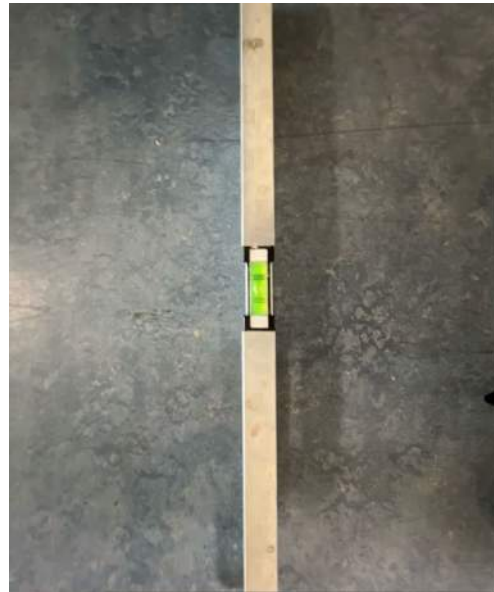
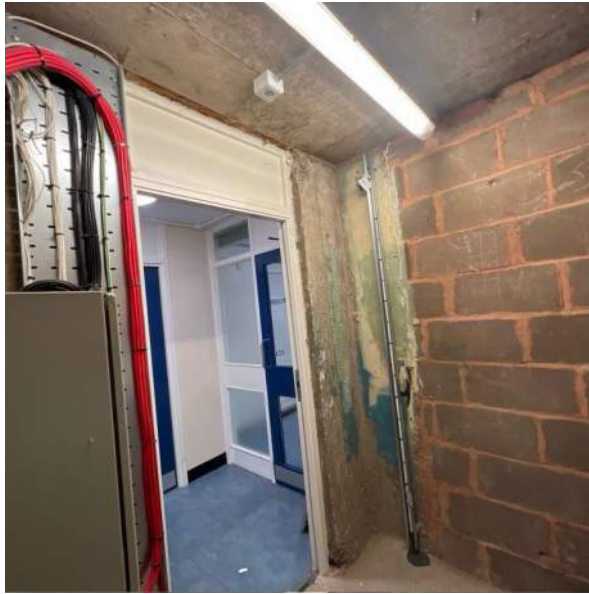
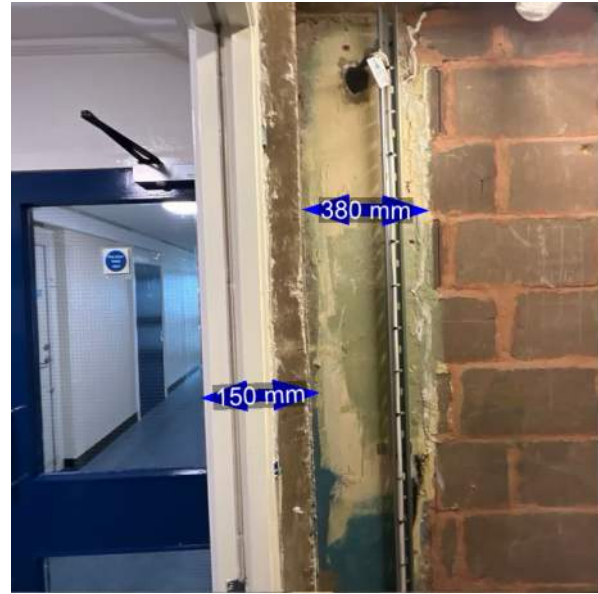
## 16th Floor Hallway

The lift and stair core located to two sides of the hallway. No jams or distortions noted to hallway doors to indicate any serviceability issues.  
Generally walls covered with finishes in hallway, likely to consist a mixture of concrete shear walls, embedded columns and block infill walls.  
Concrete walls forming part of the primary structure noted in the electric room. Walls noted to be approx. 150mm thick.

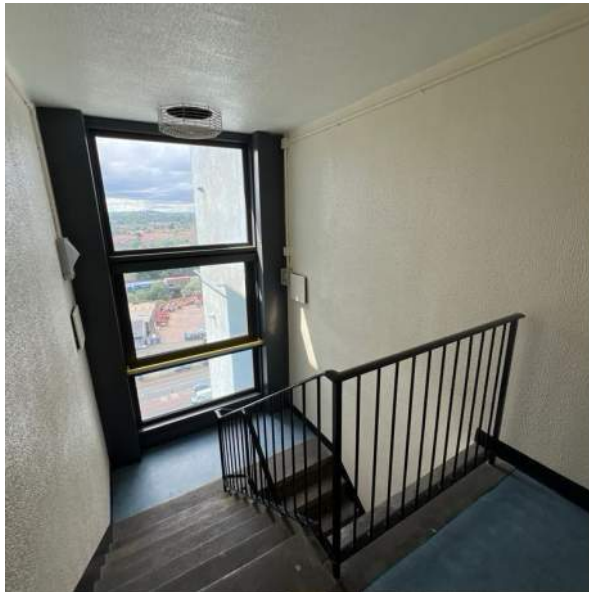
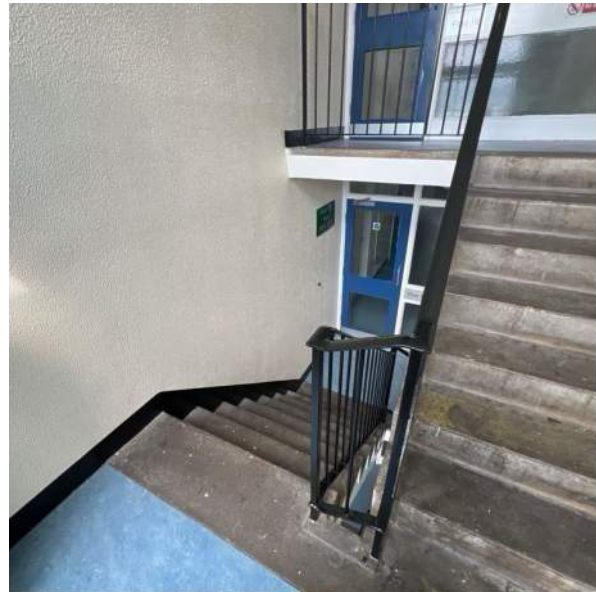
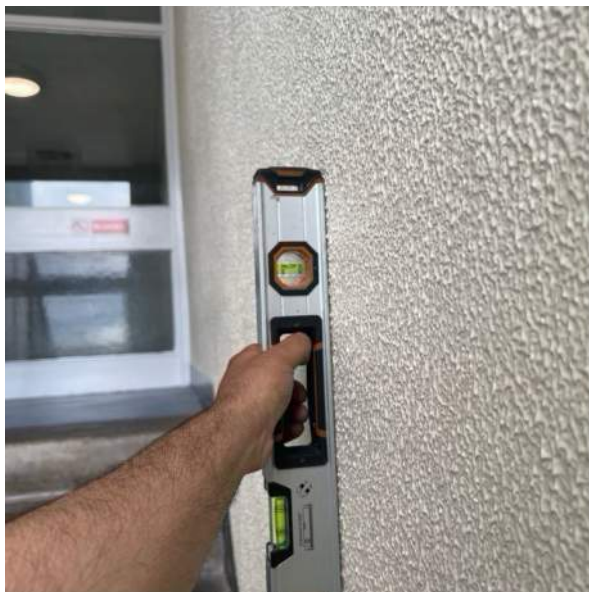
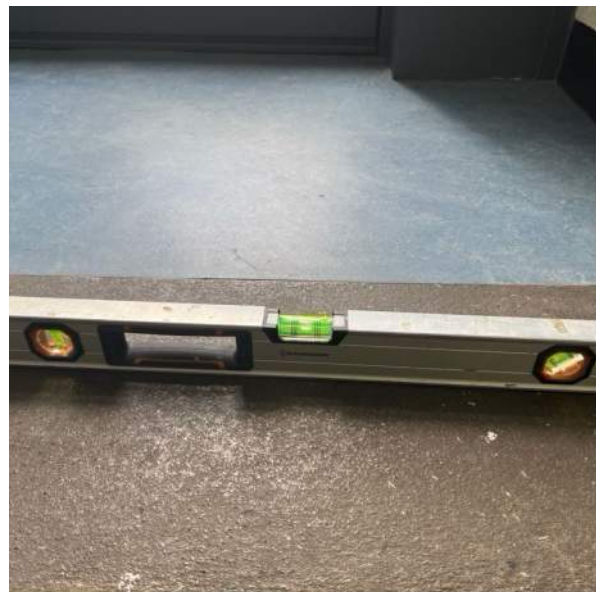
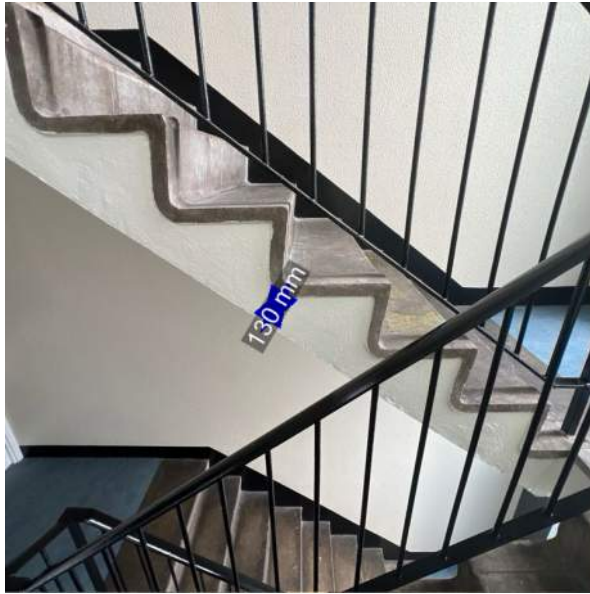
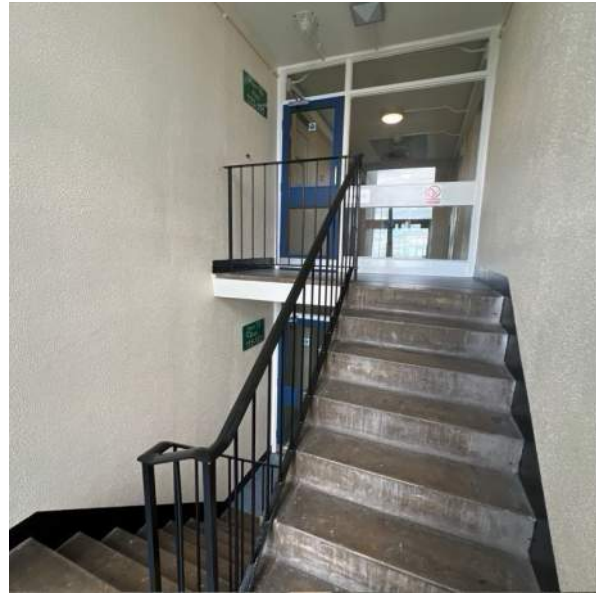
## 16th Floor Staircases (Both Sides)

Insitu concrete stairs with steel hand railing fixed to stairs. Walls and floors appear to be fairly level but some areas noted to be uneven likely due to finishes.  
Stair walls covered with finishes however these would likely form the main concrete shear core walls.  
Floor slab measures from stair platform appears to be approx. 180mm thick.

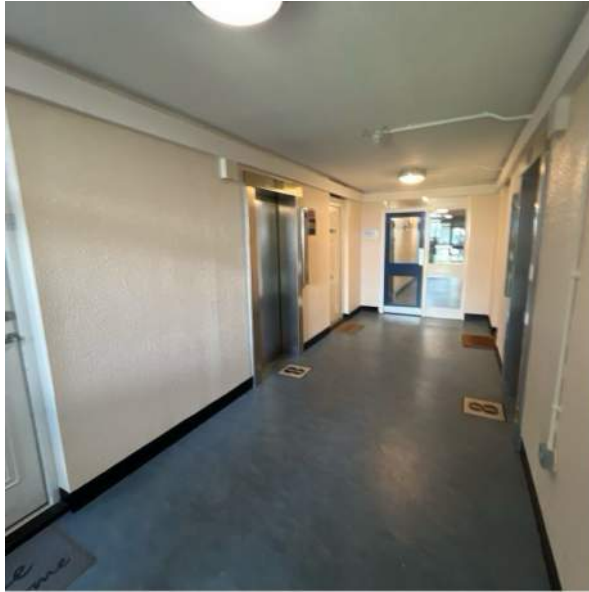
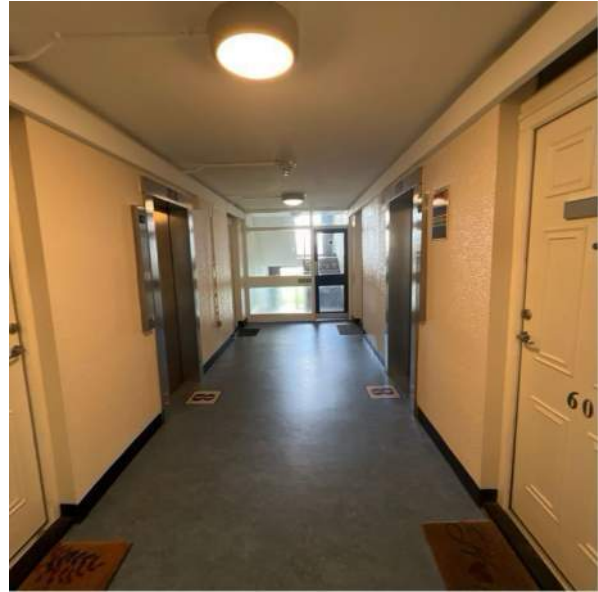
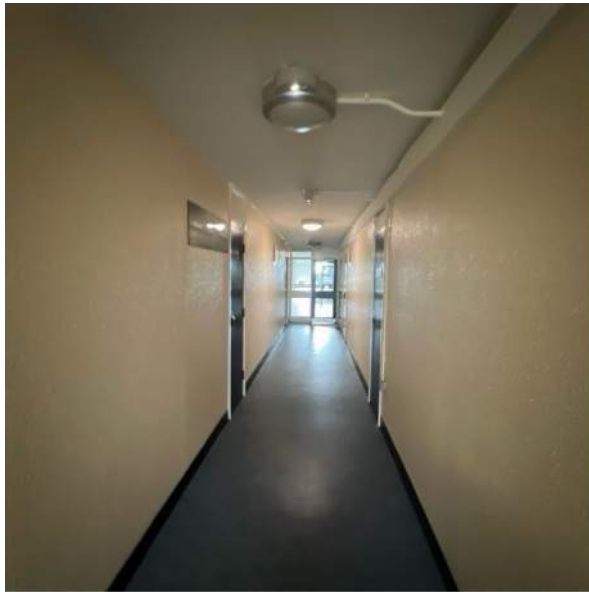
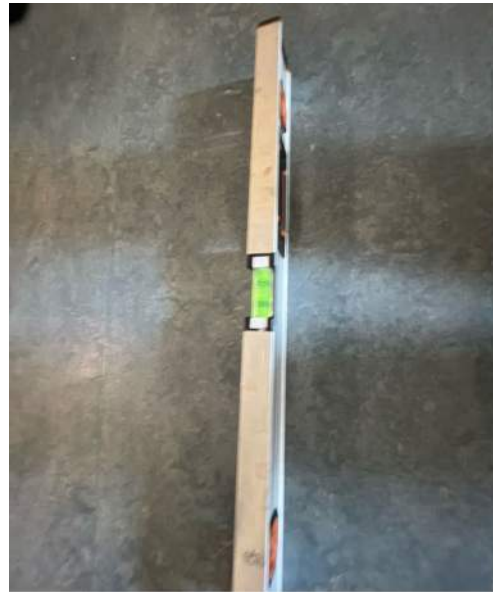
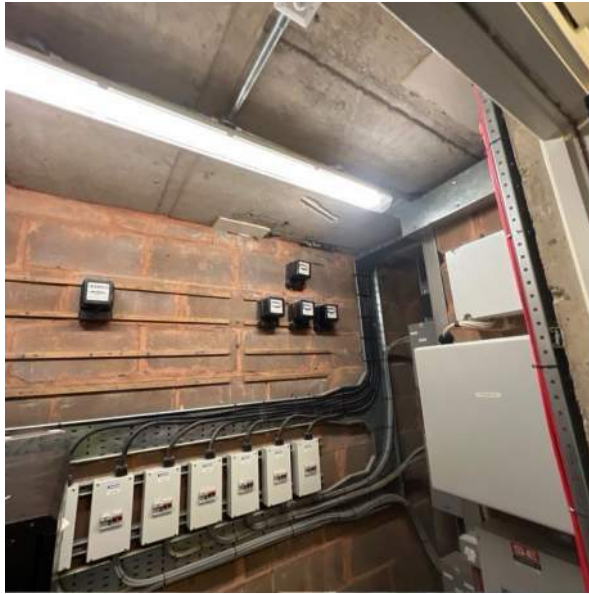
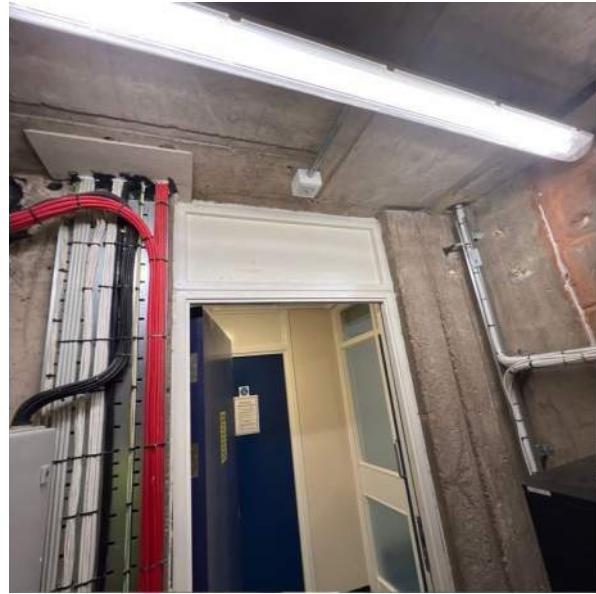
## 8th Floor Hallway

The lift and stair core located to two sides of the hallway. No jams or distortions noted to hallway doors to indicate any serviceability issues.  
Generally walls covered with finishes in hallway, likely to consist a mixture of concrete shear walls, embedded columns and block infill walls.  
Concrete walls forming part of the primary structure noted in the electric room. Walls noted to be approx. 150mm thick.  
Insitu concrete floor slabs noted in electric room.

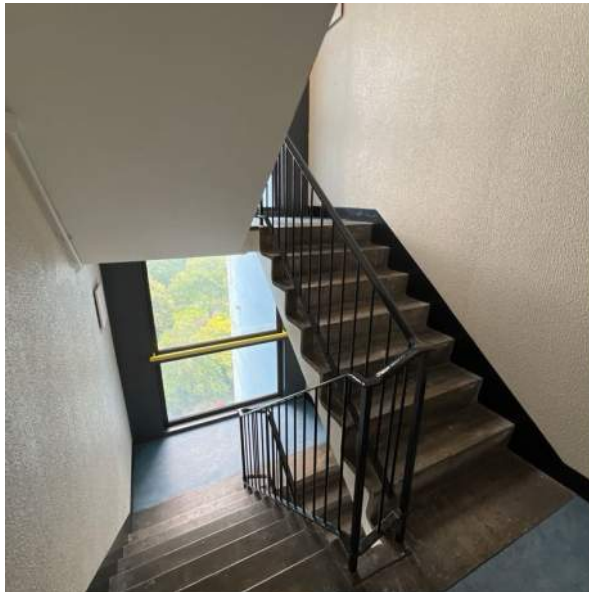
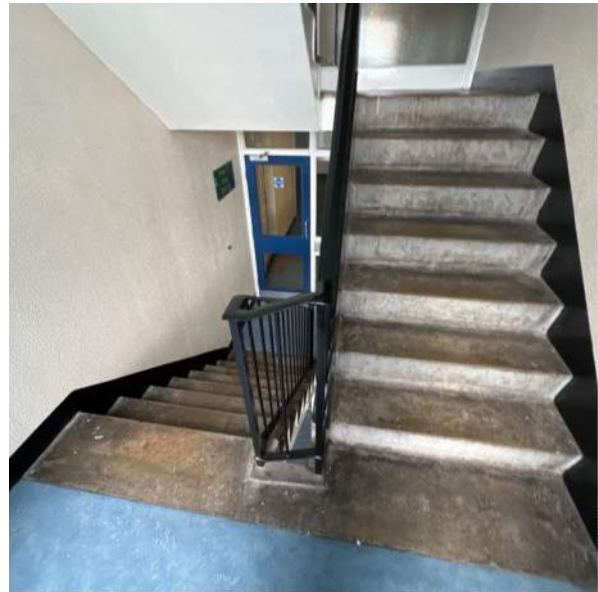
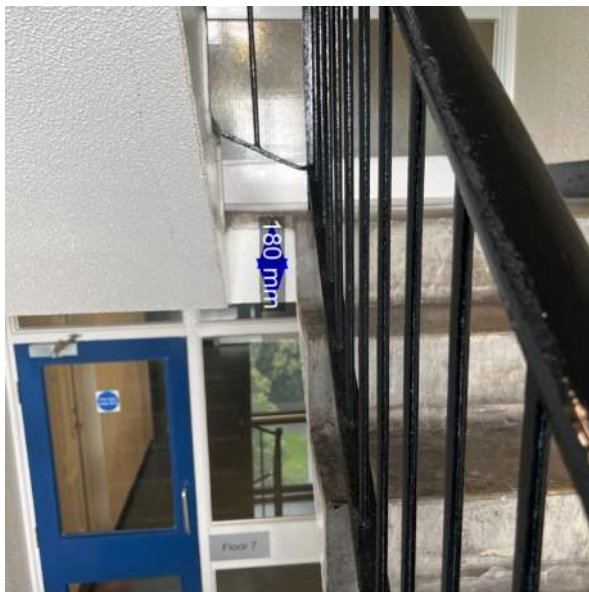
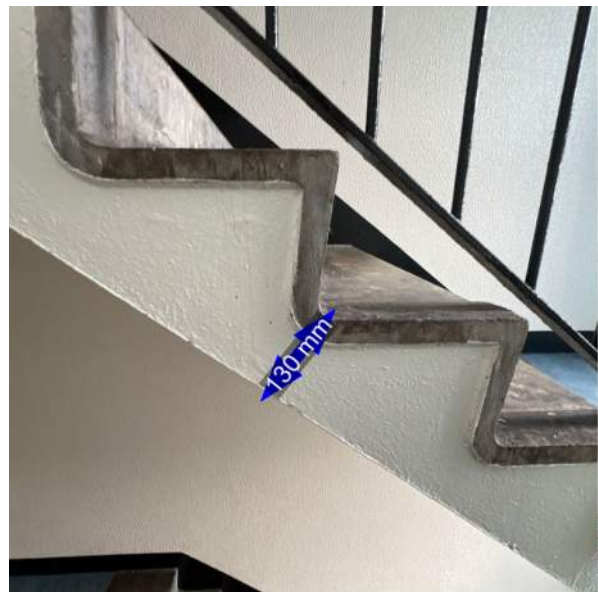
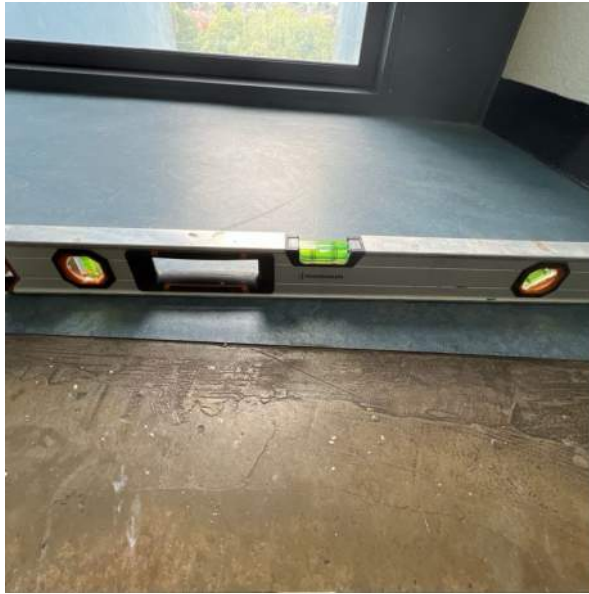
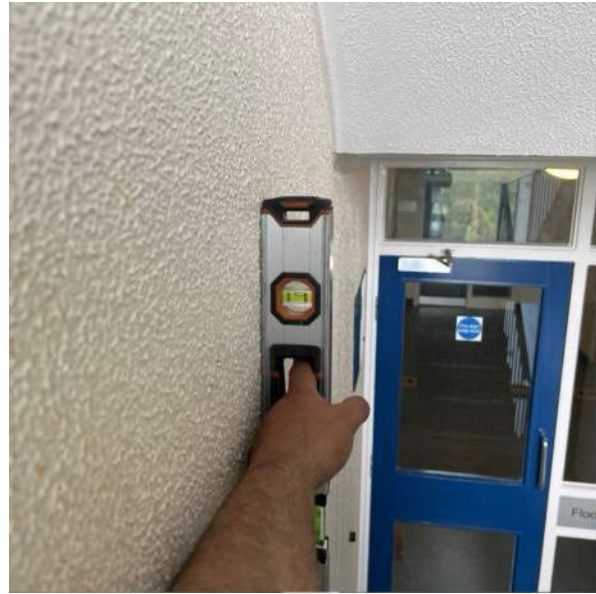
## 8th Floor Staircases (Both Sides) - Copy

Insitu concrete stairs with steel hand railing fixed to stairs. Walls and floors appear to be fairly level but some areas noted to be uneven likely due to finishes.  
Stair walls covered with finishes however these would likely form the main concrete shear core walls.  
Floor slab measures from stair platform appears to be approx. 180mm thick.

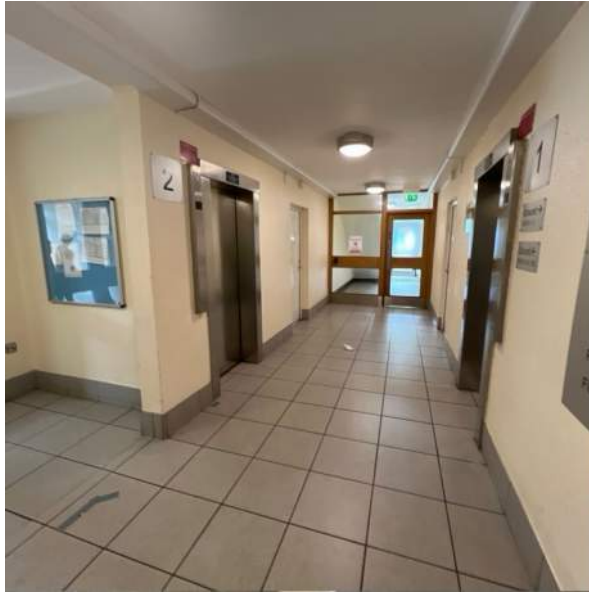
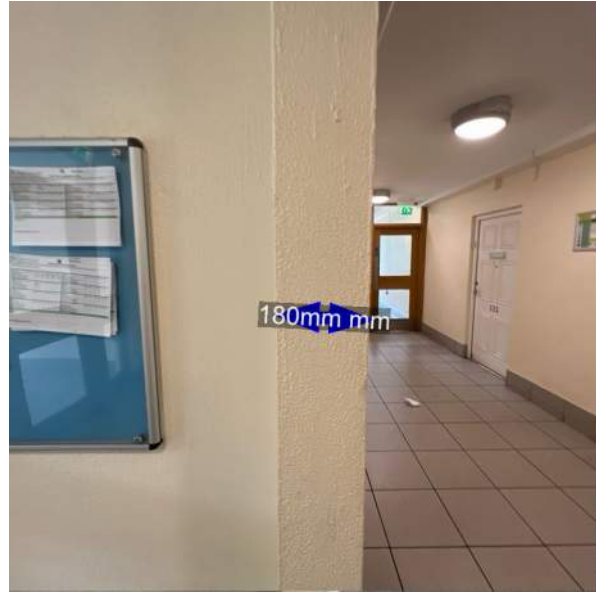
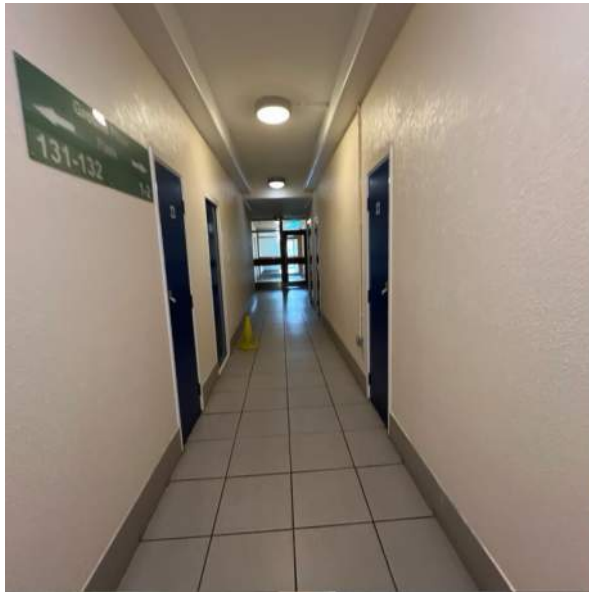
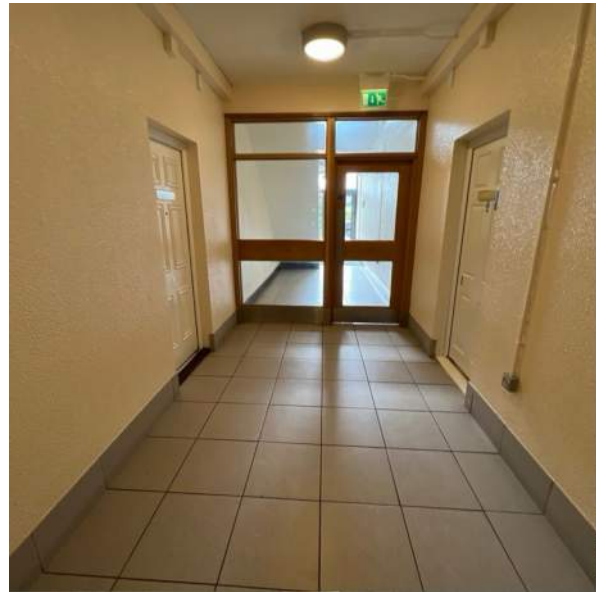
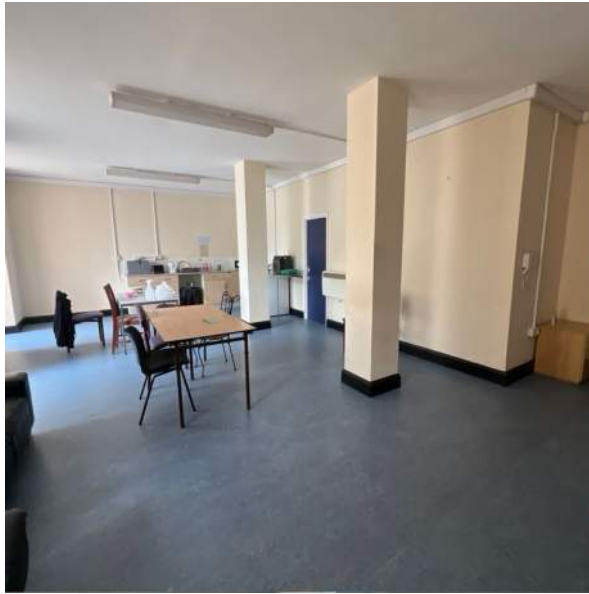
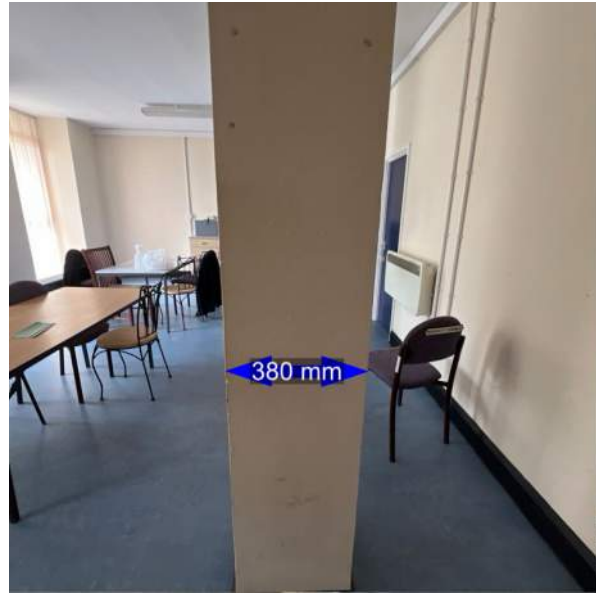
## Ground Floor Hallway

RC Concrete walls and columns noted in communal areas and accessible rooms on ground floor. The columns form part of the main primary structure of the building and were measured to be 380x380mm. Ground floor concrete walls measured to be approx. 180mm.

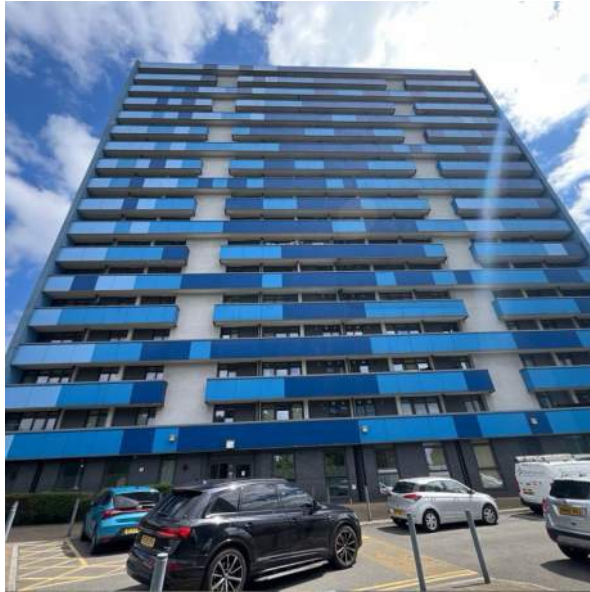
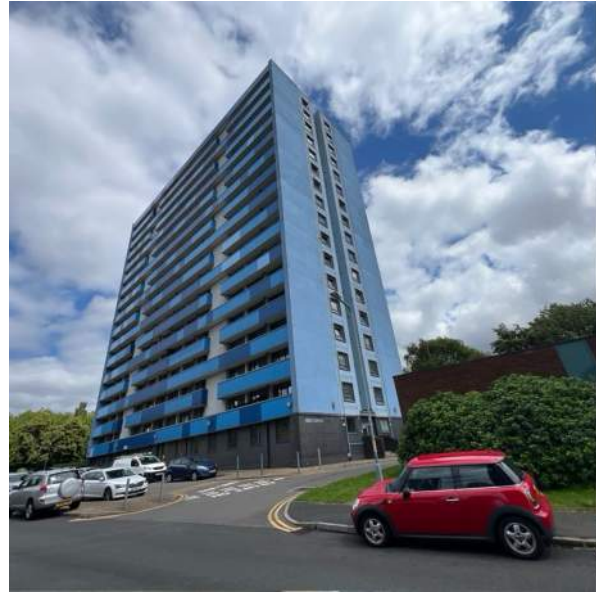
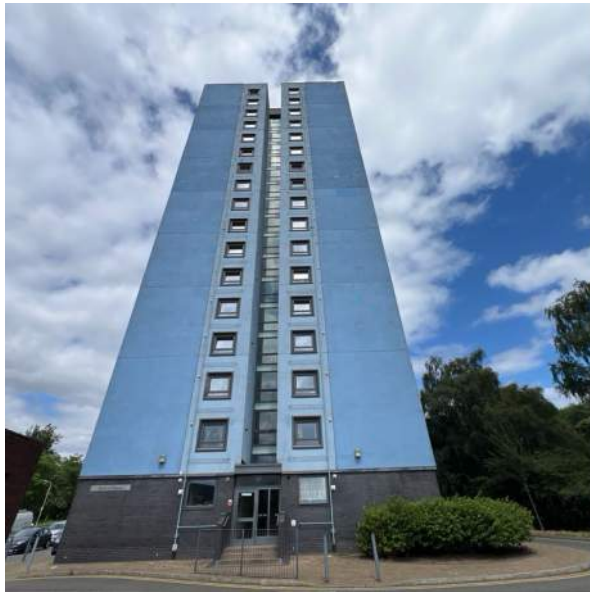
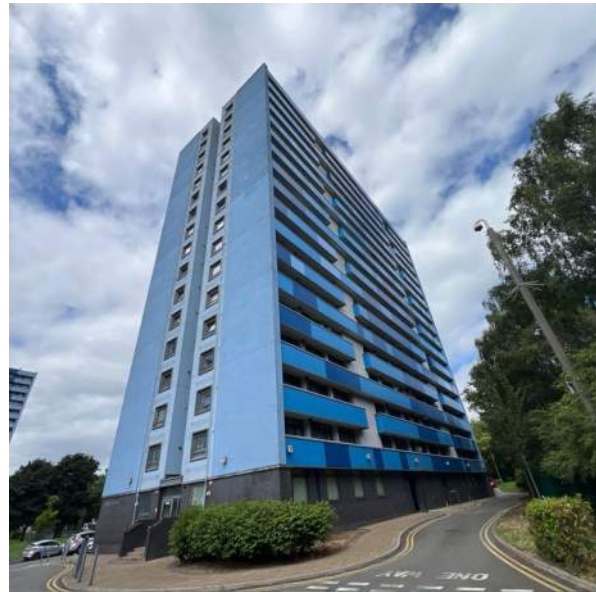
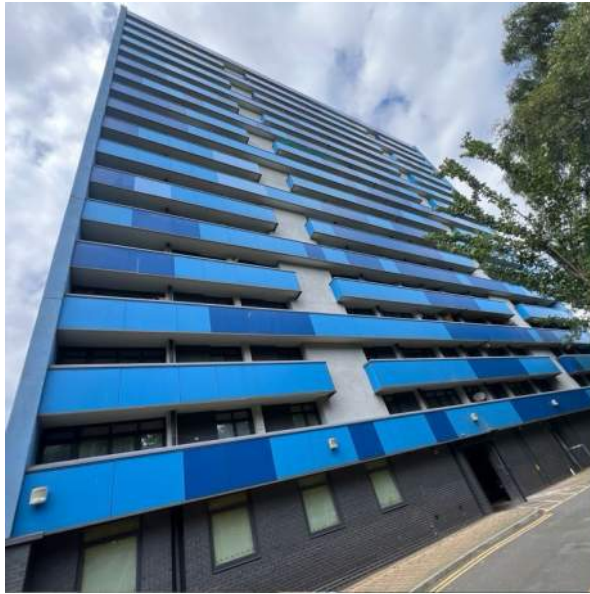
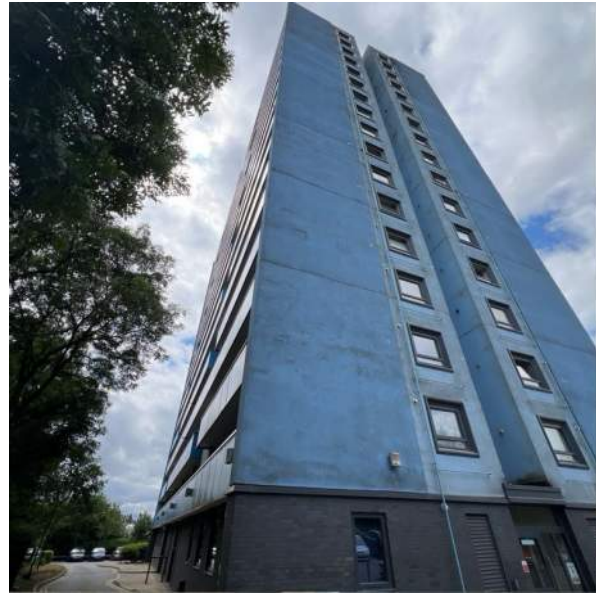
## Elevations

External ground floor level consists of brick work.  
Upper floors noted to have a rendered facade and cladding to balconies.  
Concrete columns noted to perimeter which form part of  
the primary structural elements of the building.

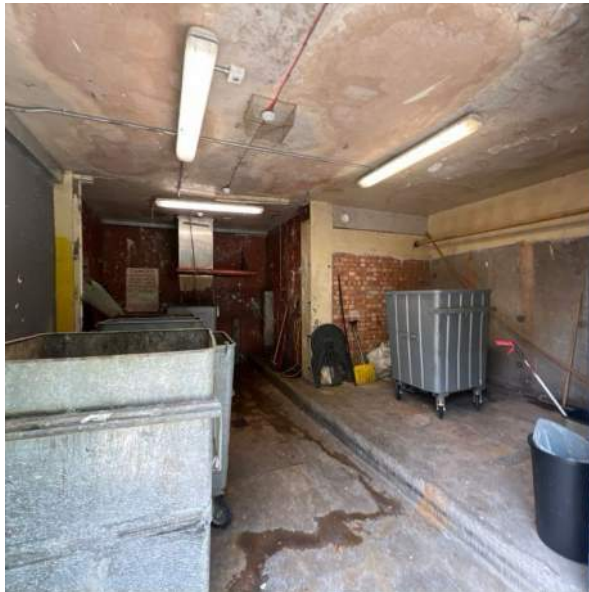
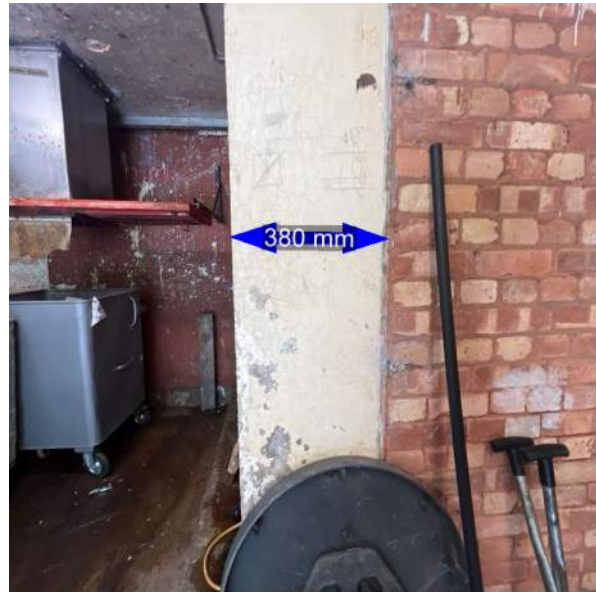
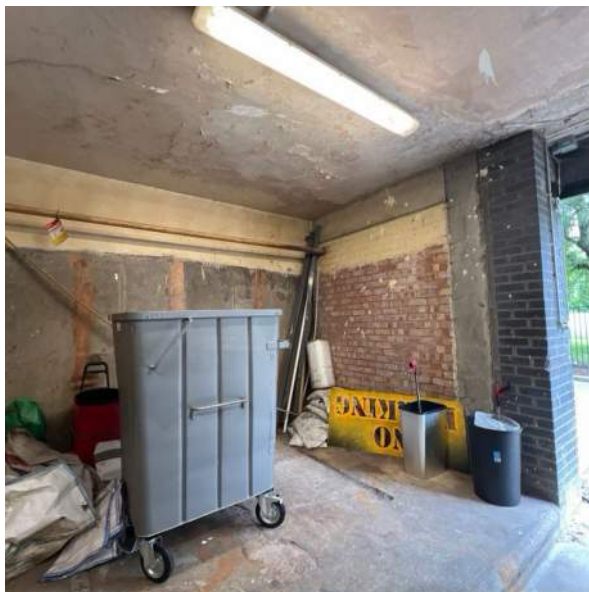
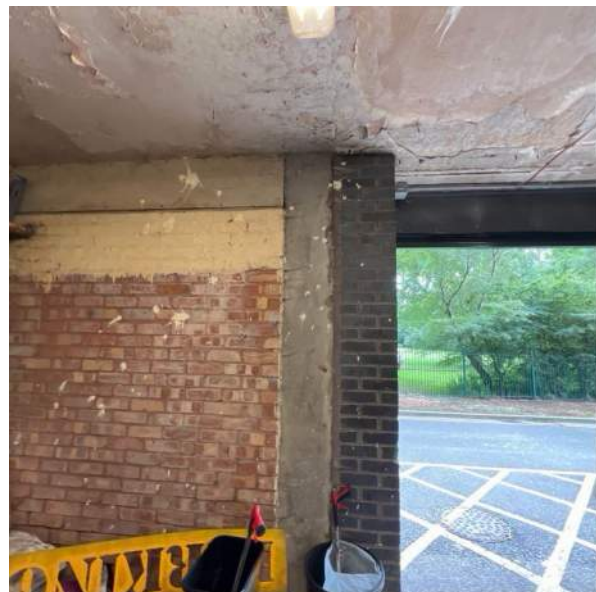
## Bin store

Exposed concrete structure noted in bin store. Concrete shear wall and 380x380mm concrete columns.
