VISUAL STRUCTURAL APPRAISAL

Kynaston House

Rydding Lane  
West Bromwich  
B71 2HD

3<sup>rd</sup> September 2025

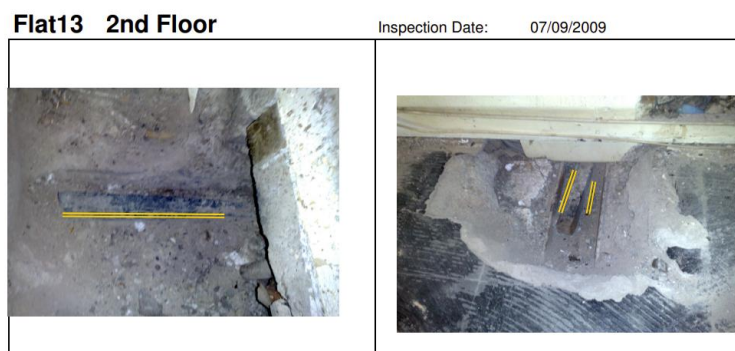
Figure 2: Photographic evidence of ties installed at Russell House. From archive information and historical communications we understand similar stiches between floor slabs and external walls are installed at Kynaston also, however we have no evidence. Therefore some intrusive investigations required to evidence their presence.

We understand that the reports referred are not available at this time and thus far we have not located photographic evidence that the ties have been installed at Kynaston as stated above. We were provided however of photographic evidence of the ties at installed at Russell House, see below. We recommend these are spot checked within Kynaston also in say 25% of the units.

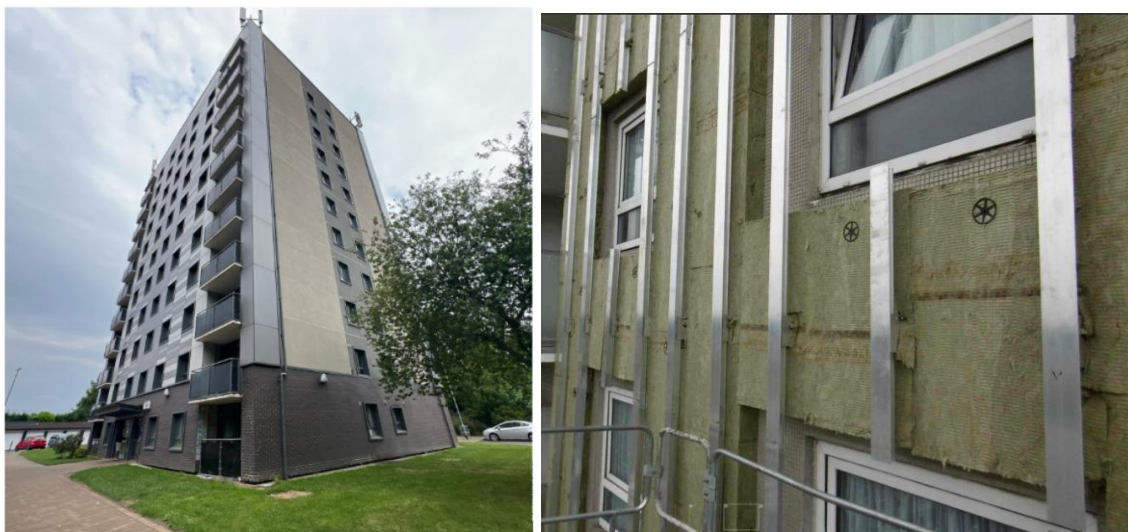
Figure 11 and 12: Building Elevations and photographs of Re-clad in progress

There are cantilevered stacked balconies at every level. These have steel railings with glass infill panels. No signs of significant movement noted.

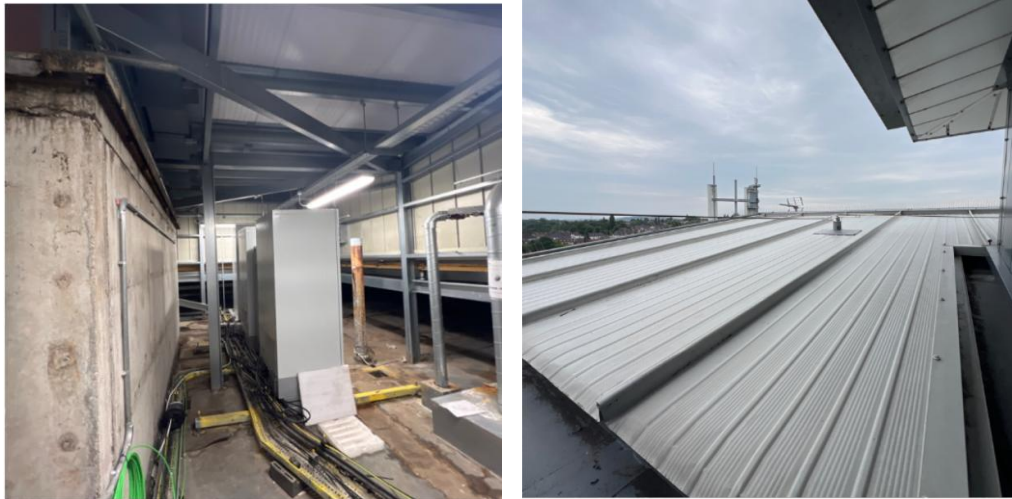
Figure 13 and 14: Roof Level

There were no tell-tale signs of any significant structural movement noted at the time of our inspection. The drainage system should be checked and cleared as part of the normal regimen of maintenance.

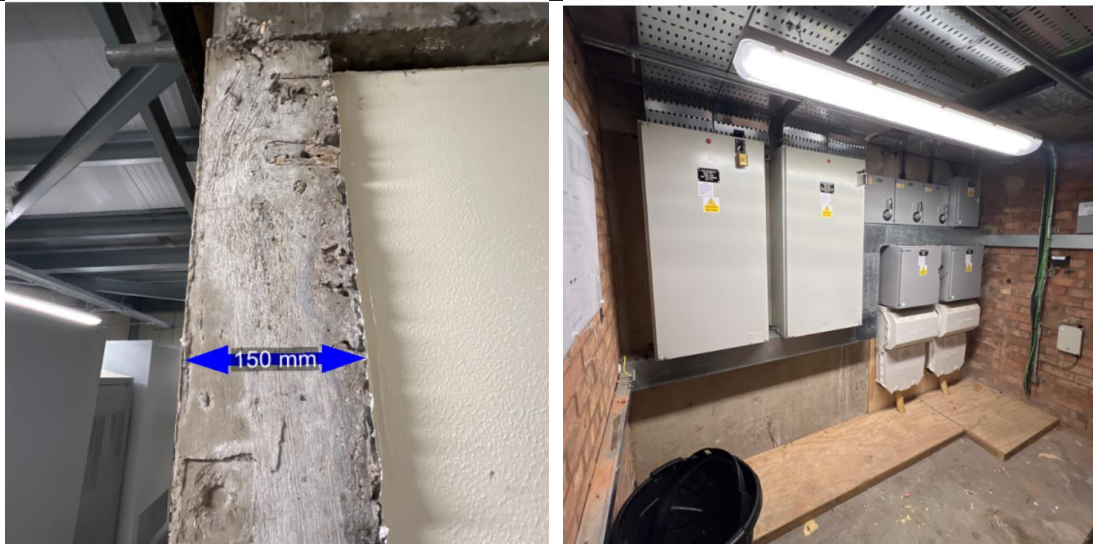
Figure 15 and 16: RC Structure

The wall panels are measured at 130-150mm thick. A cover test is required to check the resistance of the concrete section in the event of a fire.

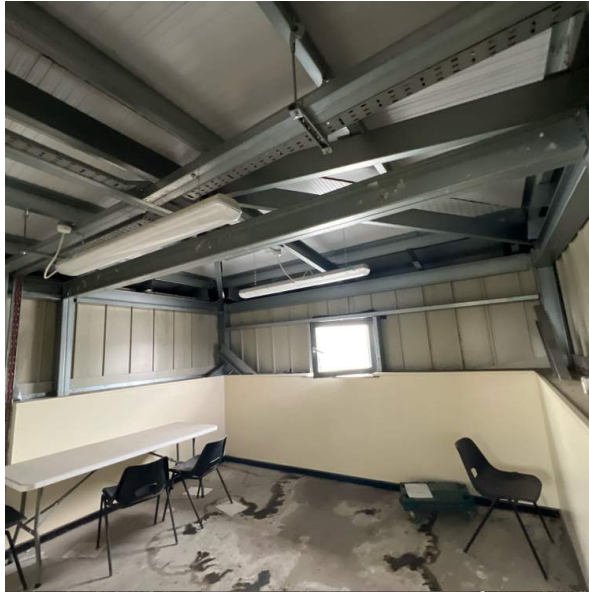
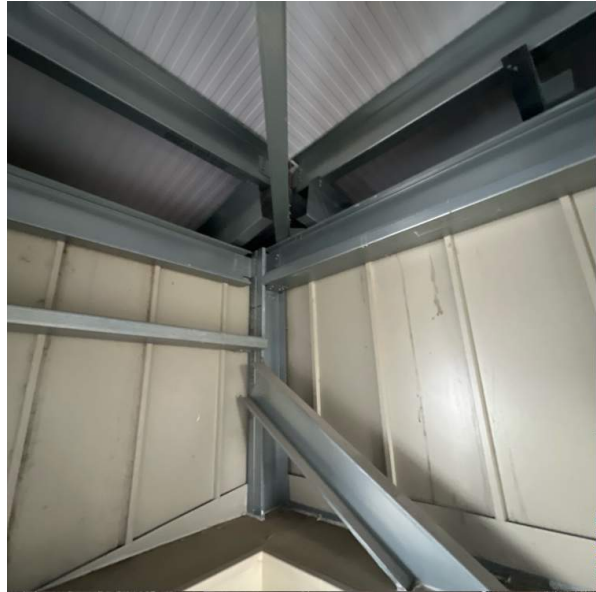
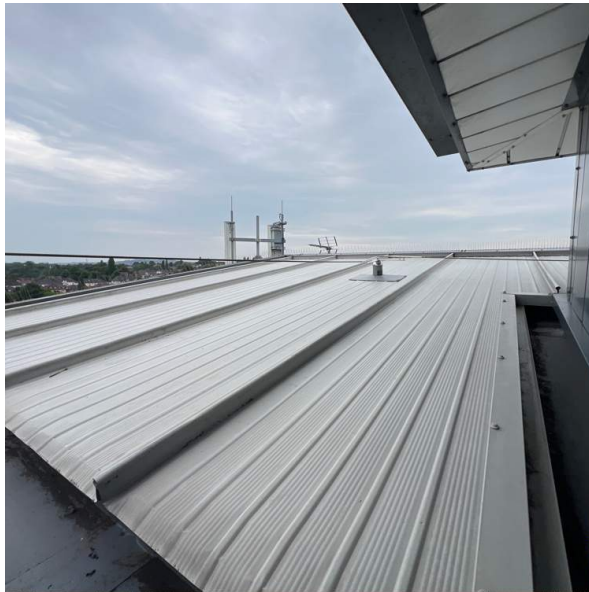
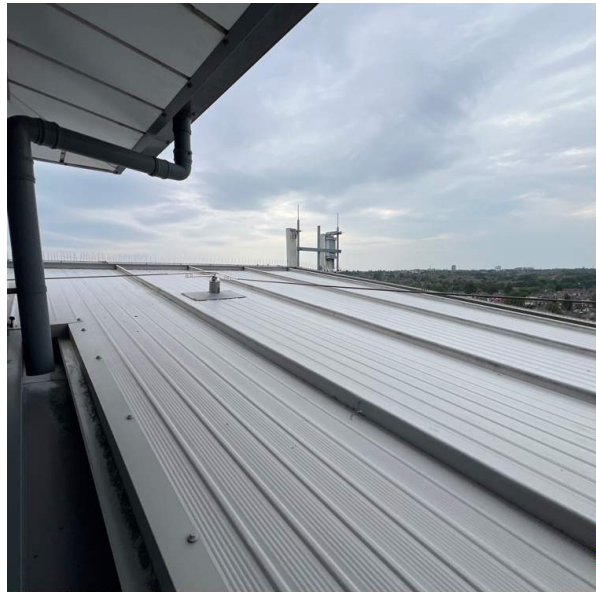
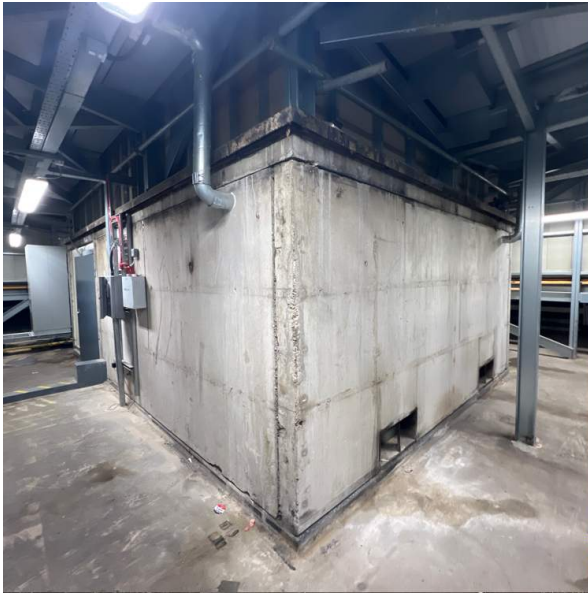
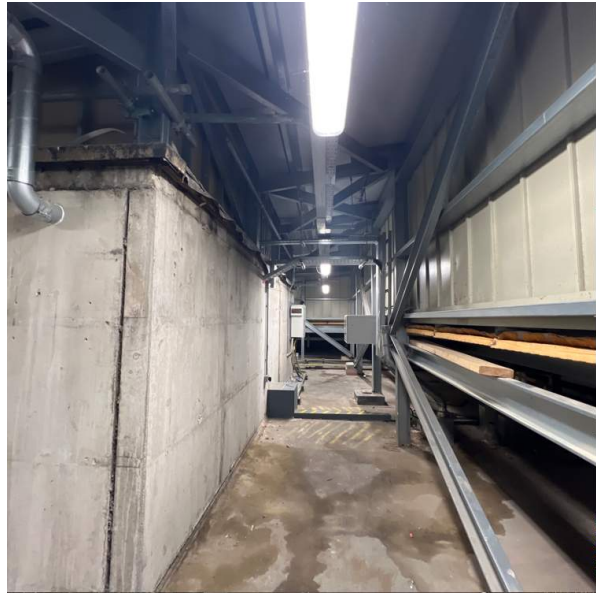
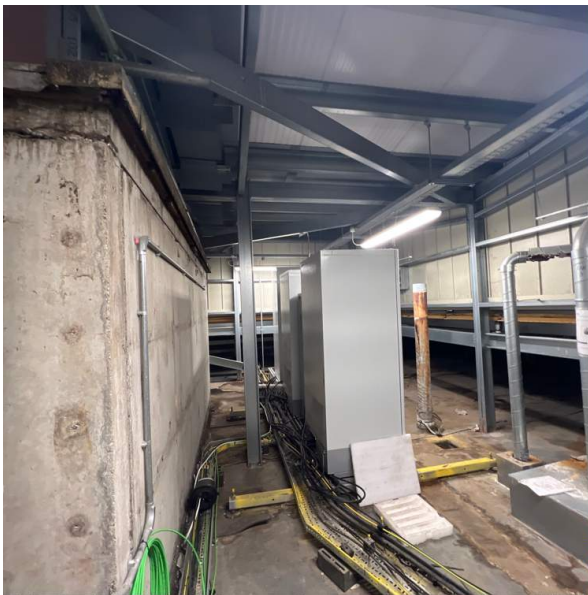
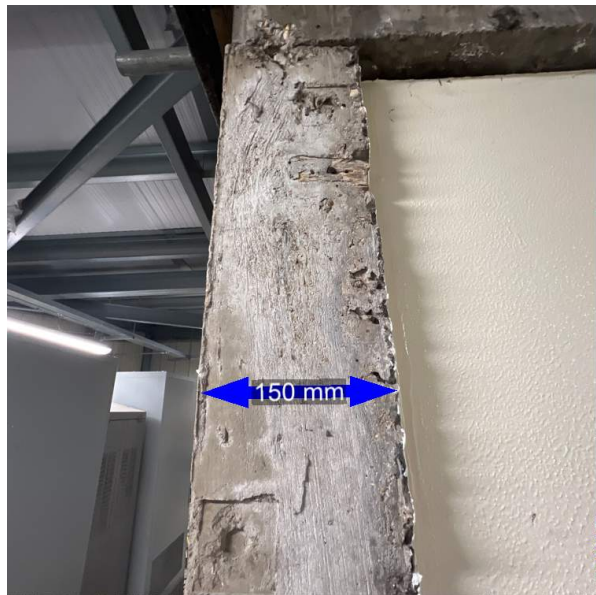
## Main Roof

Comments: A lightweight pitched roof constructed above original flat roof structure utilising beams and purlins with aluminium standing / mineral wool core profiled panels. Lift concrete shear core structure noted up to roof level.

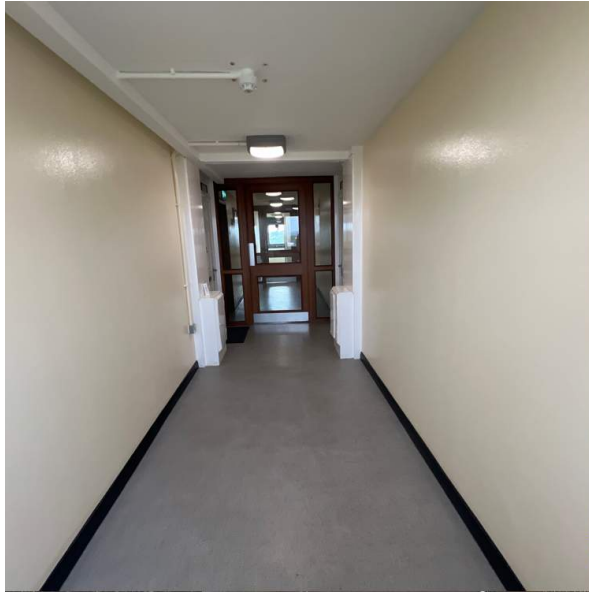
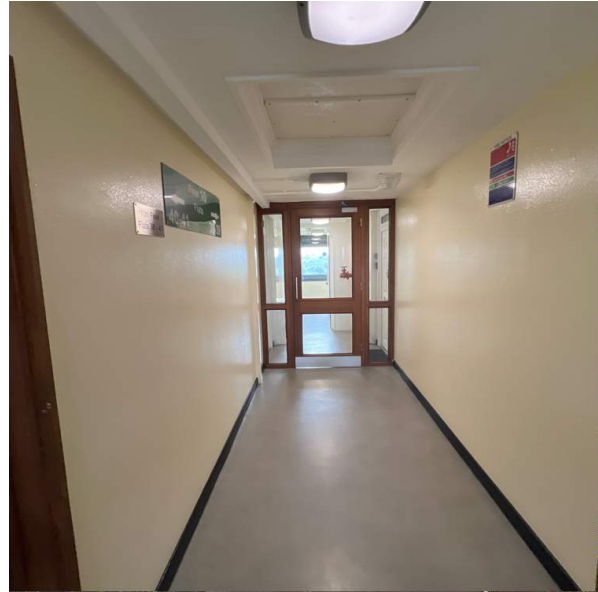
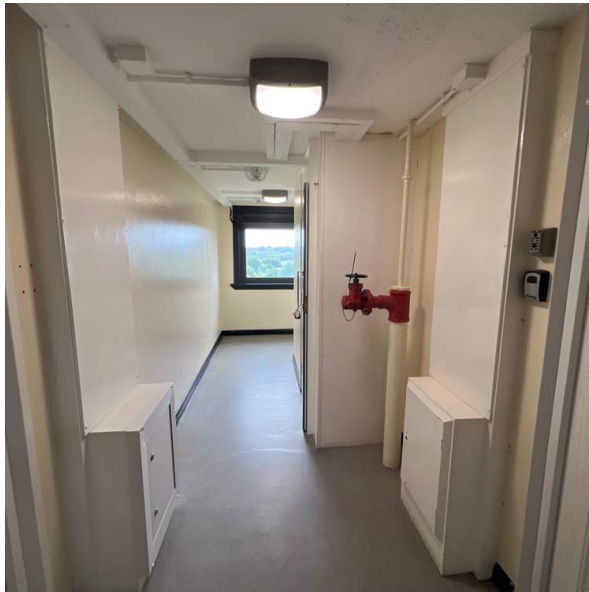
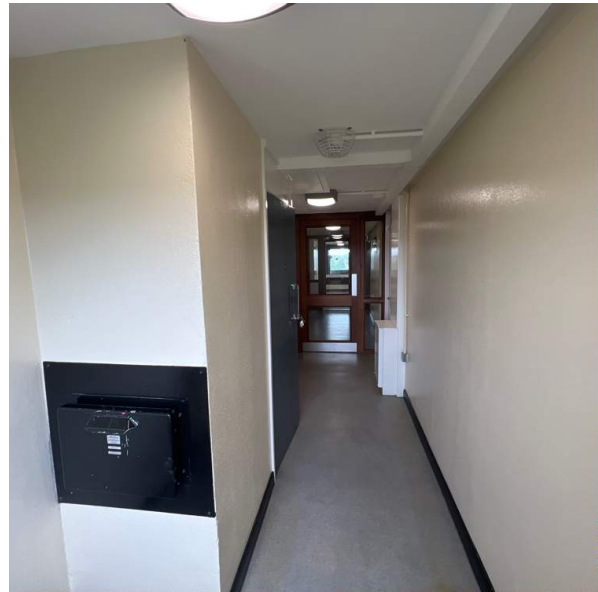
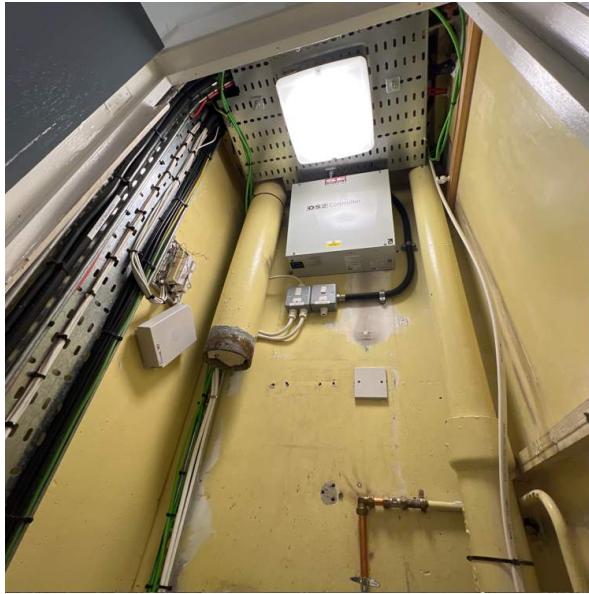
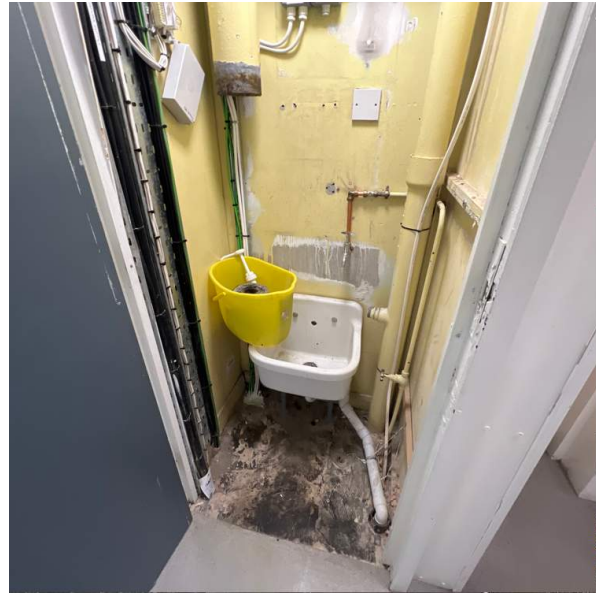
## 10th Floor Hallway

Comments: No jams or distortions noted to hallway doors to indicate any serviceability issues. Generally walls covered with finishes in hallway, likely to consist a mixture of concrete shear walls, embedded columns and masonry infill walls. Limited structure exposed. Concrete walls and infill masonry (non-load bearing) walls noted in riser cupboard.

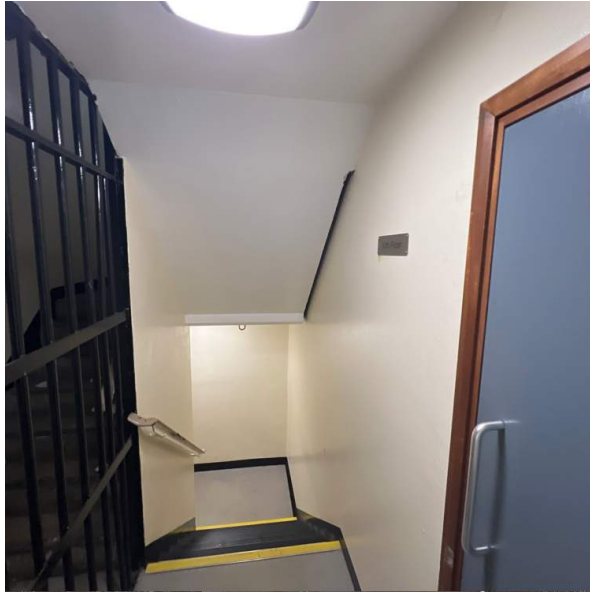
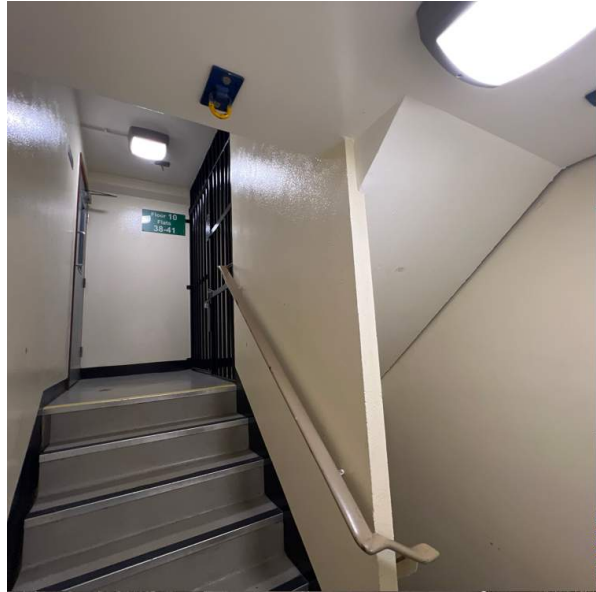
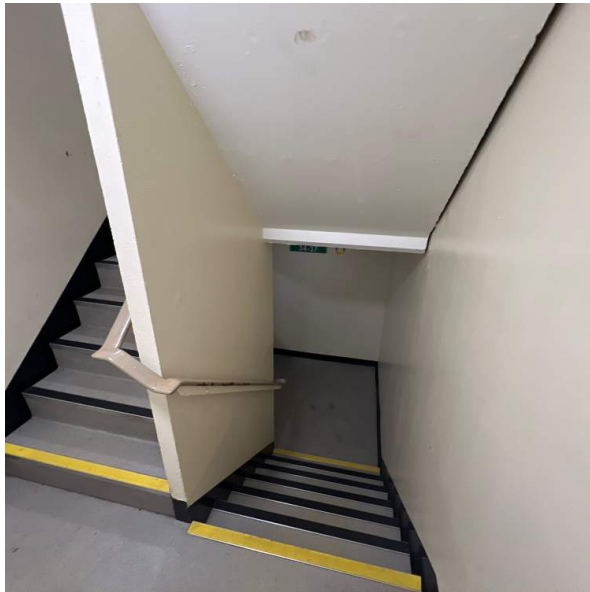
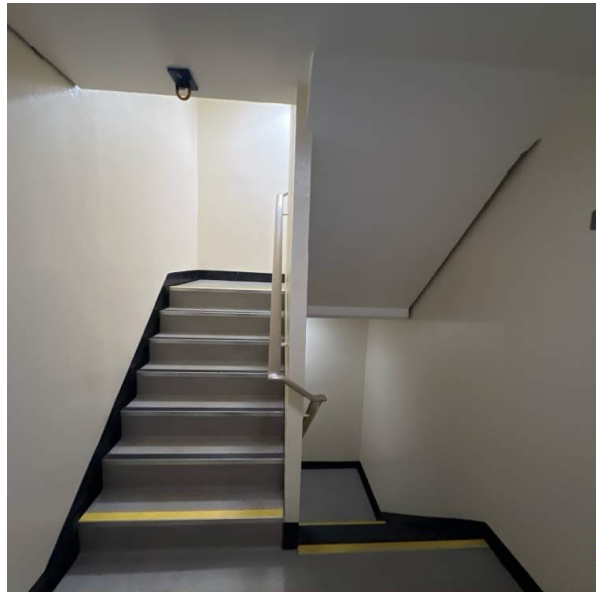
## 10th Floor Staircase

Comments:     Insitu concrete stairs.  
                     Walls and floors appear to be fairly level.  
                     Stair walls covered with finishes however these would likely form the main concrete  
                     shear core walls.

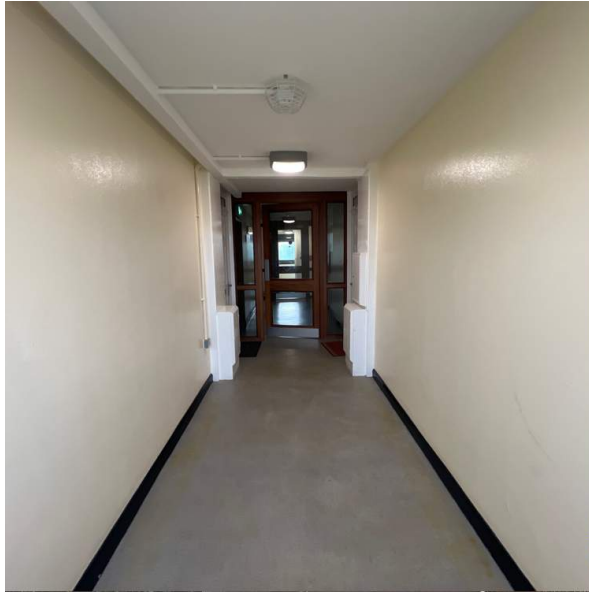
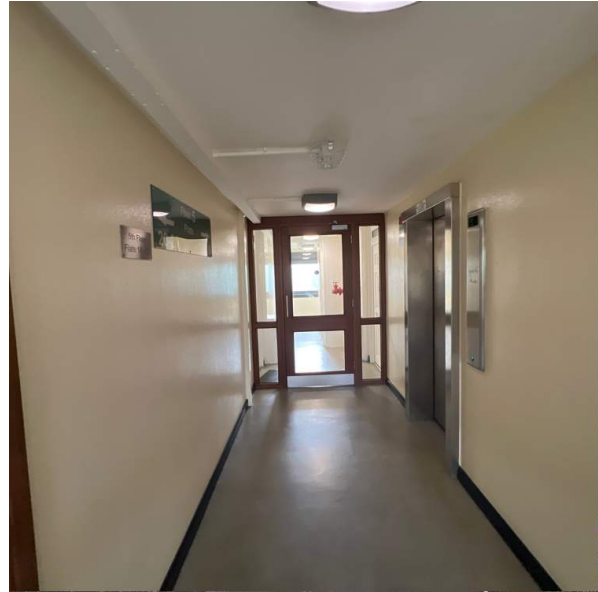
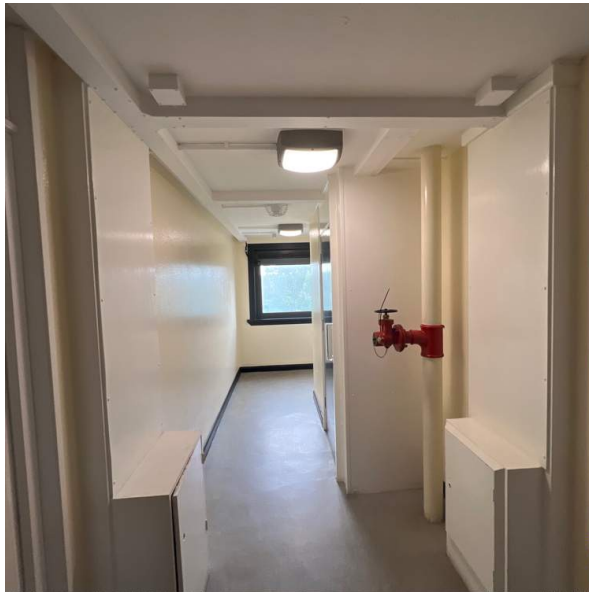
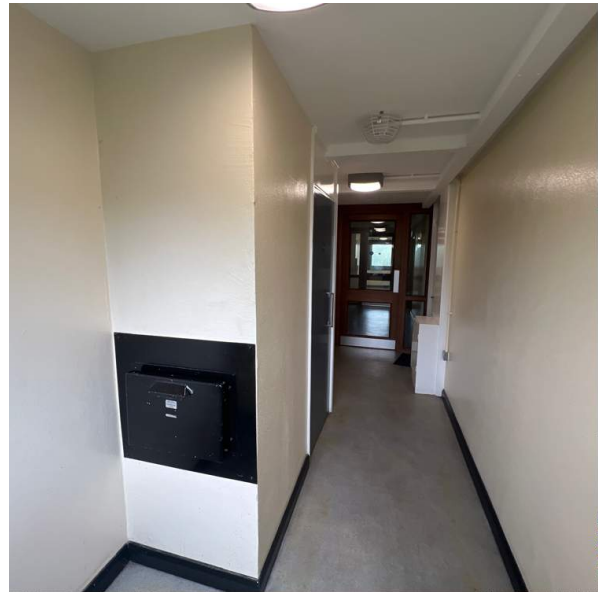
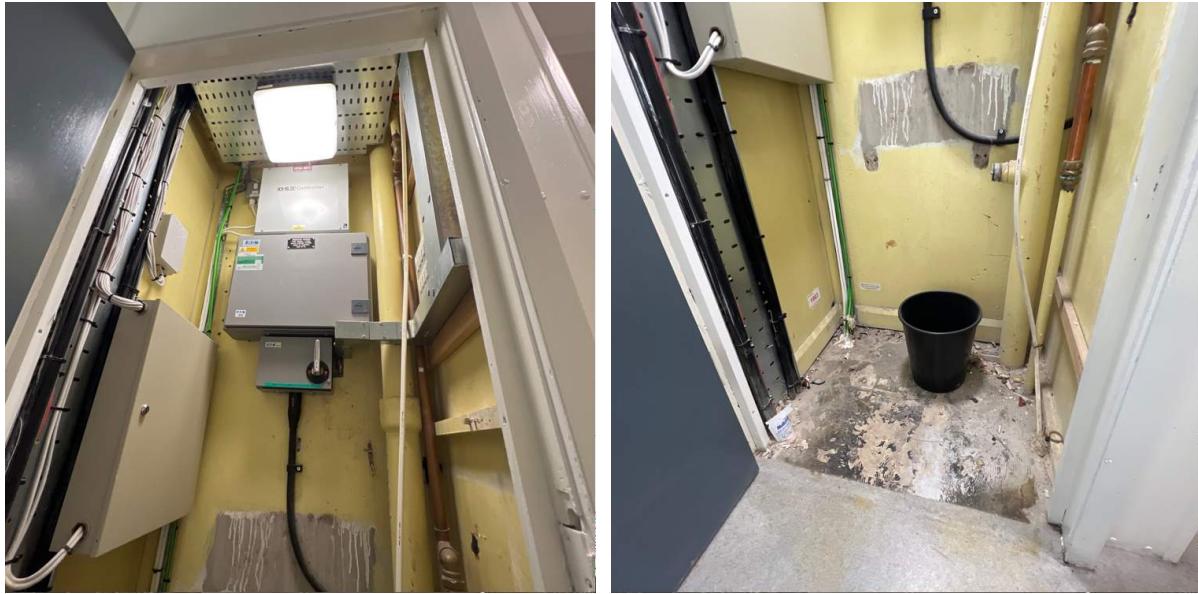
## 5th Floor Hallway

Comments: No jams or distortions noted to hallway doors to indicate any serviceability issues. Generally walls covered with finishes in hallway, likely to consist a mixture of concrete shear walls, embedded columns and masonry infill walls. Limited structure exposed. Concrete walls and infill (non-load bearing) walls noted in riser cupboard.

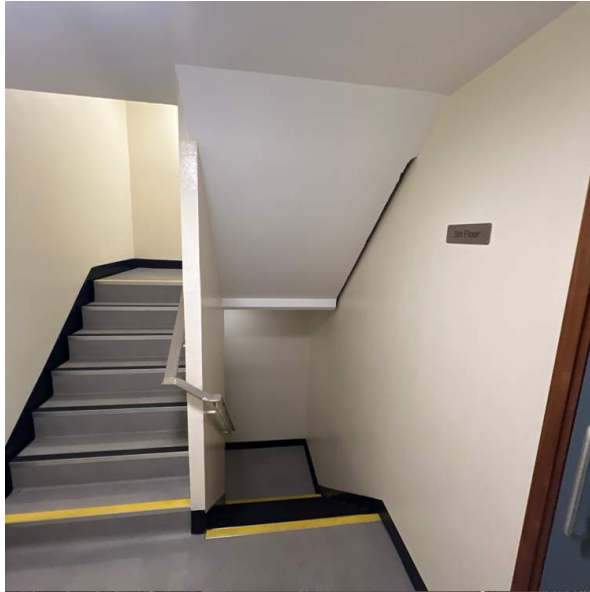
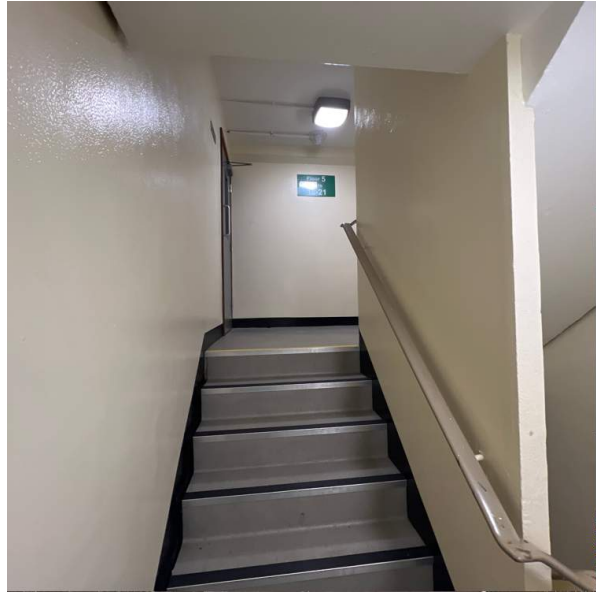
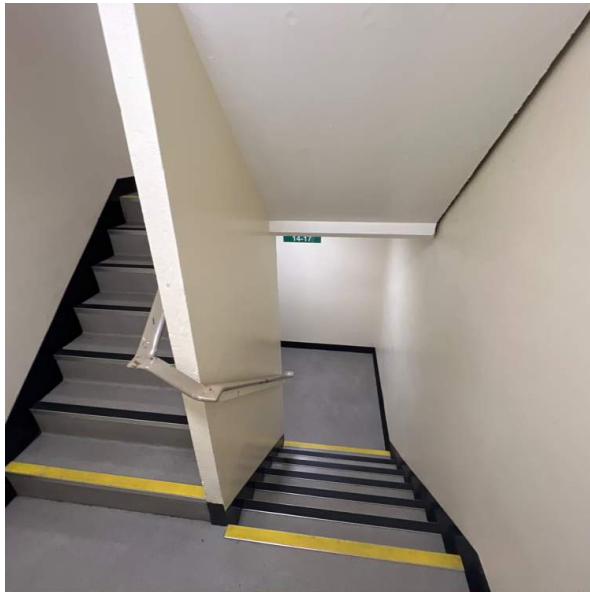
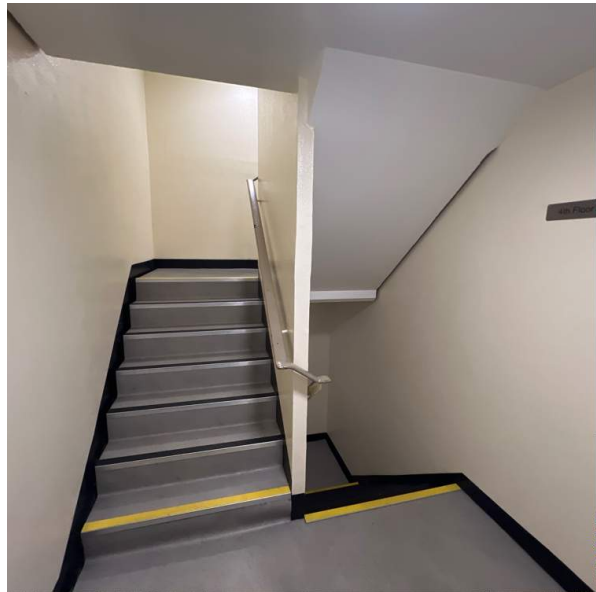
## 5th Floor Staircase

Comments:    Insitu concrete stairs.  
                  Walls and floors appear to be fairly level.  
                  Stair walls covered with finishes however these would likely form the main concrete shear core walls.

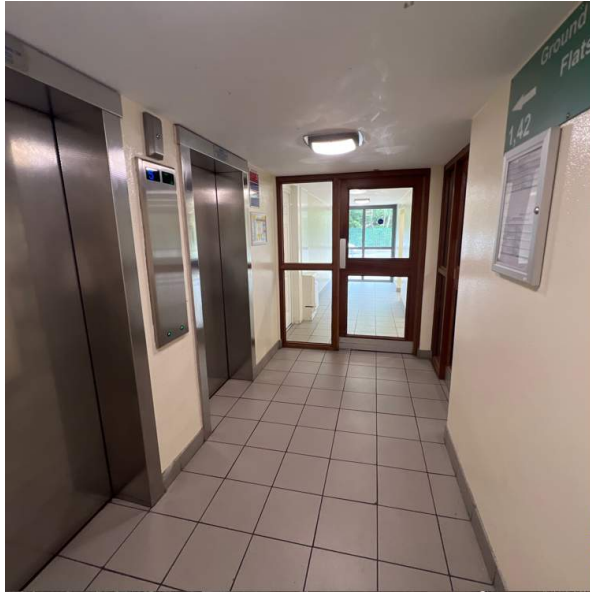
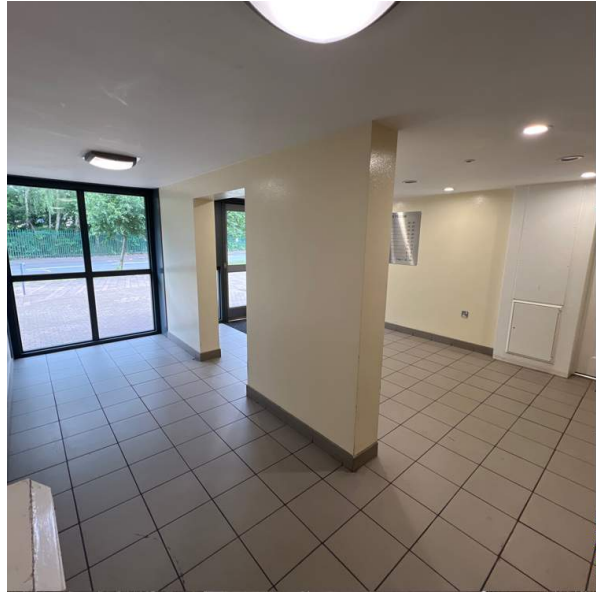
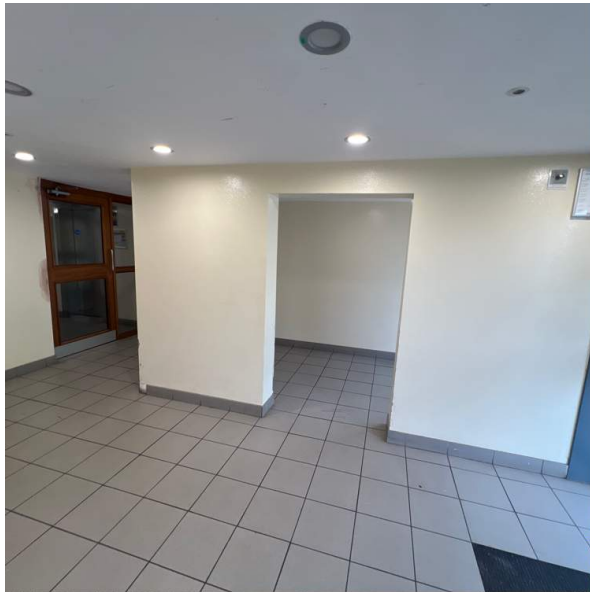
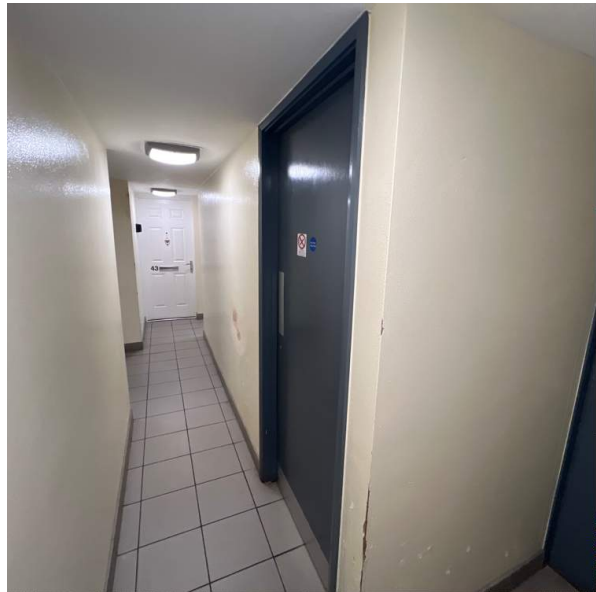
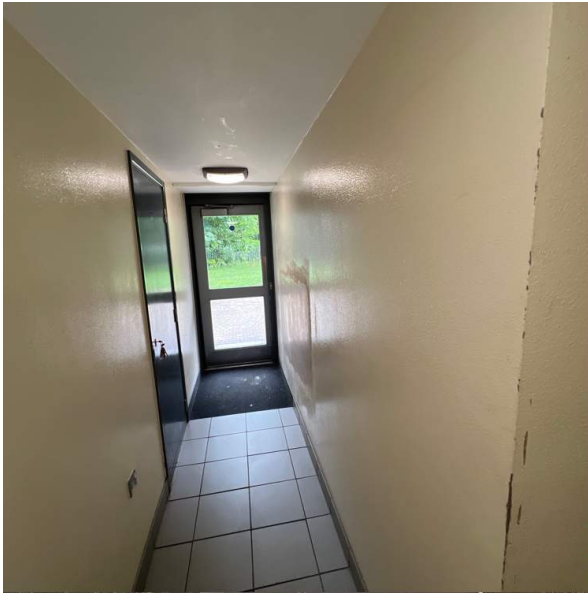
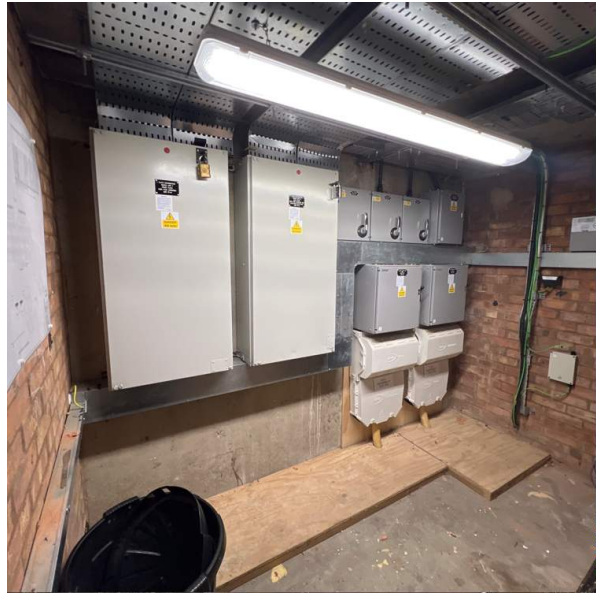
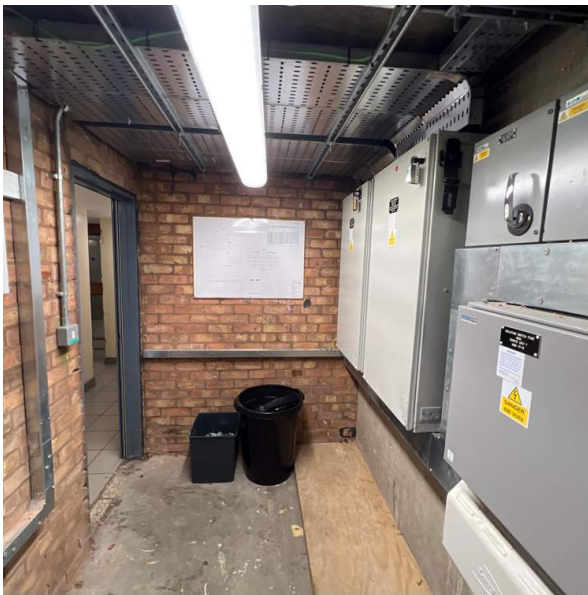
## Ground Floor Hallway

Comments: No jams or distortions noted to hallway doors to indicate any serviceability issues. Generally walls covered with finishes in hallway, likely to consist a mixture of concrete shear walls, embedded columns and masonry infill walls. RC Columns/walls noted in lobby area and in electrical room.

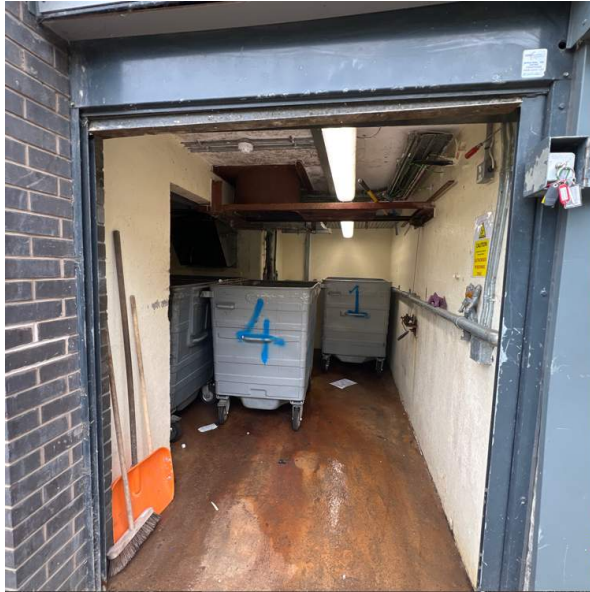
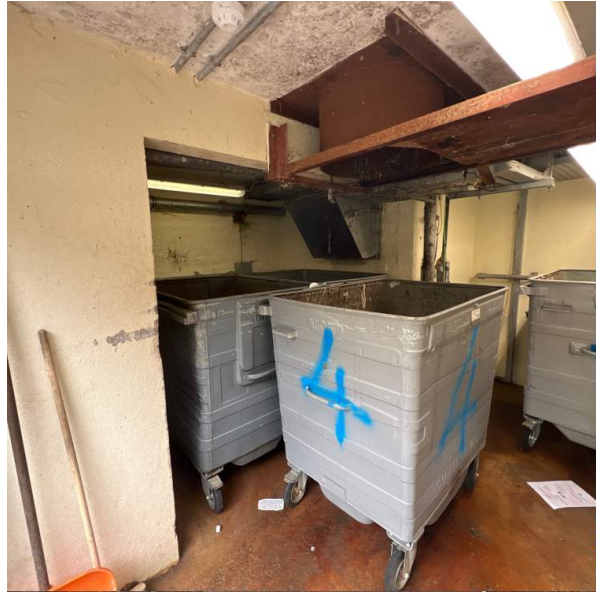
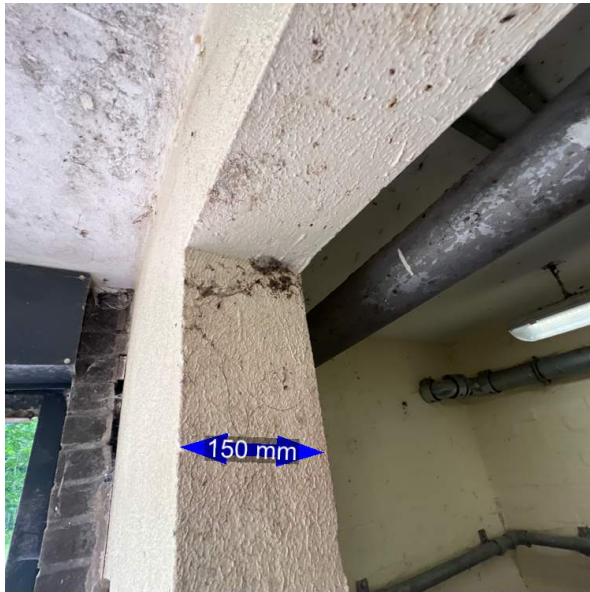
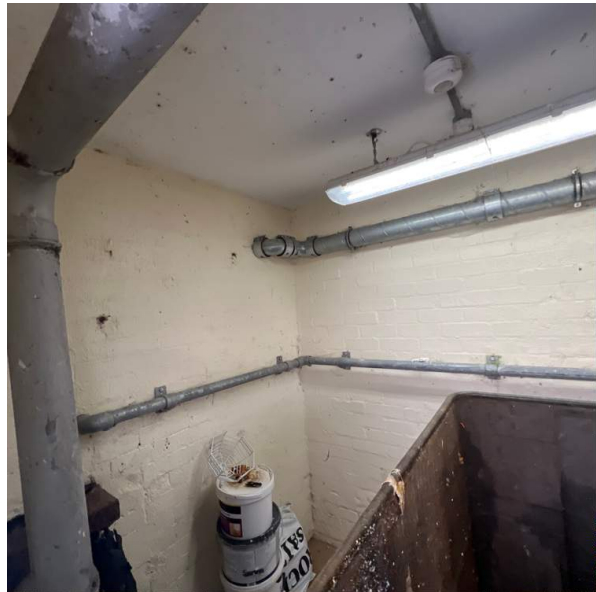
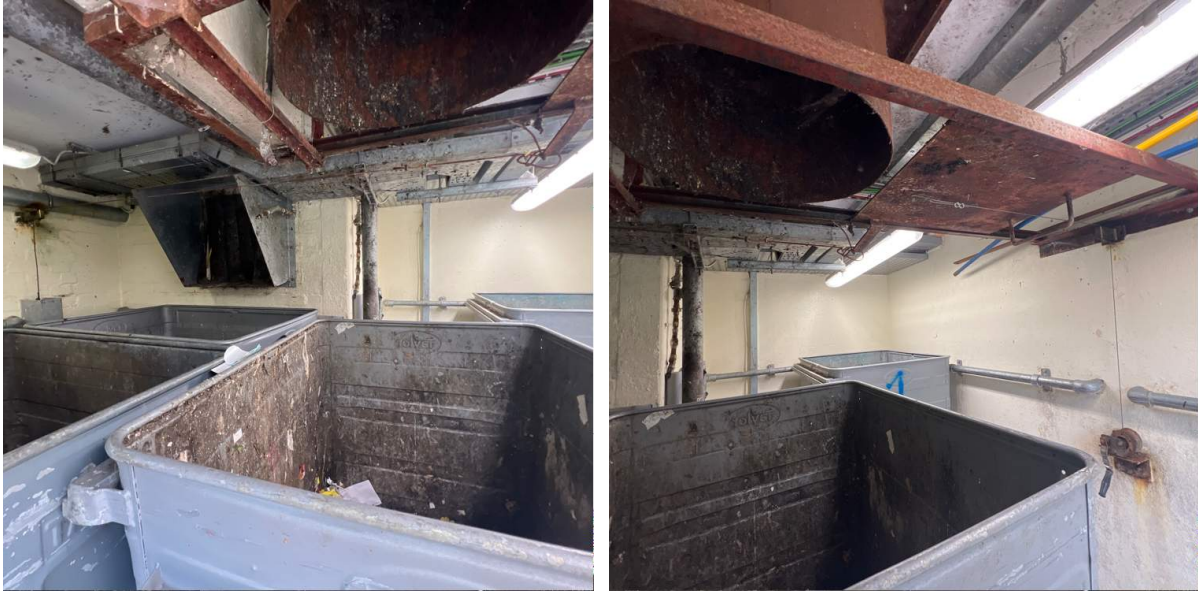
## Bin Store

Comments: RC concrete walls noted in bin store.

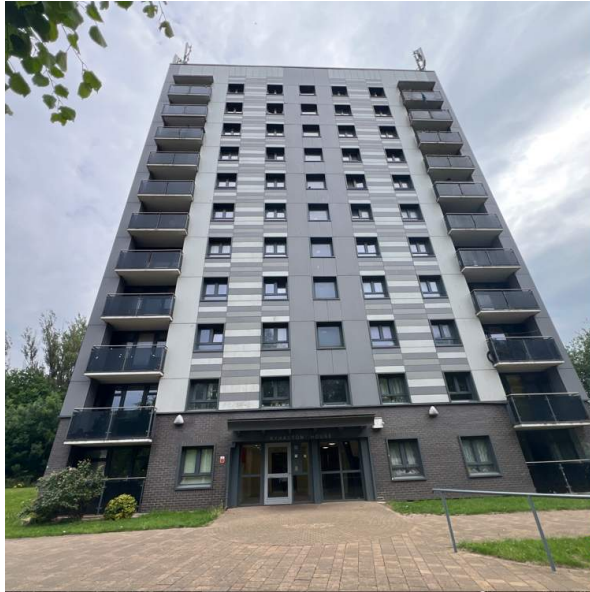
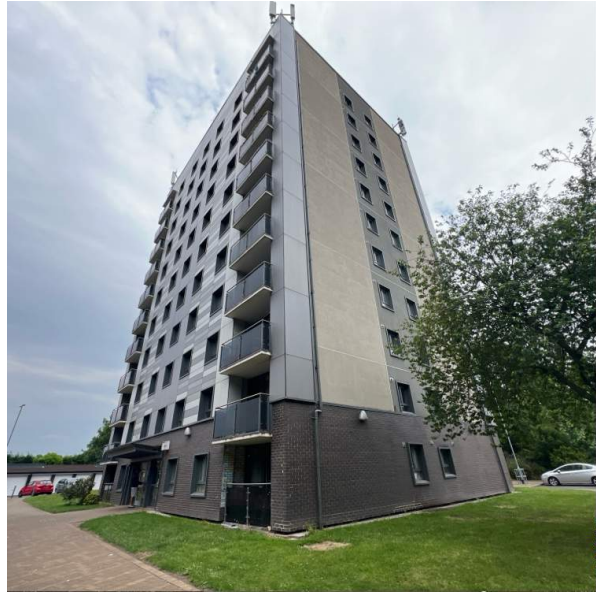
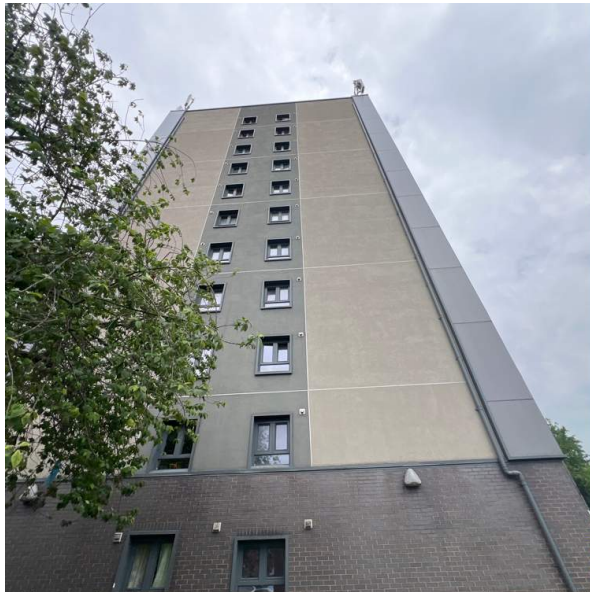
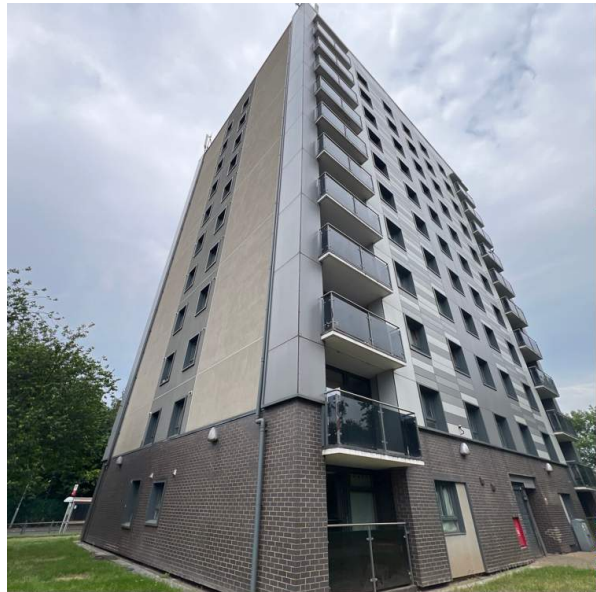
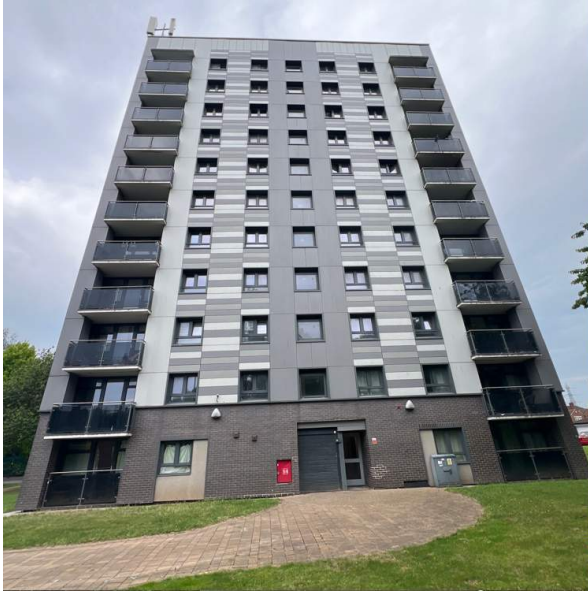
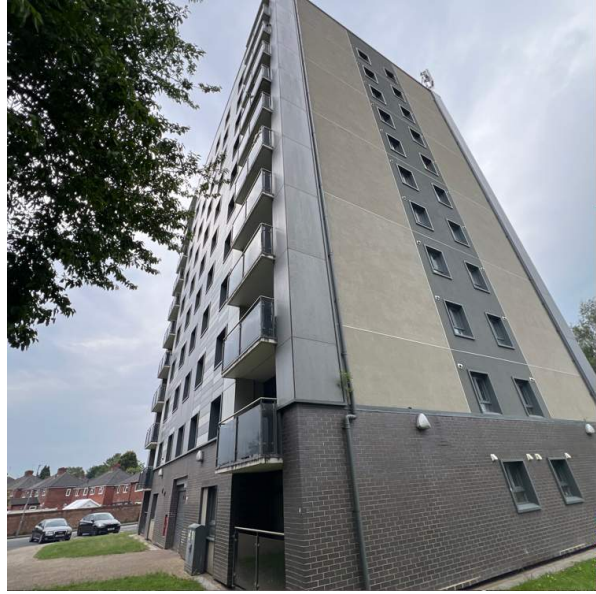
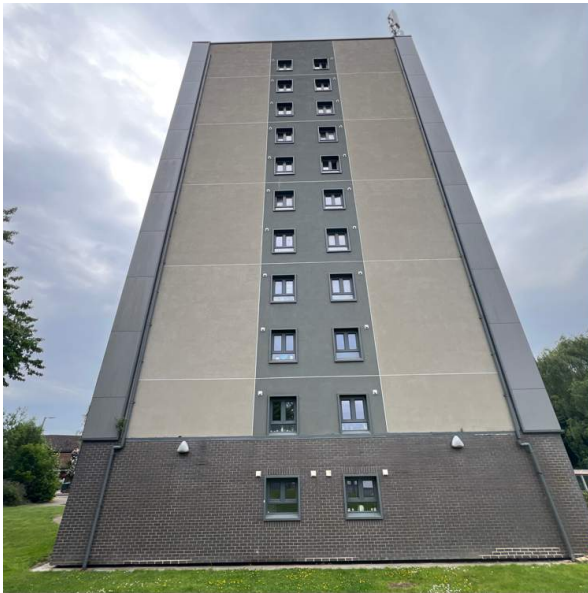
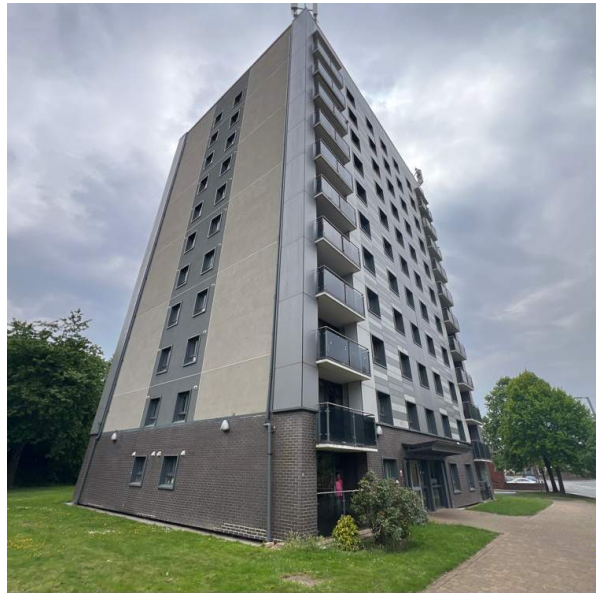
## Elevations

Comments: Brick work at ground floor level all sides. Cladded panels to upper floors, installed as part of last refurbishment works.  
Cantilevered balconies noted on each level.
