**FIRNTEC**  
BUILDING COMPLIANCE

VISUAL STRUCTURAL APPRAISAL

Lancaster House

Oldbury Road  
Oldbury  
B65 0QE

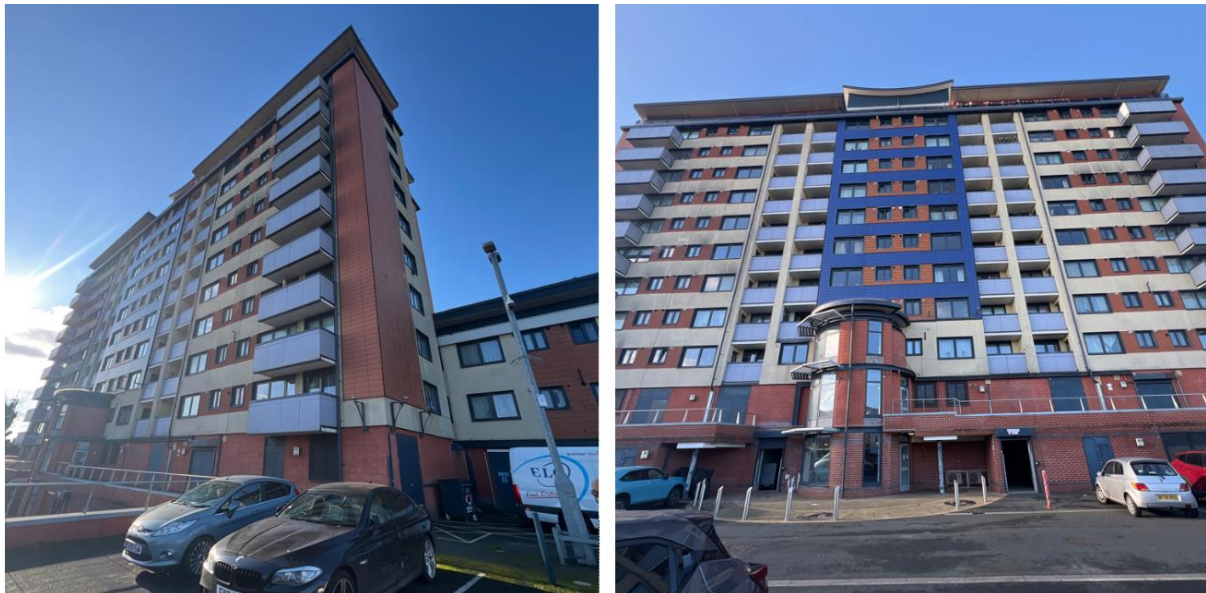
Figure 9 and 10: Building Elevations

The exterior elevations were generally in ok condition and no significant structural defects were noted to the cladding panels. There were no significant cracks or tell-tale signs of any significant structural movement noted at the time of our inspection.

The exterior panels were noted to be plumb with no signs of significant bowing, bulging or leaning noted to the panels indicating failed fixings however their presence and condition cannot be confirmed.

There are balconies at each level which are a combination of inset and formed of cantilevered RC slabs tied into the main frame, likely cast monolithically with the primary RC frame. These are finished with cement board to the balustrades.

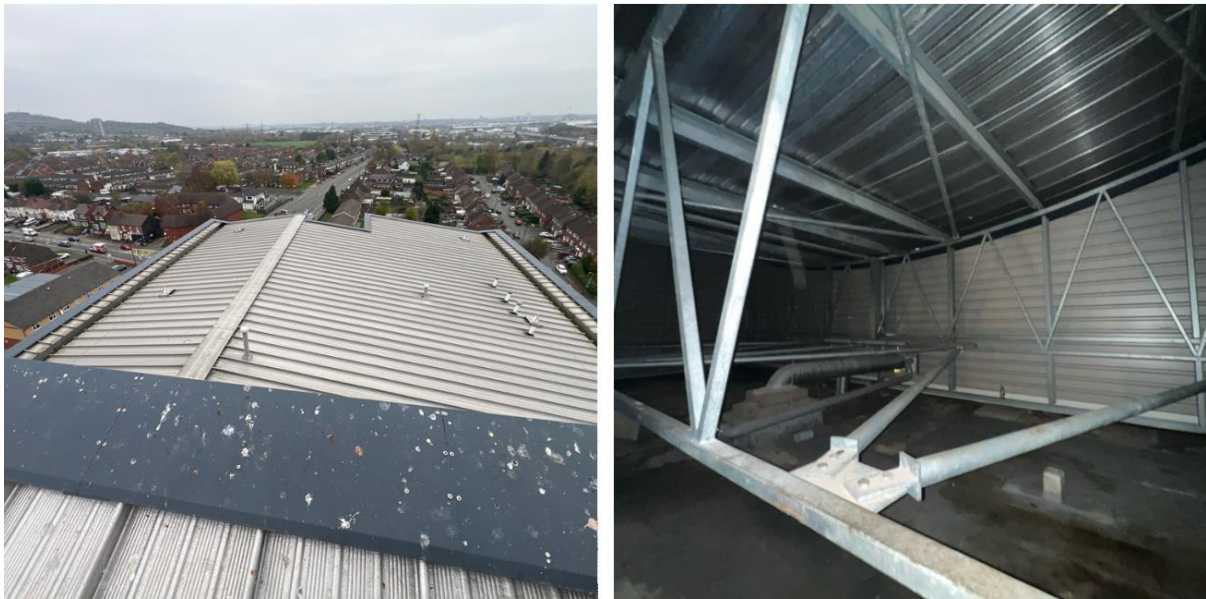
Figure 11 and 12: Roof Level

The original flat roof structure is a reinforced concrete cast slab which has been over roofed during the 2010 refurbishment with a flat to pitch conversion. The pitched roof is supported by lightweight steel trusses which support steel purlins supported off the original RC frame and clad in lightweight standing seam roofing panels. The trusses are supported of the original RC structure. Details are unknown however no signs of distress were noted.

There were no tell-tale signs of any significant structural movement noted to the steel frames at the time of our inspection. We can't confirm the fire resistance of the frame as it appears unprotected.

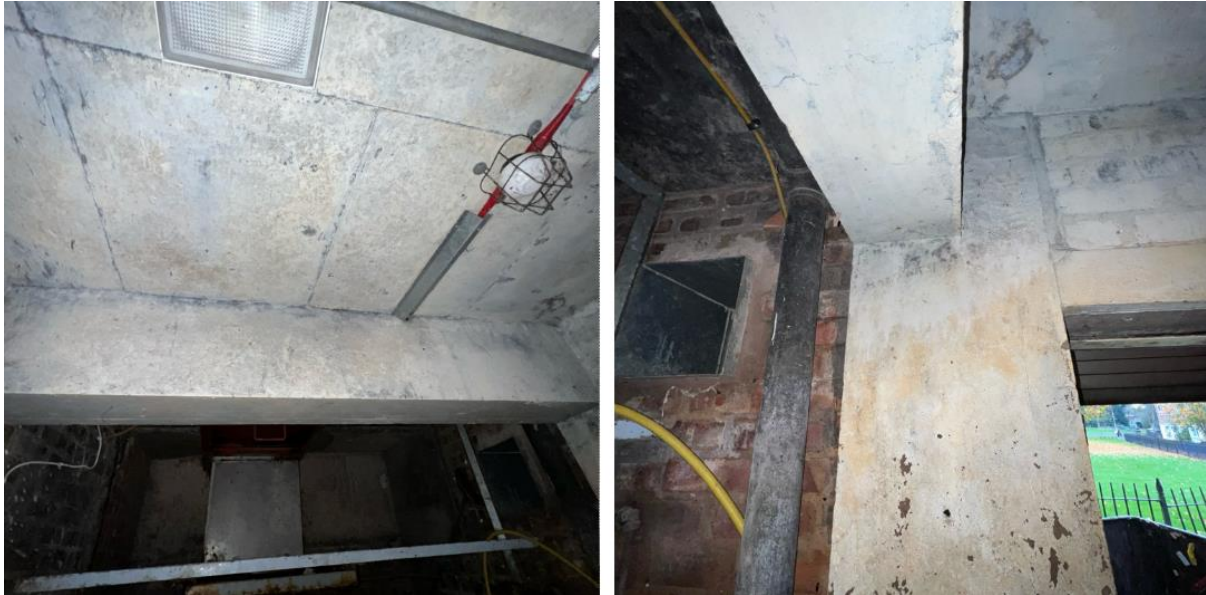
Figure 13 and 14: Structural beams, columns and slab over

The interior of the stair core walls were checked and were plumb and in line with observations made to the exterior – no significant signs of leaning or movement noted. The concrete appeared in fair condition with few BRE category 1 cracks but no structurally significant defects were noted.

The slabs are providing compartmentation to the building and therefore should meet the fire requirements. A cover meter survey is required to estimate the fire resistance of the floor slabs.

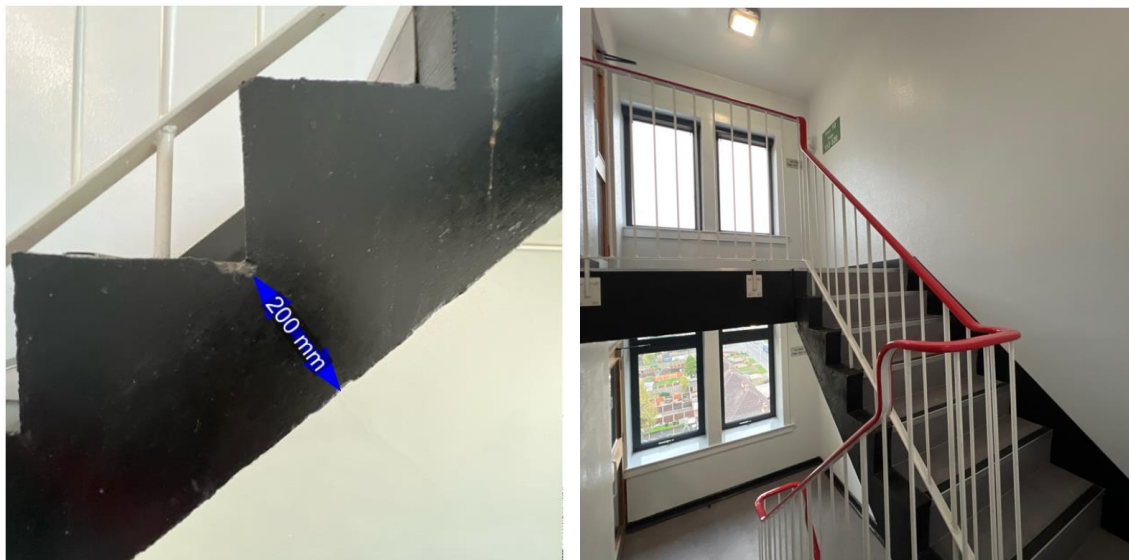
Figure 15 and 16: RC Stringer for staircase

The staircase stringer was measured at 200mm. The fire resistance of this could be inadequate and requires a cover meter test followed by a section analysis to confirm.

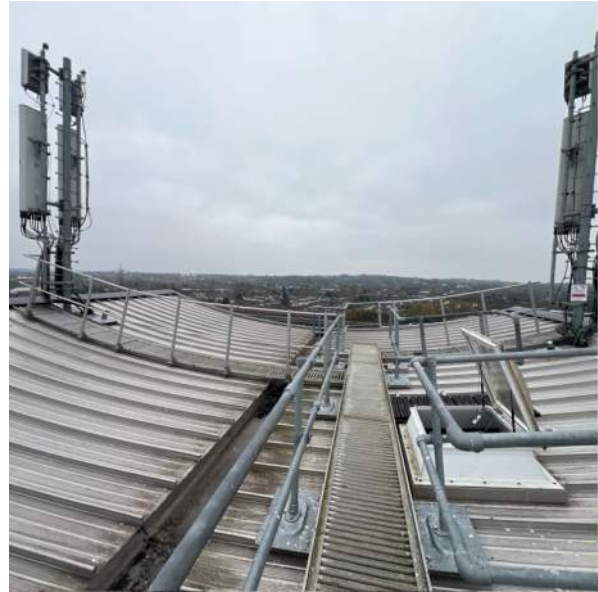
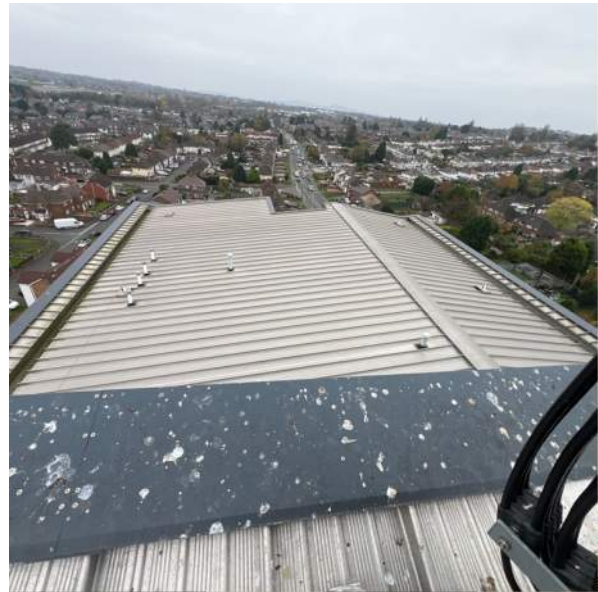
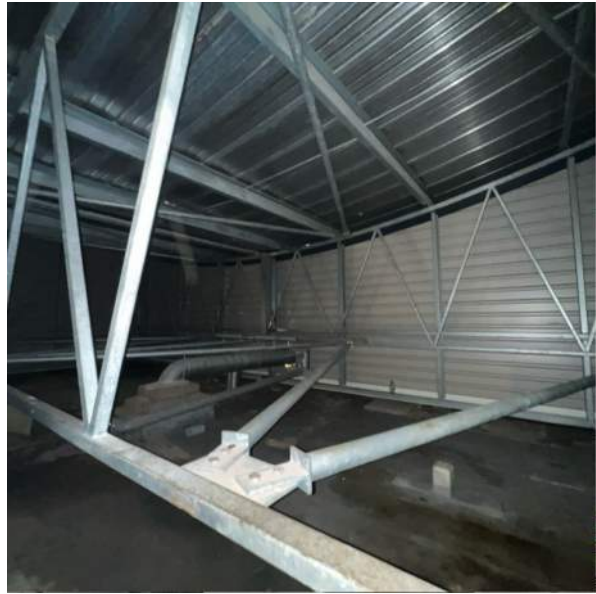
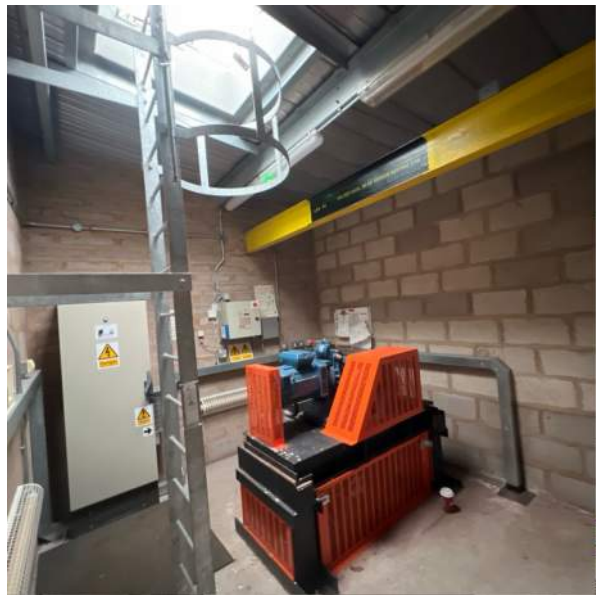
## Main Roof

Pitched Roof with profile metal sheet covering. Pitched roof/aluminium frame appears to have been added to the original building which consists of a flat roof.

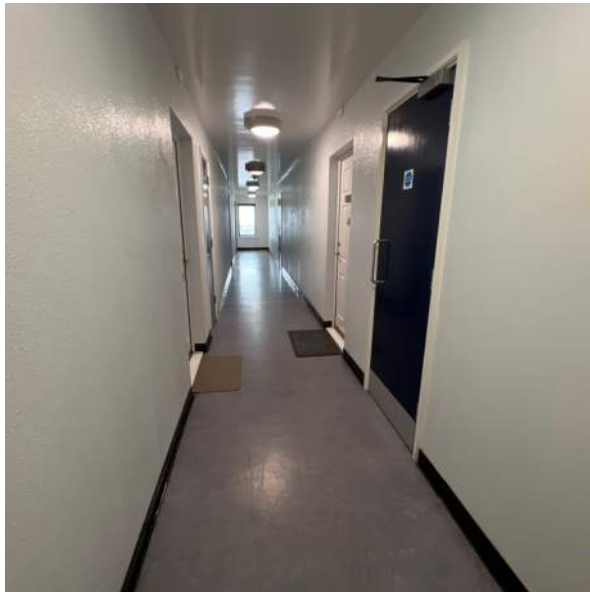
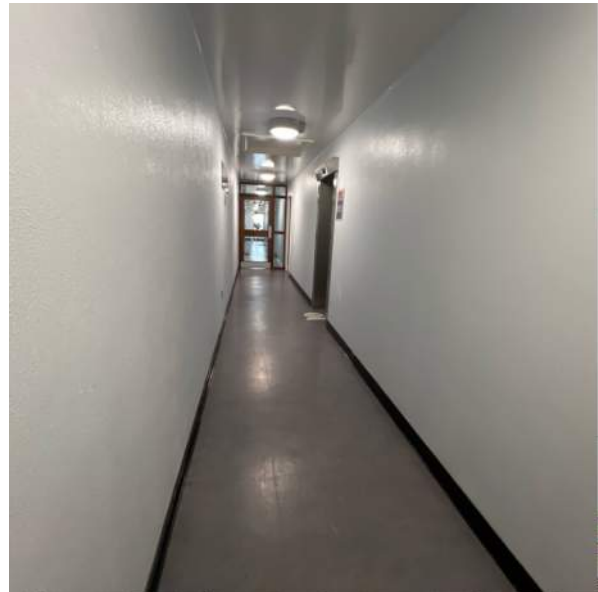
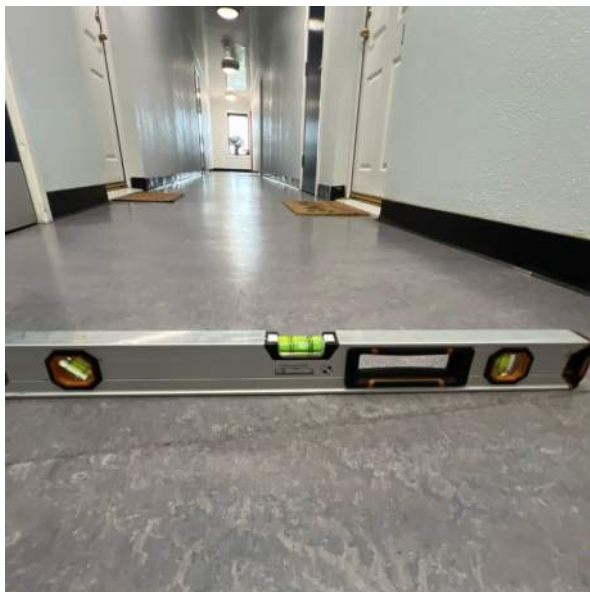
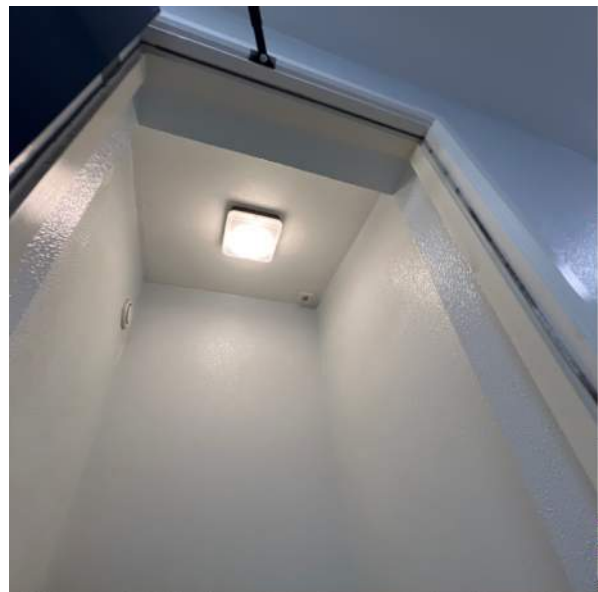
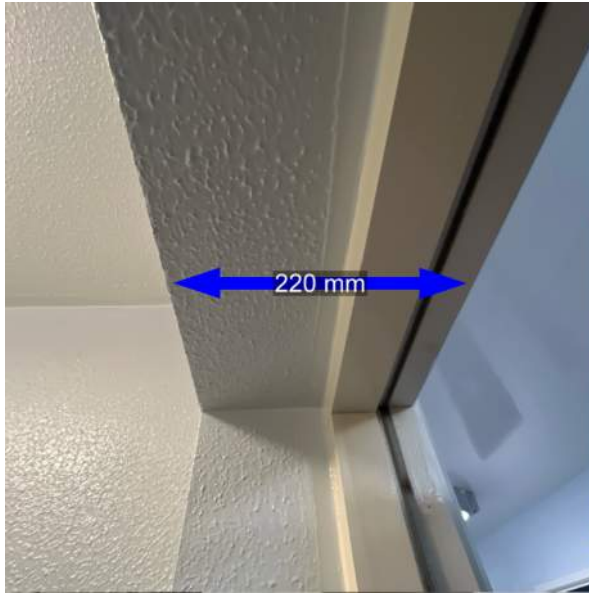
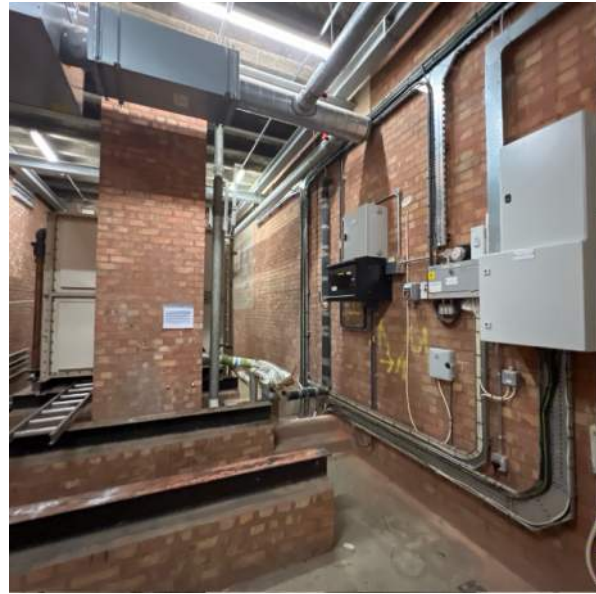
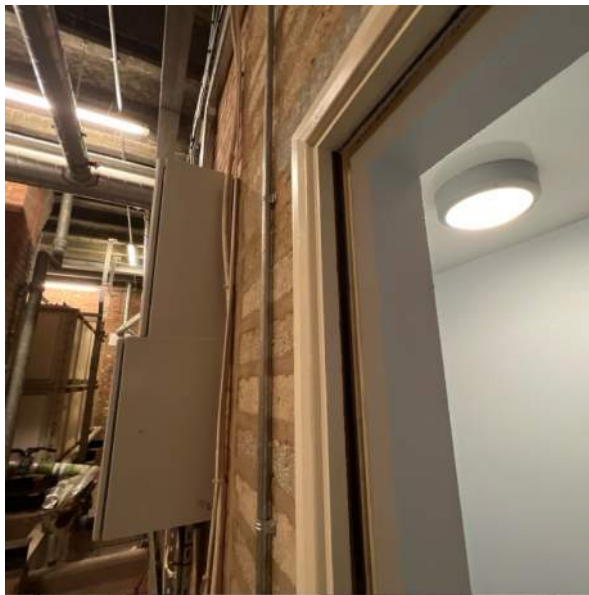
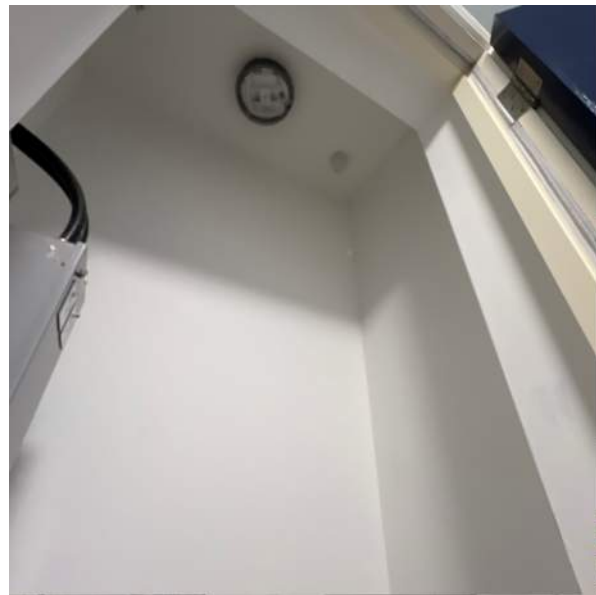
## 10th Floor Hallway

Comments: No jams or distortions noted to hallway doors to indicate any serviceability issues. Generally walls covered with finishes in hallway, likely to consist a mixture of concrete shear walls, embedded columns and block infill walls. Limited structure exposed. Infill masonry walls noted in tank room.

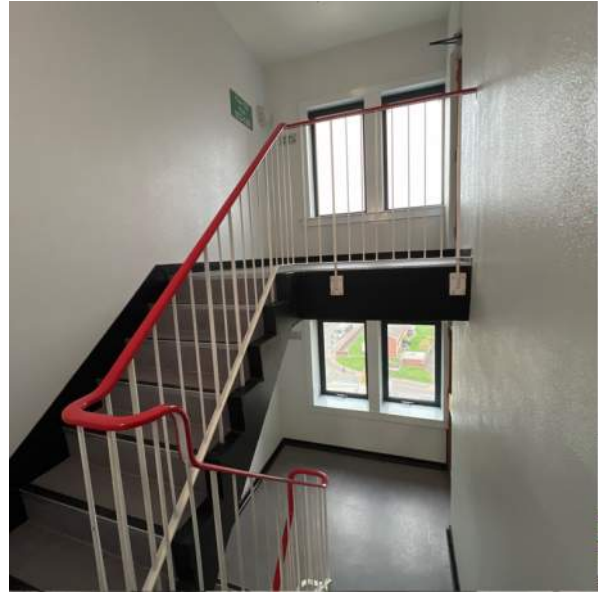
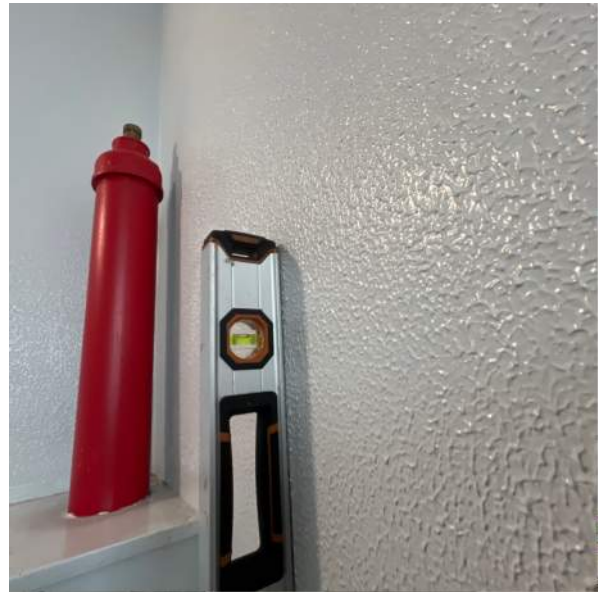
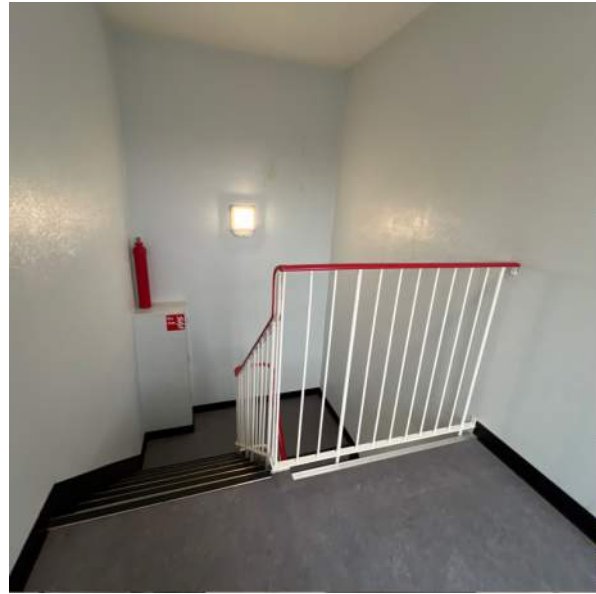
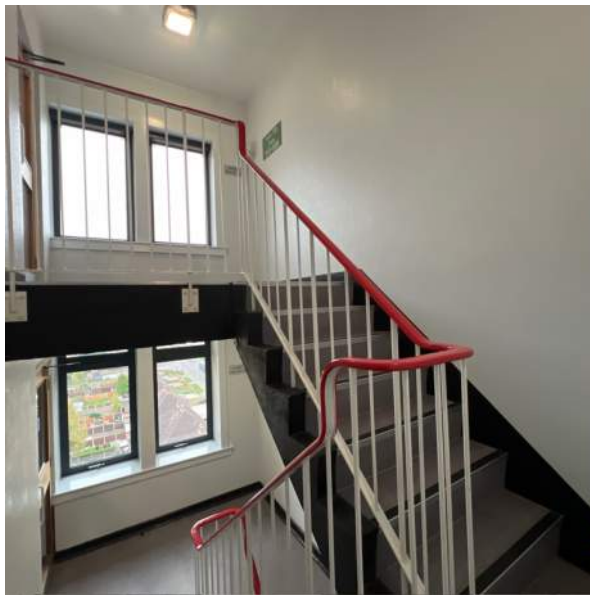
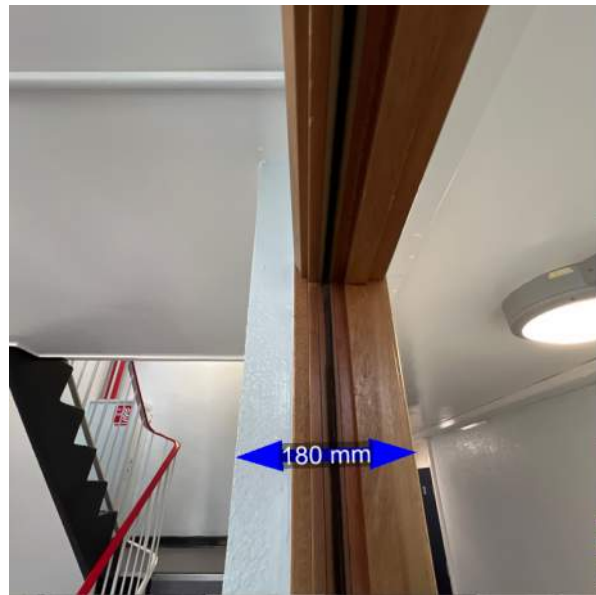
## 10th Floor Staircases

A set of staircases is located on both ends of the building. Insitu concrete stairs with steel hand railing fixed to stairs. Walls and floors appear to be fairly level. Stair walls covered with finishes however these would likely form the main concrete shear core walls.

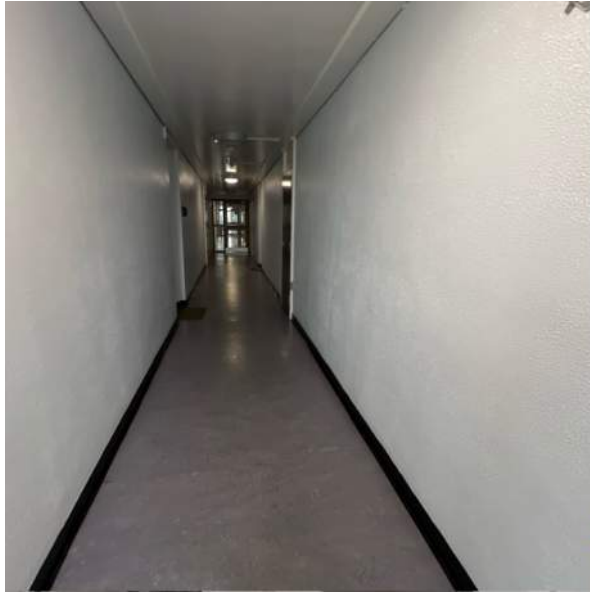
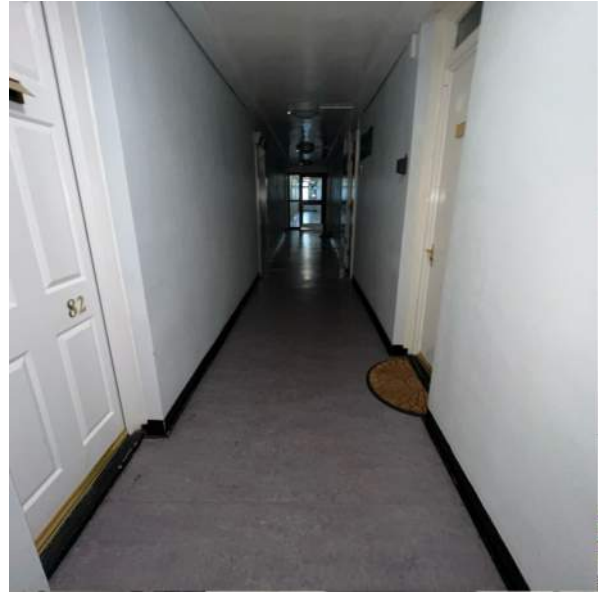
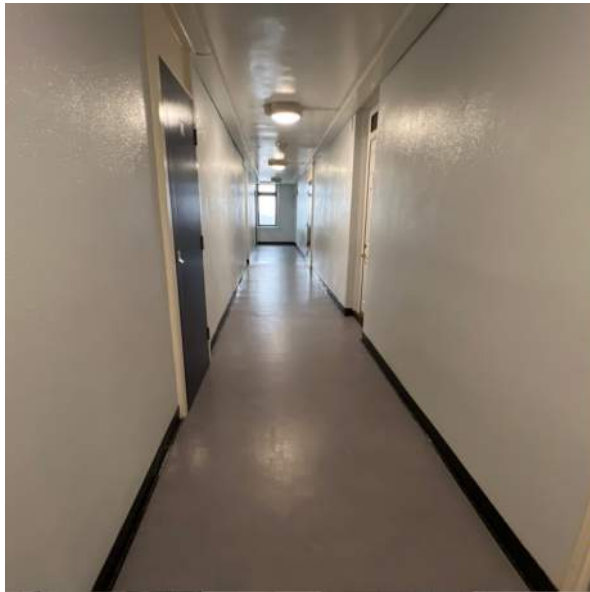
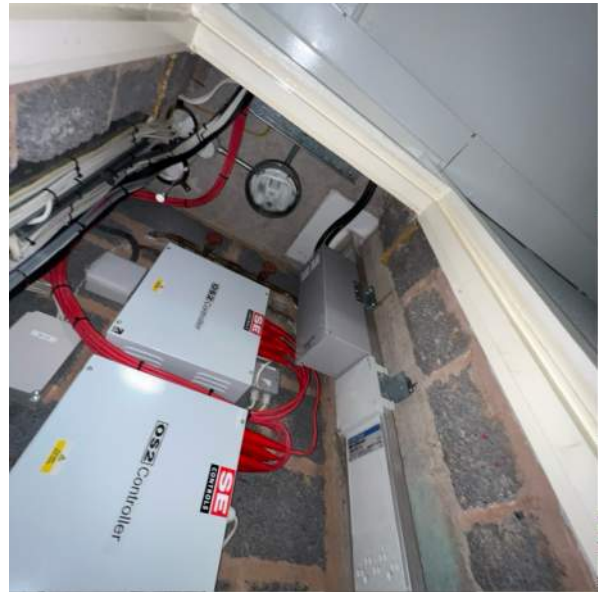
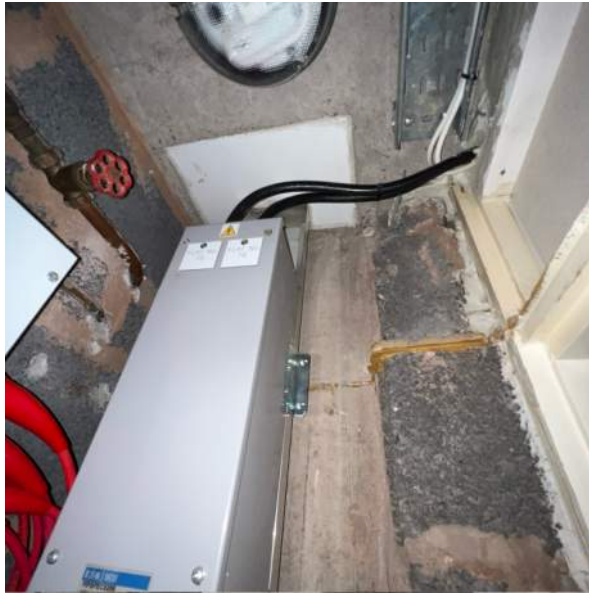
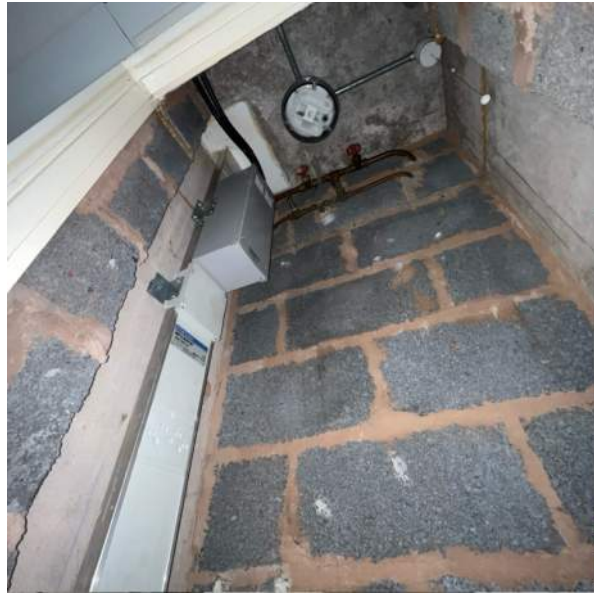
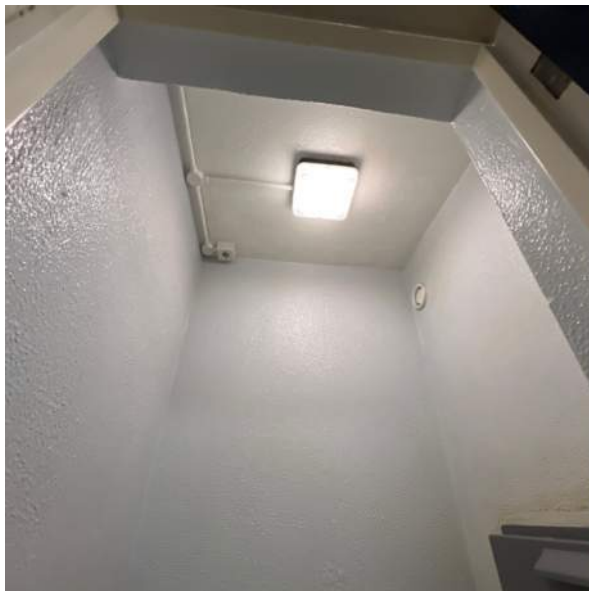
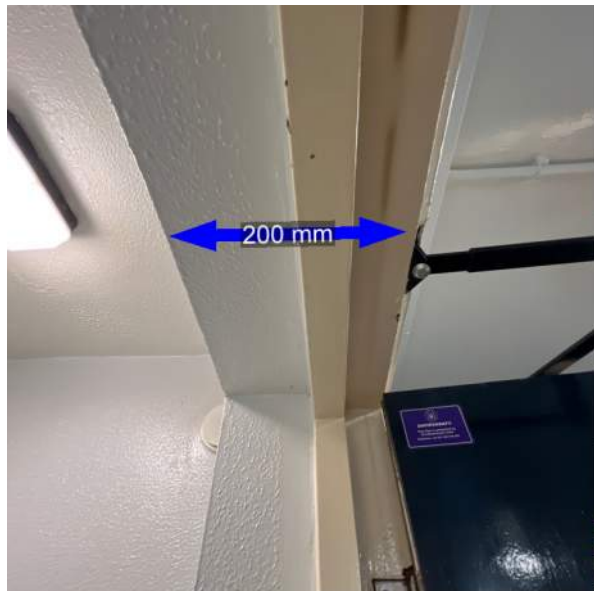
## 6th Floor Hallway

Comments: No jams or distortions noted to hallway doors to indicate any serviceability issues. Generally walls covered with finishes in hallway, likely to consist a mixture of concrete shear walls, embedded columns and block infill walls. Limited structure exposed. Partly visible concrete walls noted via electrical riser cupboards

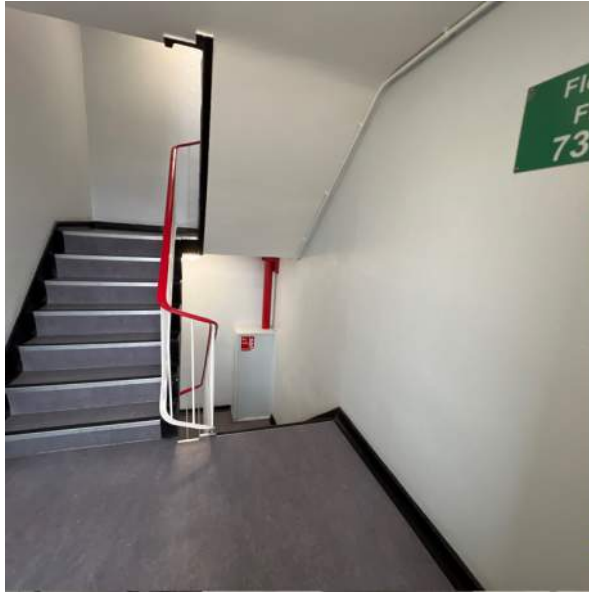
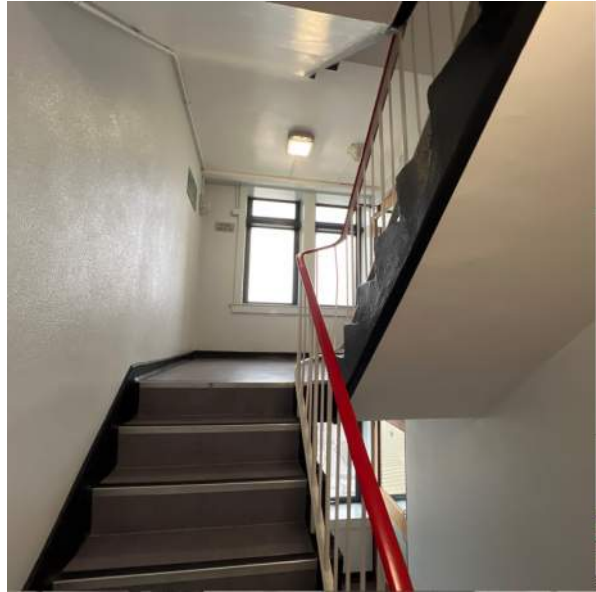
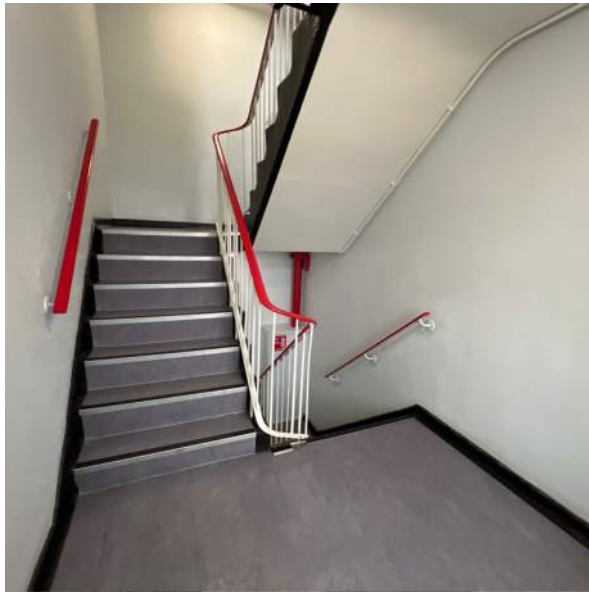
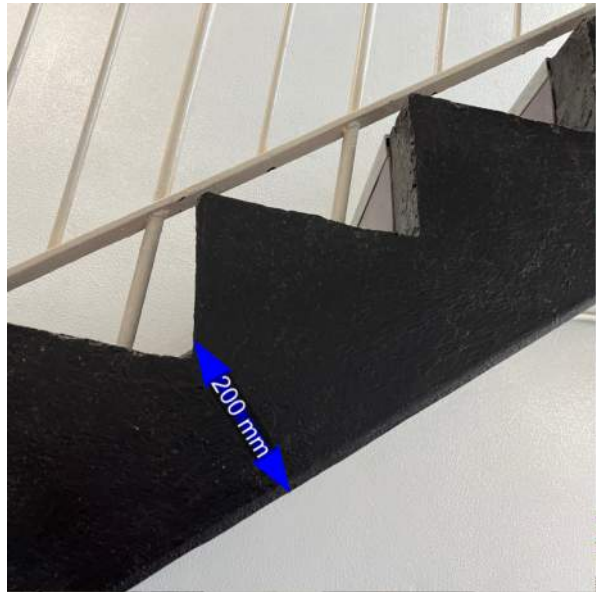
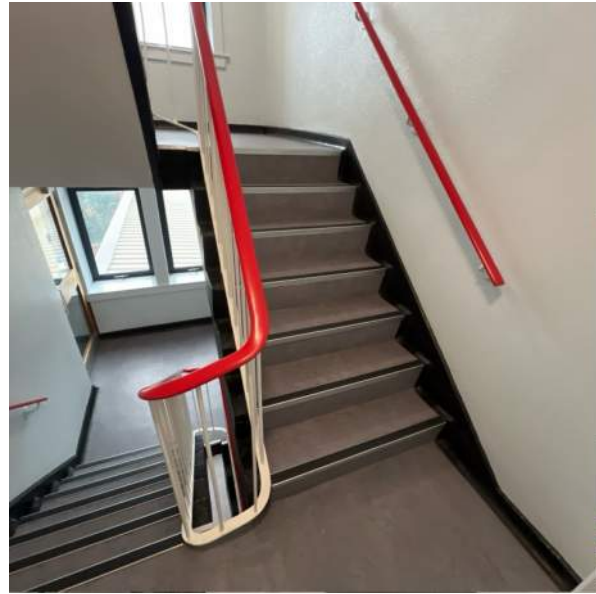
## 6th Floor Staircases

Comments: A set of staircases is located on both ends of the building. Insitu concrete stairs with steel hand railing fixed to stairs. Walls and floors appear to be fairly level. Stair walls covered with finishes however these would likely form the main concrete shear core walls.

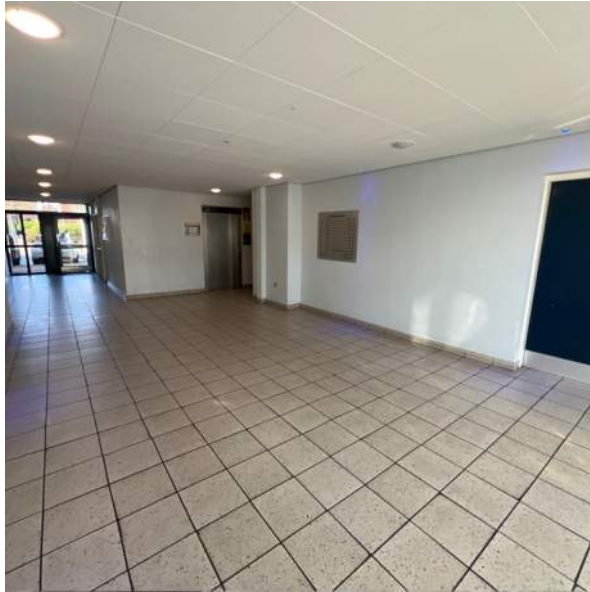
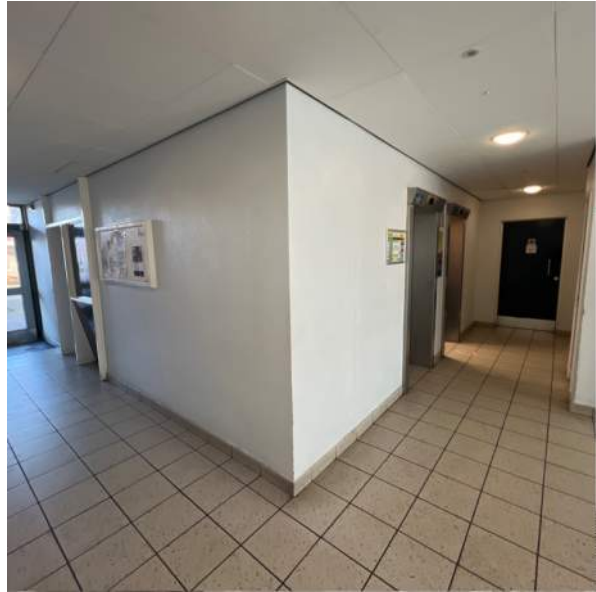
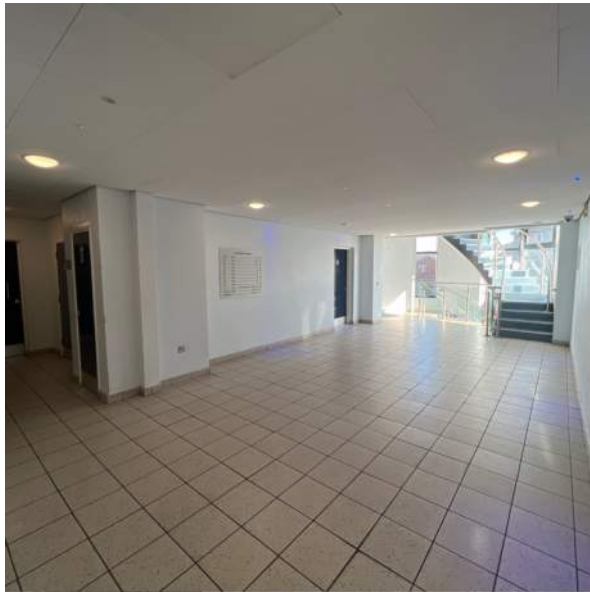
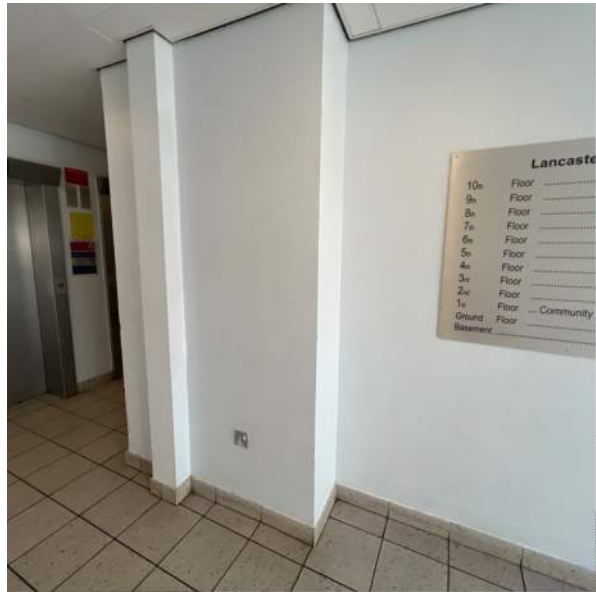
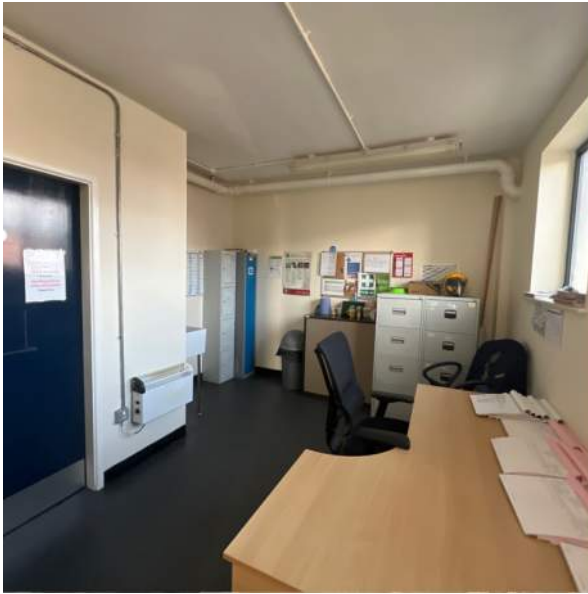
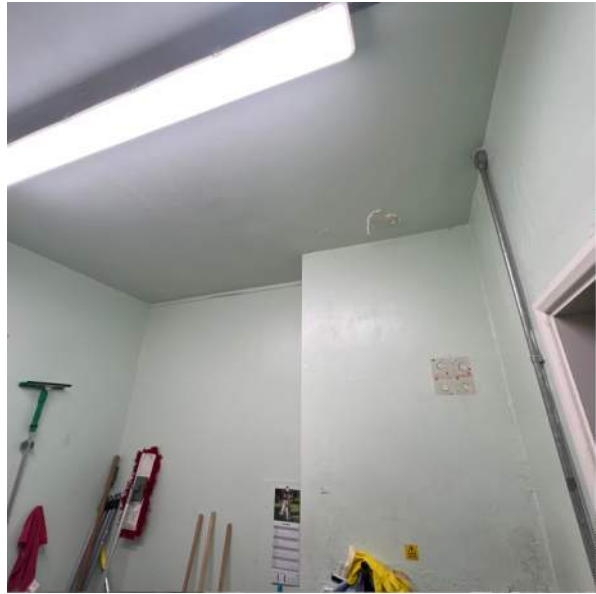
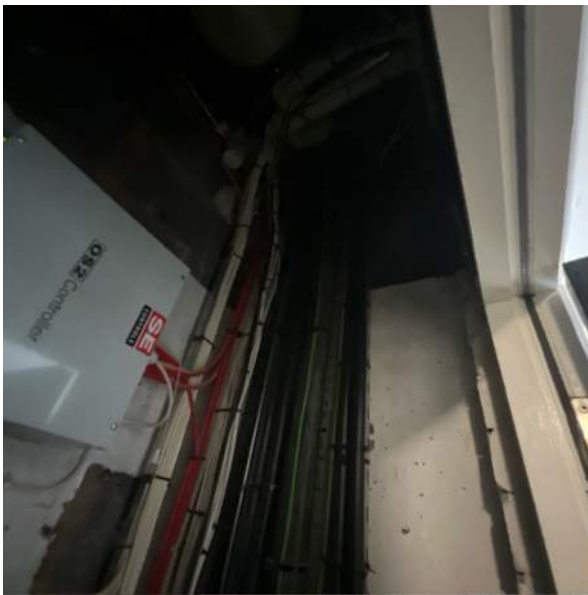
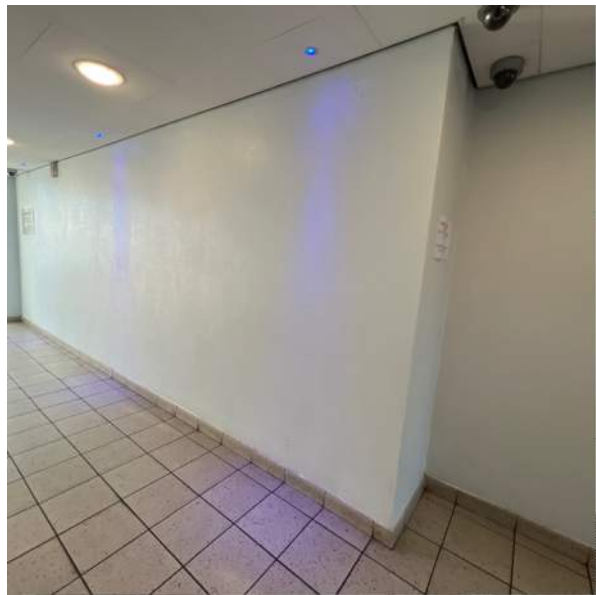
## Ground Floor Hallway

Comments: No jams or distortions noted to hallway doors to indicate any serviceability issues. Generally walls covered with finishes in hallway, likely to consist a mixture of concrete shear walls, embedded columns and block infill walls. Limited structure exposed. Partly visible concrete walls noted via riser cupboards.

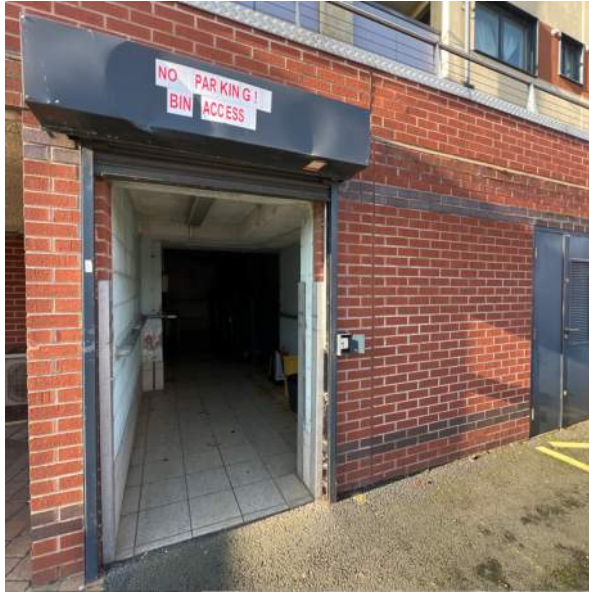
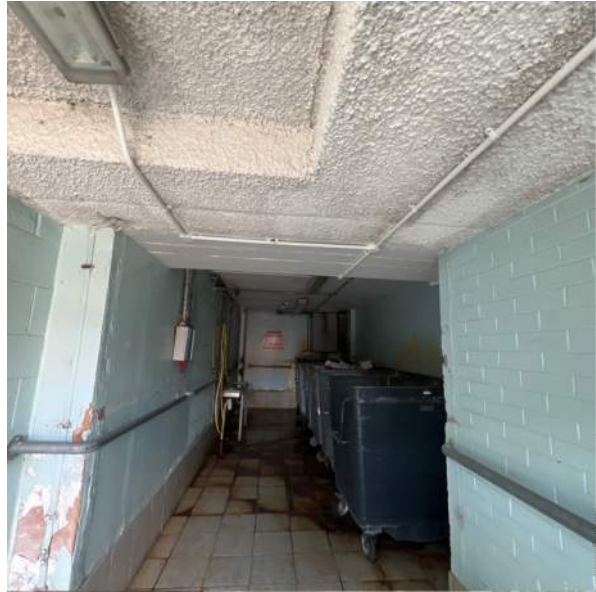
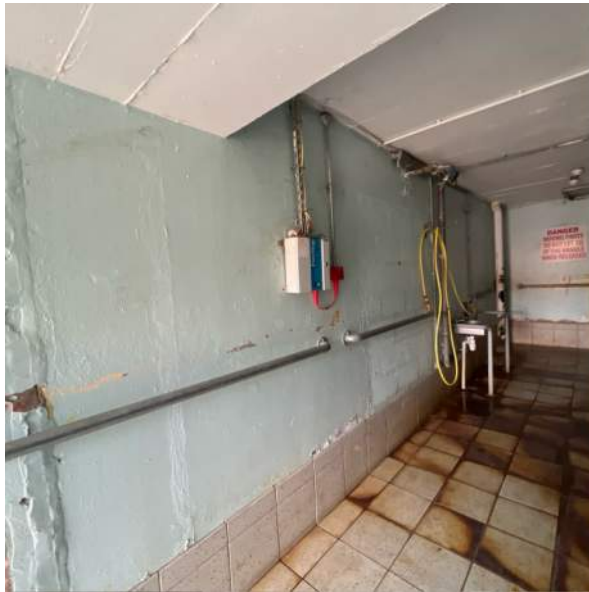
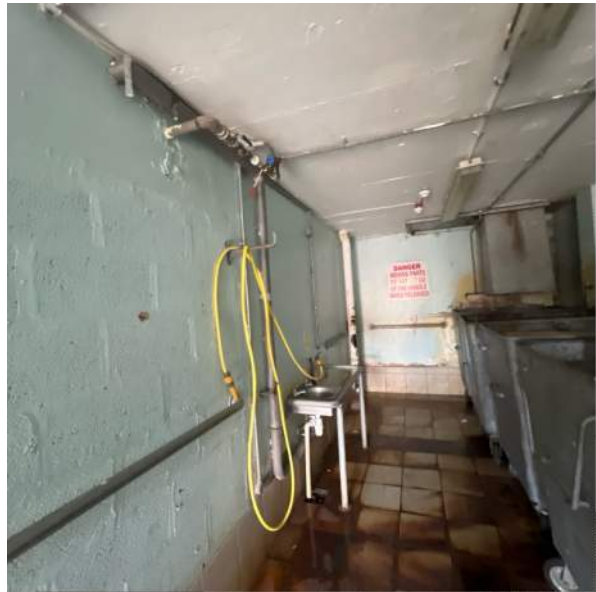
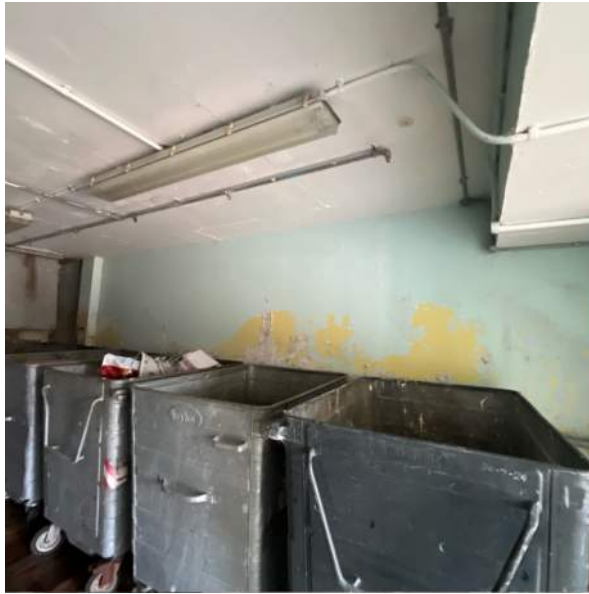
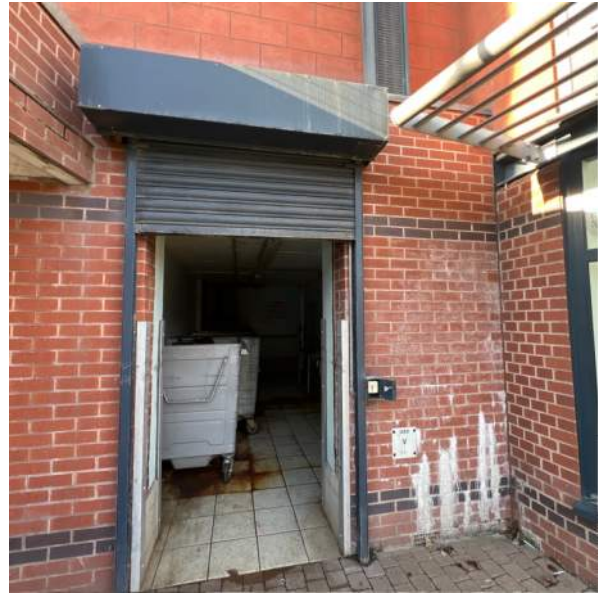
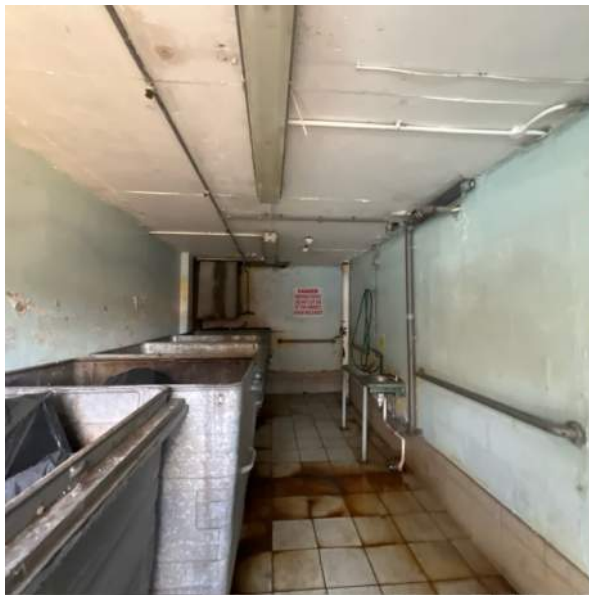
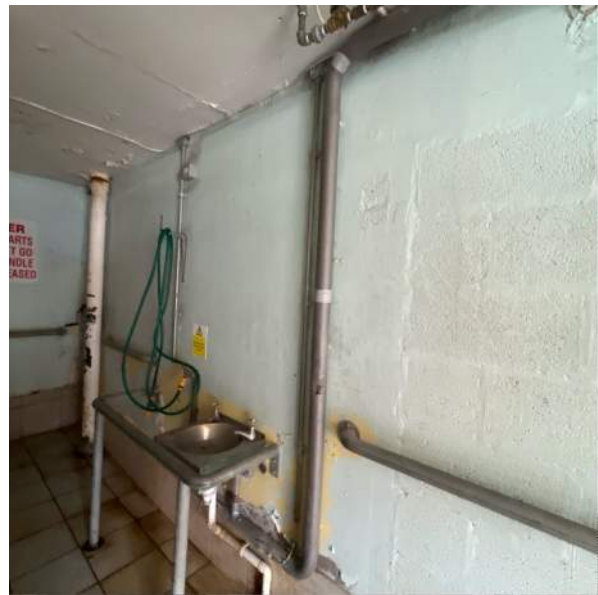
## Binstores

2no. binstores, accessed from rear car park. RC shear walls noted in binstores.

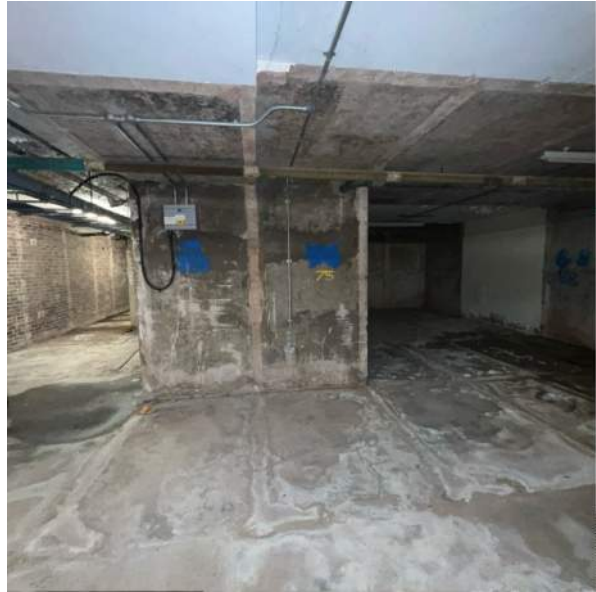
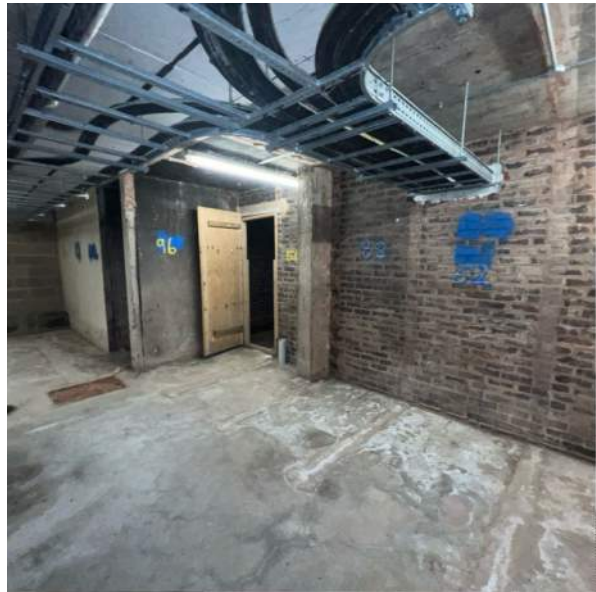
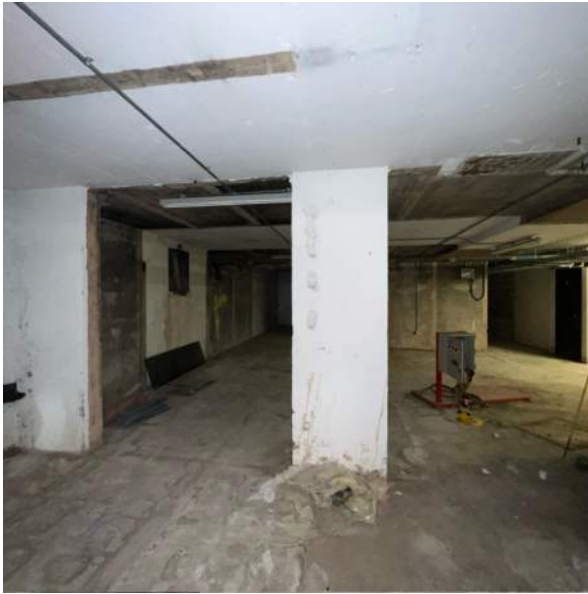
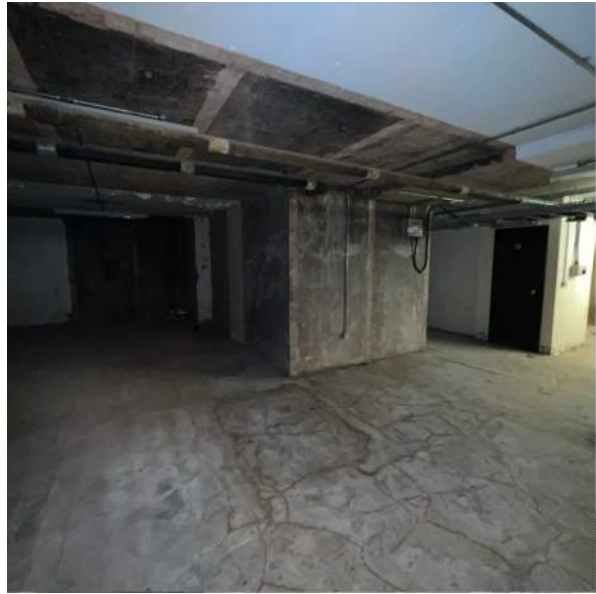
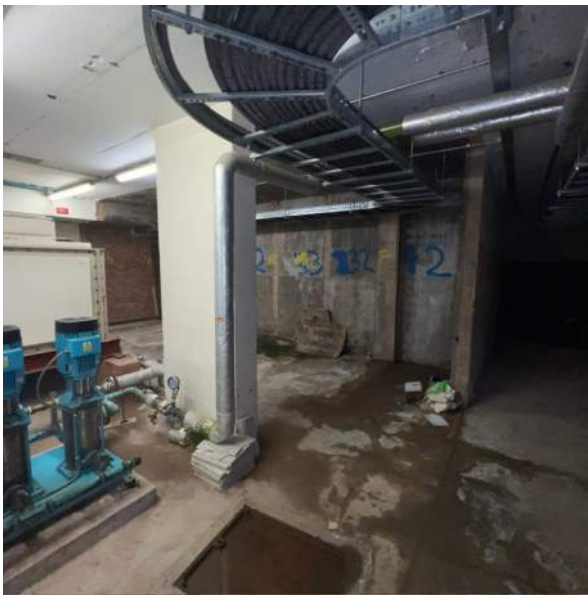
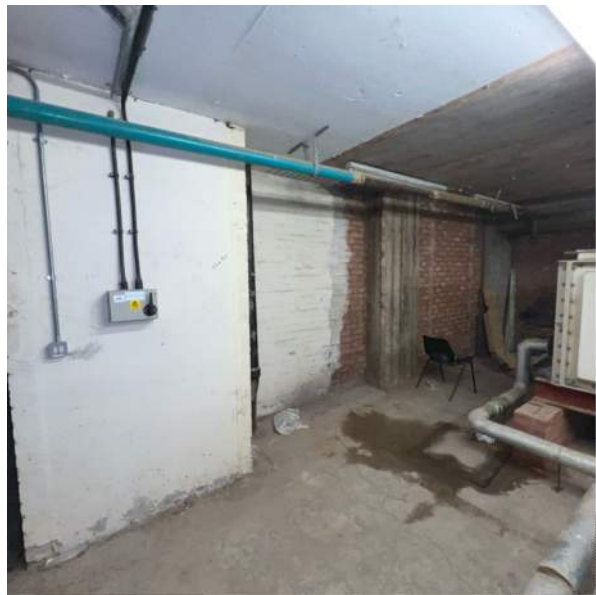
## Basement

RC Shear walls and a series of columns noted in basement. Staircase and lift shear core walls noted.
