**FIRNTEC**  
BUILDING COMPLIANCE

VISUAL STRUCTURAL APPRAISAL

Lancaster House

Oldbury Road  
Oldbury  
B65 0QE

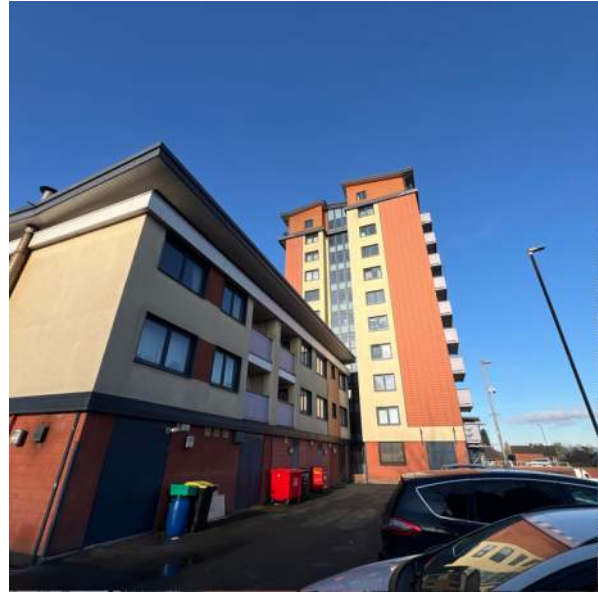
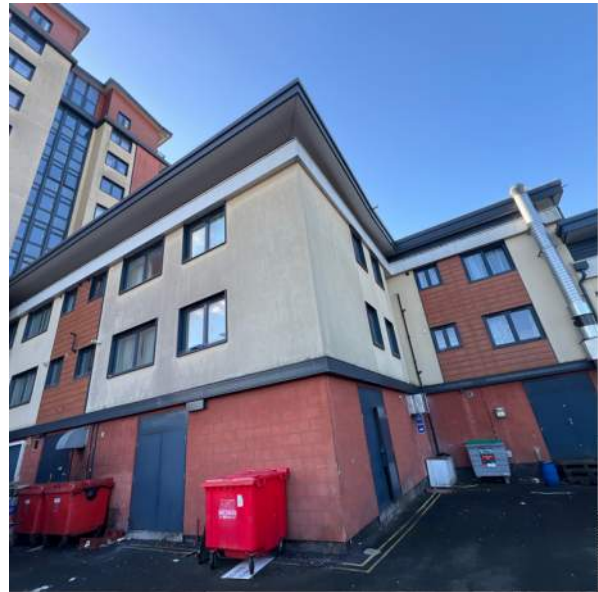
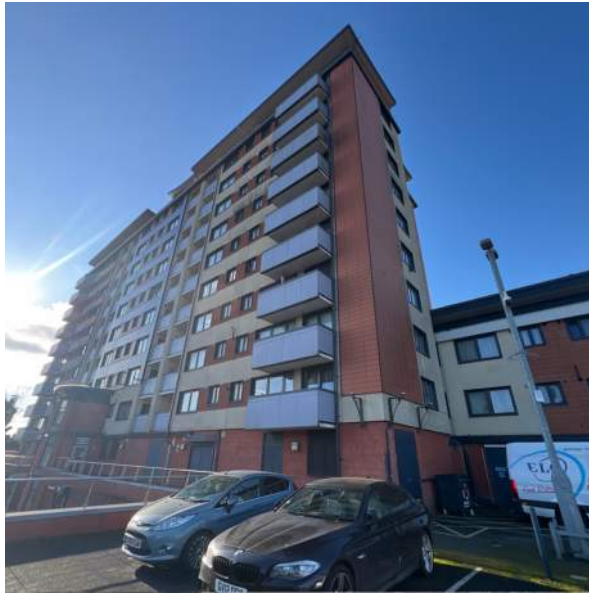
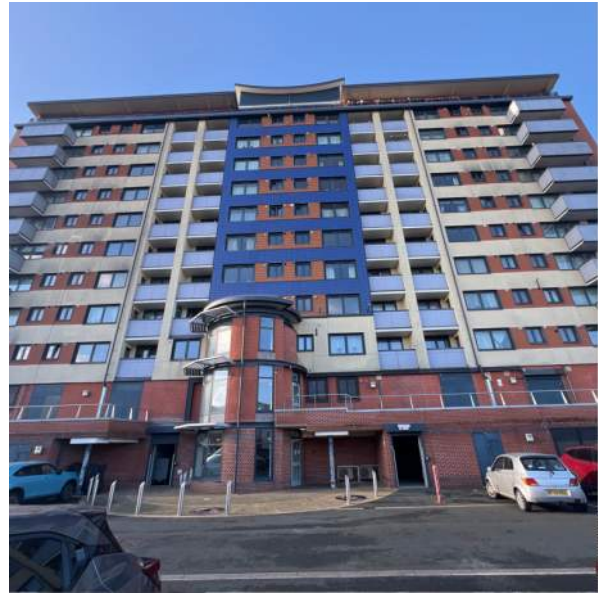
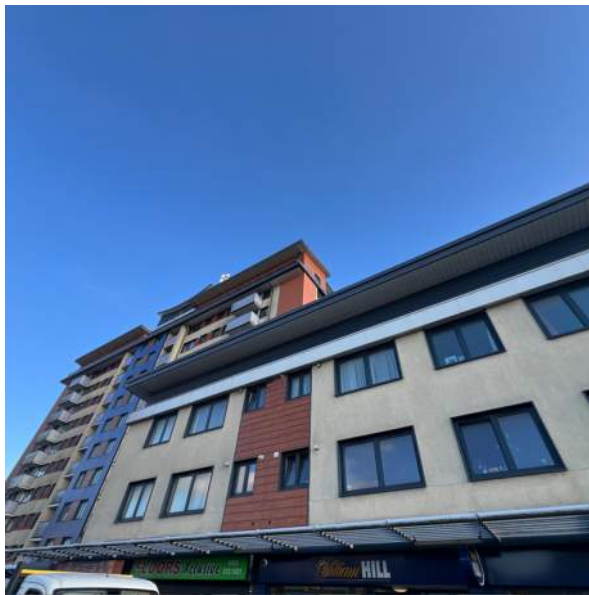
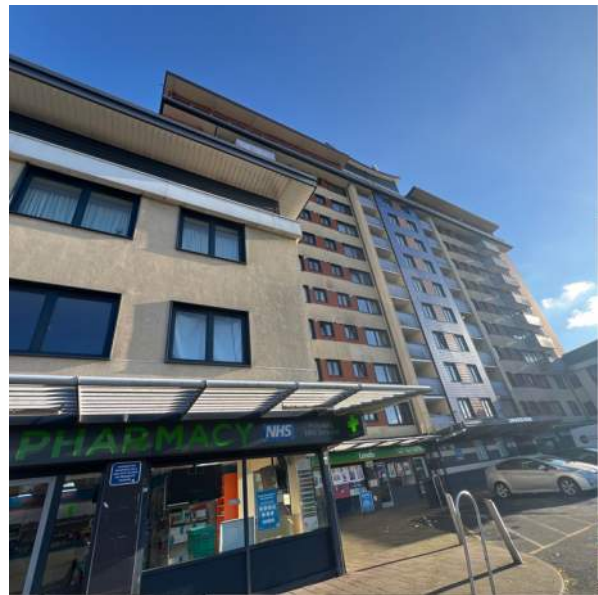
## Elevations

External facade consists of partial cladding and render. Elevations appear to be in fair condition.
