VISUAL STRUCTURAL APPRAISAL

Lawrence Court

Kingsway  
Brandhall  
B68 0HB

29<sup>th</sup> April 2025

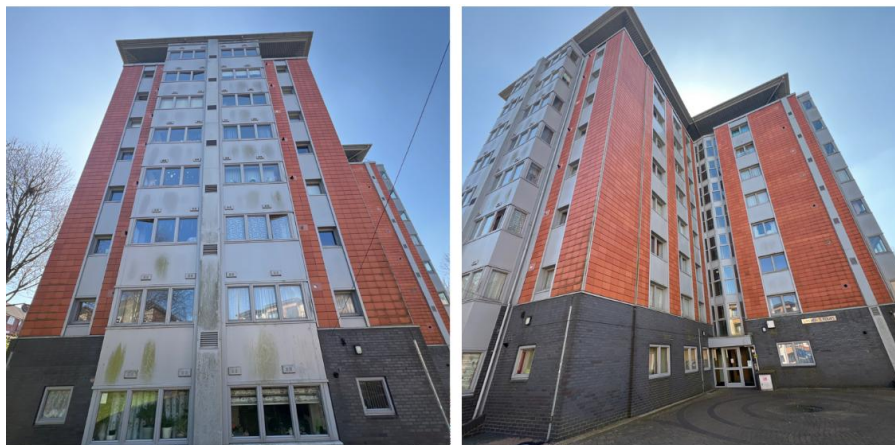
Figure 9 and 10: Building Elevations

The exterior elevations were generally in ok condition and no significant structural defects were noted to the cladding panels. There were no significant cracks or tell-tale signs of any significant structural movement noted at the time of our inspection.

The exterior panels were noted to be plumb with no signs of significant bowing, bulging or leaning noted to the panels indicating failed fixings however their presence and condition cannot be confirmed.

There are balconies at each level which are formed of cantilevered RC slabs tied into the main frame. During the 2018 refurbishment they were enclosed with aluminium panelling.

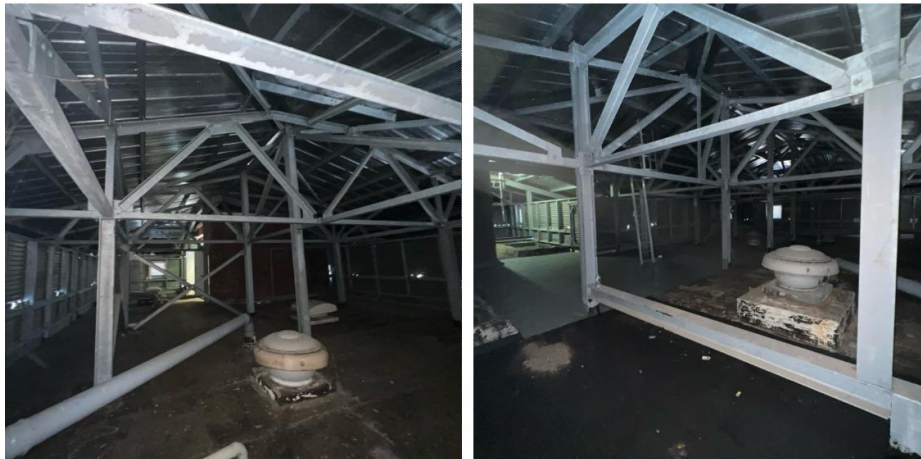
Figure 11 and 12: Roof Level

There were no tell-tale signs of any significant structural movement noted at the time of our inspection. The exterior walls were noted to be plumb with no signs of significant bowing, bulging or leaning noted to the masonry walls.

The roof has subsequently been covered with a new waterproofing covering formed of a steel frame installed to the existing roof which supports pitched corrugated sheets. This roof is not insulated and therefore acts purely as a weather barrier. The fire protection of the steel is unclear as the beams do not appear to be protected. Details of this frame should be requested from the contractor who completed the works in 2018. No signs of water ingress of that the roof is not performing as intended.

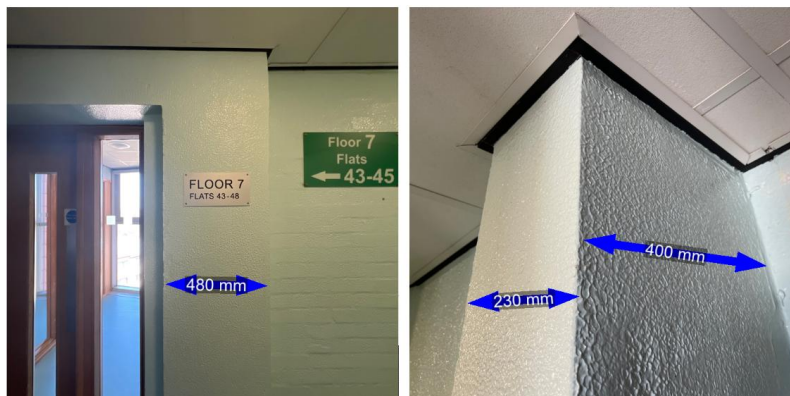
Figure 14 and 15: RC elements at upper floors

The interior of the stair core walls were checked and were plumb and in line with observations made to the exterior – no significant signs of leaning or movement noted. The concrete appeared in fair condition with few BRE category 1 cracks but no structurally significant defects were noted.

The stair stringer was noted to be 160mm thick which is what we would expect. A cover test is required to check the resistance of the concrete section in the event of a fire.

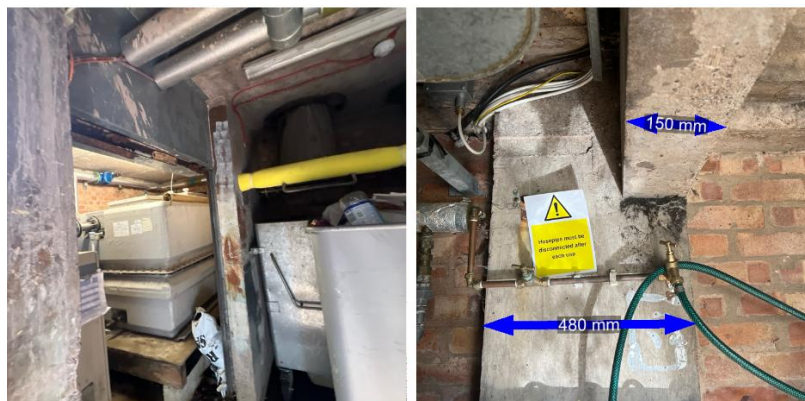
Figure 16 and 17: RC Elements visible at ground floor

There were vertical concrete walls supporting the floor plates at every level. The elements visible matched the floor layout in Figure 6. The walls appear continuous from ground to roof with no transfer structure. The overall condition of the structure observed is good.

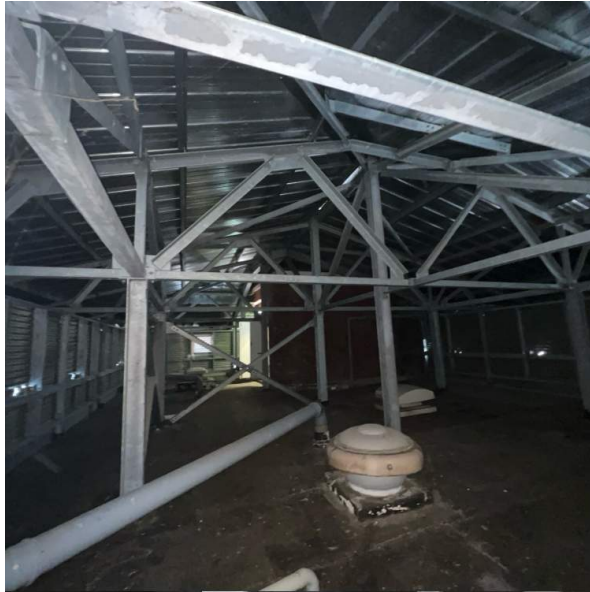
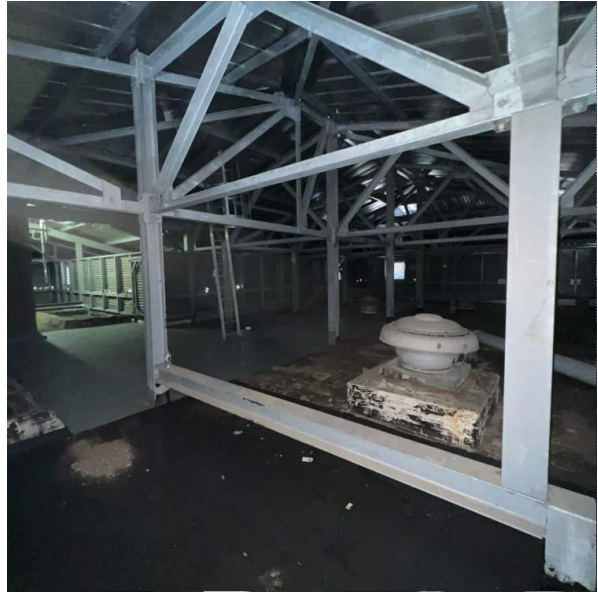
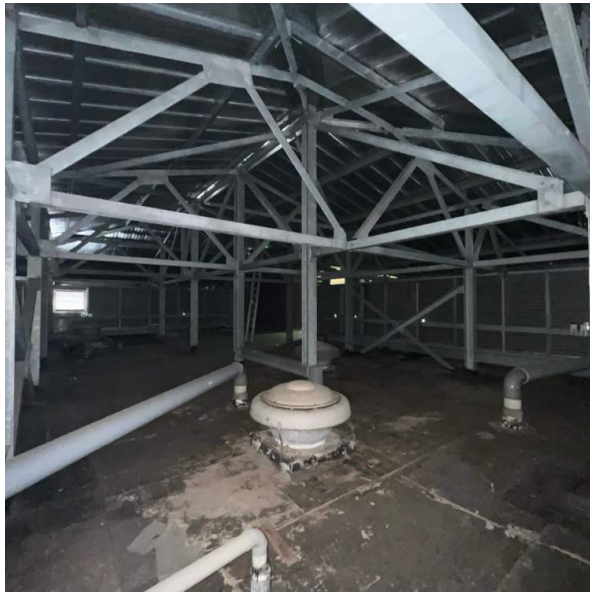
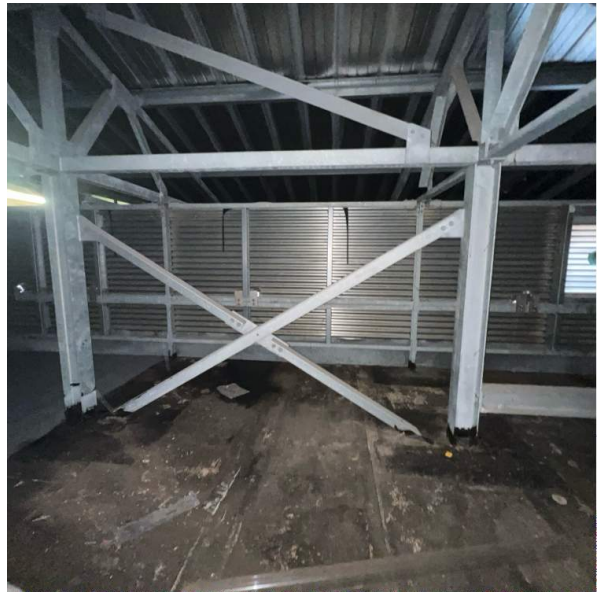
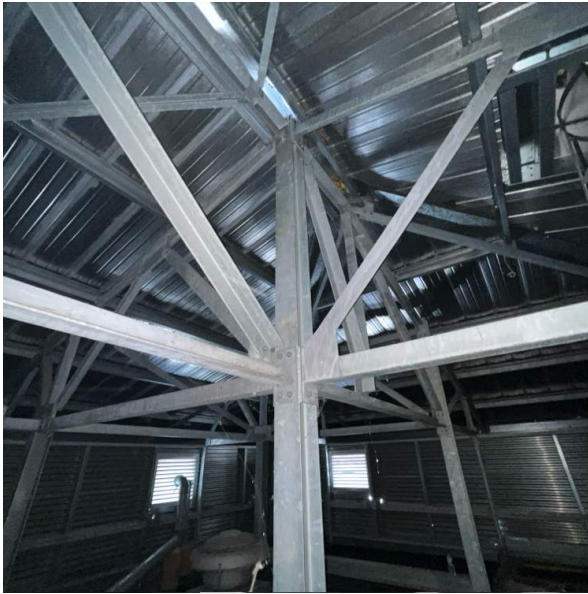
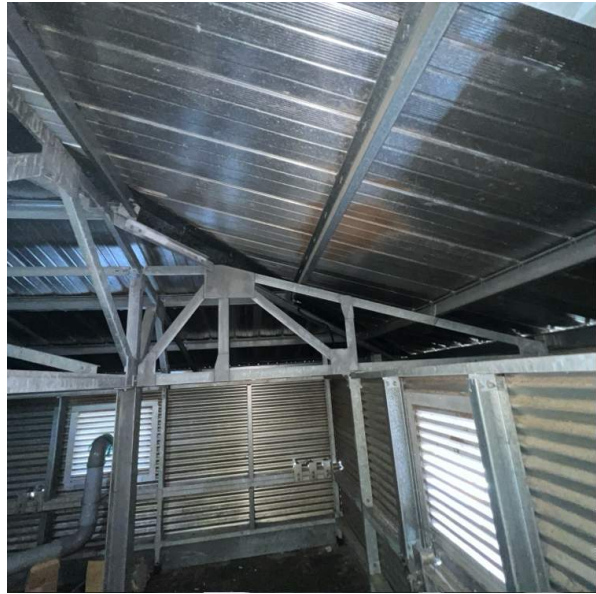
## Main Roof

Comments: A pitched roof constructed above existing original flat roof slab. Steel frame supporting purlins with aluminium standing / mineral wool core profiled panels. Masonry walls noted for motor room.

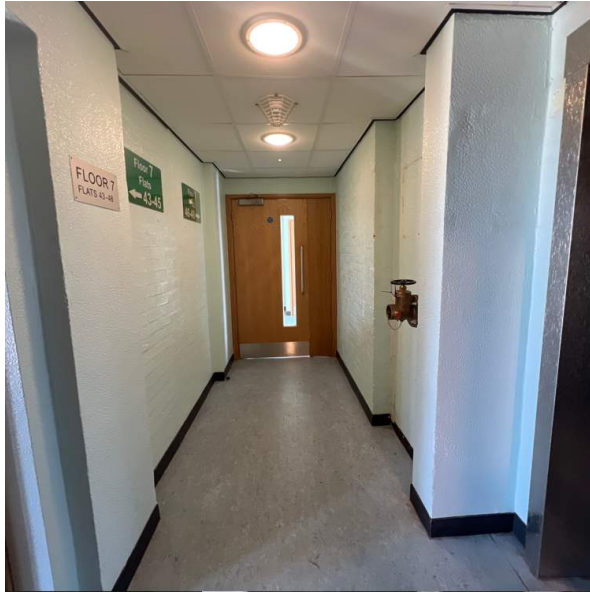
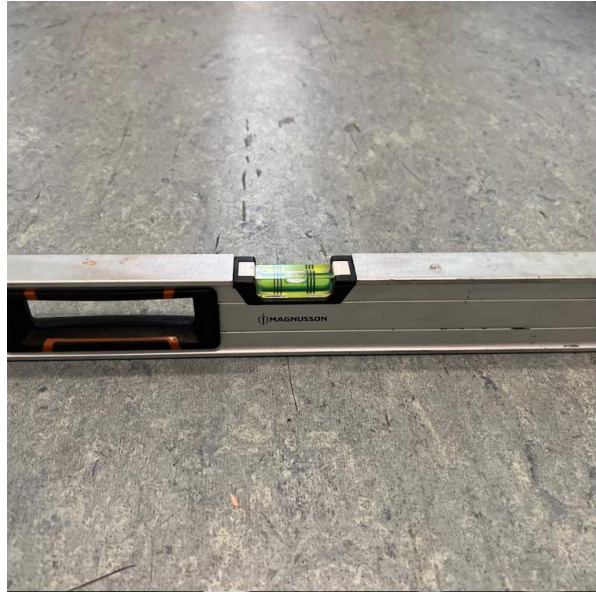
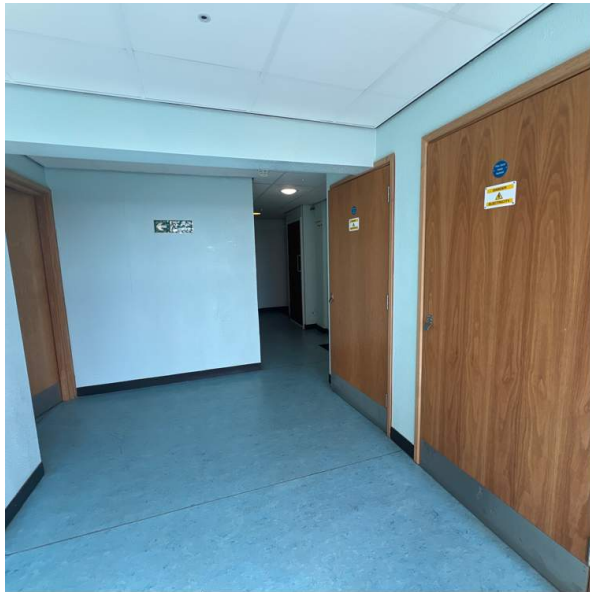
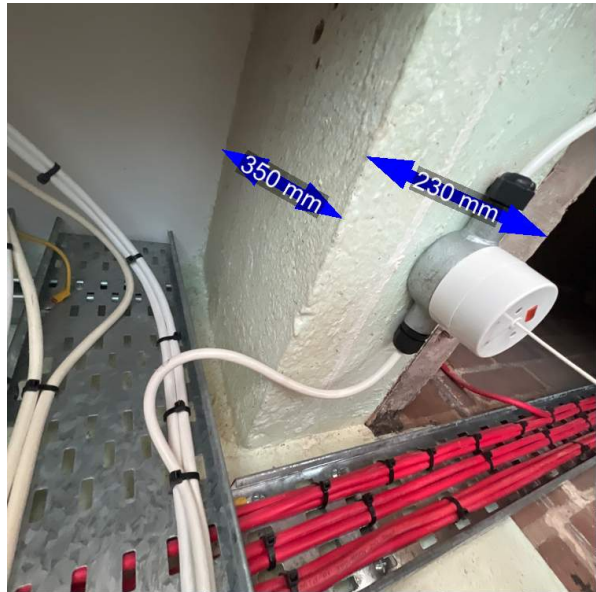
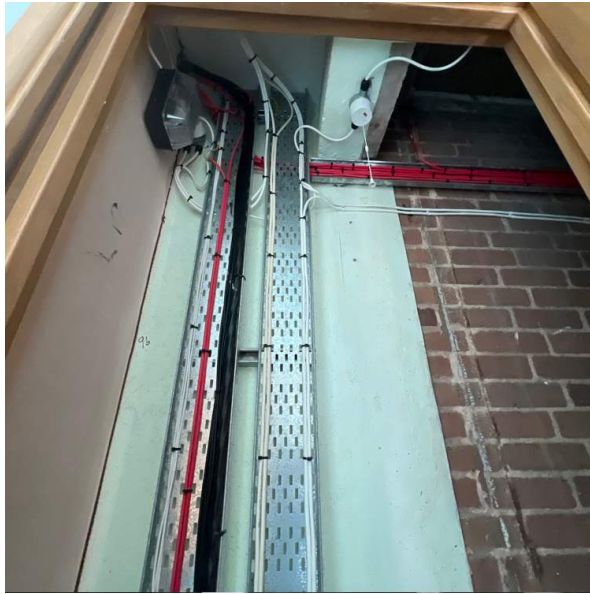
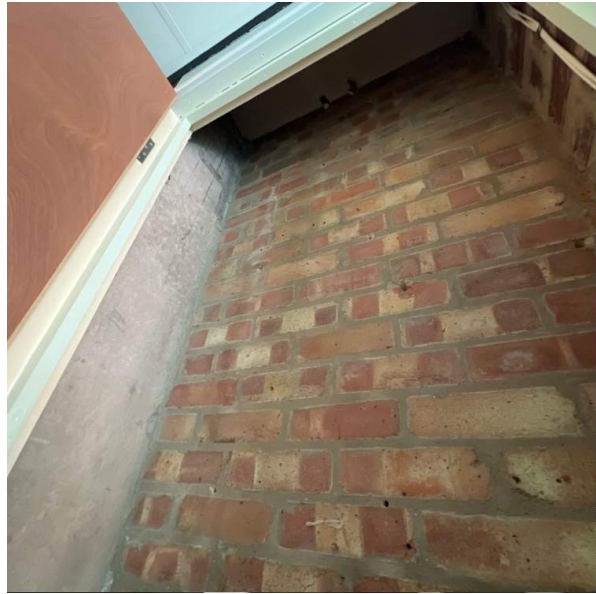
## 7th Floor Hallway

Comments: Hallway walls noted to comprise of a mixture of RC walls/columns and infill (non-load bearing) masonry walls. Concrete walls/columns noted via riser cupboards.

No jams or distortions noted to hallway doors to indicate any serviceability issues.

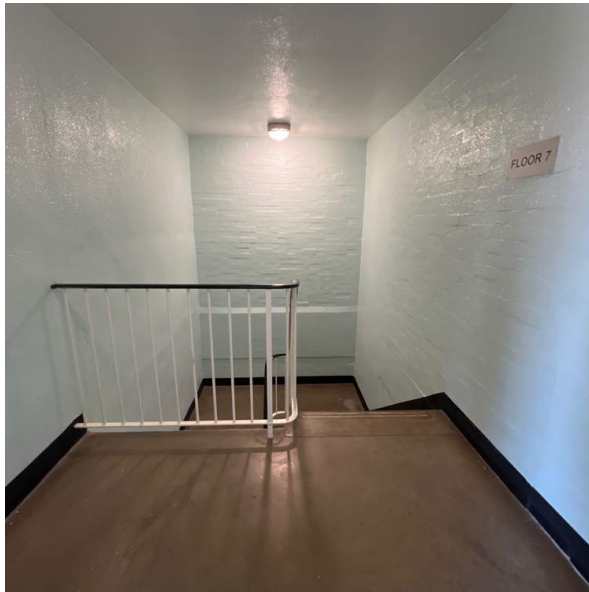
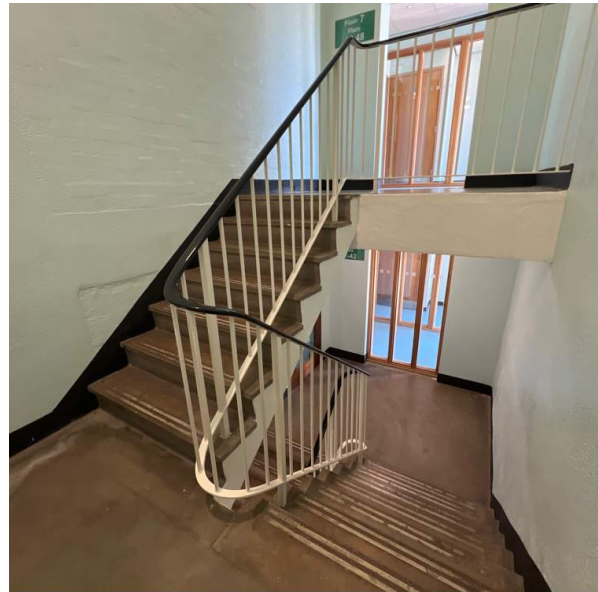
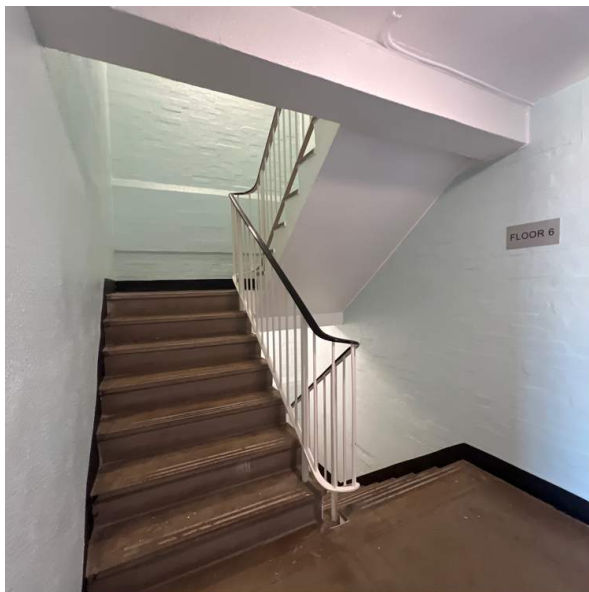
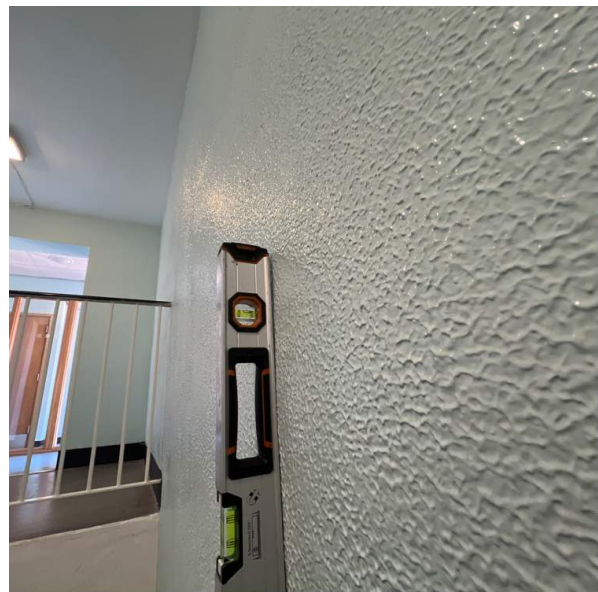
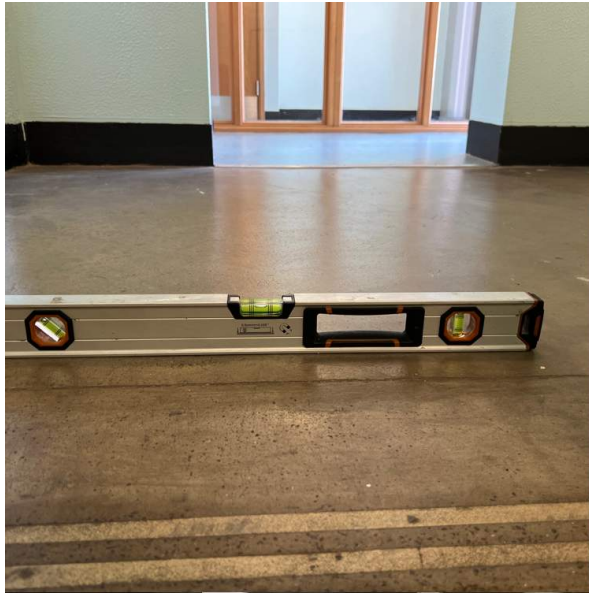
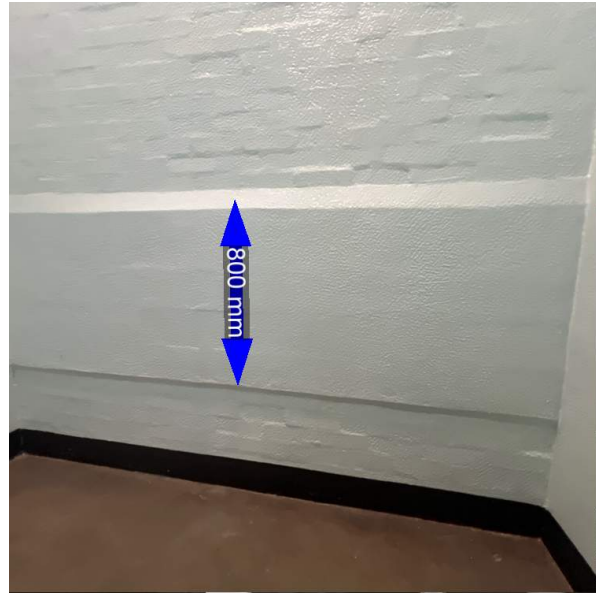
## 7th Floor Staircase

Comments: Insitu concrete stairs with steel hand railing fixed to stairs. Walls and floors appear to be fairly level.  
One side stair walls consist of a RC shear core wall. Other sides embedded with RC wall/column and beam with infill (non-load bearing) masonry.

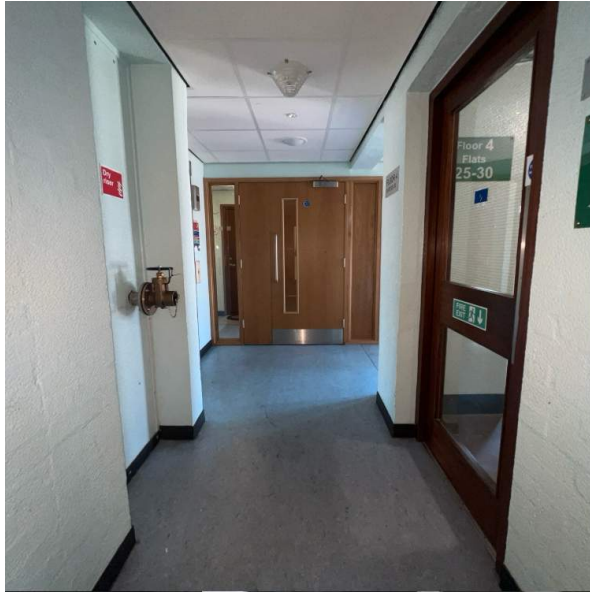
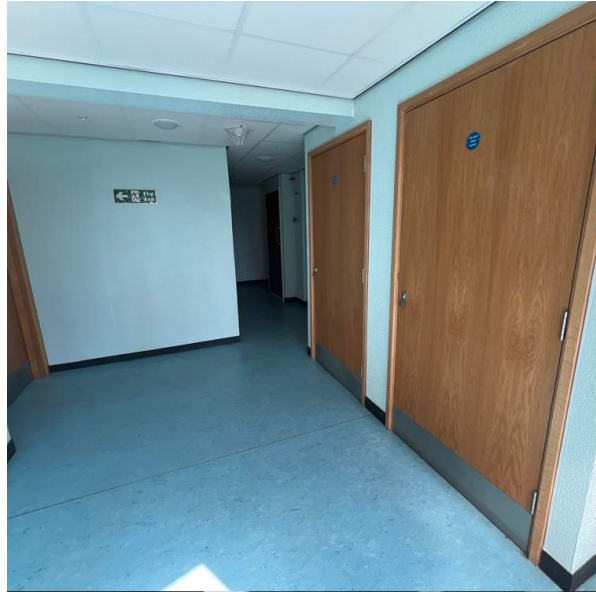
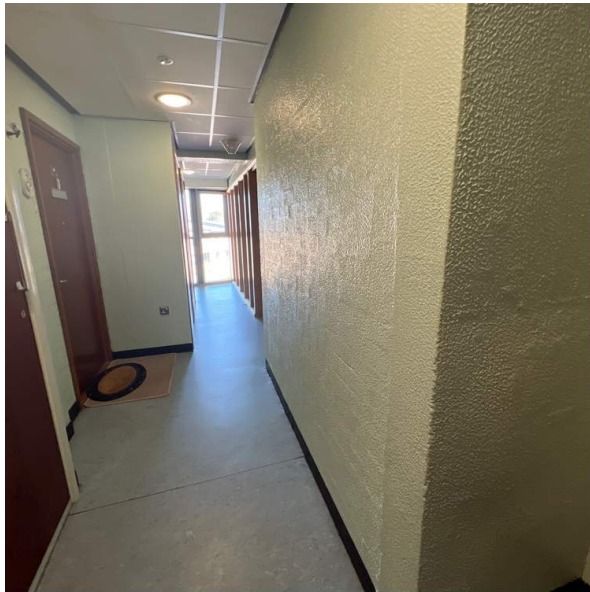
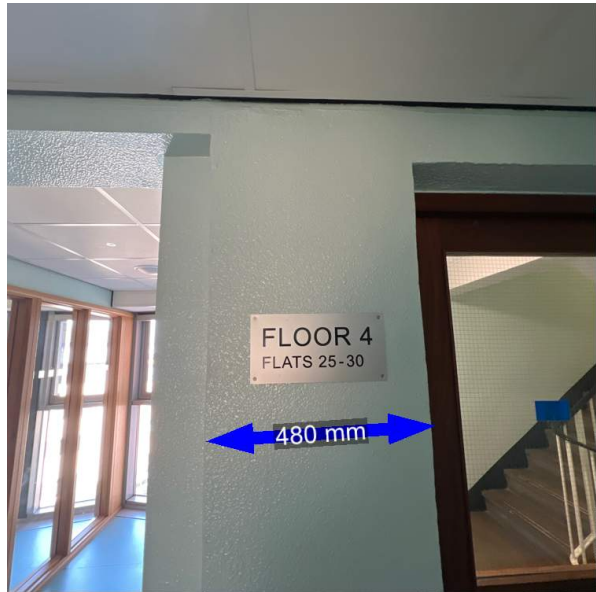
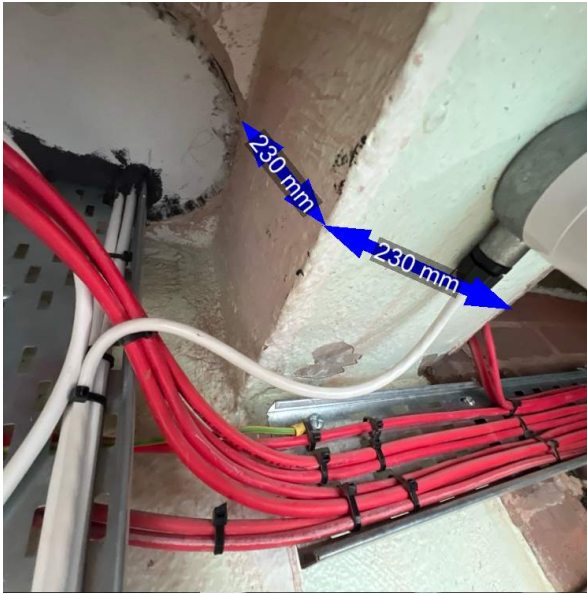
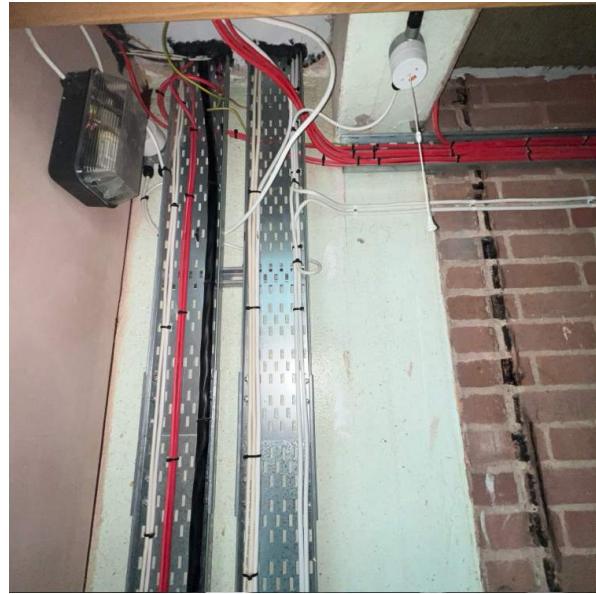
## 4th Floor Hallway

Comments: Hallway walls noted to comprise of a mixture of RC walls/columns and infill (non-load bearing) masonry walls. Concrete walls/columns noted via riser cupboards.

No jams or distortions noted to hallway doors to indicate any serviceability issues.

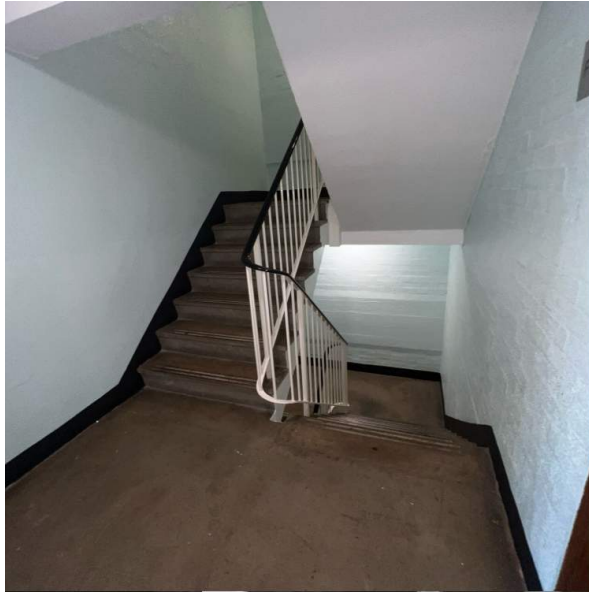
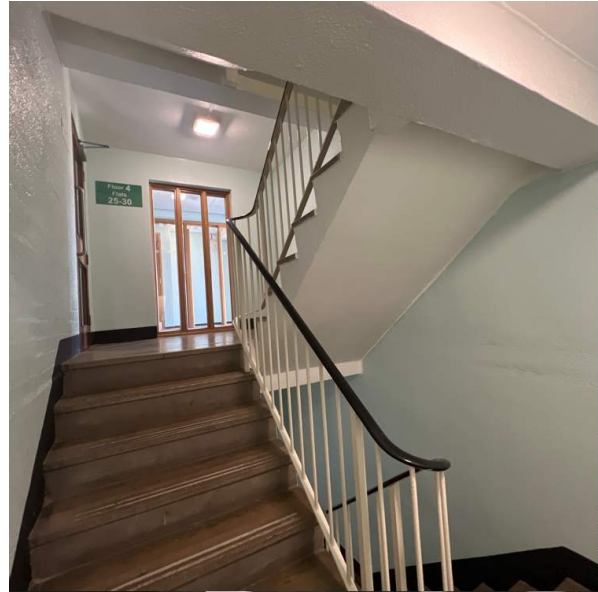
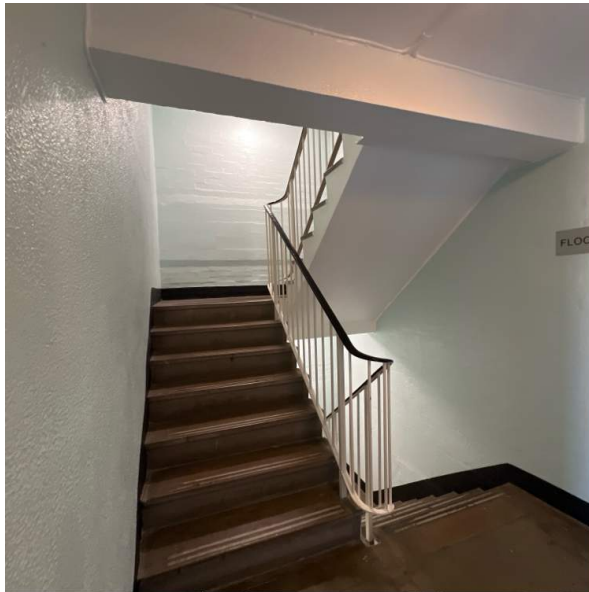
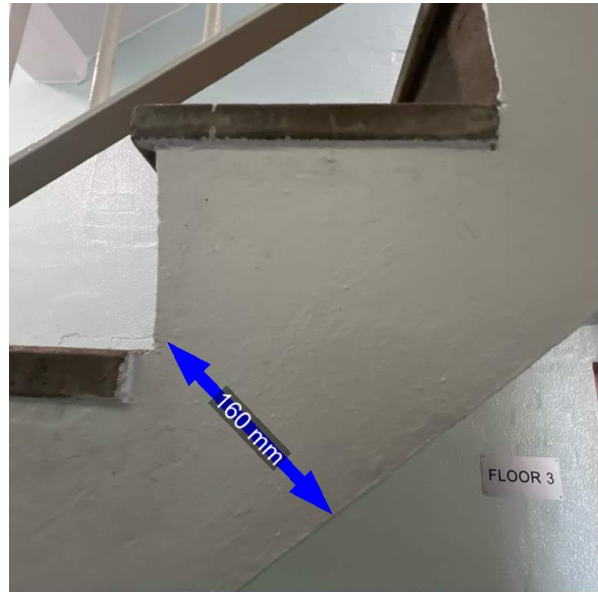
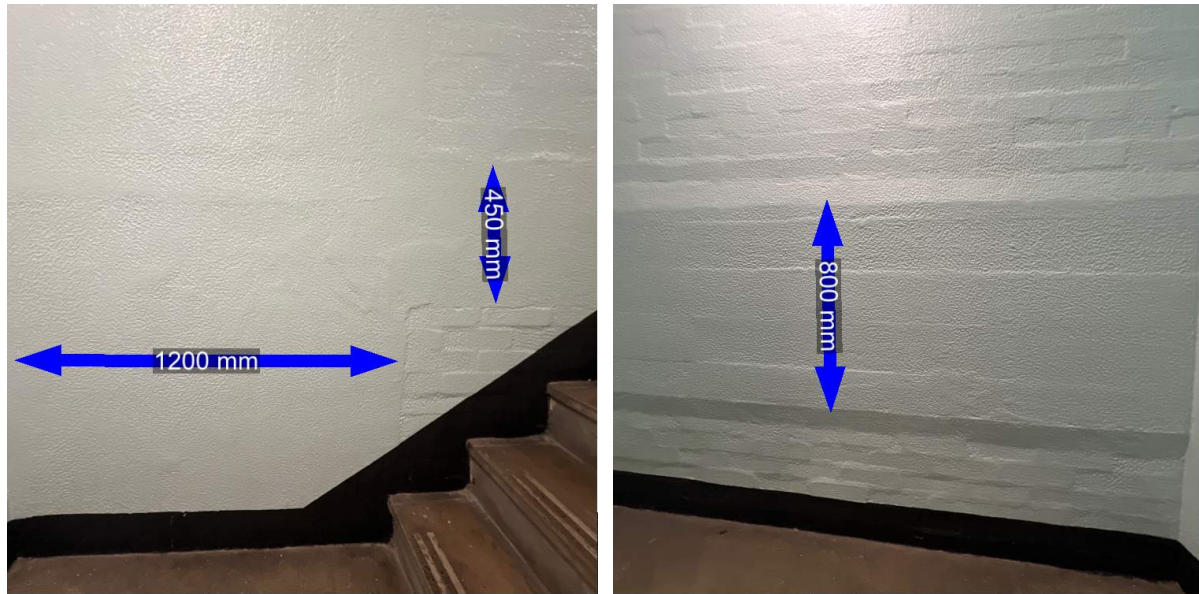
## 4th Floor Staircase

Comments: Insitu concrete stairs with steel hand railing fixed to stairs. Walls and floors appear to be fairly level.  
One side stair walls consist of a RC shear core wall. Other sides embedded with RC wall/column and beam with infill (non-load bearing) masonry.

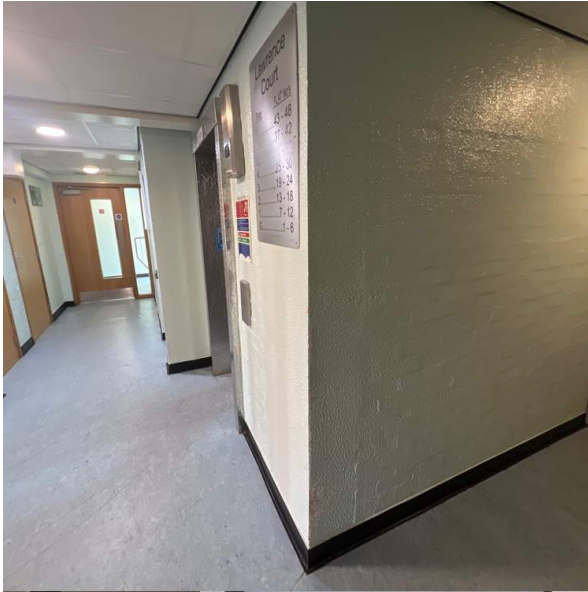
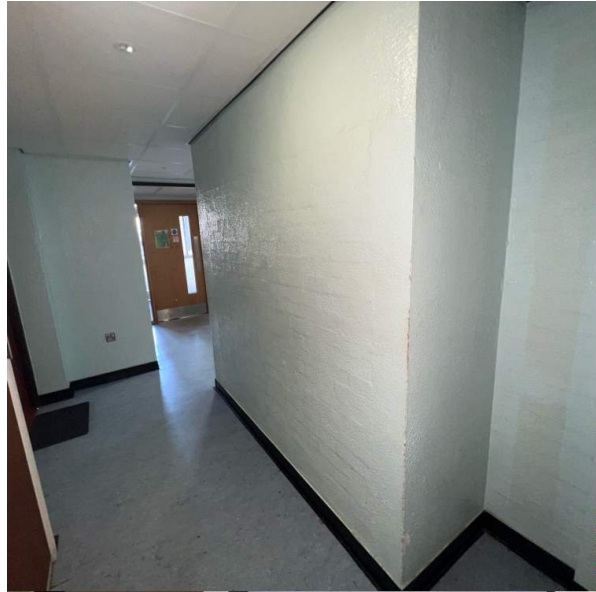
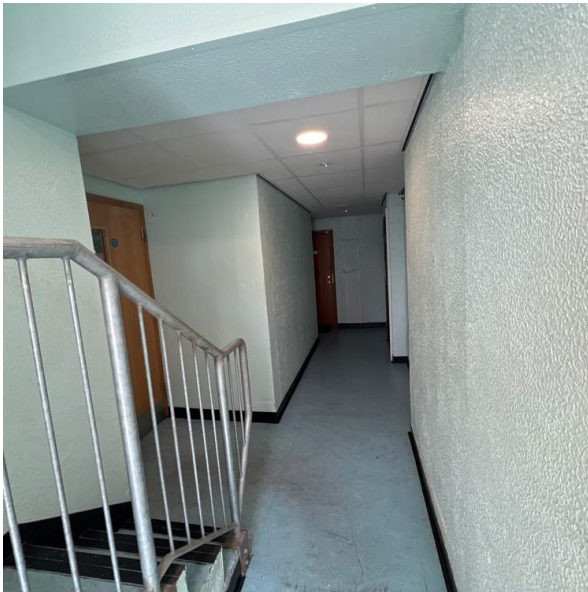
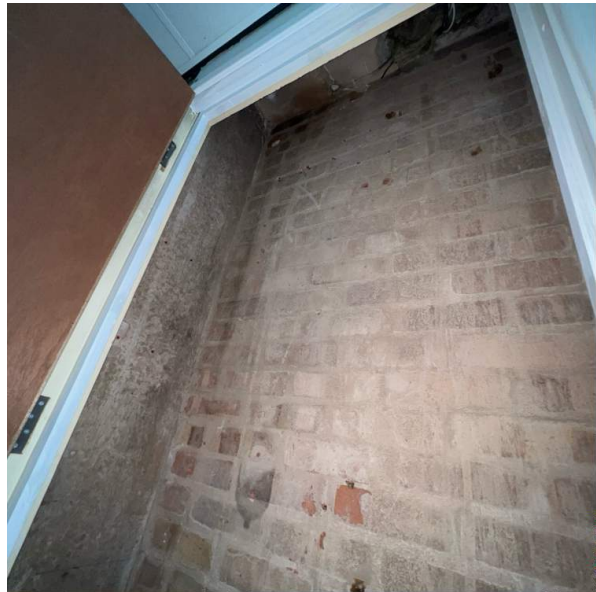
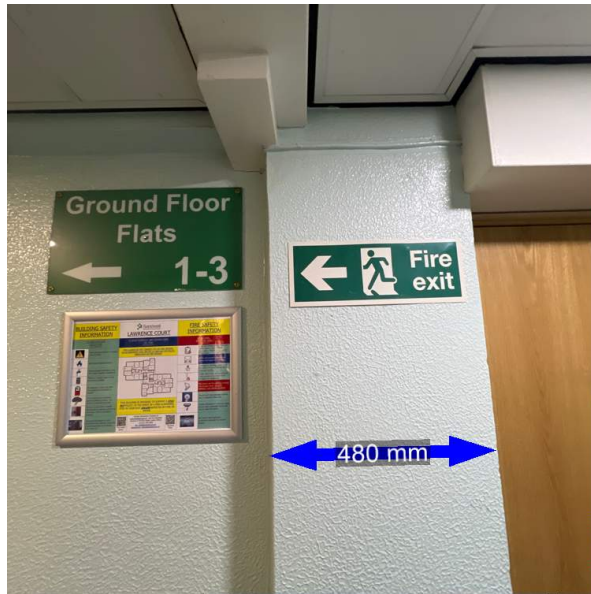
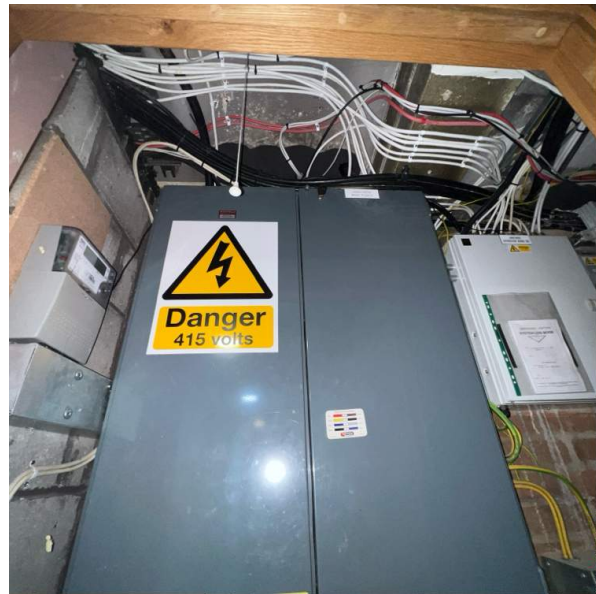
## Ground Floor Hallway

Comments: Hallway walls noted to comprise of a mixture of RC walls/columns and infill (non-load bearing) masonry walls. Concrete walls/columns noted via riser cupboards.

No jams or distortions noted to hallway doors to indicate any serviceability issues.

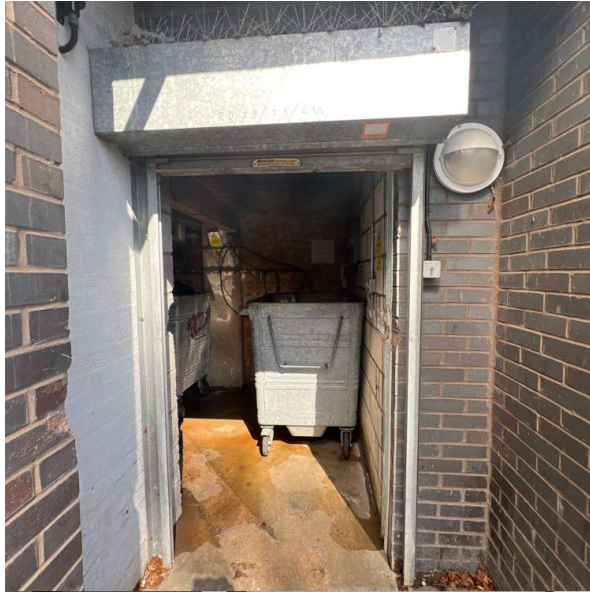
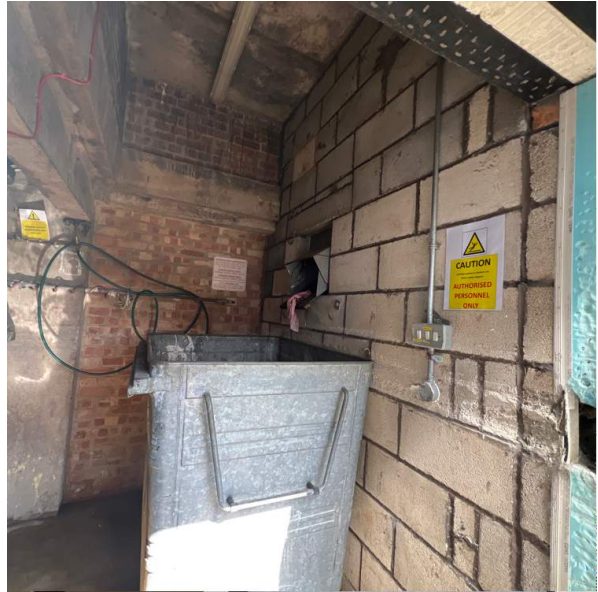
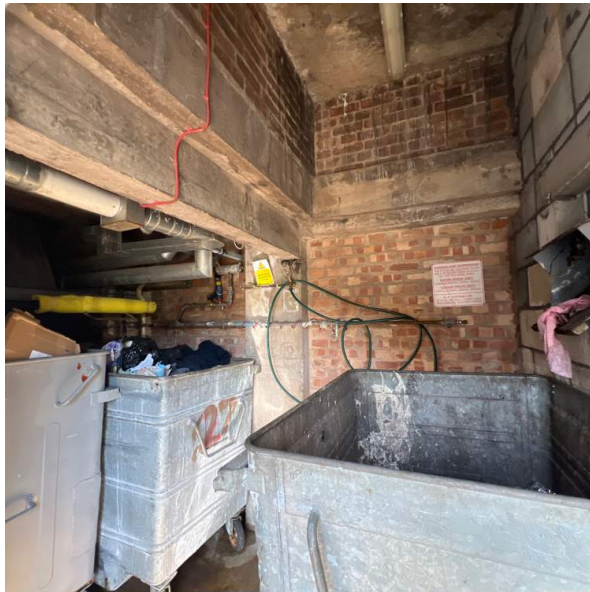
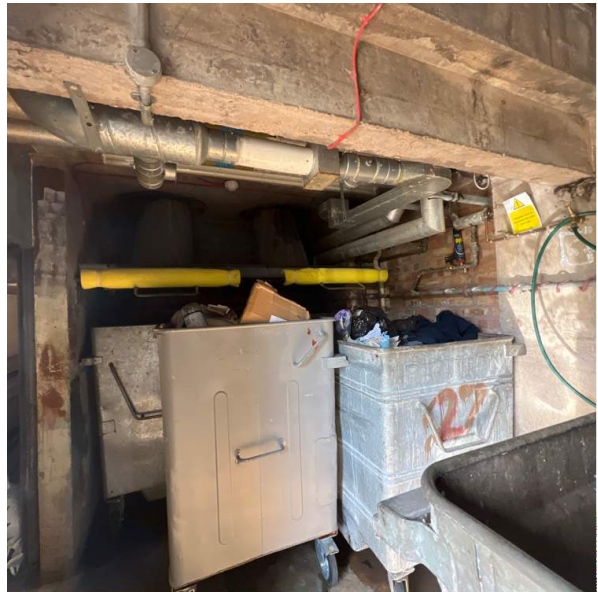
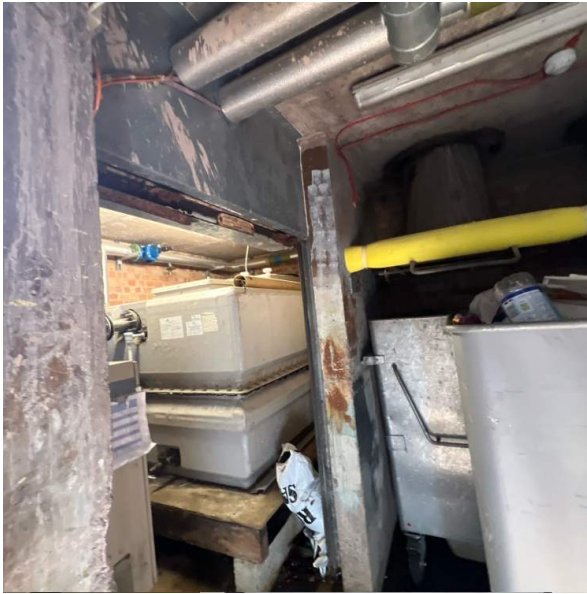
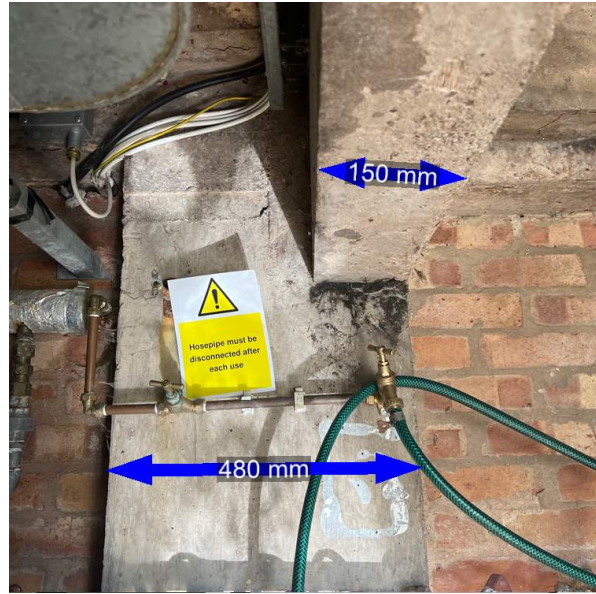
## Binstore

Comments: Mixture of RC shear walls, columns and beams with infill (non-load bearing) masonry noted in binstore.

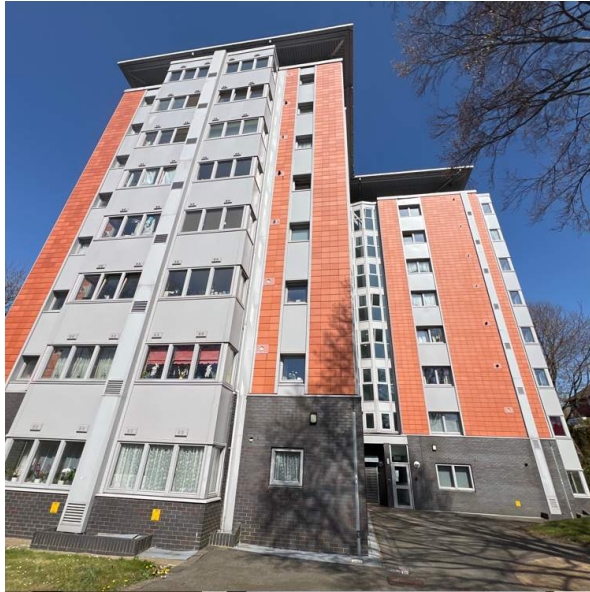
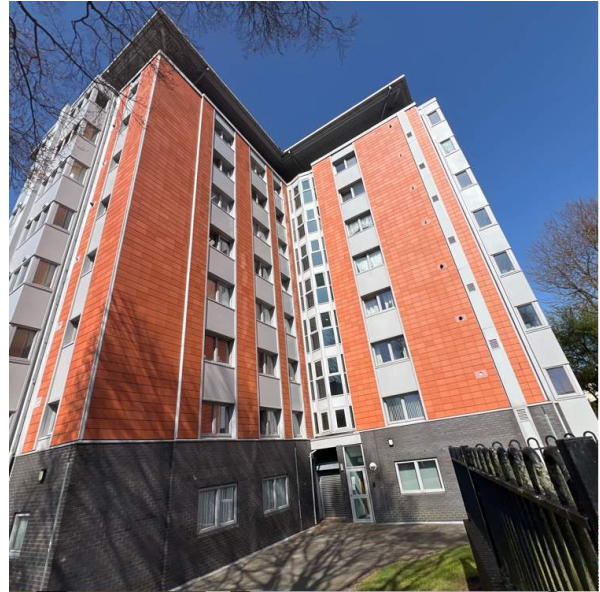
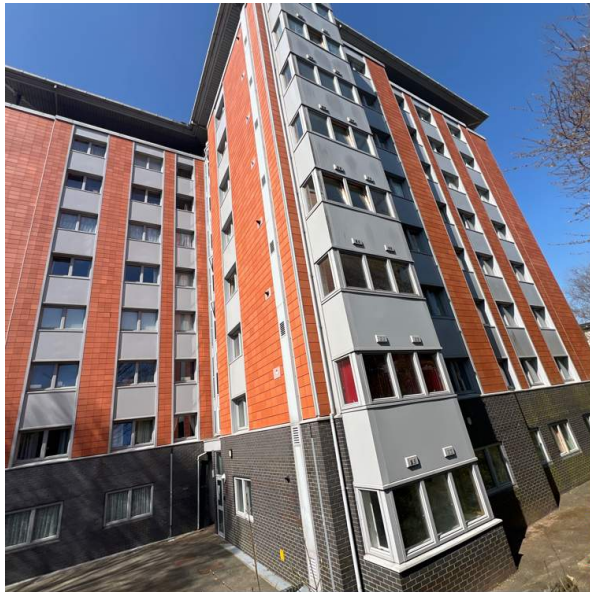
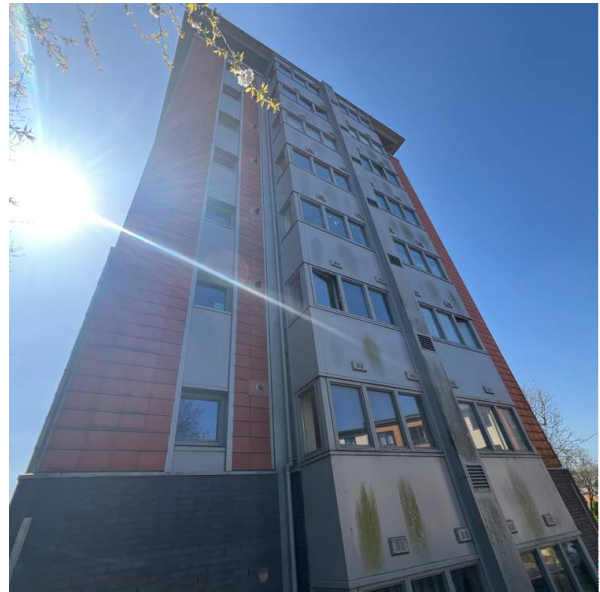
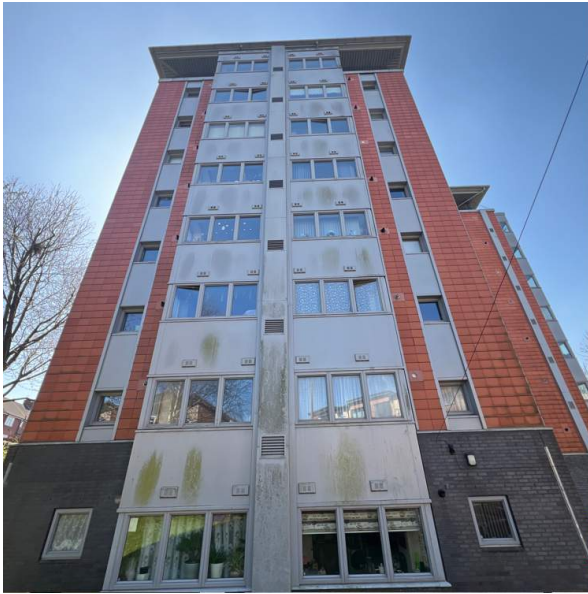
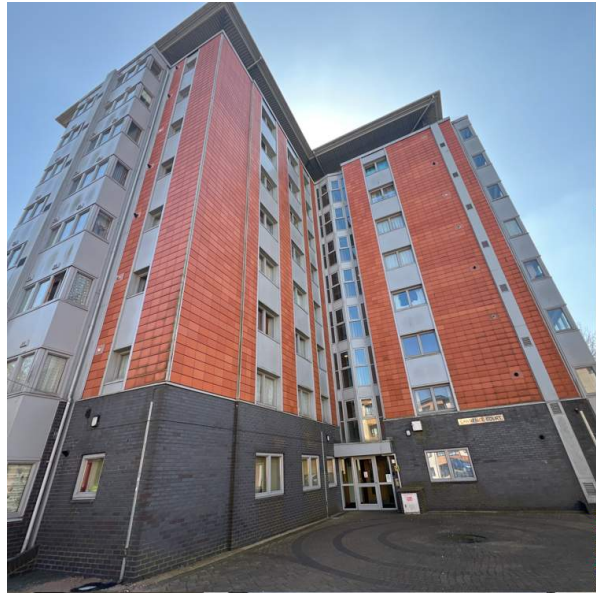
## Elevations

Ground floor level consists of brickwork. Remaining upper floors consist of cladded facade. Balconies have been encased in.
