VISUAL STRUCTURAL APPRAISAL

Lissimore House

Maria Street  
West Bromwich  
B70 6DR

29<sup>th</sup> November 2024

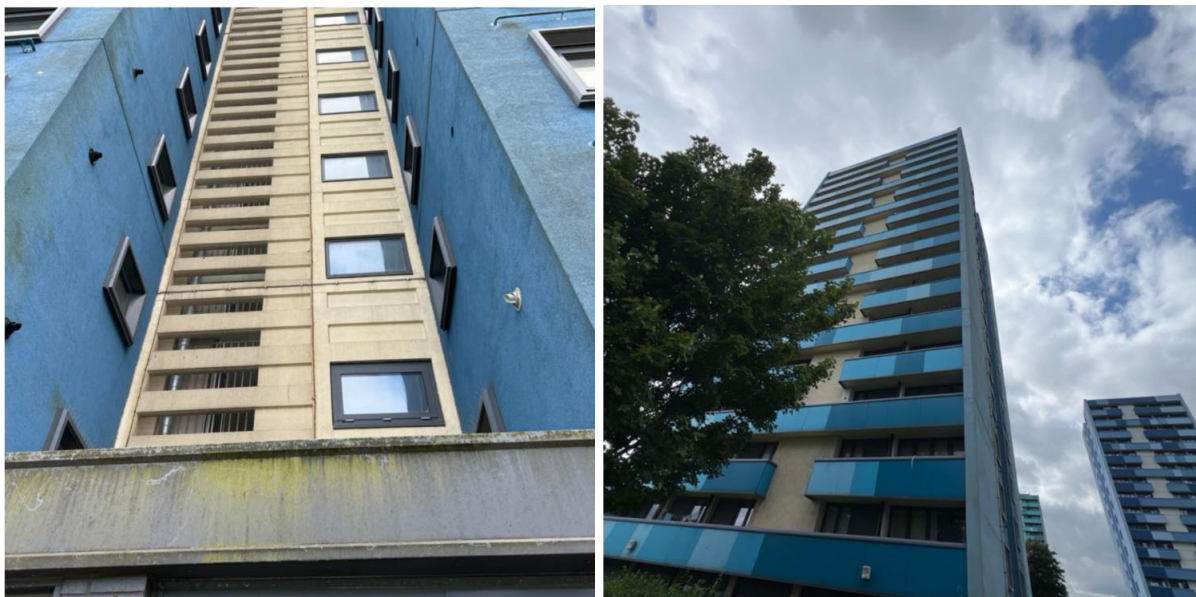
The exterior elevations were generally in ok condition and no significant structural defects were noted to the cladding panels. There were no significant cracks or tell-tale signs of any significant structural movement noted at the time of our inspection.

The exterior panels were noted to be plumb with no signs of significant bowing, bulging or leaning noted to the panels indicating failed fixings however their presence and condition cannot be confirmed.

There are balconies at each level which have been clad in High Pressure Laminate panels.

Figure 9 and 10: Precast Panels and side Elevation Balconies

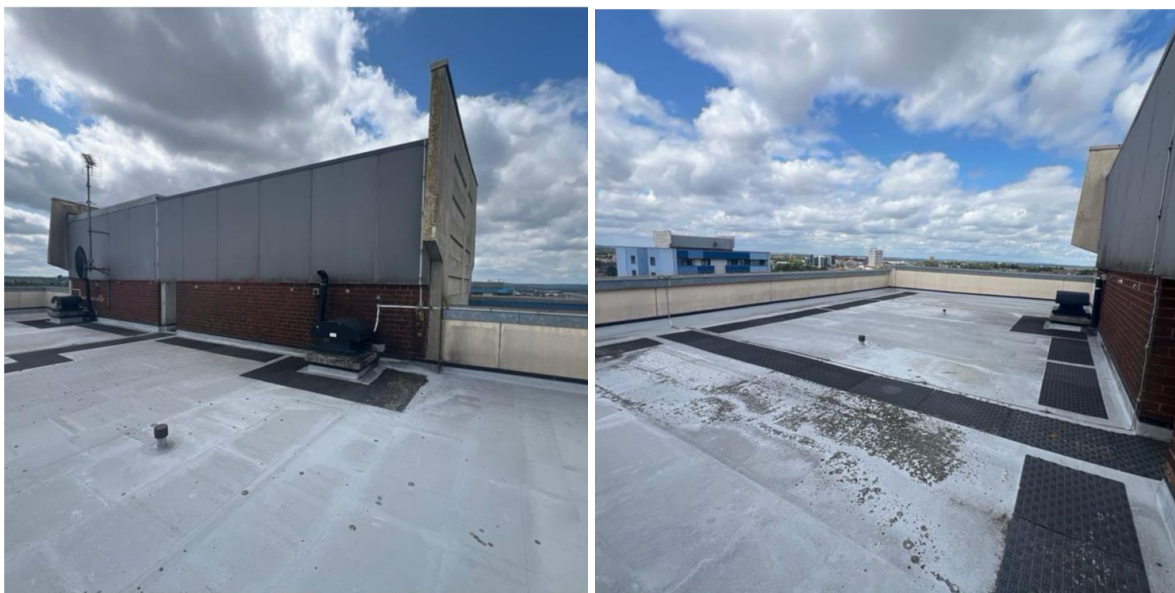
There were no tell-tale signs of any significant structural movement noted at the time of our inspection. The exterior walls were noted to be plumb with no signs of significant bowing, bulging or leaning noted to the masonry walls.

The roof has a single ply membrane finish. The exact build-up of the roof finishes were not accessible at the time of inspection. It is recommended an intrusive survey of the roof finishes is completed by a specialist surveyor to assess the condition of the roof covering.

Figure 11 and 12: Roof Level

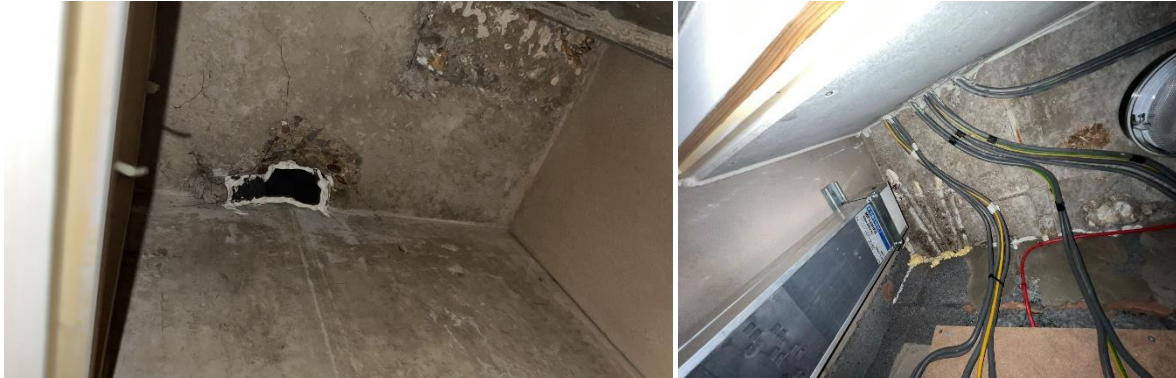
There was some local spalling noted to concrete elements in the electrical room on 9th and 16th floor. Repairs may be carried out by locally patching.

Figure 13 and 14: Localised areas of spalling

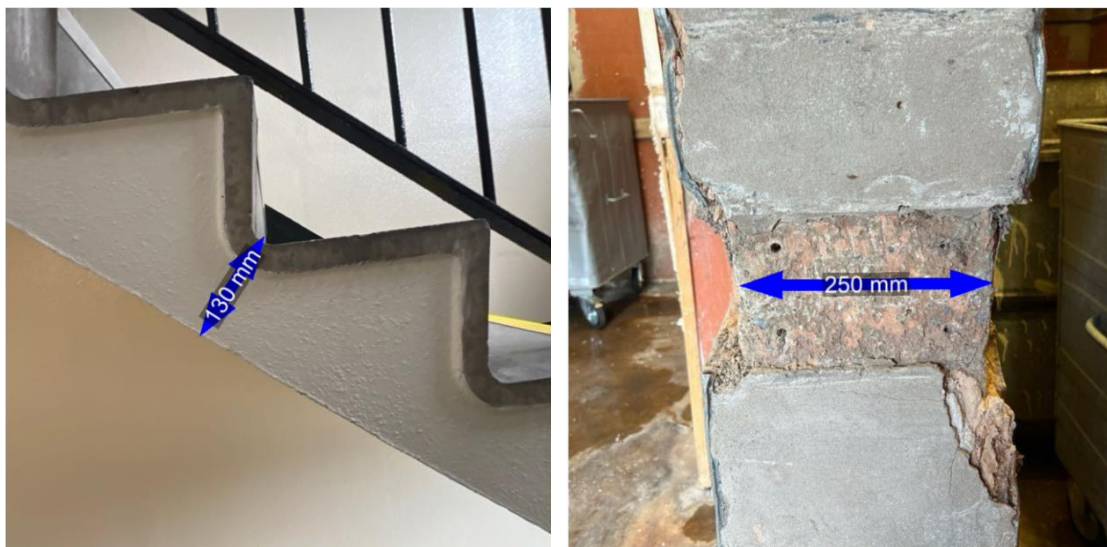
The stair stringer was noted to be 130mm thick which is less than we would expect to modern standards, a cover test is required to check the resistance of the concrete section in the event of a fire.

Figure 15 and 16: Staircase Stringer and clad column at ground floor

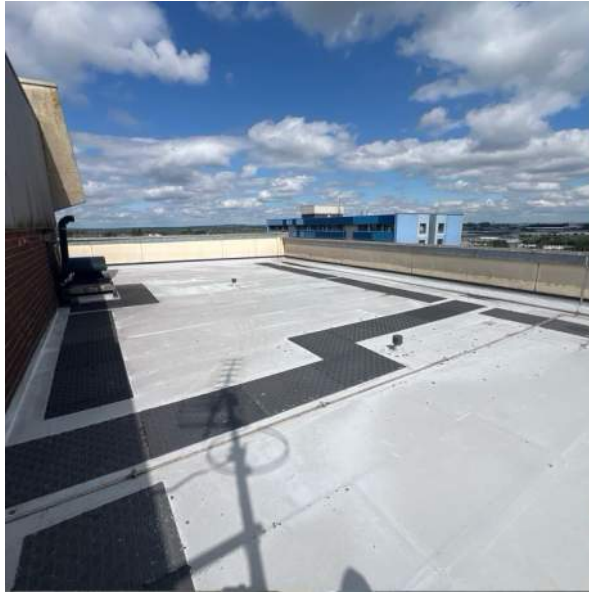
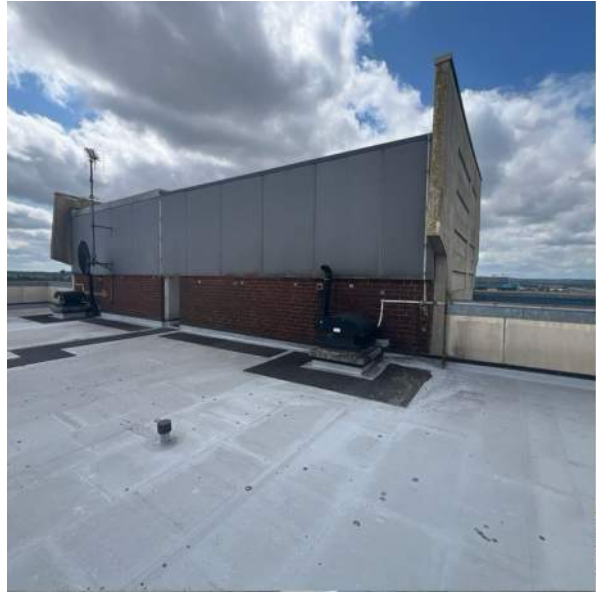
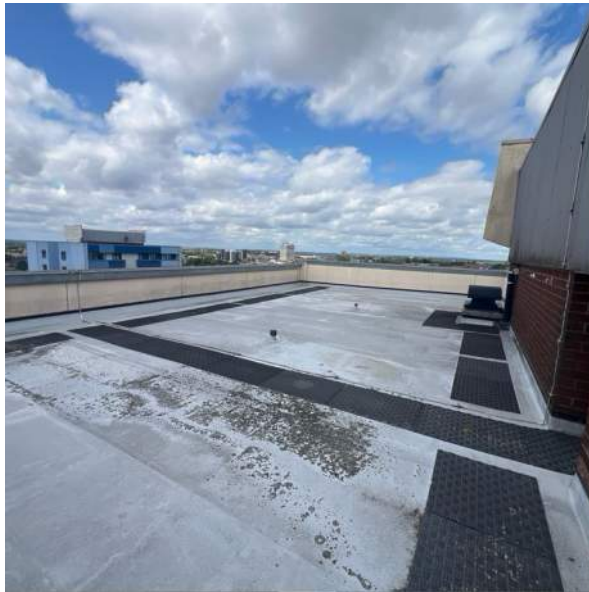
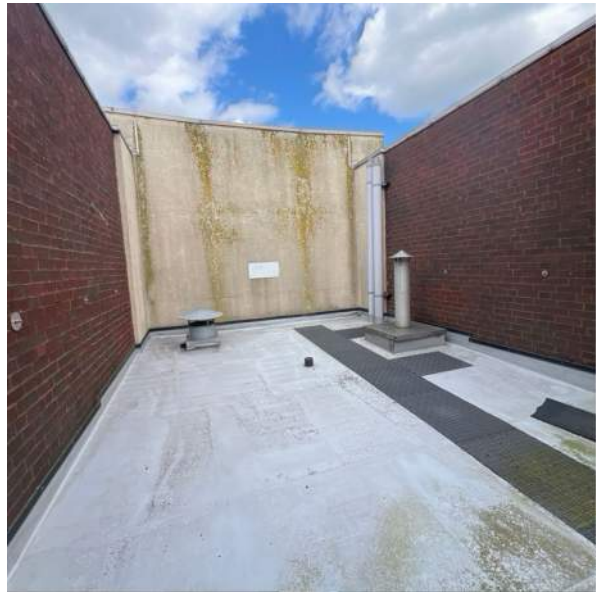
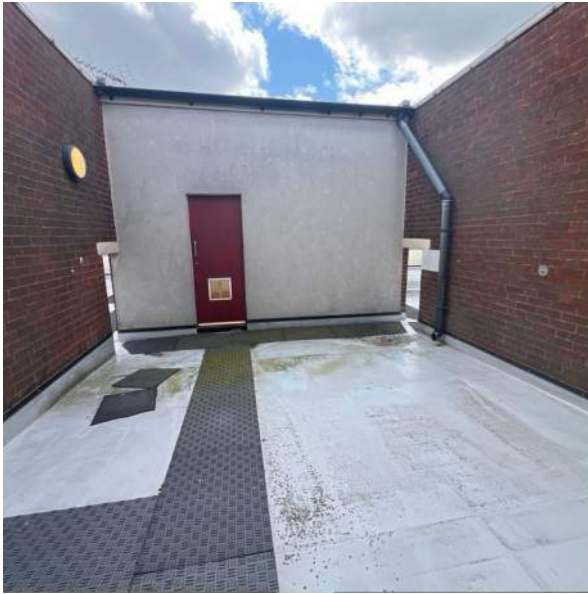
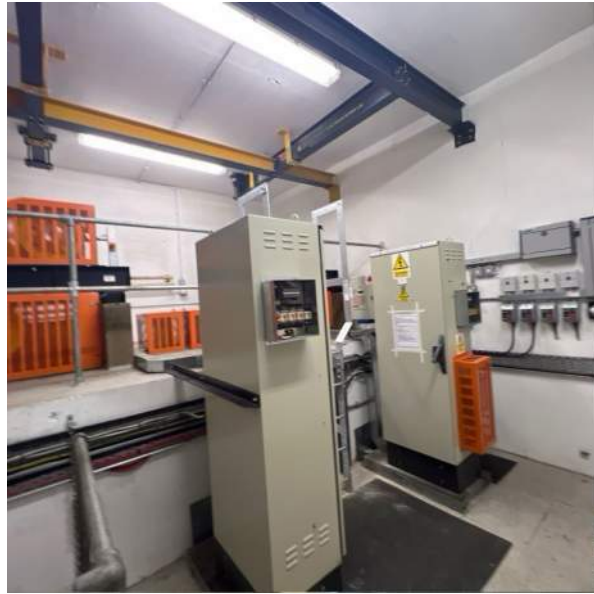
## Main Roof

Lift motor room located on roof formed of masonry walls.  
Parapet walls noted to perimeter of roof.  
Concrete roof slab approx. 200mm thick measure from access hatch.

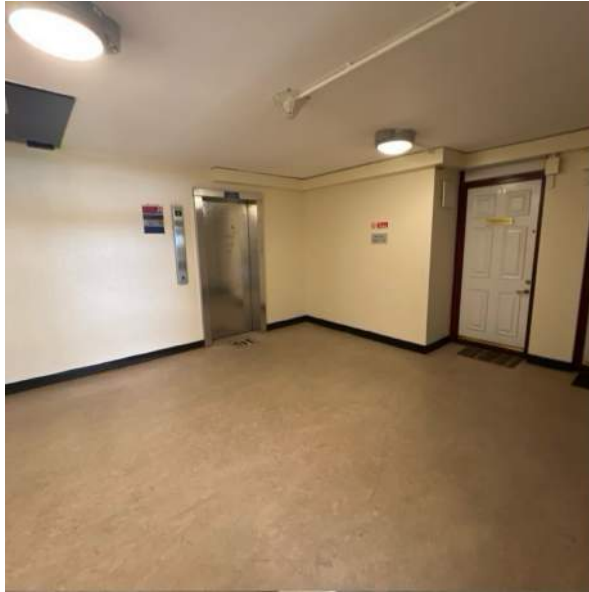
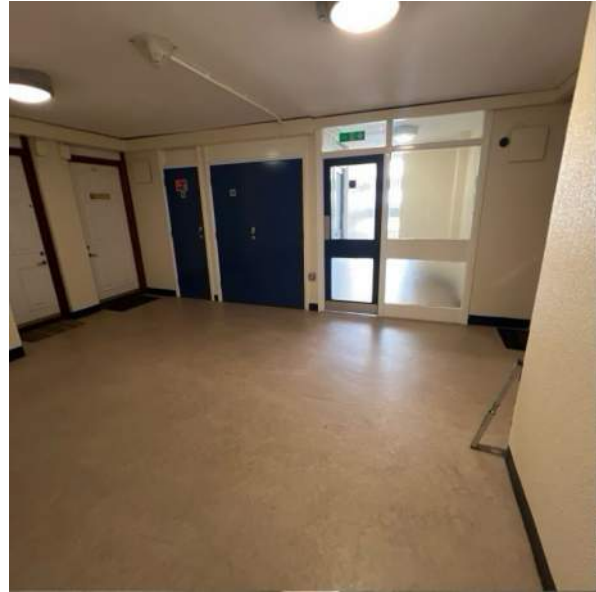
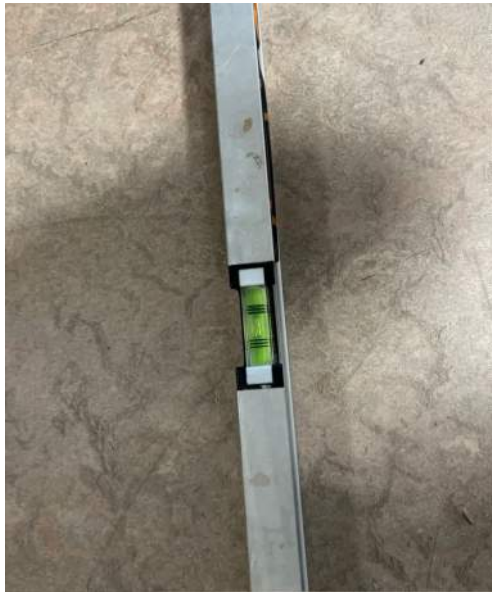
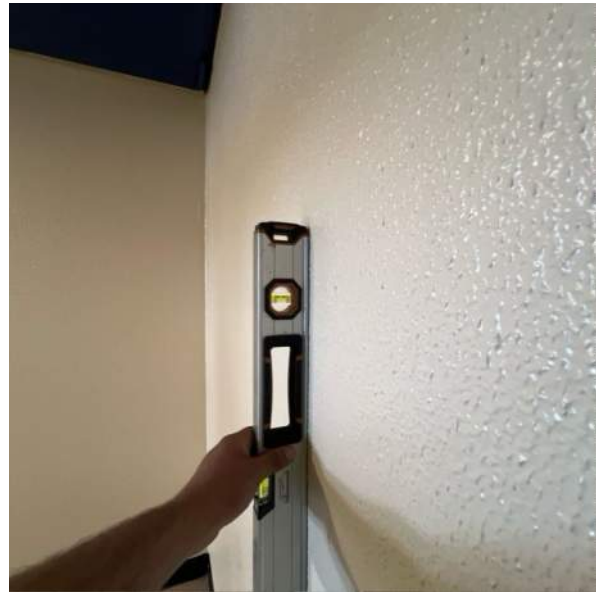
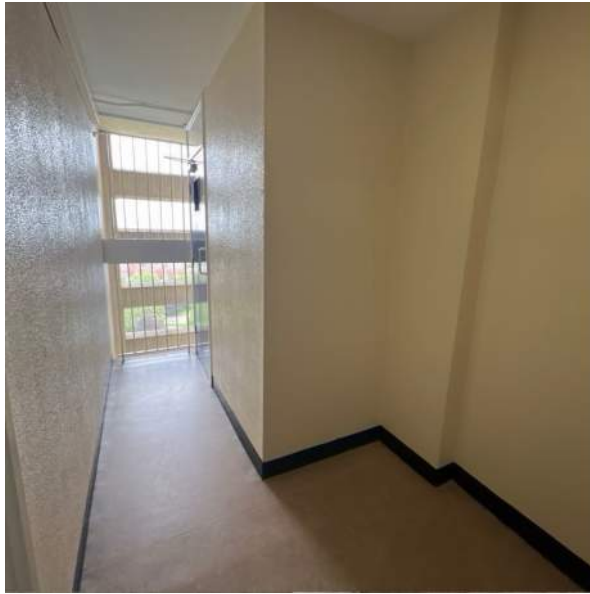
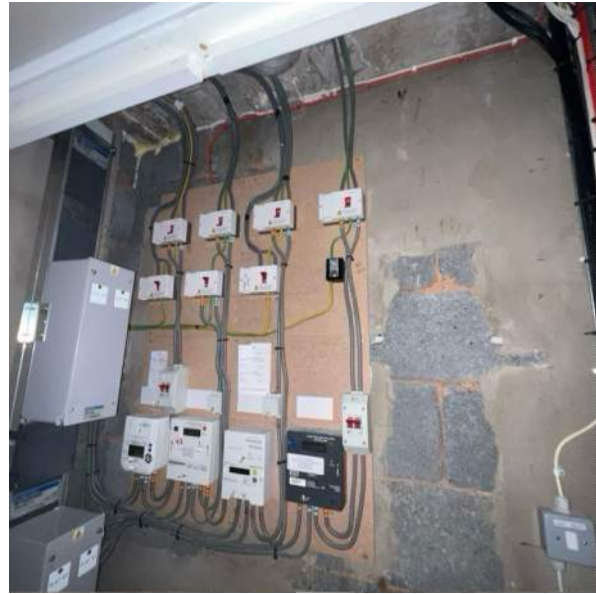
## 16th Floor Hallway

The lift and stair core are located in the hallway. No jams or distortions noted to hallway doors to indicate any serviceability issues.  
Generally walls covered with finishes in hallway, likely to consist a mixture of concrete shear walls, embedded columns and block infill walls.  
Concrete walls forming part of the primary structure noted in the dry riser. Electrical cabinet shows infill block walls.

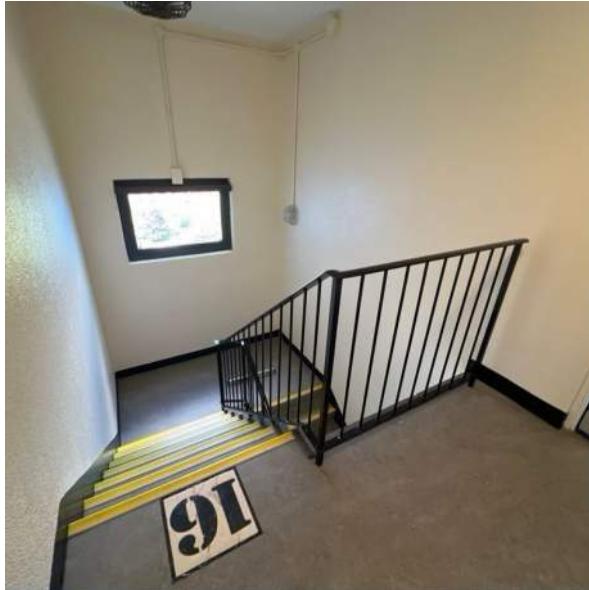
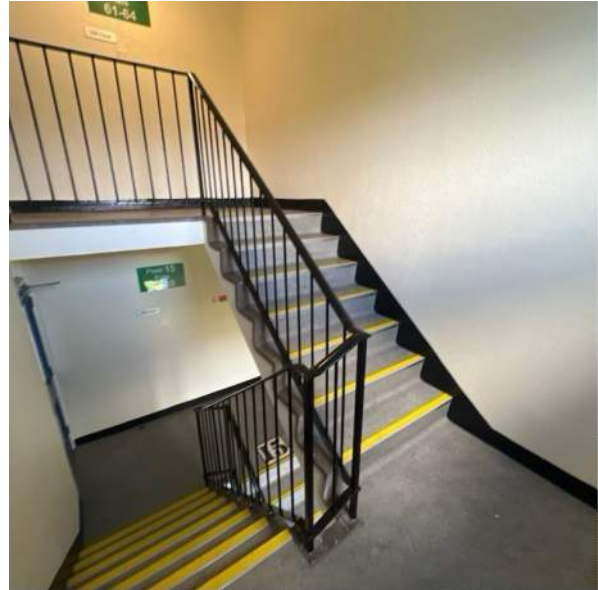
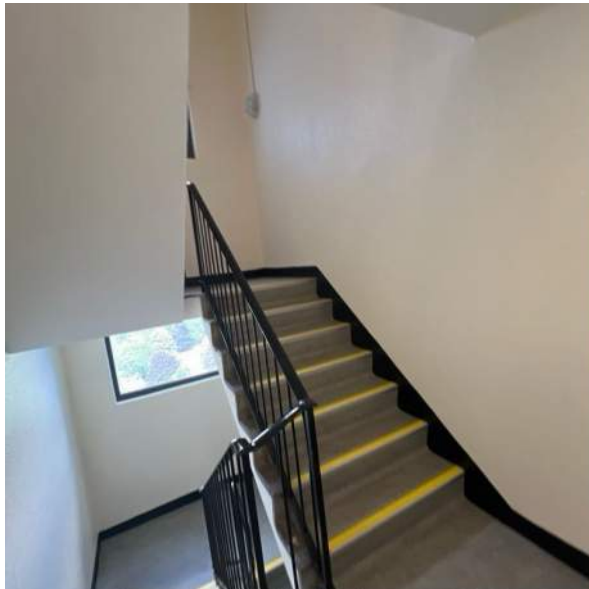
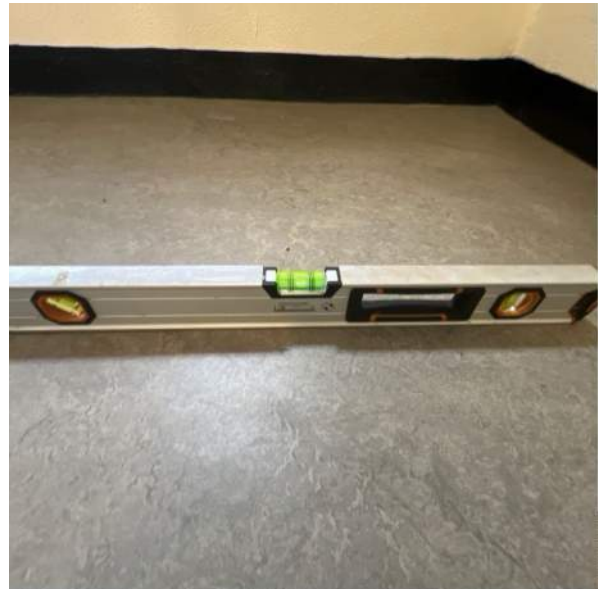
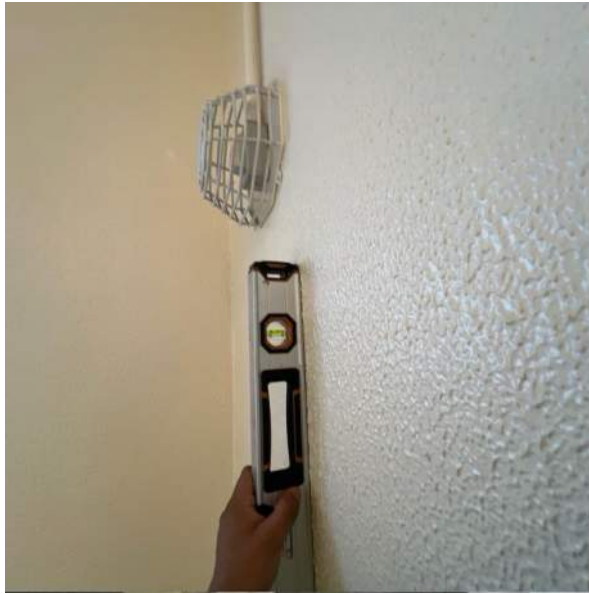
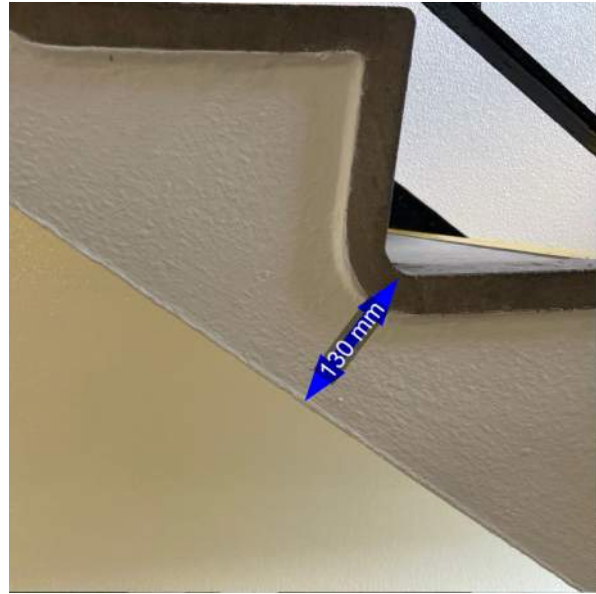
## 16th Floor Staircase

In situ concrete stairs with steel hand railing fixed to stairs. Walls and floors appear to be fairly level.

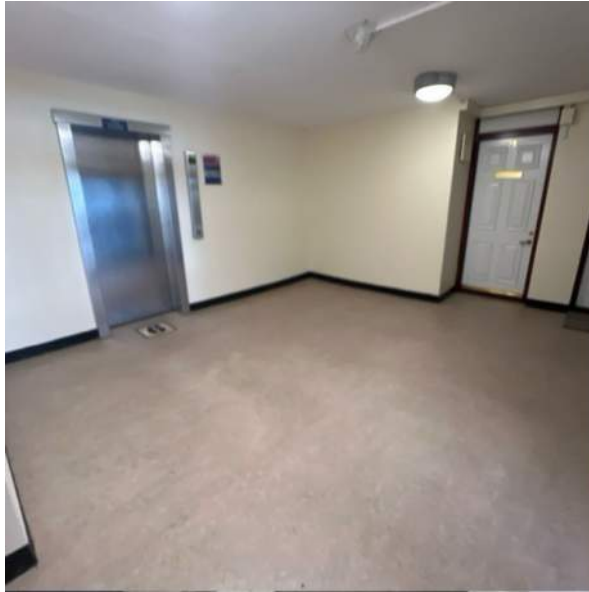
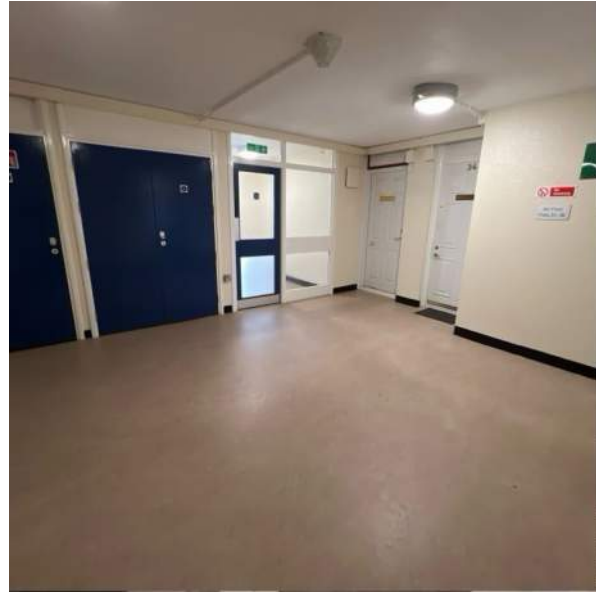
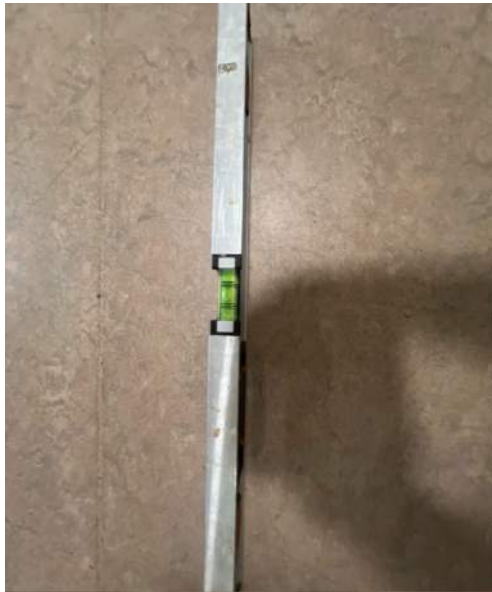
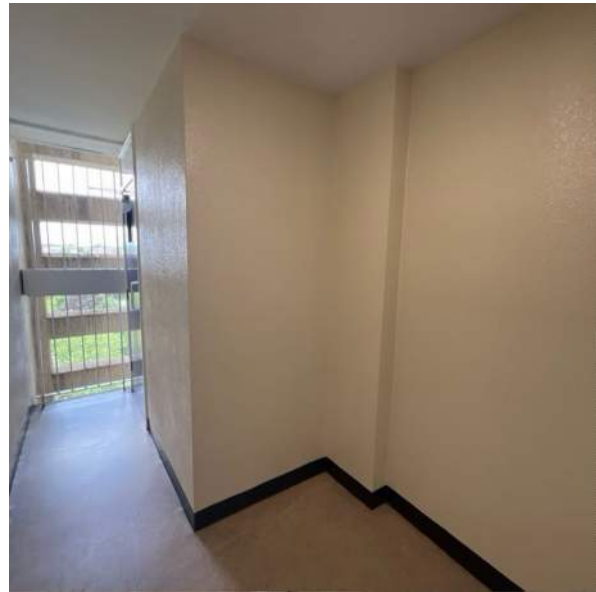
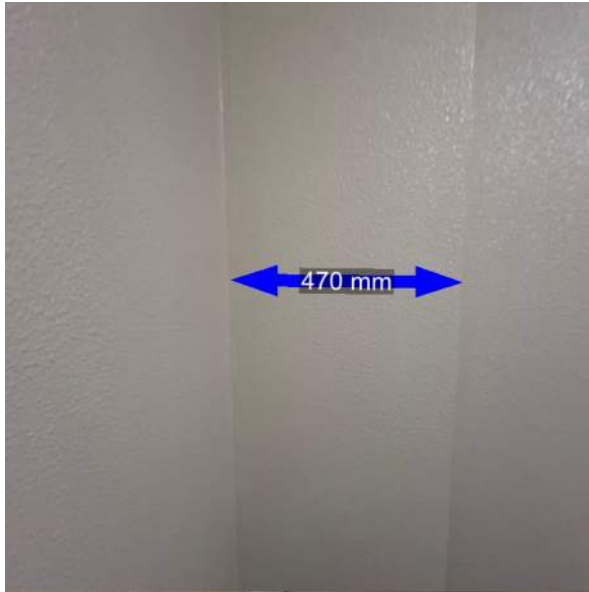
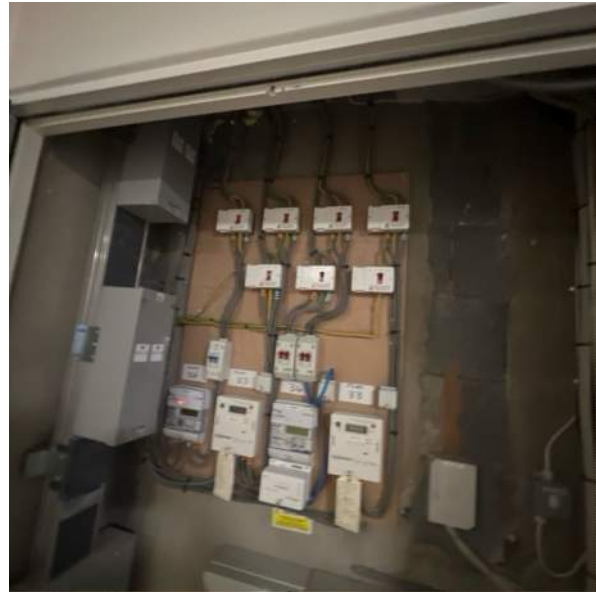
## 8th Floor Hallway

The lift and stair core are located in the hallway. No jams or distortions noted to hallway doors to indicate any serviceability issues.  
Generally walls covered with finishes in hallway, likely to consist a mixture of concrete shear walls, embedded columns and block infill walls.  
Concrete walls forming part of the primary structure noted in the dry riser. Electrical cabinet shows infill block walls.

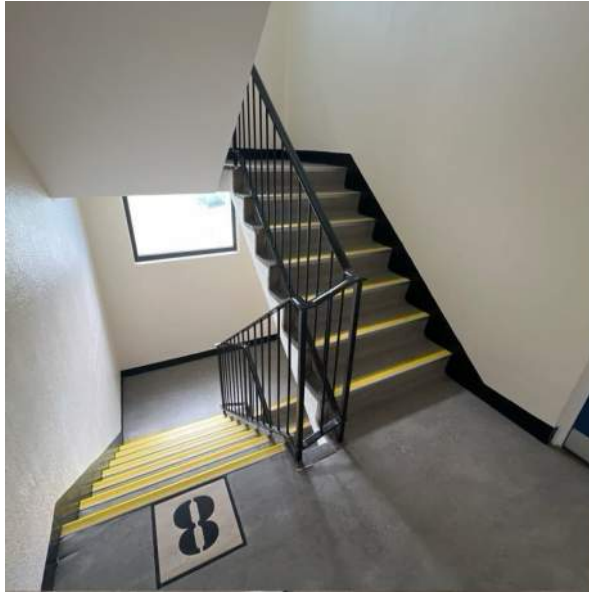
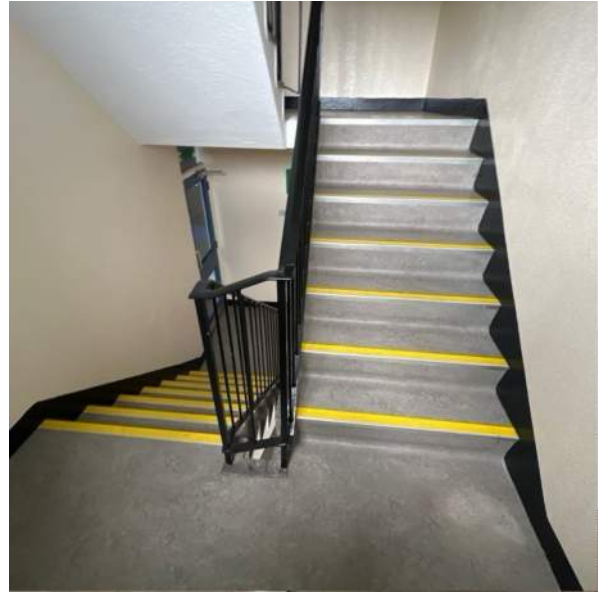
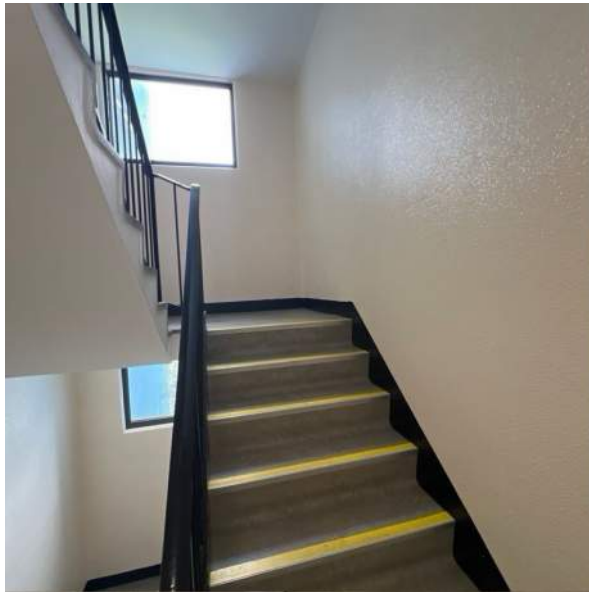
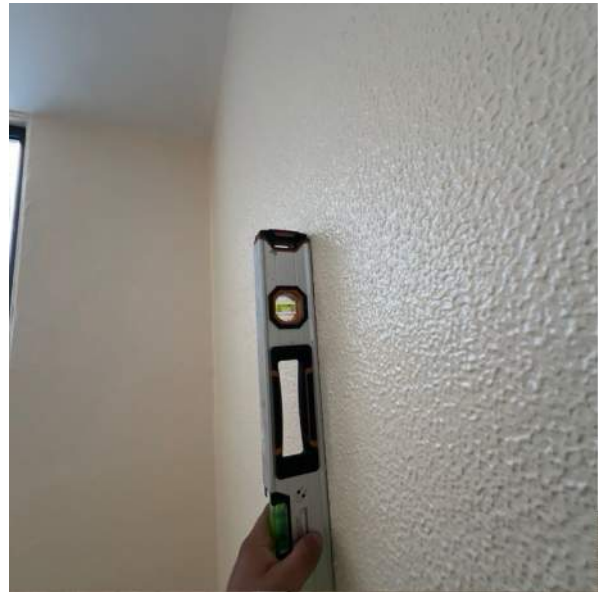
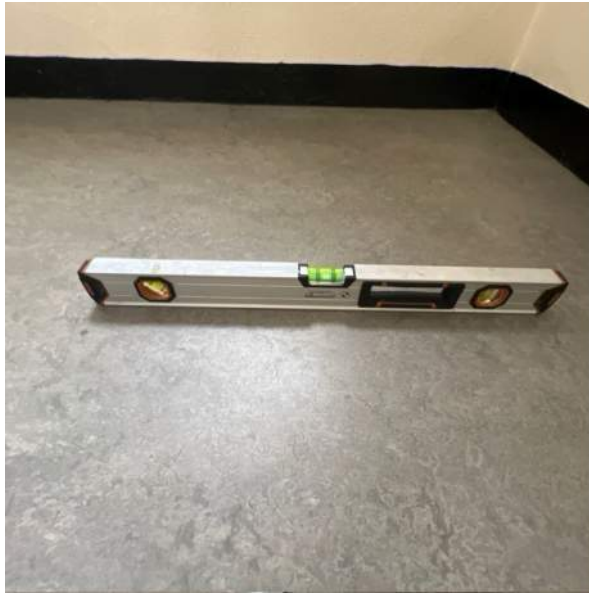
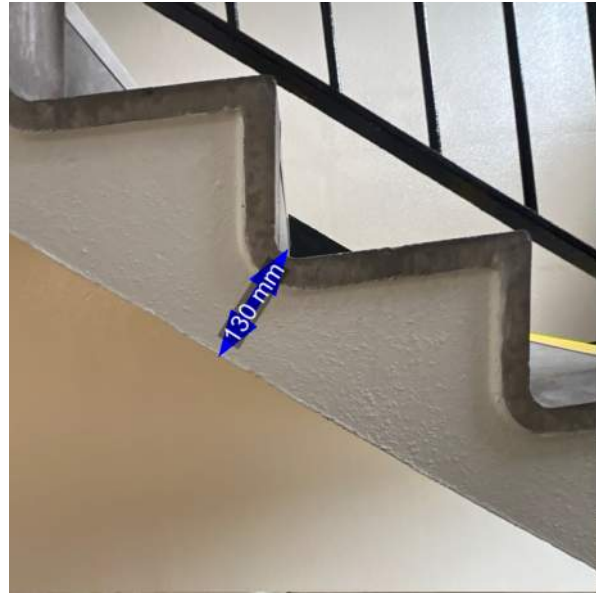
## 8th Floor Staircase

In situ concrete stairs with steel hand railing fixed to stairs. Walls and floors appear to be fairly level.

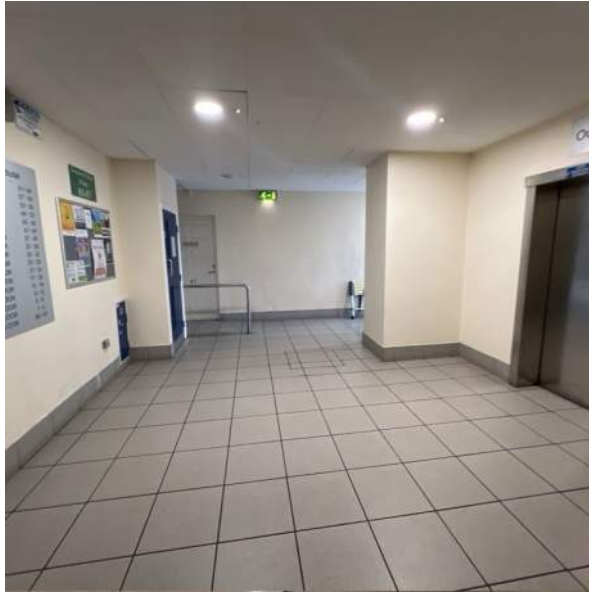
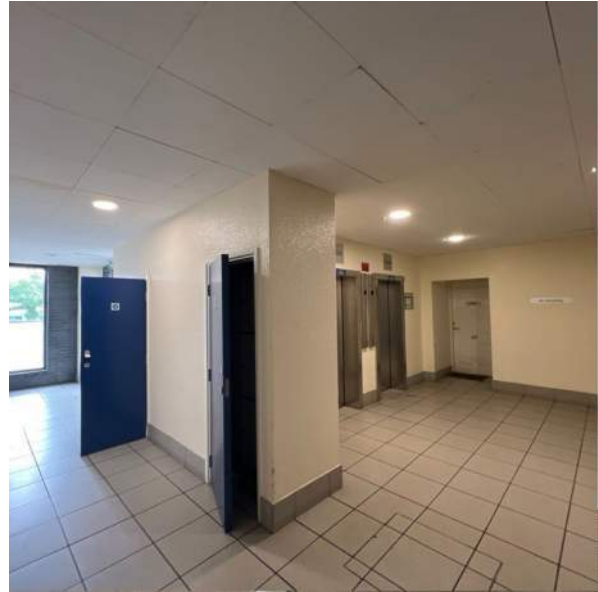
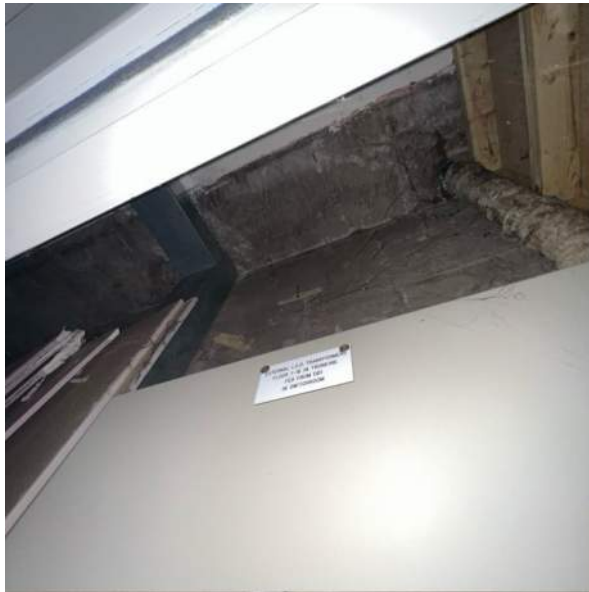
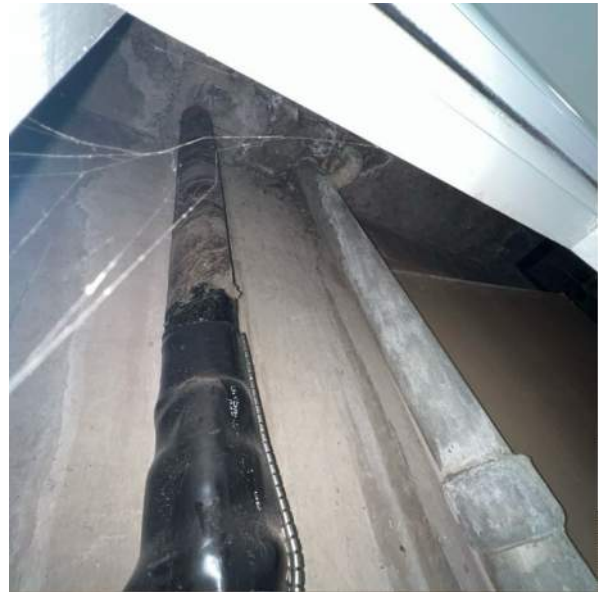
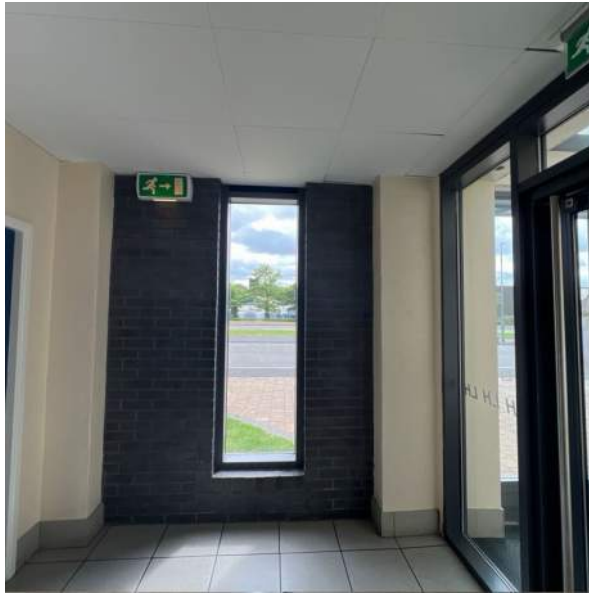
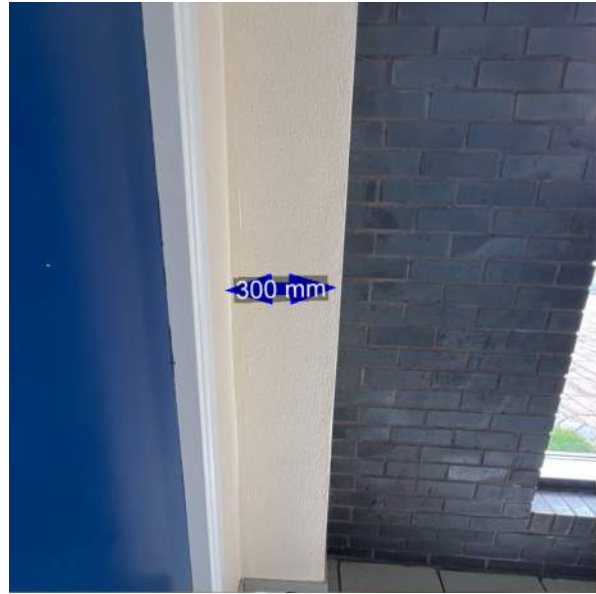
## Ground Floor Hallway

The lift and stair core are located in the hallway. No jams or distortions noted to hallway doors to indicate any serviceability issues.  
Generally walls covered with finishes in hallway, likely to consist a mixture of concrete shear walls, embedded columns and block infill walls.  
RC Concrete Shear Core wall of lift visibly noted from riser cupboard.  
Other internal main walls noted to be 300mm thick and appears to extend to staircase wall, these are likely to be shear core walls forming part of the primary structural elements.

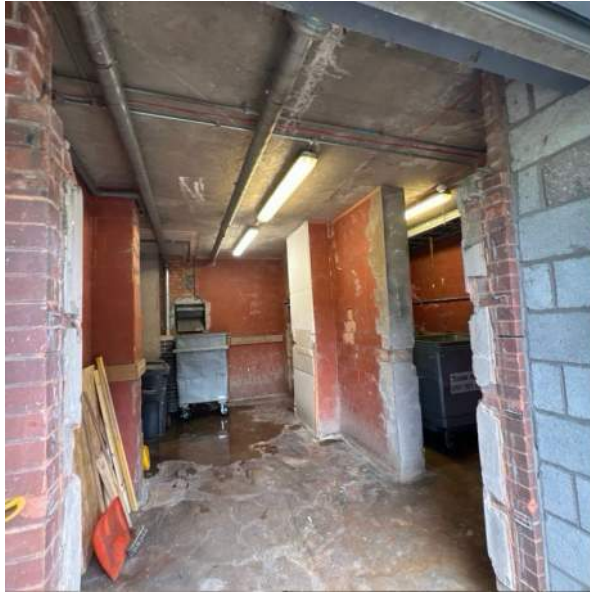
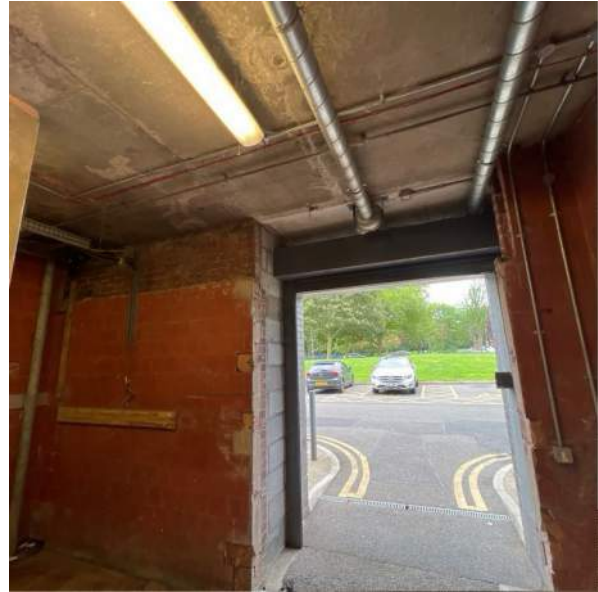
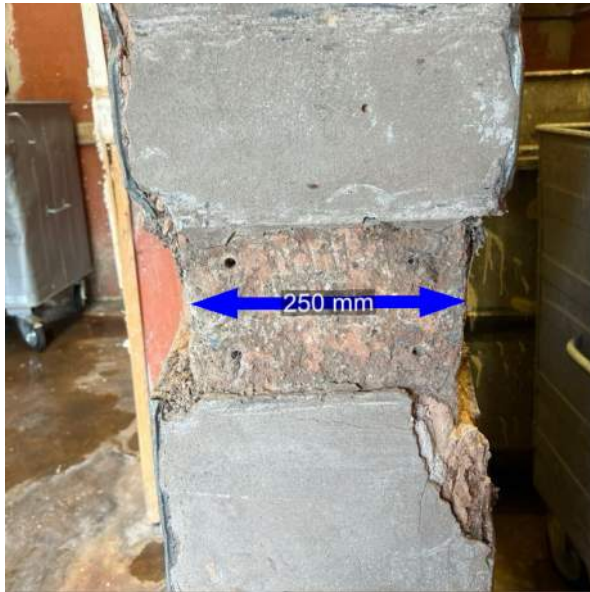
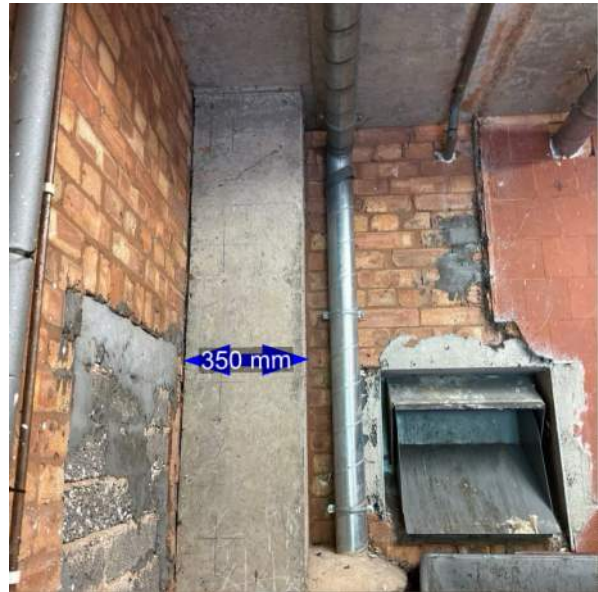
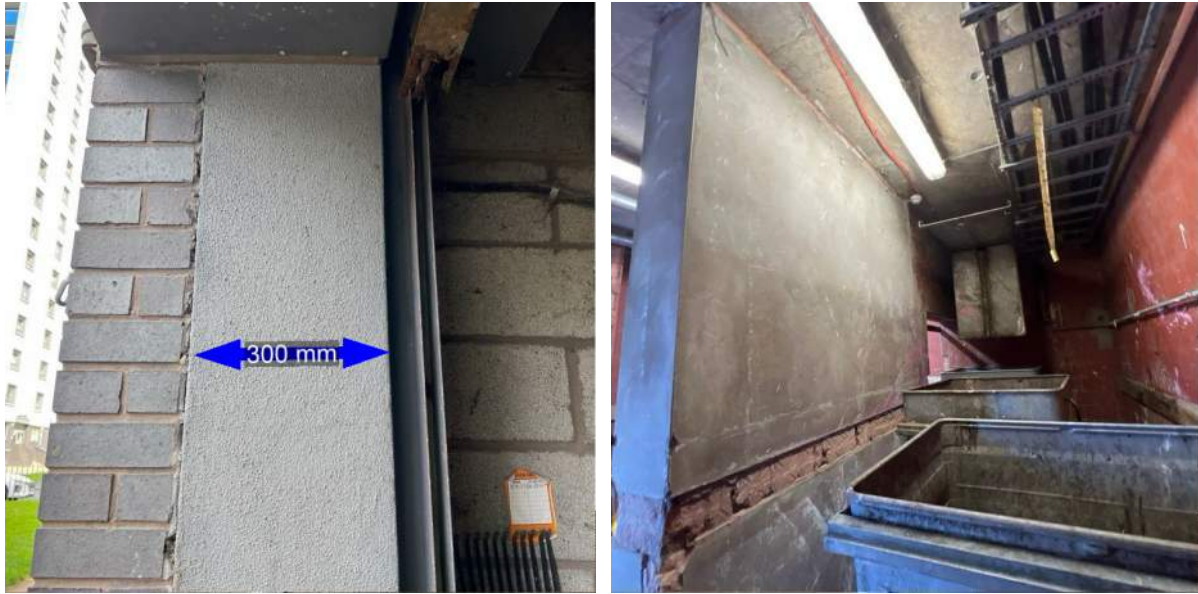
## Bin Store

Shear concrete walls (approx. 250mm wide) and embedded concrete columns noted in bin store. Concrete infill (non-load bearing walls) noted.

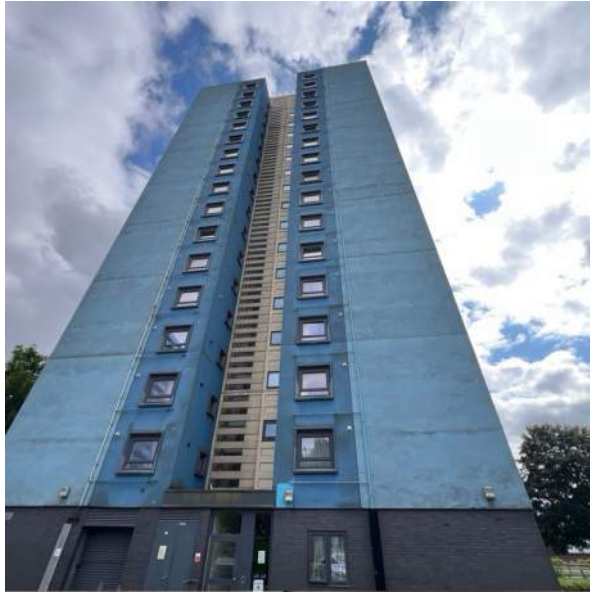
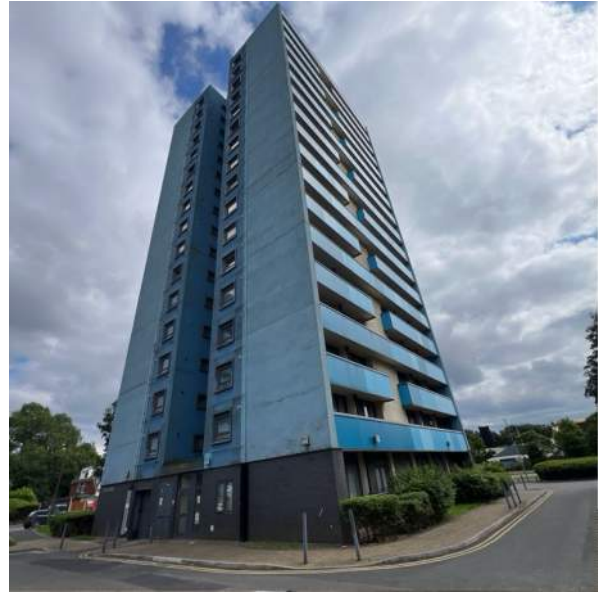
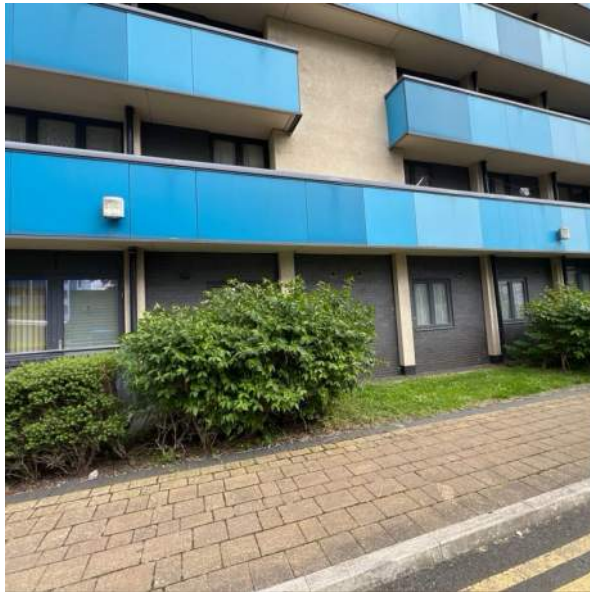
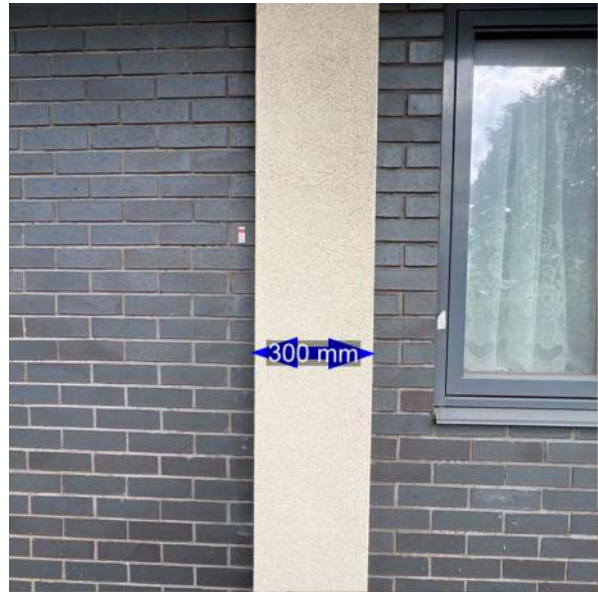
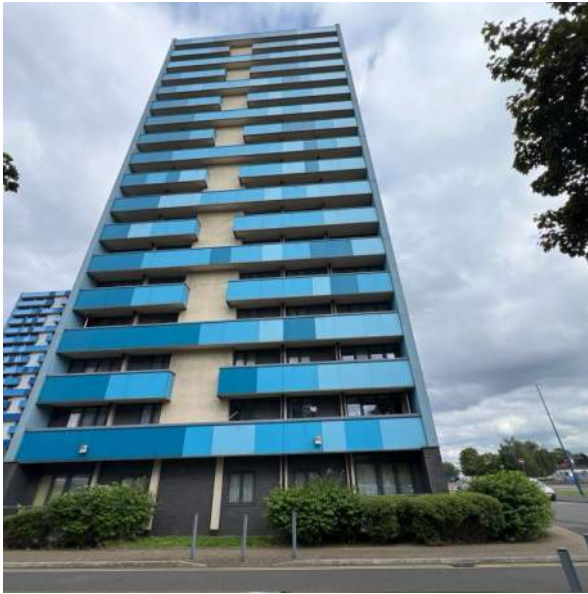
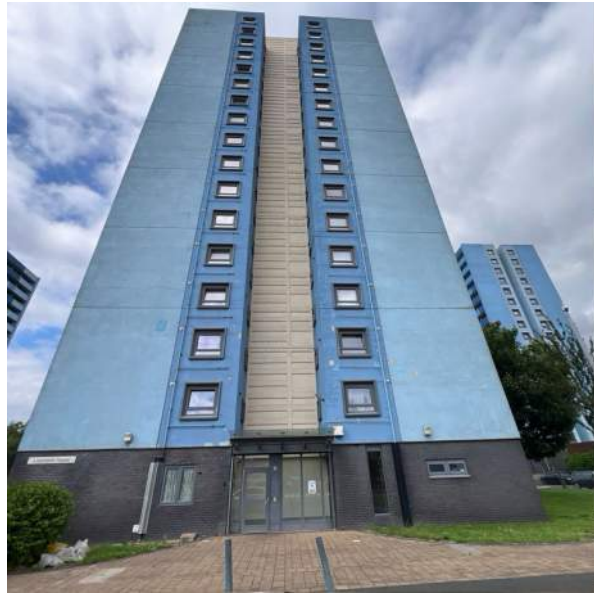
## Elevations

External ground floor level consists of brick work.  
Upper floors noted to have a rendered facade and cladding to balconies.  
Concrete columns (300mm wide) noted to perimeter which form part of the primary structural elements of the building.  
Staircase exterior appears to have a concrete panel facade feature.
