VISUAL STRUCTURAL APPRAISAL

Macaulay House

Glover St  
West Bromwich  
B70 6DY

31<sup>st</sup> January 2025

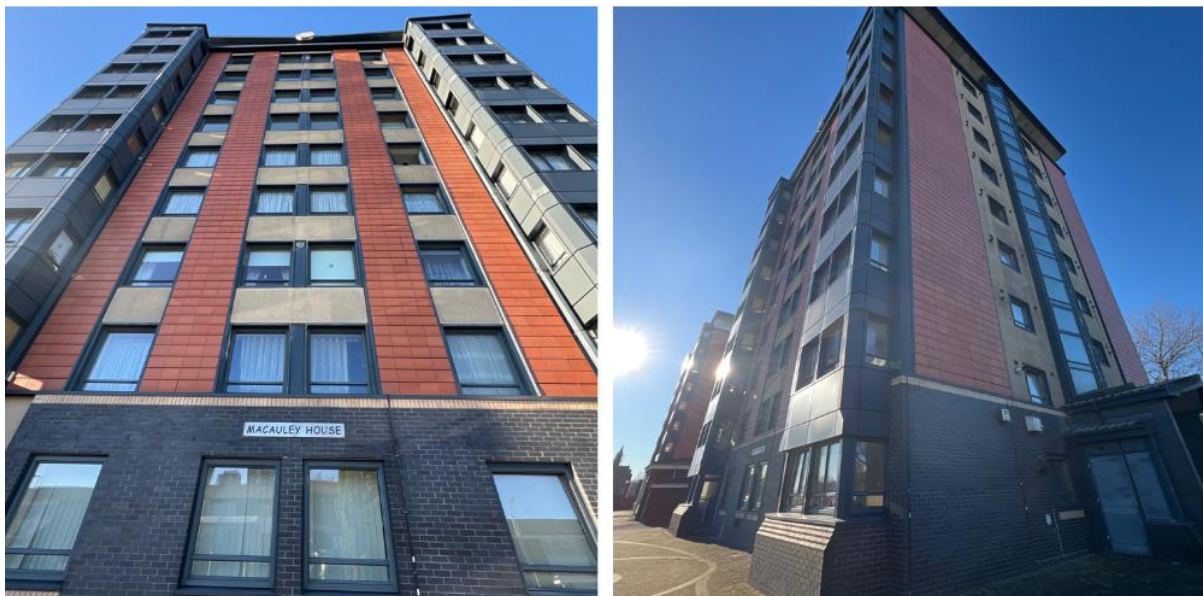
Figure 9 and 10: Building Elevations

The exterior elevations were generally in ok condition and no significant structural defects were noted to the cladding panels. There were no significant cracks or tell-tale signs of any significant structural movement noted at the time of our inspection.

The exterior panels were noted to be plumb with no signs of significant bowing, bulging or leaning noted to the panels indicating failed fixings however their presence and condition cannot be confirmed.

There are balconies at each level which are formed of cantilevered RC slabs tied into the main frame. During the 2018 refurbishment they were enclosed with aluminium panels into winter gardens.

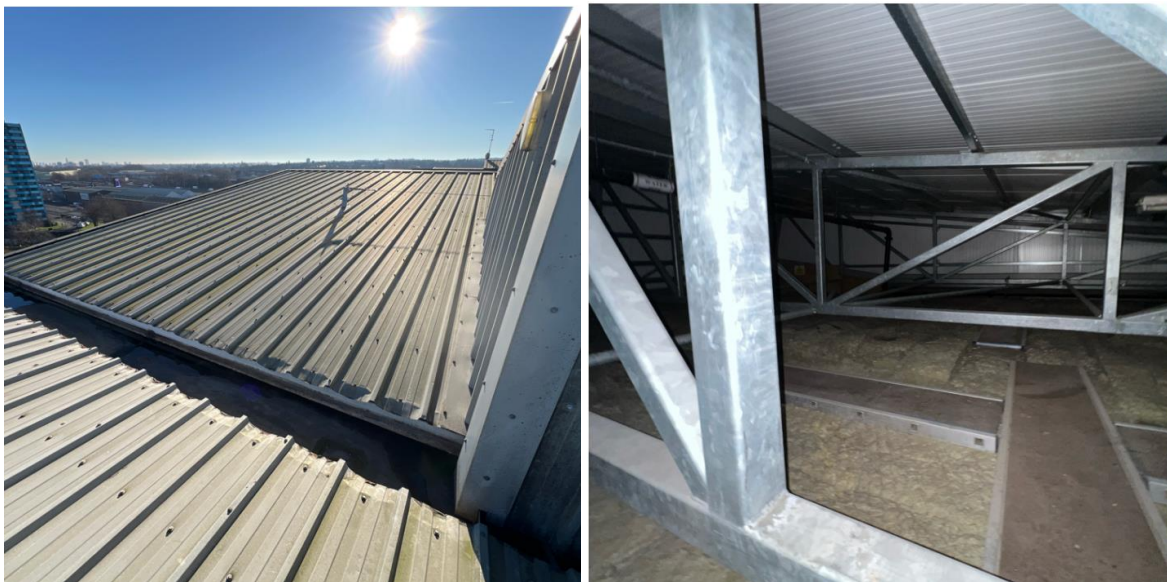
Figure 11 and 12: Roof Level

There were no tell-tale signs of any significant structural movement noted at the time of our inspection. The exterior walls were noted to be plumb with no signs of significant bowing, bulging or leaning noted to the masonry walls.

The roof has subsequently been covered with a new waterproofing covering formed of a steel frame installed to the existing roof which supports pitched corrugated sheets. This roof is not insulated and therefore acts purely as a weather barrier. The fire protection of the steel is unclear as the beams do not appear to be unprotected. Details of this frame should be requested from the contractor who completed the works in 2018. No signs of water ingress of that the roof is not performing as intended.

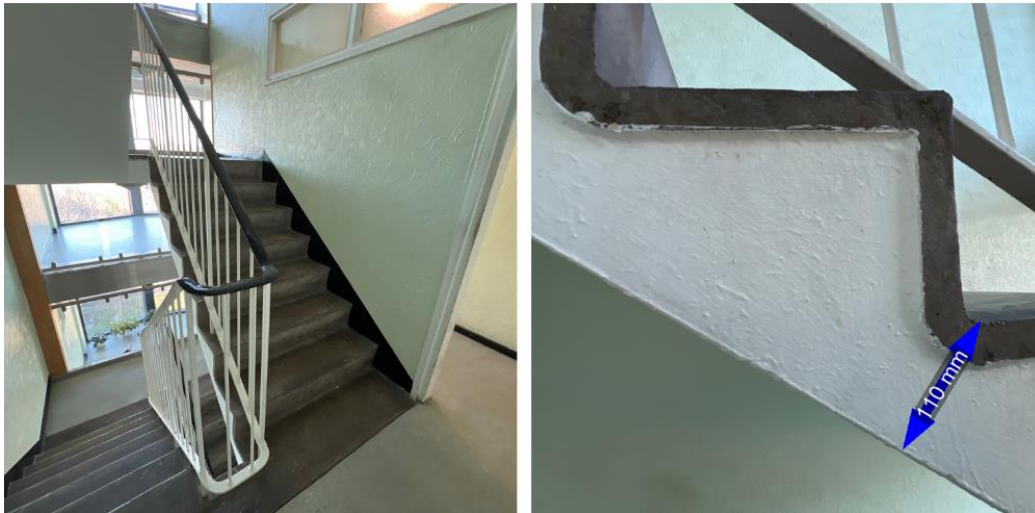
Figure 13 and 14: RC Staircase

The interior of the stair core walls were checked and were plumb and in line with observations made to the exterior – no significant signs of leaning or movement noted. The concrete appeared in fair condition with few BRE category 1 cracks but no structurally significant defects were noted.

The stair stringer was noted to be 110mm thick which seems slim, certainly short of modern standards. A cover test is required to check the resistance of the concrete section in the event of a fire.

Due to the age of the building it is wise to perform periodical health checks to the concrete elements. This should include tests for concrete strength, cover depth, carbonation, chlorides and HAC. It would appear that these tests have never been performed to this building and therefore we recommend engaging a specialist contractor within the next 24 months who will be able to perform the tests and provide a interpretive report. The fire resistance of the structure is not confirmed until the cover meter tests are completed.

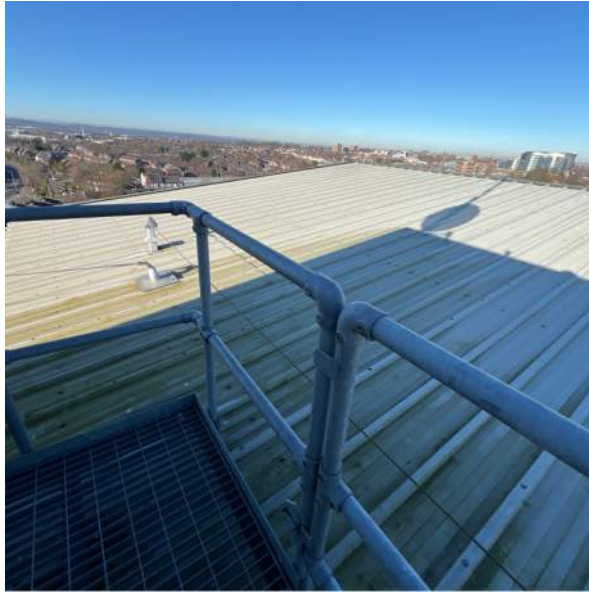
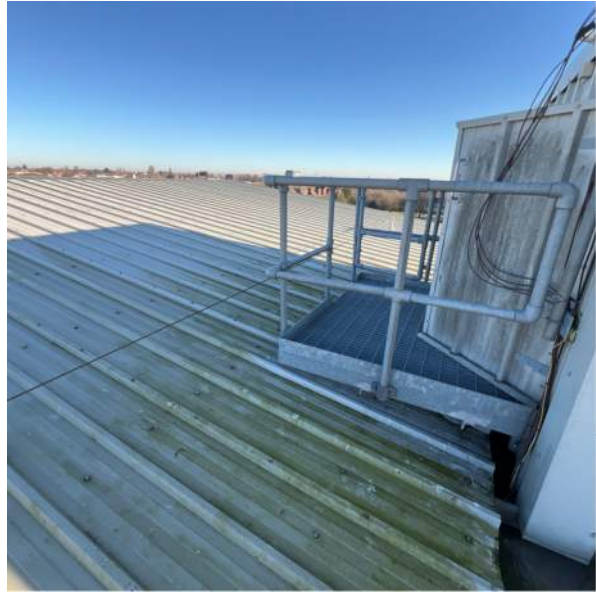
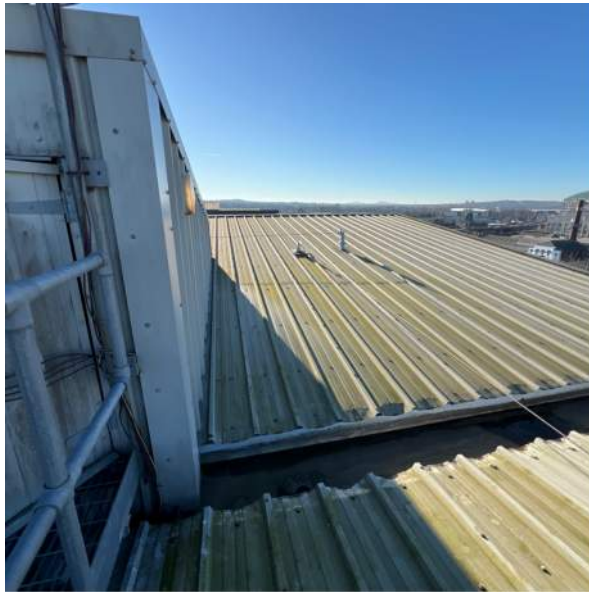
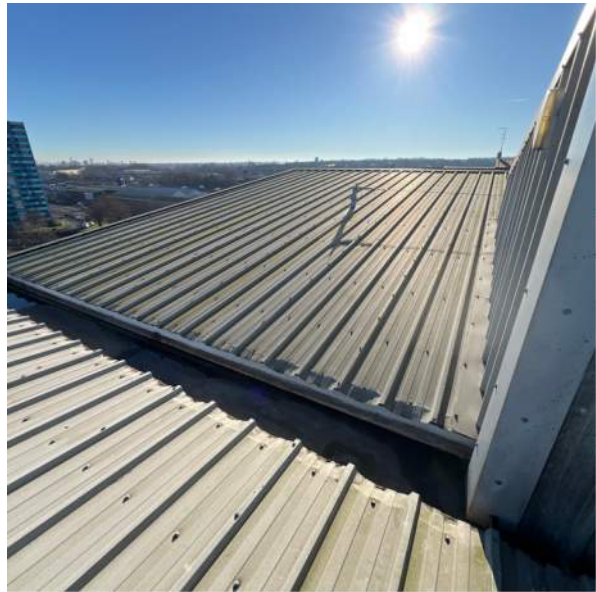
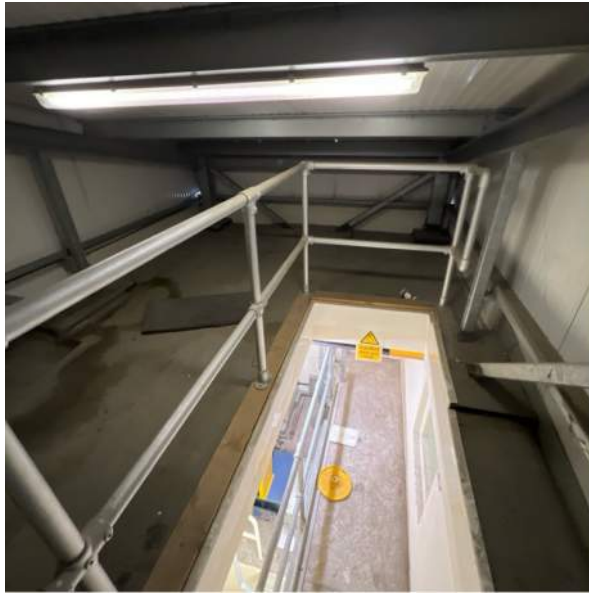
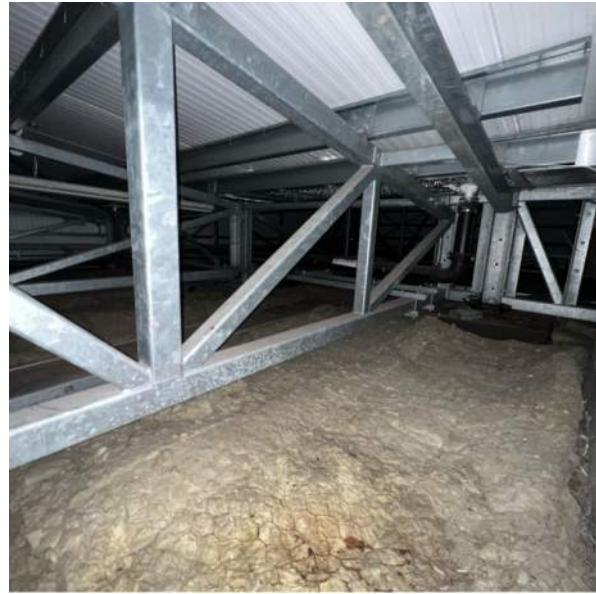
## Main Roof

Comments: A pitched roof constructed above existing original flat roof slab. Steel frame supporting purlins with aluminium standing / mineral wool core profiled panels.  
160mm thick RC core walls noted in motor room.

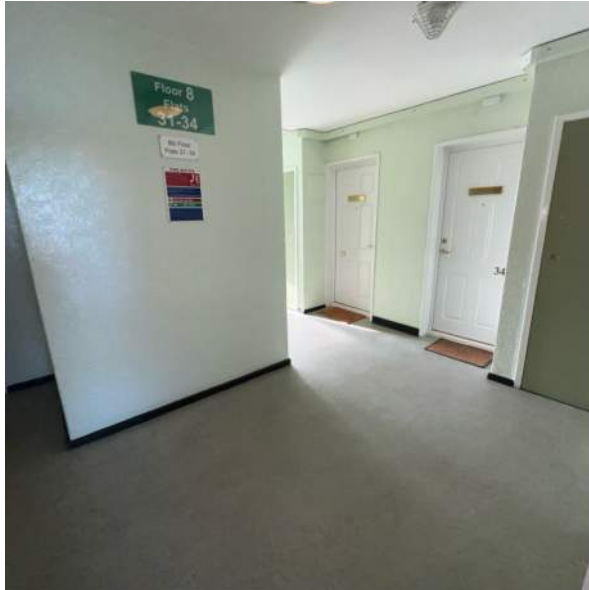
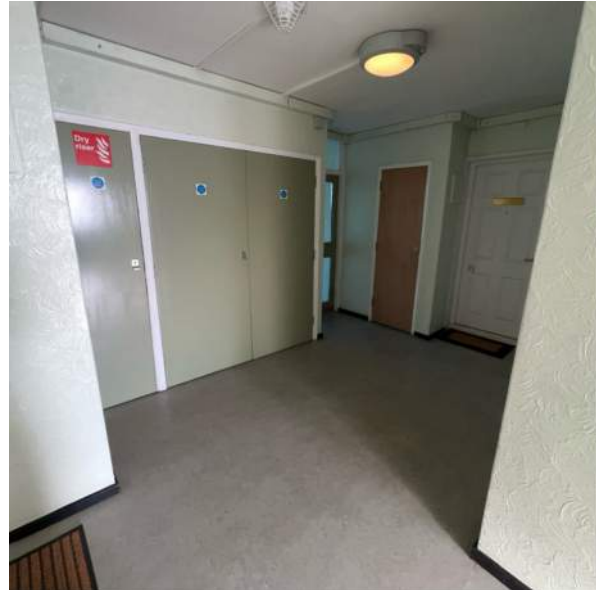
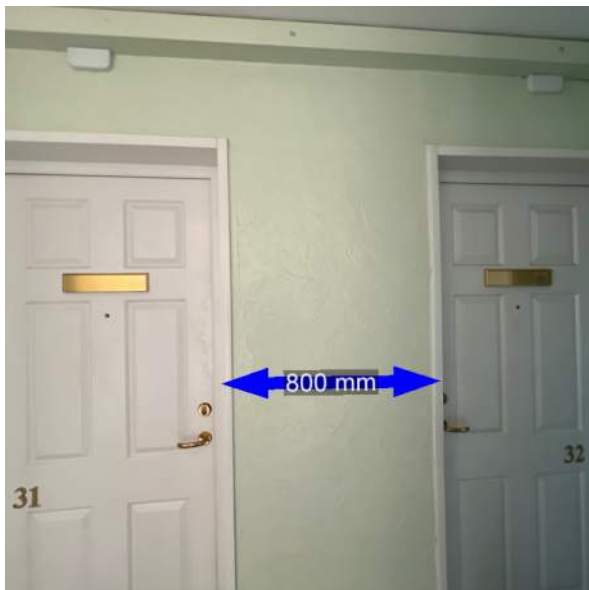
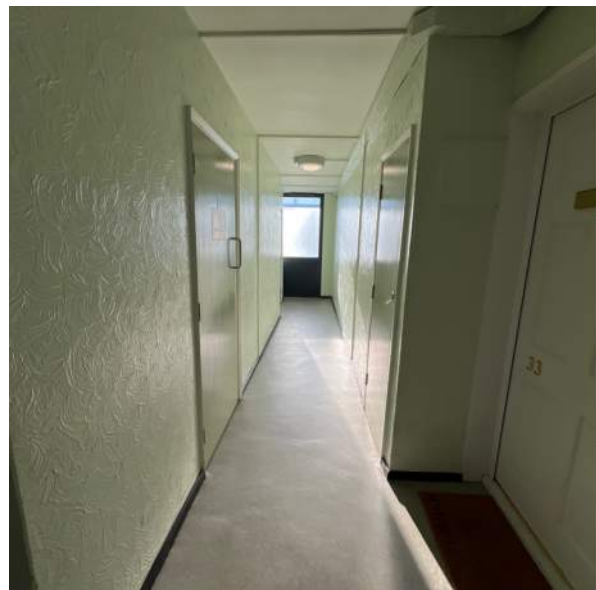
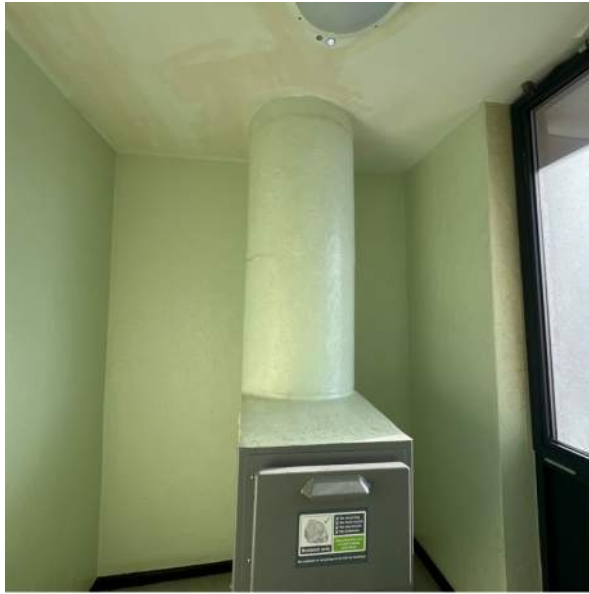
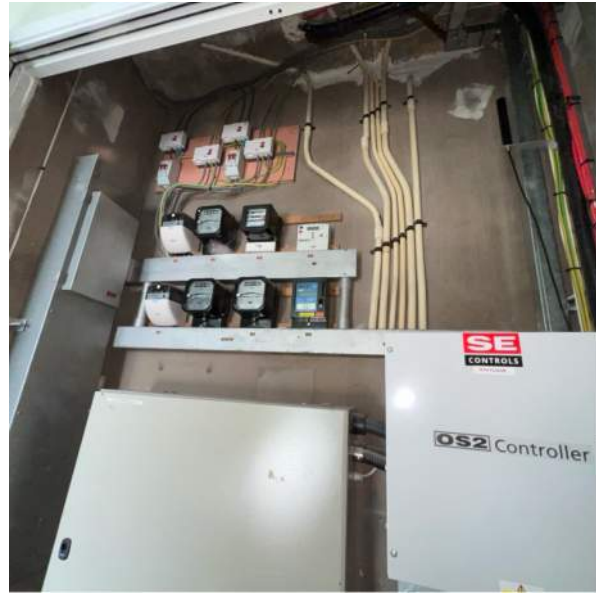
## 8th Floor Hallway

Comments: No jams or distortions noted to hallway doors to indicate any serviceability issues. Generally walls covered with finishes in hallway, likely to consist a mixture of concrete shear walls, embedded columns and masonry infill walls. Limited structure exposed. Concrete walls noted via dry riser cupboards. Electrical cupboard shows block infill walls with plaster.

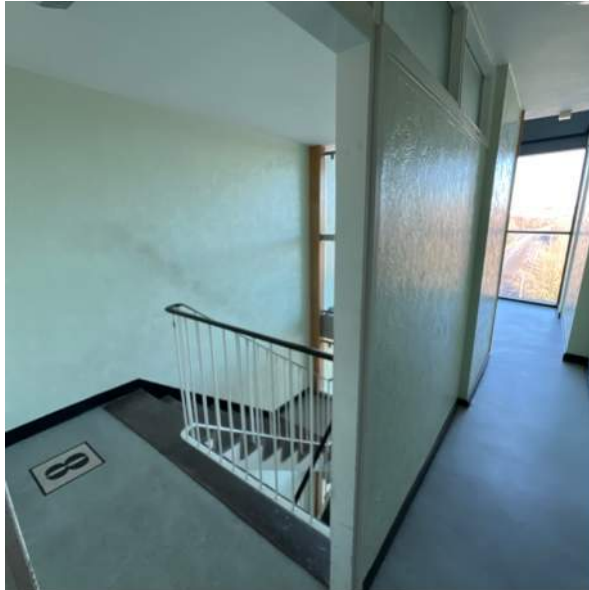
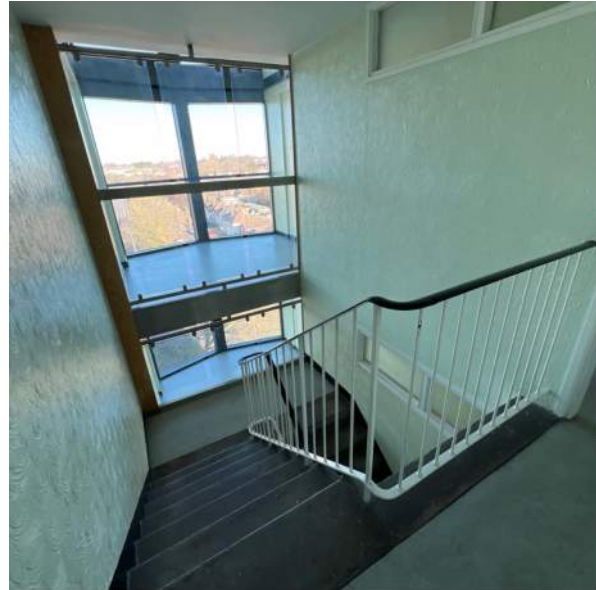
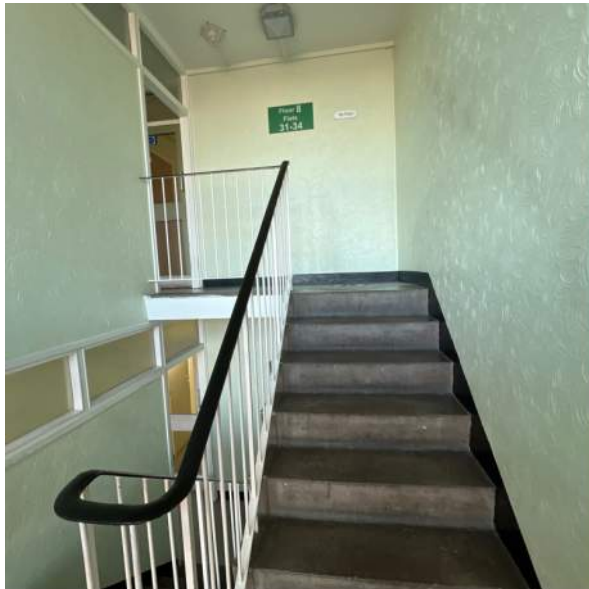
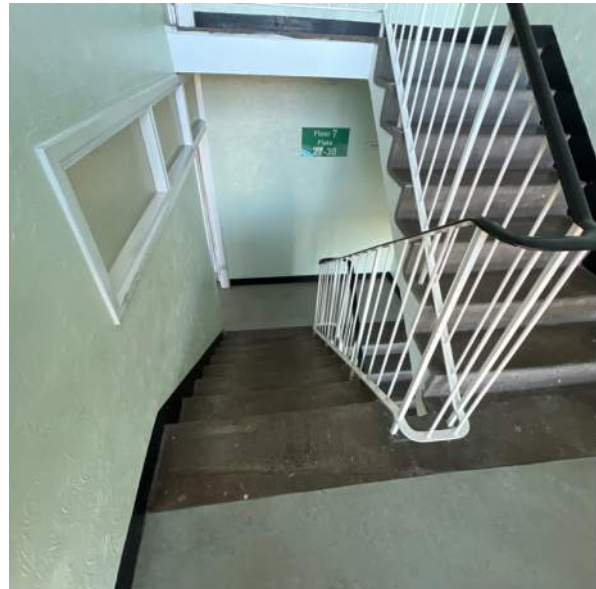
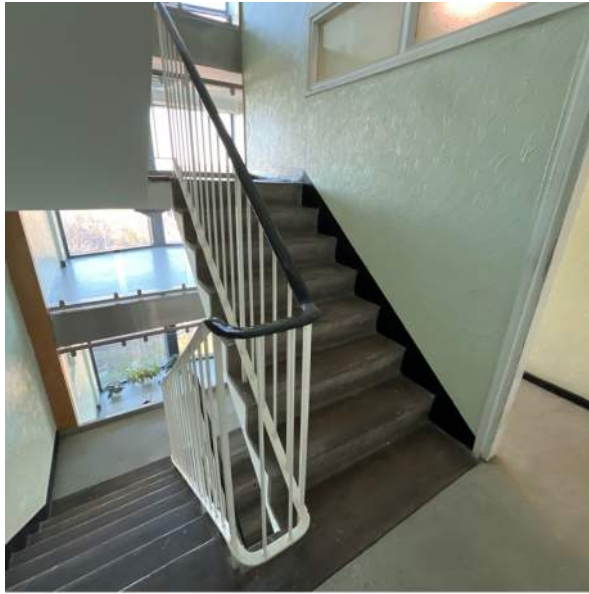
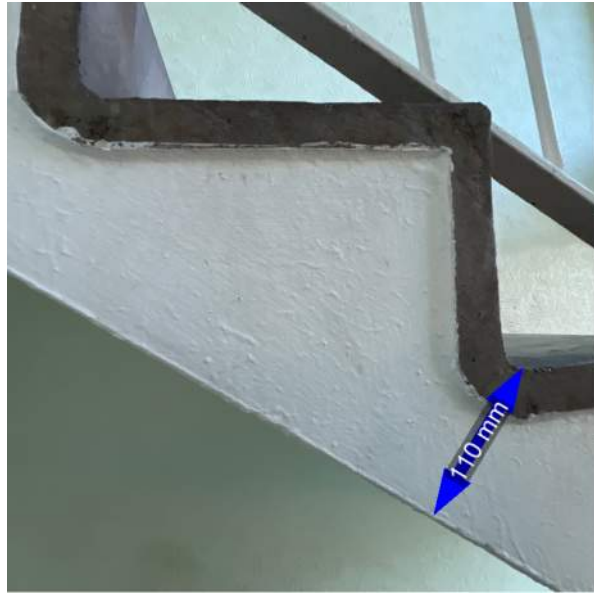
## 8th Floor Staircases

Comments: Insitu concrete stairs with steel hand railing fixed to stairs. Walls and floors appear to be fairly level.  
Stair walls covered with finishes however these would likely form the main concrete shear core walls. Partly infill/non-load bearing wall noted for one side of stair case wall.

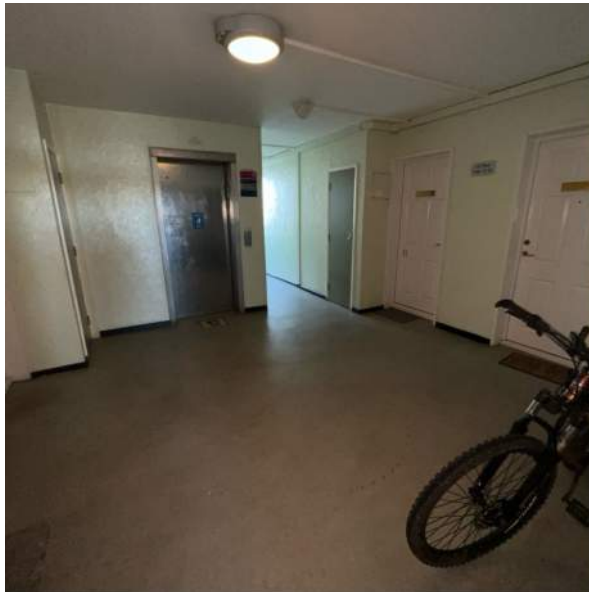
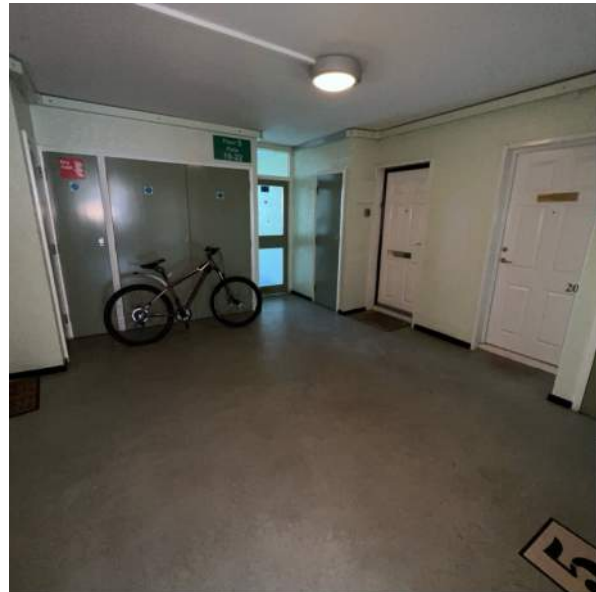
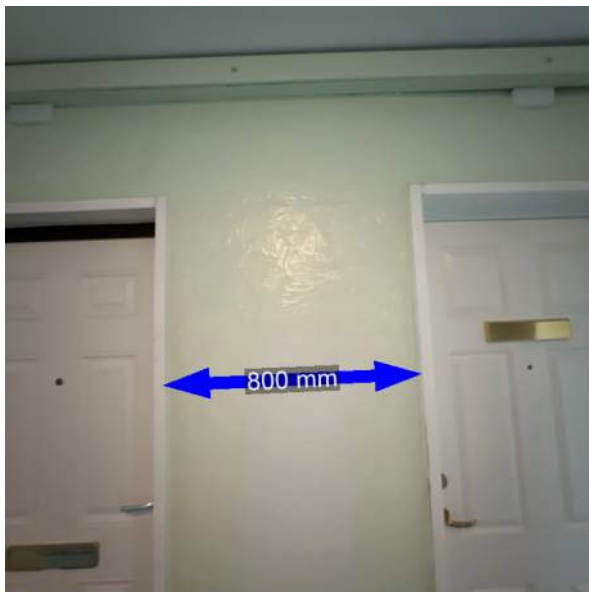
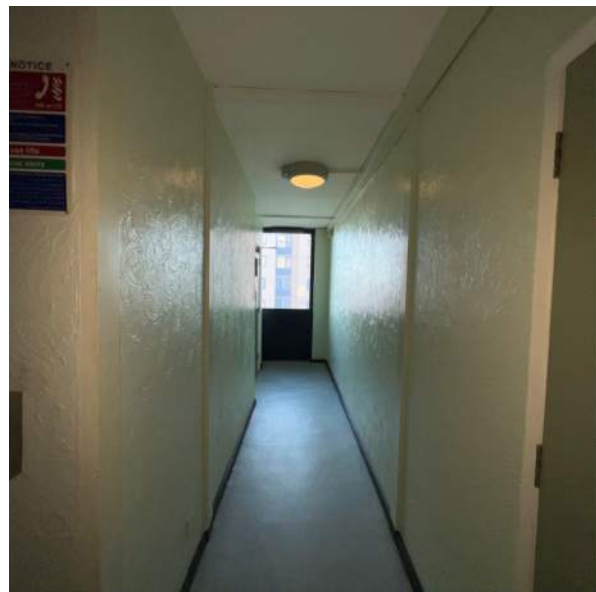
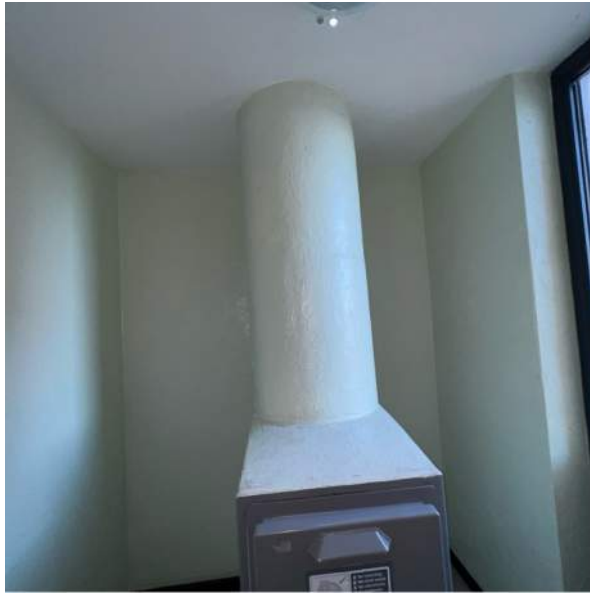
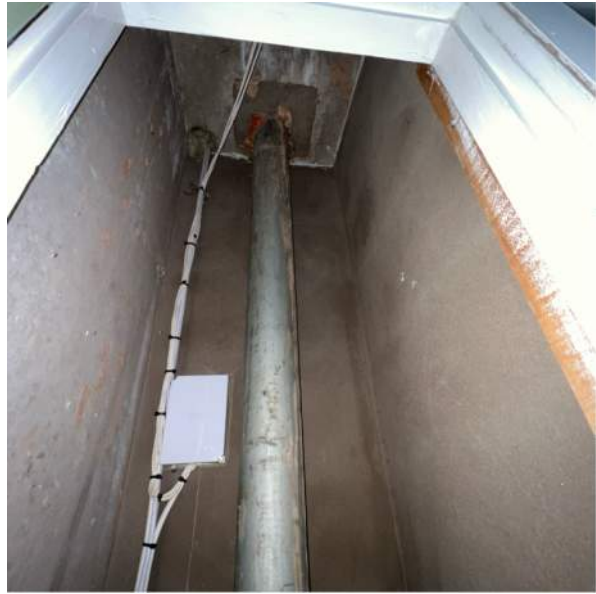
## 5th Floor Hallway

Comments: No jams or distortions noted to hallway doors to indicate any serviceability issues. Generally walls covered with finishes in hallway, likely to consist a mixture of concrete shear walls, embedded columns and masonry infill walls. Limited structure exposed. Concrete walls noted via dry riser cupboards. Electrical cupboard shows block infill walls with plaster.

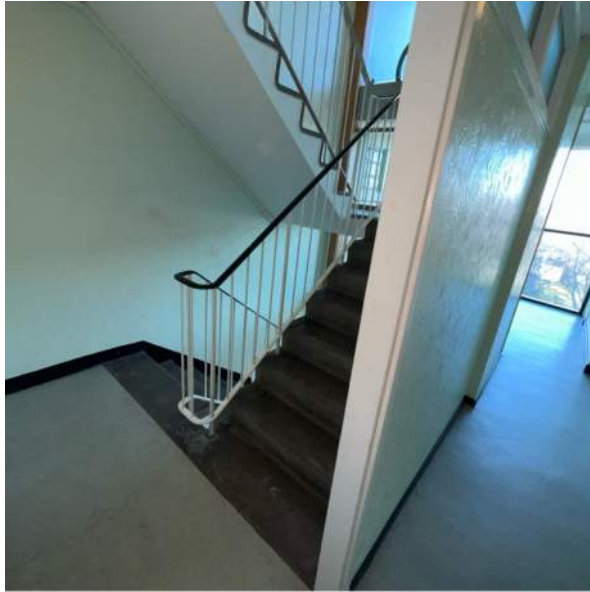
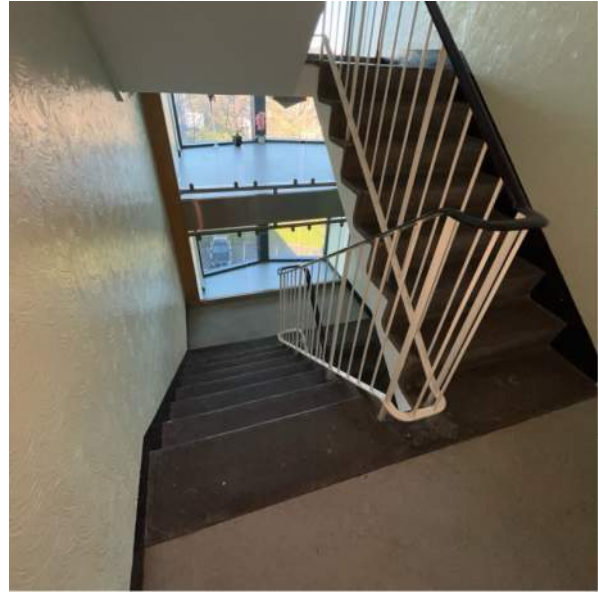
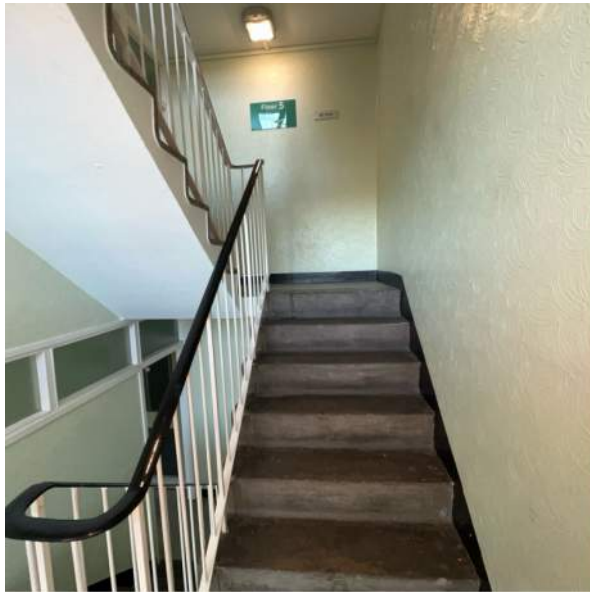
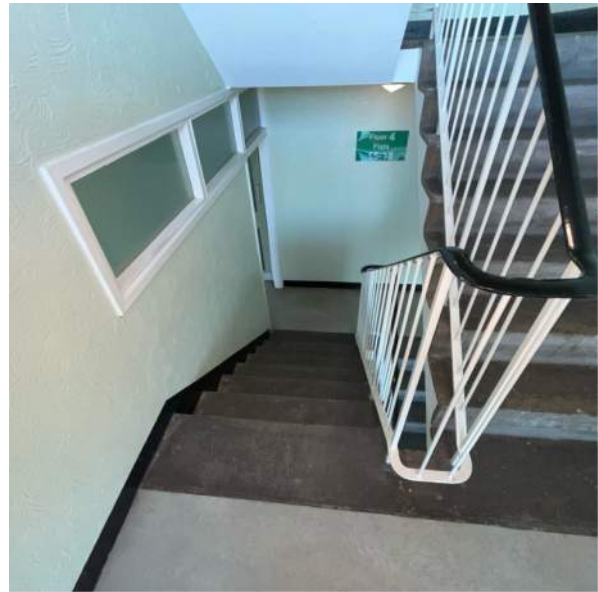
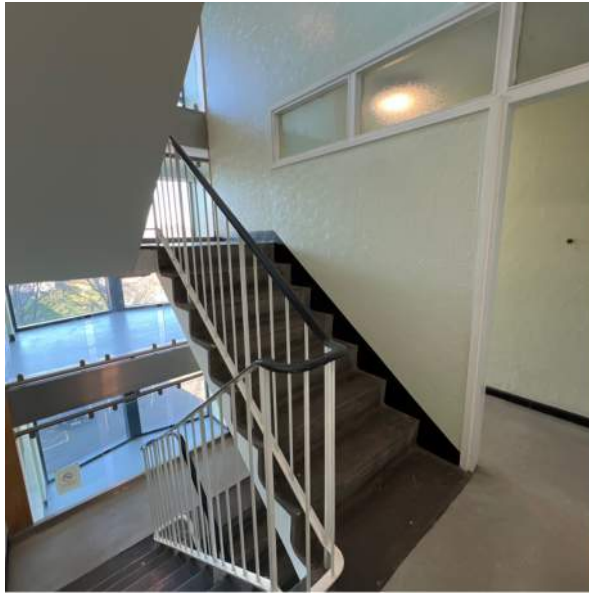
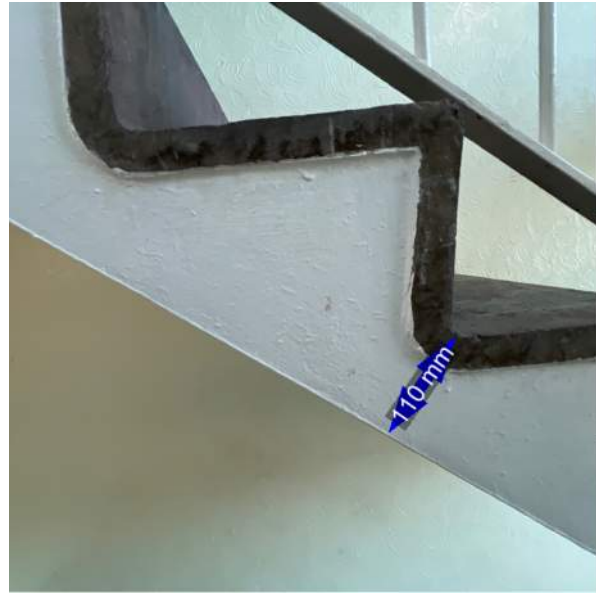
## 5th Floor Staircases

Comments: Insitu concrete stairs with steel hand railing fixed to stairs. Walls and floors appear to be fairly level.  
Stair walls covered with finishes however these would likely form the main concrete shear core walls. Partly infill/non-load bearing wall noted for one side of stair case wall.

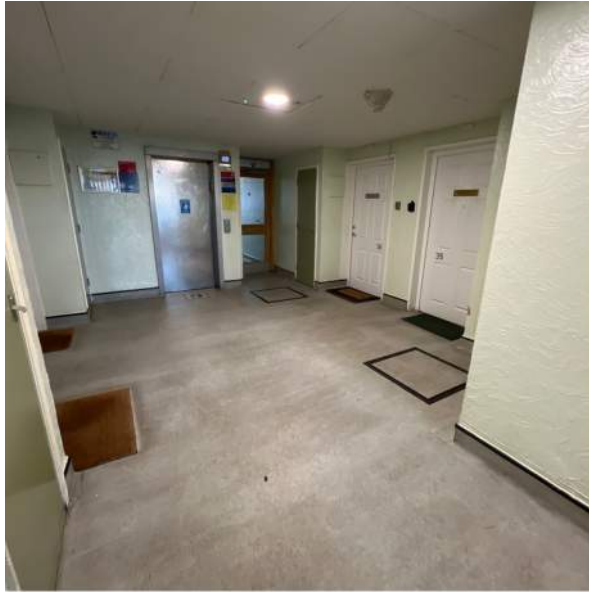
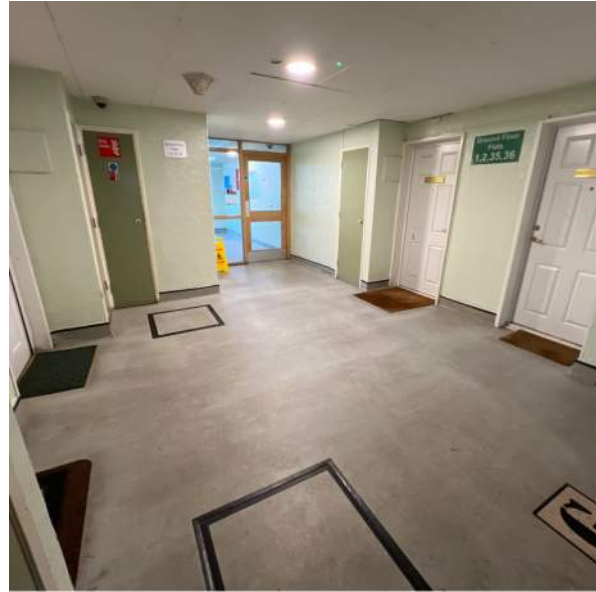
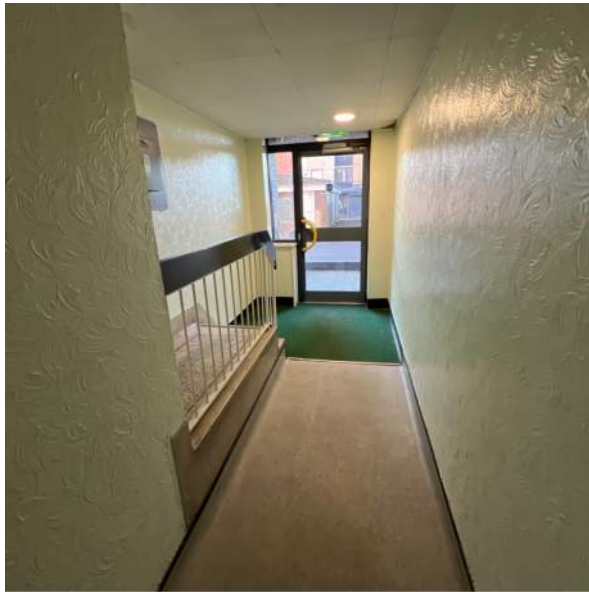
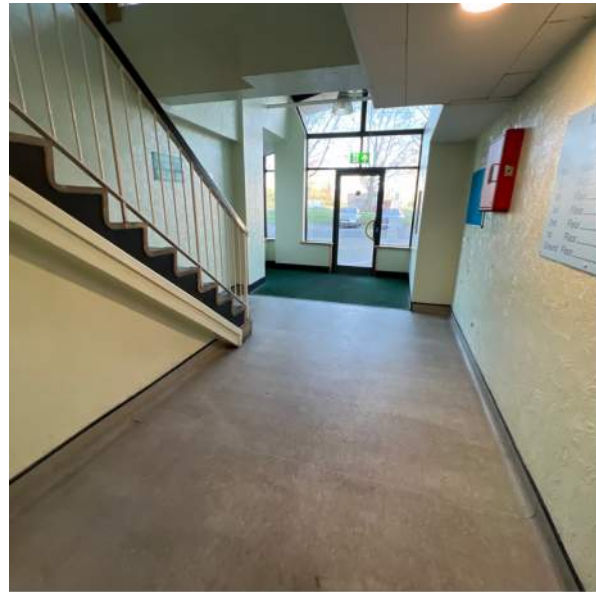
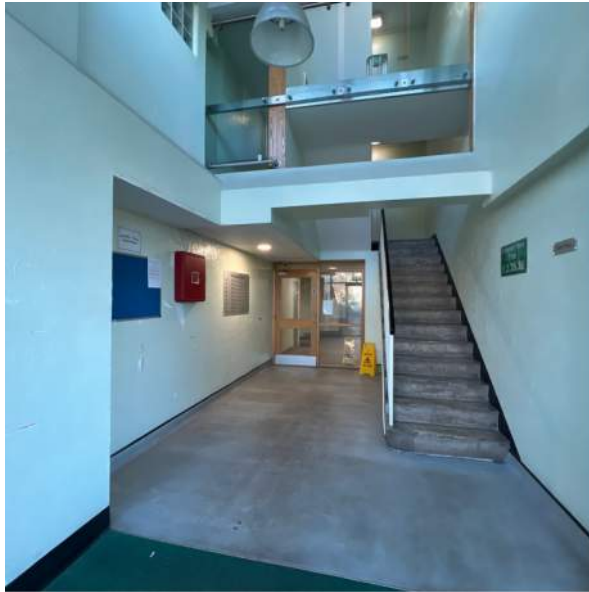
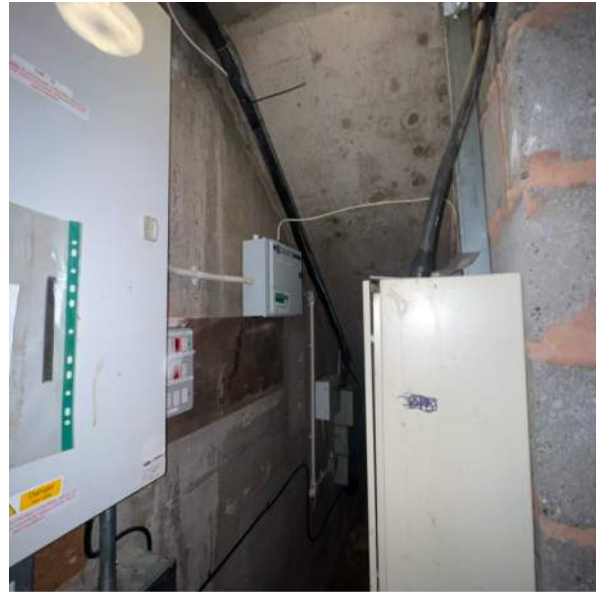
## Ground Floor Hallway

Comments: No jams or distortions noted to hallway doors to indicate any serviceability issues. Generally walls covered with finishes in hallway, likely to consist a mixture of concrete shear walls, embedded columns and block infill walls. Limited structure exposed. Partly visible concrete walls noted via riser cupboard and under stair case closet.

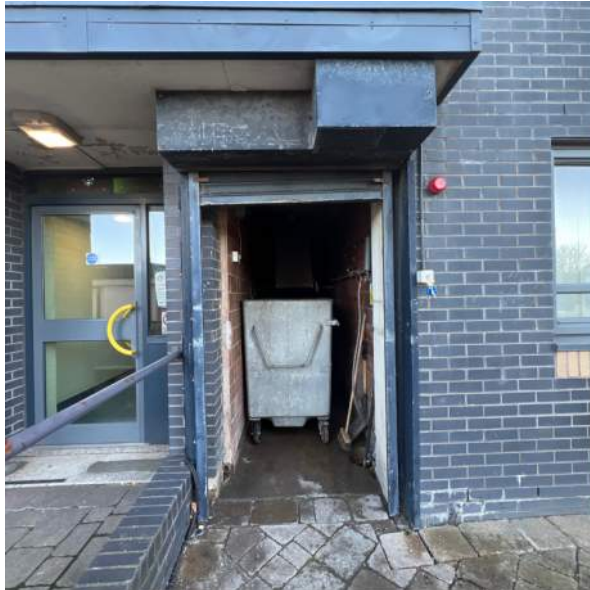
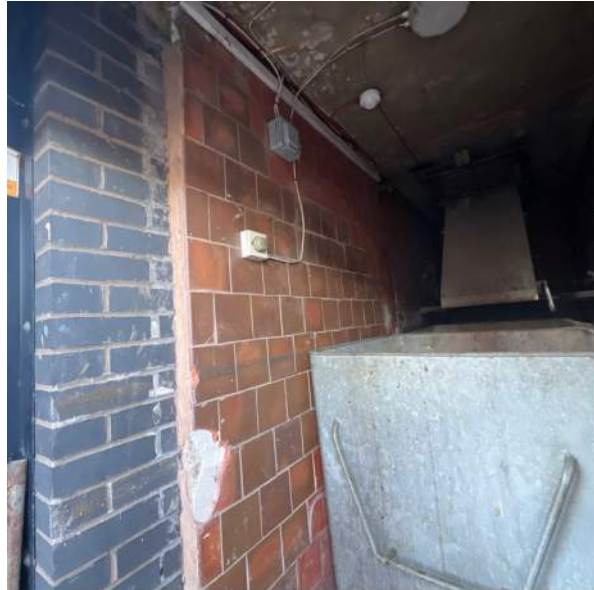
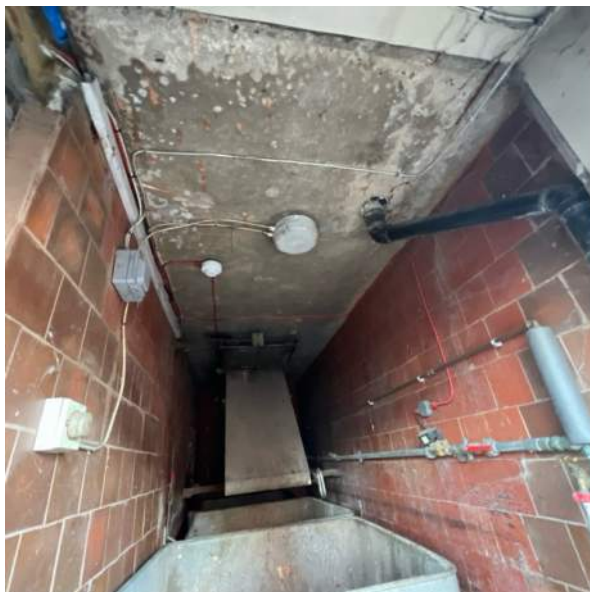
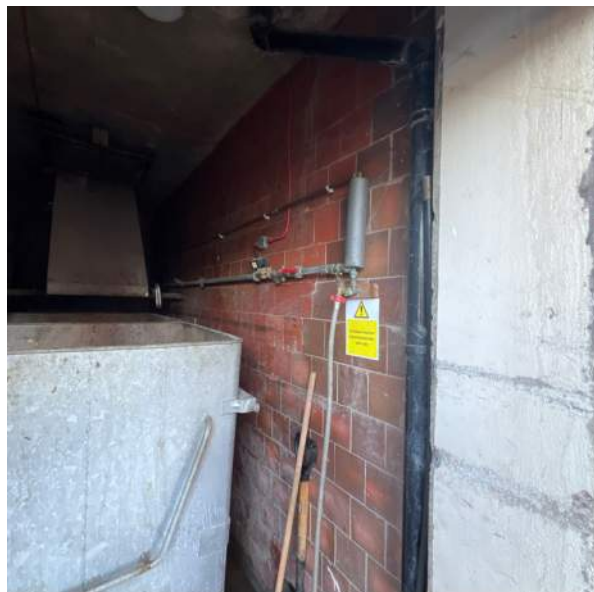
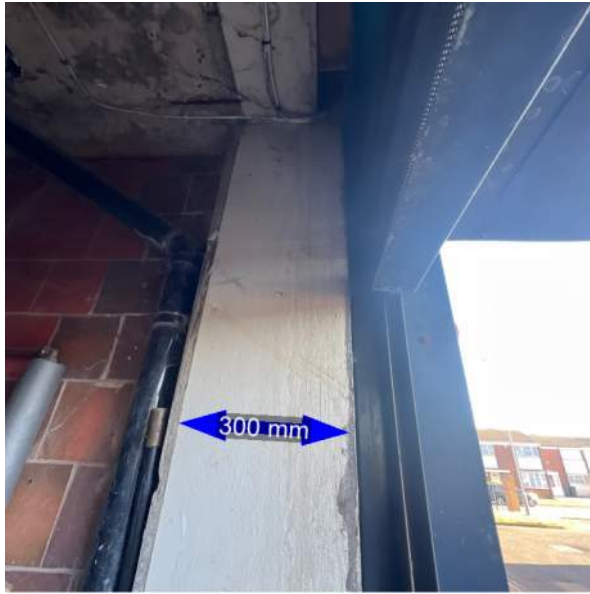
## Binstore

RC walls mainly covered with finishes. RC perimeter column noted.

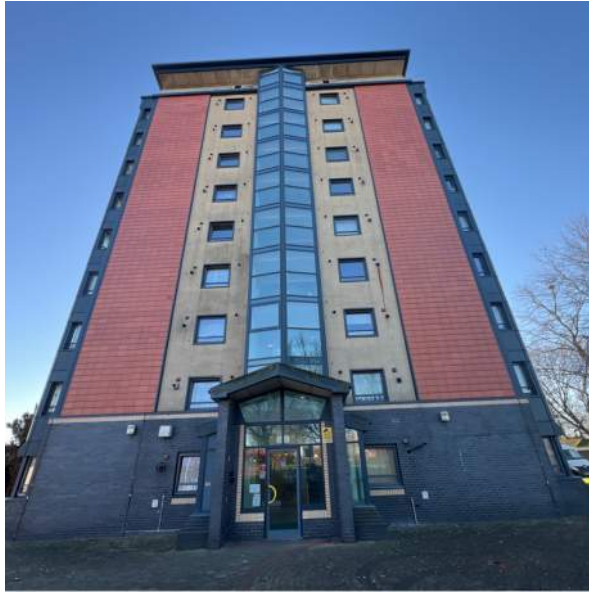
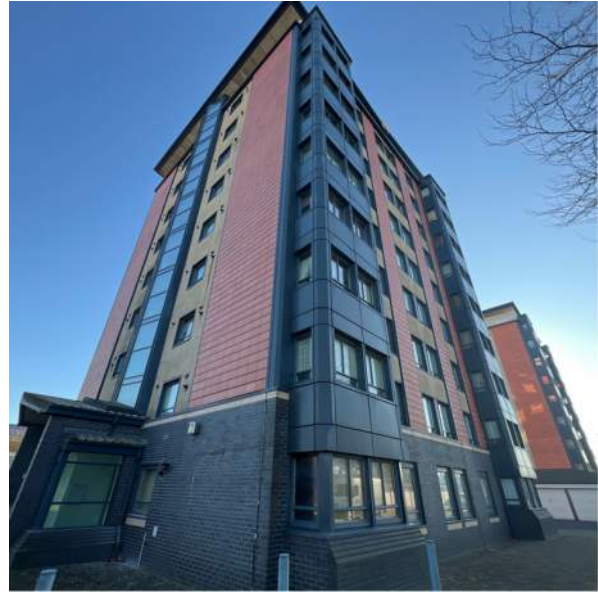
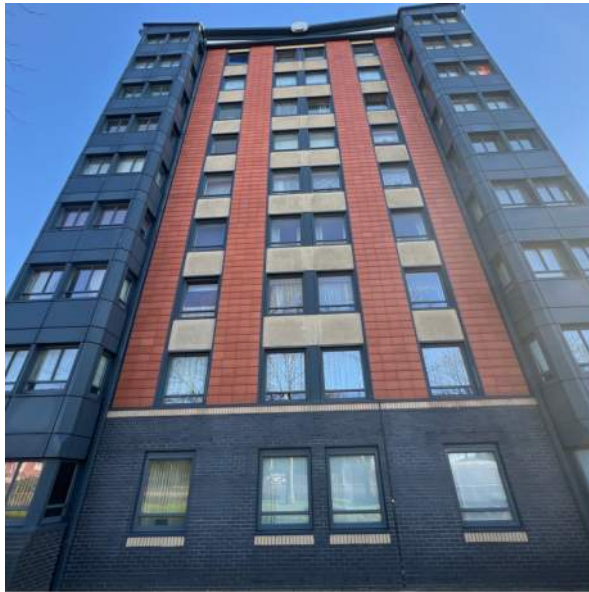
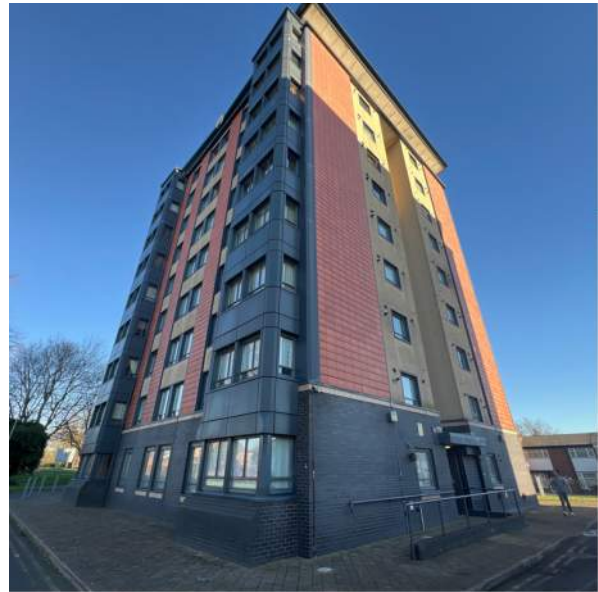
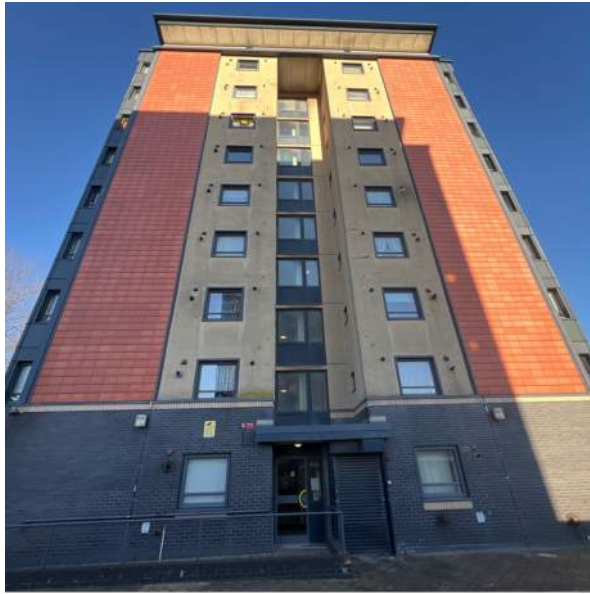
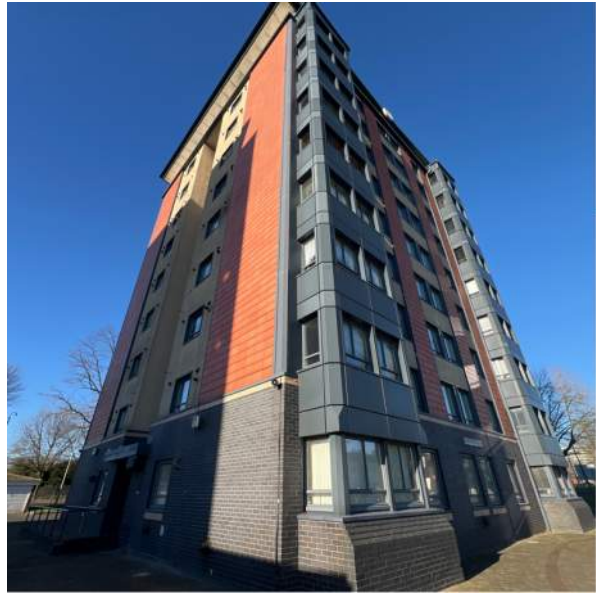
## Elevations

Ground floor level consists of brickwork. Remaining elevations consist of a mixture of rendered and cladded facade.
