VISUAL STRUCTURAL APPRAISAL

Aspen House

Beaconview Road  
West Bromwich  
B71 3EN

26<sup>th</sup> February 2025

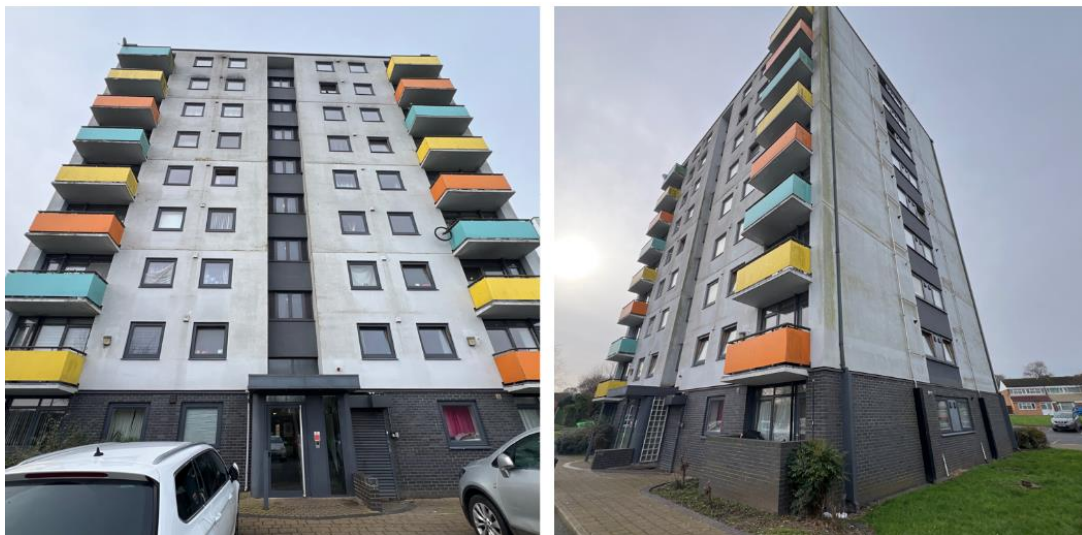
Figure 9 and 10: Building Elevations

The exterior elevations were generally in ok condition and no significant structural defects were noted to the cladding panels. There were no significant cracks or tell-tale signs of any significant structural movement noted at the time of our inspection.

The exterior panels were noted to be plumb with no signs of significant bowing, bulging or leaning noted to the panels indicating failed fixings however their presence and condition cannot be confirmed.

There are balconies at each level which are formed of cantilevered RC slabs tied into the main frame. During the 2009 refurbishment they had high pressure laminate boards installed as balustrades.

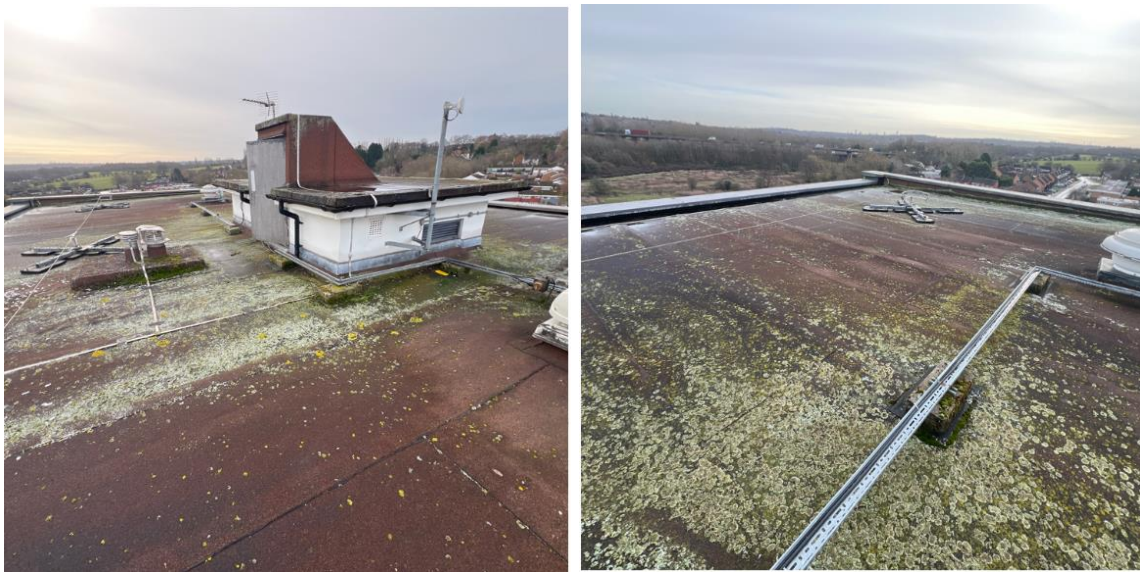
Figure 11 and 12: Roof Level

There were no tell-tale signs of any significant structural movement noted at the time of our inspection.

The roof has a asphalt finish. The exact build-up of the roof finishes were not accessible at the time of inspection. It is recommended an intrusive survey of the roof finishes is completed by a specialist surveyor to assess the condition of the roof covering.

There was moss growth and build-ups of debris noted which should be cleared as part of a normal maintenance regimen

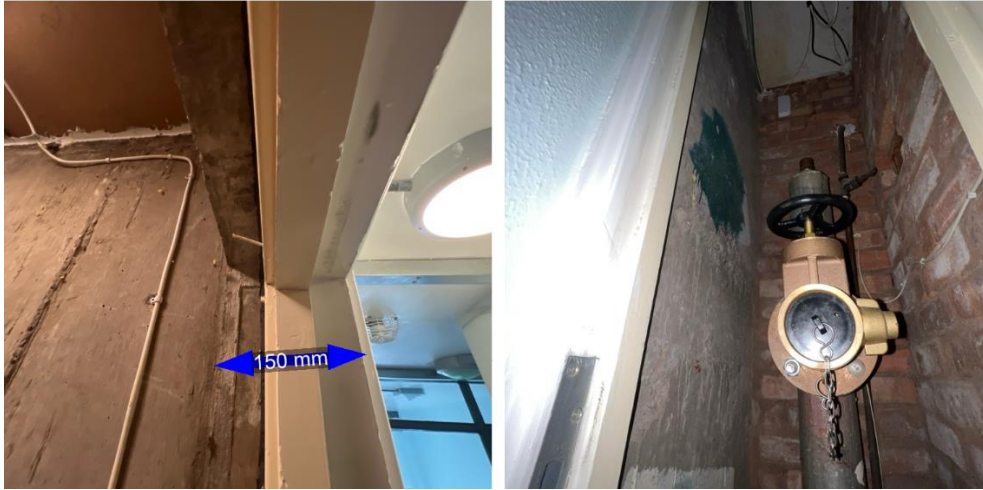
Figure 13 and 14: Vertical RC elements and staircase

The interior of the stair core walls were checked and were plumb and in line with observations made to the exterior – no significant signs of leaning or movement noted. The concrete appeared in fair condition with few BRE category 1 cracks but no structurally significant defects were noted.

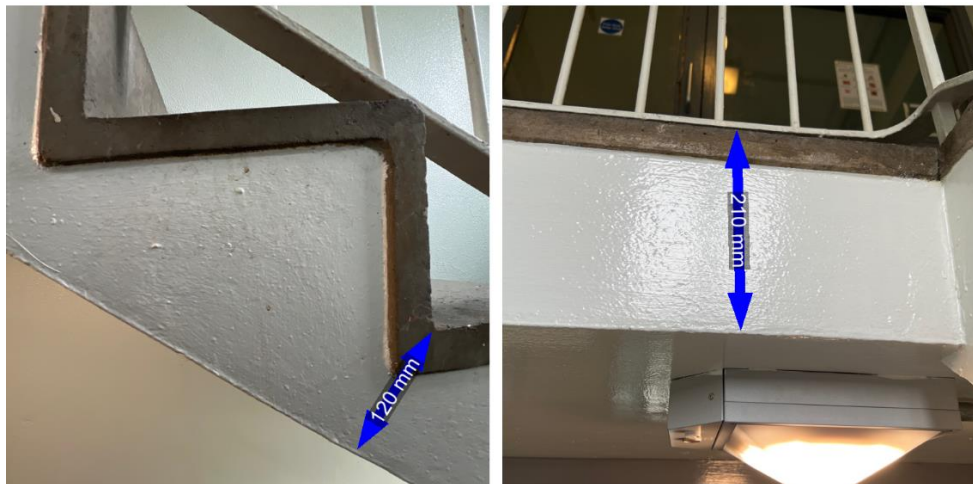
Figure 15 and 16: Stair stringer and RC slab

The stair stringer was noted to be 120mm thick which is certainly short of modern standards however may comply with standards at the time. The structural walls were measured at 150mm thick, A cover test is required to check the resistance of the concrete section in the event of a fire.

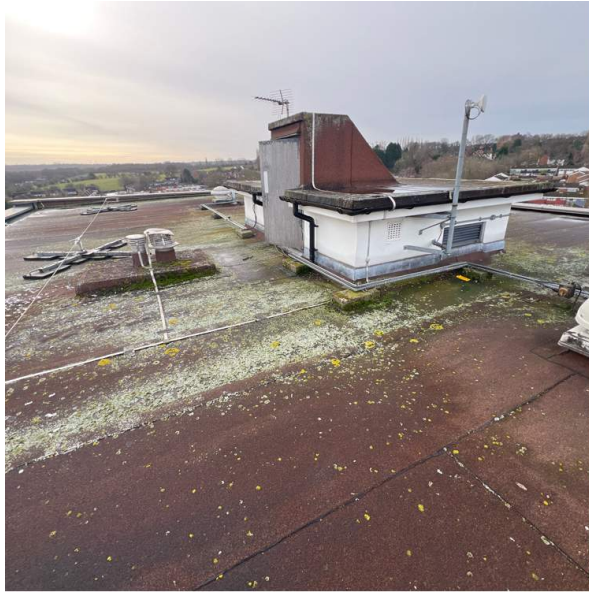
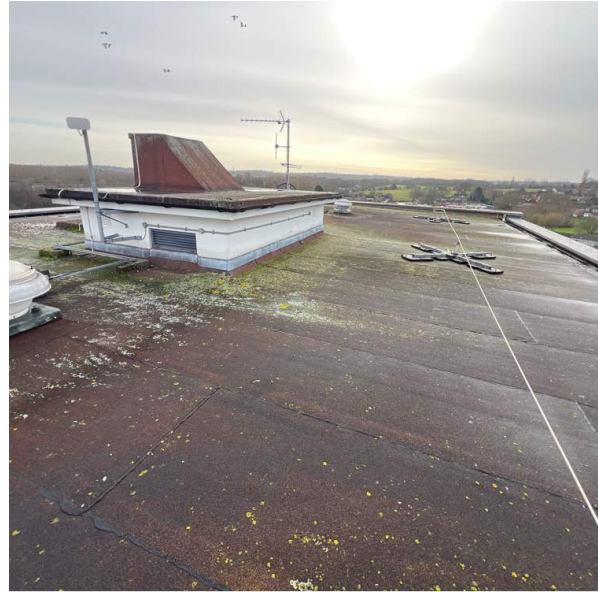
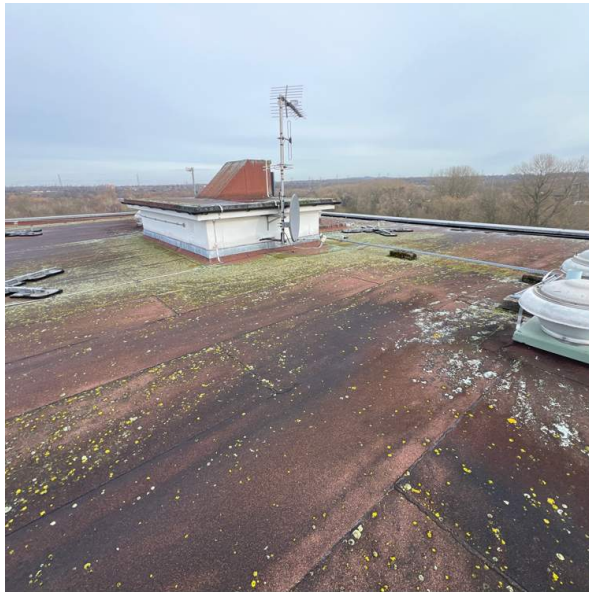
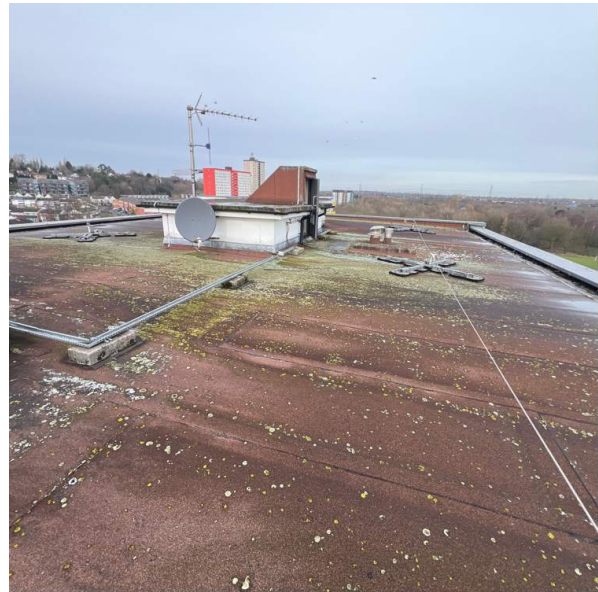
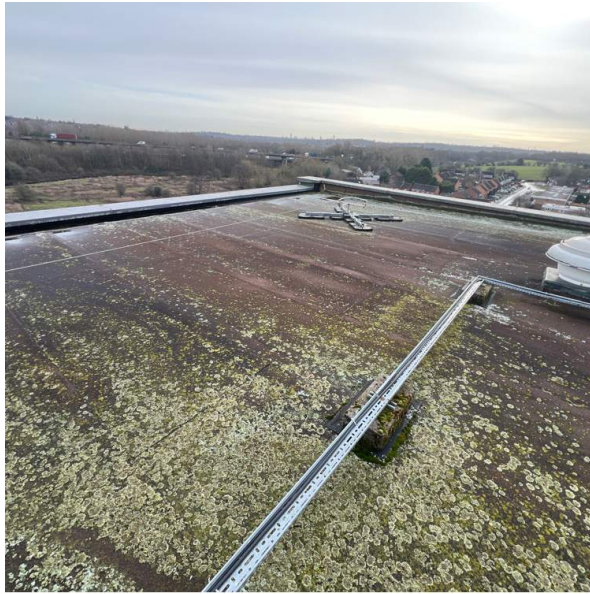
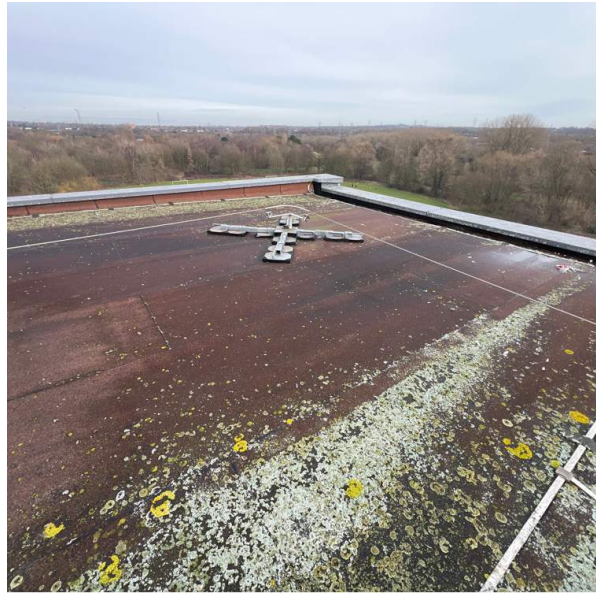
## Main Roof

Comments: Flat roof, RC concrete slab with insulated PIR board and felt coverings.

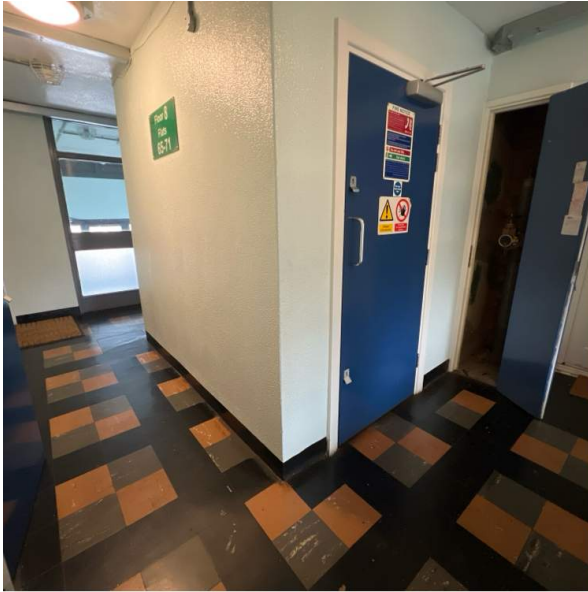
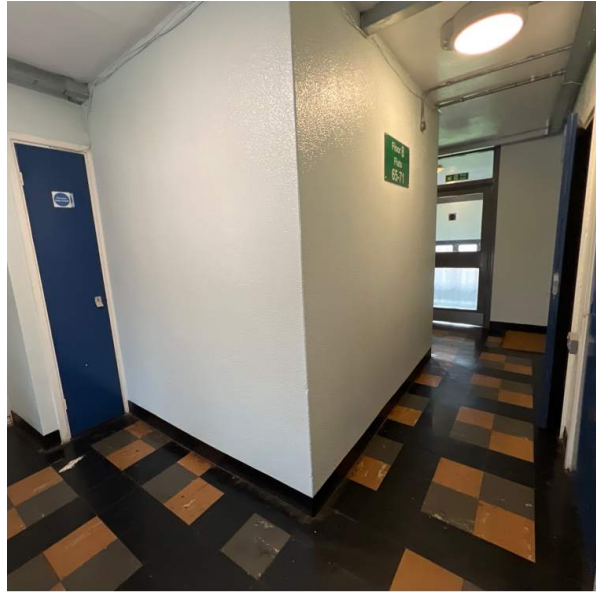
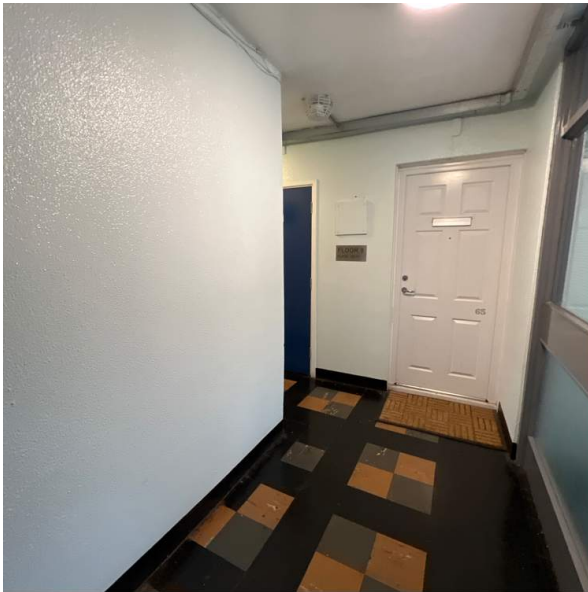
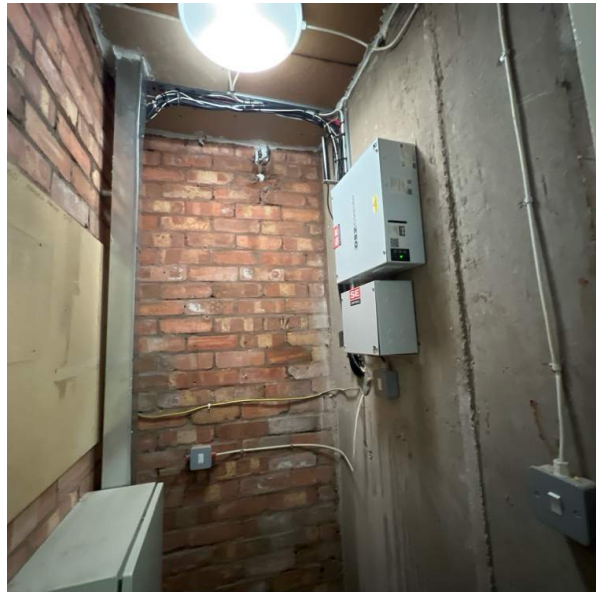
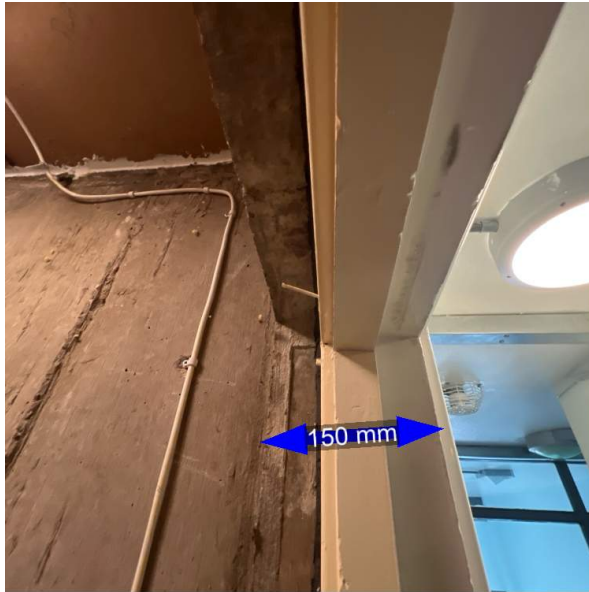
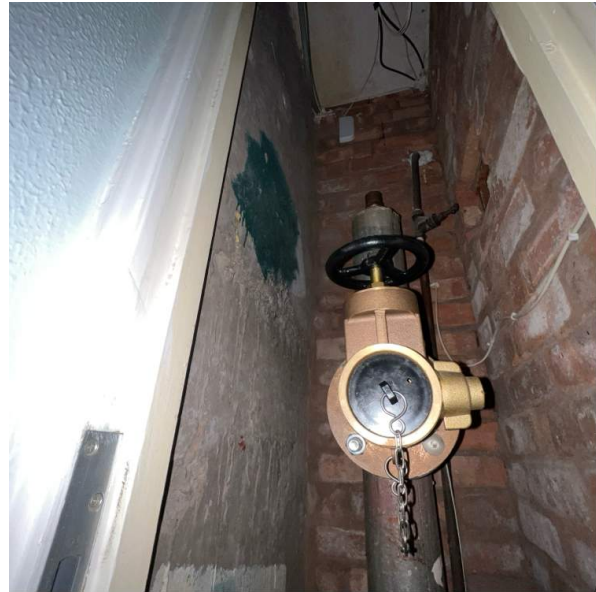
## 8th Floor Hallway

Comments: No jams or distortions noted to hallway doors to indicate any serviceability issues. Generally walls covered with finishes in hallway, likely to consist a mixture of concrete shear walls, embedded columns and masonry infill walls. Limited structure exposed. Concrete walls and infill masonry (non-load bearing) walls noted in riser cupboards.

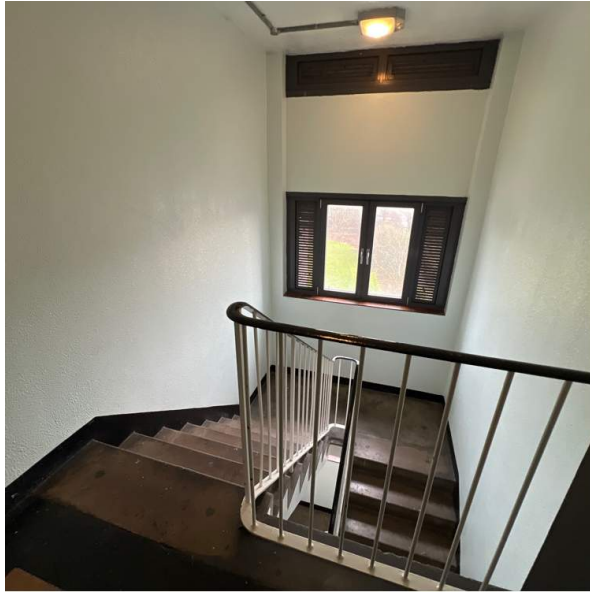
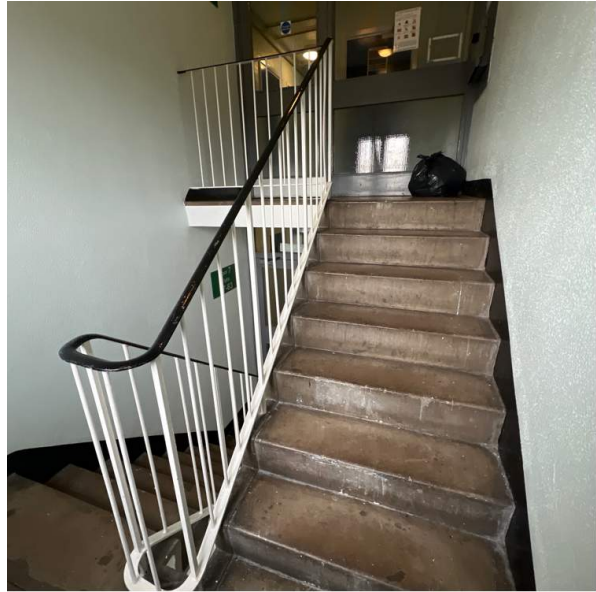
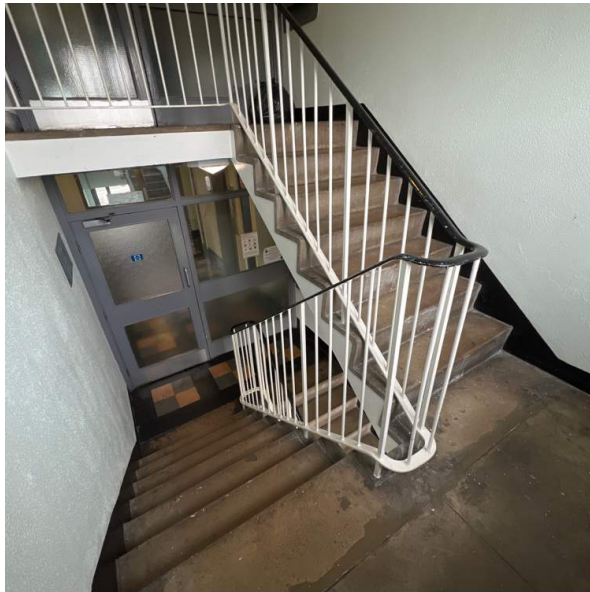
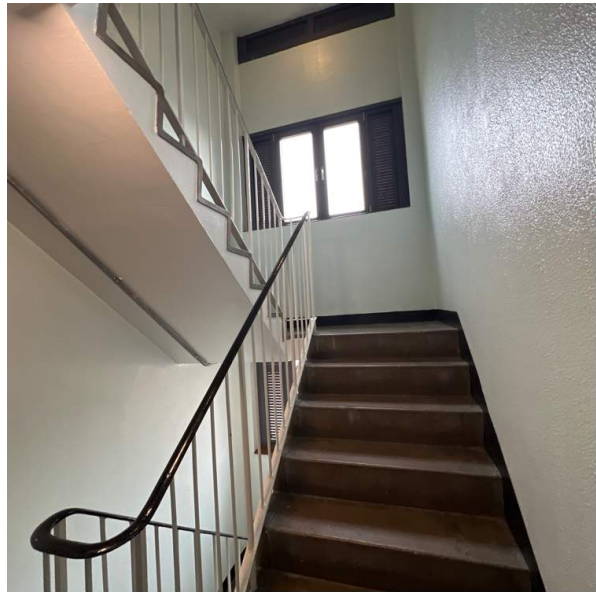
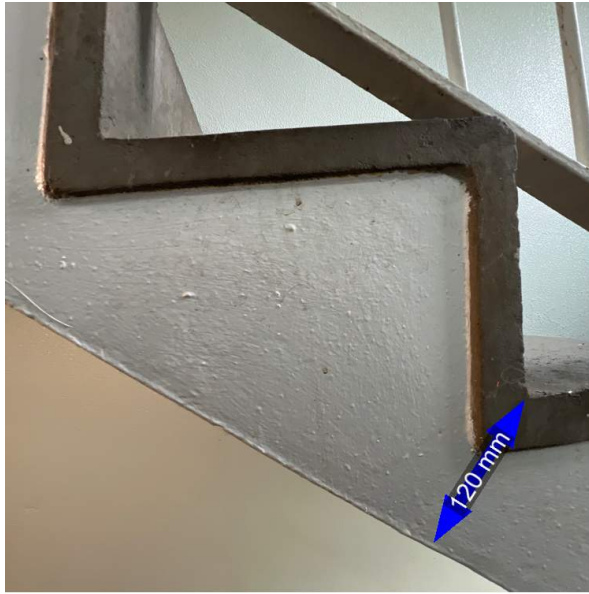
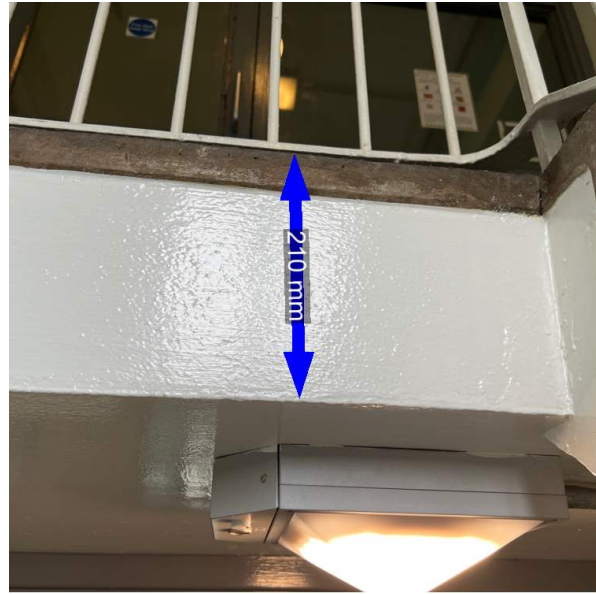
## 8th Floor Staircases

Comments: Insitu concrete stairs with steel hand railing fixed to stairs. Walls and floors appear to be fairly level.  
Stair walls covered with finishes however these would likely form the main concrete shear core walls.

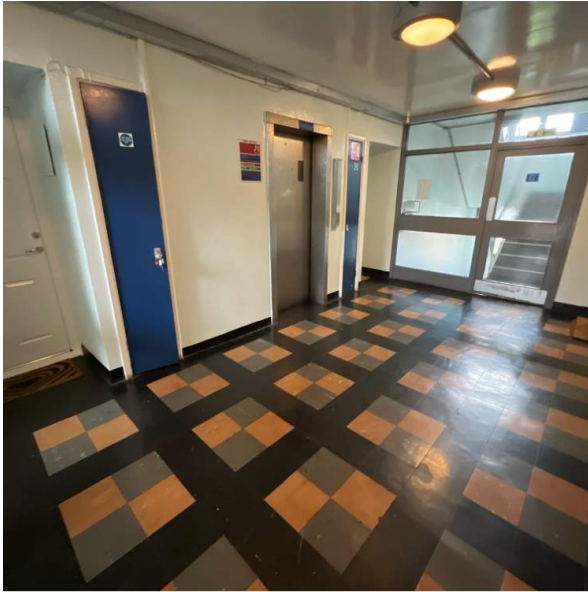
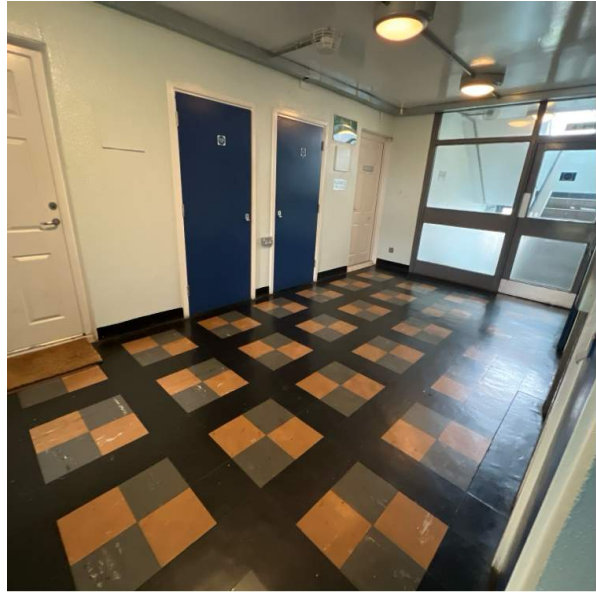
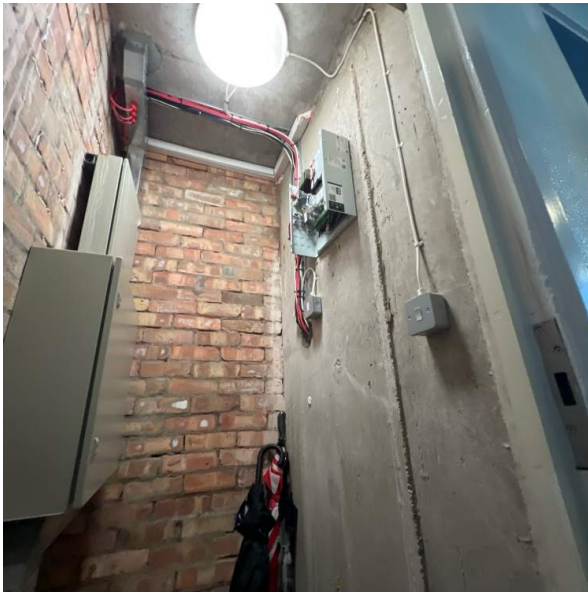
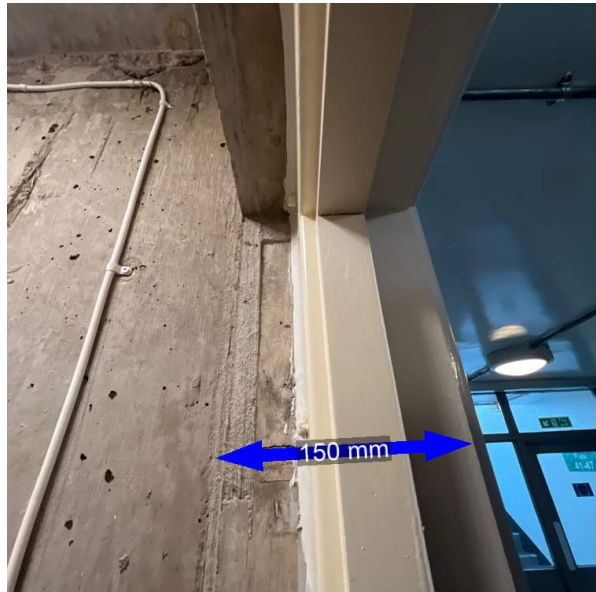
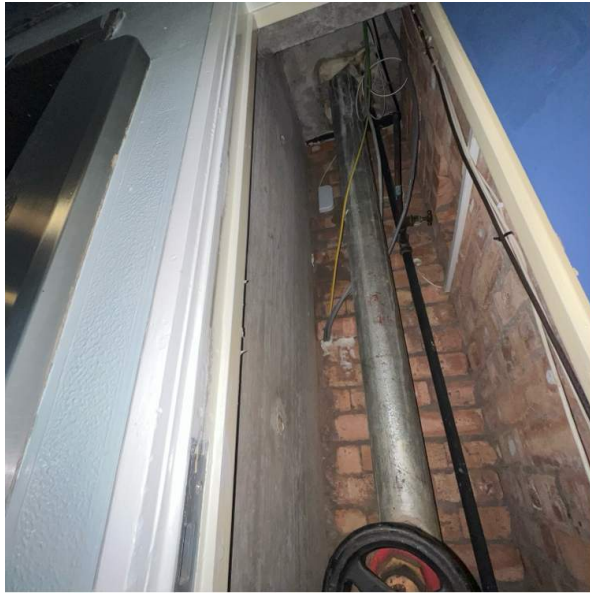
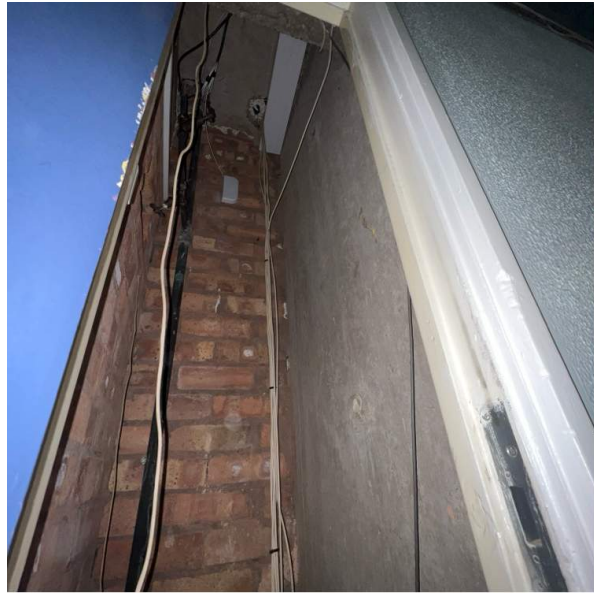
## 5th Floor Hallway

Comments: No jams or distortions noted to hallway doors to indicate any serviceability issues. Generally walls covered with finishes in hallway, likely to consist a mixture of concrete shear walls, embedded columns and masonry infill walls. Limited structure exposed. Concrete walls and infill masonry (non-load bearing) walls noted in riser cupboards.

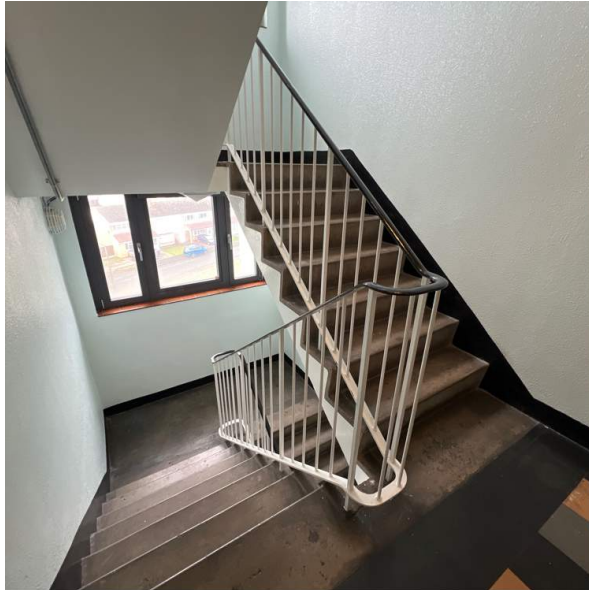
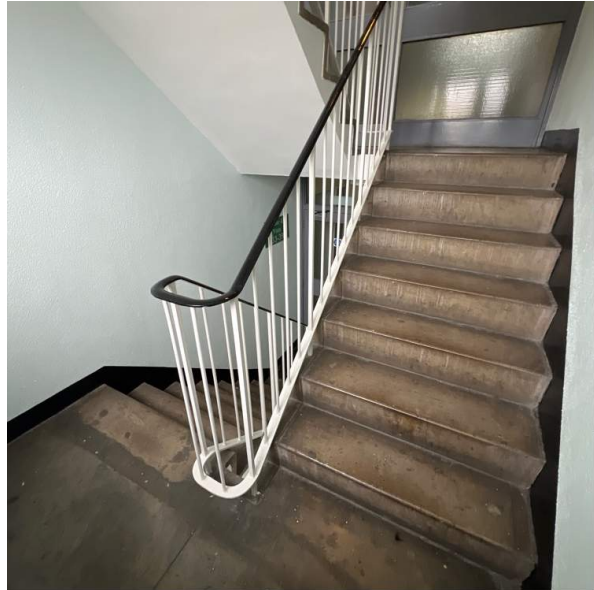
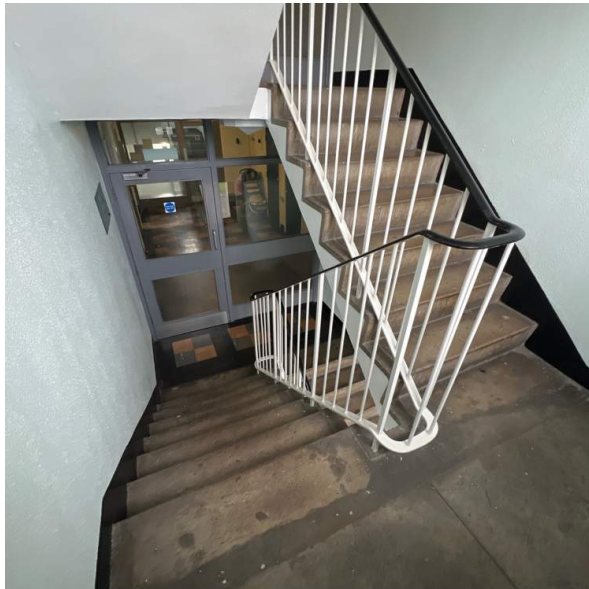
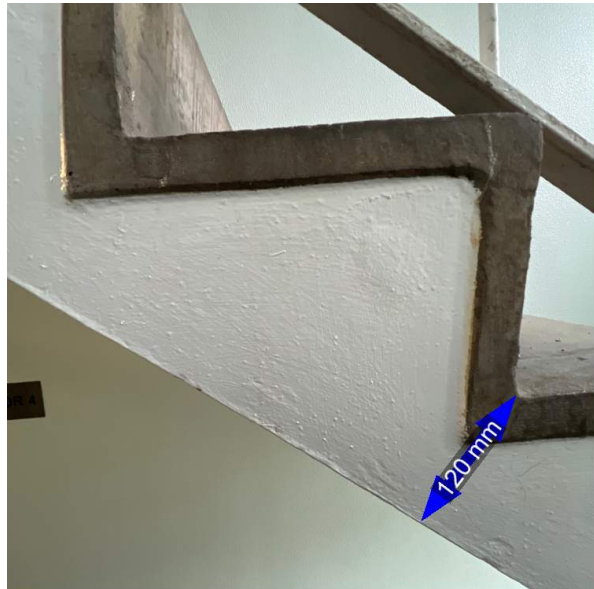
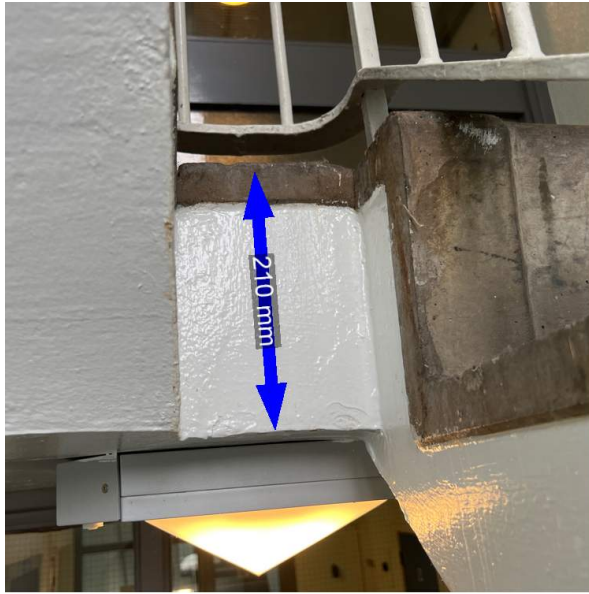
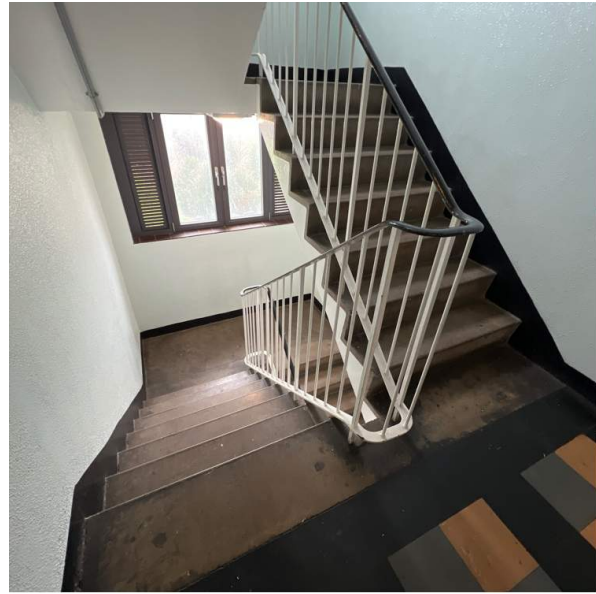
## 5th Floor Staircases

Comments: Insitu concrete stairs with steel hand railing fixed to stairs. Walls and floors appear to be fairly level.  
Stair walls covered with finishes however these would likely form the main concrete shear core walls.

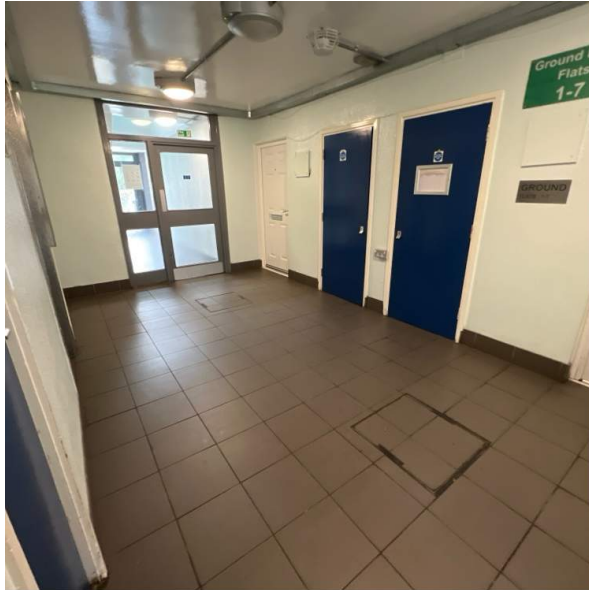
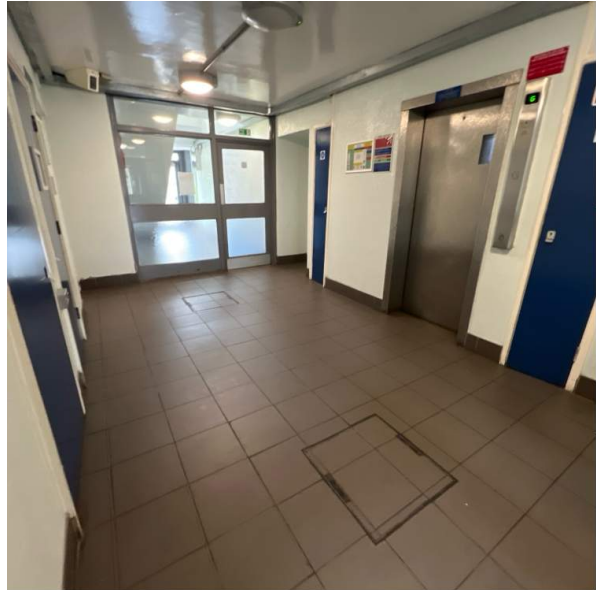
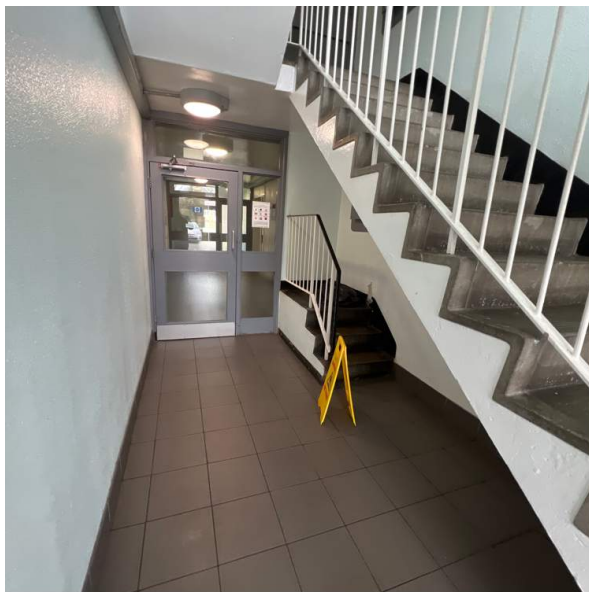
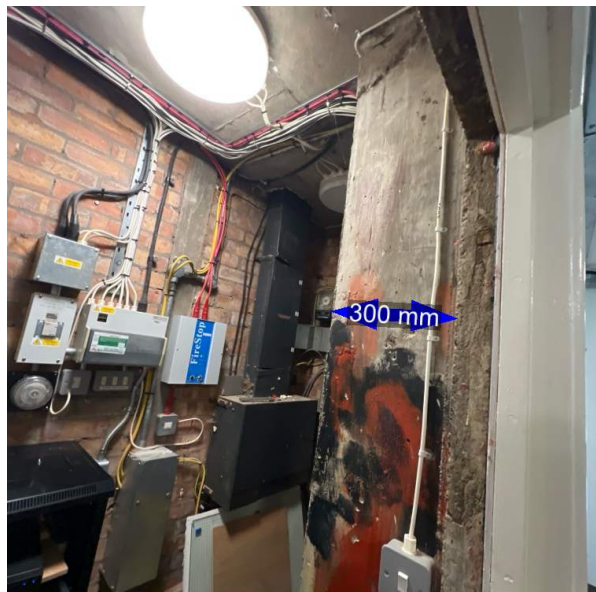
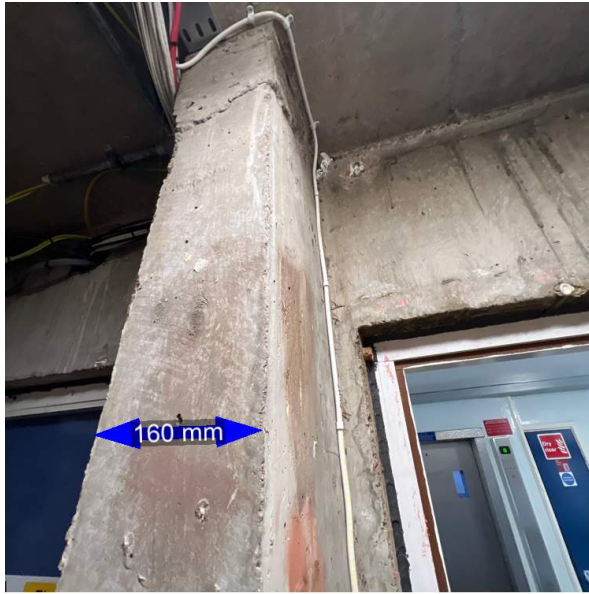
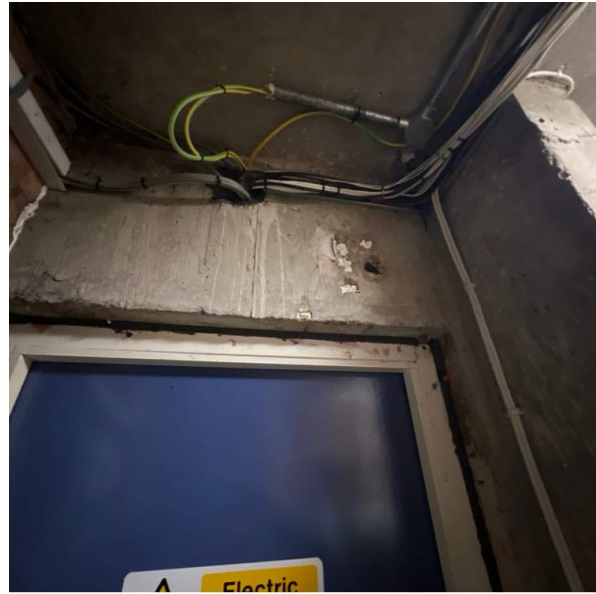
## Ground Floor Hallway

Comments: No jams or distortions noted to hallway doors to indicate any serviceability issues. Generally walls covered with finishes in hallway, likely to consist a mixture of concrete shear walls, embedded columns and masonry infill walls. Limited structure exposed. Concrete walls and infill masonry (non-load bearing) walls noted in riser cupboards.

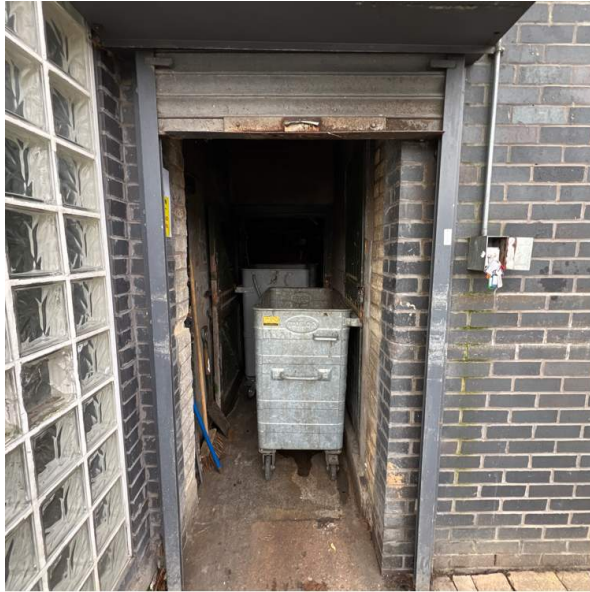
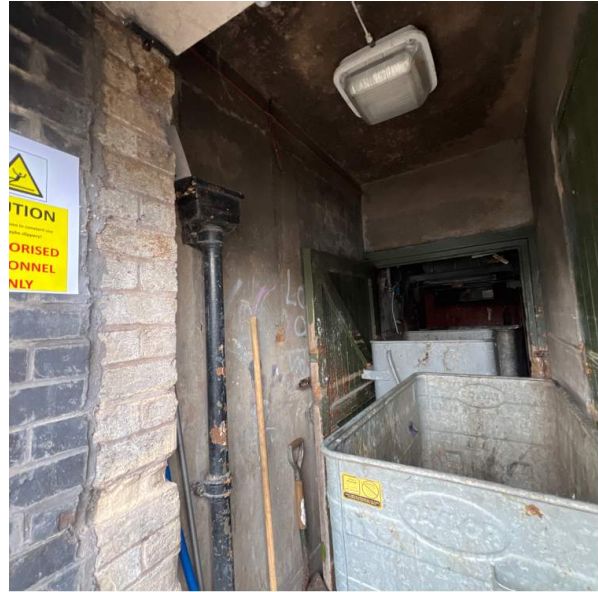
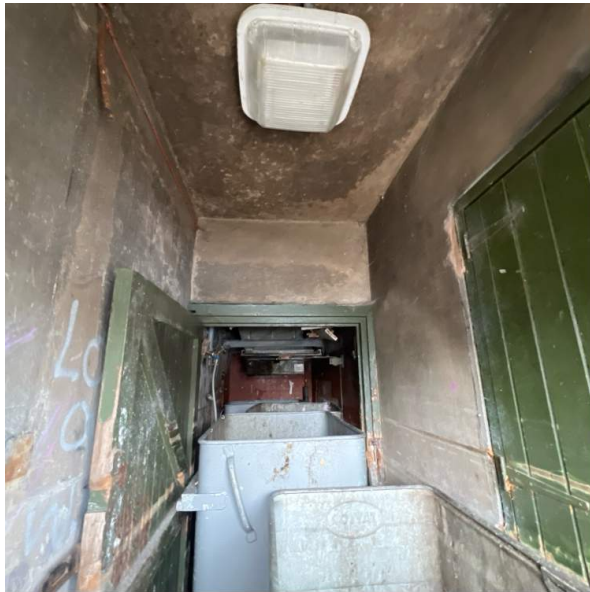
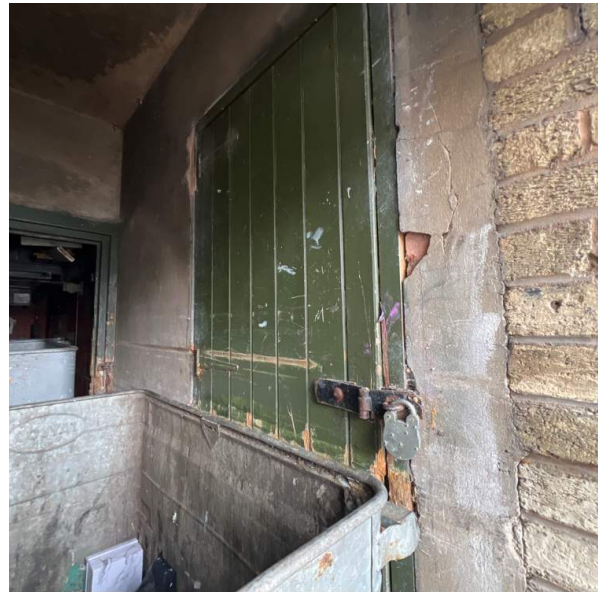
## Binstore

RC Structure/Walls and rendered infilled masonry walls noted in binstore.

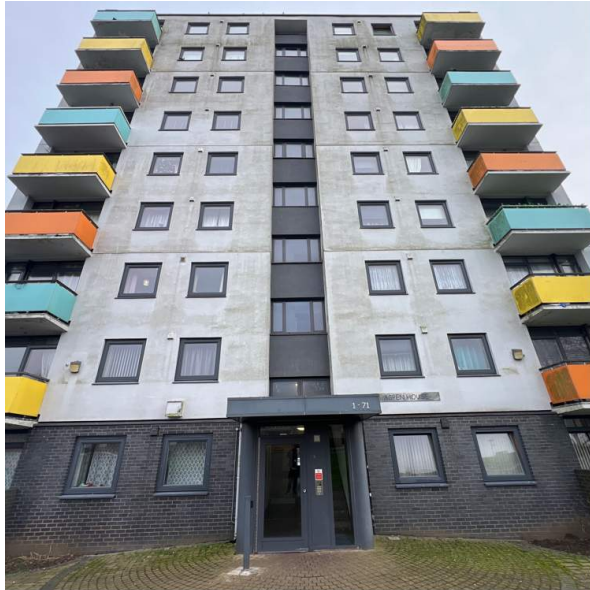
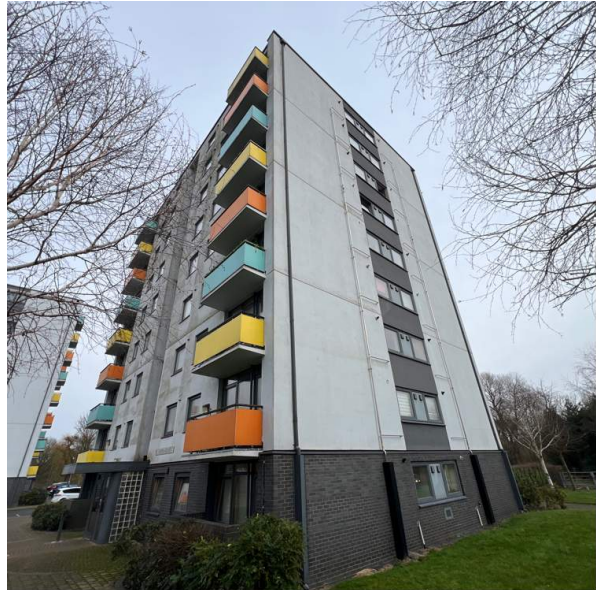
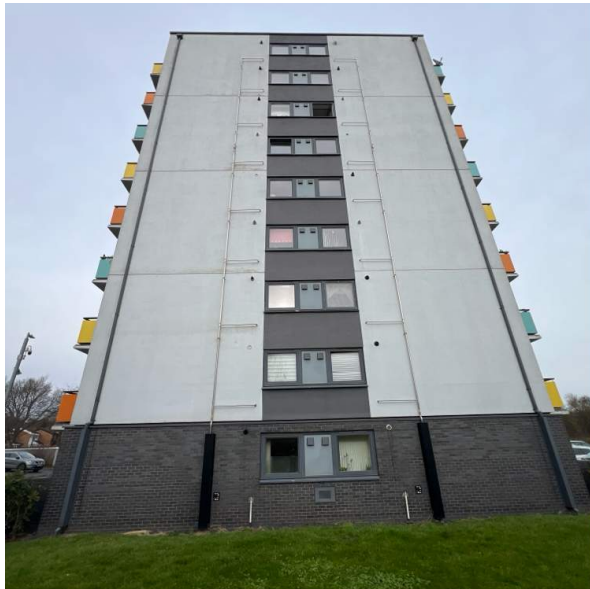
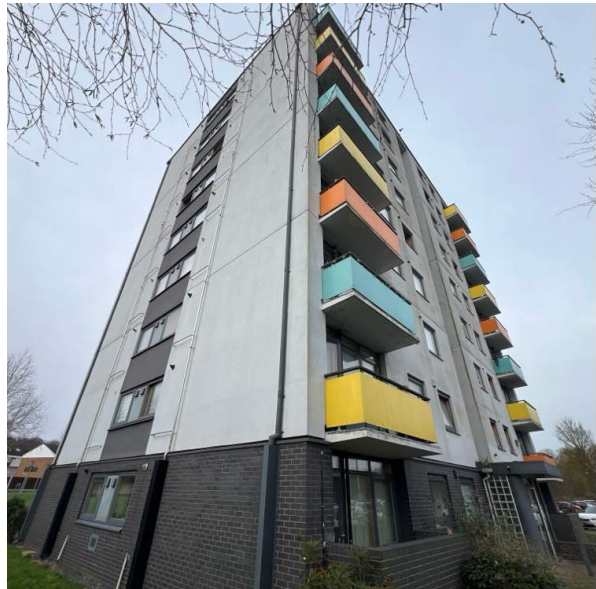
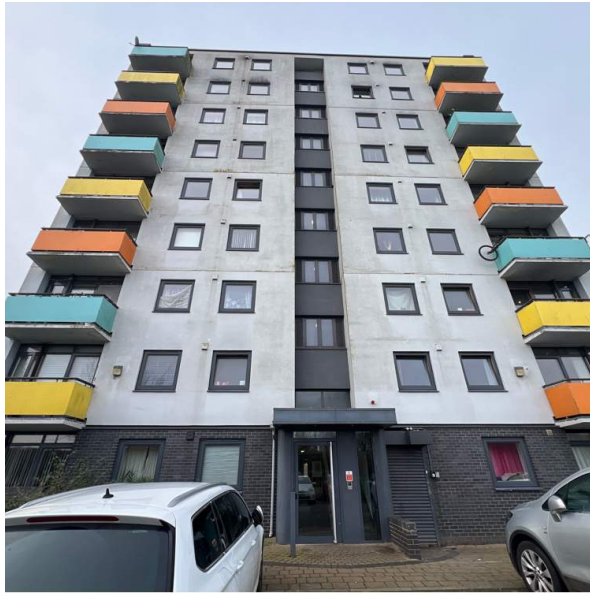
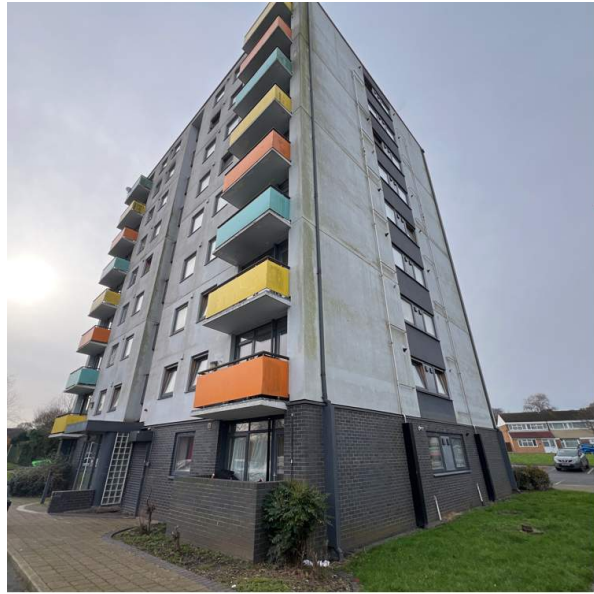
## Elevations

Ground floor level consists of brickwork. Remaining elevations consist of a rendered facade. Cladded panels to balconies.

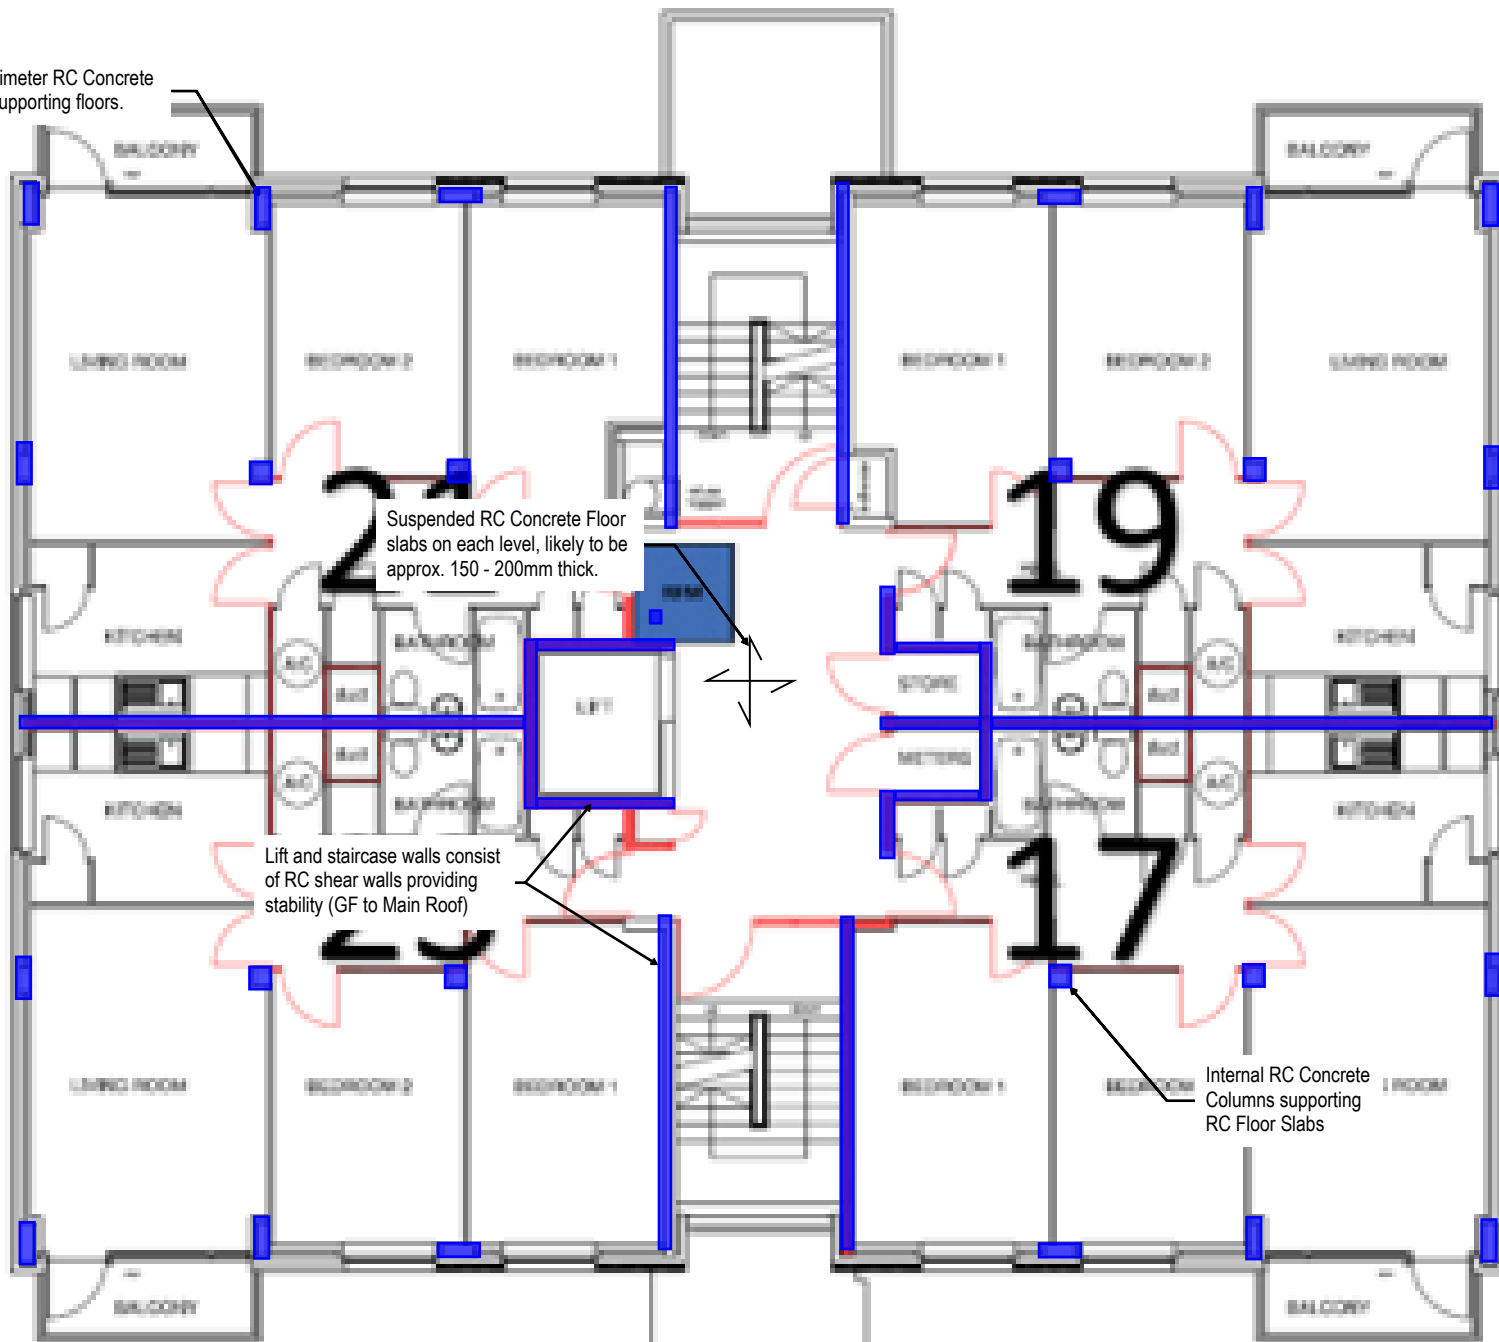
External perimeter RC Concrete Columns), supporting floors.

Suspended RC Concrete Floor slabs on each level, likely to be approx. 150 - 200mm thick.
