**FIRNTEC**  
BUILDING COMPLIANCE

VISUAL STRUCTURAL APPRAISAL

Beech House

Meadow Avenue  
West Bromwich  
B71 3EJ

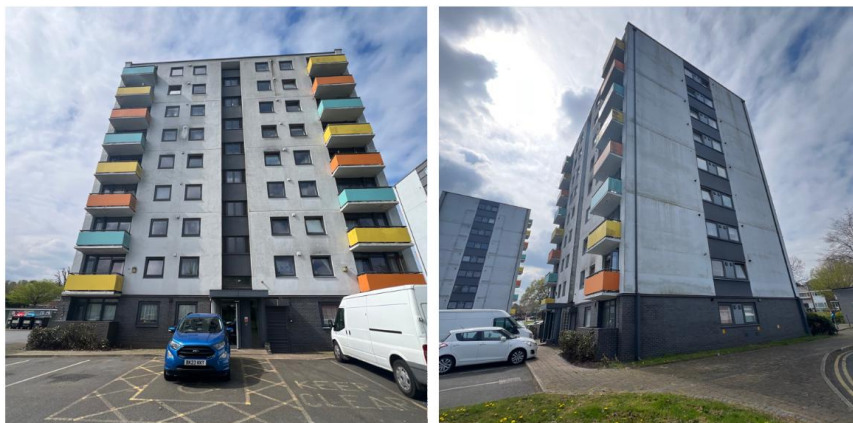
Figure 9 and 10: Building Elevations

The exterior elevations were generally in ok condition and no significant structural defects were noted to the cladding panels. There were no significant cracks or tell-tale signs of any significant structural movement noted at the time of our inspection.

The exterior panels were noted to be plumb with no signs of significant bowing, bulging or leaning noted to the panels indicating failed fixings however their presence and condition cannot be confirmed.

There are balconies at each level which are formed of cantilevered RC slabs tied into the main frame. During the 2009 refurbishment they had high pressure laminate boards installed as balustrades.

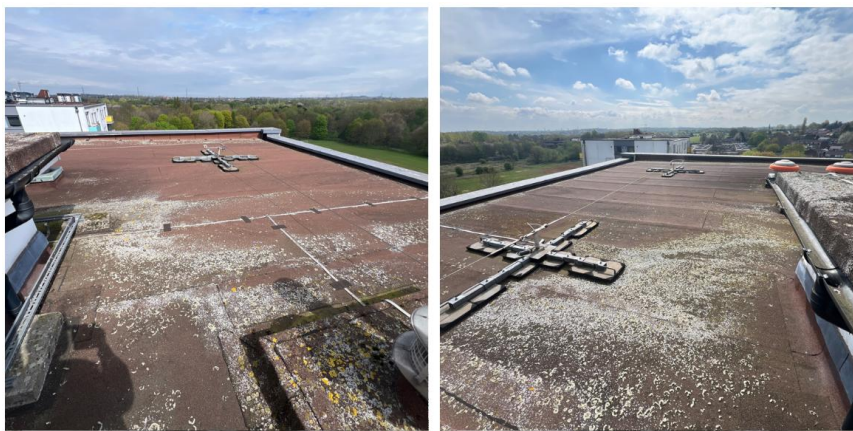
Figure 11 and 12: Roof Level

There were no tell-tale signs of any significant structural movement noted at the time of our inspection.

The roof has a asphalt finish. The exact build-up of the roof finishes were not accessible at the time of inspection. It is recommended an intrusive survey of the roof finishes is completed by a specialist surveyor to assess the condition of the roof covering.

There was moss growth and build-ups of debris noted which should be cleared as part of a normal maintenance regimen

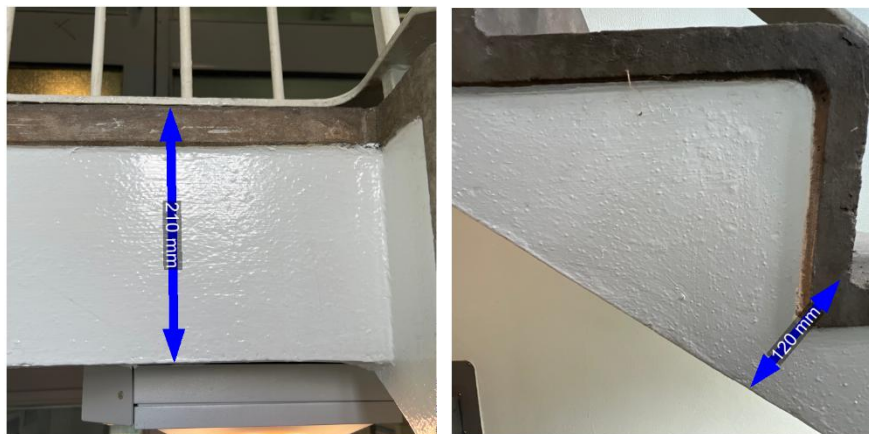
Figure 14 and 15: Stair stringer and concrete slab

The stair stringer was noted to be 120mm thick which seems slim, certainly short of modern standards. A cover test is required to check the resistance of the concrete section in the event of a fire.

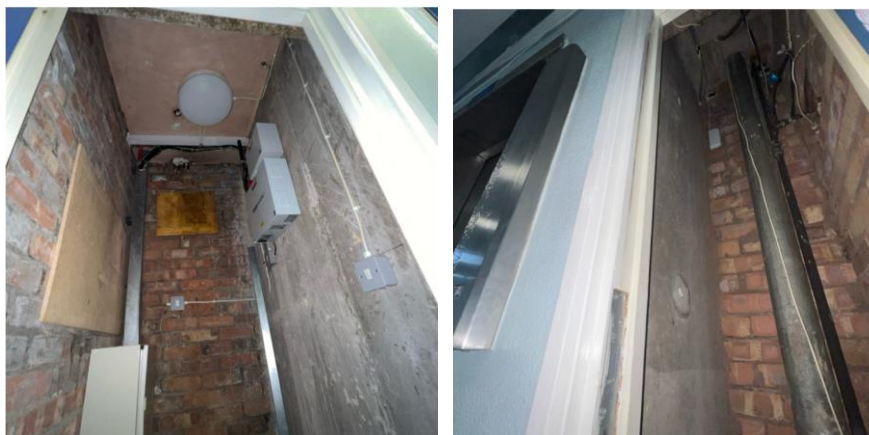
Figure 16 and 17: RC Elements visible

There were vertical concrete walls supporting the floor plates at every level. The elements visible matched the floor layout in Figure 6. The walls appear continuous from ground to roof with no transfer structure. The overall condition of the structure observed is good.

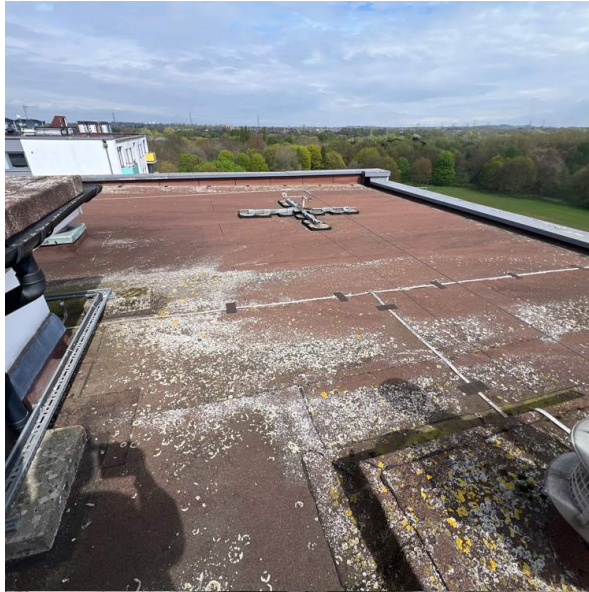
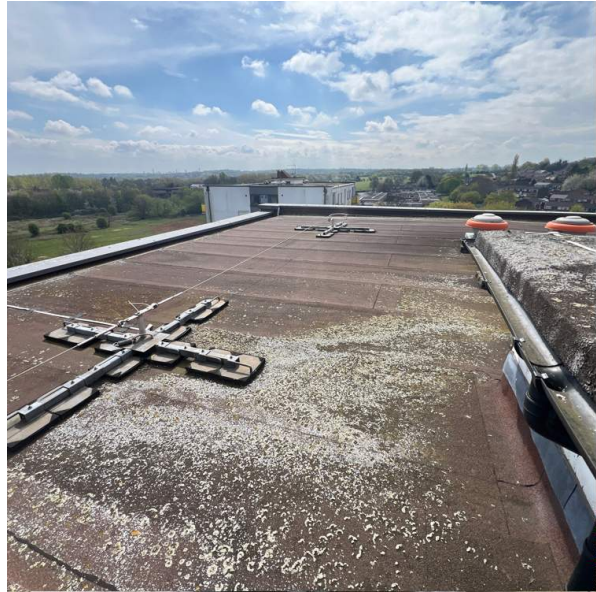
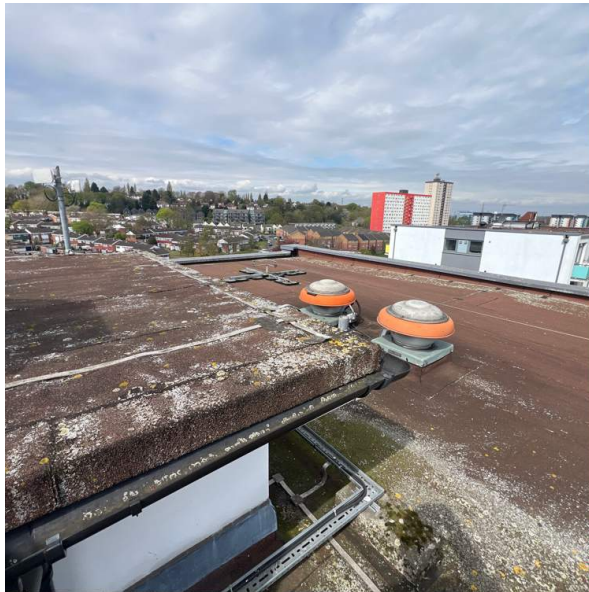
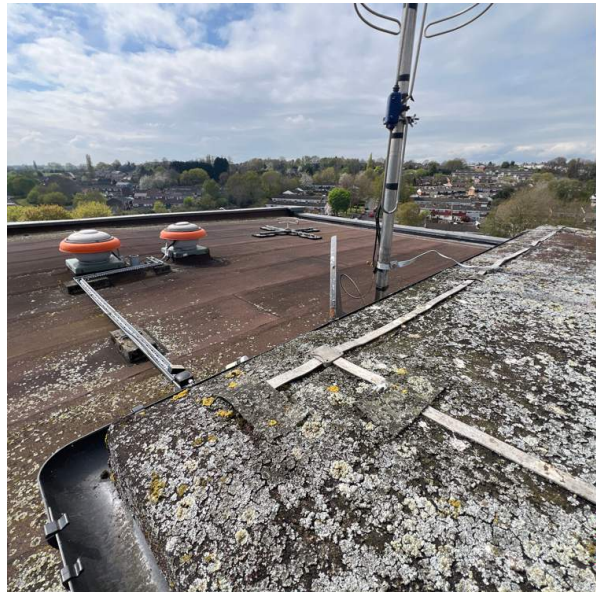
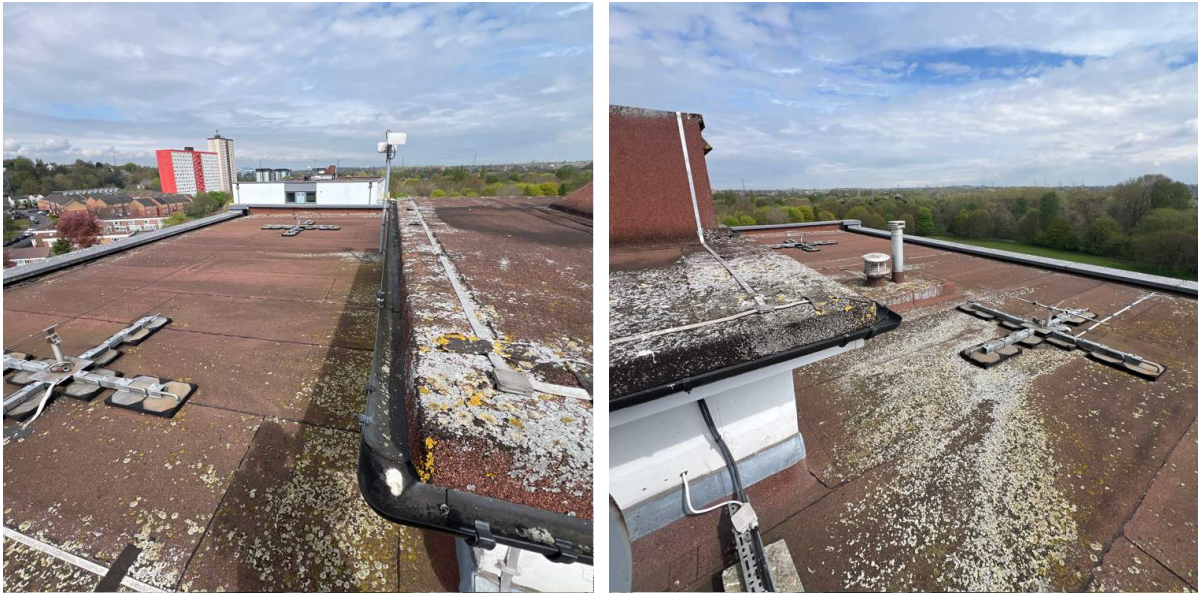
## Main Roof

Comments: Flat roof, RC concrete slab with insulated PIR board and felt coverings.

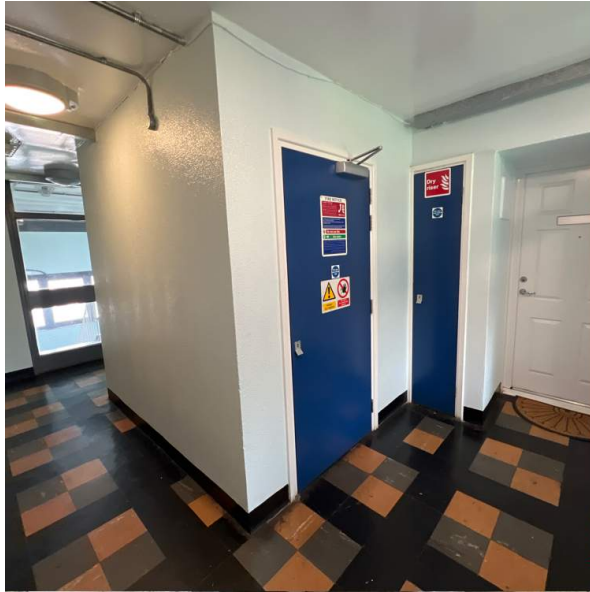
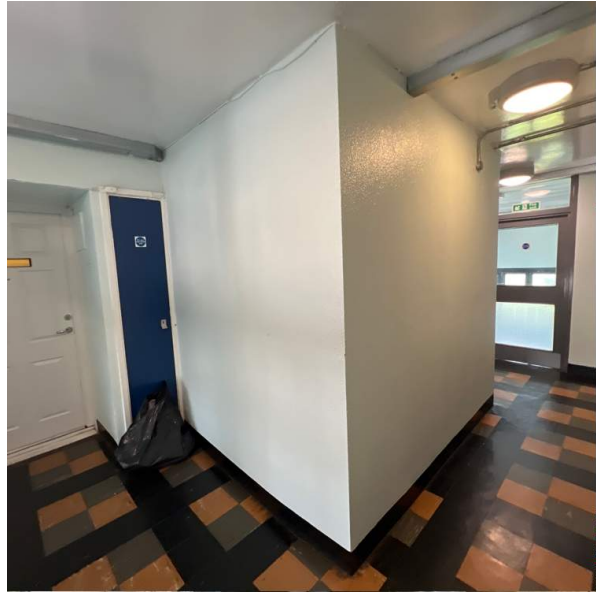
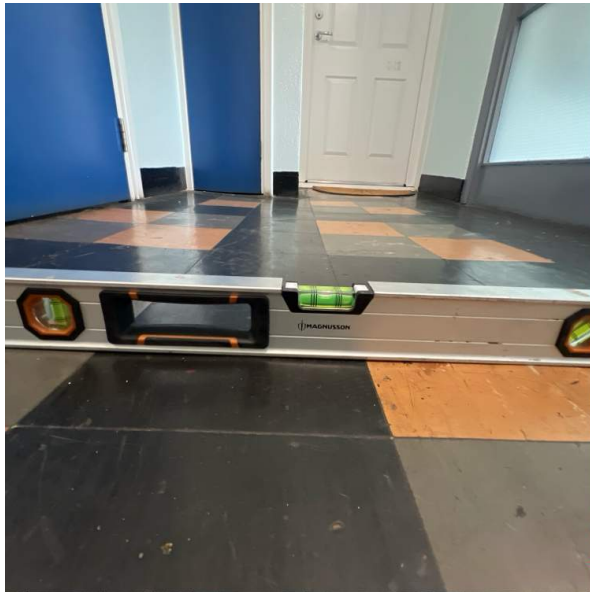
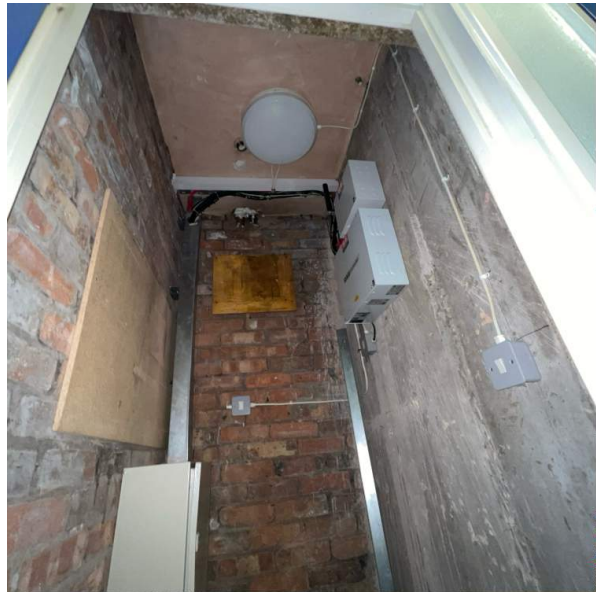
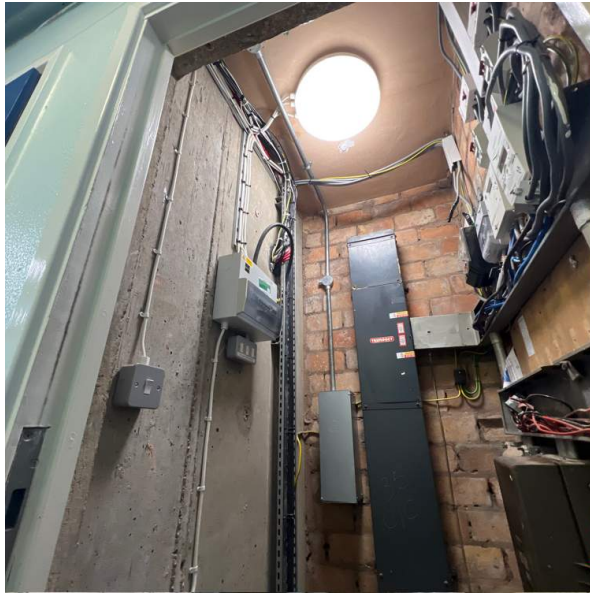
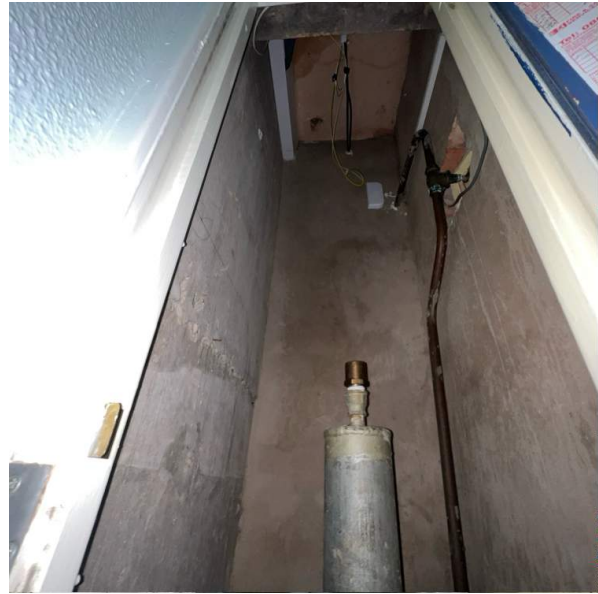
## 8th Floor Hallway

Comments: No jams or distortions noted to hallway doors to indicate any serviceability issues. Generally walls covered with finishes in hallway, likely to consist a mixture of concrete shear walls, embedded columns and masonry infill walls. Limited structure exposed. Concrete walls and infill masonry (non-load bearing) walls noted in riser cupboards. Concrete walls noted to be approx. 150mm thick.

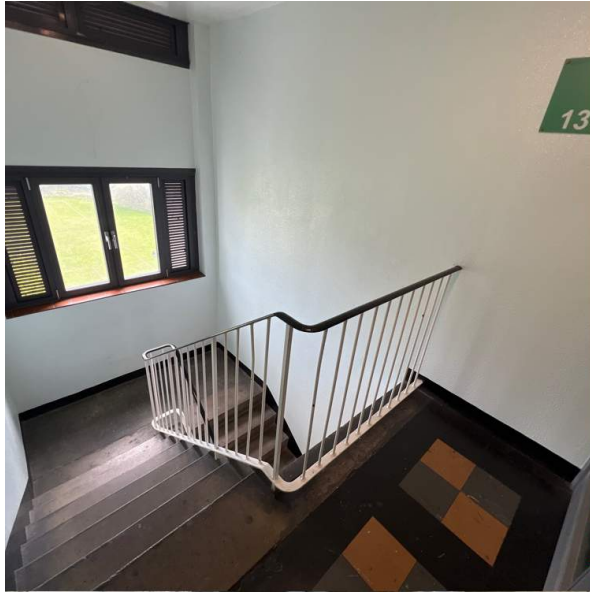
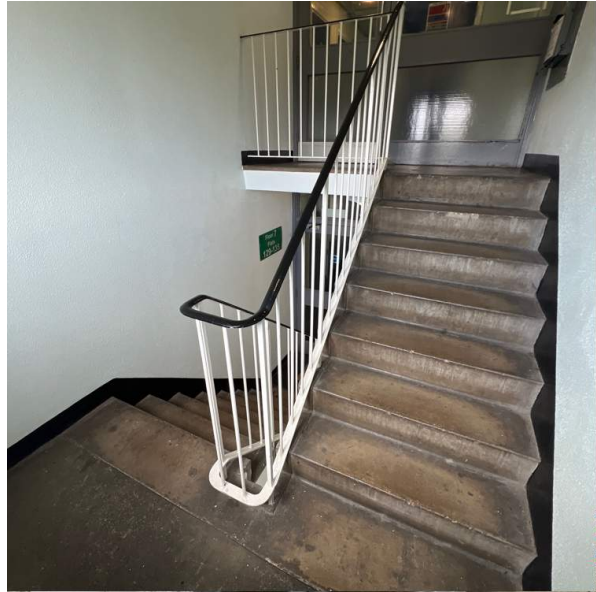
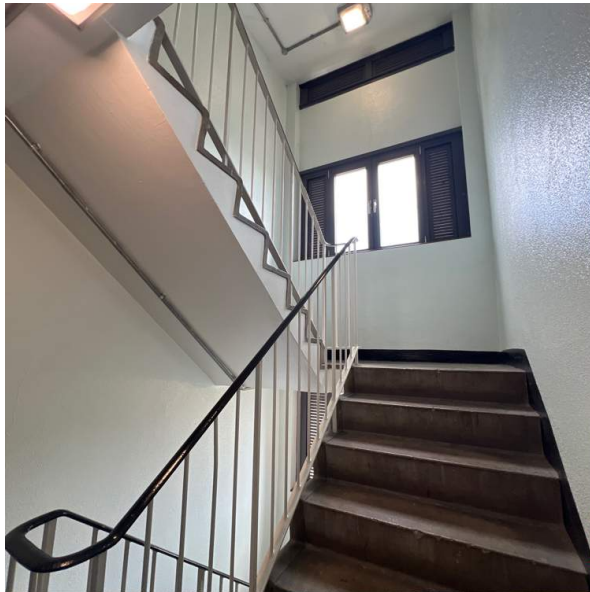
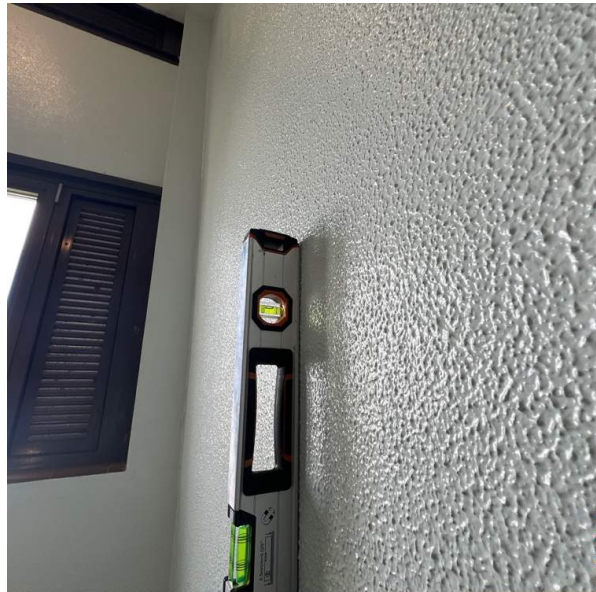
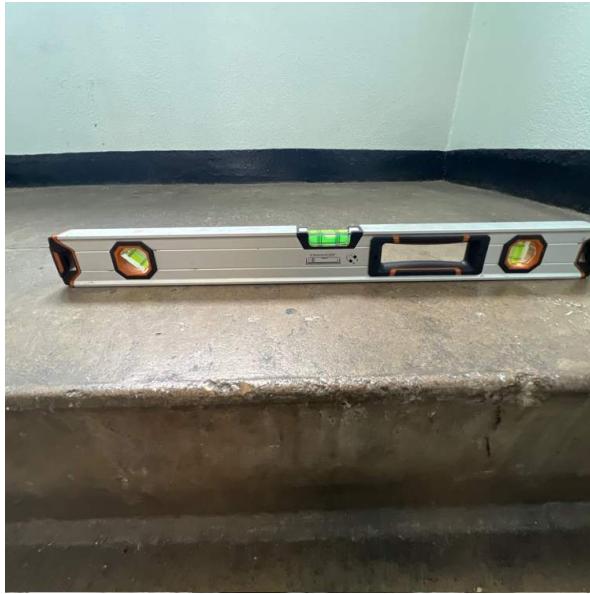
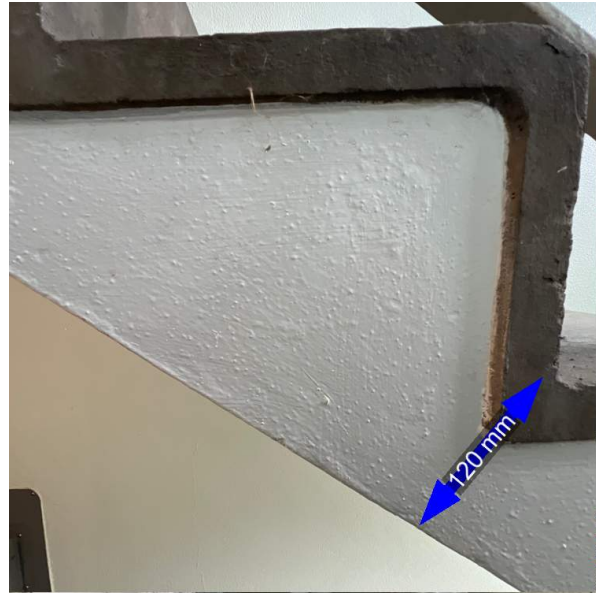
## 8th Floor Staircases

Comments: Insitu concrete stairs with steel hand railing fixed to stairs. Walls and floors appear to be fairly level.  
Stair walls covered with finishes however these would likely form the main concrete shear core walls.

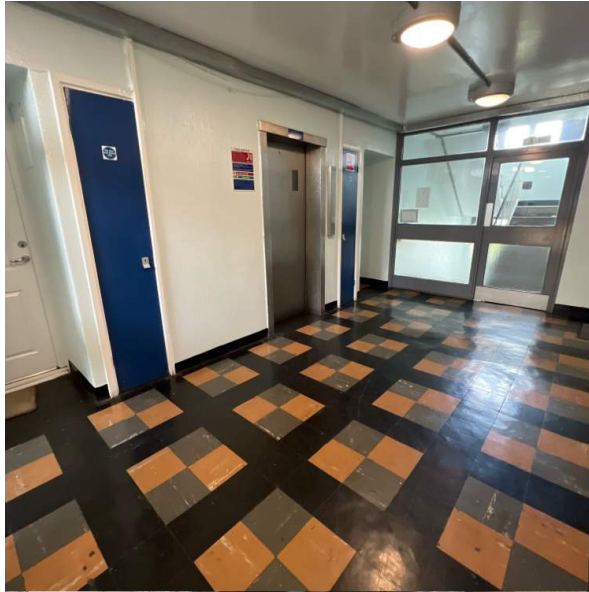
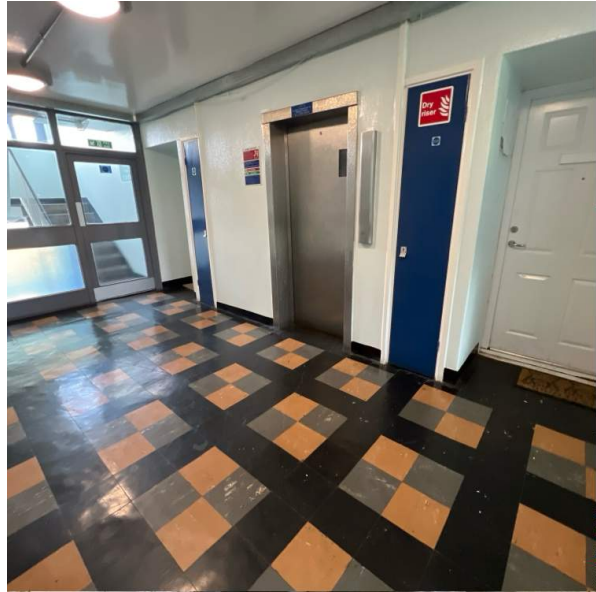
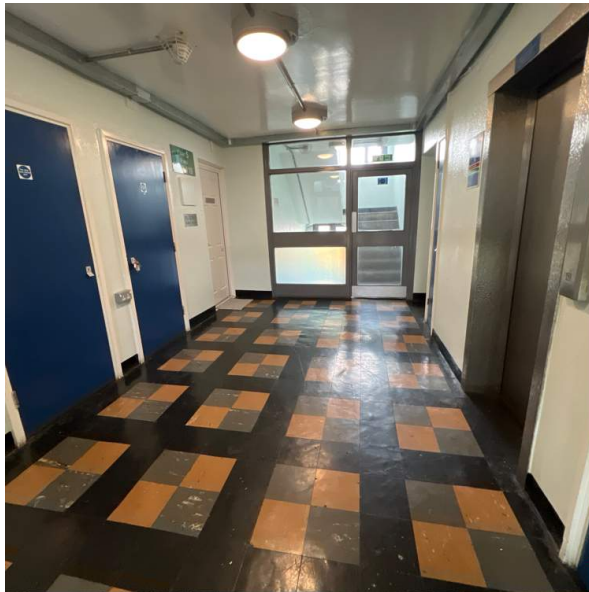
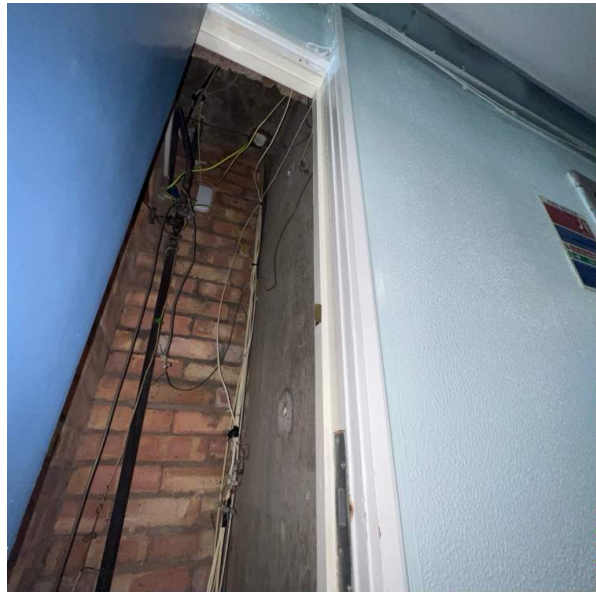
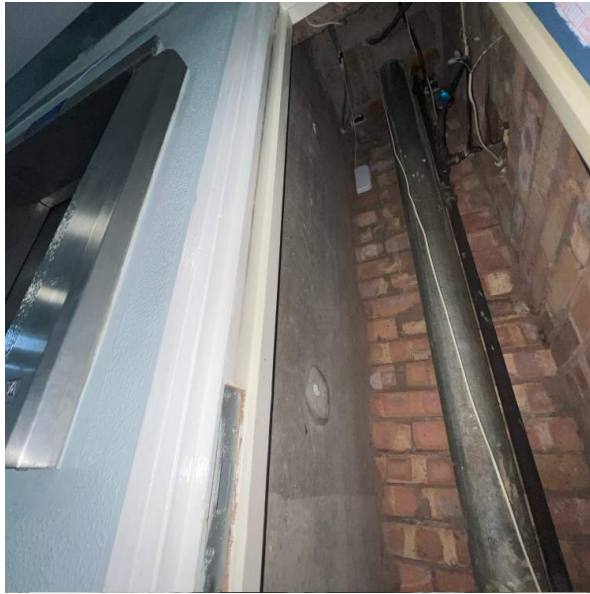
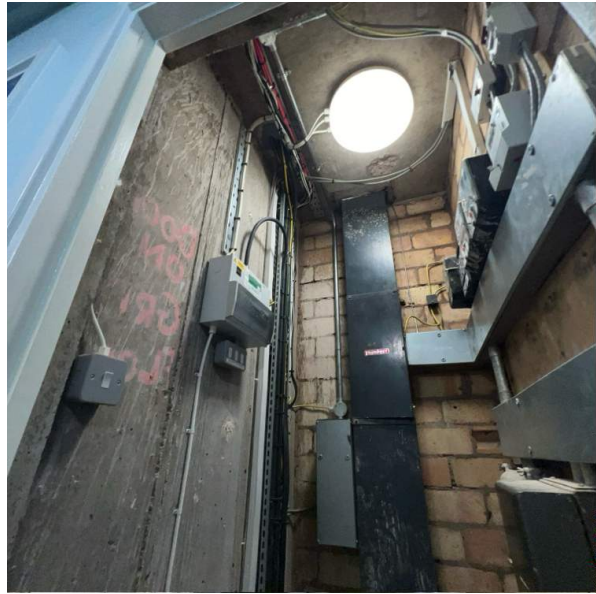
## 5th Floor Hallway

Comments: No jams or distortions noted to hallway doors to indicate any serviceability issues. Generally walls covered with finishes in hallway, likely to consist a mixture of concrete shear walls, embedded columns and masonry infill walls. Limited structure exposed. Concrete walls and infill masonry (non-load bearing) walls noted in riser cupboards.

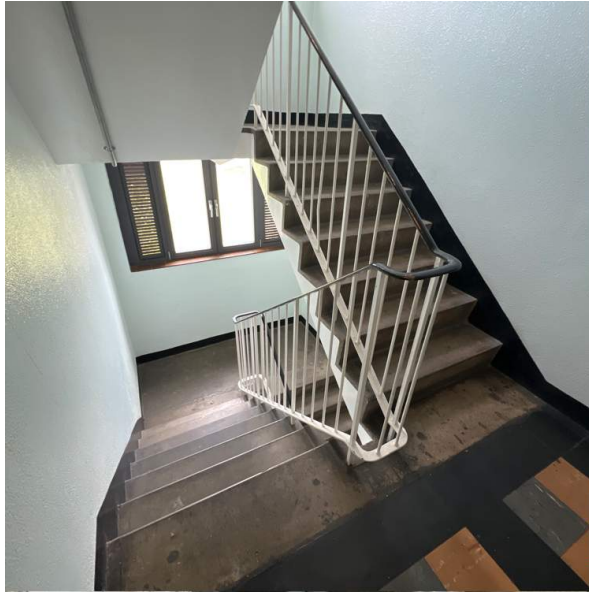
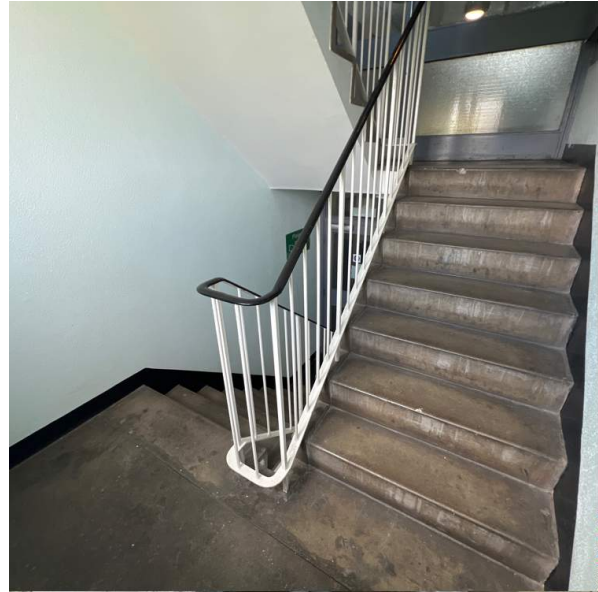
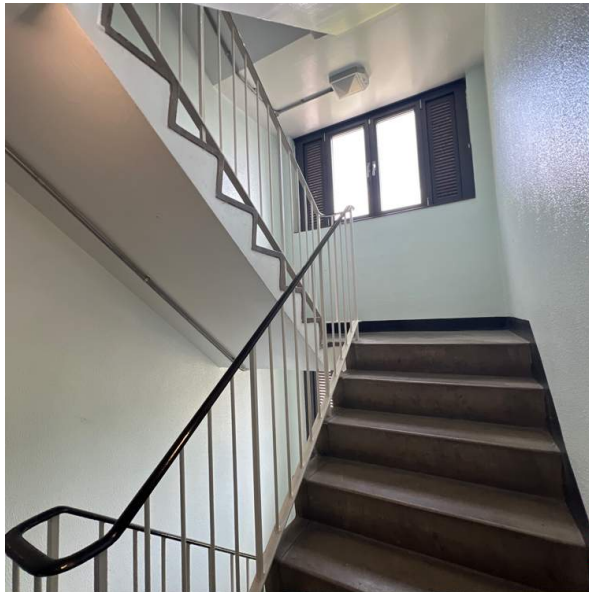
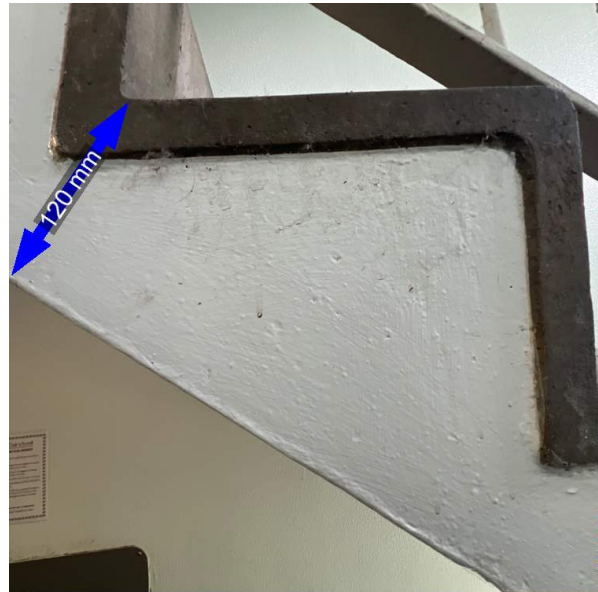
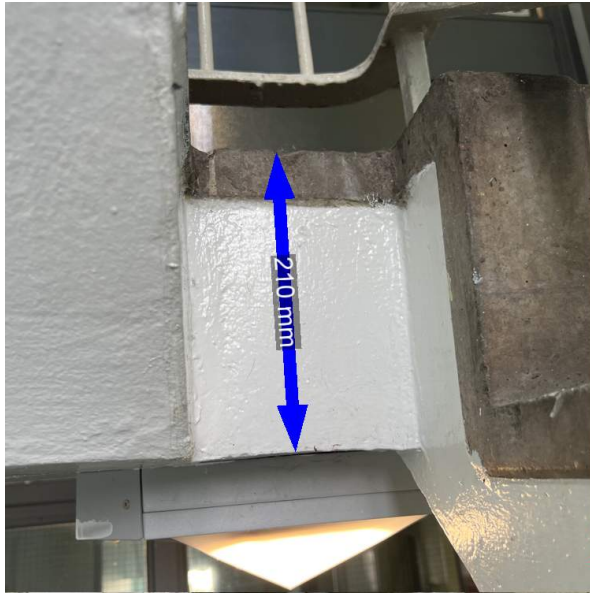
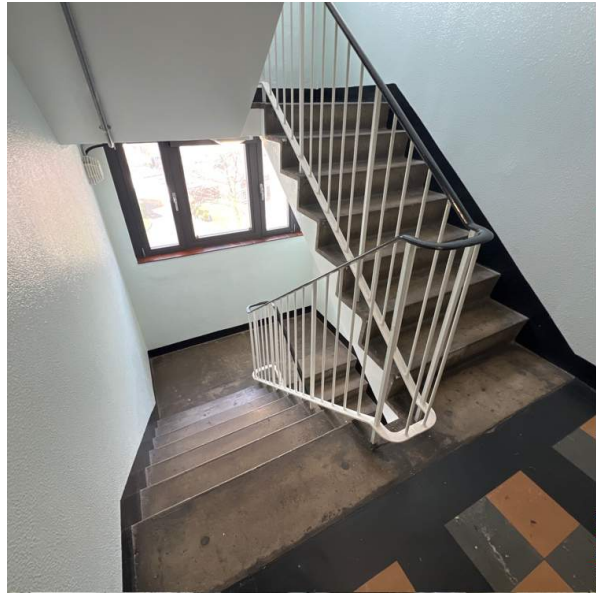
## 5th Floor Staircases

Comments: Insitu concrete stairs with steel hand railing fixed to stairs. Walls and floors appear to be fairly level.  
Stair walls covered with finishes however these would likely form the main concrete shear core walls.

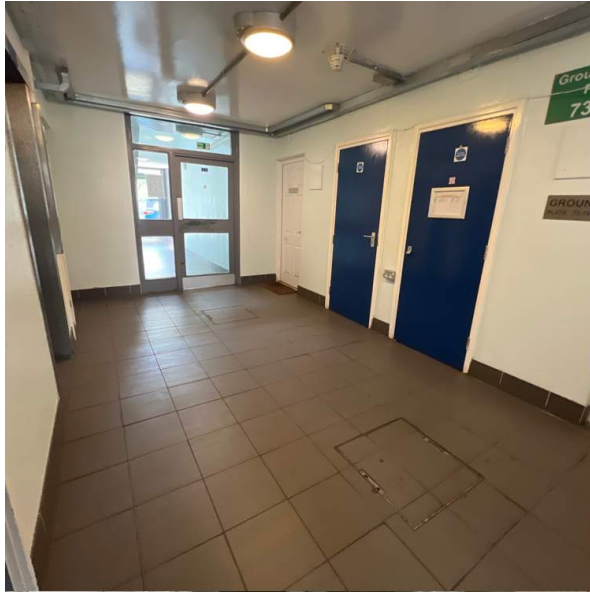
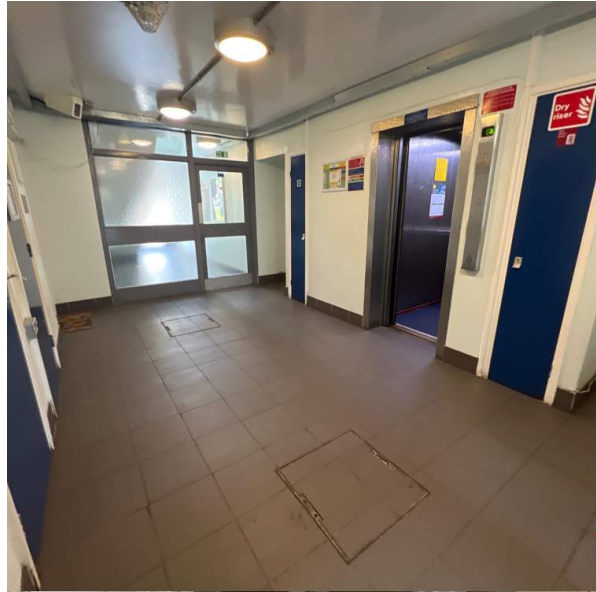
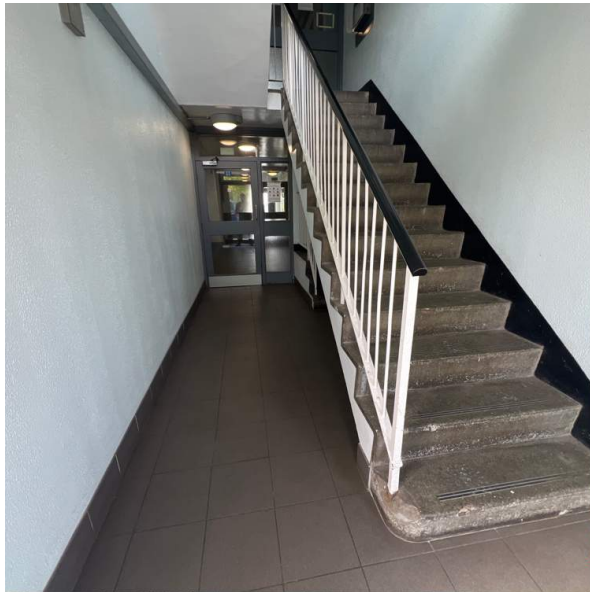
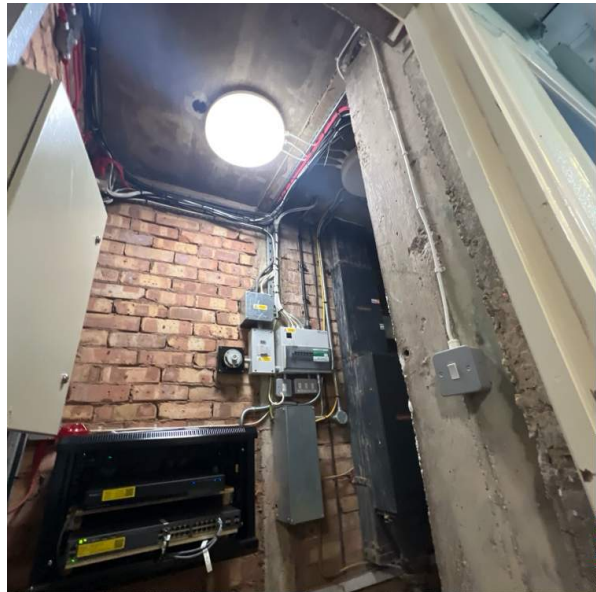
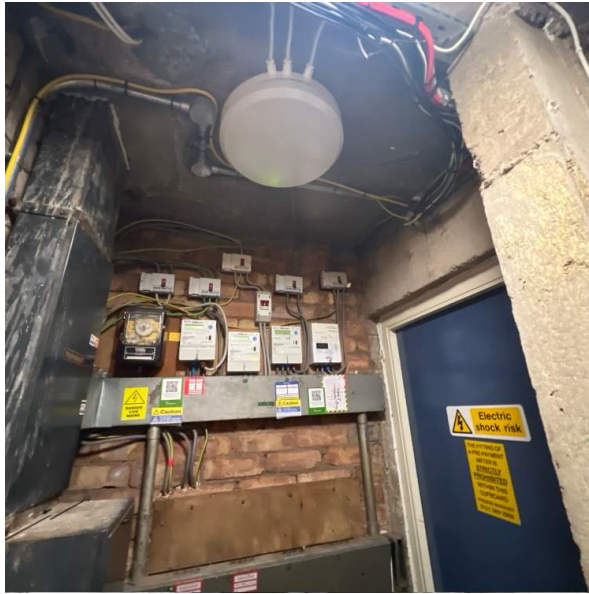
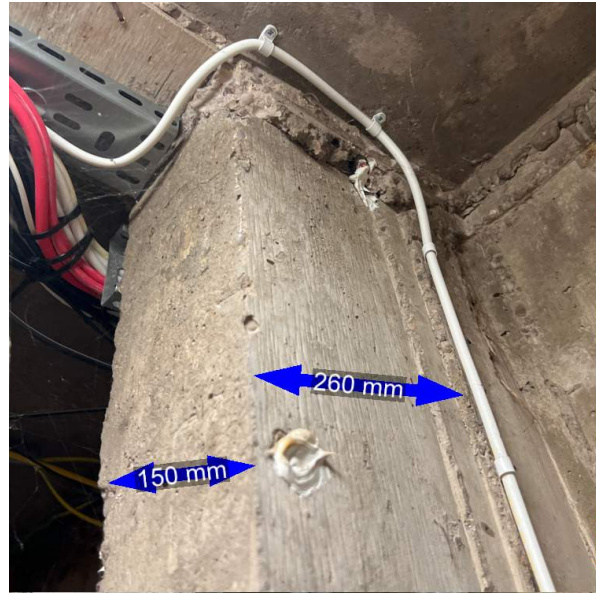
## Ground Floor Hallway

Comments: No jams or distortions noted to hallway doors to indicate any serviceability issues. Generally walls covered with finishes in hallway, likely to consist a mixture of concrete shear walls, embedded columns and masonry infill walls. Limited structure exposed. Concrete walls and infill masonry (non-load bearing) walls noted in riser cupboards.

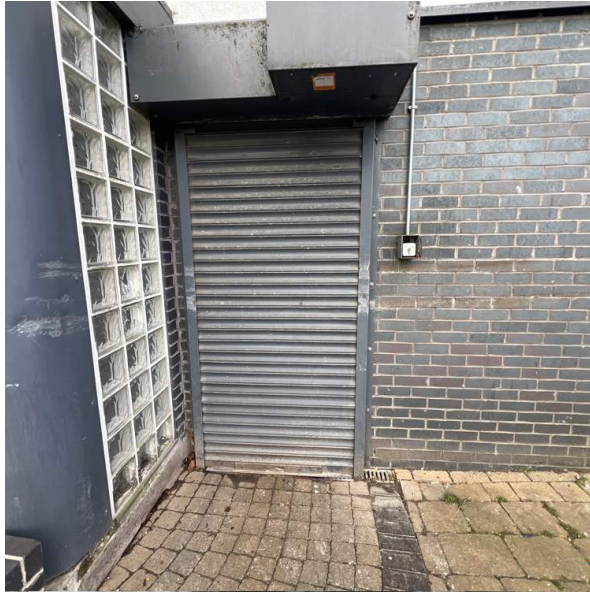
## Binstore

Binstore key jams in shutter lock during inspection therefore no access.

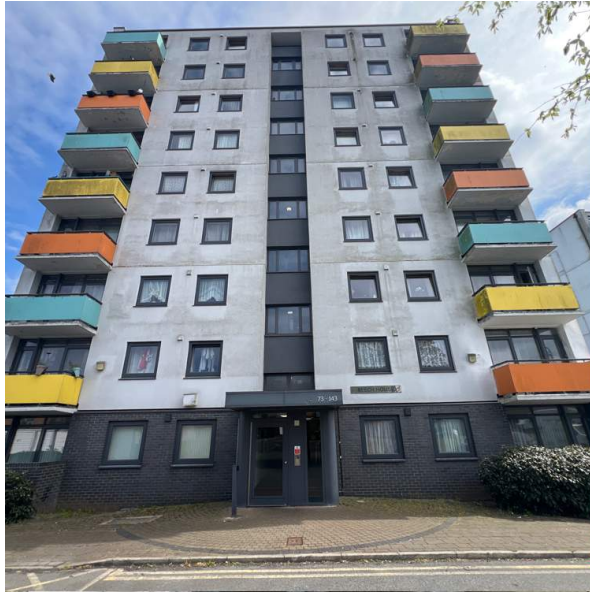
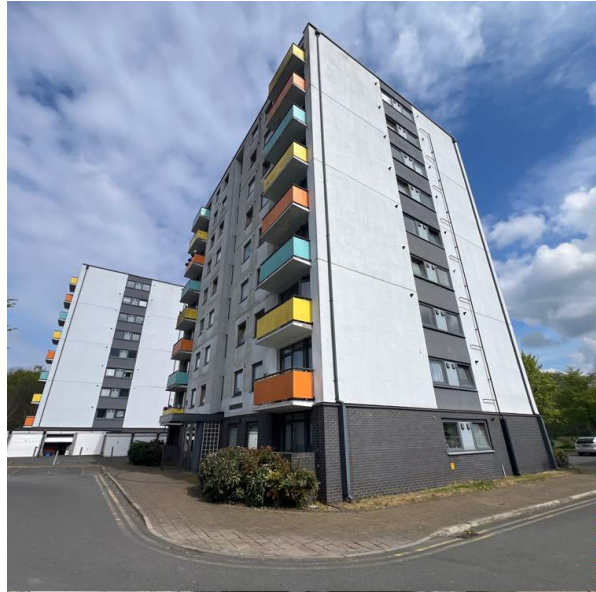
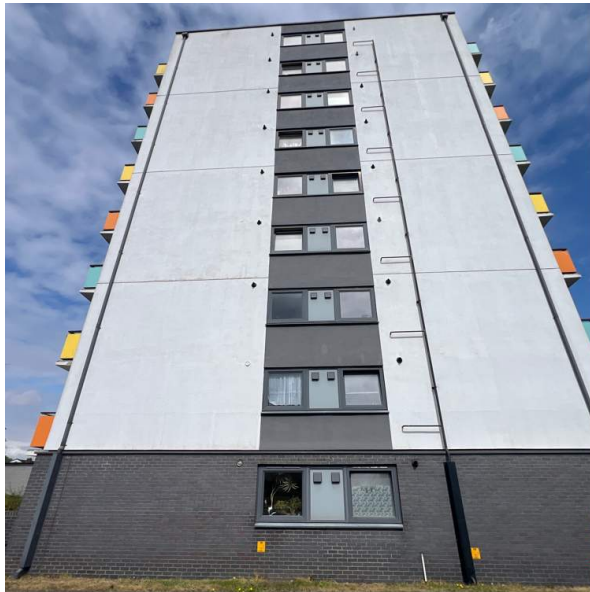
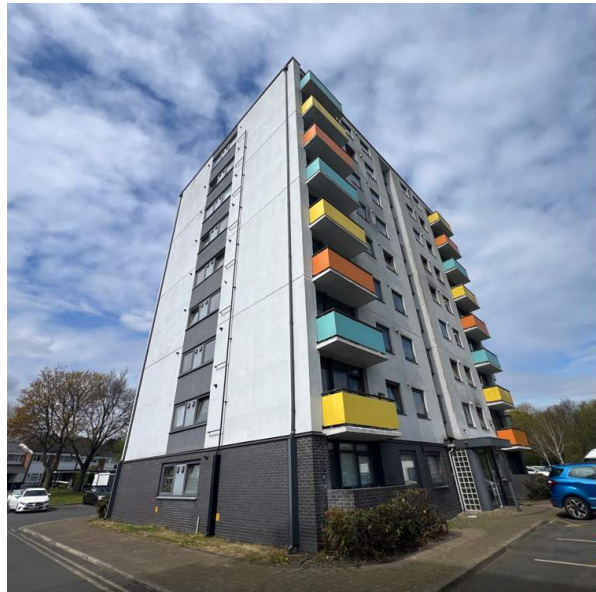
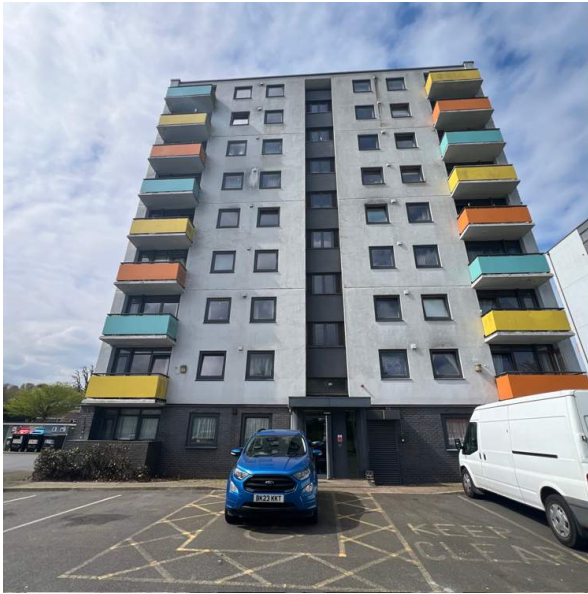
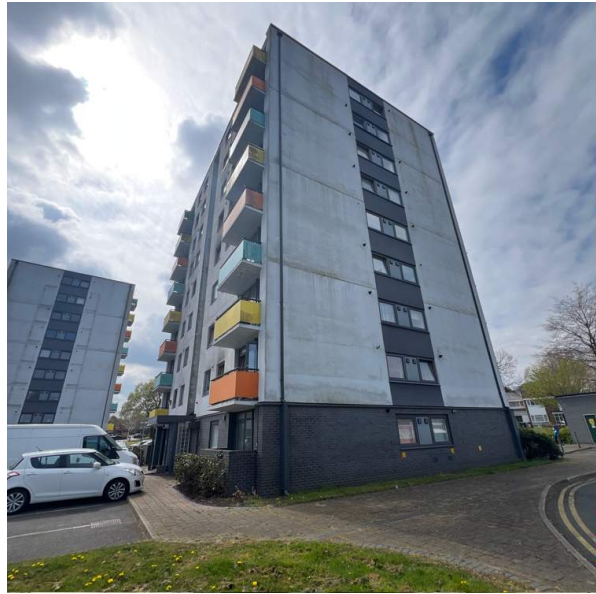
## Elevations

Ground floor level consists of brickwork. Remaining elevations consist of a rendered facade. Cladded panels to balconies.
