**FIRNTEC**  
BUILDING COMPLIANCE

VISUAL STRUCTURAL APPRAISAL

Willow House

Meadow Avenue  
West Bromwich  
B71 3EN

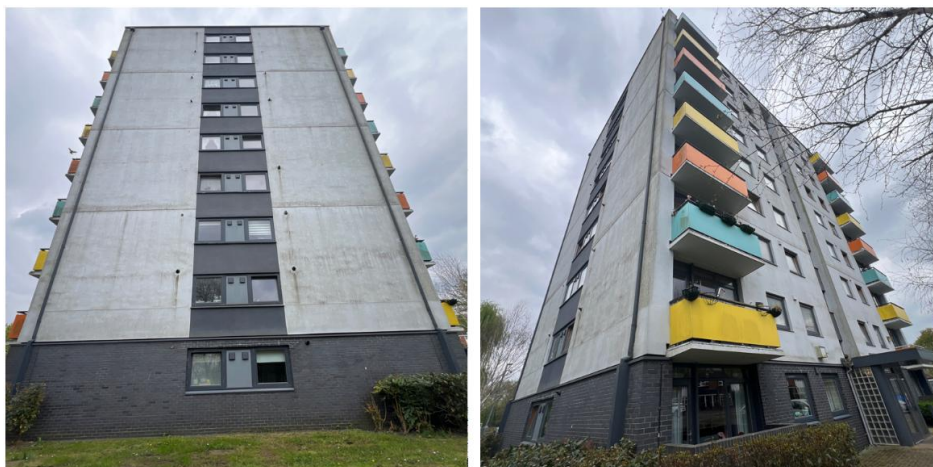
Figure 9 and 10: Building Elevations

The exterior elevations were generally in ok condition and no significant structural defects were noted to the cladding panels. There were no significant cracks or tell-tale signs of any significant structural movement noted at the time of our inspection.

The exterior panels were noted to be plumb with no signs of significant bowing, bulging or leaning noted to the panels indicating failed fixings however their presence and condition cannot be confirmed.

There are balconies at each level which are formed of cantilevered RC slabs tied into the main frame. During the 2009 refurbishment they had high pressure laminate boards installed as balustrades.

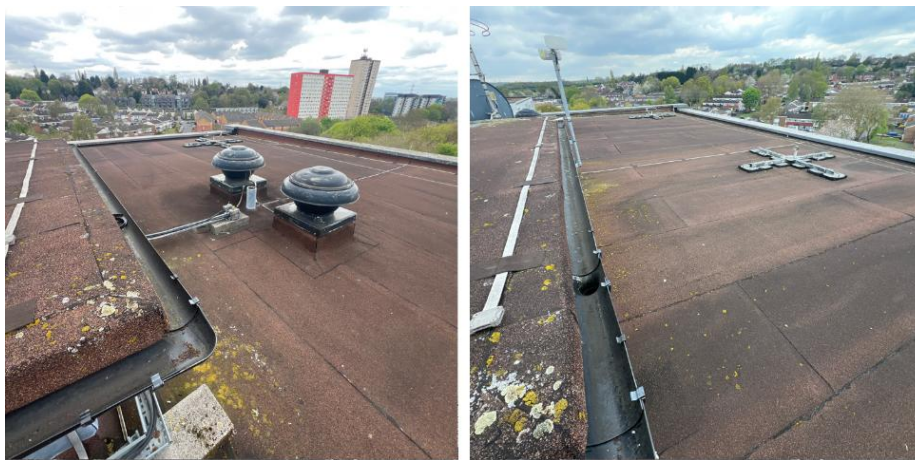
Figure 11 and 12: Roof Level

There were no tell-tale signs of any significant structural movement noted at the time of our inspection.

The roof has a asphalt finish. The exact build-up of the roof finishes were not accessible at the time of inspection. It is recommended an intrusive survey of the roof finishes is completed by a specialist surveyor to assess the condition of the roof covering.

There was moss growth and build-ups of debris noted which should be cleared as part of a normal maintenance regimen

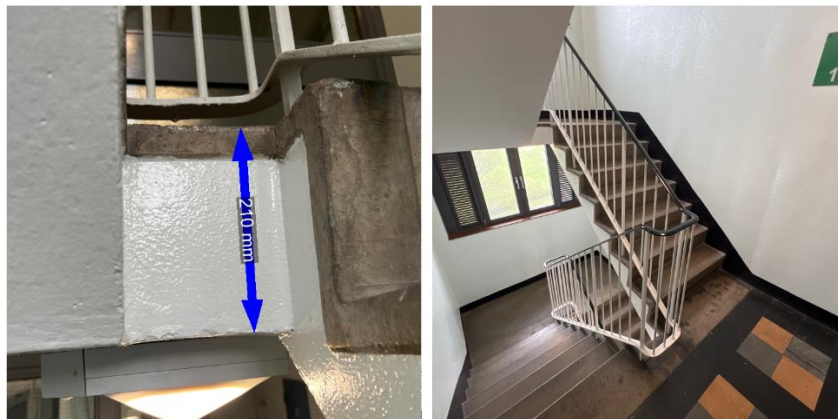
Figure 14 and 15: Stair stringer and Staircase

The stair stringer was noted to be 120mm thick which seems slim, certainly short of modern standards. A cover test is required to check the resistance of the concrete section in the event of a fire.

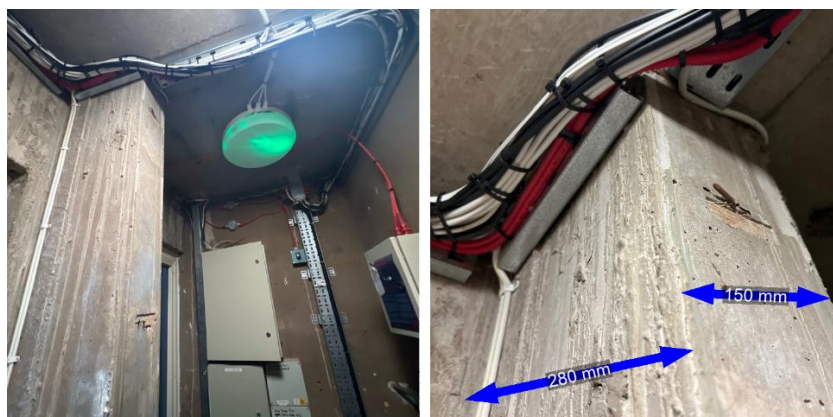
Figure 16 and 17: RC Elements visible

There were vertical concrete walls supporting the floor plates at every level. The elements visible matched the floor layout in Figure 6. The walls appear continuous from ground to roof with no transfer structure. The overall condition of the structure observed is good.

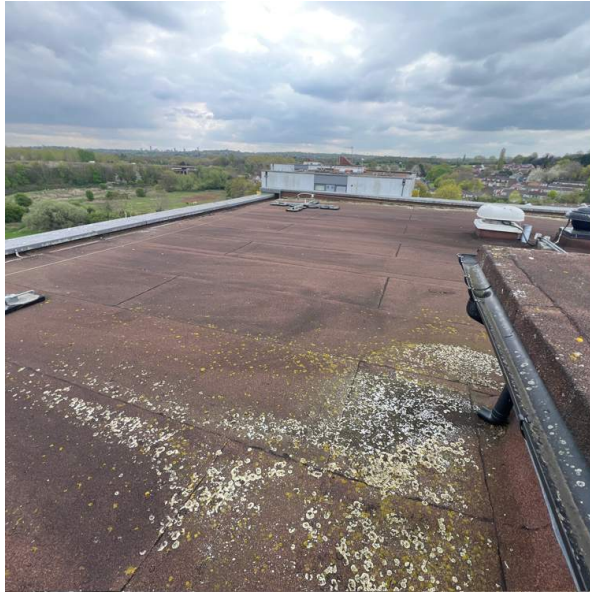
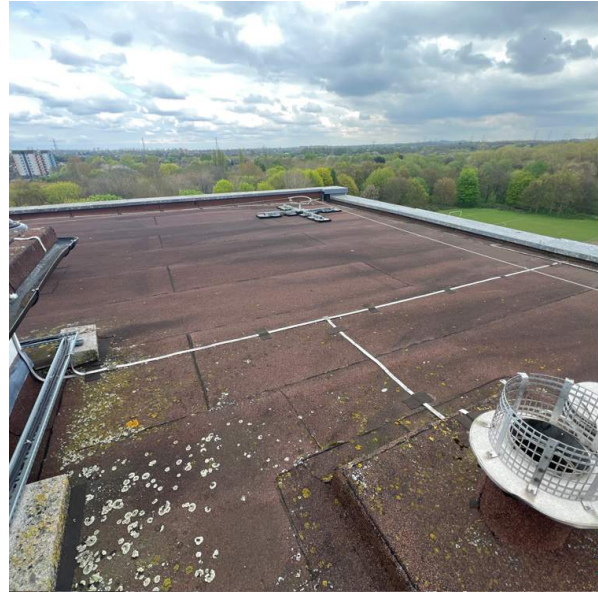
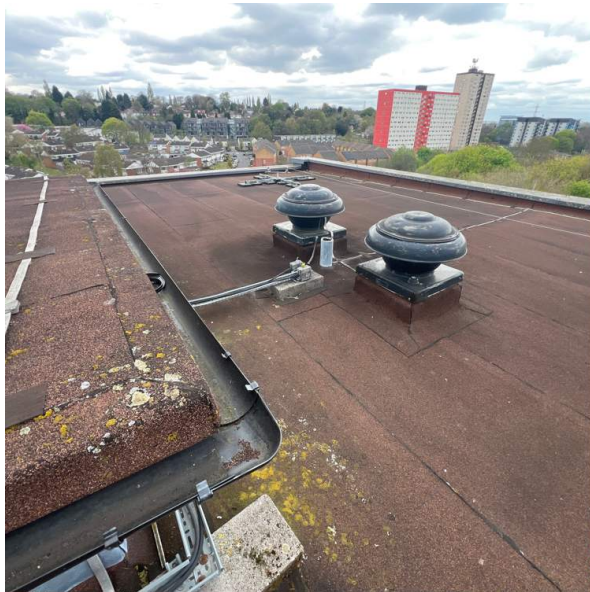
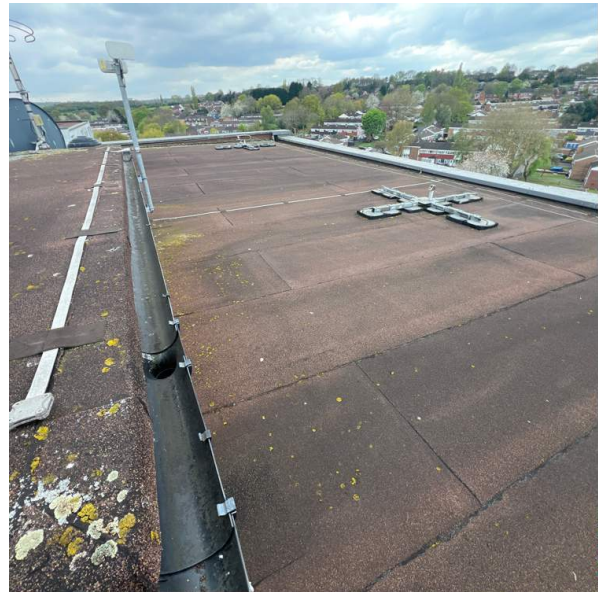
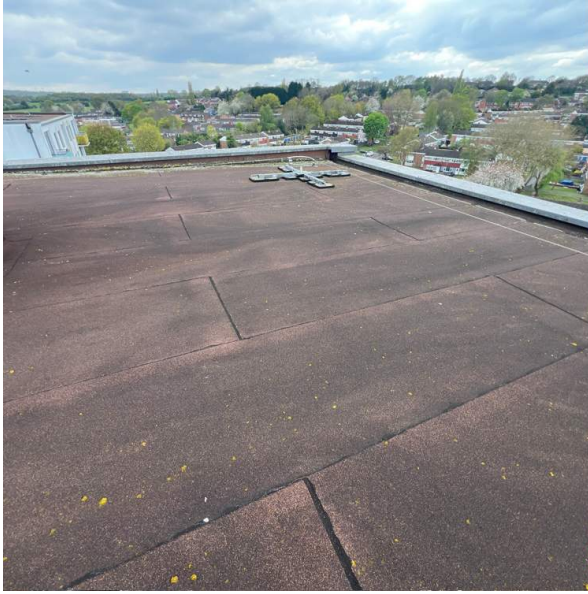
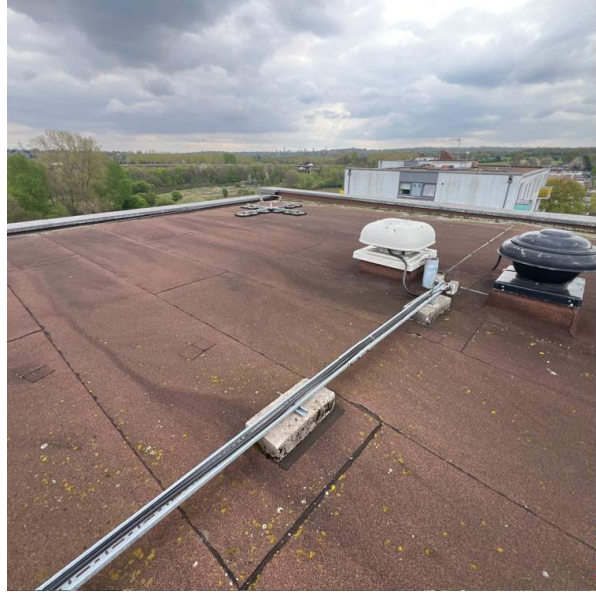
## Main Roof

Comments: Flat roof, RC concrete slab with insulated PIR board and felt coverings.

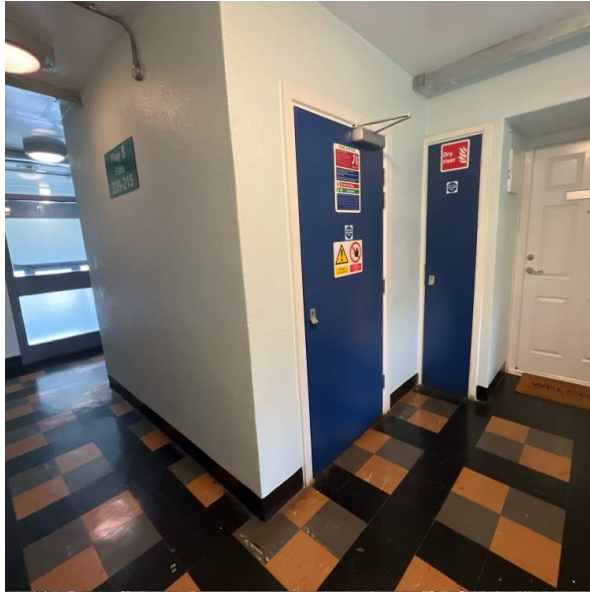
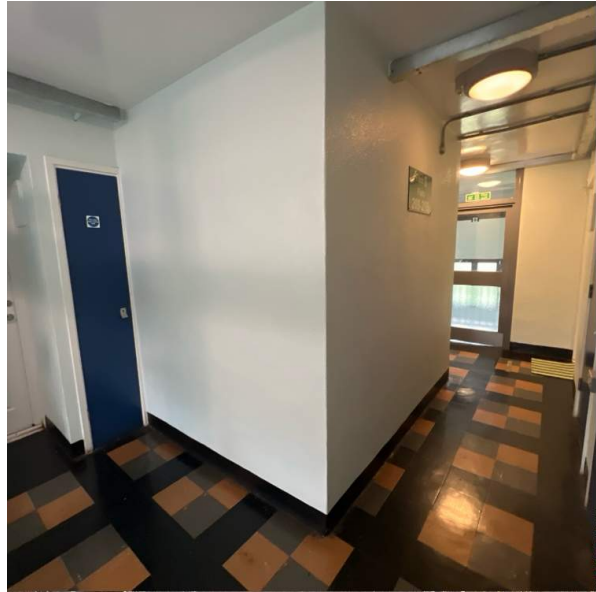
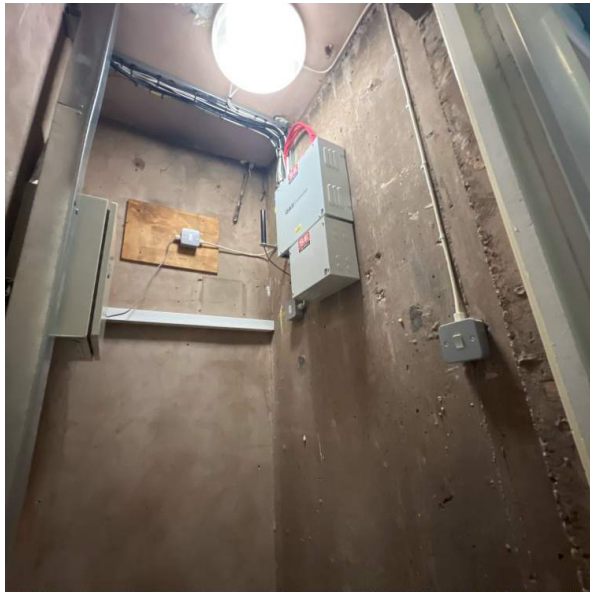
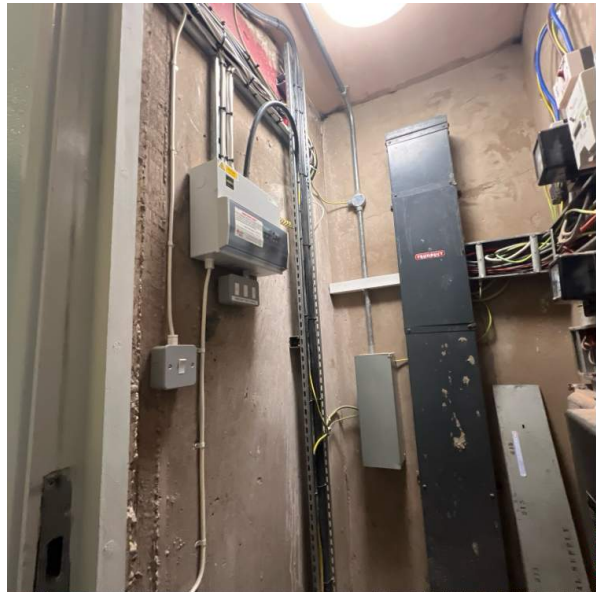
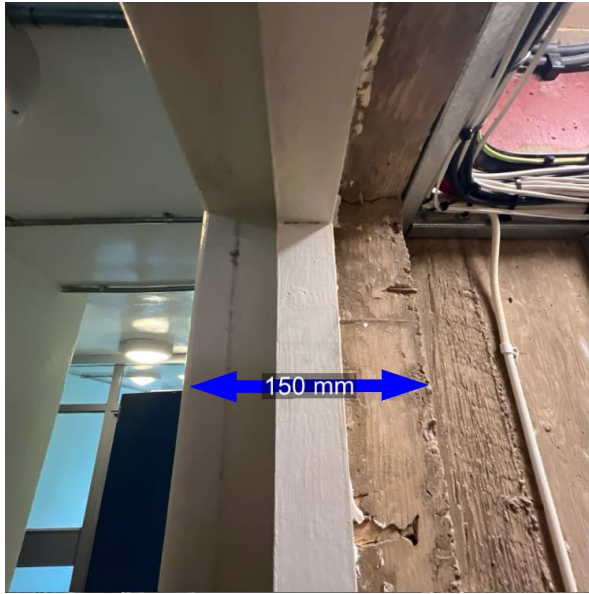
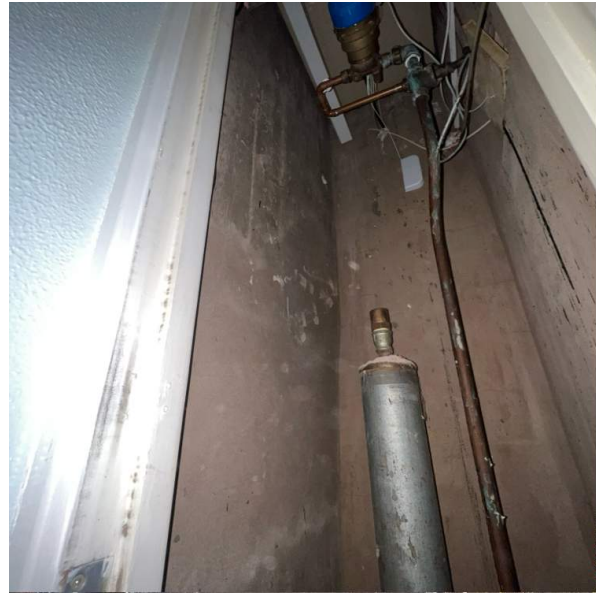
## 8th Floor Hallway

Comments: No jams or distortions noted to hallway doors to indicate any serviceability issues. Generally walls covered with finishes in hallway, likely to consist a mixture of concrete shear walls, embedded columns and masonry infill walls. Limited structure exposed. Concrete walls and infill masonry (non-load bearing) walls noted in riser cupboards. Concrete walls noted to be approx. 150mm thick.

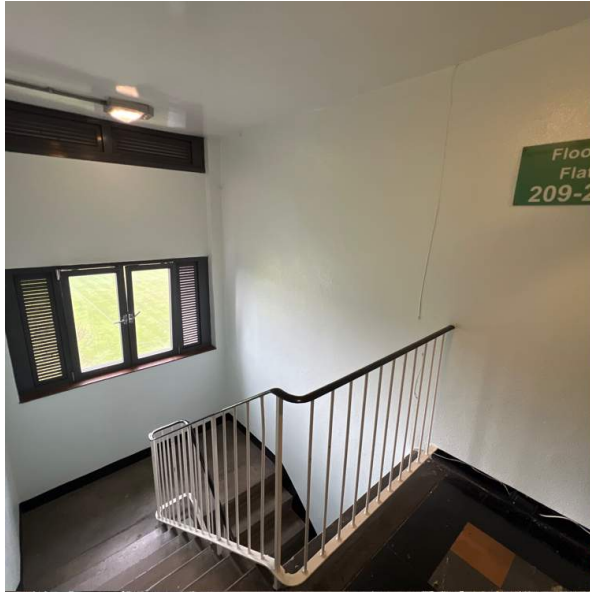
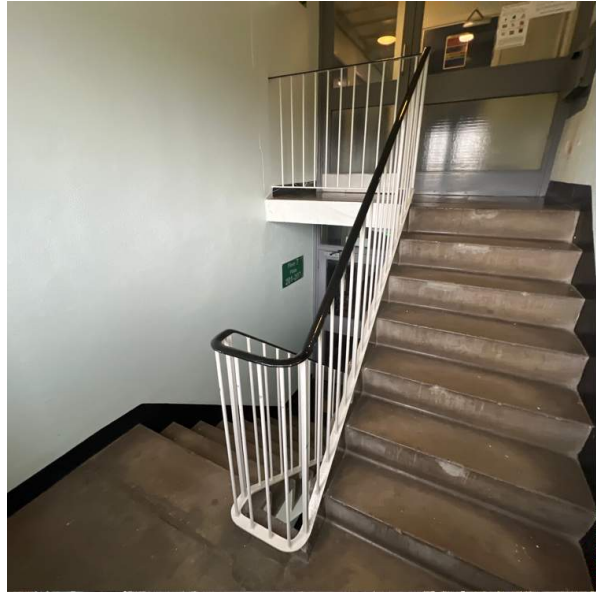
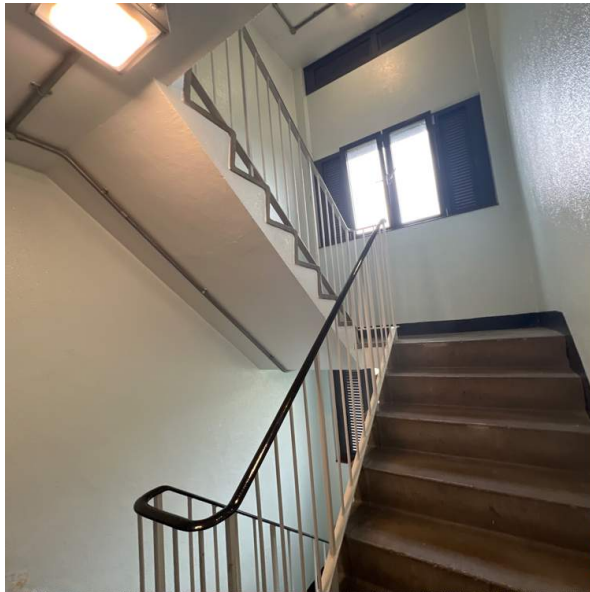
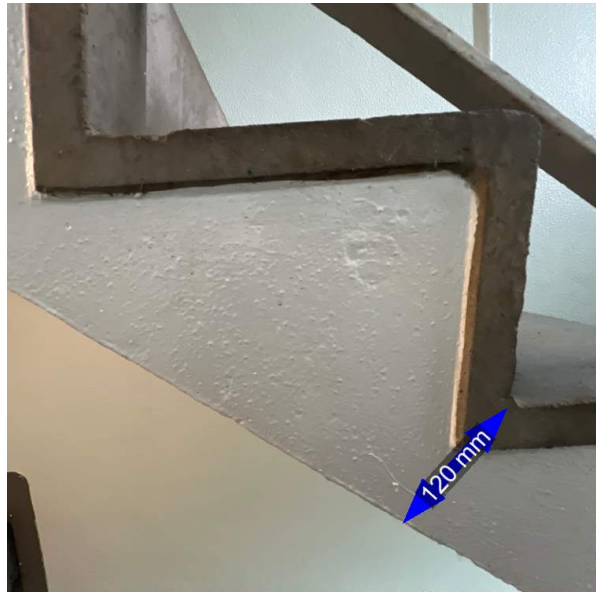
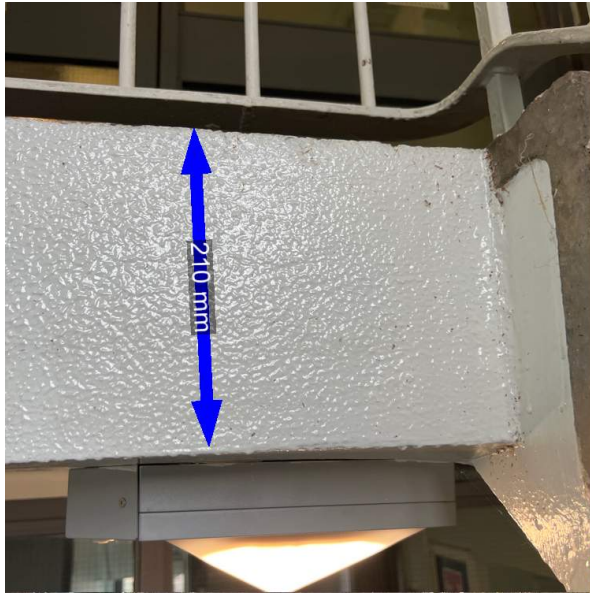
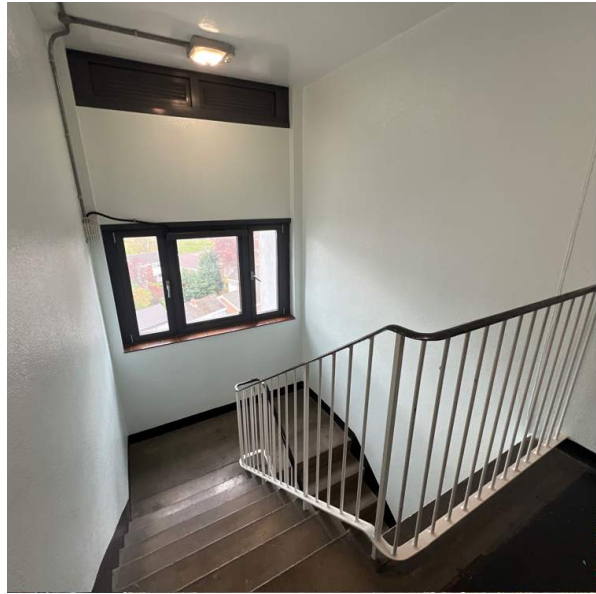
## 8th Floor Staircases

Comments: Insitu concrete stairs with steel hand railing fixed to stairs. Walls and floors appear to be fairly level.  
Stair walls covered with finishes however these would likely form the main concrete shear core walls.

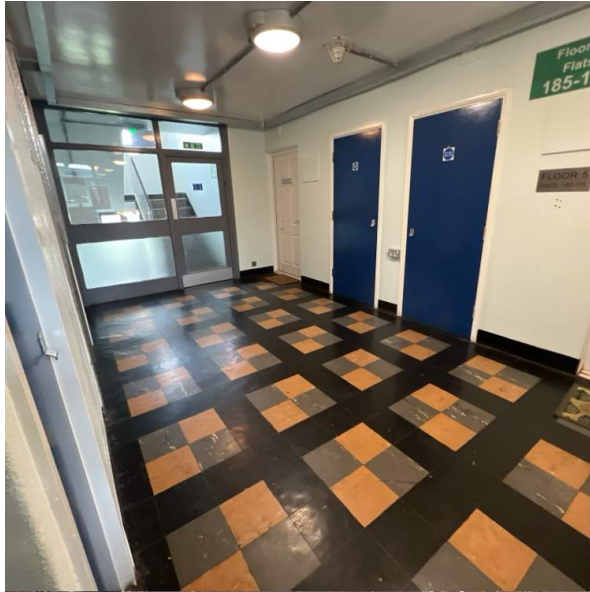
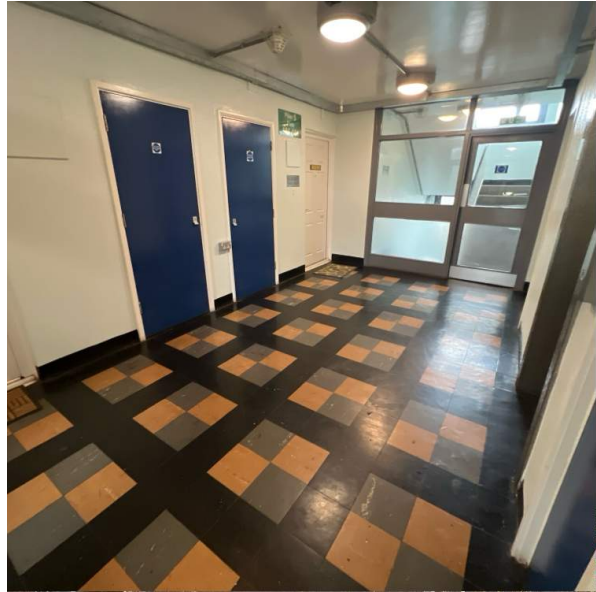
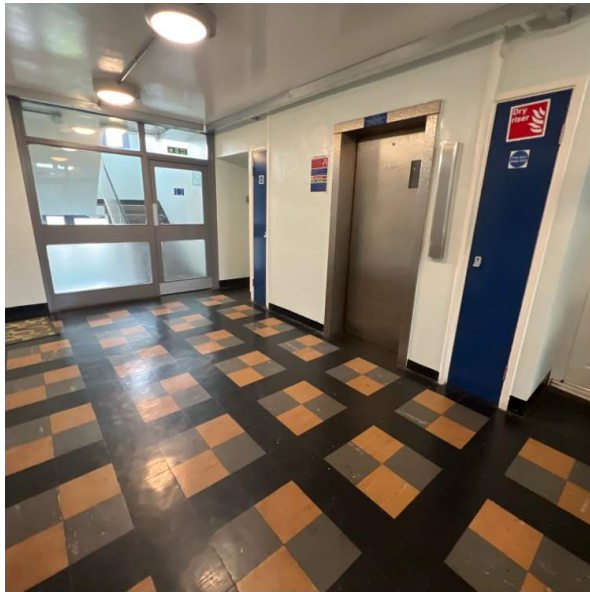
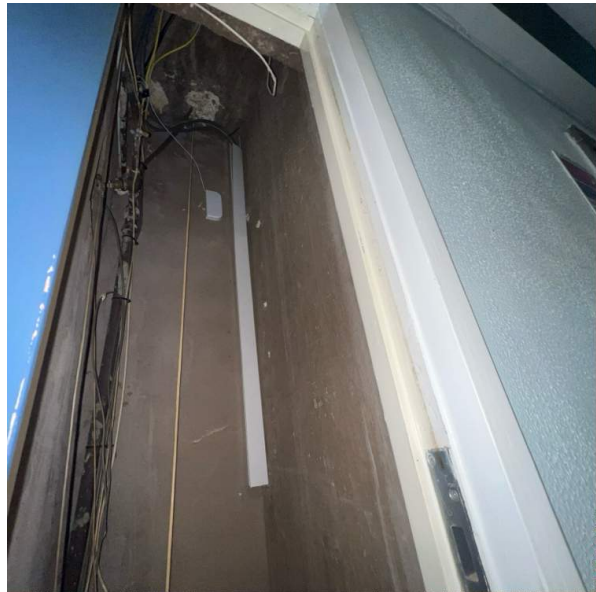
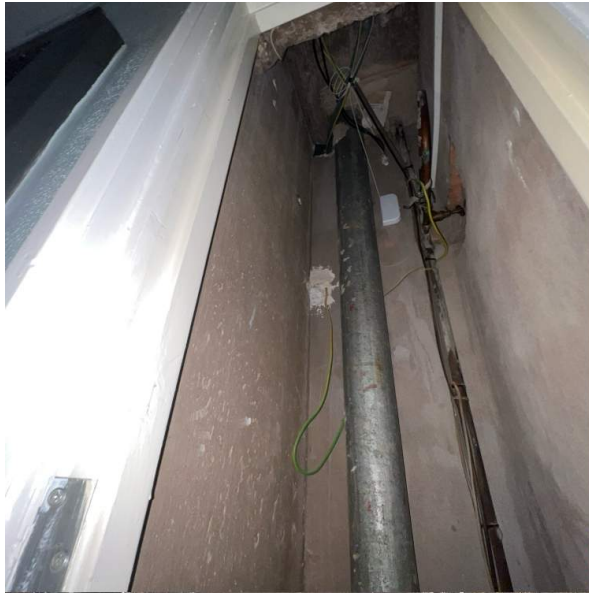
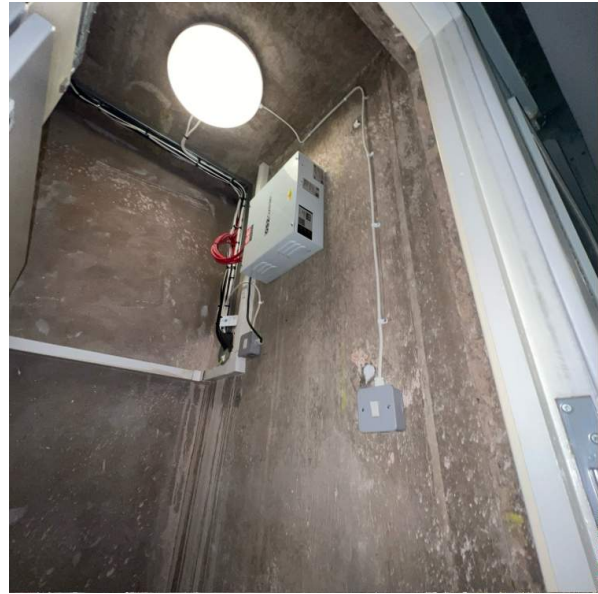
## 5th Floor Hallway

Comments: No jams or distortions noted to hallway doors to indicate any serviceability issues. Generally walls covered with finishes in hallway, likely to consist a mixture of concrete shear walls, embedded columns and masonry infill walls. Limited structure exposed. Concrete walls and infill masonry (non-load bearing) walls noted in riser cupboards.

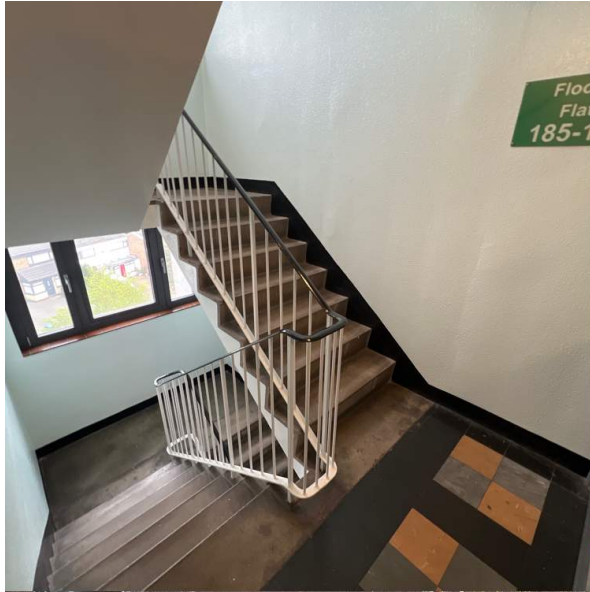
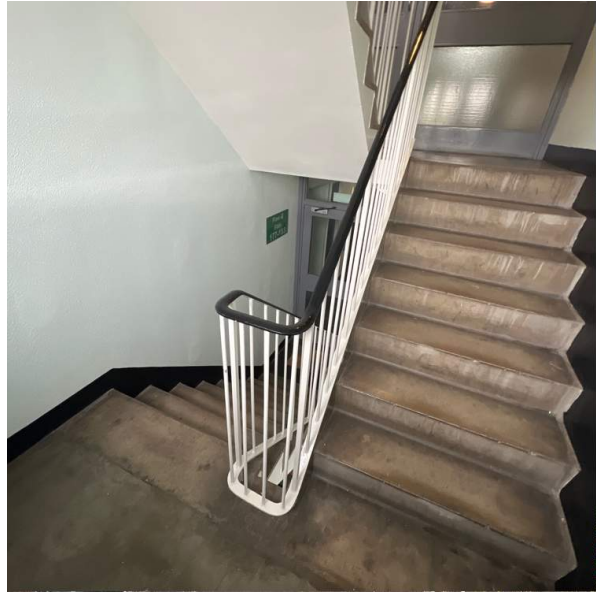
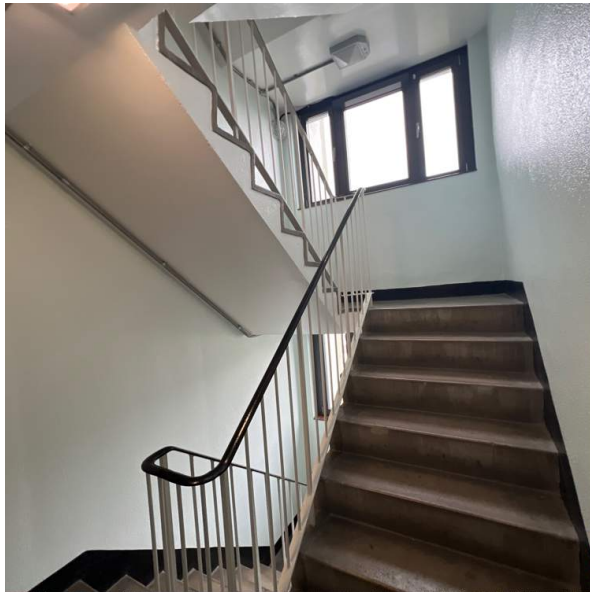
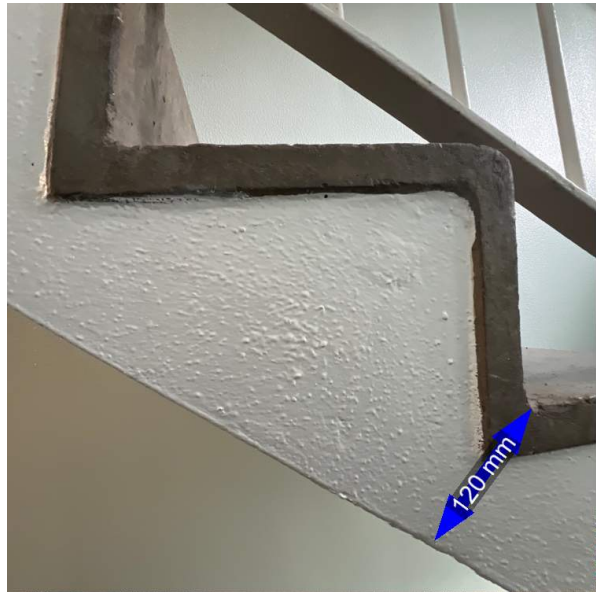
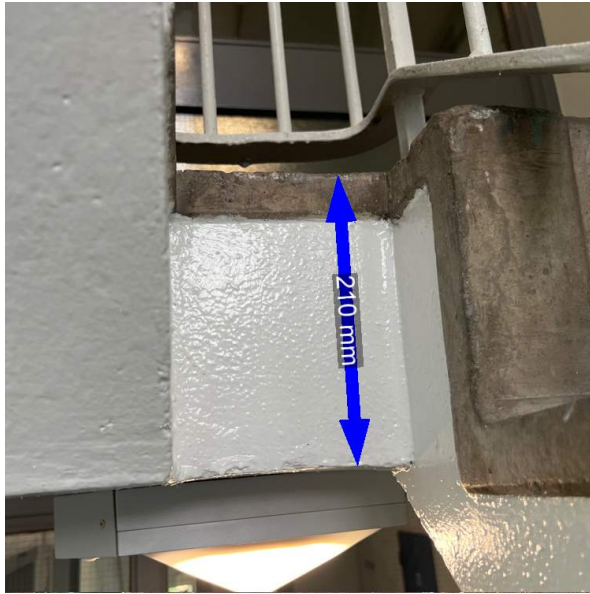
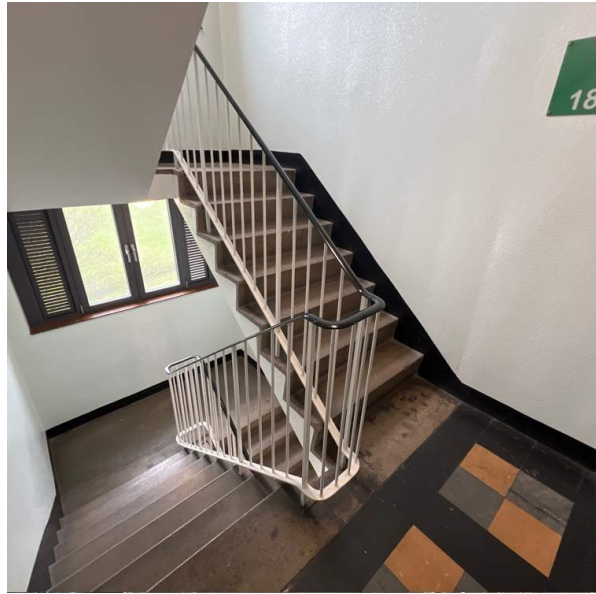
## 5th Floor Staircases

Comments: Insitu concrete stairs with steel hand railing fixed to stairs. Walls and floors appear to be fairly level.  
Stair walls covered with finishes however these would likely form the main concrete shear core walls.

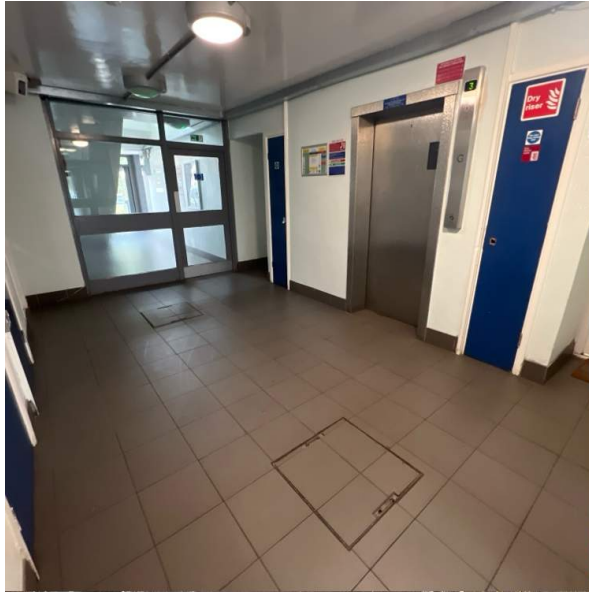
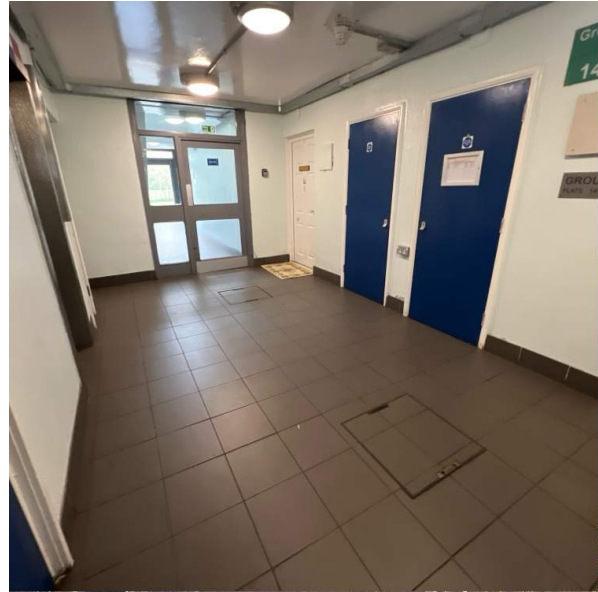
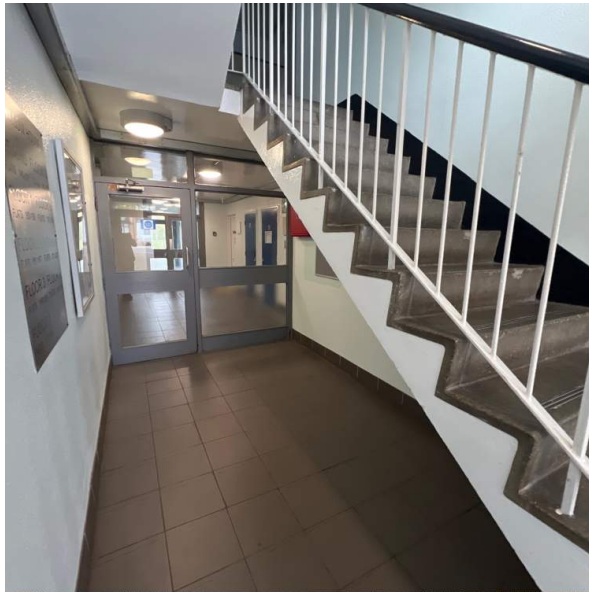
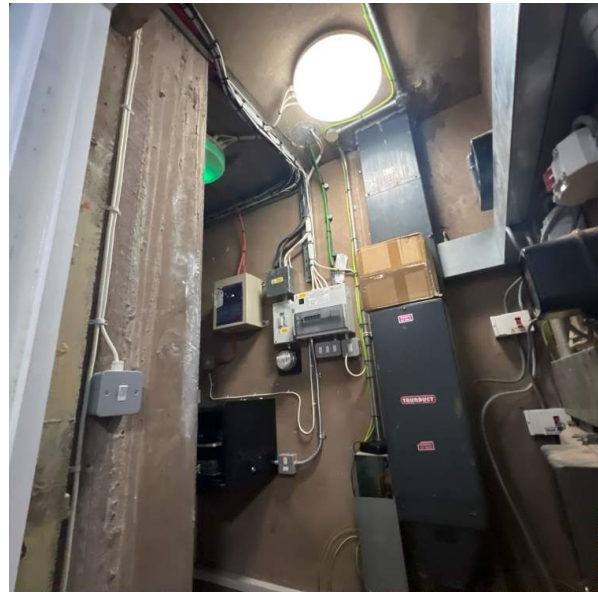
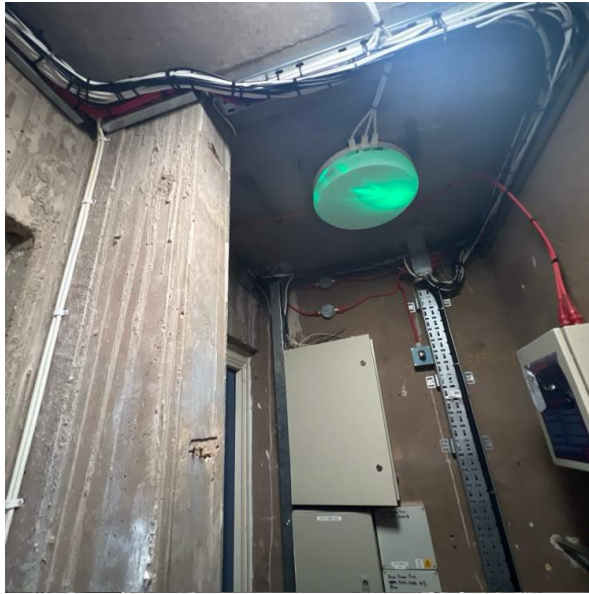
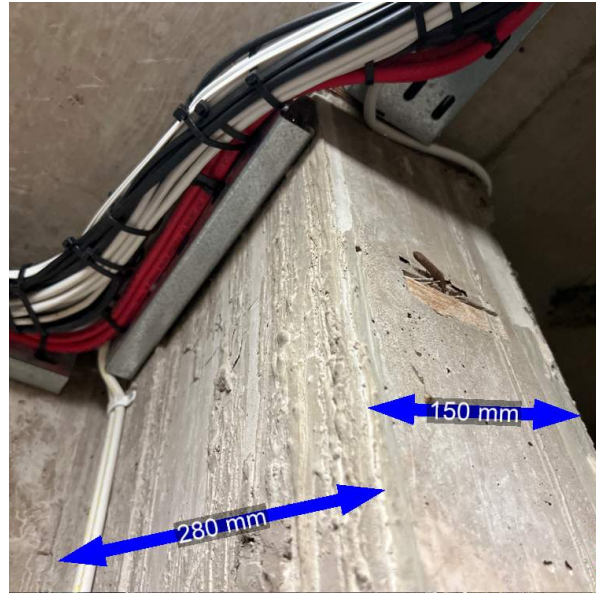
## Ground Floor Hallway

Comments: No jams or distortions noted to hallway doors to indicate any serviceability issues. Generally walls covered with finishes in hallway, likely to consist a mixture of concrete shear walls, embedded columns and masonry infill walls. Limited structure exposed. Concrete walls and infill masonry (non-load bearing) walls noted in riser cupboards.

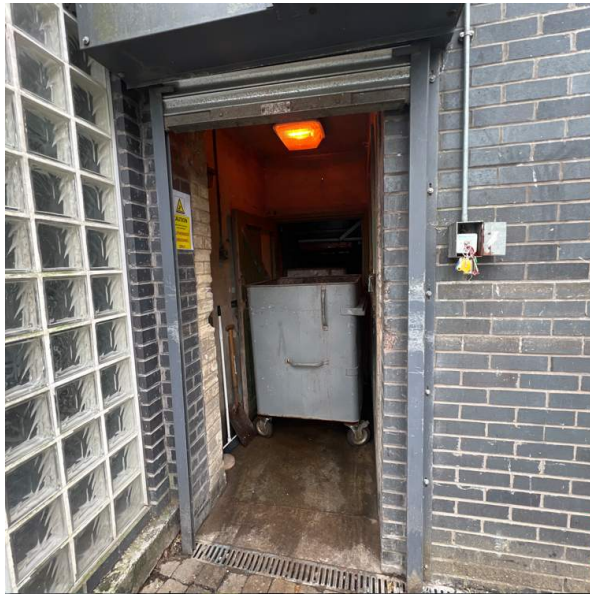
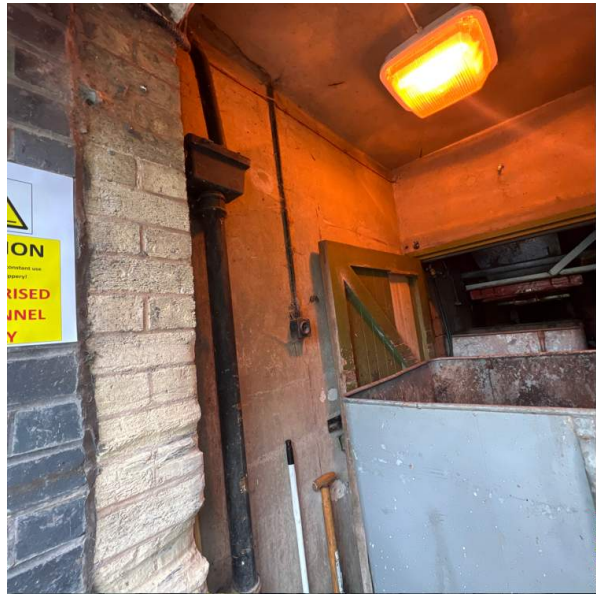
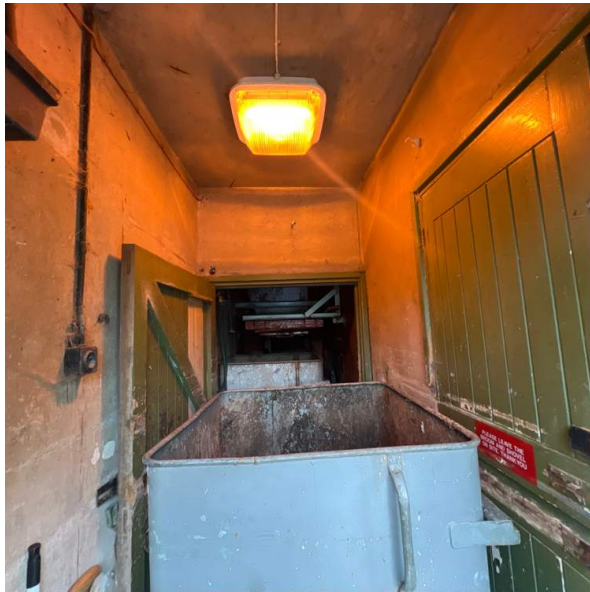
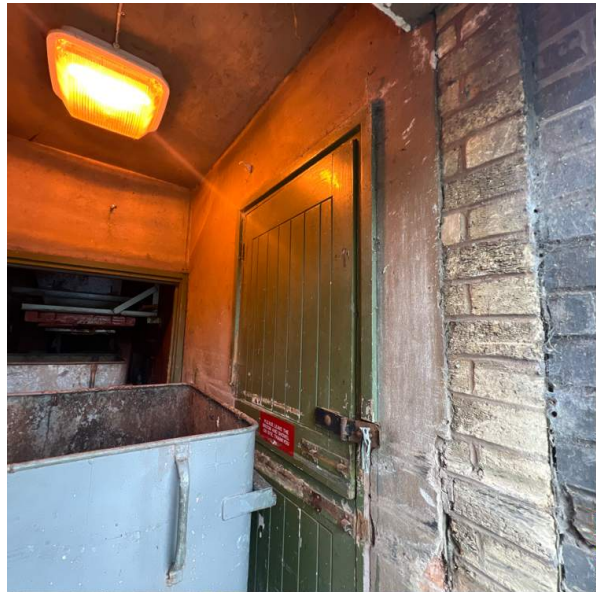
## Binstore

Comments: Main RC concrete shear walls noted in binstore.

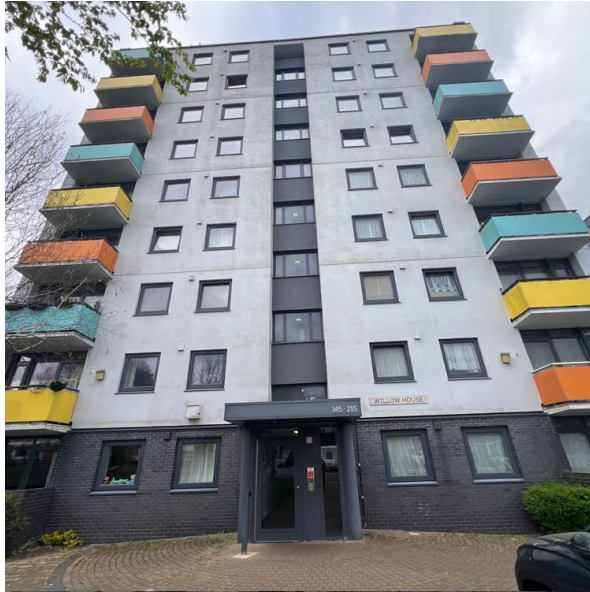
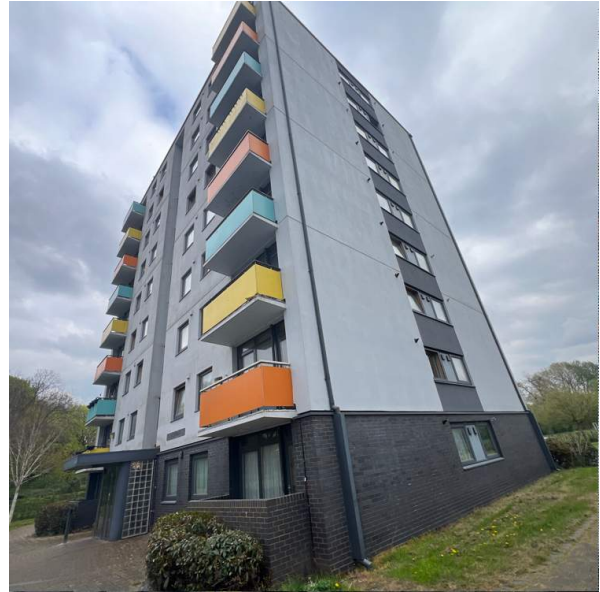
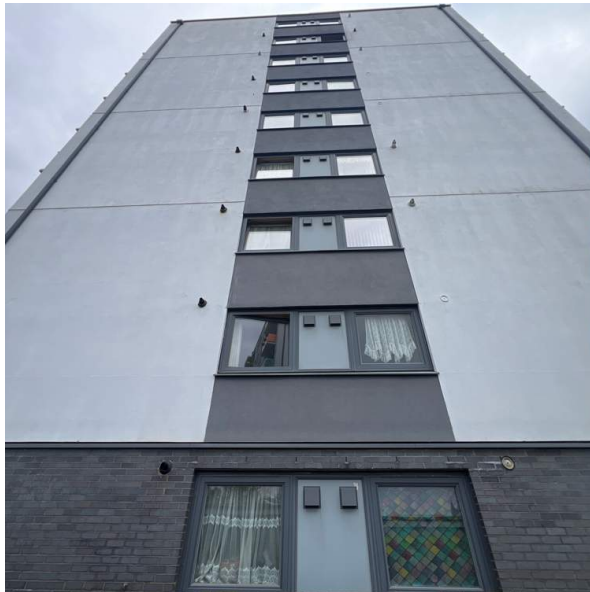
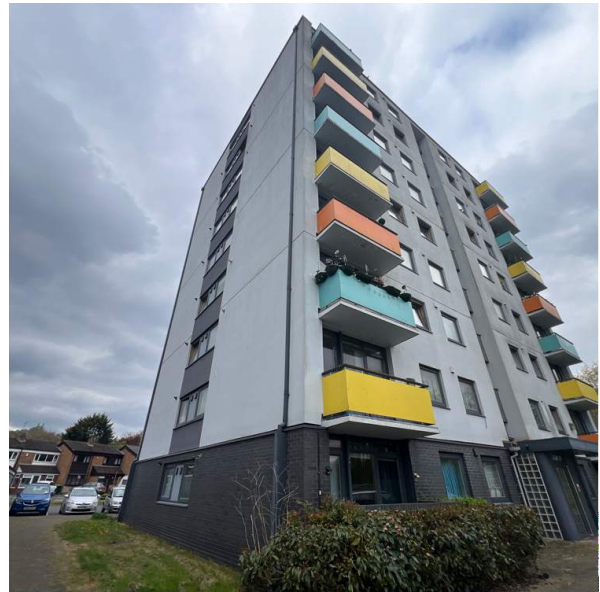
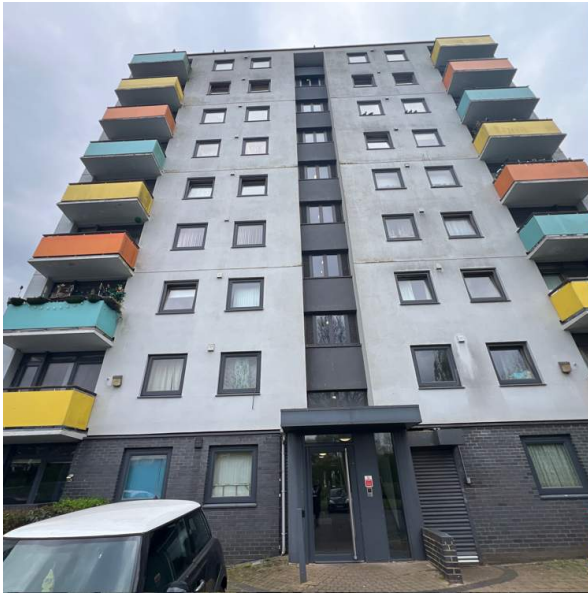
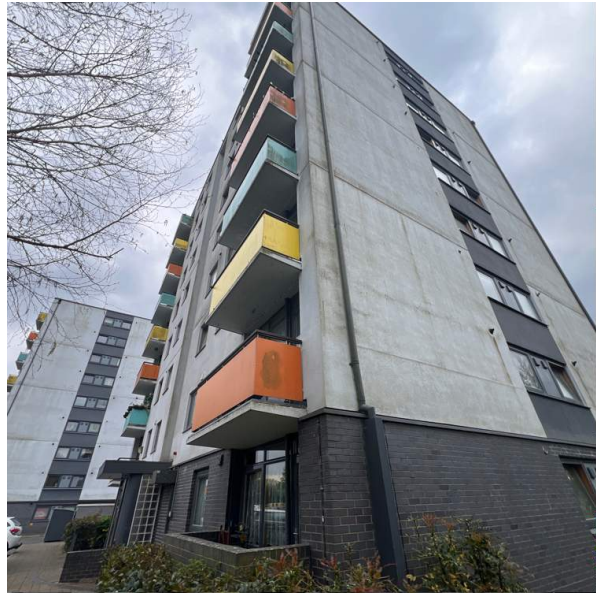
## Elevations

Ground floor level consists of brickwork. Remaining elevations consist of a rendered facade. Cladded panels to balconies.
