**FIRNTEC**  
BUILDING COMPLIANCE

VISUAL STRUCTURAL APPRAISAL

Moorlands Court

Reservoir Road  
Rowley Regis  
B65 9BM

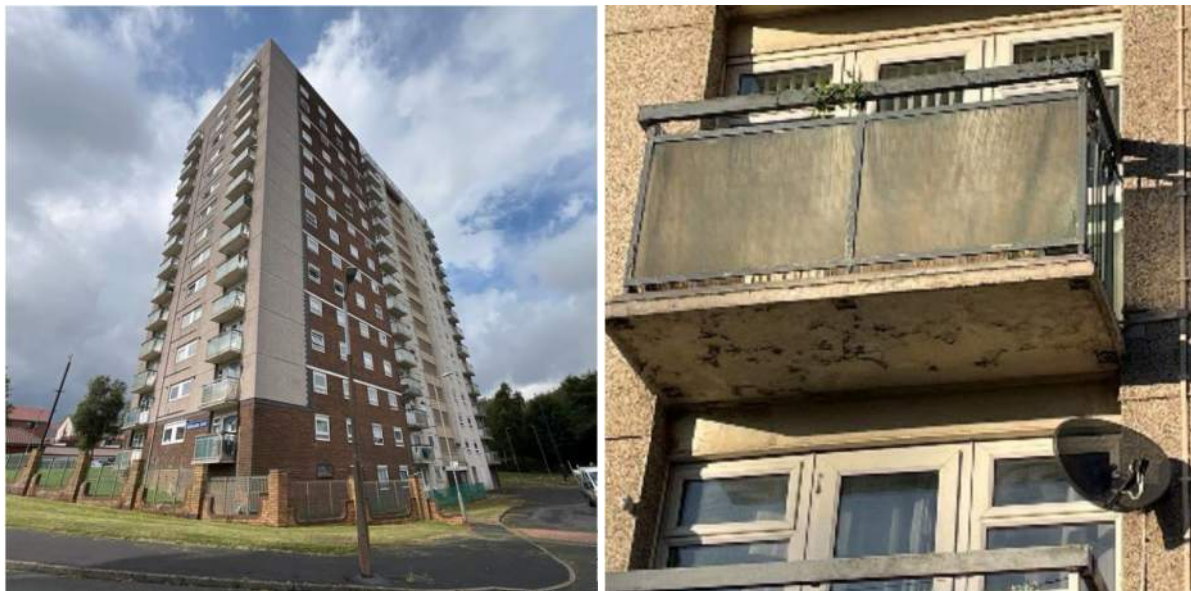
Figure 9 and 10: Building Elevations

The exterior elevations were generally in ok condition and no significant structural defects were noted to the cladding panels. There were no significant cracks or tell-tale signs of any significant structural movement noted at the time of our inspection.

The external cladding system is constructed as a cavity wall, with a stretcher bond to the outer leaf. We were unable to see within the wall cavity to confirm whether there are ties or masonry supports present. The exterior walls were noted to be plumb with no signs of significant bowing, bulging or leaning noted to the cavity walls indicating failed fixings, however their presence and condition cannot be confirmed.

The exterior panels were noted to be plumb with no signs of significant bowing, bulging or leaning noted to the panels indicating failed fixings however their presence and condition cannot be confirmed.

There are balconies at each level which are formed of cantilevered RC slabs tied into the main frame, likely cast monolithically with the primary RC frame.

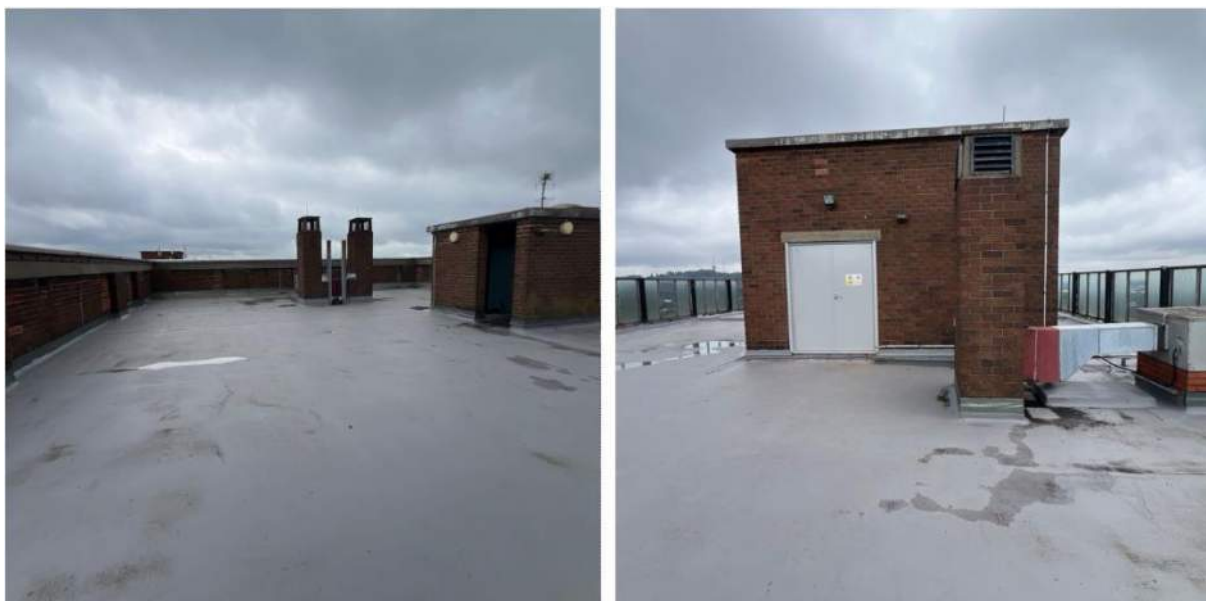
Figure 11 and 12: Roof Level

There were no tell-tale signs of any significant structural movement noted at the time of our inspection. The exterior walls were noted to be plumb with no signs of significant bowing, bulging or leaning noted to the cavity wall panels.

The roof has subsequently been covered with a new waterproofing covering formed of a single ply Sarnafil covering.

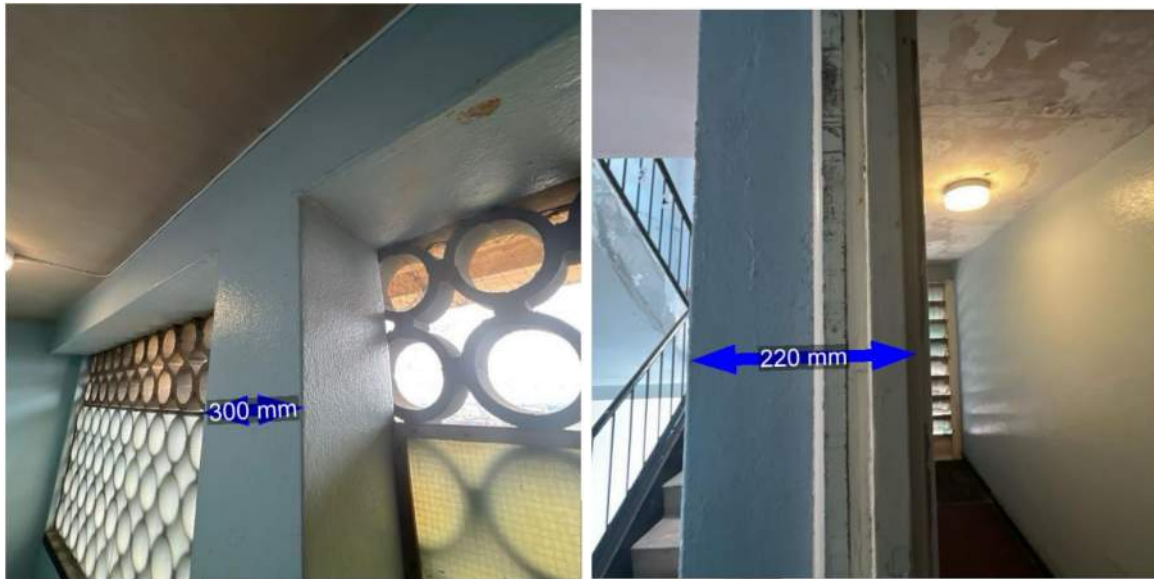
Figure 13 and 14: RC Structure

The interior of the stair core walls were checked and were plumb and in line with observations made to the exterior – no significant signs of leaning or movement noted. The concrete appeared in fair condition with few BRE category 1 cracks but no structurally significant defects were noted.

The shear walls around stair core appeared to be 220mm including finishes, therefore ~200mm RC wall. cover test is required to check the resistance of the concrete section in the event of a fire.

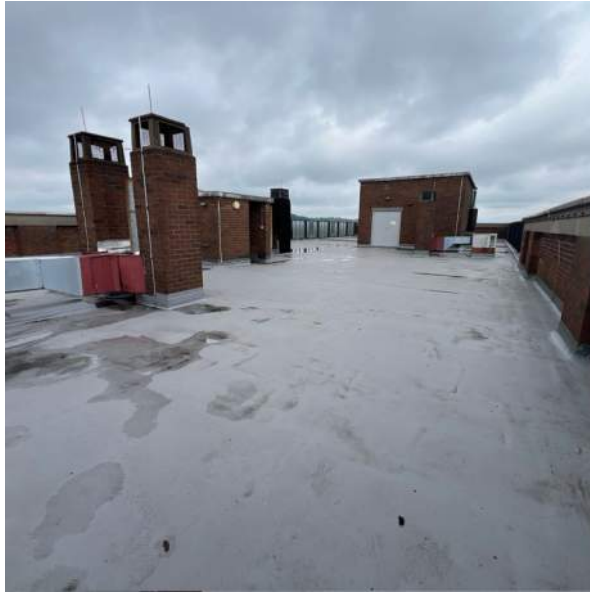
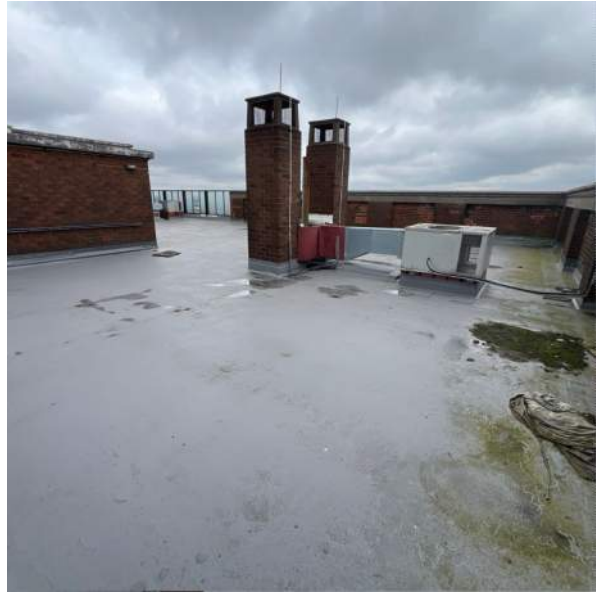
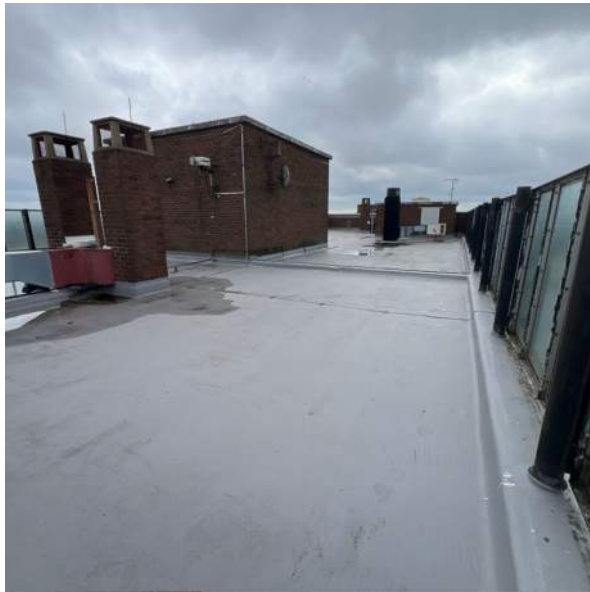
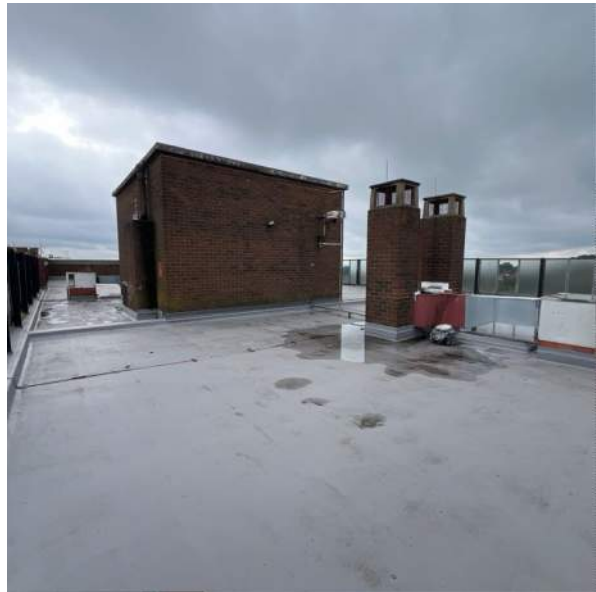
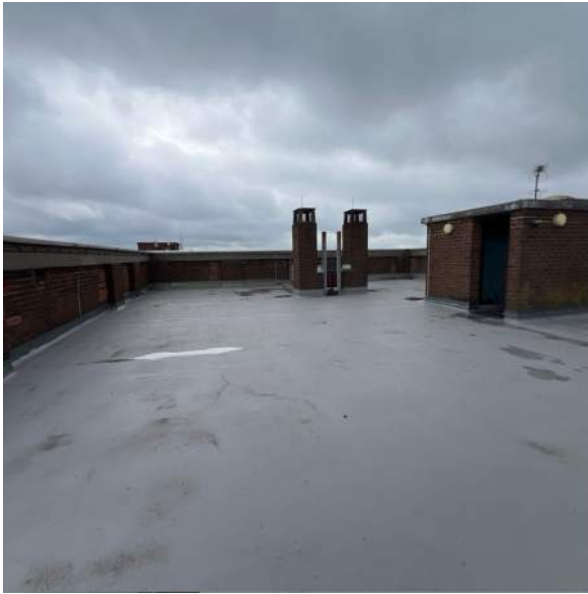
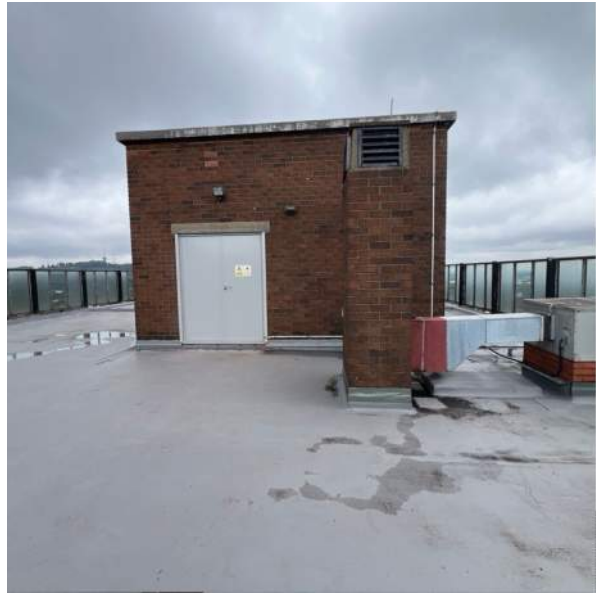
## Main Roof

Parapet walls noted to perimeter of roof.  
Insitu concrete roof slab. Masonry lift room located at roof level.

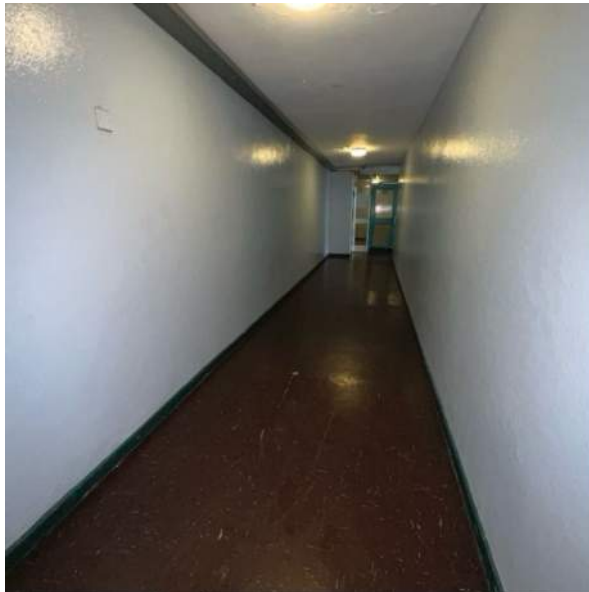
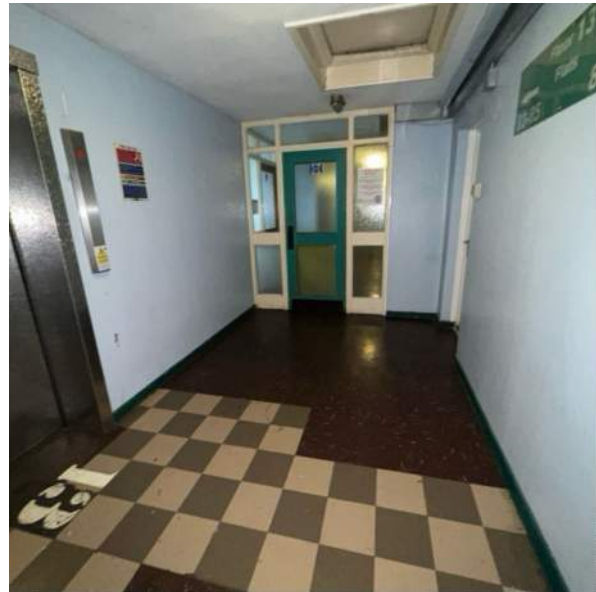
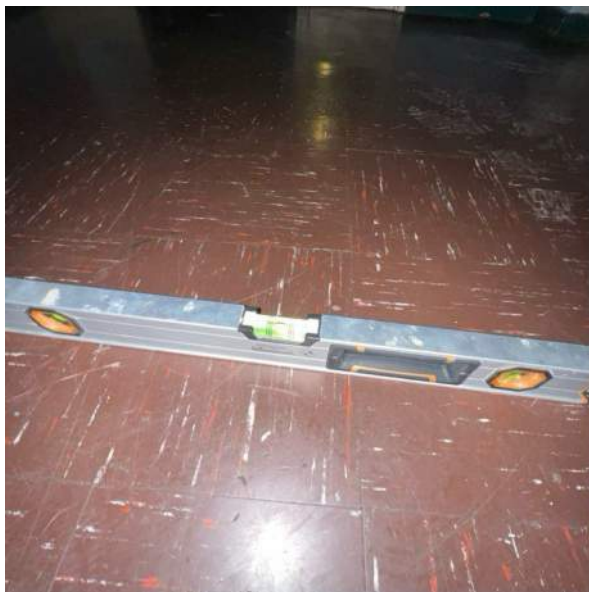
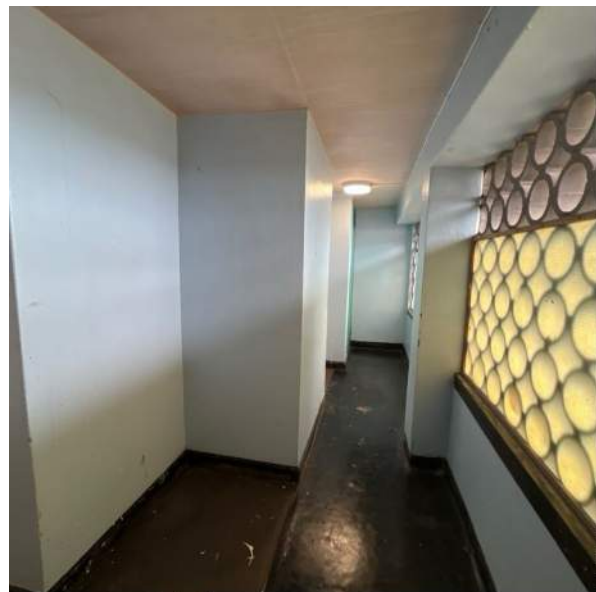
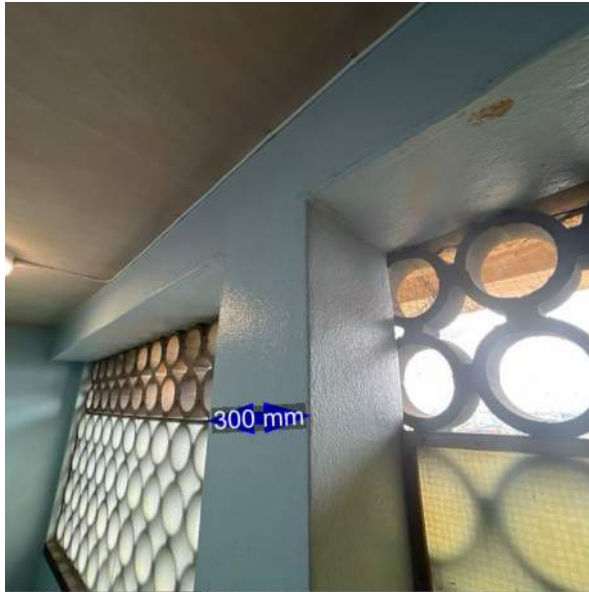
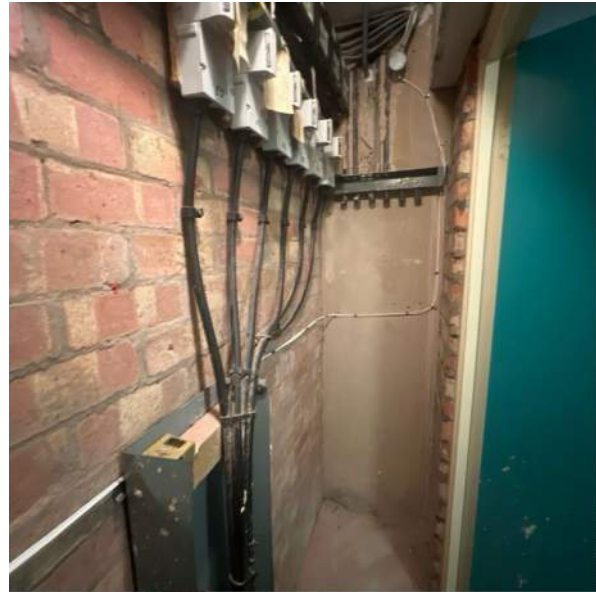
## 13th Floor Hallway

Comments: No jams or distortions noted to hallway doors to indicate any serviceability issues. Generally walls covered with finishes in hallway, likely to consist a mixture of concrete shear walls, embedded columns and block infill walls. Limited structure exposed. Partly visible concrete walls noted via electrical riser cupboards

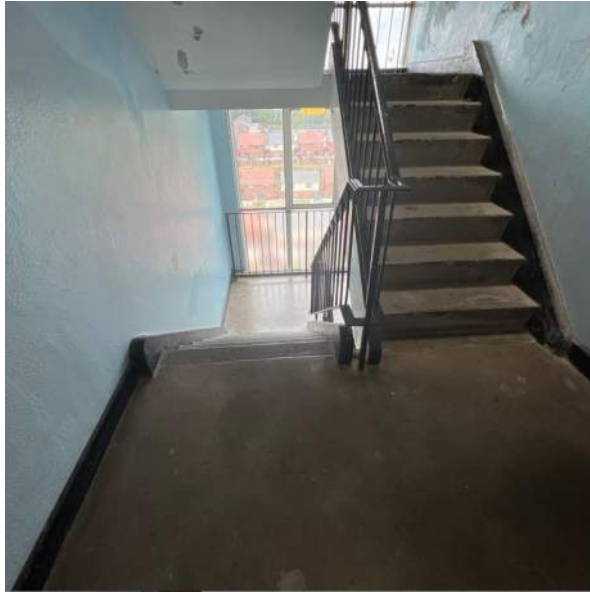
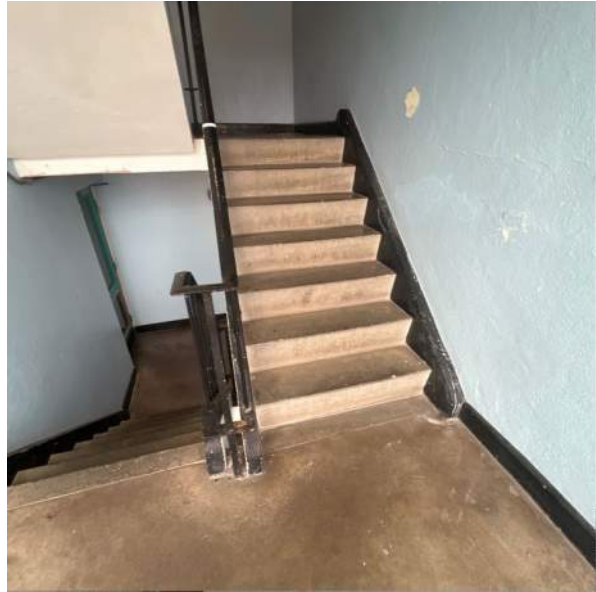
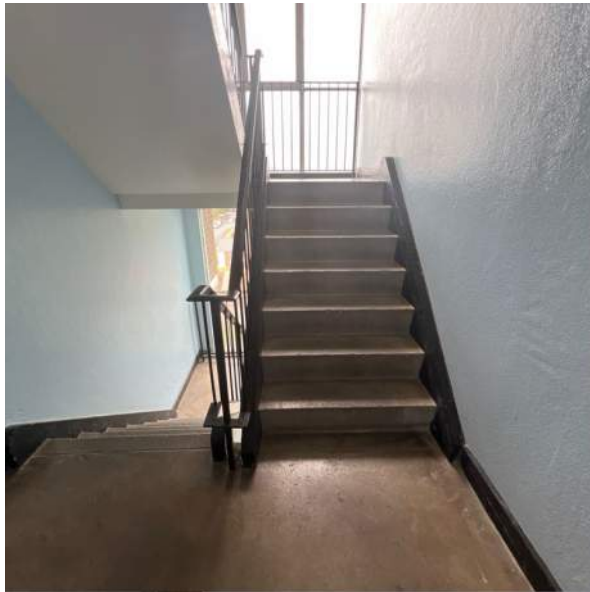
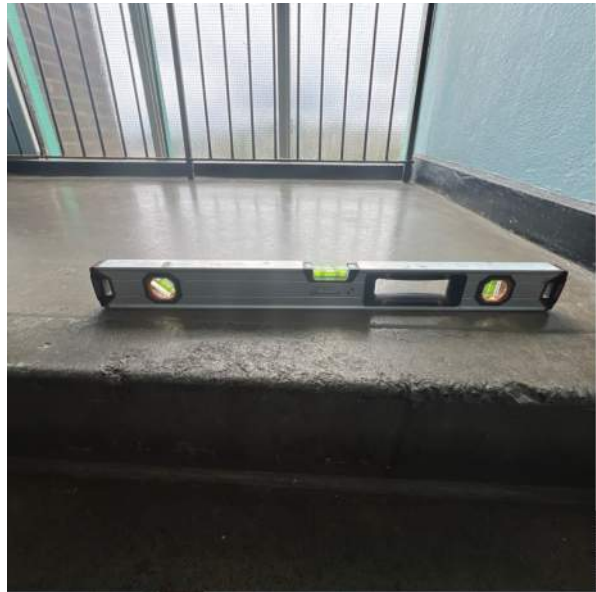
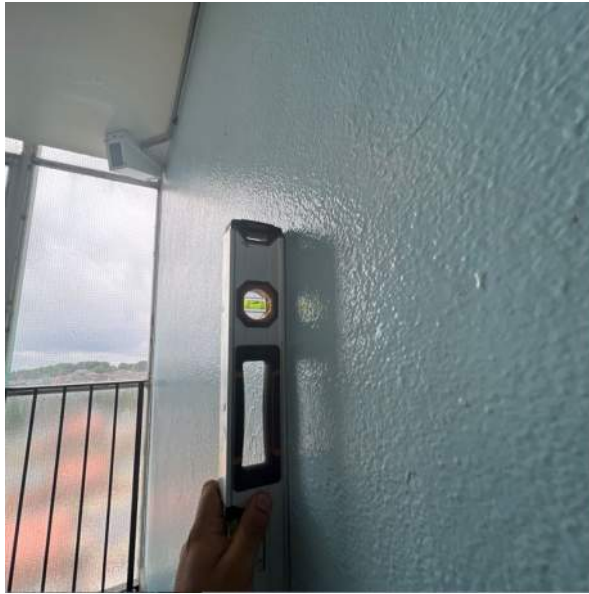
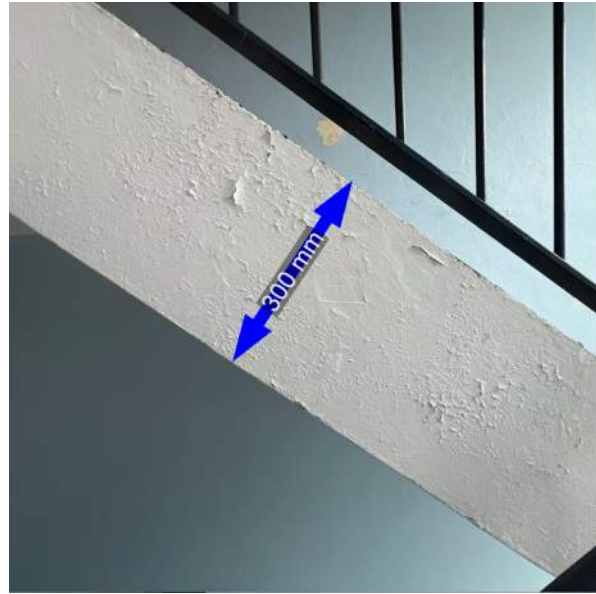
## 13th Floor Staircase

Insitu concrete stairs with steel hand railing fixed to stairs. Walls and floors appear to be fairly level.

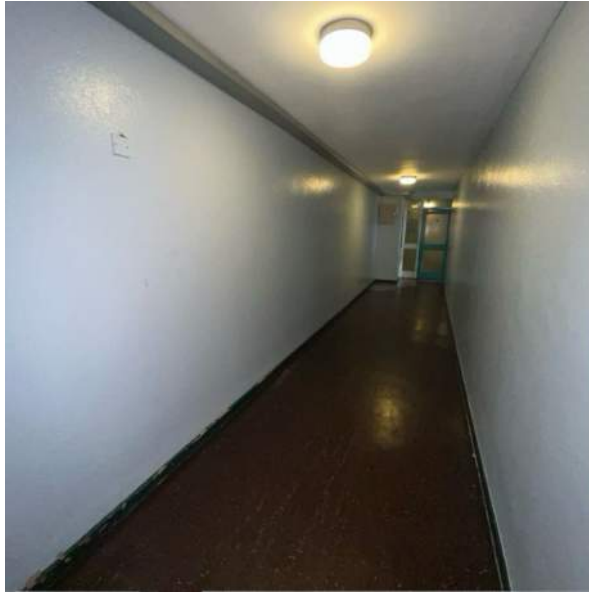
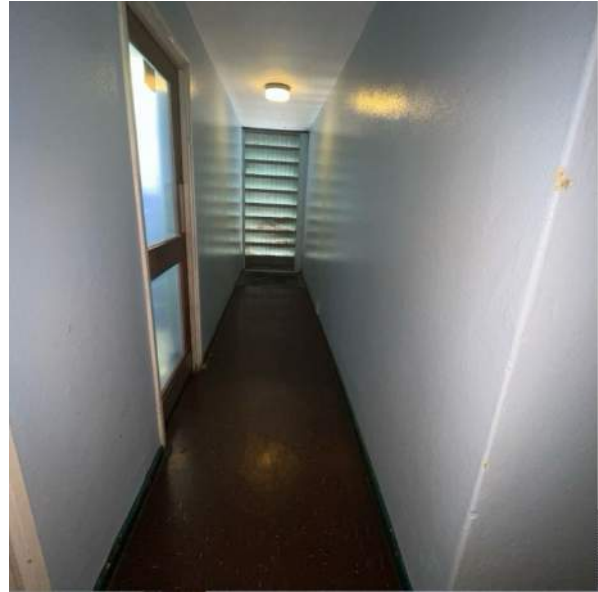
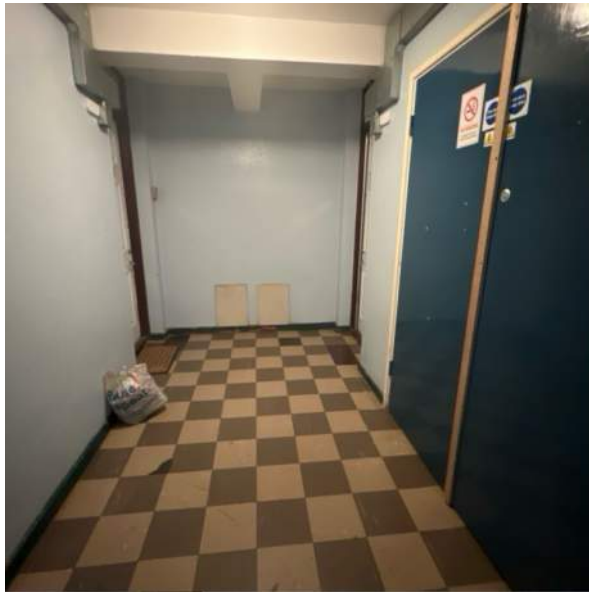
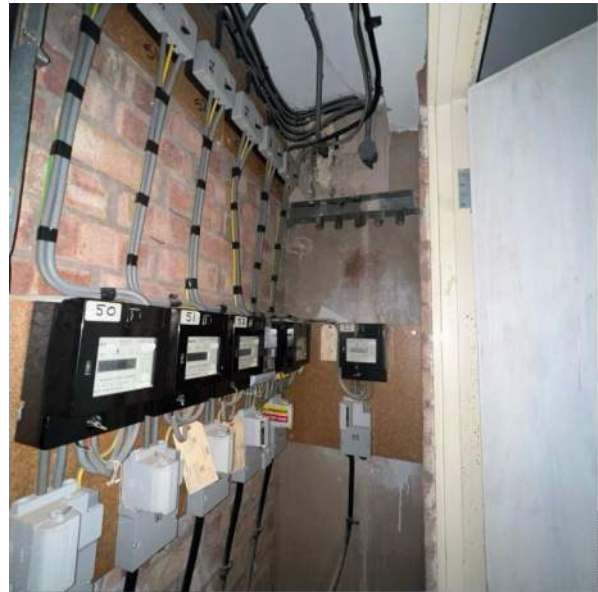
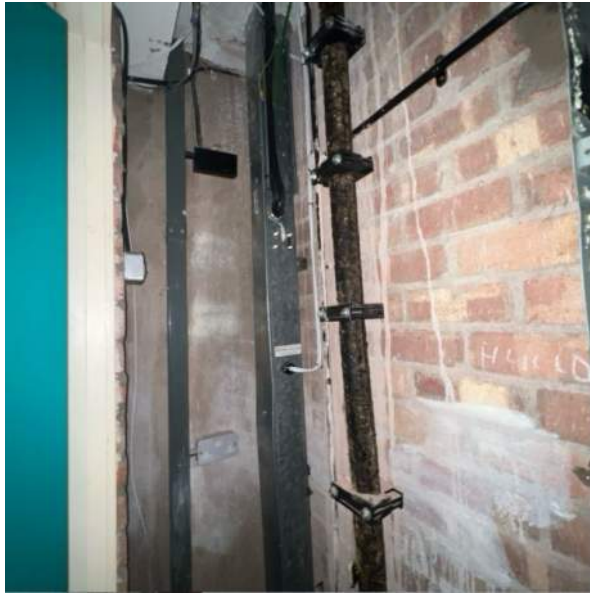
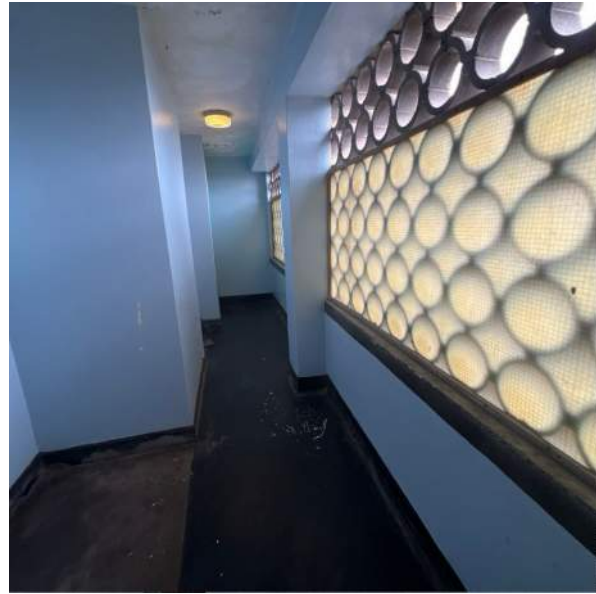
## 8th Floor Hallway

Comments: No jams or distortions noted to hallway doors to indicate any serviceability issues. Generally walls covered with finishes in hallway, likely to consist a mixture of concrete shear walls, embedded columns and block infill walls. Limited structure exposed. Partly visible concrete walls noted via electrical riser cupboards

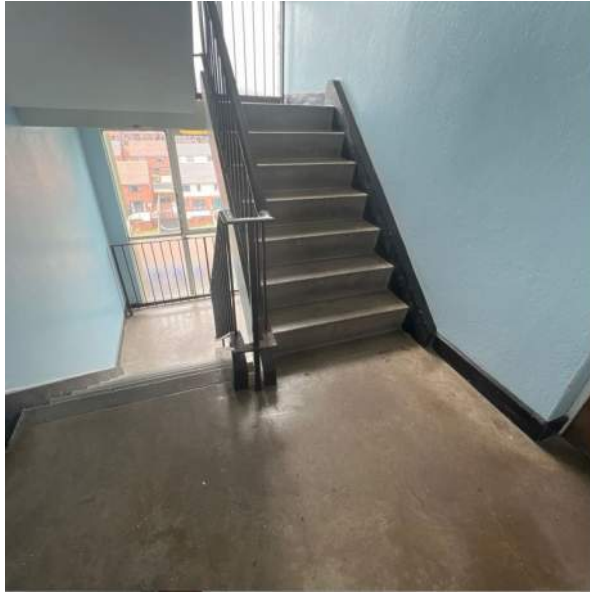
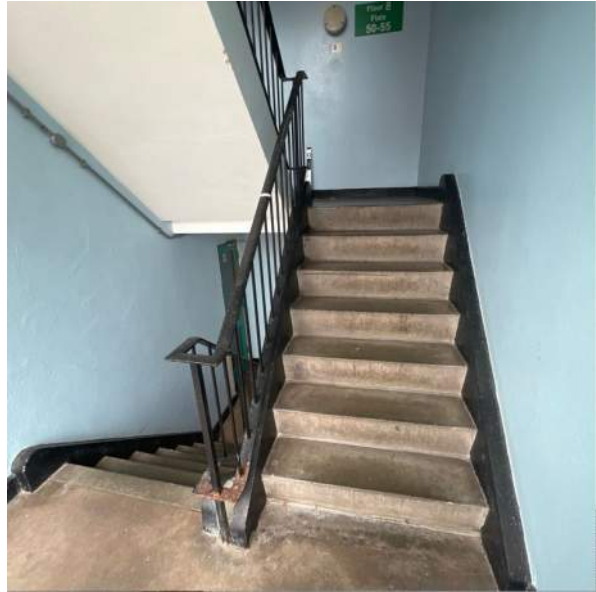
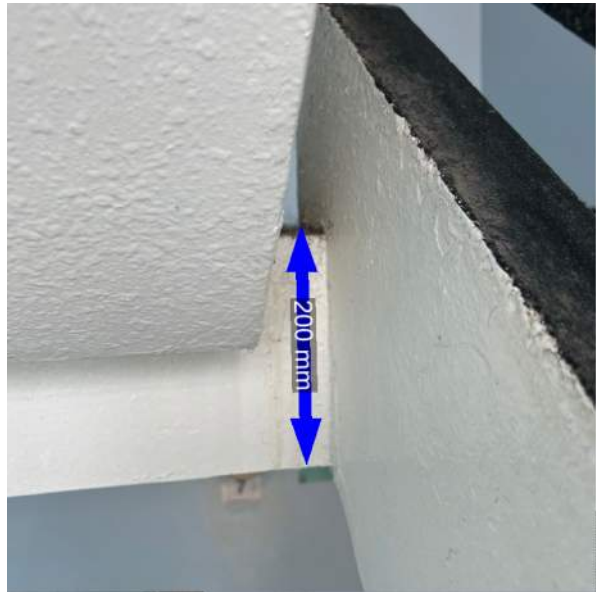
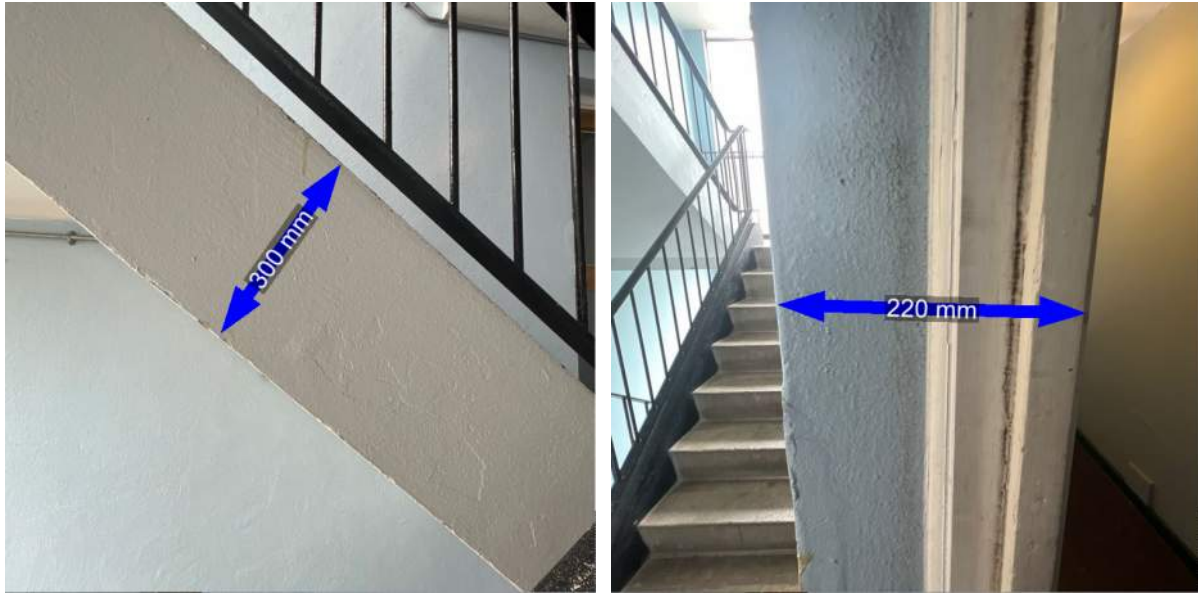
## 8th Floor Staircase

Comments: Insitu concrete stairs with steel hand railing fixed to stairs. Walls and floors appear to be fairly level.  
Stair walls covered with finishes however these would likely form the main concrete shear core walls. Stair walls approx. 220mm thick.

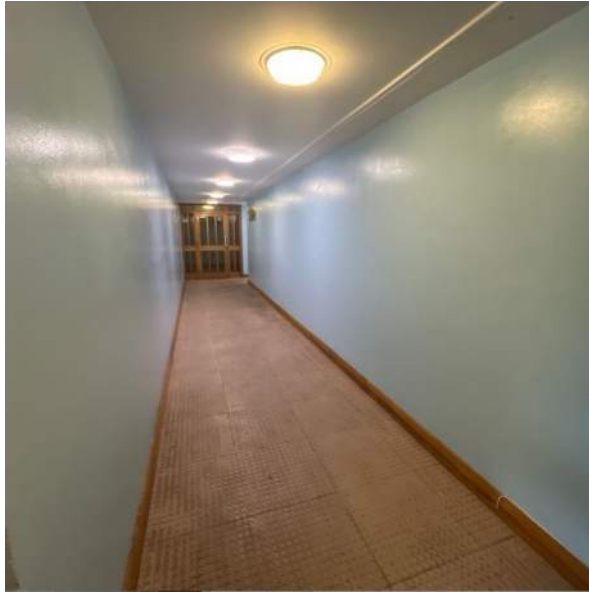
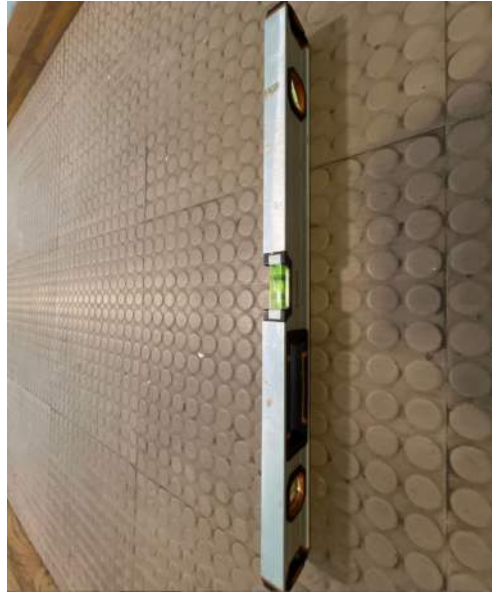
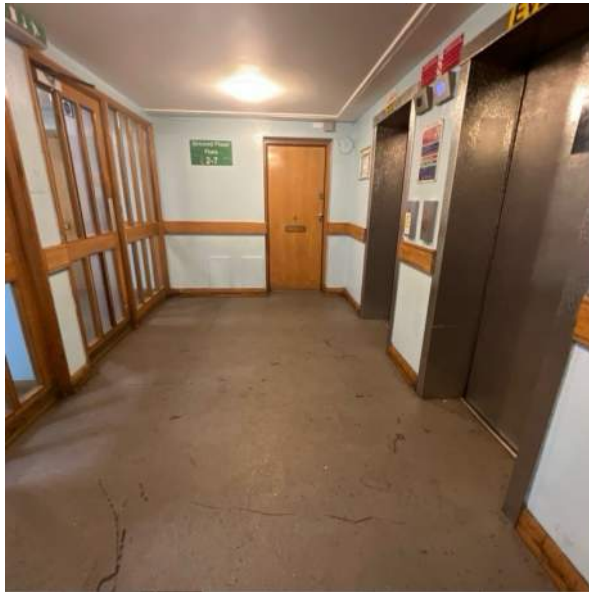
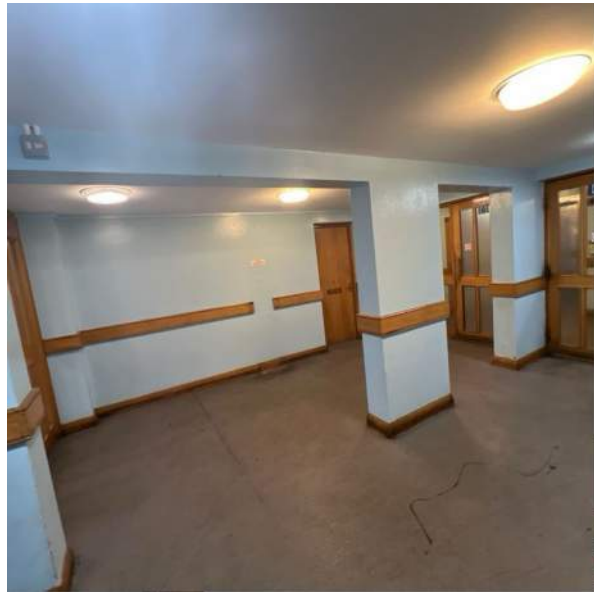
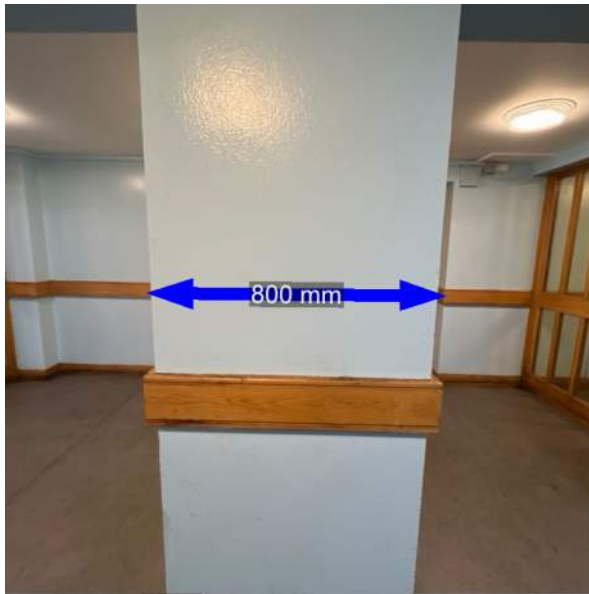
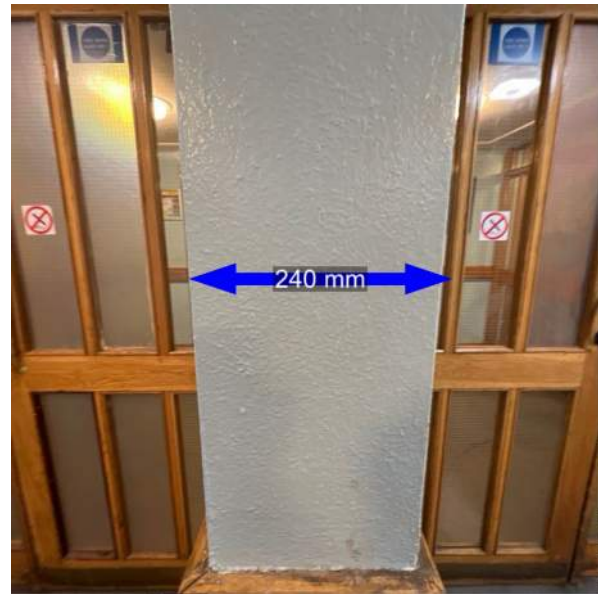
## Ground Floor Hallway

Comments: No jams or distortions noted to hallway doors to indicate any serviceability issues. Generally walls covered with finishes in hallway, likely to consist a mixture of concrete shear walls, embedded columns and block infill walls. Limited structure exposed. Partly visible concrete walls noted via electrical riser cupboards. RC Columns noted in hallway.

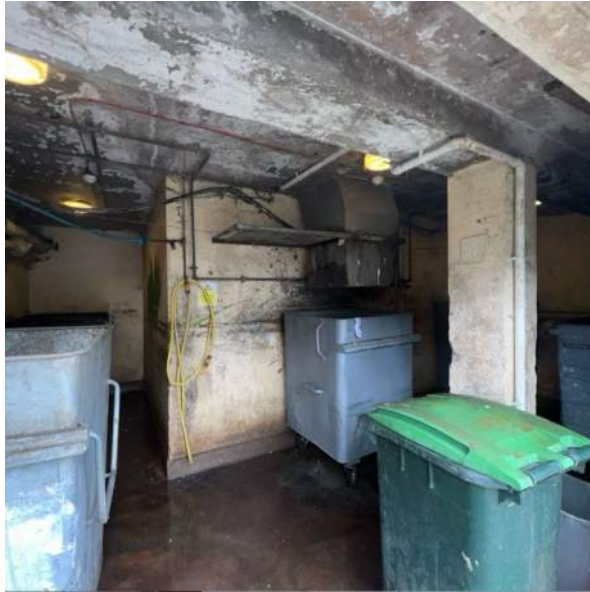
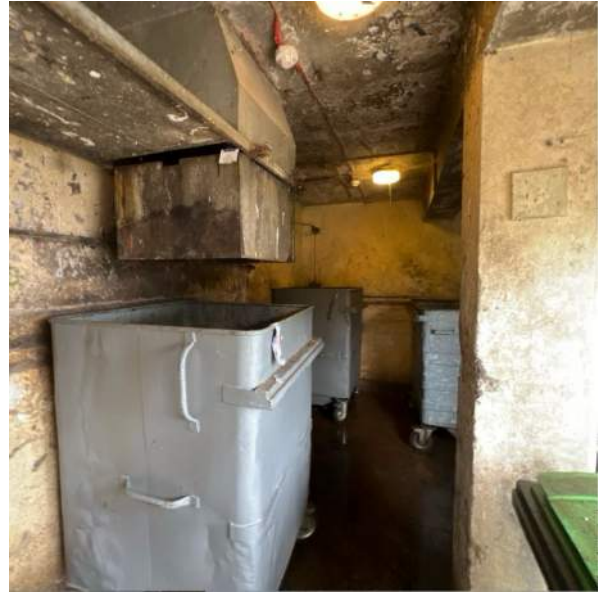
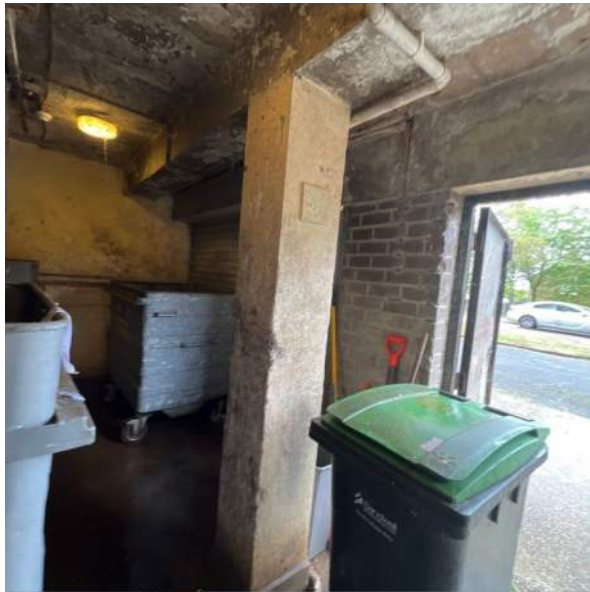
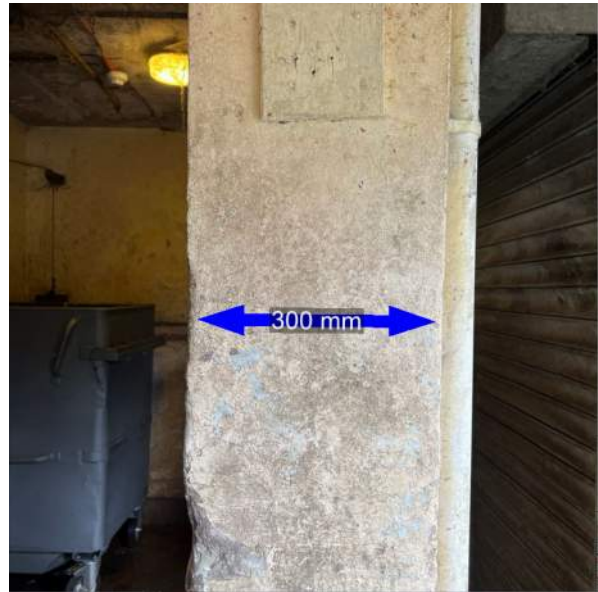
## Binstore

RC shear walls and columns noted in binstore.

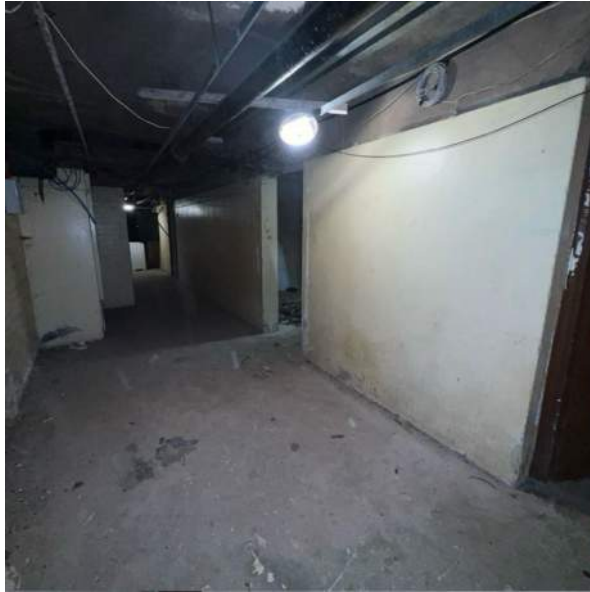
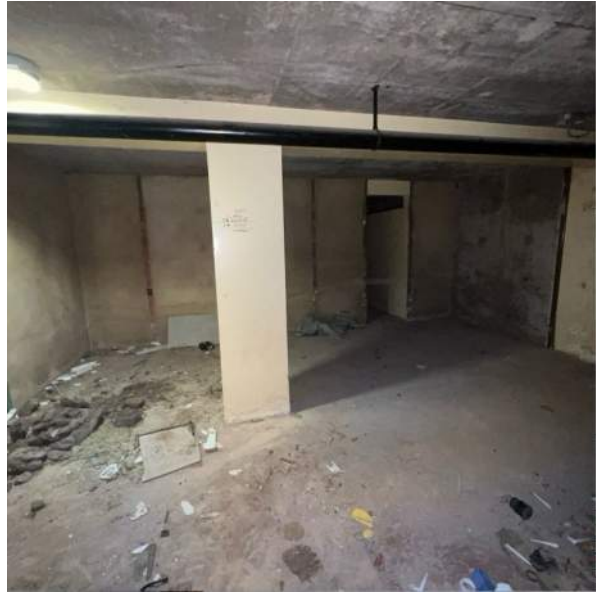
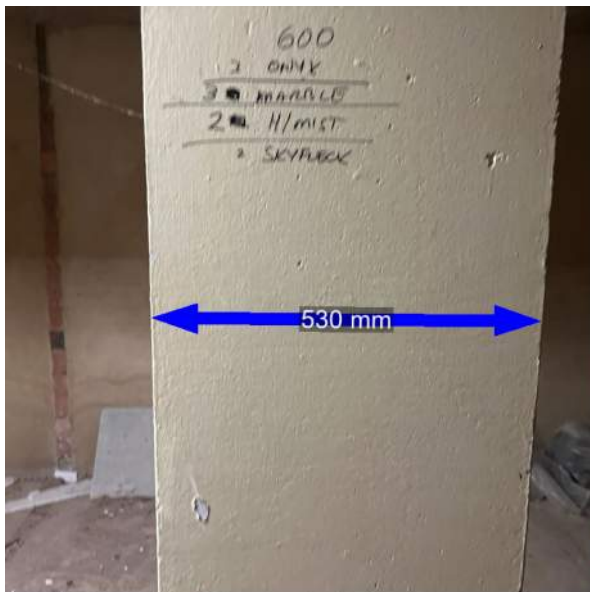
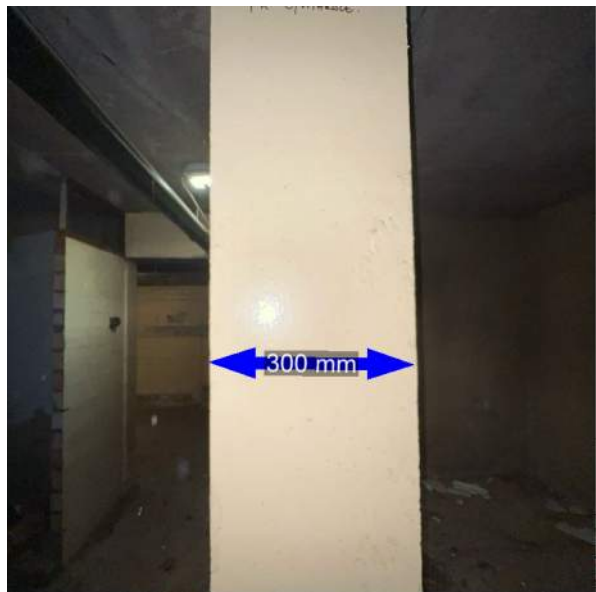
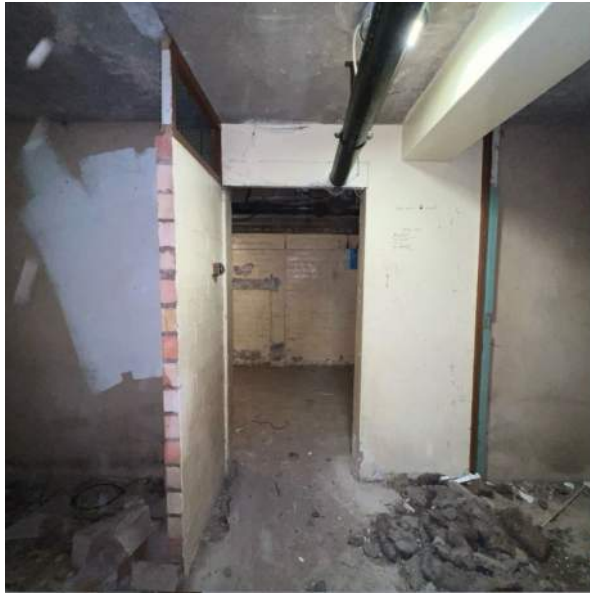
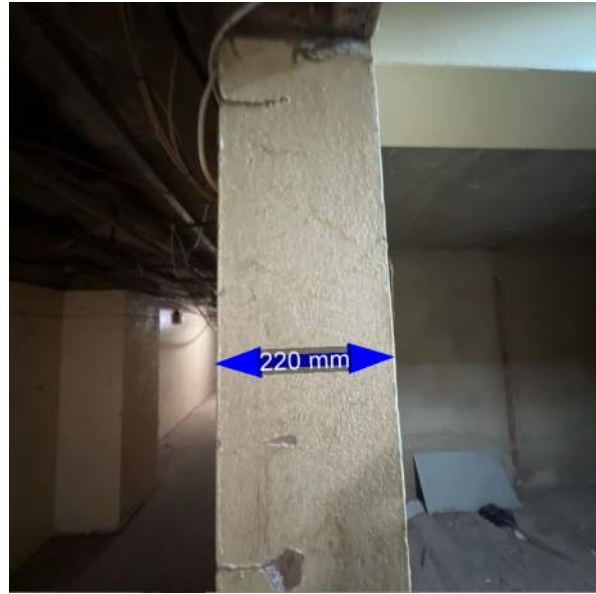
## Basement

RC structural elements (Shear walls, Columns etc) visible in basement area.

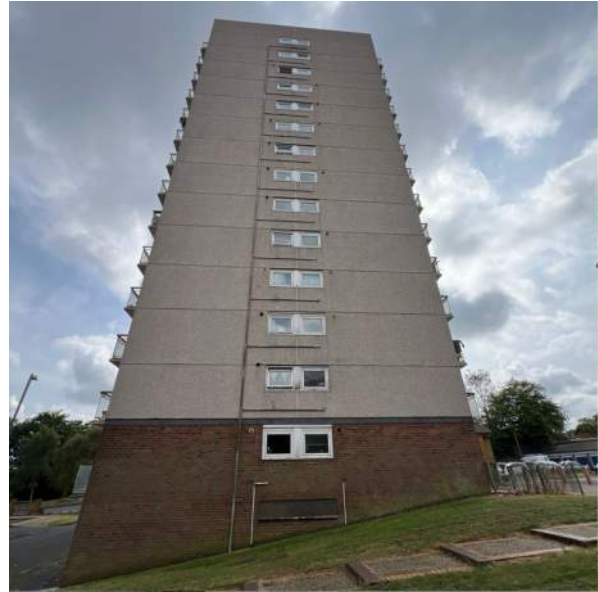
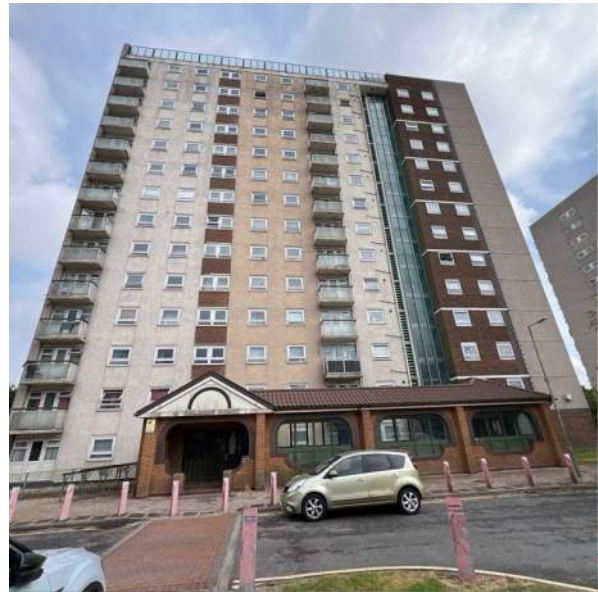
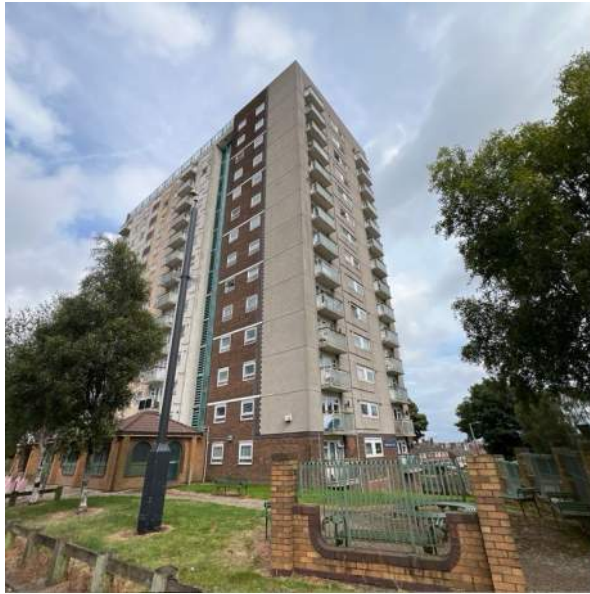
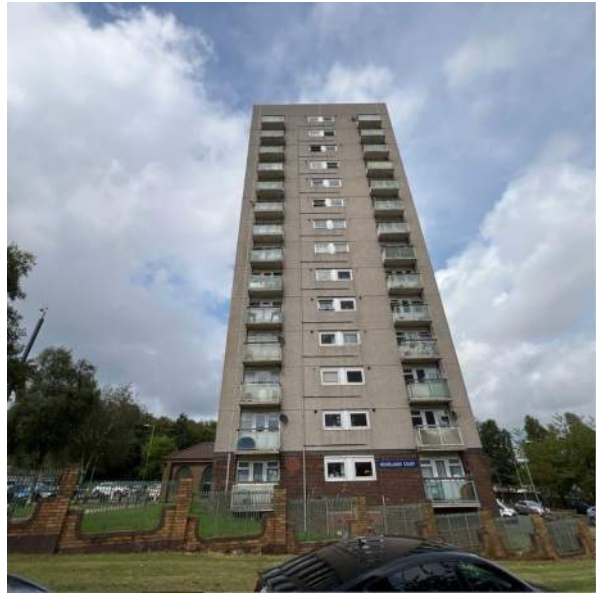
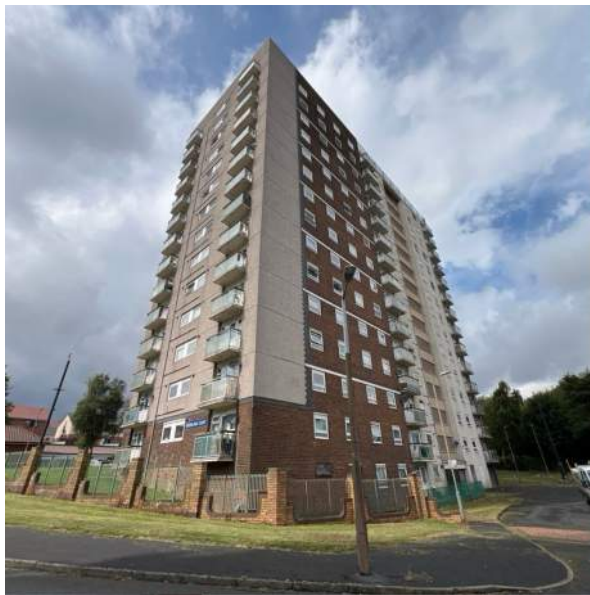
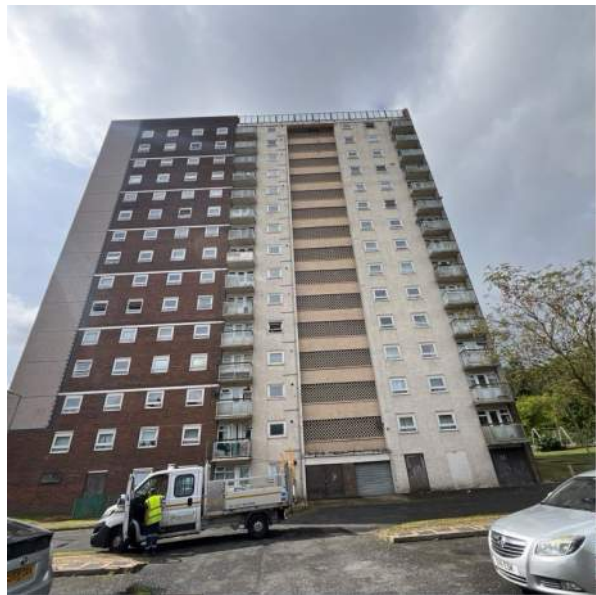
## Elevations

External facade consists of brickwork and render. Brickwork supported via floor slab at each level.
