VISUAL STRUCTURAL APPRAISAL

Mountford House

Glover Street  
West Bromwich  
B70 6DS

29<sup>th</sup> November 2024

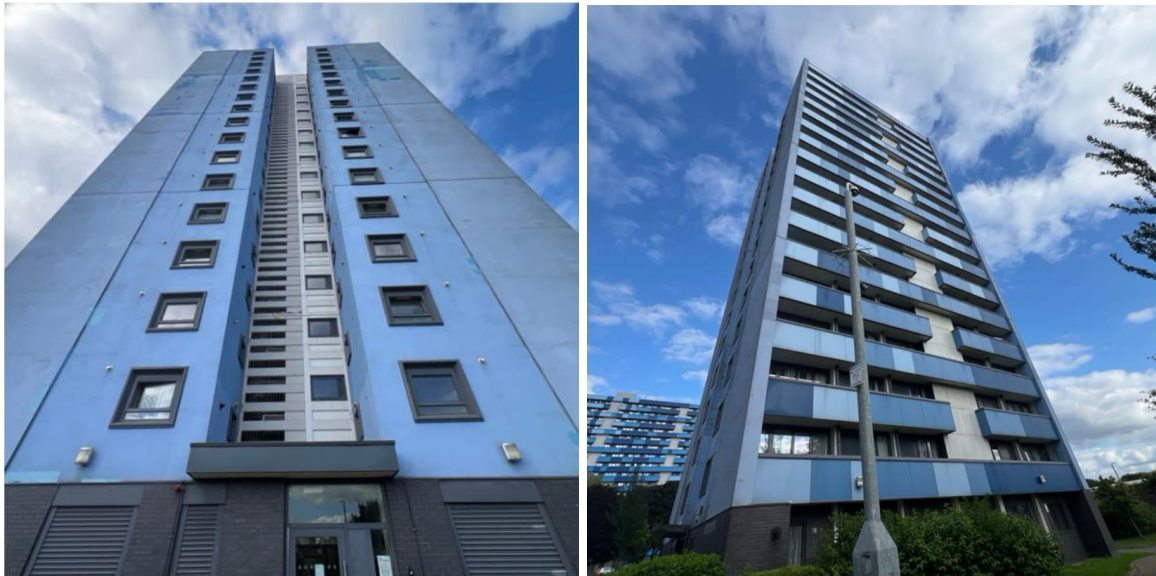
Figure 9 and 10: Front and side Elevations

The exterior elevations were generally in ok condition and no significant structural defects were noted to the cladding panels. There were no significant cracks or tell-tale signs of any significant structural movement noted at the time of our inspection.

The exterior panels were noted to be plumb with no signs of significant bowing, bulging or leaning noted to the panels indicating failed fixings however their presence and condition cannot be confirmed.

There are balconies at each level which have been clad in High Pressure Laminate panels.

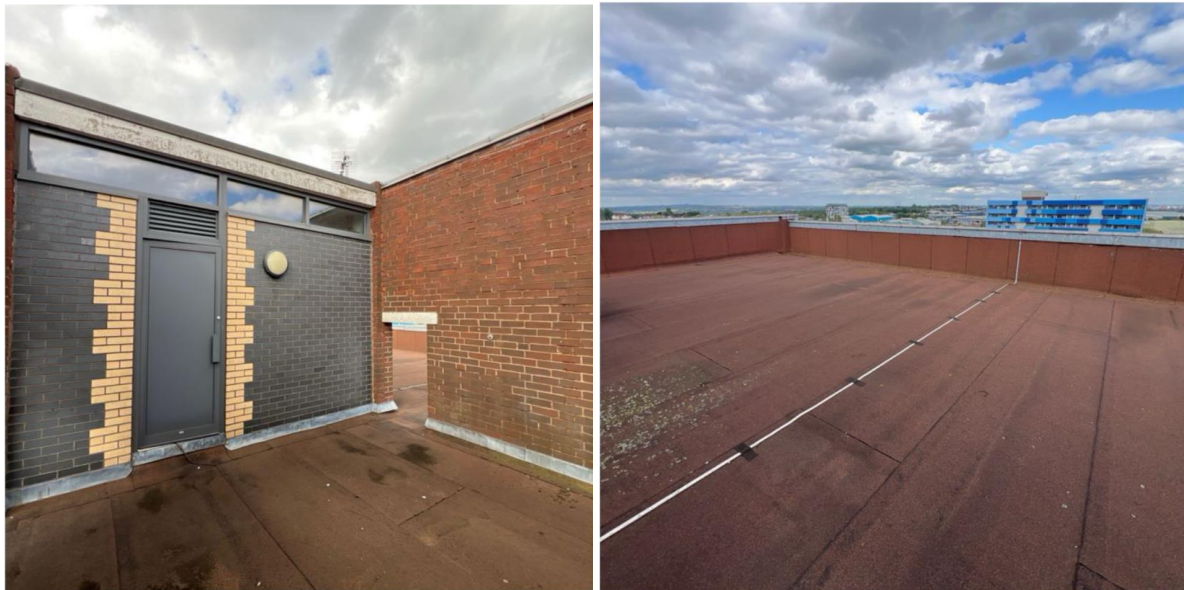
Figure 11 and 12: Roof Level

There were no tell-tale signs of any significant structural movement noted at the time of our inspection. The exterior walls were noted to be plumb with no signs of significant bowing, bulging or leaning noted to the masonry walls.

The roof has a felted finish which appears in ok condition. The exact build-up of the roof finishes were not accessible at the time of inspection. It is recommended an intrusive survey of the roof finishes is completed by a specialist surveyor to assess the condition of the roof covering.

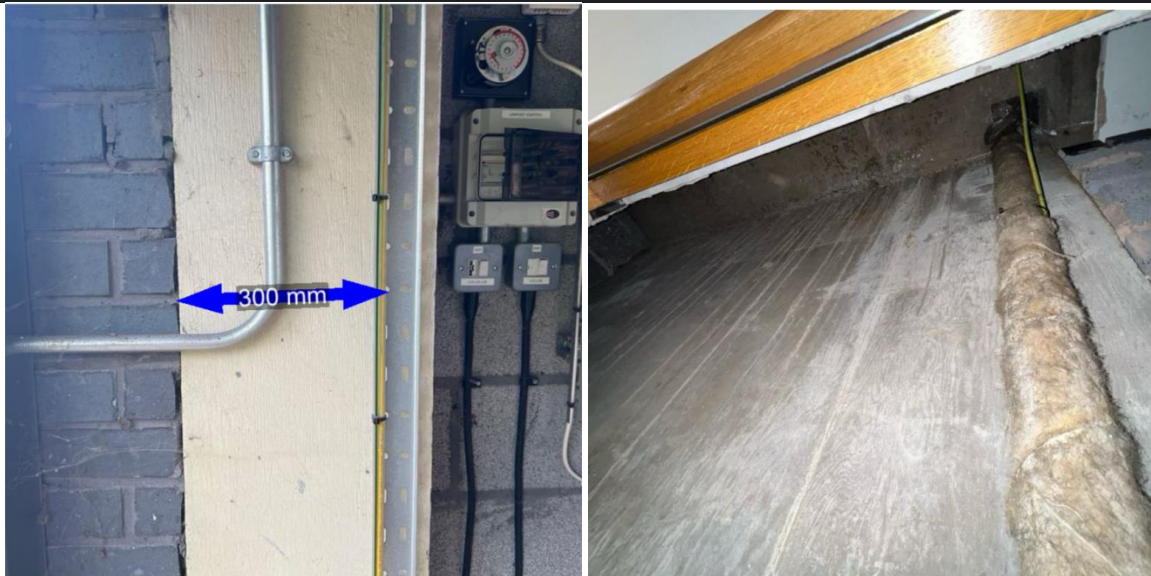
Figure 13 and 14: Vertical RC Structure Visible

The interior of the stair core walls were checked and were plumb and in line with observations made to the exterior – no significant signs of leaning or movement noted. The concrete appeared in fair condition with few BRE category 1 cracks but no structurally significant defects were noted.

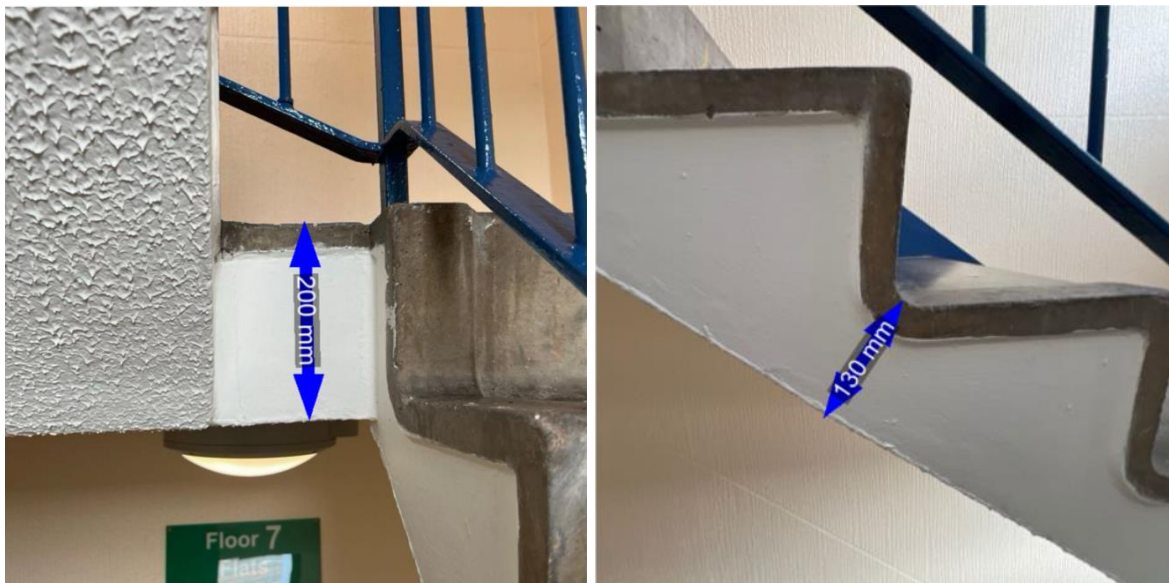
Figure 15 and 16: Staircase Stringer and landing thickness

The stair stringer was noted to be 130mm thick which is less than we would expect to modern standards, a cover test is required to check the resistance of the concrete section in the event of a fire.

Due to the age of the building it is wise to perform periodical health checks to the concrete elements. This should include tests for concrete strength, cover depth, carbonation, chlorides and HAC. It would appear that these tests have never been performed to this building and therefore we recommend engaging a specialist contractor within the next 24 months who will be able to perform the tests and provide a interpretive report. The fire resistance of the structural members can't be confirmed without the as-built covers assessed.

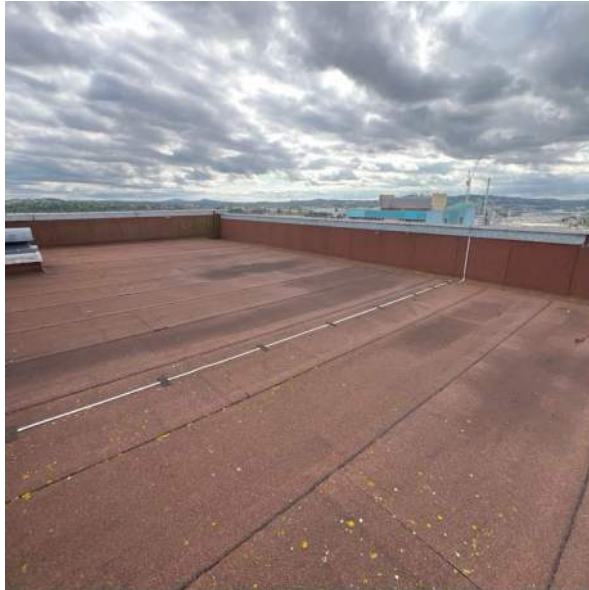
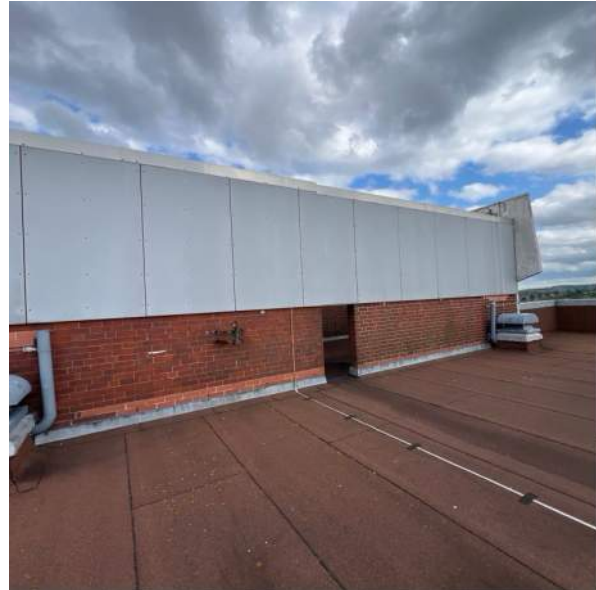
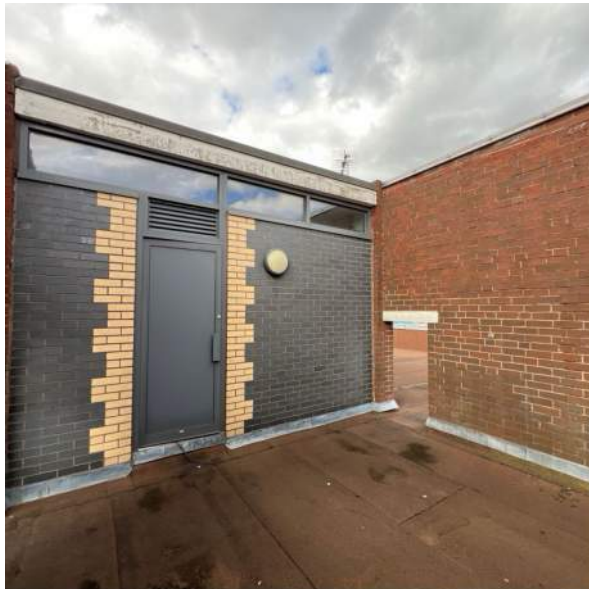
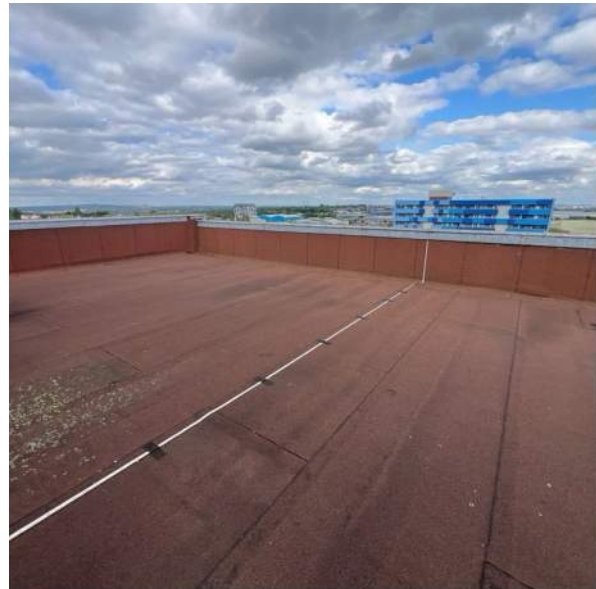
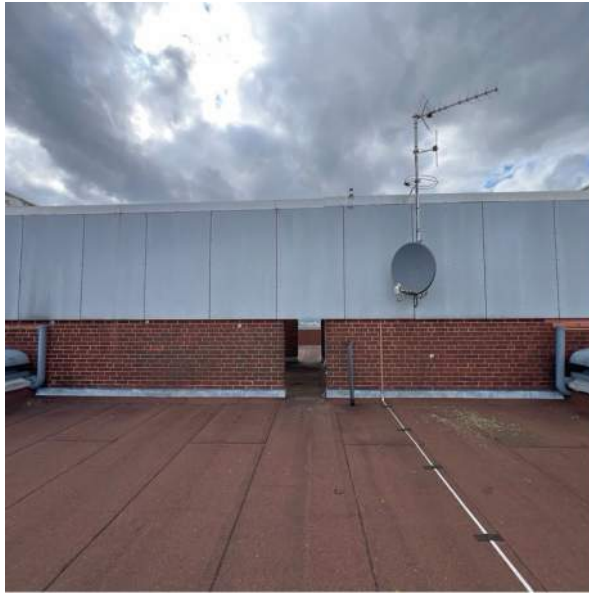
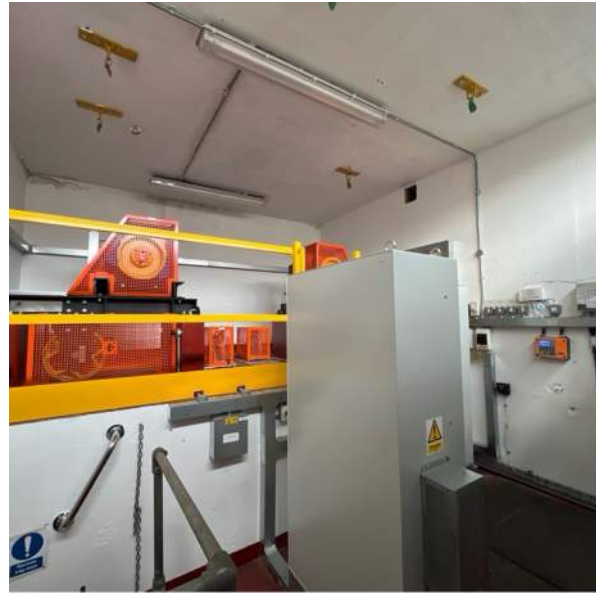
## Main Roof

Lift motor room located on roof formed of masonry walls.  
Parapet walls noted to perimeter of roof.  
Insitu concrete roof slab a felt coverings.

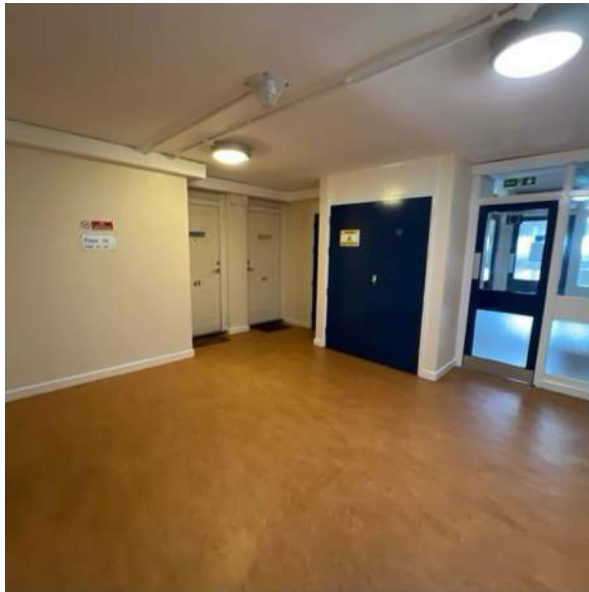
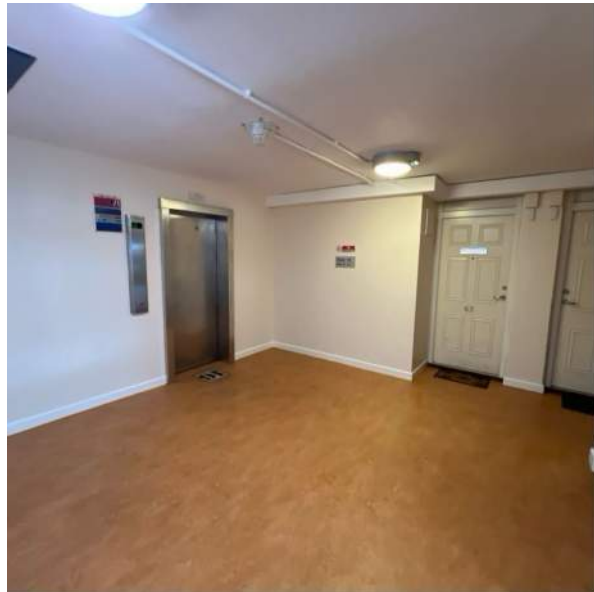
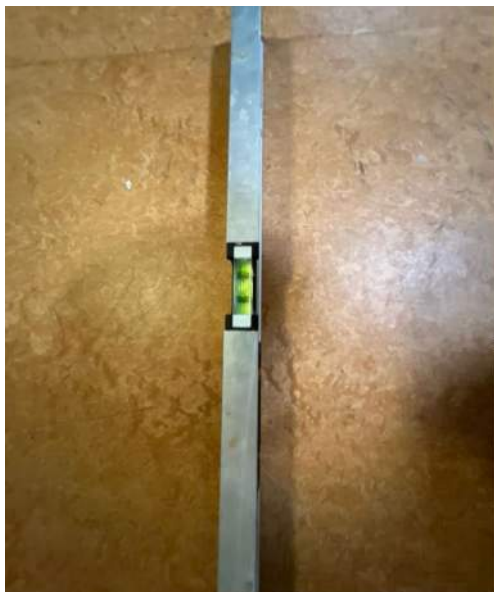
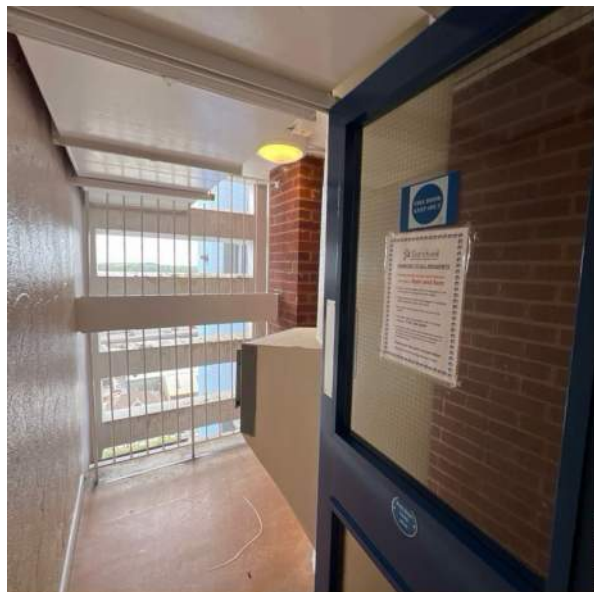
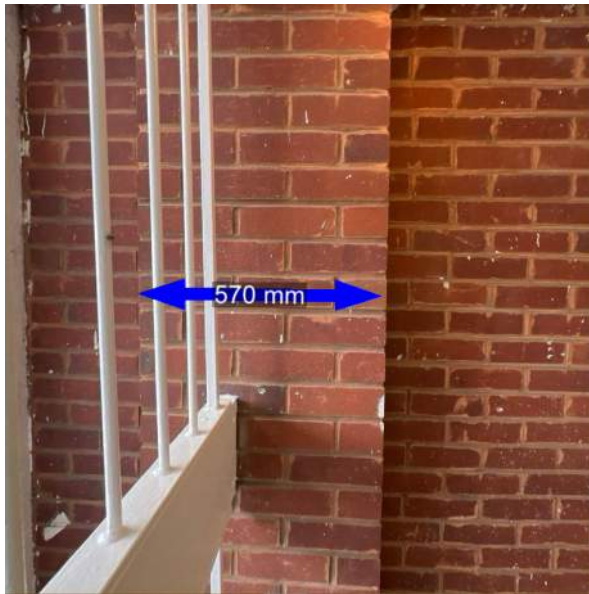
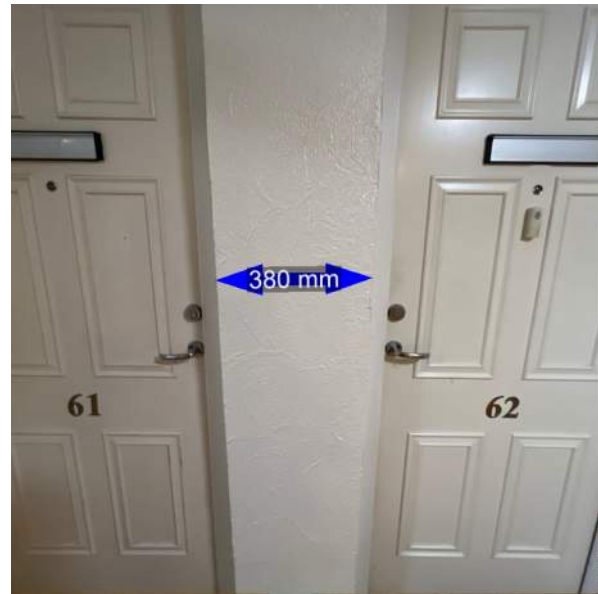
## 16th Floor Hallway

Comments: No jams or distortions noted to hallway doors to indicate any serviceability issues. Generally walls covered with finishes in hallway, likely to consist a mixture of concrete shear walls, embedded columns and block infill walls. Electrical cabinet shows infill blockwork.

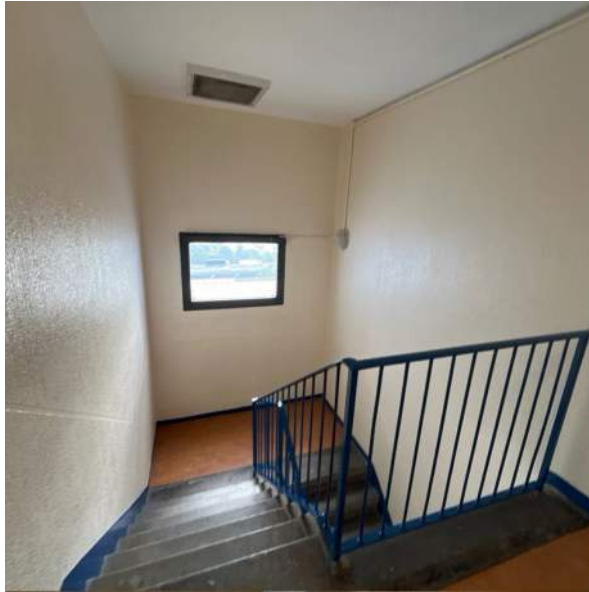
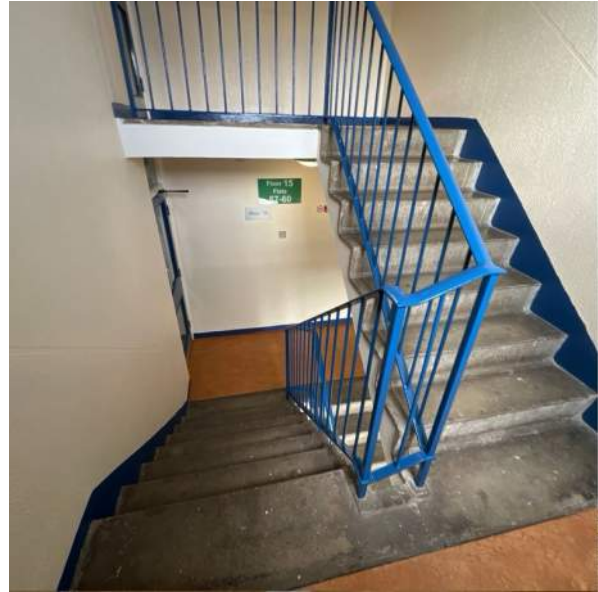
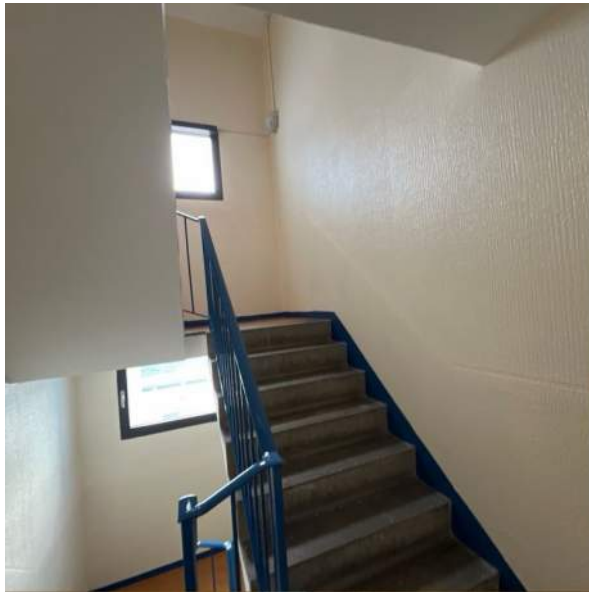
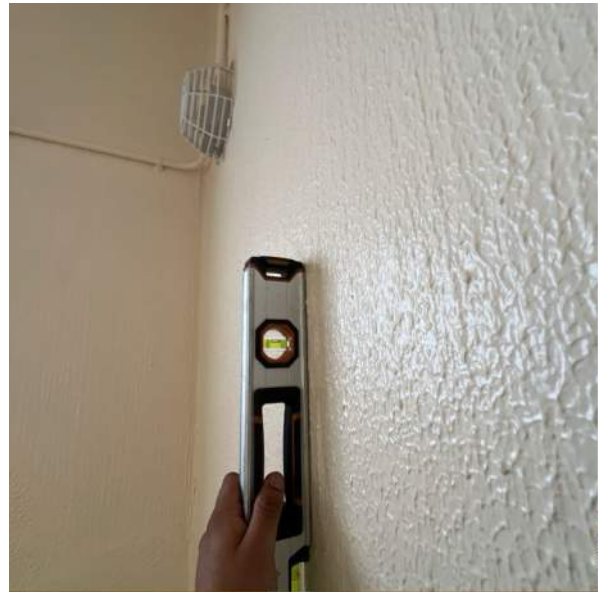
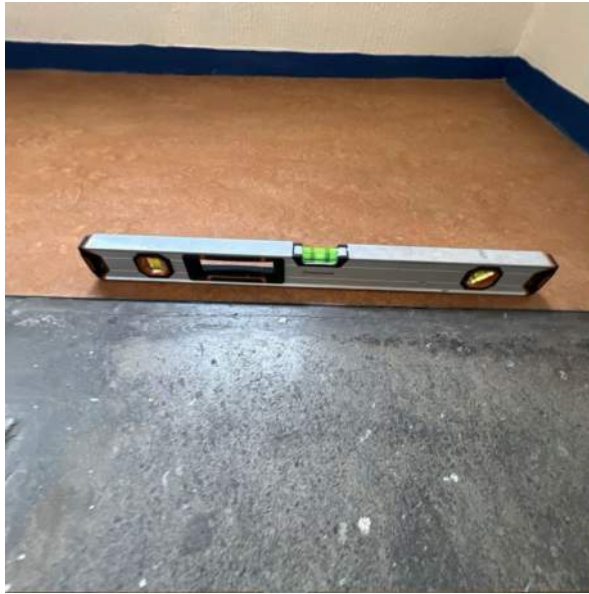
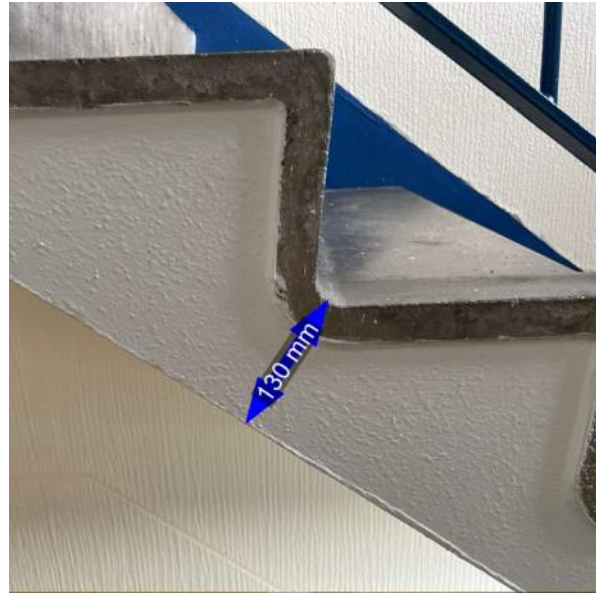
## 16th Floor Staircase

Insitu concrete stairs with steel hand railing fixed to stairs. Walls and floors appear to be fairly level.

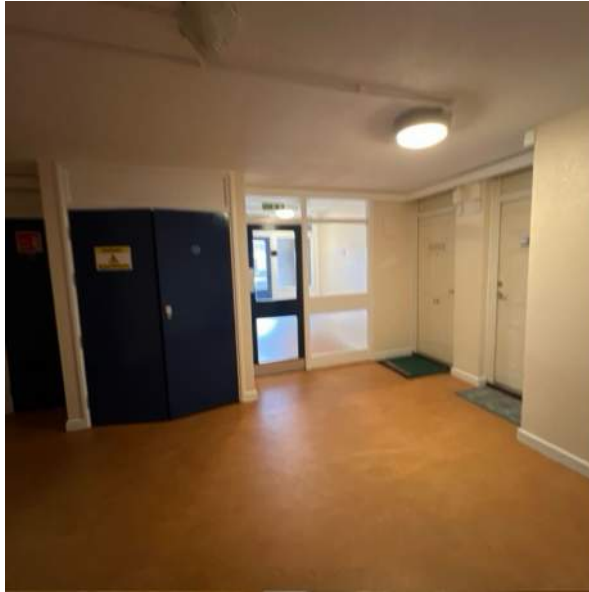
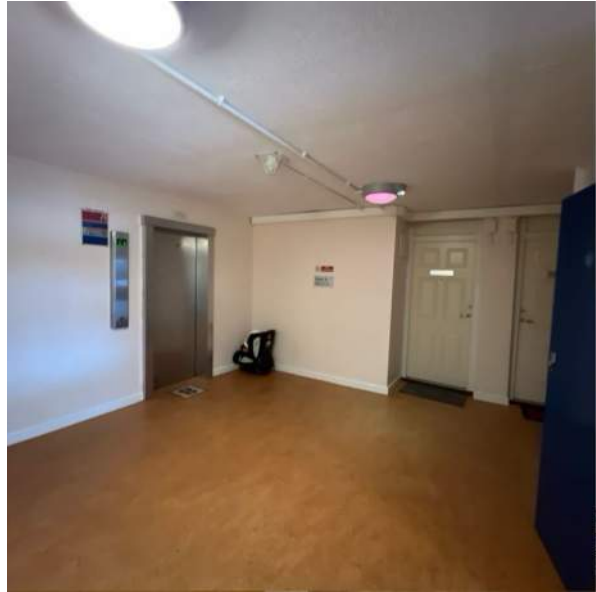
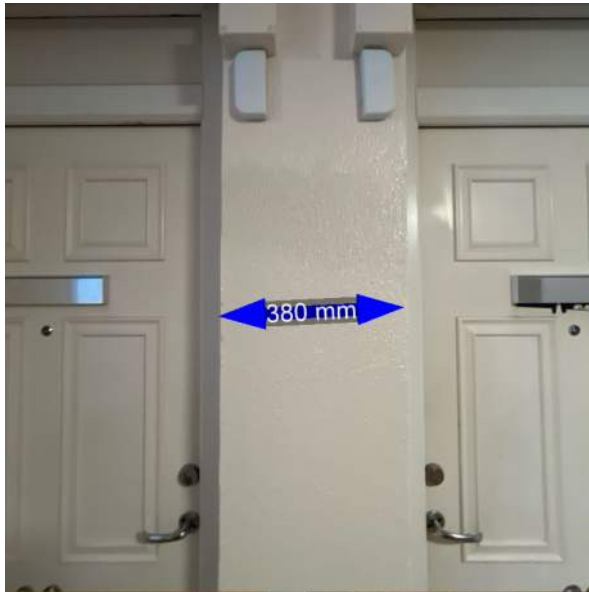
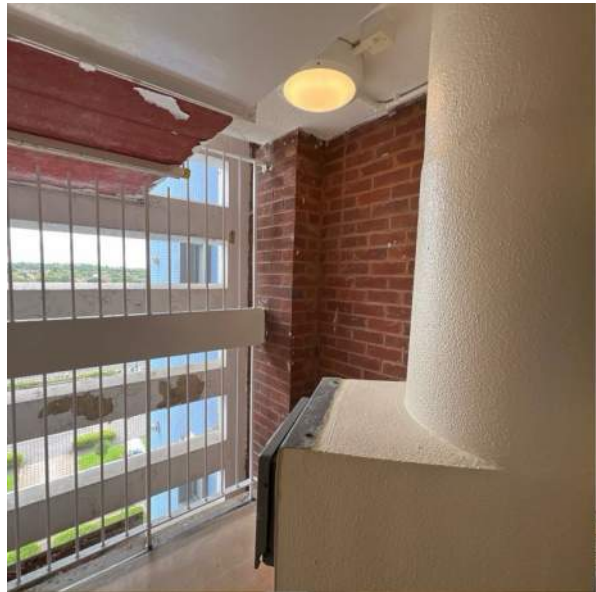
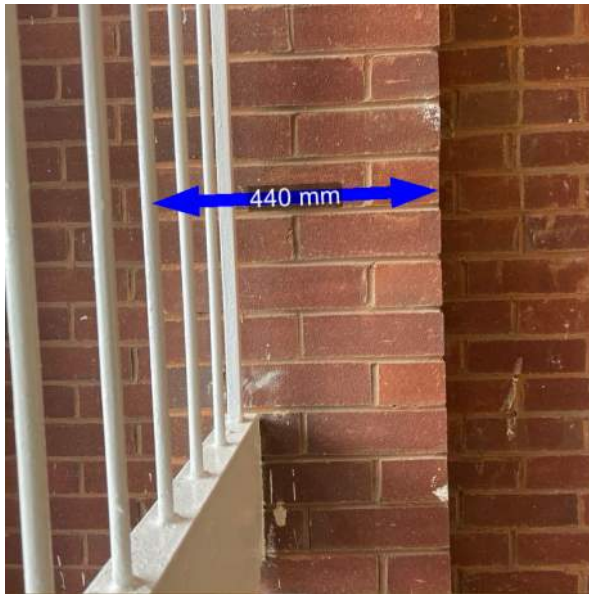
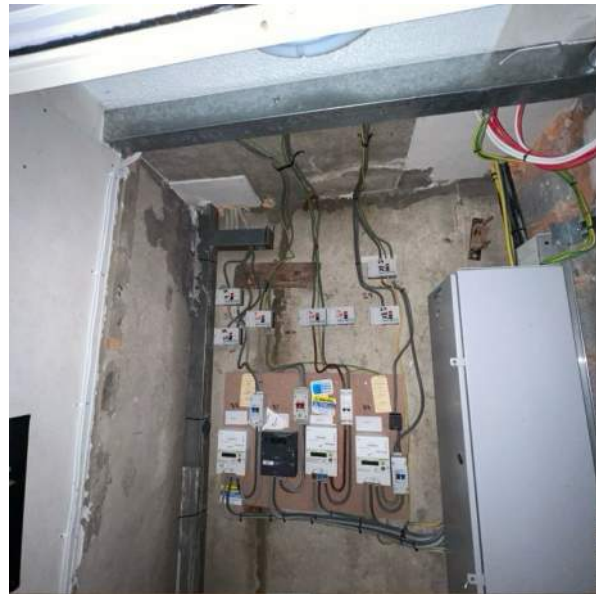
## 8th Floor Hallway

Comments: No jams or distortions noted to hallway doors to indicate any serviceability issues. Generally walls covered with finishes in hallway, likely to consist a mixture of concrete shear walls, embedded columns and block infill walls. Electrical cabinet shows infill blockwork.

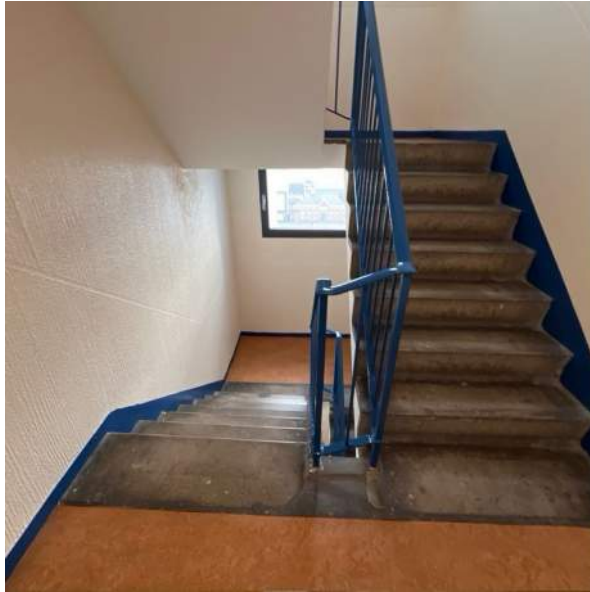
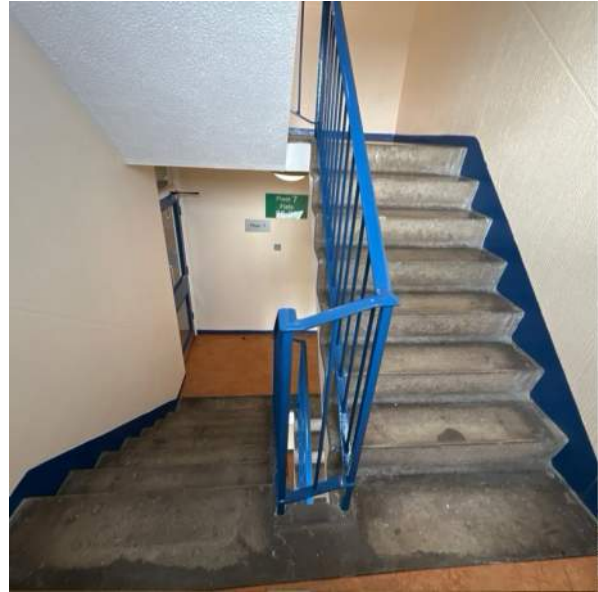
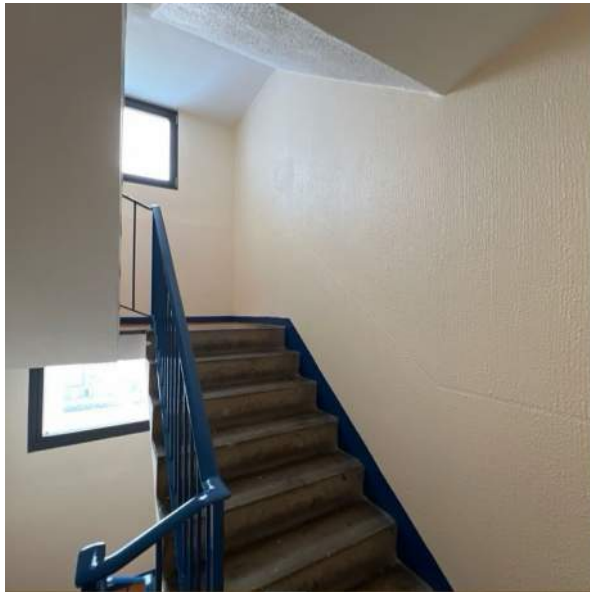
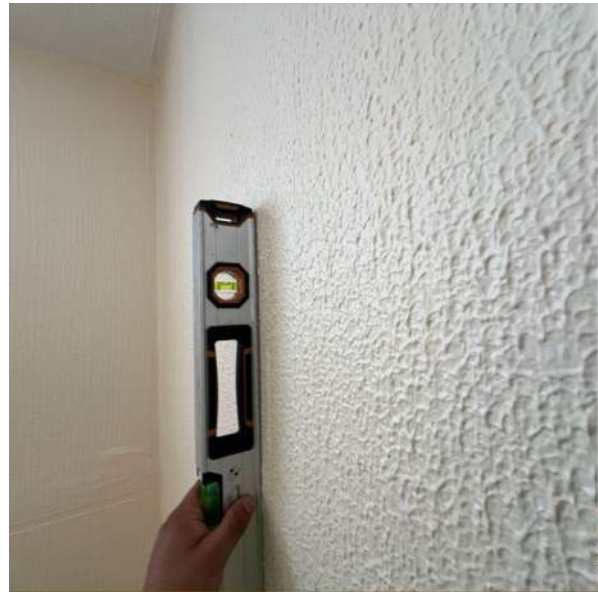
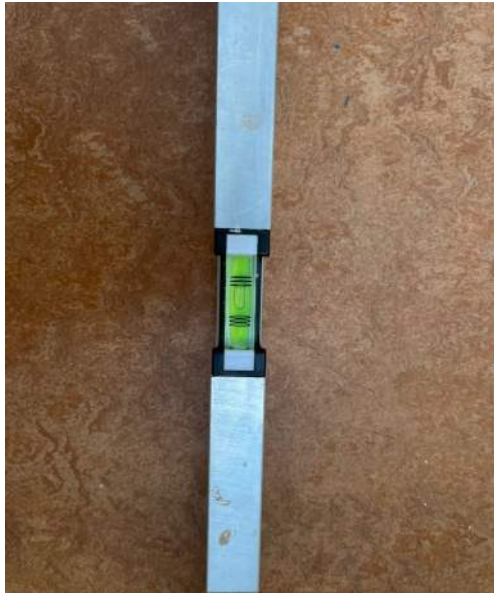
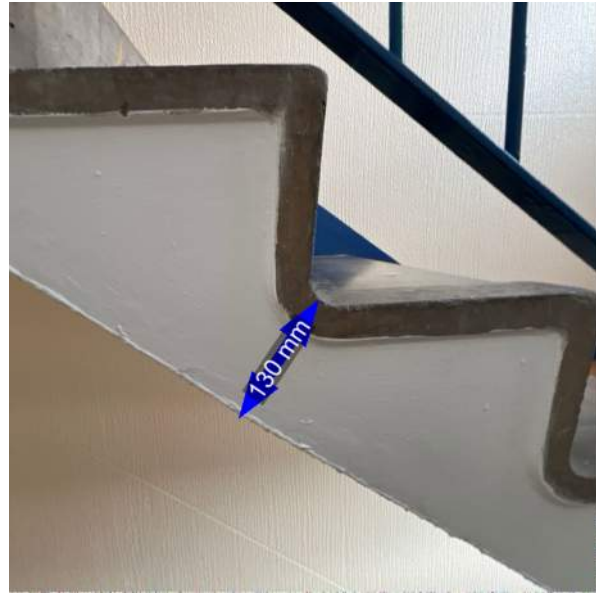
## 8th Floor Staircase

In situ concrete stairs with steel hand railing fixed to stairs. Walls and floors appear to be fairly level.

Floor slab measured from stair platform appears to be approx. 200mm thick.

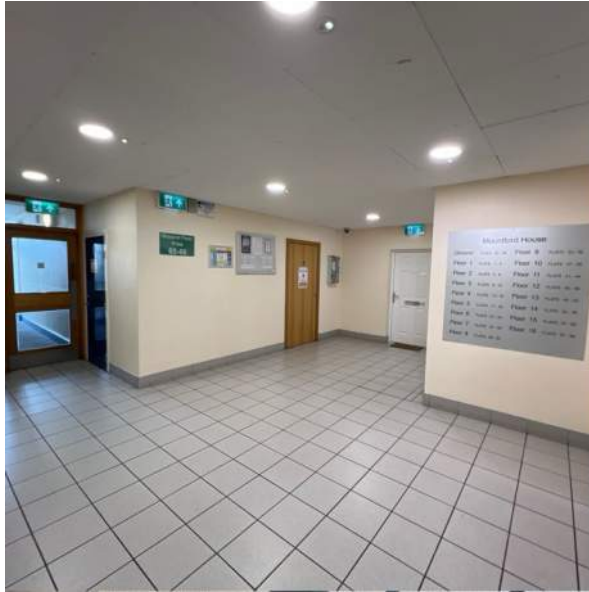
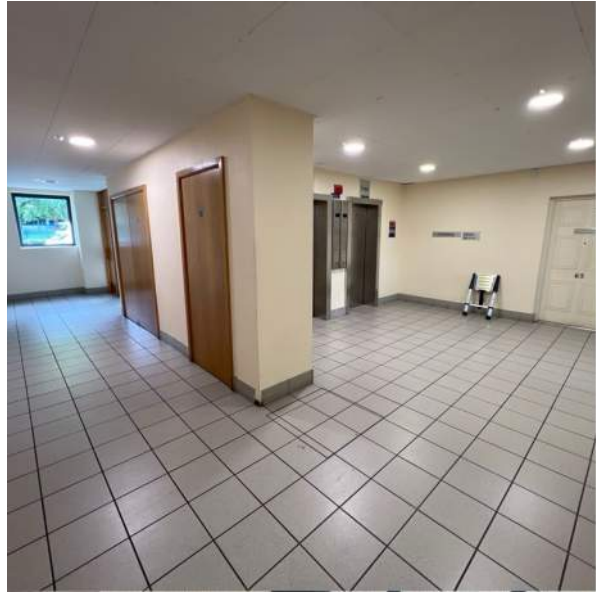
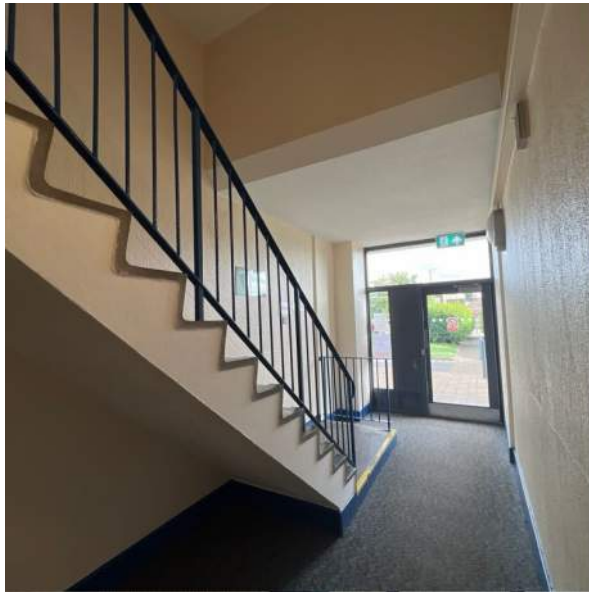
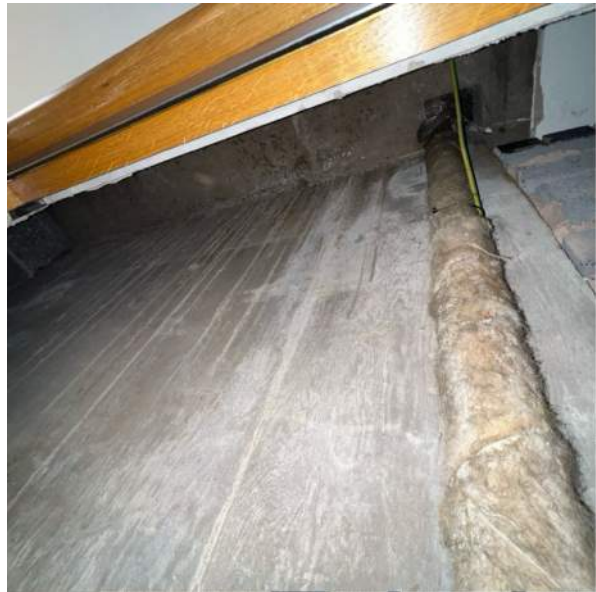
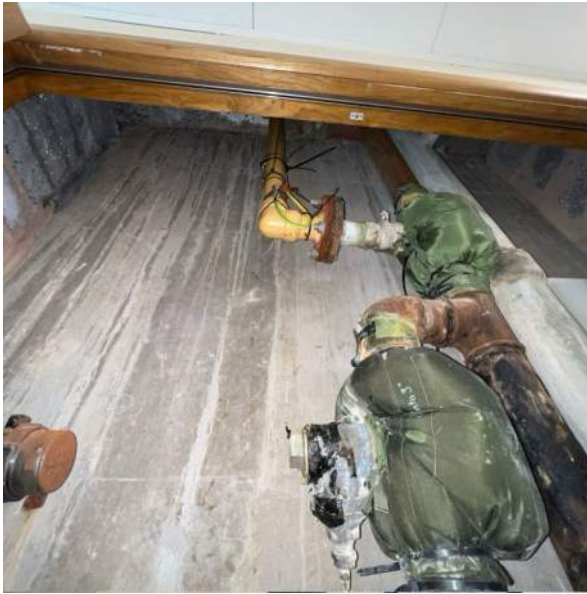
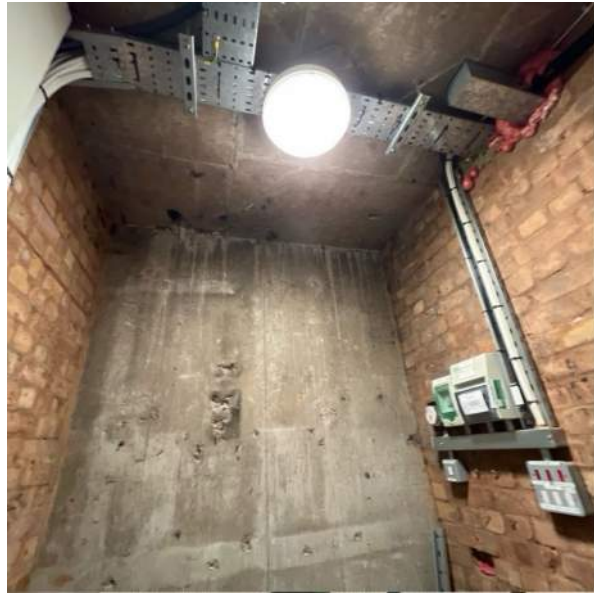
## Ground Floor Hallway

Comments: No jams or distortions noted to hallway doors to indicate any serviceability issues. Generally walls covered with finishes in hallway, likely to consist a mixture of concrete shear walls, embedded columns and block infill walls. RC Concrete Shear Core wall of lift visibly noted from riser cupboard and meterage room. Other internal main walls noted to solid concrete walls, these are likely to be shear core walls forming part of the primary structural elements.

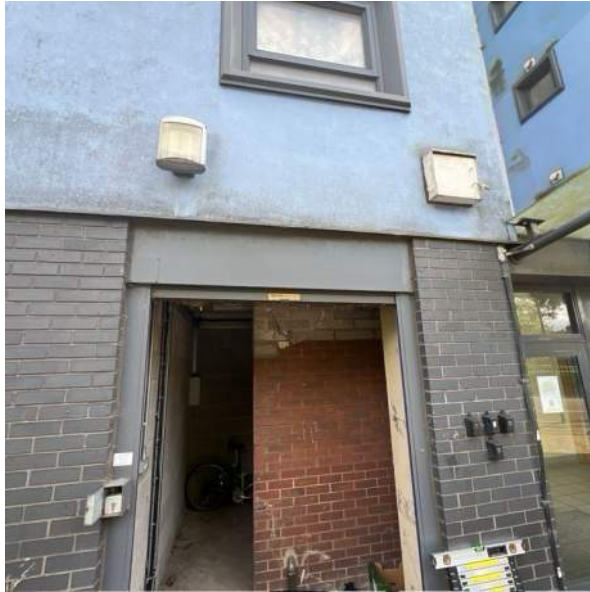
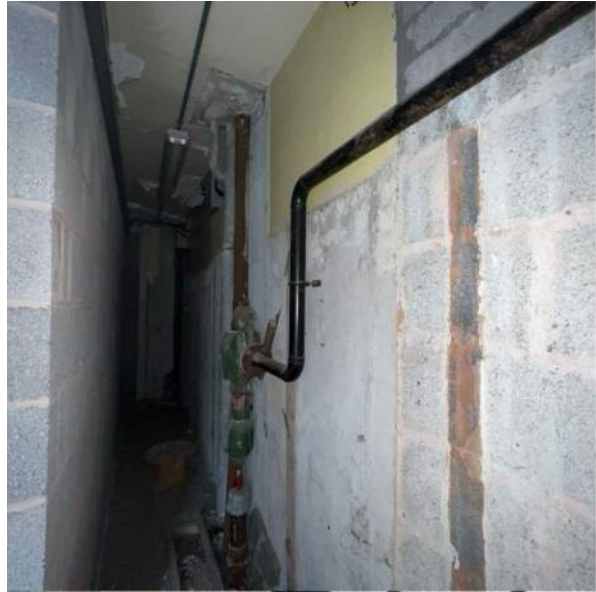
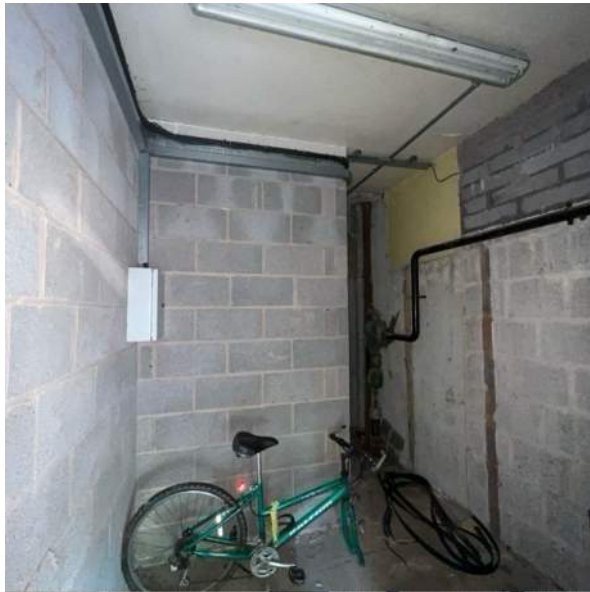
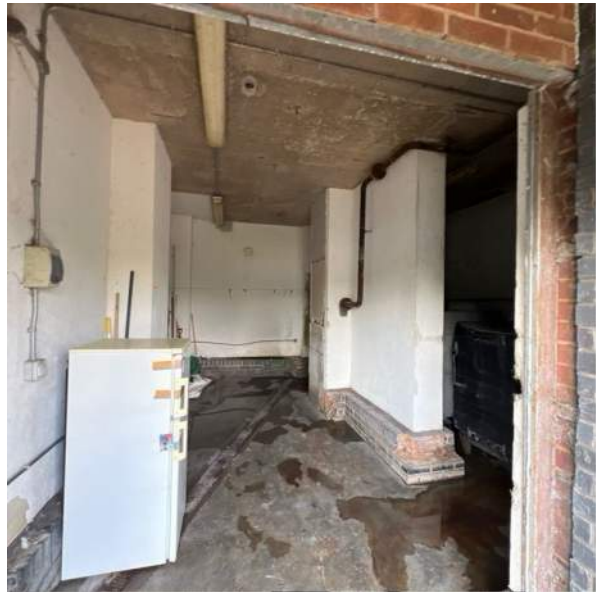
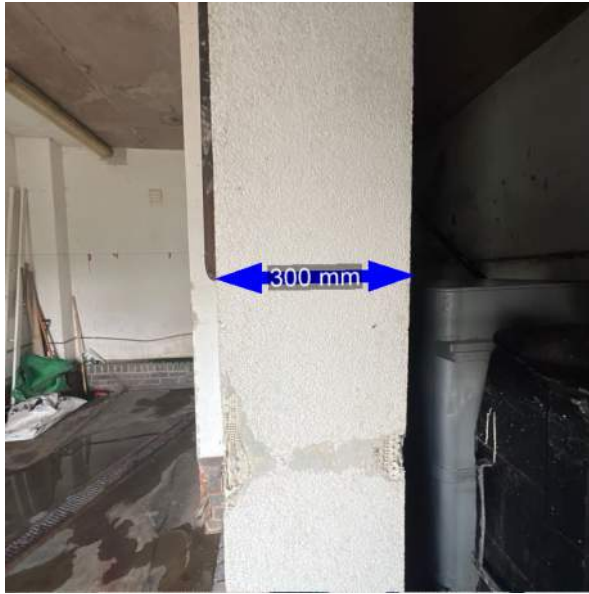
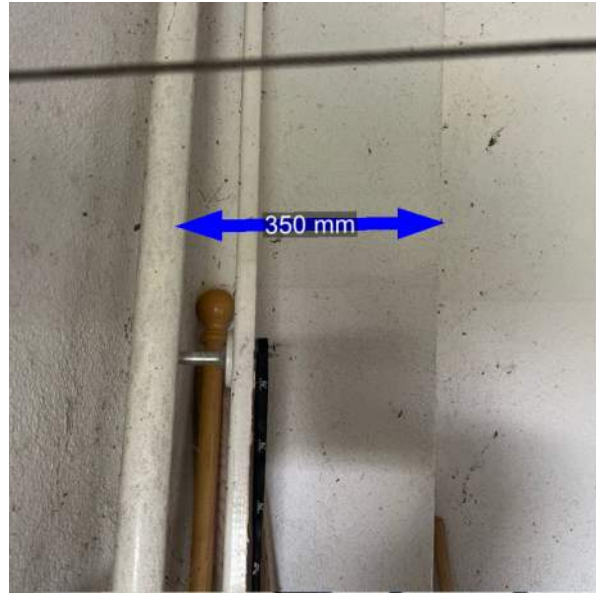
## Bin Store and Storage Areas

Shear concrete walls (300mm wide including finishes) and embedded concrete columns (approx. 350mm wide) noted in bin store and storage areas. Concrete infill (non-load bearing walls) noted.

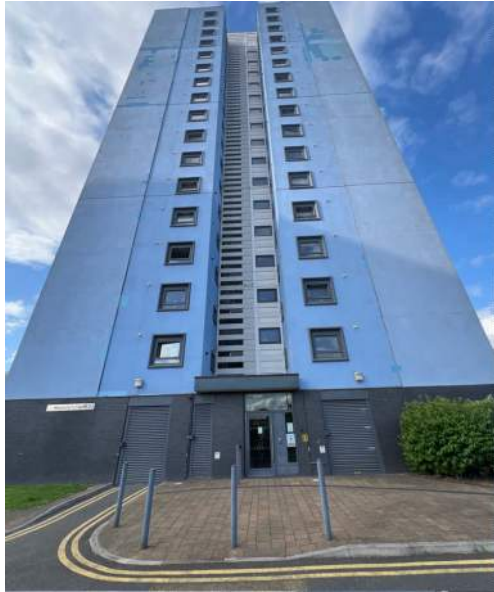
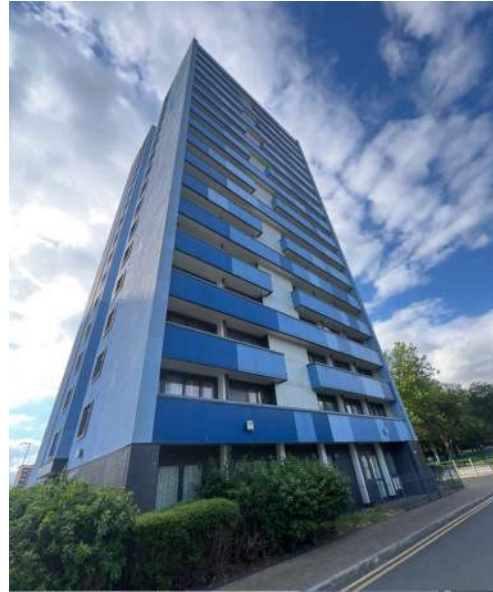
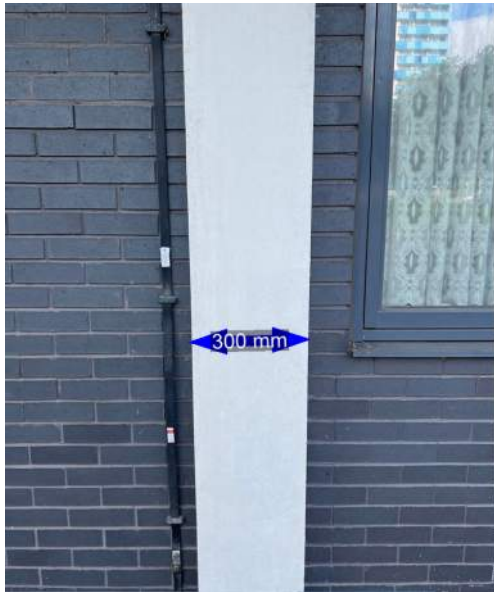
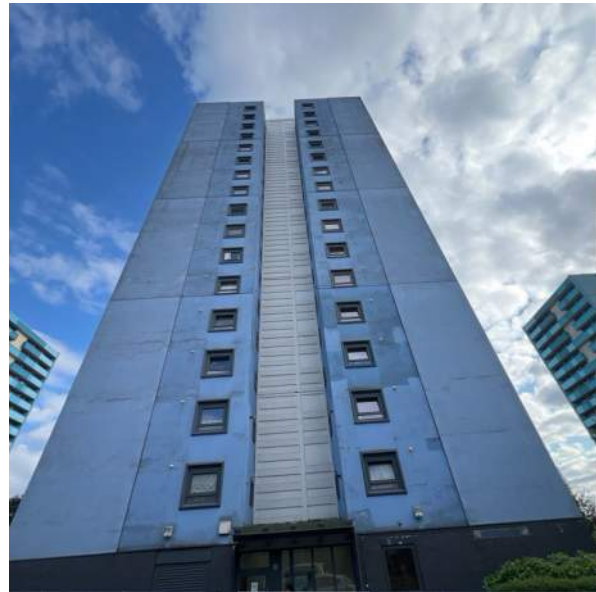
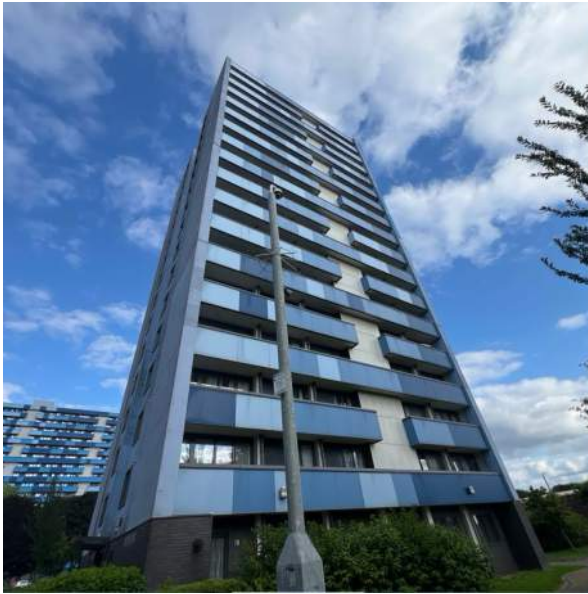
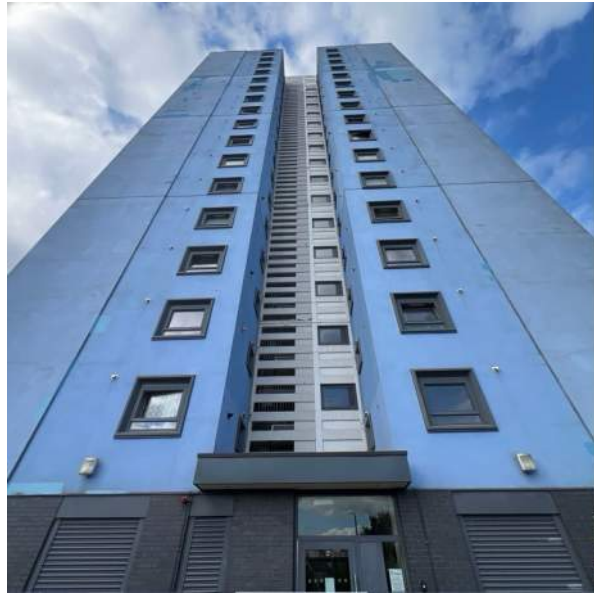
## Elevations

External ground floor level consists of brick work.  
Upper floors noted to have a rendered facade and cladding to balconies.  
Concrete columns (300mm wide) noted to perimeter which form part of the primary structural elements of the building.  
Staircase exterior appears to have a concrete panel facade feature.
