**FIRNTEC**  
BUILDING COMPLIANCE

VISUAL STRUCTURAL APPRAISAL

Neale House

31<sup>st</sup> January 2025

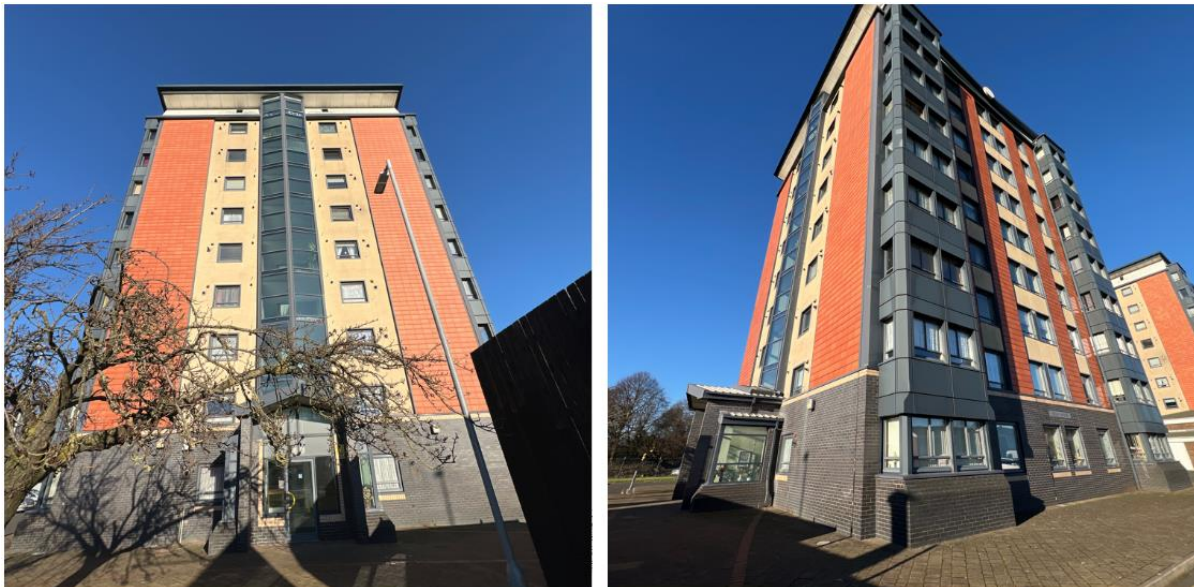
Figure 9 and 10: Building Elevations

The exterior elevations were generally in ok condition and no significant structural defects were noted to the cladding panels. There were no significant cracks or tell-tale signs of any significant structural movement noted at the time of our inspection.

The exterior panels were noted to be plumb with no signs of significant bowing, bulging or leaning noted to the panels indicating failed fixings however their presence and condition cannot be confirmed.

There are balconies at each level which are formed of cantilevered RC slabs tied into the main frame. During the 2018 refurbishment they were enclosed with aluminium panels into winter gardens.

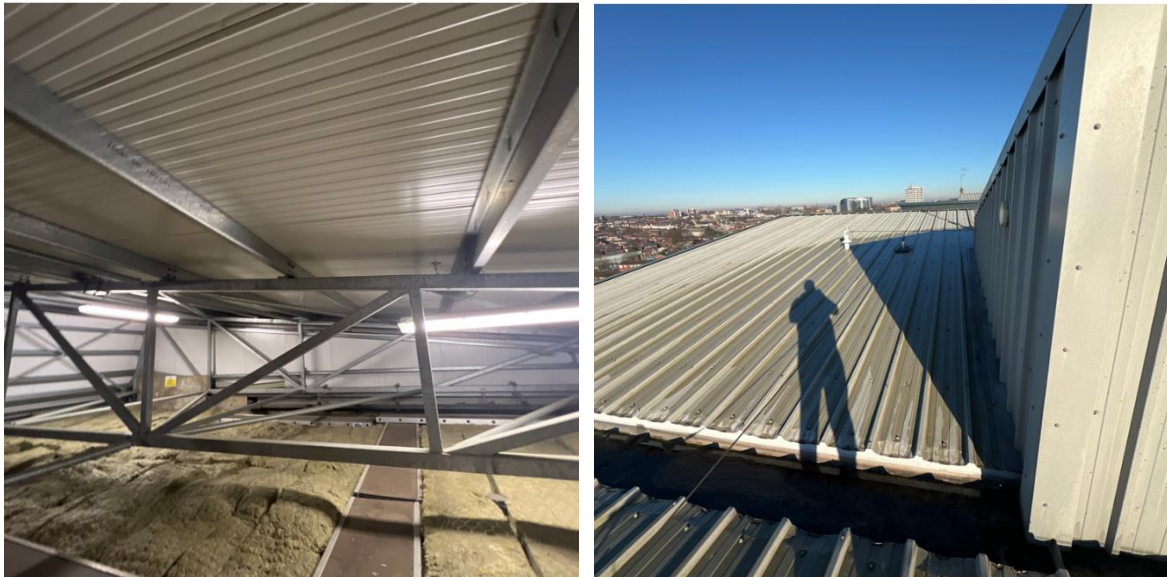
Figure 11 and 12: Roof Level

There were no tell-tale signs of any significant structural movement noted at the time of our inspection. The exterior walls were noted to be plumb with no signs of significant bowing, bulging or leaning noted to the masonry walls.

The roof has subsequently been covered with a new waterproofing covering formed of a steel frame installed to the existing roof which supports pitched corrugated sheets. This roof is not insulated and therefore acts purely as a weather barrier. The fire protection of the steel is unclear as the beams do not appear to be unprotected. Details of this frame should be requested from the contractor who completed the works in 2018. No signs of water ingress of that the roof is not performing as intended.

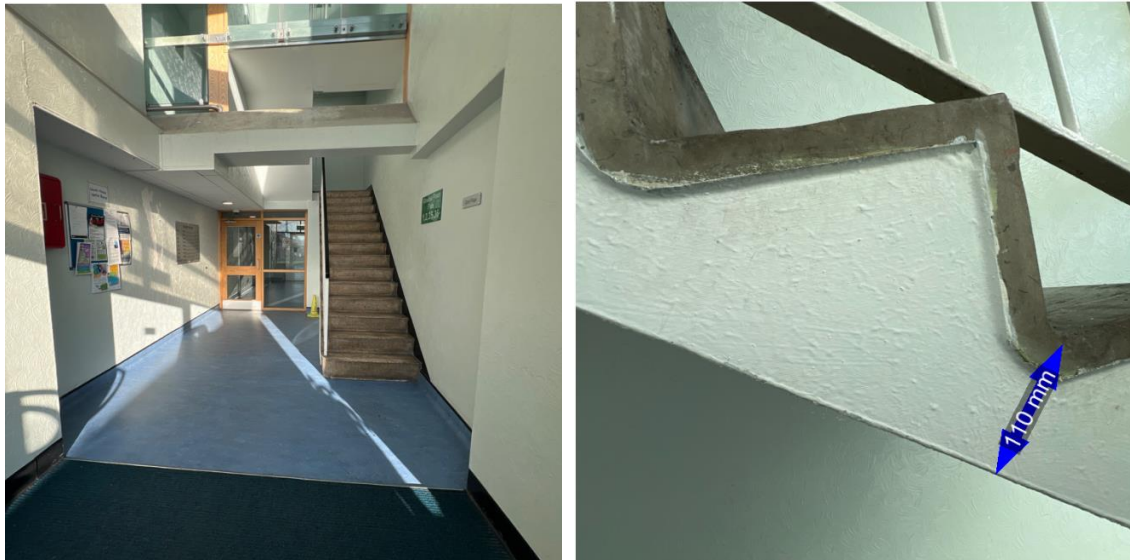
Figure 13 and 14: Entrance Atrium and staircase stringer

The interior of the stair core walls were checked and were plumb and in line with observations made to the exterior – no significant signs of leaning or movement noted. The concrete appeared in fair condition with few BRE category 1 cracks but no structurally significant defects were noted.

The stair stringer was noted to be 110mm thick which seems slim, certainly short of modern standards. A cover test is required to check the resistance of the concrete section in the event of a fire.

Due to the age of the building it is wise to perform periodical health checks to the concrete elements. This should include tests for concrete strength, cover depth, carbonation, chlorides and HAC. It would appear that these tests have never been performed to this building and therefore we recommend engaging a specialist contractor within the next 24 months who will be able to perform the tests and provide a interpretive report. The fire resistance of the structure is not confirmed until the cover meter tests are completed.

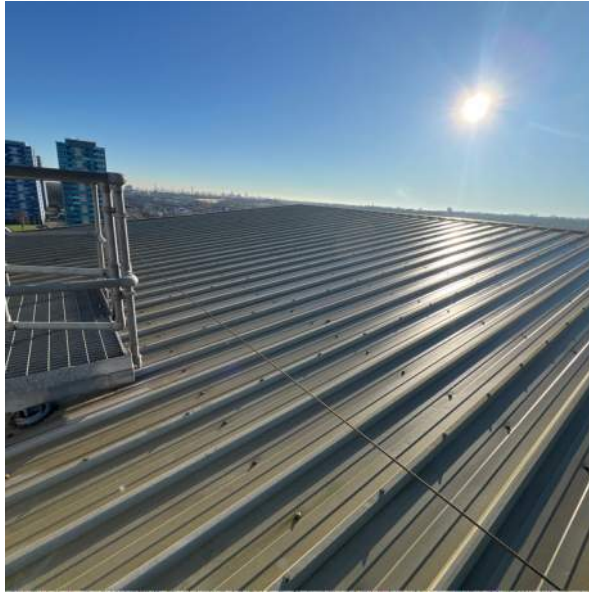
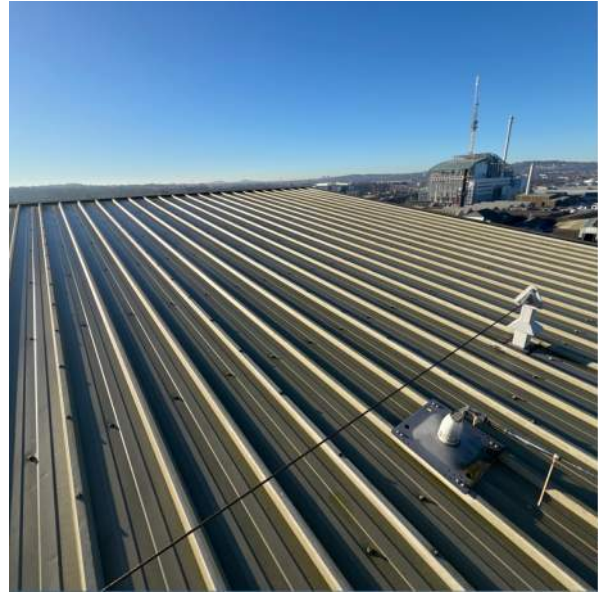
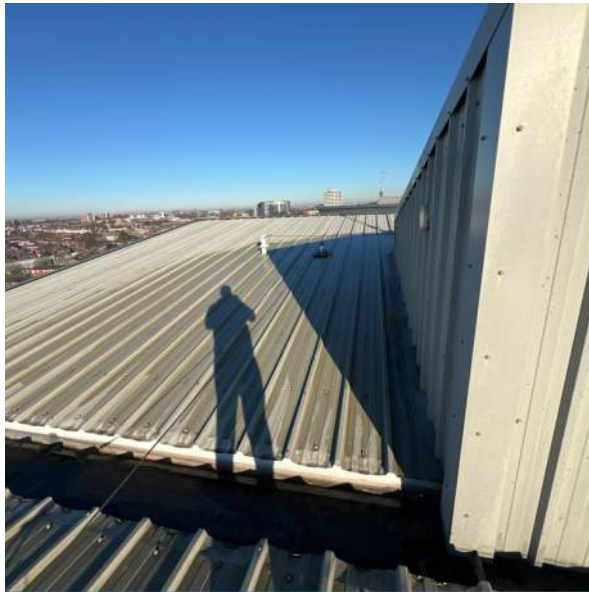
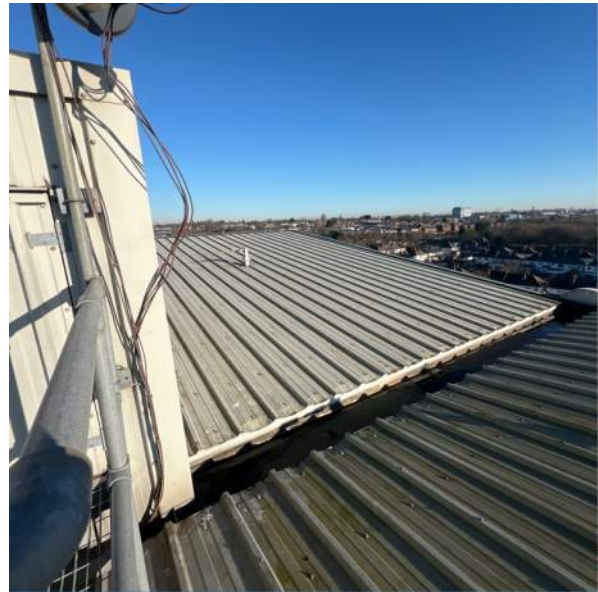
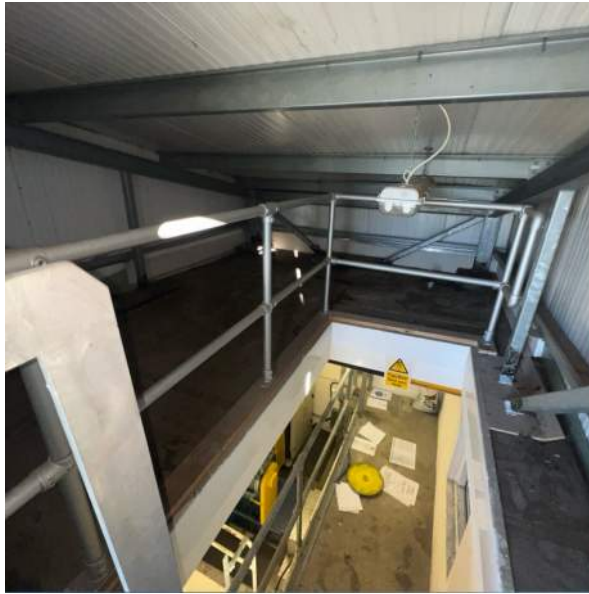
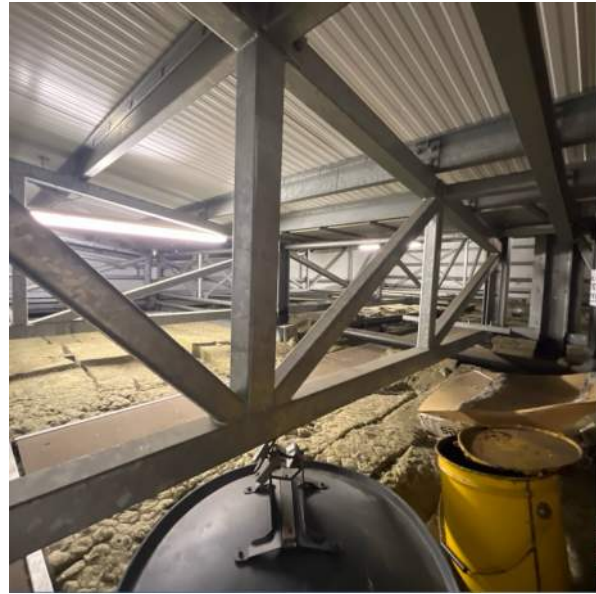
## Main Roof

Comments: A pitched roof constructed above existing original flat roof slab. Steel frame supporting purlins with aluminium standing / mineral wool core profiled panels.  
160mm thick RC core walls noted in motor room.

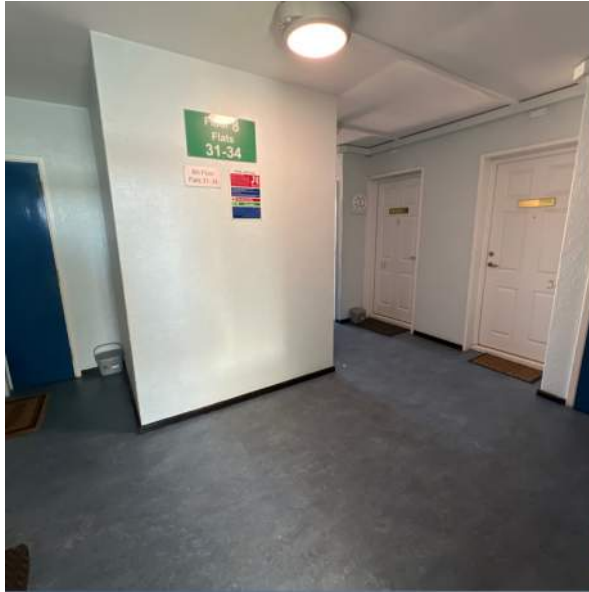
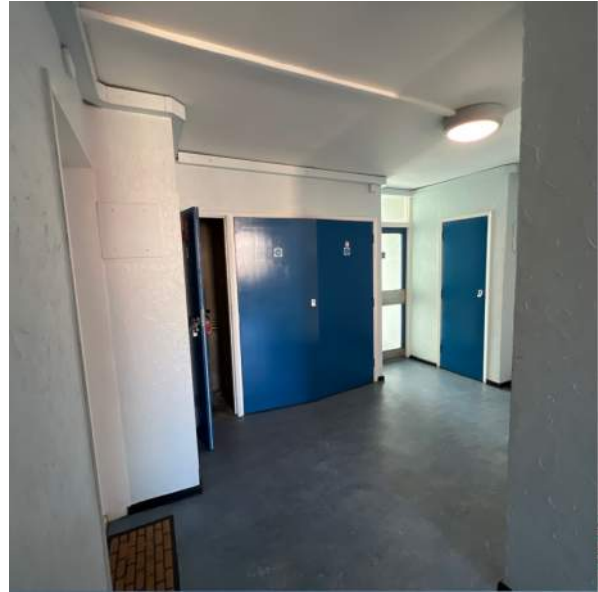
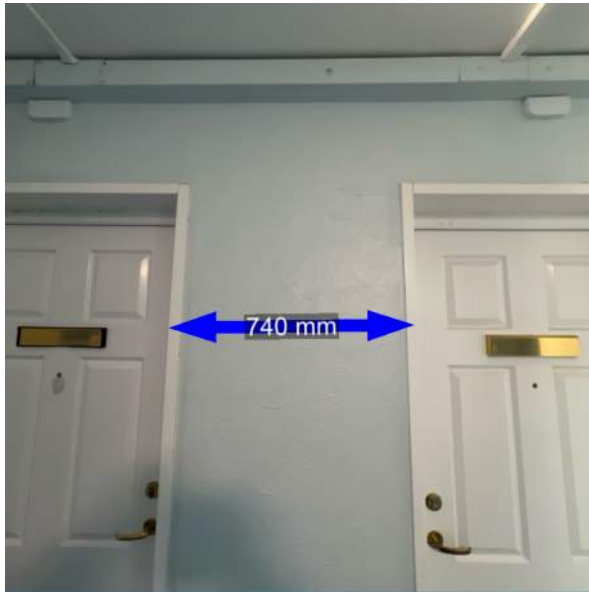
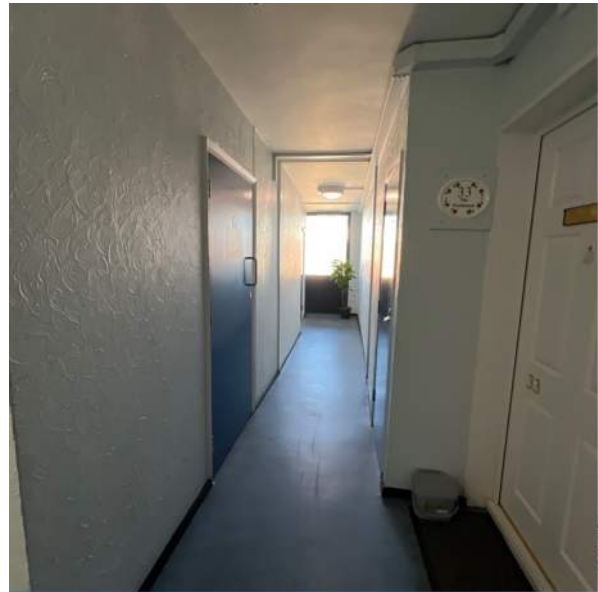
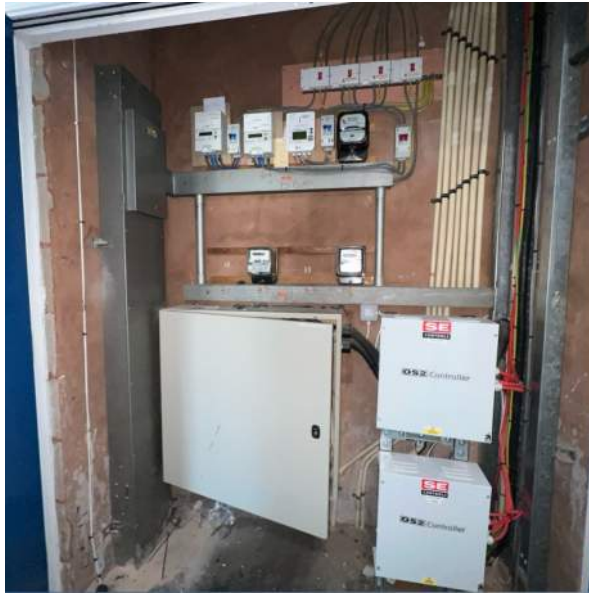
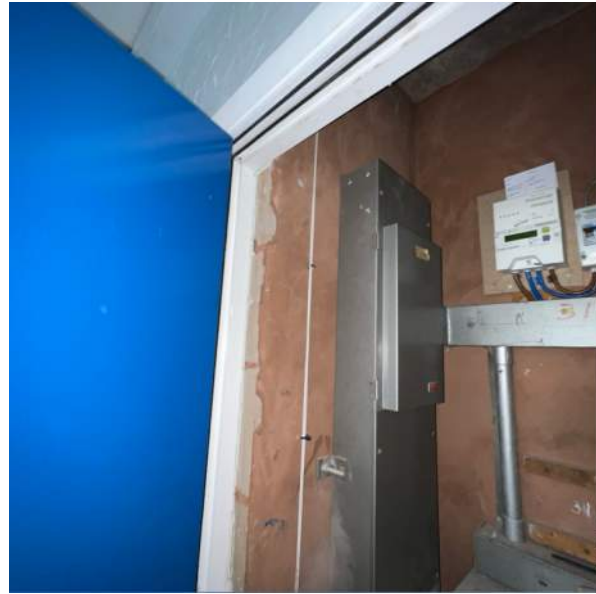
## 8th Floor Hallway

Comments: No jams or distortions noted to hallway doors to indicate any serviceability issues. Generally walls covered with finishes in hallway, likely to consist a mixture of concrete shear walls, embedded columns and masonry infill walls. Limited structure exposed. Concrete walls noted via dry riser cupboards. Electrical cupboard shows block infill walls with plaster.

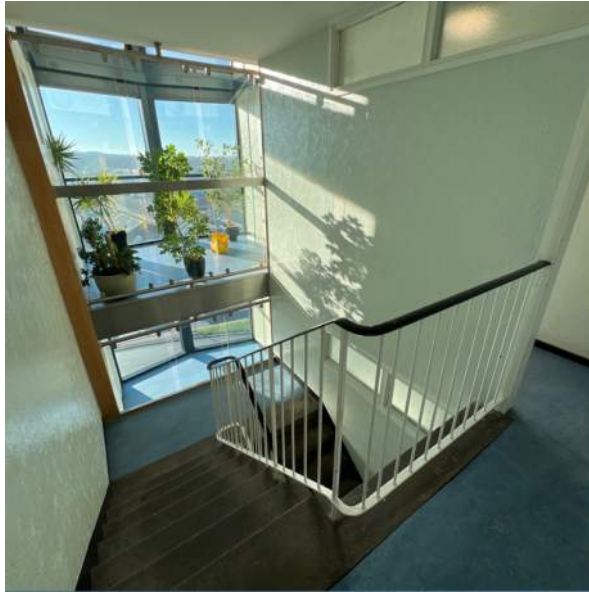
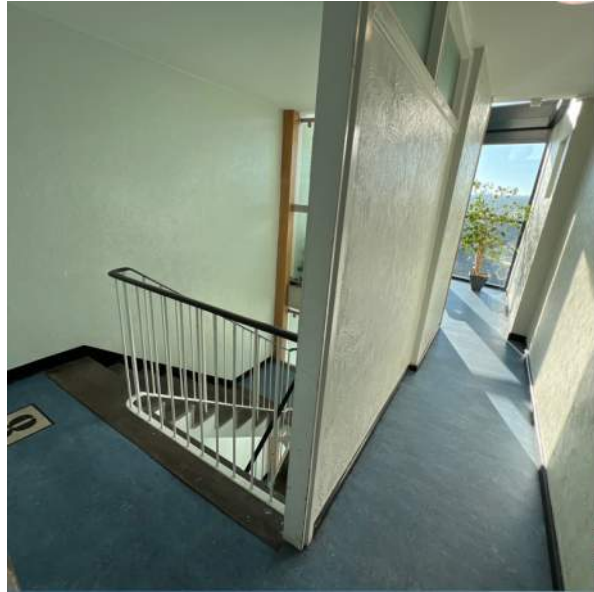
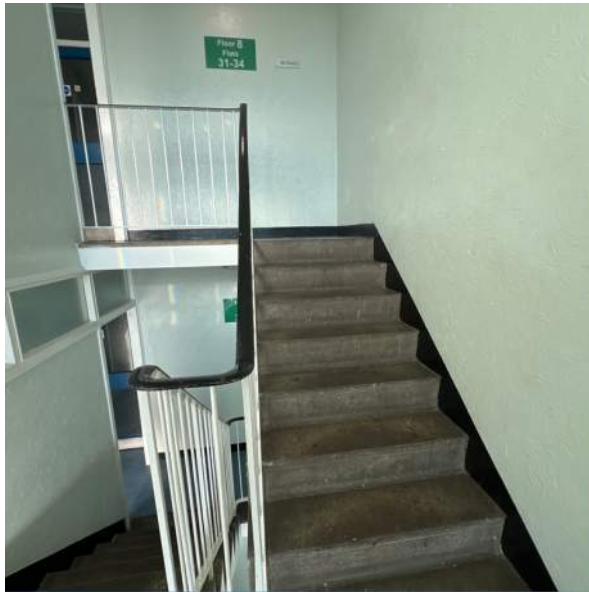
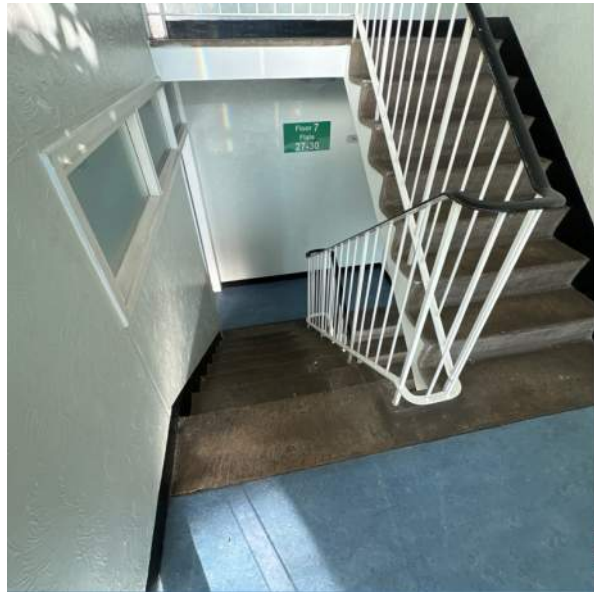
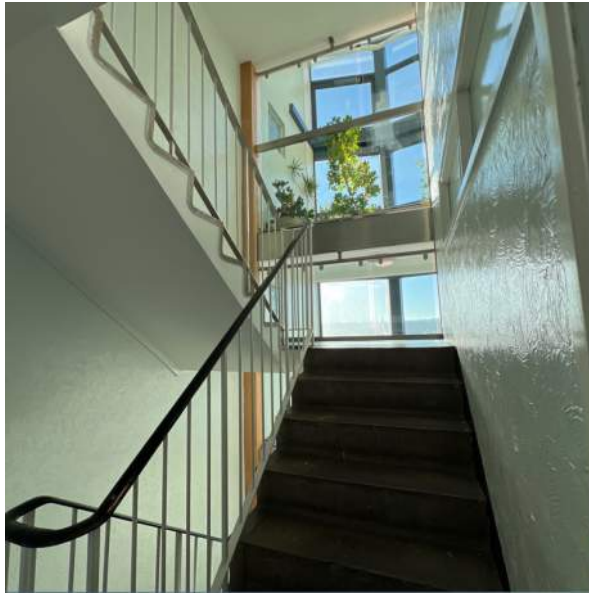
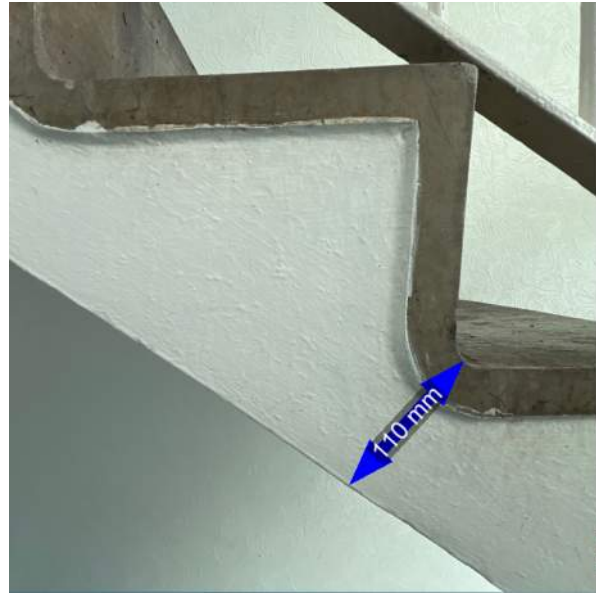
## 8th Floor Staircases

Comments: Insitu concrete stairs with steel hand railing fixed to stairs. Walls and floors appear to be fairly level.  
Stair walls covered with finishes however these would likely form the main concrete shear core walls. Partly infill/non-load bearing wall noted for one side of stair case wall.

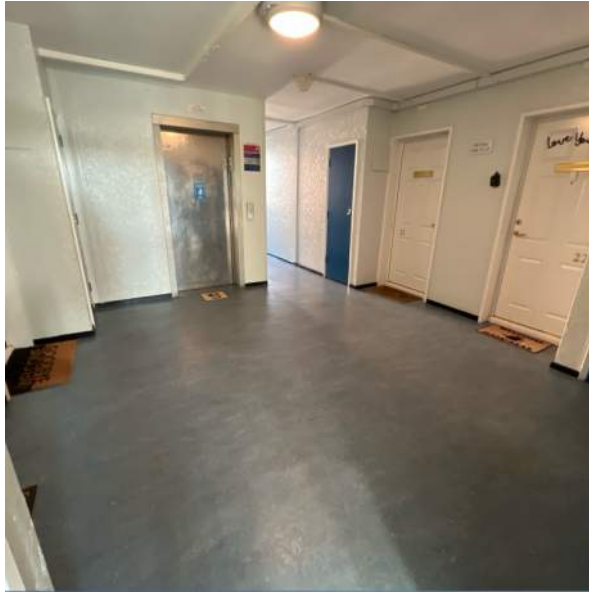
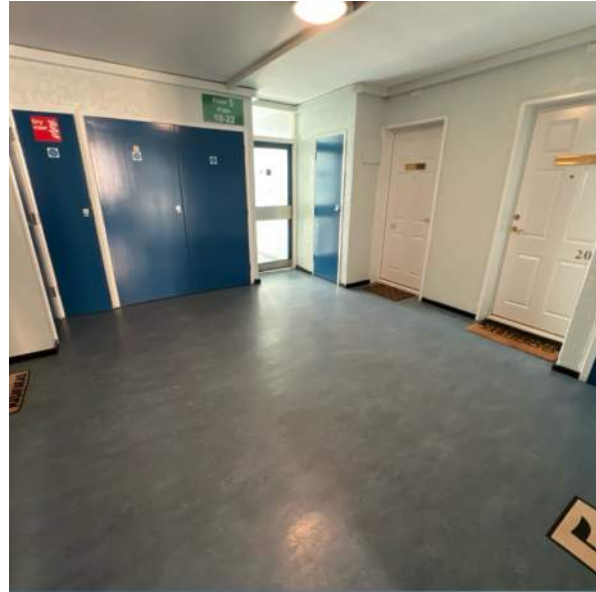
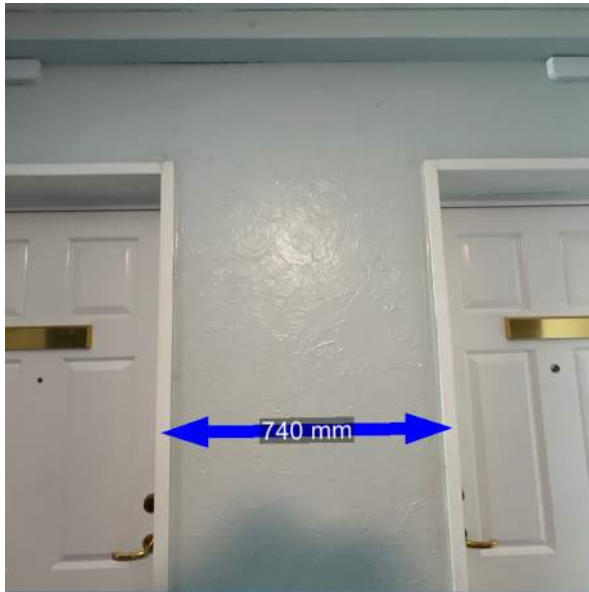
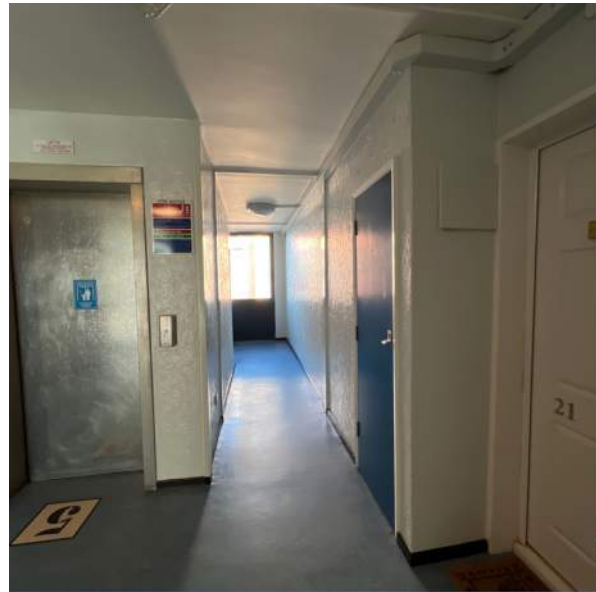
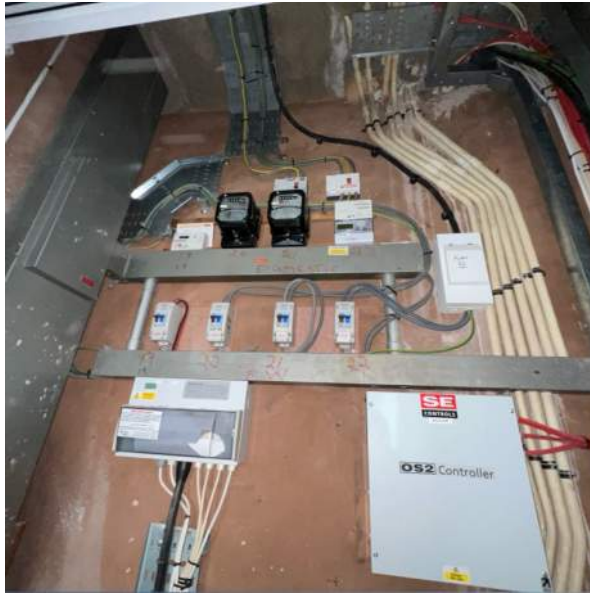
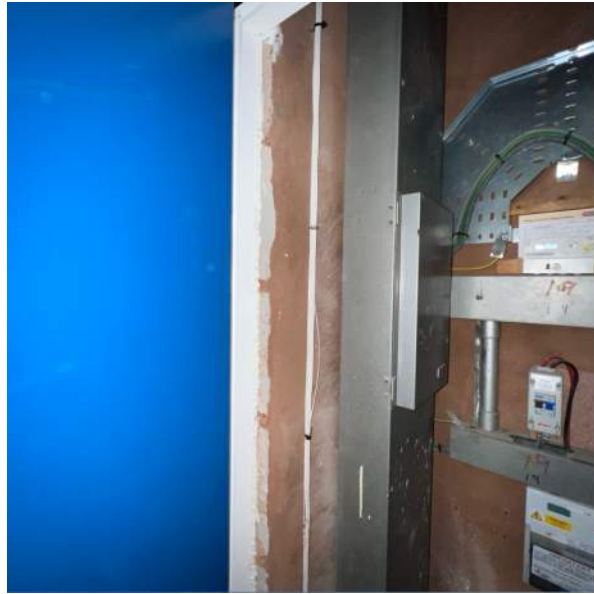
## 5th Floor Hallway

Comments: No jams or distortions noted to hallway doors to indicate any serviceability issues. Generally walls covered with finishes in hallway, likely to consist a mixture of concrete shear walls, embedded columns and masonry infill walls. Limited structure exposed. Concrete walls noted via dry riser cupboards. Electrical cupboard shows block infill walls with plaster.

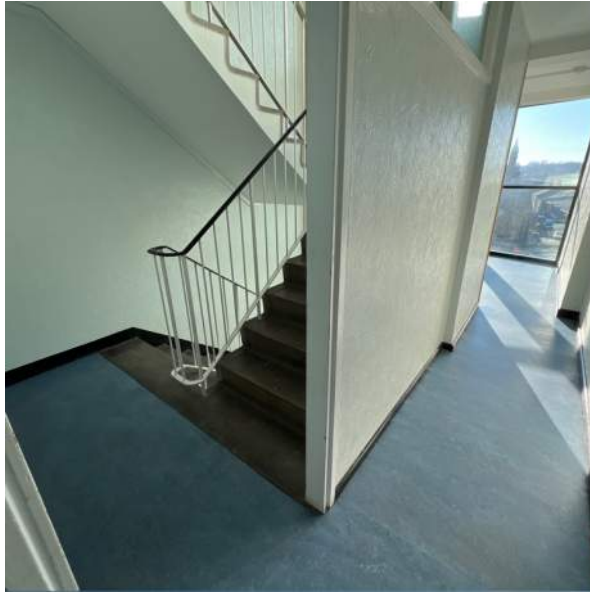
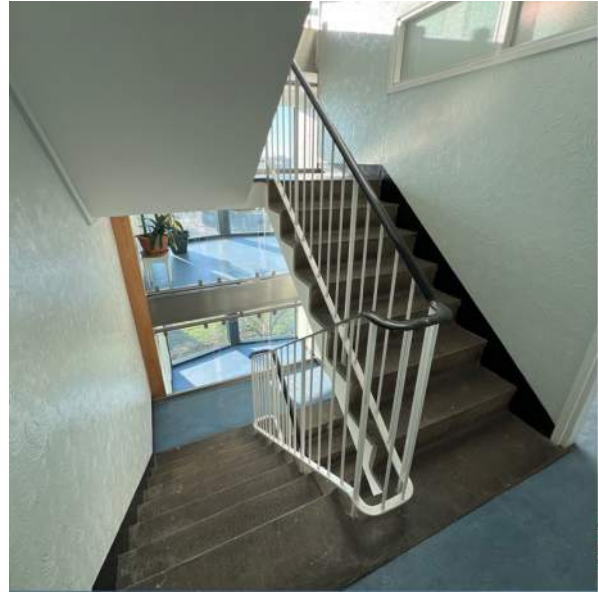
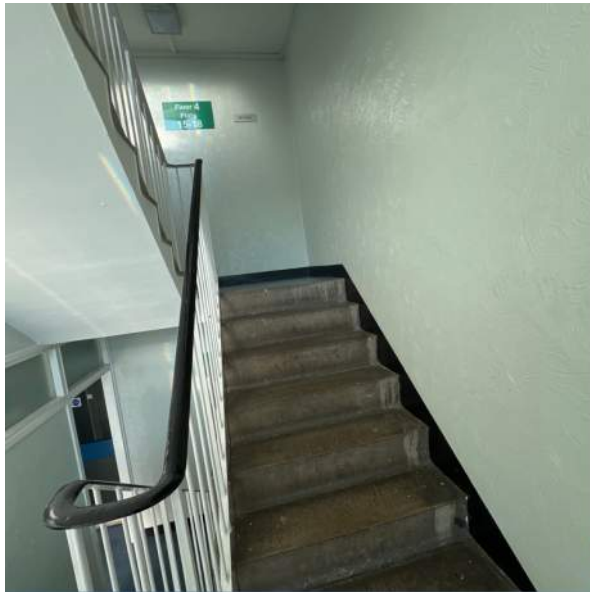
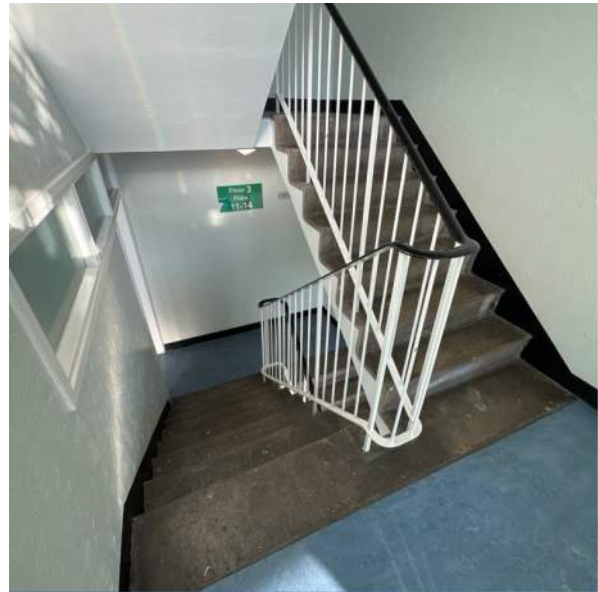
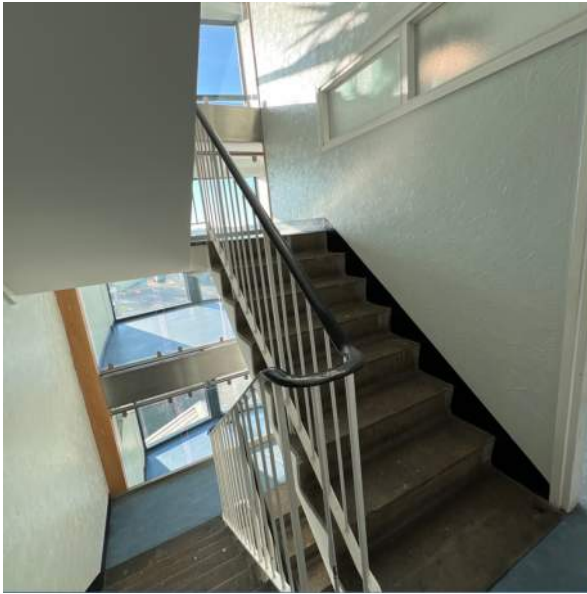
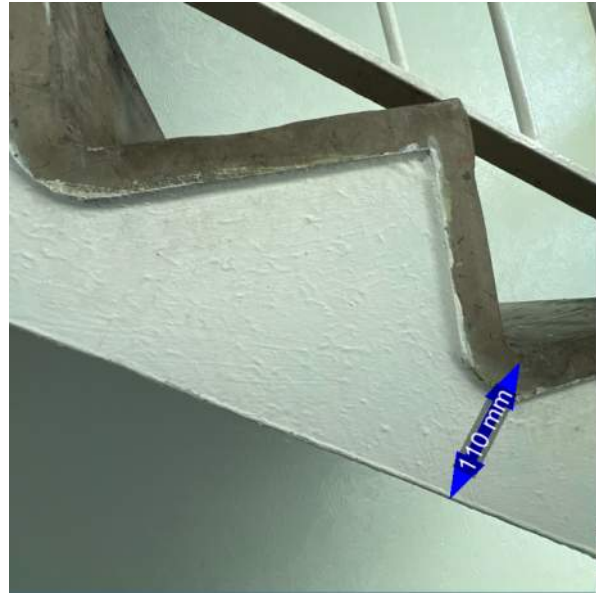
## 5th Floor Staircases

Comments: Insitu concrete stairs with steel hand railing fixed to stairs. Walls and floors appear to be fairly level.  
Stair walls covered with finishes however these would likely form the main concrete shear core walls. Partly infill/non-load bearing wall noted for one side of stair case wall.

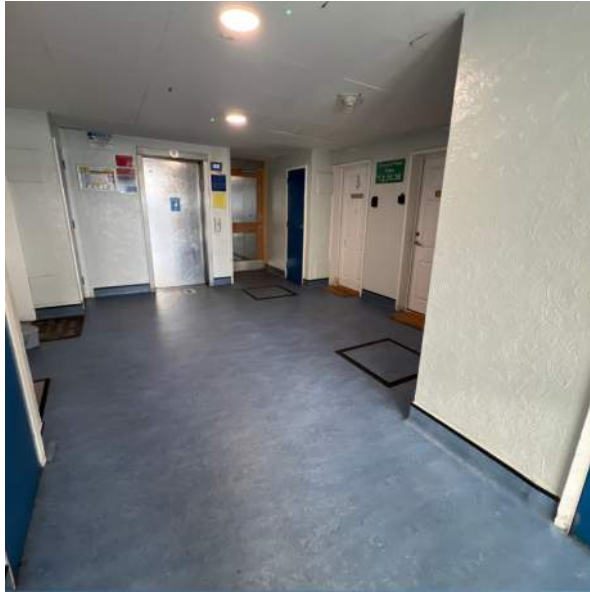
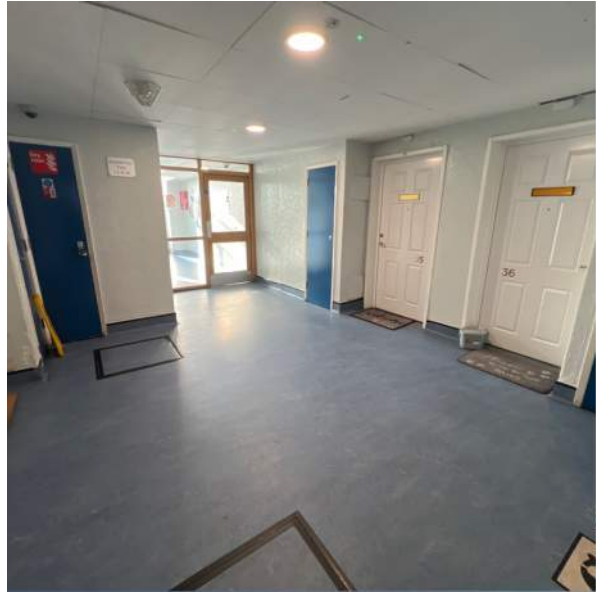
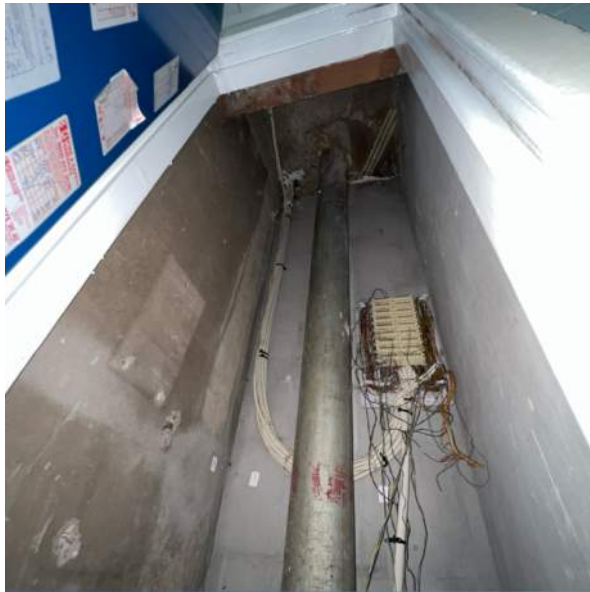
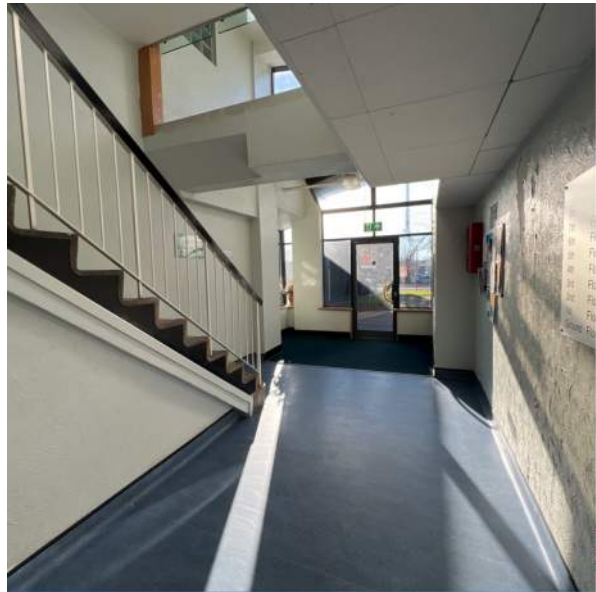
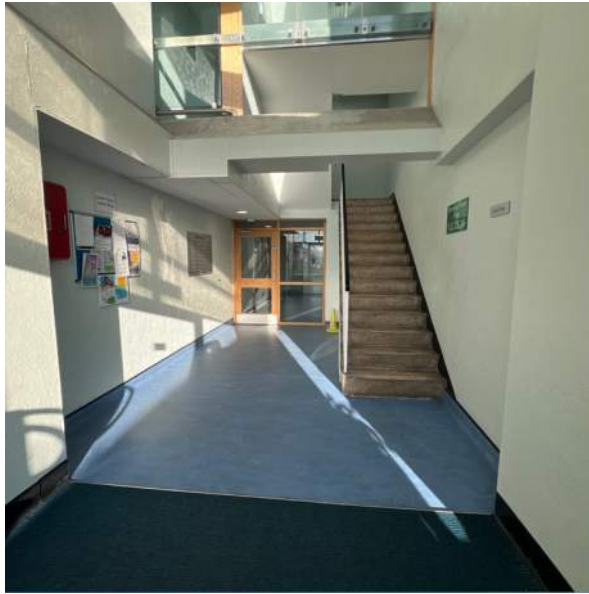
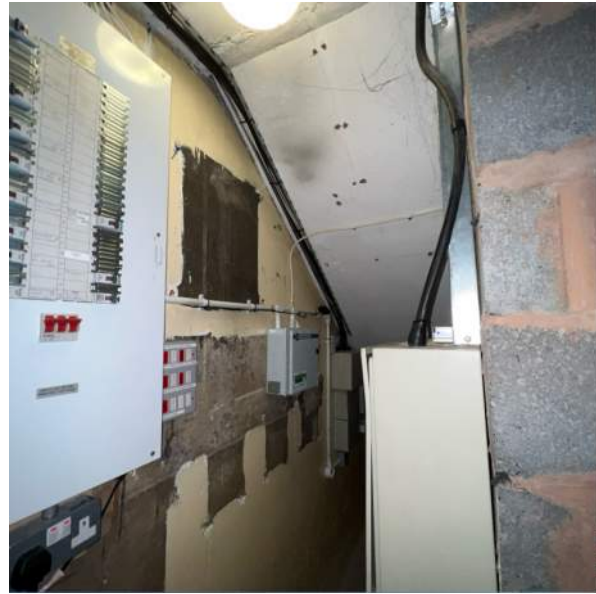
## Ground Floor Hallway

Comments: No jams or distortions noted to hallway doors to indicate any serviceability issues. Generally walls covered with finishes in hallway, likely to consist a mixture of concrete shear walls, embedded columns and block infill walls. Limited structure exposed. Partly visible concrete walls noted via riser cupboard and under stair case closet.

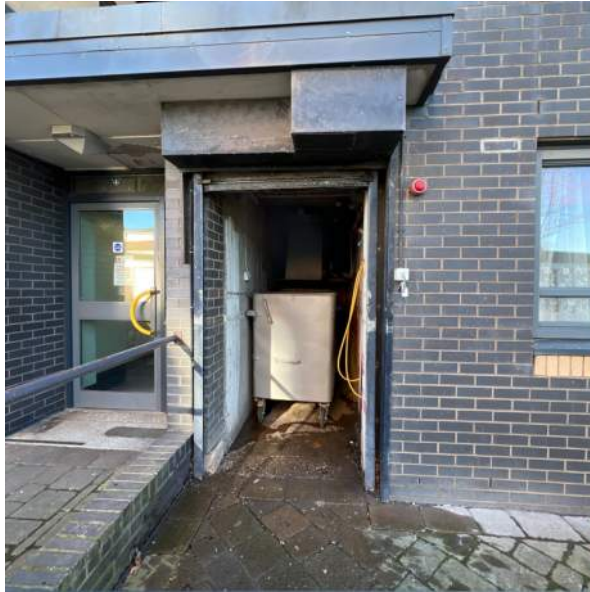
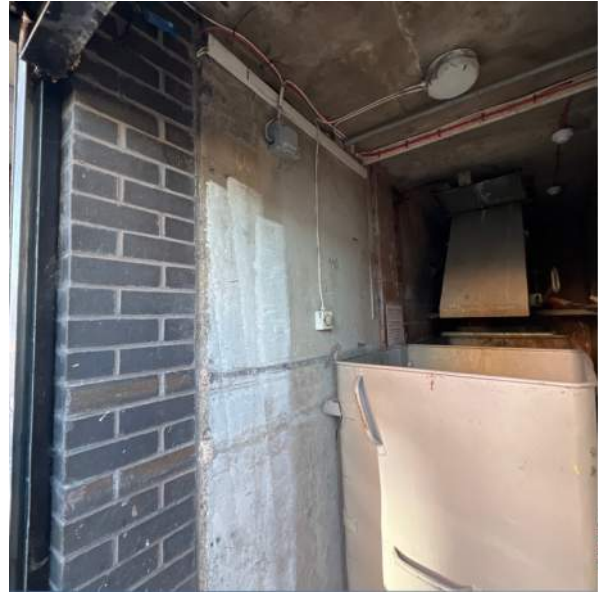
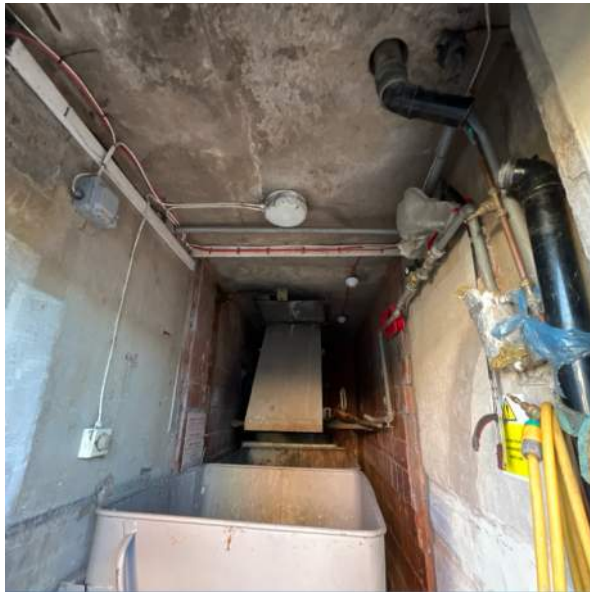
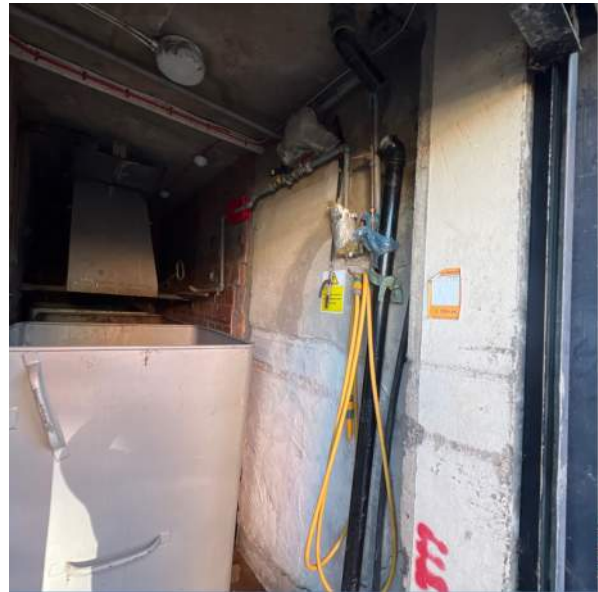
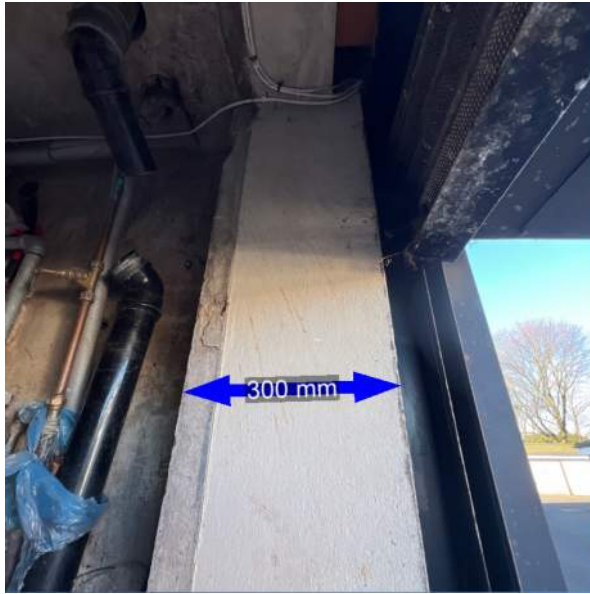
## Binstore

RC shear walls noted in binstore.

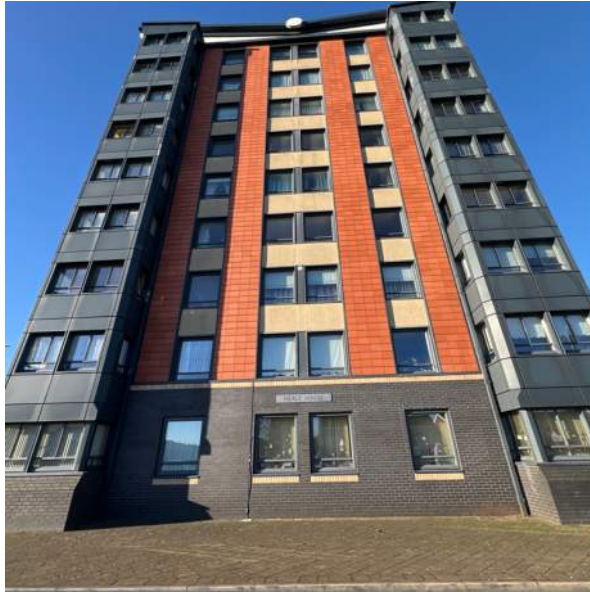
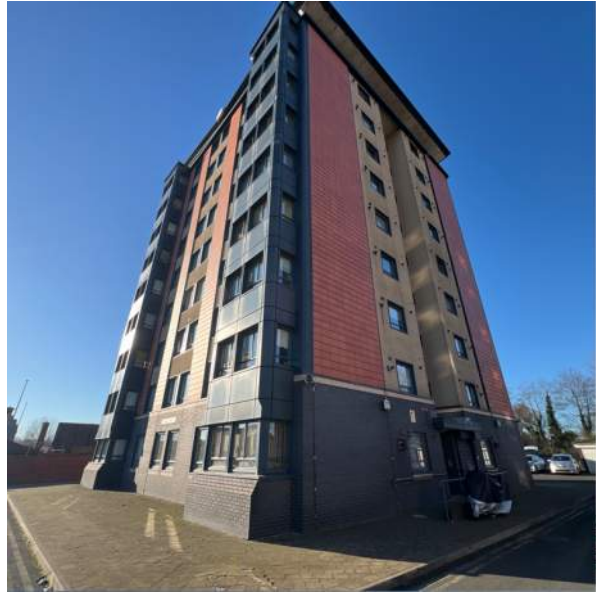
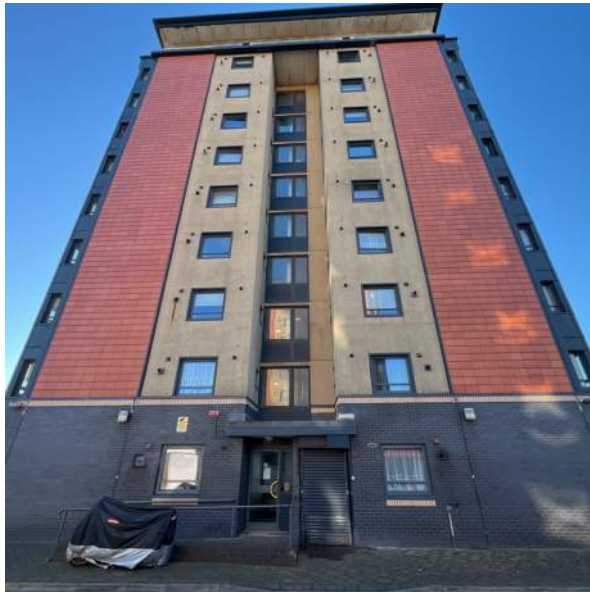
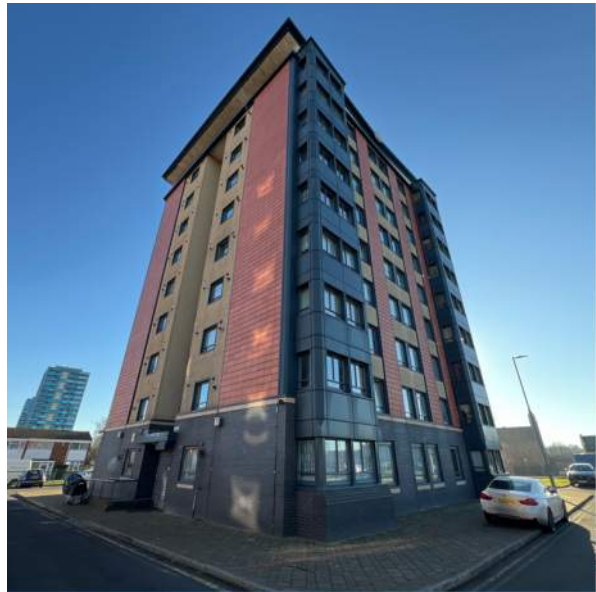
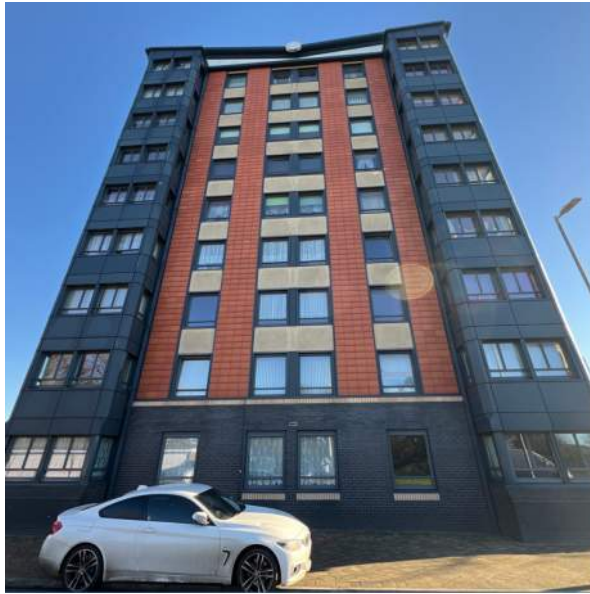
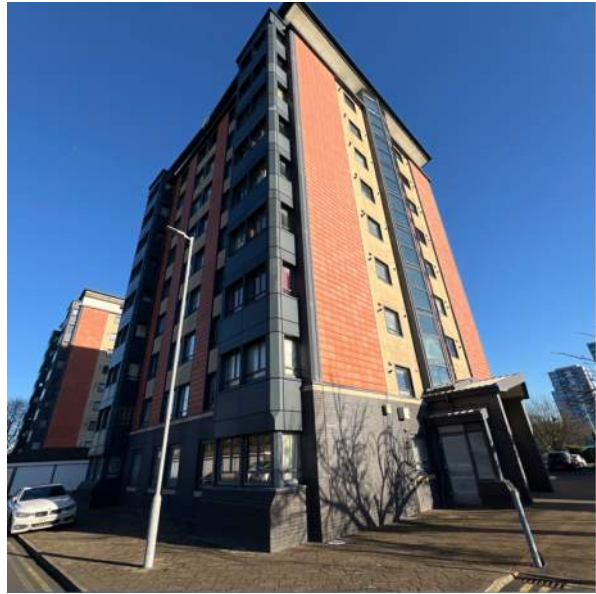
## Elevations

Ground floor level consists of brickwork. Remaining elevations consist of a mixture of rendered and cladded facade.
