**FIRNTEC**  
BUILDING COMPLIANCE

VISUAL STRUCTURAL APPRAISAL

Nelson House

Upper Church Lane  
Tipton  
DY4 9PW

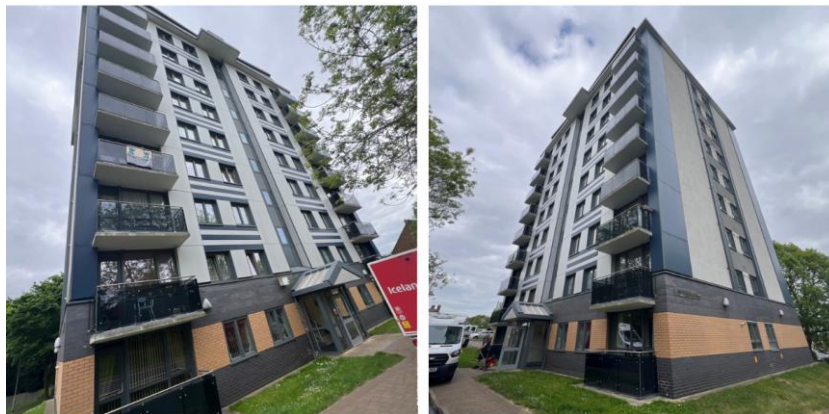
Figure 9 and 10: Building Elevations

The exterior elevations were generally in ok condition and no significant structural defects were noted to the cladding panels. There were no significant cracks or tell-tale signs of any significant structural movement noted at the time of our inspection.

The exterior panels were noted to be plumb with no signs of significant bowing, bulging or leaning noted to the panels indicating failed fixings however their presence and condition cannot be confirmed.

There are balconies at each level which are formed of cantilevered RC slabs tied into the main frame. During the 2017 refurbishment they had steel balustrades with glazed infill installed.

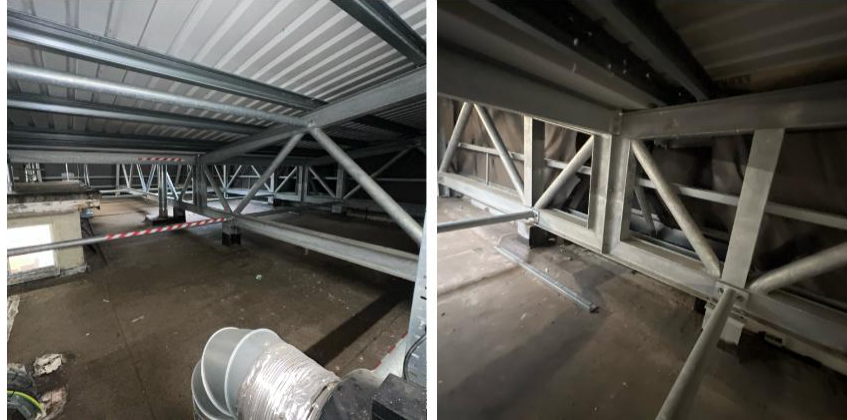
Figure 11 and 12: Lightweight steel frame

who completed the works in 2017 who Lovell Partnerships. No signs of water ingress of that the roof is not performing as intended.

The roof structure is a lightweight frame supported off steel stubs supported off the flat roof. It is not clear where these point loads bear and should be confirmed with the contractor. Note that if they align with columns under then the weight of the new roof is insignificant compared to the overall weight of the RC structure.

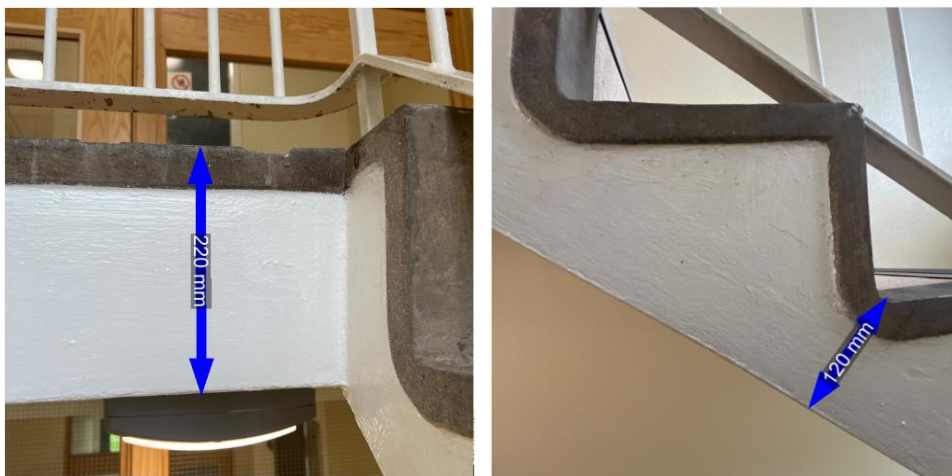
Figure 14 and 15: RC Staircase stringer and slab

The stair stringer was noted to be 130mm thick which seems slim, certainly short of modern standards. A cover test is required to check the resistance of the concrete section in the event of a fire.

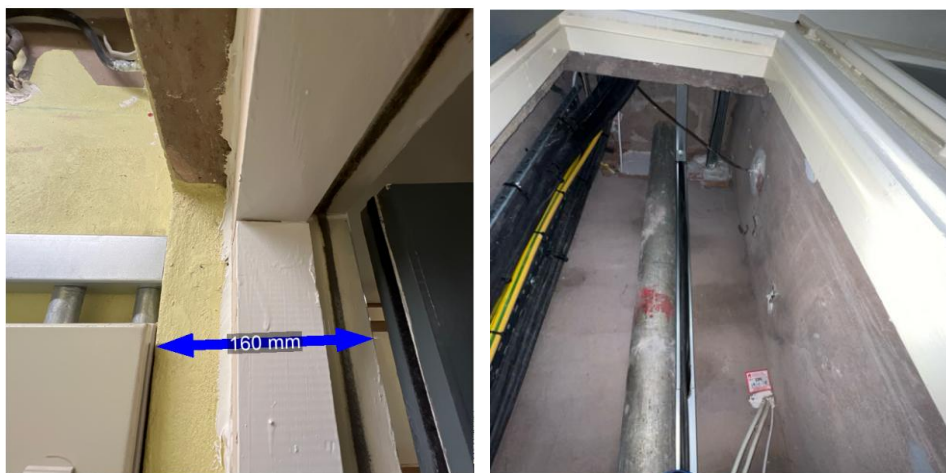
Figure 16 and 17: RC walls

There were vertical concrete walls supporting the floor plates at every level. The elements visible matched the floor layout in Figure 6. The walls appear continuous from ground to roof with no transfer structure. The overall condition of the structure observed is good.

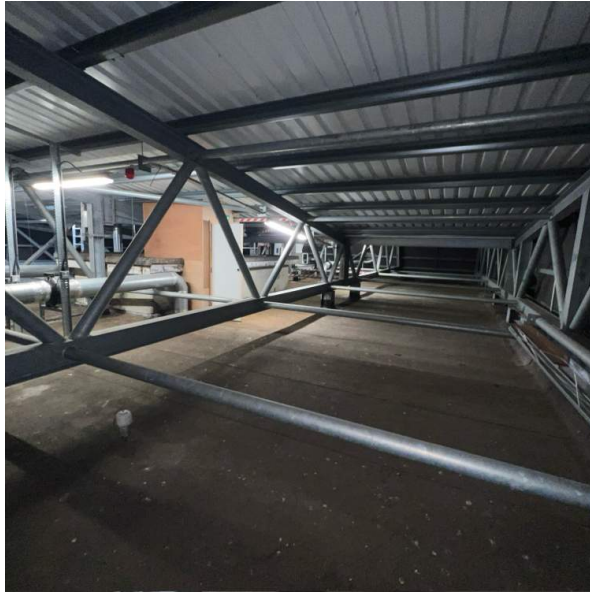
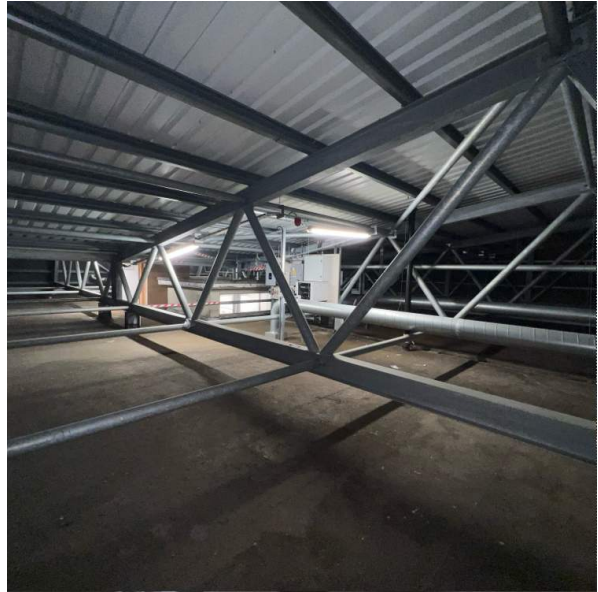
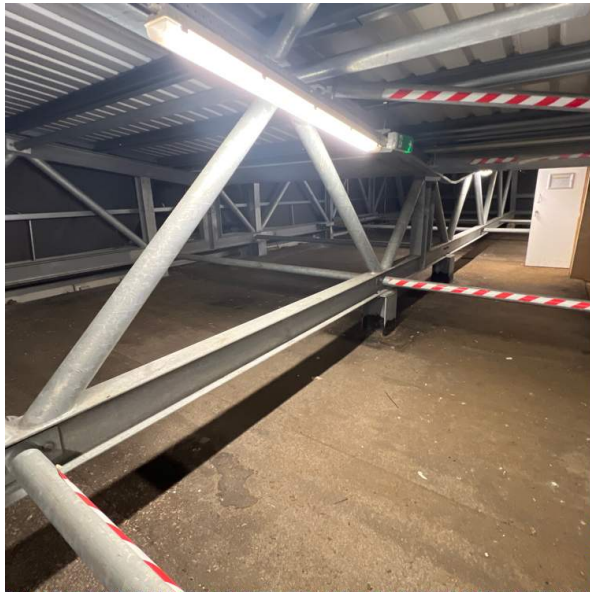
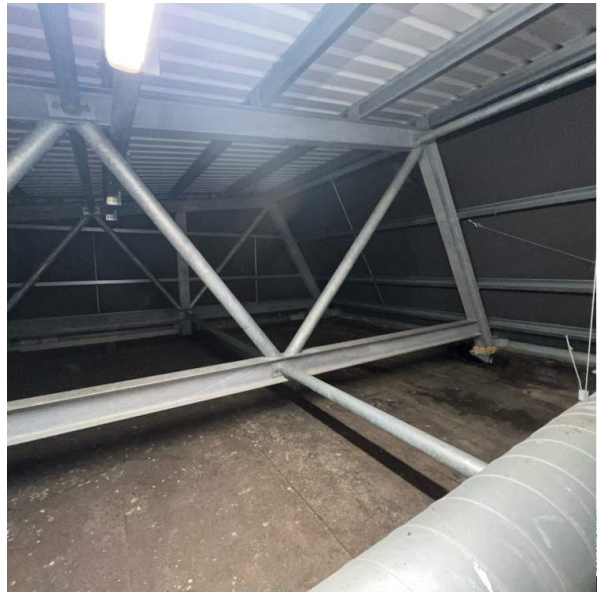
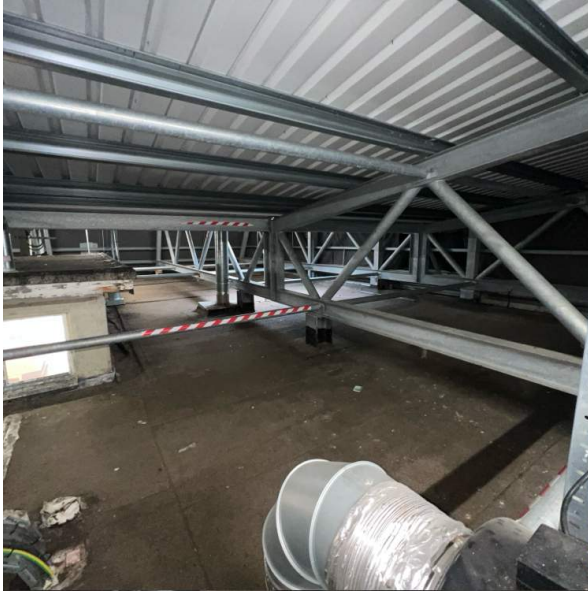
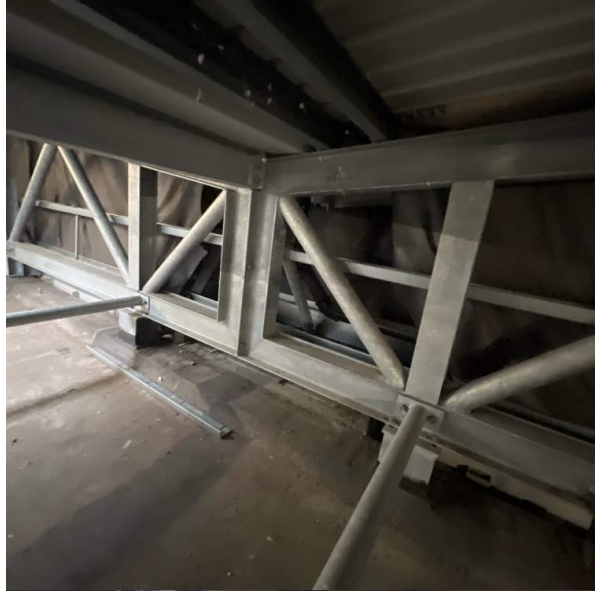
## Main Roof

Comments: Flat roof, RC concrete slab with insulated PIR board and felt coverings.  
Steel frame structure supporting pitched roof above constructed on originally flat roof.

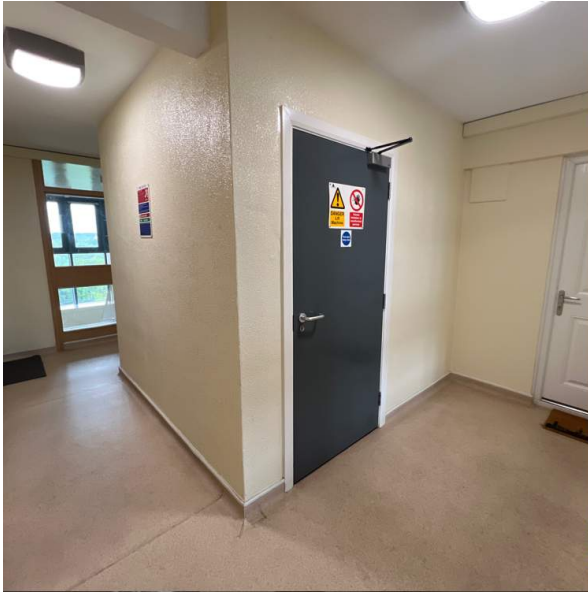
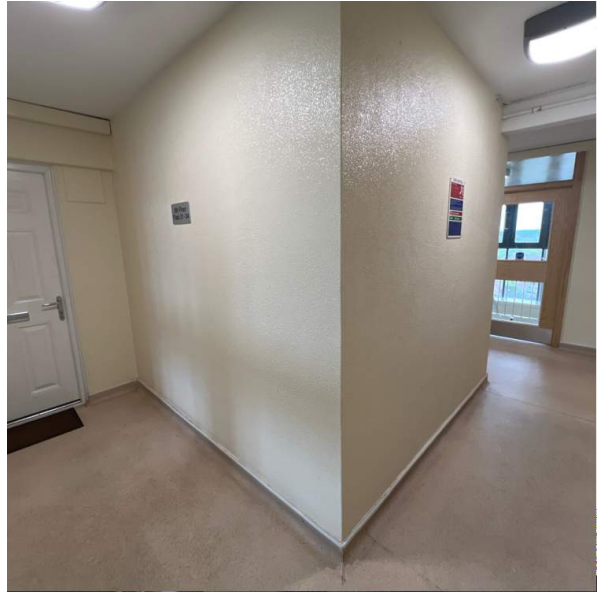
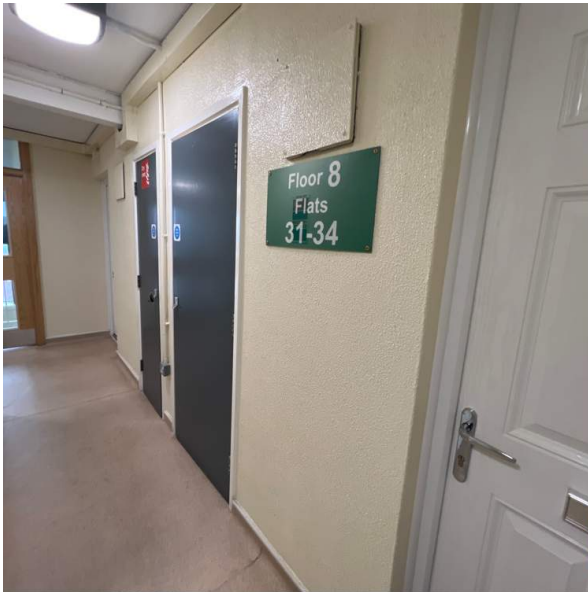
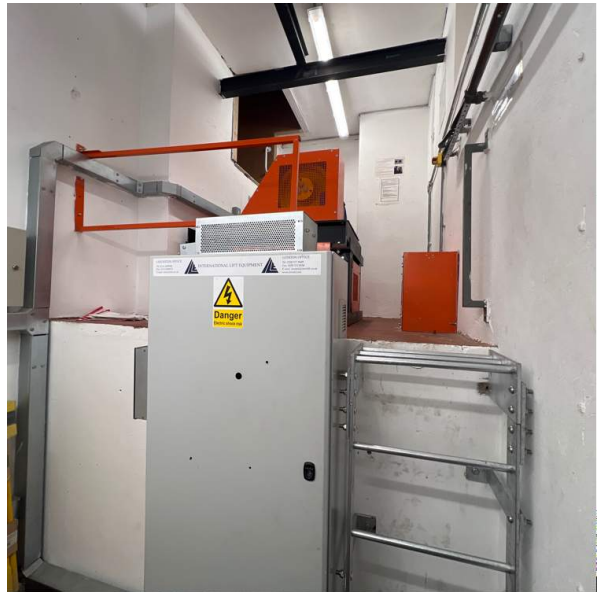
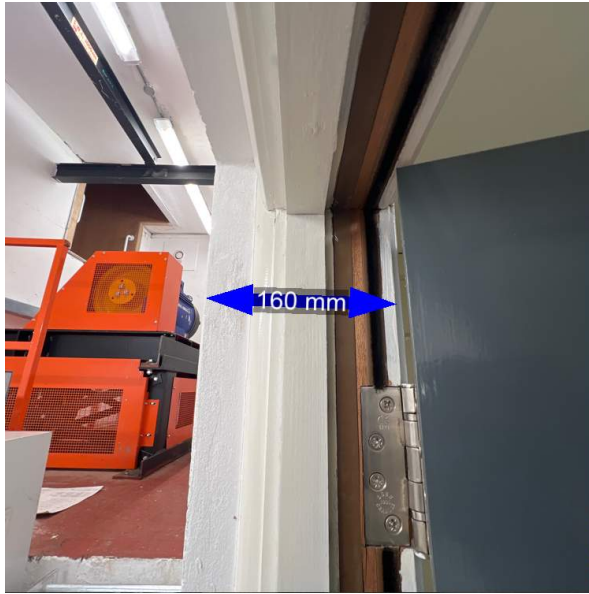
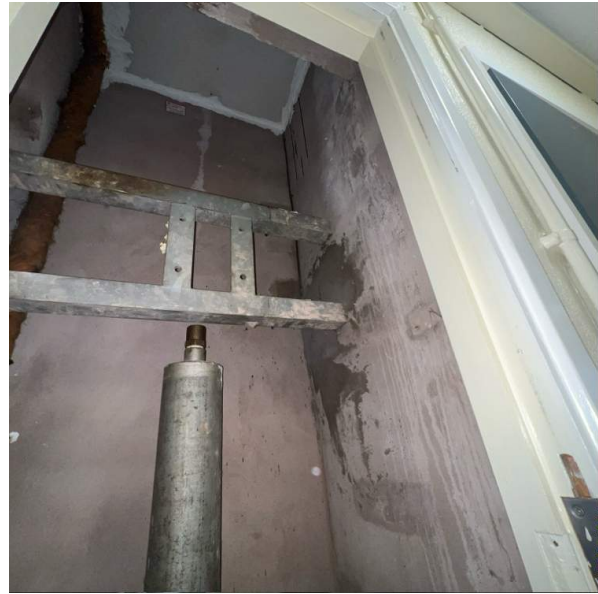
## 8th Floor Hallway

Comments: No jams or distortions noted to hallway doors to indicate any serviceability issues. Generally walls covered with finishes in hallway, likely to consist a mixture of concrete shear walls, embedded columns and masonry infill walls. Limited structure exposed. Concrete walls and infill masonry (non-load bearing) walls noted in riser cupboards and lift motor room. Concrete walls noted to be approx. 160mm thick.

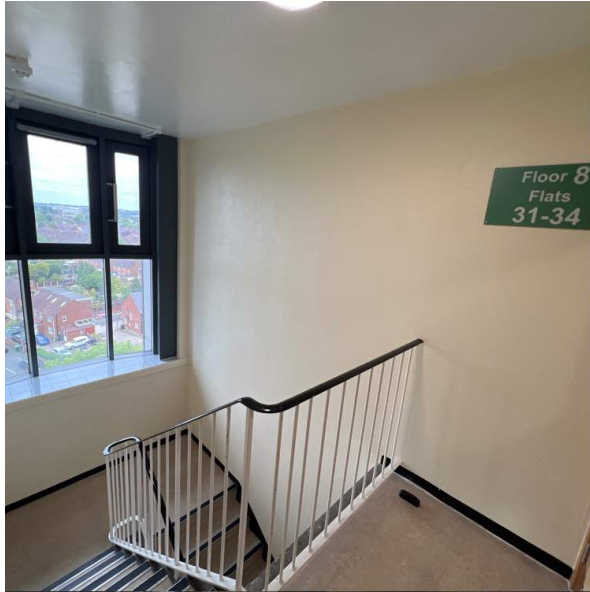
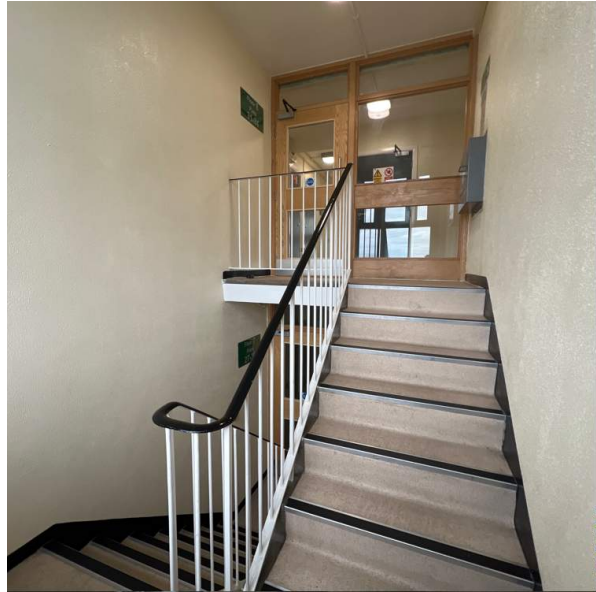
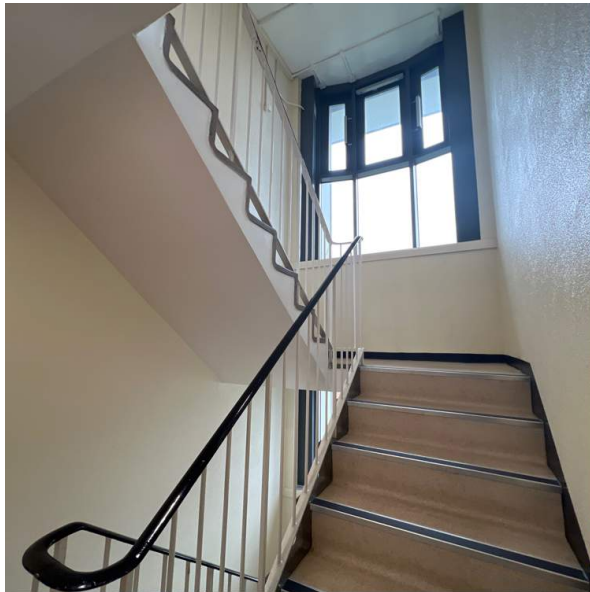
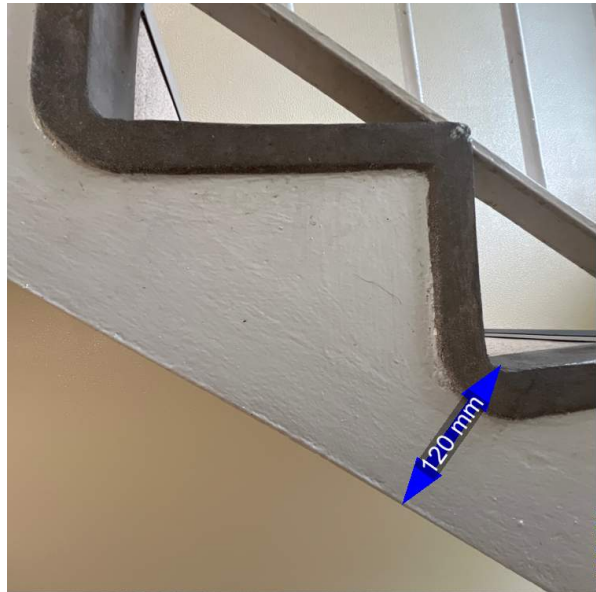
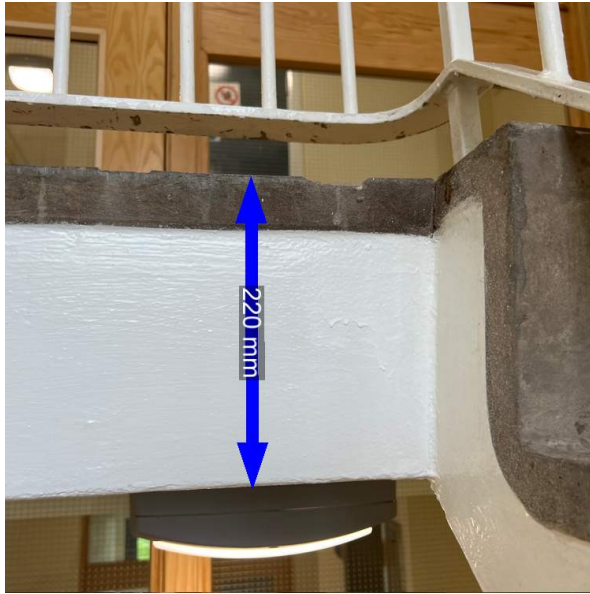
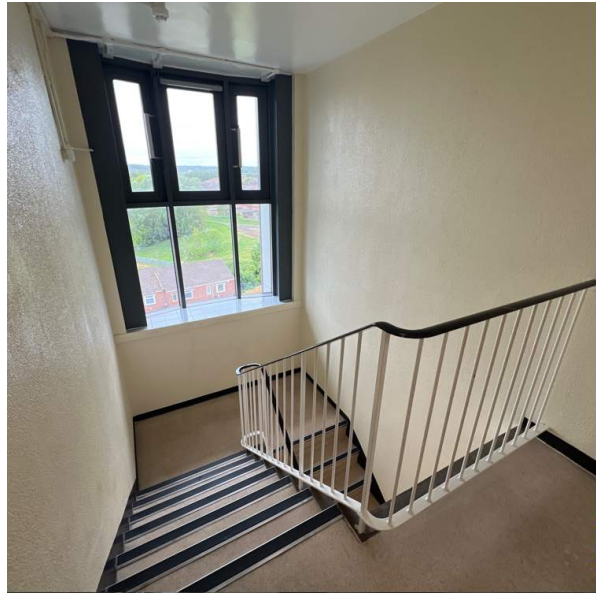
## 8th Floor Staircases

Comments: Insitu concrete stairs with steel hand railing fixed to stairs. Walls and floors appear to be fairly level.  
Stair walls covered with finishes however these would likely form the main concrete shear core walls.

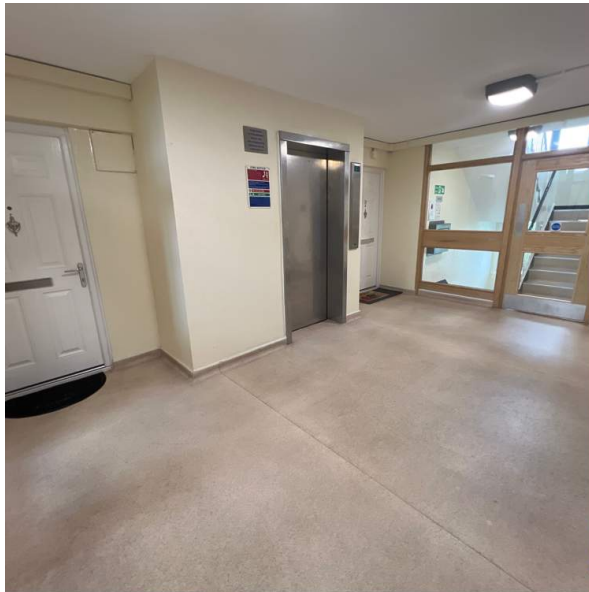
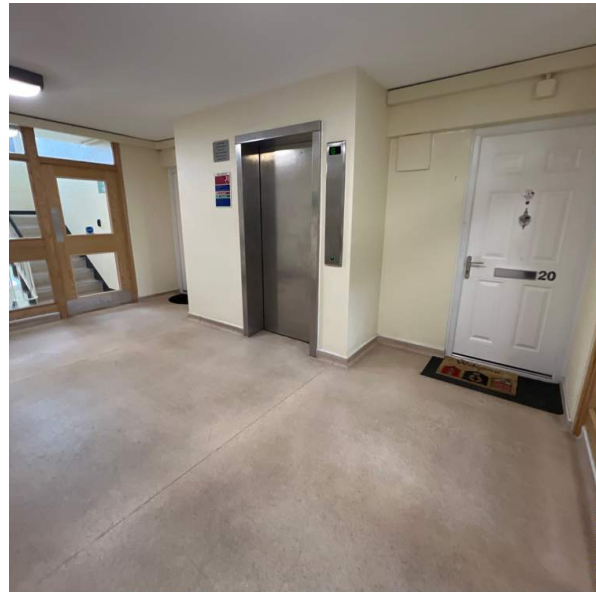
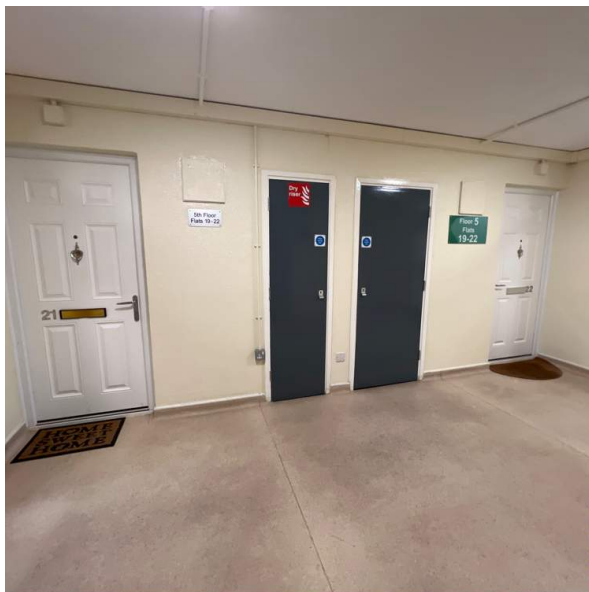
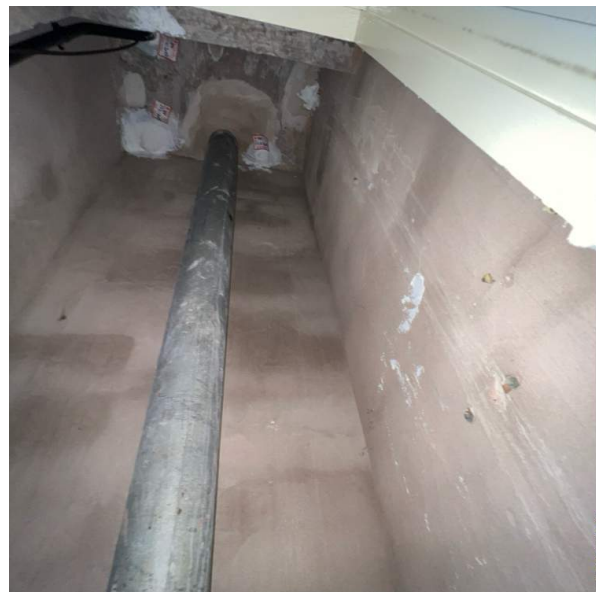
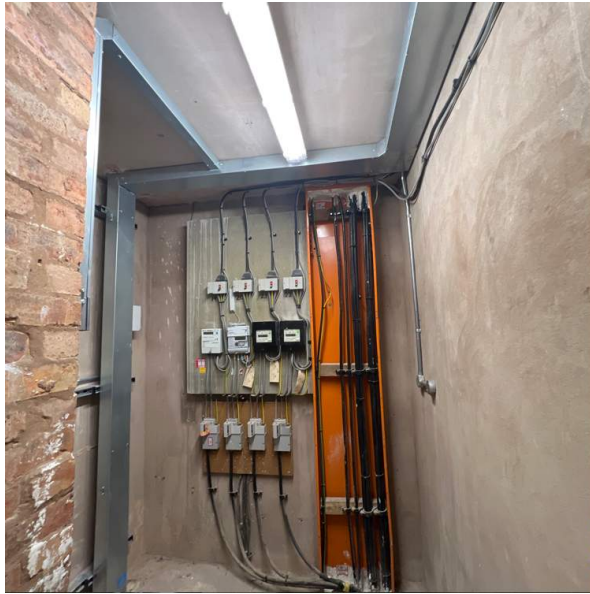
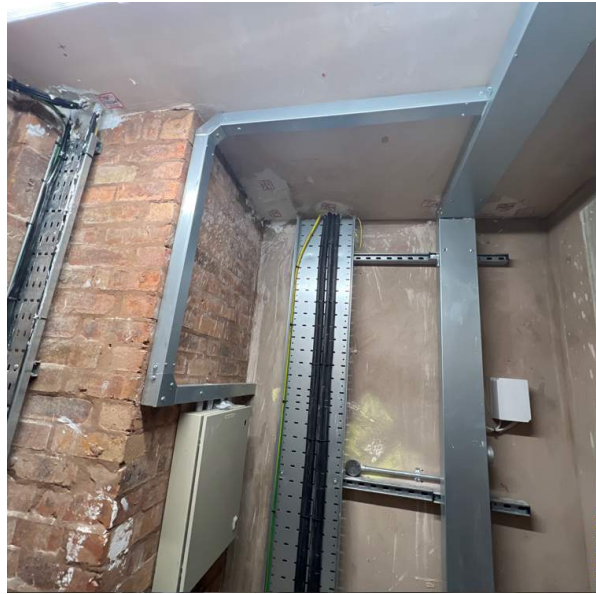
## 5th Floor Hallway

Comments: No jams or distortions noted to hallway doors to indicate any serviceability issues. Generally walls covered with finishes in hallway, likely to consist a mixture of concrete shear walls, embedded columns and masonry infill walls. Limited structure exposed. Concrete walls and infill masonry (non-load bearing) walls noted in riser cupboards. Concrete walls noted to be approx. 160mm thick.

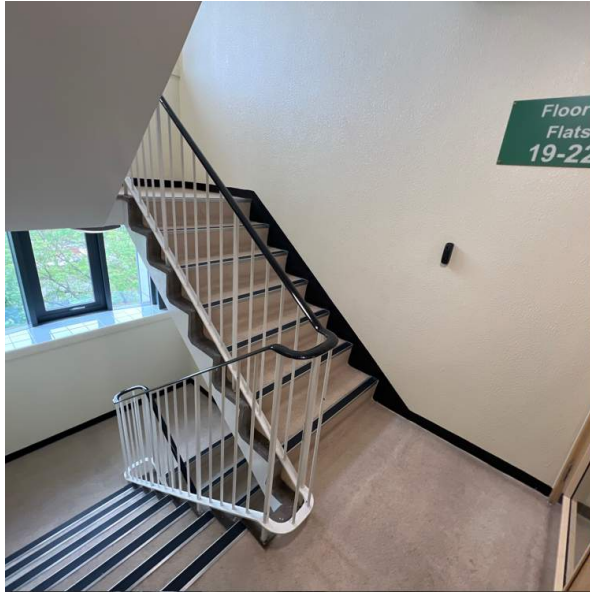
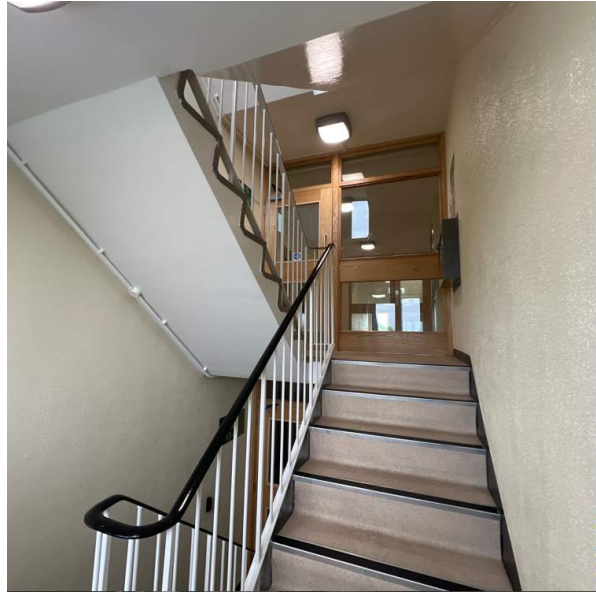
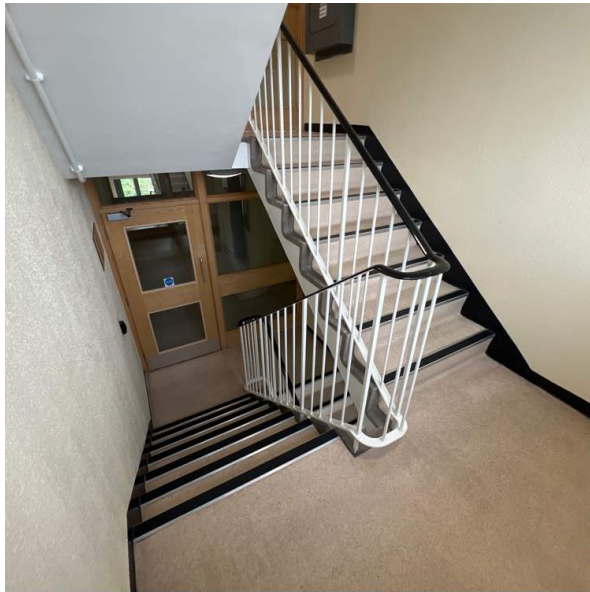
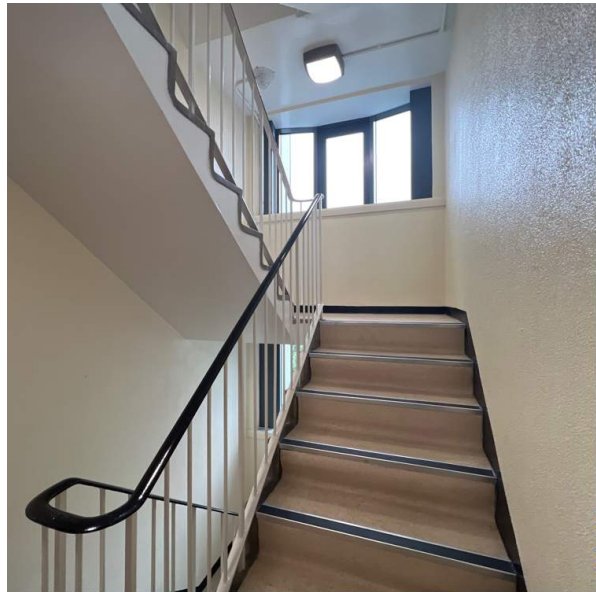
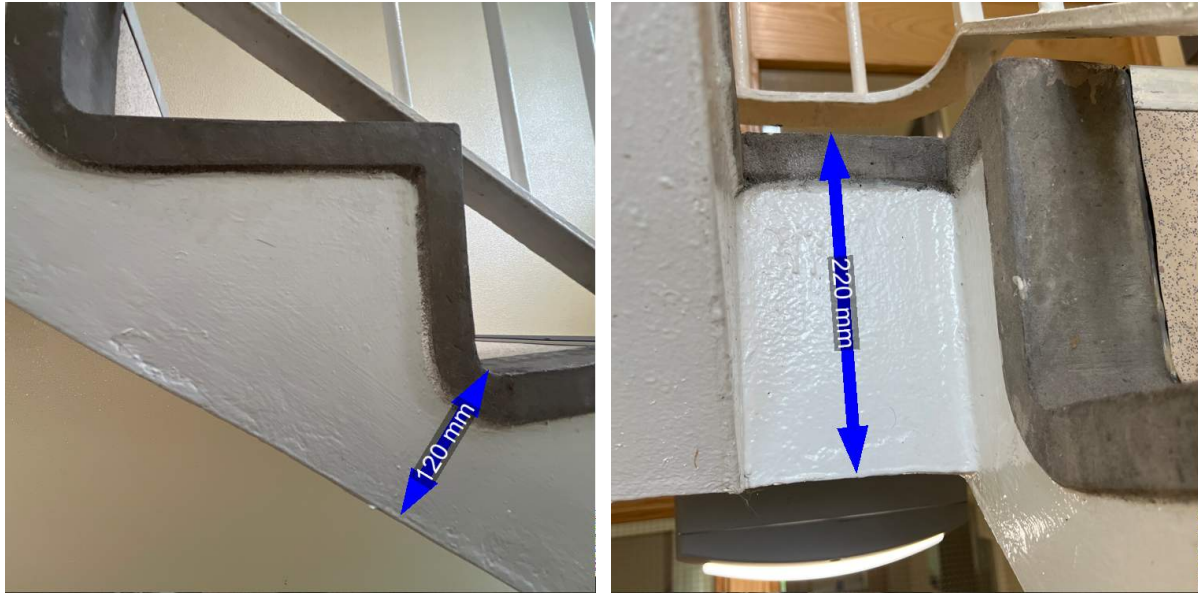
## 5th Floor Staircases

Comments: Insitu concrete stairs with steel hand railing fixed to stairs. Walls and floors appear to be fairly level.  
Stair walls covered with finishes however these would likely form the main concrete shear core walls.

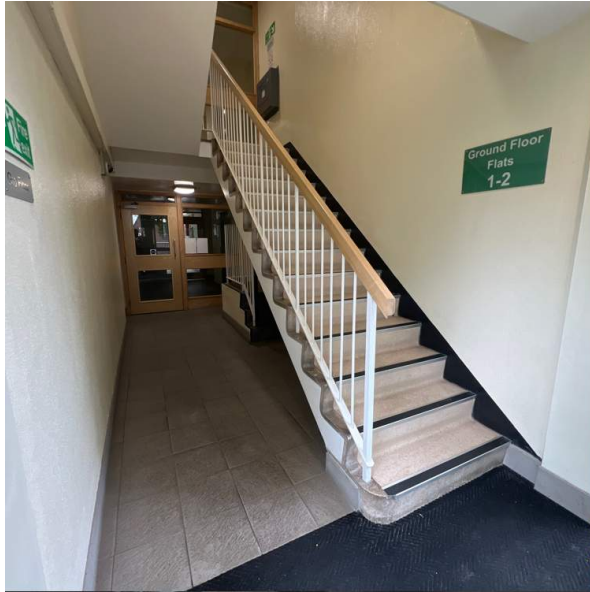
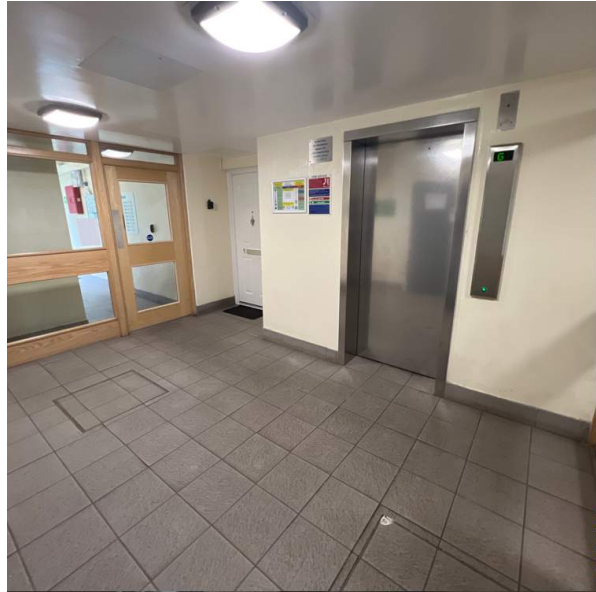
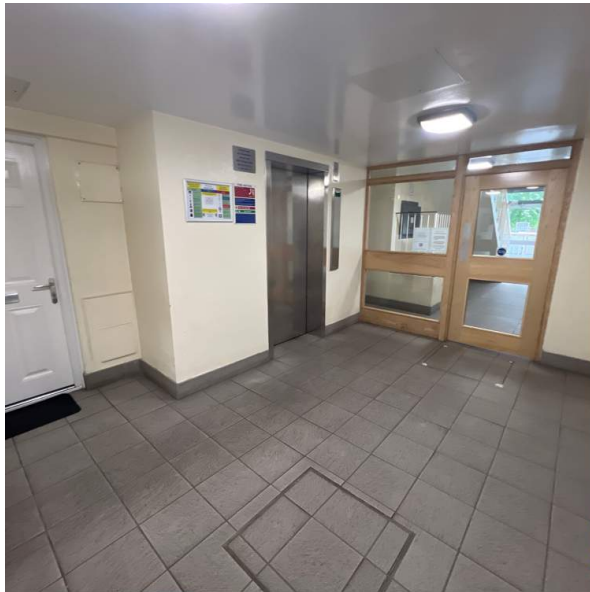
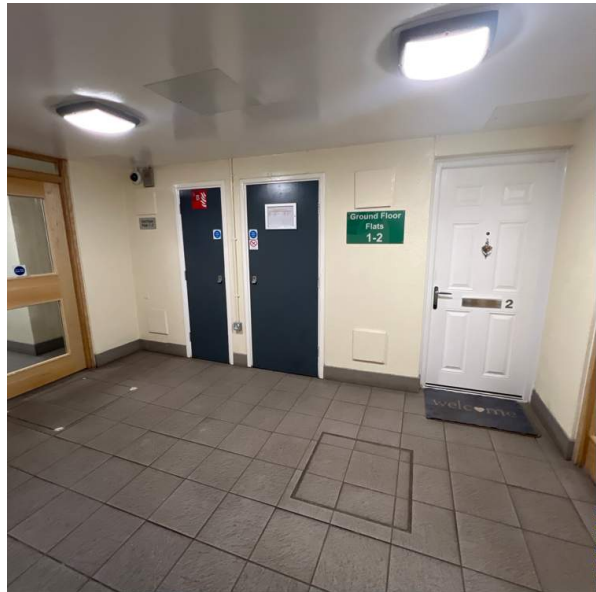
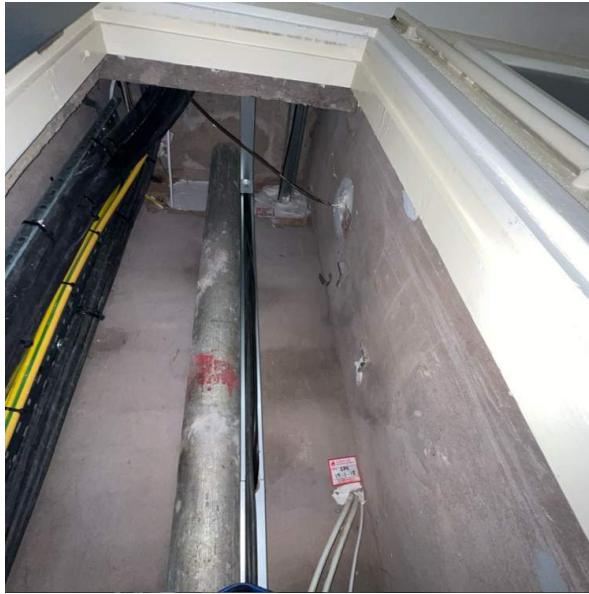
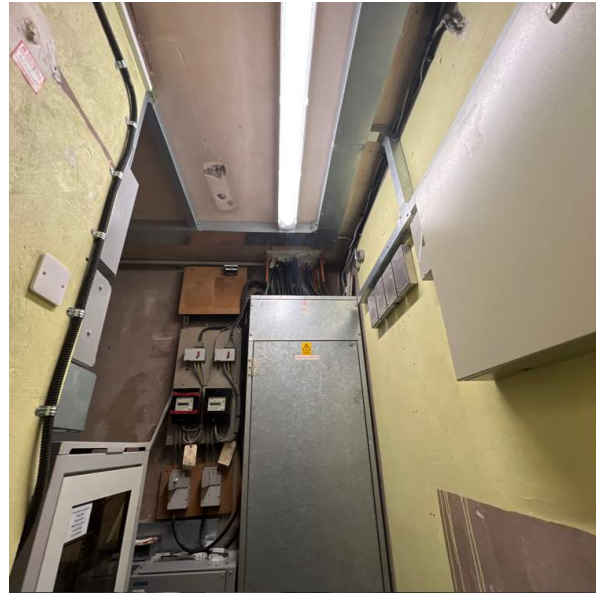
## Ground Floor Hallway

Comments: No jams or distortions noted to hallway doors to indicate any serviceability issues. Generally walls covered with finishes in hallway, likely to consist a mixture of concrete shear walls, embedded columns and masonry infill walls. Limited structure exposed. Concrete walls and infill masonry (non-load bearing) walls noted in riser cupboards.

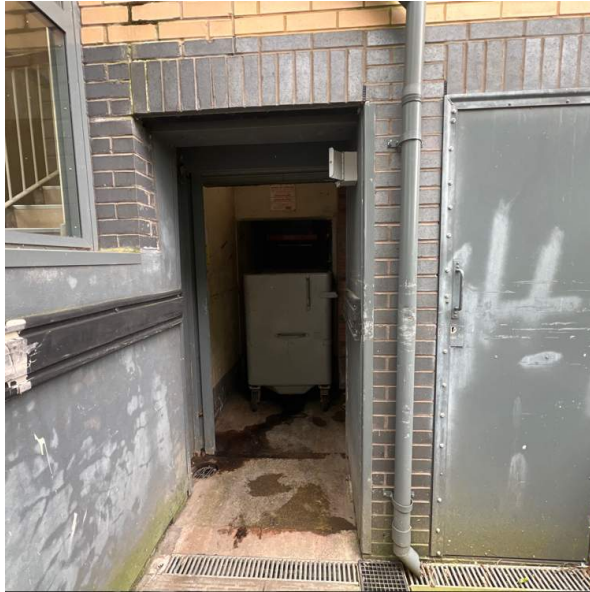
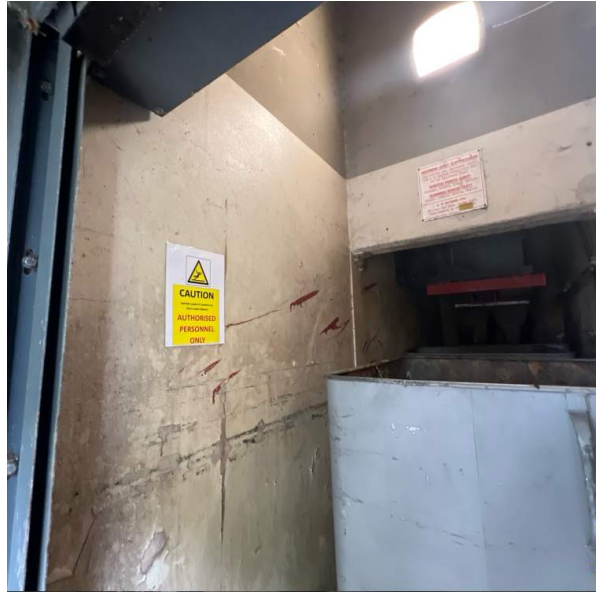
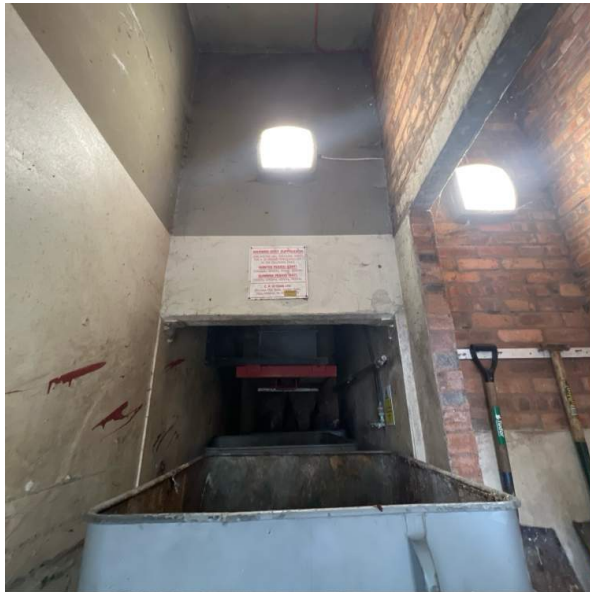
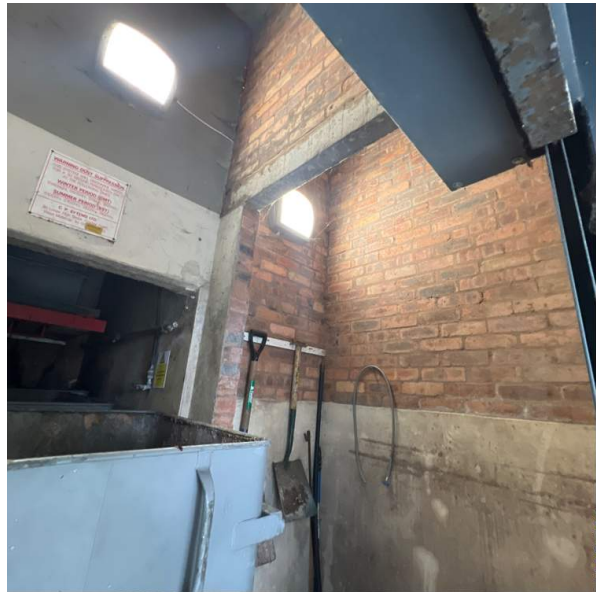
## Binstore

Comments: Main RC concrete shear walls noted in binstore.

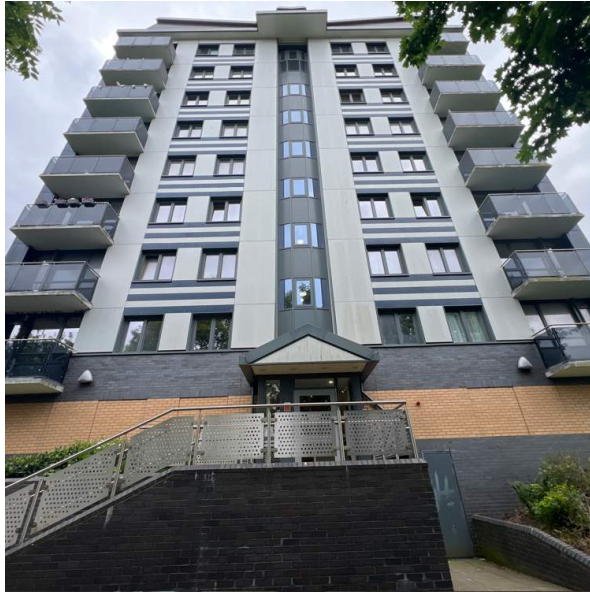
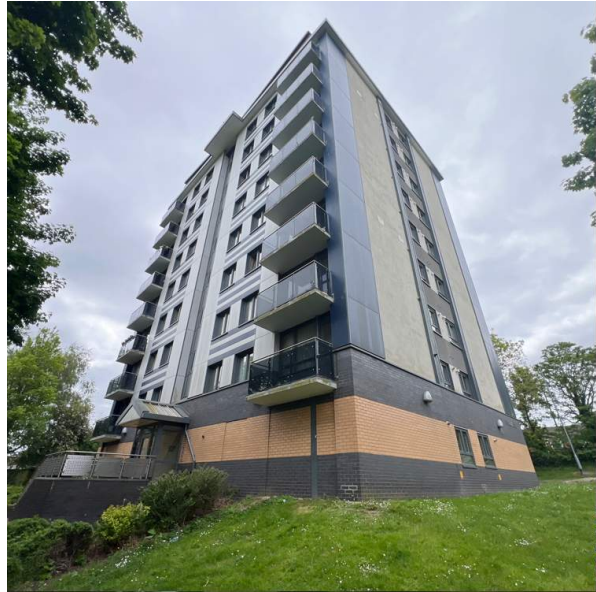
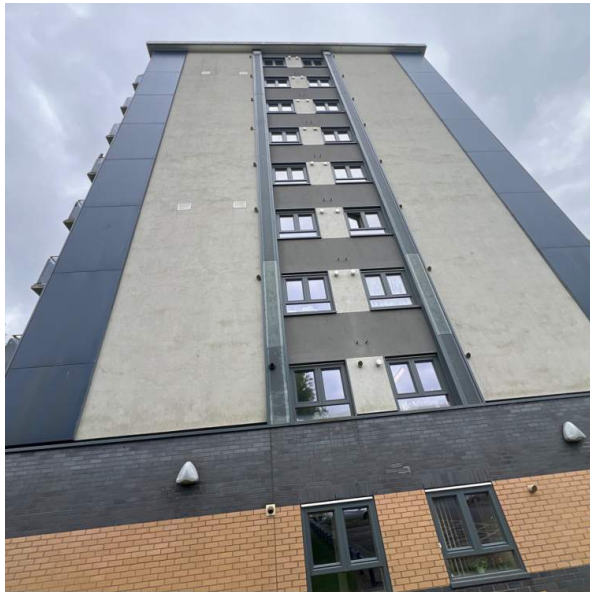
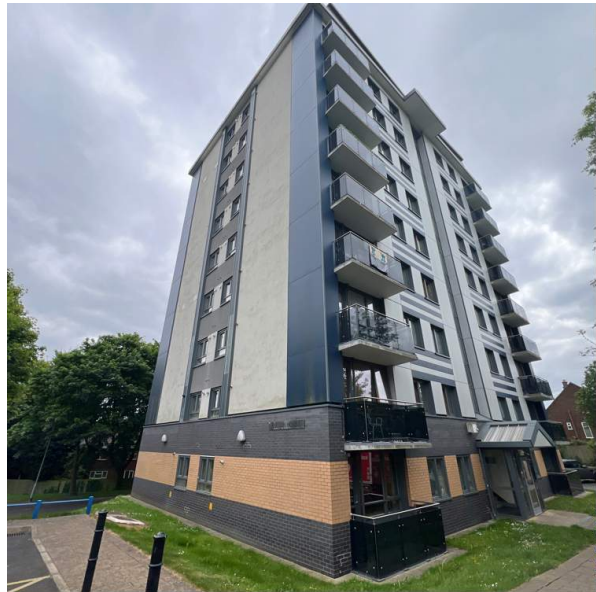
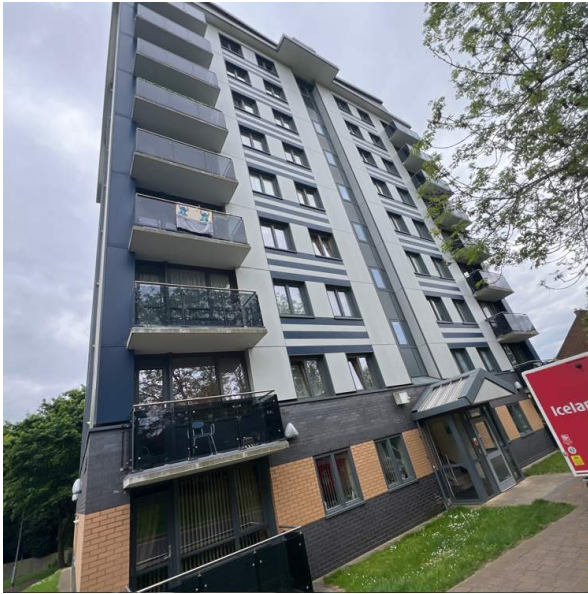
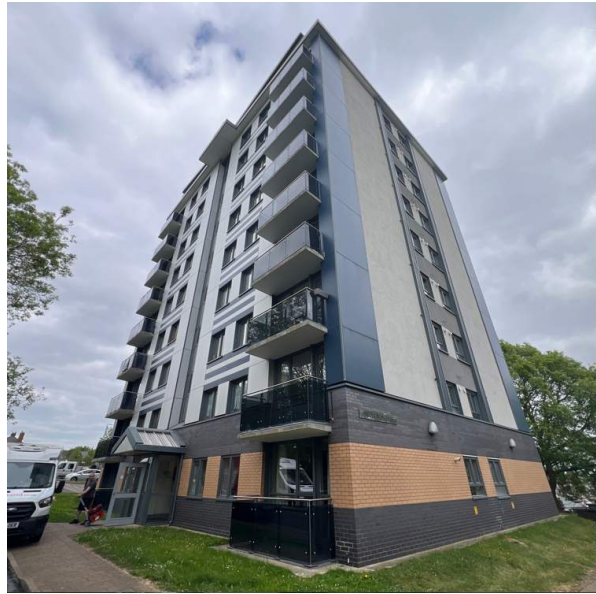
## Elevations

Comments: Brick work at ground floor level all sides. Upper floors cladded to front and rear elevations and rendered facade to side elevations. Cantilevered balconies noted on each level.
