**FIRNTEC**  
BUILDING COMPLIANCE

VISUAL STRUCTURAL APPRAISAL

Oak Court  
Acacia Avenue  
West Brom  
WS5 4BN

24<sup>th</sup> June 2025

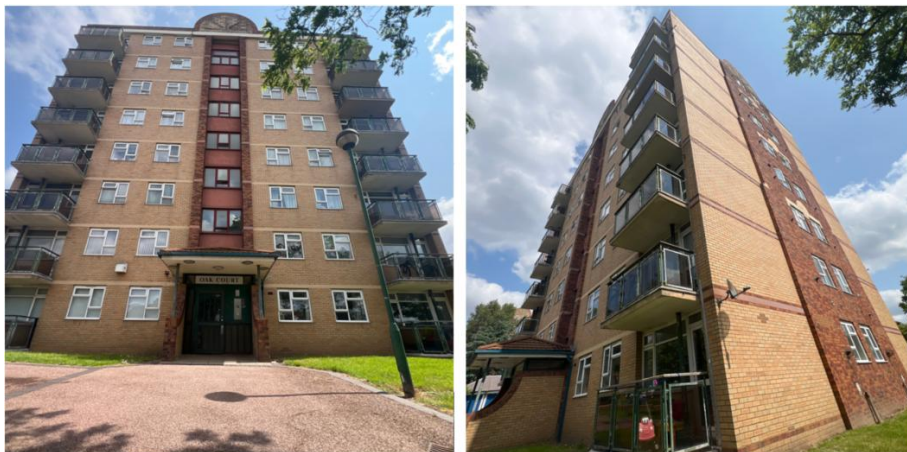
Figure 9 and 10: Building Elevations

The exterior elevations were generally in ok condition and no significant structural defects were noted to the infill panels. There were no significant cracks or tell-tale signs of any significant structural movement noted at the time of our inspection.

The exterior panels were noted to be plumb with no signs of significant bowing, bulging or leaning noted to the panels indicating failed fixings however their presence and condition cannot be confirmed.

The gable elevations have what appears to be an additional layer of brickwork external to the outer leaf. It is not clear if it is original or built after. It is in ok condition and provides some protection to slab edge and is therefore not considered a risk.

There are balconies at each level which are formed of cantilevered RC slabs tied into the main frame. The balconies would benefit from a refurbishment. The cantilevered slabs should be checked for internal corrosion potential at the benchmark inspections.

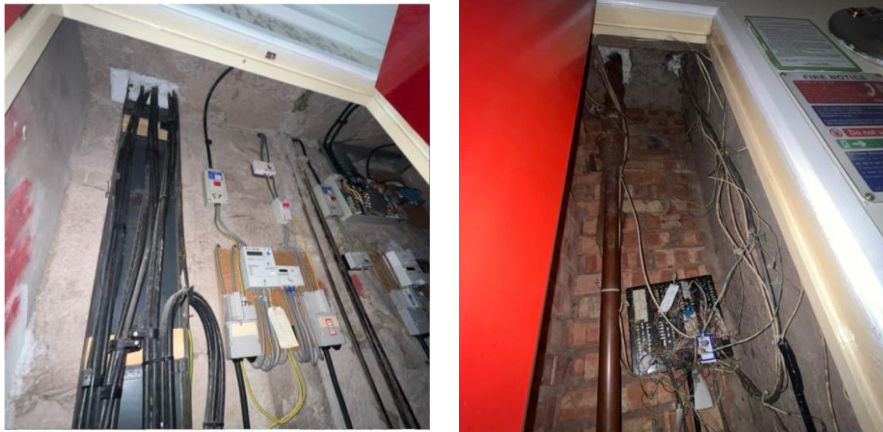
Figure 12 and 13: RC Internal Elements

There were vertical concrete walls supporting the floor plates at every level. The elements visible matched the floor layout in Figure 6. The walls appear continuous from ground to roof with no transfer structure. The overall condition of the structure observed is good.

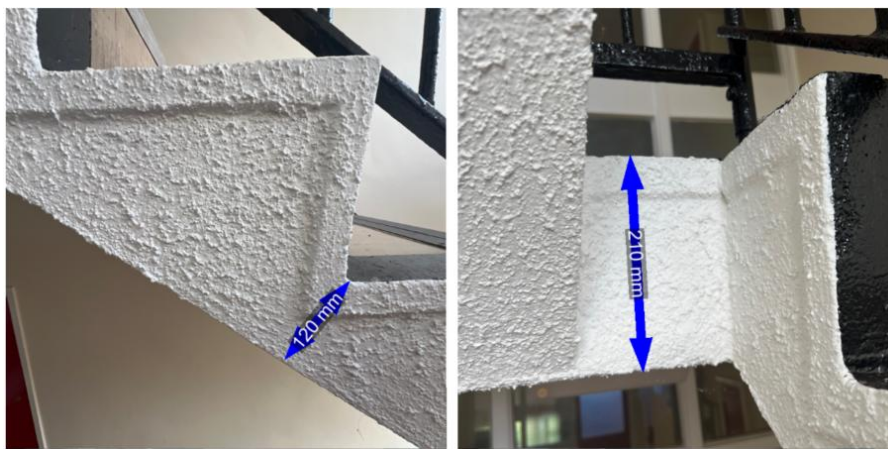
Figure 14 and 15: Stair Stringer and Landing

The stair stringer was noted to be 120mm thick which seems slim, certainly short of modern standards. A cover test is required to check the resistance of the concrete section in the event of a fire.

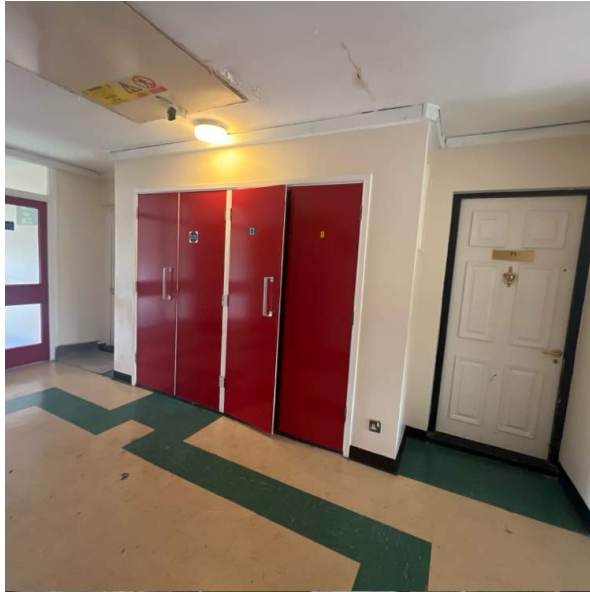
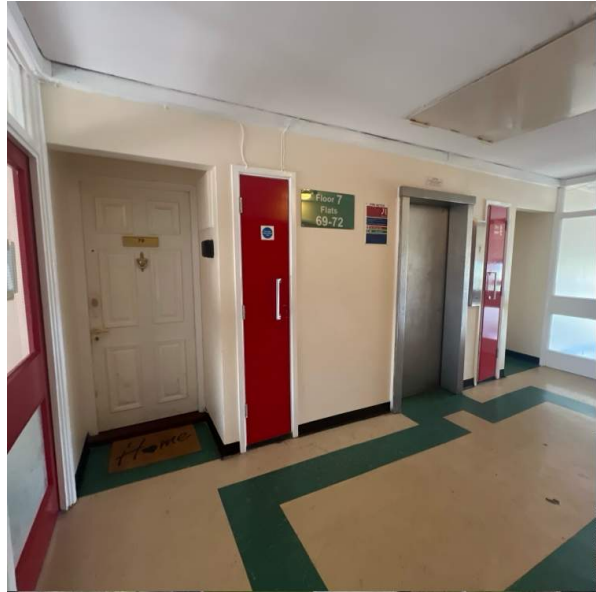
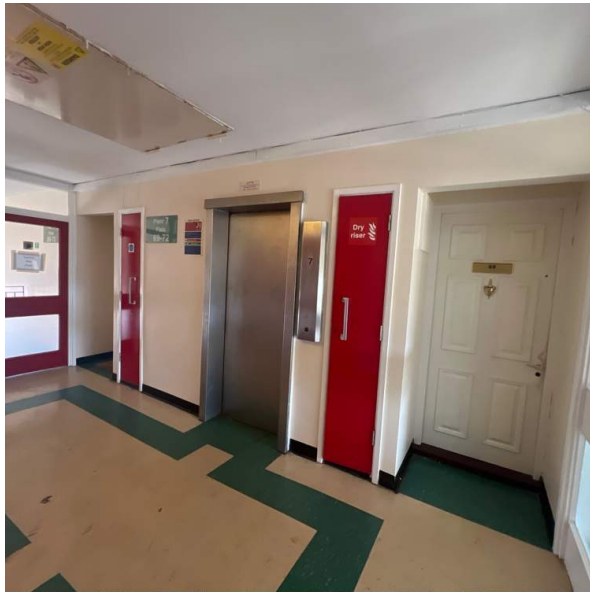
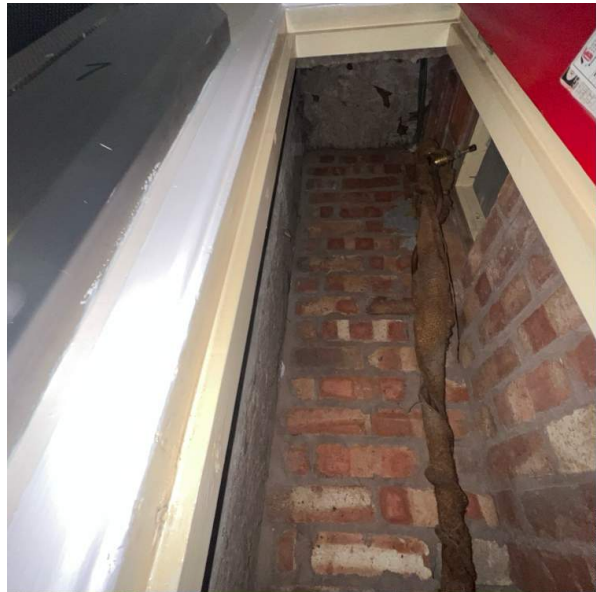
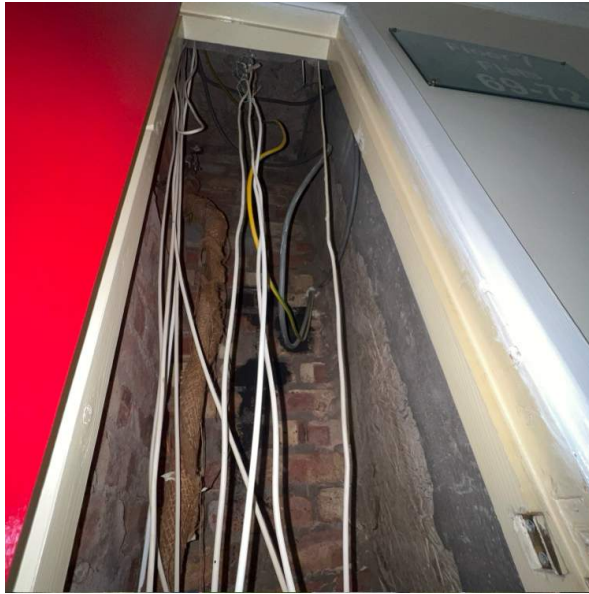
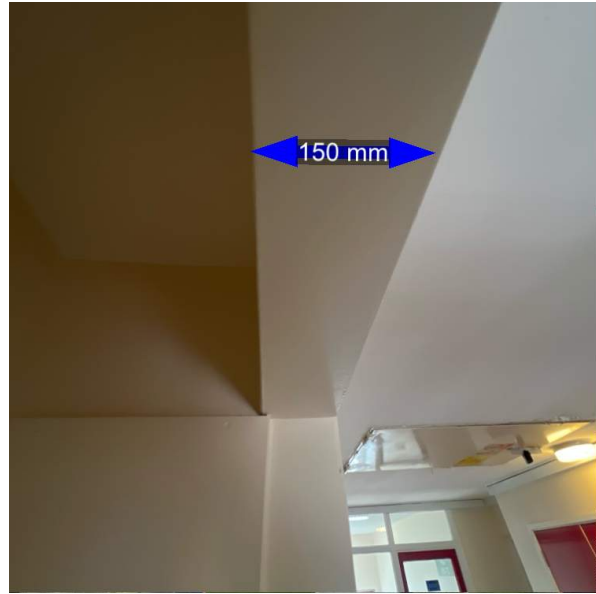
## 7th Floor Hallway

Comments: No jams or distortions noted to hallway doors to indicate any serviceability issues. Generally walls covered with finishes in hallway, likely to consist a mixture of concrete shear walls, embedded columns and masonry infill walls. Limited structure exposed. Concrete walls and infill masonry (non-load bearing) walls noted in riser cupboards.

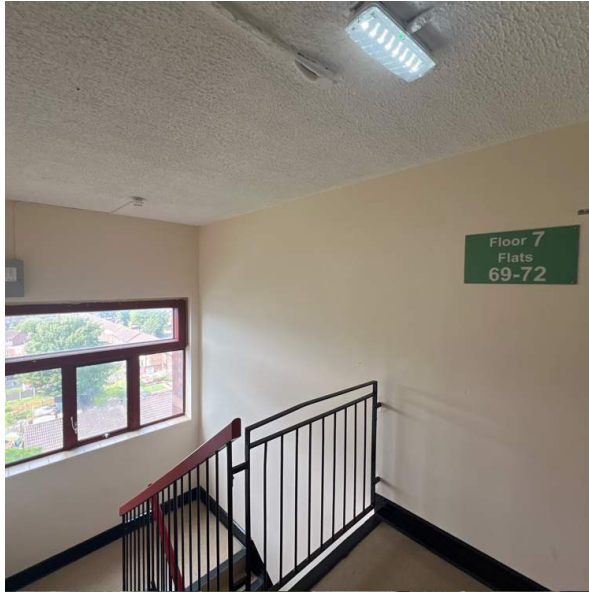
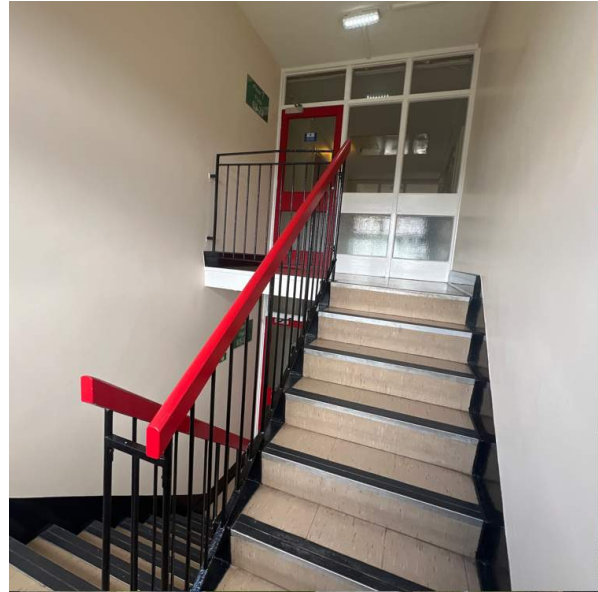
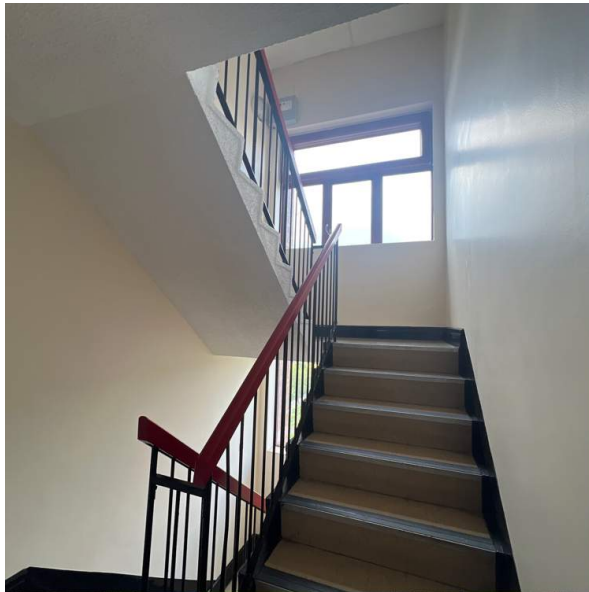
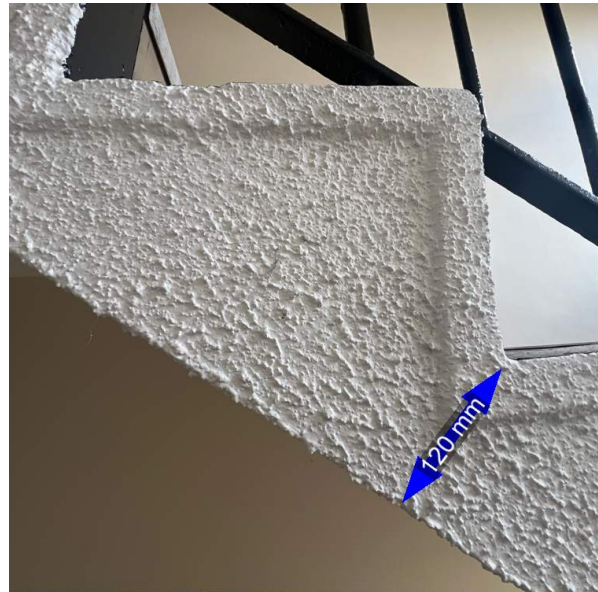
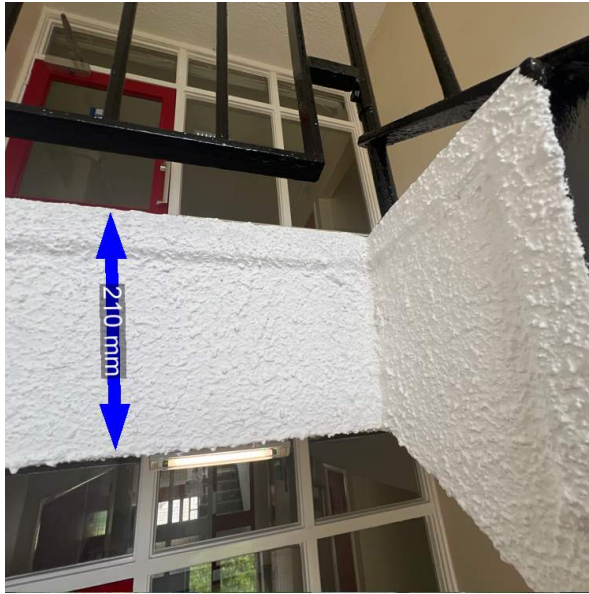
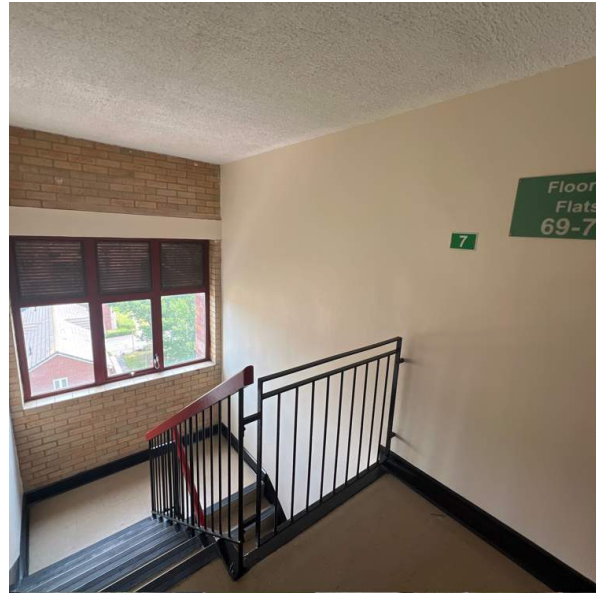
## 7th Floor Staircases

Comments: Insitu concrete stairs with steel hand railing fixed to stairs. Walls and floors appear to be fairly level.  
Stair walls covered with finishes however these would likely form the main concrete shear core walls.

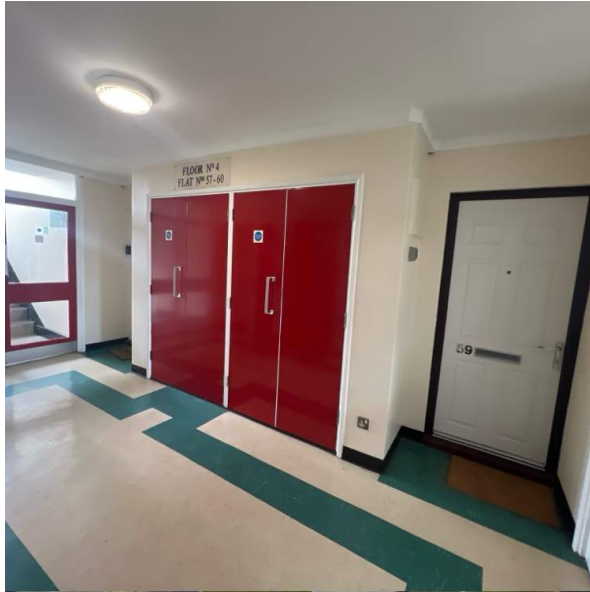
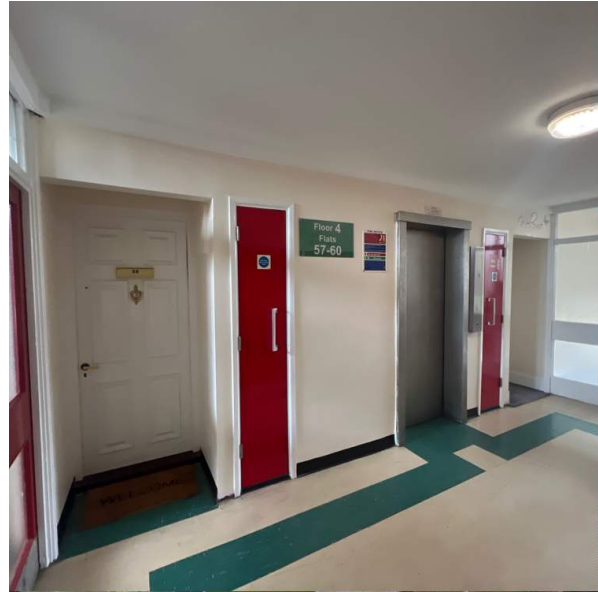
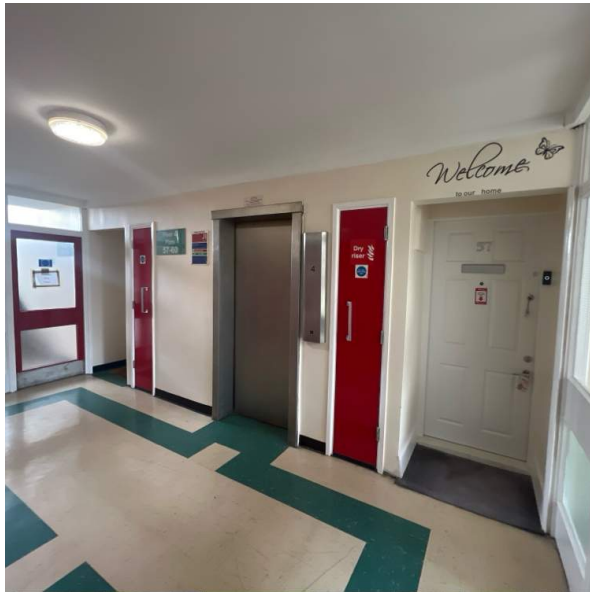
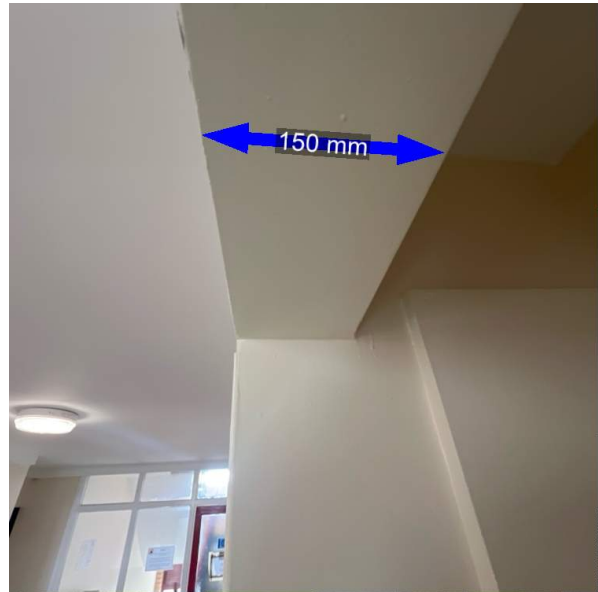
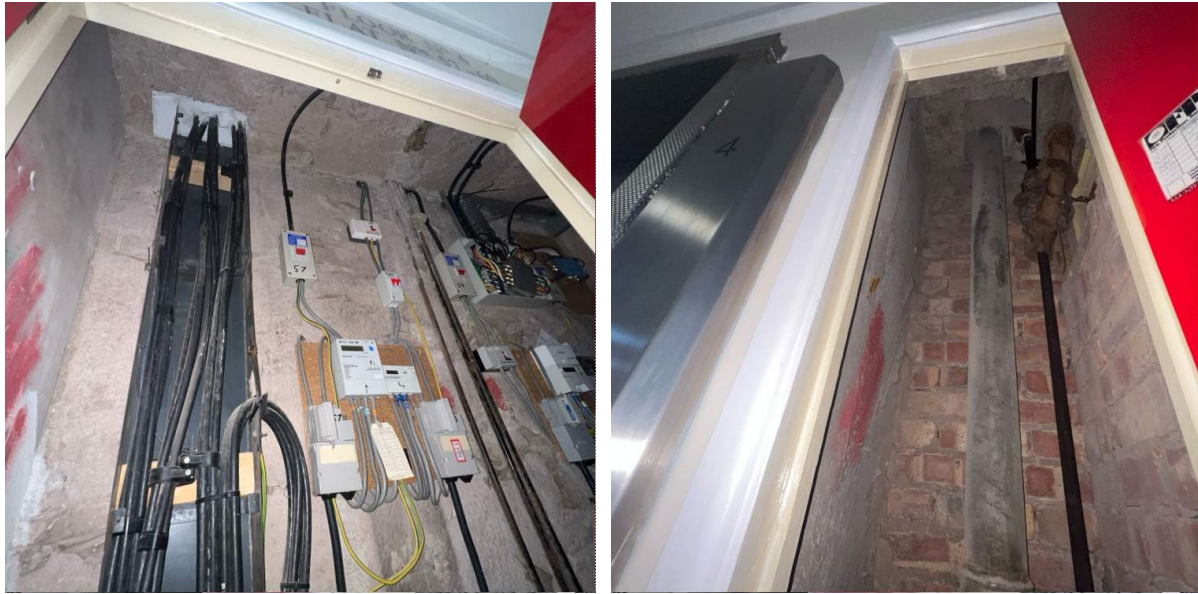
## 4th Floor Hallway

Comments: No jams or distortions noted to hallway doors to indicate any serviceability issues. Generally walls covered with finishes in hallway, likely to consist a mixture of concrete shear walls, embedded columns and masonry infill walls. Limited structure exposed. Concrete walls and infill masonry (non-load bearing) walls noted in riser cupboards.

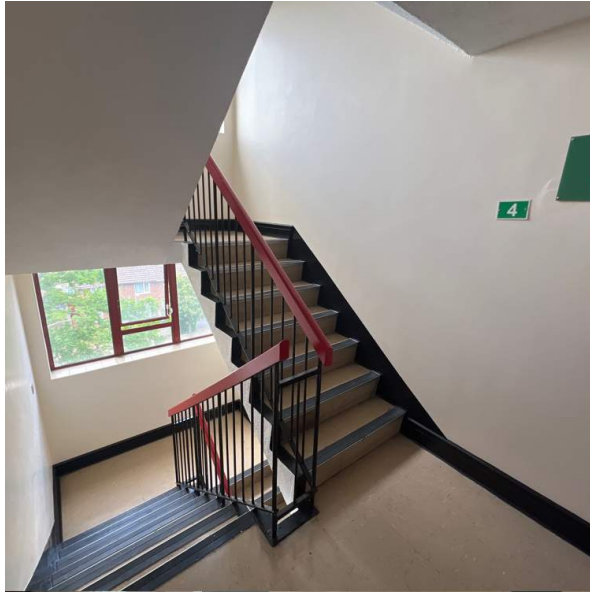
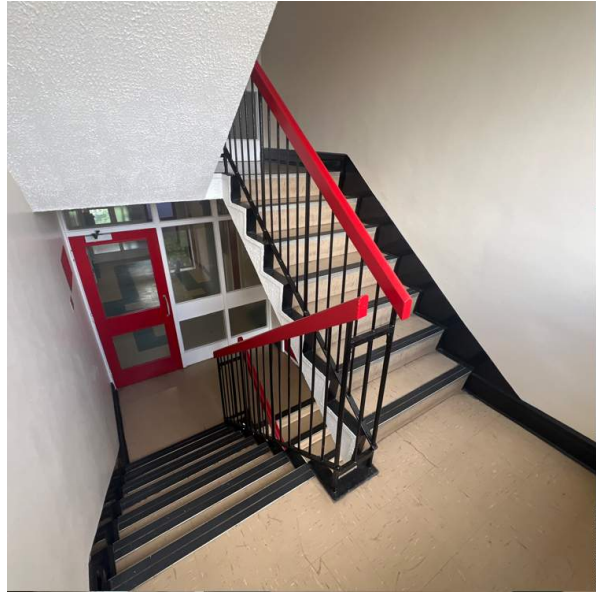
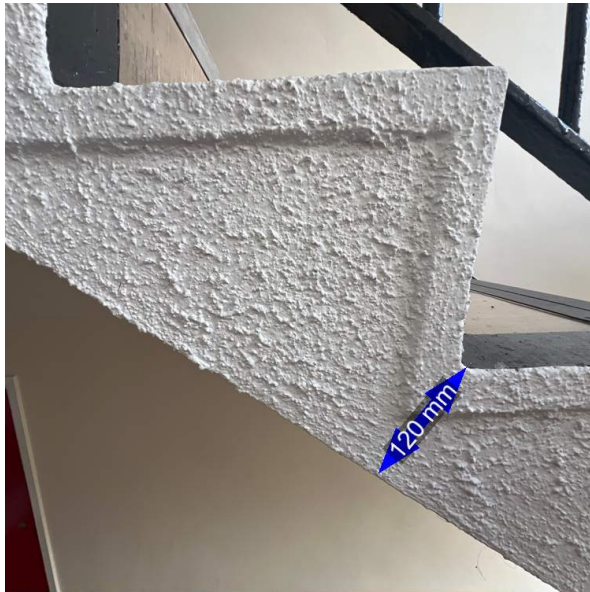
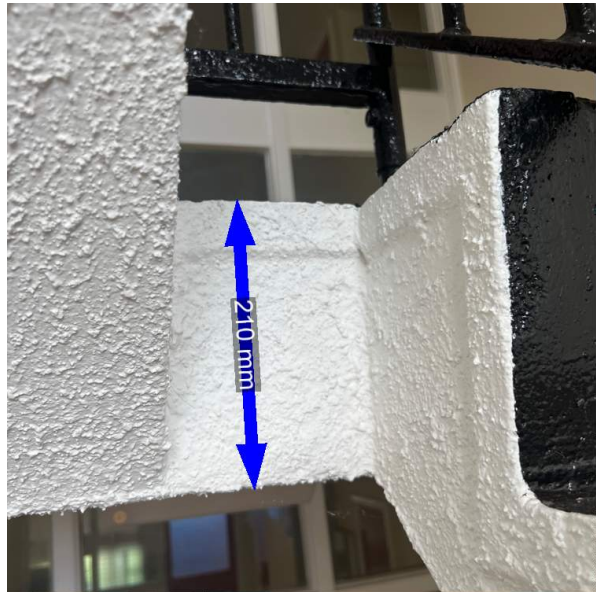
## 4th Floor Staircases

Comments: Insitu concrete stairs with steel hand railing fixed to stairs. Walls and floors appear to be fairly level.  
Stair walls covered with finishes however these would likely form the main concrete shear core walls.

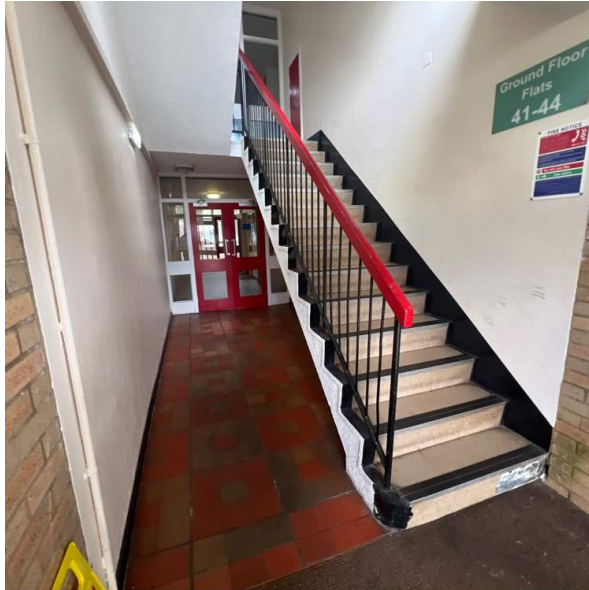
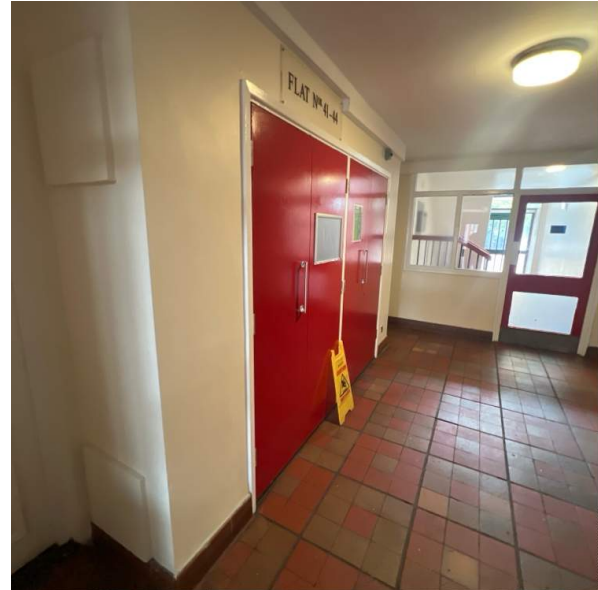
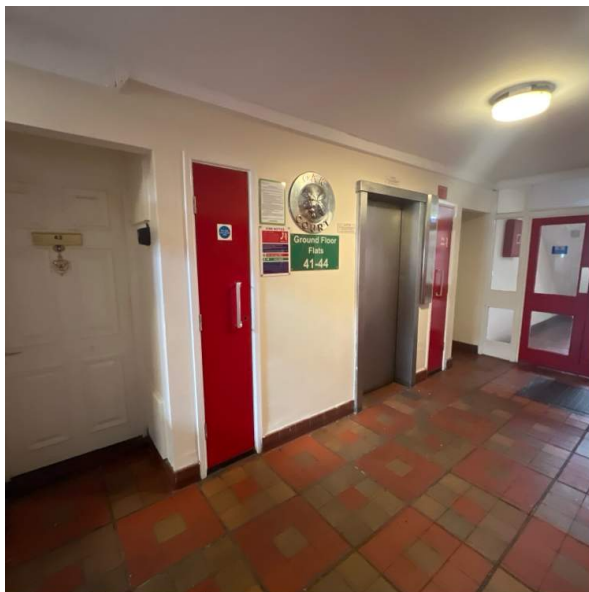
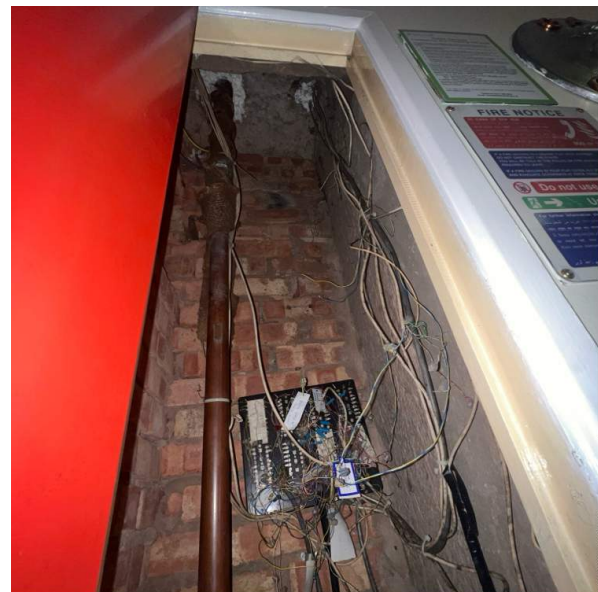
## Ground Floor Hallway

Comments: No jams or distortions noted to hallway doors to indicate any serviceability issues. Generally walls covered with finishes in hallway, likely to consist a mixture of concrete shear walls, embedded columns and masonry infill walls. Limited structure exposed. Concrete walls and infill masonry (non-load bearing) walls noted in riser cupboards.

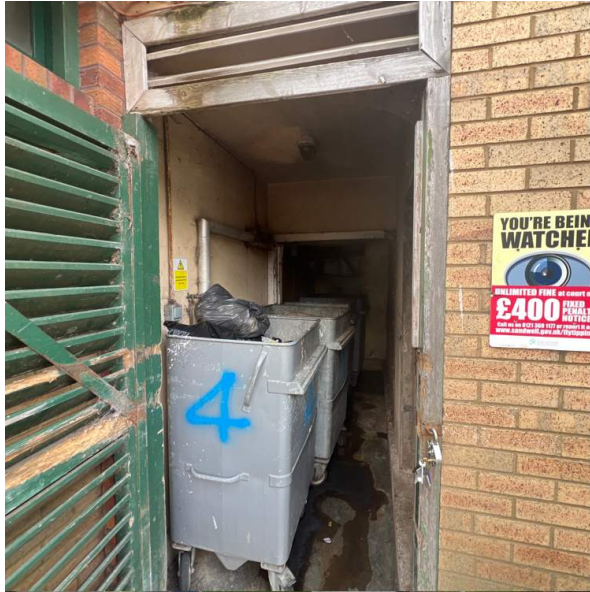
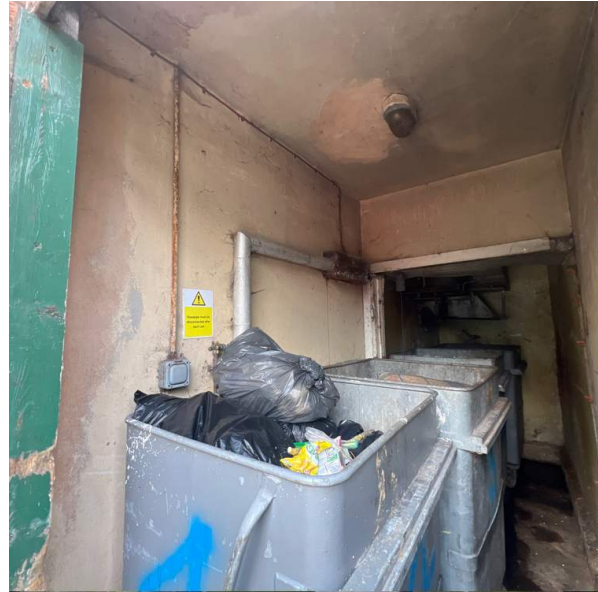
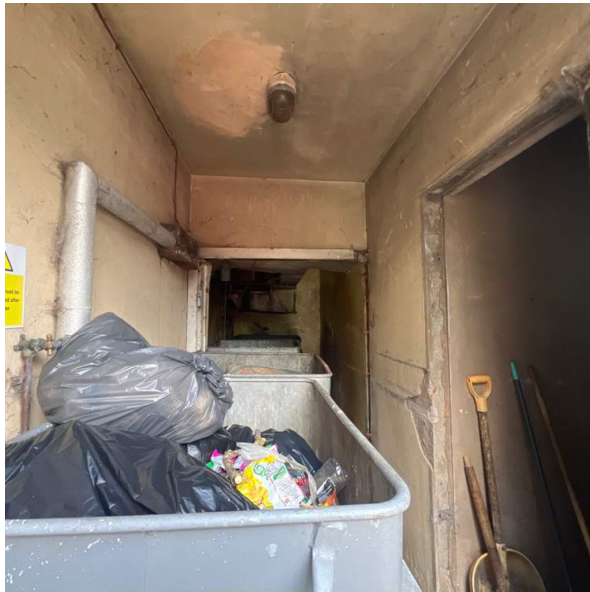
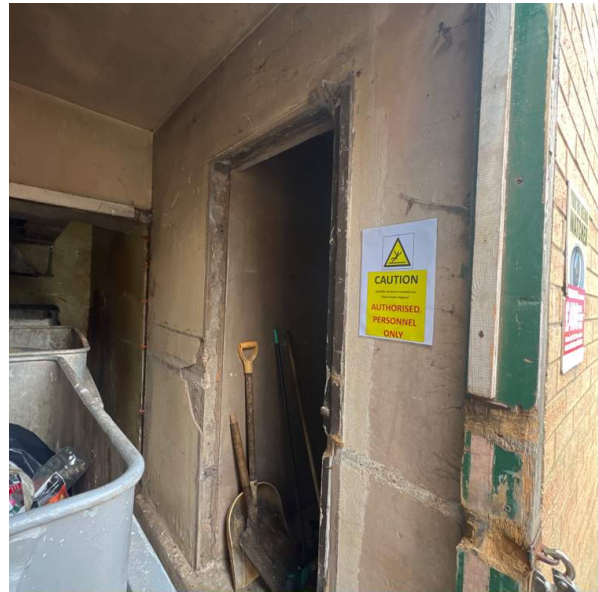
## Bin Store

Comments: RC concrete walls noted in bin store.

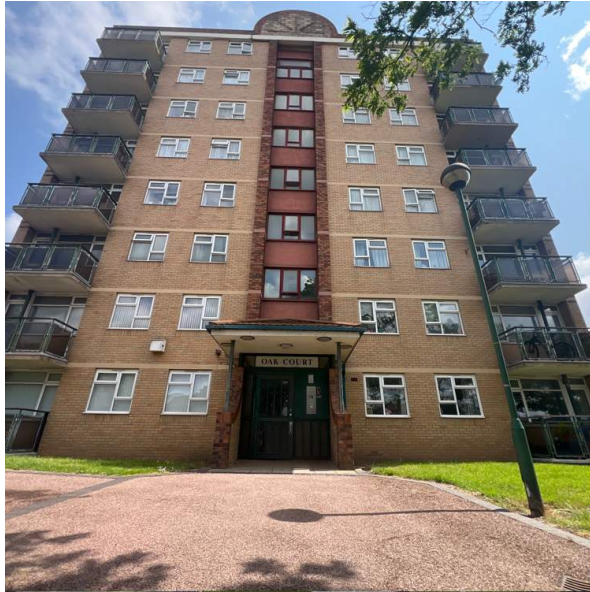
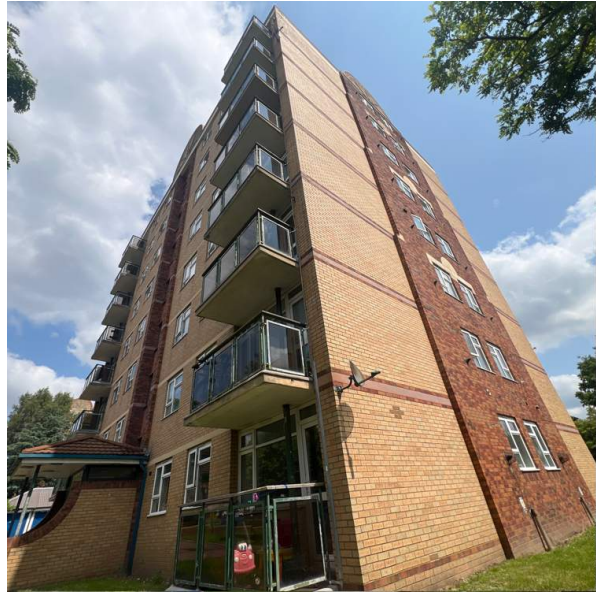
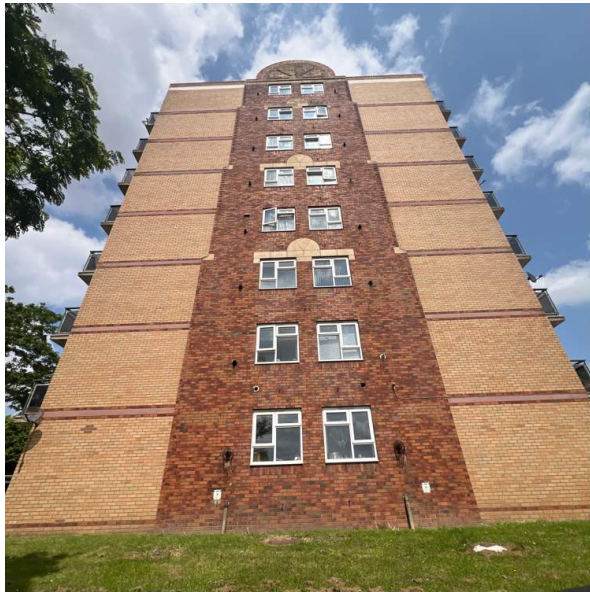
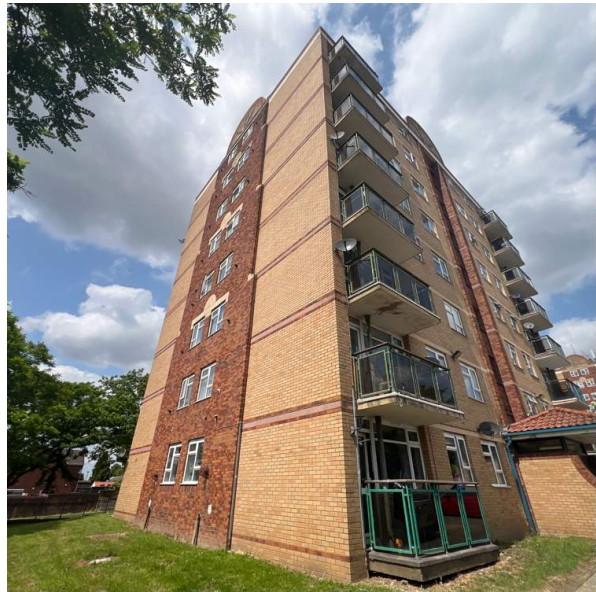
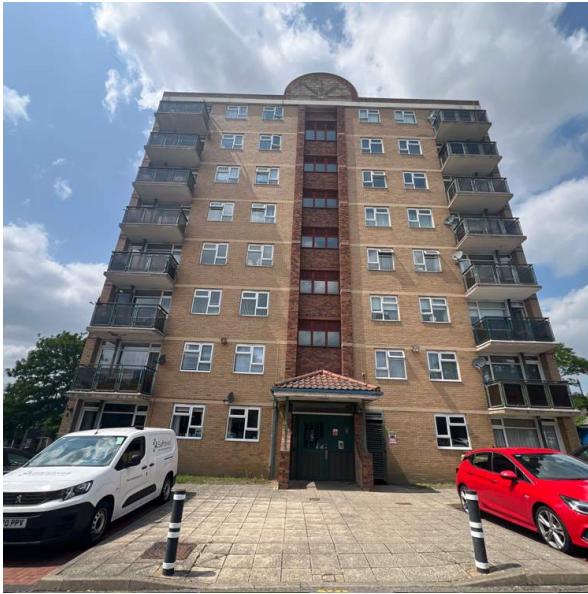
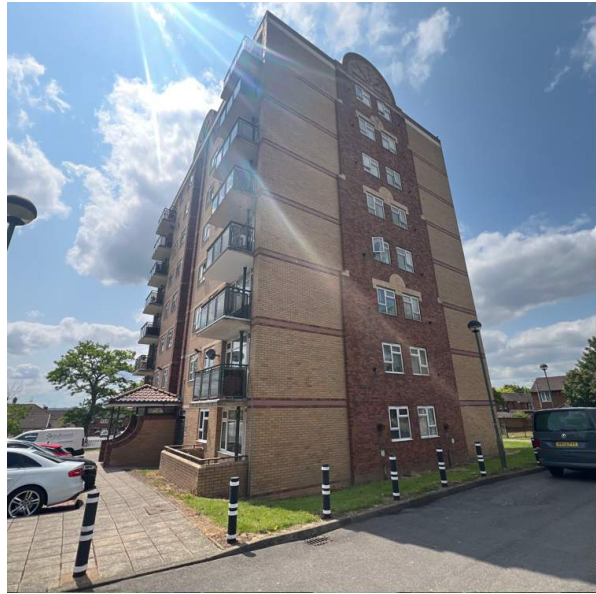
## Elevations

Comments: External facade consists of brick work on all levels to all elevations. Cantilevered balconies situated on each level.
