VISUAL STRUCTURAL APPRAISAL

Paget House  
Sedgeley Road East  
Tipton  
DY4 7TU

24<sup>th</sup> June 2025

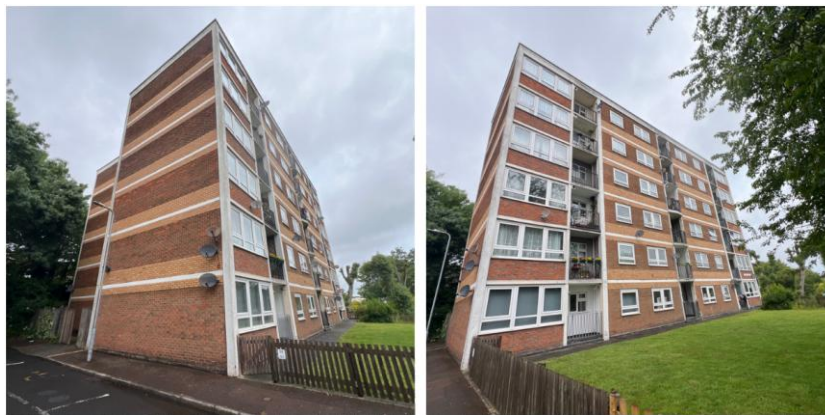
Figure 9 and 10: Building Elevations

The exterior elevations were generally in ok condition and no significant structural defects were noted to the infill panels. There were no significant cracks or tell-tale signs of any significant structural movement noted at the time of our inspection.

The exterior panels were noted to be plumb with no signs of significant bowing, bulging or leaning noted to the panels indicating failed fixings however their presence and condition cannot be confirmed.

There are inset balconies at each level to the long elevation which are formed of RC slabs tied into the main frame. The balconies would benefit from a refurbishment with widespread failed coatings throughout. The exposed slabs should be checked for internal corrosion potential at the benchmark inspections.

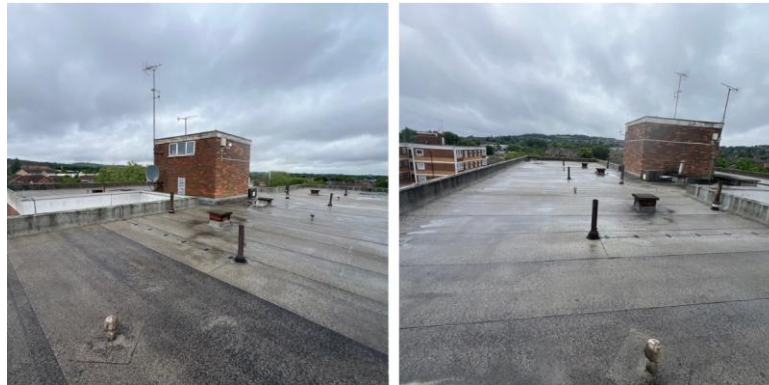
Figure 11 and 12: Roof Level

The flat roof structure is a reinforced concrete cast slab. There is an enclosure which partially covers the roof area which covers the access stairs. The enclosure would benefit from a refurbishment, the timber fascia should be replaced.

There were no tell-tale signs of any significant structural movement noted at the time of our inspection.

The roof has a felted waterproofing system. The exact build-up of the roof finishes were not accessible at the time of inspection. It is recommended an intrusive survey of the roof finishes is completed by a specialist surveyor to assess the condition of the roof covering although they were noted in good condition with no known water ingress issues and therefore a low risk element.

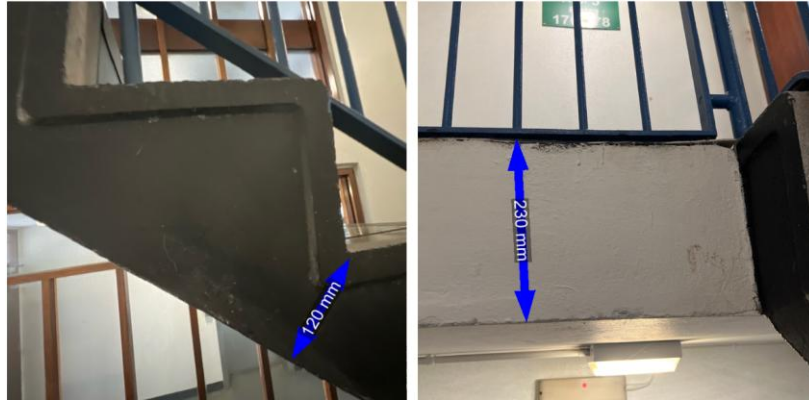
Figure 14 and 15: Slab edge and stair stringer

The interior of the stair core walls were checked and were plumb and in line with observations made to the exterior – no significant signs of leaning or movement noted. The concrete appeared in fair condition with few BRE category 1 cracks but no structurally significant defects were noted.

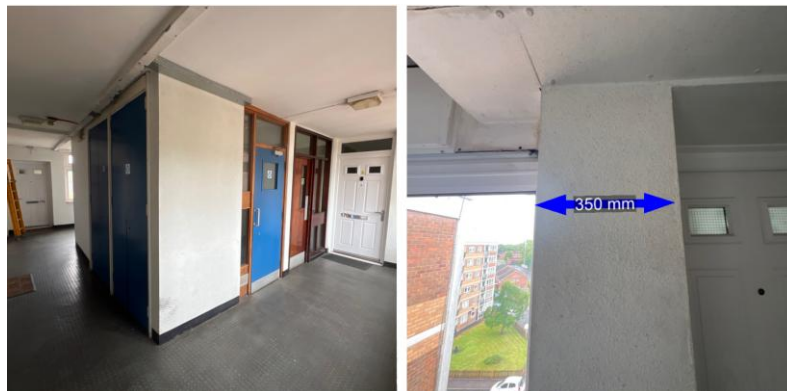
Figure 16 and 17: RC internal elements and communal space

The floors in the communal landings were noted to be solid concrete floors. The floors were checked with a spirit level and were considered level and within tolerance. The doors and windows to the communal landings from the stair core all appeared to be level and opened and closed without difficulty. There were no signs of structural movement detected.

There were vertical concrete walls supporting the floor plates at every level. The elements visible matched the floor layout in Figure 6. The walls appear continuous from ground to roof with no transfer structure. The overall condition of the structure observed is good.

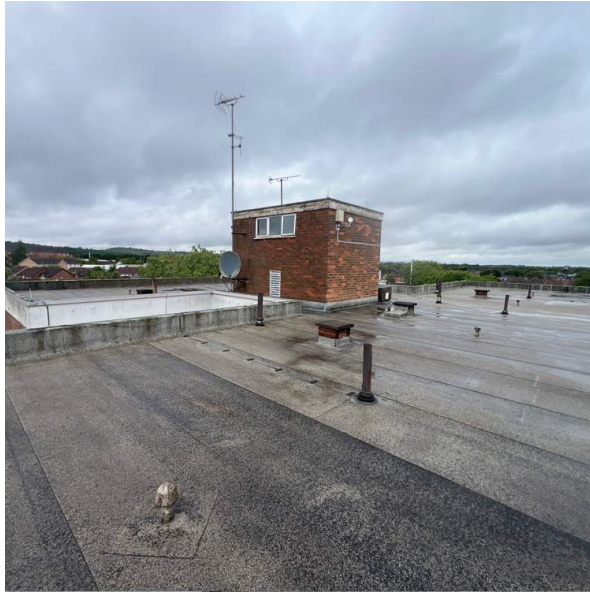
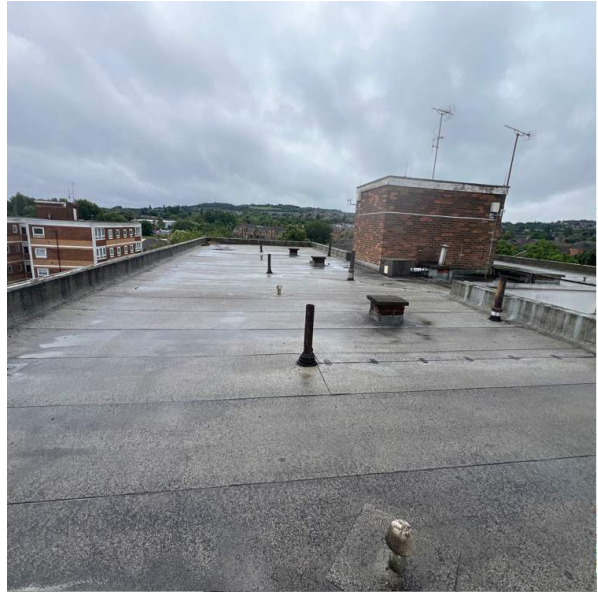
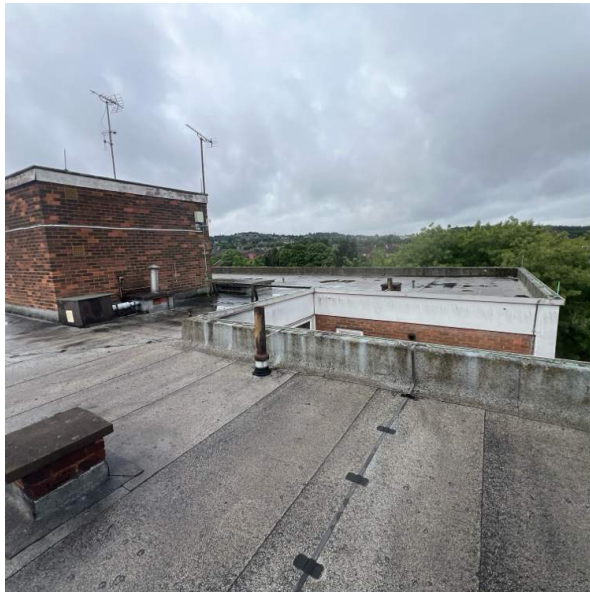
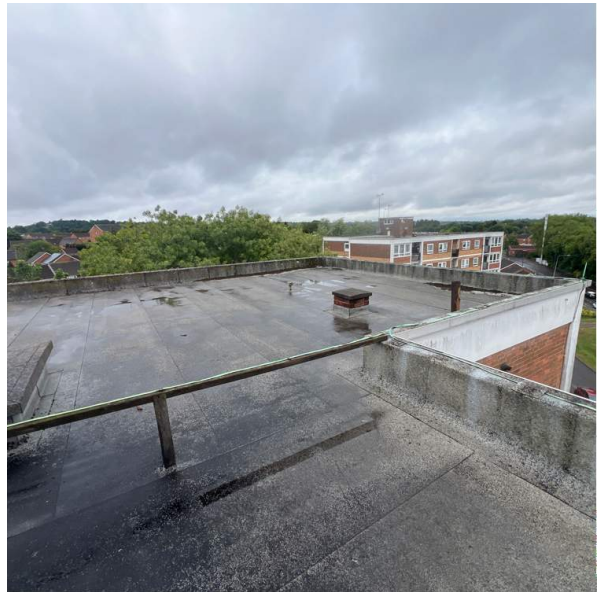
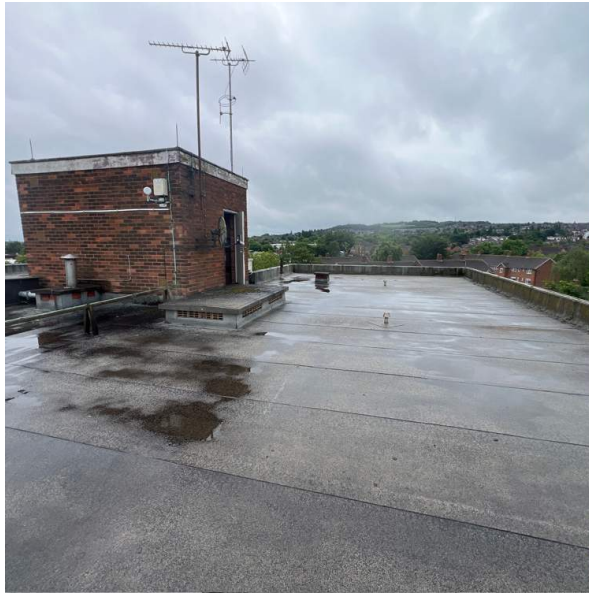
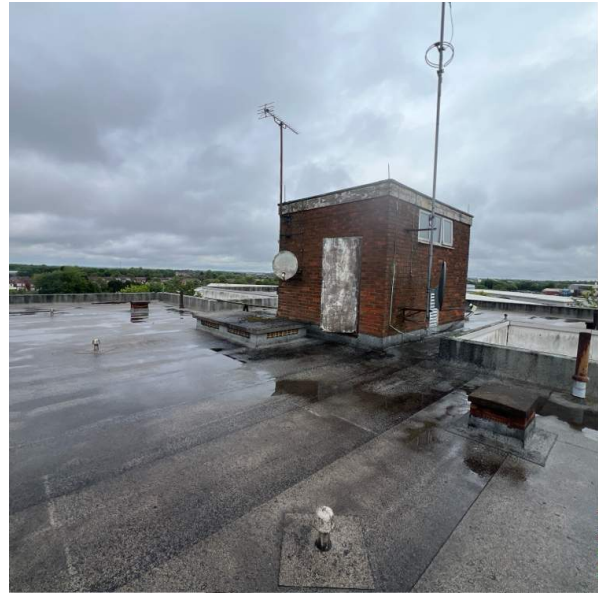
## Main Roof

Comments: Flat roof, RC concrete slab with insulated PIR board and felt coverings.

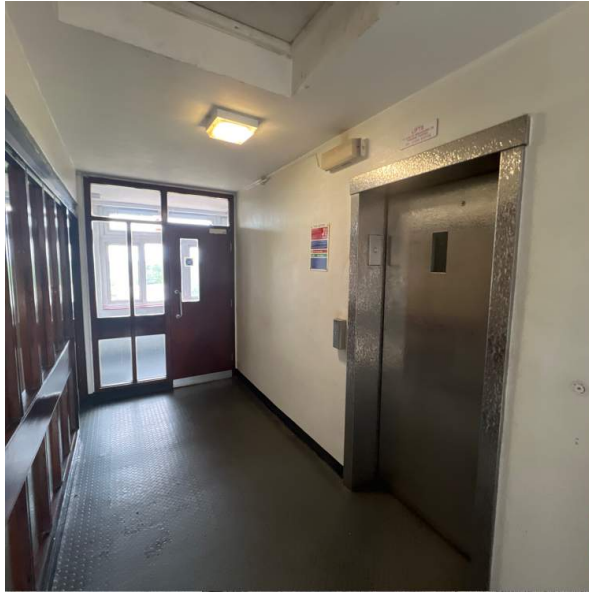
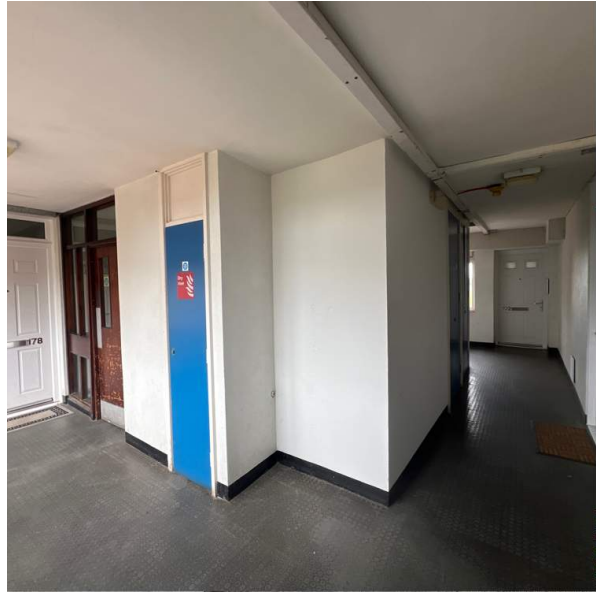
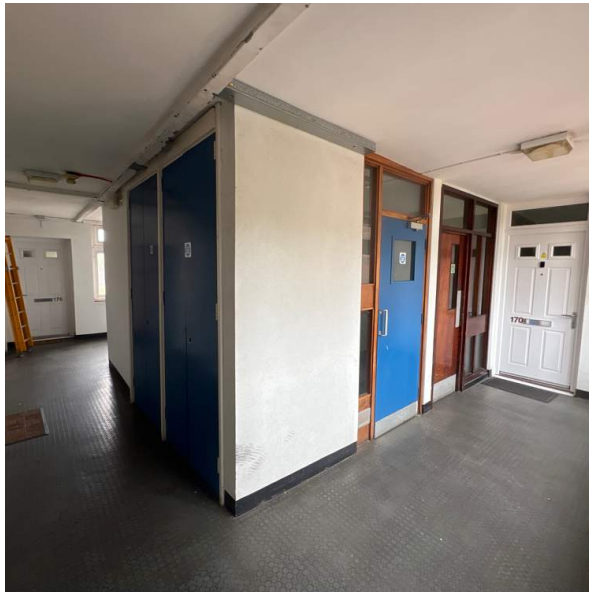
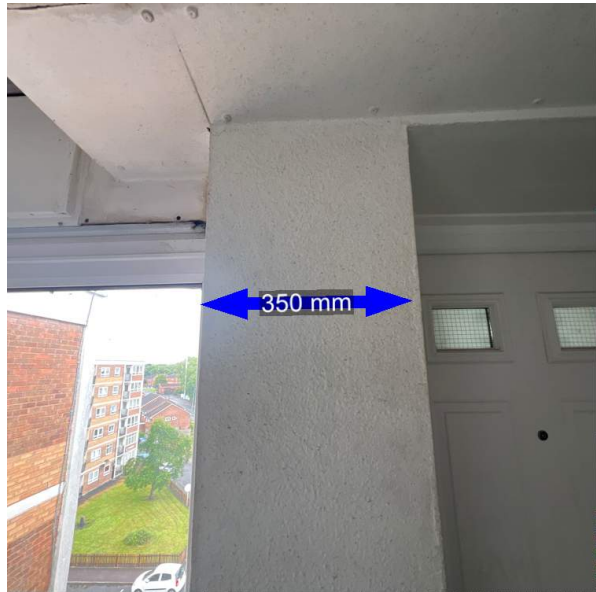
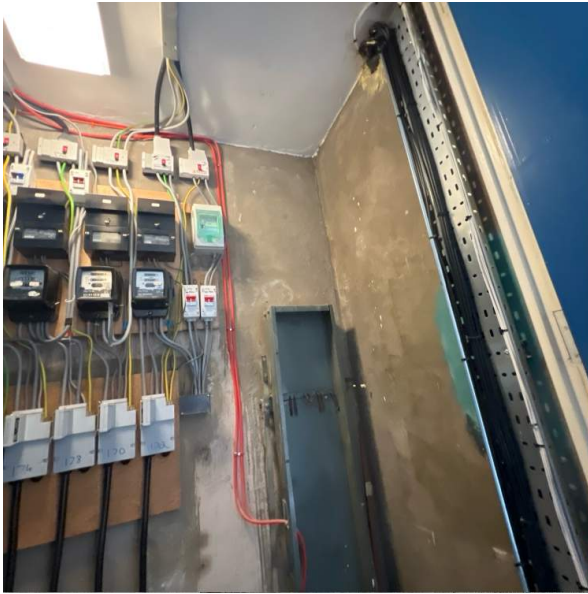
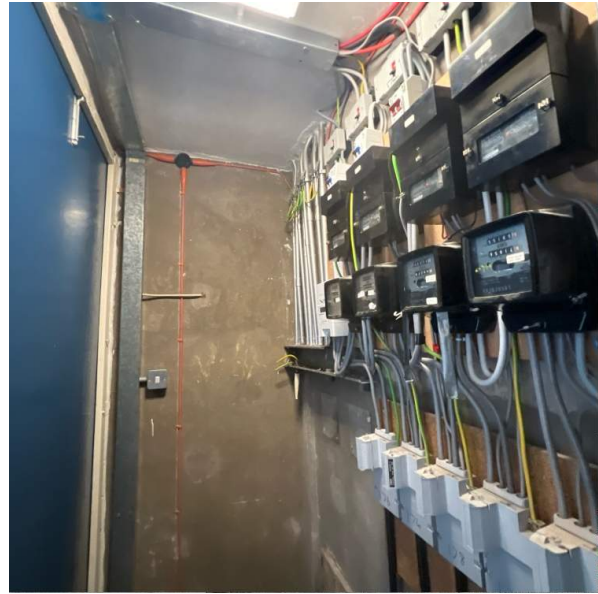
## 5th Floor Hallway

Comments: No jams or distortions noted to hallway doors to indicate any serviceability issues. Generally walls covered with finishes in hallway, likely to consist a mixture of concrete shear walls, embedded columns and masonry infill walls. Limited structure exposed. Concrete structure and rendered infill masonry (non-load bearing) walls noted in riser cupboards. Some superficial/non-structural cracks to finishes.

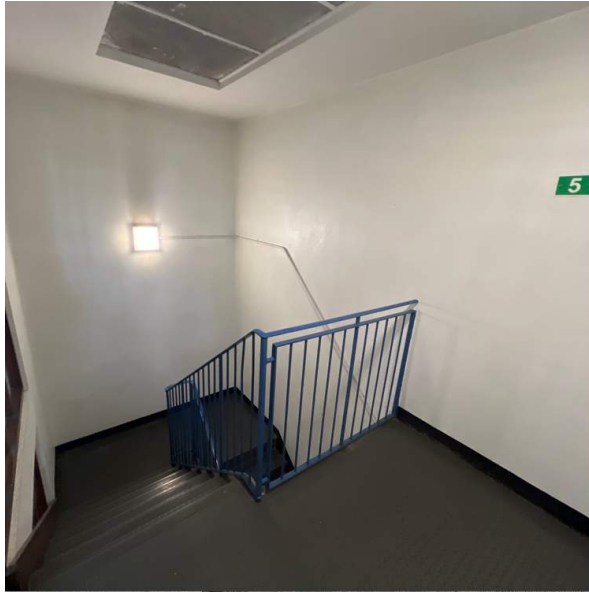
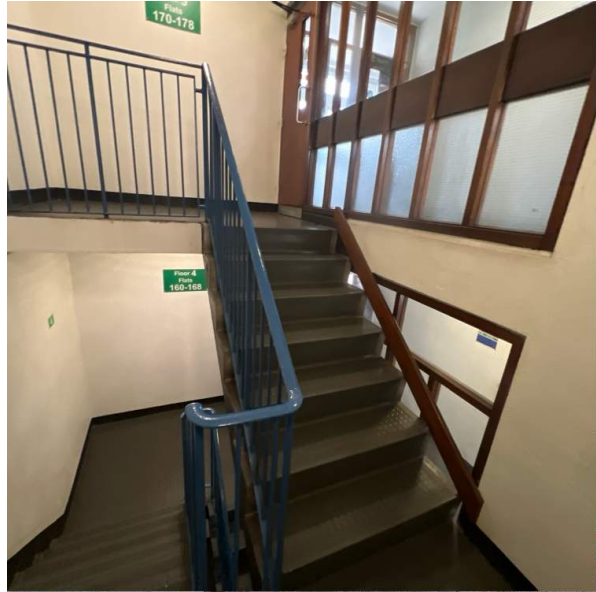
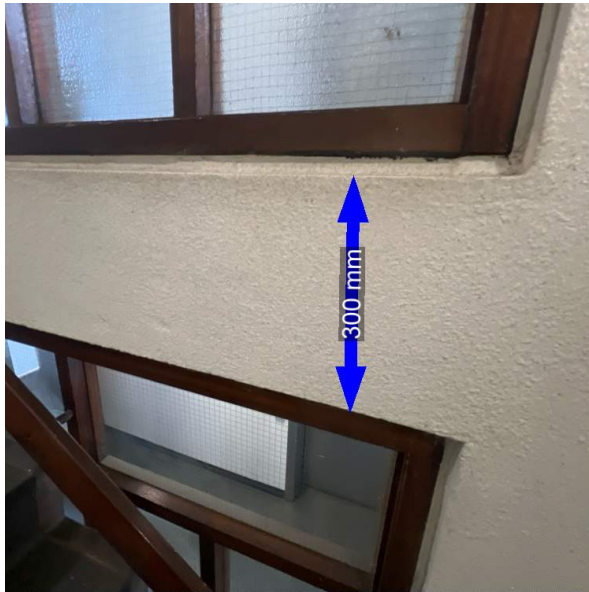
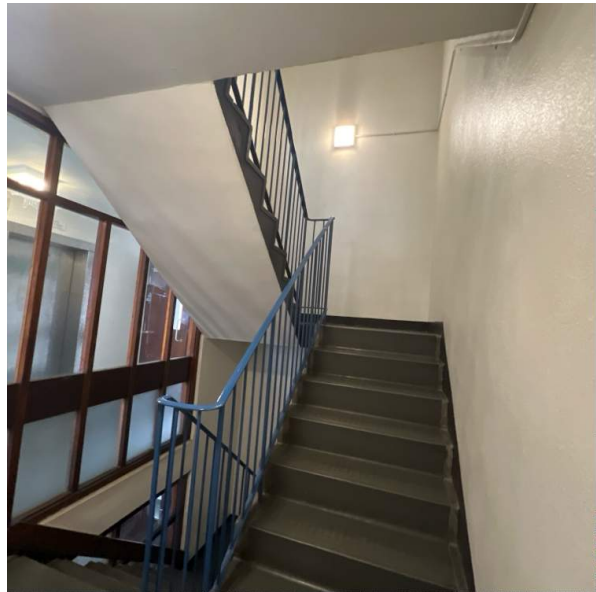
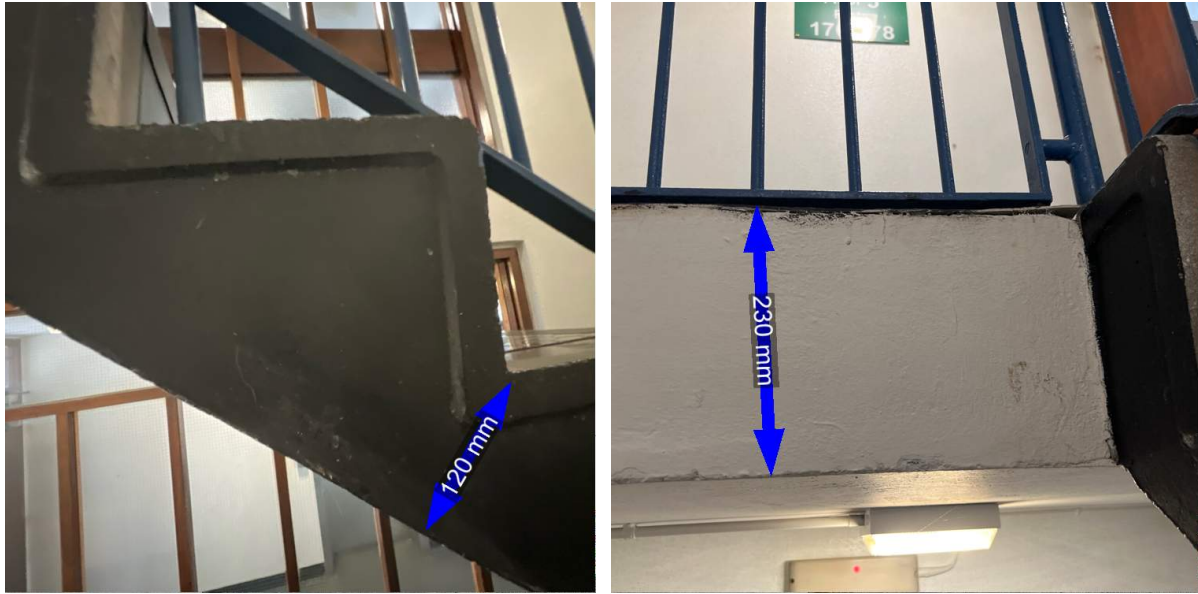
## 5th Floor Staircases

Comments: Insitu concrete stairs with steel hand railing fixed to stairs. Walls and floors appear to be fairly level.  
Stair walls covered with finishes however these would likely form the main concrete shear core walls. One side of staircase wall consists of an RC concrete beam and infill partition/glazing.

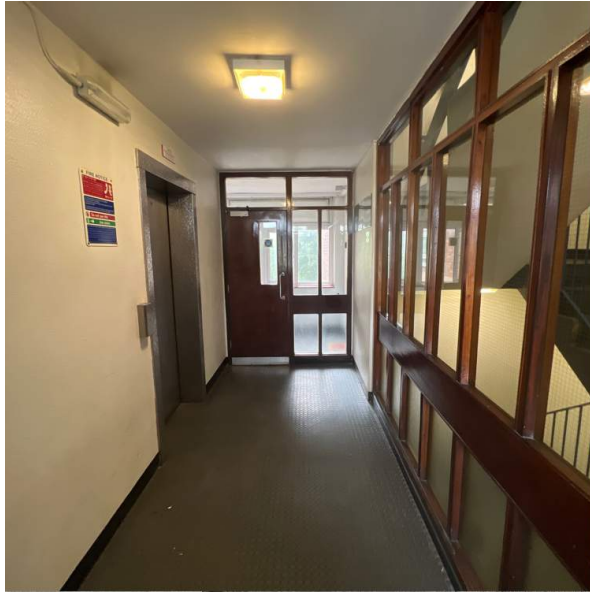
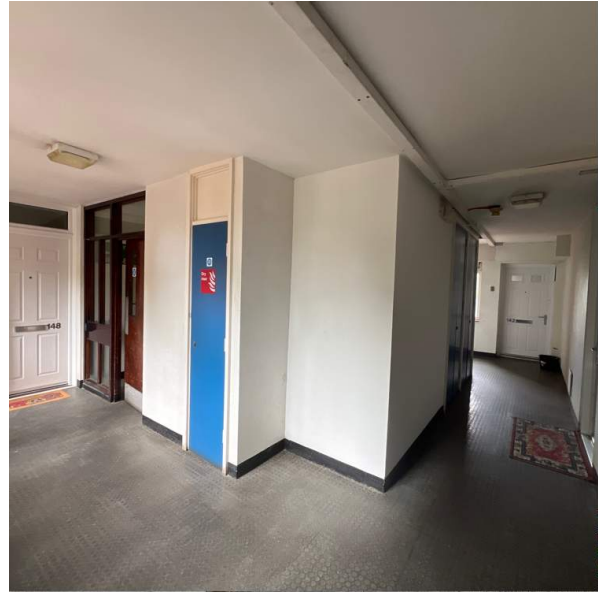
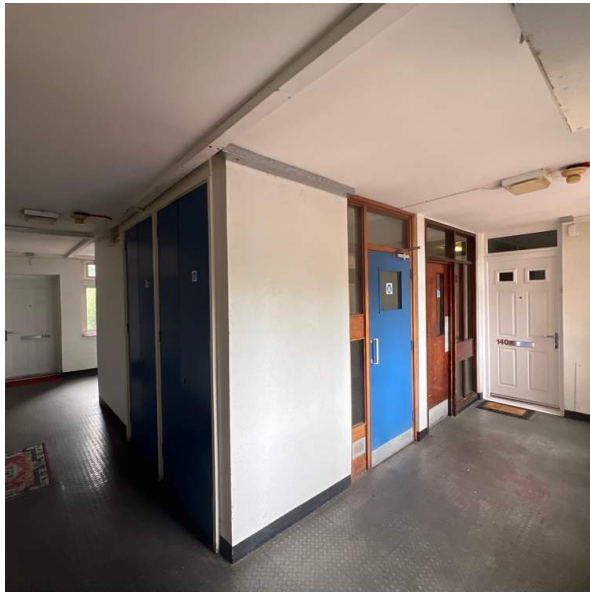
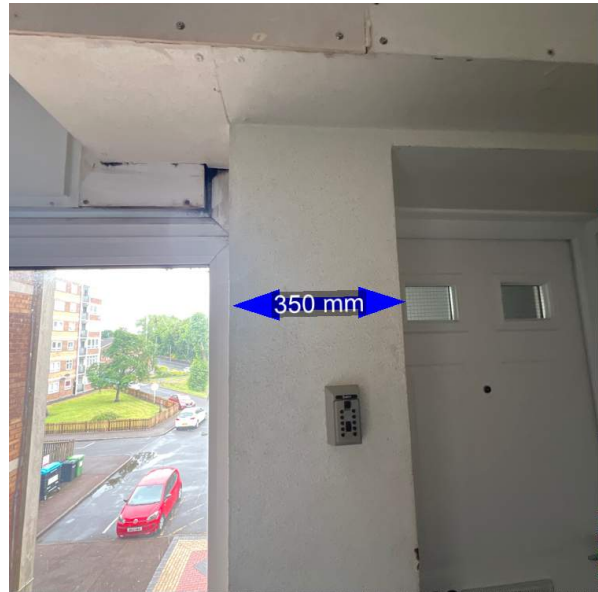
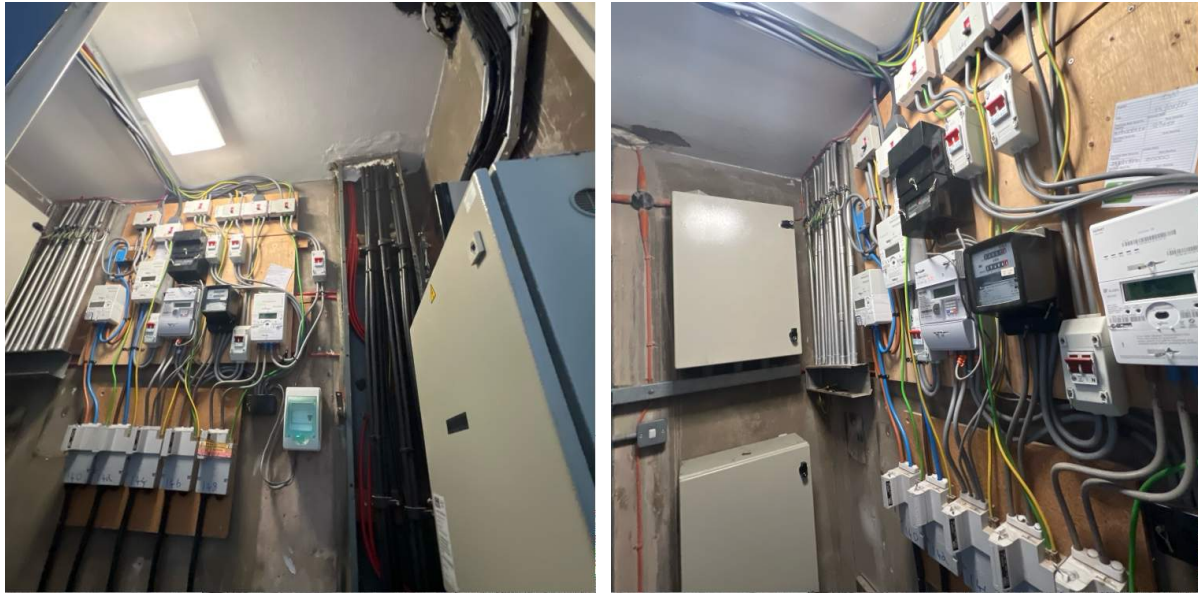
## 2nd Floor Hallway

Comments: No jams or distortions noted to hallway doors to indicate any serviceability issues. Generally walls covered with finishes in hallway, likely to consist a mixture of concrete shear walls, embedded columns and masonry infill walls. Limited structure exposed. Concrete structure and rendered infill masonry (non-load bearing) walls noted in riser cupboards.

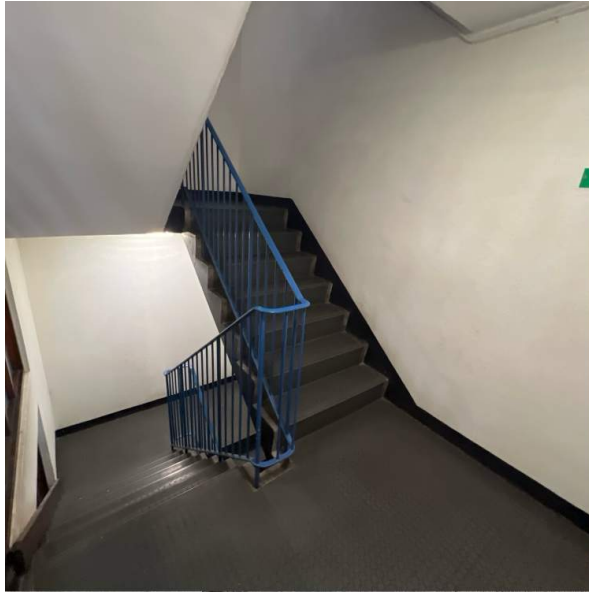
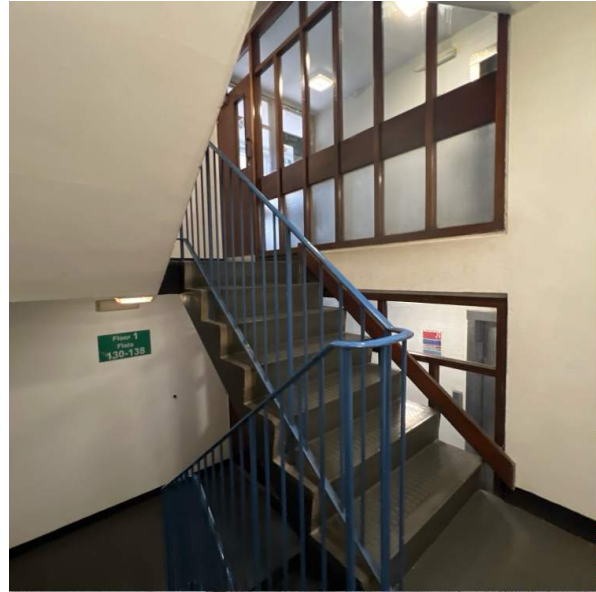
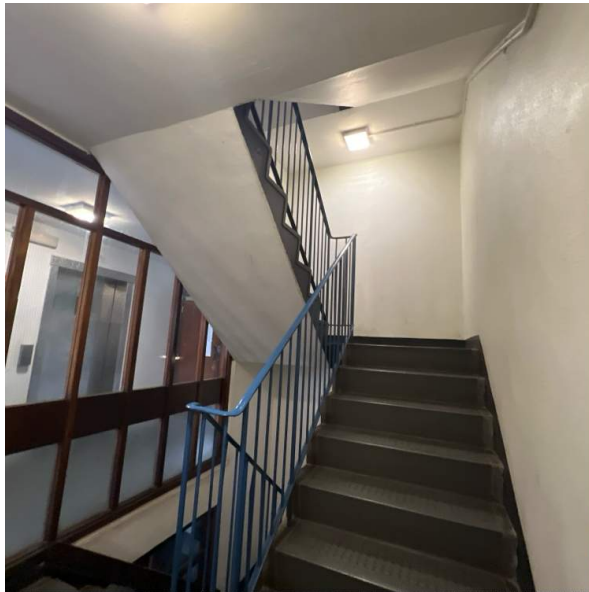
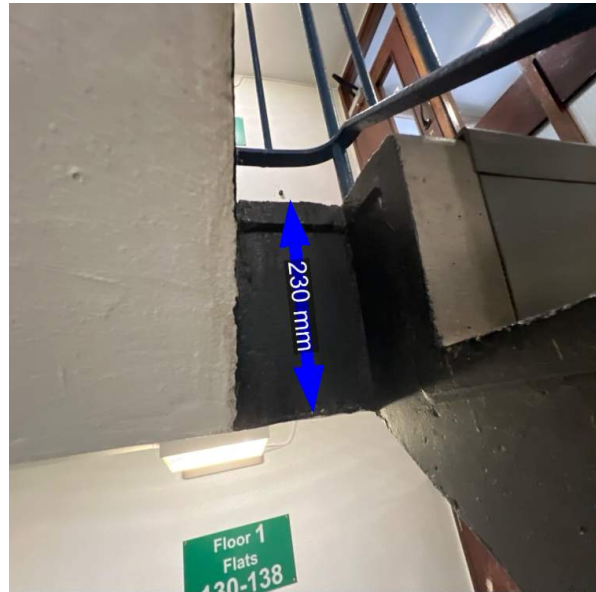
## 2nd Floor Staircases

Comments: Insitu concrete stairs with steel hand railing fixed to stairs. Walls and floors appear to be fairly level.  
Stair walls covered with finishes however these would likely form the main concrete shear core walls. One side of staircase wall consists of an RC concrete beam and infill partition/glazing.

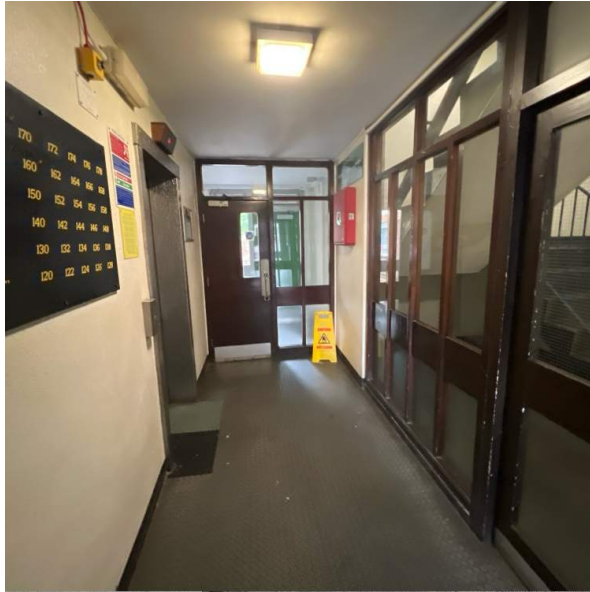
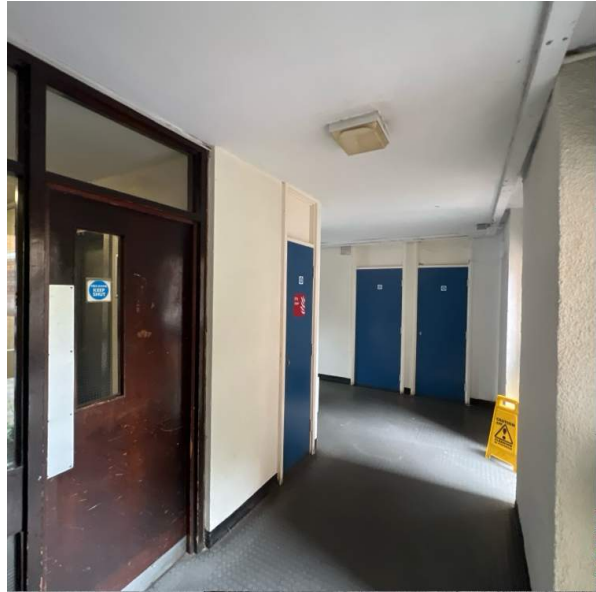
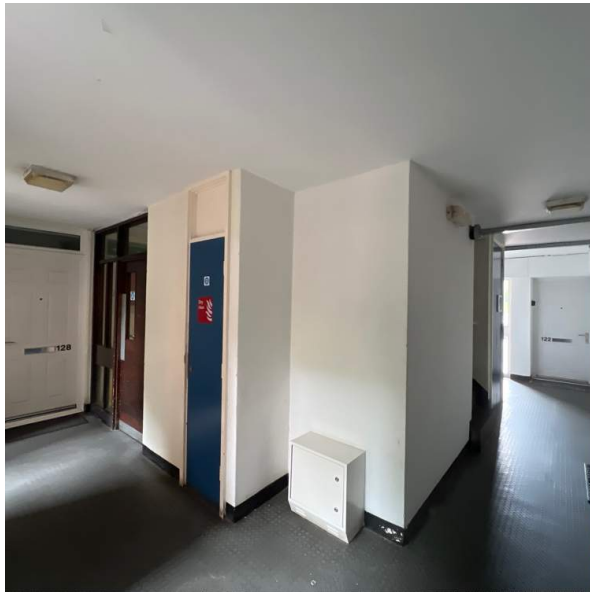
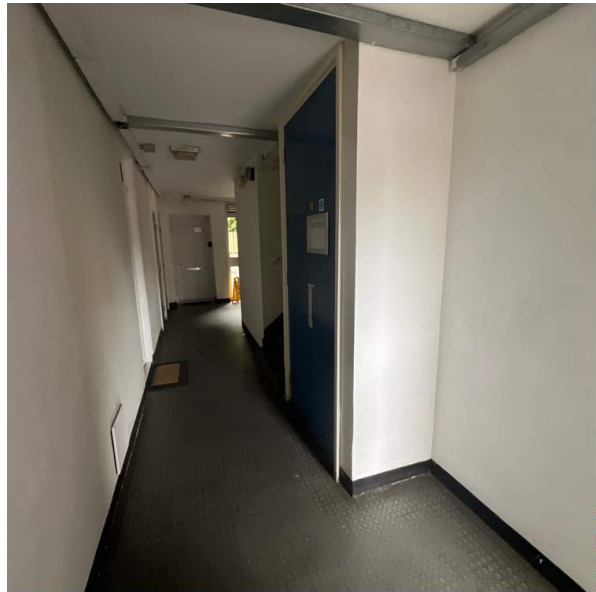
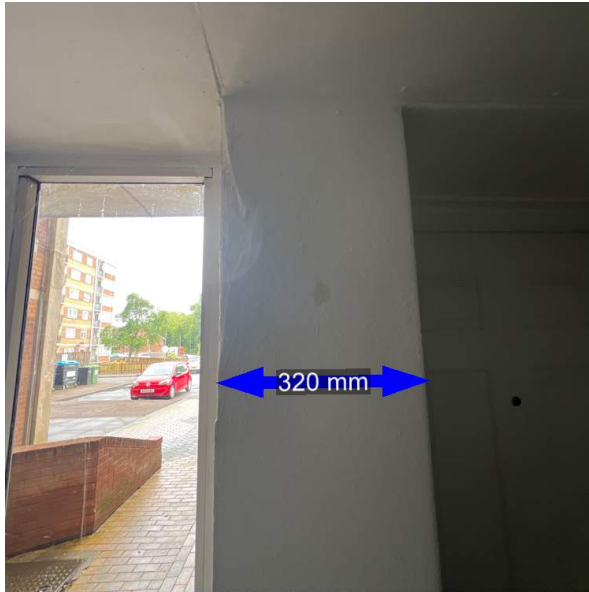
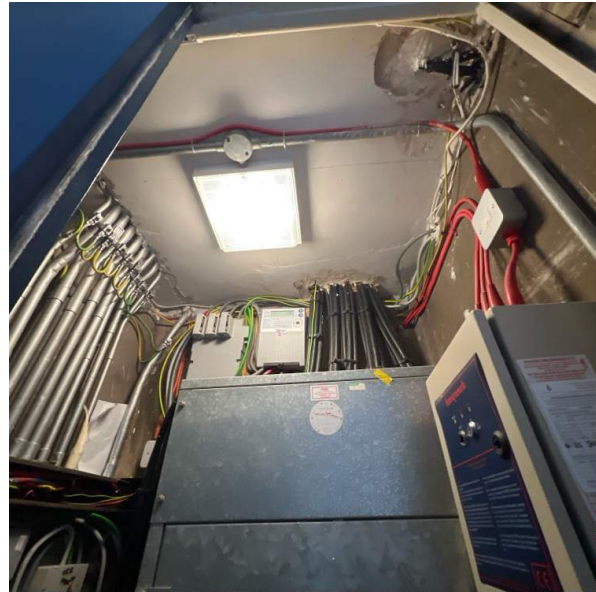
## Ground Floor Hallway

Comments: No jams or distortions noted to hallway doors to indicate any serviceability issues. Generally walls covered with finishes in hallway, likely to consist a mixture of concrete shear walls, embedded columns and masonry infill walls. Limited structure exposed. Concrete structure and rendered infill masonry (non-load bearing) walls noted in riser cupboards.

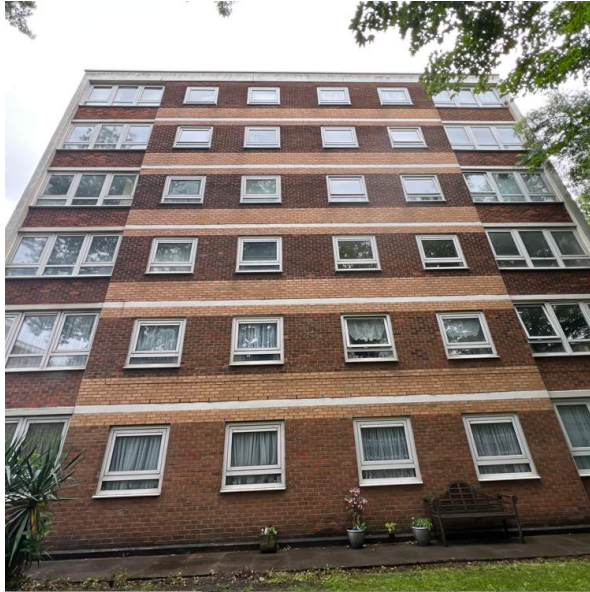
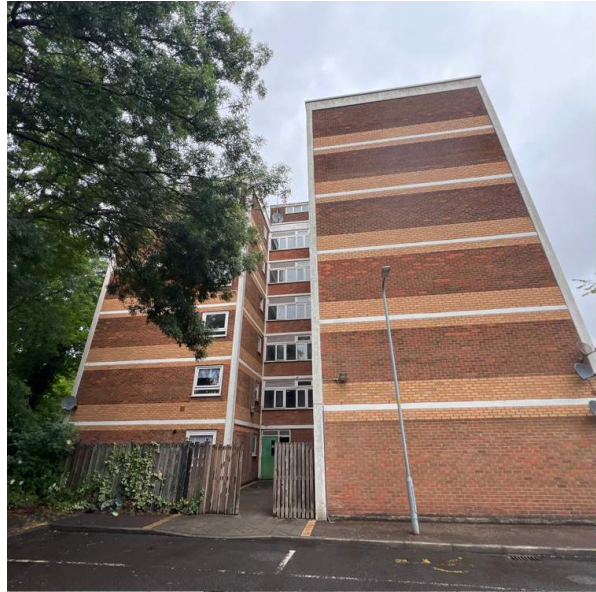
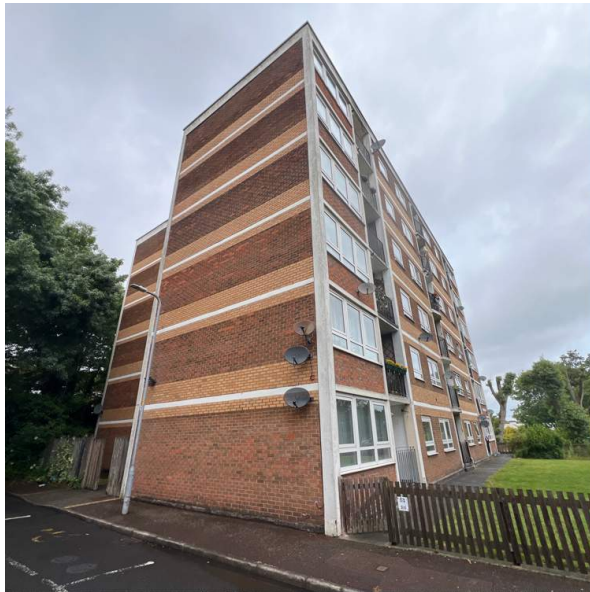
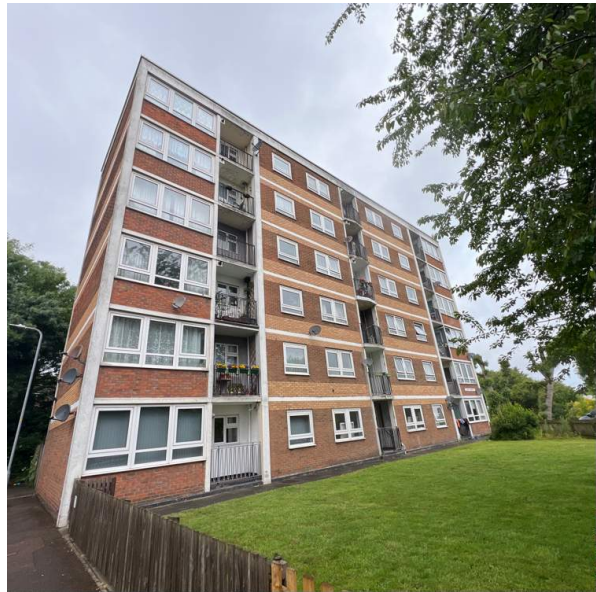
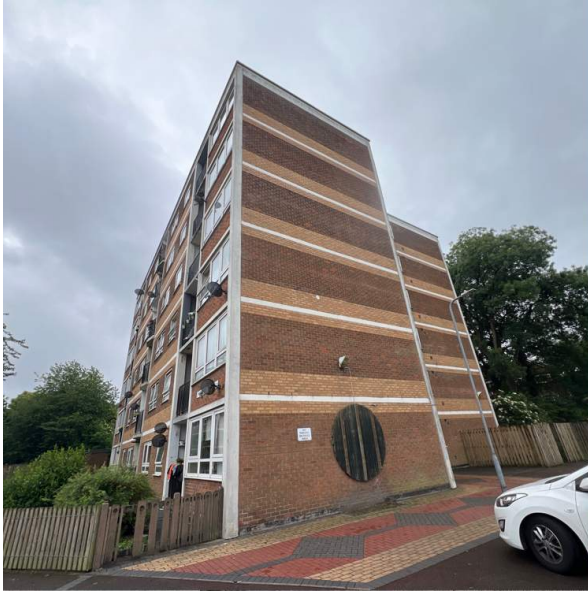
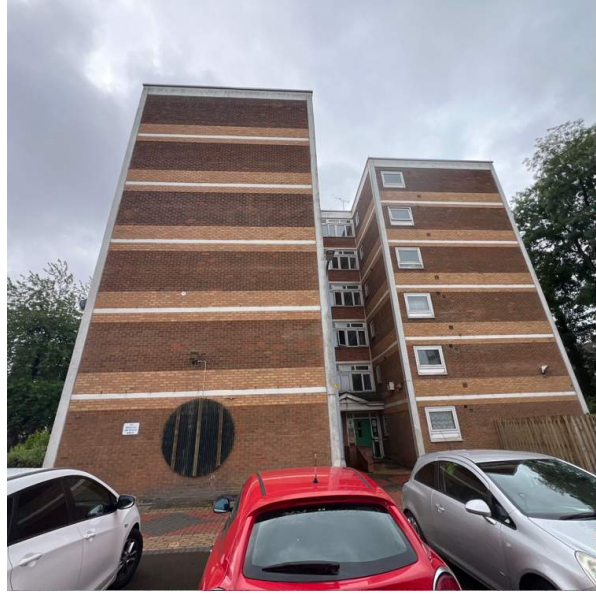
## Elevations

Comments: External facade consists of brick work to all elevations GF to top floor.  
Elevations generally in fair condition.  
RC columns forming part of main structural elements noted to perimeter of building.
