VISUAL STRUCTURAL APPRAISAL

1-82 Russell House

Holyhead Road  
Wednesbury  
WS10 7BA

13<sup>th</sup> November 2024

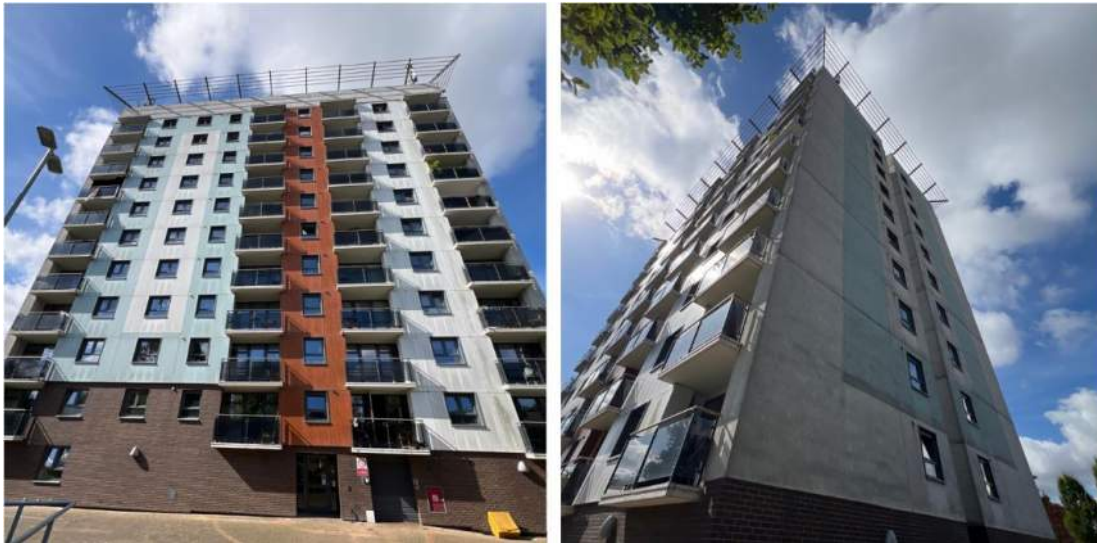
Figure 9 and 10: Building Elevations

The exterior walls were noted to be plumb with no signs of significant bowing, bulging or leaning noted to the cladding indicating failed fixings, however their presence and condition cannot be confirmed.

There are cantilevered stacked balconies at every level. These have steel railings with glass infill panels. No signs of significant movement noted.

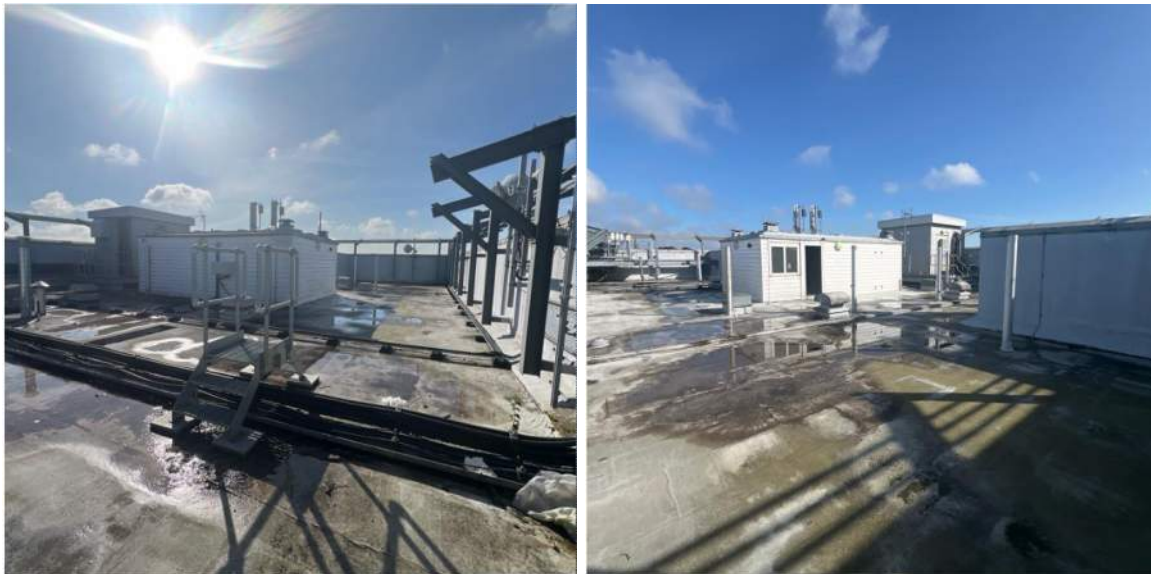
Figure 11 and 12: Roof Level

There were no tell-tale signs of any significant structural movement noted at the time of our inspection. There were some localised areas of ponding, the drainage system should be checked and cleared as part of the normal regimen of maintenance.

A subsequent waterproofing covering was installed, likely during the 2012 refurbishment, which appears to be a single ply membrane.

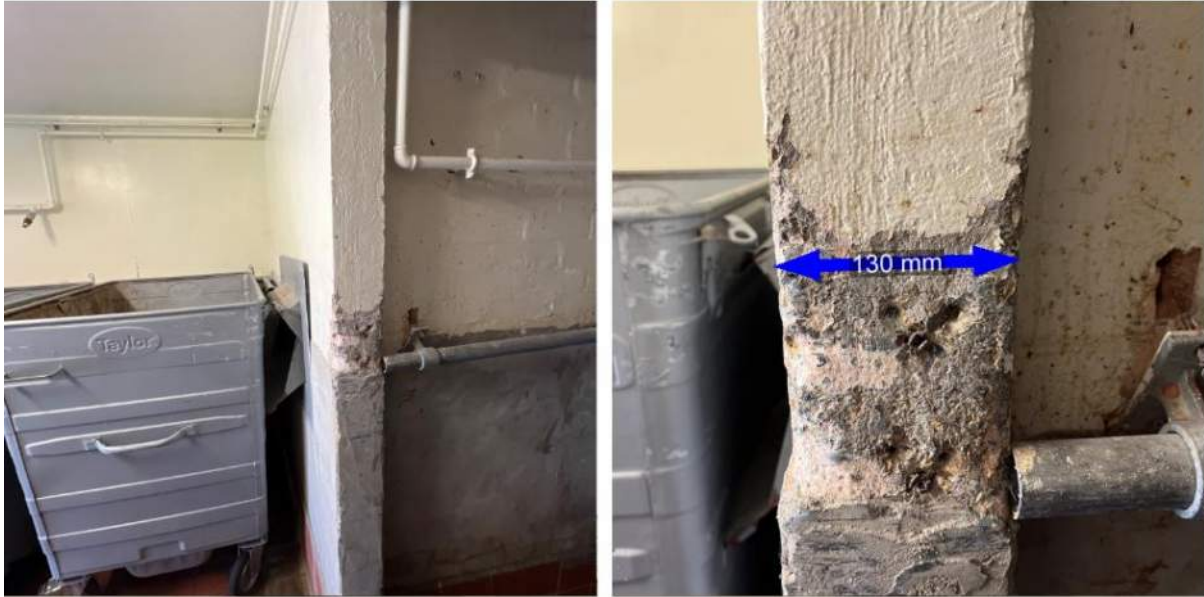
Figure 13 and 14: RC Structure

The wall panels are measured at 130-150mm thick. A cover test is required to check the resistance of the concrete section in the event of a fire.

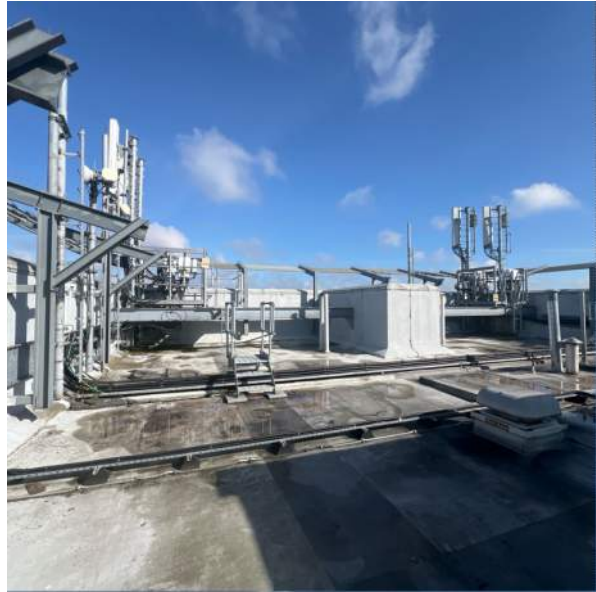
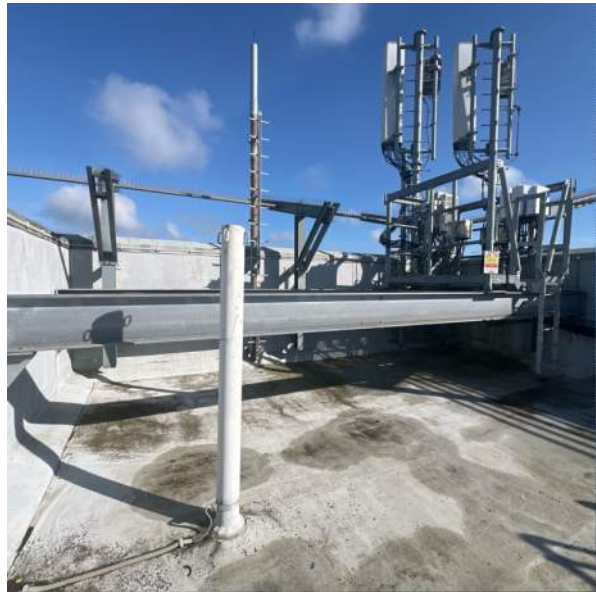
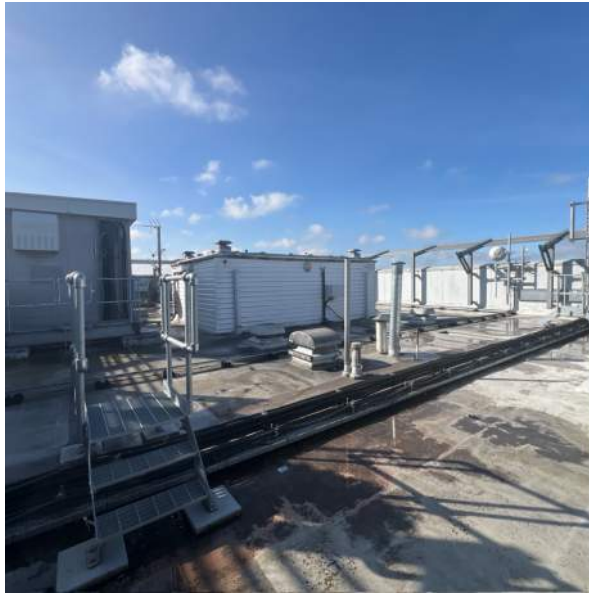
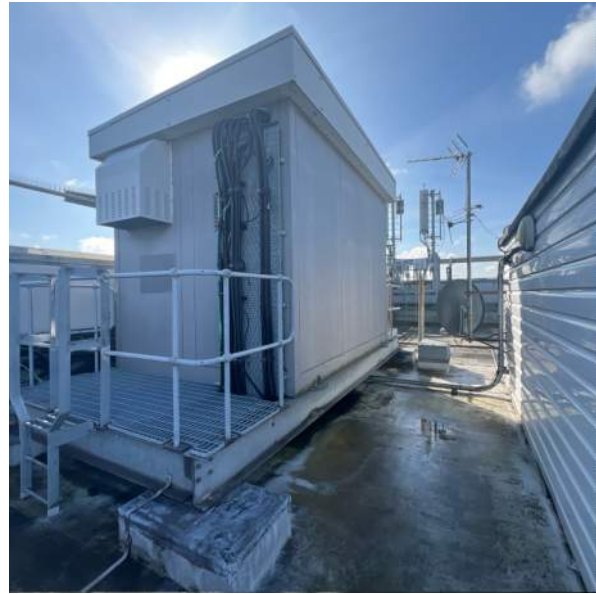
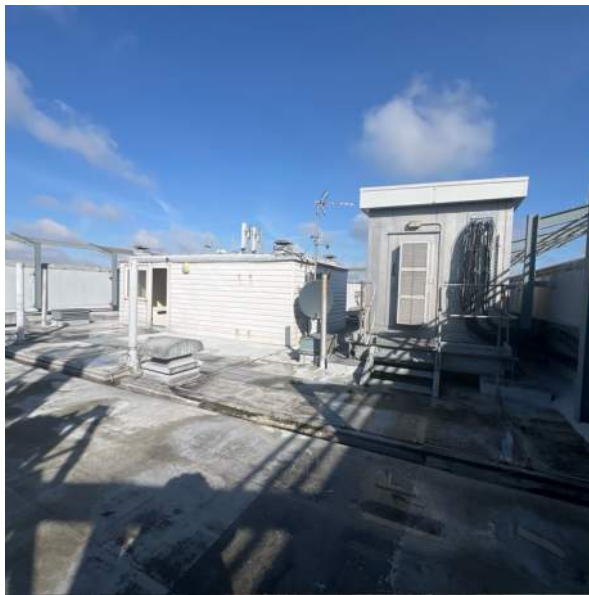
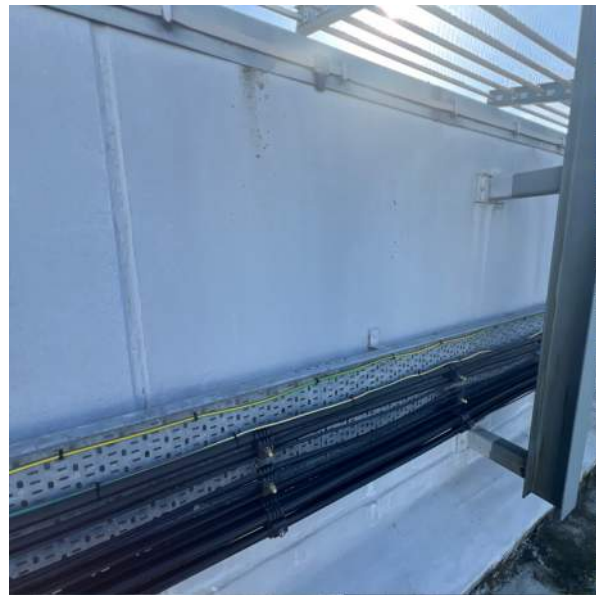
## Main Roof

2m Parapet walls noted to perimeter of roof, appear to be precast concrete elements.  
Electrical and Radio equipment installed at roof level.  
Roof finishes with PiR insulation and coverings.  
Some areas of ponding noted.

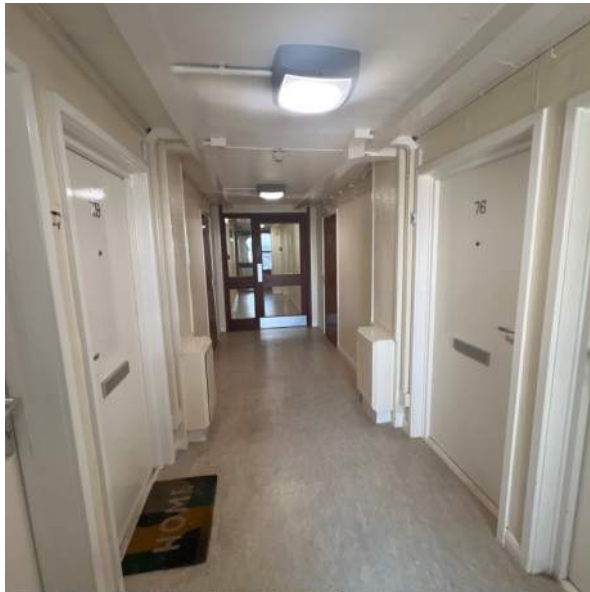
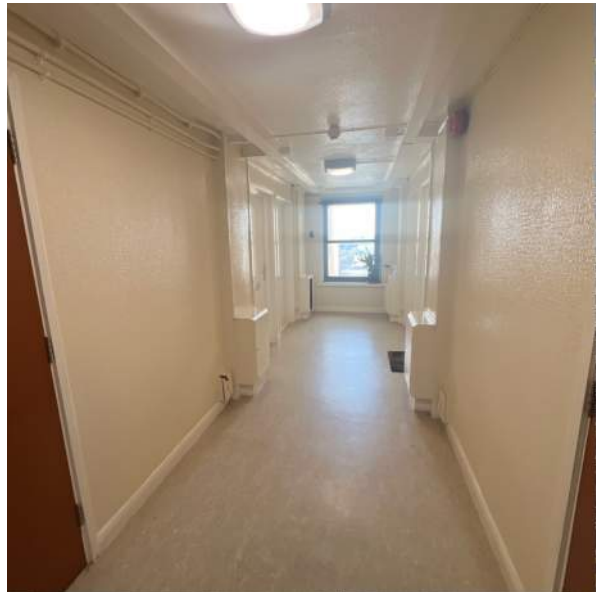
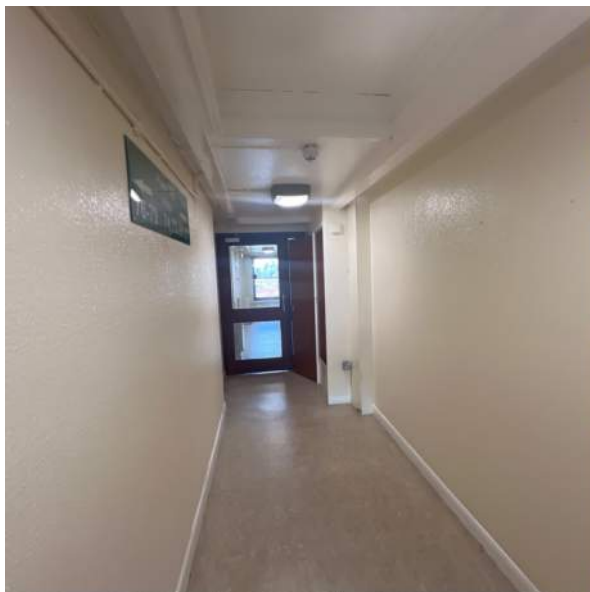
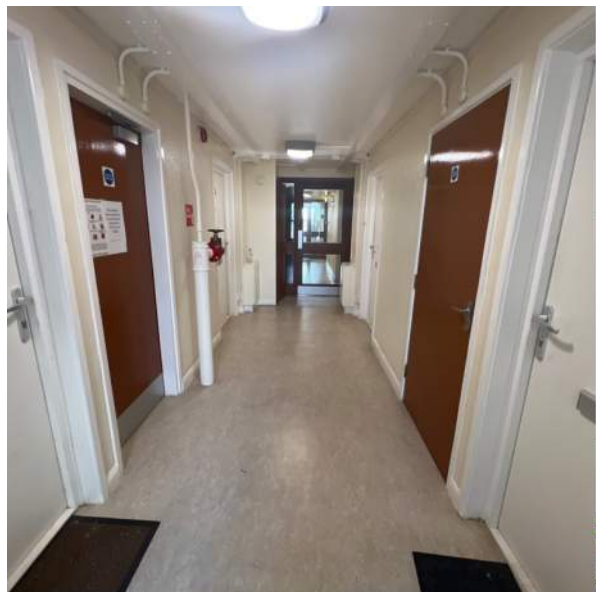
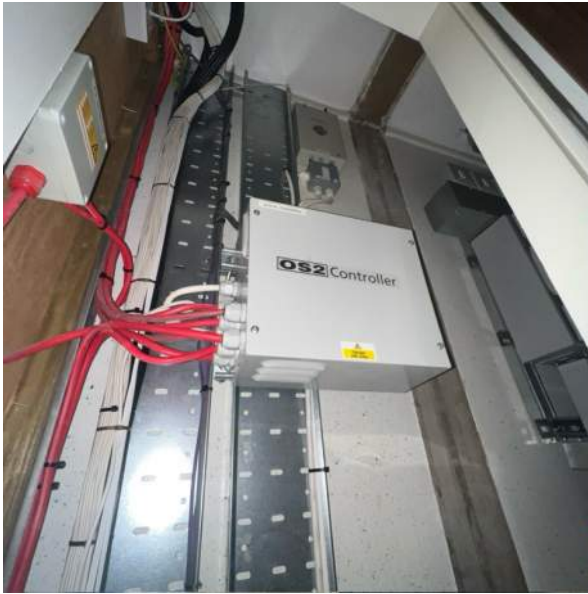
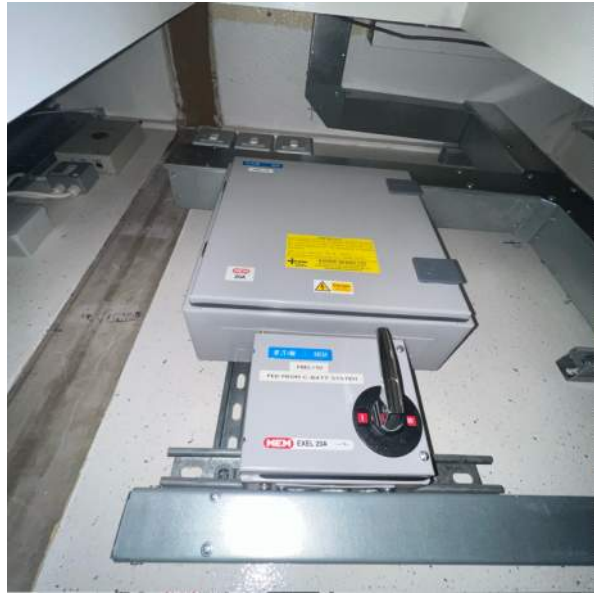
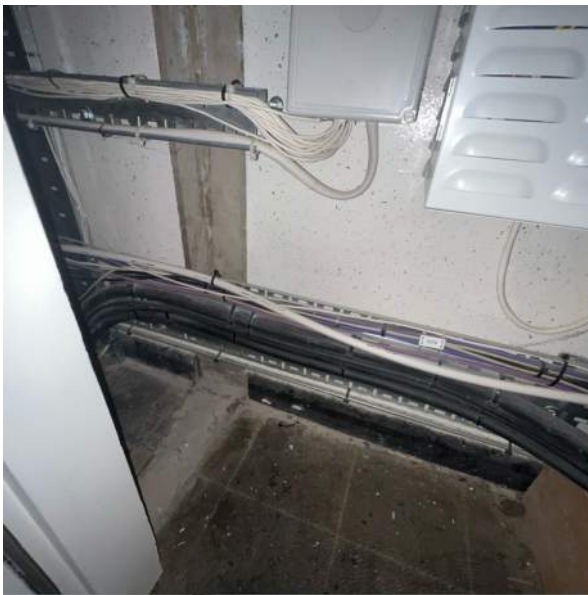
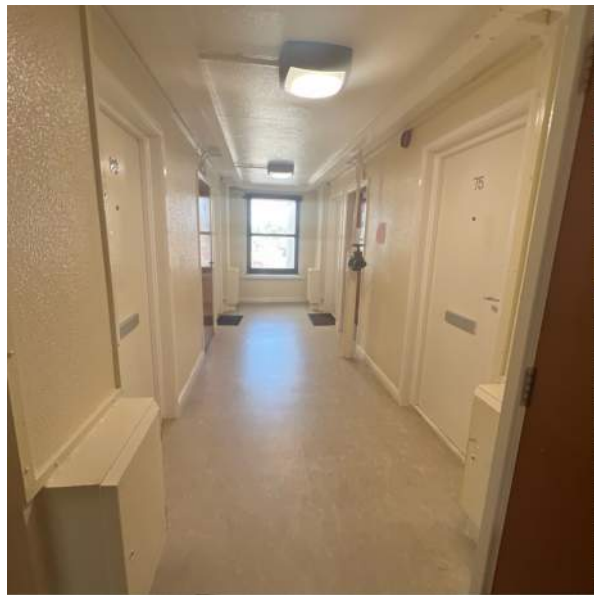
## 10th Floor Hallway

Comments: No jams or distortions noted to hallway doors to indicate any serviceability issues. Generally walls covered with finishes in hallway, likely to consist a mixture of concrete shear walls and infill (non-load bearing) walls. Limited structure exposed. Partly visible concrete walls noted via electrical riser cupboards. Possible joints noted indicating signs of the LPS construction.

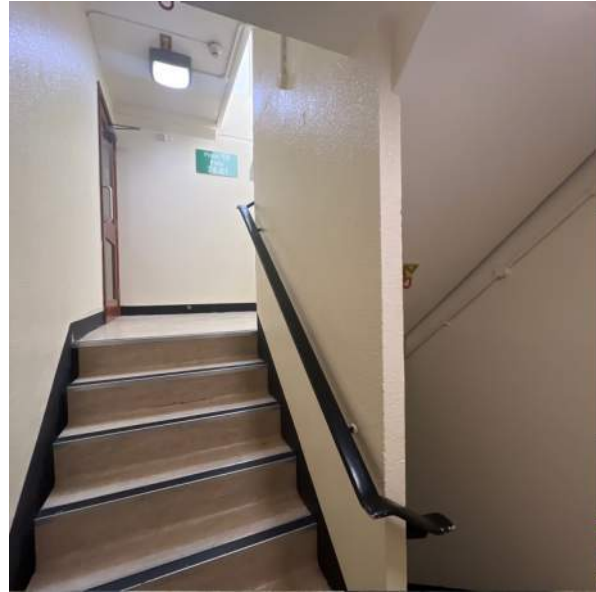
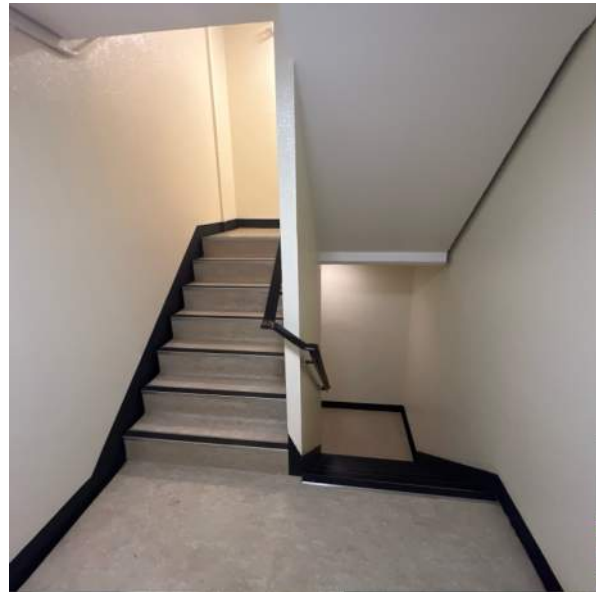
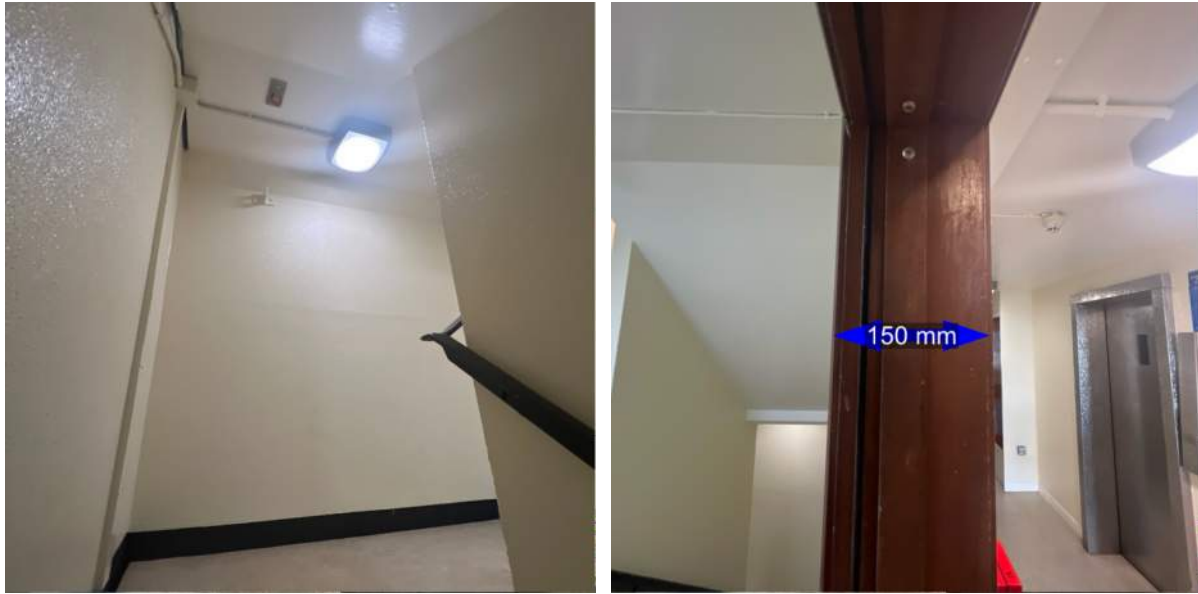
## 10th Floor Staircase

Comments: Walls and floors appear to be fairly level.  
Stair walls covered with finishes however these would likely form the main concrete shear core walls.

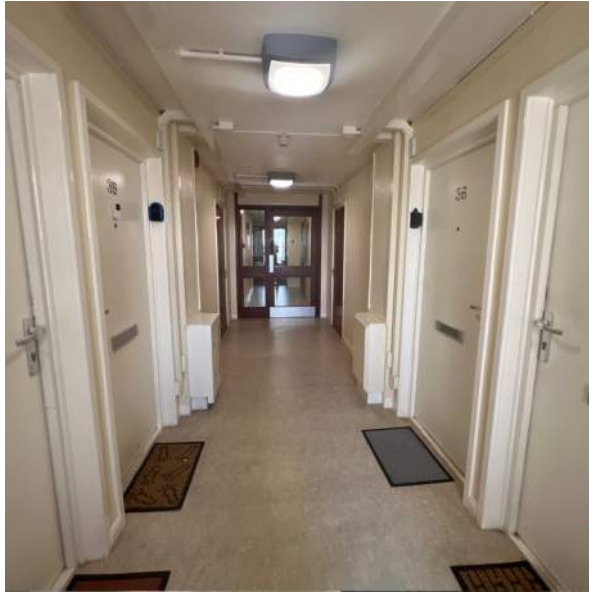
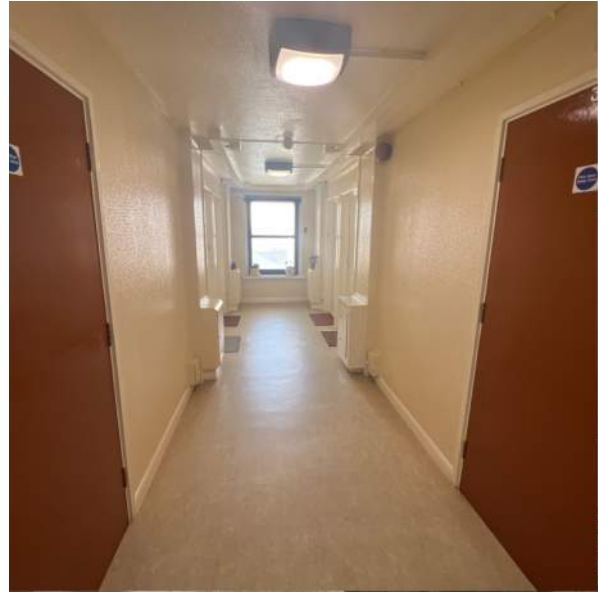
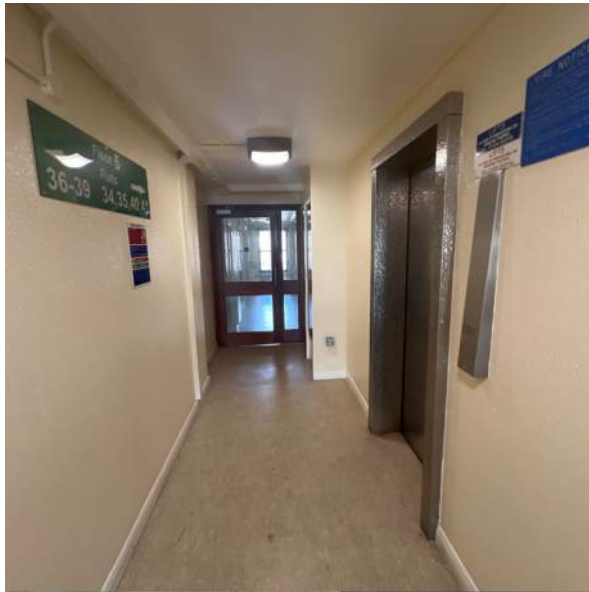
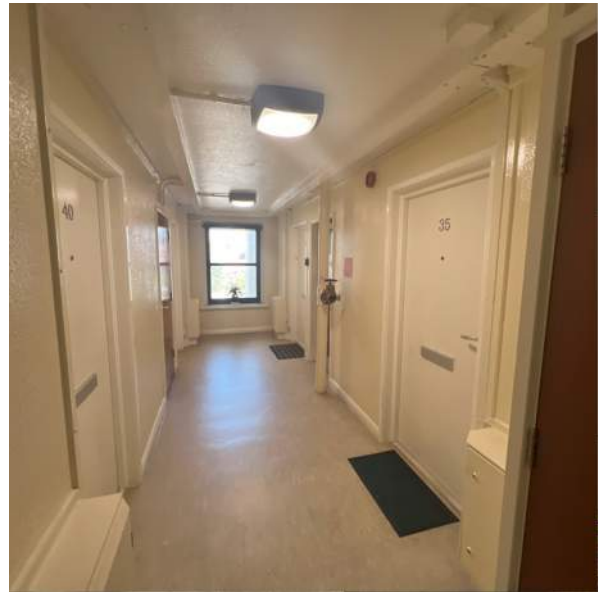
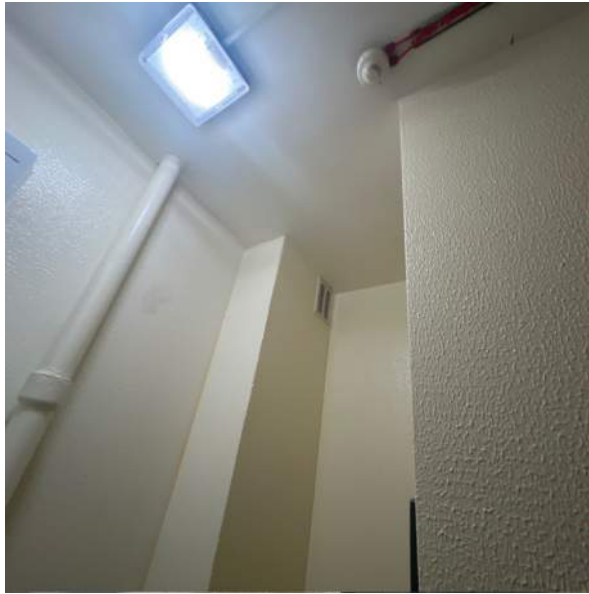
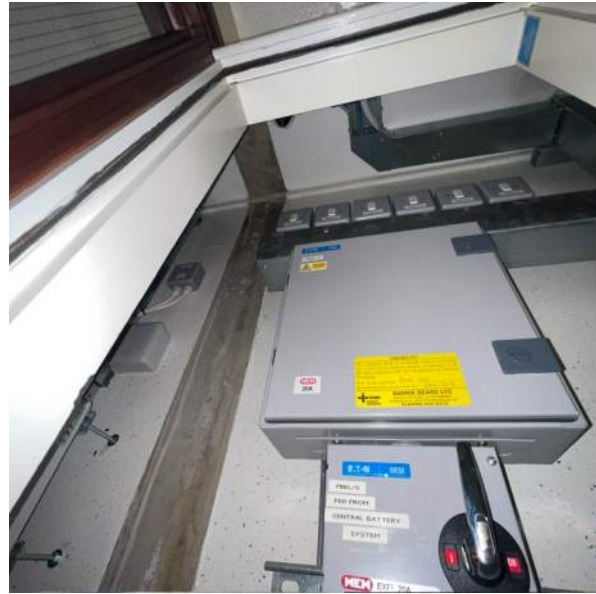
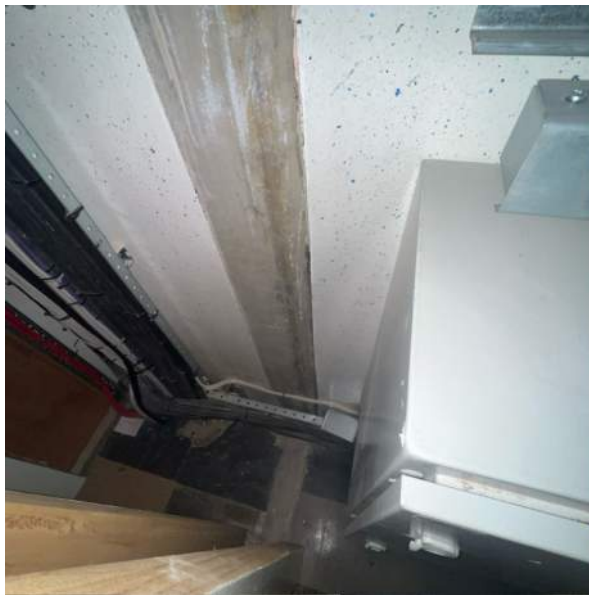
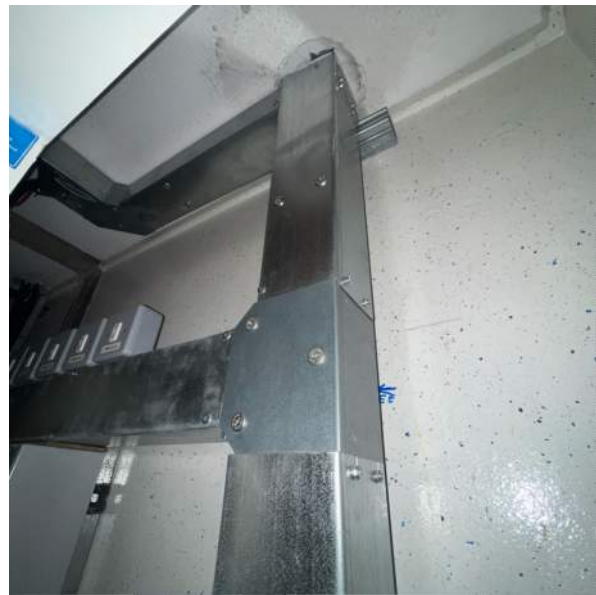
## 5th Floor Hallway

Comments: No jams or distortions noted to hallway doors to indicate any serviceability issues. Generally walls covered with finishes in hallway, likely to consist a mixture of concrete shear walls and infill (non-load bearing) walls. Limited structure exposed. Partly visible concrete walls noted via electrical riser cupboards

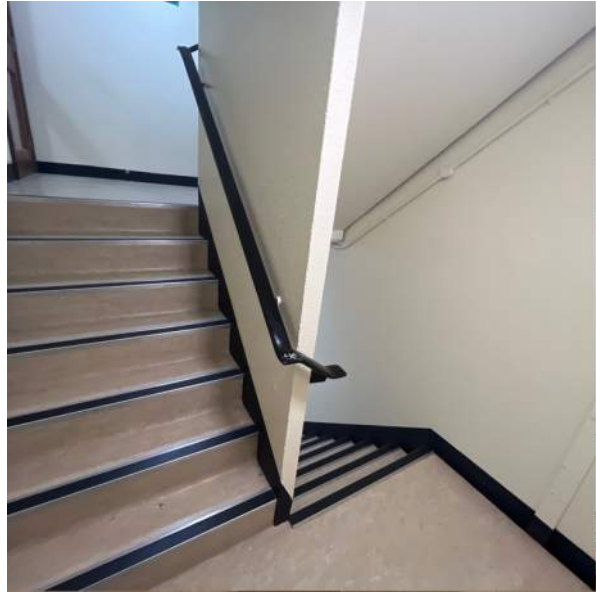
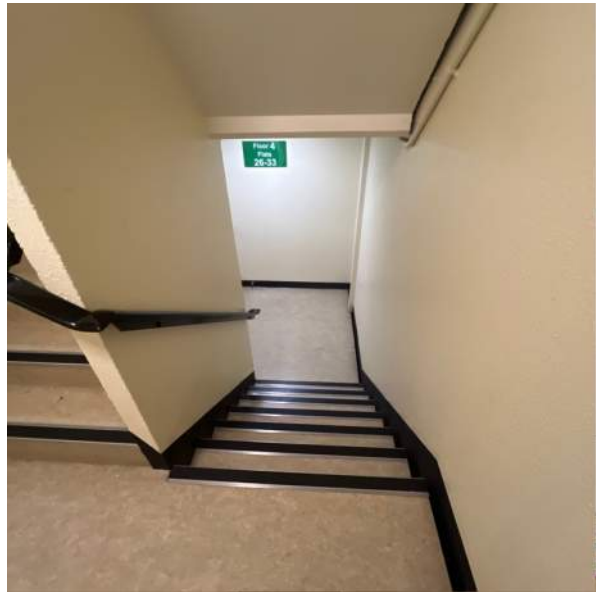
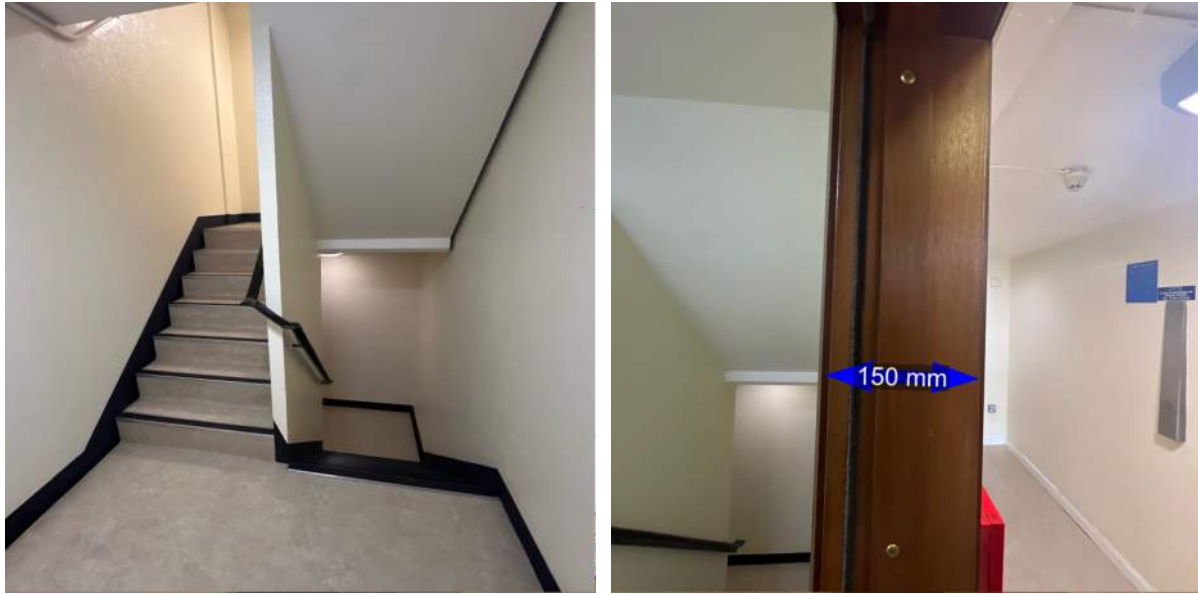
## 5th Floor Staircase

Comments: Walls and floors appear to be fairly level.  
Stair walls covered with finishes however these would likely form the main concrete shear core walls.

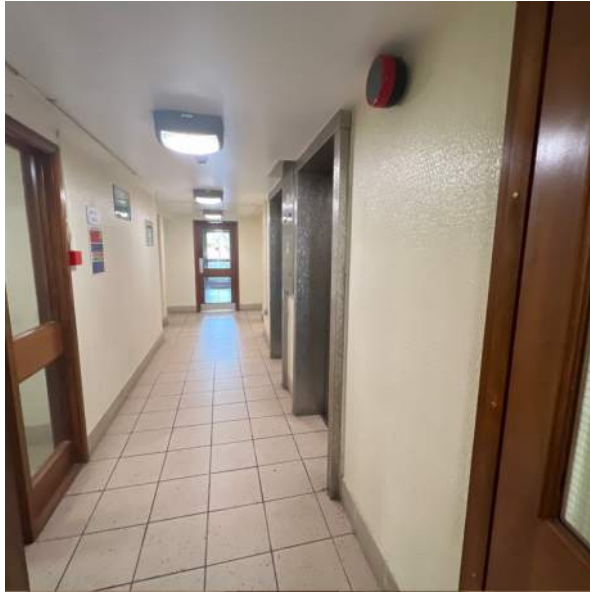
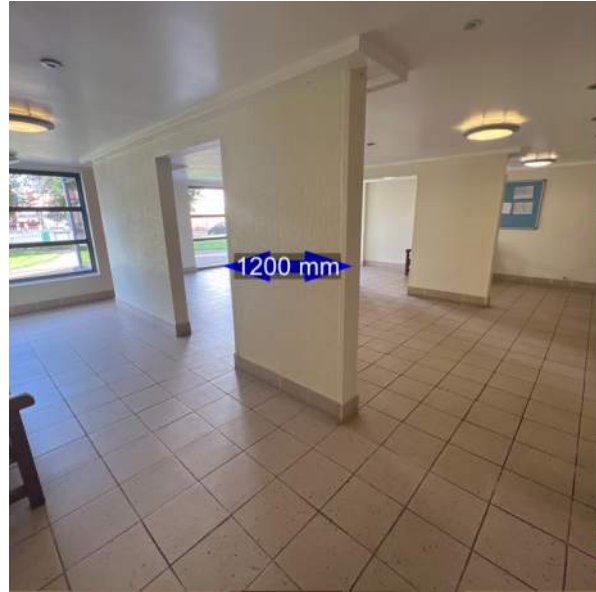
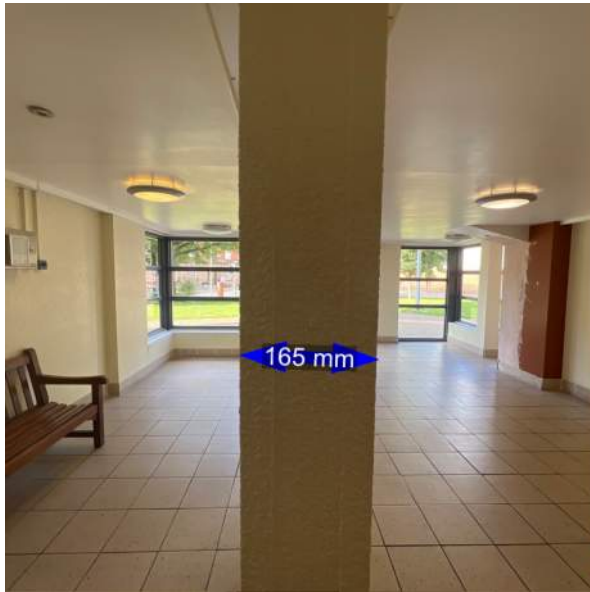
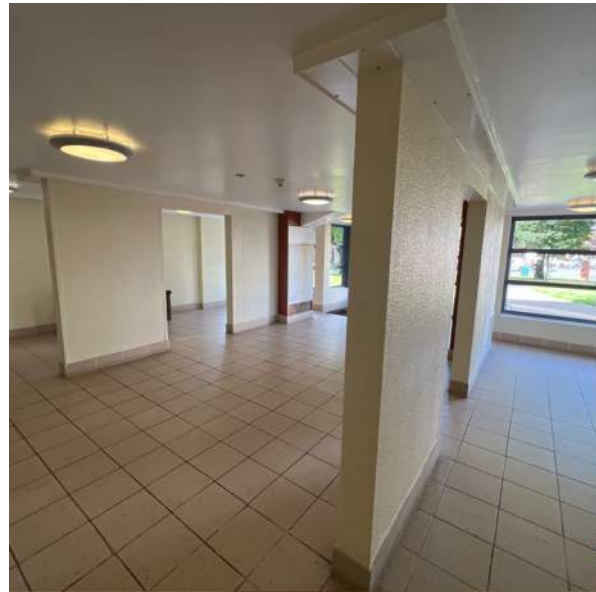
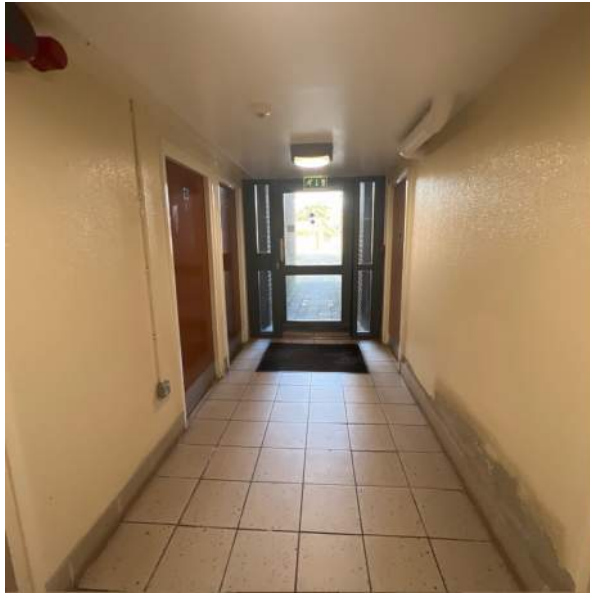
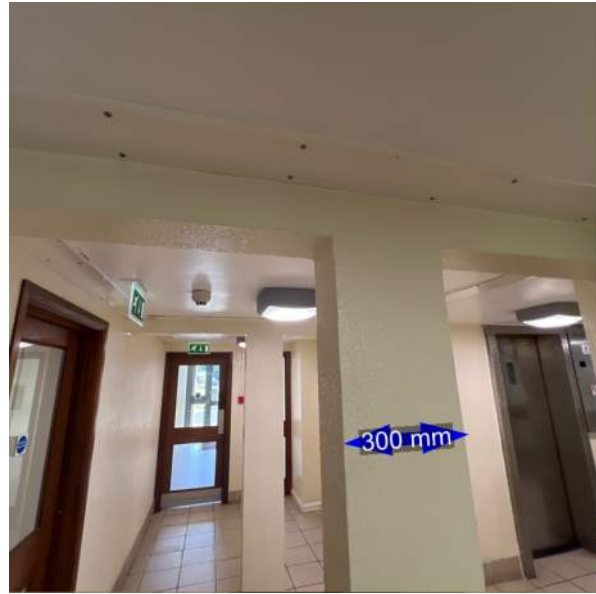
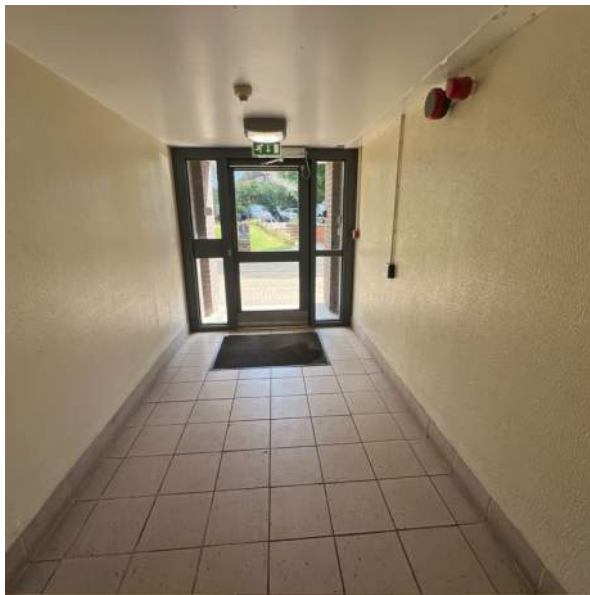
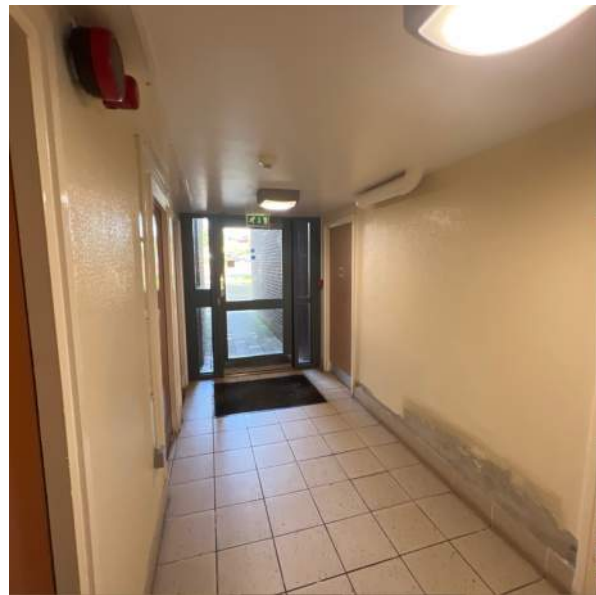
## Ground Floor Hallway

Comments: No jams or distortions noted to hallway doors to indicate any serviceability issues. Generally walls covered with finishes in hallway, likely to consist a mixture of concrete shear walls and infill (non-load bearing) walls. Limited structure exposed. Concrete panels and columns noted in lobby area.

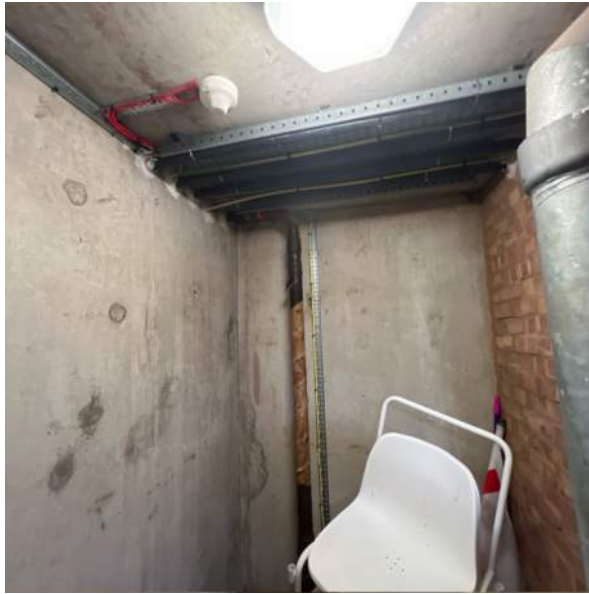
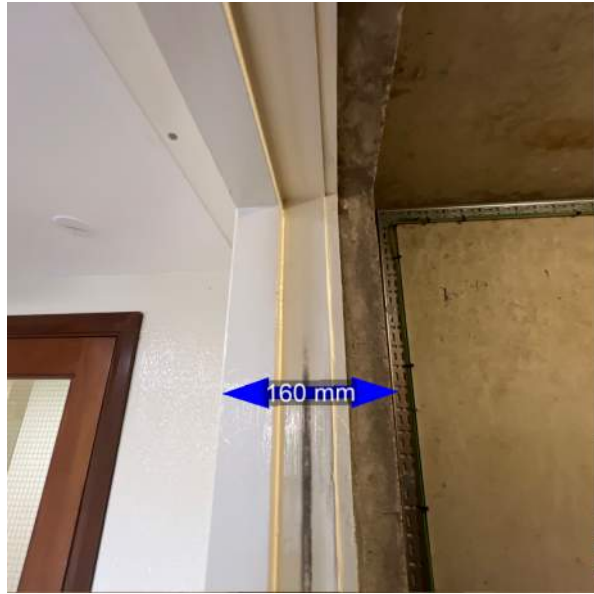
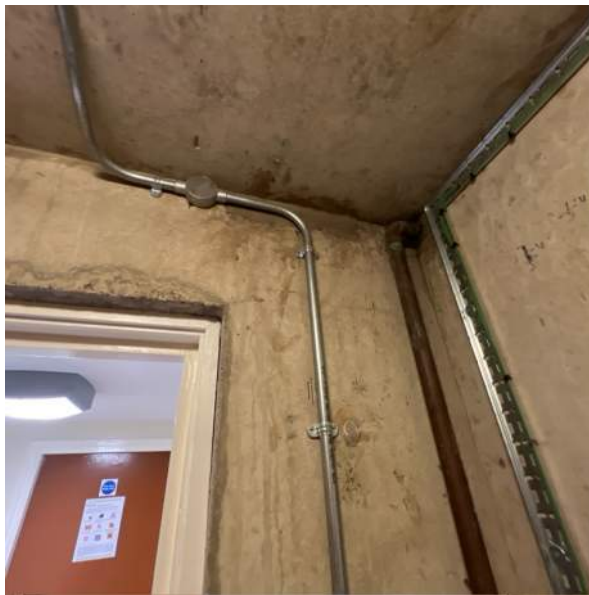
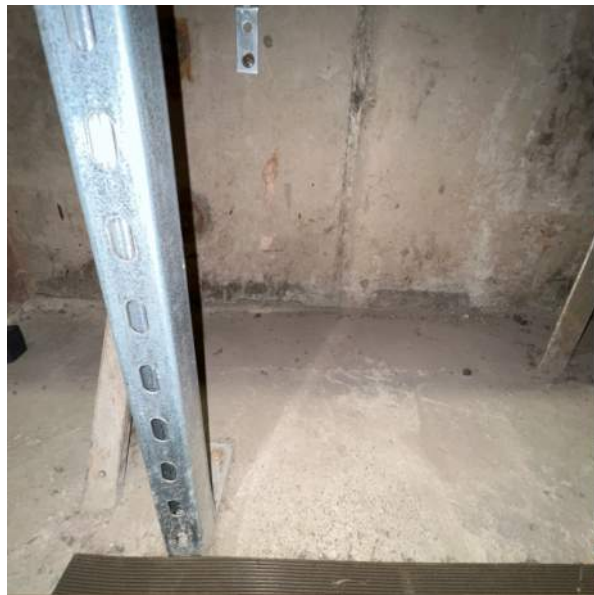
## Ground Floor Accessible Rooms

Concrete elements exposed in accessible rooms. Thickness of panels noted to be approx. 150mm.  
Some infill masonry (non-load bearing) walls noted.

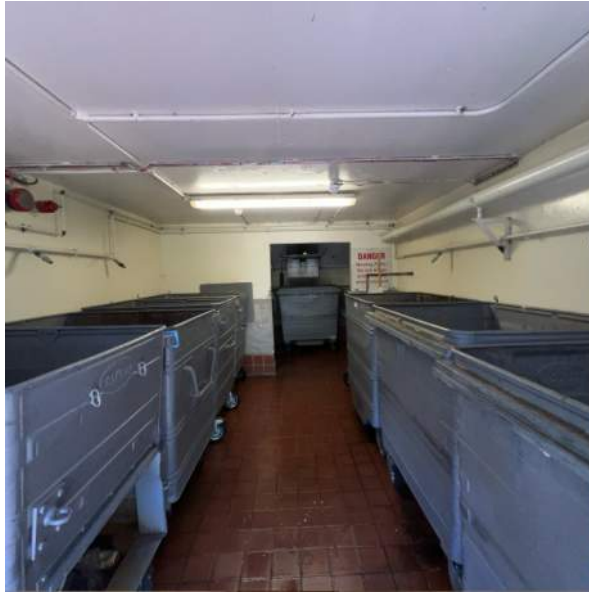
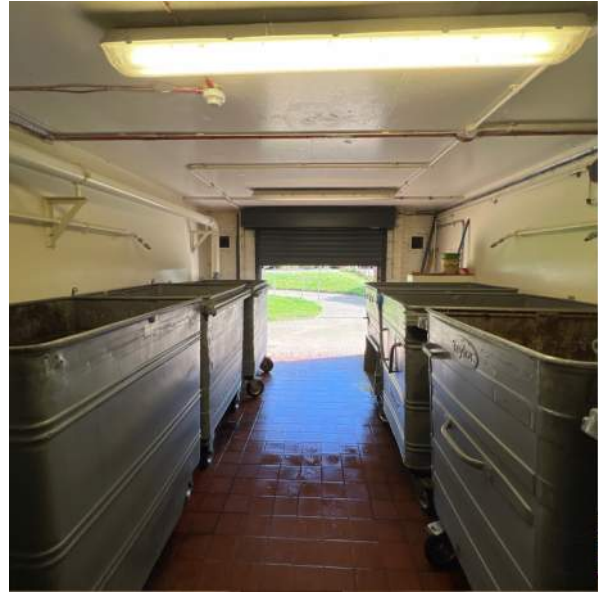
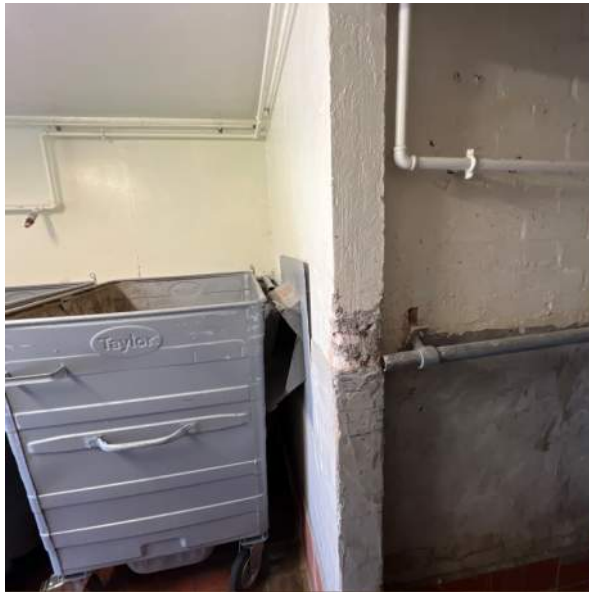
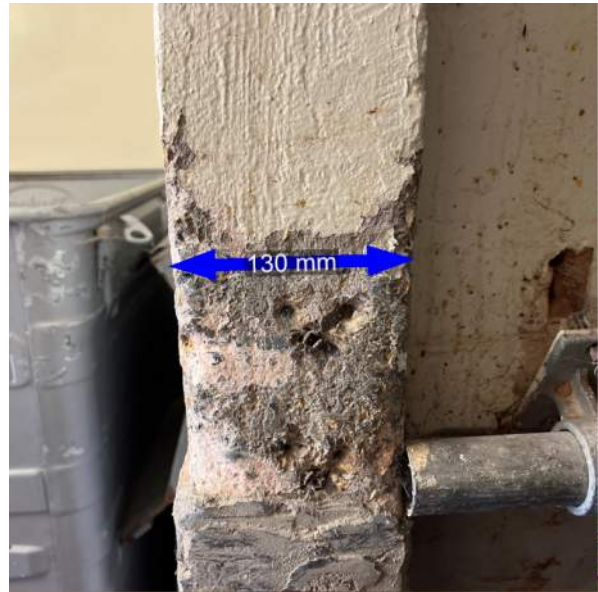
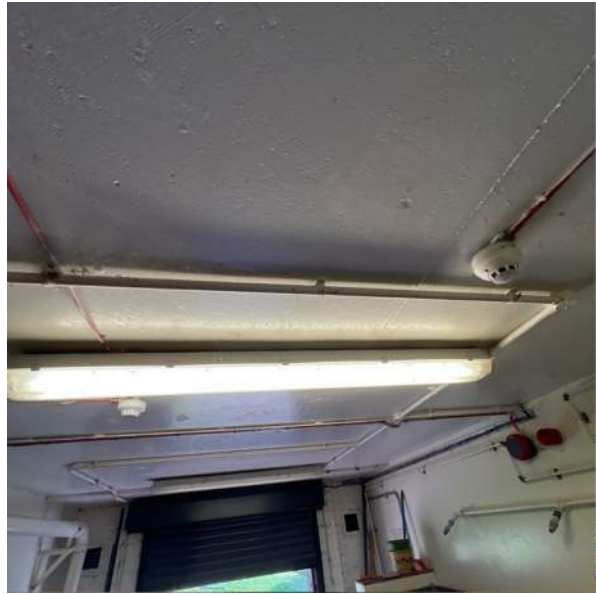
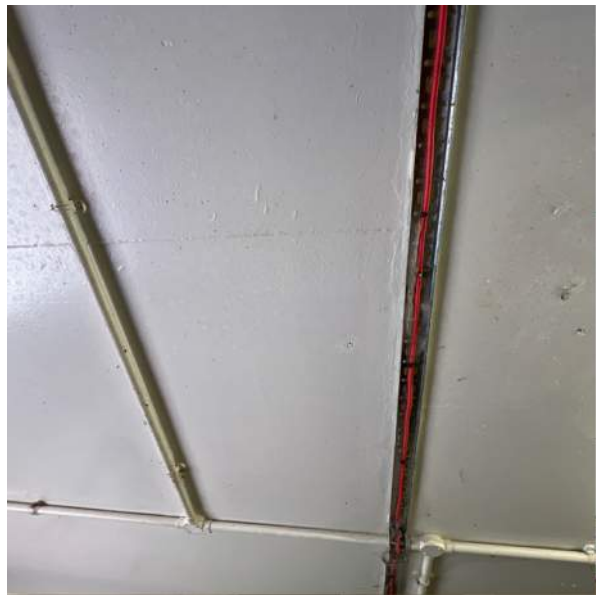
## Binstore

Comments: Concrete elements visible in binstore, mostly covered with finish.

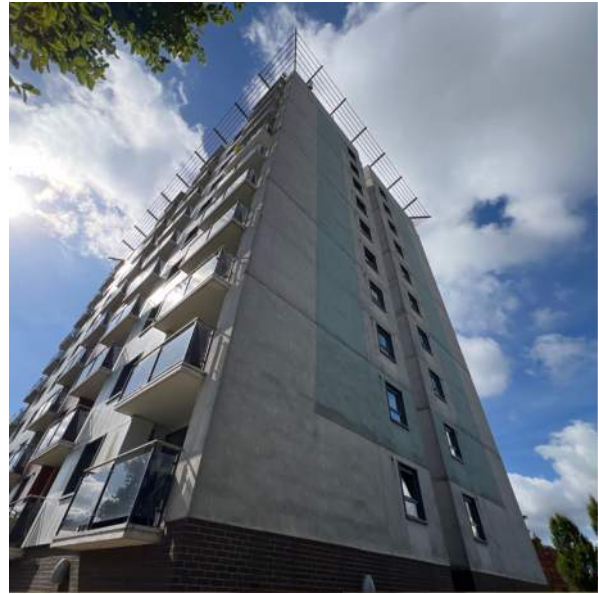
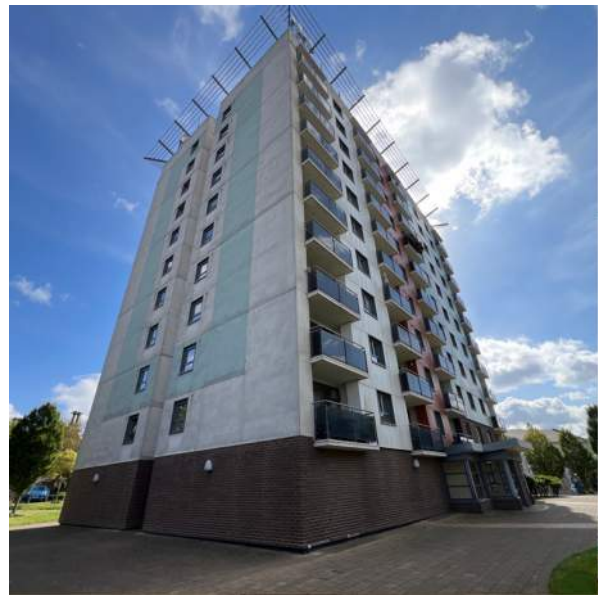
## Elevations

External facade consists of brickwork at ground floor and cladded facade to upper levels and render.

External perimeter appear to be formed of RC Concrete Wall Panels.
