**FIRNTEC**  
BUILDING COMPLIANCE

VISUAL STRUCTURAL APPRAISAL

Scott House  
Coniston Crescent  
Hamstead  
B43 5RD

27<sup>th</sup> May 2025

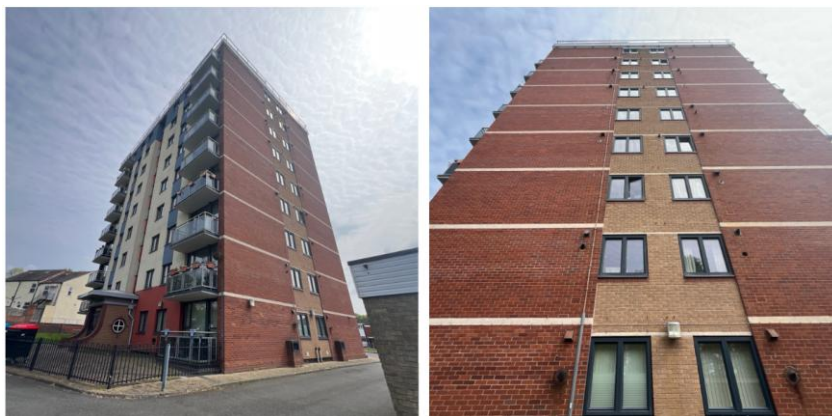
Figure 9 and 10: Building Elevations

The exterior elevations were generally in ok condition and no significant structural defects were noted to the cladding. There were no significant cracks or tell-tale signs of any significant structural movement noted at the time of our inspection.

The exterior panels were noted to be plumb with no signs of significant bowing, bulging or leaning noted to the panels indicating failed fixings however their presence and condition cannot be confirmed.

The front and rear elevations were overclad in 2008 with an external wall render system.

There are balconies at each level which are formed of cantilevered RC slabs tied into the main frame. The balconies have had the balustrades refurbished with steel framed glazing. The cantilevered slabs should be checked for internal corrosion potential at the benchmark inspections.

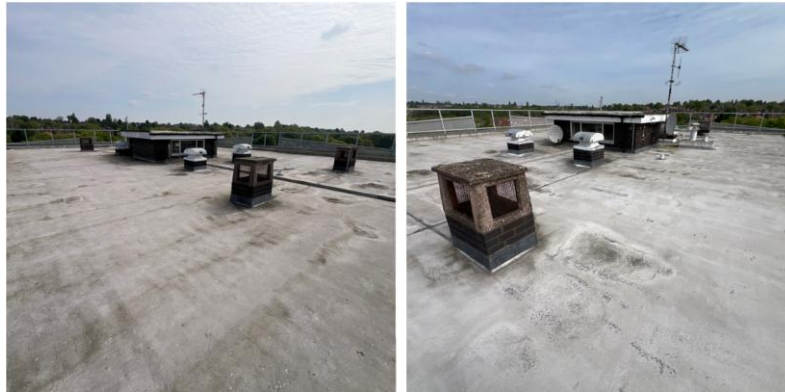
Figure 11 and 12: Roof Level

There were no tell-tale signs of any significant structural movement noted at the time of our inspection.

The roof has an liquid membrane waterproofing system. The exact build-up of the roof finishes were not accessible at the time of inspection. It is recommended an intrusive survey of the roof finishes is completed by a specialist surveyor to assess the condition of the roof covering although they were noted in good condition with no known water ingress issues and therefore a low risk element.

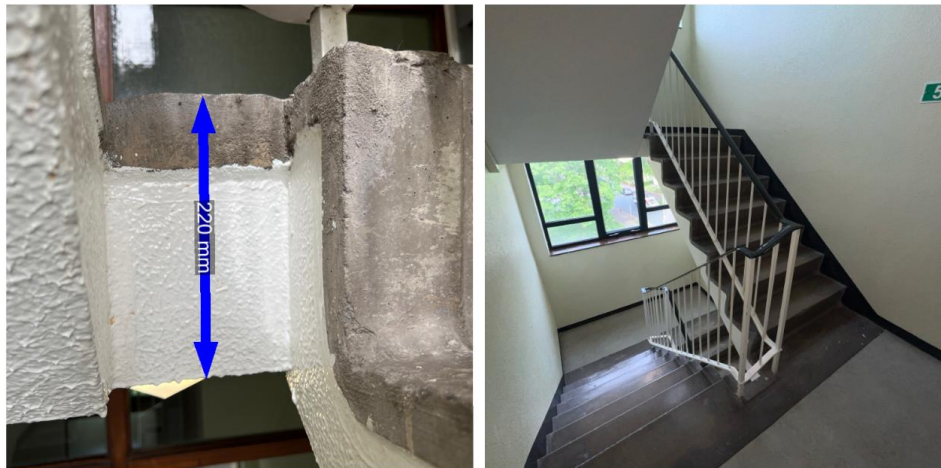
Figure 14 and 15: Slab edge and stair stringer

The interior of the stair core walls were checked and were plumb and in line with observations made to the exterior – no significant signs of leaning or movement noted. The concrete appeared in fair condition with few BRE category 1 cracks but no structurally significant defects were noted.

The stair stringer was noted to be 120mm thick which seems slim, certainly short of modern standards. A cover test is required to check the resistance of the concrete section in the event of a fire.

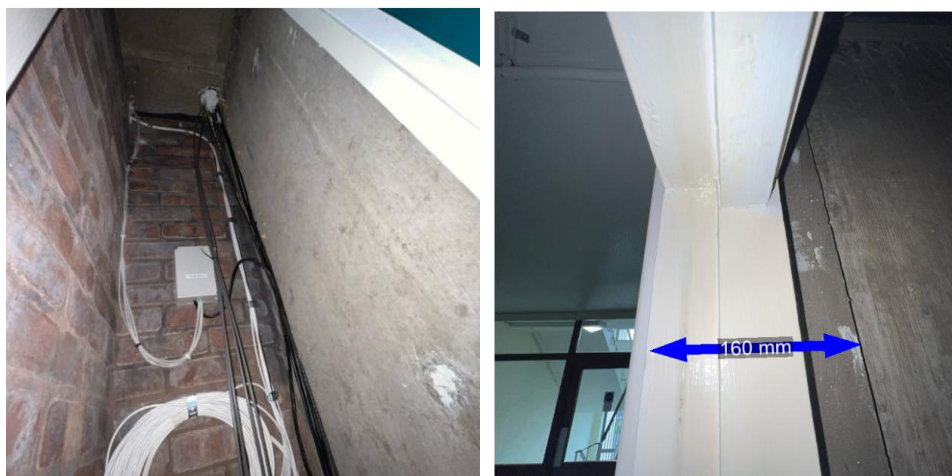
Figure 16 and 17: RC internal elements

The floors in the communal landings were noted to be solid concrete floors. The floors were checked with a spirit level and were considered level and within tolerance. The doors and windows to the communal landings from the stair core all appeared to be level and opened and closed without difficulty. There were no signs of structural movement detected.

There were vertical concrete walls supporting the floor plates at every level. The elements visible matched the floor layout in Figure 6. The walls appear continuous from ground to roof with no transfer structure. The overall condition of the structure observed is good.

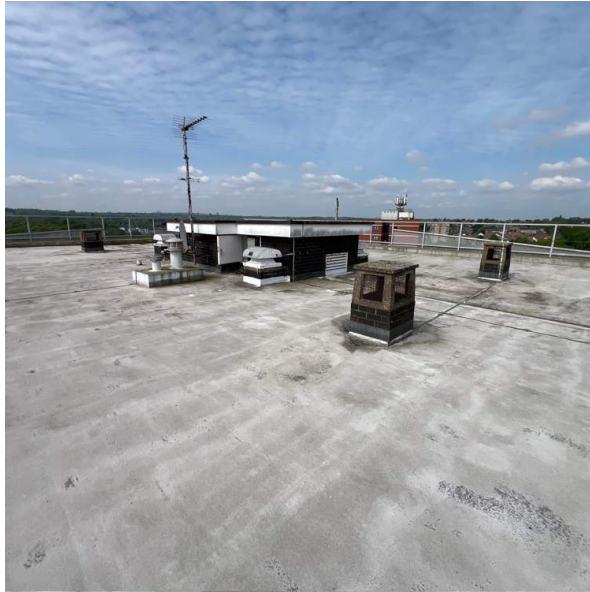
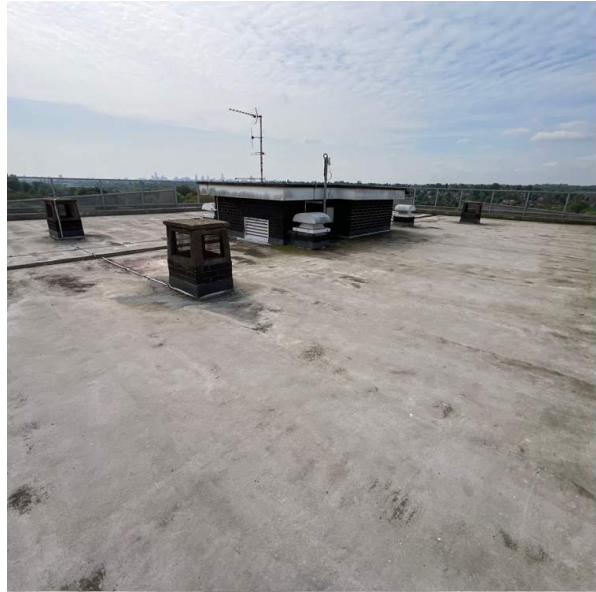
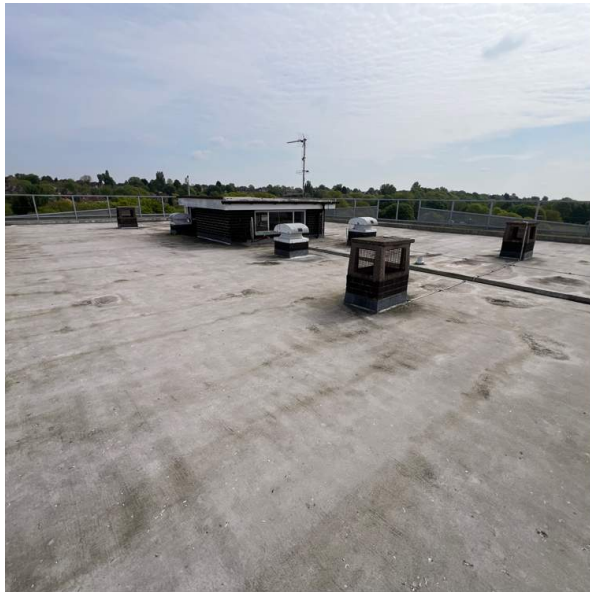
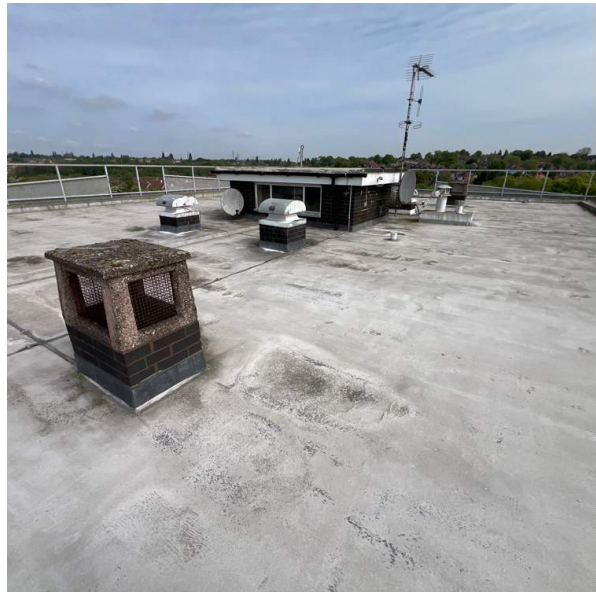
## Main Roof

Comments: Flat roof, RC concrete slab with insulated PIR board and felt coverings.

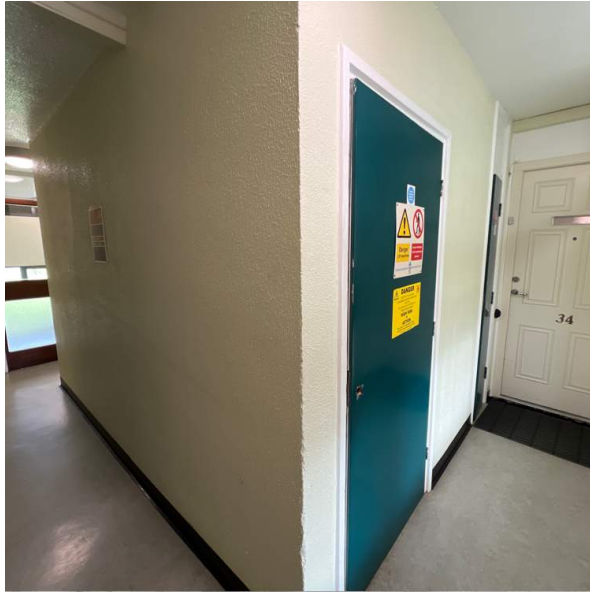
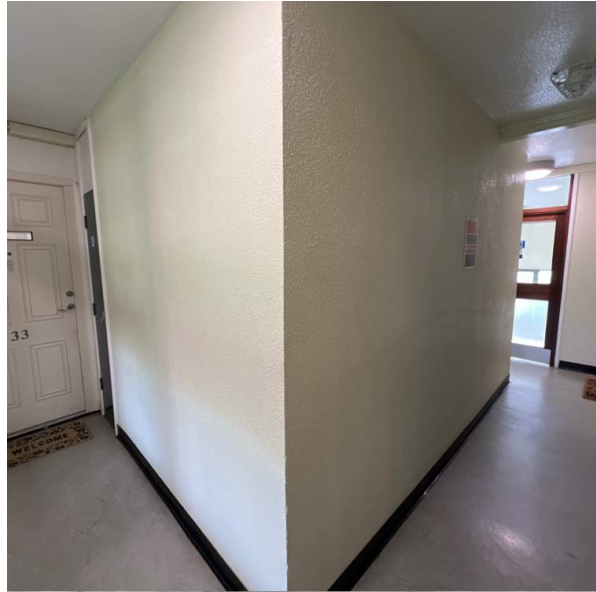
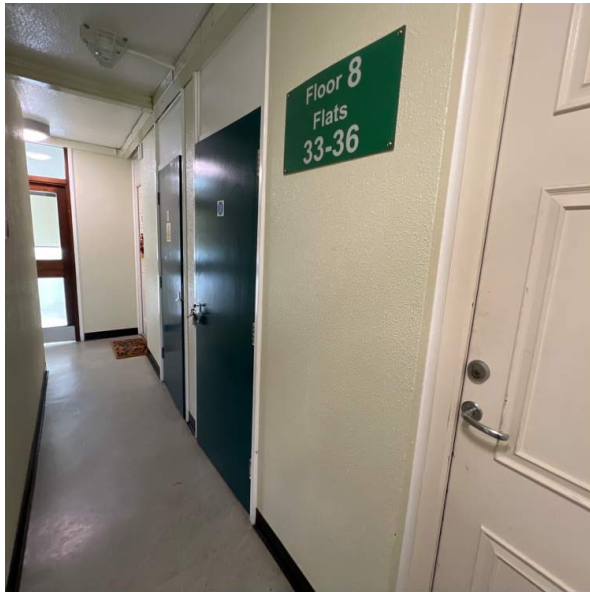
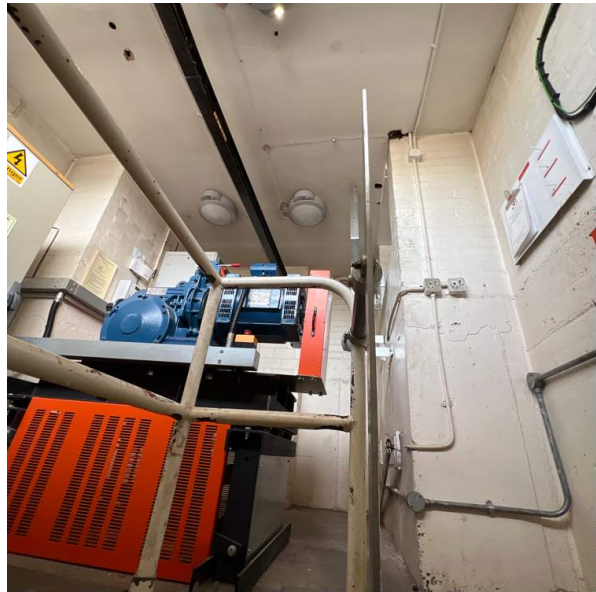
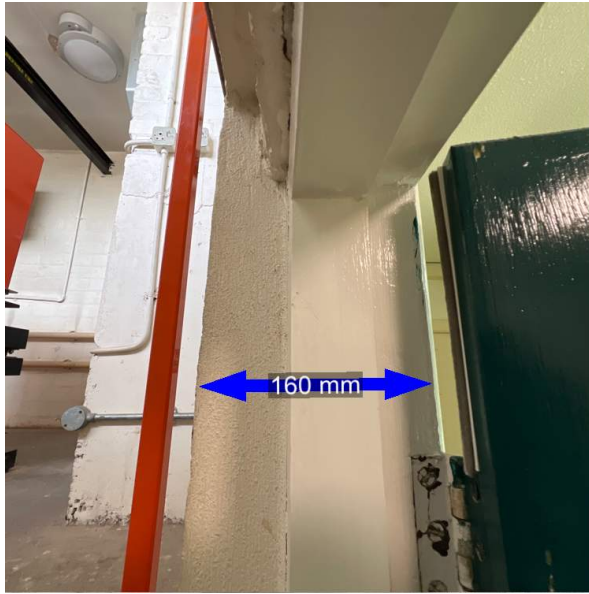
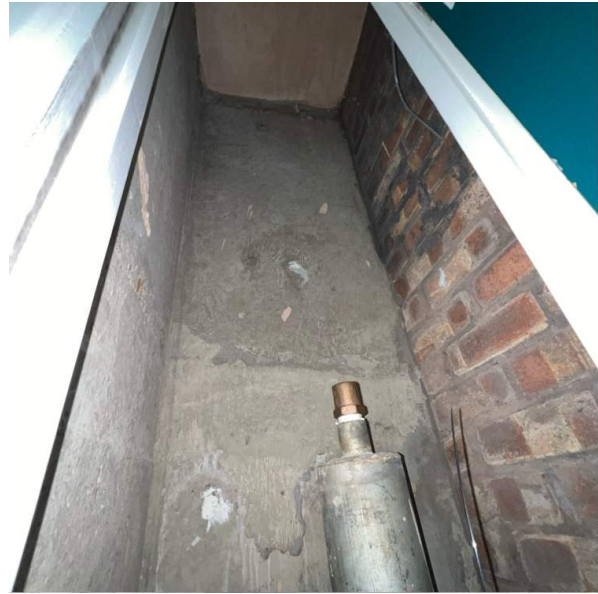
## 8th Floor Hallway

Comments: No jams or distortions noted to hallway doors to indicate any serviceability issues. Generally walls covered with finishes in hallway, likely to consist a mixture of concrete shear walls, embedded columns and masonry infill walls. Limited structure exposed. Concrete walls and infill masonry (non-load bearing) walls noted in riser cupboards and loft motor room. Concrete walls noted to be approx. 160mm thick.

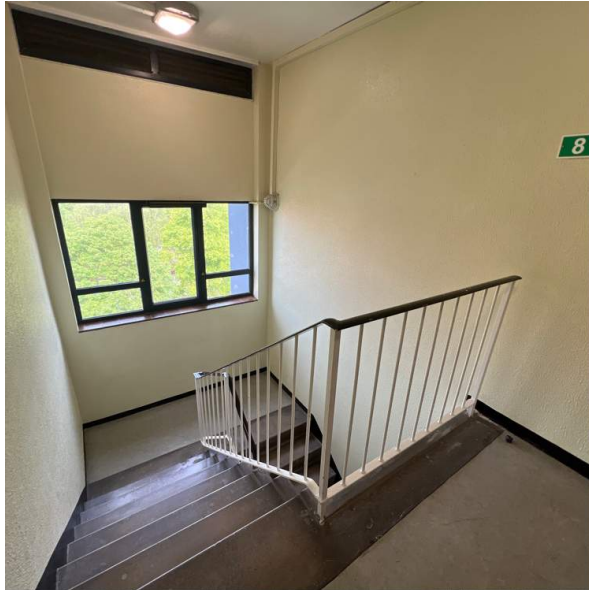
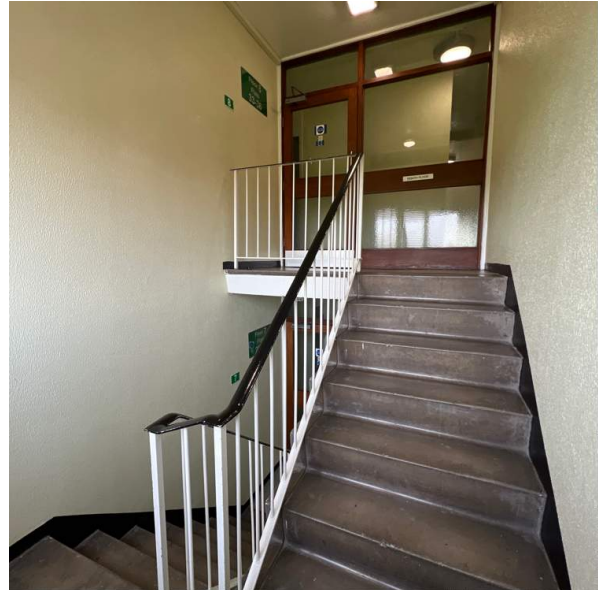
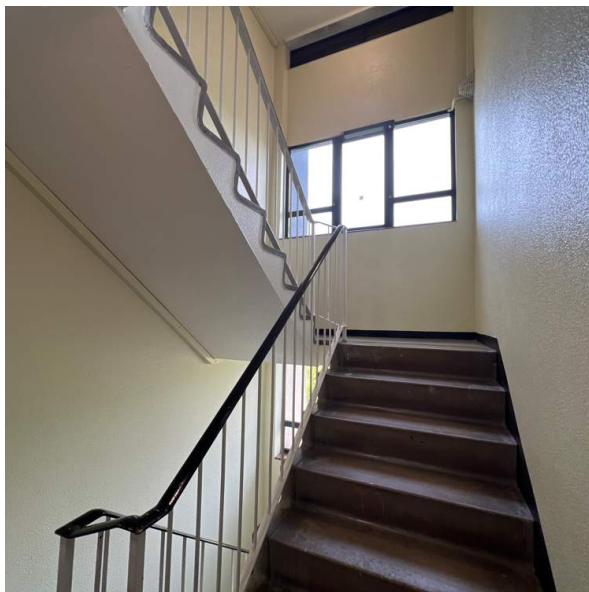
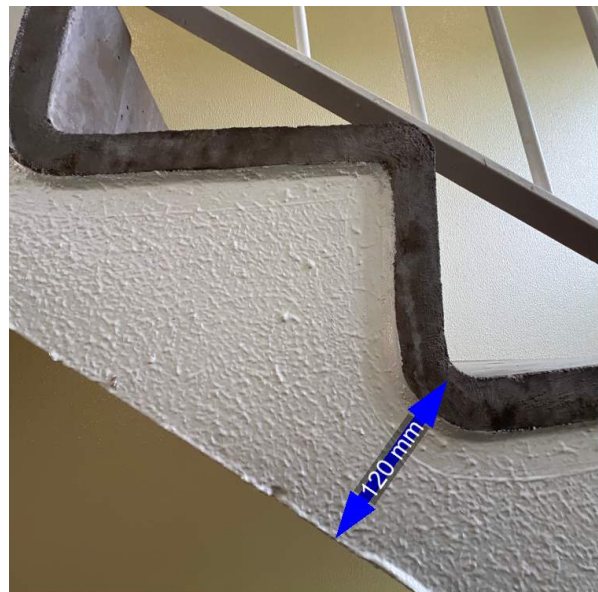
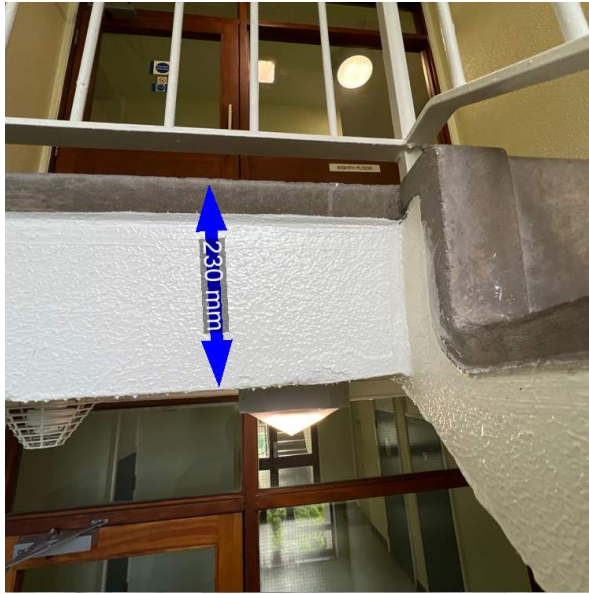
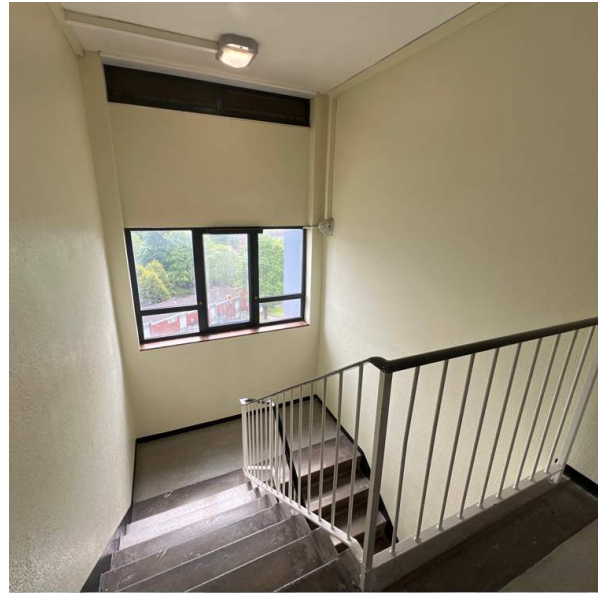
## 8th Floor Staircases

Comments: Insitu concrete stairs with steel hand railing fixed to stairs. Walls and floors appear to be fairly level.  
Stair walls covered with finishes however these would likely form the main concrete shear core walls.

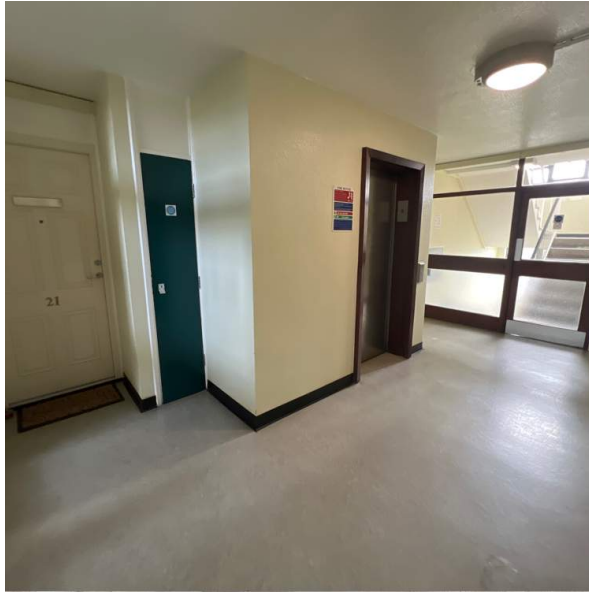
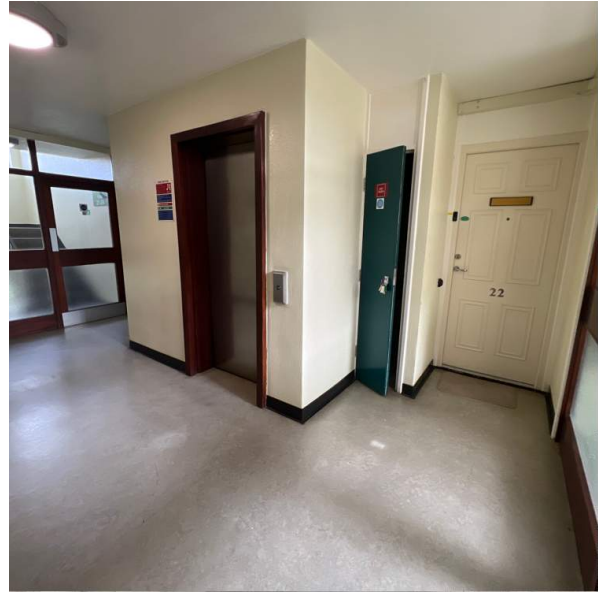
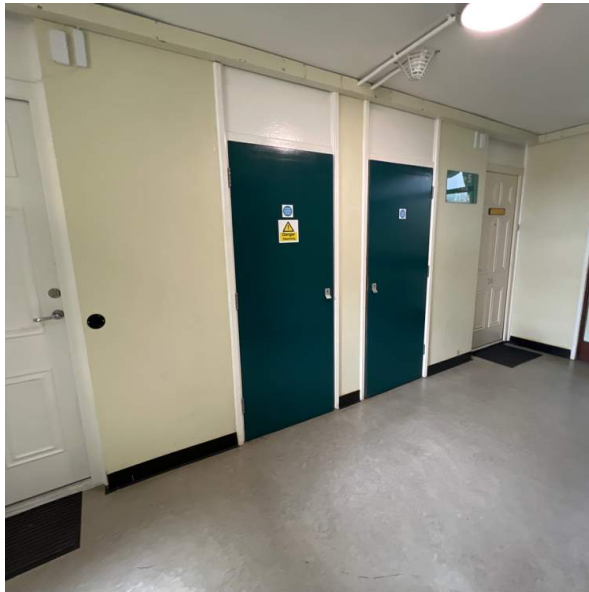
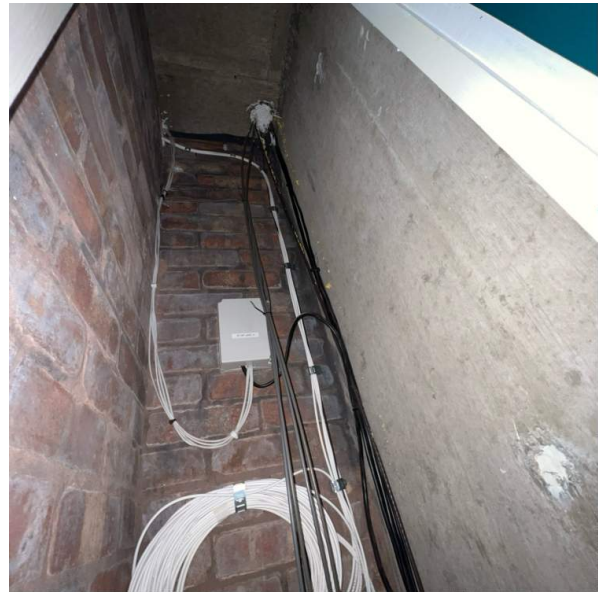
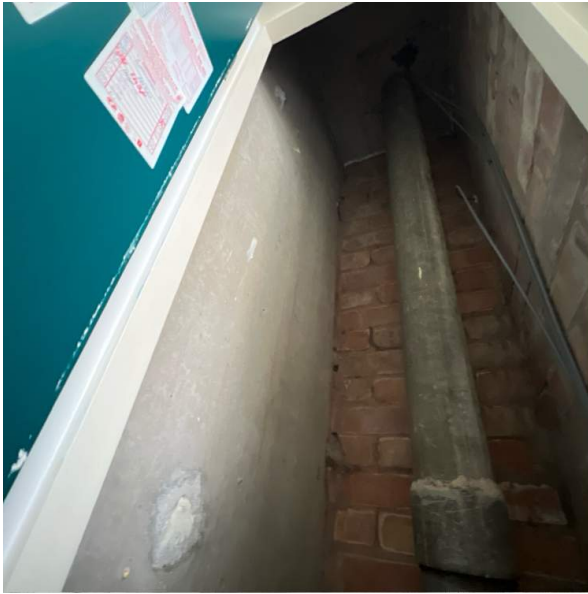
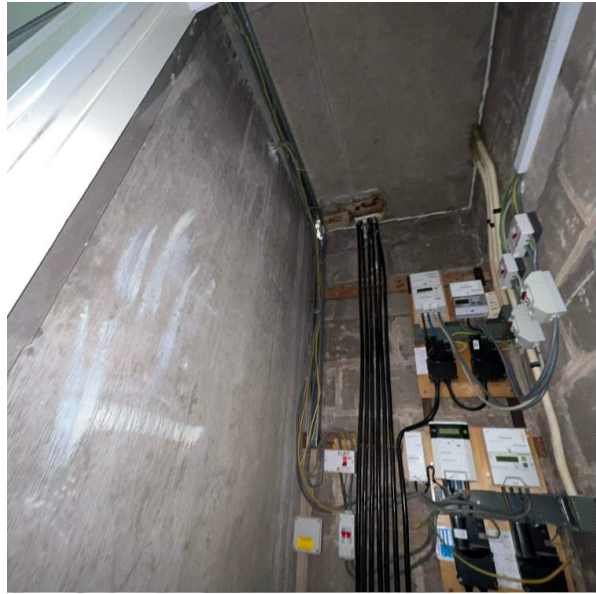
## 5th Floor Hallway

Comments: No jams or distortions noted to hallway doors to indicate any serviceability issues. Generally walls covered with finishes in hallway, likely to consist a mixture of concrete shear walls, embedded columns and masonry infill walls. Limited structure exposed. Concrete walls and infill masonry (non-load bearing) walls noted in riser cupboards. Concrete walls noted to be approx. 160mm thick.

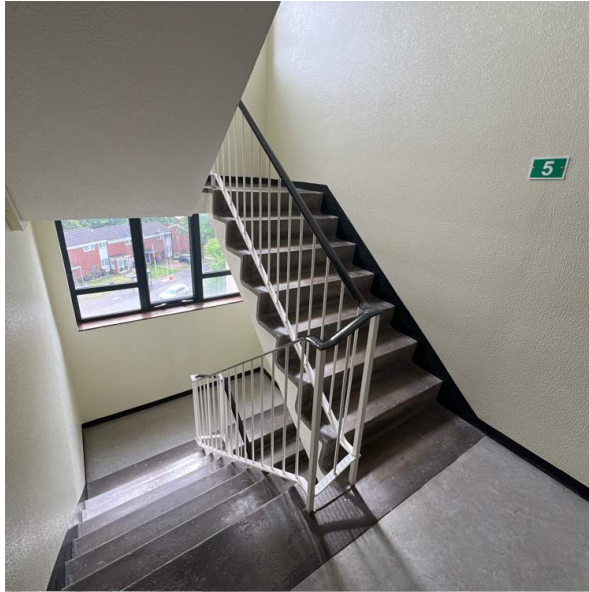
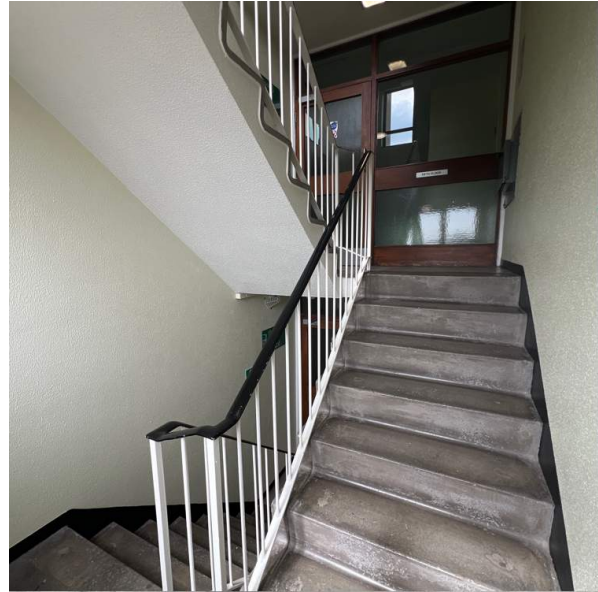
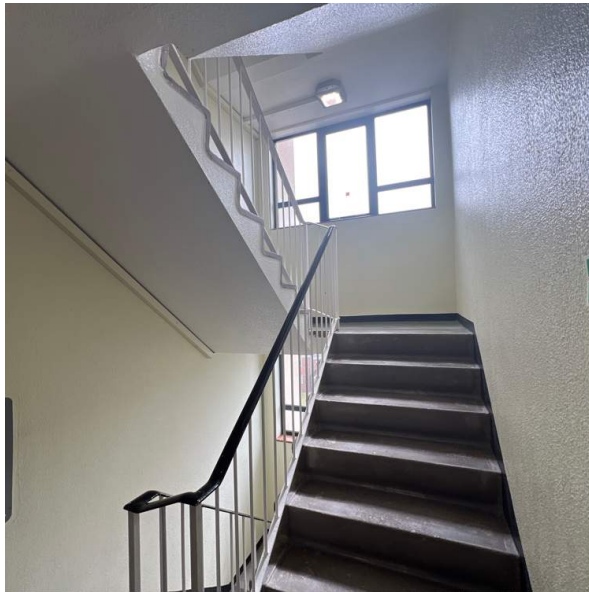
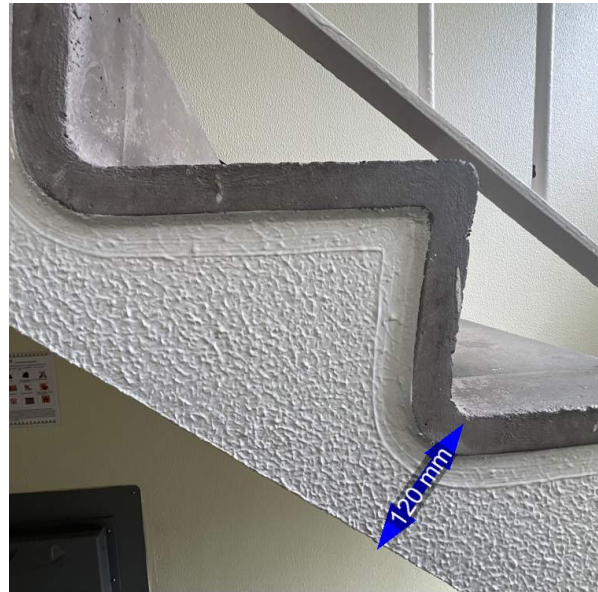
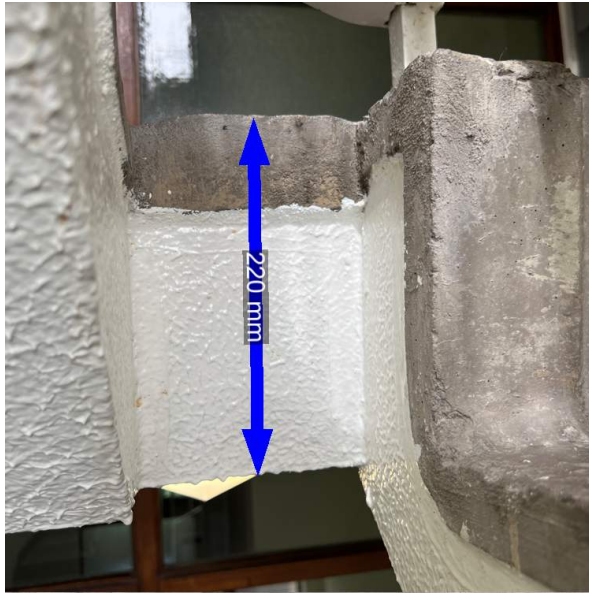
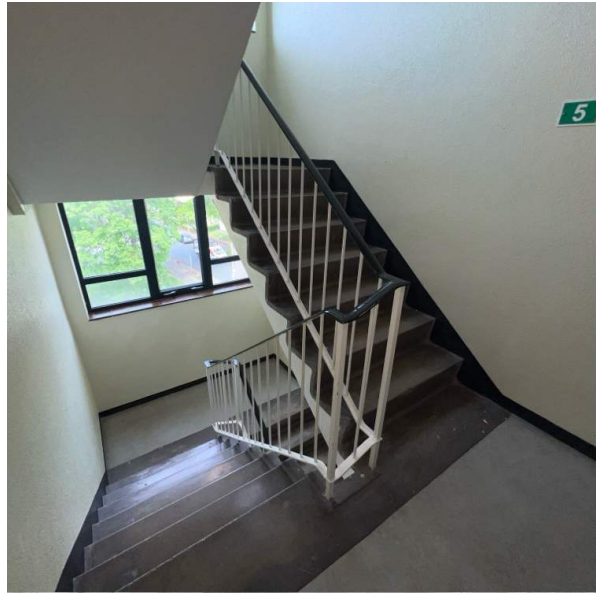
## 5th Floor Staircases

Comments: Insitu concrete stairs with steel hand railing fixed to stairs. Walls and floors appear to be fairly level.  
Stair walls covered with finishes however these would likely form the main concrete shear core walls.

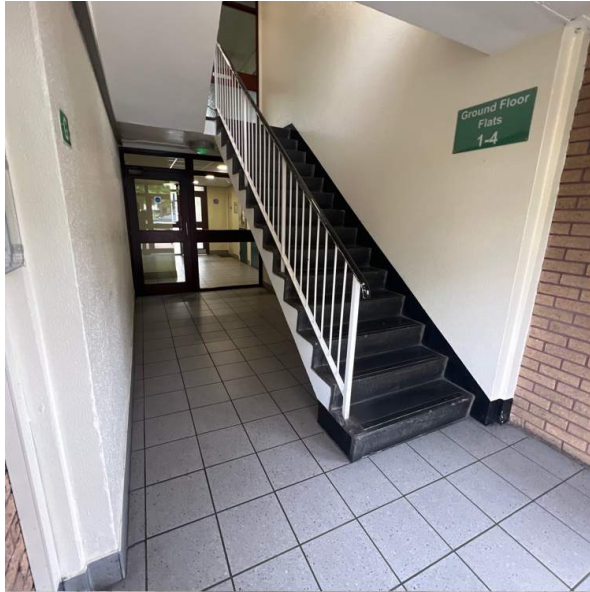
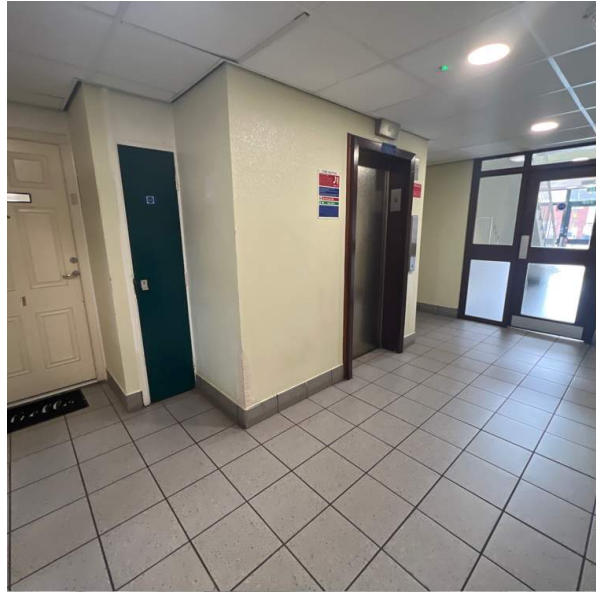
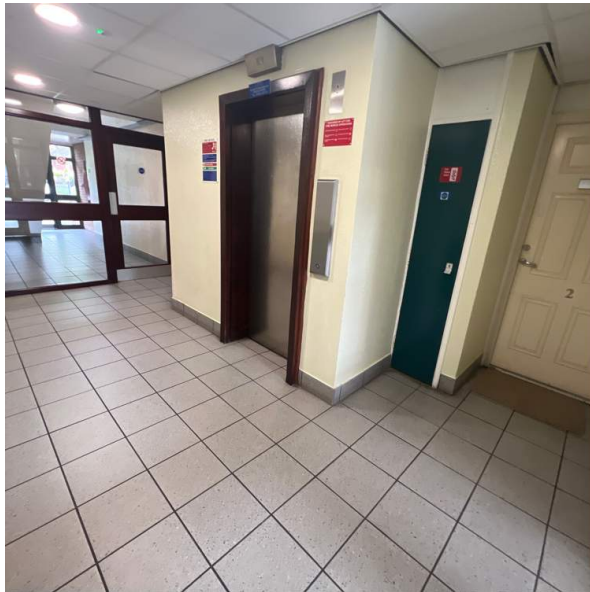
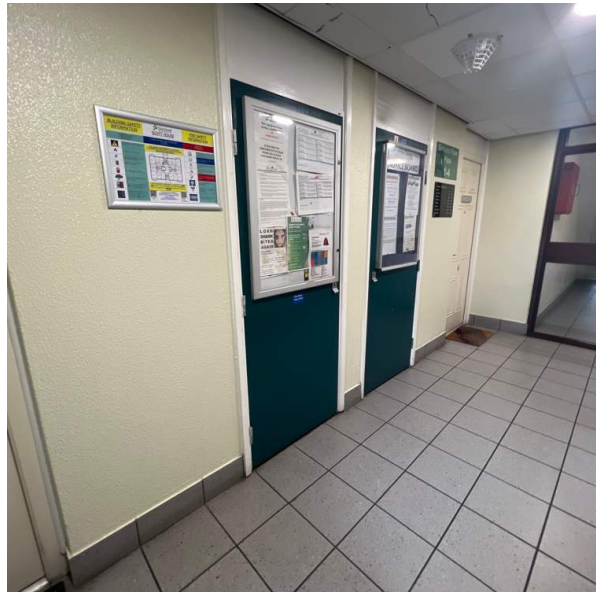
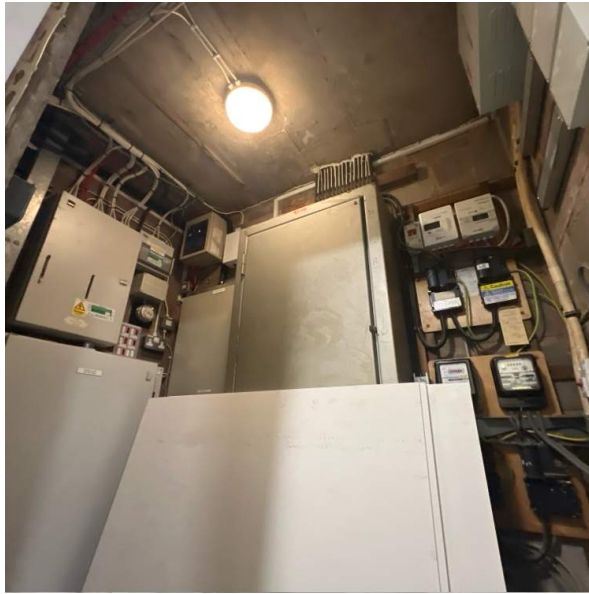
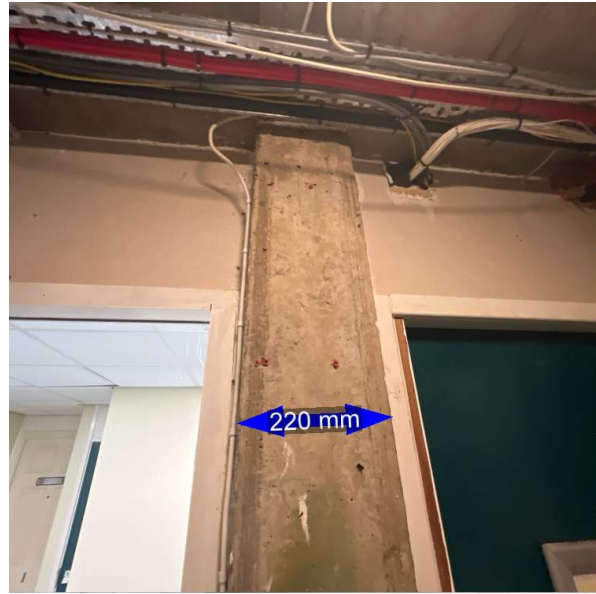
## Ground Floor Hallway

Comments: No jams or distortions noted to hallway doors to indicate any serviceability issues. Generally walls covered with finishes in hallway, likely to consist a mixture of concrete shear walls, embedded columns and masonry infill walls. Limited structure exposed. Concrete walls and infill masonry (non-load bearing) walls noted in riser cupboards.

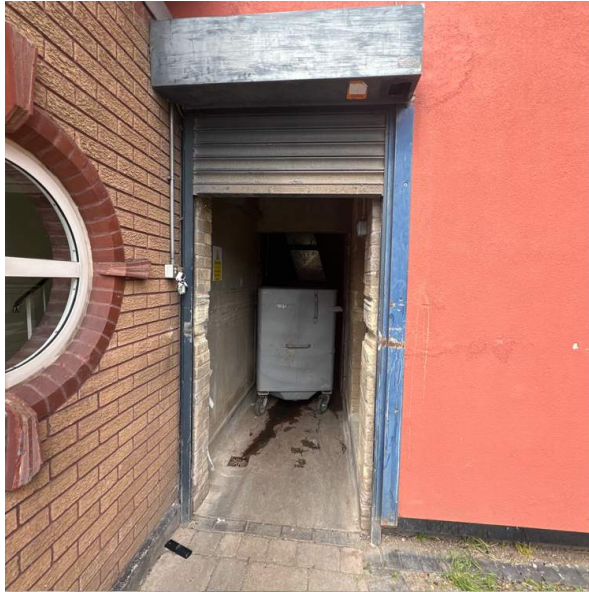
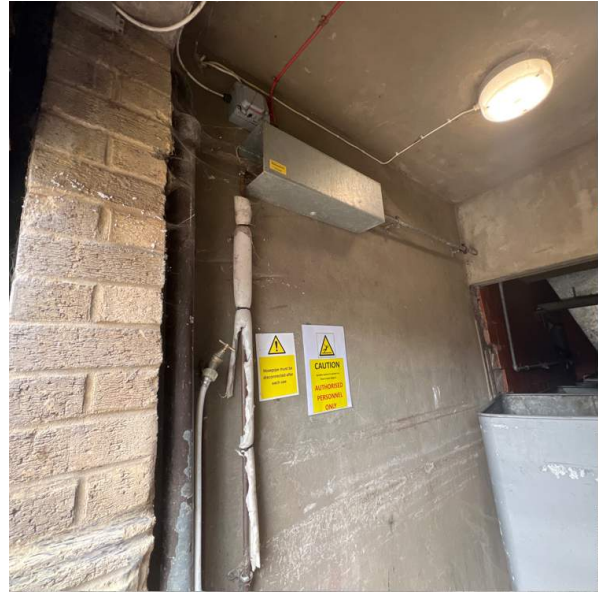
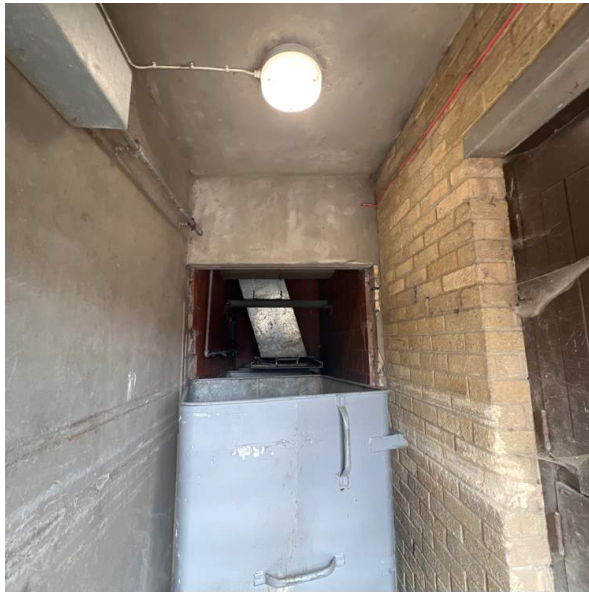
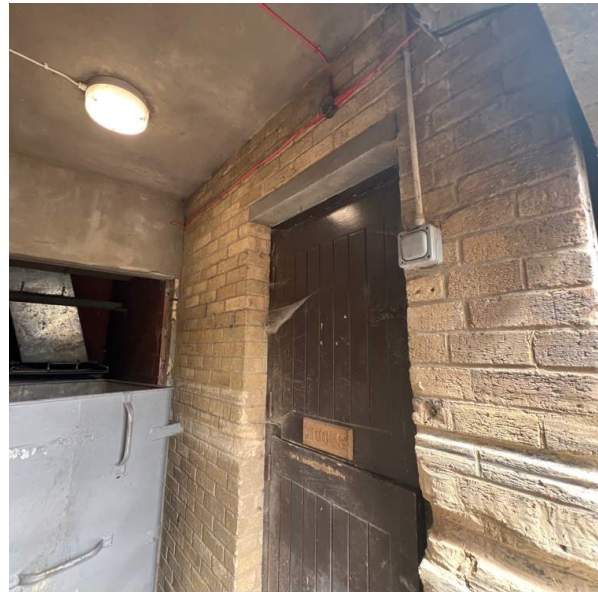
## Binstore

Comments: Main RC concrete shear walls noted in binstore.

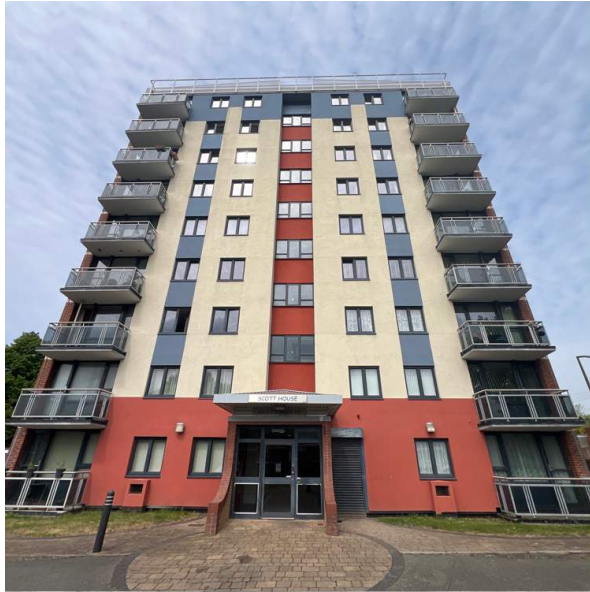
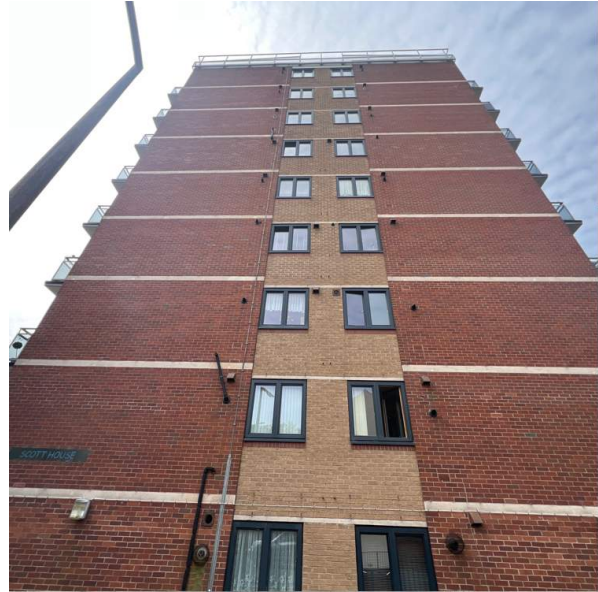
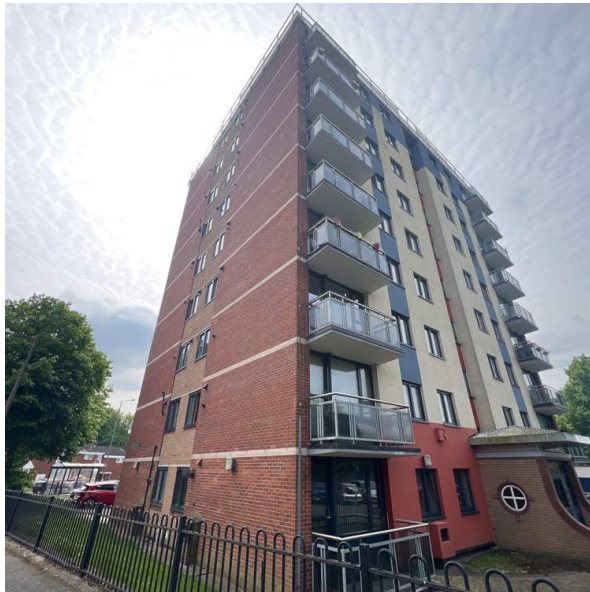
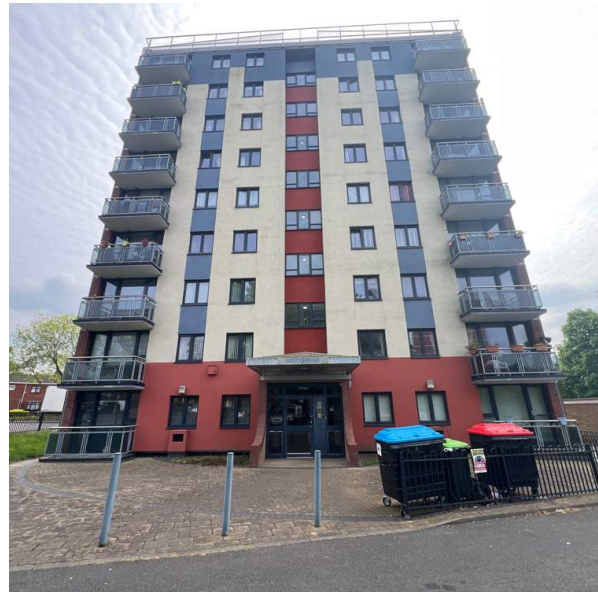
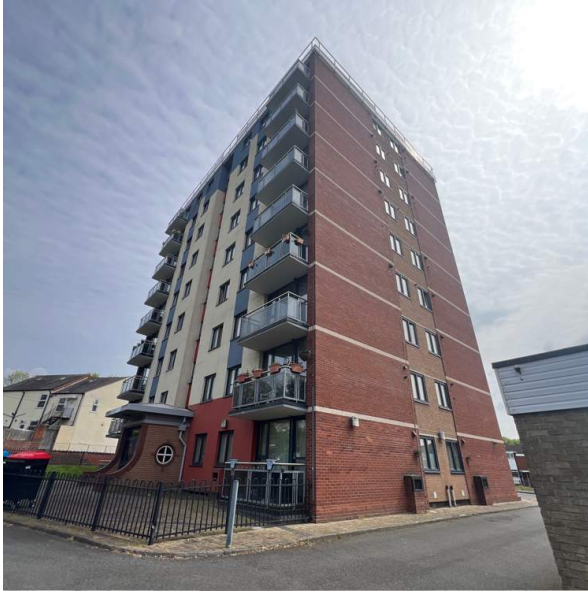
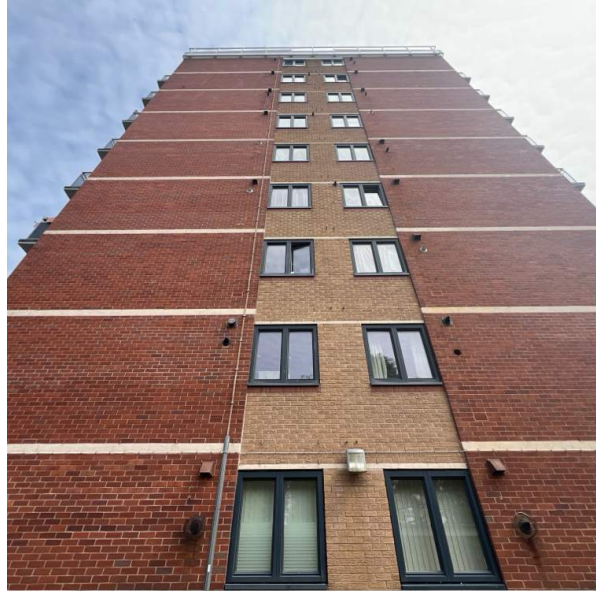
## Elevations

Comments: Front and rear elevations noted to have rendered facades. Side elevations consist of brickwork.  
Cantilevered balconies noted on each level.
