**FIRNTEC**  
BUILDING COMPLIANCE

VISUAL STRUCTURAL APPRAISAL

Sheapecoate House

31<sup>st</sup> January 2025

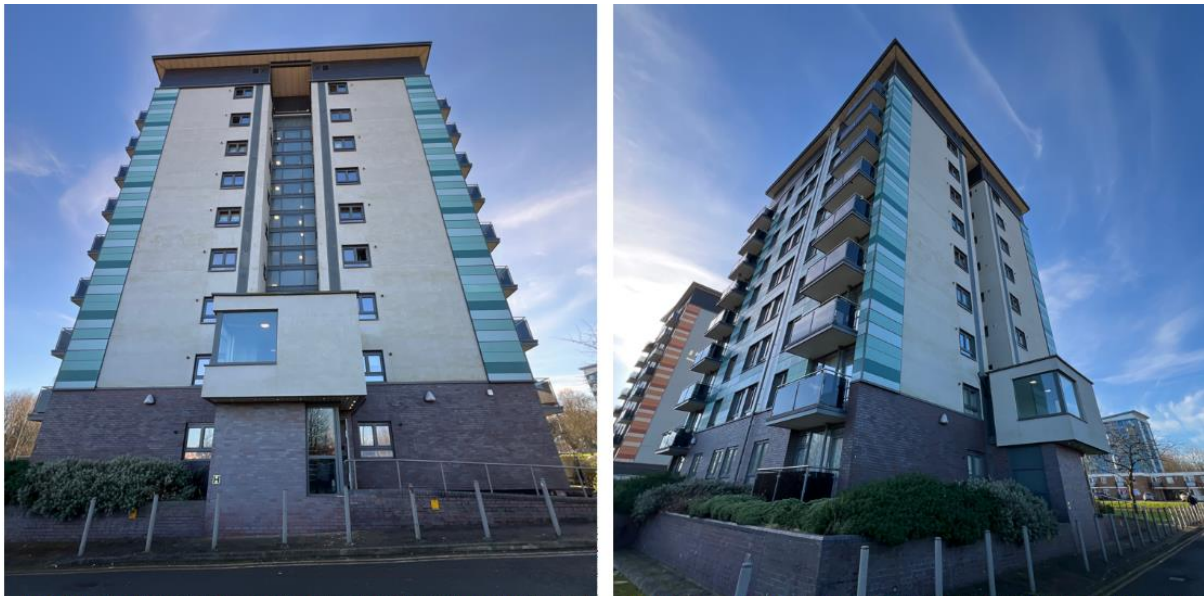
Figure 9 and 10: Building Elevations

The exterior elevations were generally in ok condition and no significant structural defects were noted to the cladding panels. There were no significant cracks or tell-tale signs of any significant structural movement noted at the time of our inspection.

The exterior panels were noted to be plumb with no signs of significant bowing, bulging or leaning noted to the panels indicating failed fixings however their presence and condition cannot be confirmed.

There are balconies at each level which are formed of cantilevered RC slabs tied into the main frame. During the 2015 refurbishment they had steel balustrades with glazed infill installed.

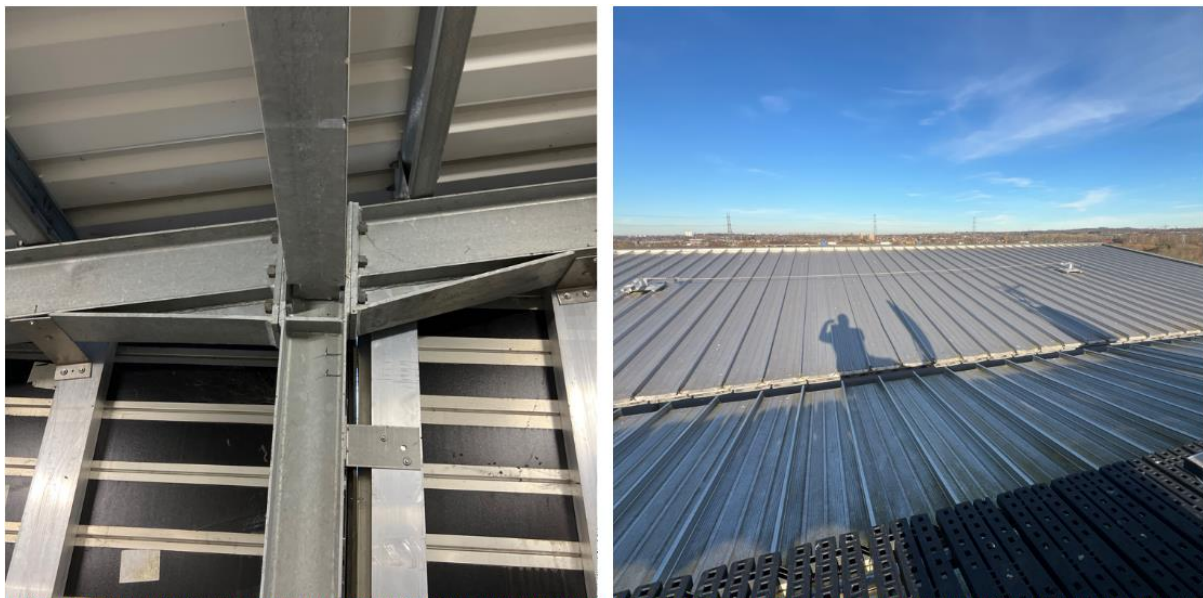
Figure 11 and 12: Roof Level

There were no tell-tale signs of any significant structural movement noted at the time of our inspection. The exterior walls were noted to be plumb with no signs of significant bowing, bulging or leaning noted to the masonry walls.

The roof has subsequently been covered with a new waterproofing covering formed of a steel frame installed to the existing roof which supports pitched corrugated sheets. This roof is not insulated and therefore acts purely as a weather barrier. The fire protection of the steel is unclear as the beams do not appear to be unprotected. Details of this frame should be requested from the contractor who completed the works in 2015. No signs of water ingress of that the roof is not performing as intended.

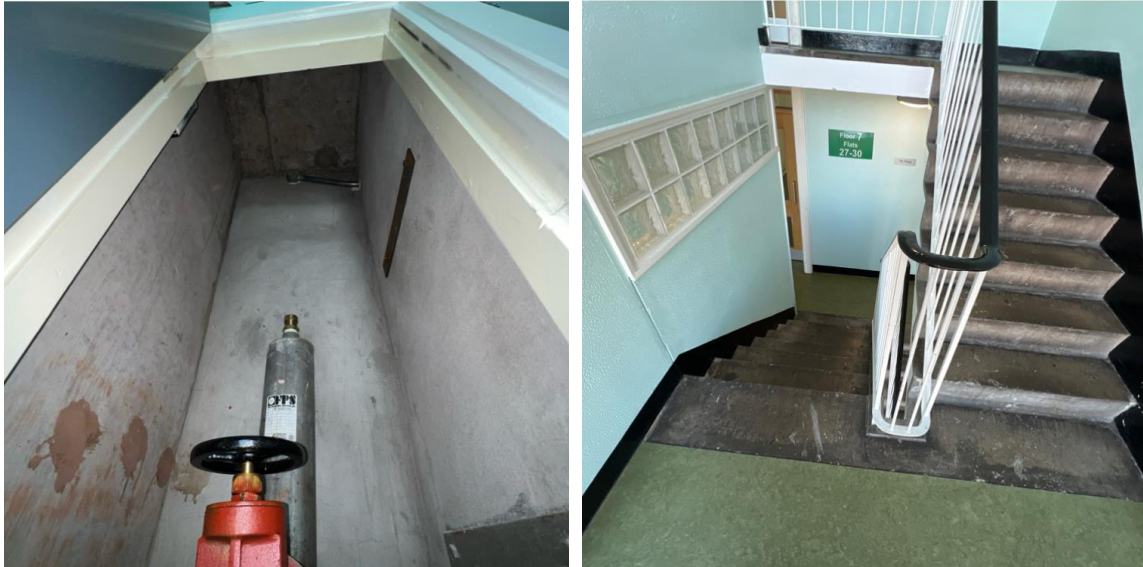
Figure 13 and 14: Vertical RC elements and staircase

The interior of the stair core walls were checked and were plumb and in line with observations made to the exterior – no significant signs of leaning or movement noted. The concrete appeared in fair condition with few BRE category 1 cracks but no structurally significant defects were noted.

The stair stringer was noted to be 110mm thick which seems slim, certainly short of modern standards. A cover test is required to check the resistance of the concrete section in the event of a fire.

Due to the age of the building it is wise to perform periodical health checks to the concrete elements. This should include tests for concrete strength, cover depth, carbonation, chlorides and HAC. It would appear that these tests have never been performed to this building and therefore we recommend engaging a specialist contractor within the next 24 months who will be able to perform the tests and provide a interpretive report. The fire resistance of the structure is not confirmed until the cover meter tests are completed.

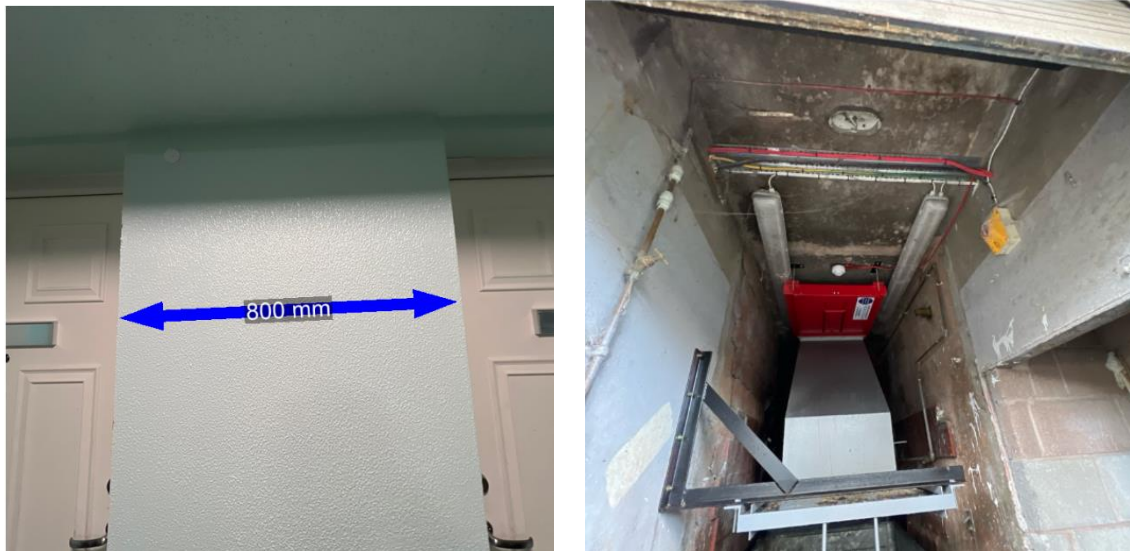
Figure 15 and 16: RC Column at typical level and slab viewed at GF

The floors in the communal landings were noted to be solid concrete floors. The floors were checked with a spirit level and were considered level and within tolerance. The doors and windows to the communal landings from the stair core all appeared to be level and opened and closed without difficulty. There were no signs of structural movement detected.

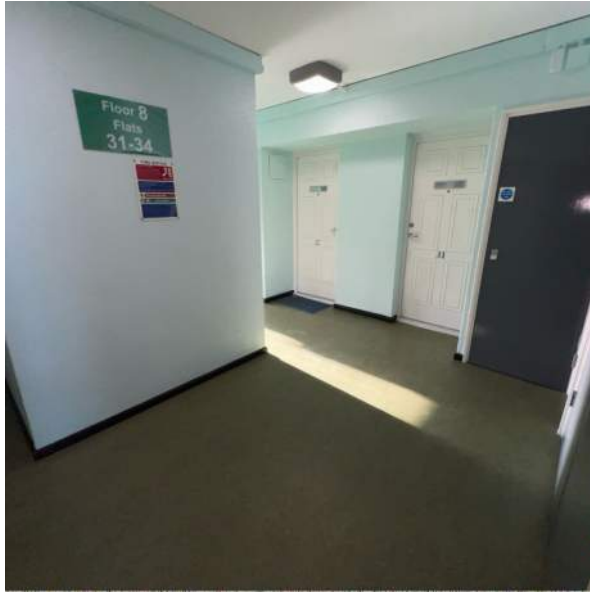
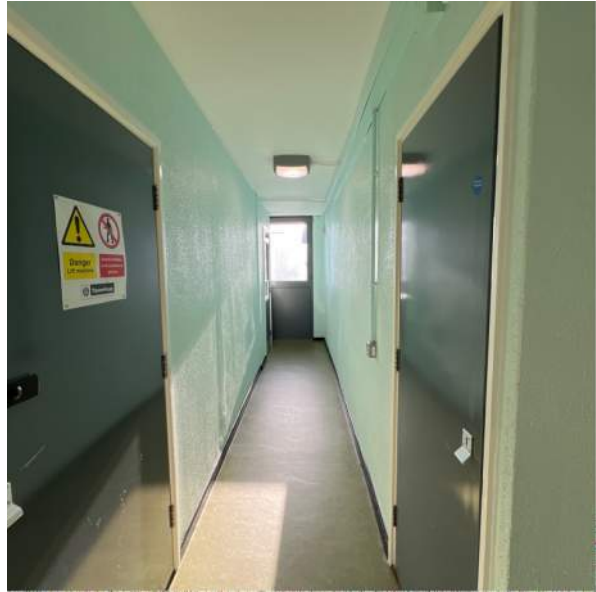
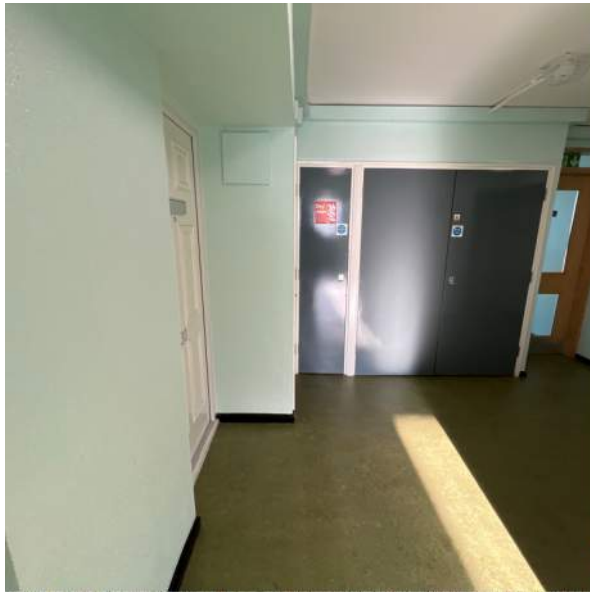
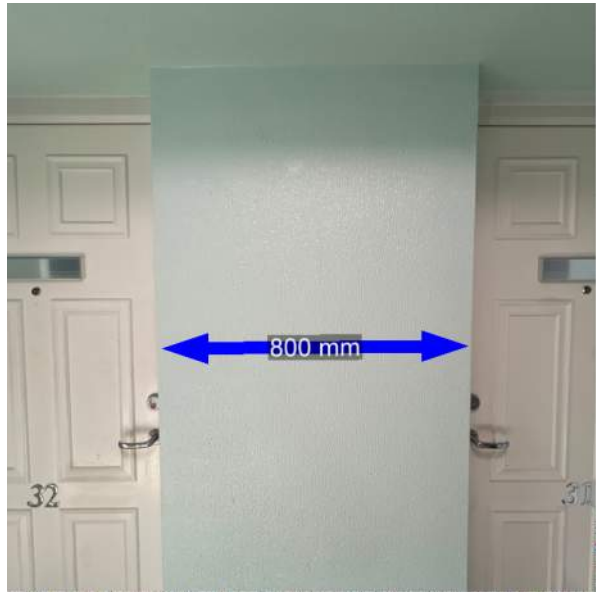
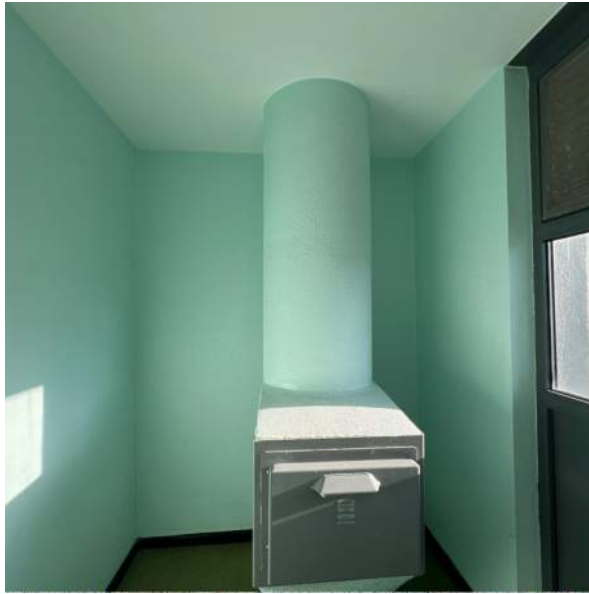
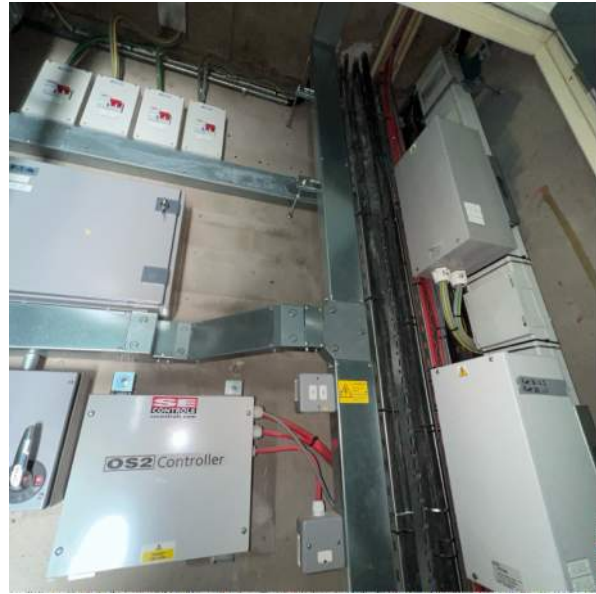
## 8th Floor Hallway

Comments: No jams or distortions noted to hallway doors to indicate any serviceability issues. Generally walls covered with finishes in hallway, likely to consist a mixture of concrete shear walls, embedded columns and masonry infill walls. Limited structure exposed. Concrete walls noted via riser cupboards.

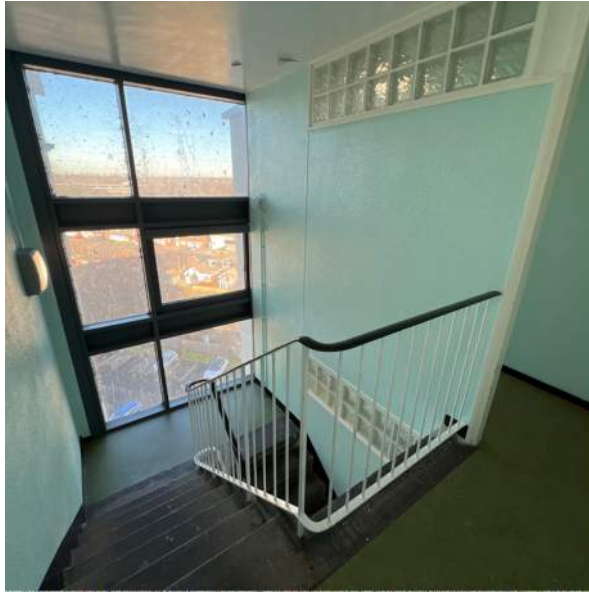
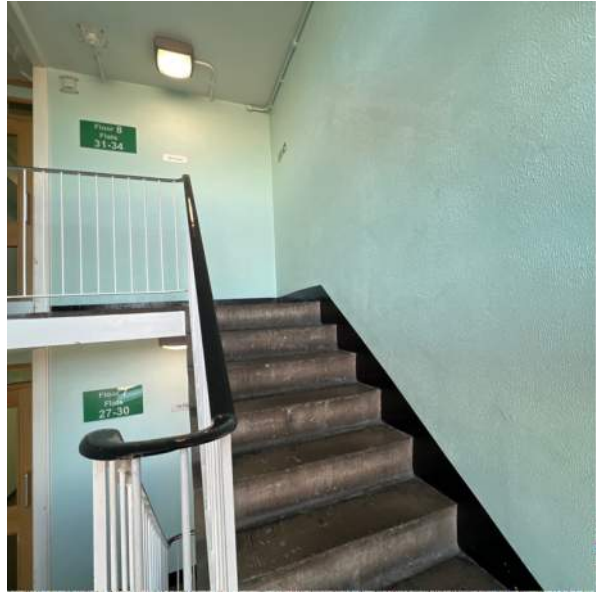
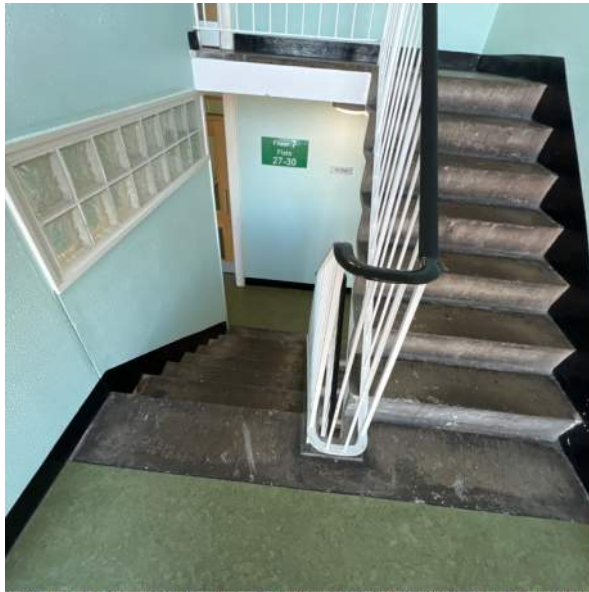
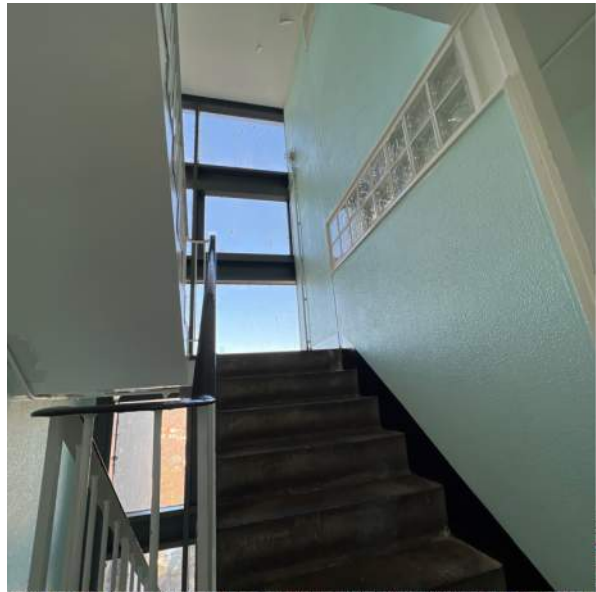
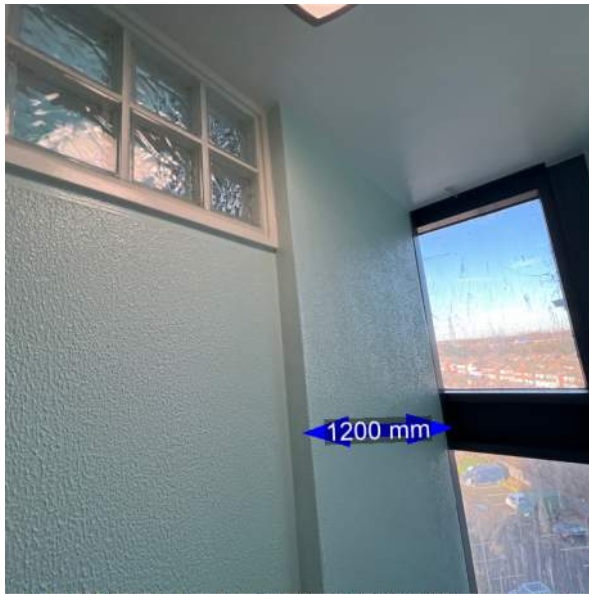
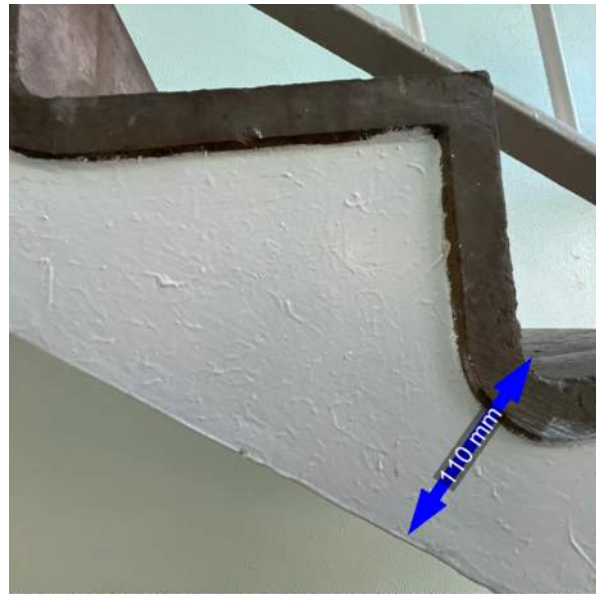
## 8th Floor Staircases

Comments: Insitu concrete stairs with steel hand railing fixed to stairs. Walls and floors appear to be fairly level.  
Stair walls covered with finishes however these would likely form the main concrete shear core walls. Partly infill/non-load bearing wall noted for one side of stair case wall.

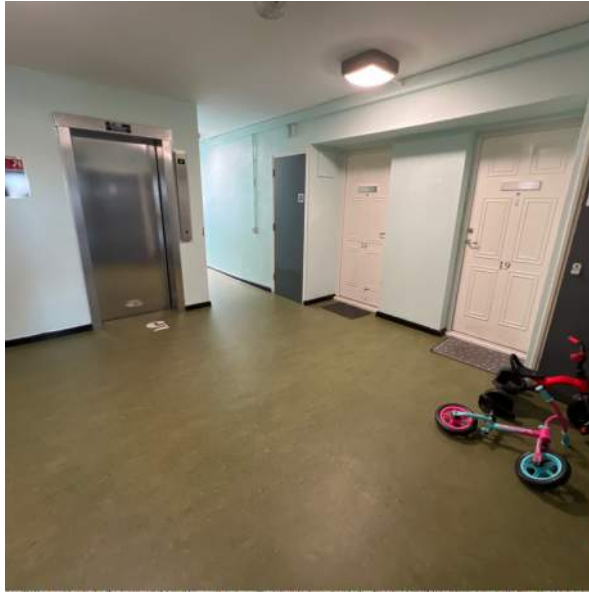
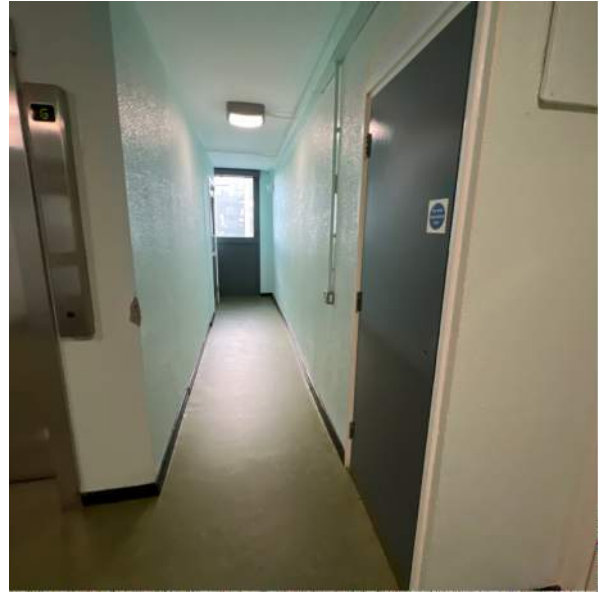
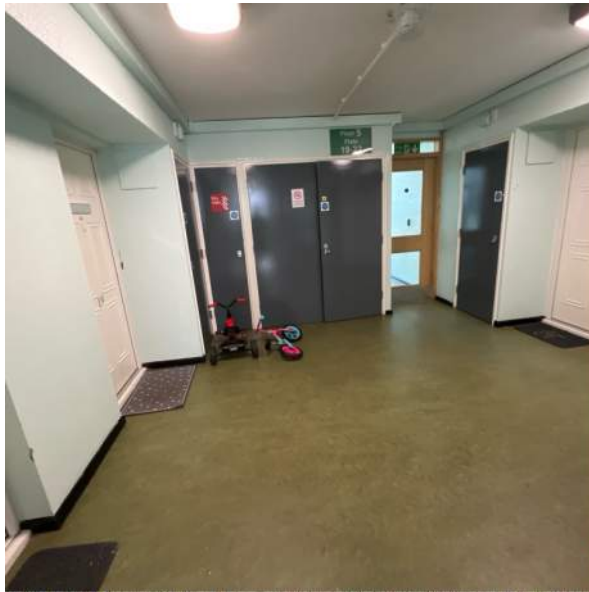
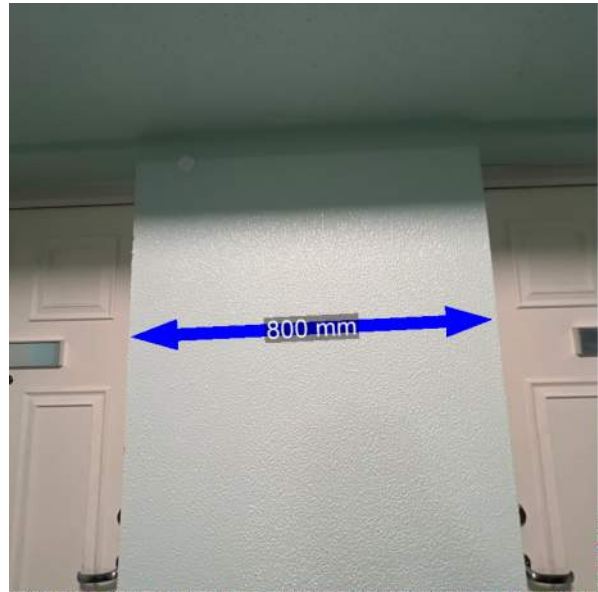
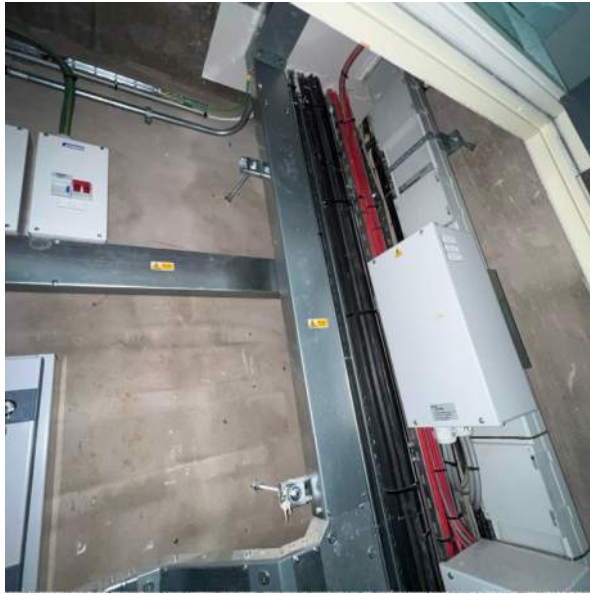
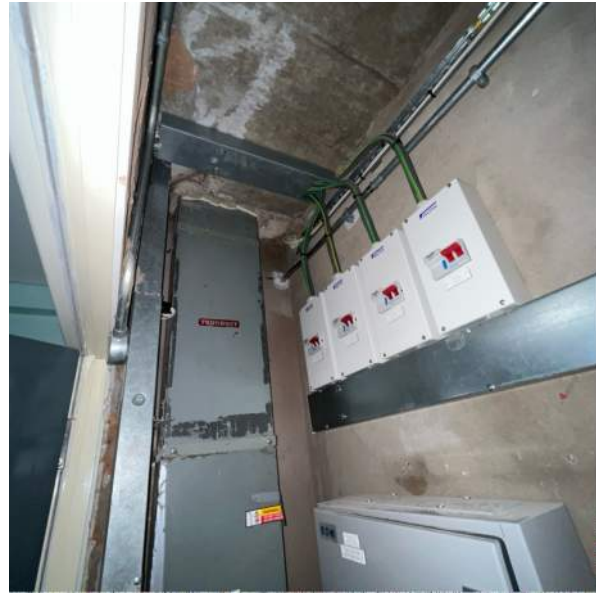
## 5th Floor Hallway

Comments: No jams or distortions noted to hallway doors to indicate any serviceability issues. Generally walls covered with finishes in hallway, likely to consist a mixture of concrete shear walls, embedded columns and masonry infill walls. Limited structure exposed. Concrete walls noted via riser cupboards.

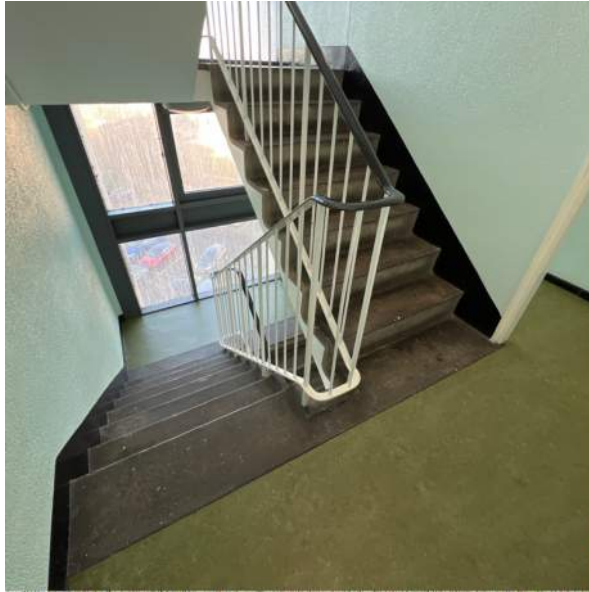
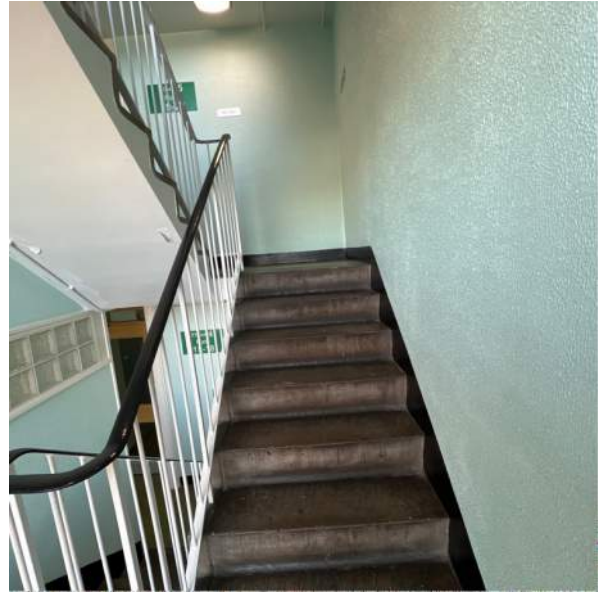
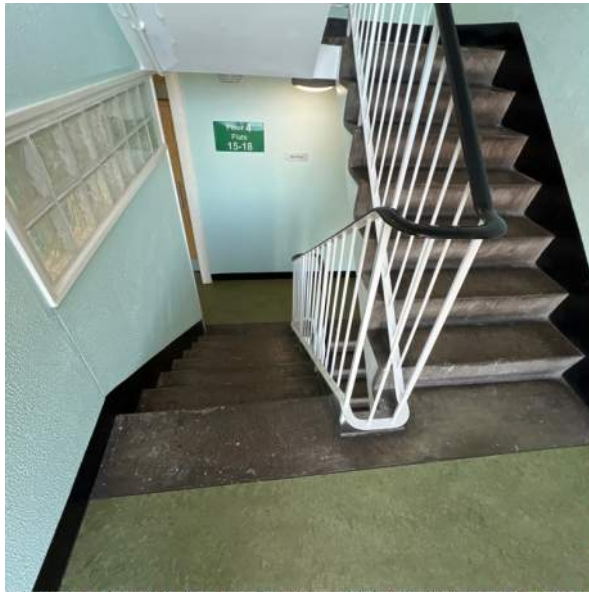
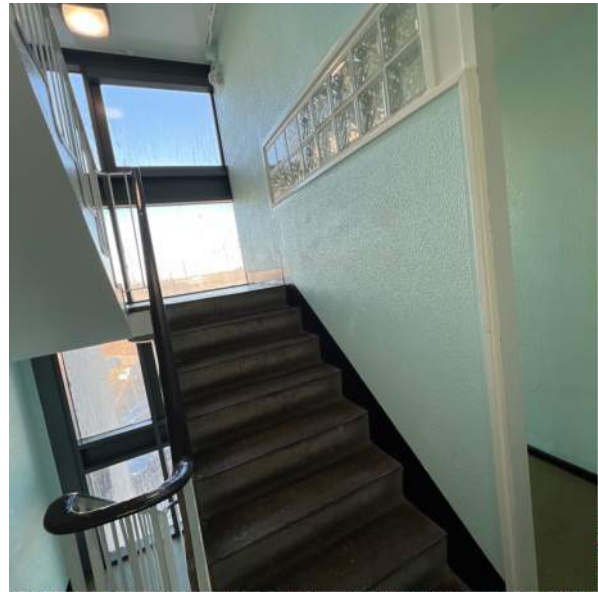
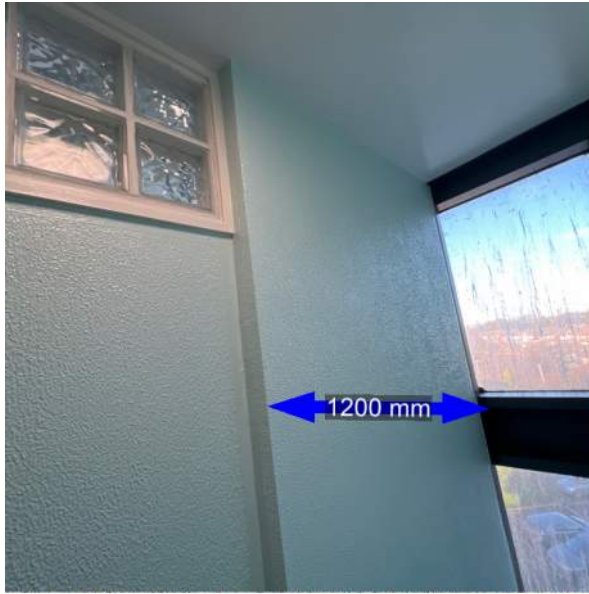
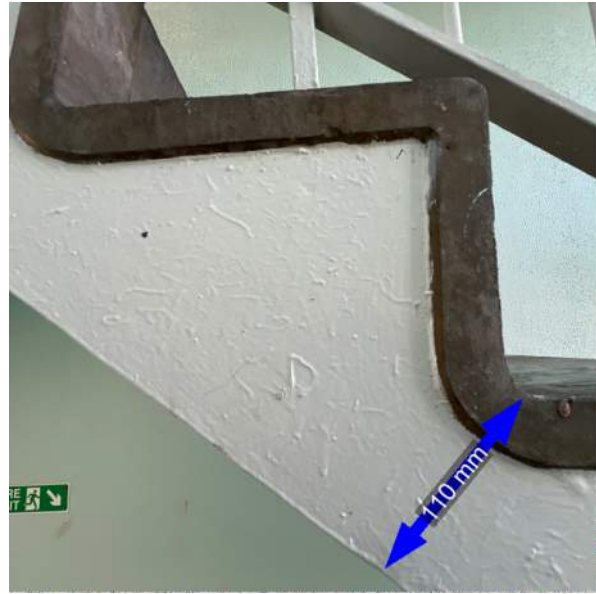
## 5th Floor Staircases

Comments: Insitu concrete stairs with steel hand railing fixed to stairs. Walls and floors appear to be fairly level.  
Stair walls covered with finishes however these would likely form the main concrete shear core walls. Partly infill/non-load bearing wall noted for one side of stair case wall.

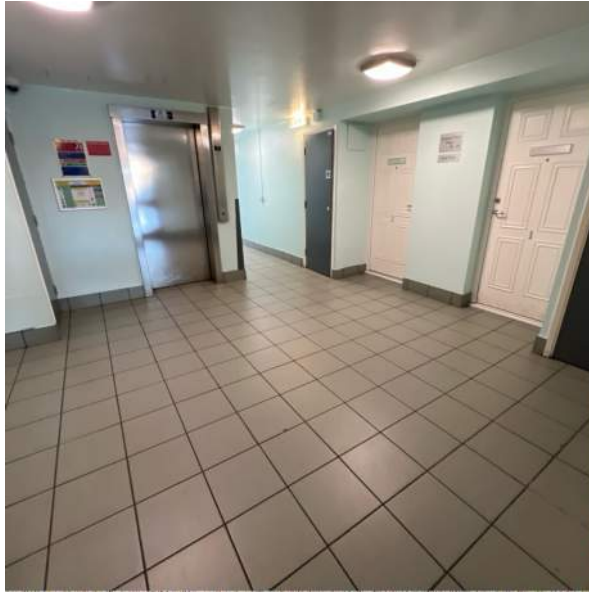
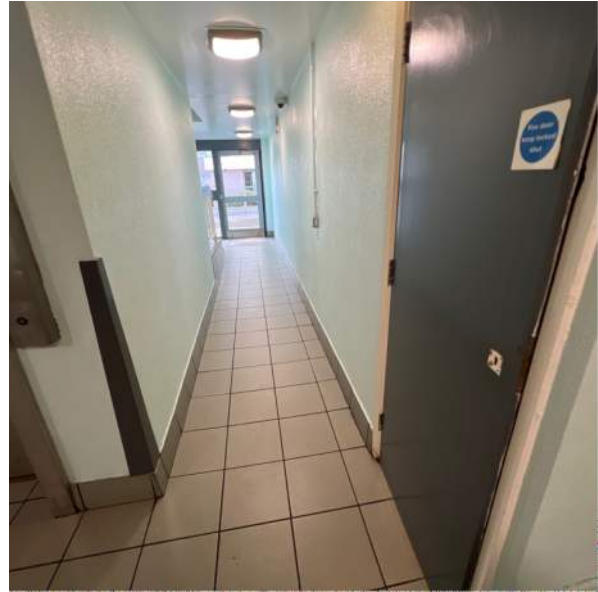
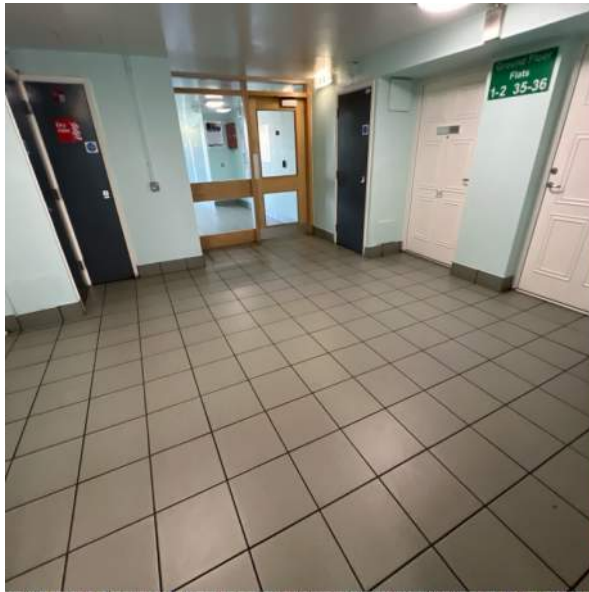
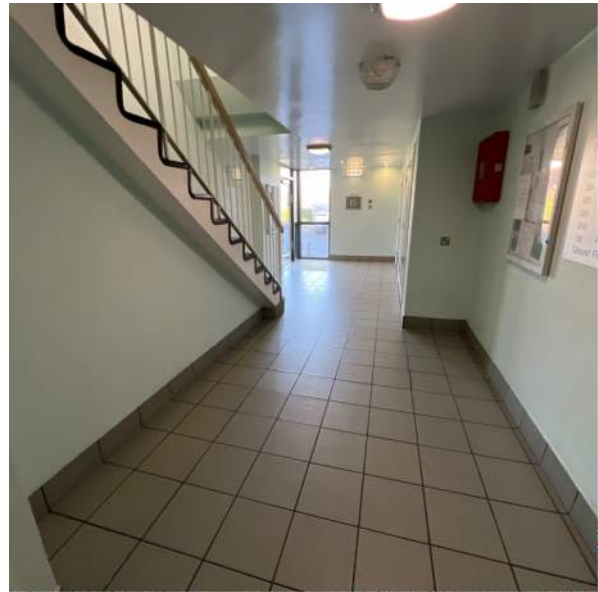
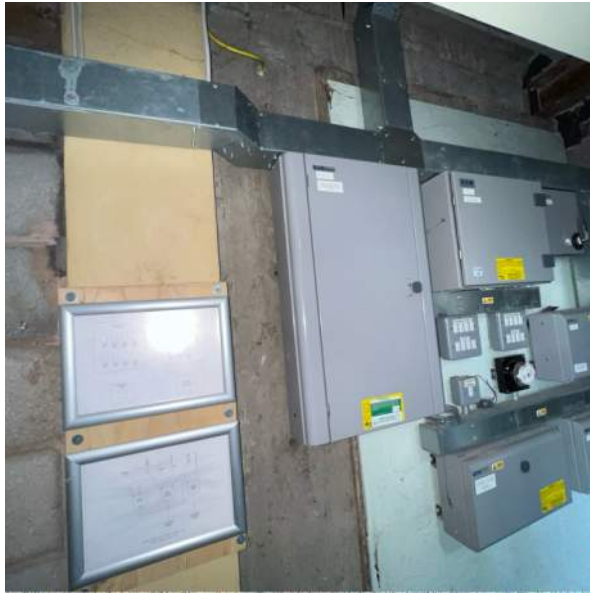
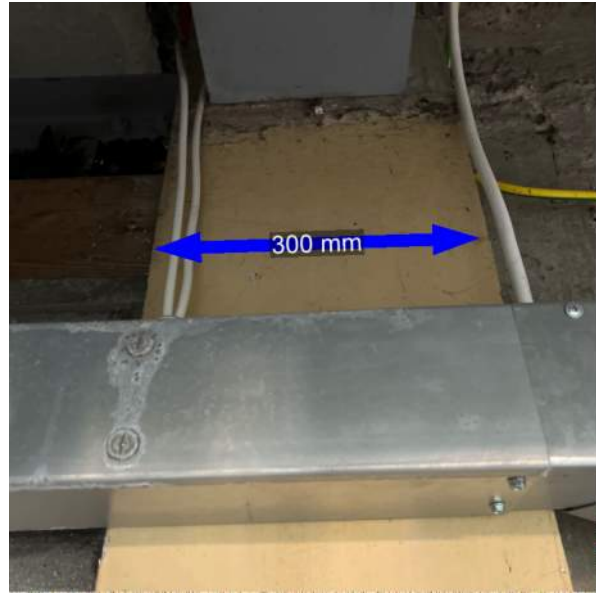
## Ground Floor Hallway

Comments: No jams or distortions noted to hallway doors to indicate any serviceability issues. Generally walls covered with finishes in hallway, likely to consist a mixture of concrete shear walls, embedded columns and block infill walls. Limited structure exposed. Partly visible concrete walls noted via electrical riser cupboards.

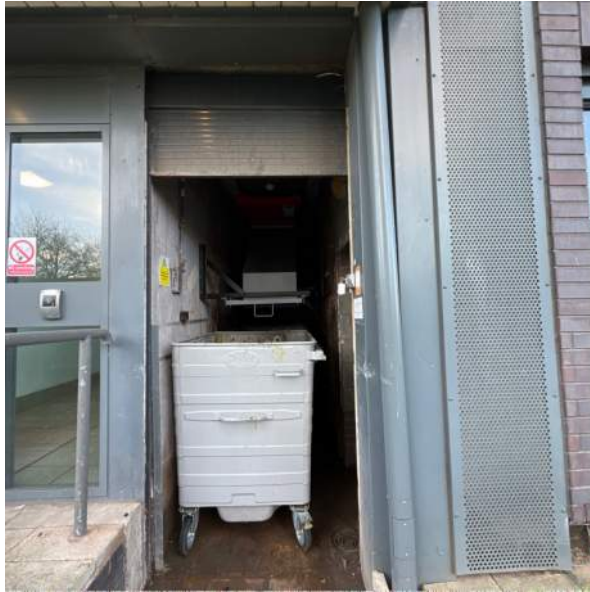
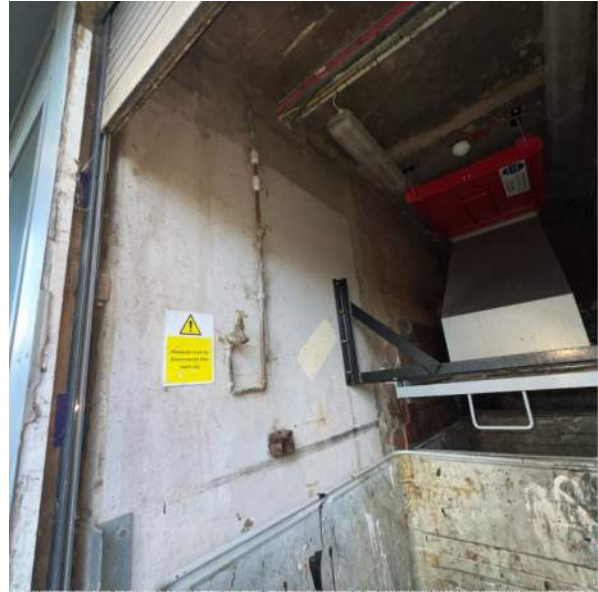
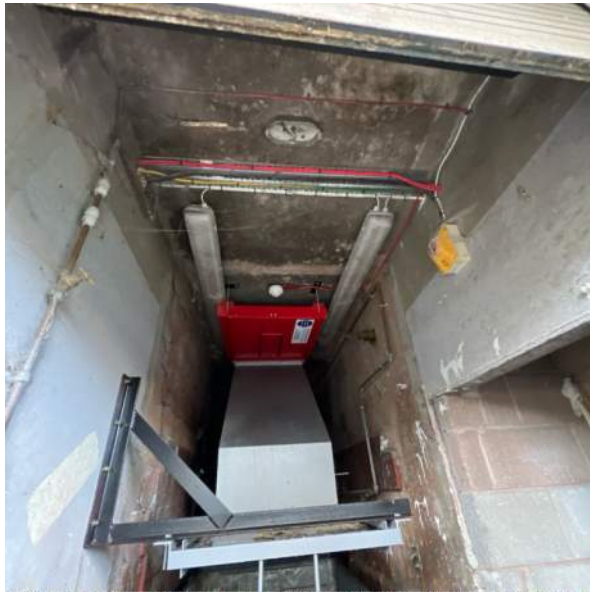
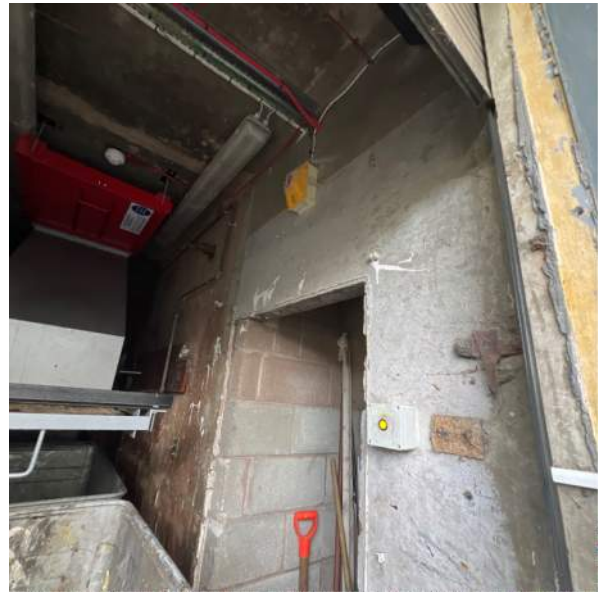
## Binstore

RC shear walls noted in binstore.

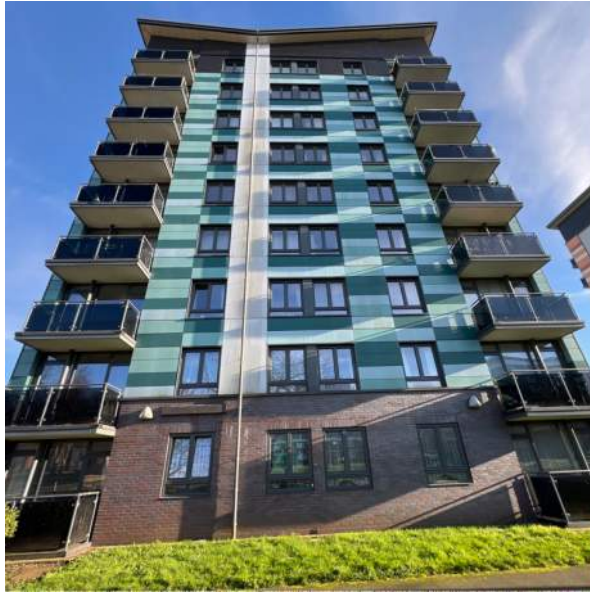
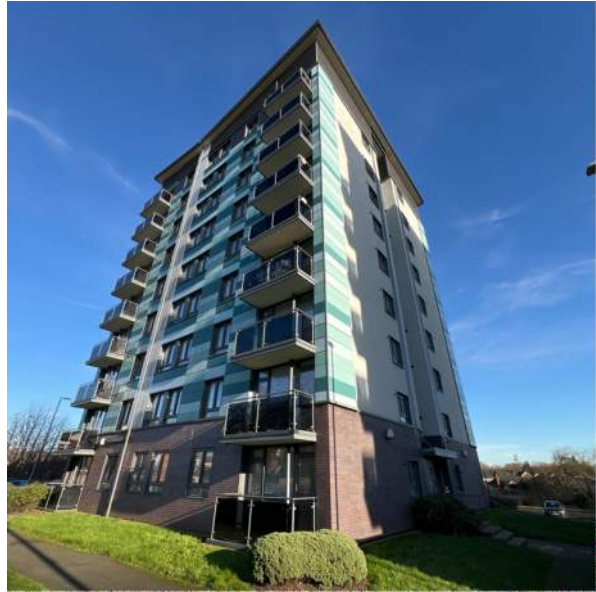
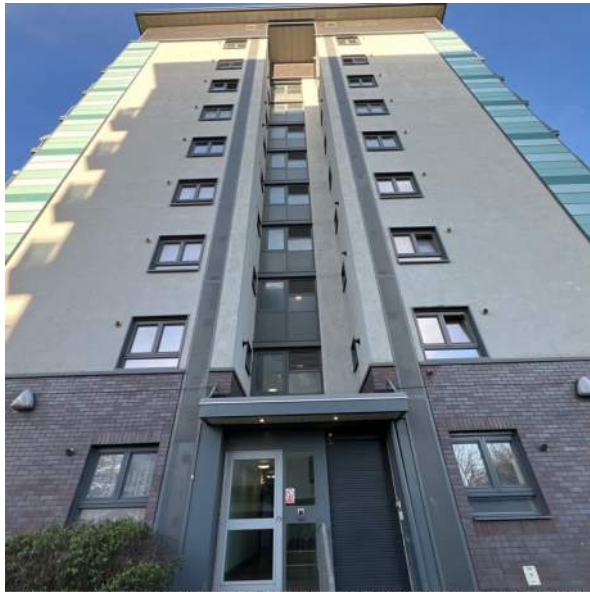
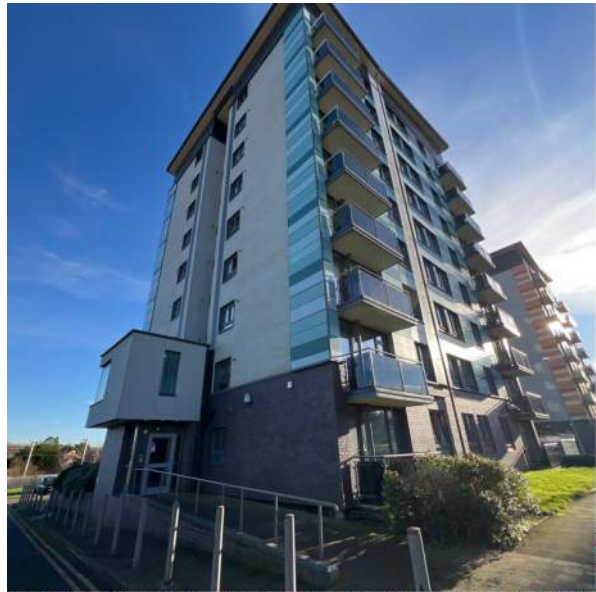
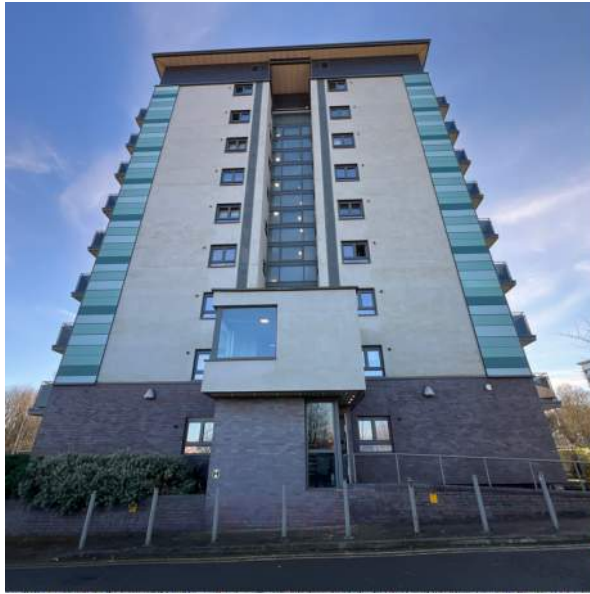
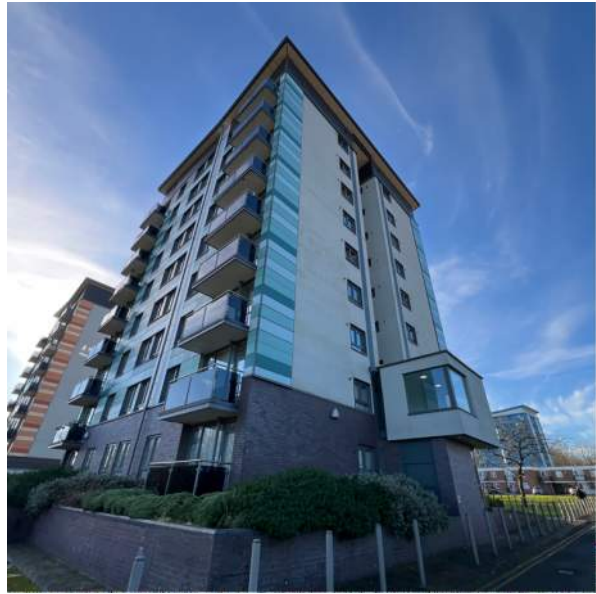
## Elevations

Ground floor level consists of brickwork. Remaining elevations consist of a mixture of rendered and cladded facade.

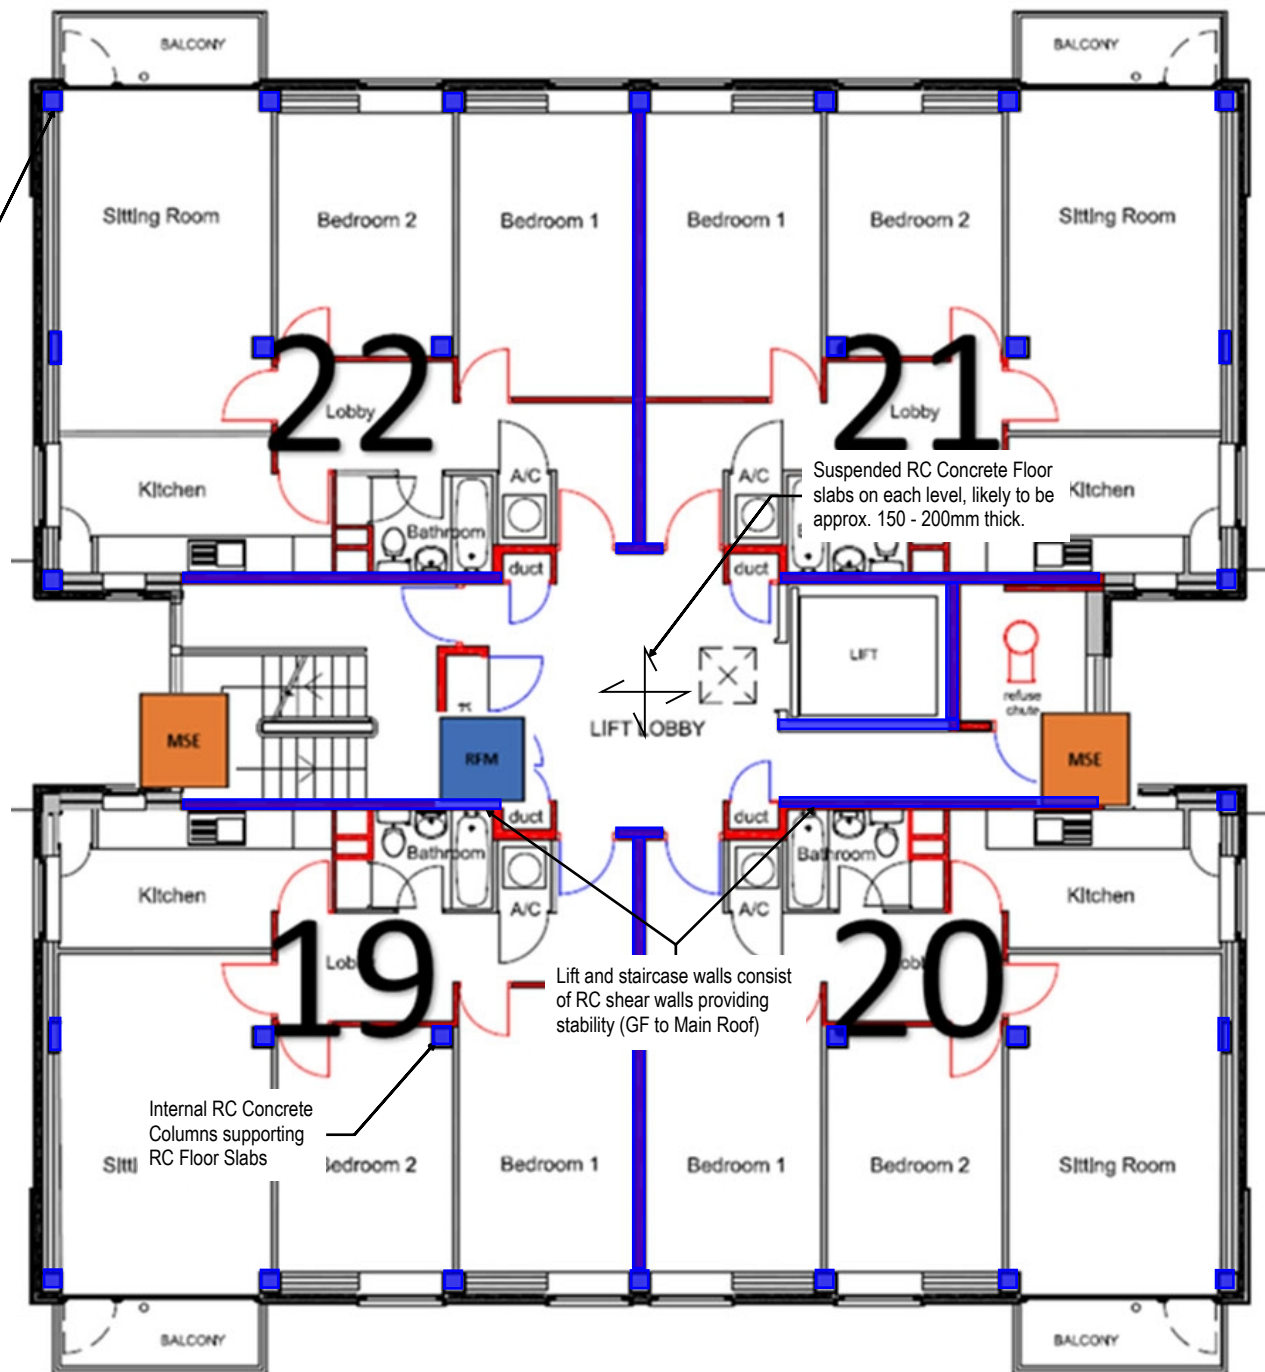
External perimeter RC Concrete Columns), supporting floors.

Lift and staircase walls consist of RC shear walls providing stability (GF to Main Roof)

Suspended RC Concrete Floor slabs on each level, likely to be approx. 150 - 200mm thick.
