VISUAL STRUCTURAL APPRAISAL

St Clements House

Hallam St  
West Bromwich  
B71 4HB

26<sup>th</sup> February 2025

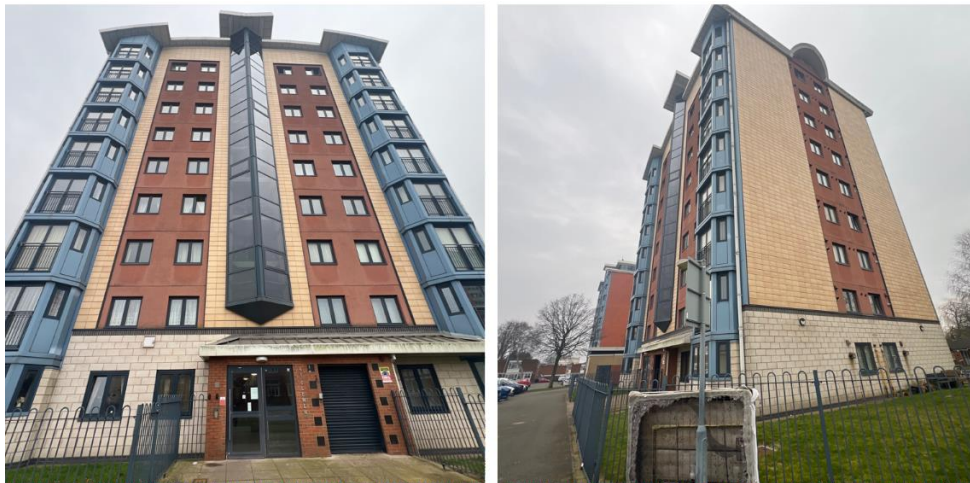
Figure 9 and 10: Building Elevations

The exterior elevations were generally in ok condition and no significant structural defects were noted to the cladding panels. There were no significant cracks or tell-tale signs of any significant structural movement noted at the time of our inspection.

The exterior panels were noted to be plumb with no signs of significant bowing, bulging or leaning noted to the panels indicating failed fixings however their presence and condition cannot be confirmed.

There are balconies at each level which are formed of cantilevered RC slabs tied into the main frame. During the 2007 refurbishment they were enclosed with aluminium panels and glazing.

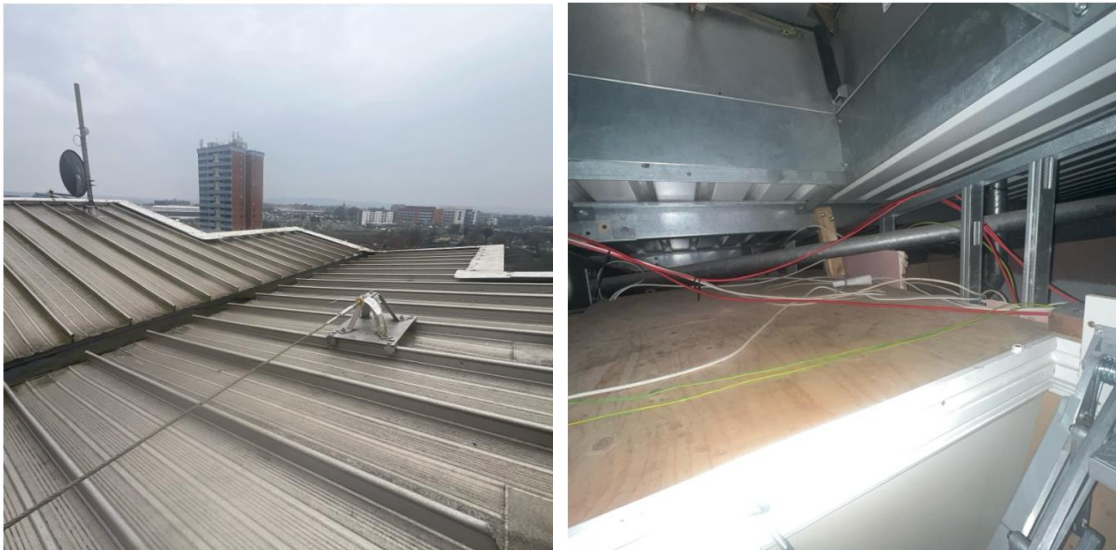
Figure 11 and 12: Roof Level

There were no tell-tale signs of any significant structural movement noted at the time of our inspection. The exterior walls were noted to be plumb with no signs of significant bowing, bulging or leaning noted to the masonry walls.

The roof has subsequently been covered with a new waterproofing covering formed of a steel frame installed to the existing roof which supports pitched corrugated sheets. This roof is not insulated and therefore acts purely as a weather barrier. The fire protection of the steel is unclear as the beams do not appear to be unprotected. Details of this frame should be requested from the contractor who completed the works in 2007. No signs of water ingress of that the roof is not performing as intended.

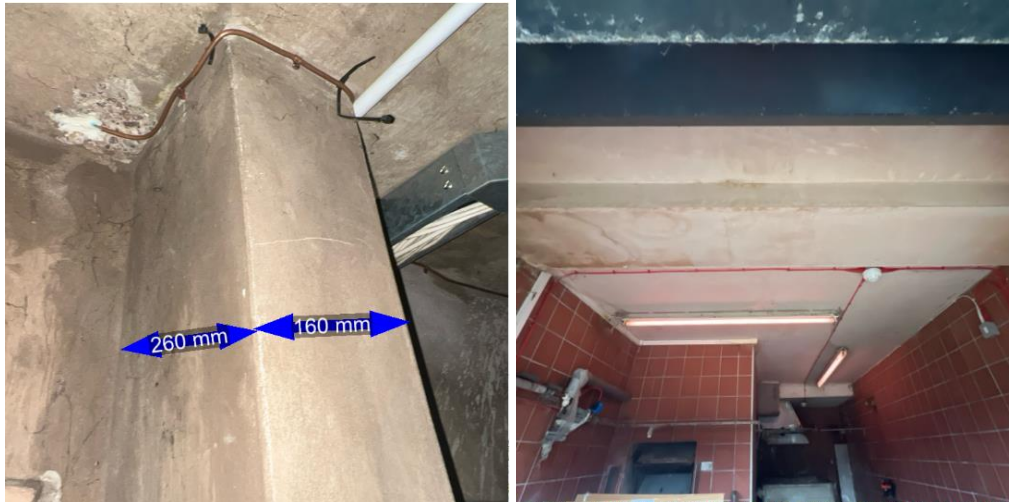
Figure 13 and 14: Vertical RC elements beam

The interior of the stair core walls were checked and were plumb and in line with observations made to the exterior – no significant signs of leaning or movement noted. The

concrete appeared in fair condition with few BRE category 1 cracks but no structurally significant defects were noted.

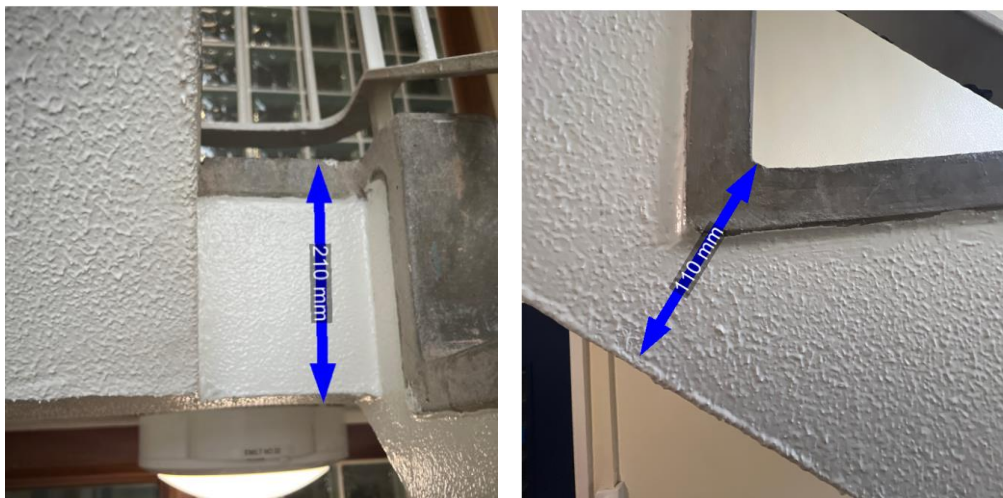
Figure 15 and 16: Stair stringer and RC slab

The stair stringer was noted to be 110mm thick which is certainly short of modern standards however may comply with standards at the time. The structural walls were measured at 150mm thick, A cover test is required to check the resistance of the concrete section in the event of a fire.

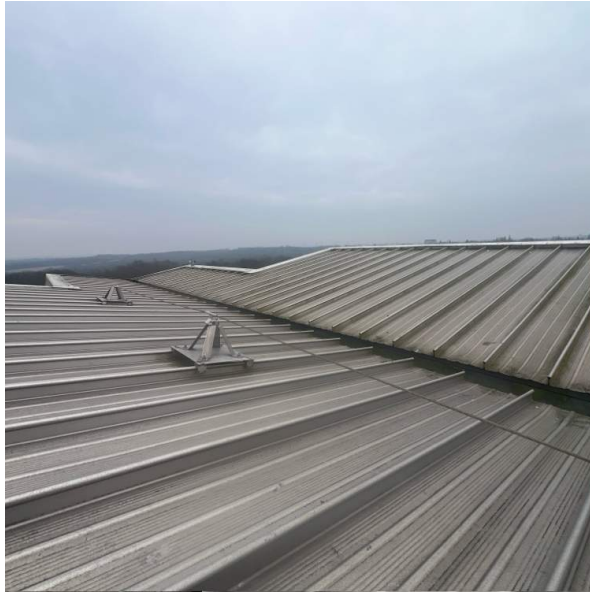
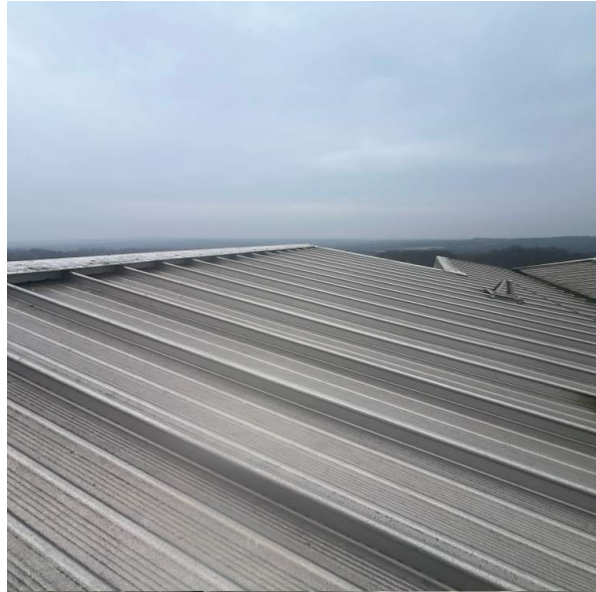
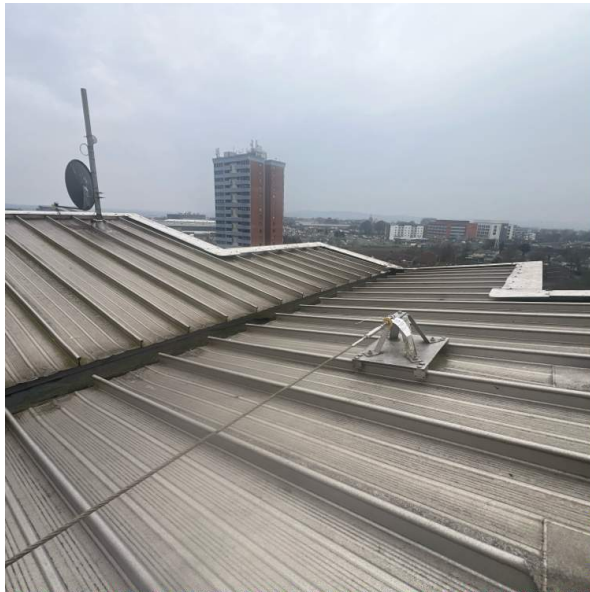
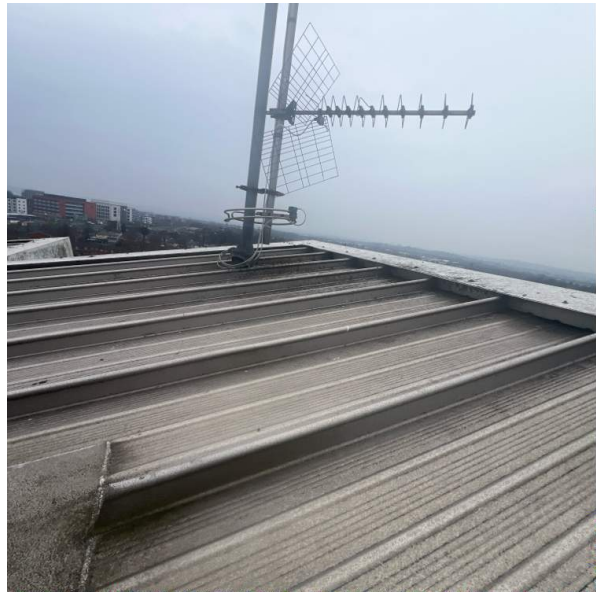
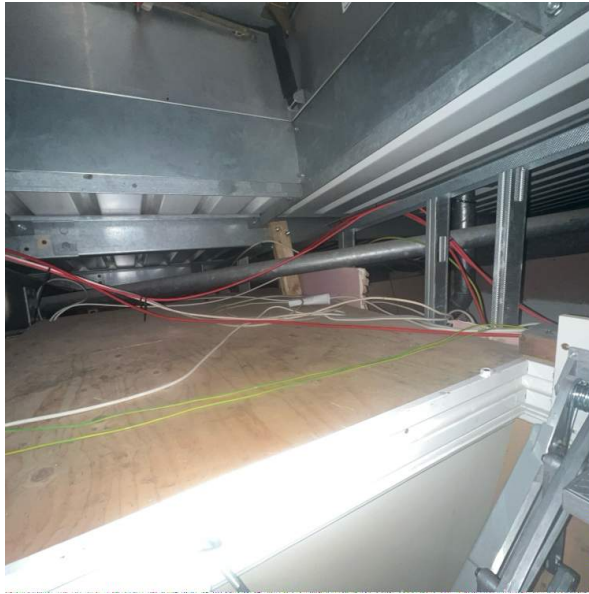
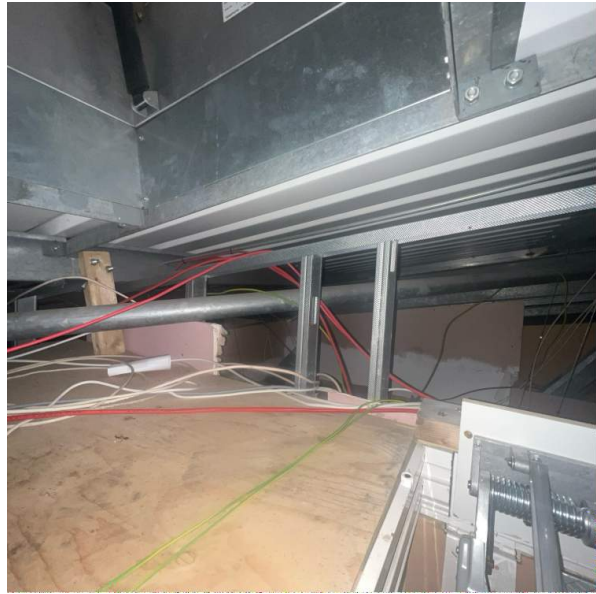
## Main Roof

Comments: A lightweight pitched roof was constructed during the refurbishment utilising beams and purlins with aluminium standing / mineral wool core profiled panels.

Roof level floor partly forms a communal area.

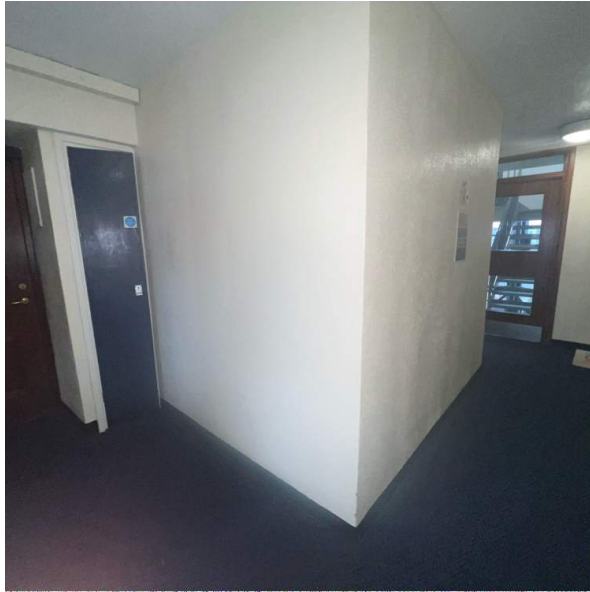
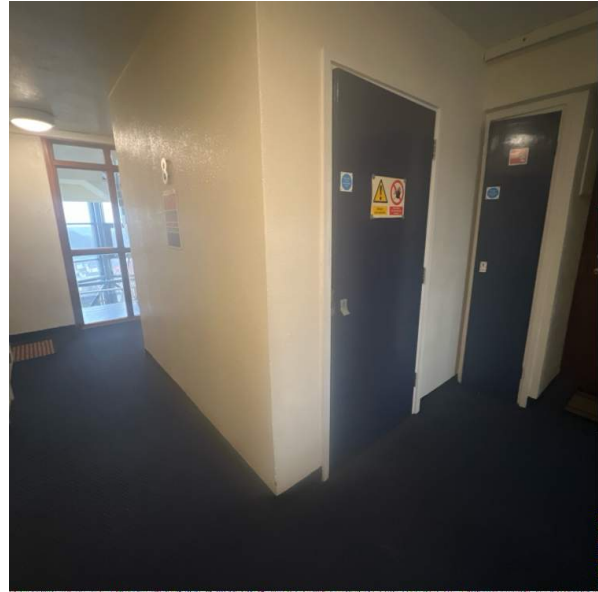
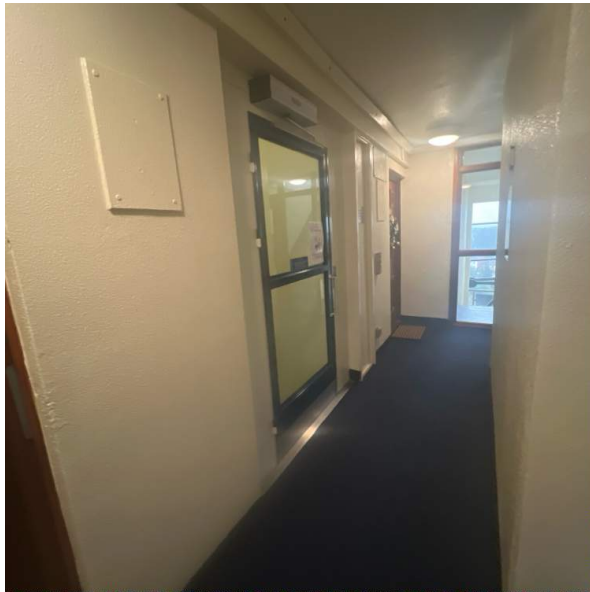
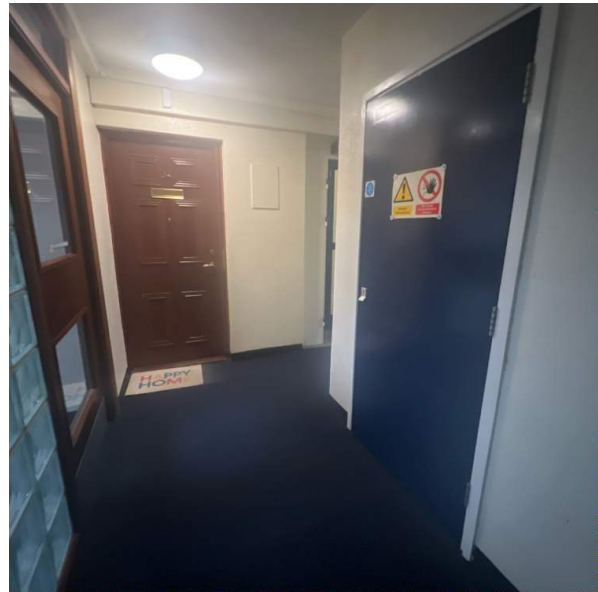
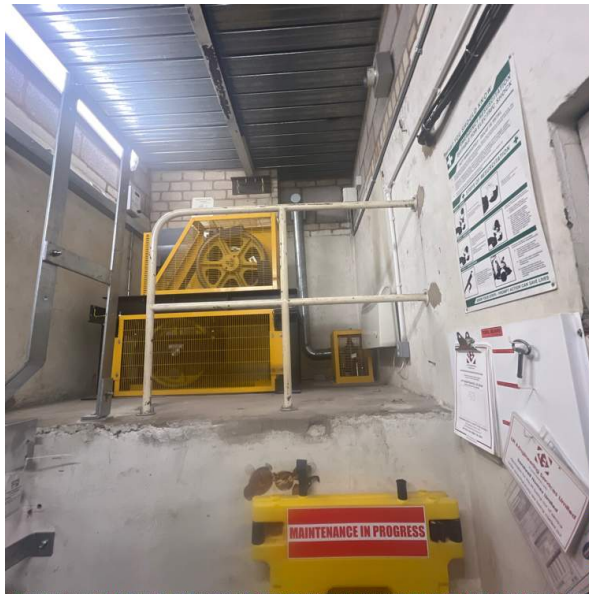
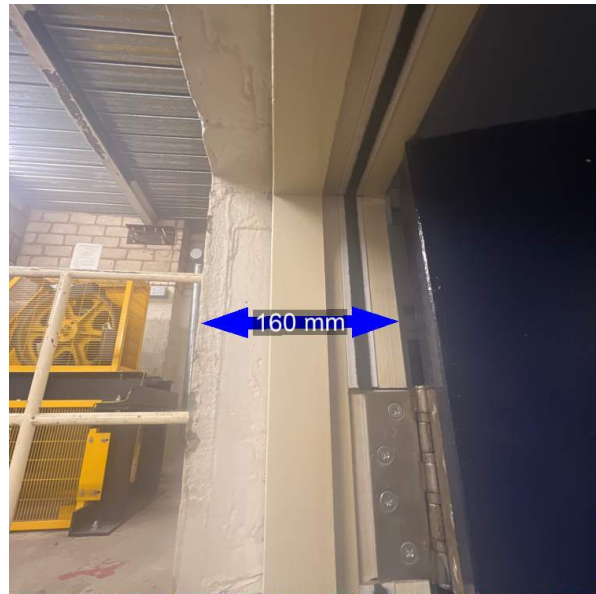
## 9th Floor Hallway

Comments: No jams or distortions noted to hallway doors to indicate any serviceability issues. Generally walls covered with finishes in hallway, likely to consist a mixture of concrete shear walls, embedded columns and masonry infill walls. Limited structure exposed. Concrete walls noted via riser cupboard and lift motor room.

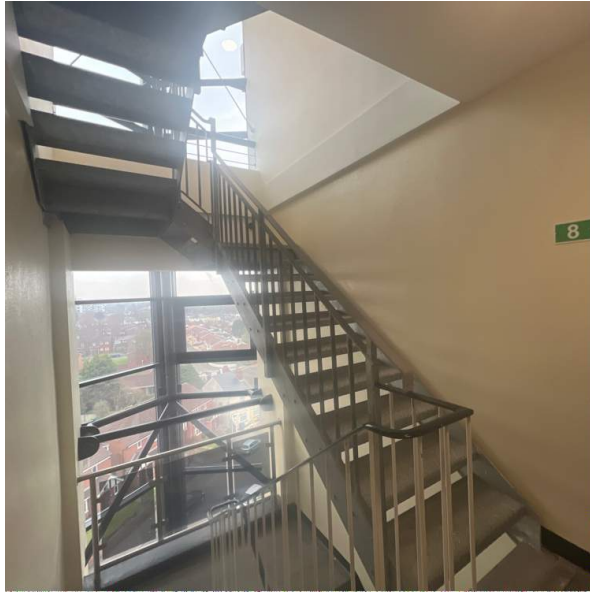
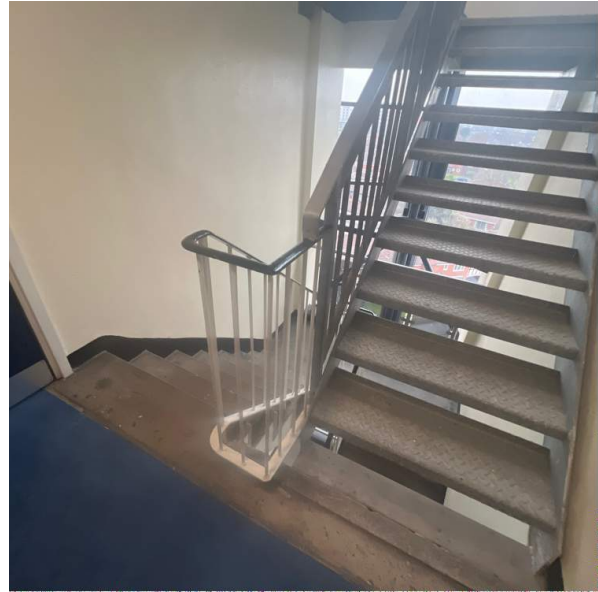
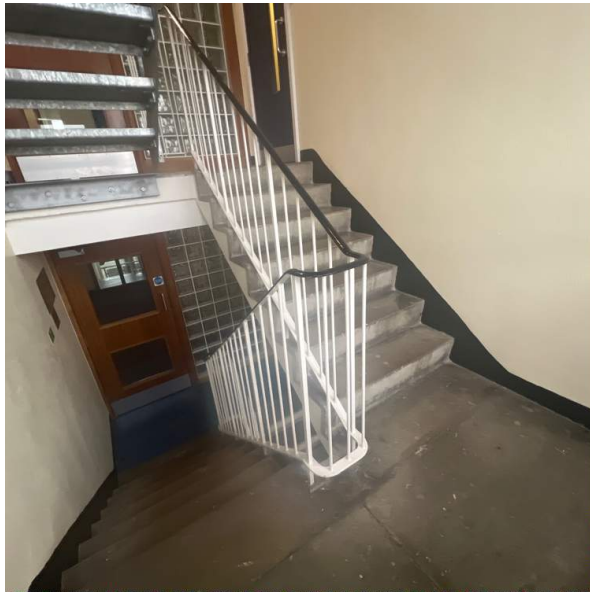
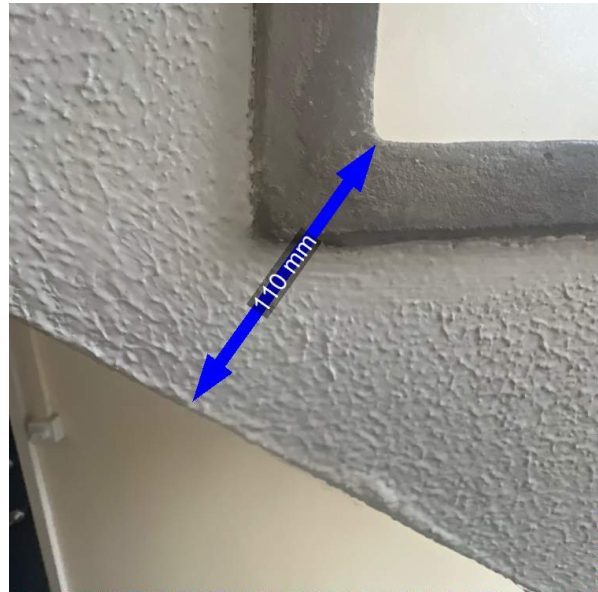
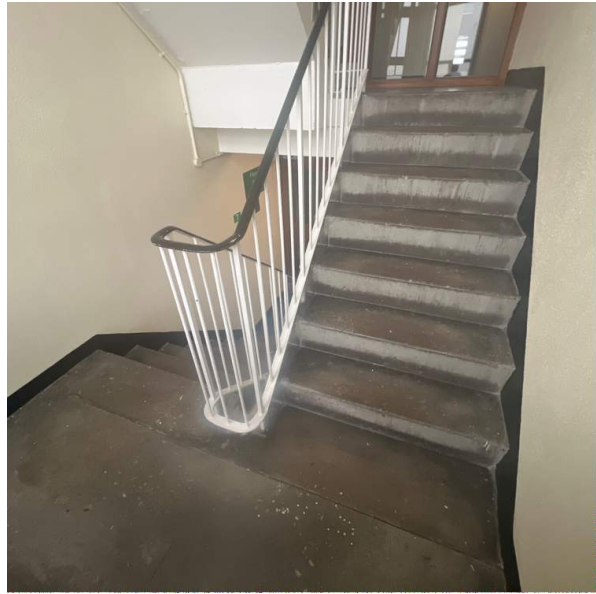
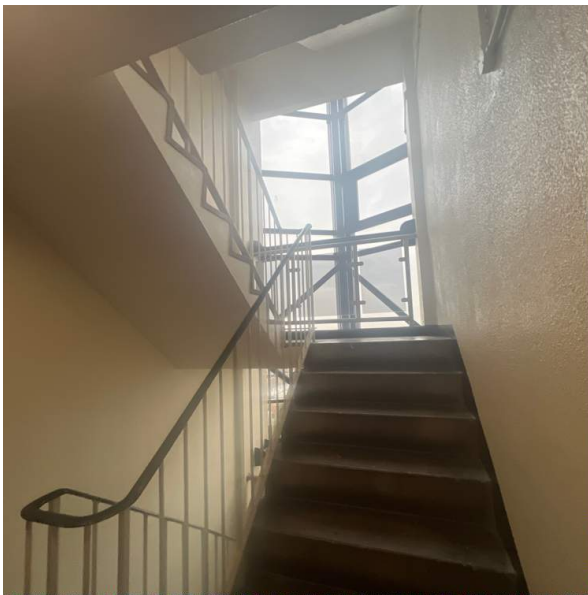
## 9th Floor Staircases

Comments: 2 sets of staircases present. Insitu concrete stairs with steel hand railing fixed to stairs. Walls and floors appear to be fairly level. Stair walls covered with finishes however these would likely form the main concrete shear core walls. A set of steel stairs also present leading to roof level.

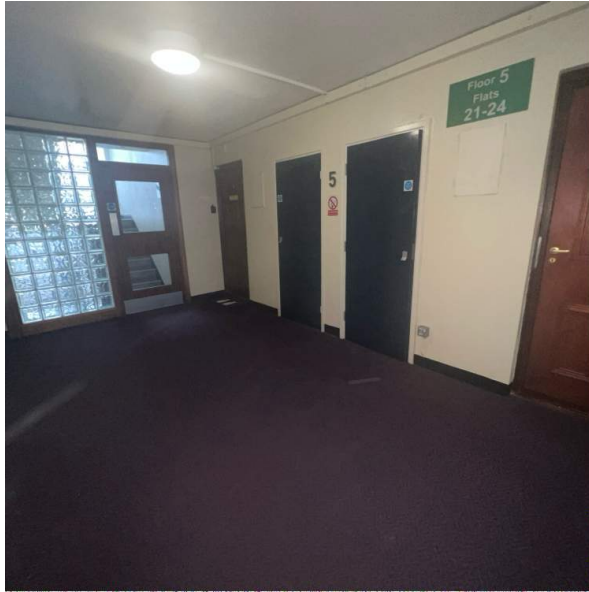
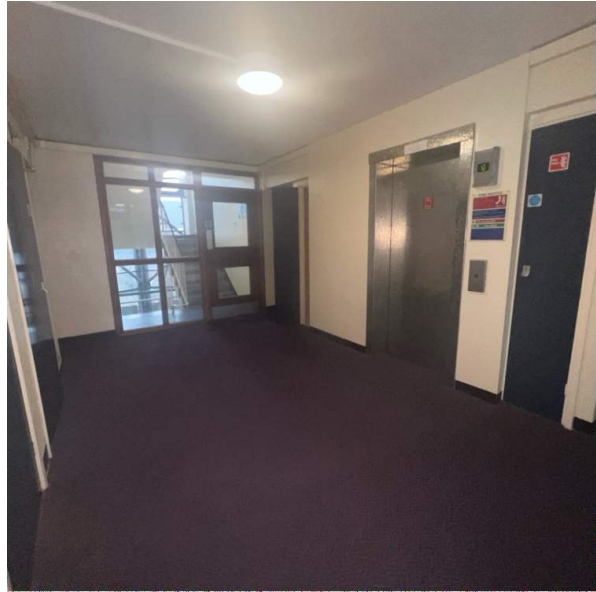
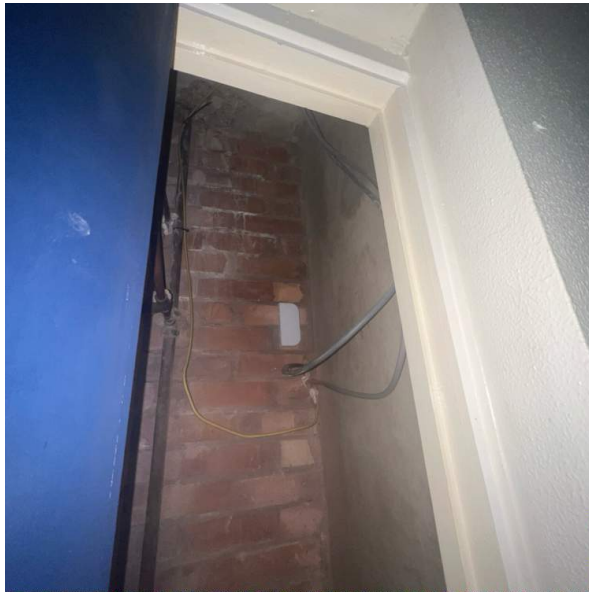
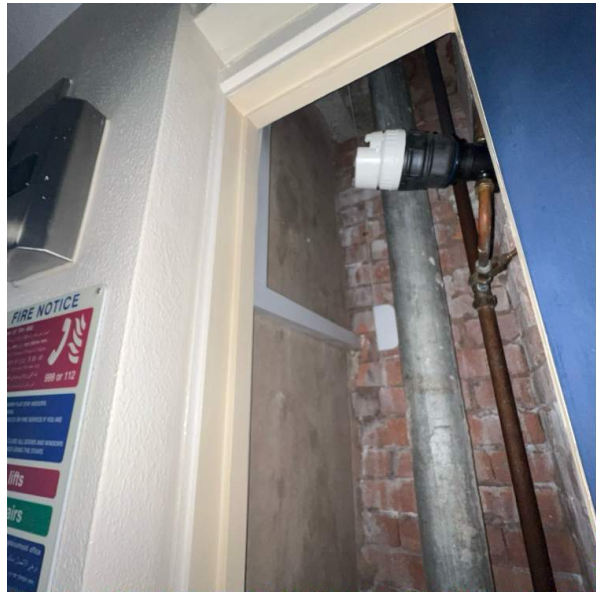
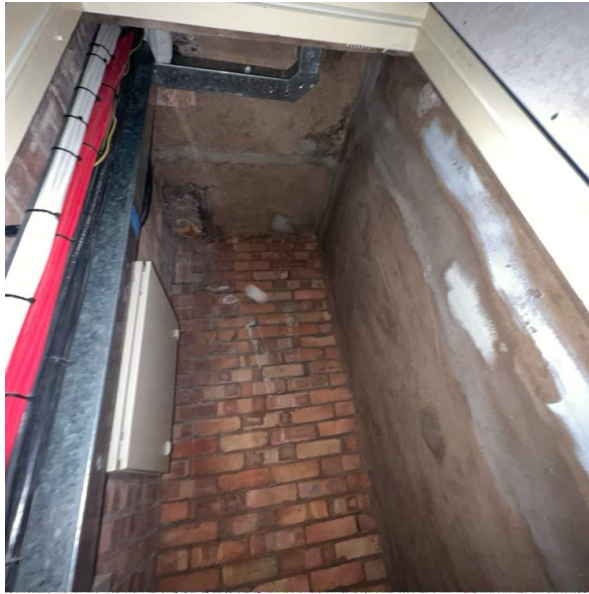
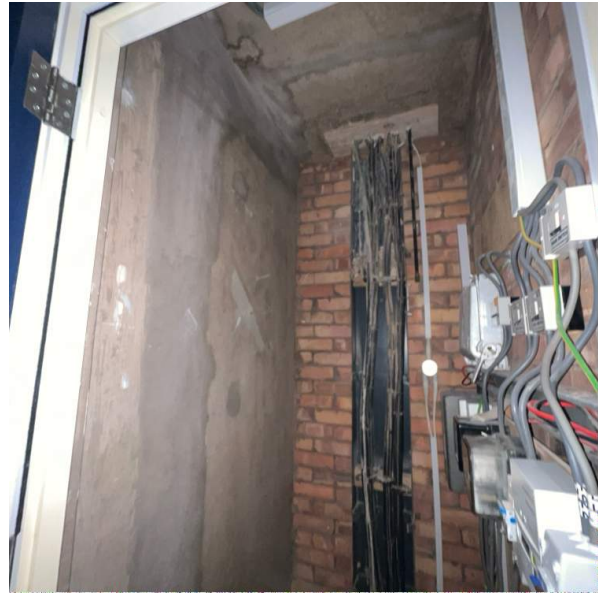
## 5th Floor Hallway

Comments: No jams or distortions noted to hallway doors to indicate any serviceability issues. Generally walls covered with finishes in hallway, likely to consist a mixture of concrete shear walls, embedded columns and masonry infill walls. Limited structure exposed. Concrete walls noted via riser cupboard. Lift walls appear to be solid concrete walls.

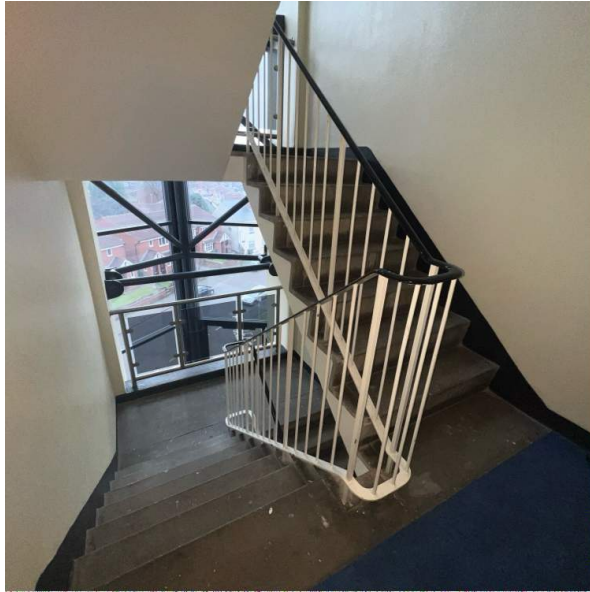
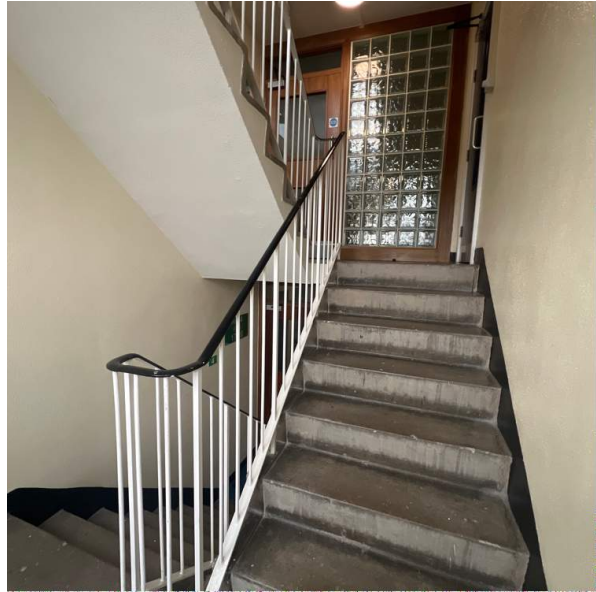
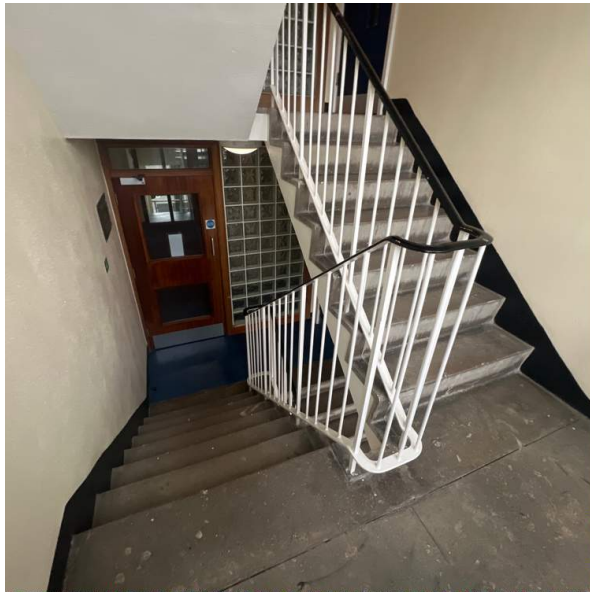
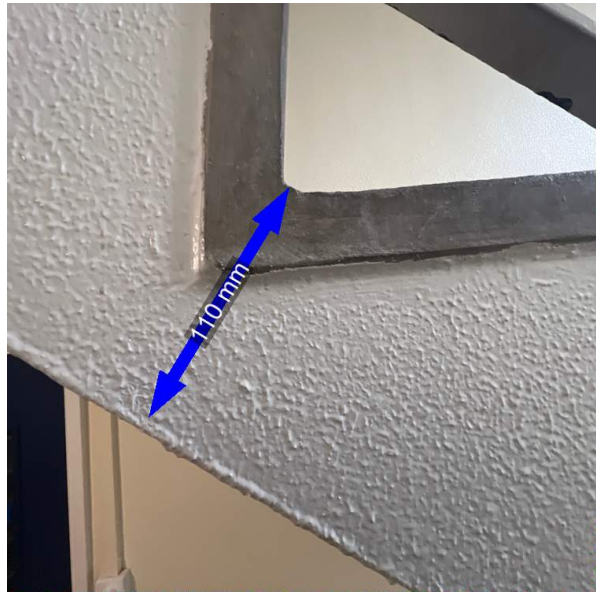
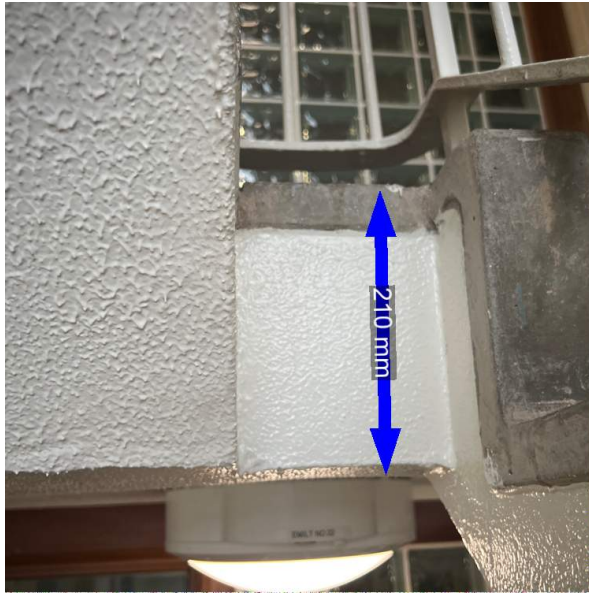
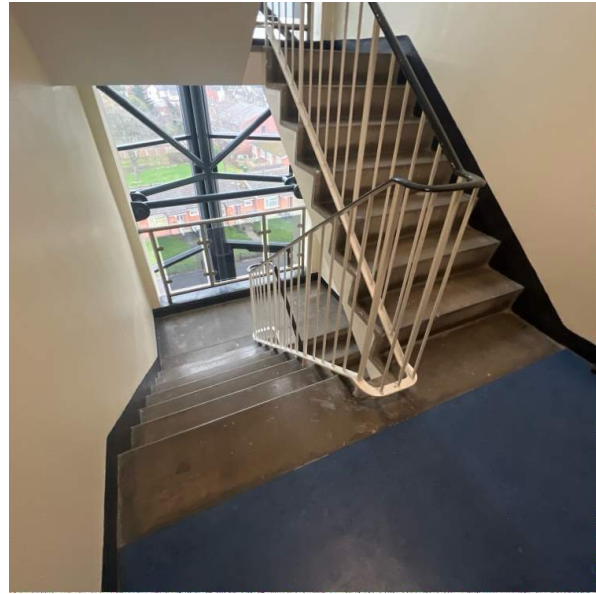
## 5th Floor Staircases

2 sets of staircases present. Insitu concrete stairs with steel hand railing fixed to stairs. Walls and floors appear to be fairly level. Stair walls covered with finishes however these would likely form the main concrete shear core walls.

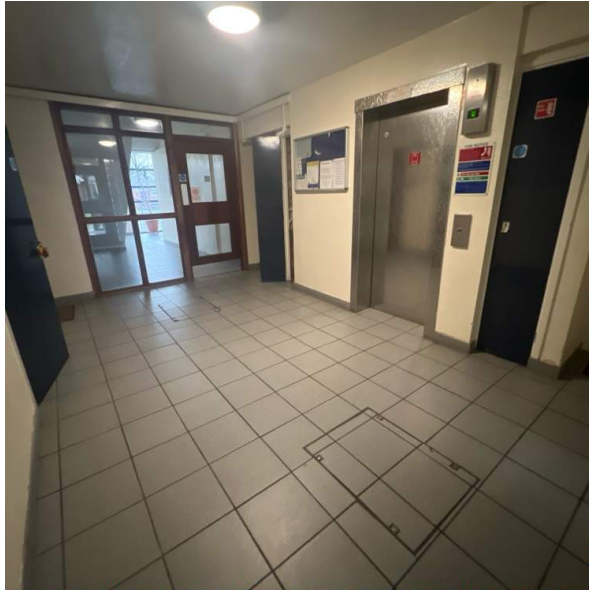
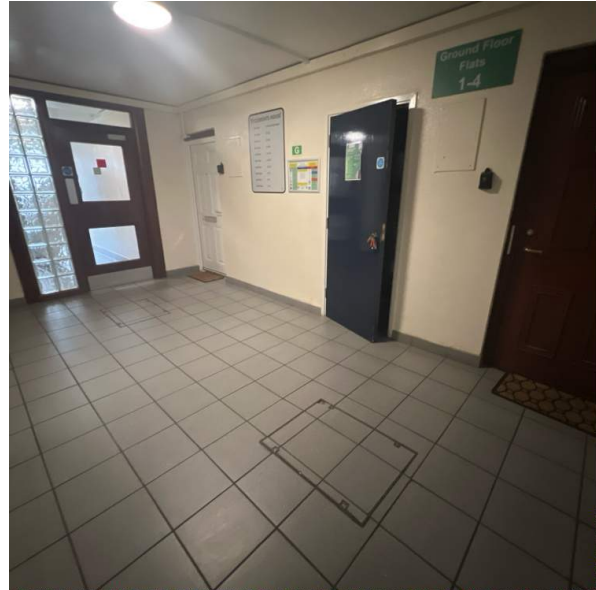
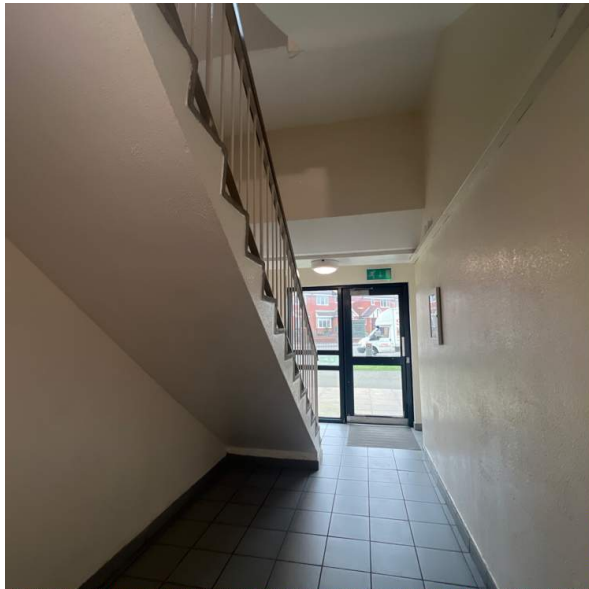
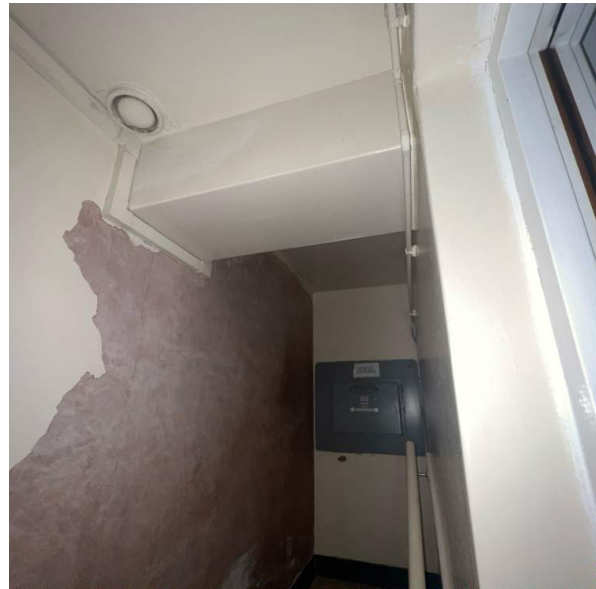
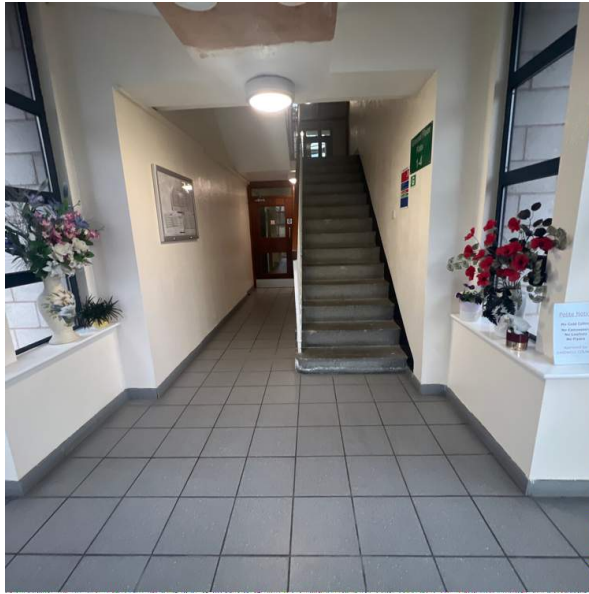
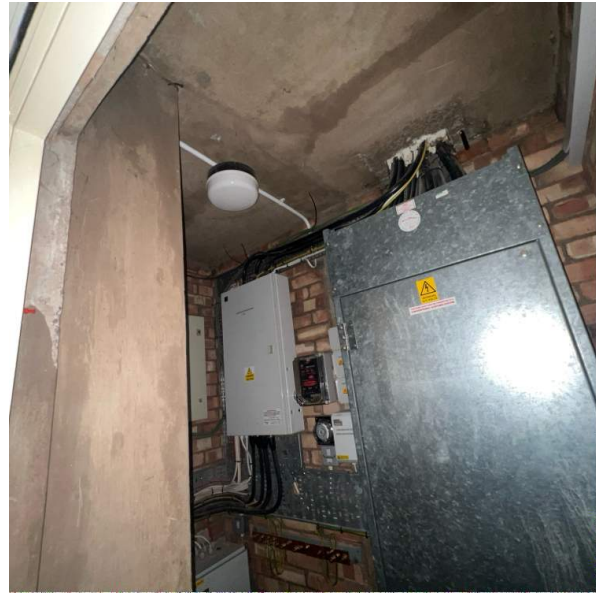
## Ground Floor Hallway

Comments: No jams or distortions noted to hallway doors to indicate any serviceability issues. Generally walls covered with finishes in hallway, likely to consist a mixture of concrete shear walls, embedded columns and block infill walls. Limited structure exposed. Partly visible concrete walls noted via electrical riser cupboard. RC columns noted in electric cupboard.

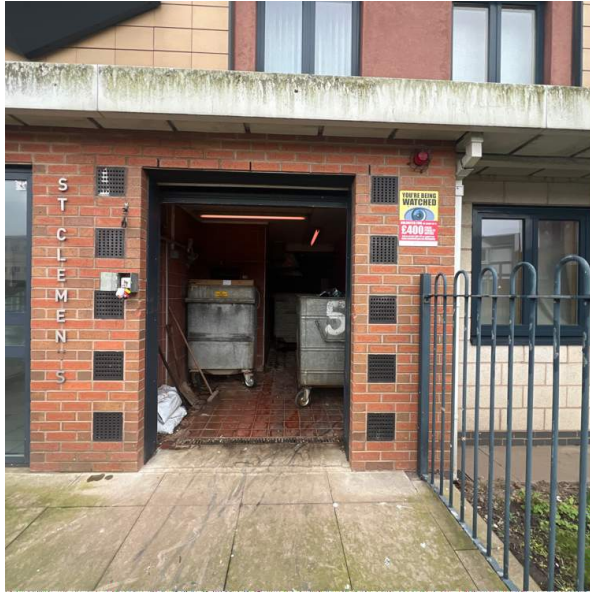
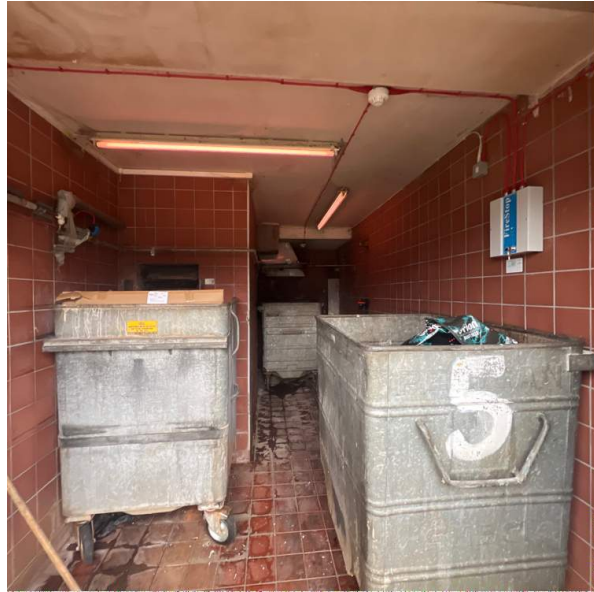
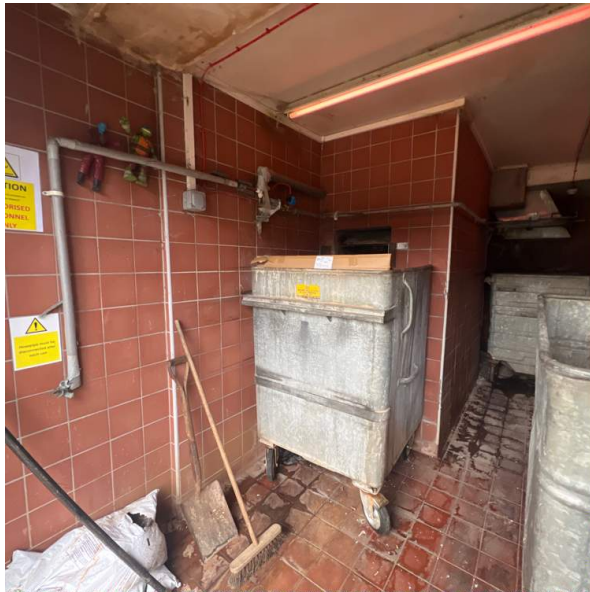
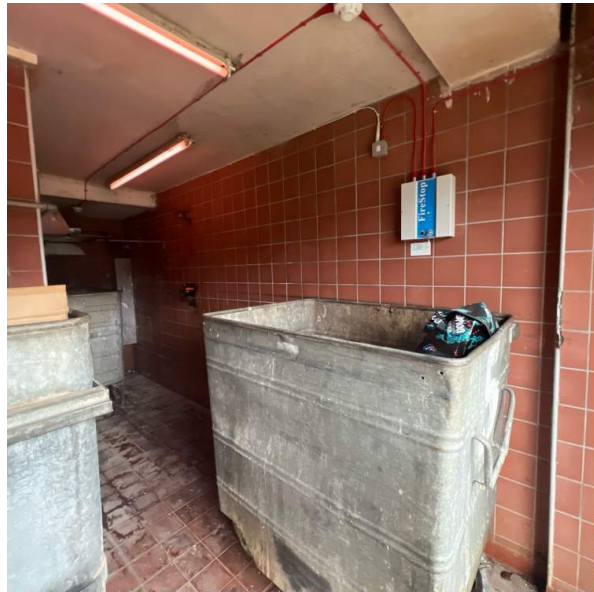
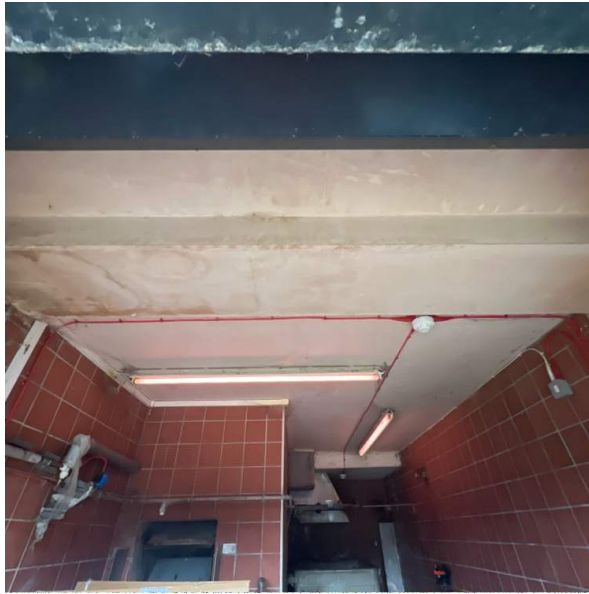
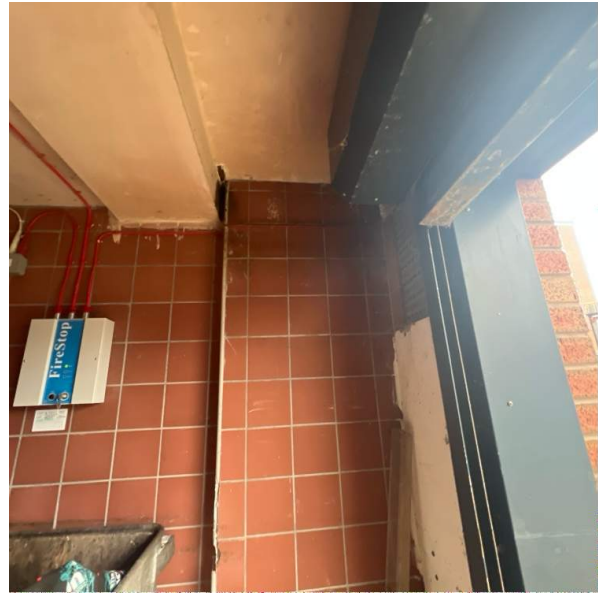
## Binstore

RC shear walls noted in binstore.

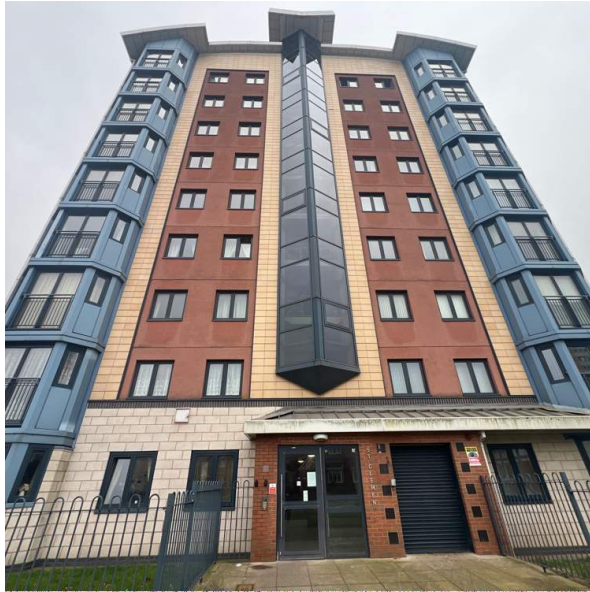
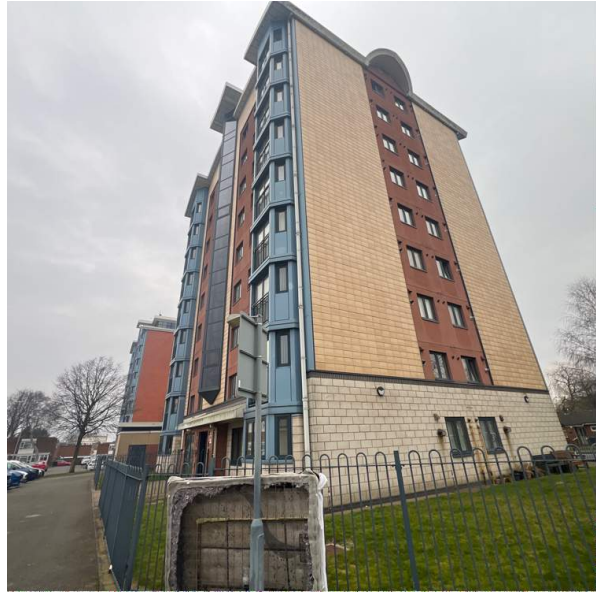
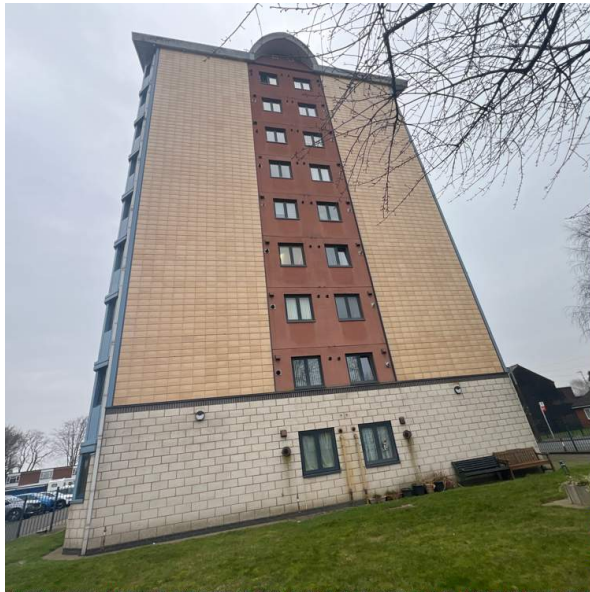
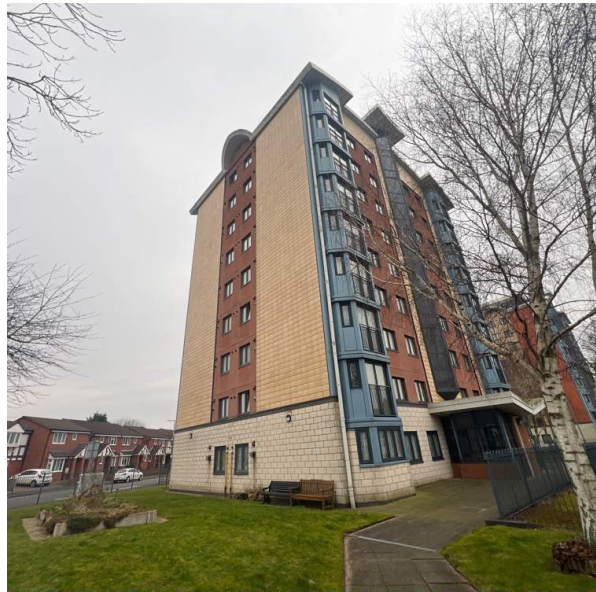
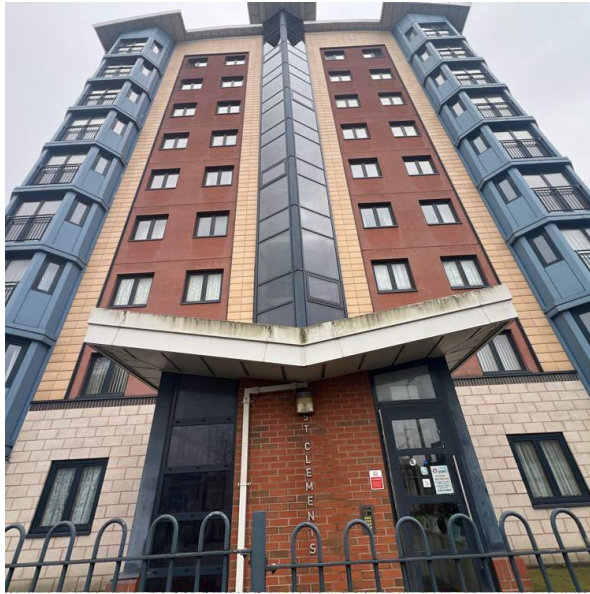
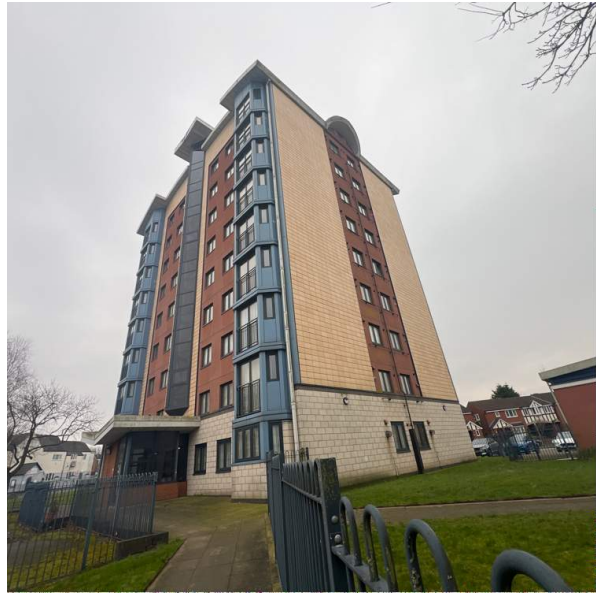
## Elevations

External facade consist of blockwork to the ground floor level. All other levels consist of a mixture of render, tiles and aluminium panel cladding and encased balconies.

External perimeter RC Concrete Columns), supporting floors.
