VISUAL STRUCTURAL APPRAISAL

St Giles Court

Reservoir Road  
Rowley Regis  
B65 9PE

21<sup>st</sup> November 2024

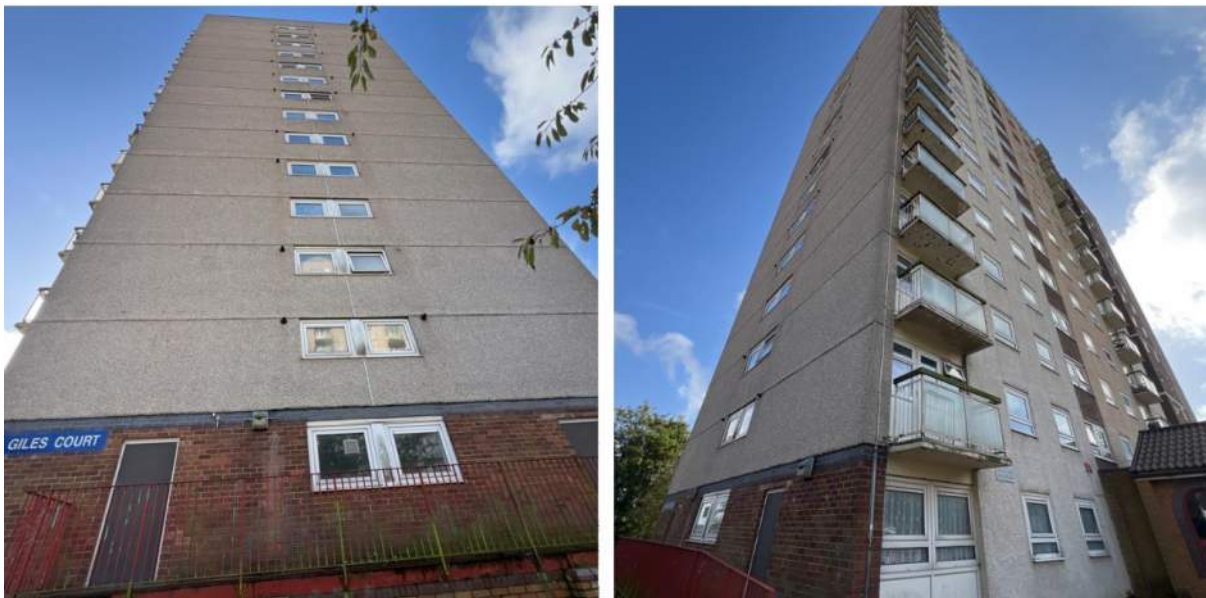
The exterior elevations were generally in ok condition and no significant structural defects were noted to the cladding panels. There were no significant cracks or tell-tale signs of any significant structural movement noted at the time of our inspection.

The external cladding system is constructed as a cavity wall, with a stretcher bond to the outer leaf. We were unable to see within the wall cavity to confirm whether there are ties or masonry supports present. The exterior walls were noted to be plumb with no signs of significant bowing, bulging or leaning noted to the cavity walls indicating failed fixings, however their presence and condition cannot be confirmed.

The exterior panels were noted to be plumb with no signs of significant bowing, bulging or leaning noted to the panels indicating failed fixings however their presence and condition cannot be confirmed.

There are balconies at each level which are formed of cantilevered RC slabs tied into the main frame, likely cast monolithically with the primary RC frame.

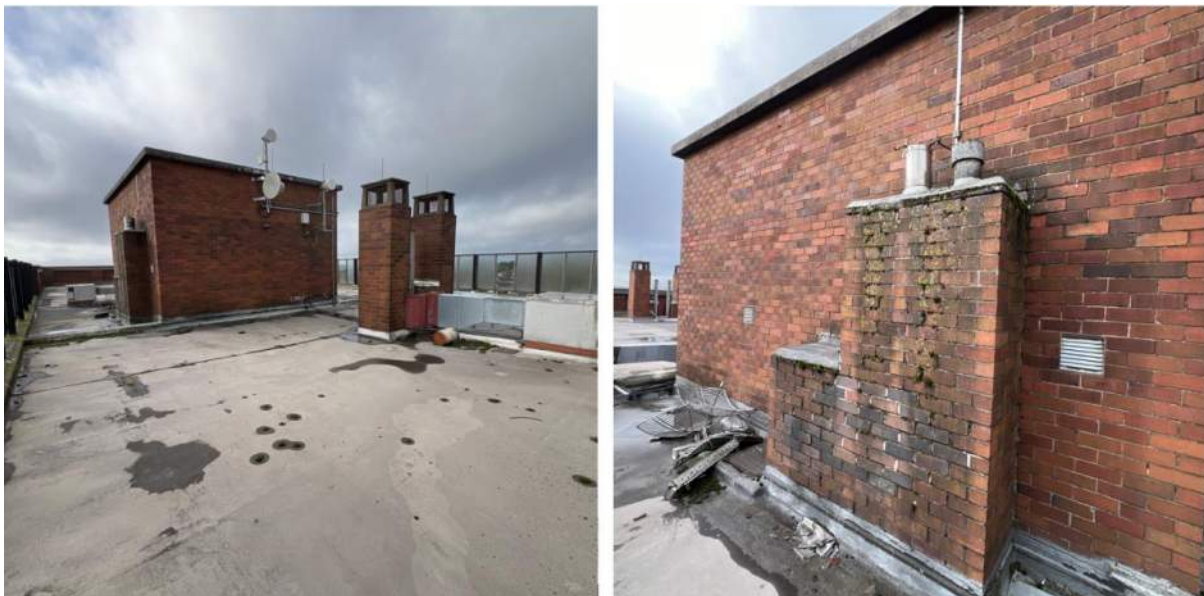
There were no tell-tale signs of any significant structural movement noted at the time of our inspection. The exterior walls were noted to be plumb with no signs of significant bowing, bulging or leaning noted to the cavity wall panels.

The roof has subsequently been covered with a new waterproofing covering formed of a single ply Sarnafil covering.

There was some accumulation of debris and rubbish on the roof which should be cleared as part of the normal regimen of maintenance.

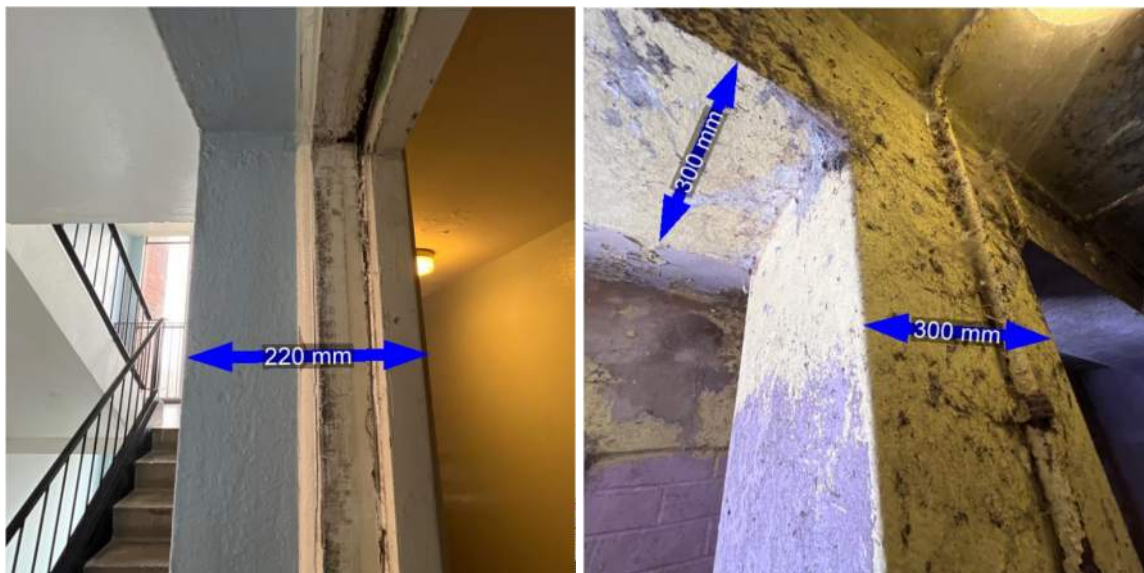
The interior of the stair core walls were checked and were plumb and in line with observations made to the exterior – no significant signs of leaning or movement noted. The concrete appeared in fair condition with few BRE category 1 cracks but no structurally significant defects were noted.

The shear walls around stair core appeared to be 220mm including finishes, therefore ~200mm RC wall. cover test is required to check the resistance of the concrete section in the event of a fire.

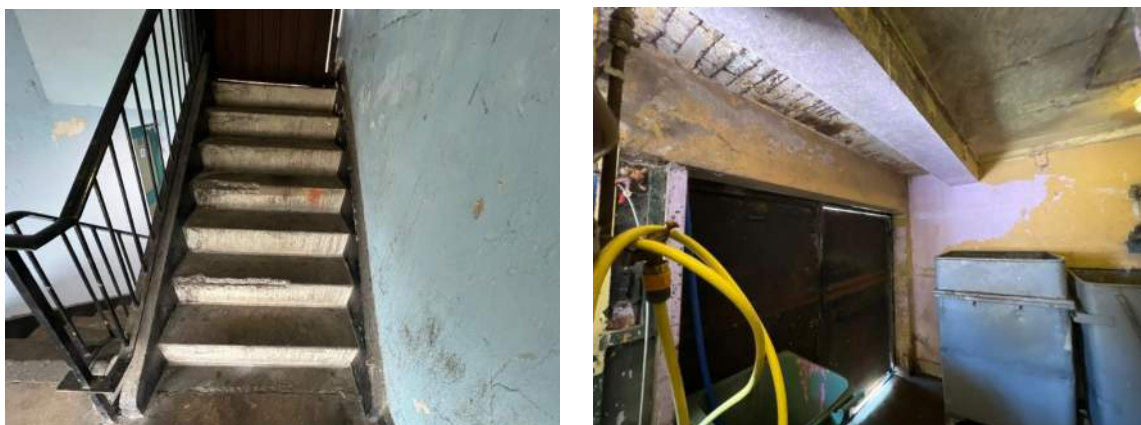
| Ref no | Observations | Risk Rating | Mitigation | Timescale |
|---|---|---|---|---|
| StGiles 004/2024 | Spalling to staircase steps leading to roof level and underside of slab soffit in bin store. | Low/Medium | Engage a concrete repair contractor to brush back the exposed steel reinforcement bars, apply a protective coating and cover with a layer of concrete mix/repair mortar. | Within the next 8-12 Months |

There was spalling to the RC structure at the staircase steps leading to roof level and to the underside of slab soffit in bin store. Refer to figures 15 and 16. These should be repaired by brushing back the

Figure 15 and 16: Defects to RC Structure

exposed steel reinforcement bars, apply a protective coating and cover with a layer of concrete mix/repair mortar.

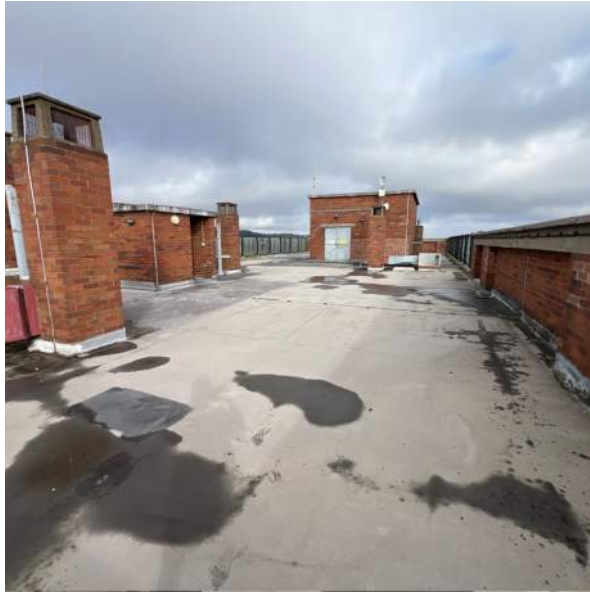
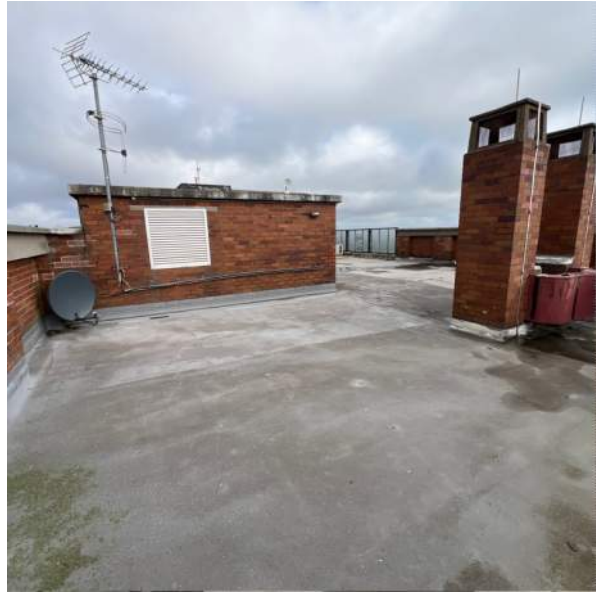
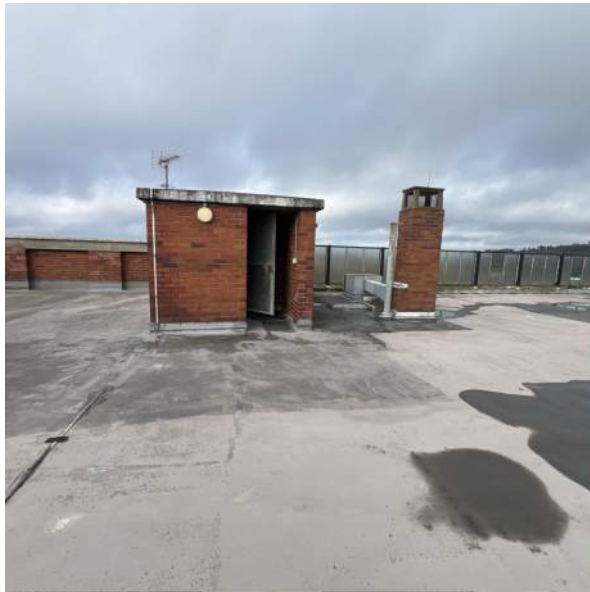
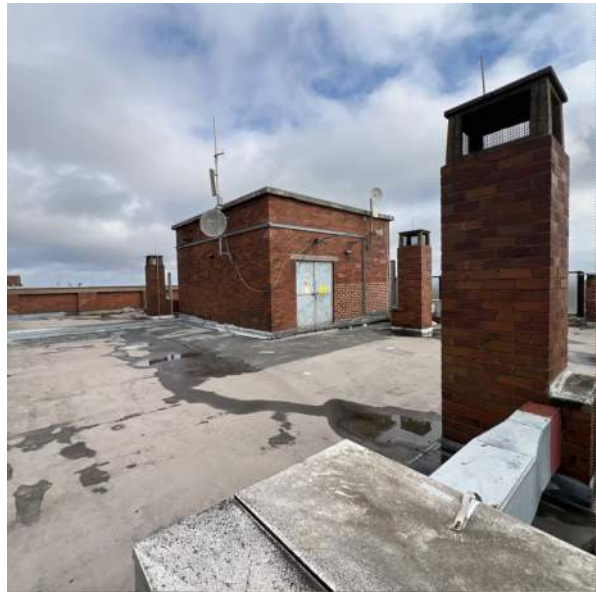
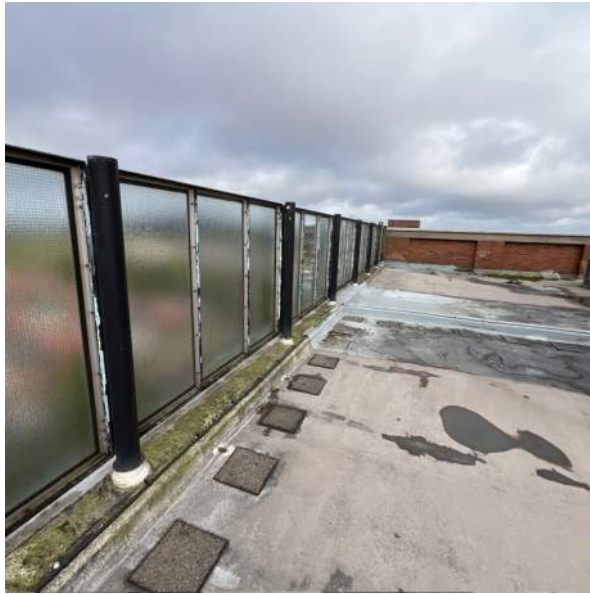
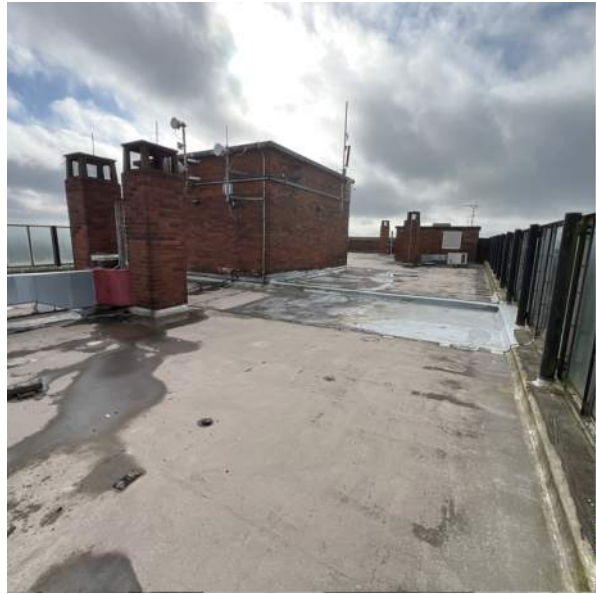
## Main Roof

Parapet walls noted to perimeter of roof.  
Insitu concrete roof slab. Masonry lift room located at roof level.

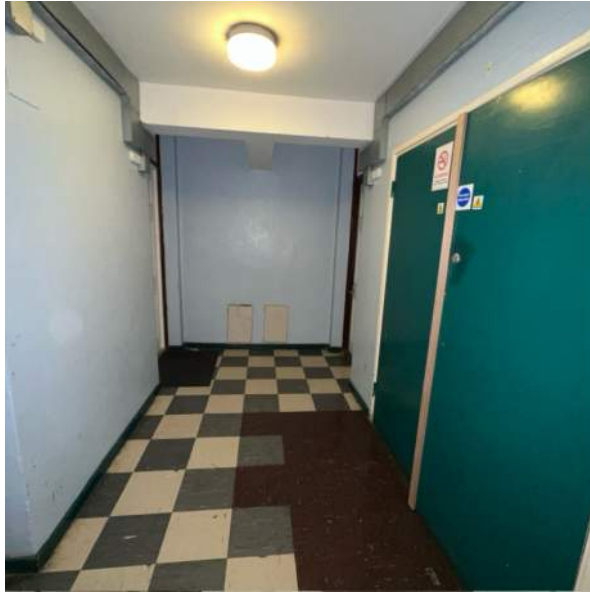
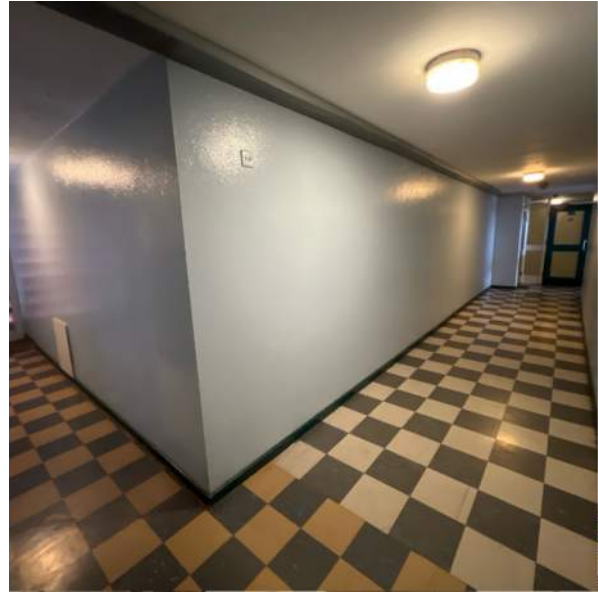
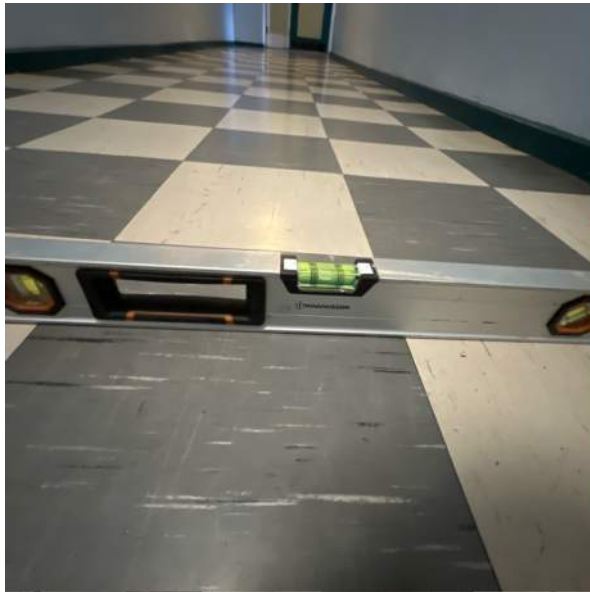
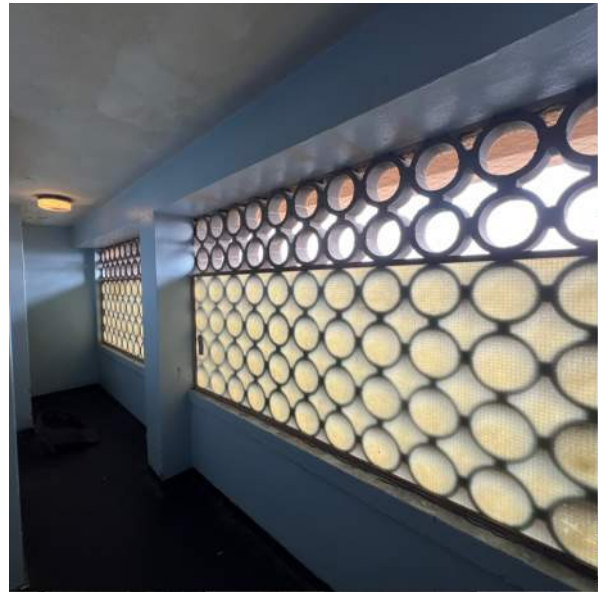
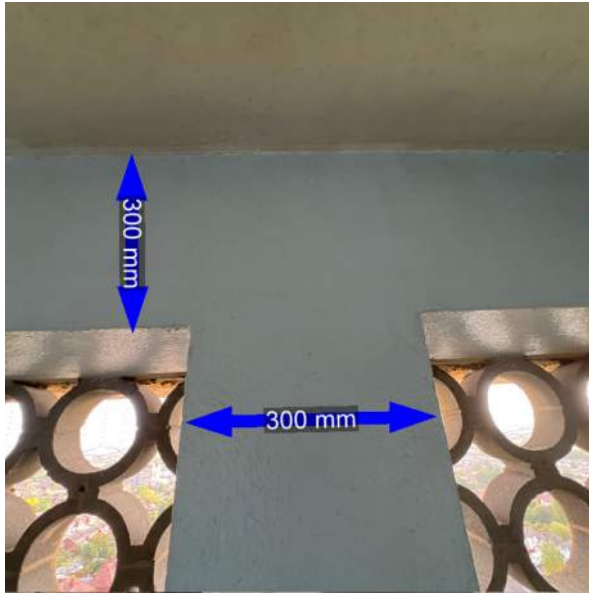
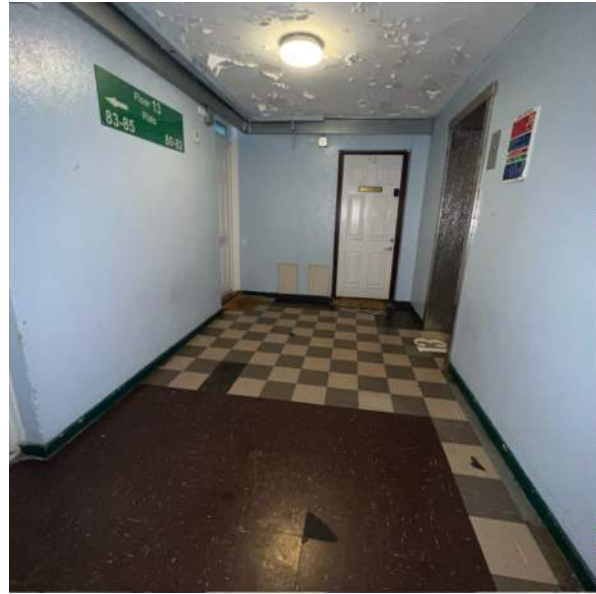
## 13th Floor Hallway

Comments: No jams or distortions noted to hallway doors to indicate any serviceability issues. Generally walls covered with finishes in hallway, likely to consist a mixture of concrete shear walls, embedded columns and block infill walls. Limited structure exposed. Partly visible concrete walls noted via electrical riser cupboards

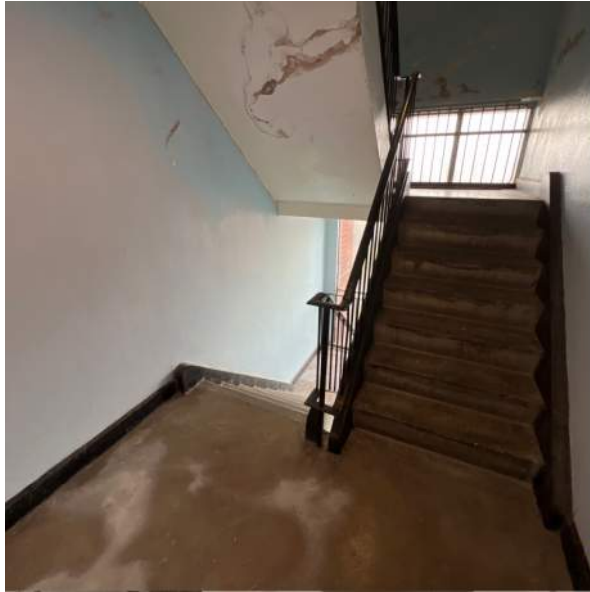
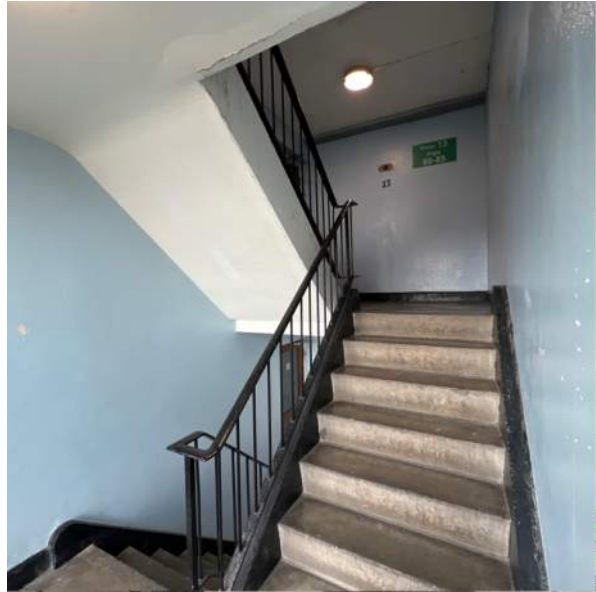
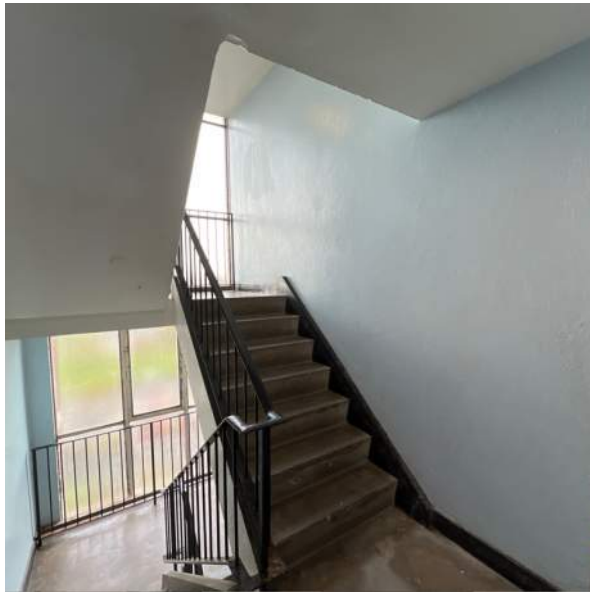
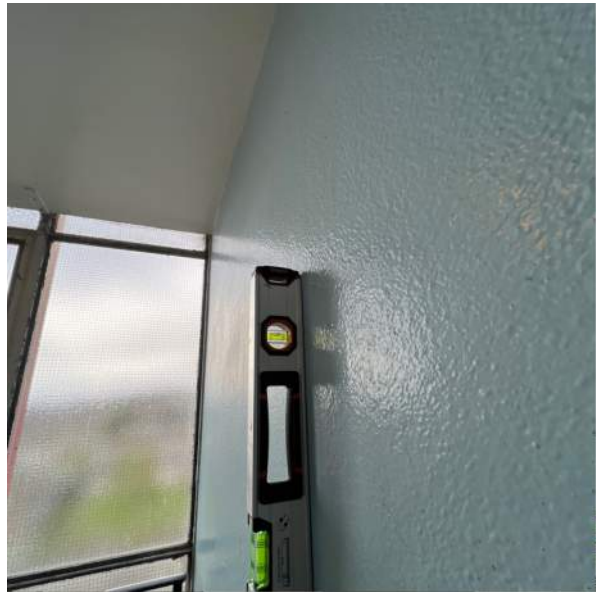
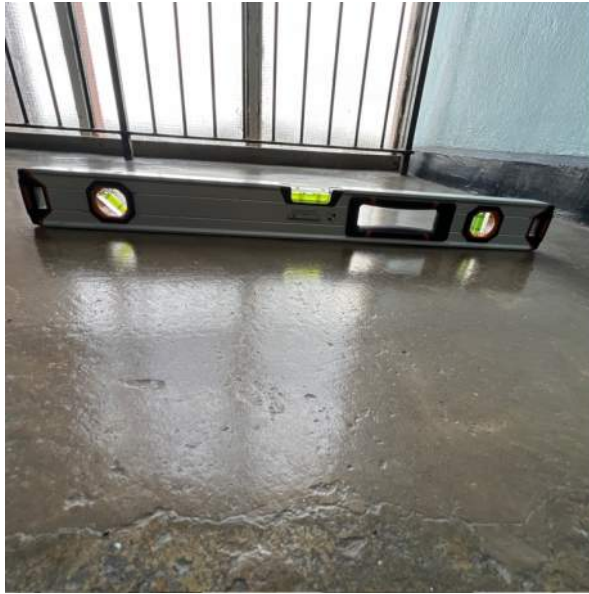
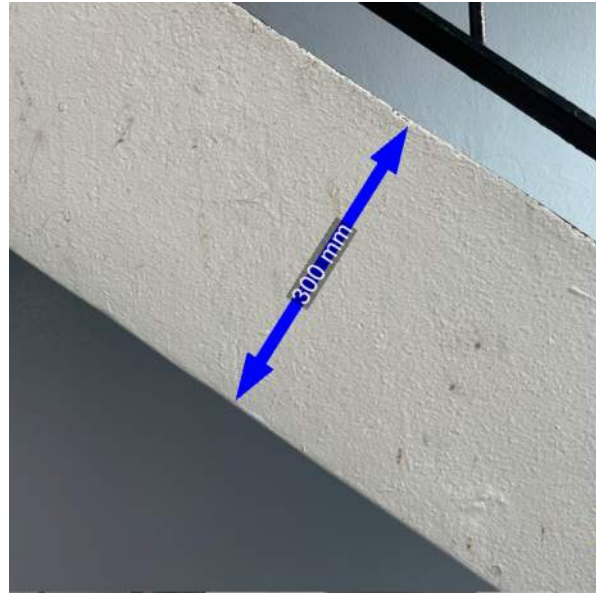
## 13th Floor Staircase

Insitu concrete stairs with steel hand railing fixed to stairs. Walls and floors appear to be fairly level.

Stair walls covered with finishes however these would likely form the main concrete shear core walls.

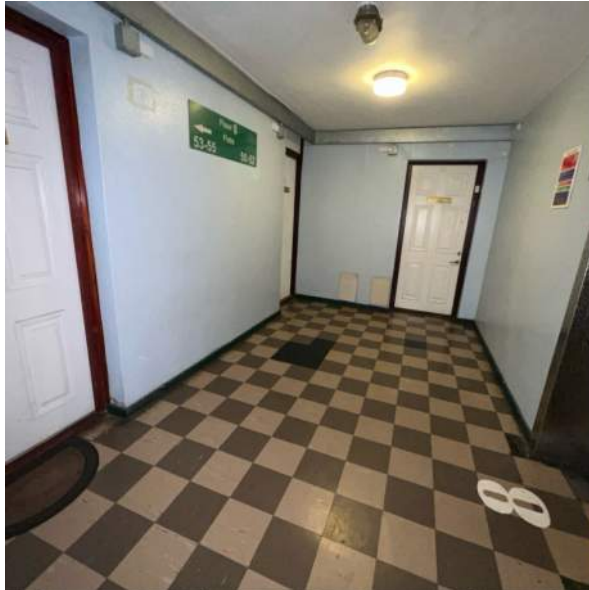
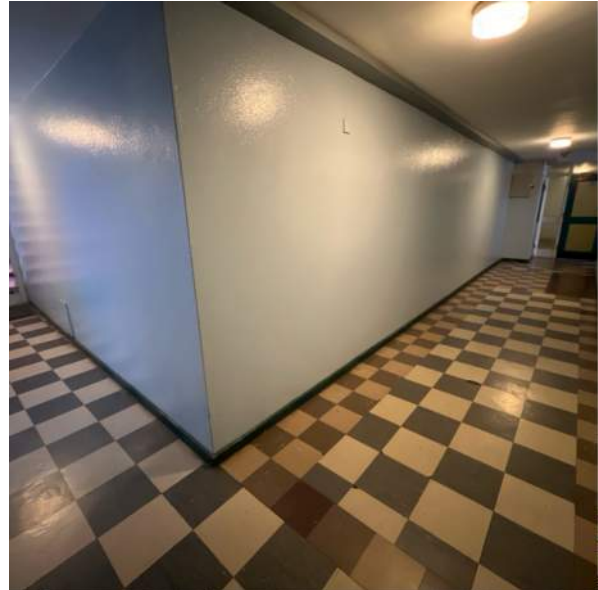
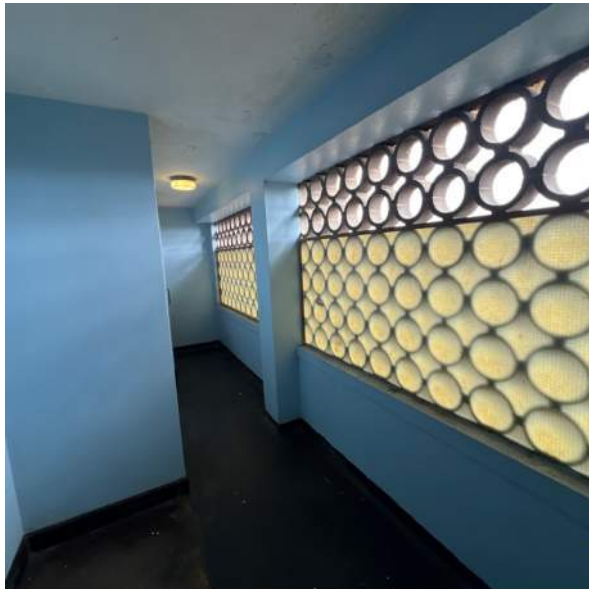
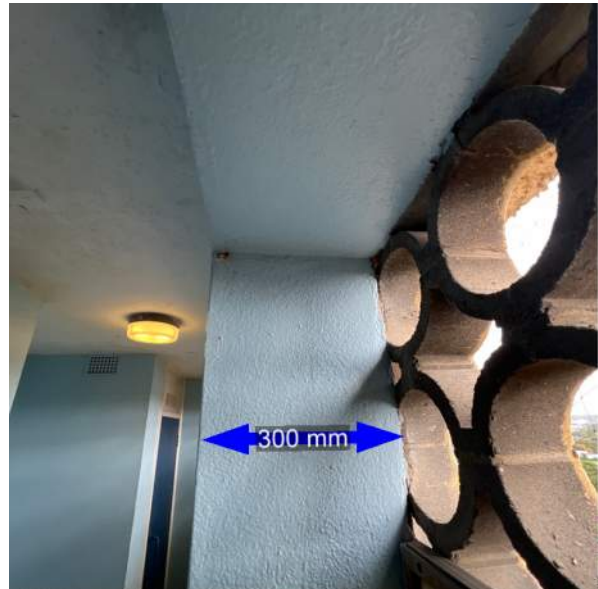
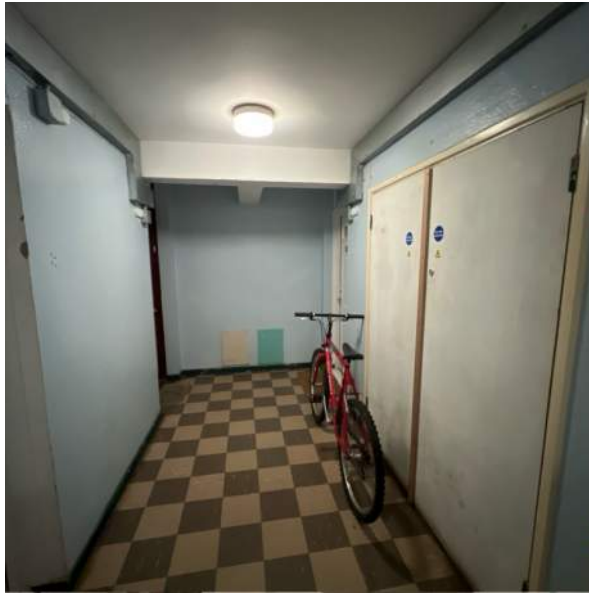
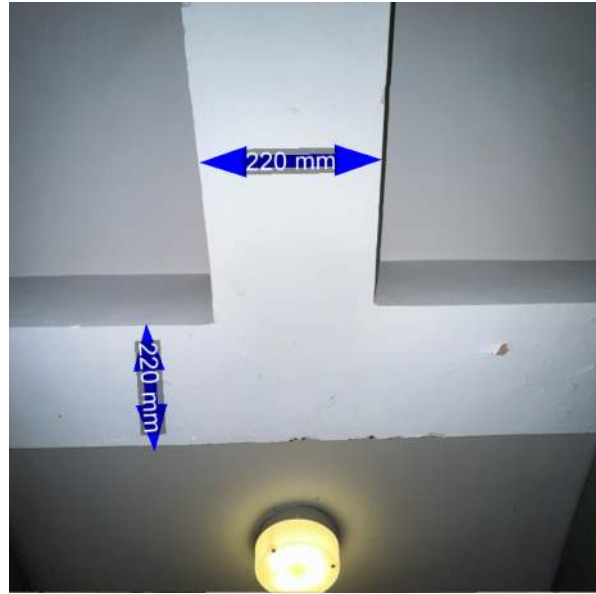
## 8th Floor Hallway

Comments: No jams or distortions noted to hallway doors to indicate any serviceability issues. Generally walls covered with finishes in hallway, likely to consist a mixture of concrete shear walls, embedded columns and block infill walls. Limited structure exposed. Partly visible concrete walls noted via electrical riser cupboards

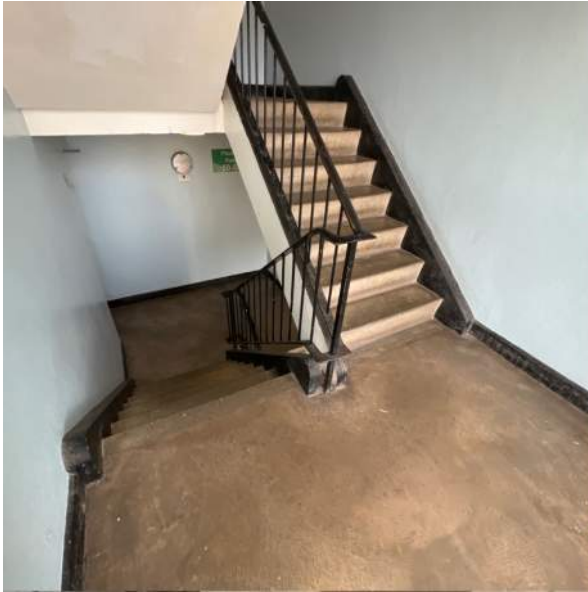
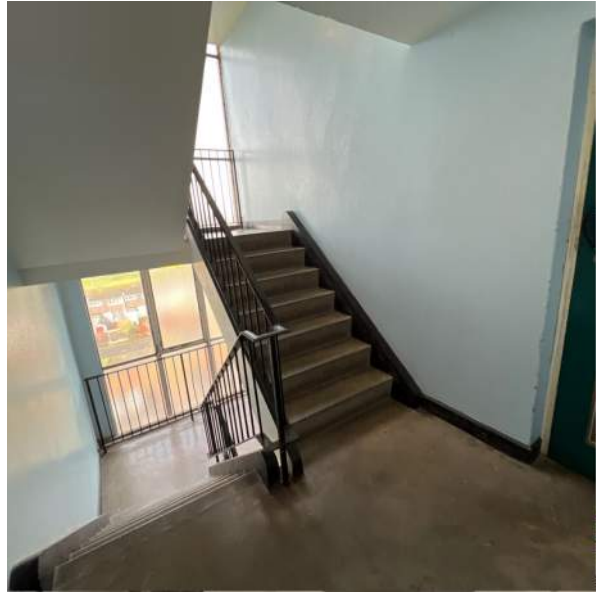
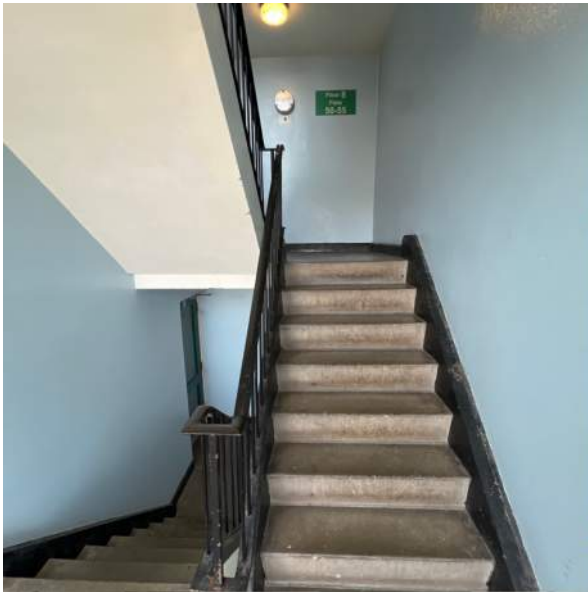
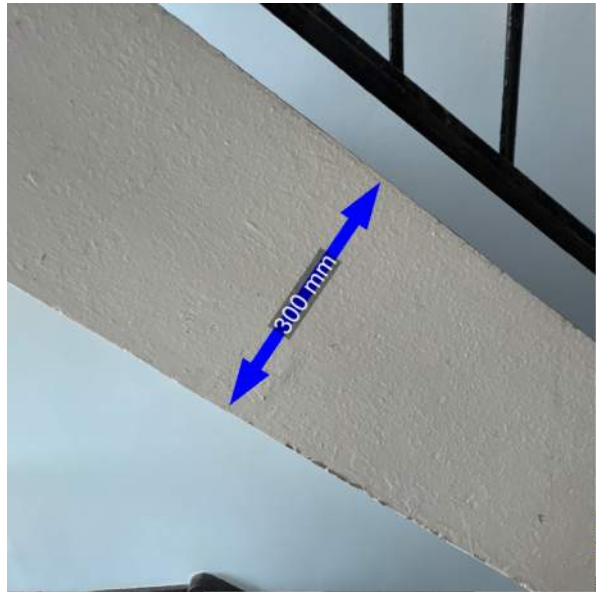
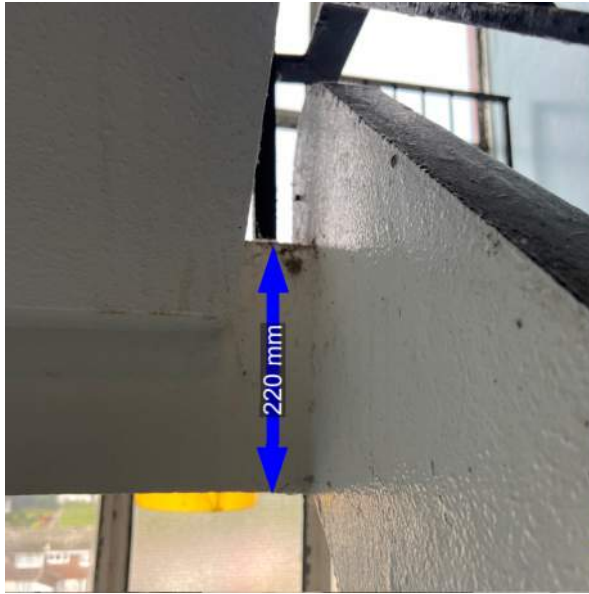
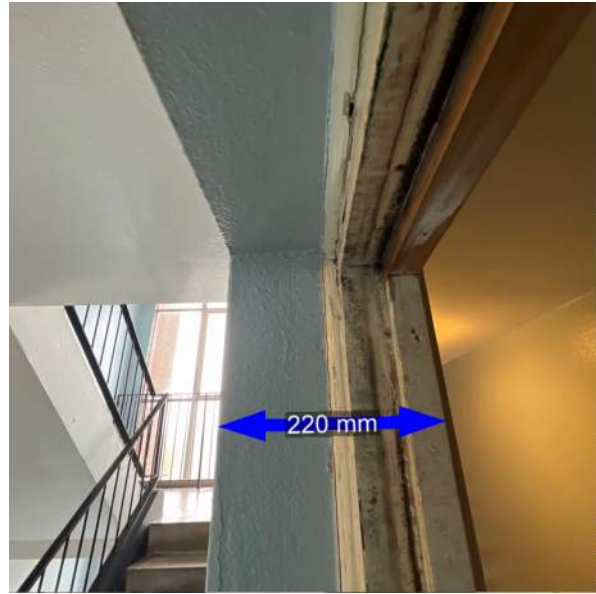
## 8th Floor Staircase

Comments: Insitu concrete stairs with steel hand railing fixed to stairs. Walls and floors appear to be fairly level.  
Stair walls covered with finishes however these would likely form the main concrete shear core walls. Stair walls approx. 220mm thick.

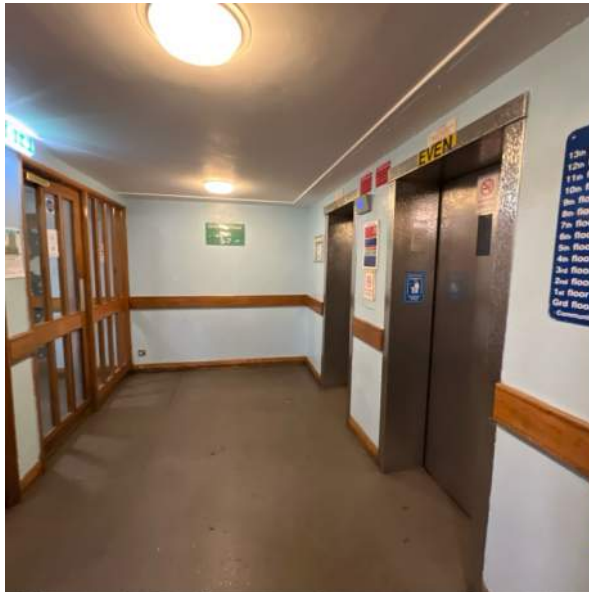
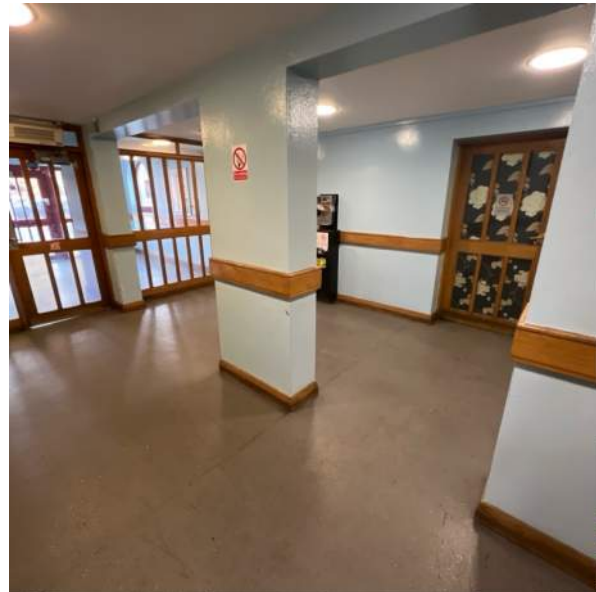
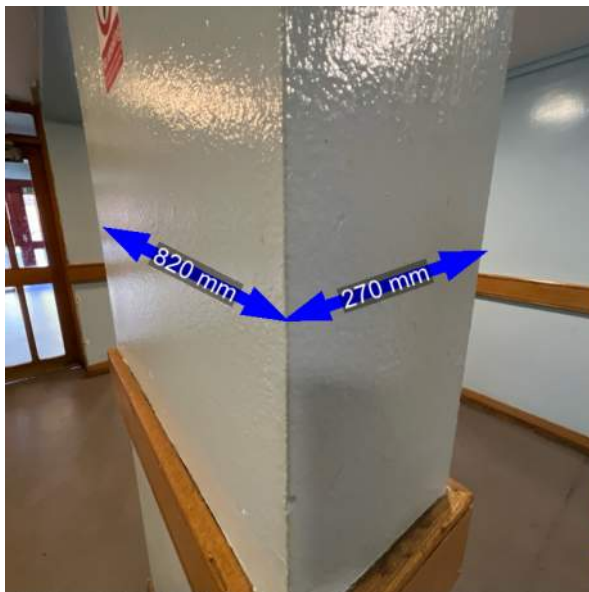
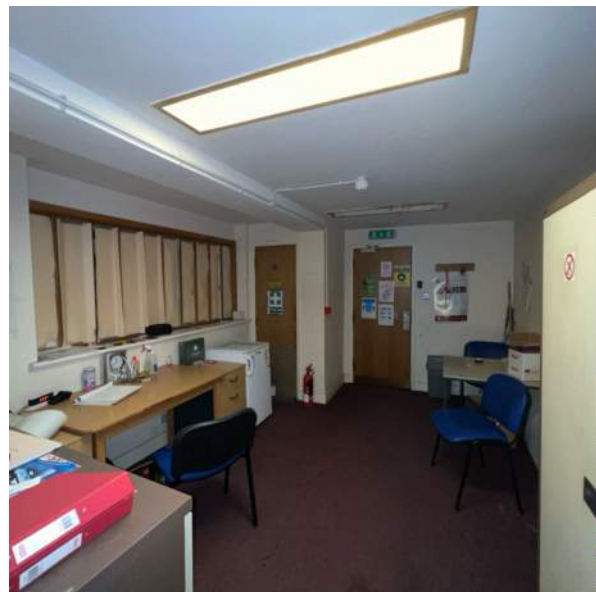
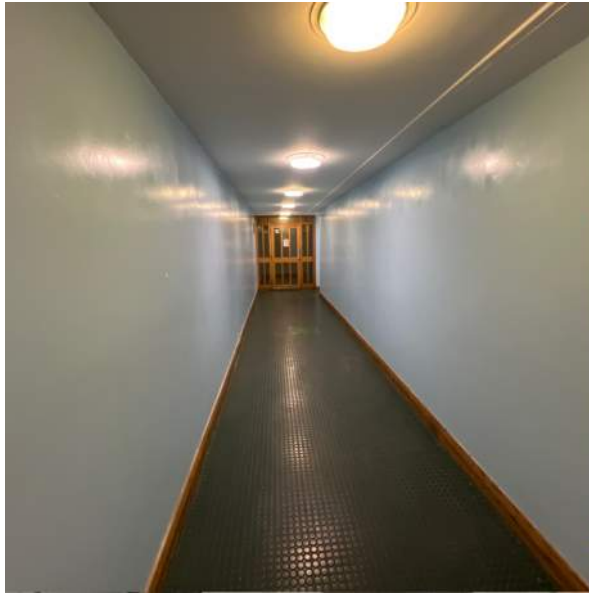
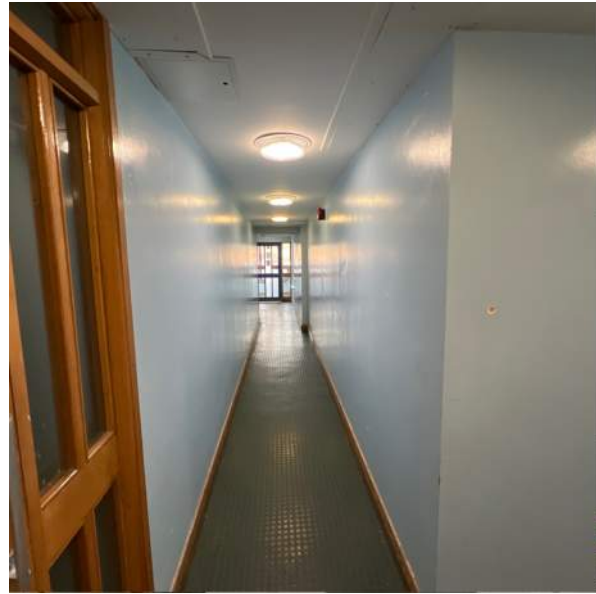
## Ground Floor Hallway

Comments: No jams or distortions noted to hallway doors to indicate any serviceability issues. Generally walls covered with finishes in hallway, likely to consist a mixture of concrete shear walls, embedded columns and block infill walls. Limited structure exposed. Partly visible concrete walls noted via electrical riser cupboards. RC Columns noted in hallway.

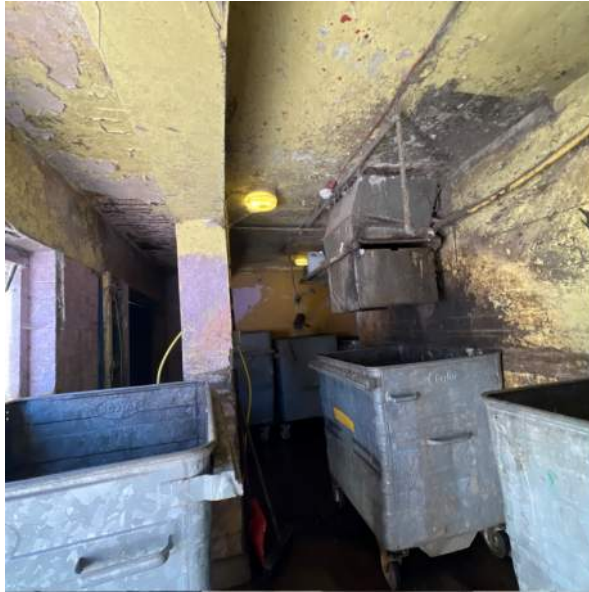
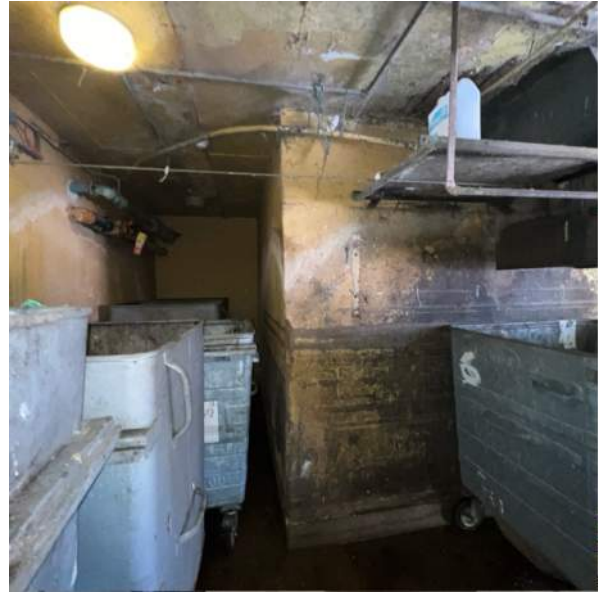
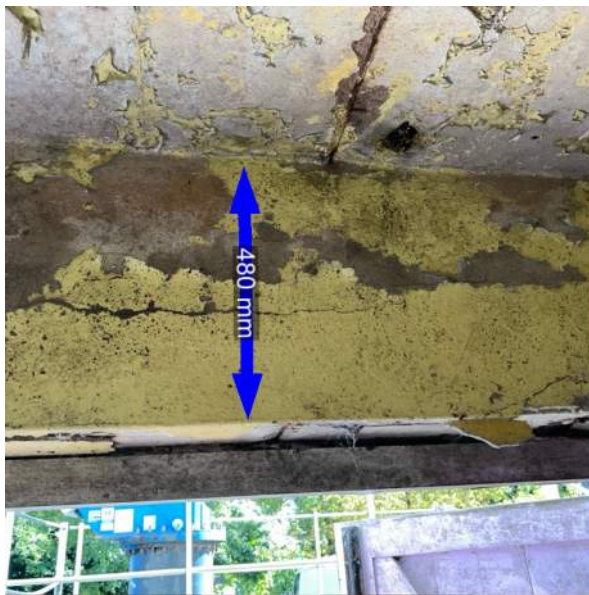
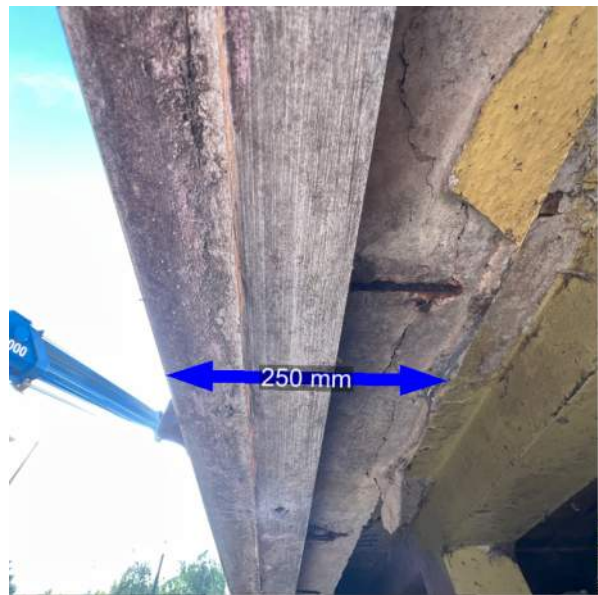
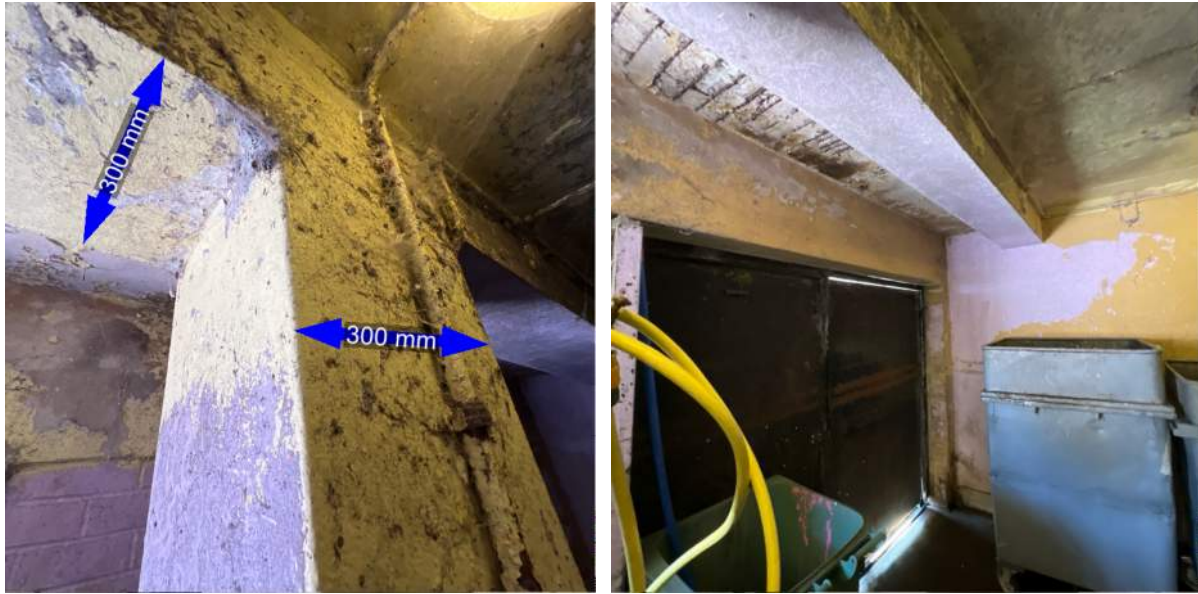
## Binstore

RC shear walls, columns and beams noted in binstore.

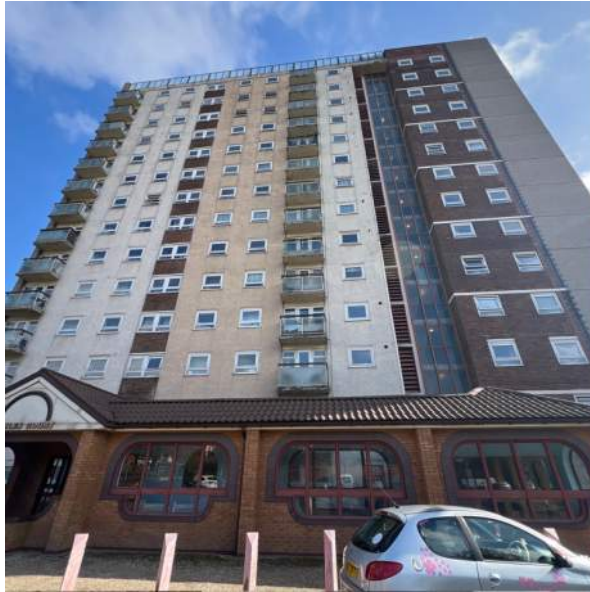
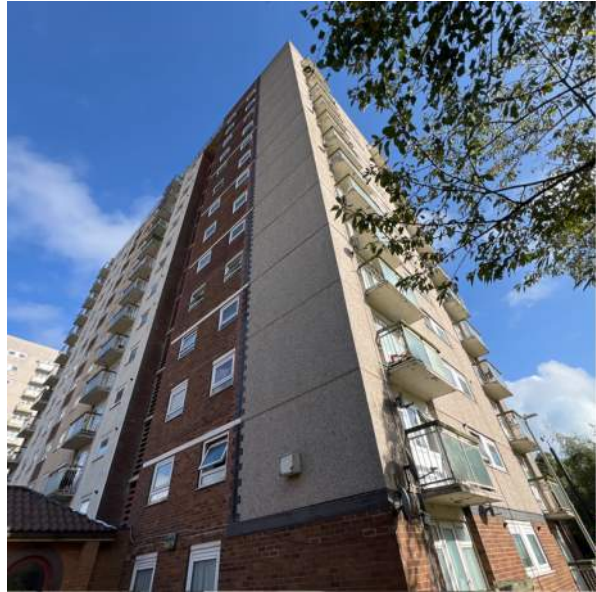
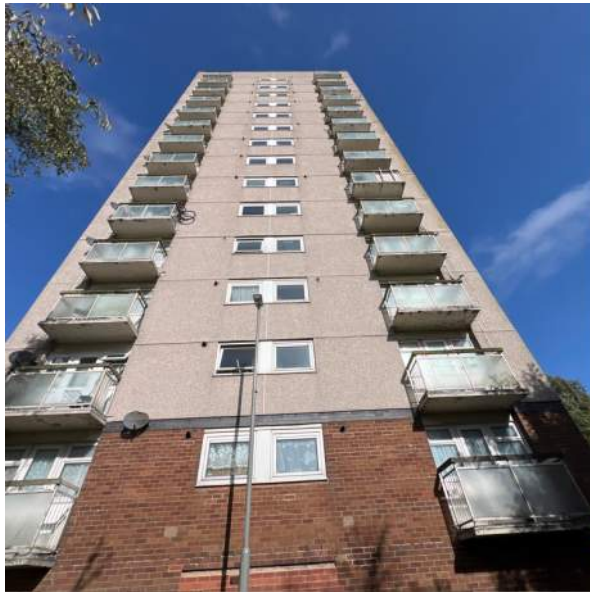
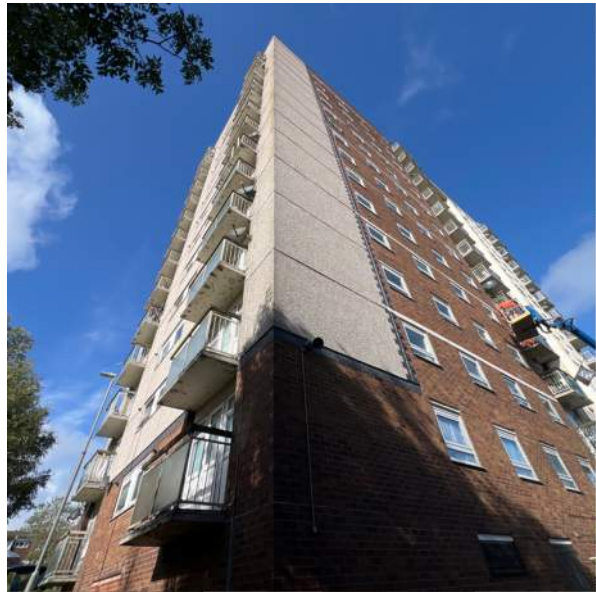
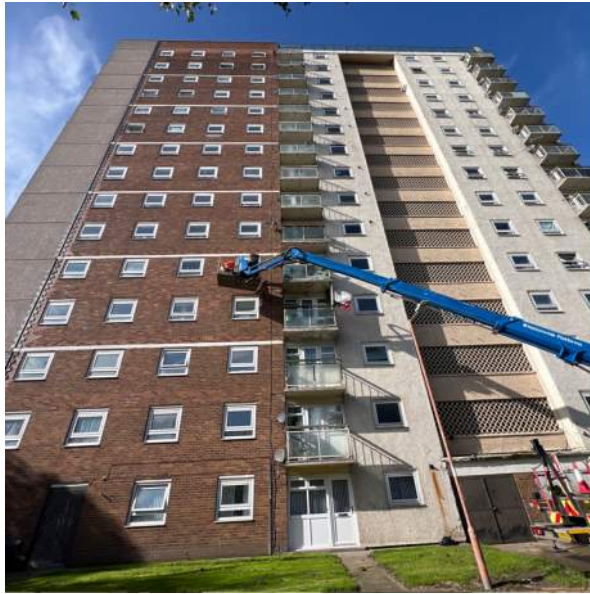
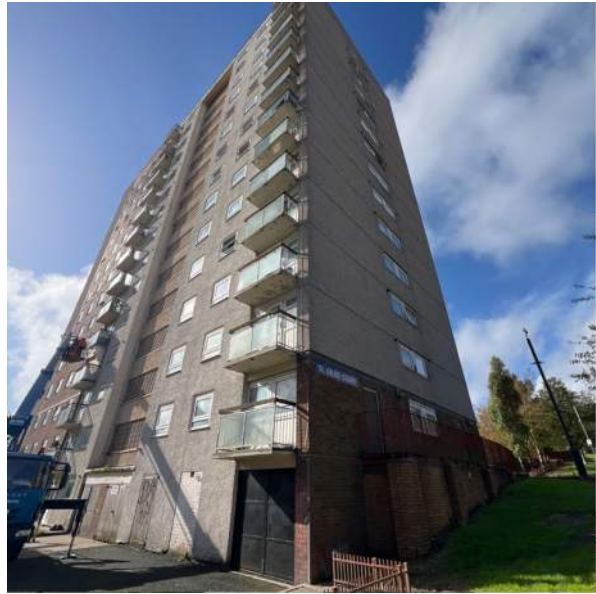
## Elevations

External facade consists of brickwork and render. Brickwork supported via floor slab at each level.
