VISUAL STRUCTURAL APPRAISAL

St Marys House

Summer Street  
West Bromwich  
B71 4HZ

31<sup>st</sup> July 2024

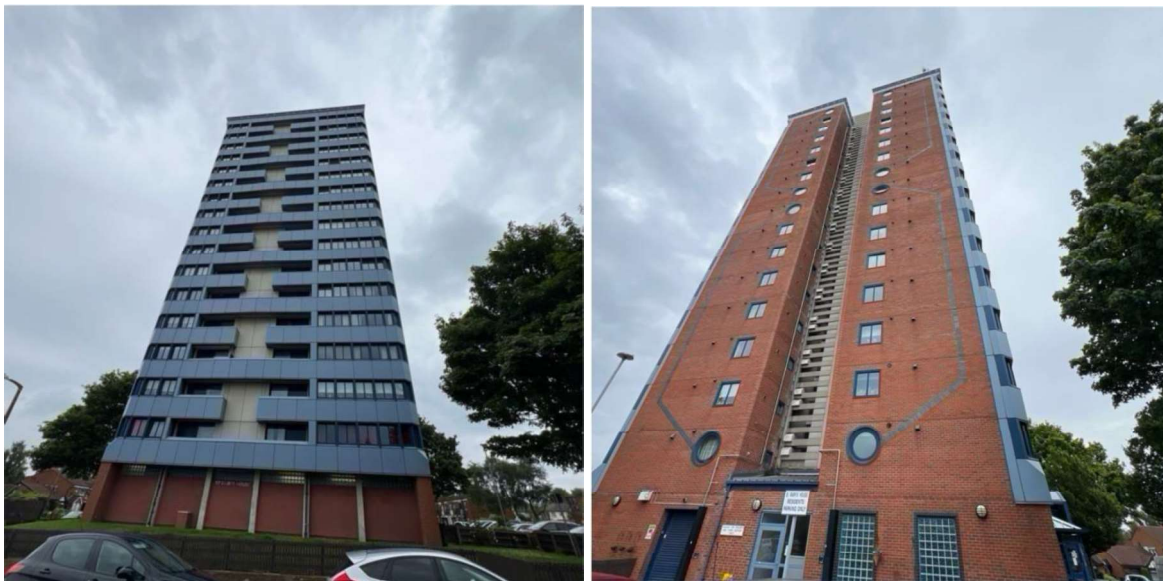
Figure 9 and 10: Front and side Elevations

The exterior elevations were generally in ok condition and no significant structural defects were noted to the cladding panels. There were no significant cracks or tell-tale signs of any significant structural movement noted at the time of our inspection.

The external cladding system is formed of a mix of aluminium panels, brickwork and concrete panels along stair core. The fire risk assessment states that all elements of the cladding have a fire rating A1.

The exterior panels were noted to be plumb with no signs of significant bowing, bulging or leaning noted to the panels indicating failed fixings however their presence and condition cannot be confirmed.

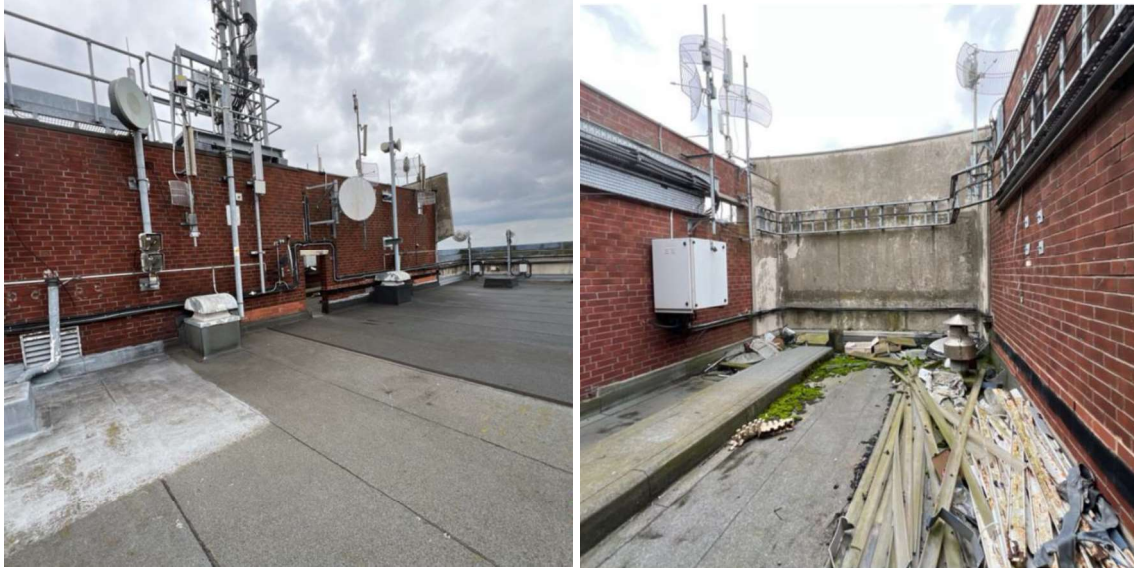
Figure 11 and 12: Roof level enclosure and debris

The roof has a felt finish. The exact build-up of the roof finishes were not accessible at the time of inspection. It is recommended an intrusive survey of the roof finishes is completed by a specialist surveyor to assess the condition of the roof covering.

There was moss growth and build-ups of debris noted which should be cleared as part of a normal maintenance regimen

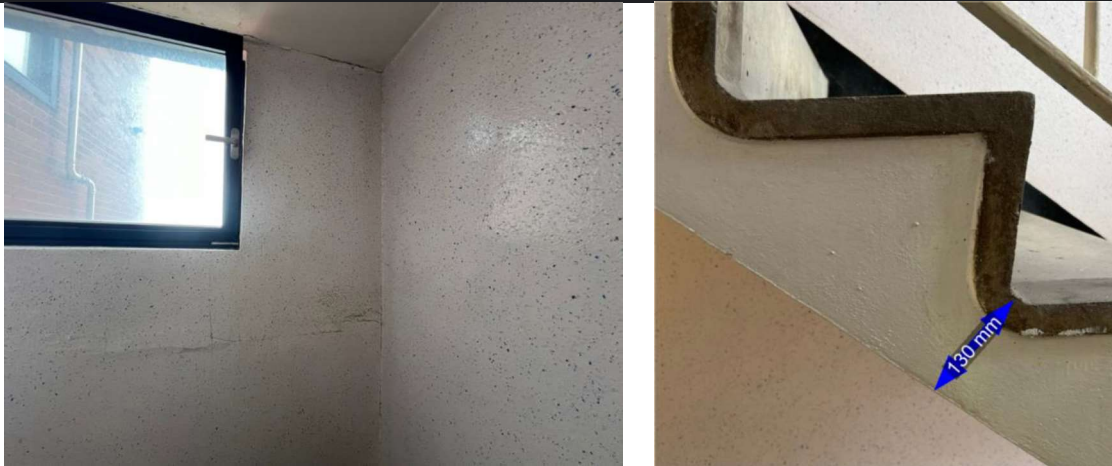
Figure 13 and 14: BRE 1 crack within stair core and staircase

The interior of the stair core walls were checked and were plumb and in line with observations made to the exterior – no significant signs of leaning or movement noted. There is a vertical crack (BRE Category 1 crack) noted to finishes in staircase between main stair wall and external wall joint. The vertical crack was noted in the staircase to the finishes noted on most levels. Cracking is likely to indicate some thermal movement and does not appear to be structurally significant in its current state. The crack is advised to be monitored and checked in future inspections.

The stair stringer was noted to be 130mm thick which is less than we would expect to modern standards, a cover test is required to check the resistance of the concrete section in the event of a fire.

Due to the age of the building it is wise to perform periodical health checks to the concrete elements. This should include tests for concrete strength, cover depth, carbonation, chlorides and HAC. It would appear that these tests have never been performed to this building and therefore we recommend engaging a specialist contractor within the next 24 months who will be able to perform the tests and provide a interpretive report. The cover tests will also provide information on the fire resistance of the structural frame and the staircase stringer.

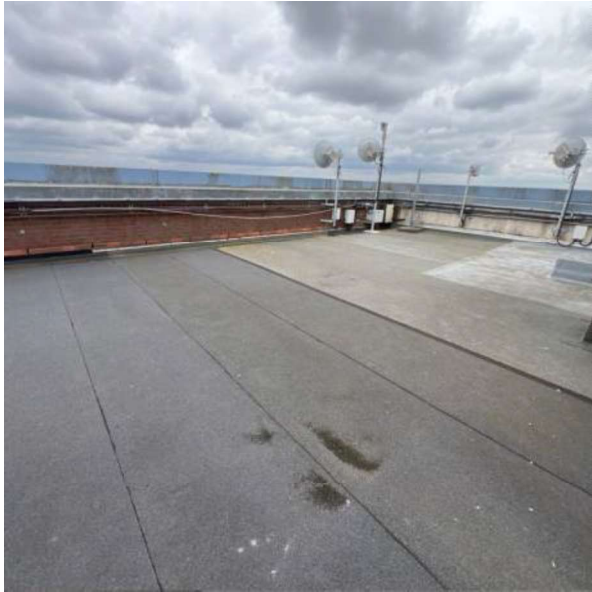
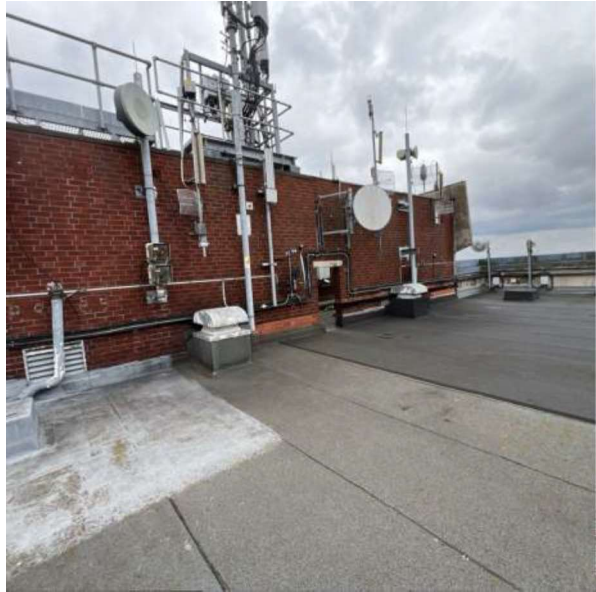
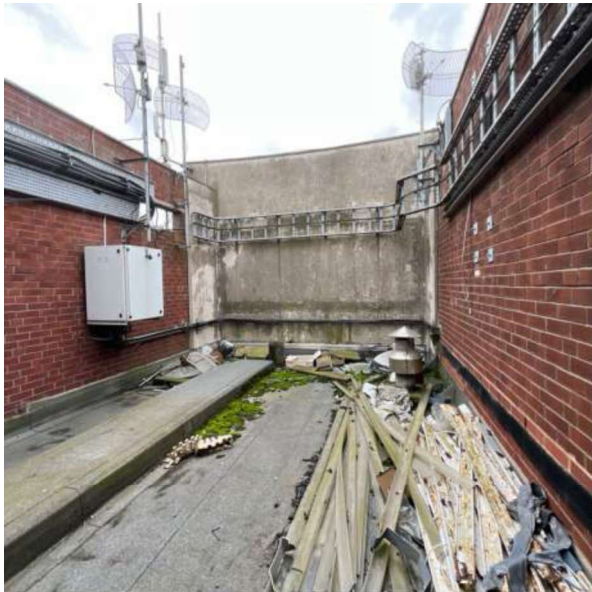
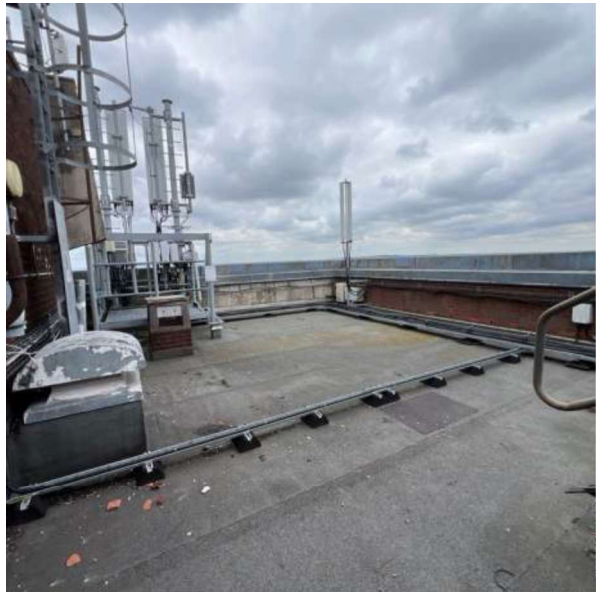
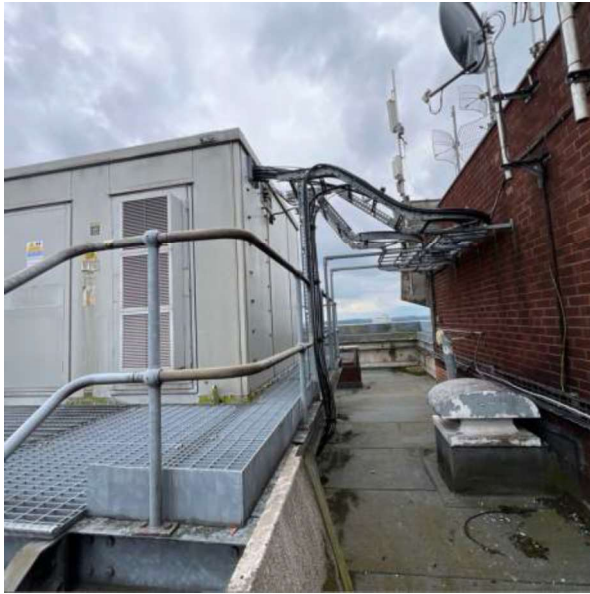
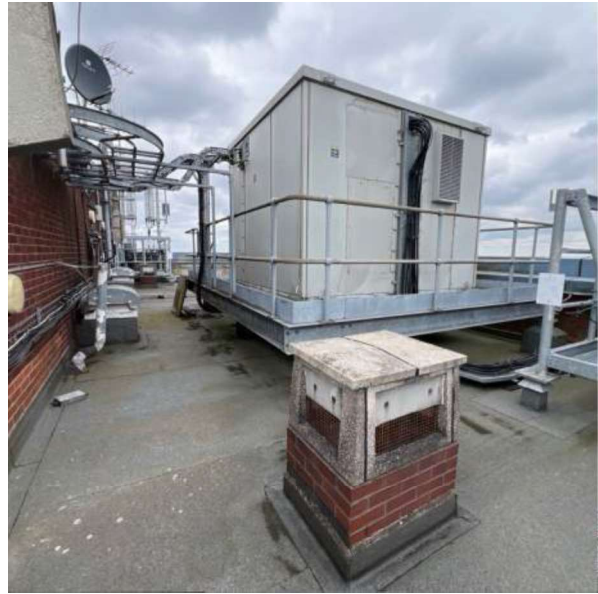
## Main Roof

Lift motor room located on roof formed of masonry walls.  
Parapet walls noted to perimeter of roof.  
Insitu concrete roof slab with insulated PIR Boad and felt roof coverings.

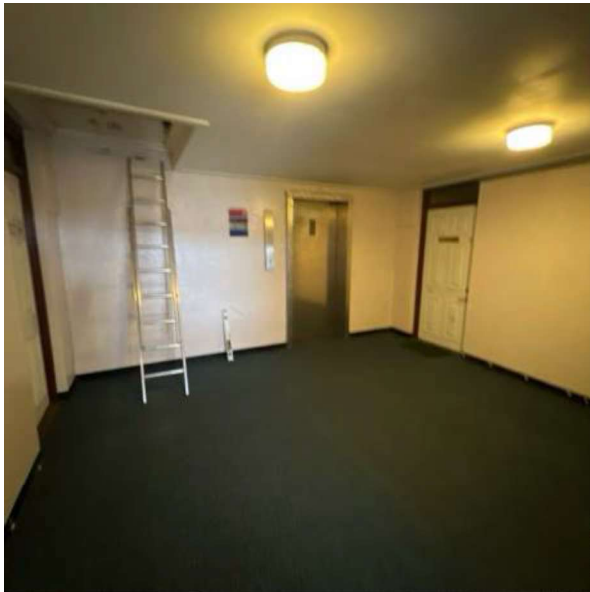
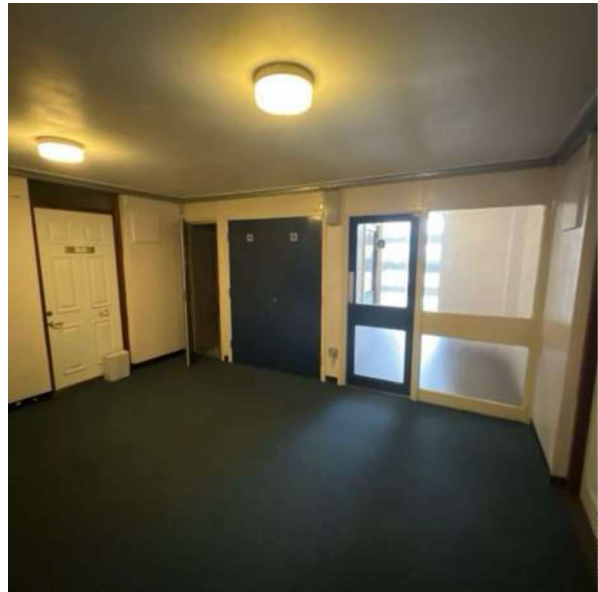
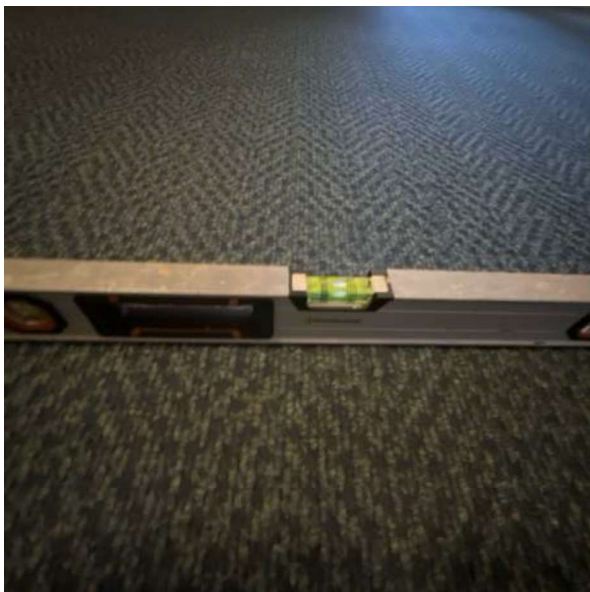
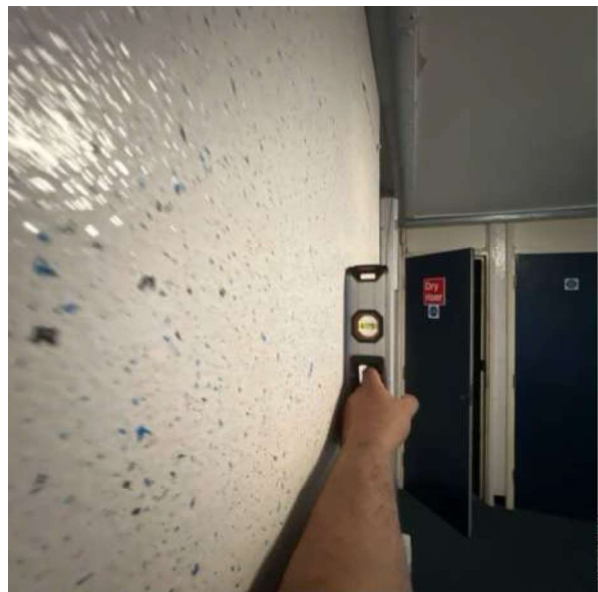
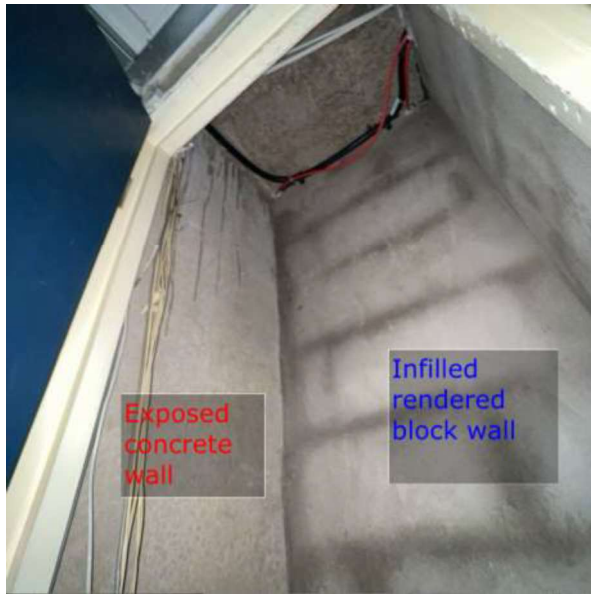
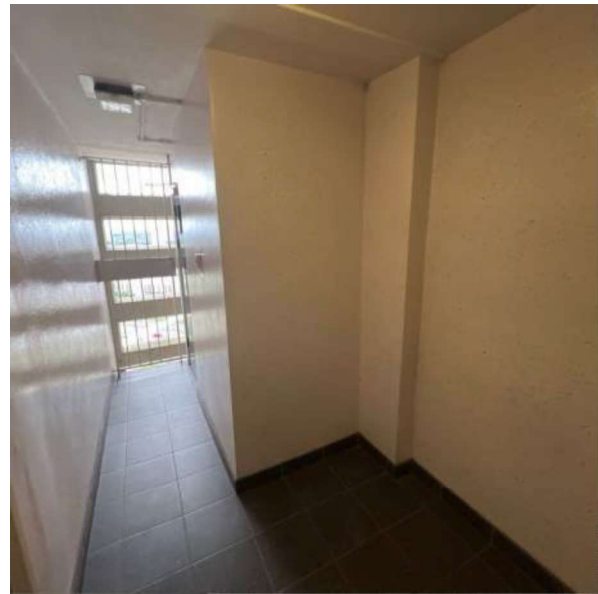
## 16th Floor Hallway

Comments: No jams or distortions noted to hallway doors to indicate any serviceability issues. Generally walls covered with finishes in hallway, likely to consist a mixture of concrete shear walls, embedded columns and block infill walls. Electrical cabinet shows infill blockwork with render on top. Dry riser cupboard shows some exposed concrete (likely forms part of the staircase shear wall).

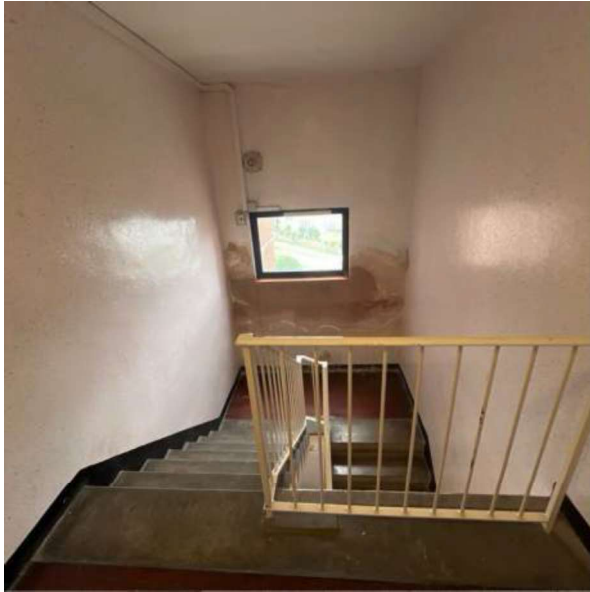
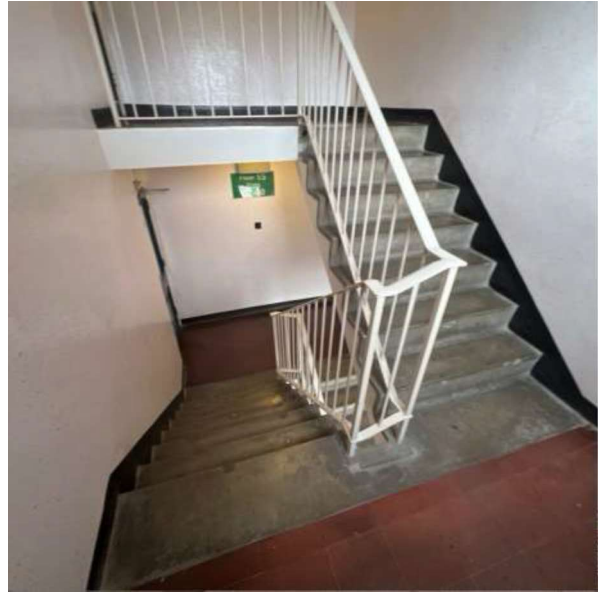
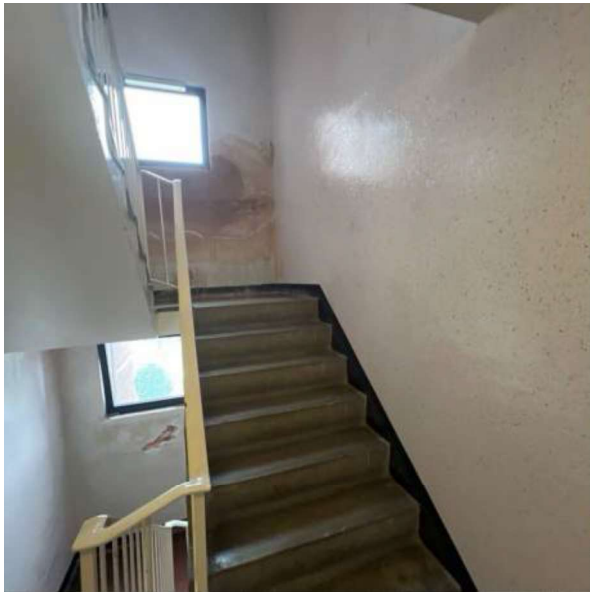
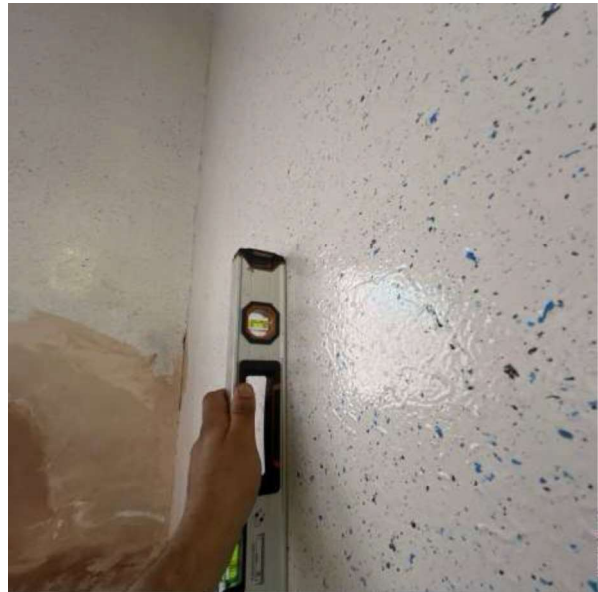
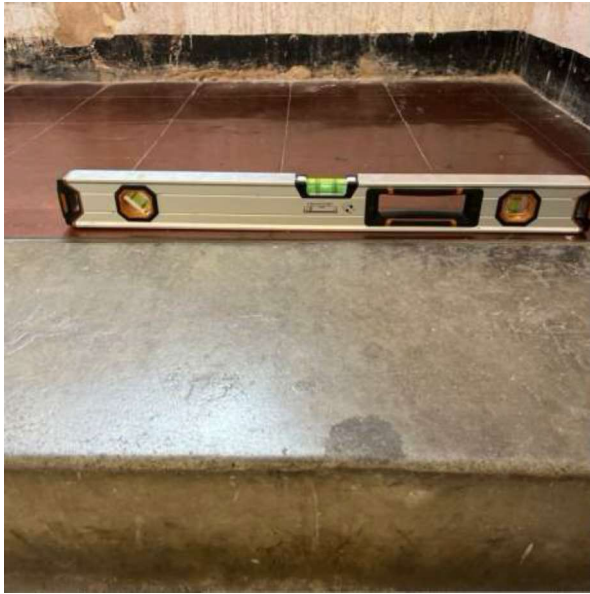
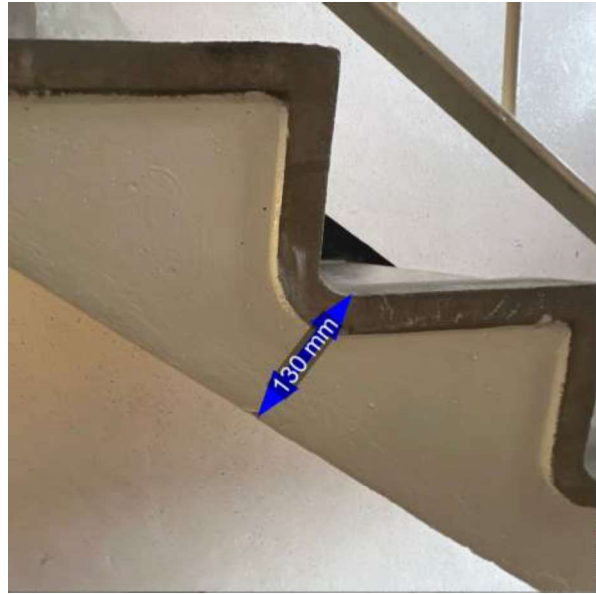
## 16th Floor Staircase

In situ concrete stairs with steel hand railing fixed to stairs. Walls and floors appear to be fairly level.

Floor slab measures from stair platform appears to be approx. 220mm thick.

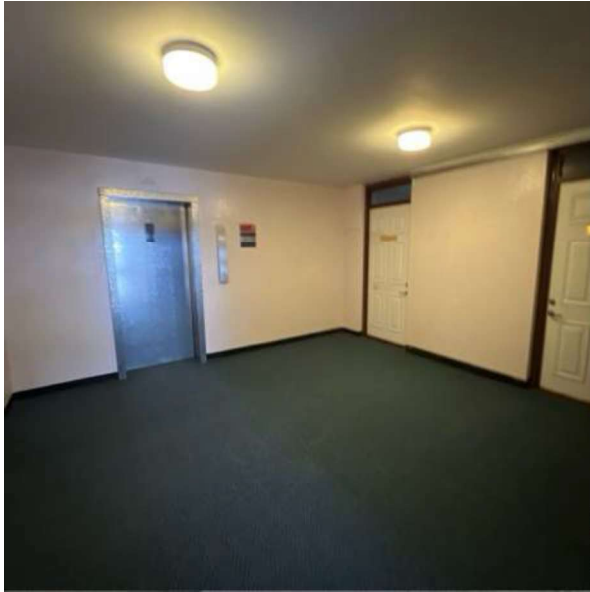
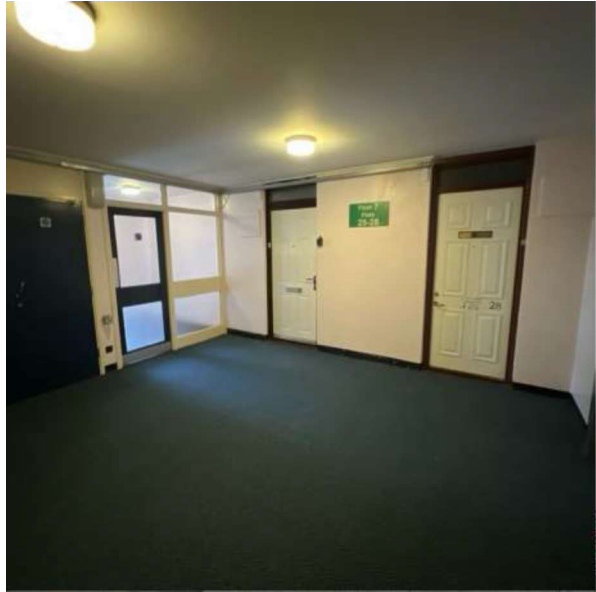
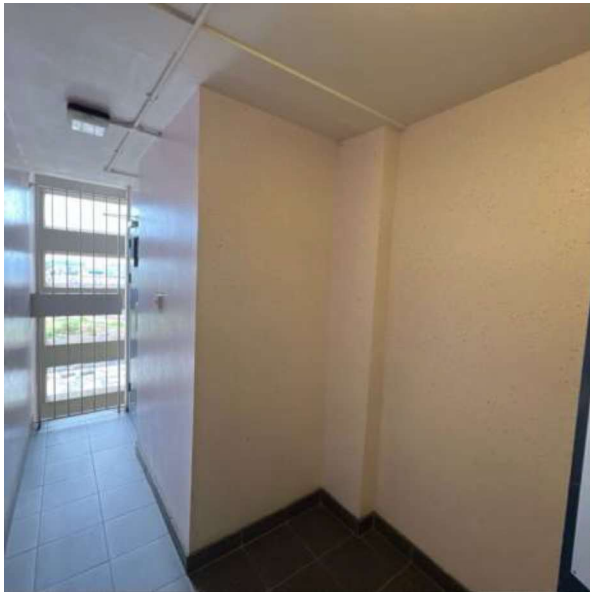
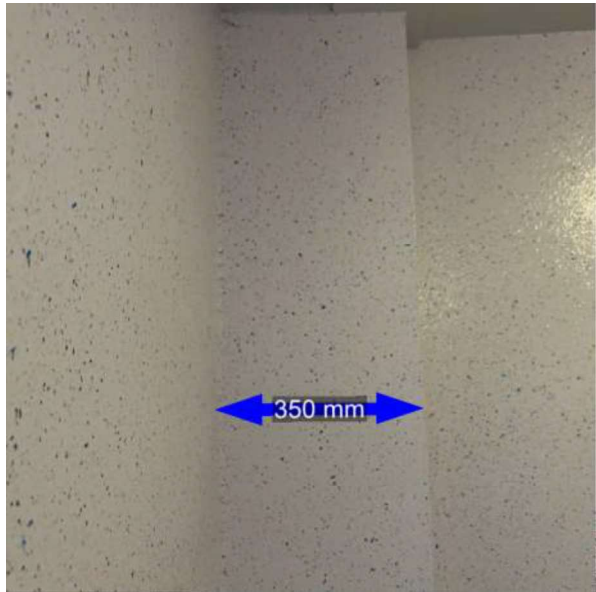
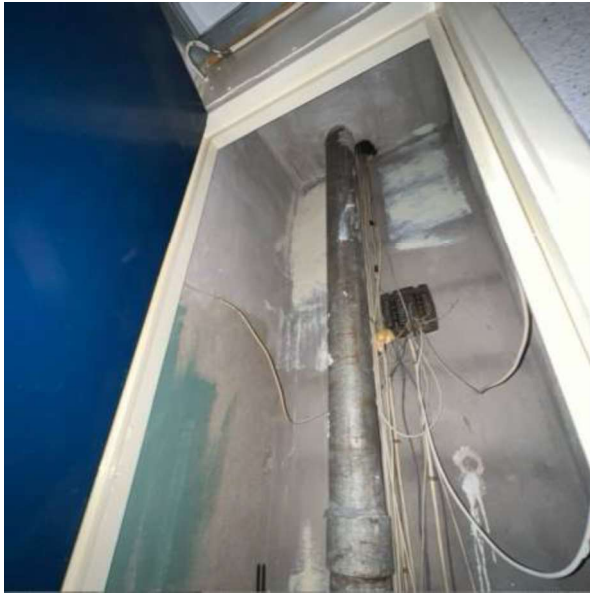
## 8th Floor Hallway

Comments: No jams or distortions noted to hallway doors to indicate any serviceability issues.  
Generally walls covered with finishes in hallway, likely to consist a mixture of concrete shear walls, embedded columns and block infill walls.  
Electrical cabinet shows infill blockwork with render.  
Dry riser cupboard shows exposed concrete likely to form part of stair shear core wall.

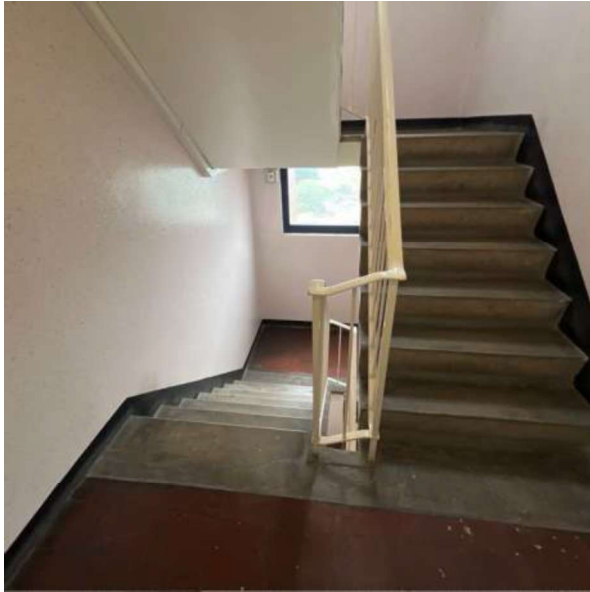
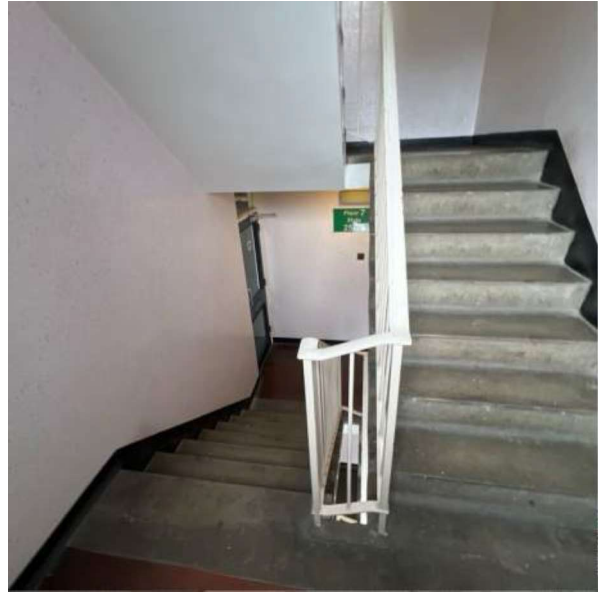
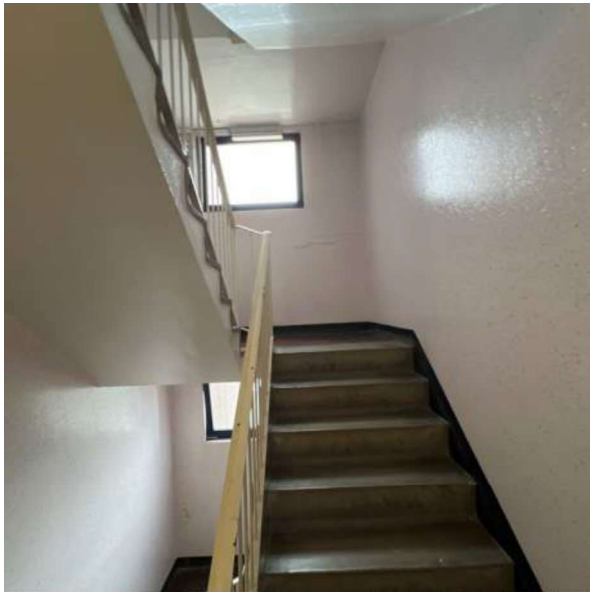
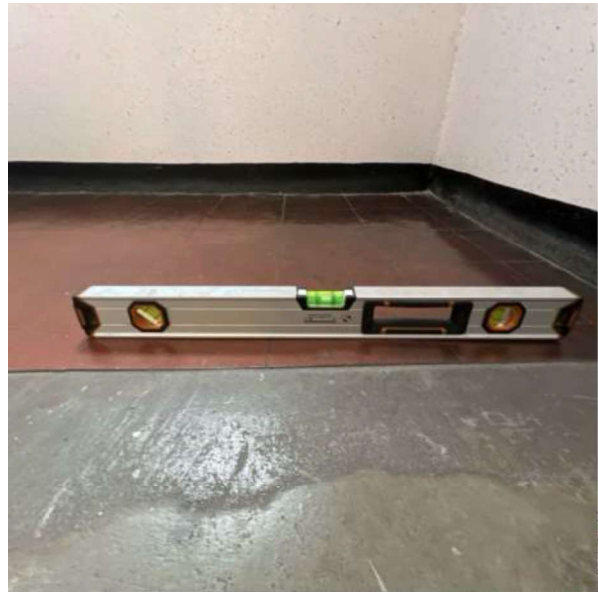
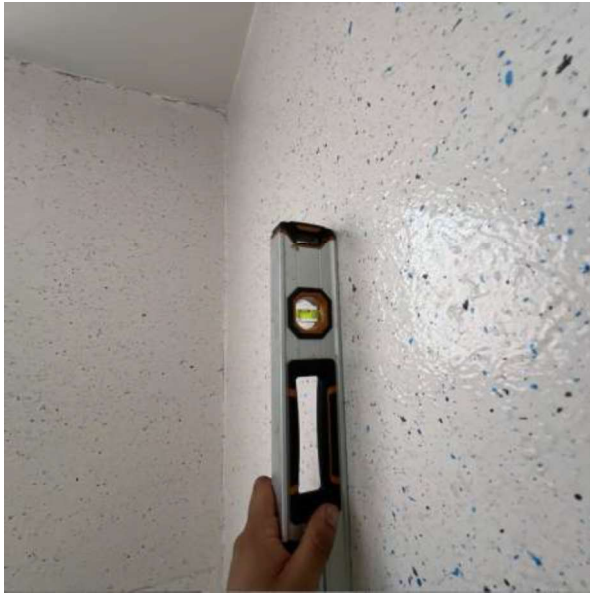
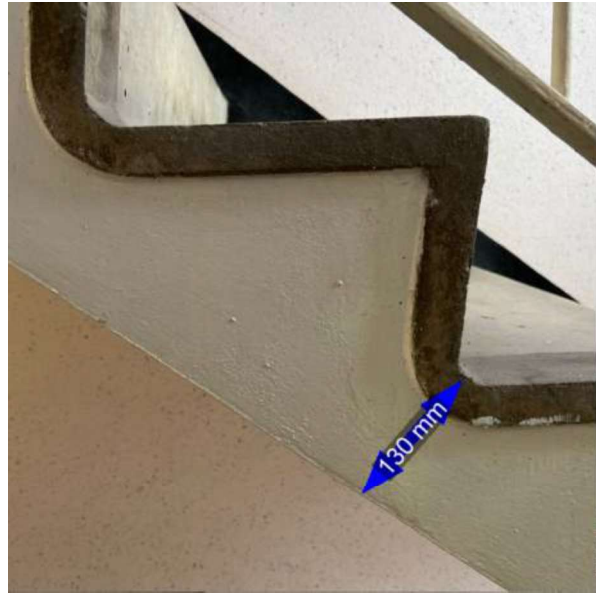
## 8th Floor Staircase

Insitu concrete stairs with steel hand railing fixed to stairs. Walls and floors appear to be fairly level.

Floor slab measured from stair landing platform appears to be approx. 220mm thick.

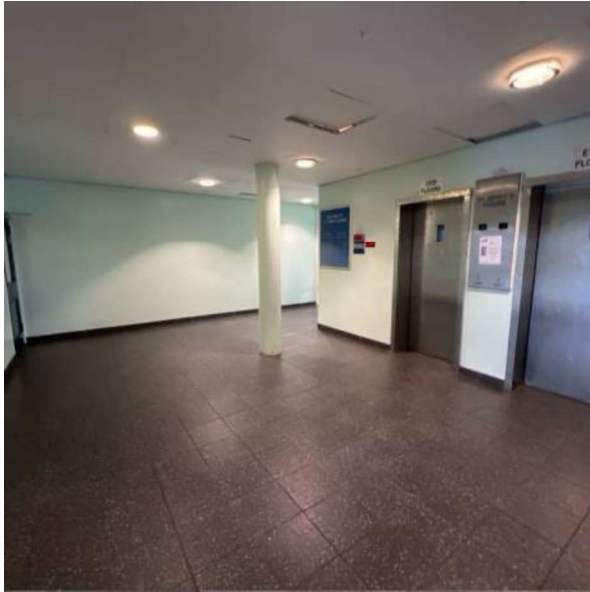
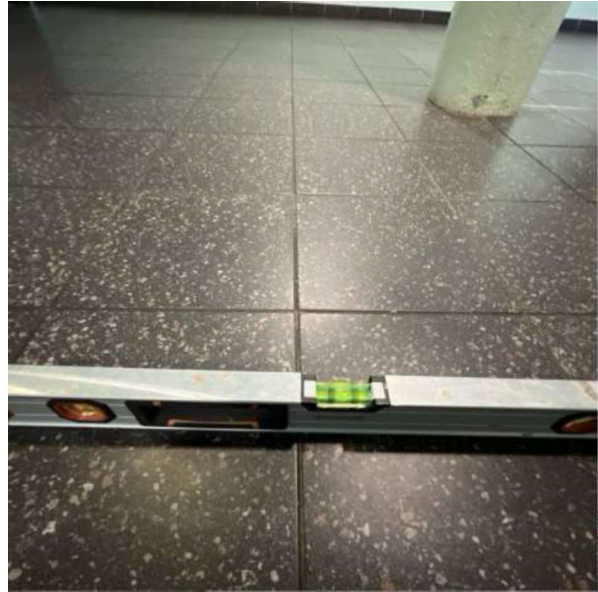
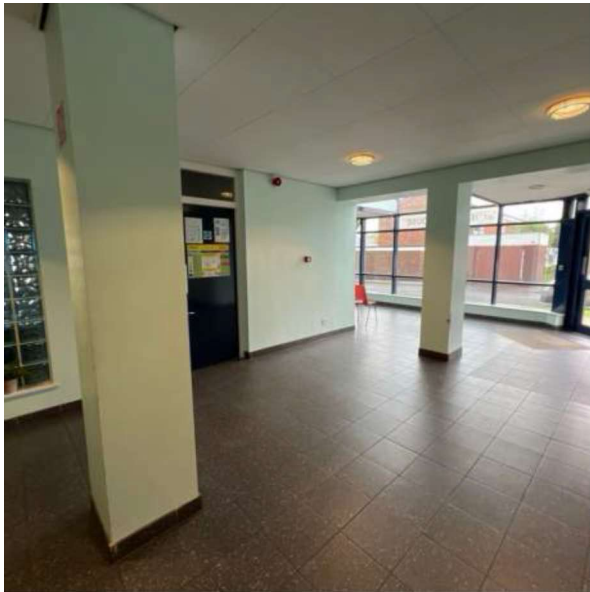
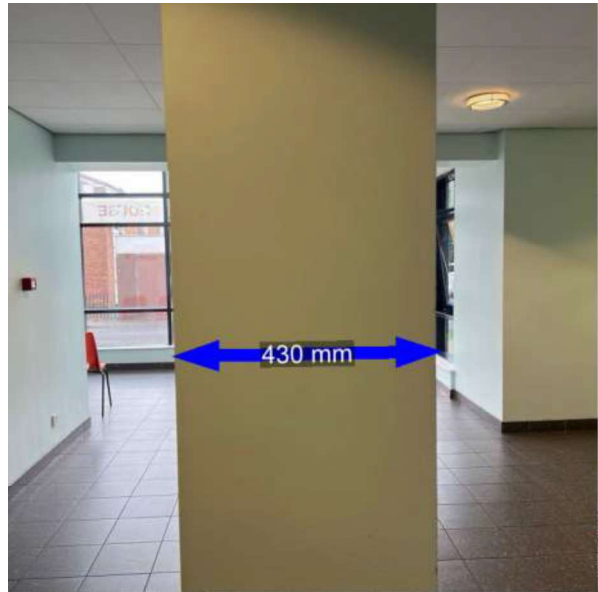
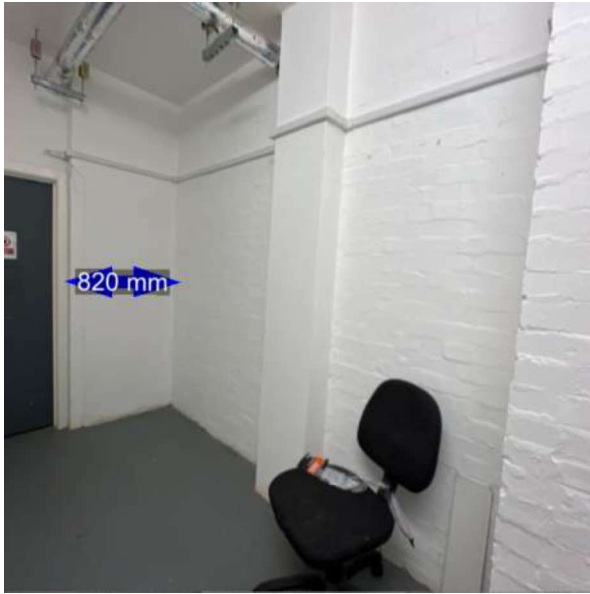
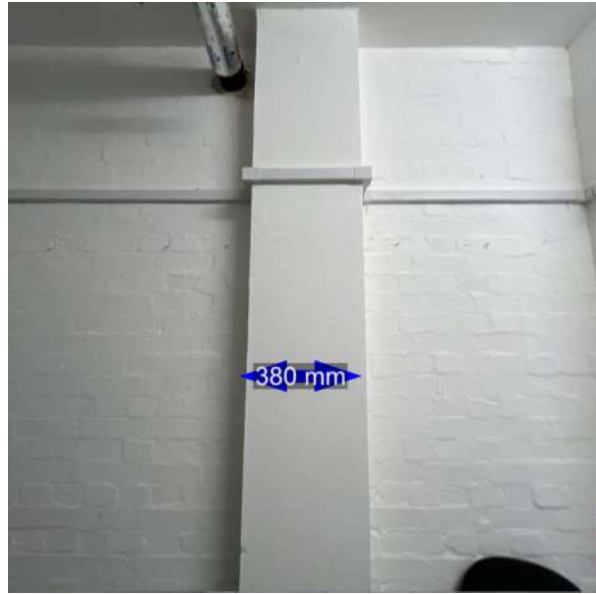
## Ground Floor Hallway

Comments: No jams or distortions noted to hallway doors to indicate any serviceability issues. Generally walls covered with finishes in hallway, likely to consist a mixture of concrete shear walls, embedded columns and block infill walls. RC Concrete Shear Core wall of lift visibly noted from riser cupboard and meterage room. Other internal main walls noted to solid concrete walls, these are likely to be shear core walls forming part of the primary structural elements.

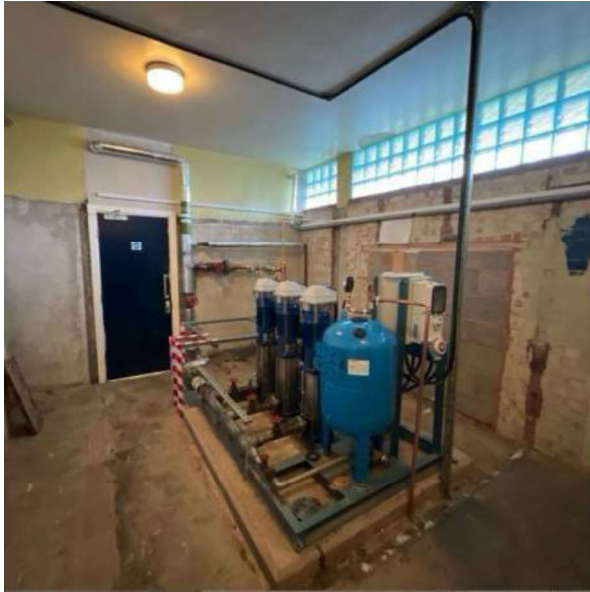
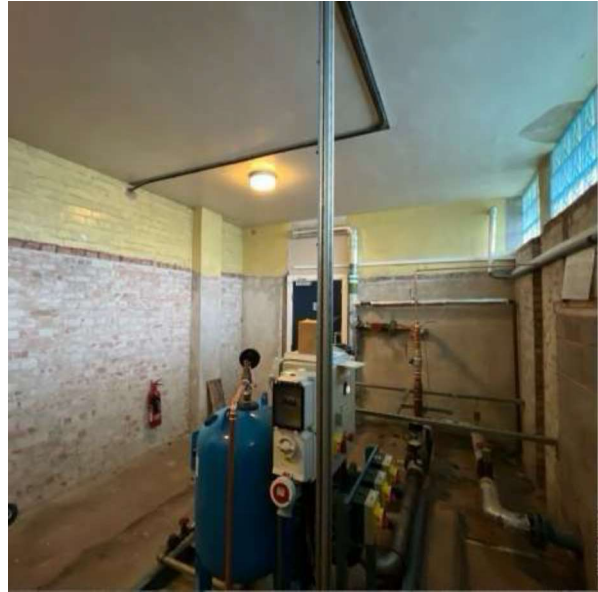
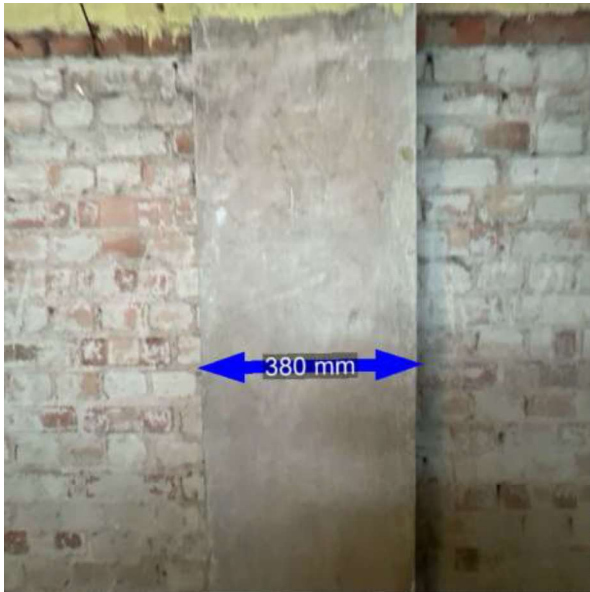
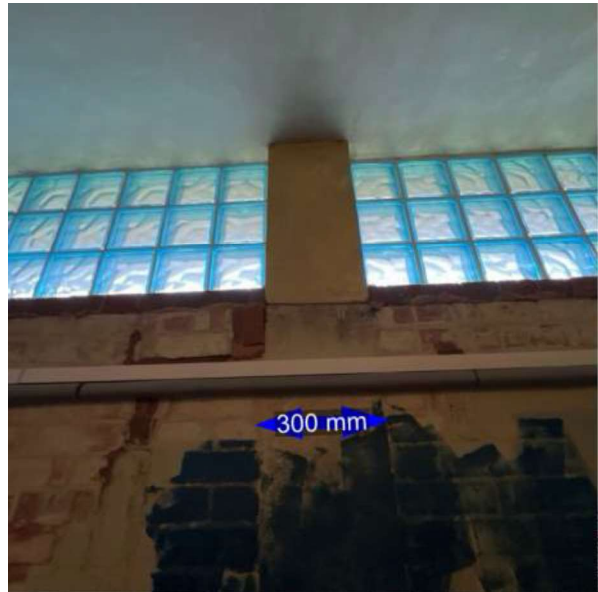
## Pump Room

Comments: Exposed internal columns (380mm wide) and external perimeter columns (300mm wide) noted.  
Infill masonry walls (non-load bearing) between columns.

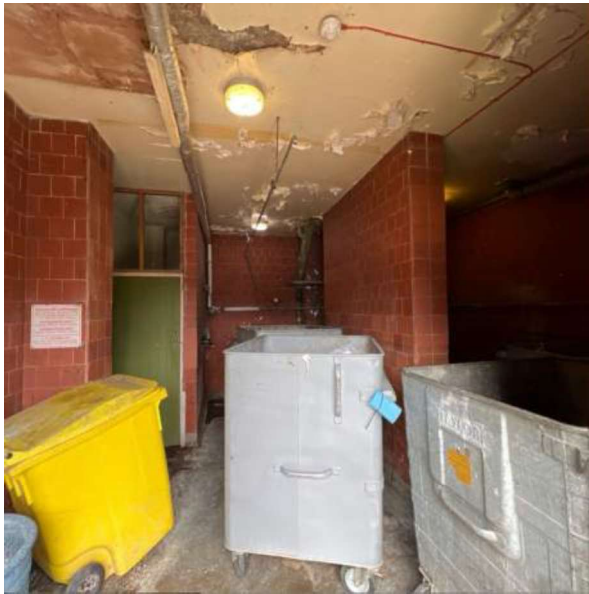
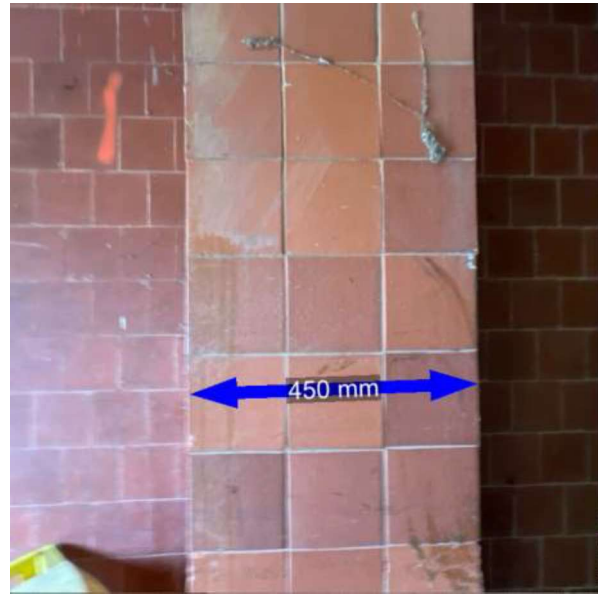
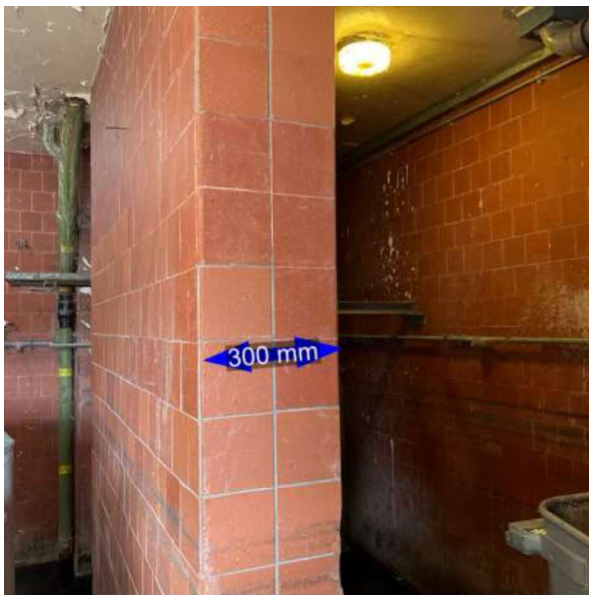
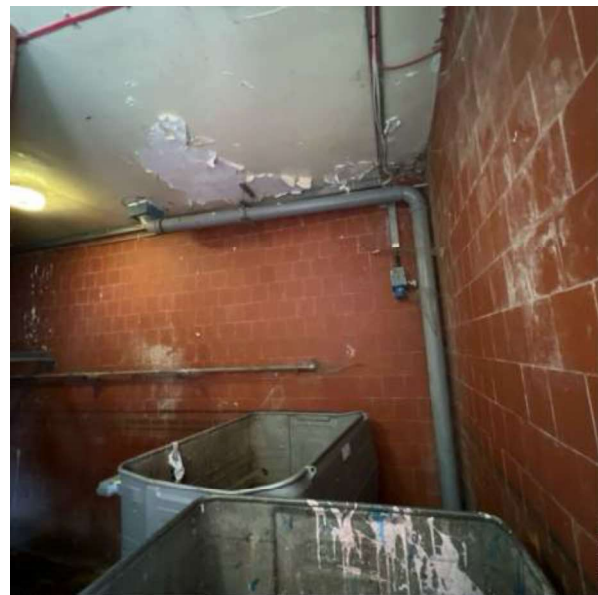
## Bin Store

Comments: Concrete elements mainly covered with tiles. Shear concrete walls (300mm wide including finishes) and embedded concrete columns (approx. 300mm wide) noted in bin store and storage areas. Concrete infill (non-load bearing walls) noted.

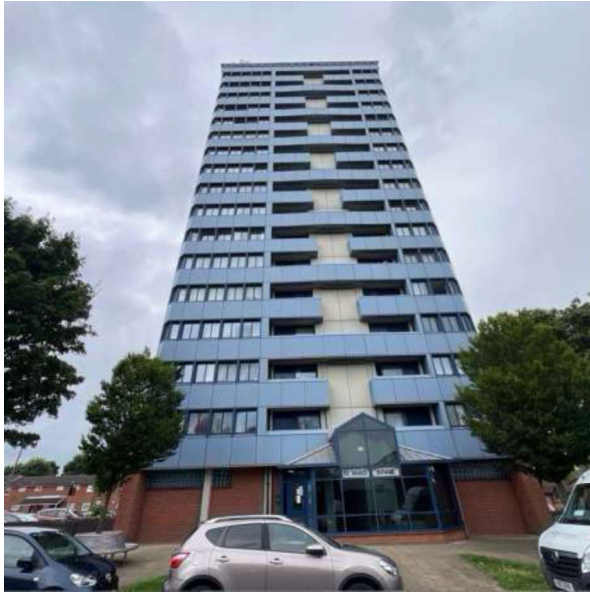
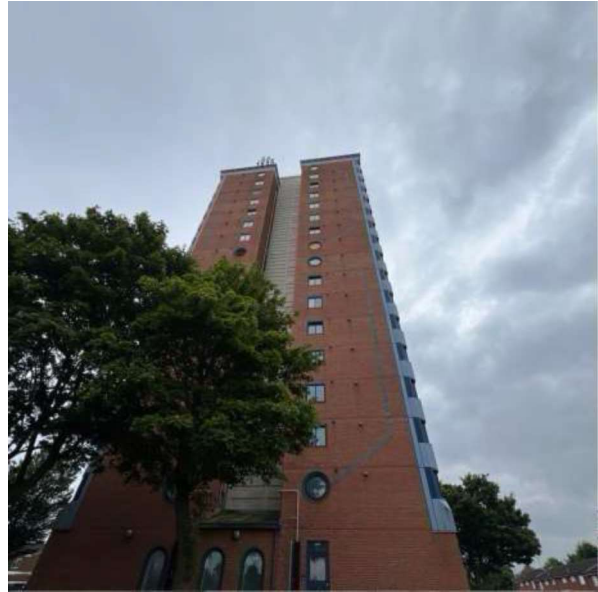
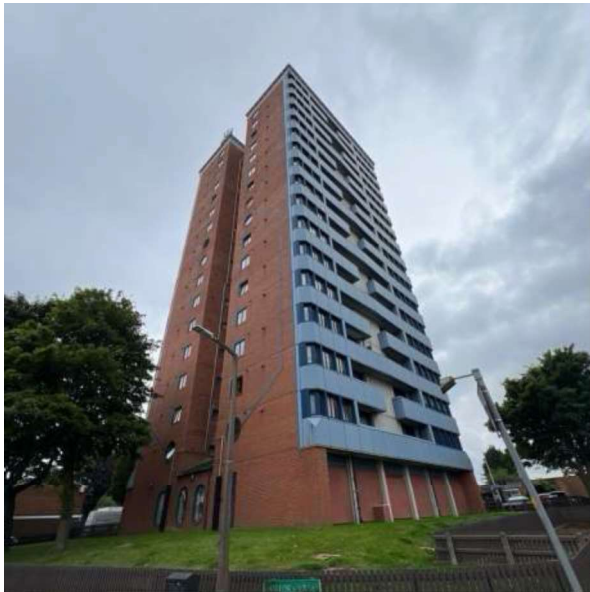
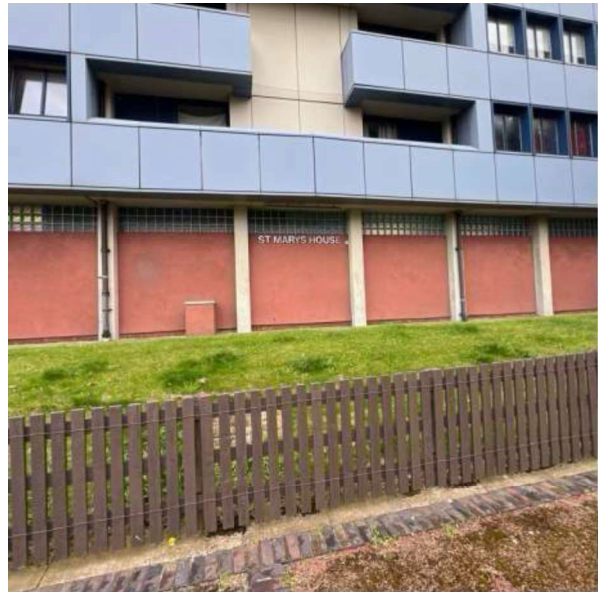
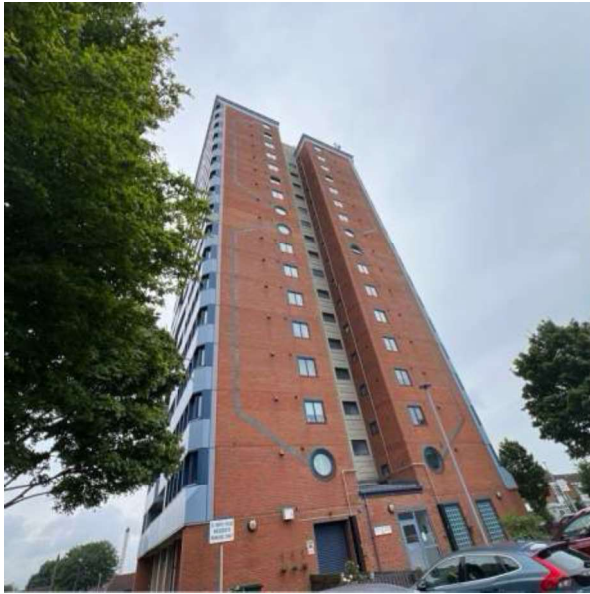
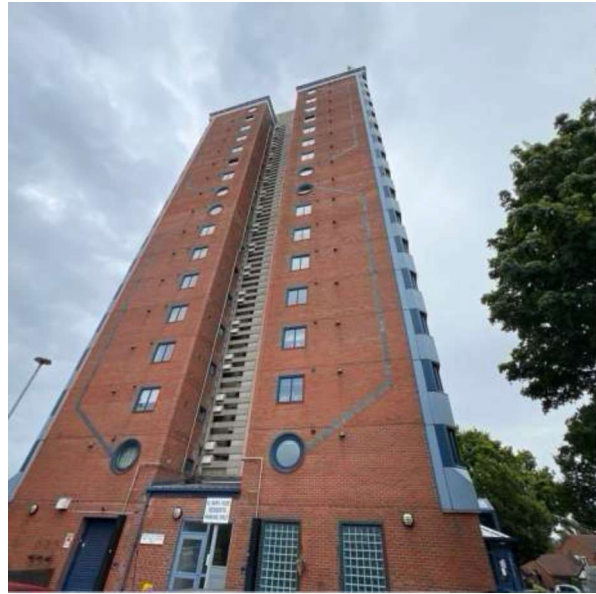
## Elevations

Two faces of exterior formed of brickwork facade whilst the other two faces have a cladded facade. Balconies inset to cladding.  
Concrete columns (300mm wide) noted to perimeter which form part of the primary structural elements of the building.  
Staircase exterior appears to have a concrete panel facade feature.
