VISUAL STRUCTURAL APPRAISAL

Stanton House

Beaconview Road  
West Bromwich  
B71 3PW

26<sup>th</sup> February 2025

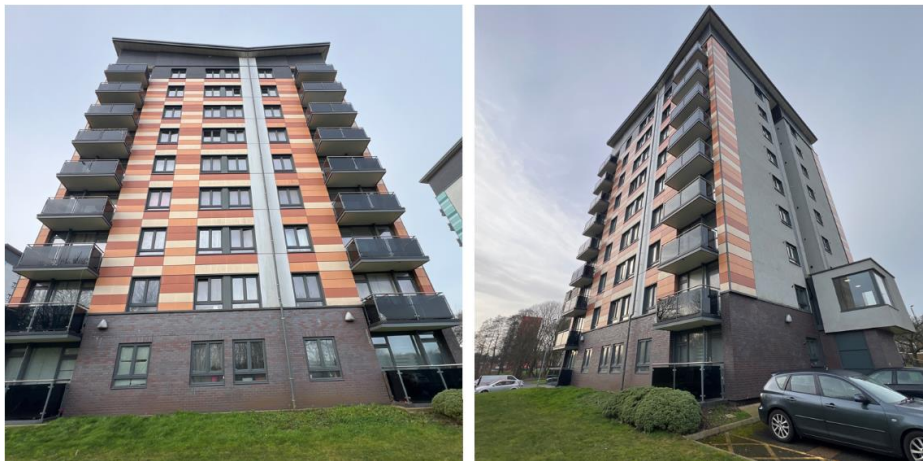
Figure 9 and 10: Building Elevations

The exterior elevations were generally in ok condition and no significant structural defects were noted to the cladding panels. There were no significant cracks or tell-tale signs of any significant structural movement noted at the time of our inspection.

The exterior panels were noted to be plumb with no signs of significant bowing, bulging or leaning noted to the panels indicating failed fixings however their presence and condition cannot be confirmed.

There are balconies at each level which are formed of cantilevered RC slabs tied into the main frame. During the 2015 refurbishment they had steel balustrades with glazed infill installed.

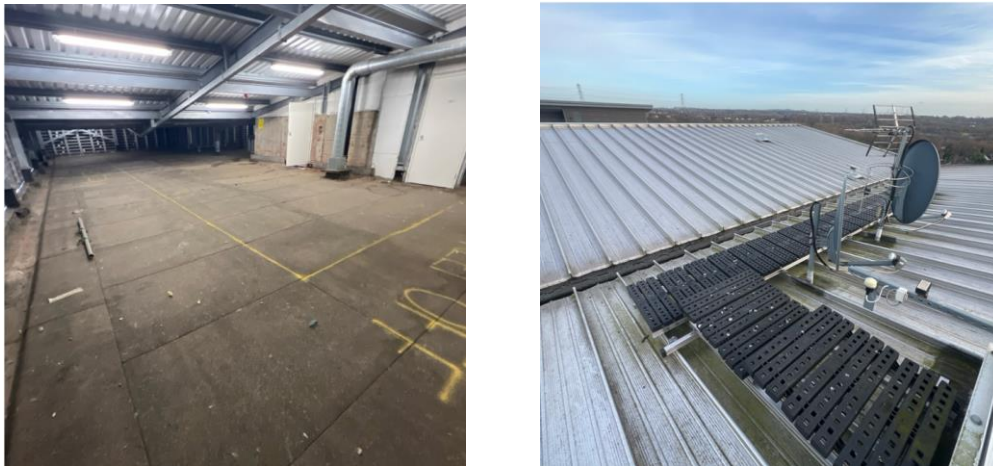
Figure 11 and 12: Roof Level

There were no tell-tale signs of any significant structural movement noted at the time of our inspection. The exterior walls were noted to be plumb with no signs of significant bowing, bulging or leaning noted to the masonry walls.

The roof has subsequently been covered with a new waterproofing covering formed of a steel frame installed to the existing roof which supports pitched corrugated sheets. This roof is not insulated and therefore acts purely as a weather barrier. The fire protection of the steel is unclear as the beams do not appear to be unprotected. Details of this frame should be requested from the contractor who completed the works in 2015. No signs of water ingress of that the roof is not performing as intended.

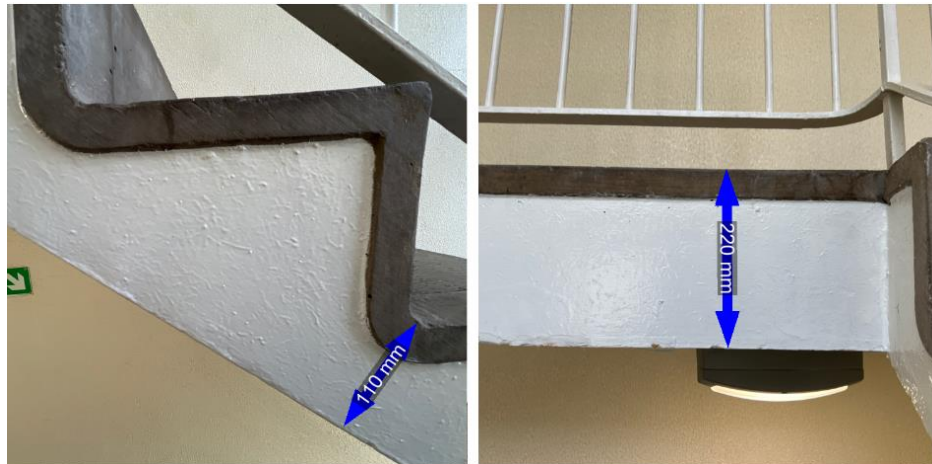
Figure 13 and 14: RC Staircase stringer and slab

The stair stringer was noted to be 110mm thick which seems slim, certainly short of modern standards. A cover test is required to check the resistance of the concrete section in the event of a fire.

Due to the age of the building it is wise to perform periodical health checks to the concrete elements. This should include tests for concrete strength, cover depth, carbonation, chlorides and HAC. It would appear that these tests have never been performed to this building and therefore we recommend engaging a specialist contractor within the next 24 months who will be able to perform the tests and provide a interpretive report. The fire resistance of the structure is not confirmed until the cover meter tests are completed.

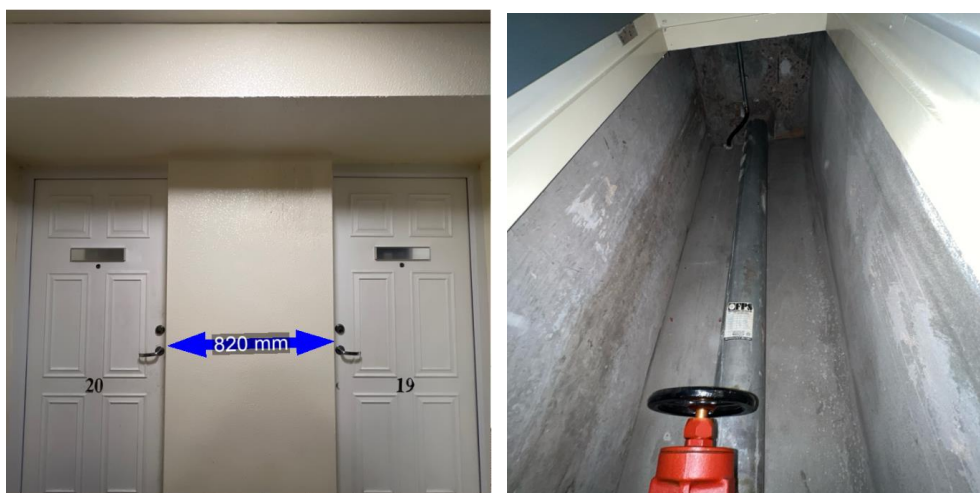
Figure 15 and 16: RC Column at typical level and slab viewed within service cupboard.

The interior of the stair core walls were checked and were plumb and in line with observations made to the exterior – no significant signs of leaning or movement noted. The concrete appeared in fair condition with few BRE category 1 cracks but no structurally significant defects were noted.

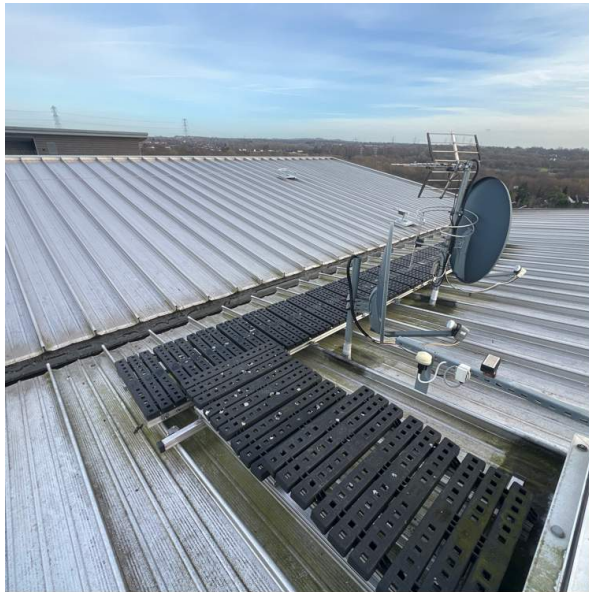
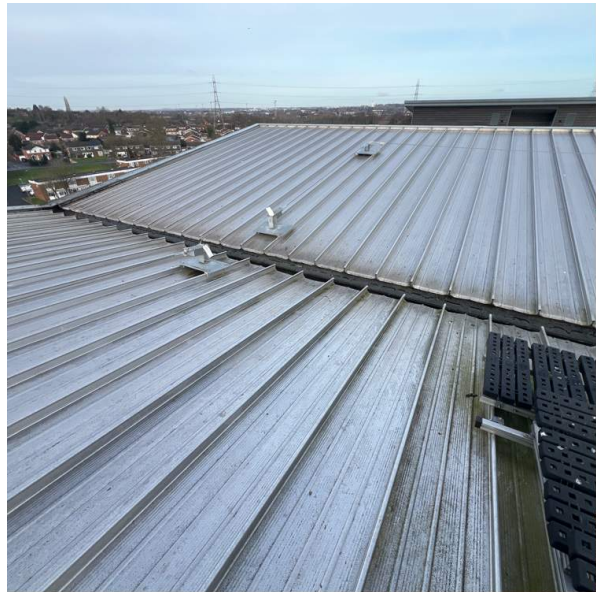
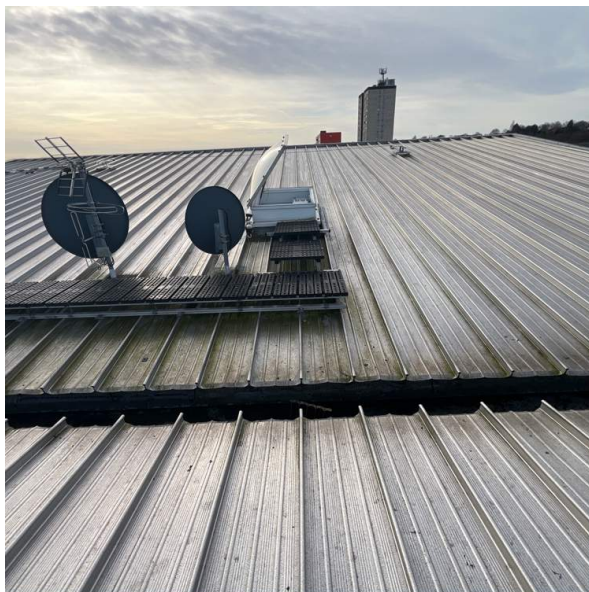
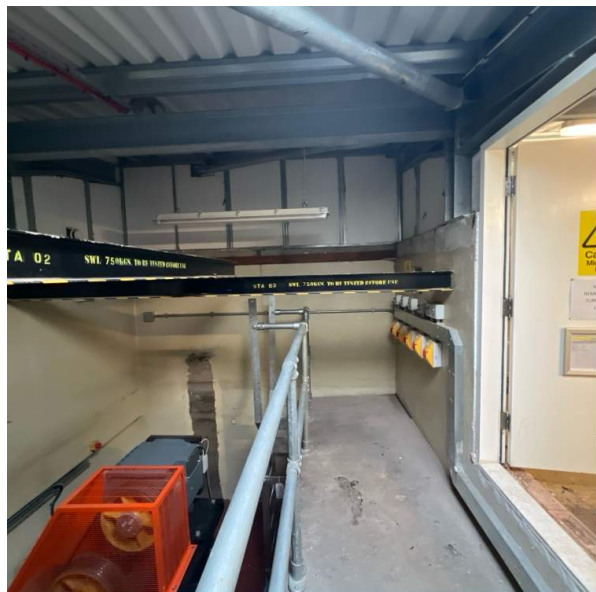
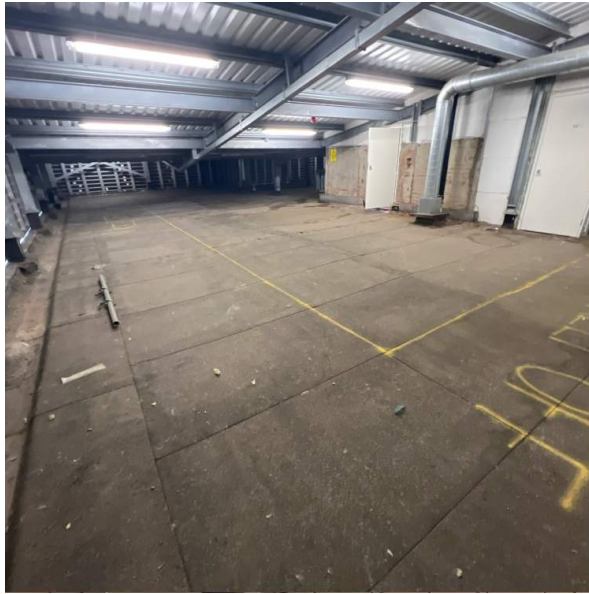
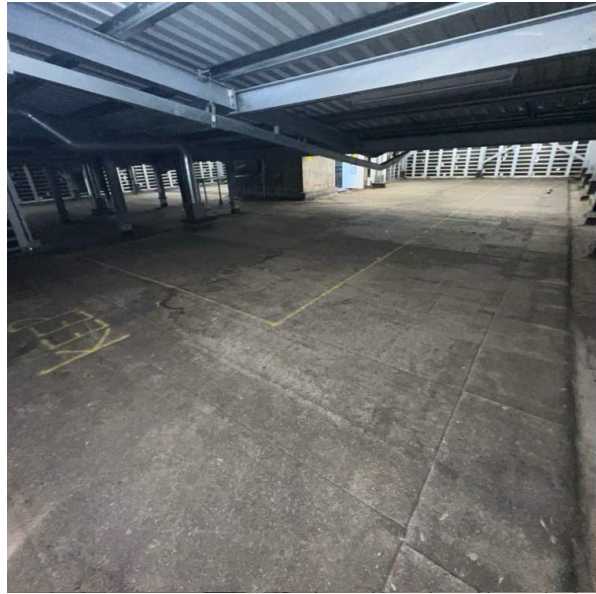
## Main Roof

Comments: A pitched roof constructed above existing original flat roof slab. Steel frame supporting purlins with aluminium standing / mineral wool core profiled panels.  
160mm thick RC core walls noted in motor room.

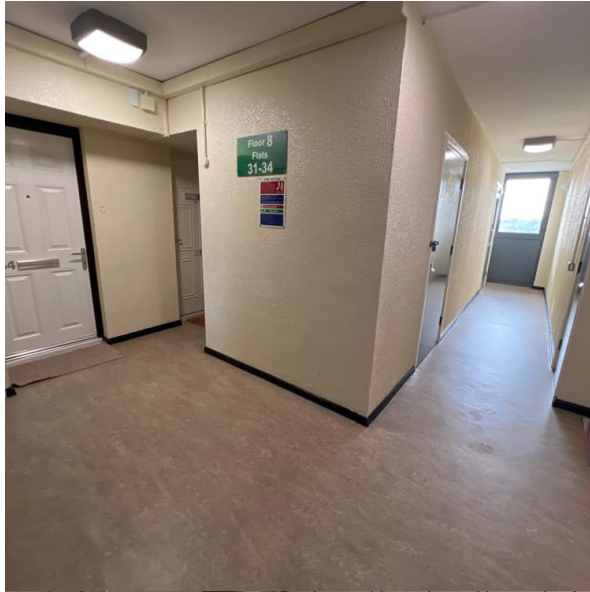
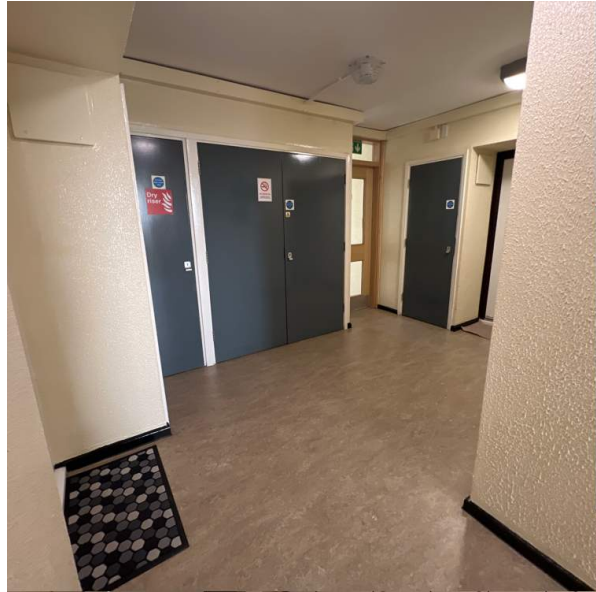
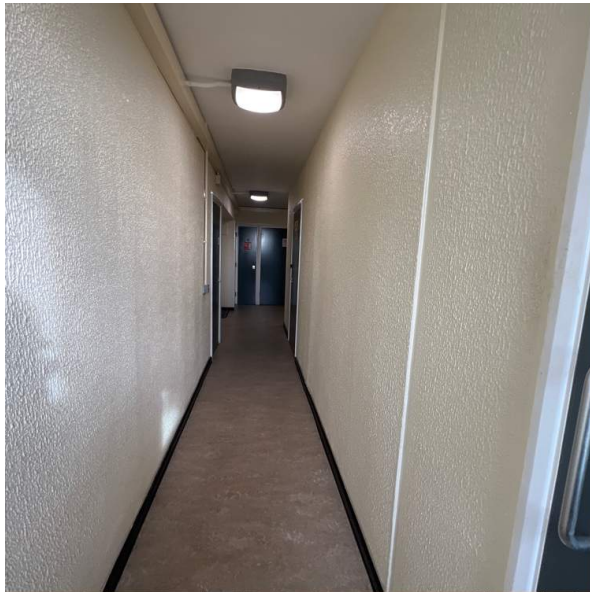
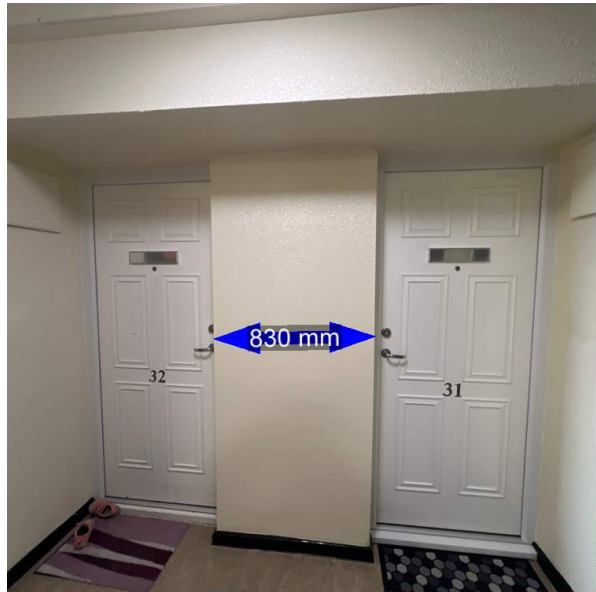
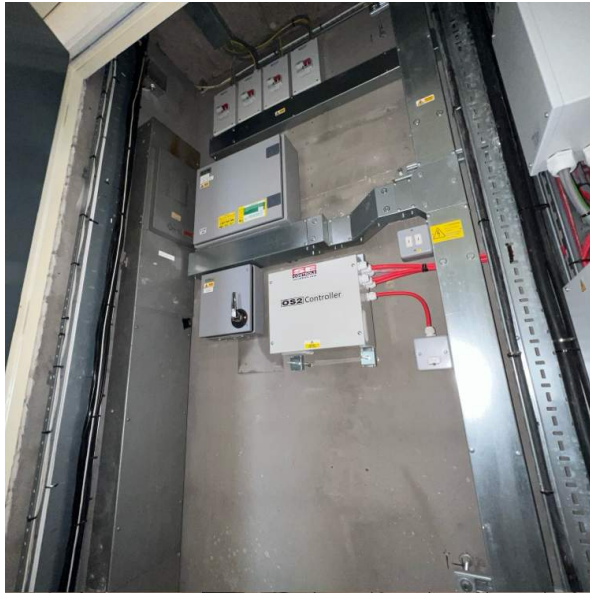
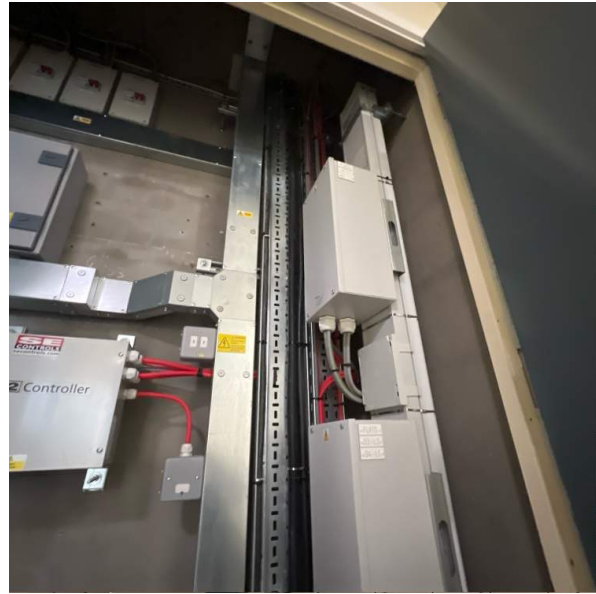
## 8th Floor Hallway

Comments: No jams or distortions noted to hallway doors to indicate any serviceability issues. Generally walls covered with finishes in hallway, likely to consist a mixture of concrete shear walls, embedded columns and masonry infill walls. Limited structure exposed. Concrete walls noted via dry riser cupboards. Electrical cupboard shows block infill walls with plaster.

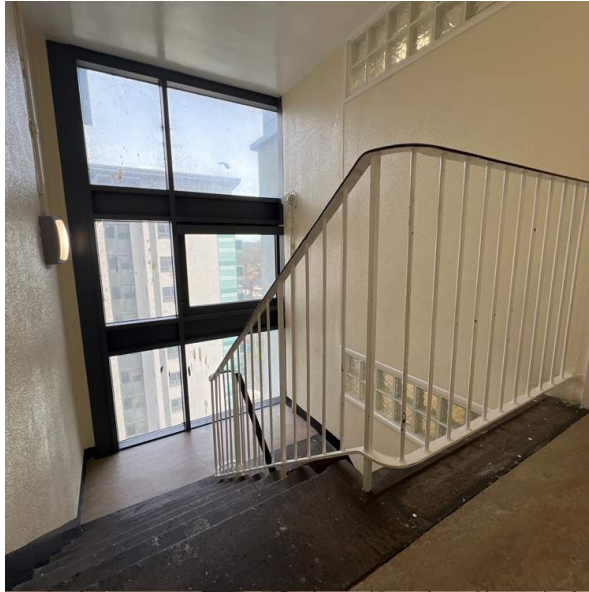
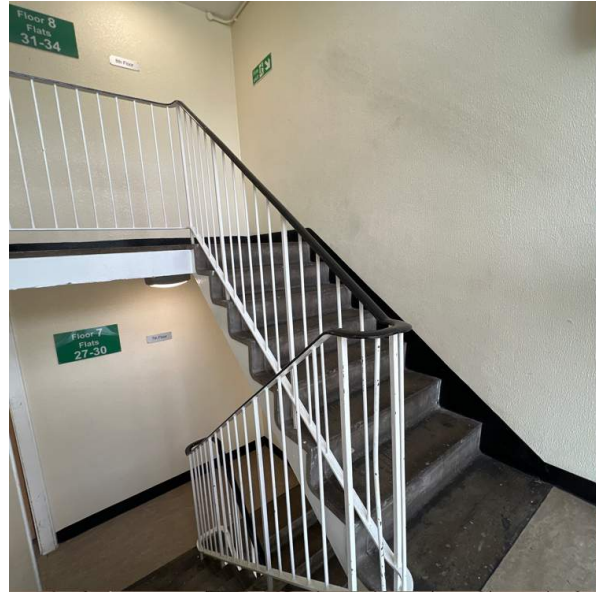
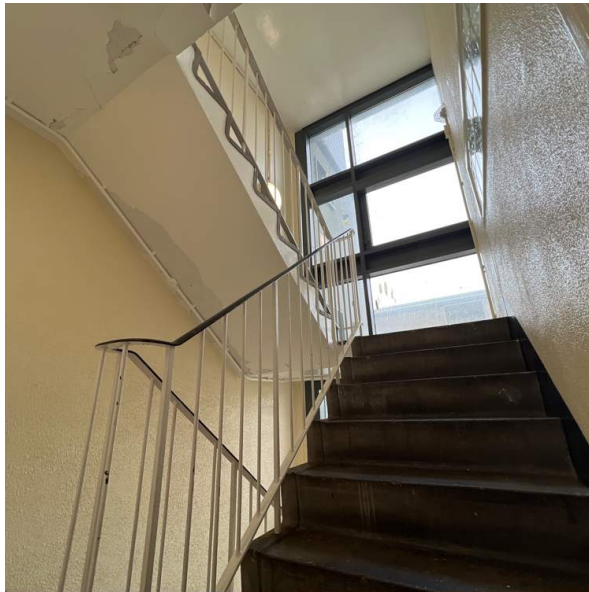
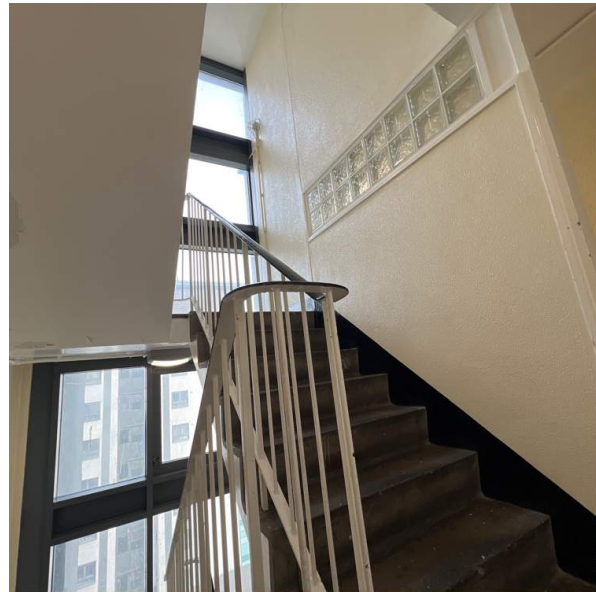
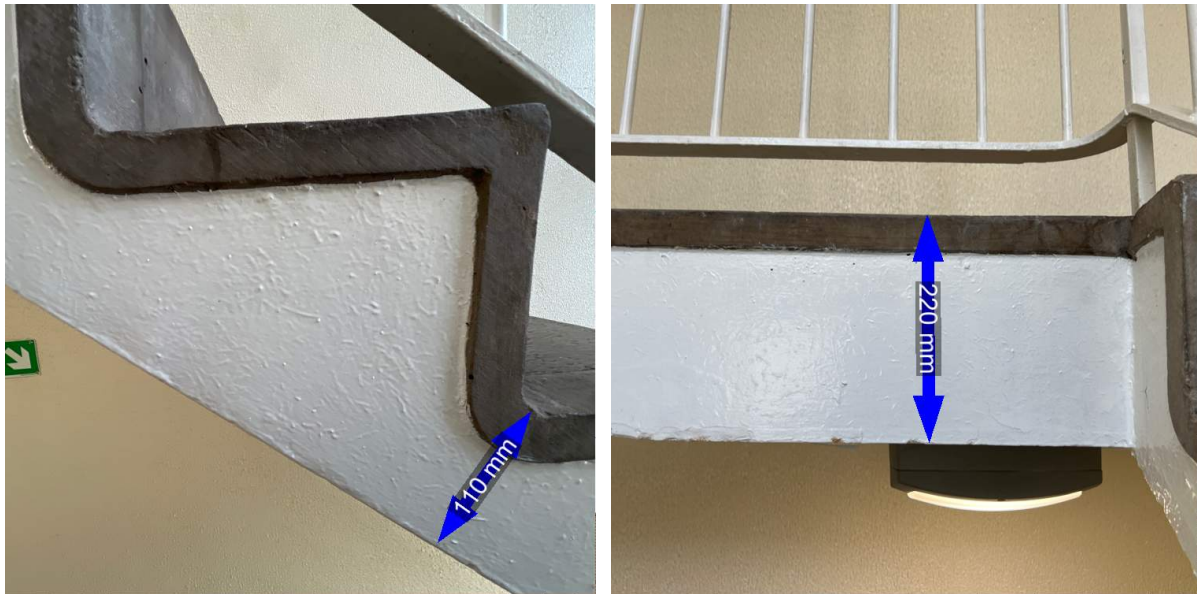
## 8th Floor Staircases

Comments: Insitu concrete stairs with steel hand railing fixed to stairs. Walls and floors appear to be fairly level.  
Stair walls covered with finishes however these would likely form the main concrete shear core walls. Partly infill/non-load bearing wall noted for one side of stair case wall.

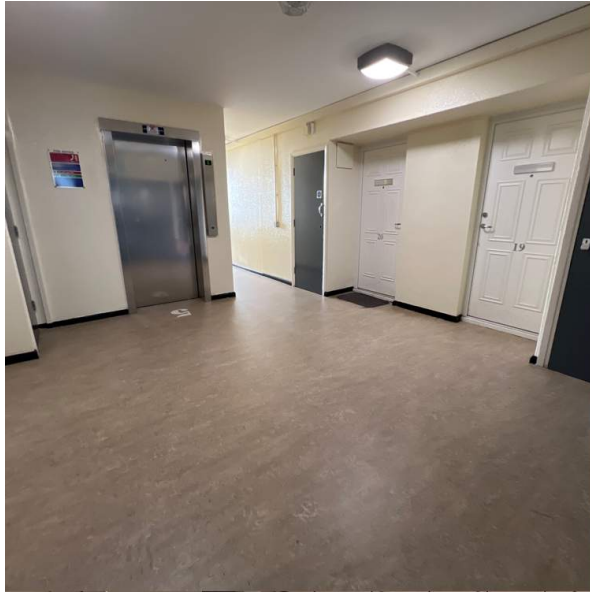
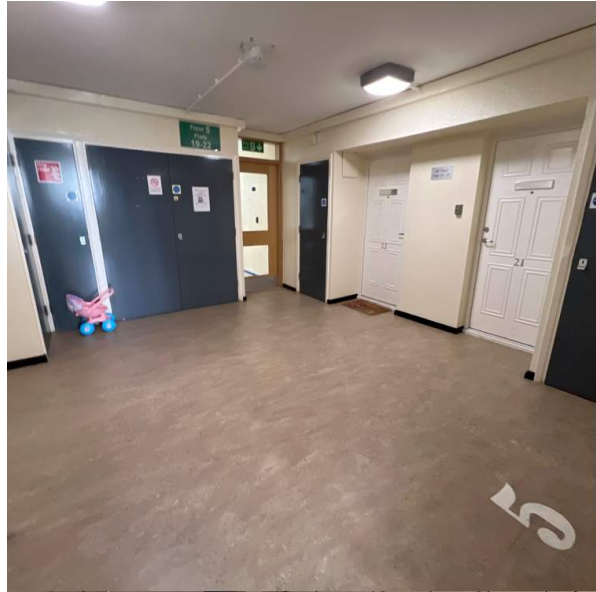
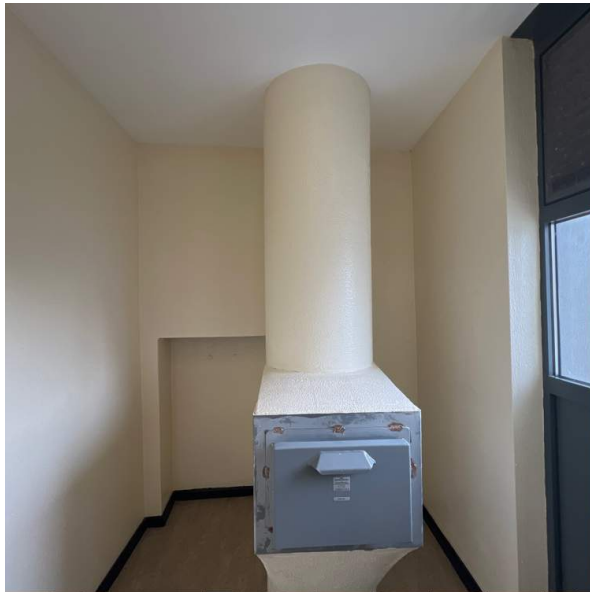
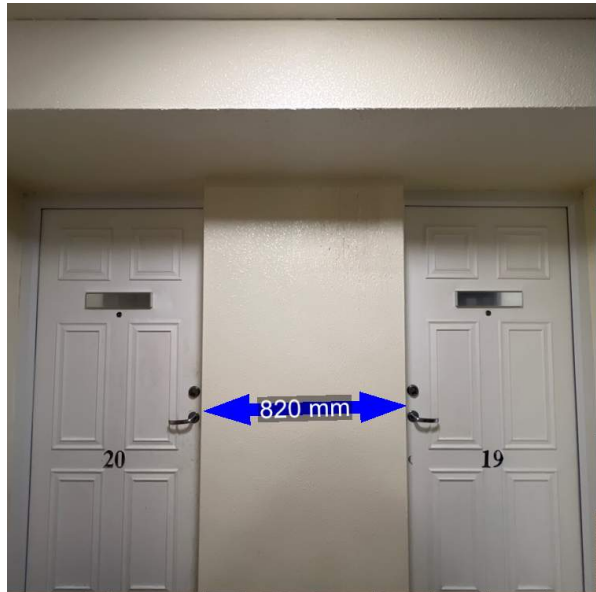
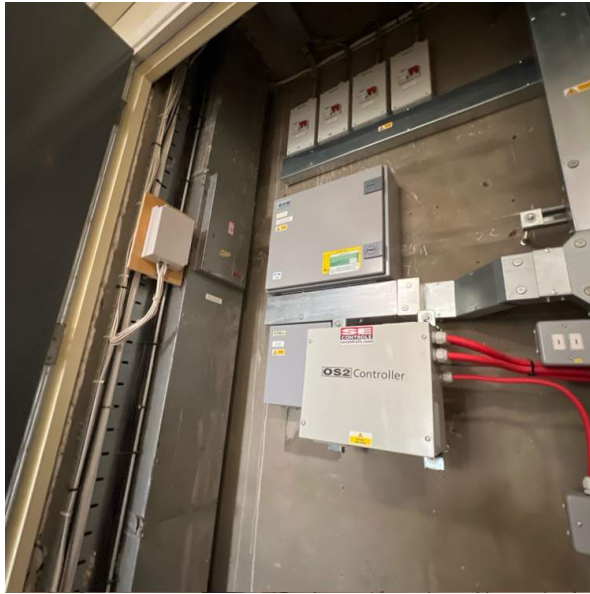
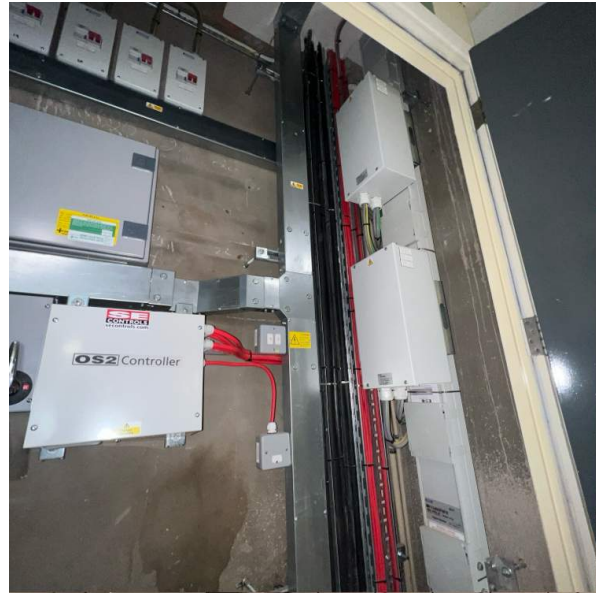
## 5th Floor Hallway

Comments: No jams or distortions noted to hallway doors to indicate any serviceability issues. Generally walls covered with finishes in hallway, likely to consist a mixture of concrete shear walls, embedded columns and masonry infill walls. Limited structure exposed. Concrete walls noted via dry riser cupboards. Electrical cupboard shows block infill walls with plaster.

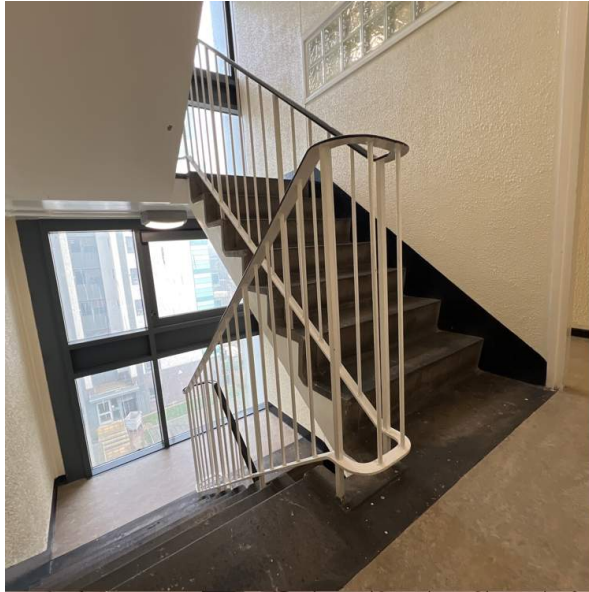
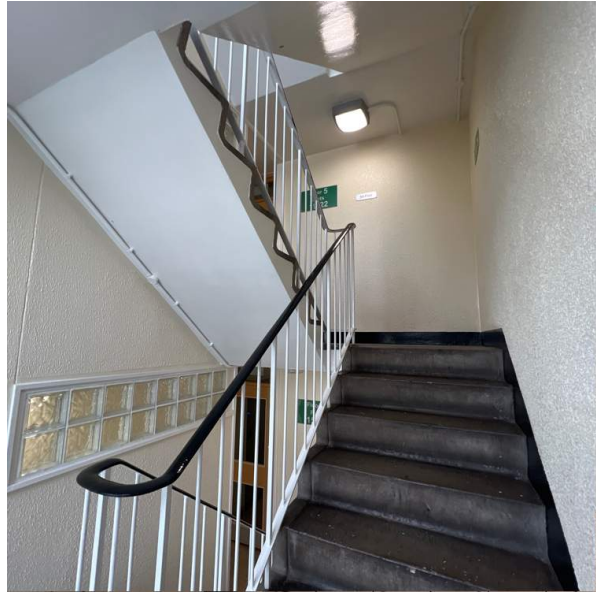
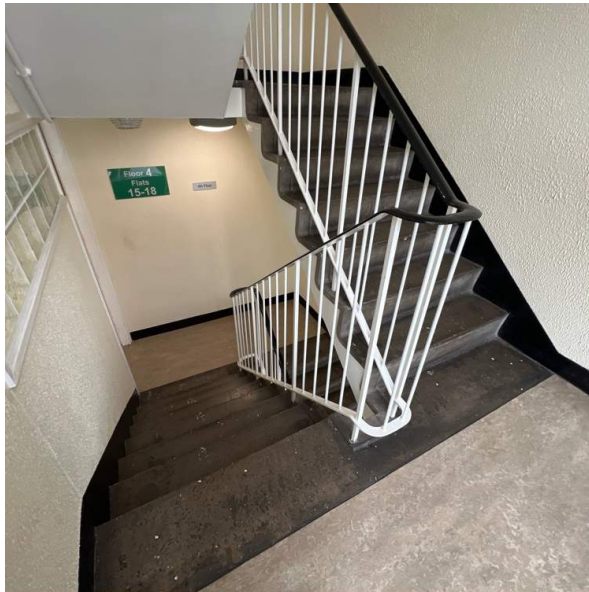
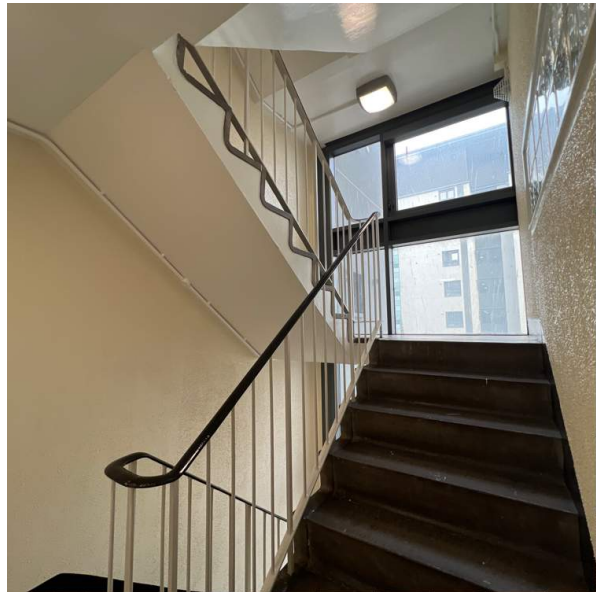
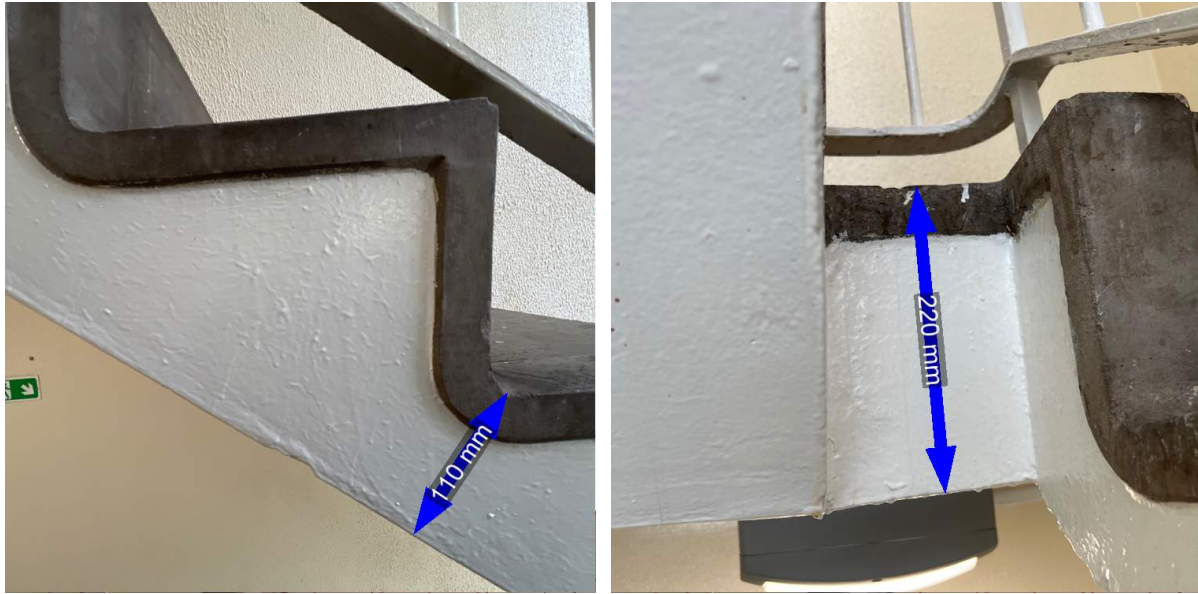
## 5th Floor Staircases

Comments: Insitu concrete stairs with steel hand railing fixed to stairs. Walls and floors appear to be fairly level.  
Stair walls covered with finishes however these would likely form the main concrete shear core walls. Partly infill/non-load bearing wall noted for one side of stair case wall.

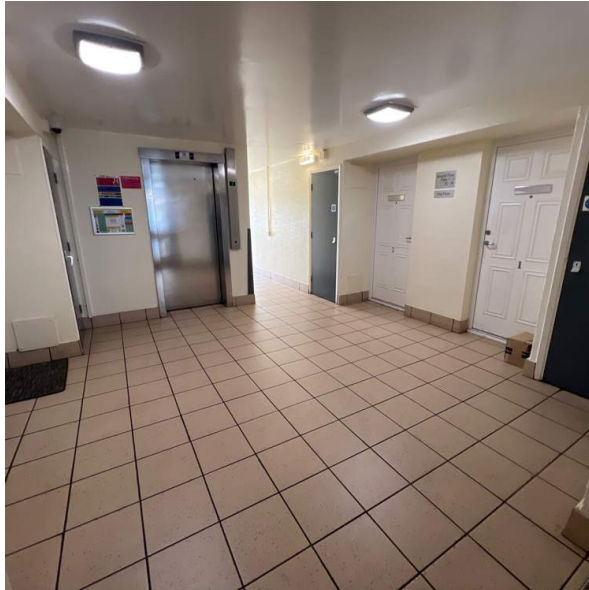
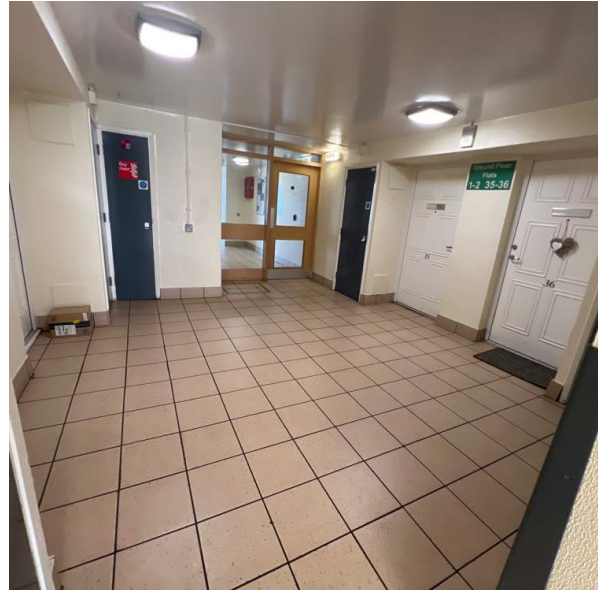
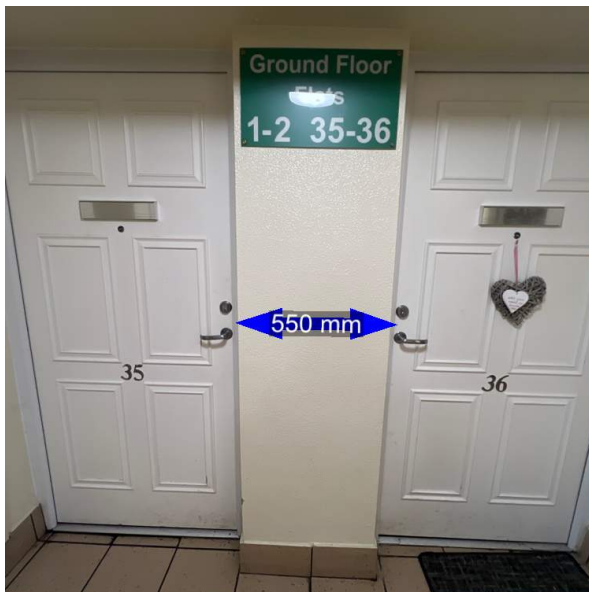
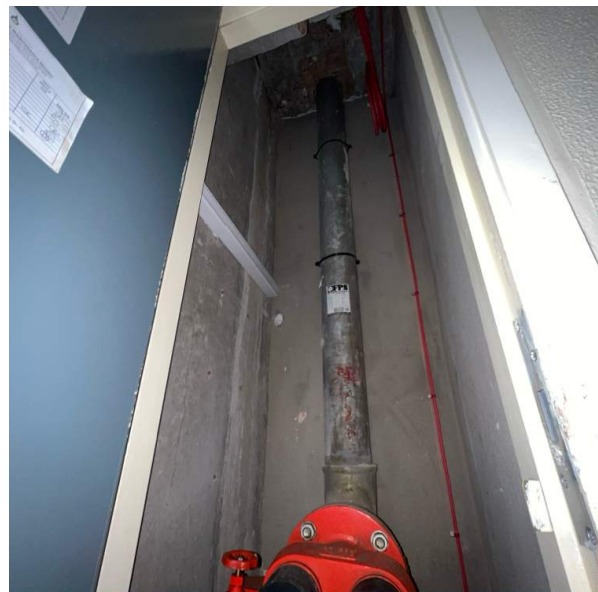
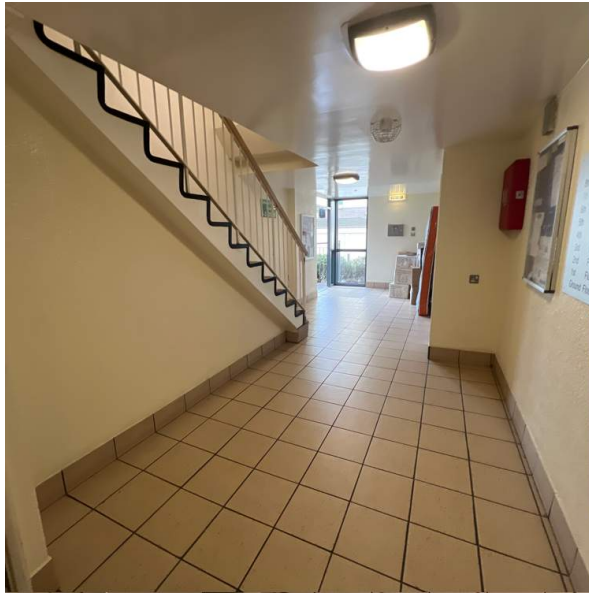
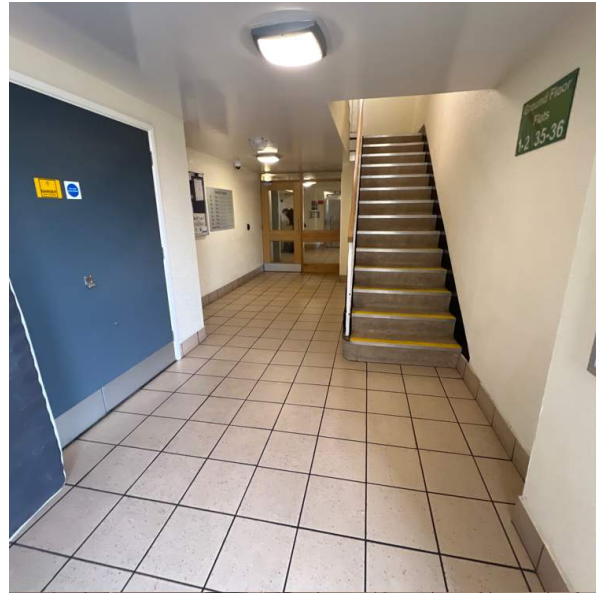
## Ground Floor Hallway

Comments: No jams or distortions noted to hallway doors to indicate any serviceability issues. Generally walls covered with finishes in hallway, likely to consist a mixture of concrete shear walls, embedded columns and block infill walls. Limited structure exposed. Partly visible concrete walls noted via riser cupboard and under stair case closet.

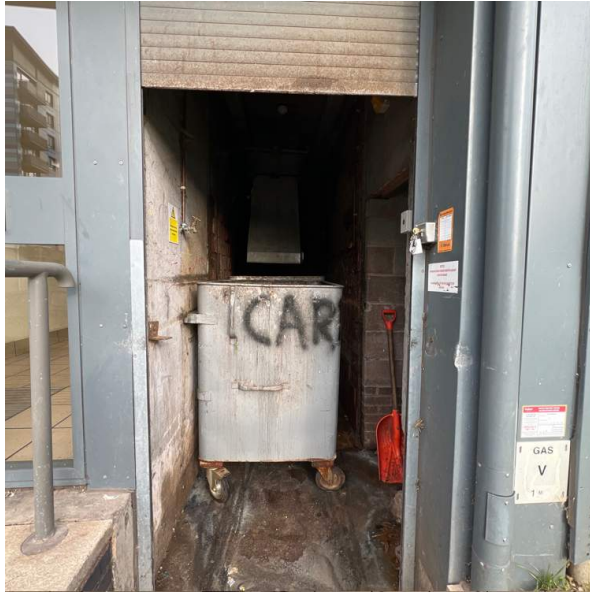
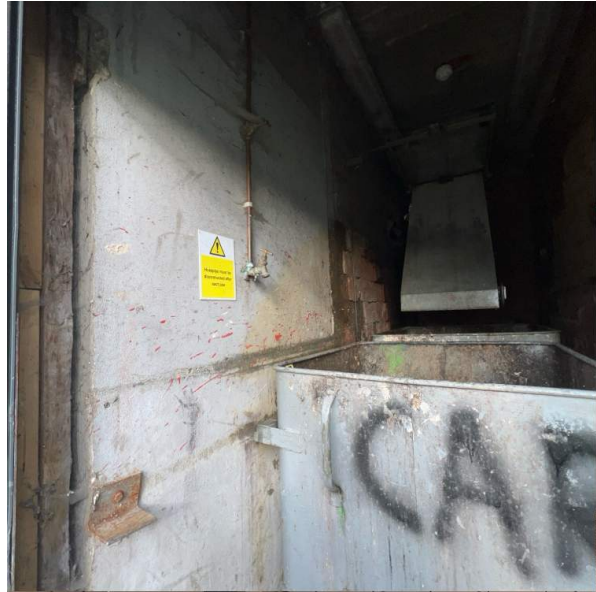
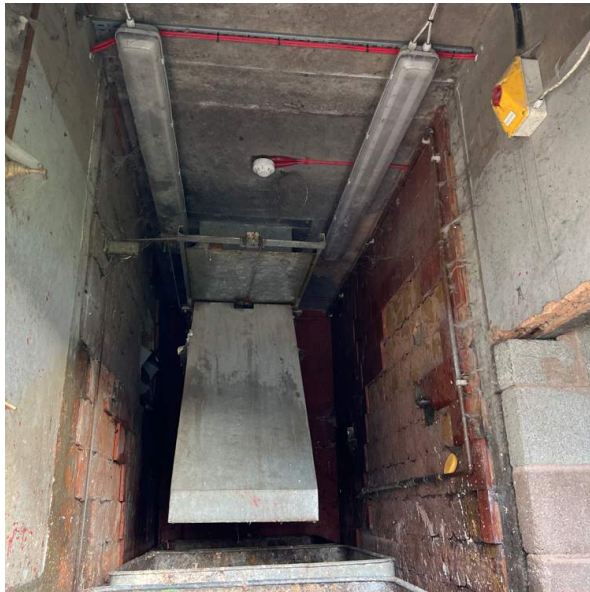
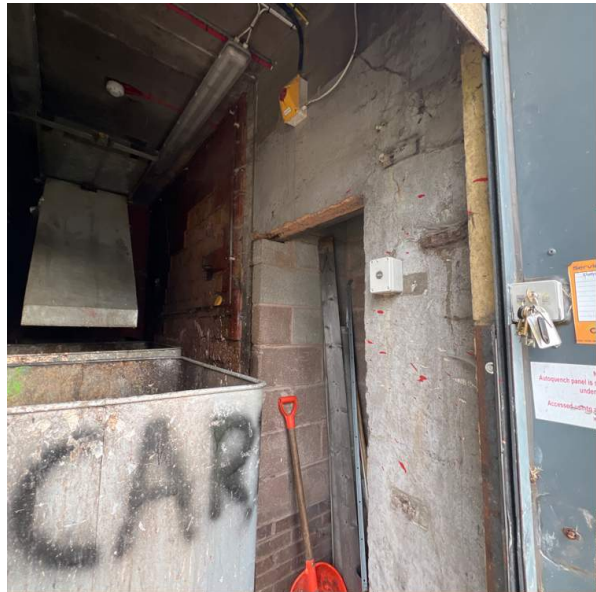
## Binstore

RC walls mainly covered with finishes.

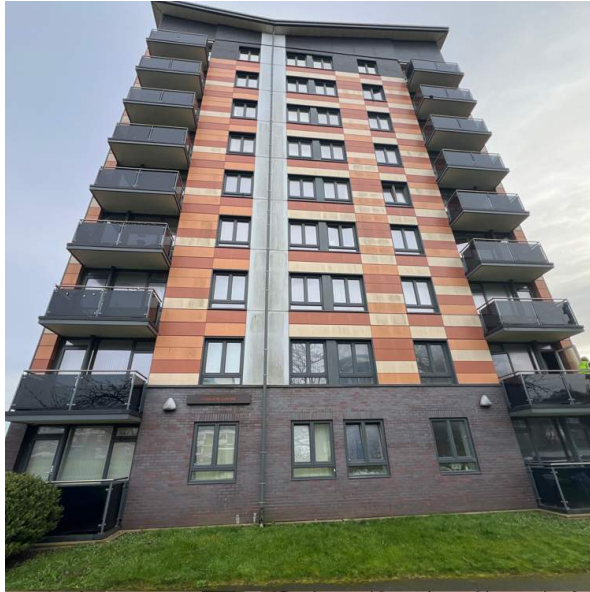
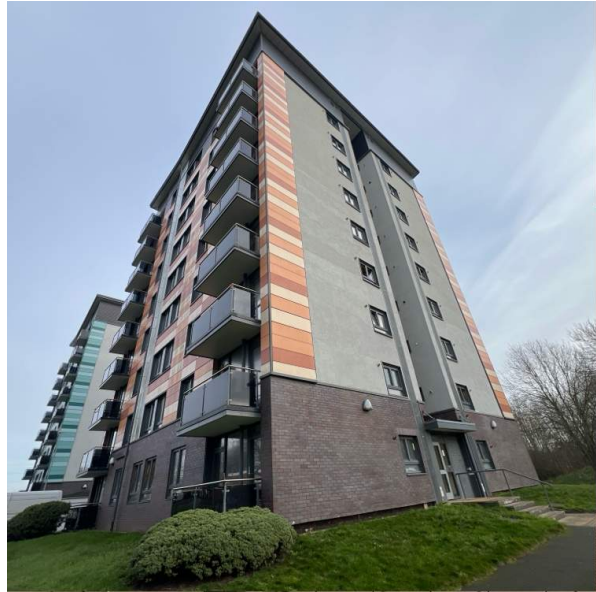
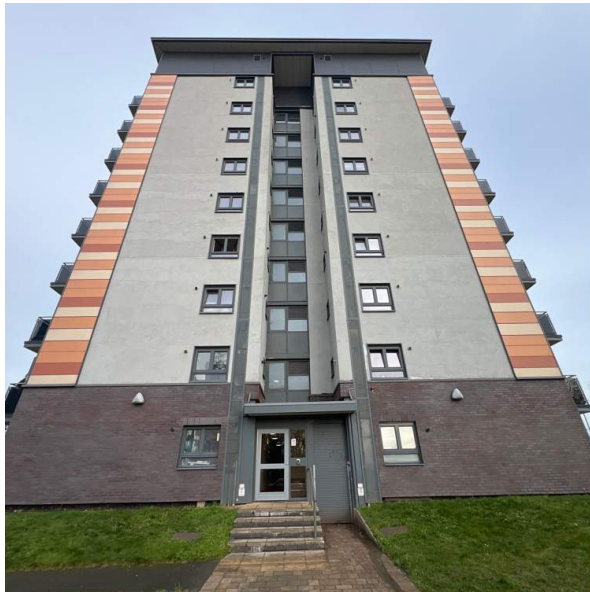
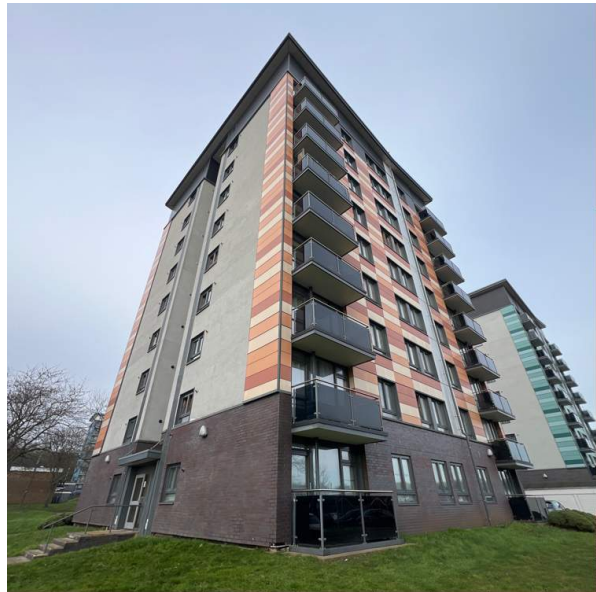
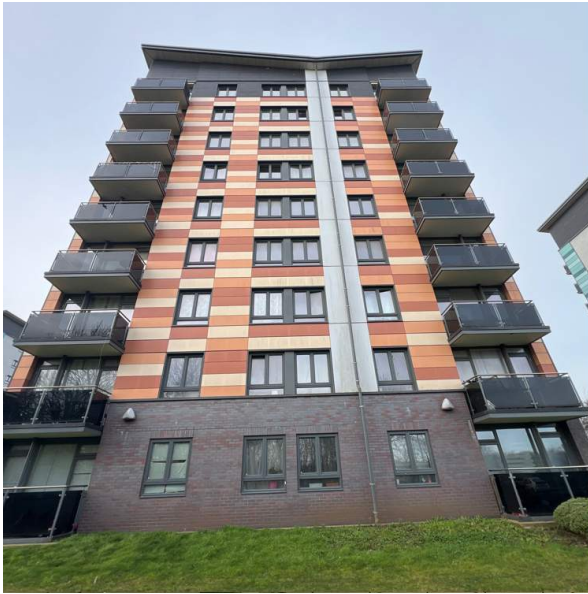
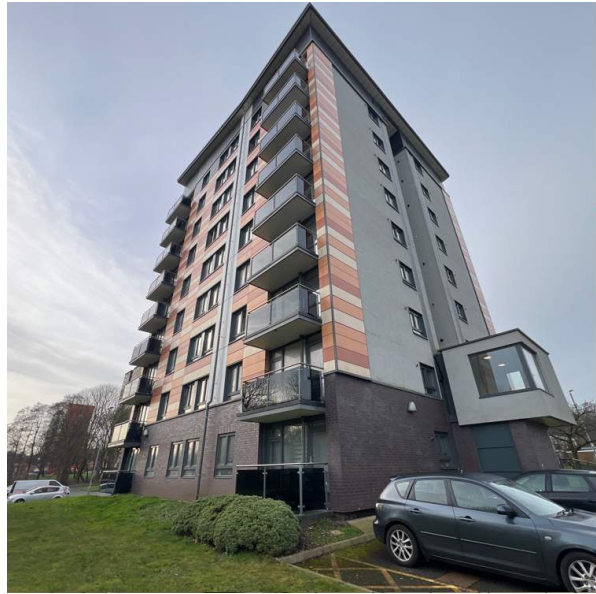
## Elevations

Ground floor level consists of brickwork. Remaining elevations consist of a mixture of rendered and cladded facade.

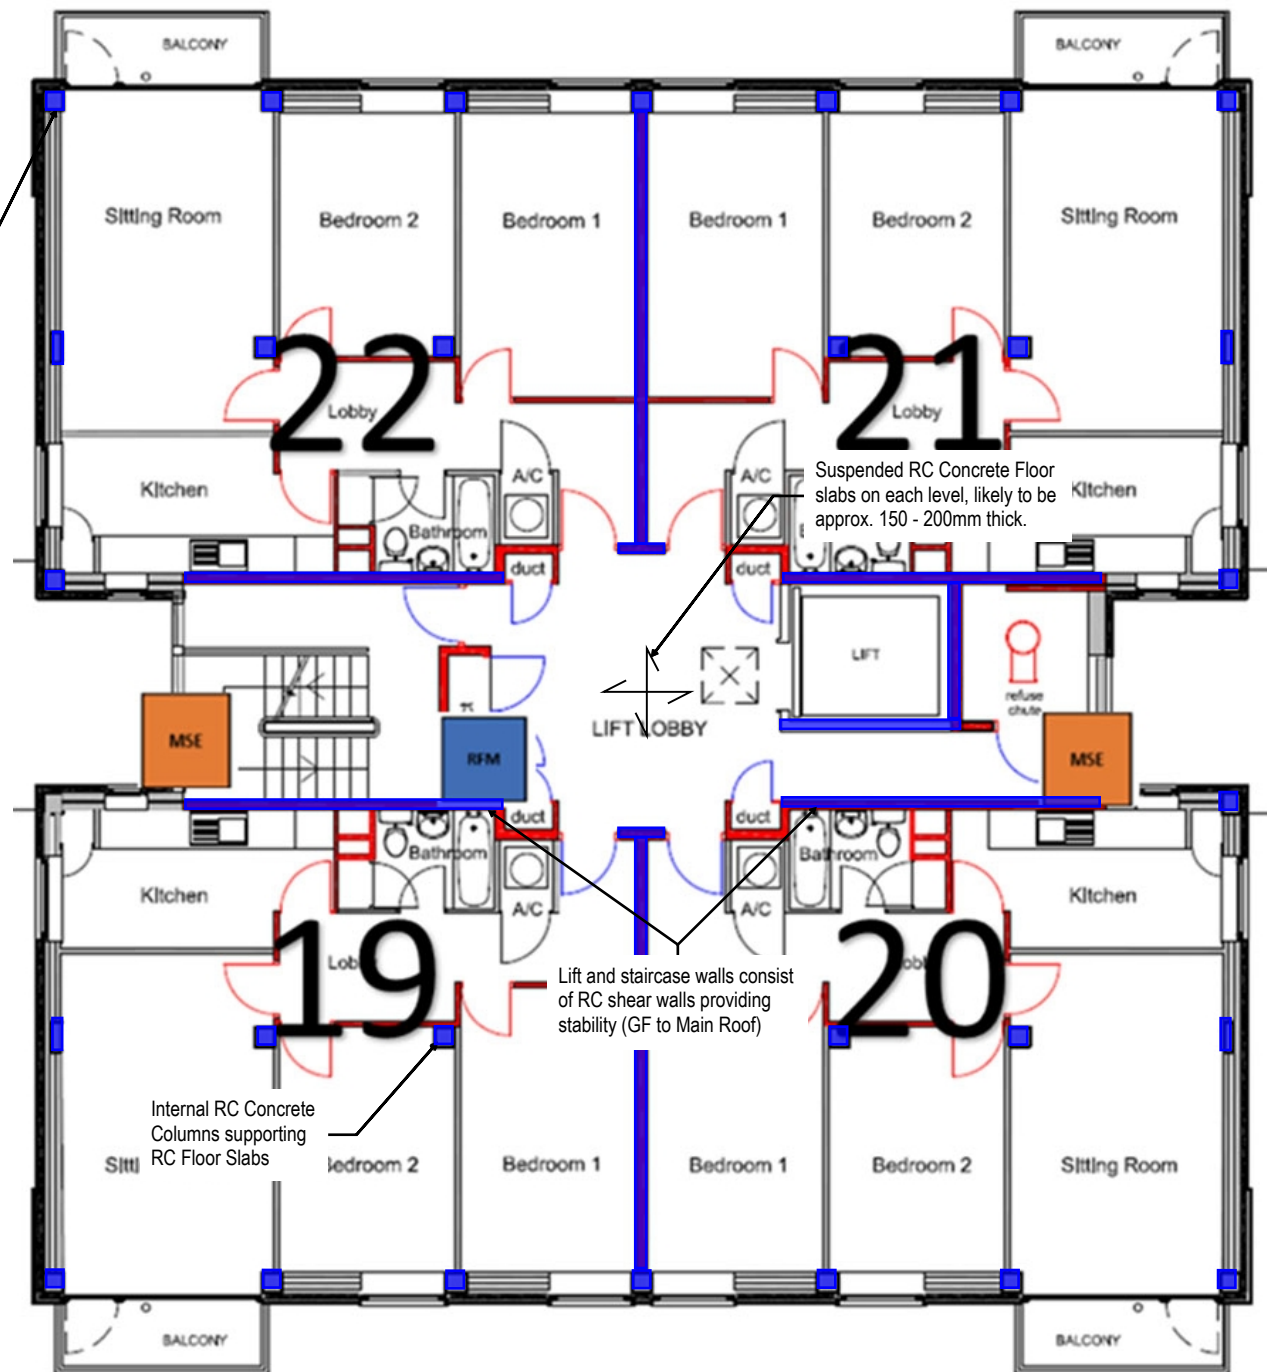
External perimeter RC Concrete Columns), supporting floors.

Lift and staircase walls consist of RC shear walls providing stability (GF to Main Roof)

Suspended RC Concrete Floor slabs on each level, likely to be approx. 150 - 200mm thick.
