VISUAL STRUCTURAL APPRAISAL

Thompson Gardens

1-89 Hales Lane  
Smethwick  
B67 6RX

29<sup>th</sup> November 2024

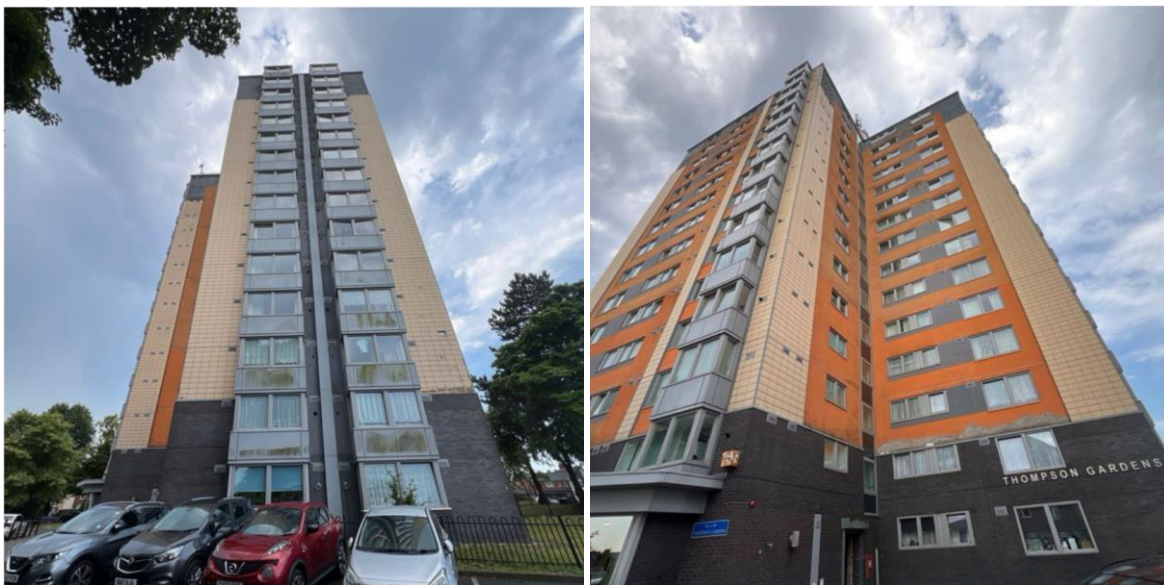
Figure 9 and 10: Elevations

The exterior elevations were generally in ok condition and no significant structural defects were noted to the cladding panels. There were no significant cracks or tell-tale signs of any significant structural movement noted at the time of our inspection.

The exterior panels were noted to be plumb with no signs of significant bowing, bulging or leaning noted to the panels indicating failed fixings however their presence and condition cannot be confirmed.

The aluminium panels which enclose the balconies should be cleaned as part of the normal regimen on maintenance as various were showing signs of dirt accumulated from moisture.

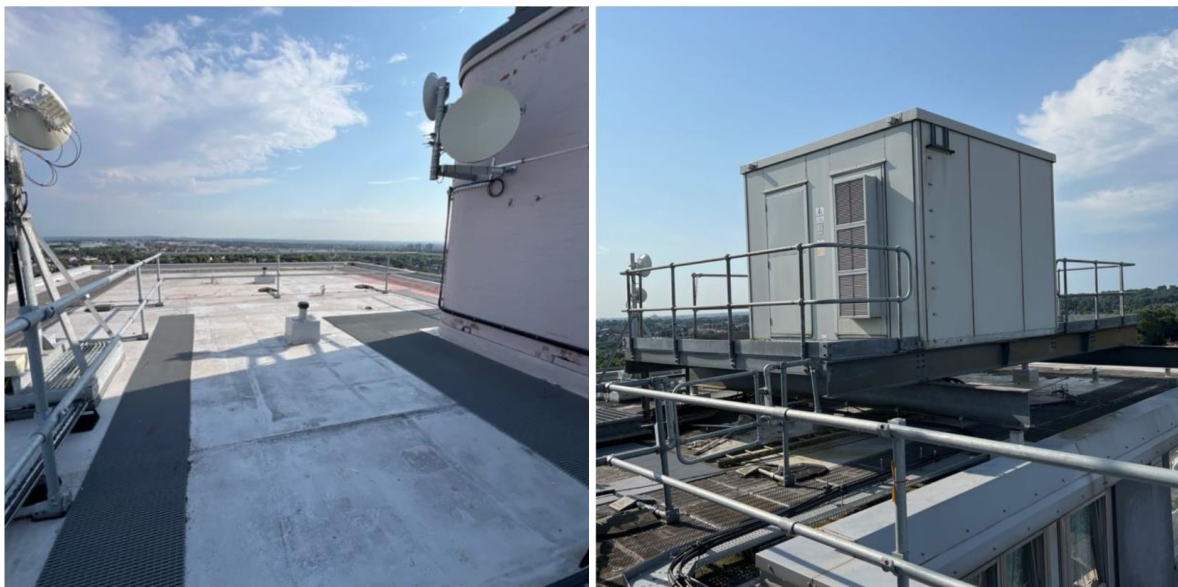
Figure 11 and 12: Roof Level

There were no tell-tale signs of any significant structural movement noted at the time of our inspection. The exterior walls were noted to be plumb with no signs of significant bowing, bulging or leaning noted to the masonry.

The roof has a single ply membrane finish. The exact build-up of the roof finishes were not accessible at the time of inspection. It is recommended an intrusive survey of the roof finishes is completed by a specialist surveyor to assess the condition of the roof covering.

A telecommunications center has been installed to the roof installed off a steel frame which is bolted down to concrete upstand supported off the roof structure. It is unclear if the pads are supported off the slab directly or the beams, however there were no signs of stress surrounding the bearings.

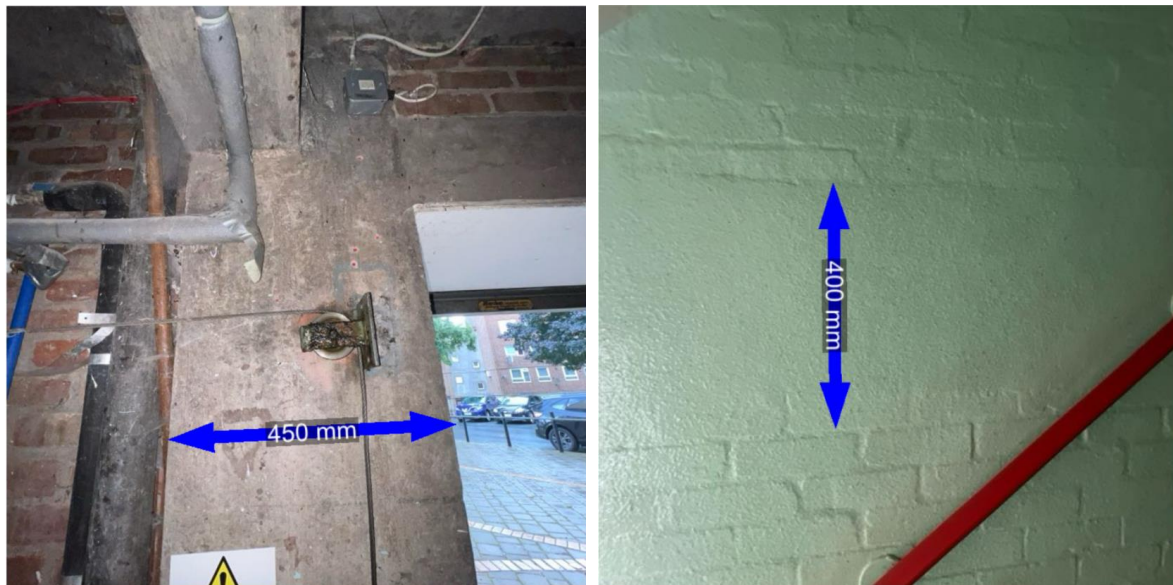
Figure 13 and 14: Vertical and Horizontal RC Structure Visible

The interior of the stair core walls were checked and were plumb and in line with observations made to the exterior – no significant signs of leaning or movement noted. The concrete appeared in fair condition with few BRE category 1 cracks but no structurally significant defects were noted.

The stair stringer was noted to be 150mm thick, a cover test is required to check the resistance of the concrete section in the event of a fire.

The slabs are providing compartmentation to the building and therefore should meet the fire requirements. A cover meter survey is required to estimate the fire resistance of the floor slabs.

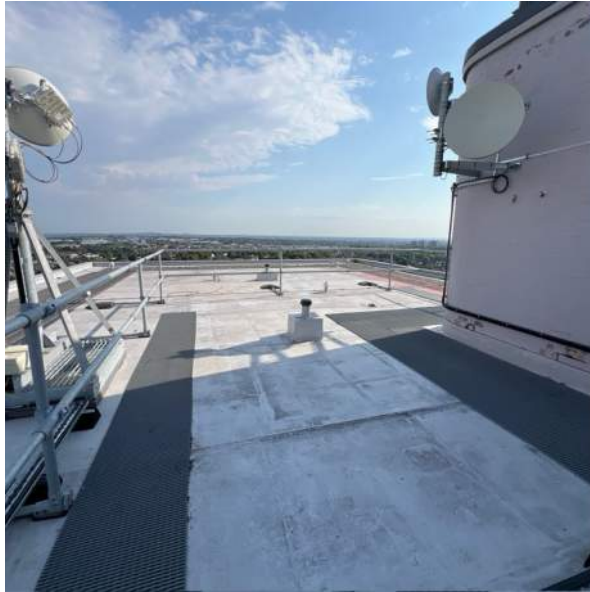
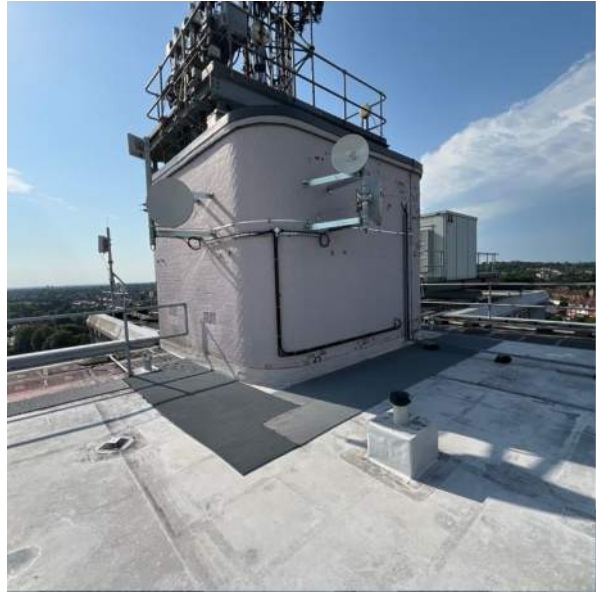
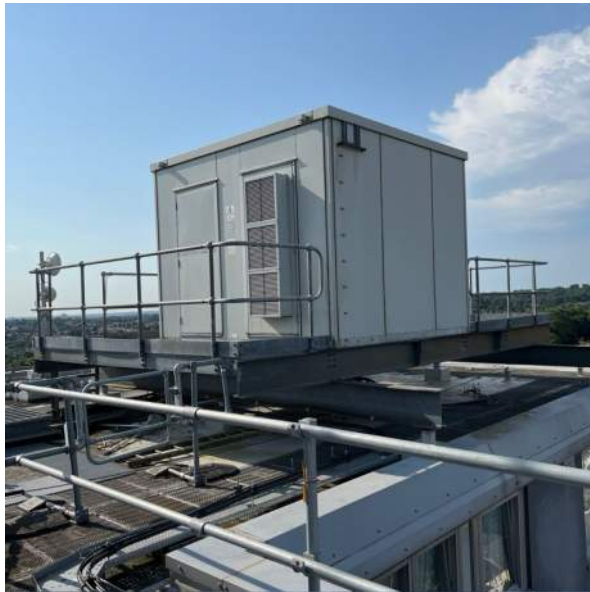
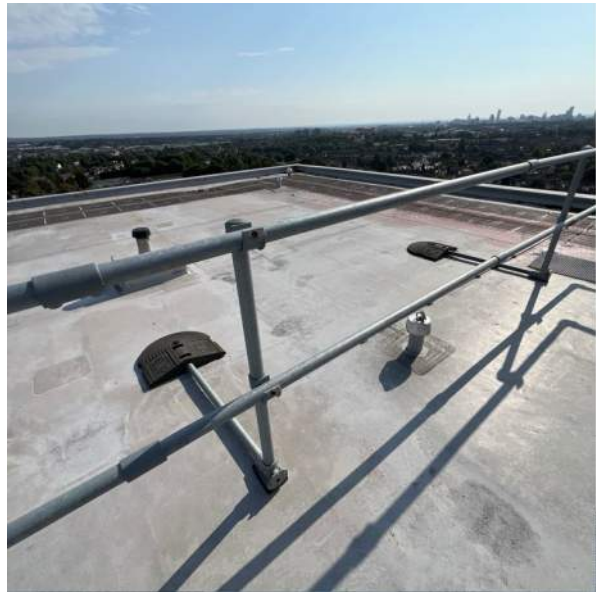
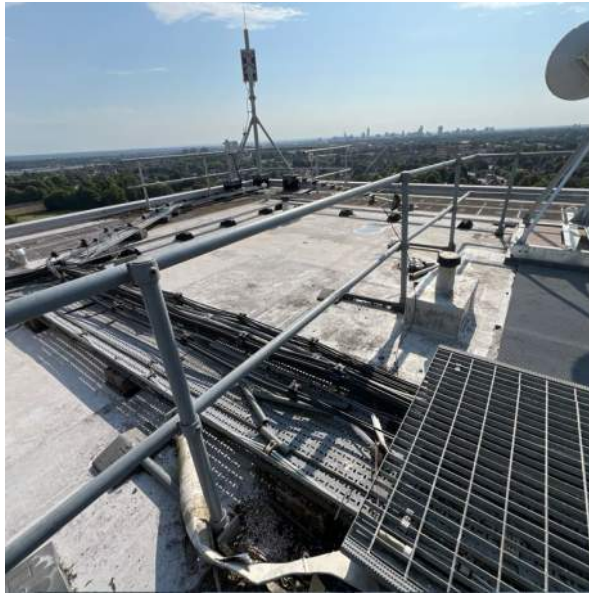
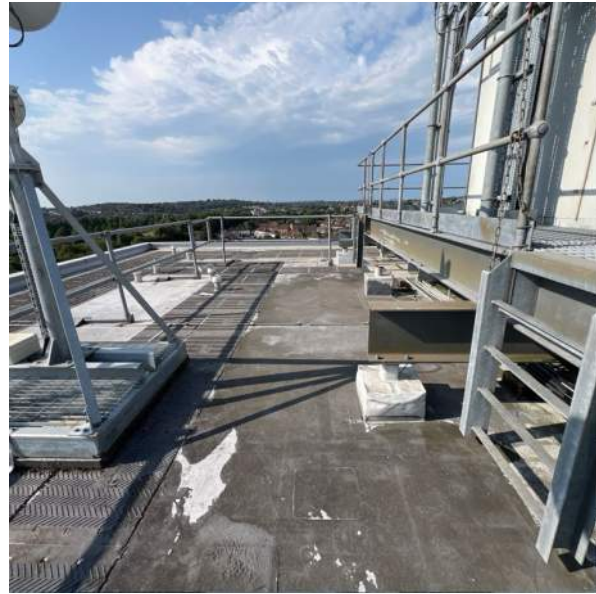
## Main Roof

Lift motor room located on roof formed of masonry walls.  
Telecomms building noted to roof supported of steel frame fixed to main roof.  
Insitu concrete roof slab with insulated PIR Boad and felt roof coverings.

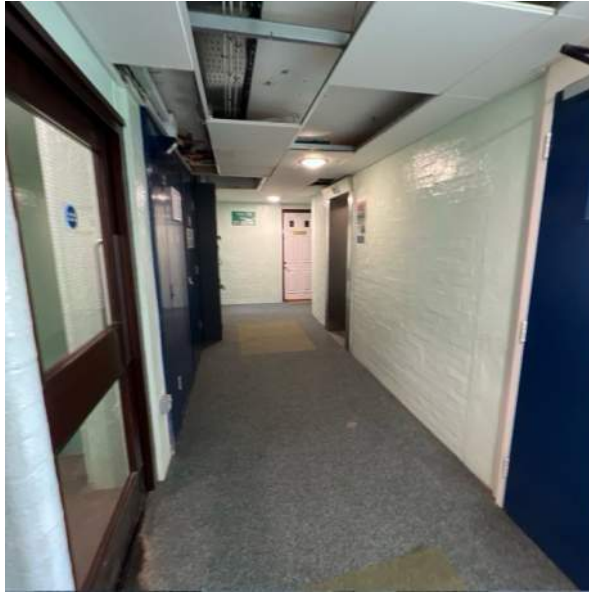
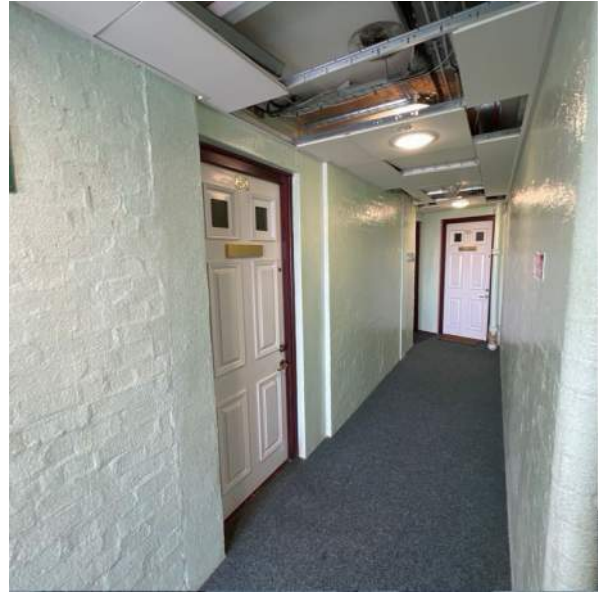
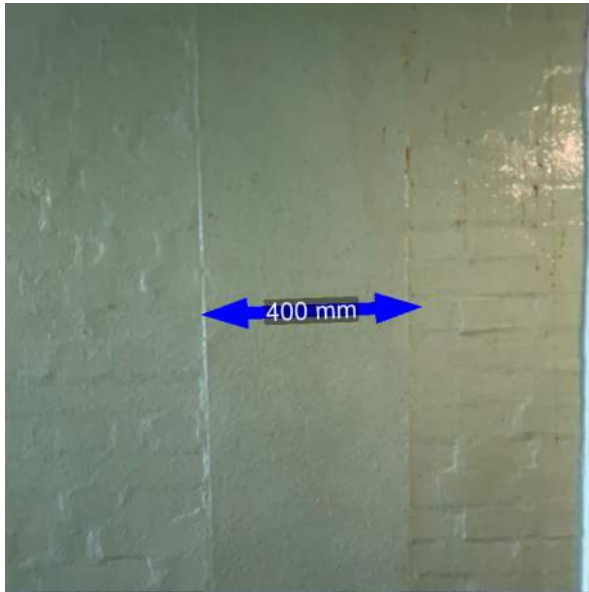
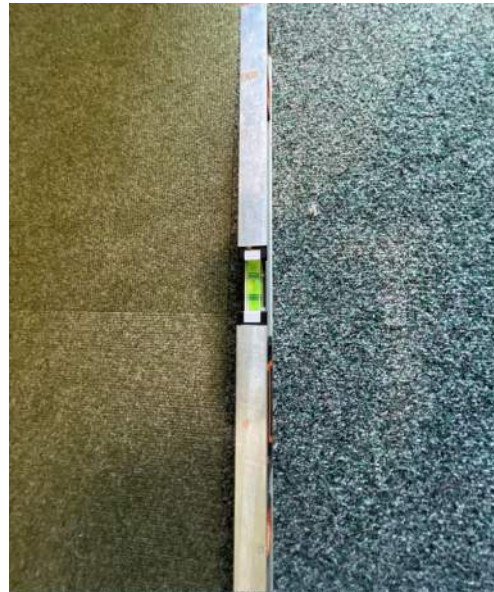
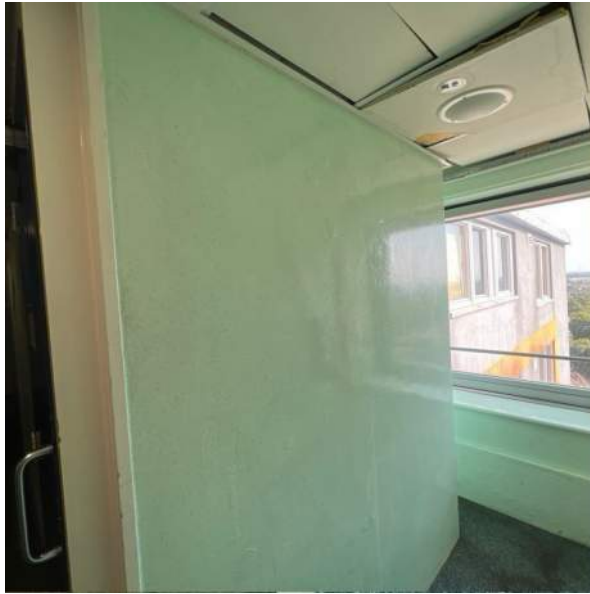
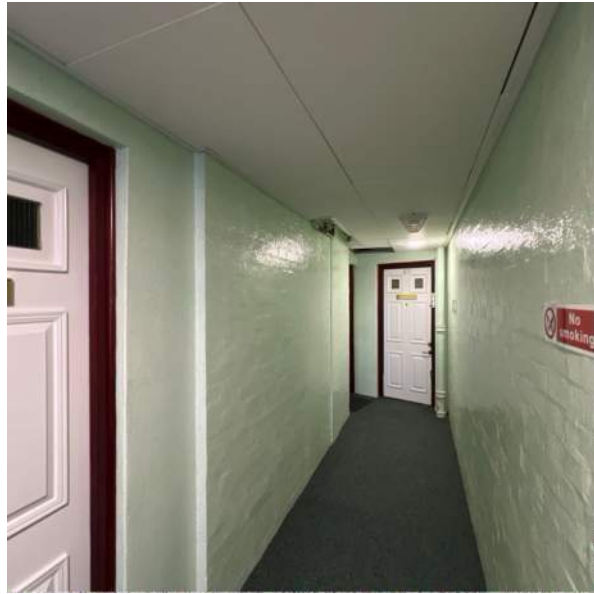
## 14th Floor Hallway

Comments: No jams or distortions noted to hallway doors to indicate any serviceability issues. Hallway walls generally formed of infill masonry (non-load bearing brickwork) with embedded structural columns and shear walls. Electrical dry riser cupboard shows infill masonry with partly exposed concrete column (rendered). Floors and walls were mainly level.

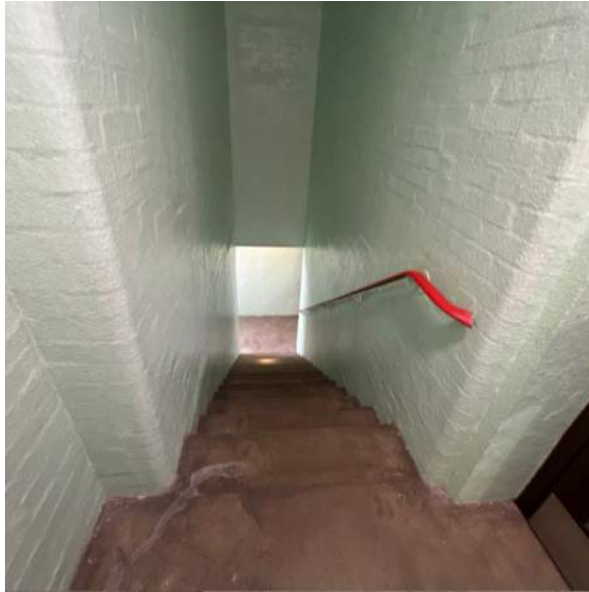
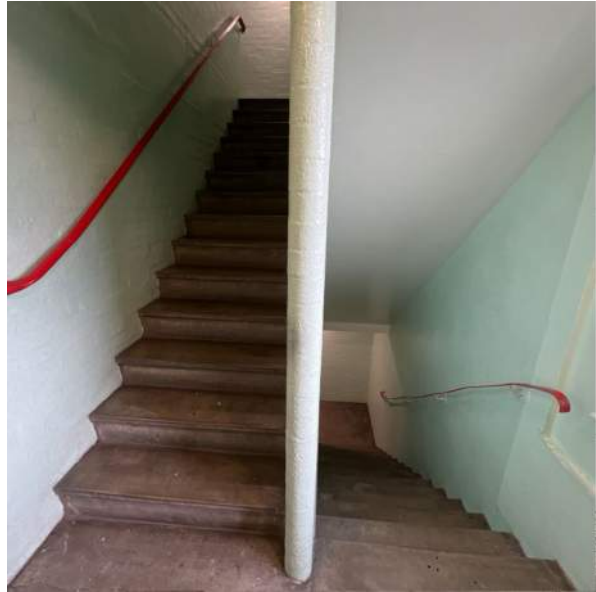
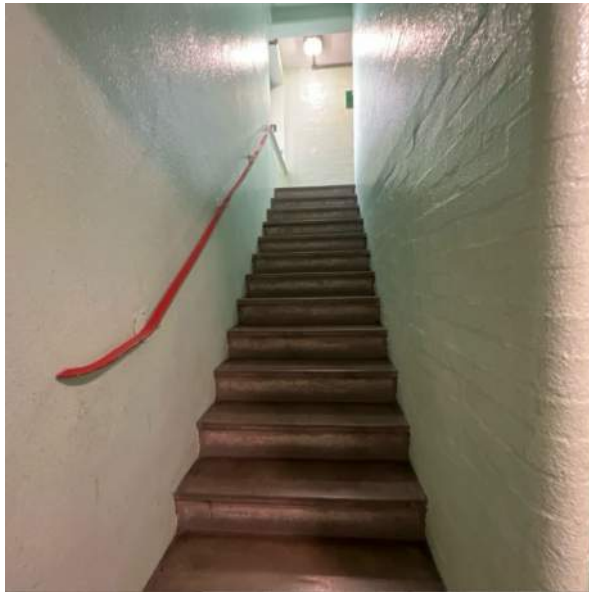
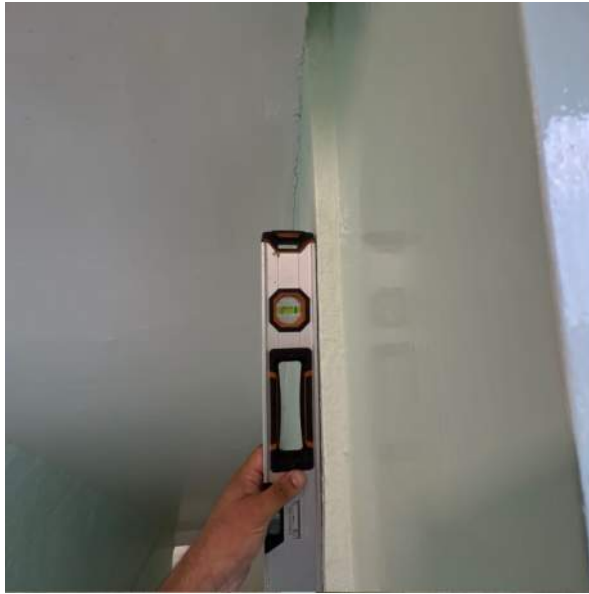
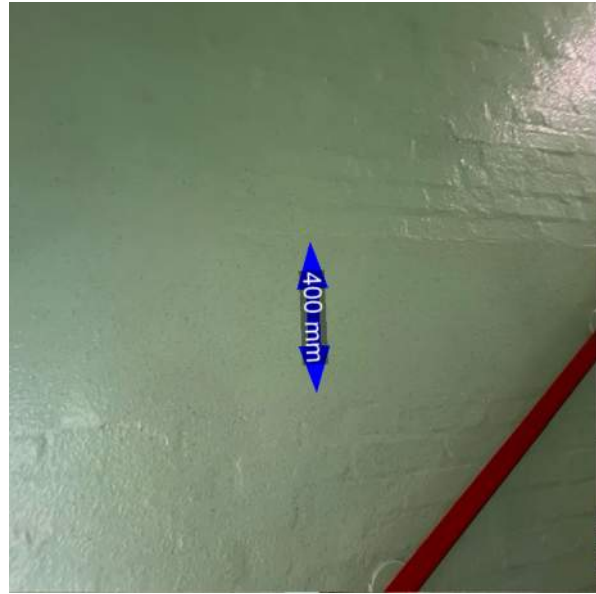
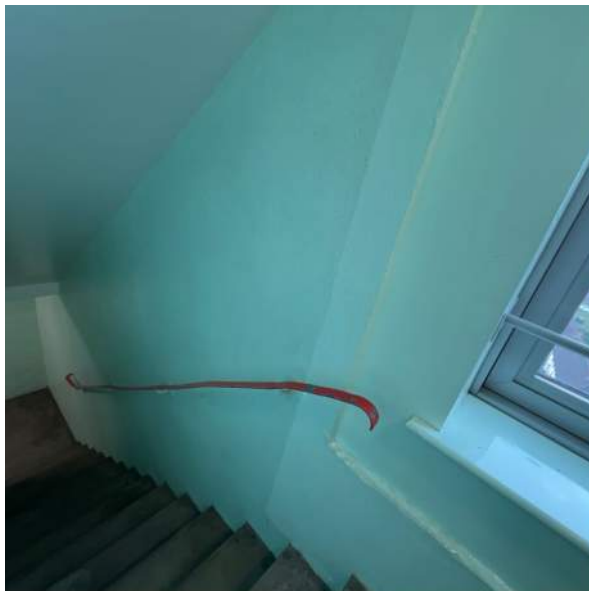
## 14th Floor Staircase

Insitu concrete stairs. Walls and floors appear to be fairly level.  
Stair walls predominantly formed of infill masonry walls (non-load bearing) and embedded RC Concrete beams and columns noted.  
Side wall of stair case appears to be formed of a concrete shear wall.

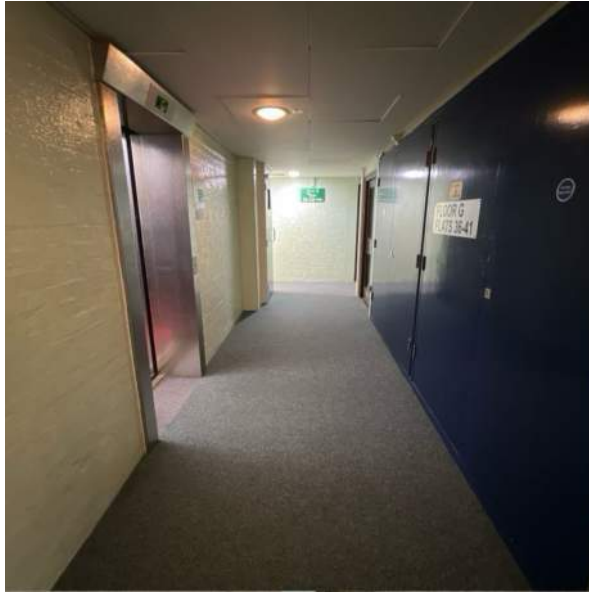
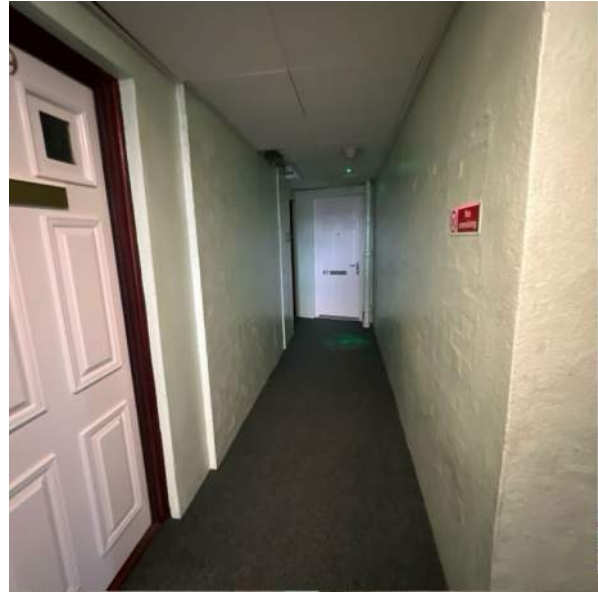
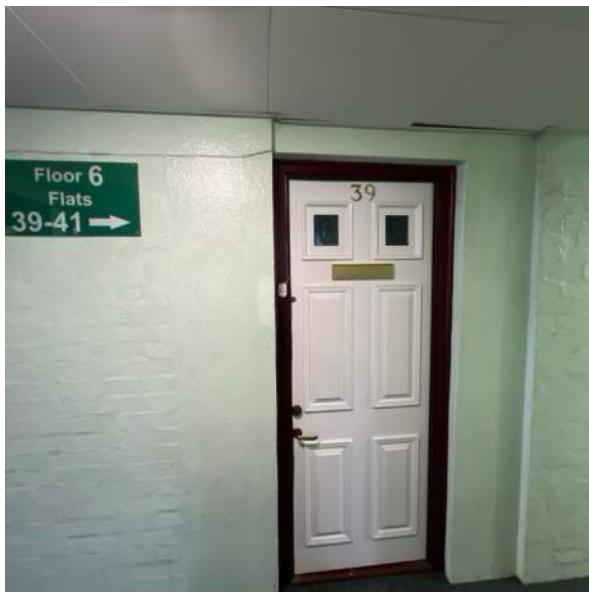
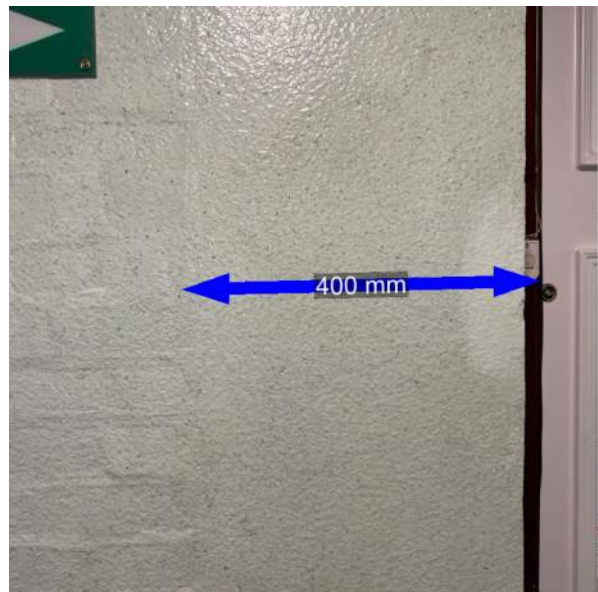
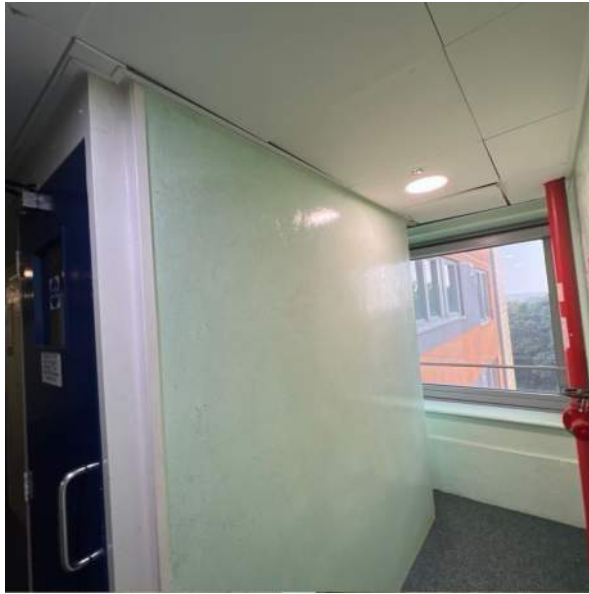
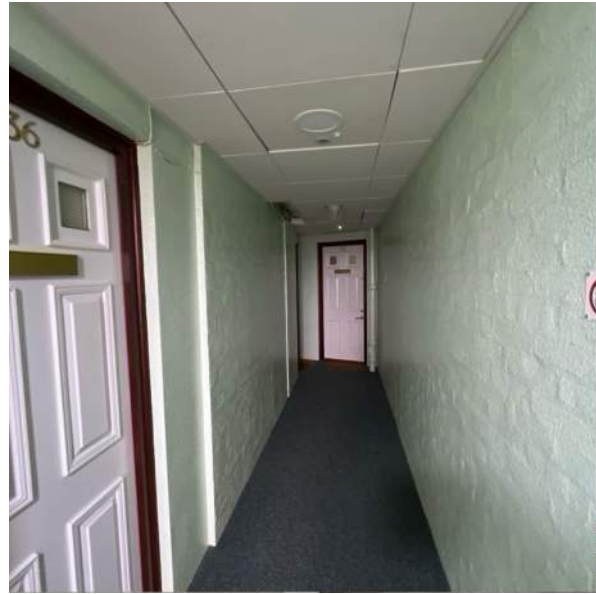
## 6th Floor Hallway

Comments: No jams or distortions noted to hallway doors to indicate any serviceability issues. Hallway walls generally formed of infill masonry (non-load bearing brickwork) with embedded structural columns and shear walls. Electrical dry riser cupboard shows infill masonry with partly exposed concrete columns.

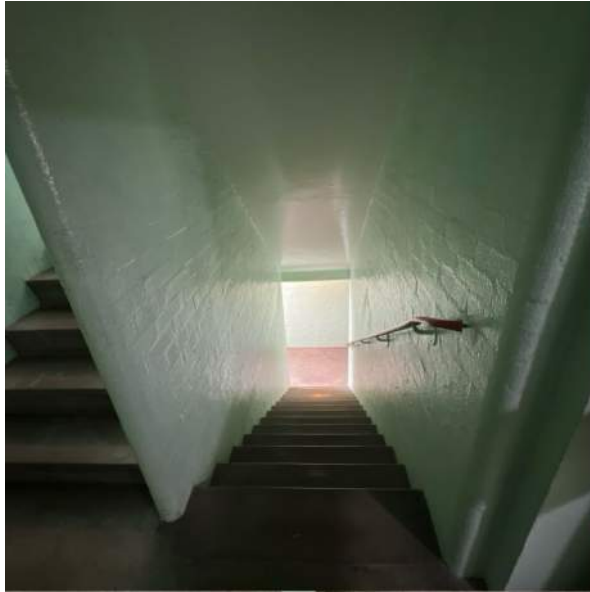
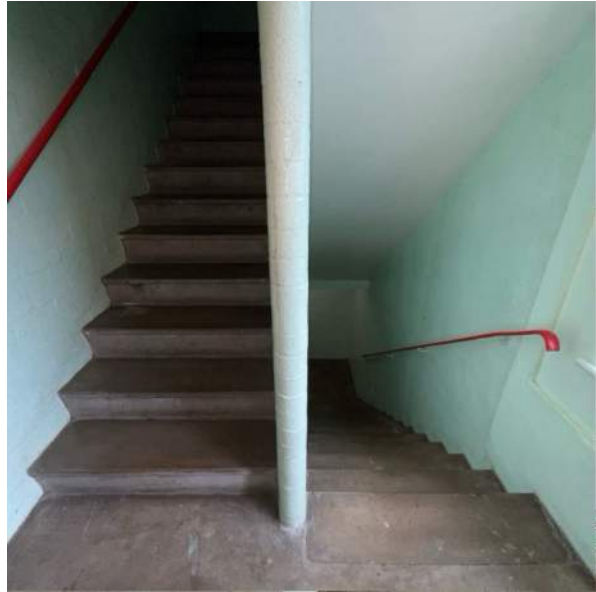
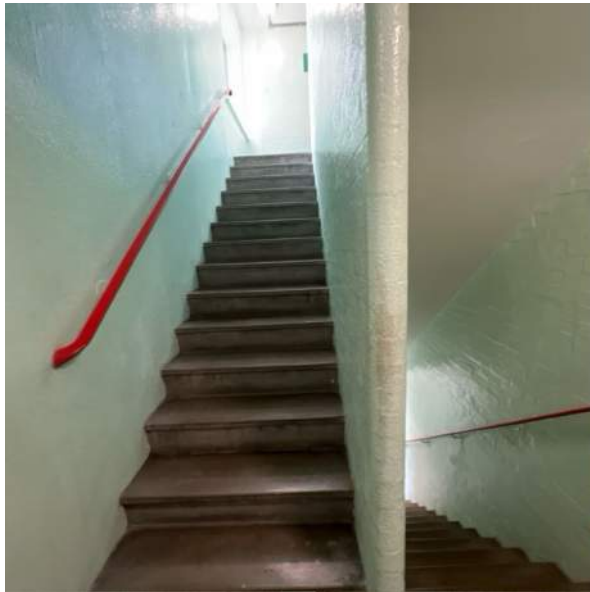
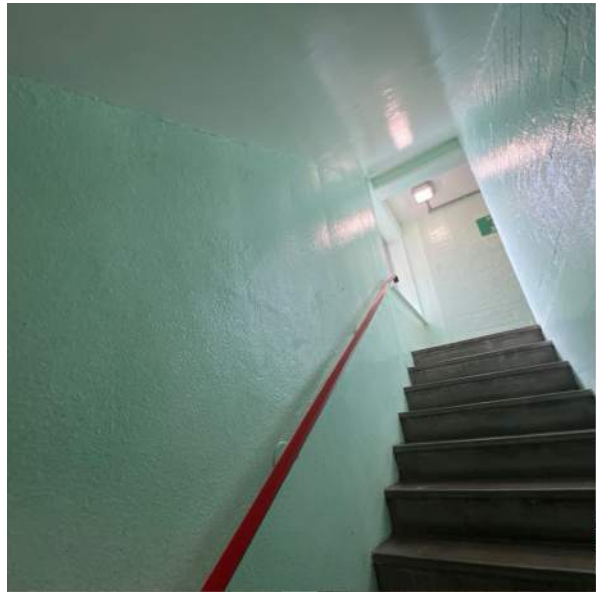
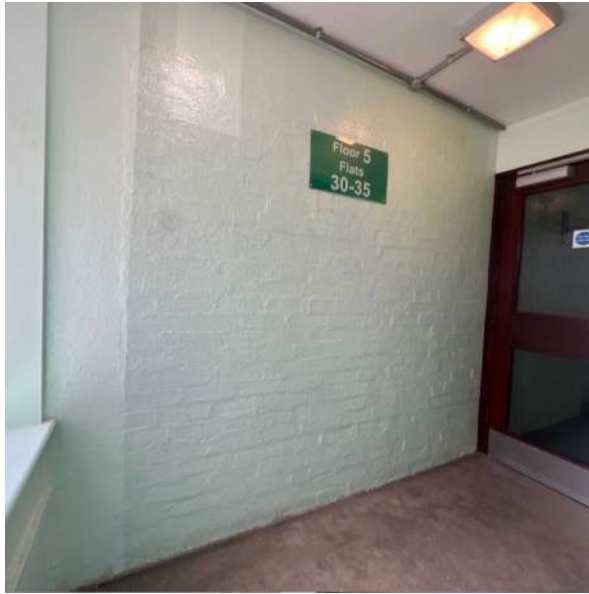
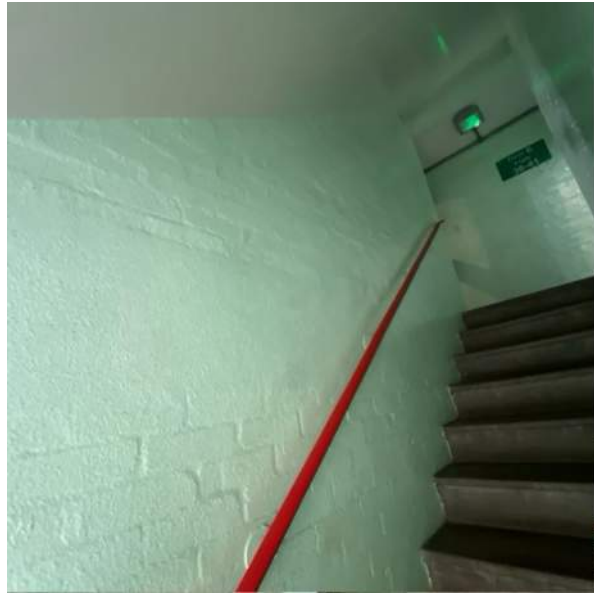
## 6th Floor Staircase

Insitu concrete stairs. Walls and floors appear to be fairly level.  
Stair walls predominantly formed of infill masonry walls (non-load bearing) and embedded RC Concrete beams and columns noted.  
Side wall of stair case appears to be formed of a concrete shear wall.

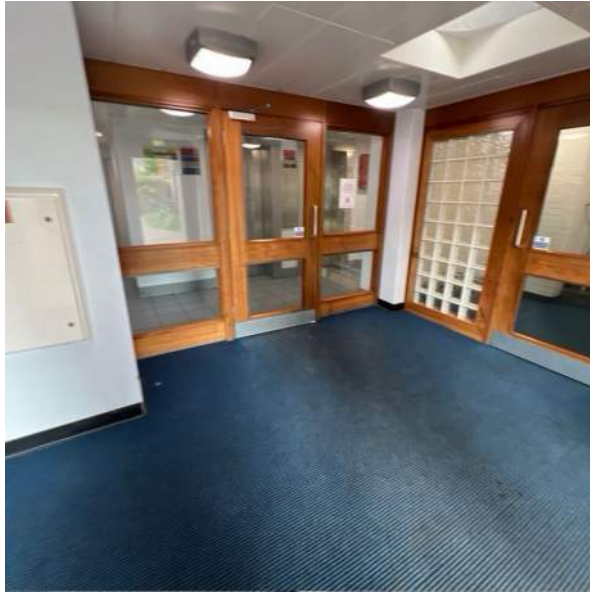
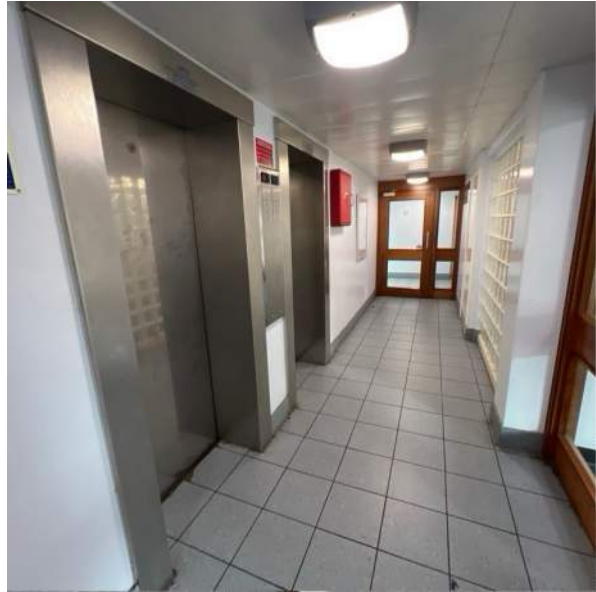
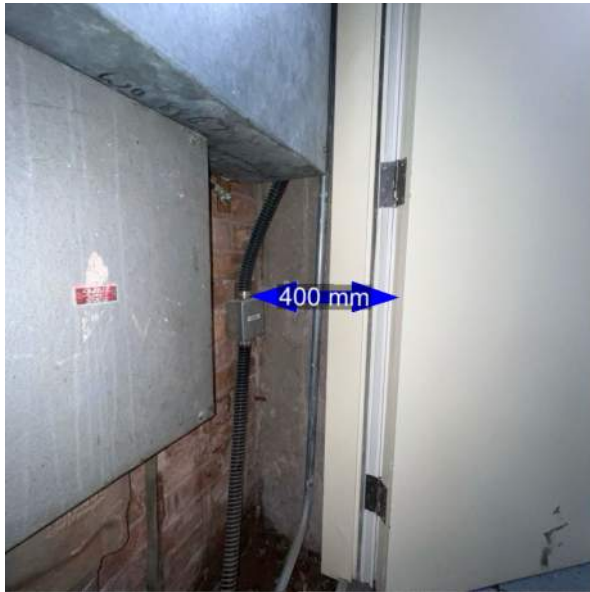
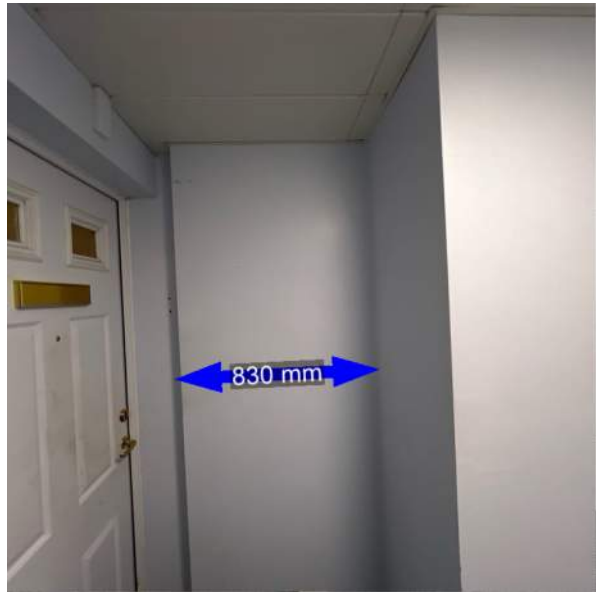
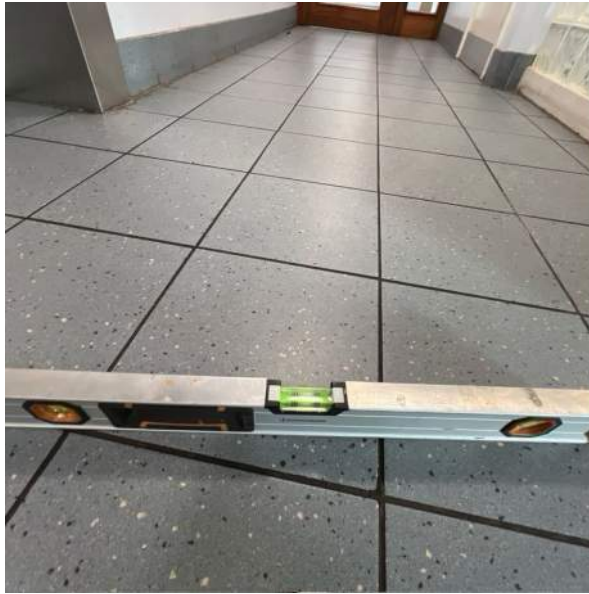
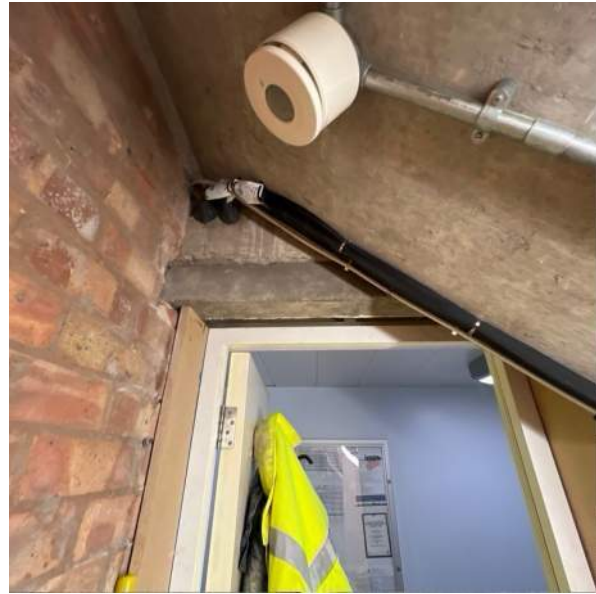
## Ground Floor Hallway

Comments: No jams or distortions noted to hallway doors to indicate any serviceability issues. Hallway walls generally formed of infill masonry (non-load bearing brickwork) with embedded structural columns and shear walls. Electrical dry riser cupboard shows infill masonry with partly exposed concrete columns. RC columns noted via pump room and janets cupboard.

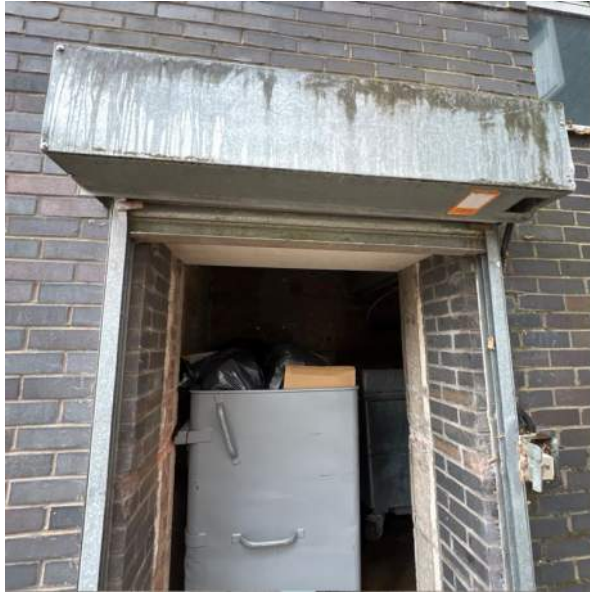
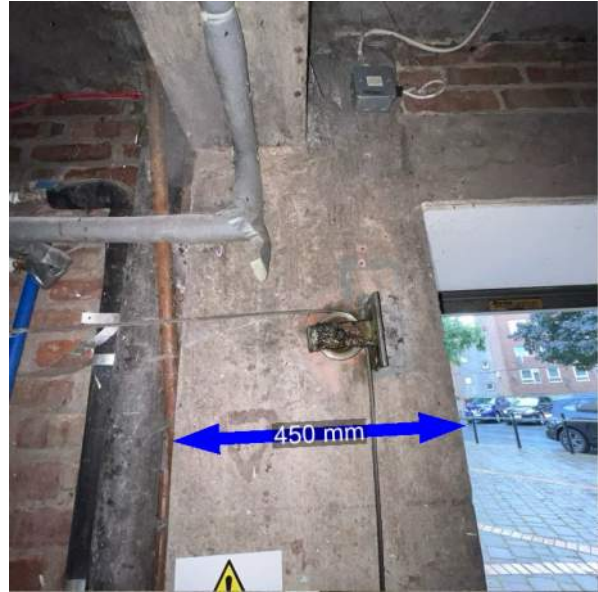
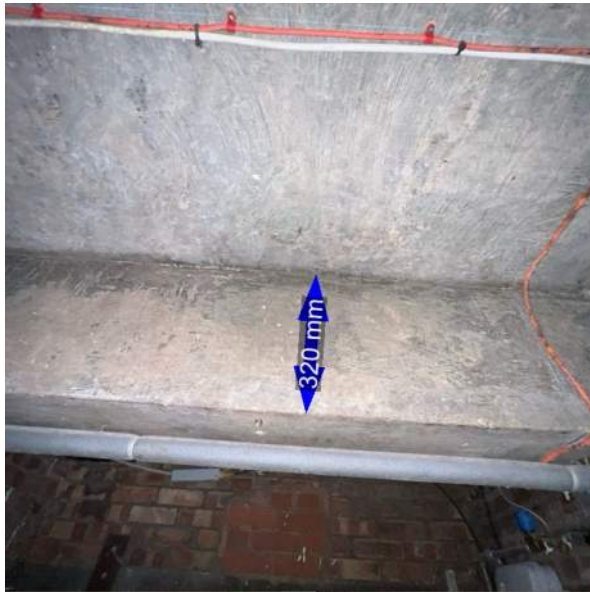
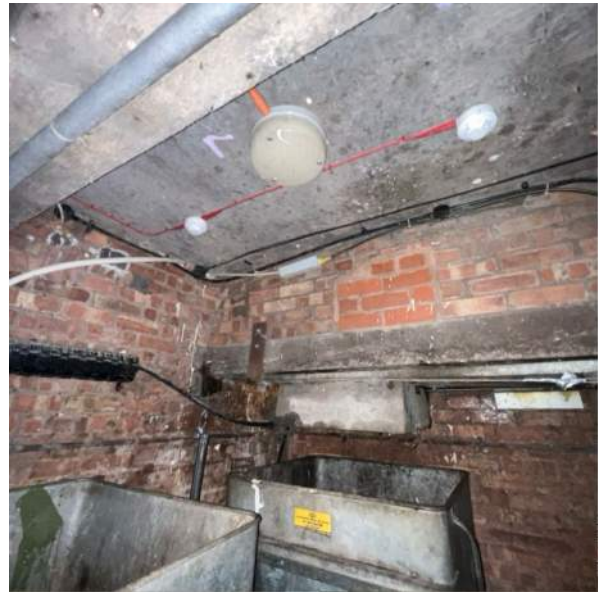
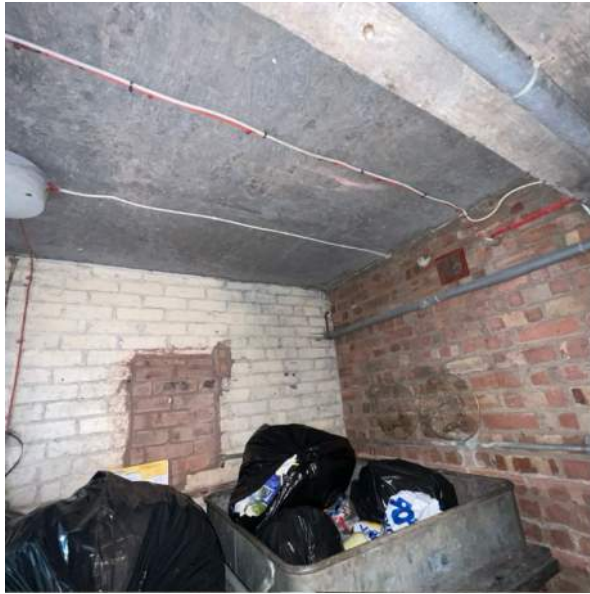
## Bin Store

RC column noted approx. 450 wide.

RC Beam noted approx. 320mm dp (from underside of ceiling).

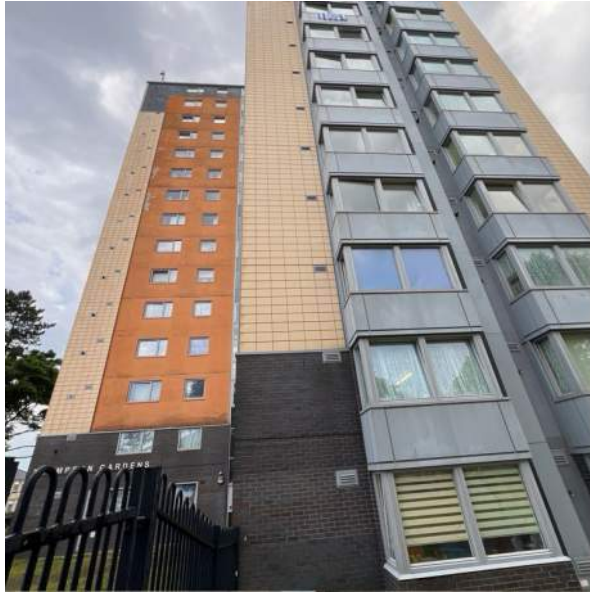
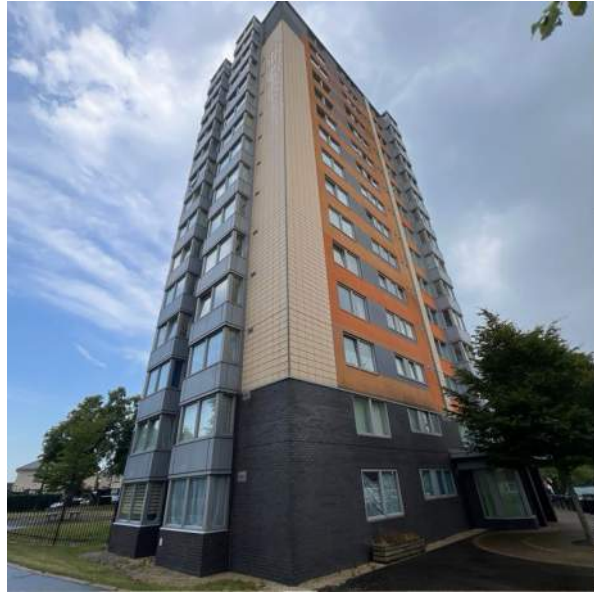
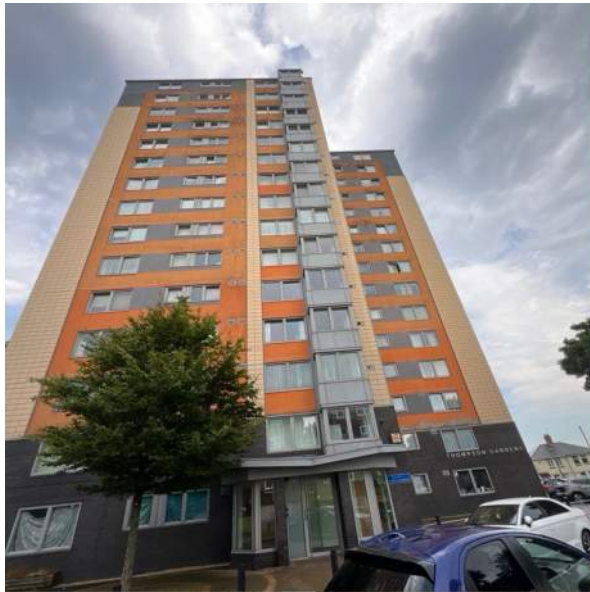
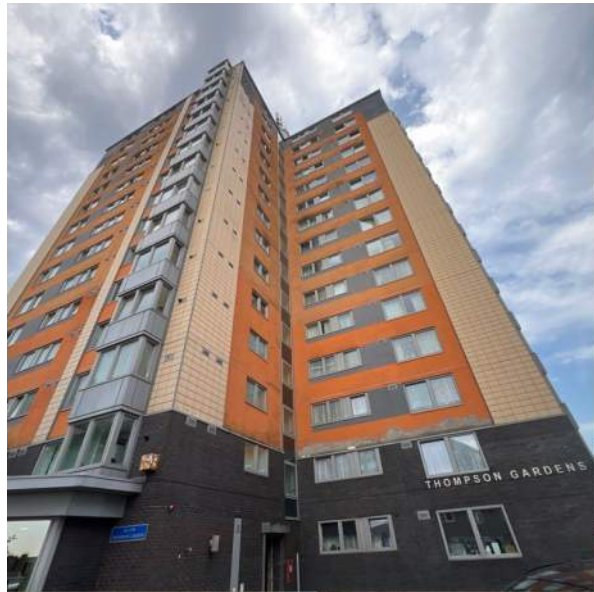
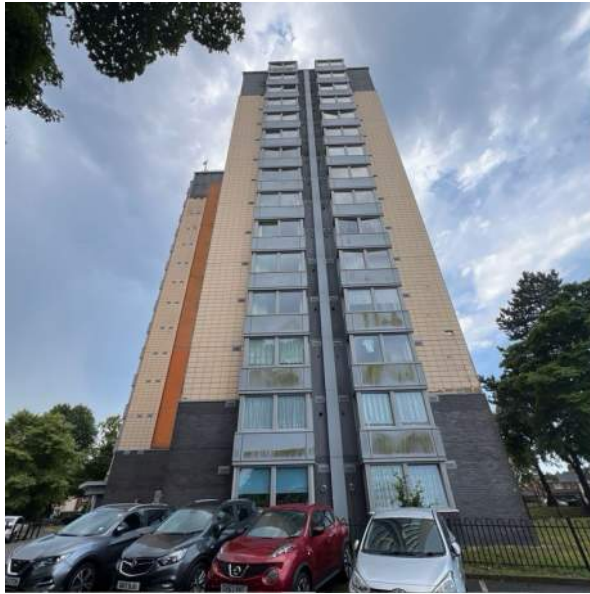
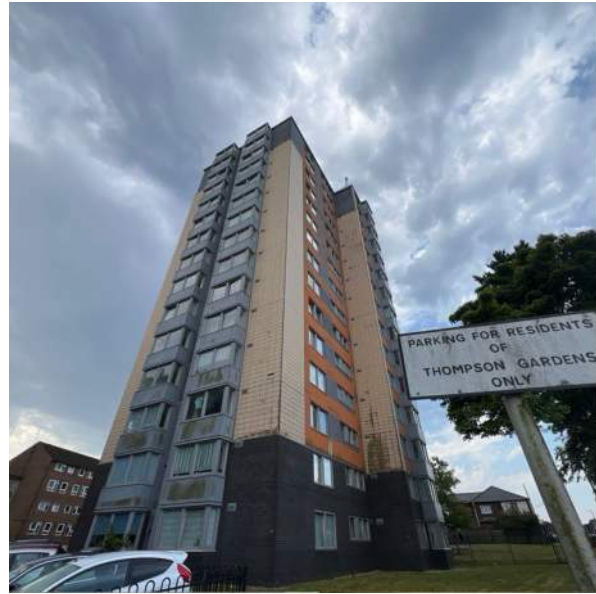
## Elevations

External ground and first level consists of brick work.  
Remaining floors noted to have a cladded facade to exterior.  
Some general maintenance/cleaning required to cladding.
