VISUAL STRUCTURAL APPRAISAL

Wallace House

Badsey Rd  
Oldbury  
B69 1ER

12<sup>th</sup> November 2024

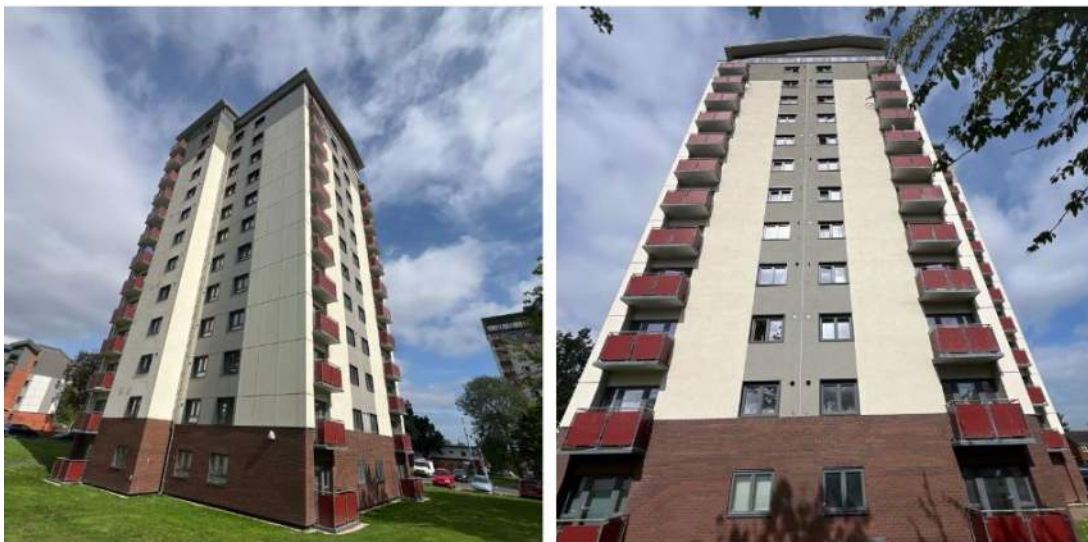
Figure 9 and 10: Building Elevations

The exterior elevations were generally in ok condition and no significant structural defects were noted to the cladding panels. There were no significant cracks or tell-tale signs of any significant structural movement noted at the time of our inspection.

The exterior panels were noted to be plumb with no signs of significant bowing, bulging or leaning noted to the panels indicating failed fixings however their presence and condition cannot be confirmed.

There are balconies at each level which are formed of cantilevered RC slabs tied into the main frame, likely cast monolithically with the primary RC frame.

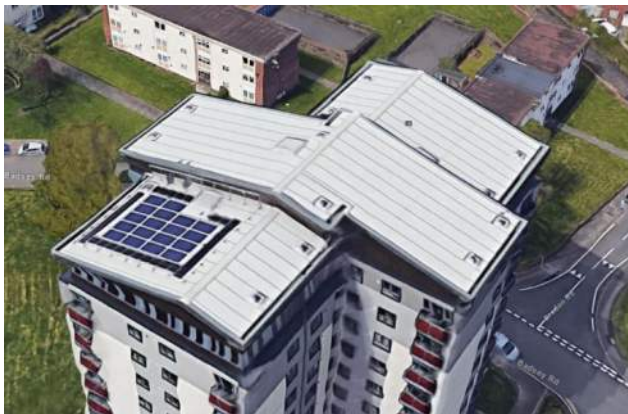
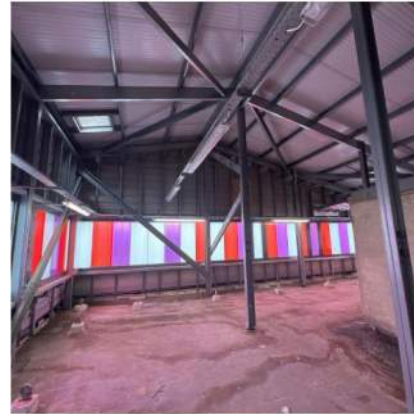
Figure 11 and 12: Roof Level

There were no tell-tale signs of any significant structural movement noted at the time of our inspection. The exterior walls were noted to be plumb with no signs of significant bowing, bulging or leaning noted to the masonry walls.

The roof has subsequently been covered with a new waterproofing covering formed of a steel frame installed to the existing roof which supports pitched corrugated sheets. This roof is not insulated and therefore acts purely as a weather barrier. The fire protection of the steel is unclear as the beams do not appear to be protected. Details of this frame should be requested from the contractor who completed the works in 2018.

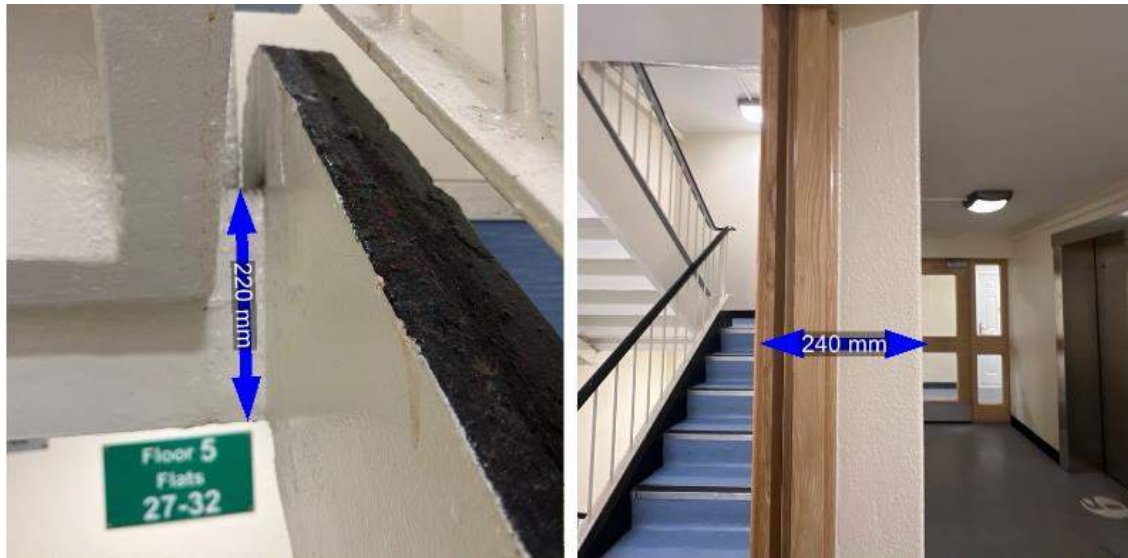
Figure 13 and 14: RC Structure

The interior of the stair core walls were checked and were plumb and in line with observations made to the exterior – no significant signs of leaning or movement noted. The concrete appeared in fair condition with few BRE category 1 cracks but no structurally significant defects were noted.

The shear walls around stair core appeared to be 240mm including finishes, therefore ~200mm RC wall. A cover test is required to check the resistance of the concrete section in the event of a fire.

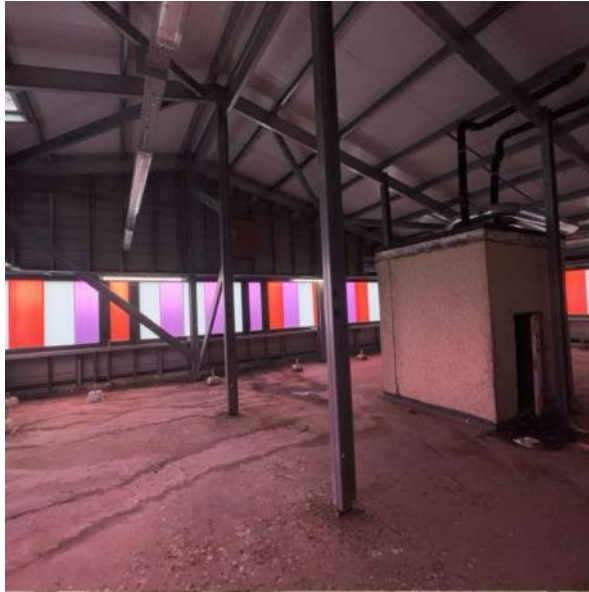
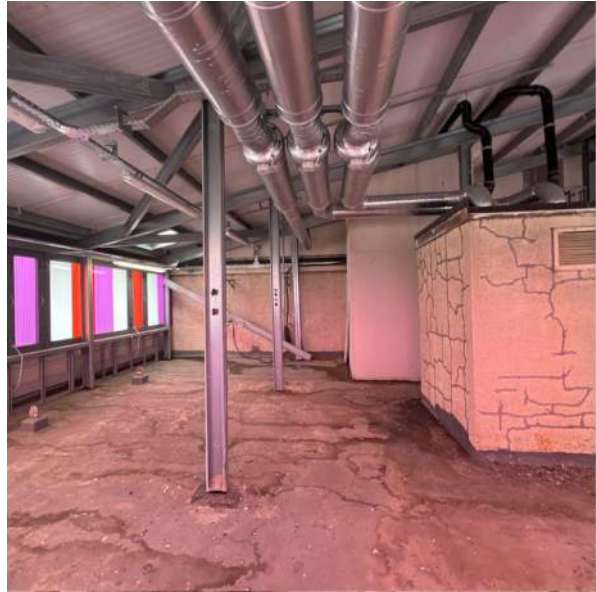
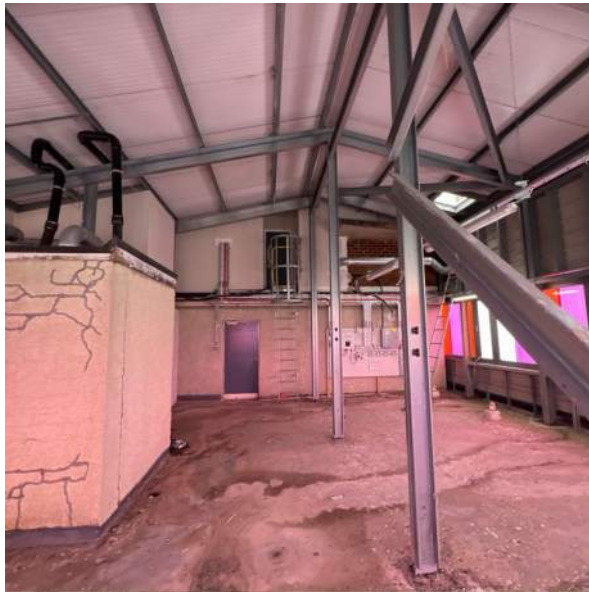
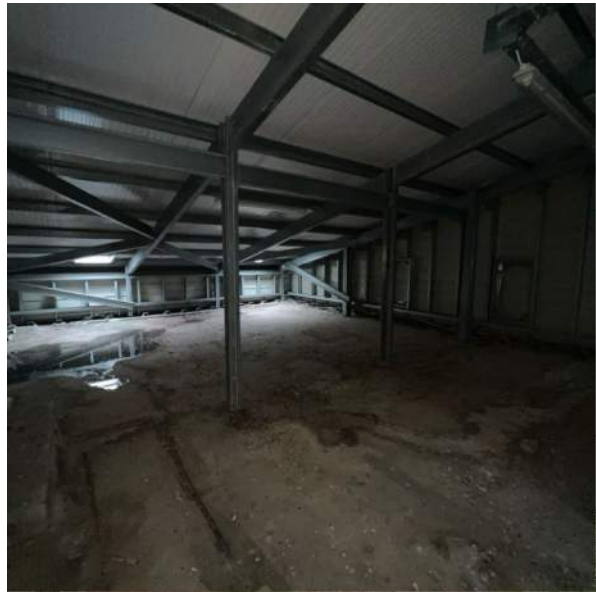
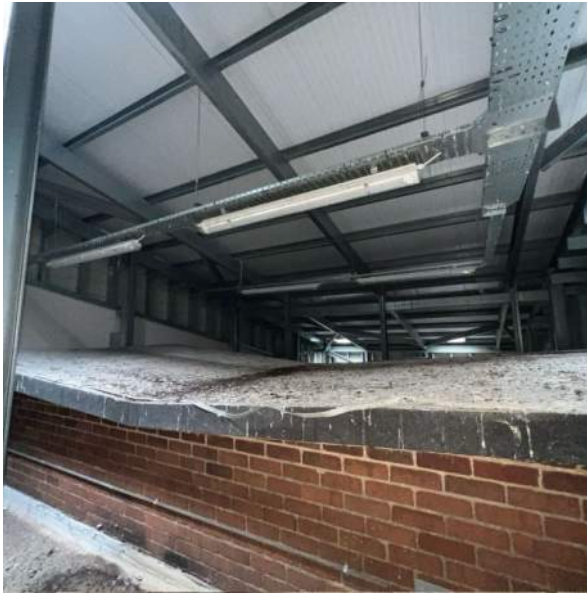
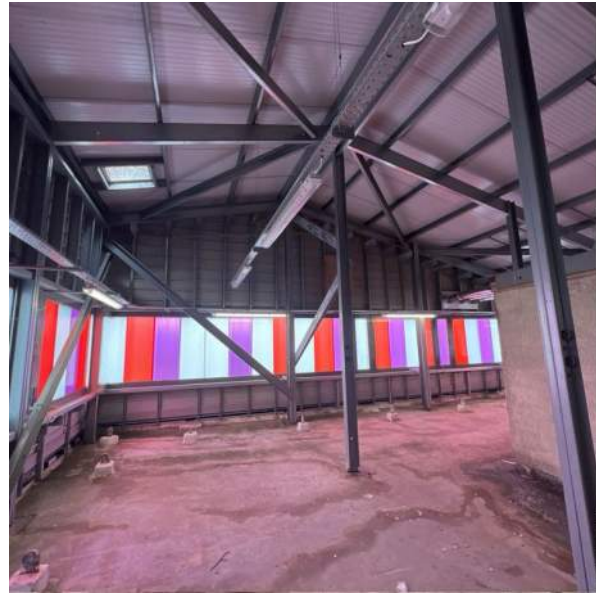
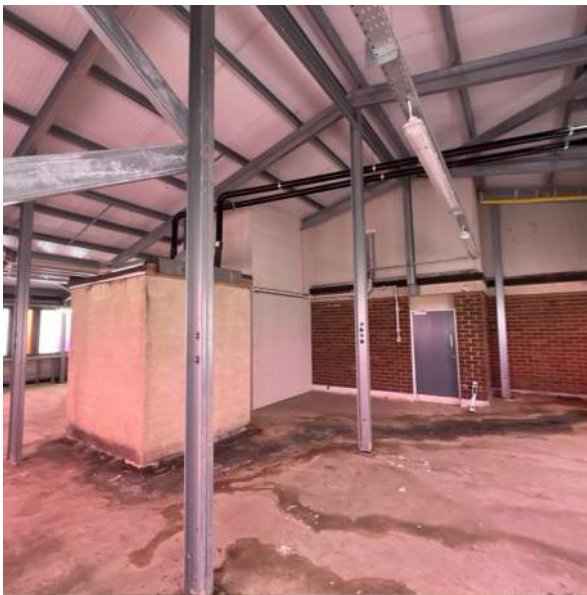
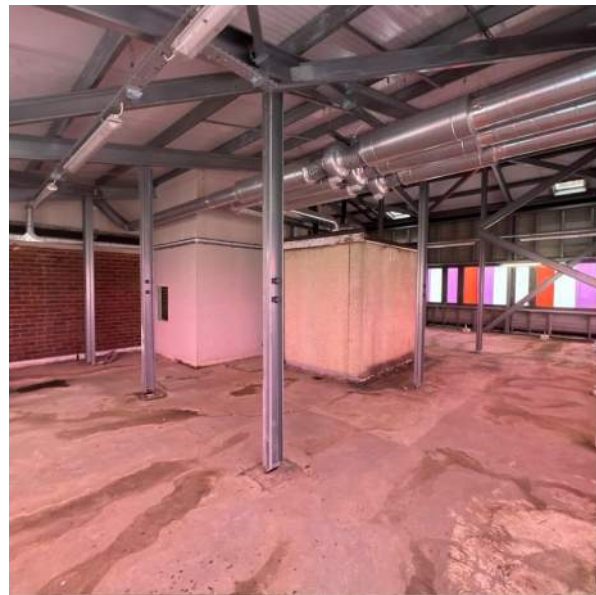
## Main Roof

Comments: Roof structure consists of a lower and higher section and is formed of a concrete slab with a Lightweight SFS (appear to be cold rolled) frame with a pitched roof fixed on to main roof structure. Frame columns fixed to perimeter of roof. Some historical staining to roof slab.

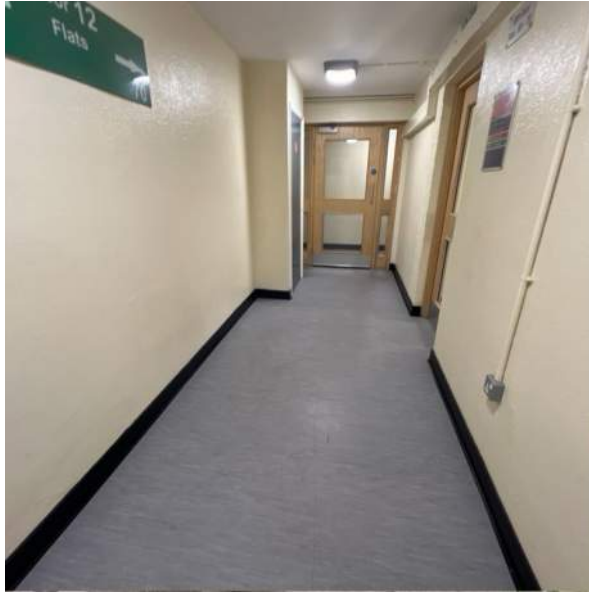
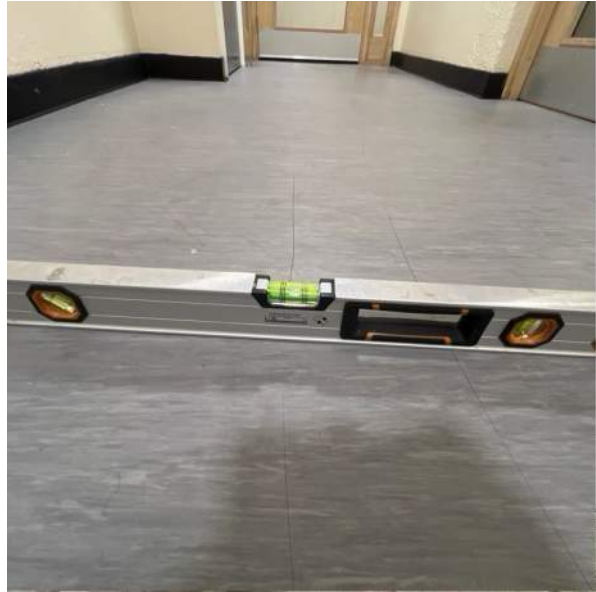
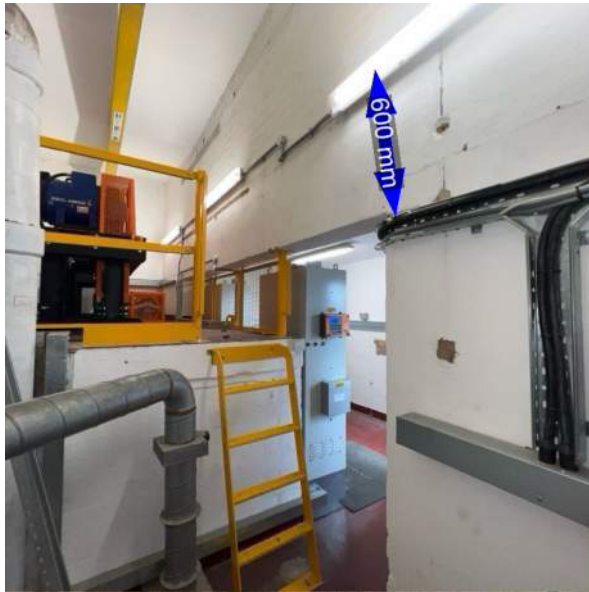
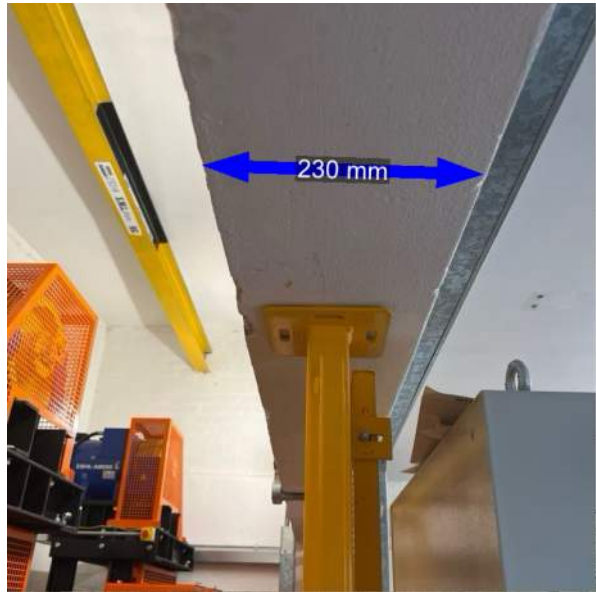
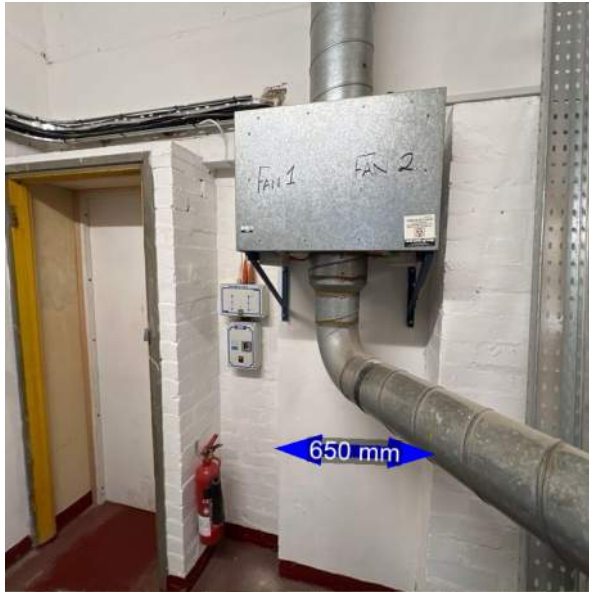
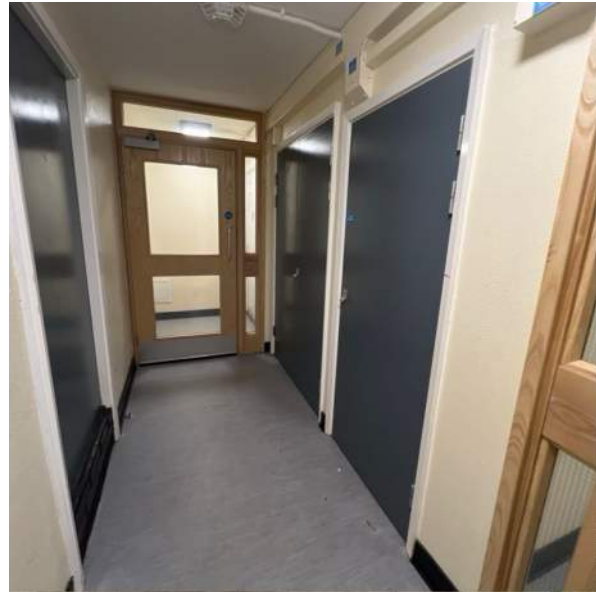
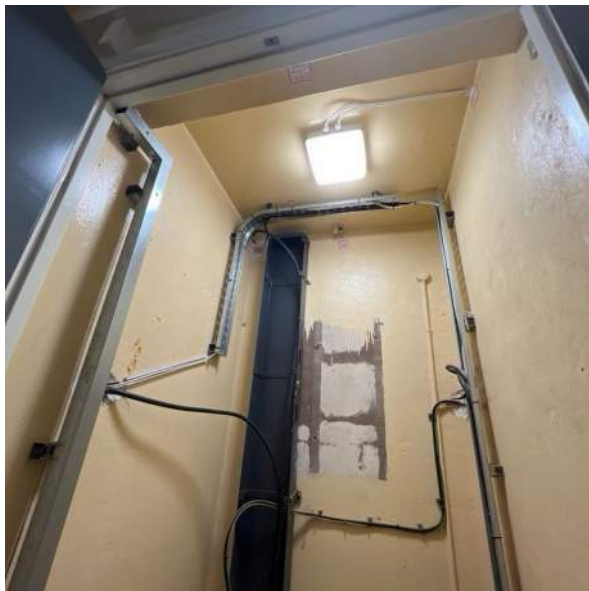
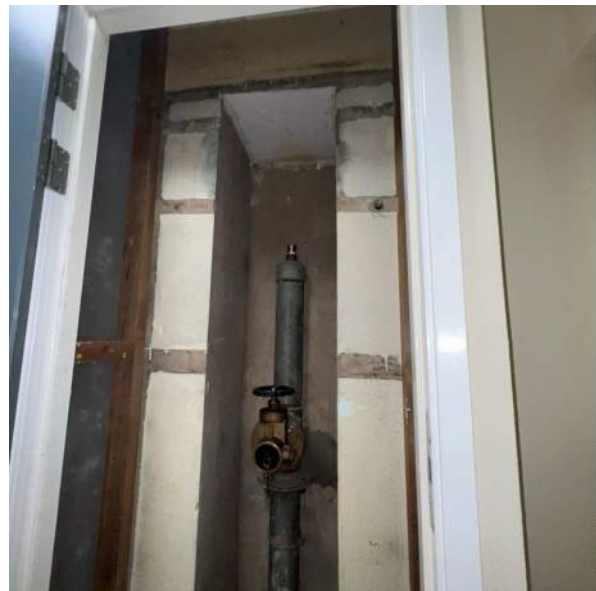
## 12th Floor Hallway

Comments: No jams or distortions noted to hallway doors to indicate any serviceability issues. Generally walls covered with finishes in hallway, likely to consist a mixture of concrete shear walls and embedded columns with internal partition walls. Visible concrete elements (RC Beams and Columns) noted via lift room. Some infill (non-load bearing) masonry noted, some of which are rendered.

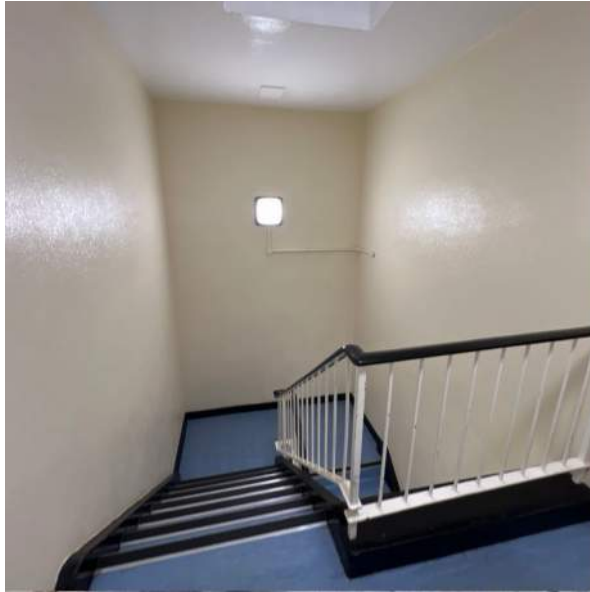
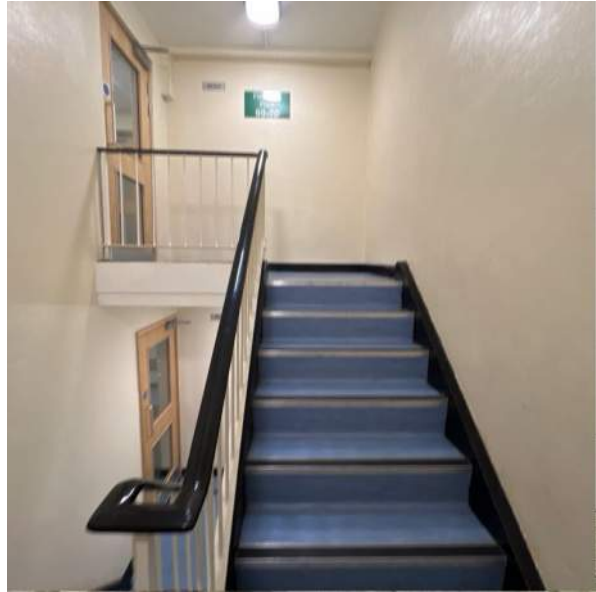
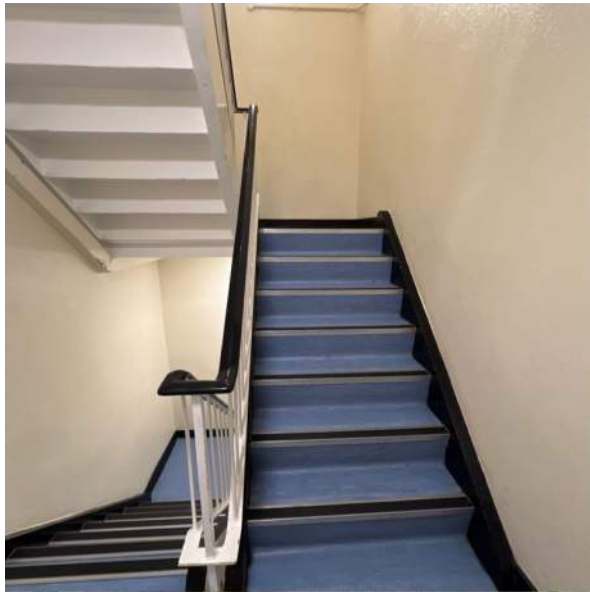
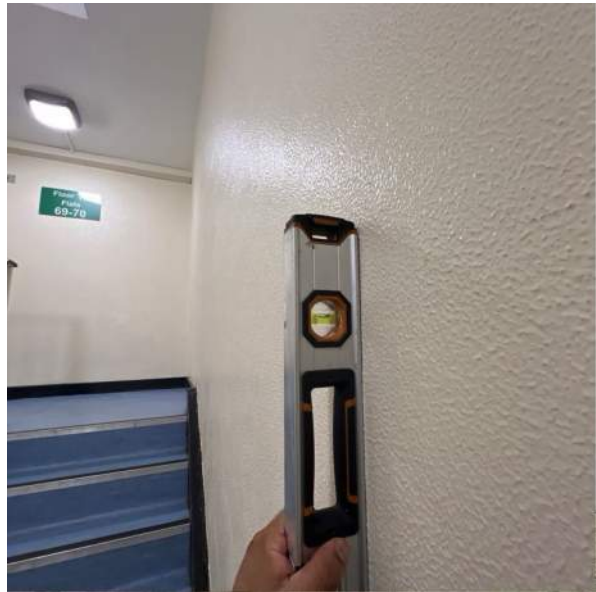
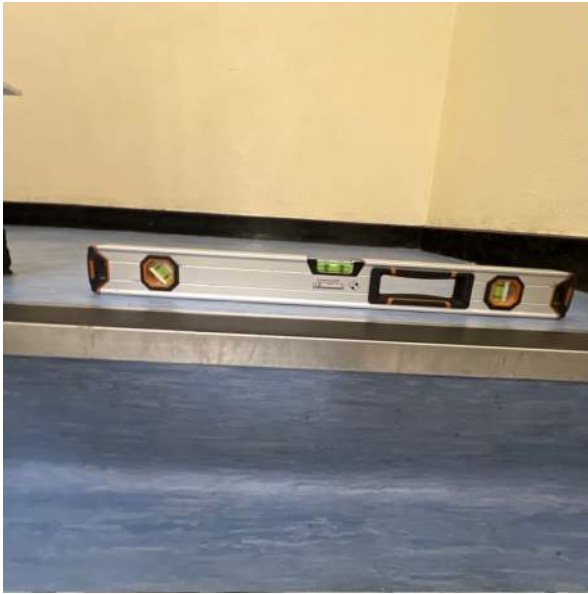
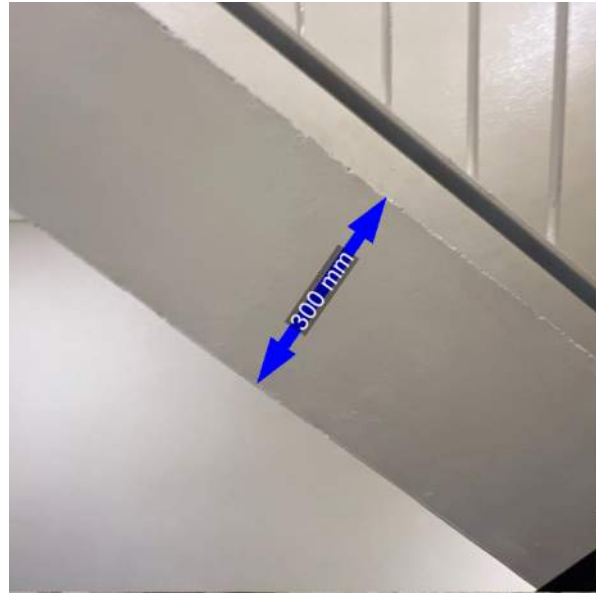
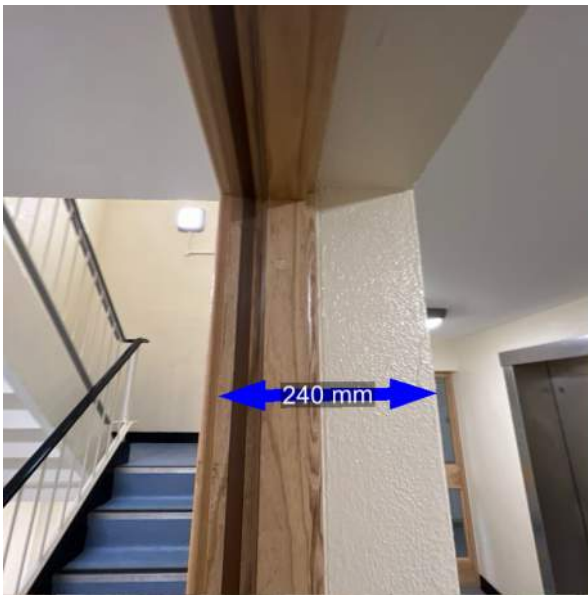
## 12th Floor Staircase

In situ concrete stairs with steel hand railing fixed to stairs. Walls and floors appear to be fairly level.

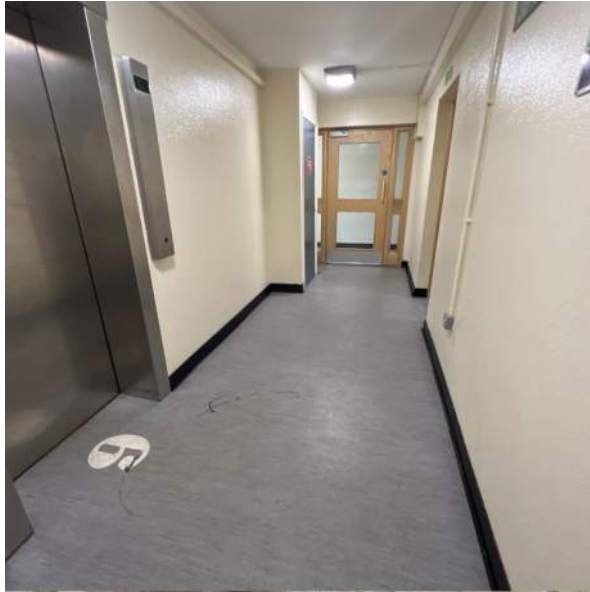
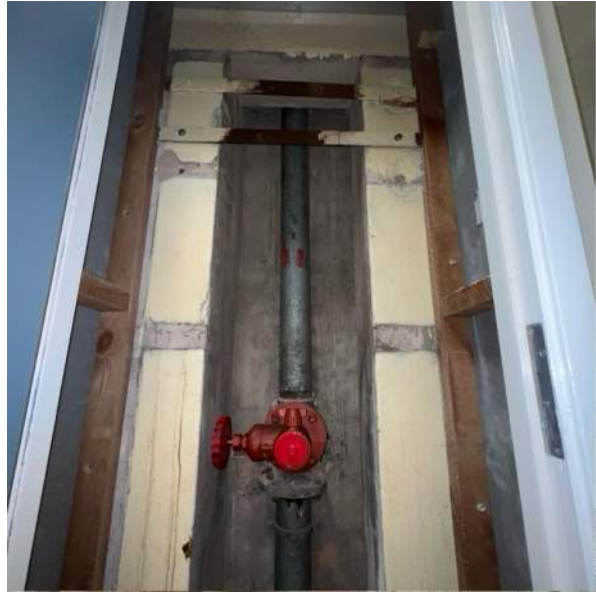
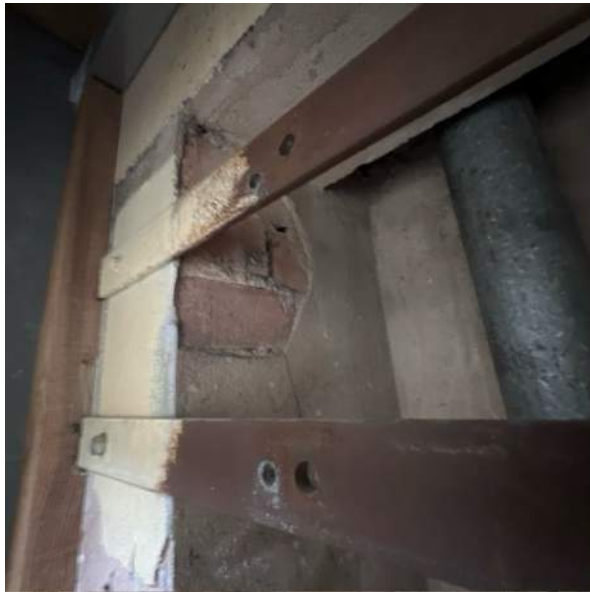
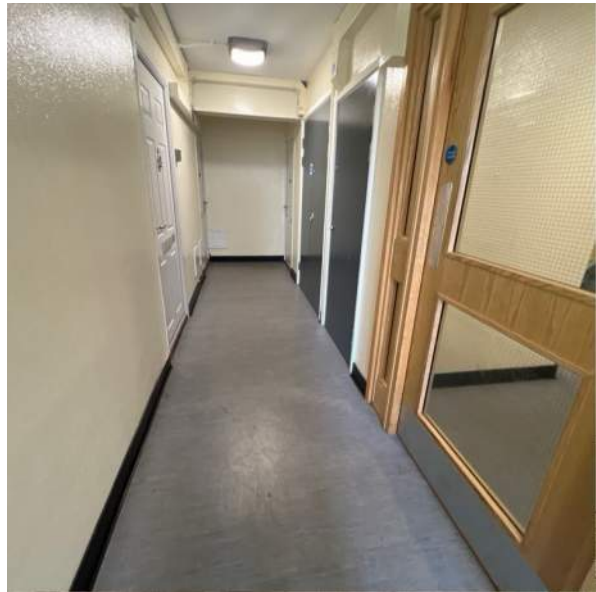
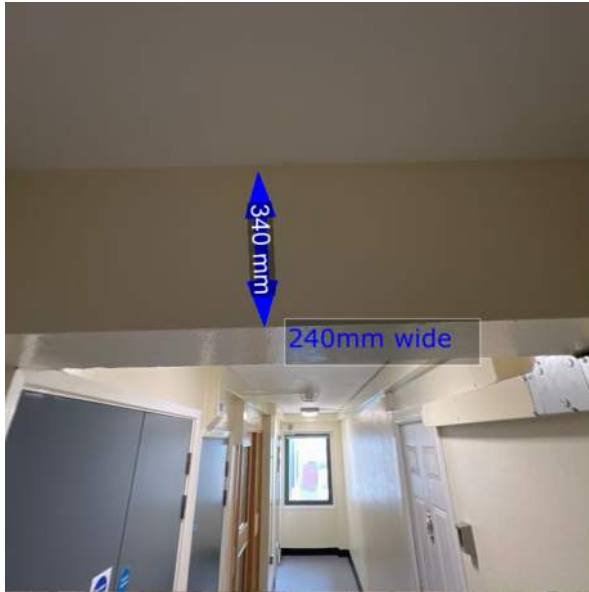
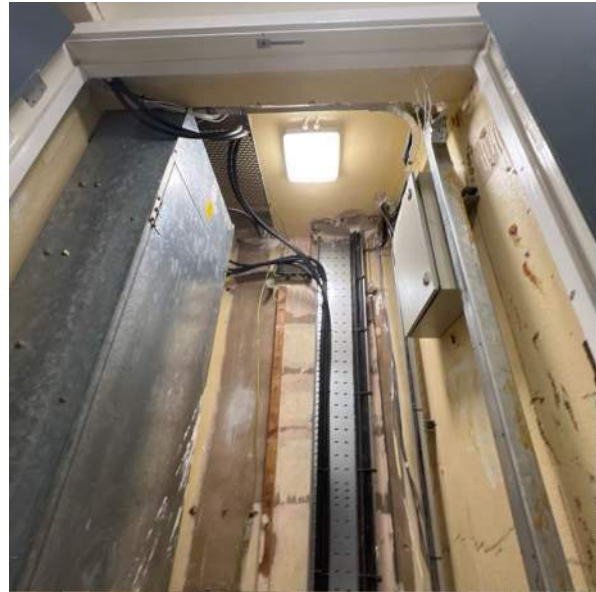
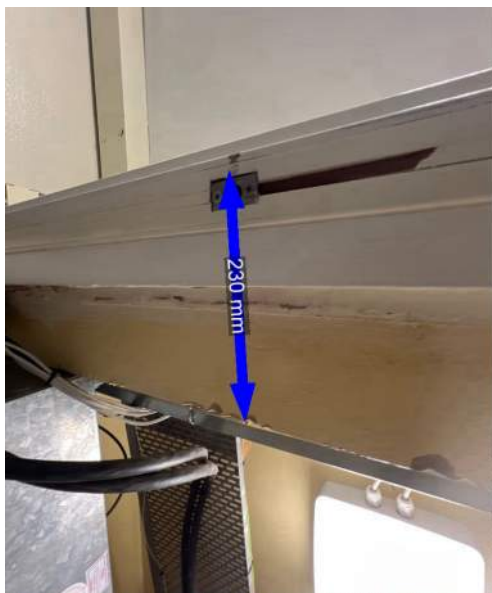
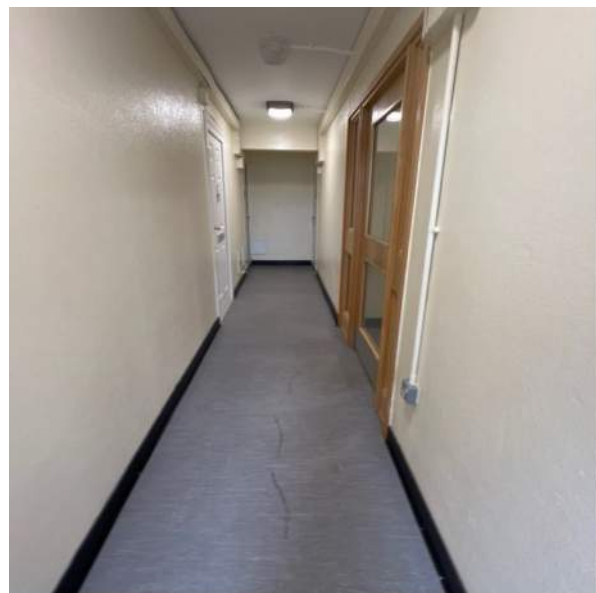
## 6th Floor Hallway

No jams or distortions noted to hallway doors to indicate any serviceability issues. Generally walls covered with finishes in hallway, likely to consist a mixture of concrete shear walls and embedded columns with internal partition walls. Possible concrete walls noted via riser cupboard. Some infill (non-load bearing) masonry noted some of which are rendered.

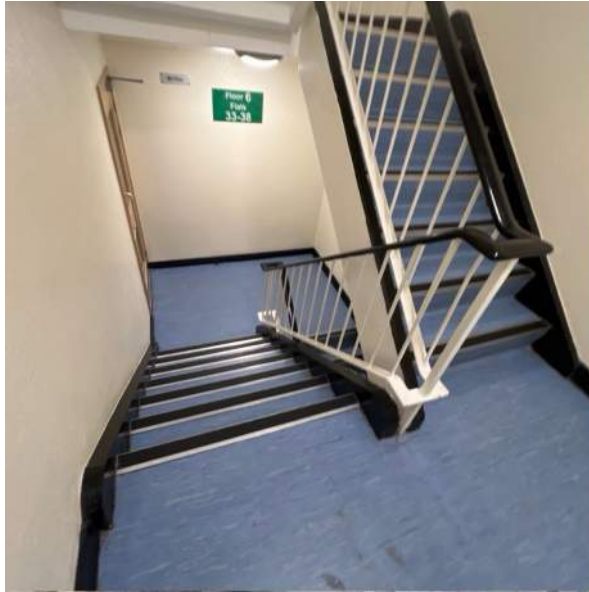
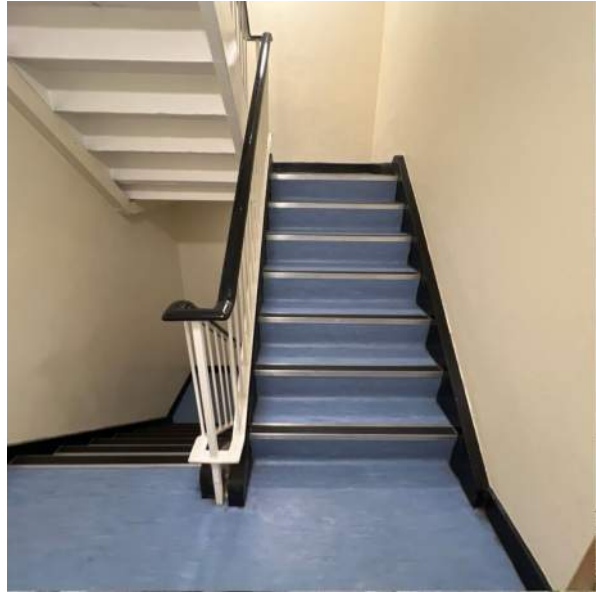
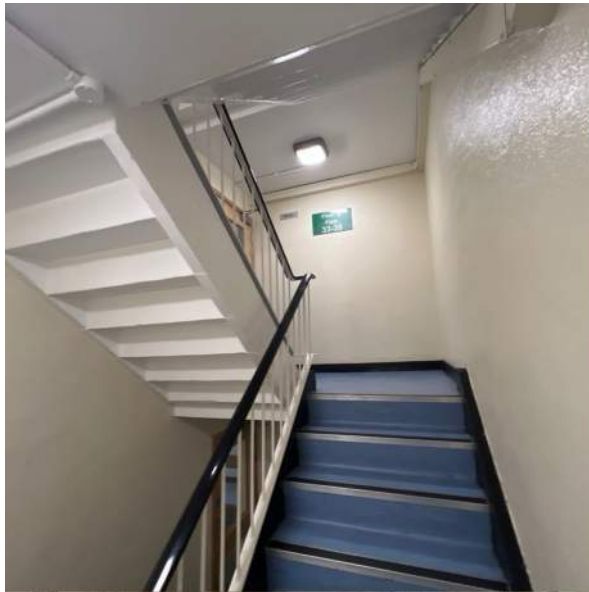
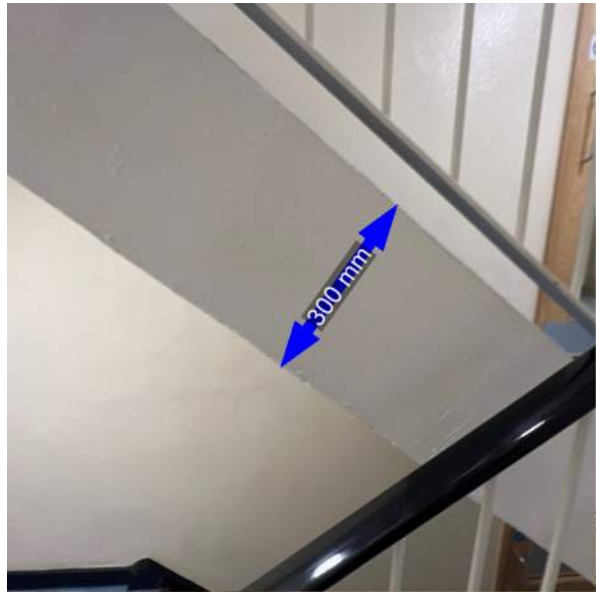
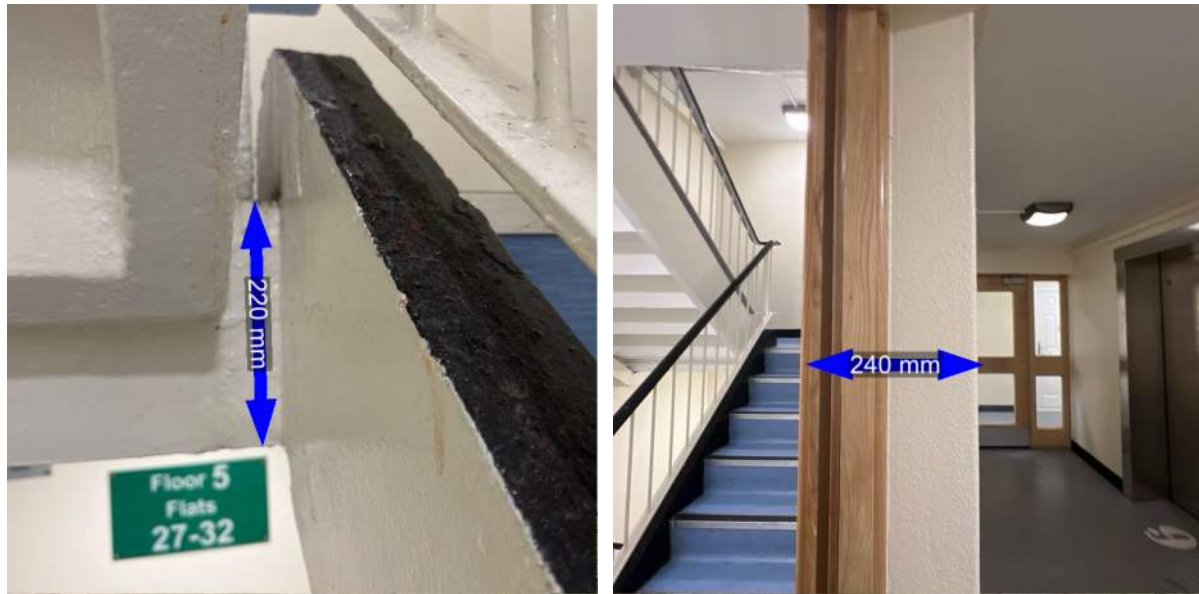
## 6th Floor Staircase

In situ concrete stairs with steel hand railing fixed to stairs. Walls and floors appear to be fairly level.

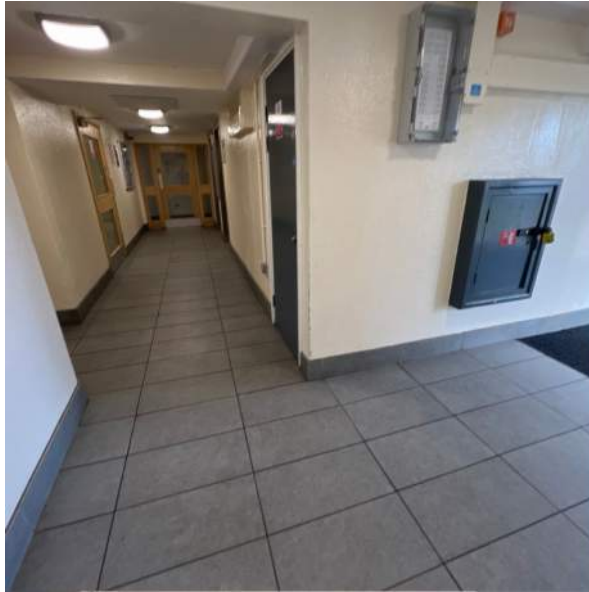
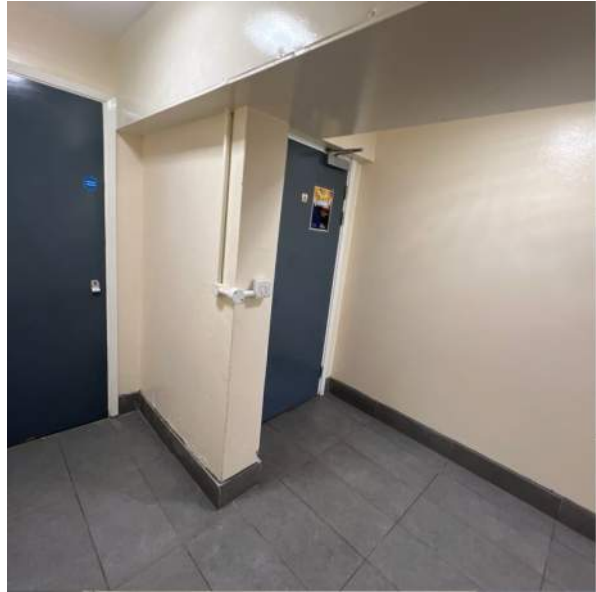
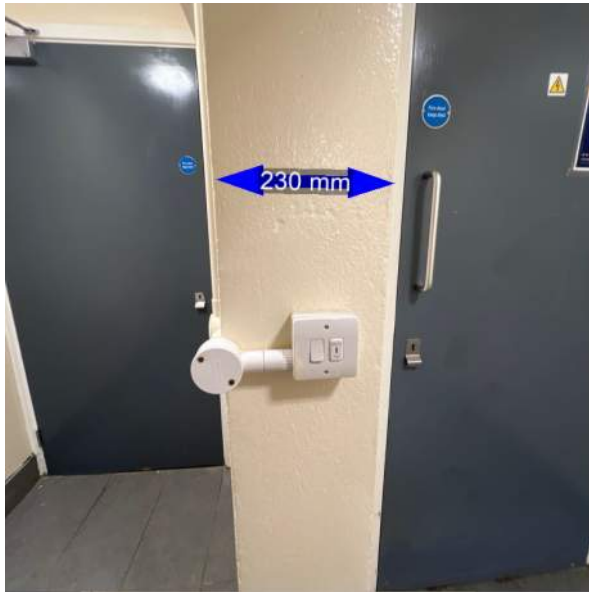
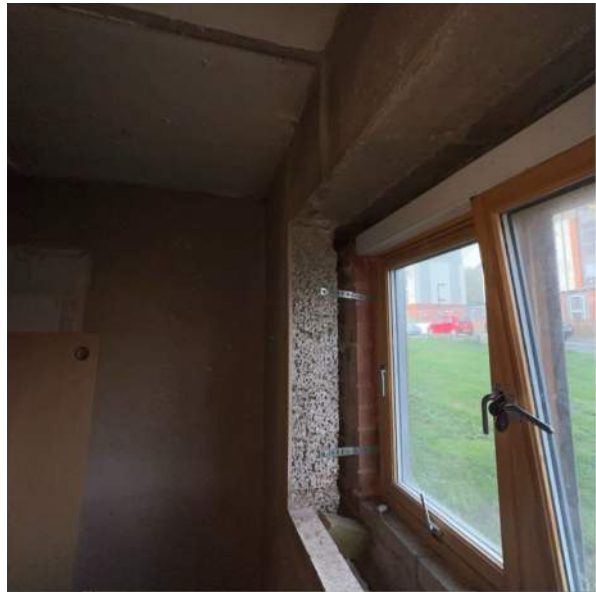
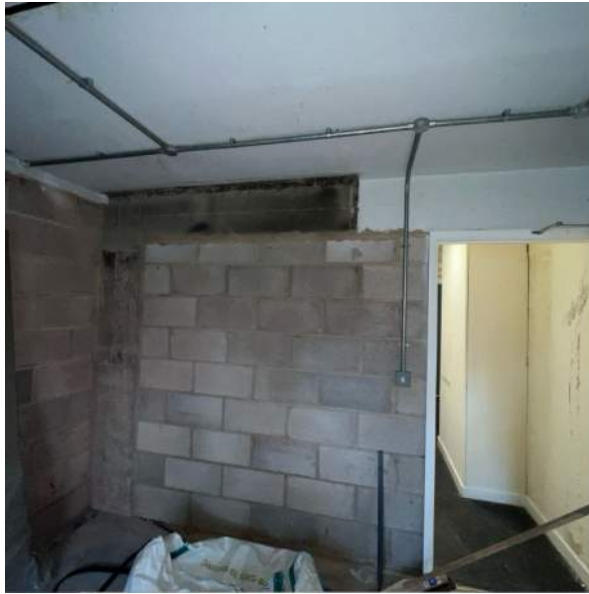
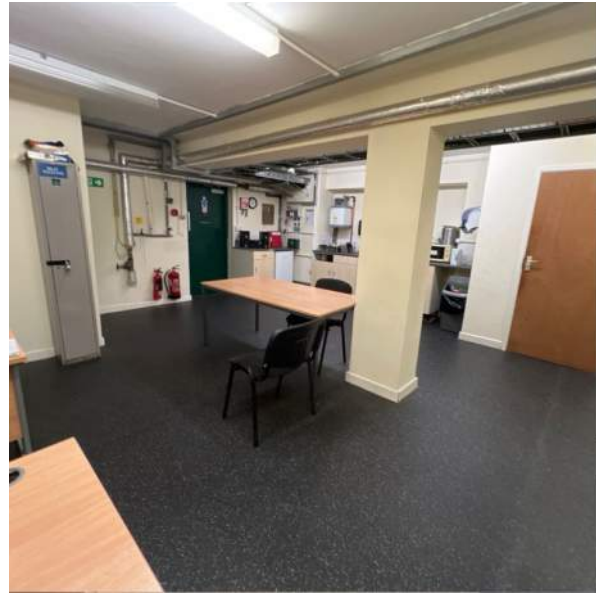
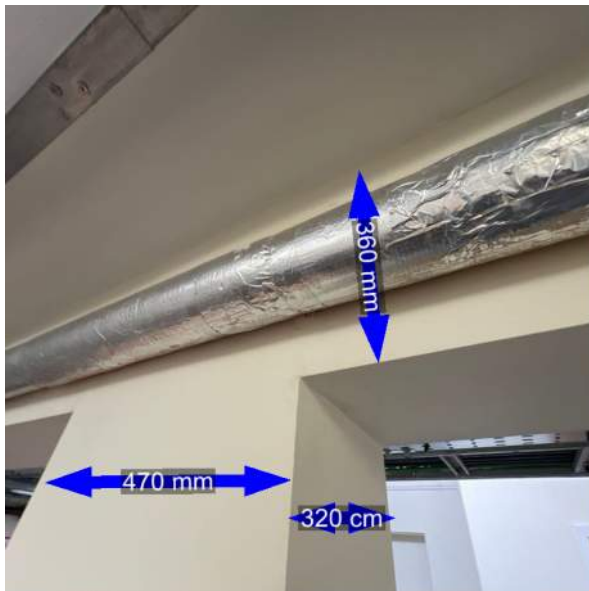
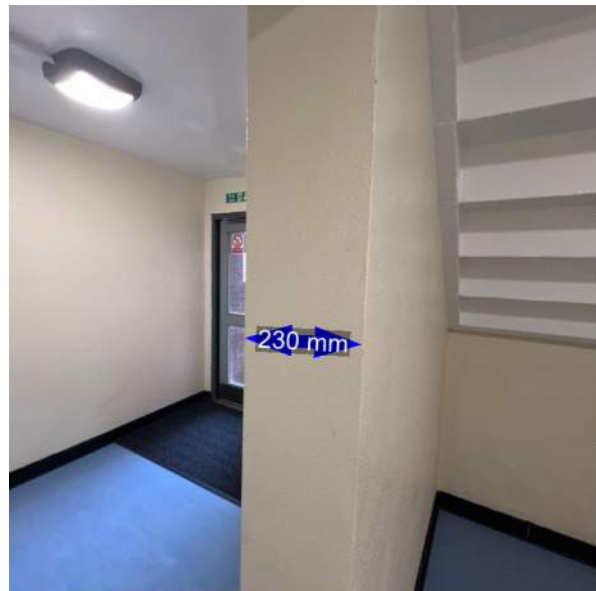
## Ground Floor Hallway

No jams or distortions noted to hallway doors to indicate any serviceability issues. Generally walls covered with finishes in hallway, likely to consist a mixture of concrete shear walls and embedded columns with internal partition walls. Concrete frame consisting of RC columns, Shear Walls and RC Beams noted in visible areas of ground floor rooms. Infill (non-load bearing) walls noted. Perimeter walls noted to have RC columns/walls and No-fines concrete infill walls.

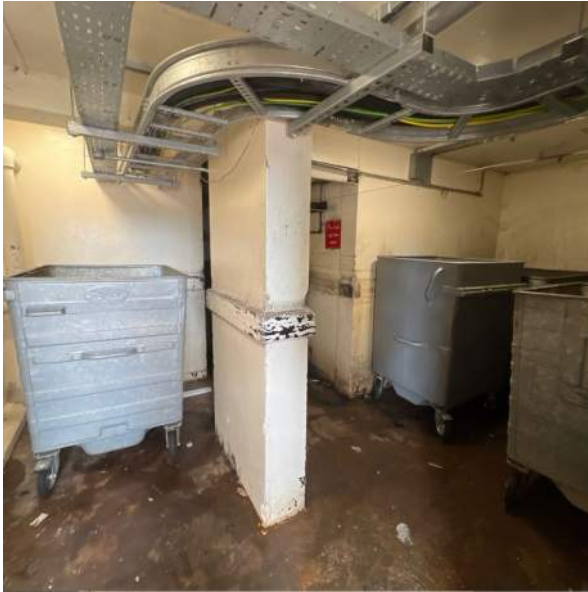
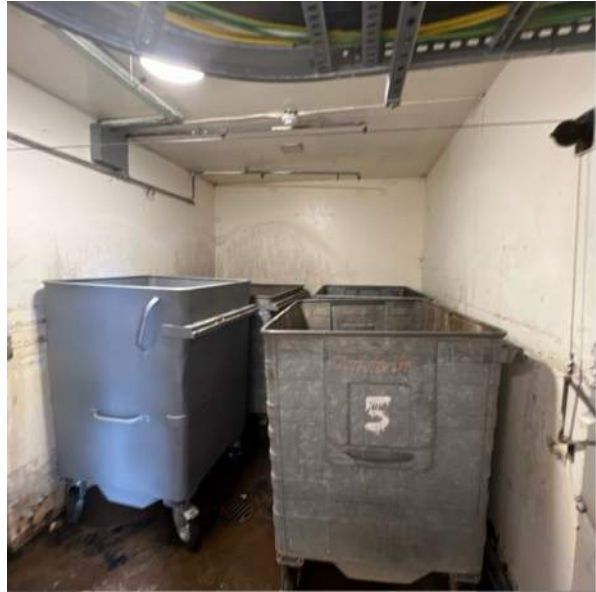
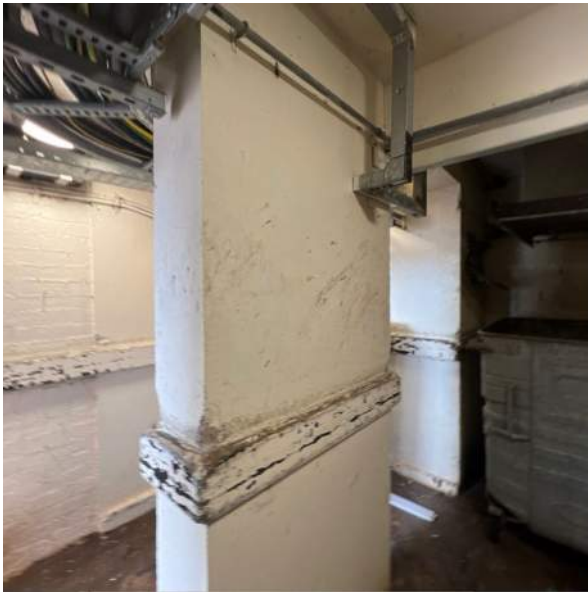
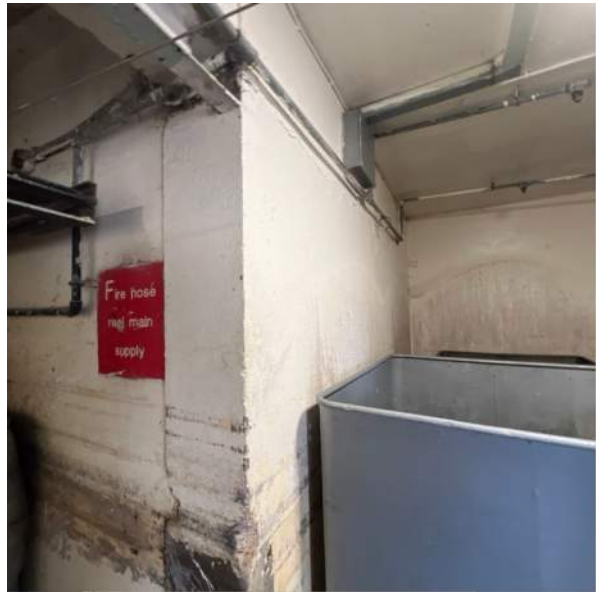
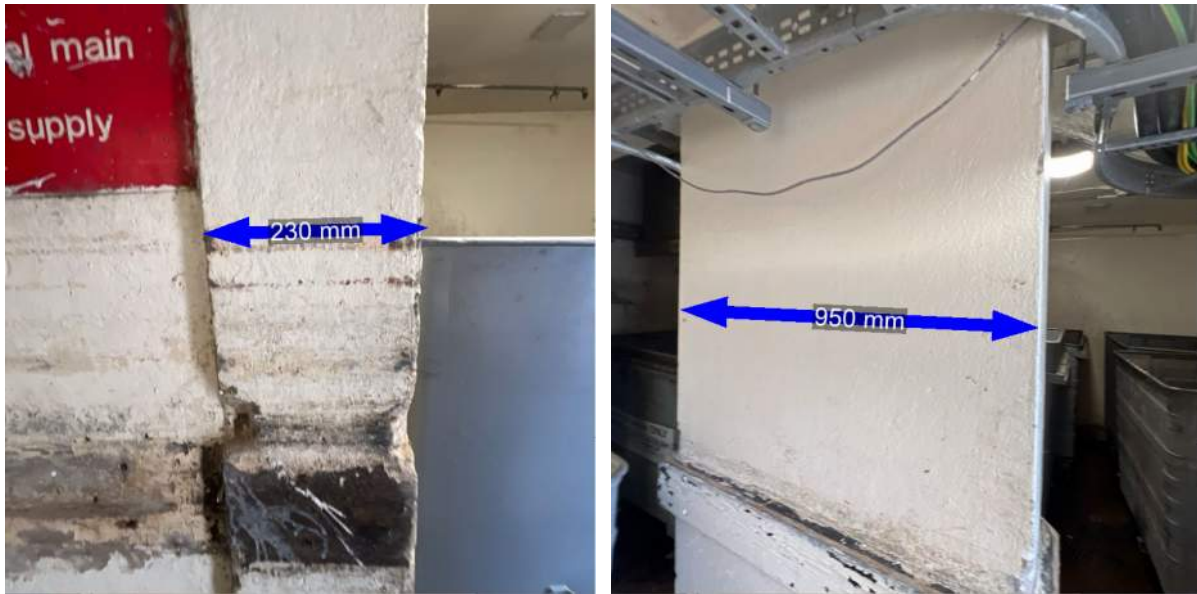
## Bin Store

Comments: RC shear walls, columns and beams noted.  
Infill (non-load bearings) masonry walls noted.
