VISUAL STRUCTURAL APPRAISAL

Wallace House

Badsey Rd  
Oldbury  
B69 1ER

12<sup>th</sup> November 2024

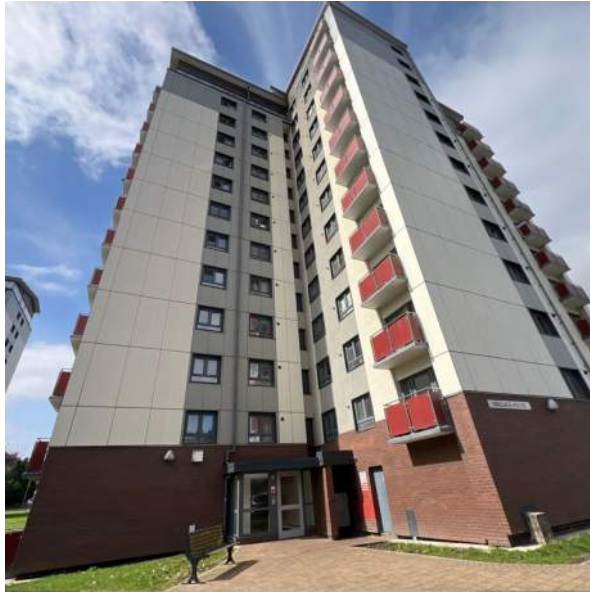
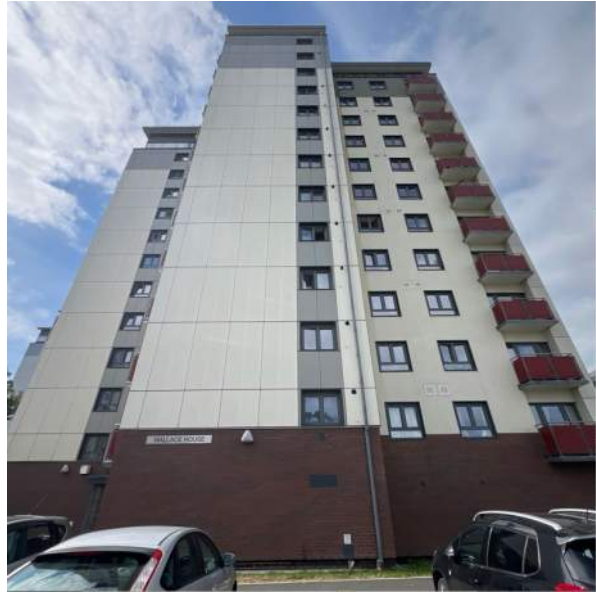
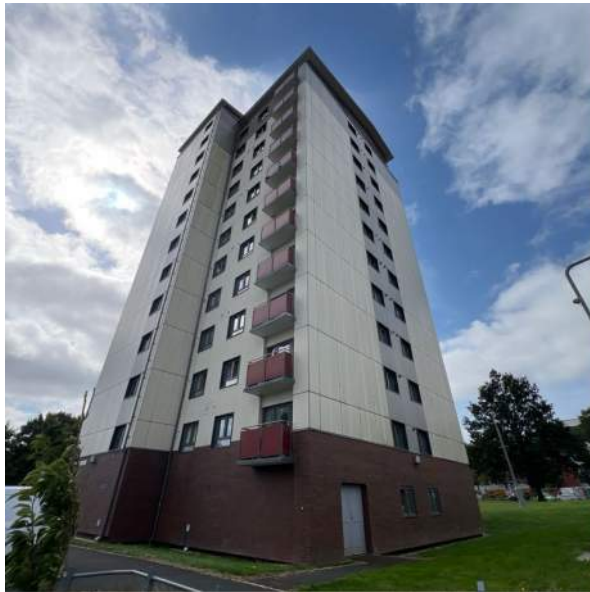
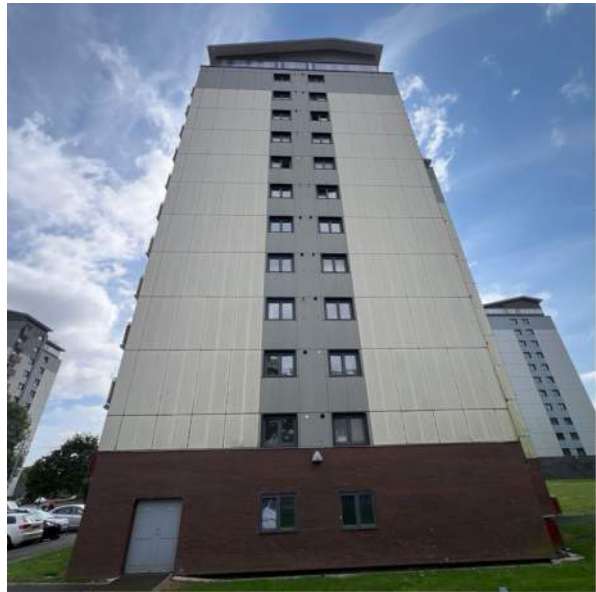
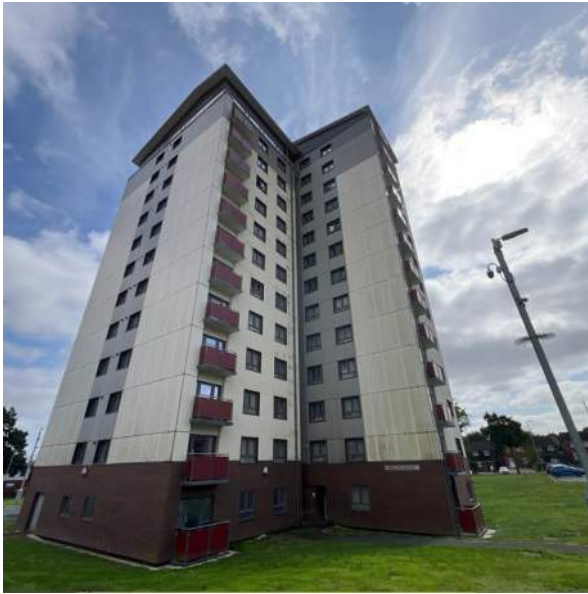
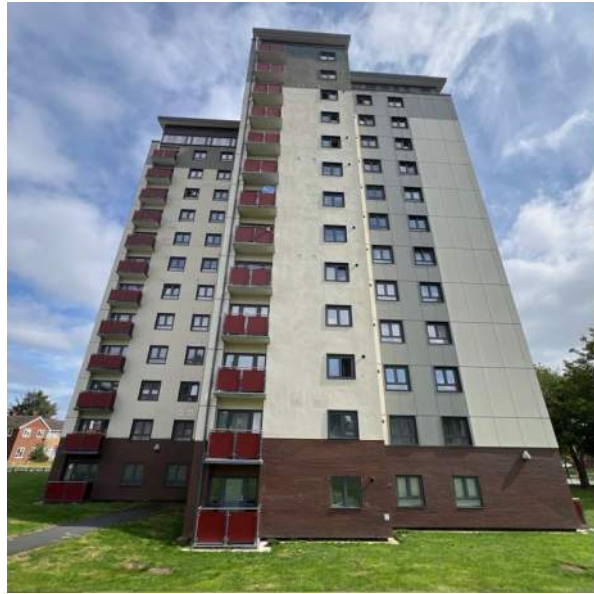
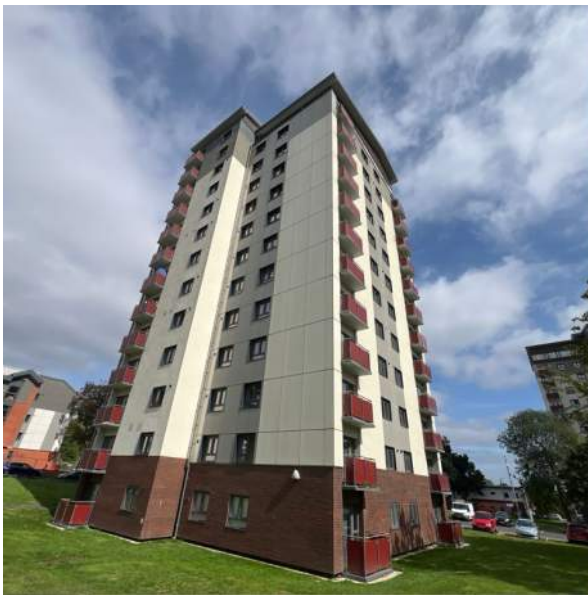
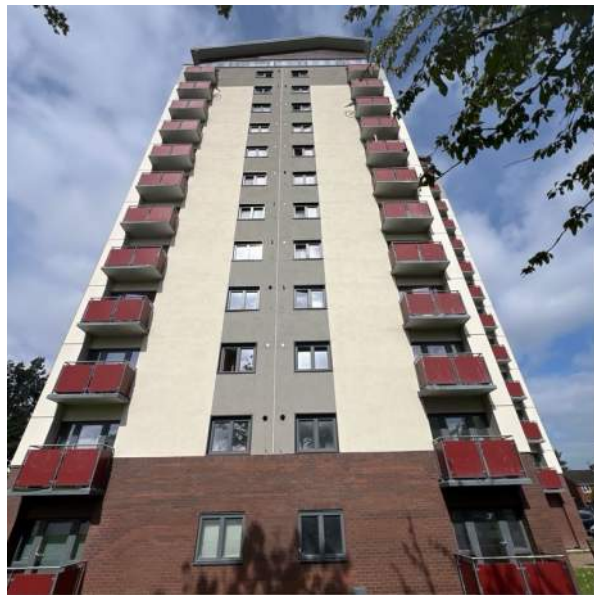
## Elevations

External ground floor level consists of brick work.  
Remaining floors noted to have a cladded facade to exterior. Balconies noted.  
Some staining noted to cladding.
