VISUAL STRUCTURAL APPRAISAL

Wesley Court

Southbank Road  
Oldbury  
B64 6LQ

29<sup>th</sup> November 2024

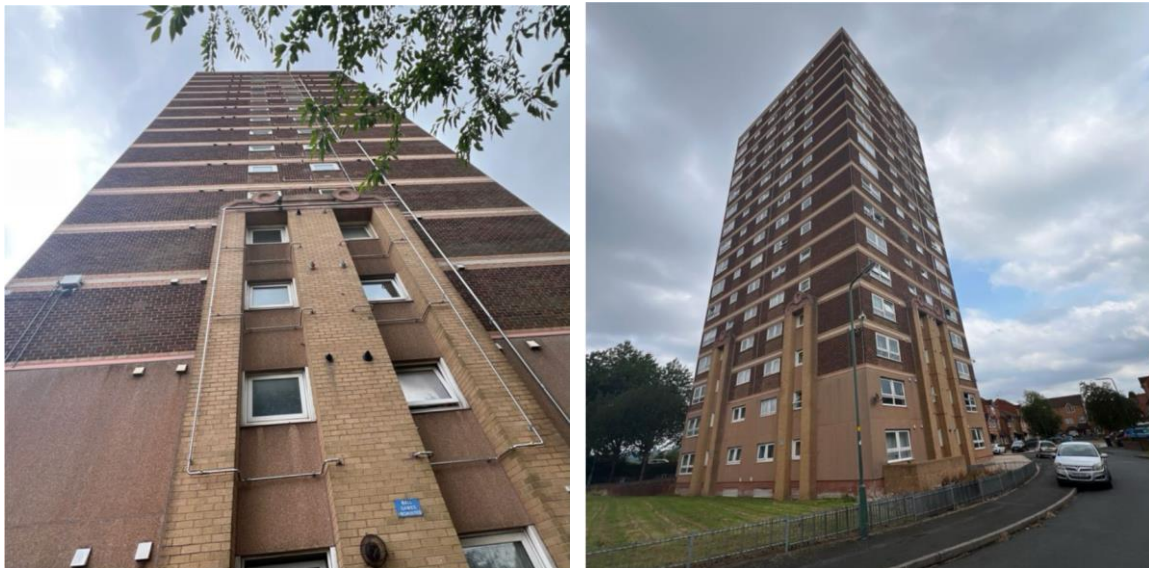
Figure 9 and 10: Elevations

The exterior elevations were generally in ok condition and no significant structural defects were noted to the infill panels. There were no significant cracks or tell-tale signs of any significant structural movement noted at the time of our inspection.

There were Resin-Stenni panels to ground and first floor. The remaining upper levels are constructed as a cavity wall, with a stretcher bond to the outer leaf. We were unable to see within the wall cavity to confirm whether there are ties or masonry supports present. The exterior walls were noted to be plumb with no signs of significant bowing, bulging or leaning noted to the cavity walls indicating failed fixings, however their presence and condition cannot be confirmed.

The exterior panels were noted to be plumb with no signs of significant bowing, bulging or leaning noted to the panels indicating failed fixings however their presence and condition cannot be confirmed.

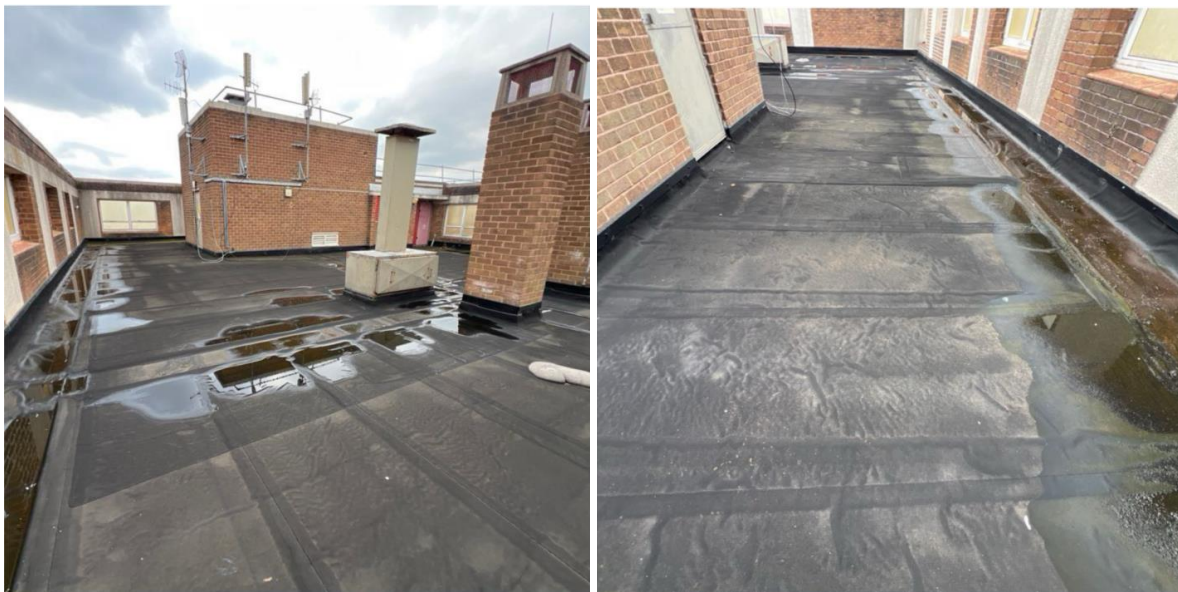
Figure 11 and 12: Roof Level

There were no tell-tale signs of any significant structural movement noted at the time of our inspection. The exterior walls were noted to be plumb with no signs of significant bowing, bulging or leaning noted to the cavity wall panels.

The roof has a single ply membrane finish. The exact build-up of the roof finishes were not accessible at the time of inspection. It is recommended an intrusive survey of the roof finishes is completed by a specialist surveyor to assess the condition of the roof covering.

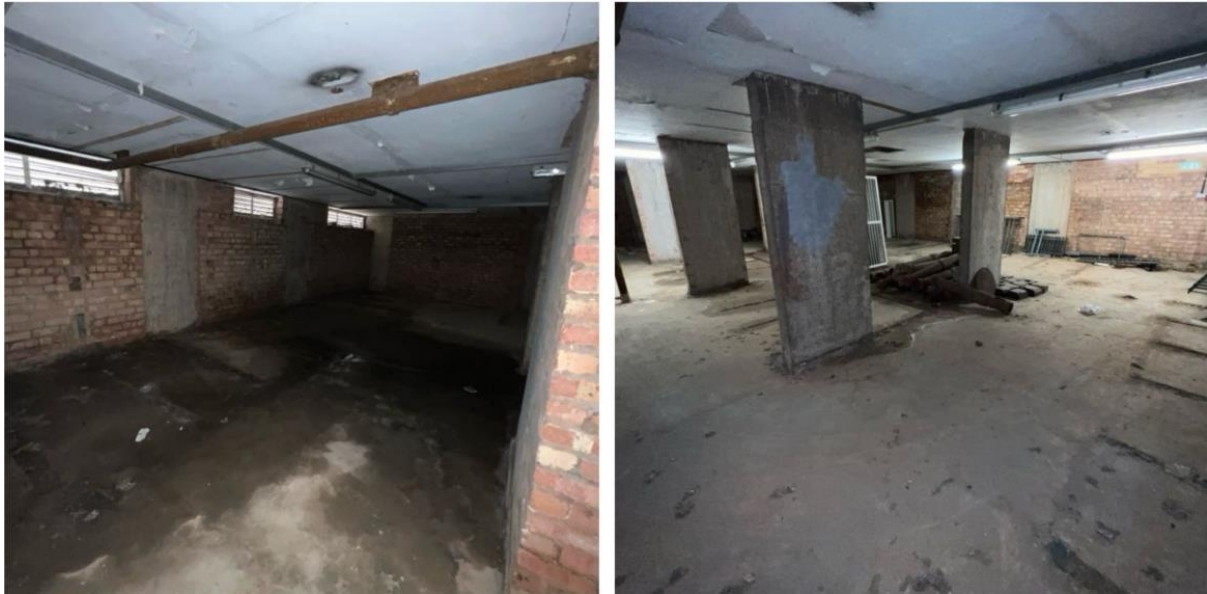
Figure 13 and 14: Vertical RC Structure Visible

There is a basement across the footprint of the building with the RC layout visible. The slabs are providing compartmentation to the building and therefore should meet the fire requirements. A cover meter survey is required to estimate the fire resistance of the floor slabs.

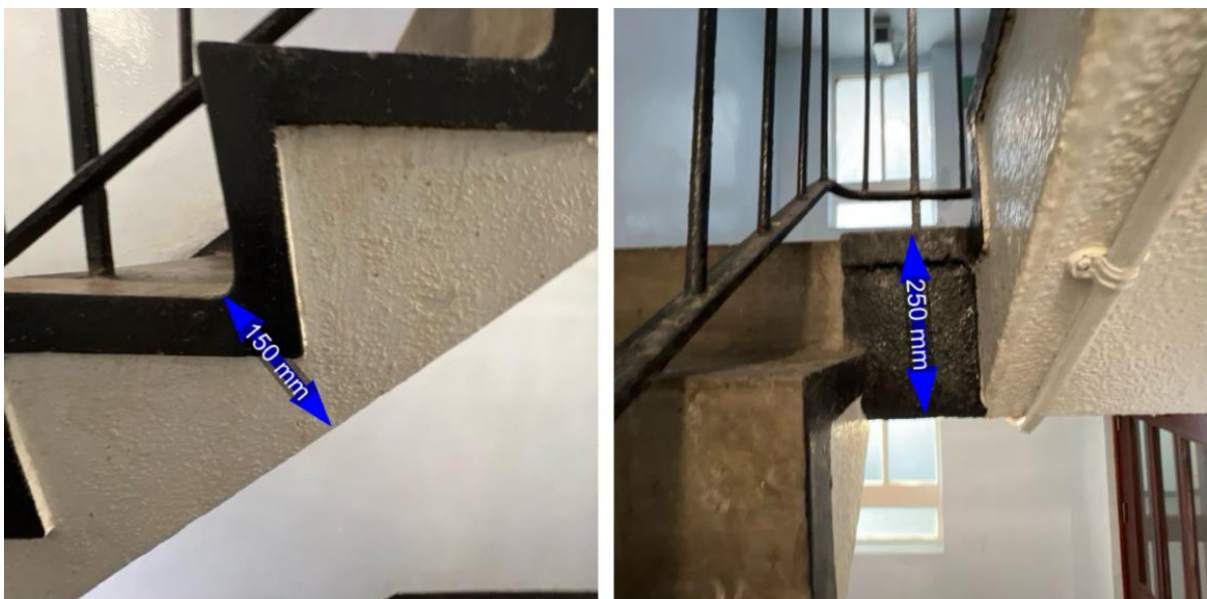
Figure 15 and 16: Staircase Stringer and shear wall

The stair stringer was noted to be 150mm thick, a cover test is required to check the resistance of the concrete section in the event of a fire.

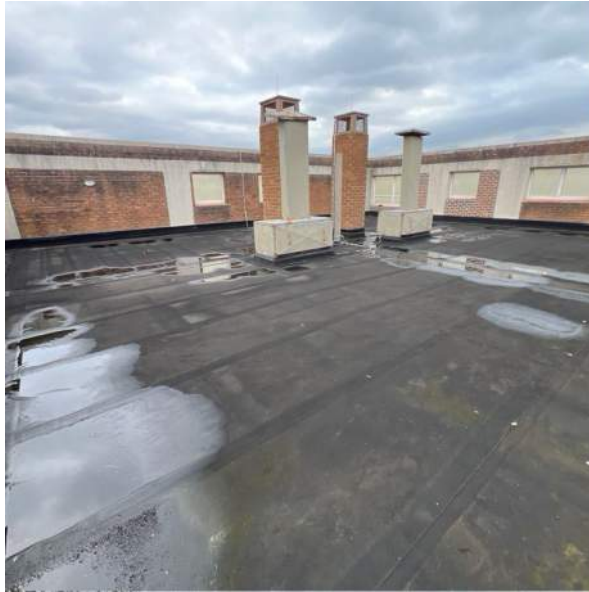
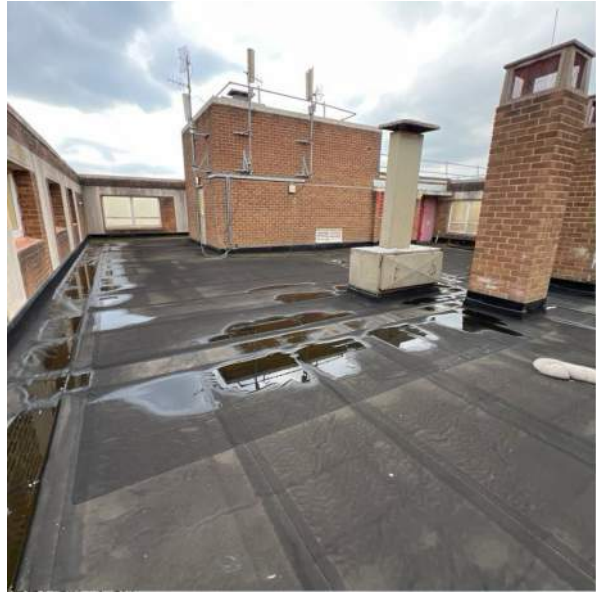
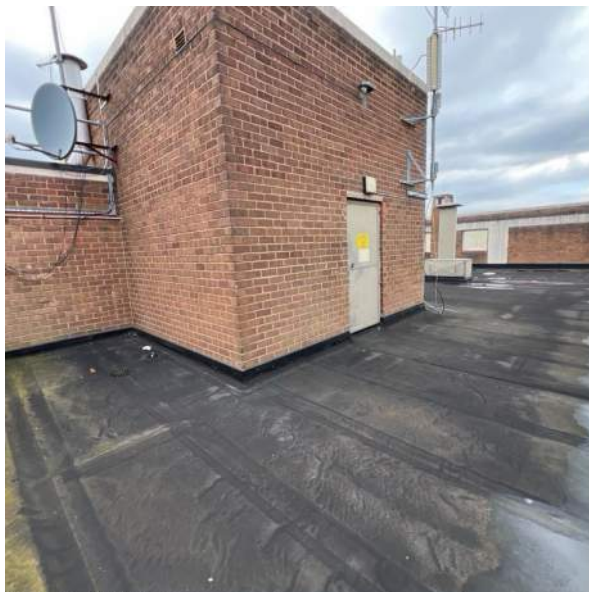
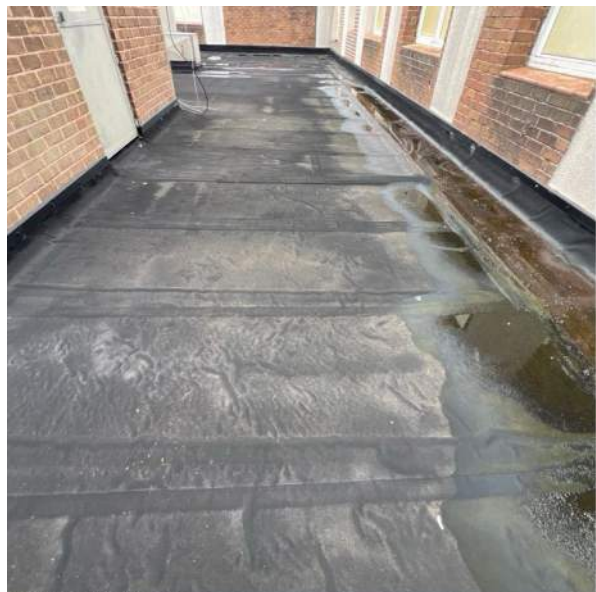
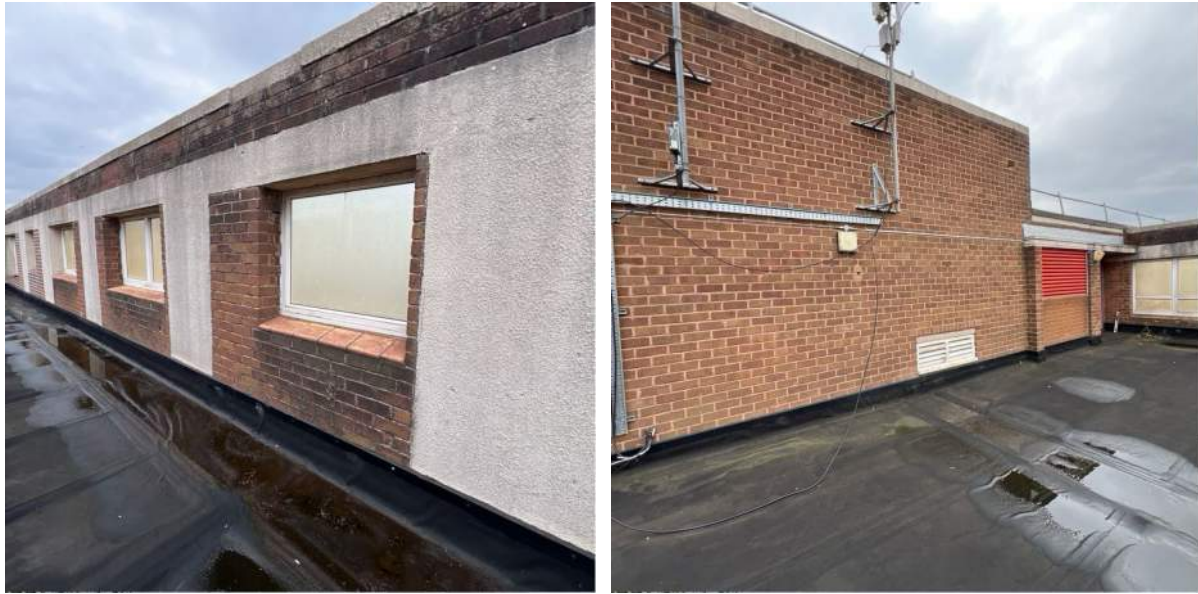
## Main Roof

Comments: Access via 15th floor full height metal door.

Parapet walls noted to perimeter of roof.

In situ concrete roof slab with insulated PIR Boad and felt roof coverings

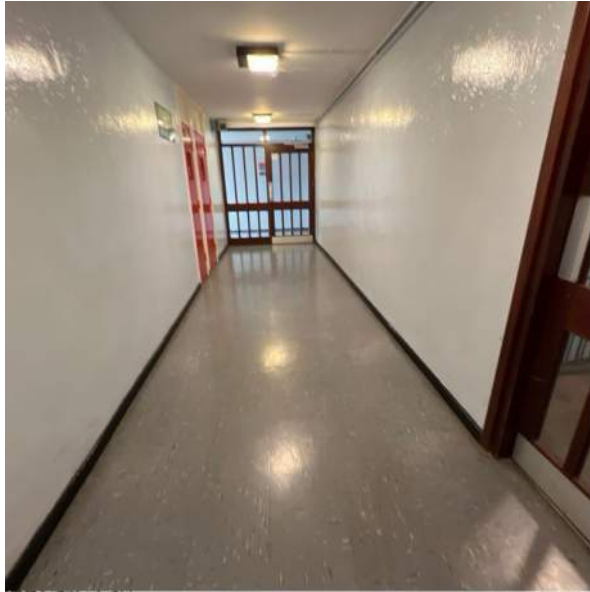
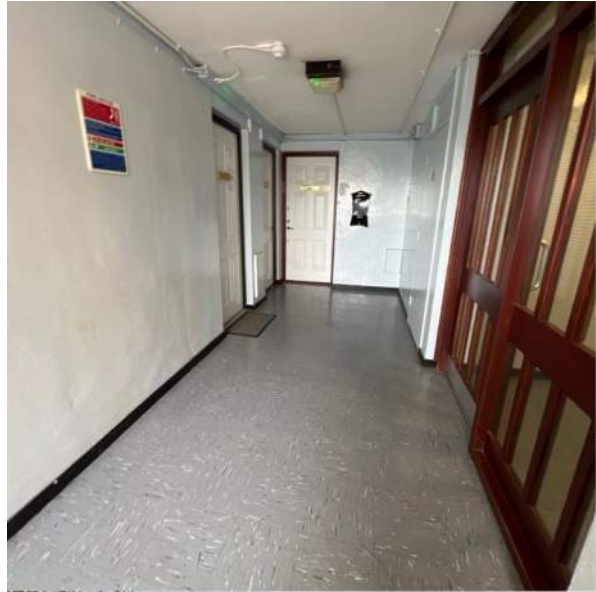
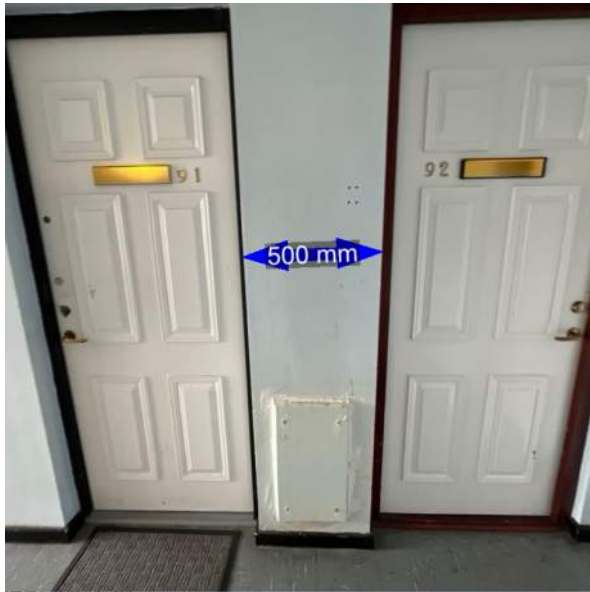
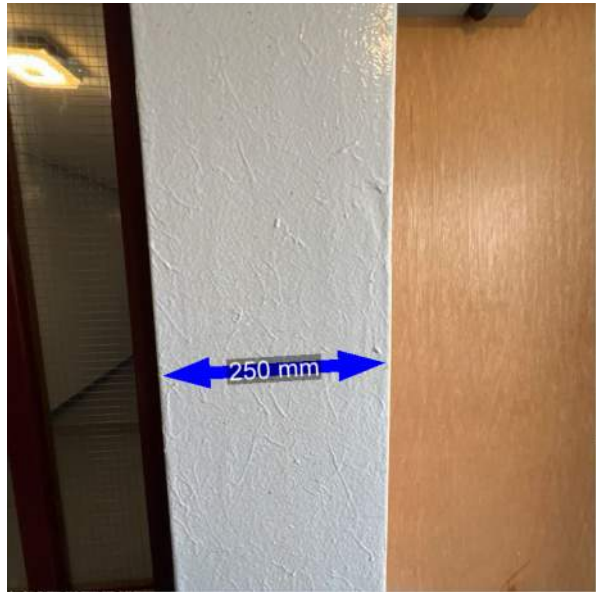
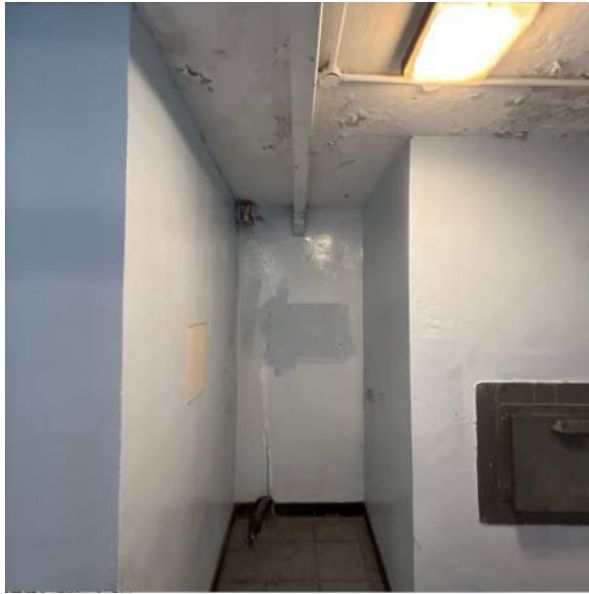
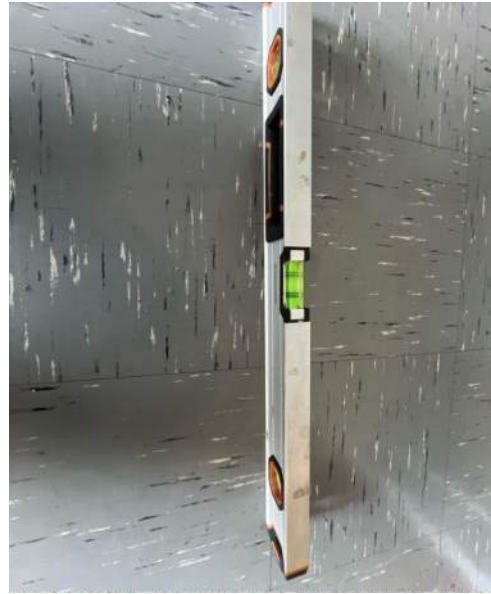
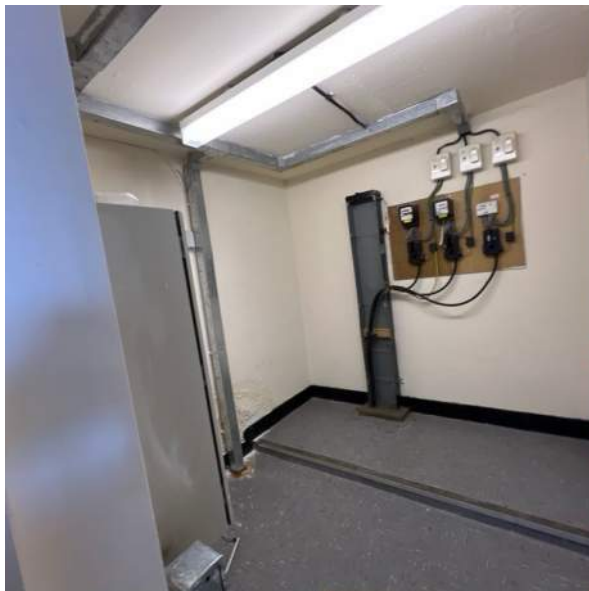
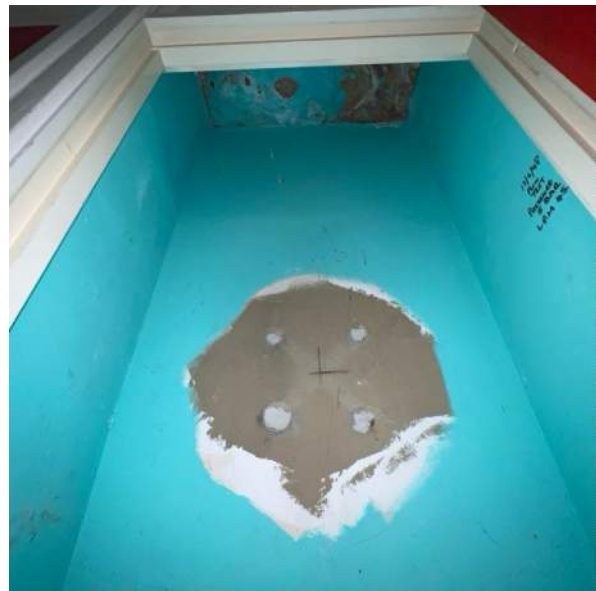
## 15th Floor Hallway

Comments: No jams or distortions noted to hallway doors to indicate any serviceability issues. Generally walls covered with finishes in hallway, likely to consist a mixture of concrete shear walls, embedded columns and block infill walls. Limited structure exposed.

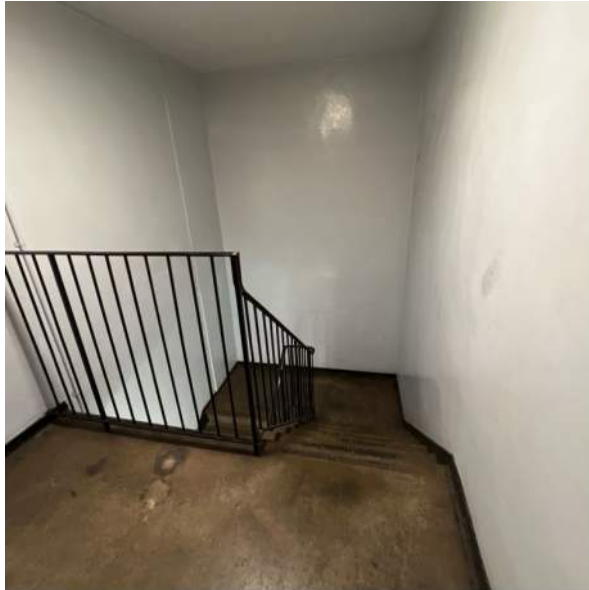
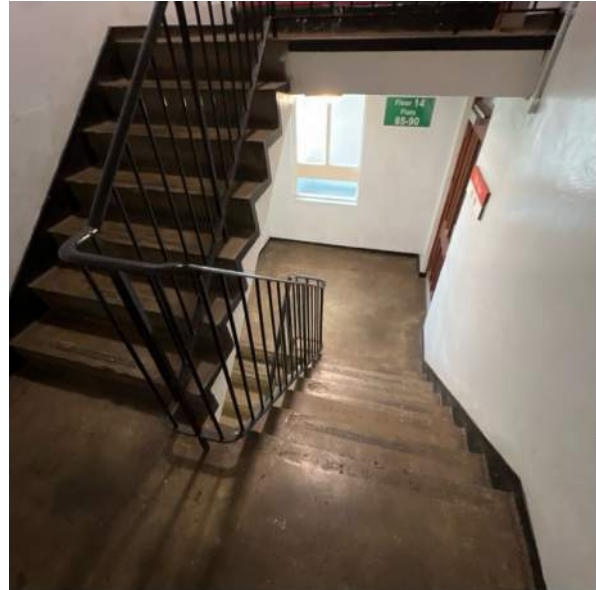
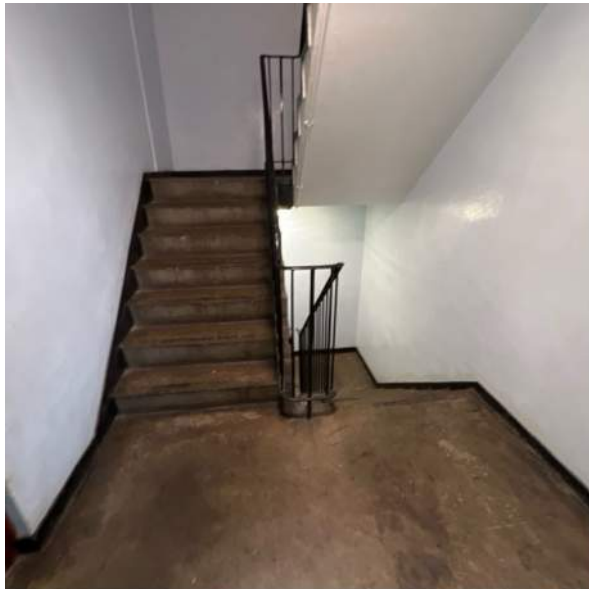
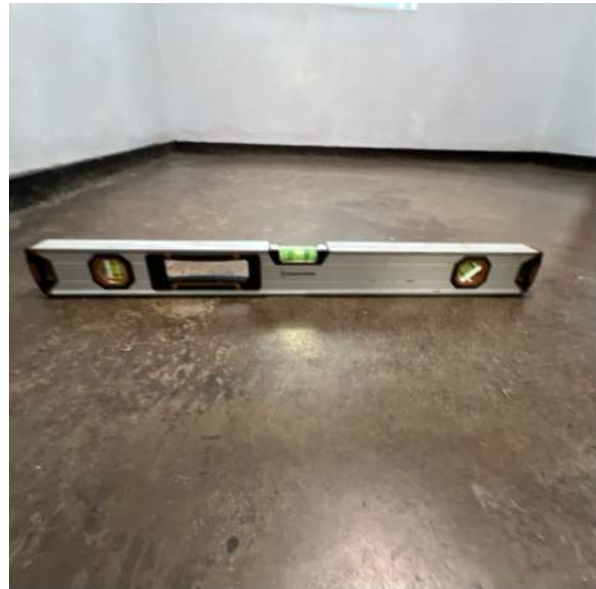
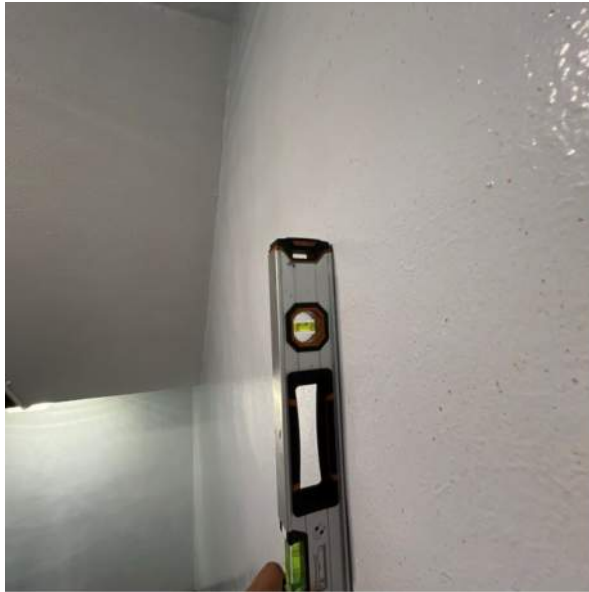
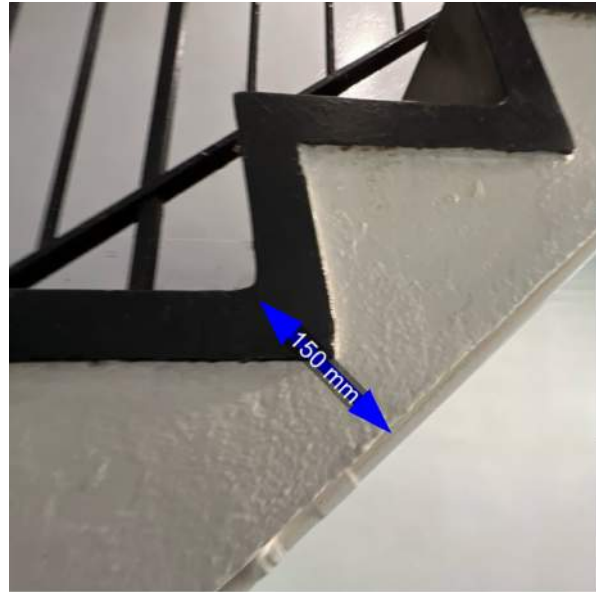
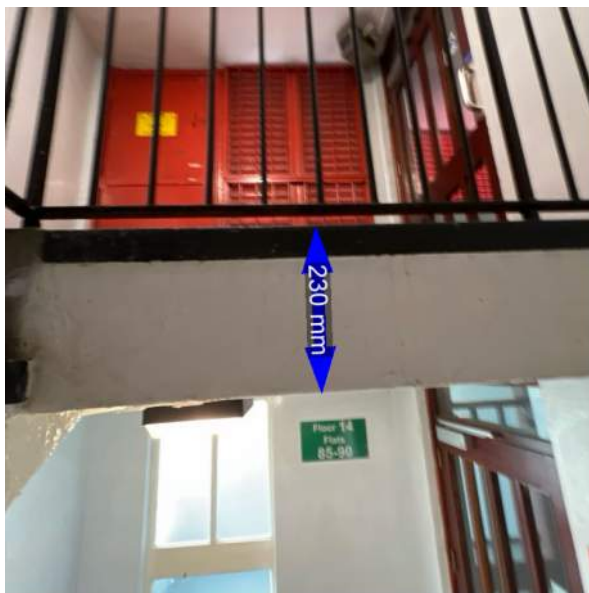
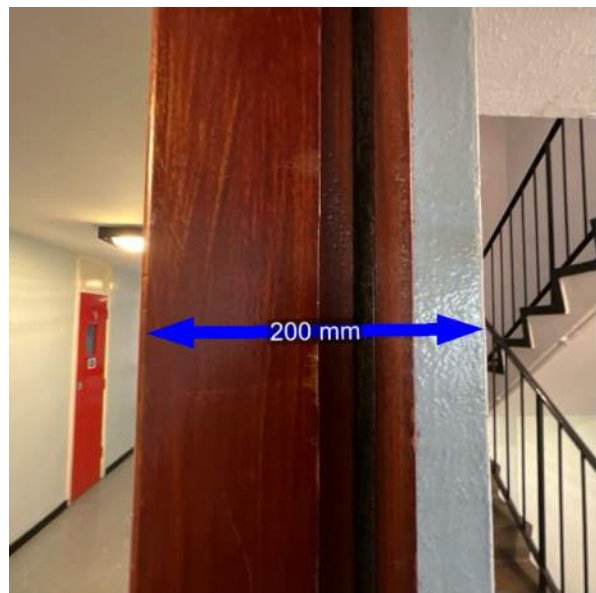
## 15th Floor Staircase

Insitu concrete stairs with steel hand railing fixed to stairs. Walls and floors appear to be fairly level.

Stair walls covered with finishes however these would likely form the main concrete shear core walls. Stair walls approx. 200mm thick.

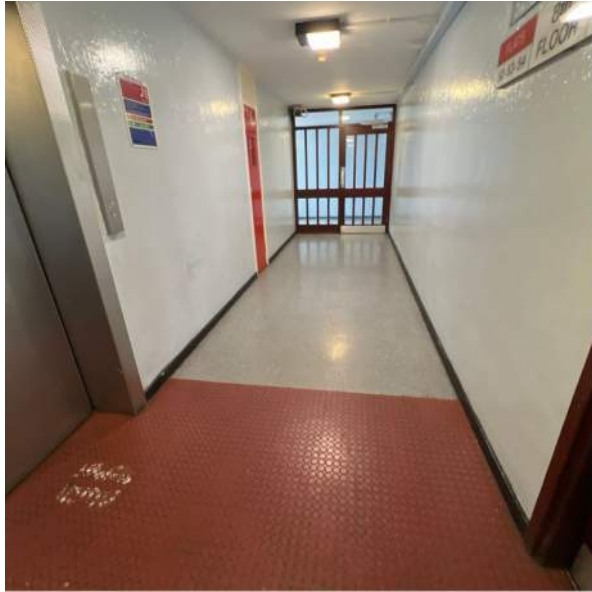
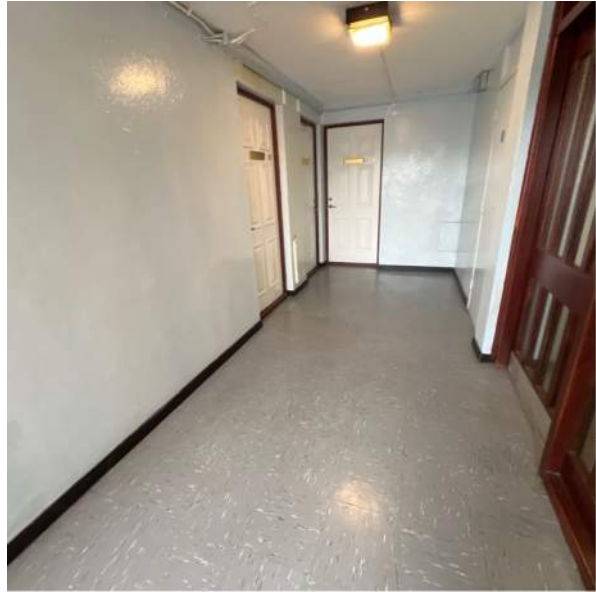
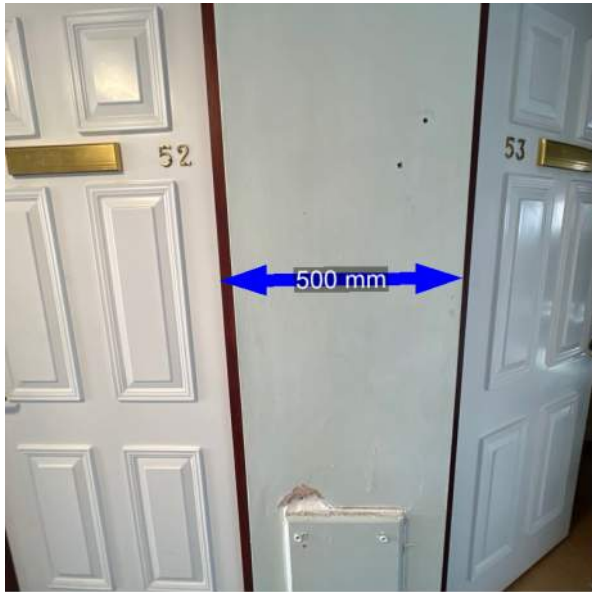
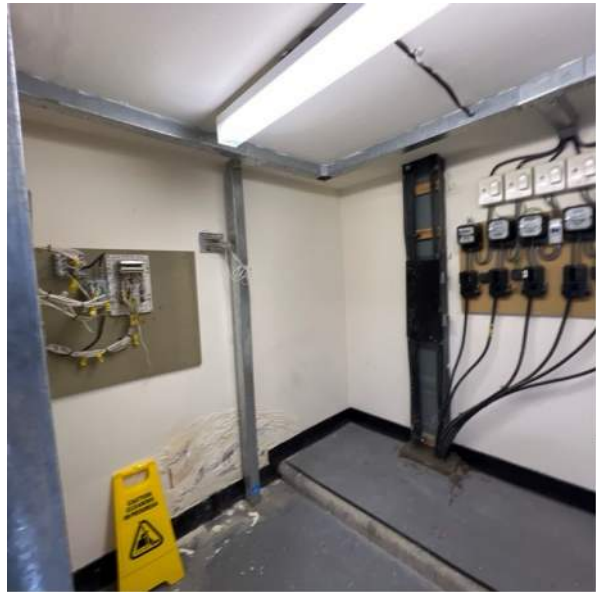
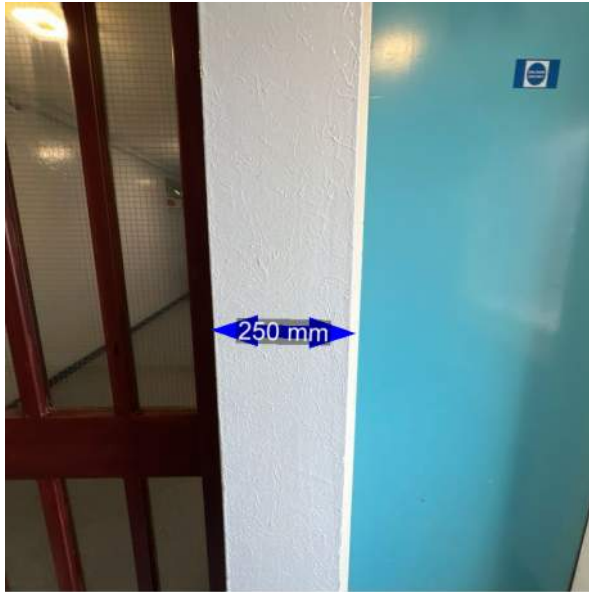
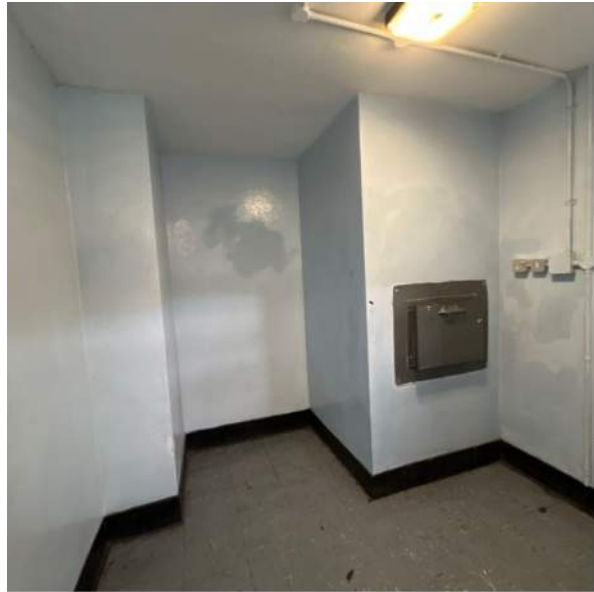
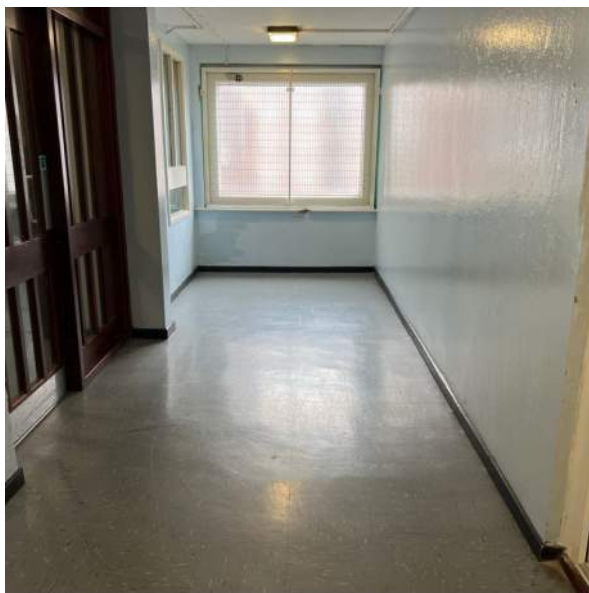
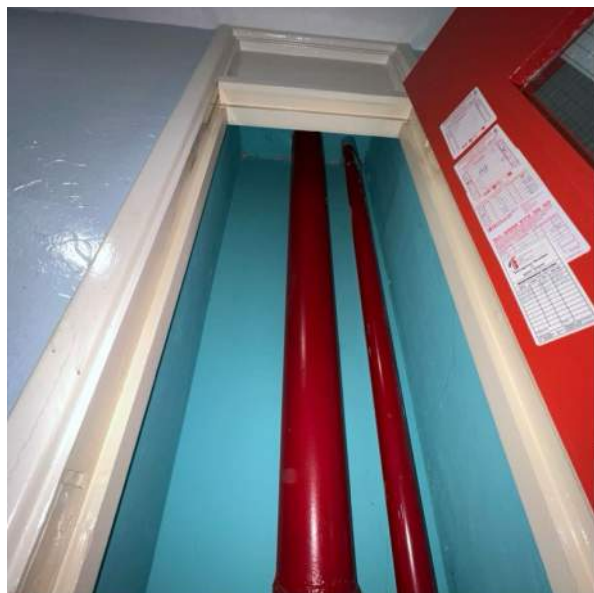
## 8th Floor Hallway

Comments: No jams or distortions noted to hallway doors to indicate any serviceability issues. Generally walls covered with finishes in hallway, likely to consist a mixture of concrete shear walls, embedded columns and block infill walls. Limited structure exposed.

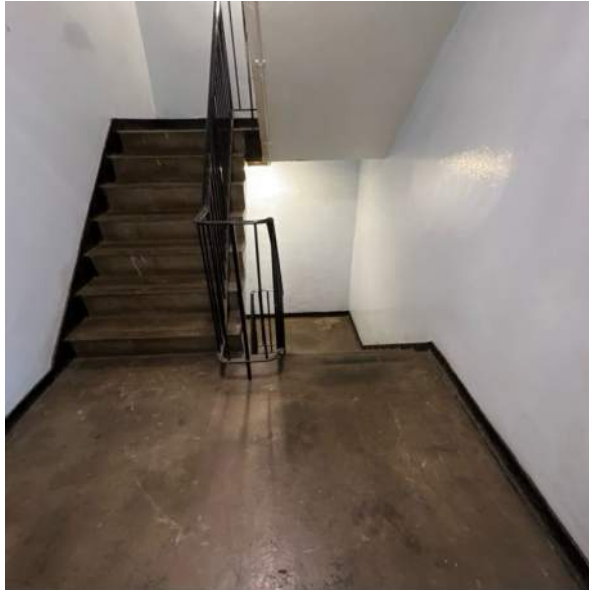
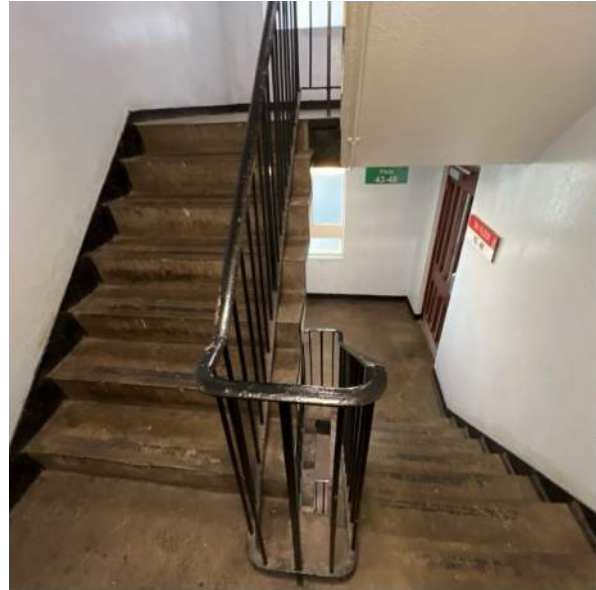
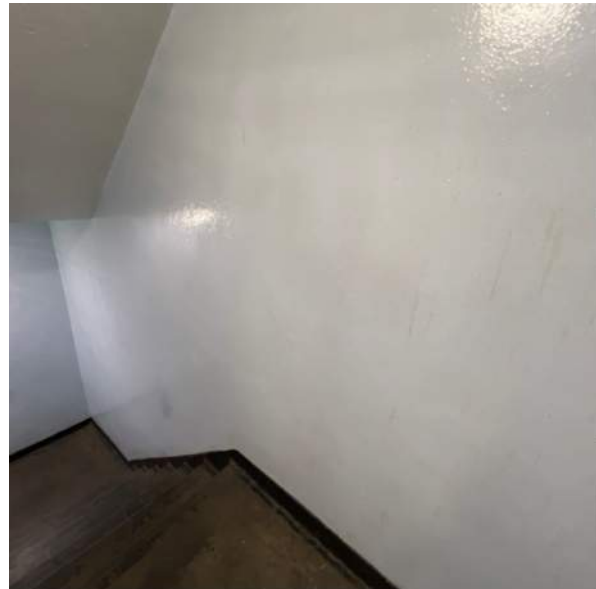
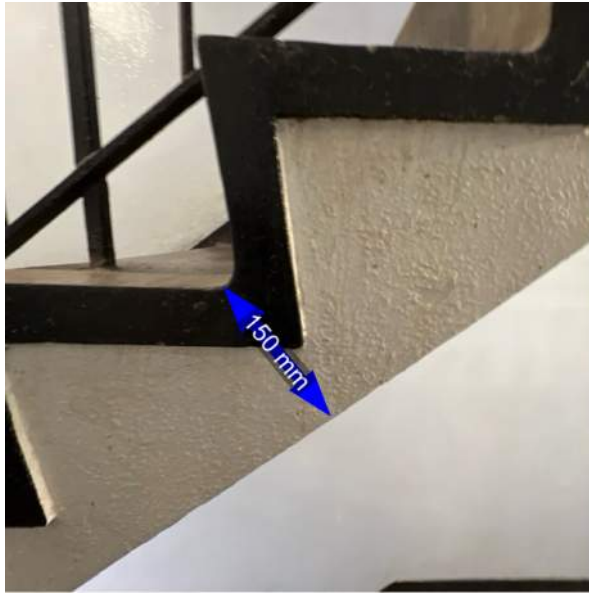
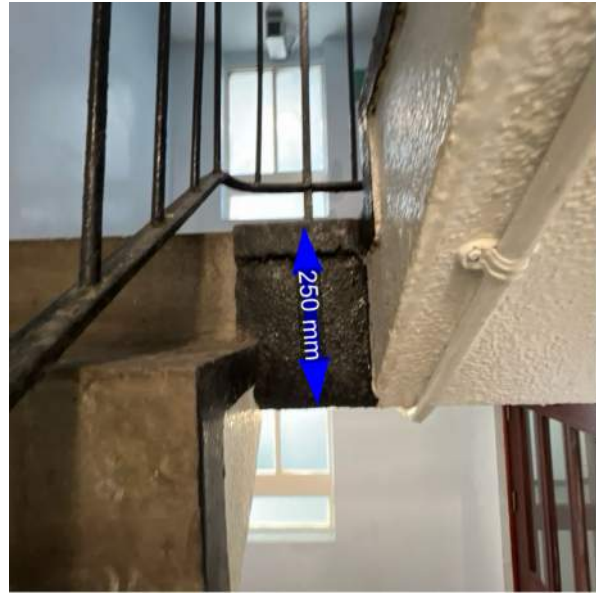
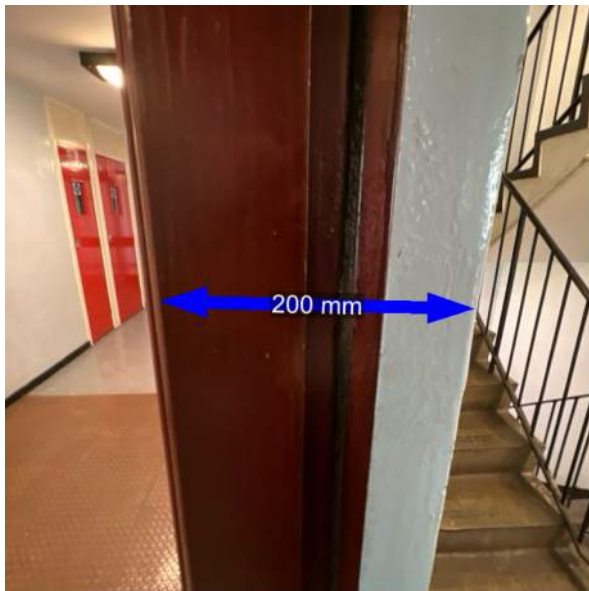
## 8th Floor Staircase

Comments: Insitu concrete stairs with steel hand railing fixed to stairs. Walls and floors appear to be fairly level.  
Stair walls covered with finishes however these would likely form the main concrete shear core walls. Stair walls approx. 200mm thick.

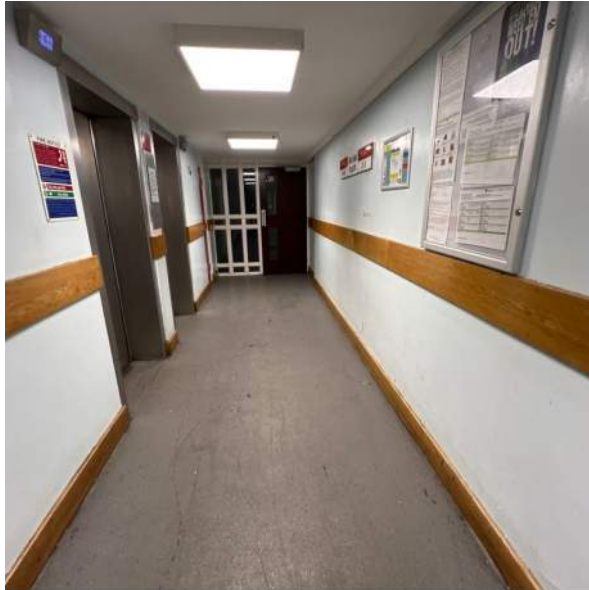
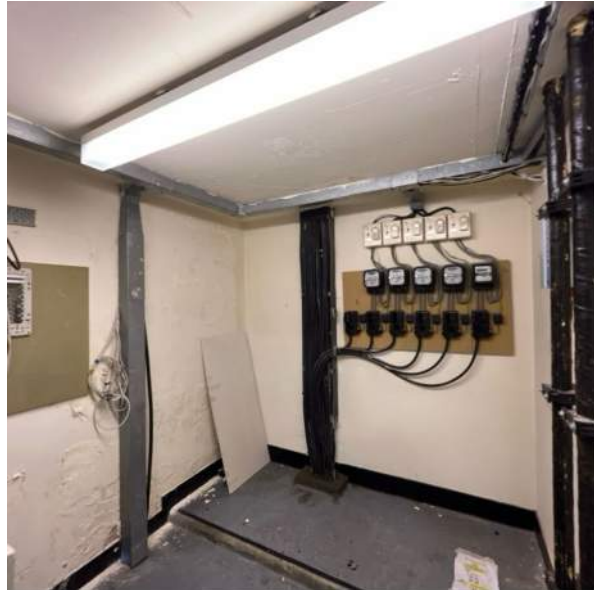
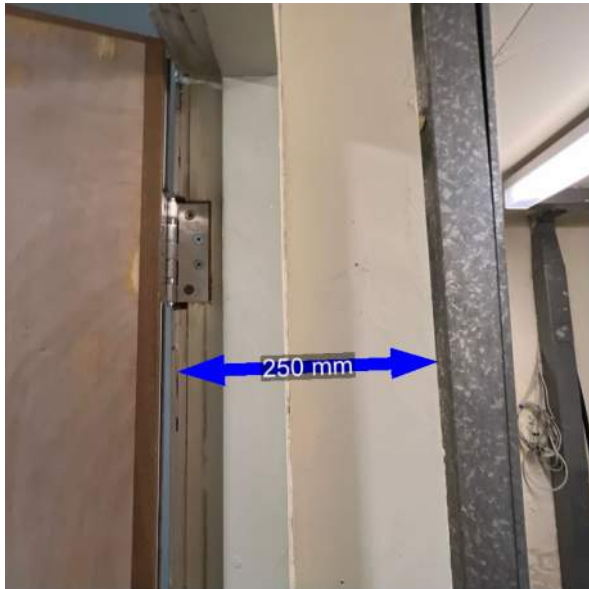
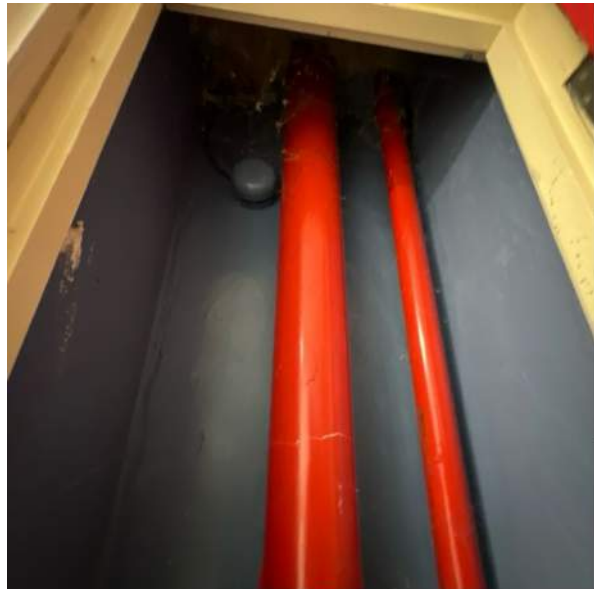
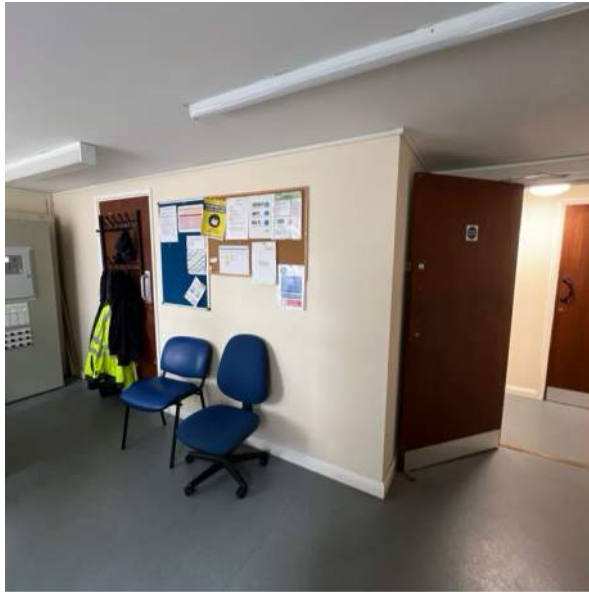
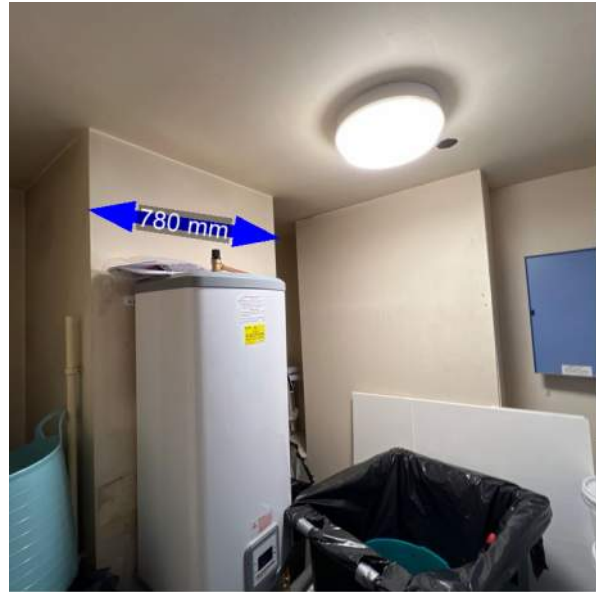
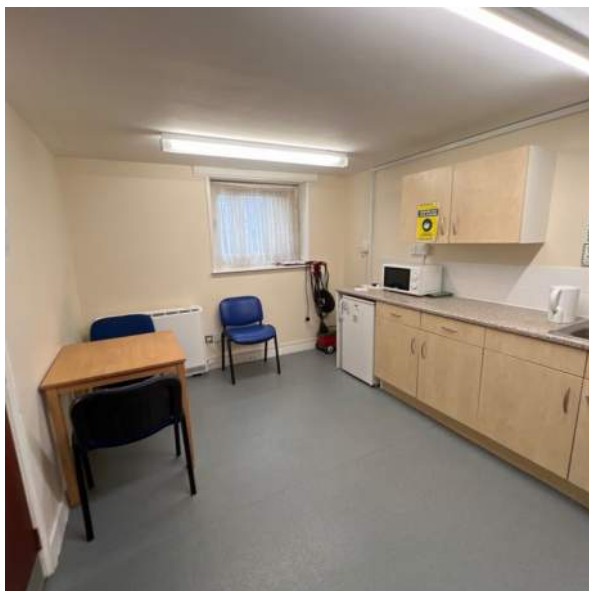
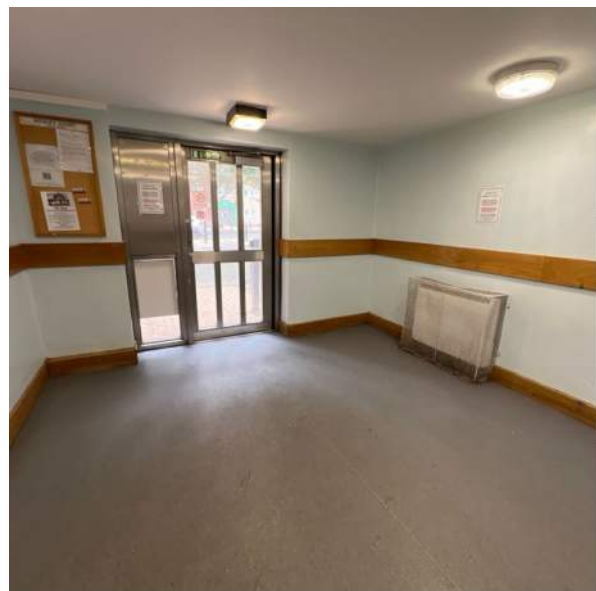
## Ground Floor Hallway

Comments: No jams or distortions noted to hallway doors to indicate any serviceability issues. Generally walls covered with finishes in hallway, likely to consist a mixture of concrete shear walls, embedded columns and block infill walls. Columns noted in hallway area.

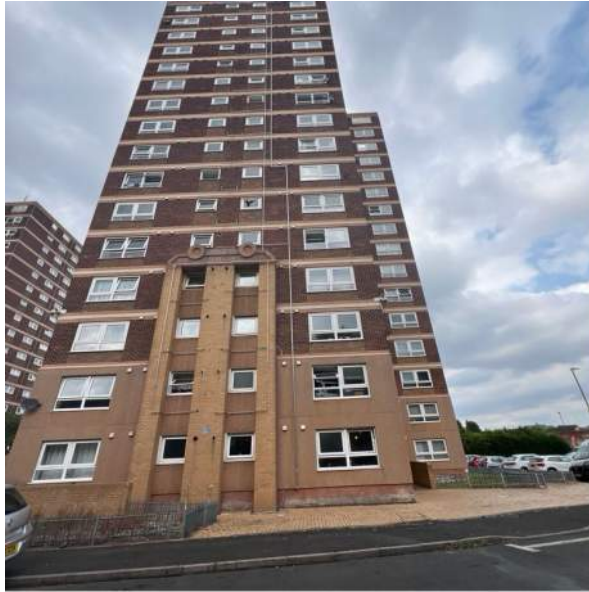
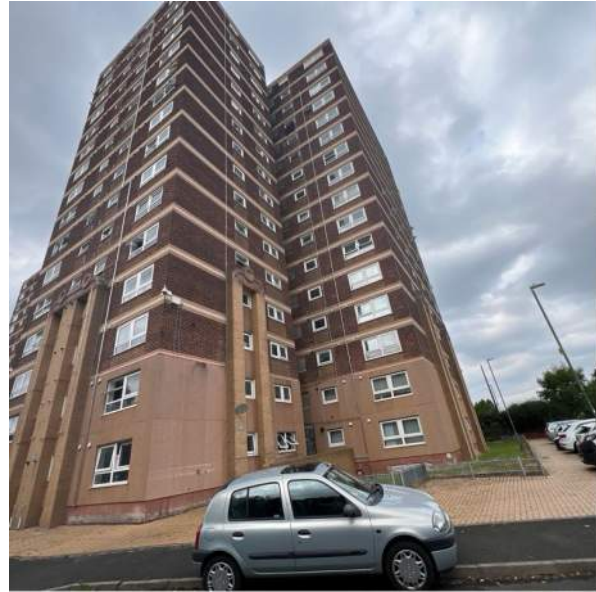
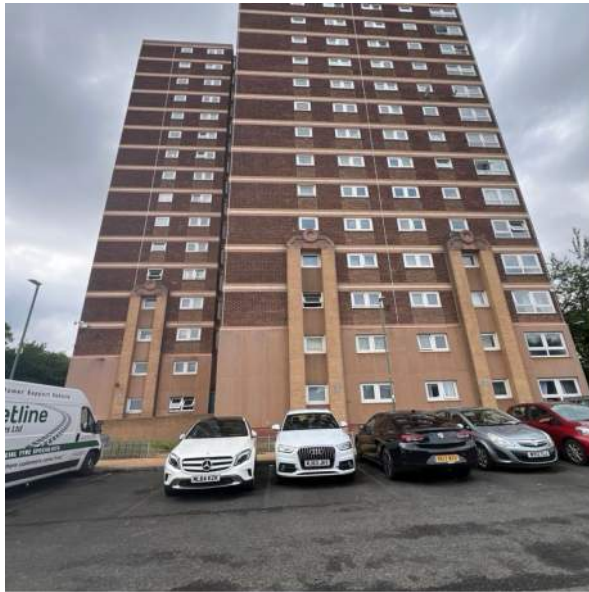
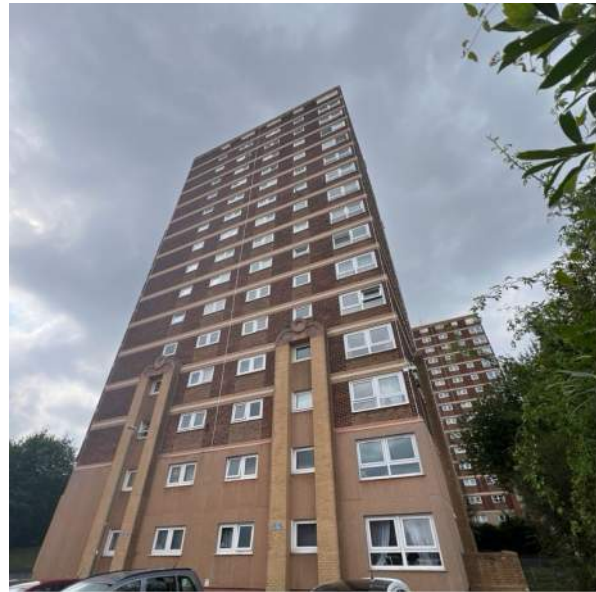
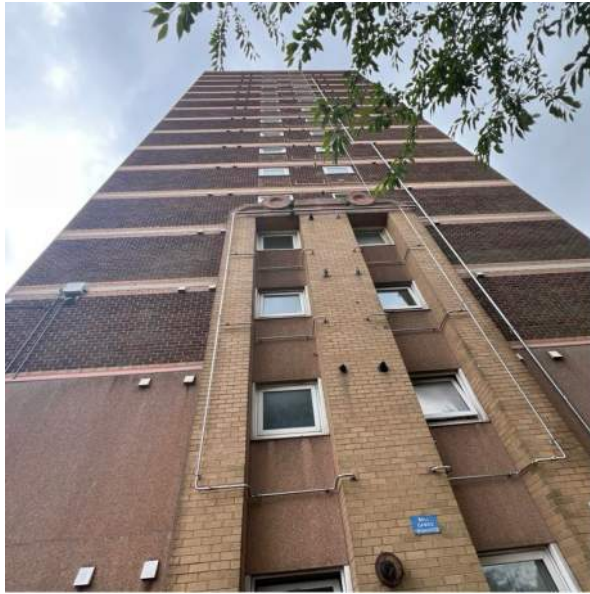
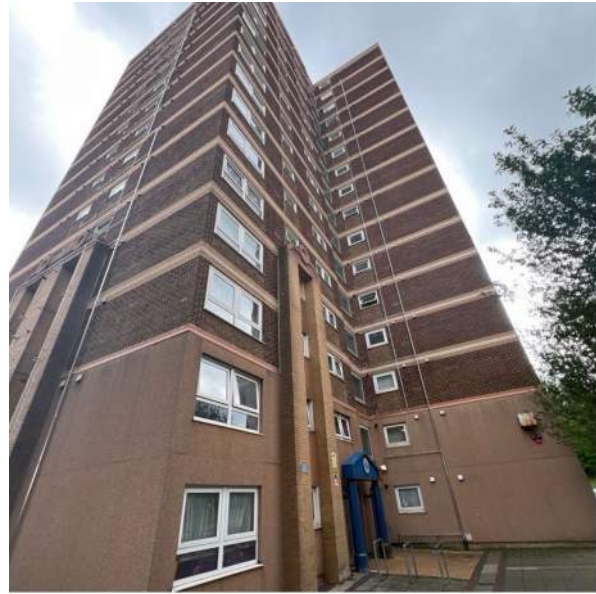
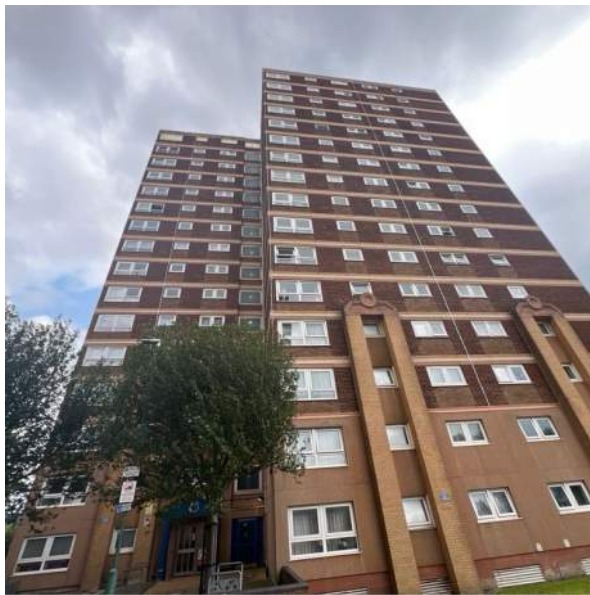
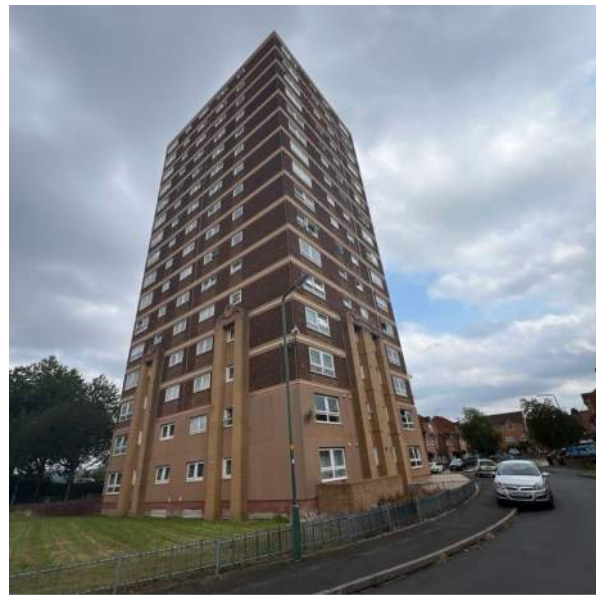
## Elevations

Comments: Ground and first floors of elevations noted to be rendered. Remaining floors consist of infill masonry (brickwork) appear to be supported off the RC slab at each level.
