VISUAL STRUCTURAL APPRAISAL

Wesley Court

Southbank Road  
Oldbury  
B64 6LQ

29<sup>th</sup> November 2024

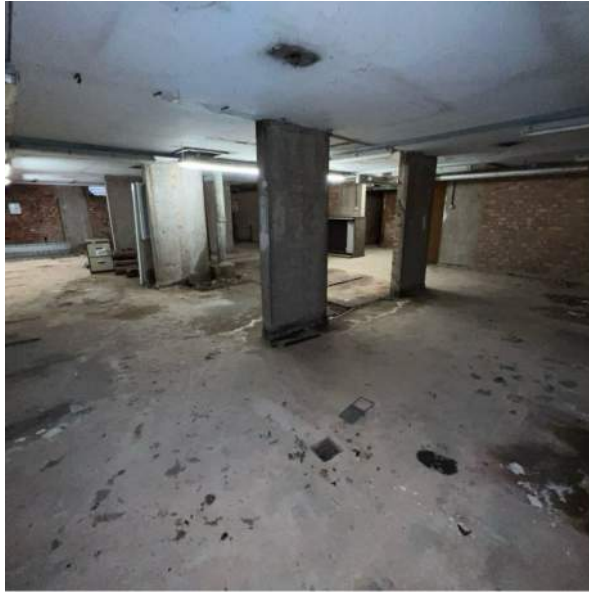
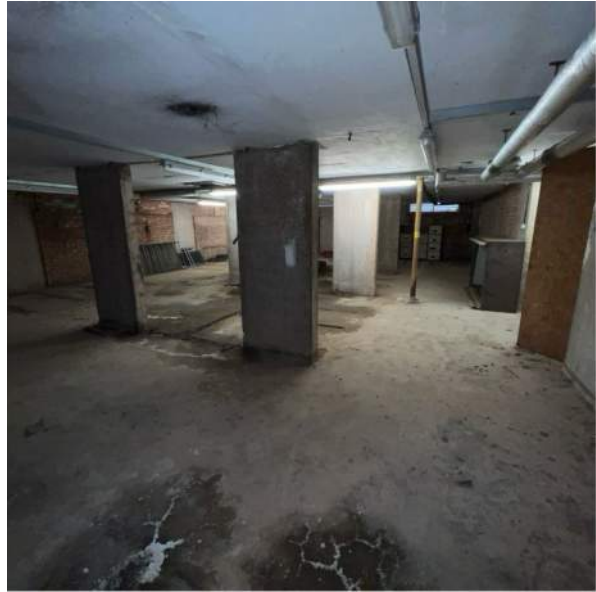
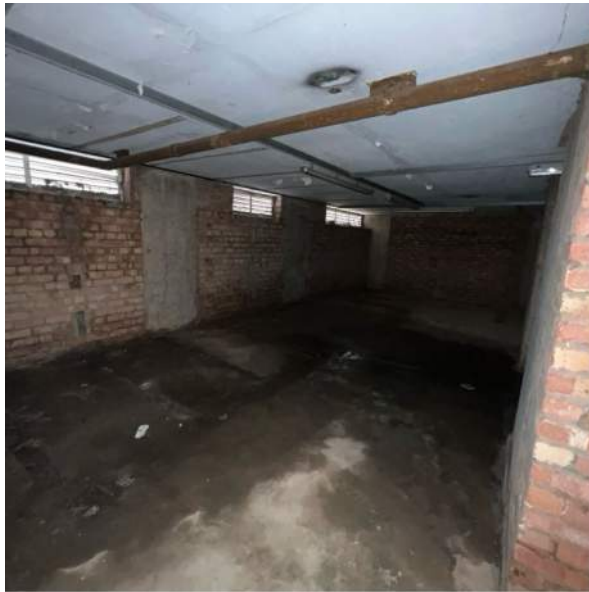
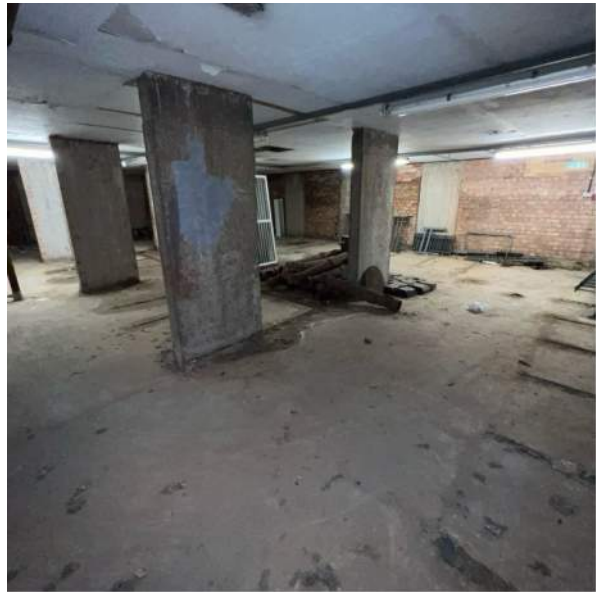
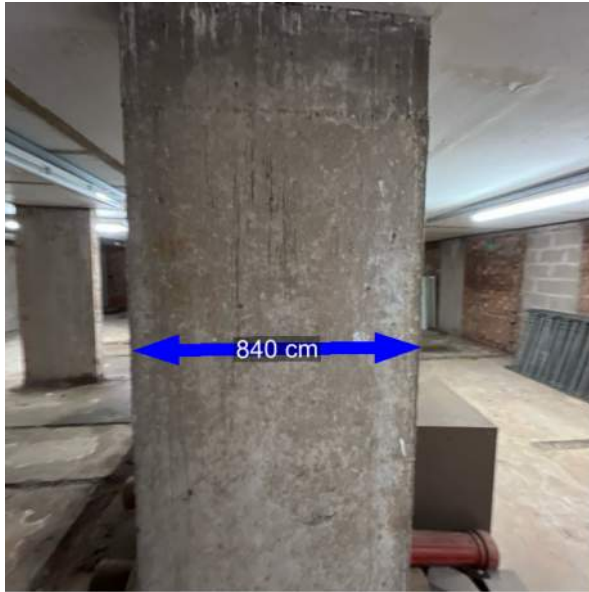
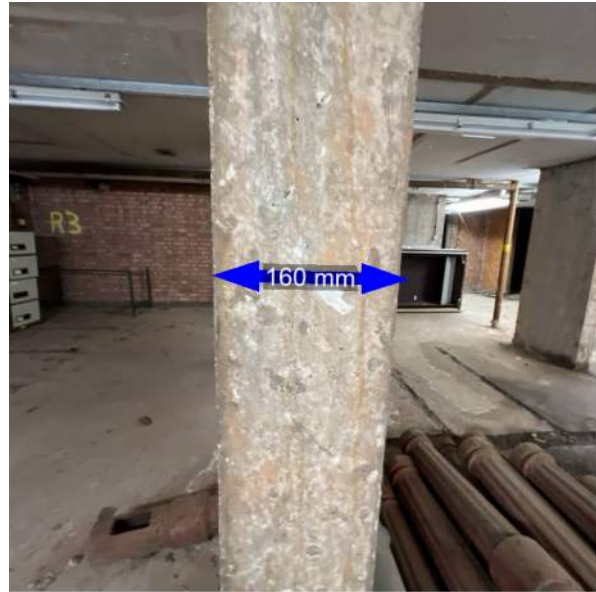
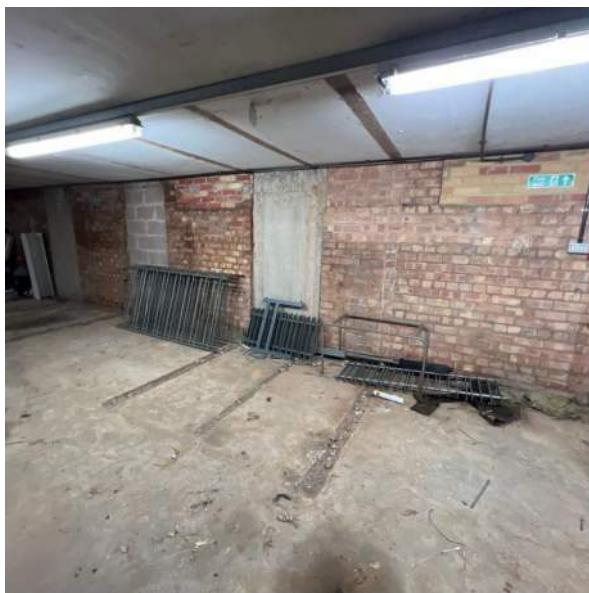
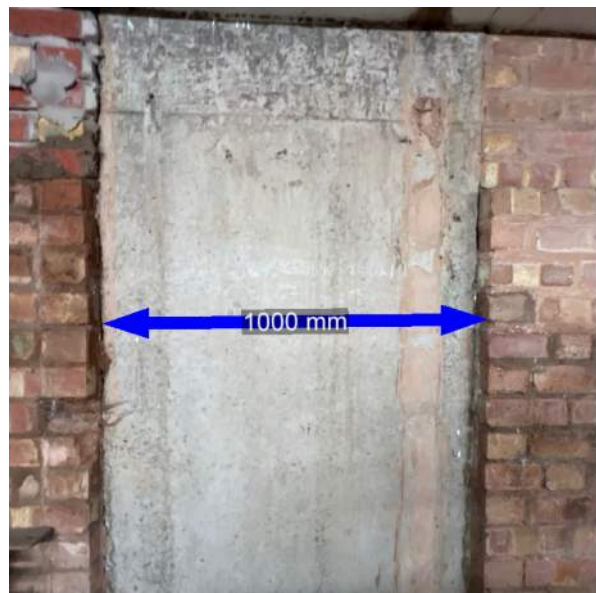
## Basement

RC structure exposed. A series of internal and perimeter columns noted forming the primary structural elements of the structure.
