**FIRNTEC**  
BUILDING COMPLIANCE

VISUAL STRUCTURAL APPRAISAL

Wimberger House

Hallam St  
West Bromwich  
B71 4HA

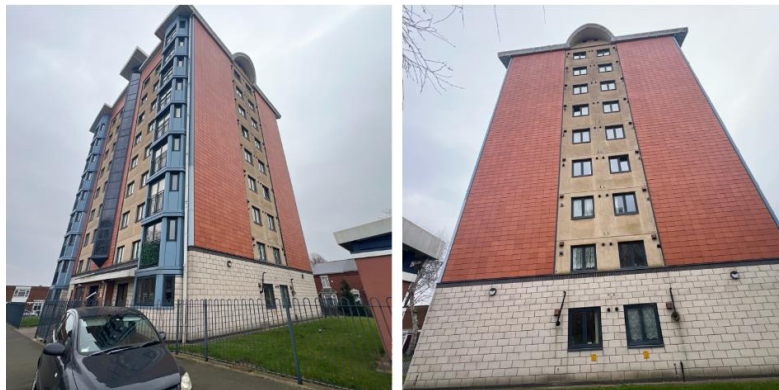
Figure 9 and 10: Building Elevations

The exterior elevations were generally in ok condition and no significant structural defects were noted to the cladding panels. There were no significant cracks or tell-tale signs of any significant structural movement noted at the time of our inspection.

The exterior panels were noted to be plumb with no signs of significant bowing, bulging or leaning noted to the panels indicating failed fixings however their presence and condition cannot be confirmed.

There are balconies at each level which are formed of cantilevered RC slabs tied into the main frame. During the 2007 refurbishment they were enclosed with aluminium panels and glazing.

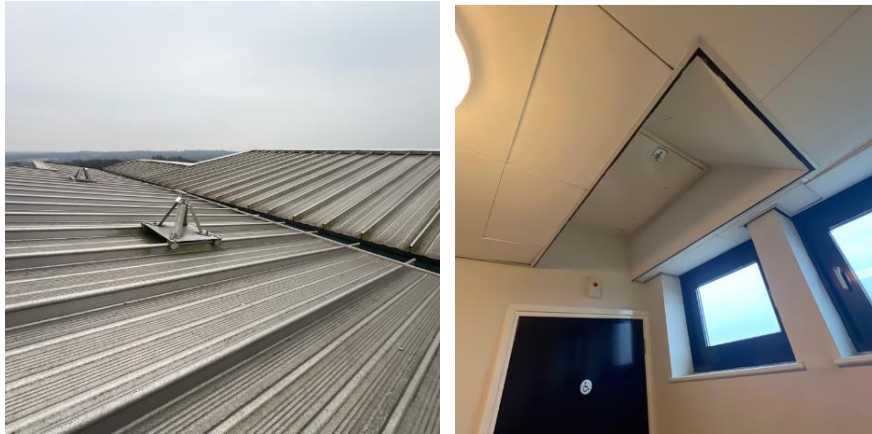
Figure 11 and 12: Roof Level

There were no tell-tale signs of any significant structural movement noted at the time of our inspection. The exterior walls were noted to be plumb with no signs of significant bowing, bulging or leaning noted to the cladding.

The roof has subsequently been covered with a new waterproofing covering formed of a steel frame installed to the existing roof which supports pitched corrugated sheets. This roof is not insulated and therefore acts purely as a weather barrier. The fire protection of the steel is unclear as the beams do not appear to be unprotected. Details of this frame should be requested from the contractor who completed the works in 2007. No signs of water ingress of that the roof is not performing as intended.

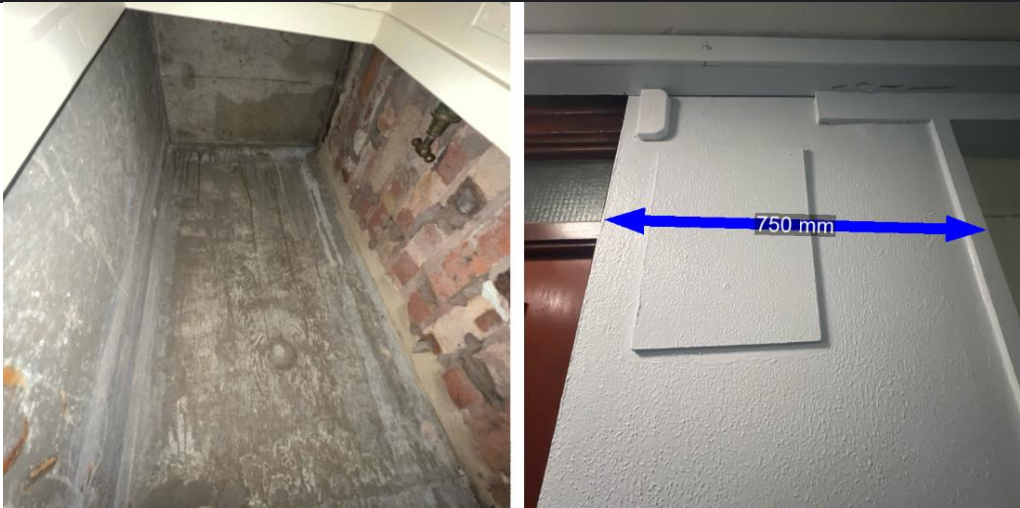
Figure 13 and 14: Vertical RC elements

The interior of the stair core walls were checked and were plumb and in line with observations made to the exterior – no significant signs of leaning or movement noted. The concrete appeared in fair condition with few BRE category 1 cracks but no structurally significant defects were noted.

The stair stringer was noted to be 110mm thick which is certainly short of modern standards however may comply with standards at the time. The structural walls were measured at 150mm thick, A cover test is required to check the resistance of the concrete section in the event of a fire.

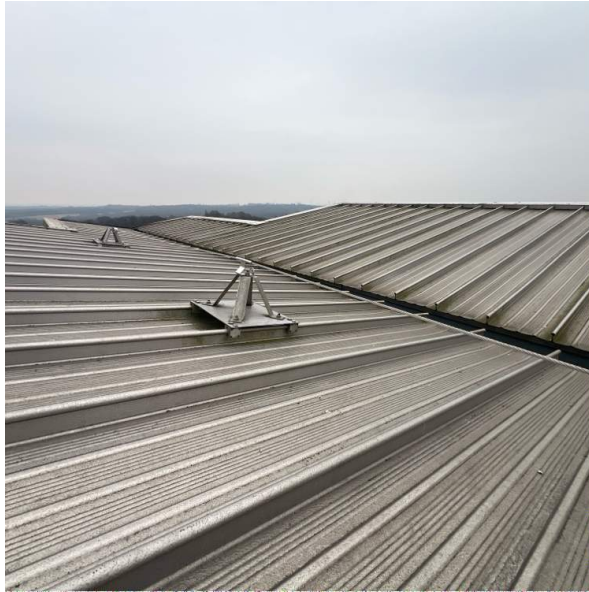
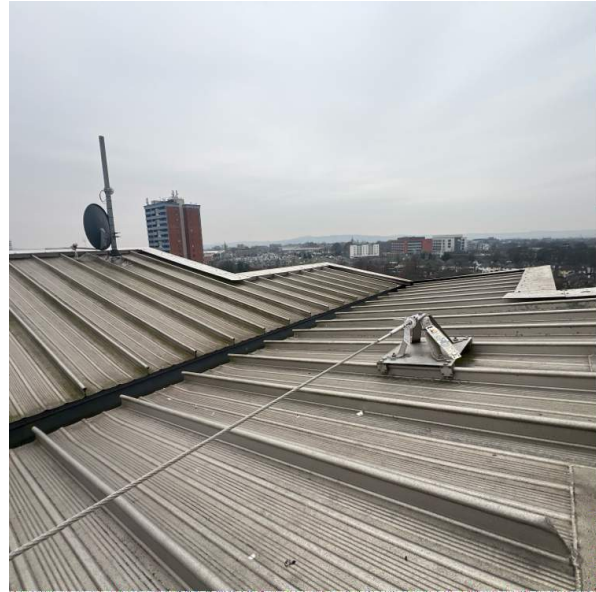
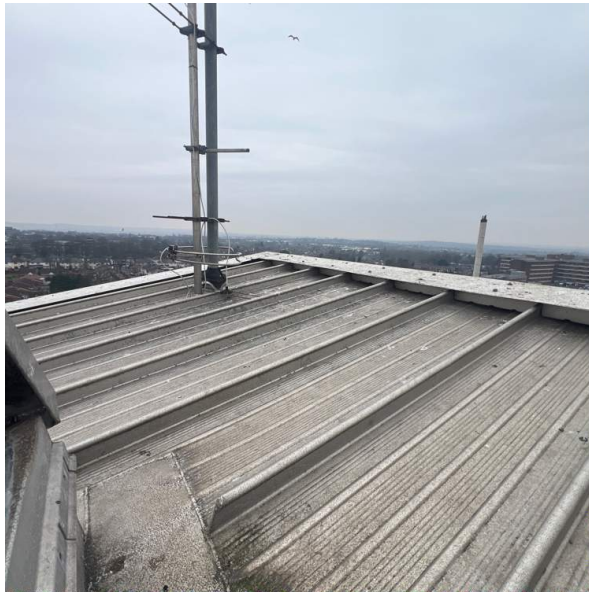
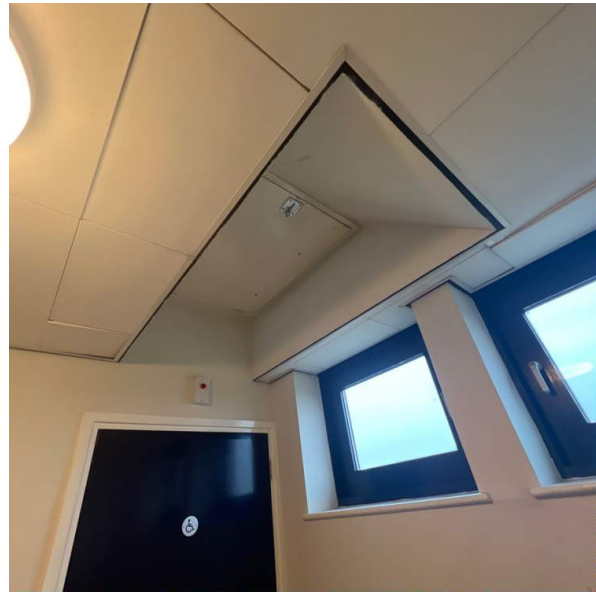
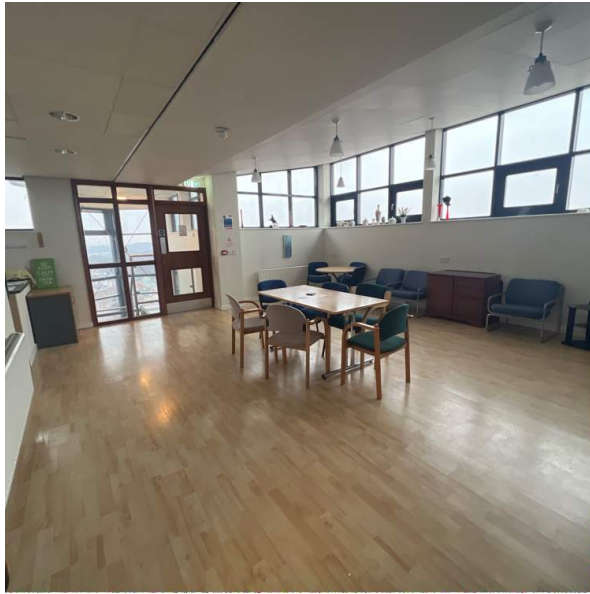
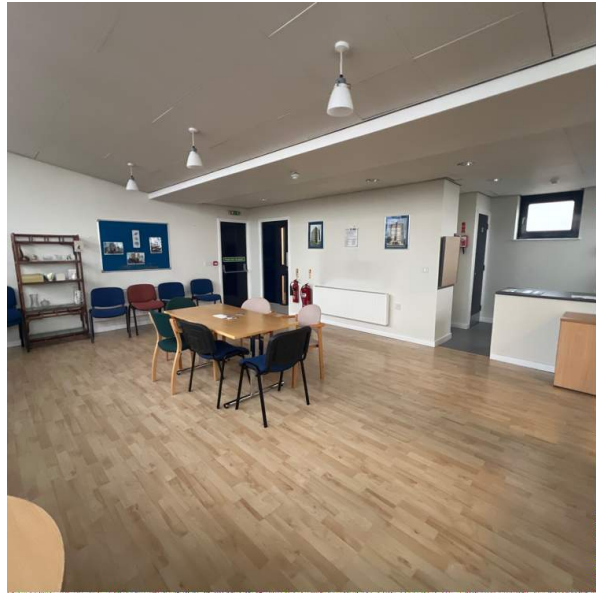
## Main Roof

Comments: A lightweight pitched roof was constructed during the refurbishment utilising beams and purlins with aluminium standing / mineral wool core profiled panels.

Roof level floor partly forms a communal area.

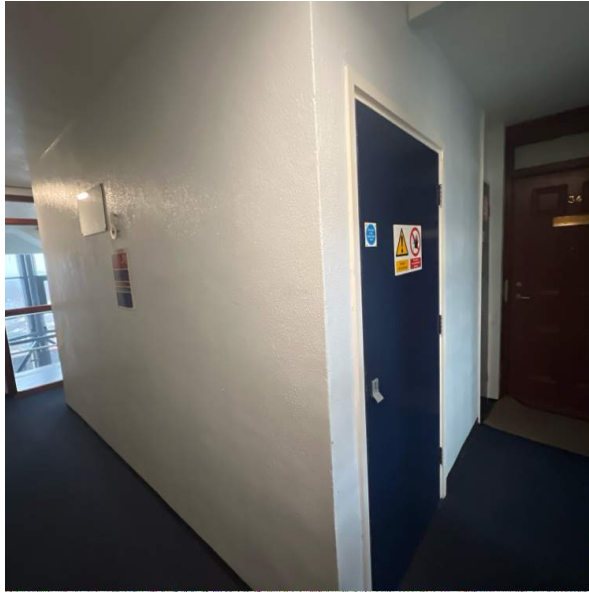
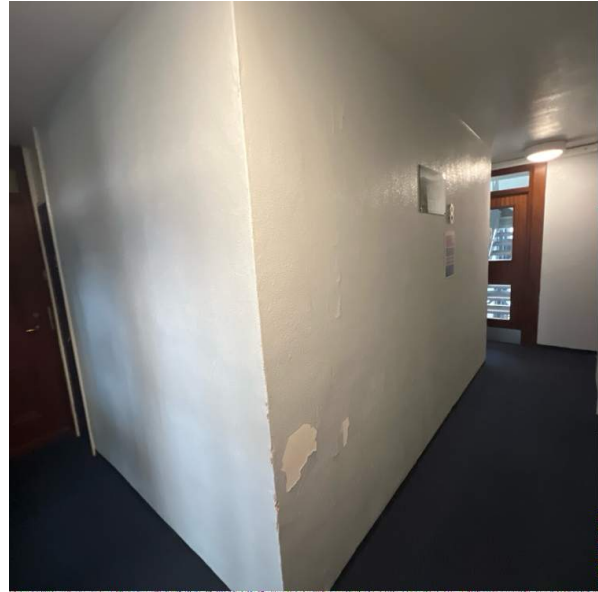
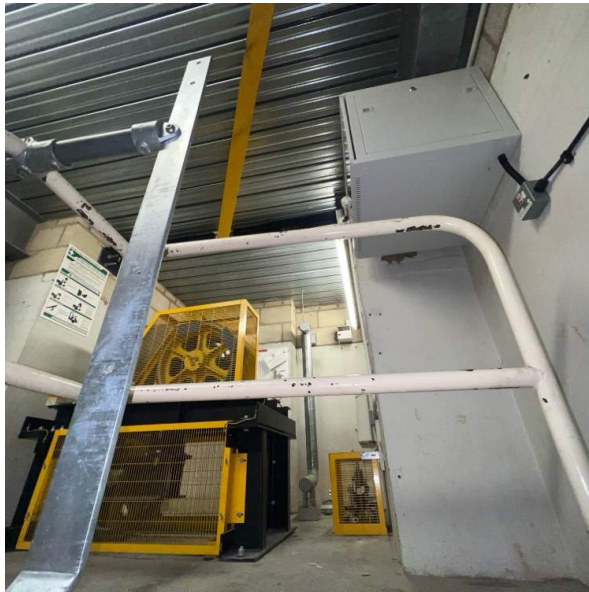
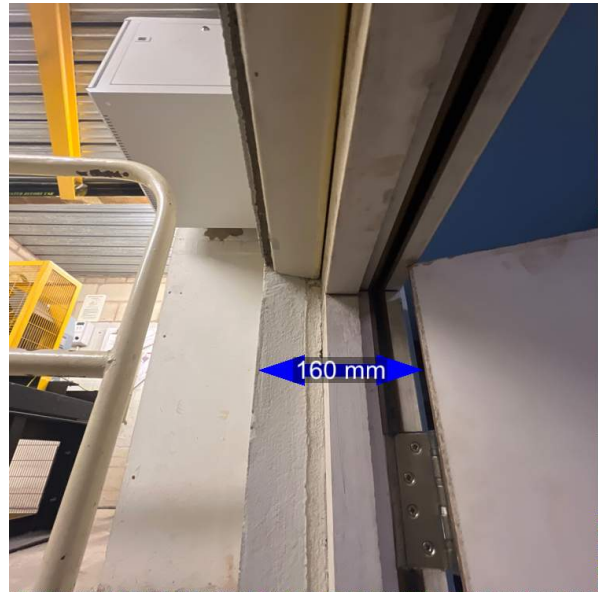
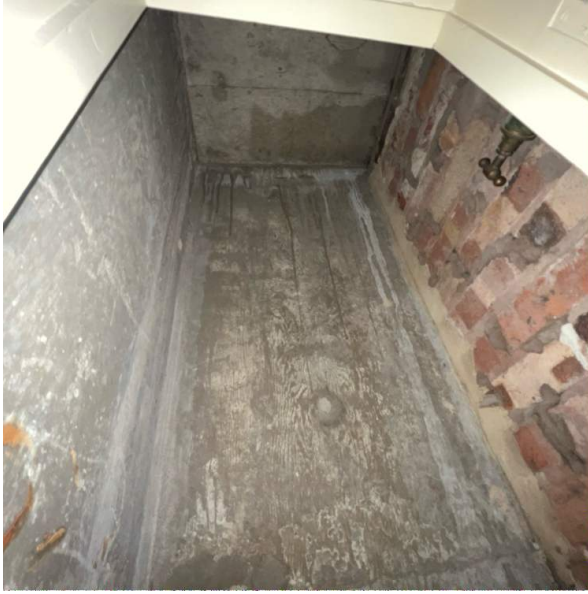
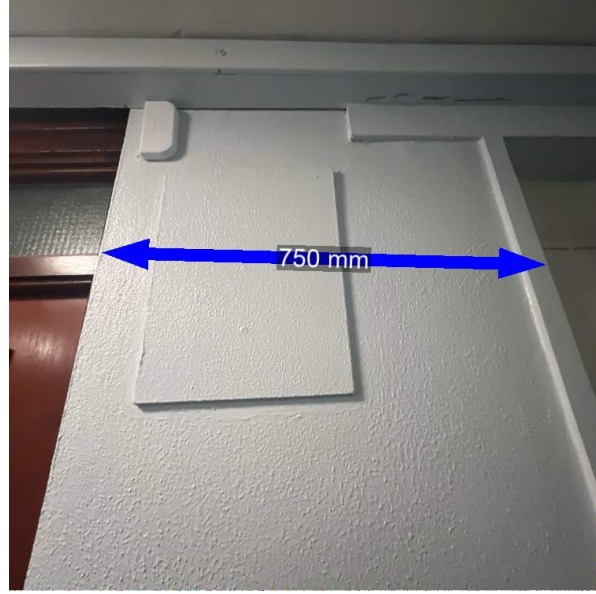
## 9th Floor Hallway

Comments: No jams or distortions noted to hallway doors to indicate any serviceability issues. Generally walls covered with finishes in hallway, likely to consist a mixture of concrete shear walls, embedded columns and masonry infill walls. Limited structure exposed. Concrete walls noted via riser cupboard and lift motor room.

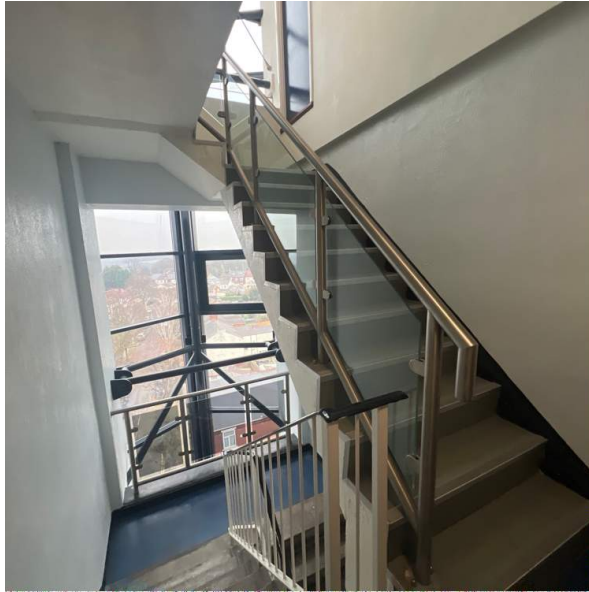
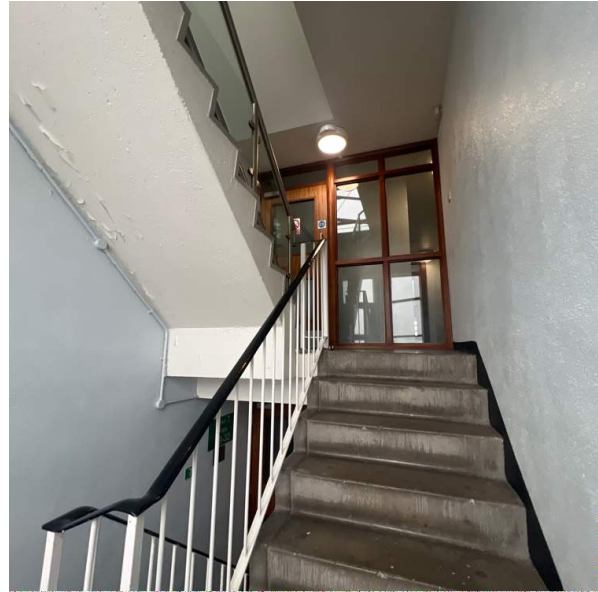
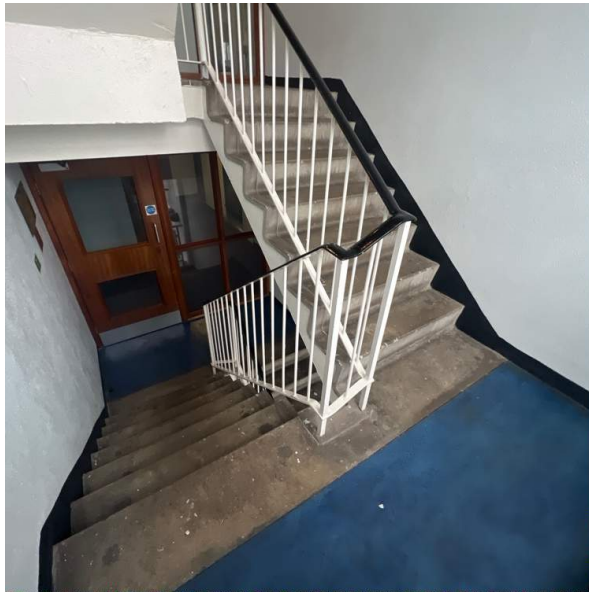
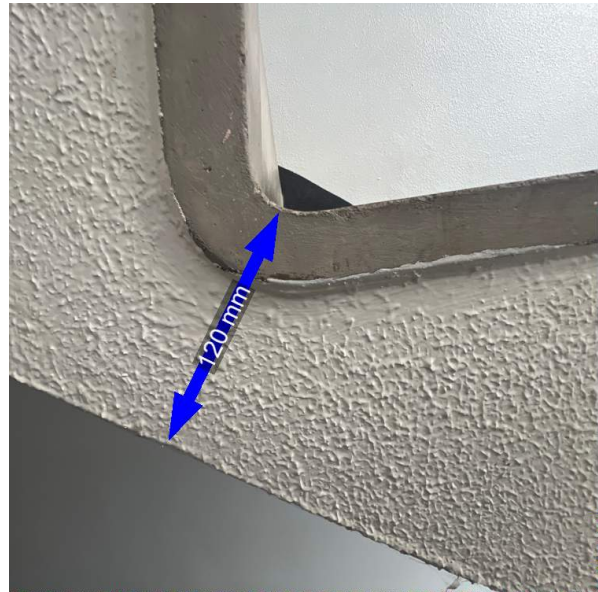
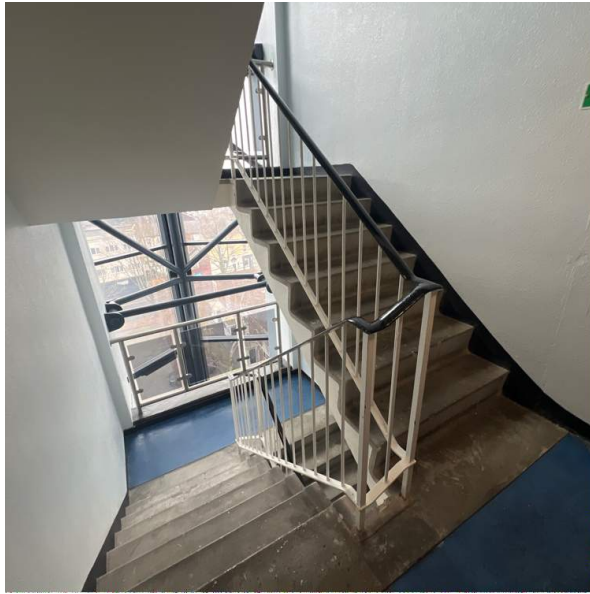
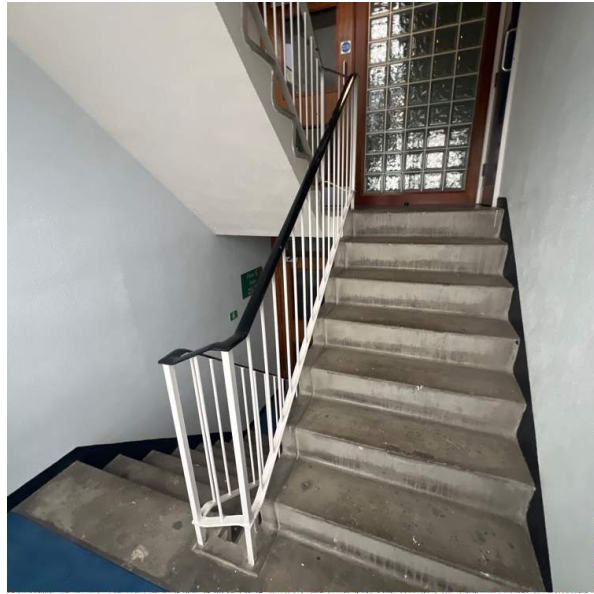
## 9th Floor Staircases

Comments: 2 sets of staircases present. Insitu concrete stairs with steel hand railing fixed to stairs. Walls and floors appear to be fairly level. Stair walls covered with finishes however these would likely form the main concrete shear core walls. A set of steel stairs also present leading to roof level.

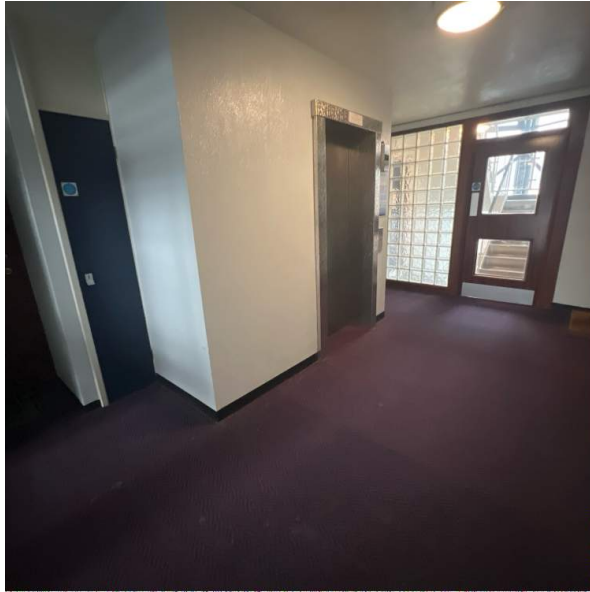
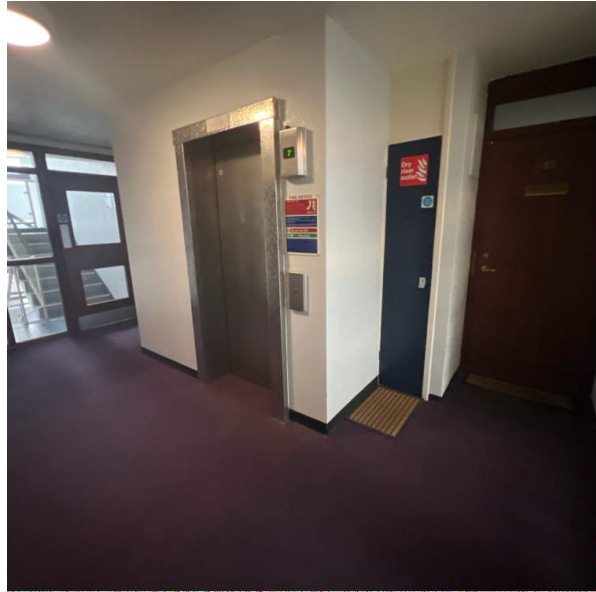
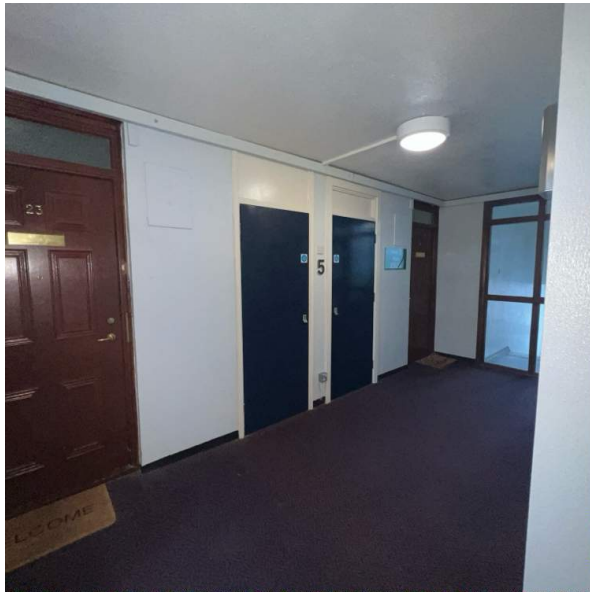
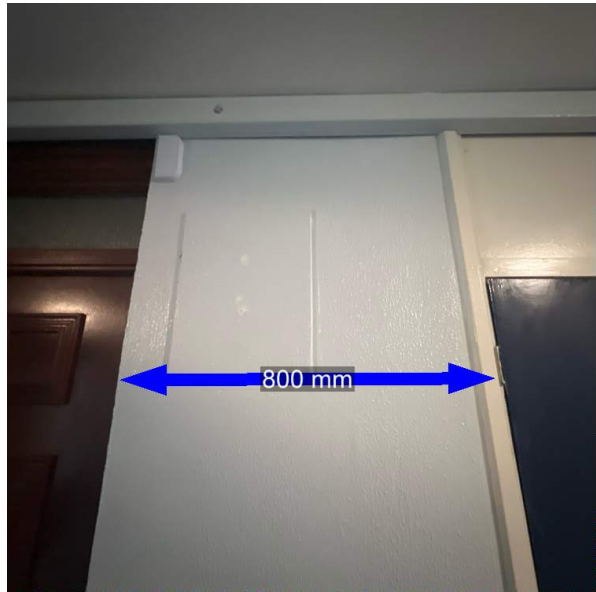
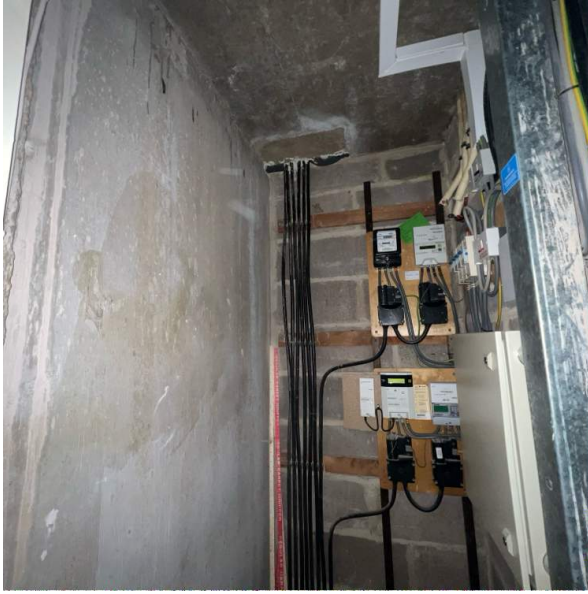
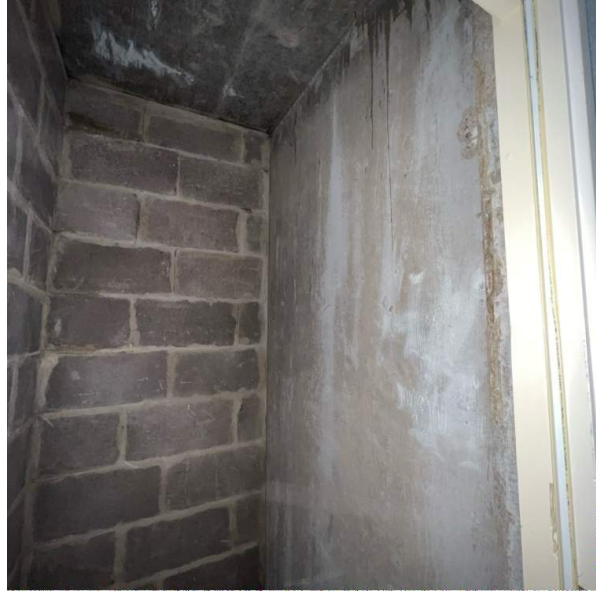
## 5th Floor Hallway

Comments: No jams or distortions noted to hallway doors to indicate any serviceability issues. Generally walls covered with finishes in hallway, likely to consist a mixture of concrete shear walls, embedded columns and masonry infill walls. Limited structure exposed. Concrete walls noted via riser cupboard. Lift walls appear to be solid concrete walls.

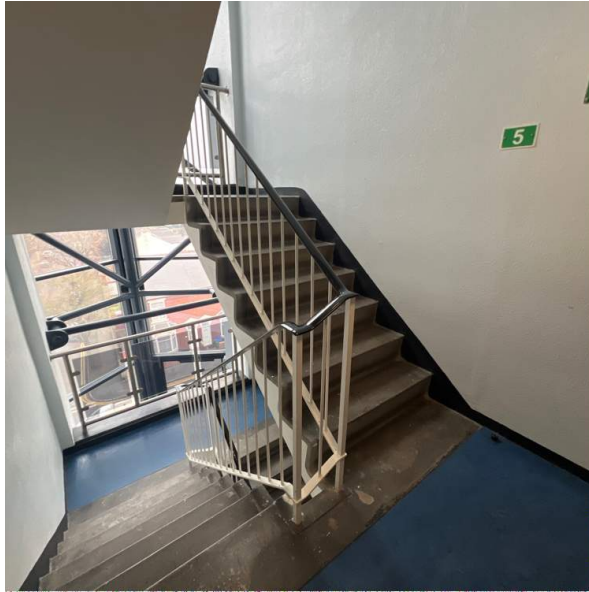
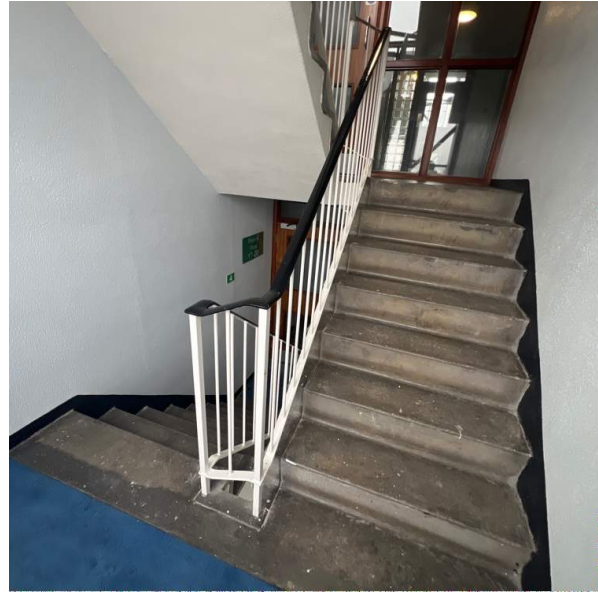
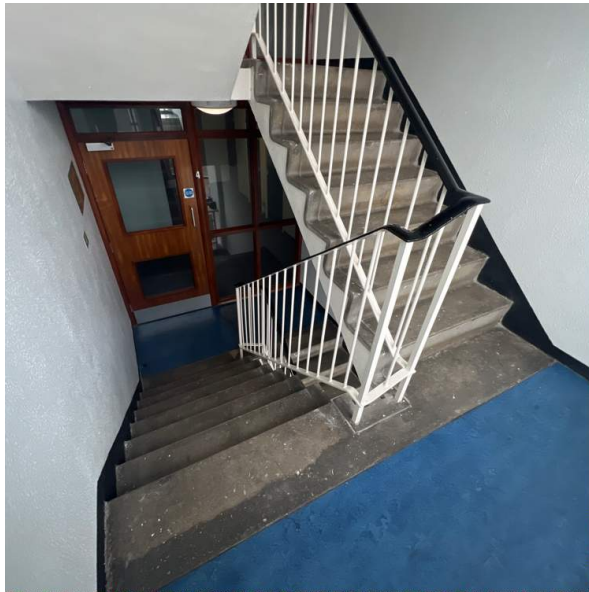
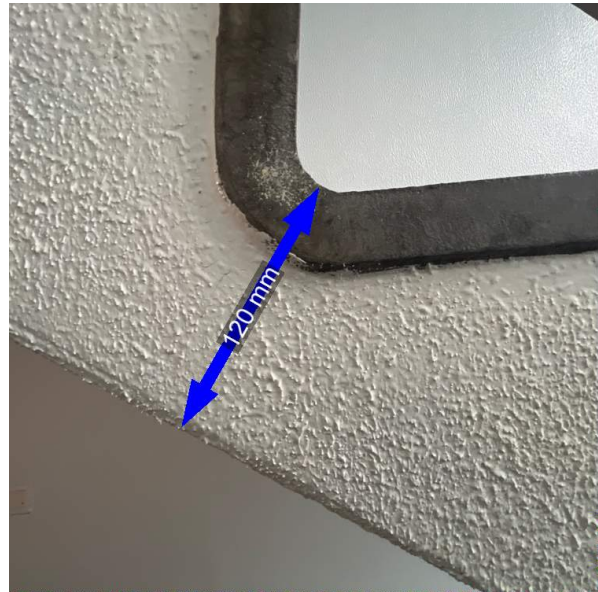
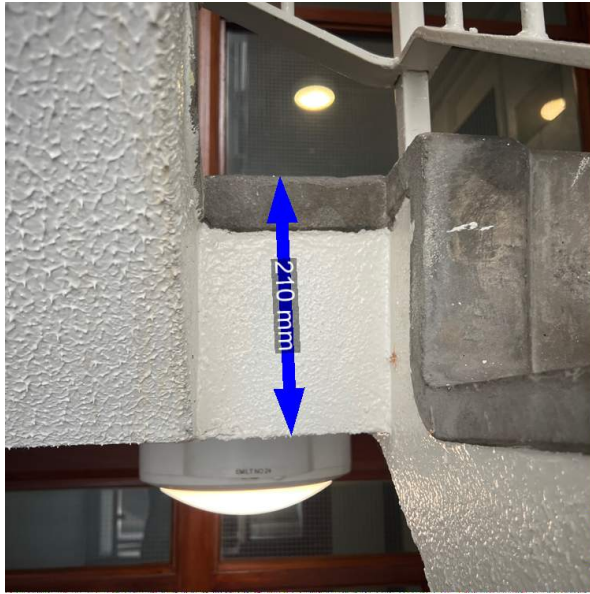
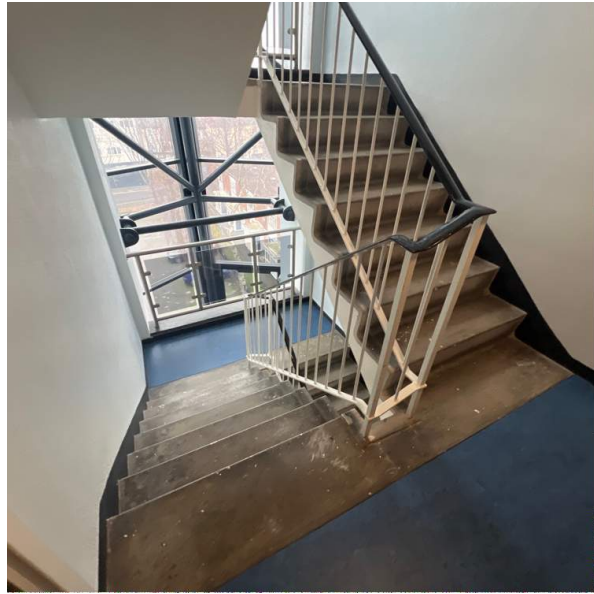
## 5th Floor Staircases

2 sets of staircases present. In situ concrete stairs with steel hand railing fixed to stairs. Walls and floors appear to be fairly level. Stair walls covered with finishes however these would likely form the main concrete shear core walls.

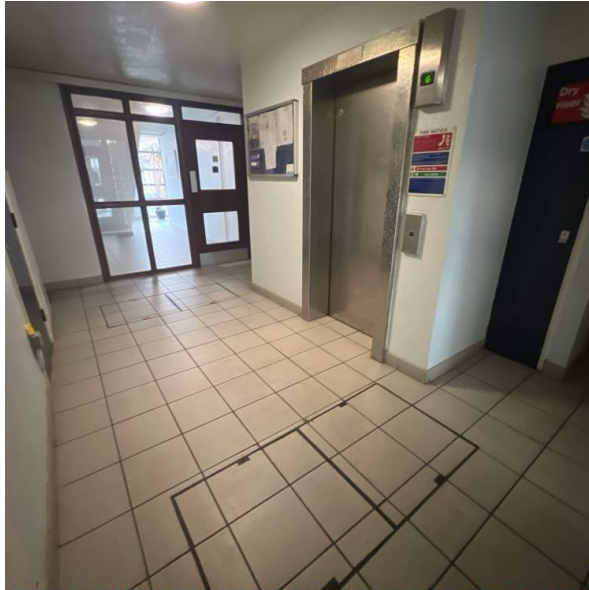
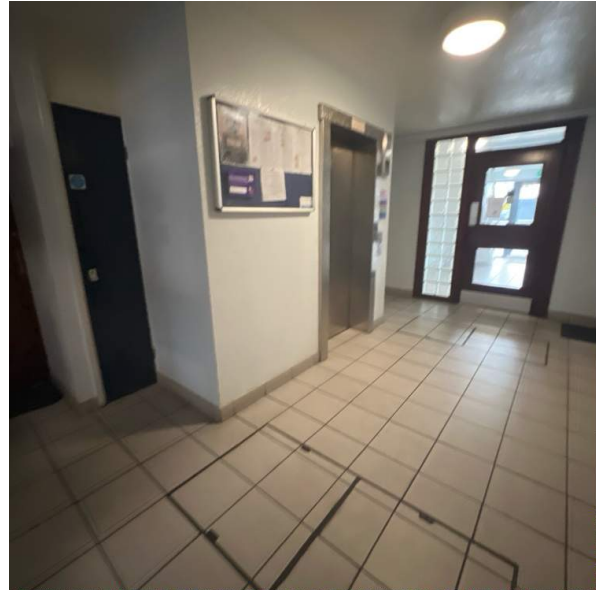
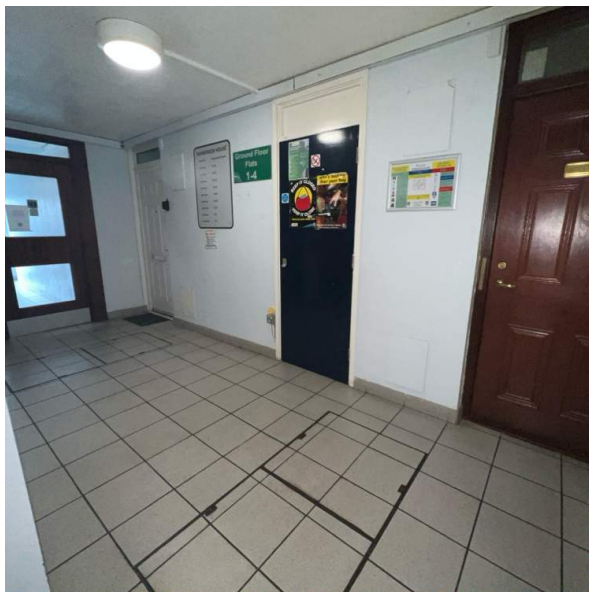
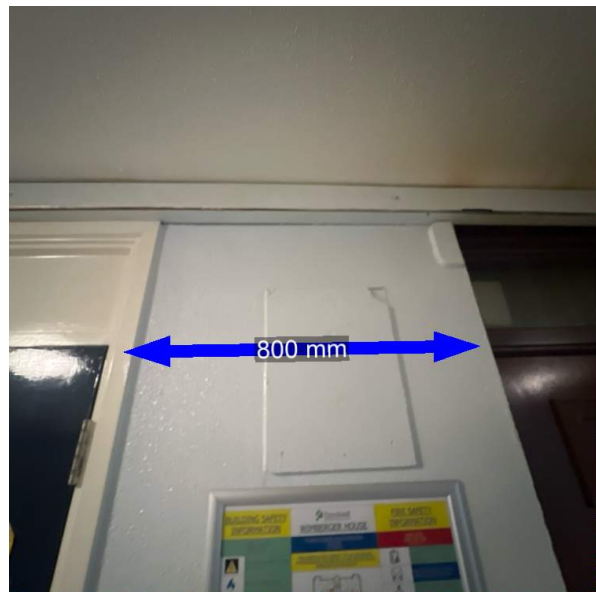
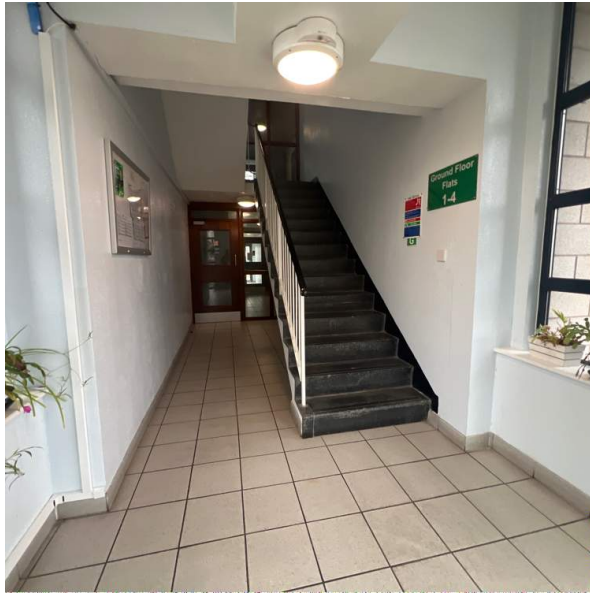
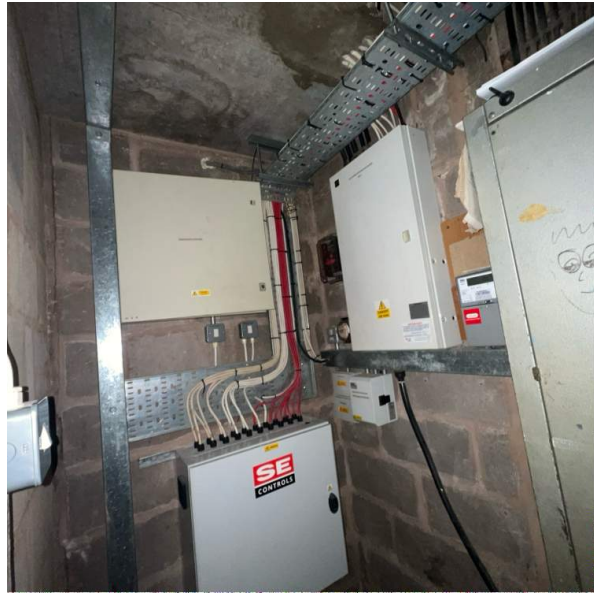
## Ground Floor Hallway

Comments: No jams or distortions noted to hallway doors to indicate any serviceability issues. Generally walls covered with finishes in hallway, likely to consist a mixture of concrete shear walls, embedded columns and block infill walls. Limited structure exposed. Partly visible concrete walls noted via electrical riser cupboard. RC columns noted in electric cupboard.

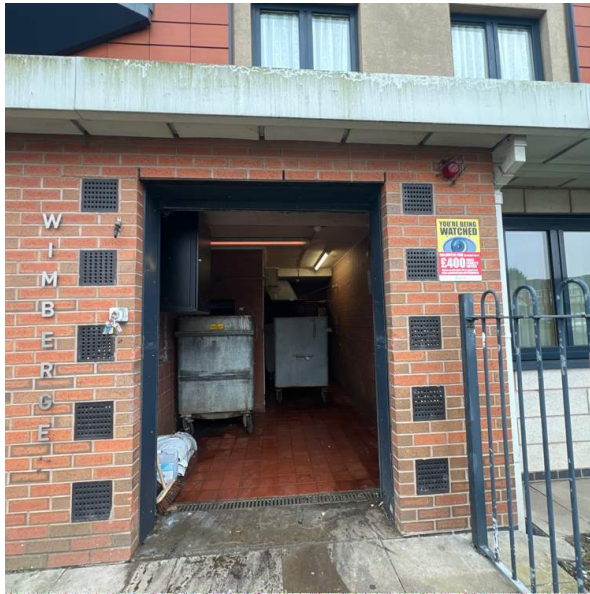
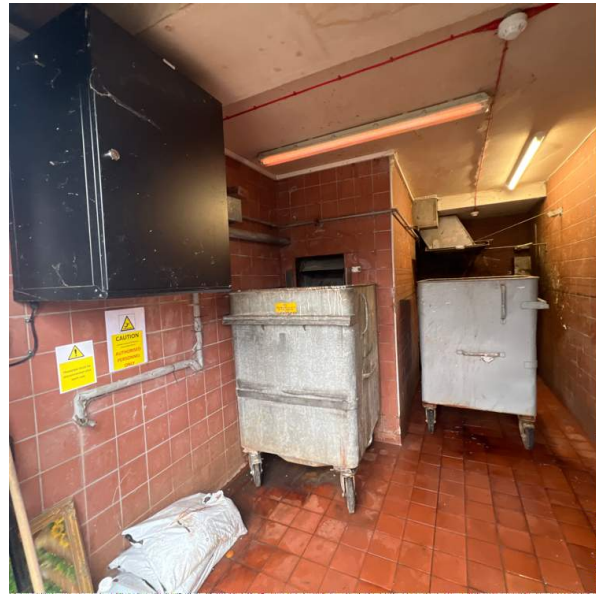
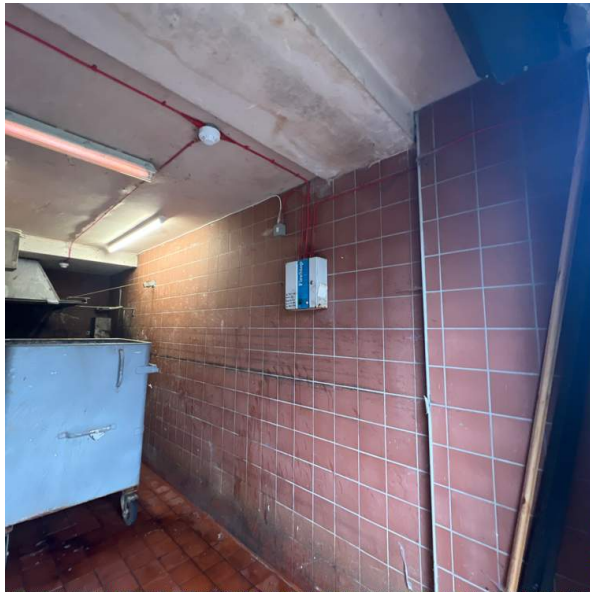
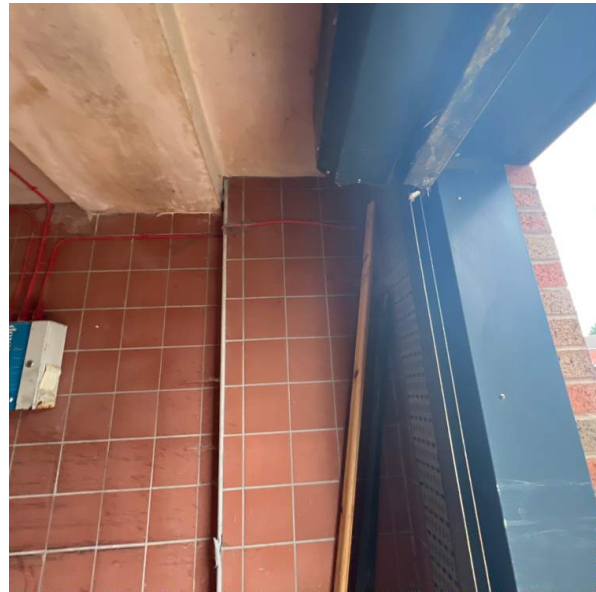
## Binstore

RC shear walls noted in binstore.

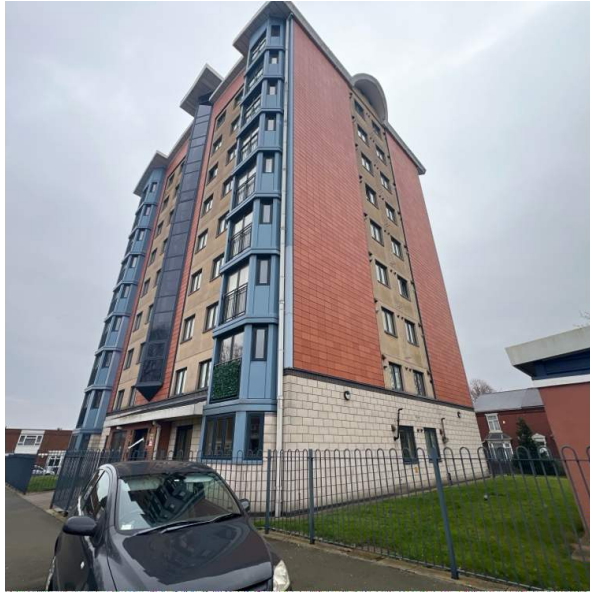
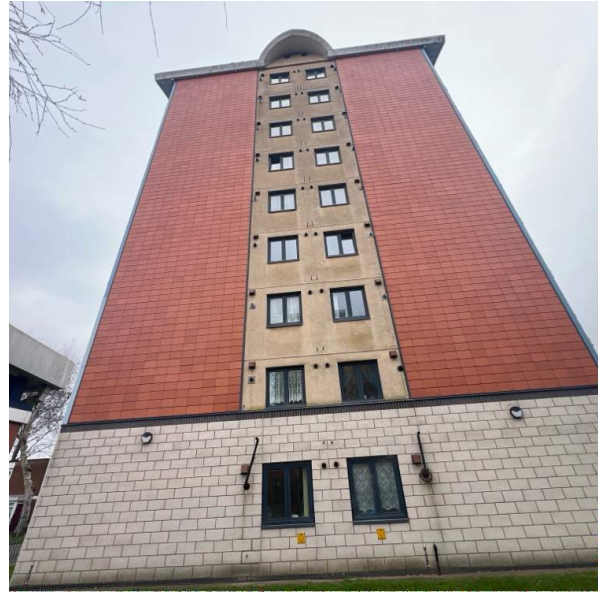
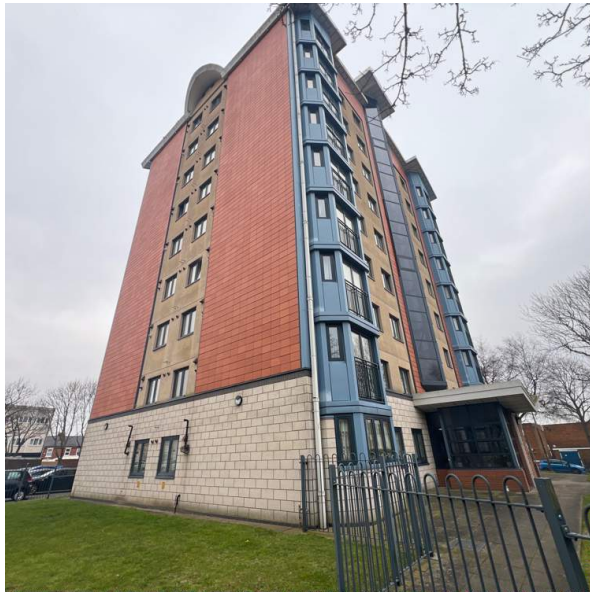
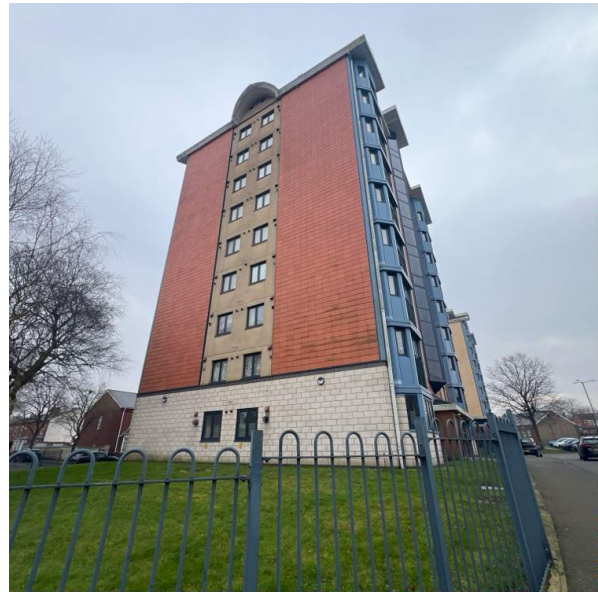
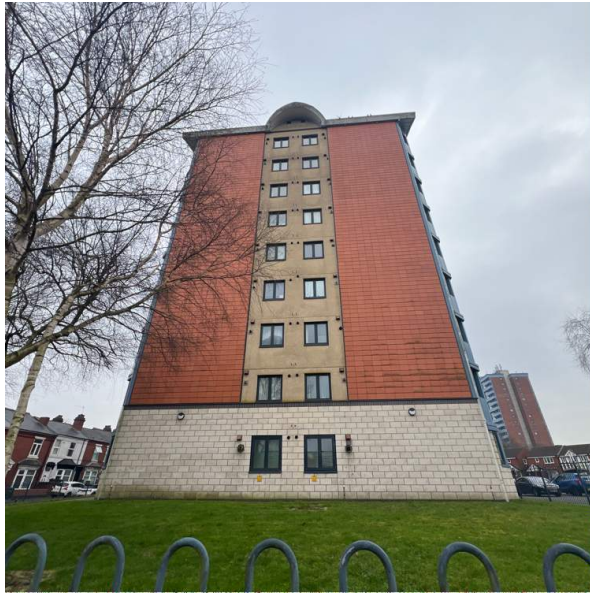
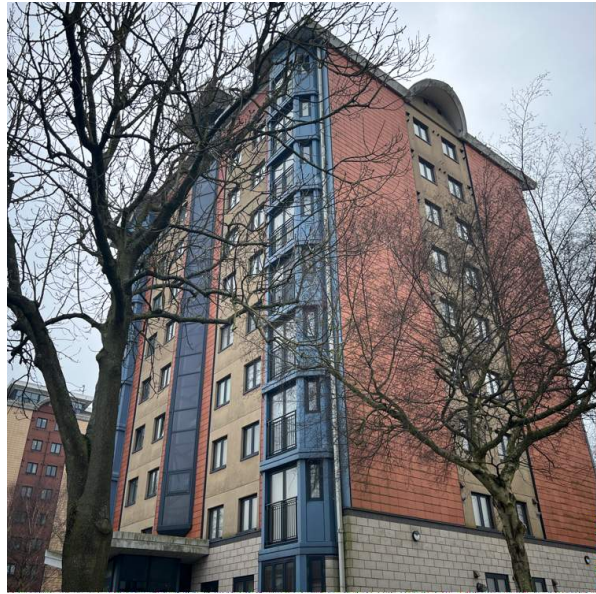
## Elevations

External facade consist of blockwork to the ground floor level. All other levels consist of a mixture of render, tiles and aluminium panel cladding and encased balconies.

External perimeter RC Concrete Columns), supporting floors.

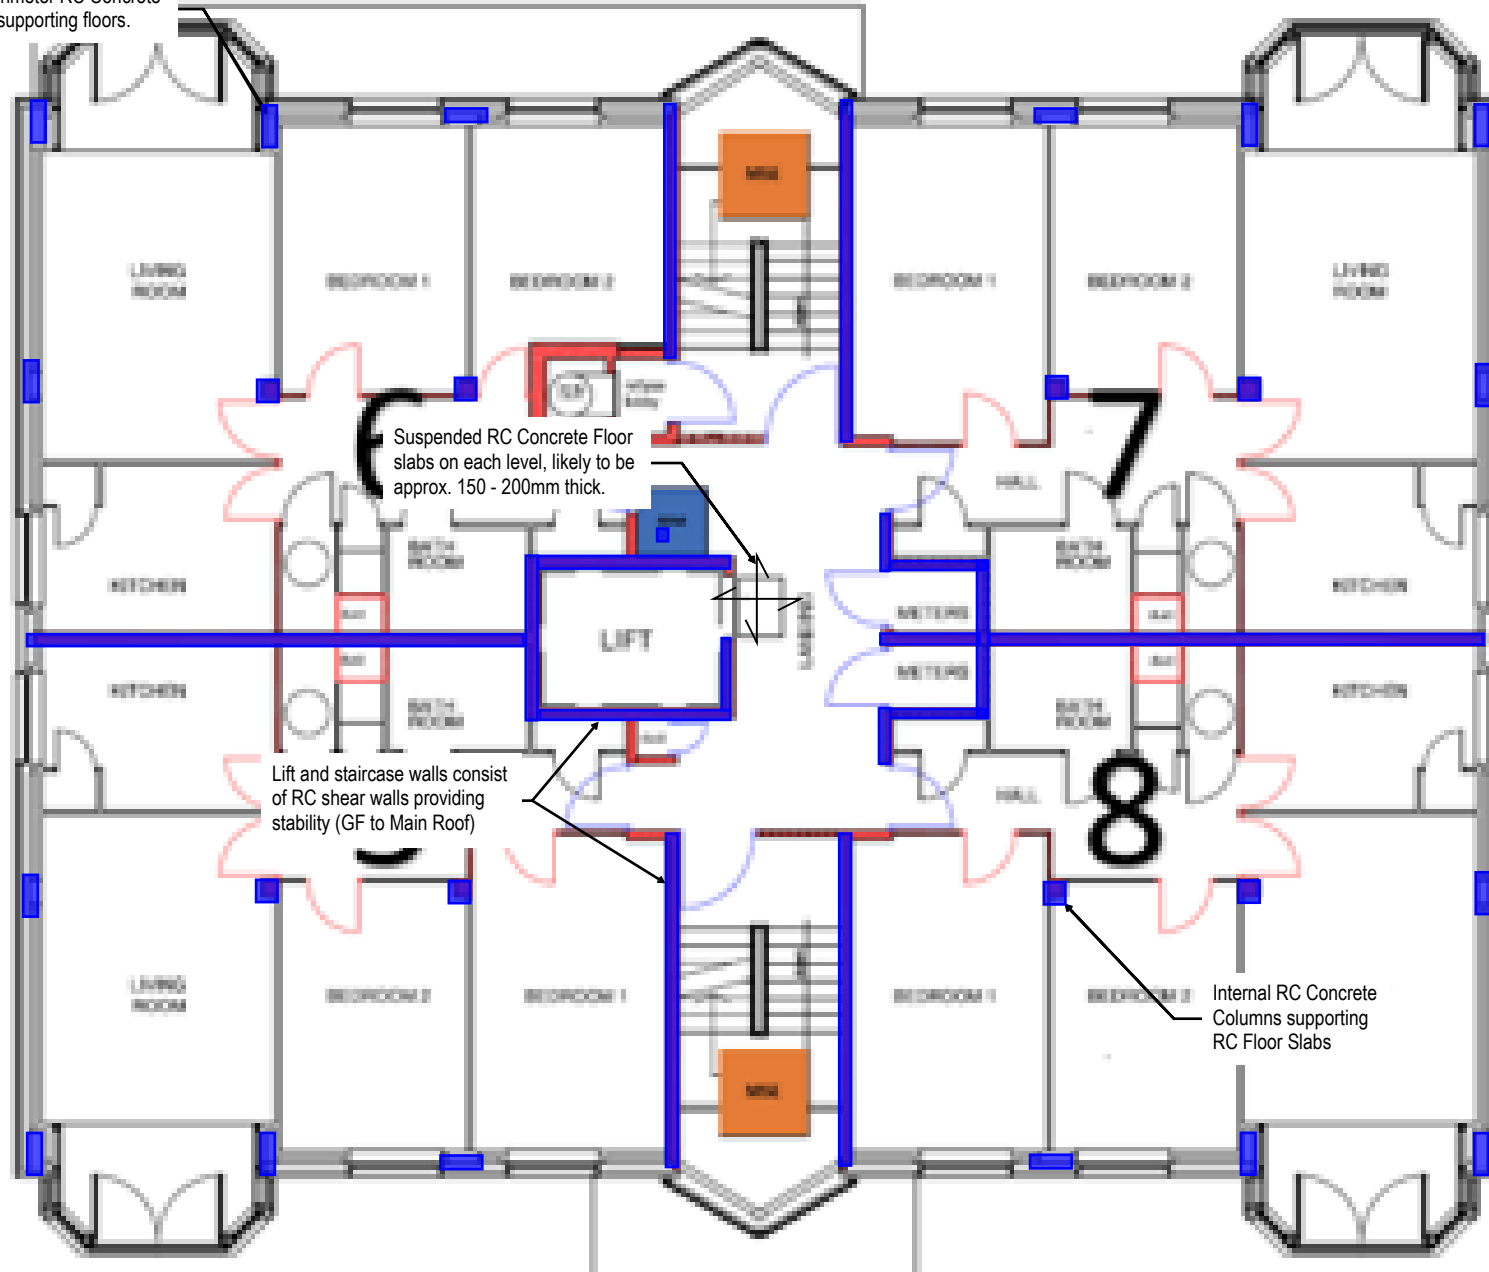
## WIMBERGER HOUSE TYPICAL FLOOR LAYOUT

RC Shear/Core Walls & Columns. Annotated on plan shown indicatively based on limited site observations and general floor plan arrangement. Likely other locations present where not shown on plan. All floors appear to align with minimum transfer structure present.
