**FIRNTEC**  
BUILDING COMPLIANCE

VISUAL STRUCTURAL APPRAISAL

Wyndmill Crescent

26<sup>th</sup> February 2025

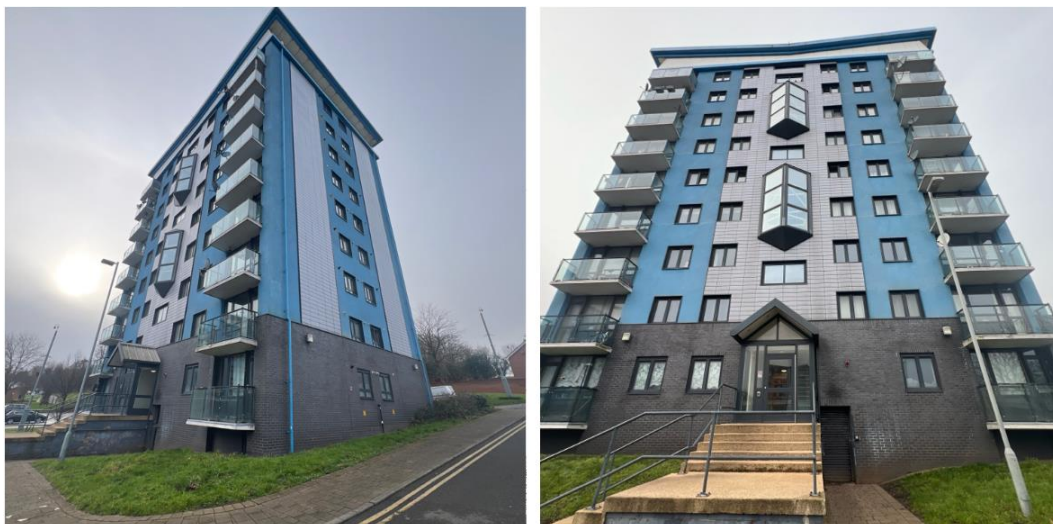
Figure 9 and 10: Building Elevations

The exterior elevations were generally in ok condition and no significant structural defects were noted to the cladding panels. There were no significant cracks or tell-tale signs of any significant structural movement noted at the time of our inspection.

The exterior panels were noted to be plumb with no signs of significant bowing, bulging or leaning noted to the panels indicating failed fixings however their presence and condition cannot be confirmed.

There are balconies at each level which are formed of cantilevered RC slabs tied into the main frame. During the 2015 refurbishment they had steel balustrades with glazed infill installed.

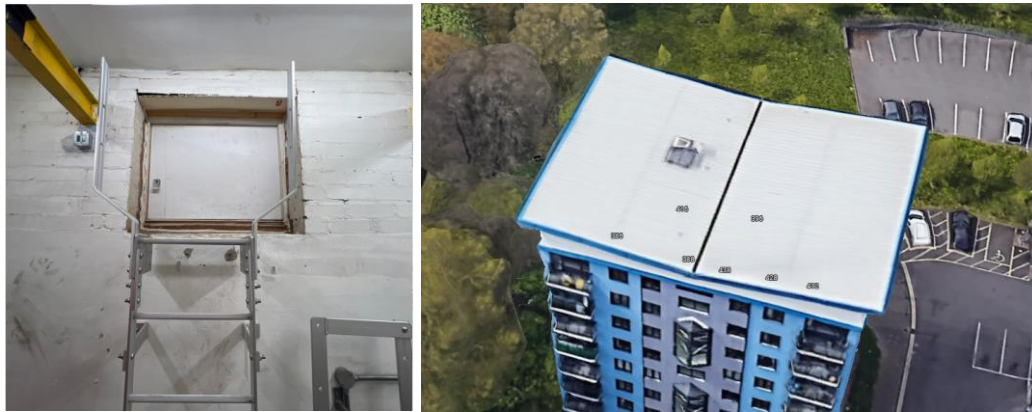
Figure 11 and 12: Access latch closed and Roof Level from satellite

There was no access to the roof level at the time of our survey. The original roof is a reinforced concrete cast slab.

The roof has subsequently been covered with a new waterproofing covering formed of a steel frame installed to the existing roof which supports pitched corrugated sheets. This roof is not insulated and therefore acts purely as a weather barrier. The fire protection of the steel is unclear as the beams do not appear to be unprotected. Details of this frame should be requested from the contractor who completed the works in 2015. No signs of water ingress of that the roof is not performing as intended.

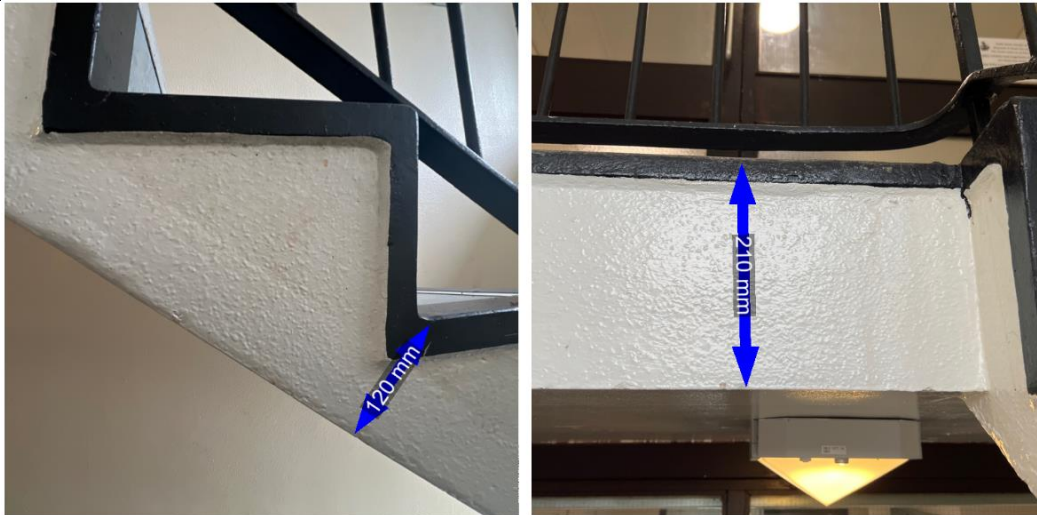
Figure 13 and 14: RC Staircase stringer and slab

The stair stringer was noted to be 110mm thick which seems slim, certainly short of modern standards. A cover test is required to check the resistance of the concrete section in the event of a fire.

Due to the age of the building it is wise to perform periodical health checks to the concrete elements. This should include tests for concrete strength, cover depth, carbonation, chlorides and HAC. It would appear that these tests have never been performed to this building and therefore we recommend engaging a specialist contractor within the next 24 months who will be able to perform the tests and provide a interpretive report. The fire resistance of the structure is not confirmed until the cover meter tests are completed.

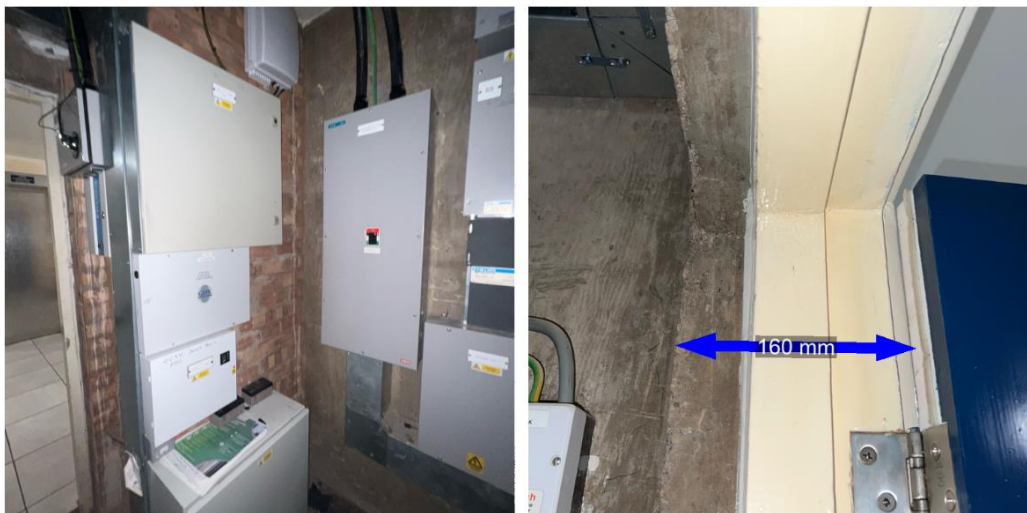
Figure 15 and 16: RC walls

The interior of the stair core walls were checked and were plumb and in line with observations made to the exterior – no significant signs of leaning or movement noted. The concrete appeared in fair condition with few BRE category 1 cracks but no structurally significant defects were noted.

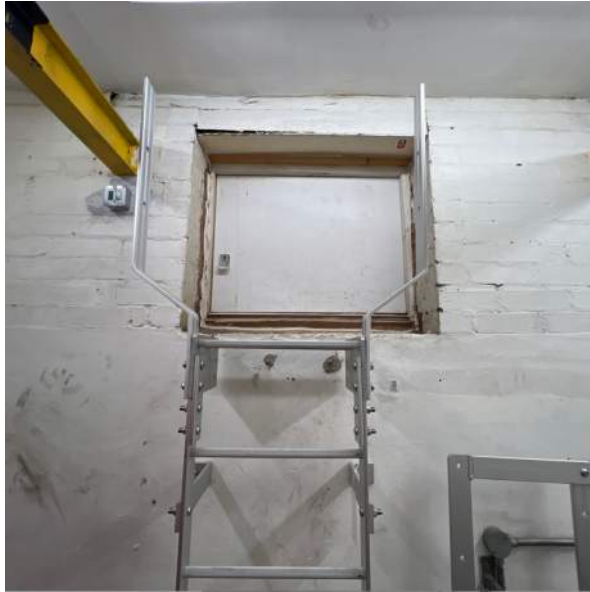
## Main Roof

Comments: No access to roof during inspection.

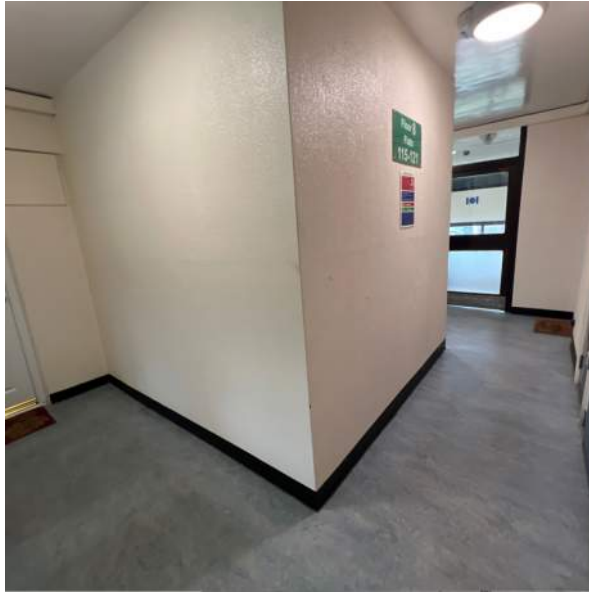
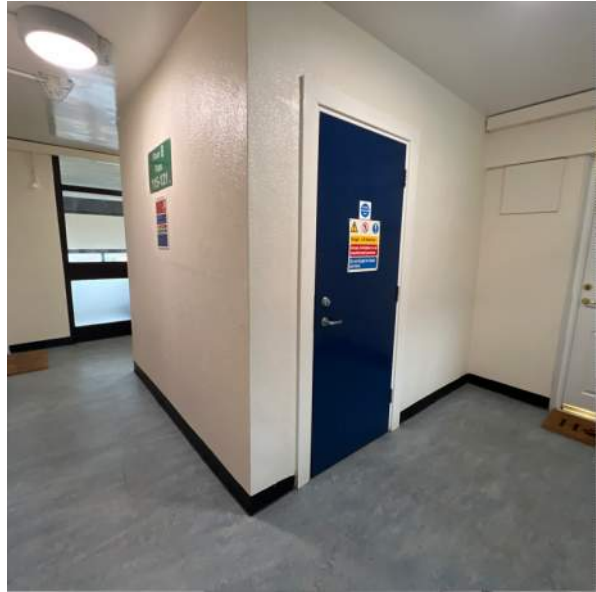
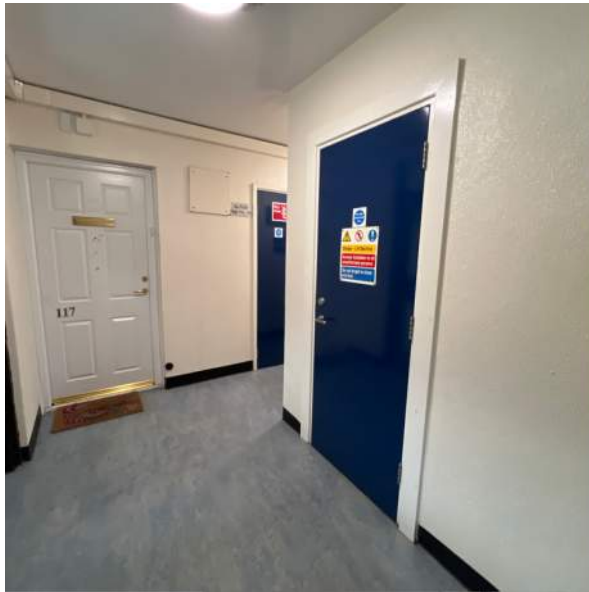
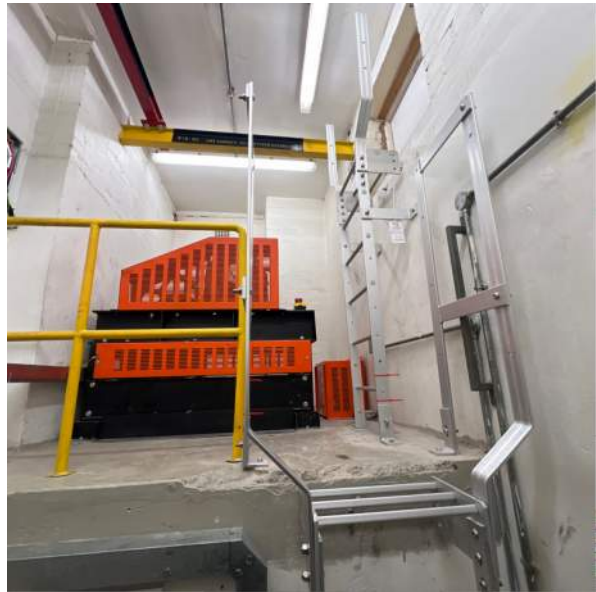
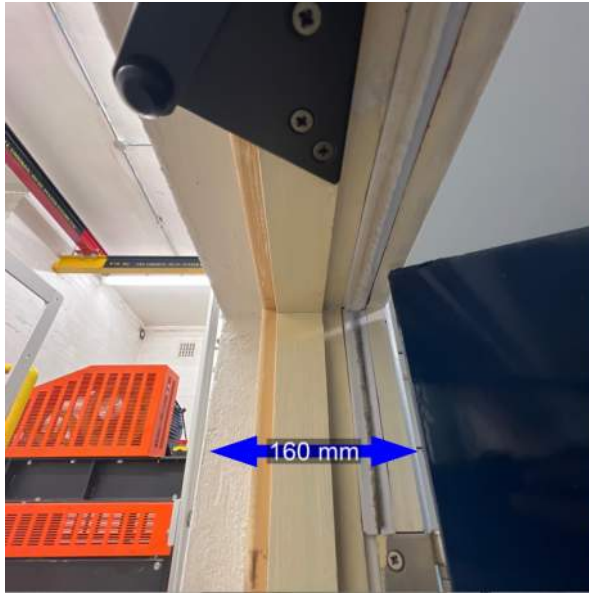
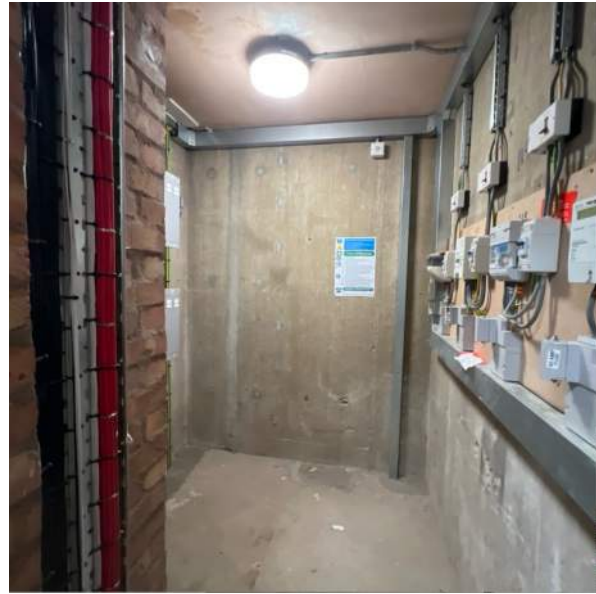
## 8th Floor Hallway

Comments: No jams or distortions noted to hallway doors to indicate any serviceability issues. Generally walls covered with finishes in hallway, likely to consist a mixture of concrete shear walls, embedded columns and masonry infill walls. Limited structure exposed. Concrete walls and infill masonry (non-load bearing) walls noted in riser cupboards.

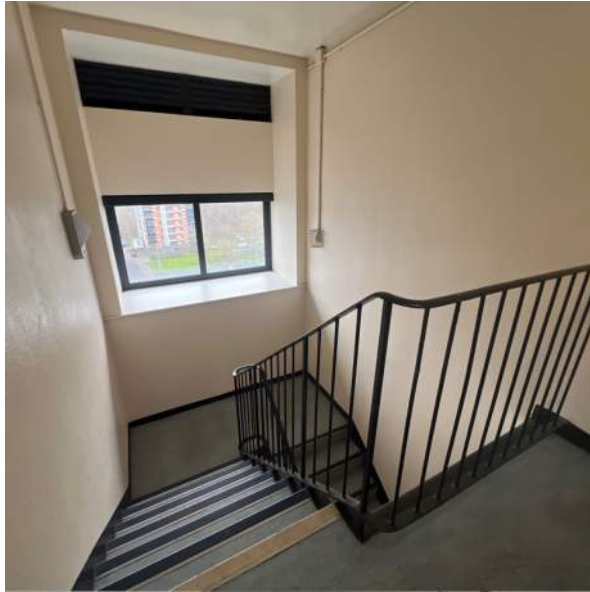
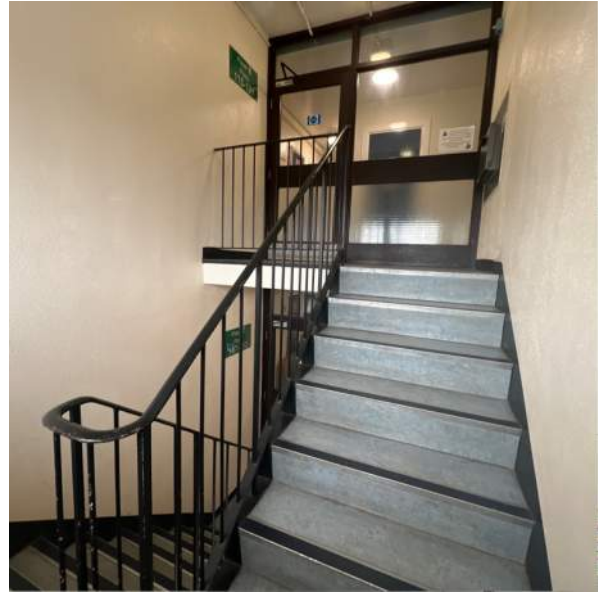
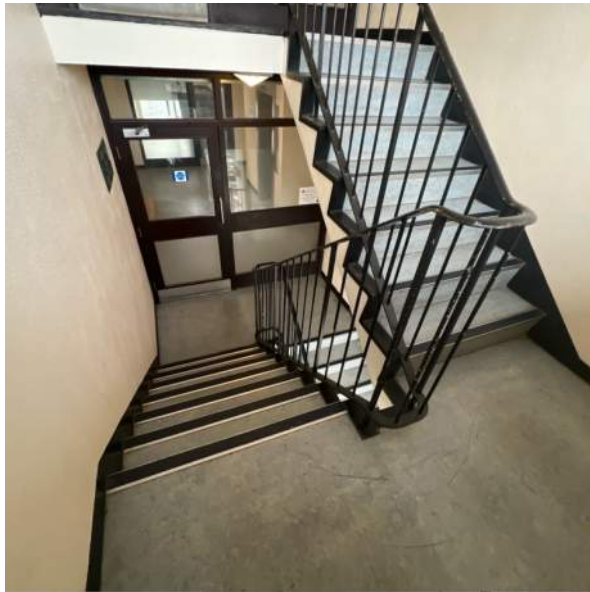
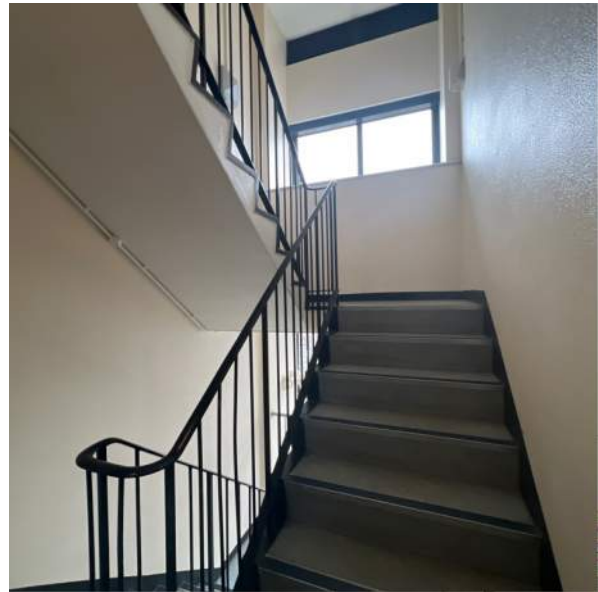
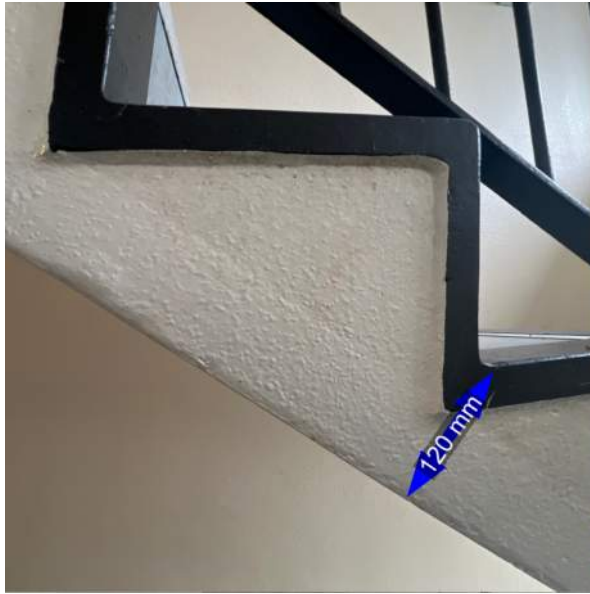
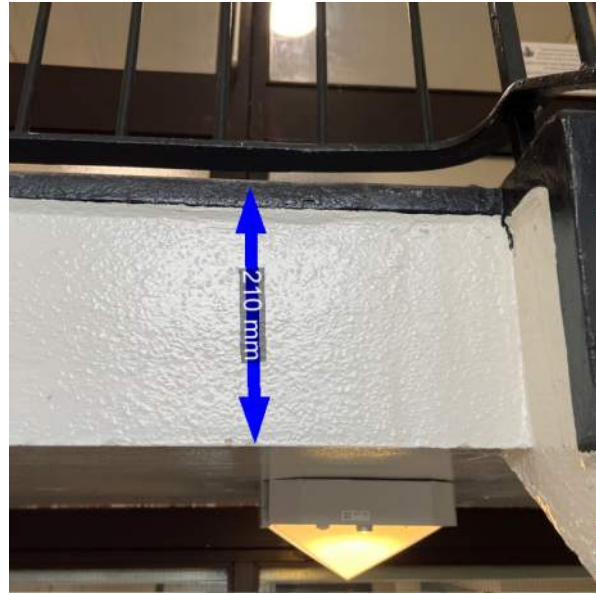
## 8th Floor Staircases

Comments: Insitu concrete stairs with steel hand railing fixed to stairs. Walls and floors appear to be fairly level.  
Stair walls covered with finishes however these would likely form the main concrete shear core walls.

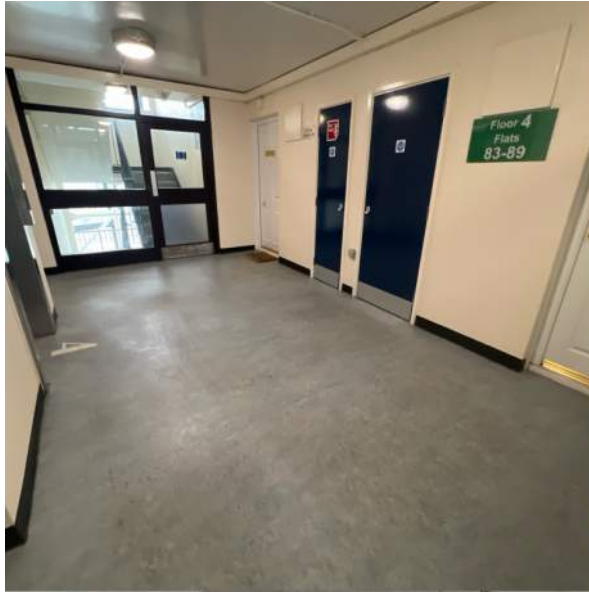
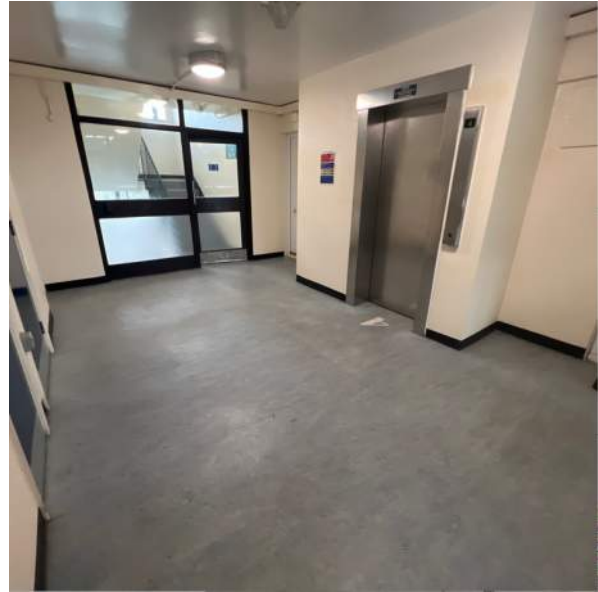
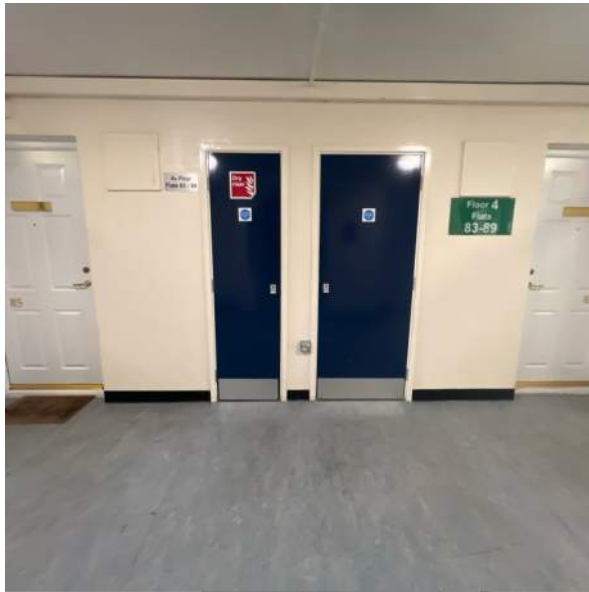
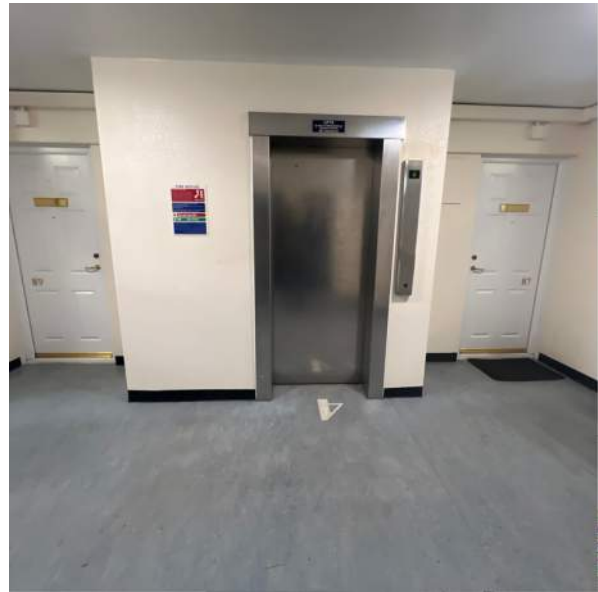
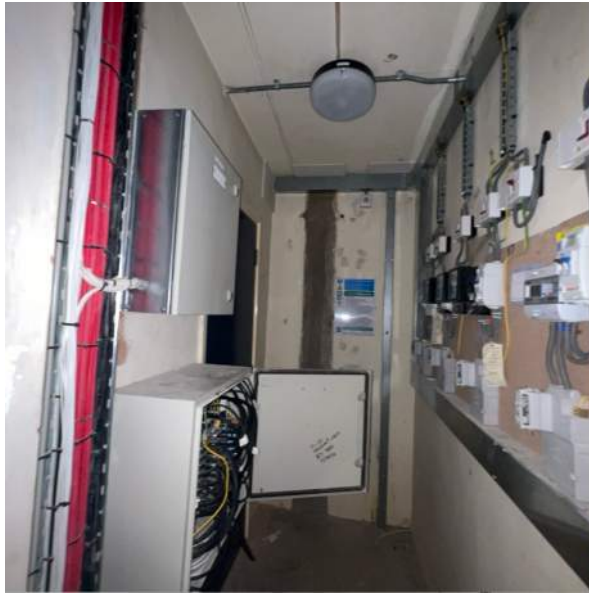
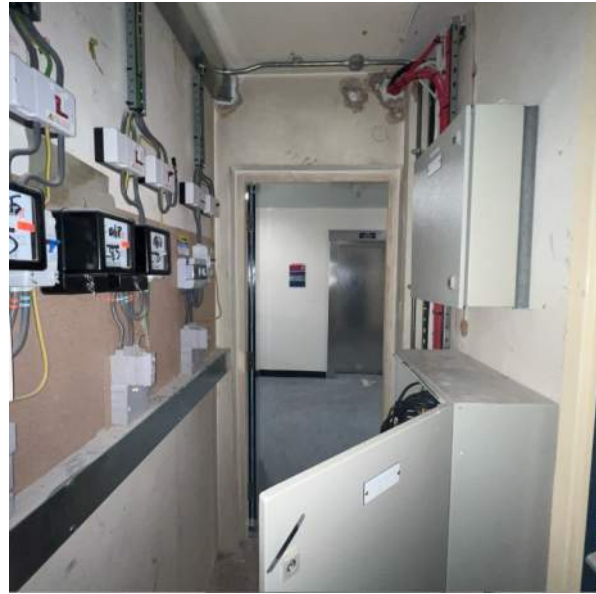
## 4th Floor Hallway

Comments: No jams or distortions noted to hallway doors to indicate any serviceability issues. Generally walls covered with finishes in hallway, likely to consist a mixture of concrete shear walls, embedded columns and masonry infill walls. Limited structure exposed. Concrete walls and infill masonry (non-load bearing) walls noted in riser cupboards.

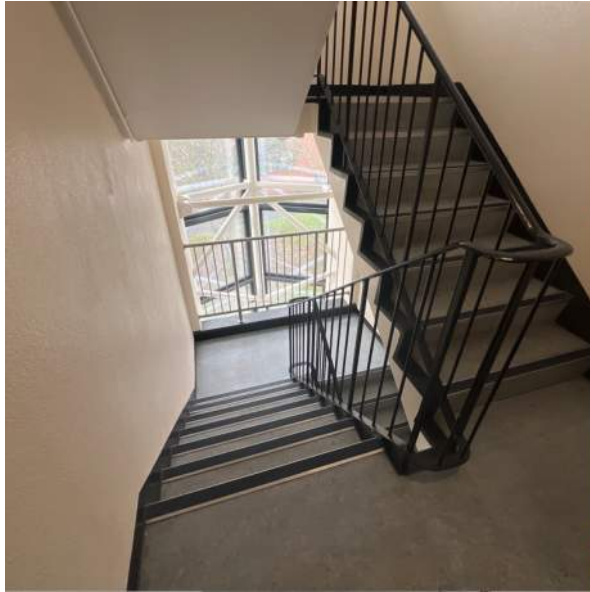
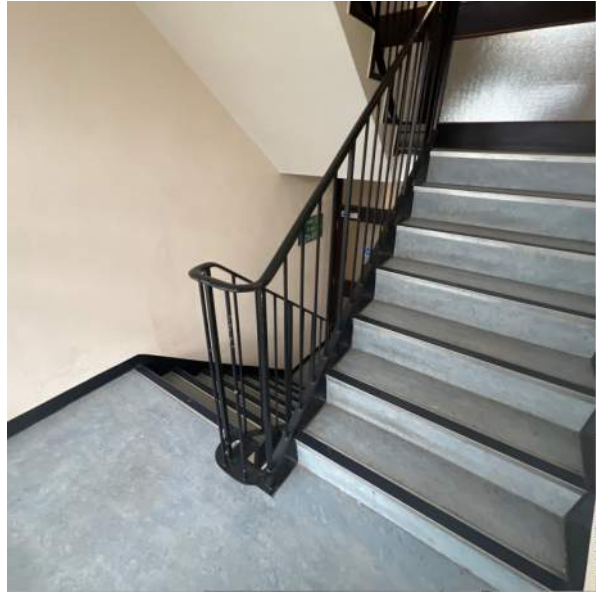
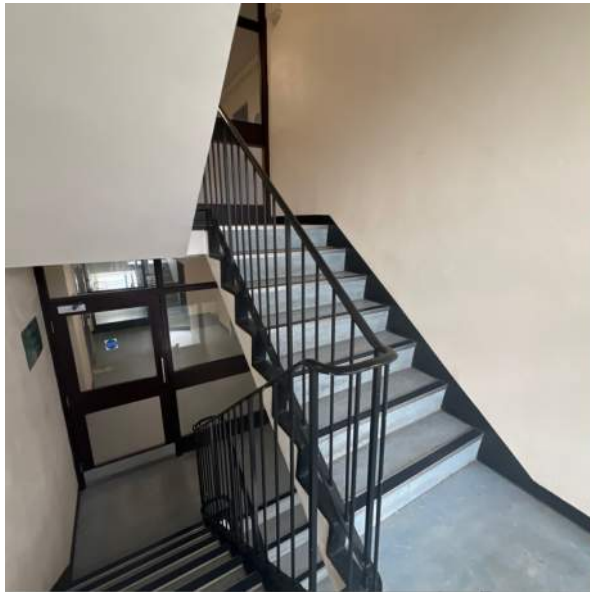
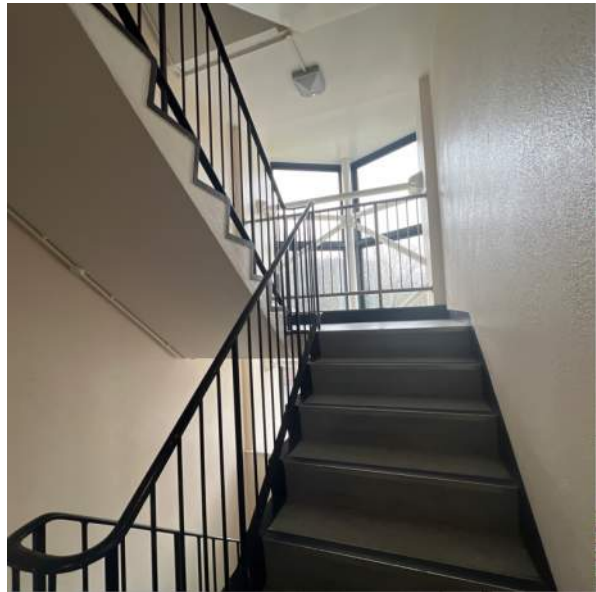
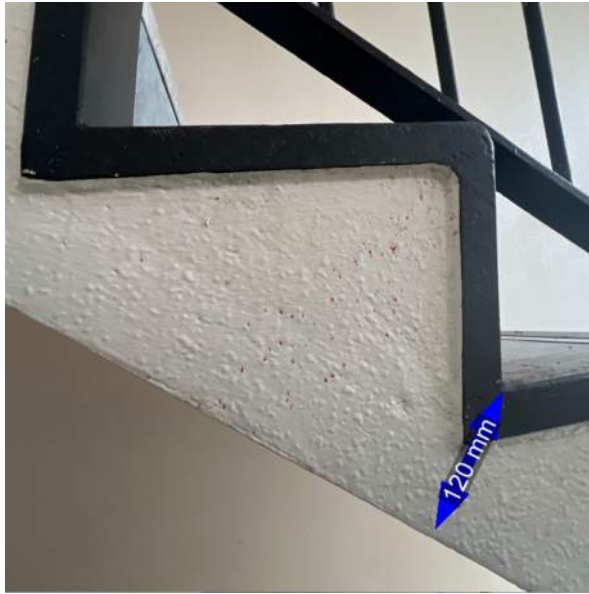
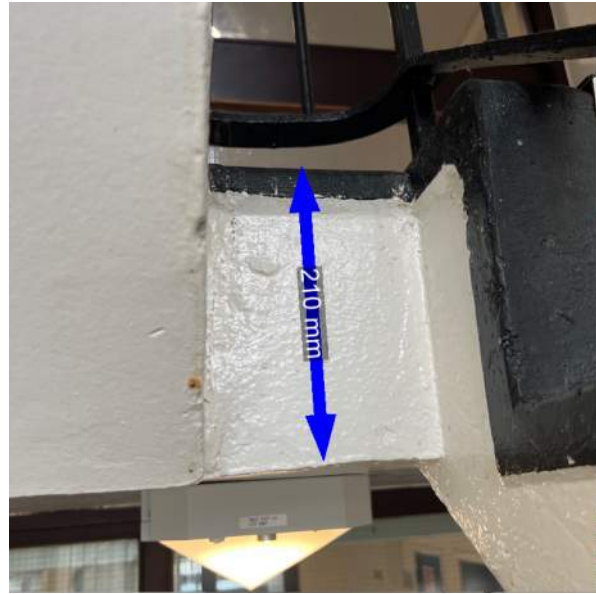
## 4th Floor Staircases

Comments: Insitu concrete stairs with steel hand railing fixed to stairs. Walls and floors appear to be fairly level.  
Stair walls covered with finishes however these would likely form the main concrete shear core walls.

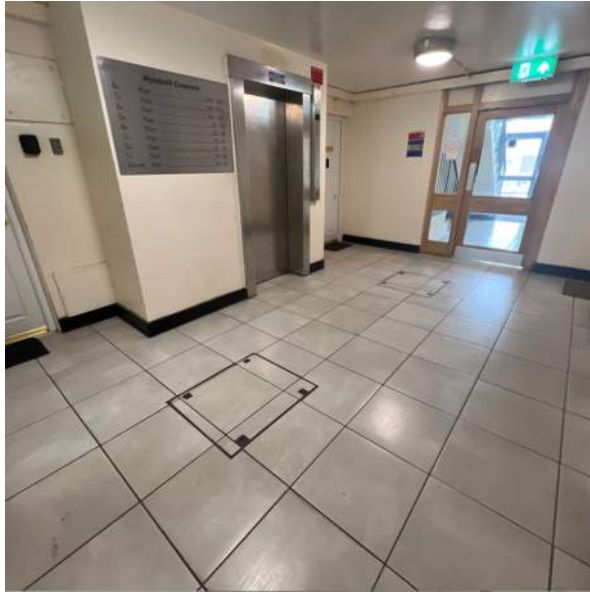
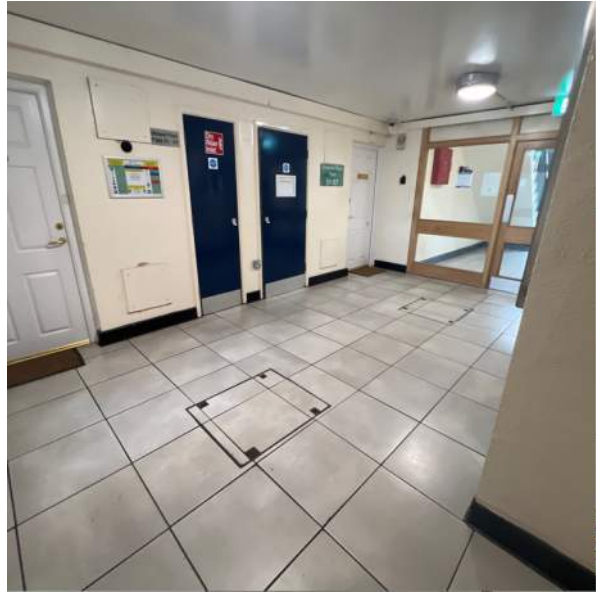
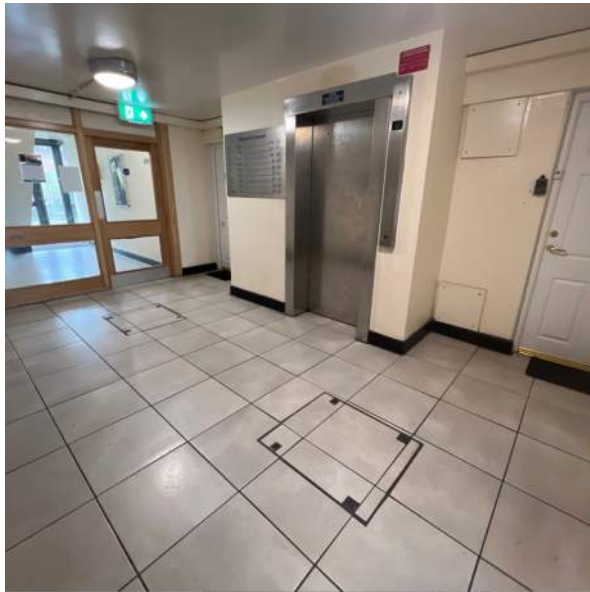
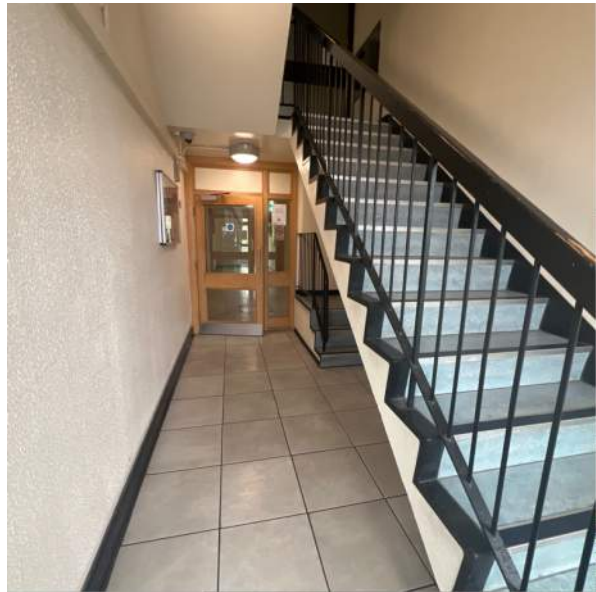
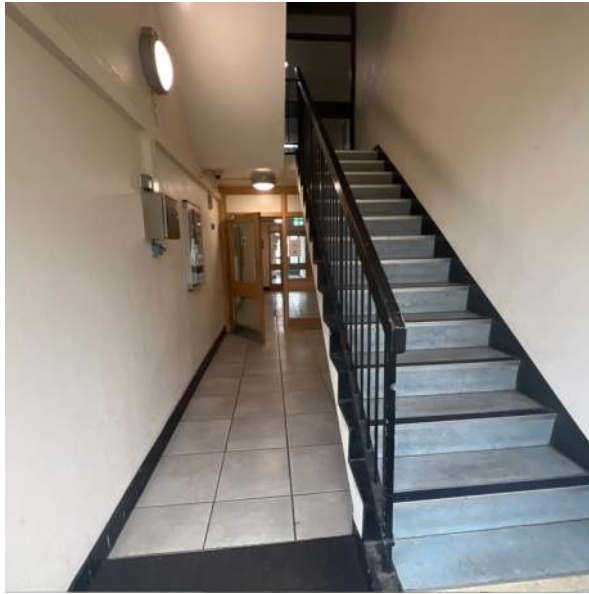
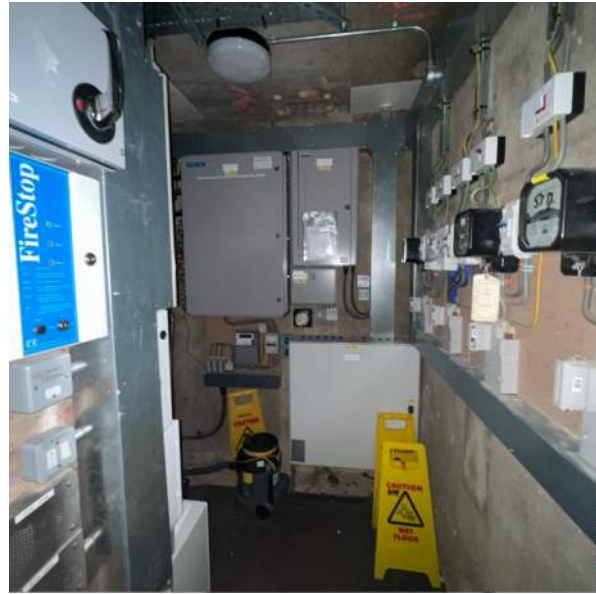
## Ground Floor Hallway

Comments: No jams or distortions noted to hallway doors to indicate any serviceability issues. Generally walls covered with finishes in hallway, likely to consist a mixture of concrete shear walls, embedded columns and masonry infill walls. Limited structure exposed. Concrete walls and infill masonry (non-load bearing) walls noted in riser cupboards.

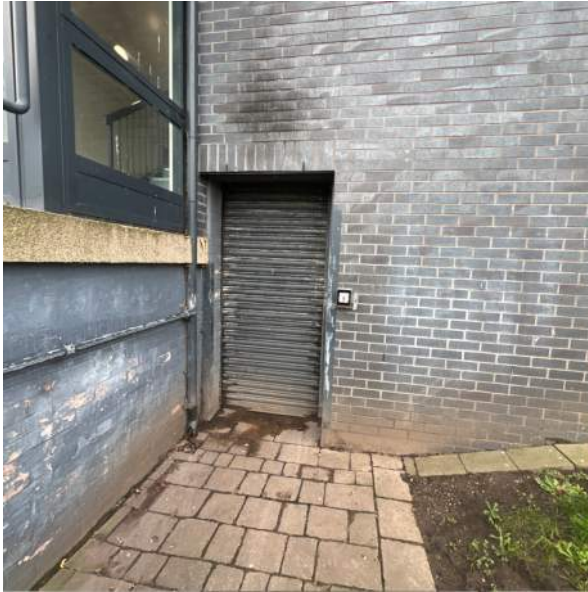
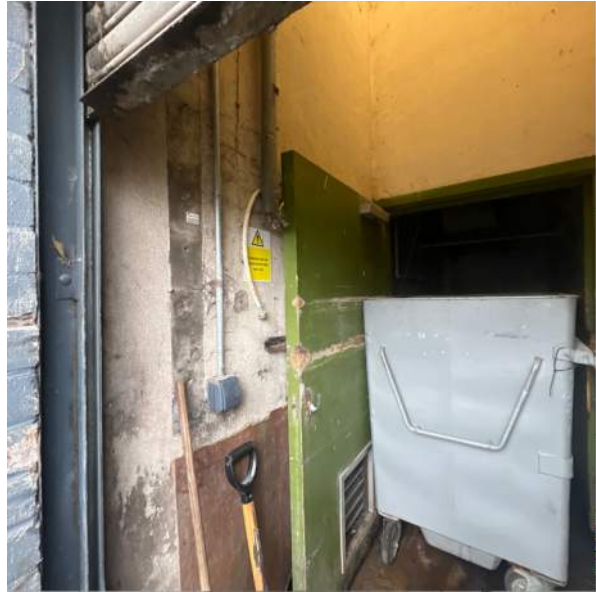
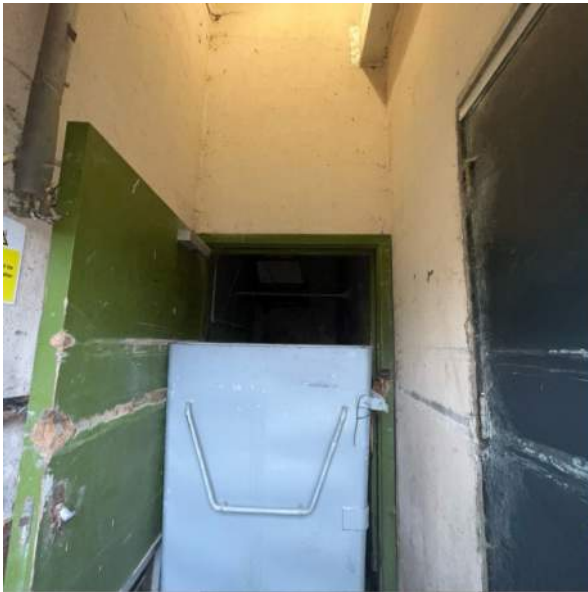
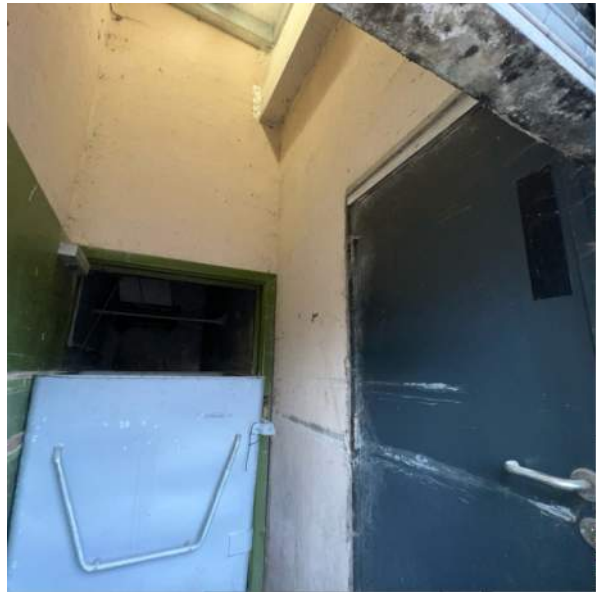
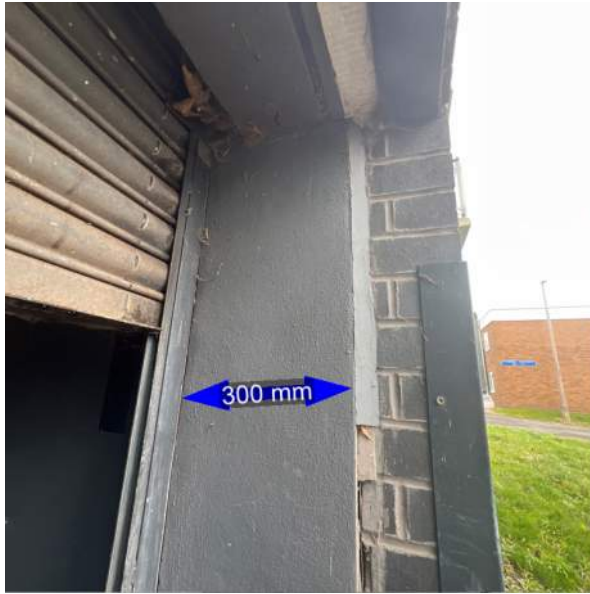
## Binstore

RC walls mainly covered with finishes. RC perimeter column noted.

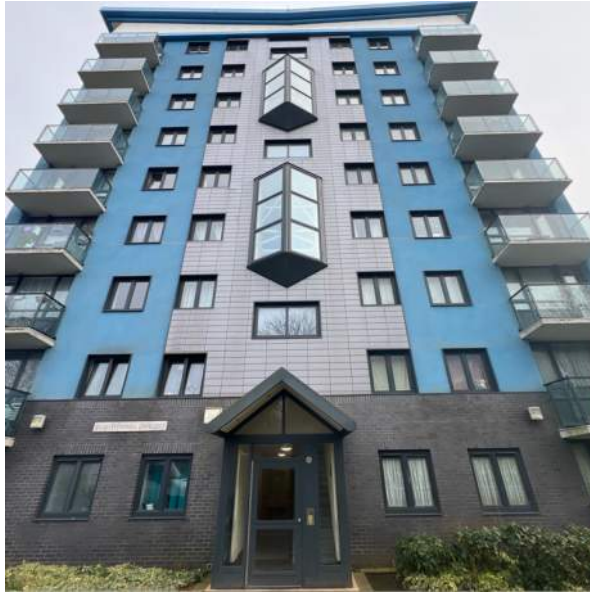
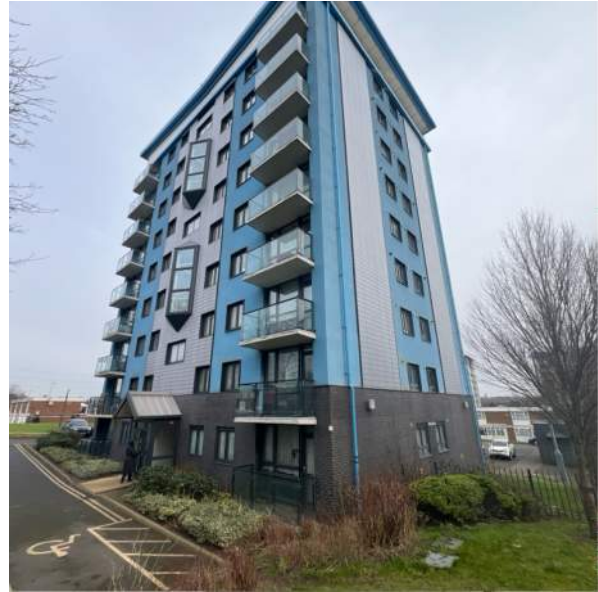
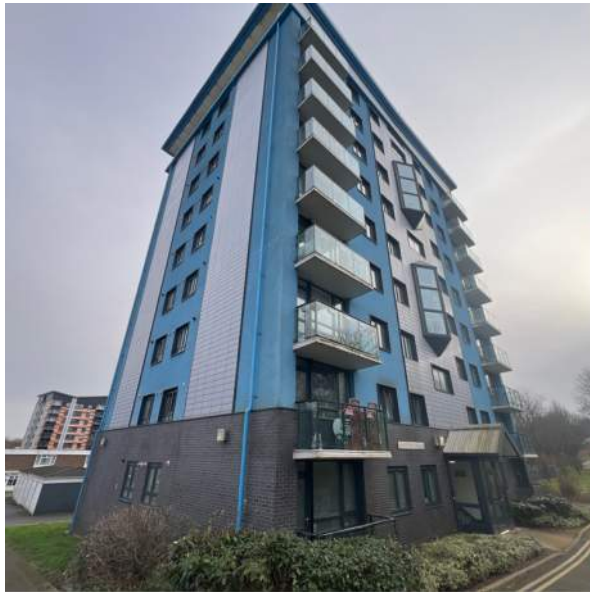
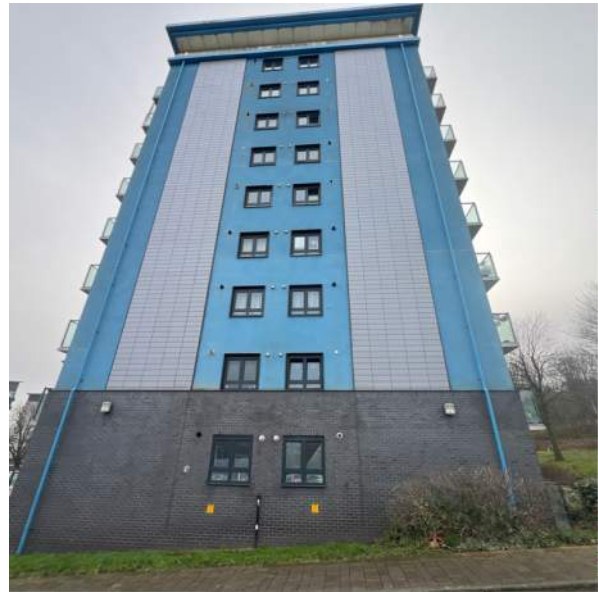
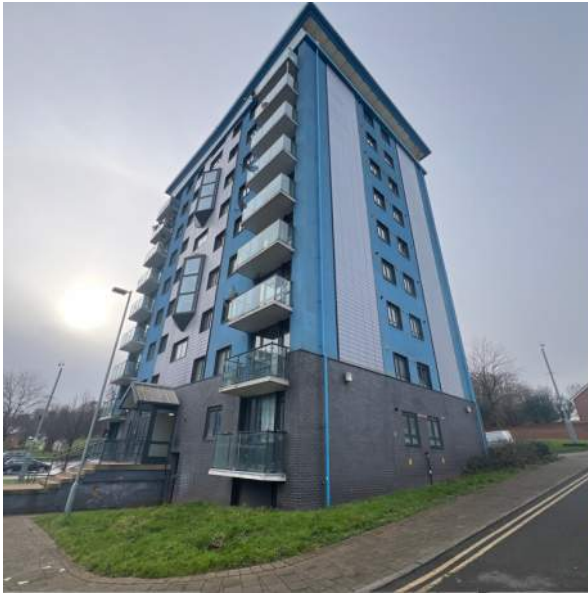
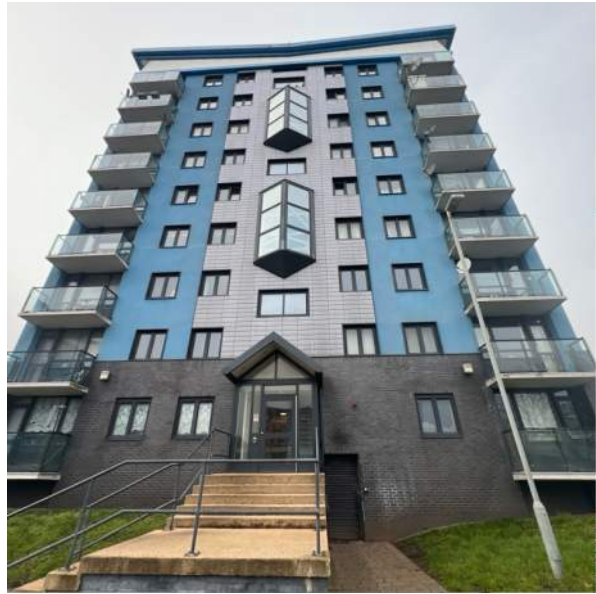
## Elevations

Ground floor level consists of brickwork. Remaining elevations consist of a mixture of rendered and cladded facade.

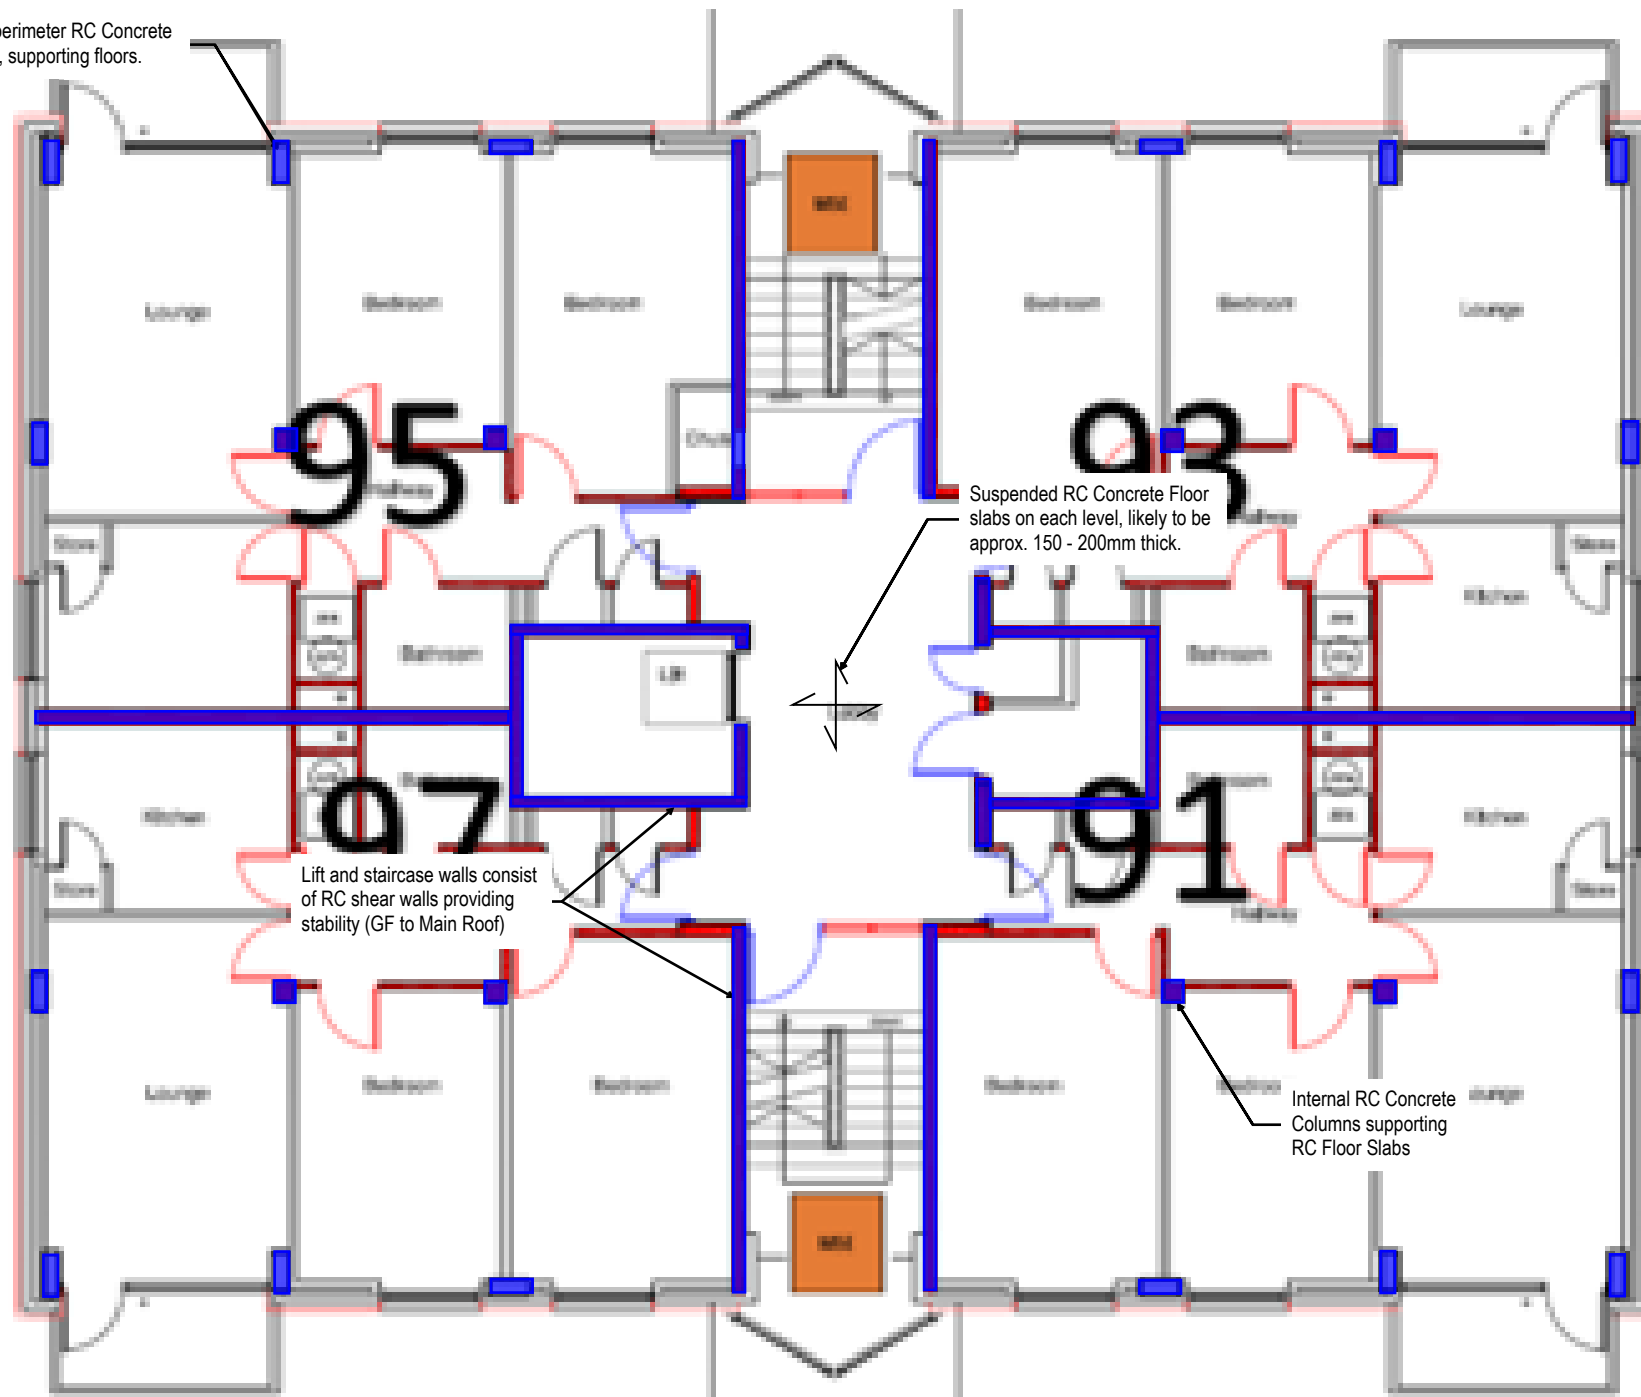
External perimeter RC Concrete Columns), supporting floors.

Suspended RC Concrete Floor slabs on each level, likely to be approx. 150 - 200mm thick.

Lift and staircase walls consist of RC shear walls providing stability (GF to Main Roof)
