**FIRNTEC**  
BUILDING COMPLIANCE

VISUAL STRUCTURAL APPRAISAL

Wyrley House  
Sedgeley Road East  
Tipton  
DY4 7TT

24<sup>th</sup> June 2025

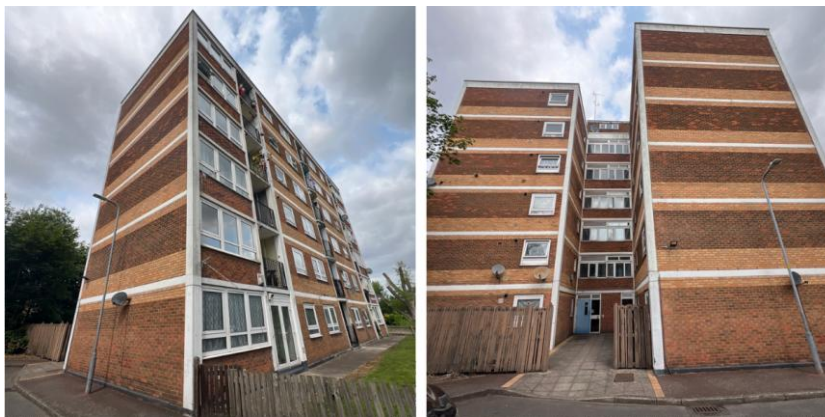
Figure 9 and 10: Building Elevations

The exterior elevations were generally in ok condition and no significant structural defects were noted to the infill panels. There were no significant cracks or tell-tale signs of any significant structural movement noted at the time of our inspection.

The exterior panels were noted to be plumb with no signs of significant bowing, bulging or leaning noted to the panels indicating failed fixings however their presence and condition cannot be confirmed.

There are inset balconies at each level to the long elevation which are formed of RC slabs tied into the main frame. The balconies would benefit from a refurbishment with widespread failed coatings throughout. The exposed slabs should be checked for internal corrosion potential at the benchmark inspections.

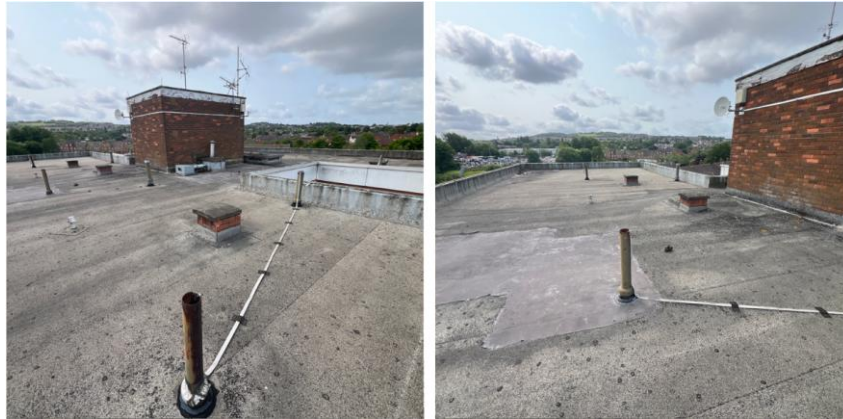
Figure 11 and 12: Roof Level

The flat roof structure is a reinforced concrete cast slab. There is an enclosure which partially covers the roof area which covers the access stairs. The enclosure would benefit from a refurbishment, the timber fascia should be replaced.

There were no tell-tale signs of any significant structural movement noted at the time of our inspection.

The roof has a felted waterproofing system. The exact build-up of the roof finishes were not accessible at the time of inspection. It is recommended an intrusive survey of the roof finishes is completed by a specialist surveyor to assess the condition of the roof covering although they were noted in good condition with no known water ingress issues and therefore a low risk element.

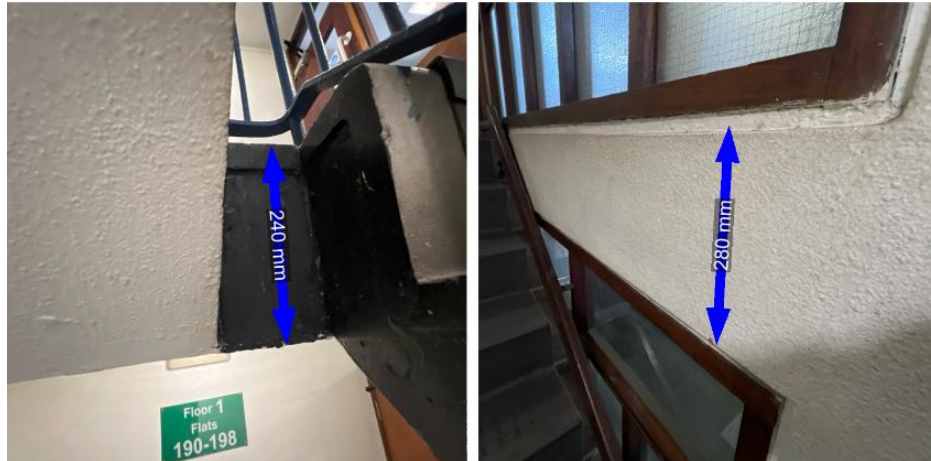
Figure 14 and 15: Slab edges including screed and finishes

The interior of the stair core walls were checked and were plumb and in line with observations made to the exterior – no significant signs of leaning or movement noted. The concrete appeared in fair condition with few BRE category 1 cracks but no structurally significant defects were noted.

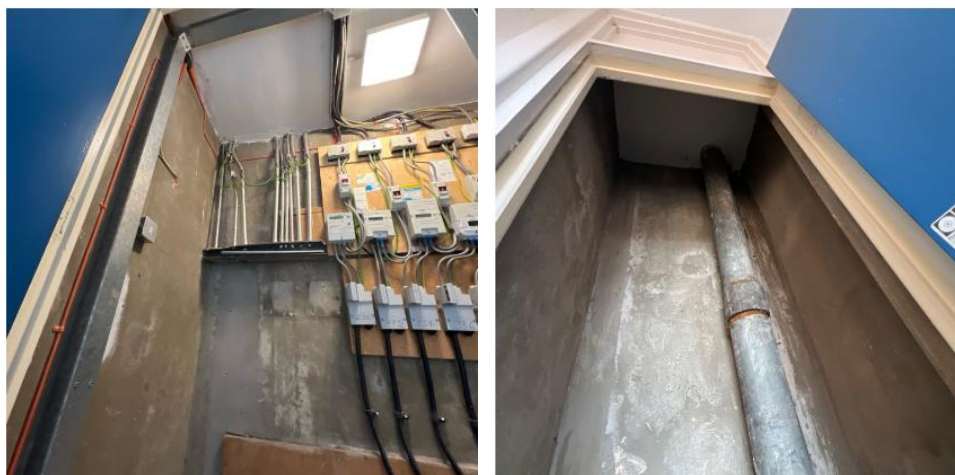
Figure 16 and 17: RC internal elements and communal space

There were vertical concrete walls supporting the floor plates at every level. The elements visible matched the floor layout in Figure 6. The walls appear continuous from ground to roof with no transfer structure. The overall condition of the structure observed is good.

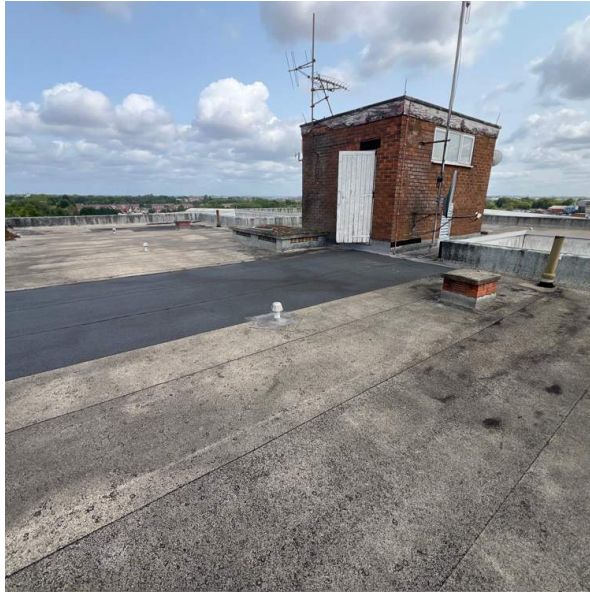
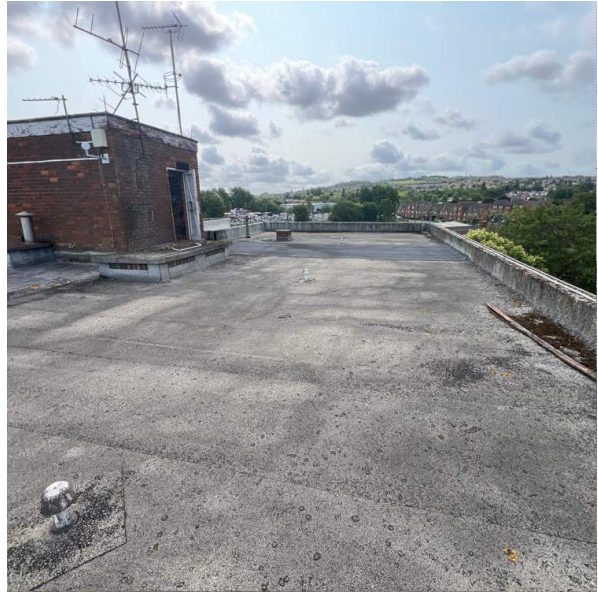
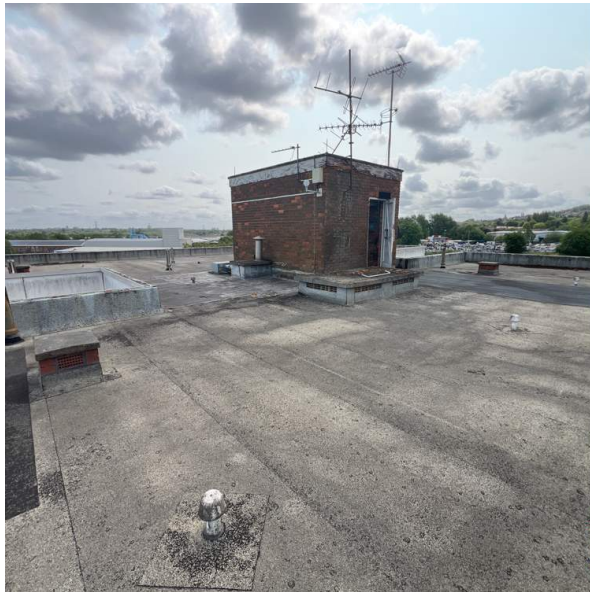
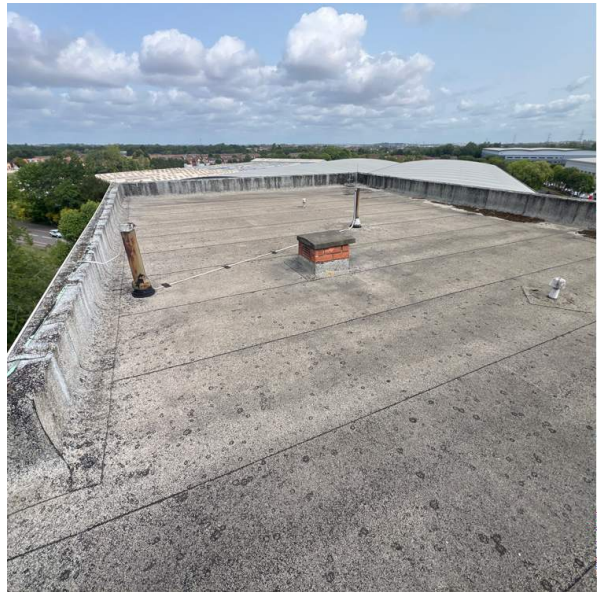
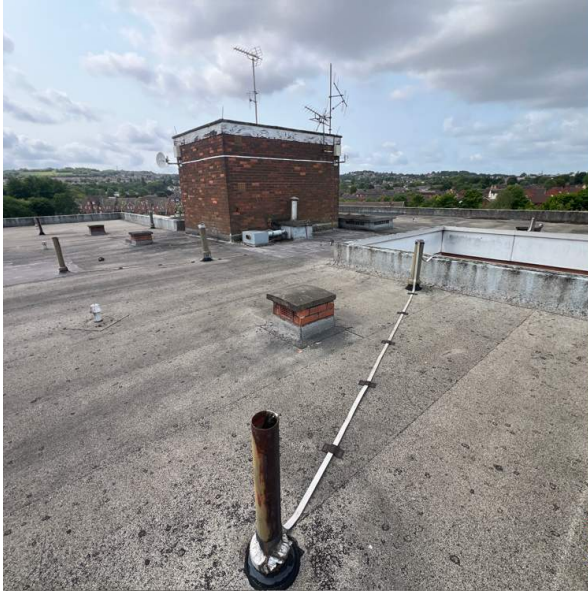
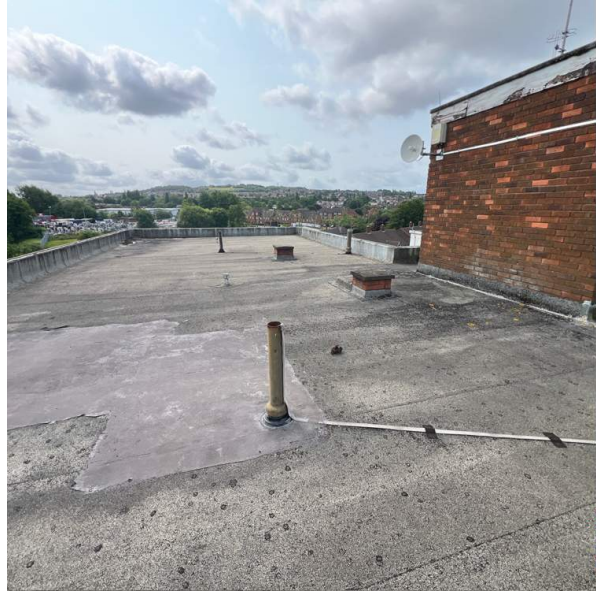
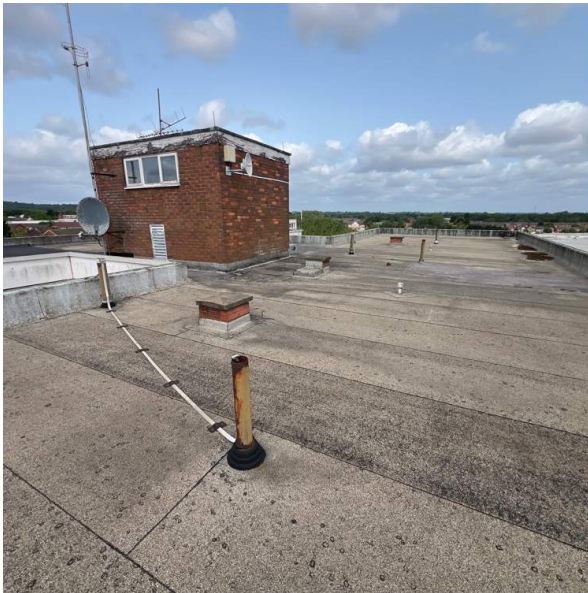
## Main Roof

Comments: Flat roof, RC concrete slab with insulated PIR board and felt coverings.

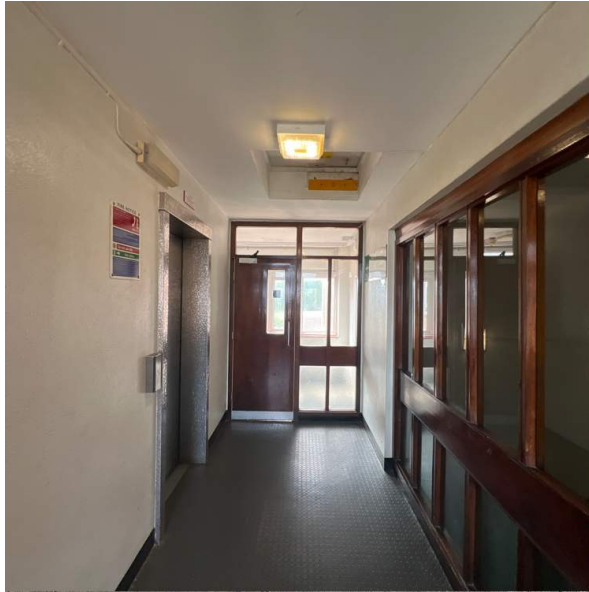
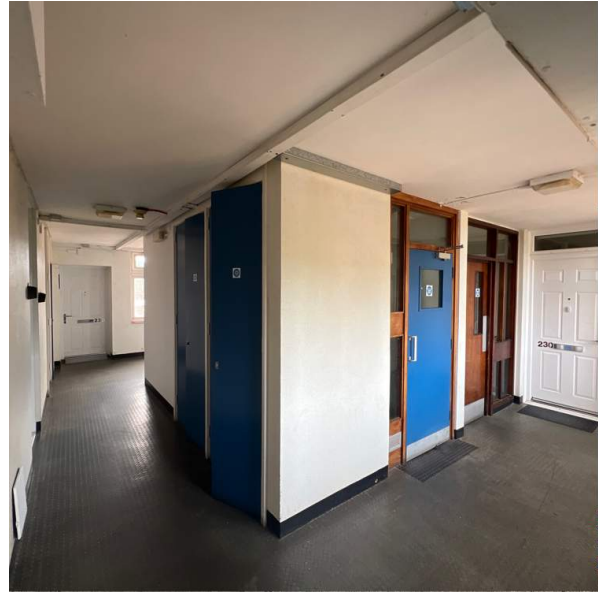
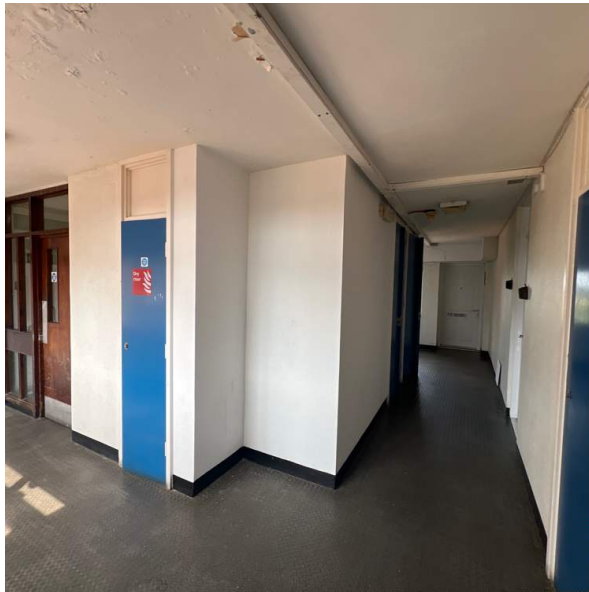
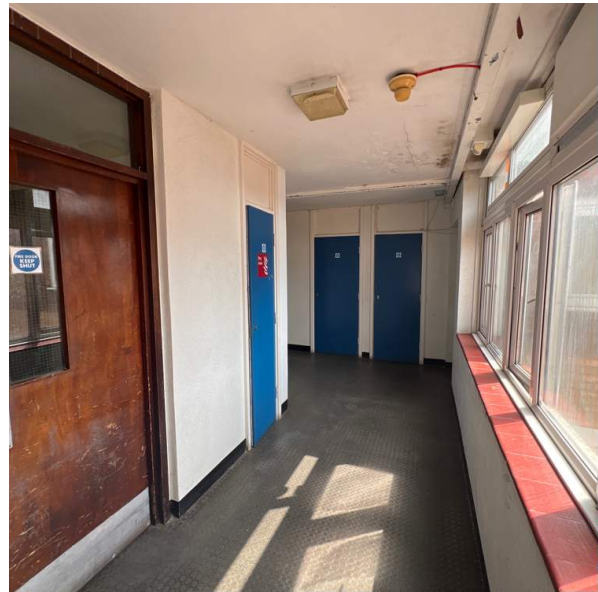
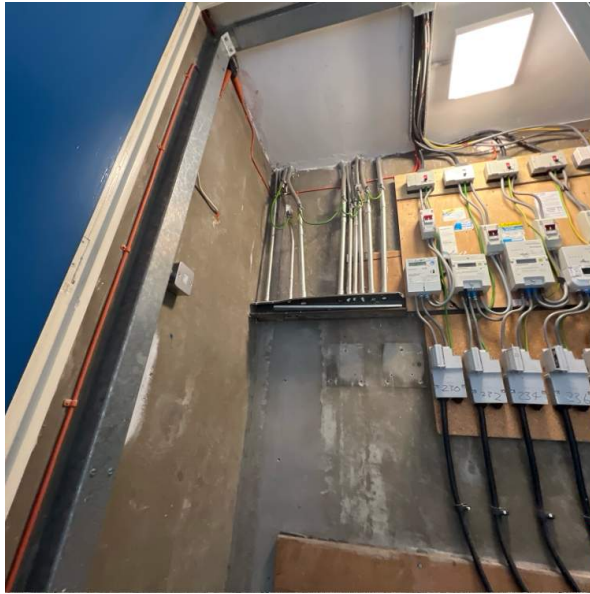
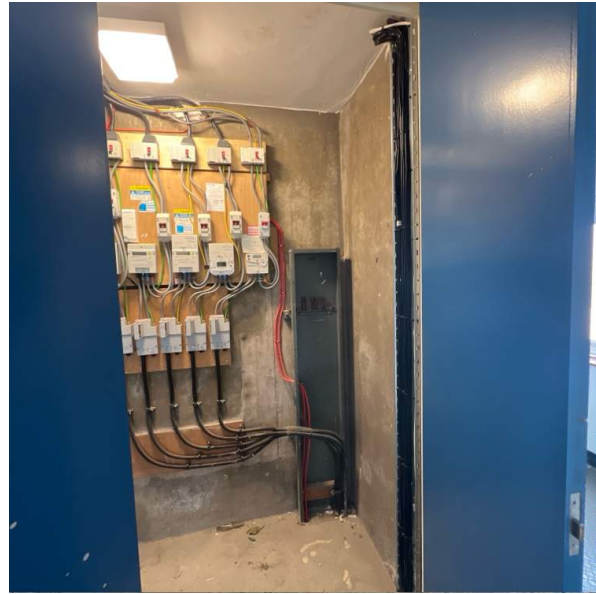
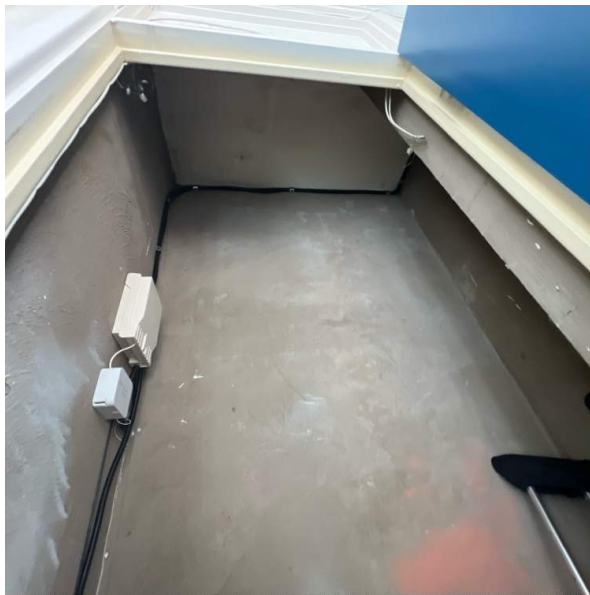
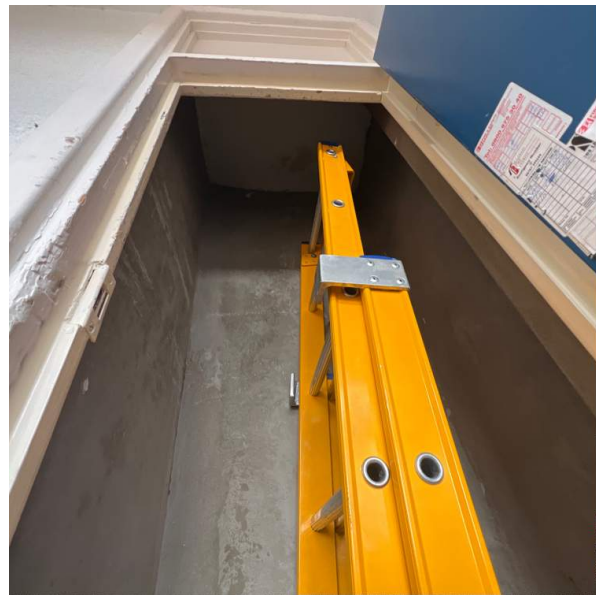
## 5th Floor Hallway

Comments: No jams or distortions noted to hallway doors to indicate any serviceability issues. Generally walls covered with finishes in hallway, likely to consist a mixture of concrete shear walls, embedded columns and masonry infill walls. Limited structure exposed. Concrete structure and rendered infill masonry (non-load bearing) walls noted in riser cupboards. Some superficial/non-structural cracks to finishes.

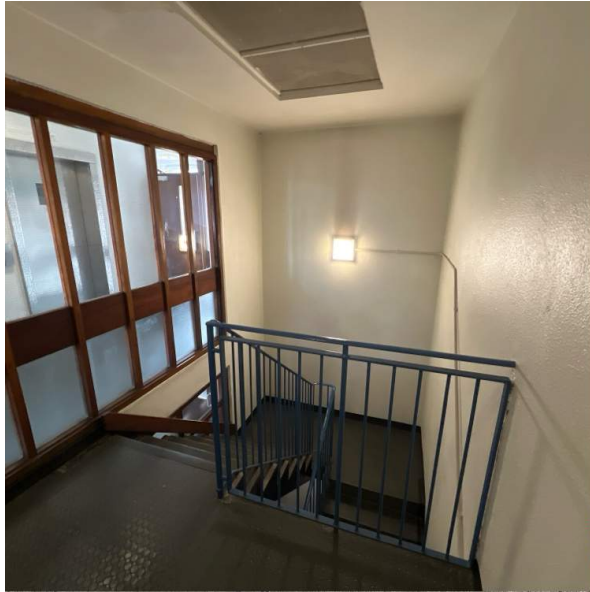
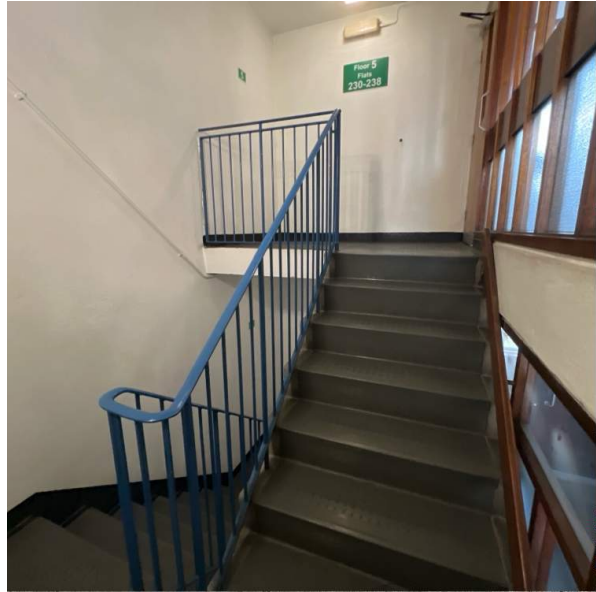
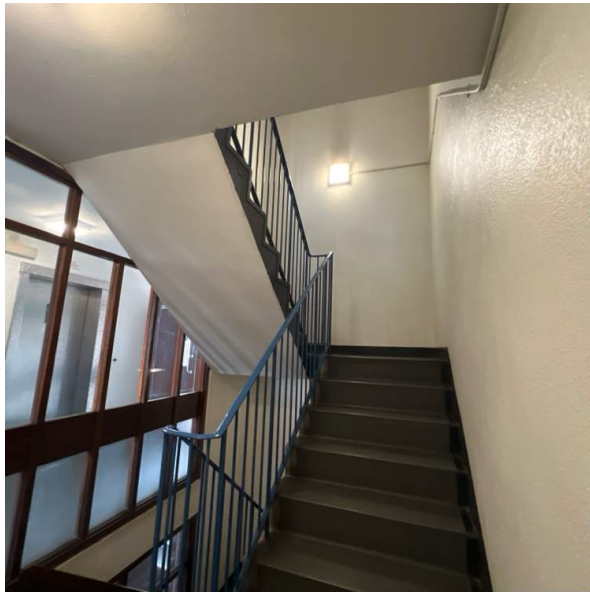
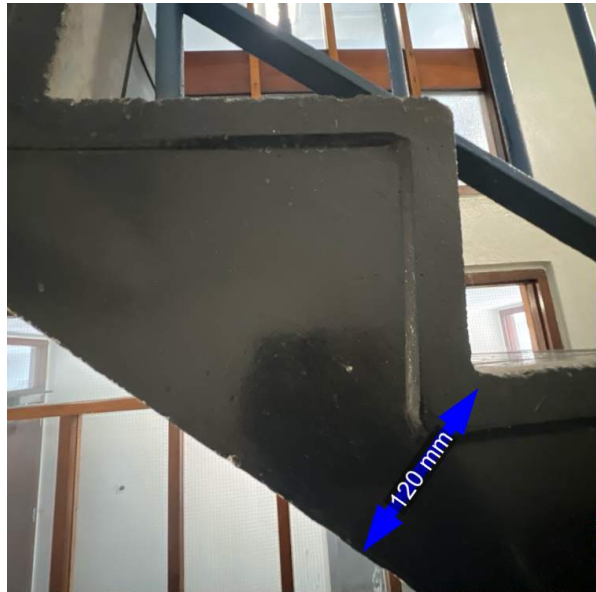
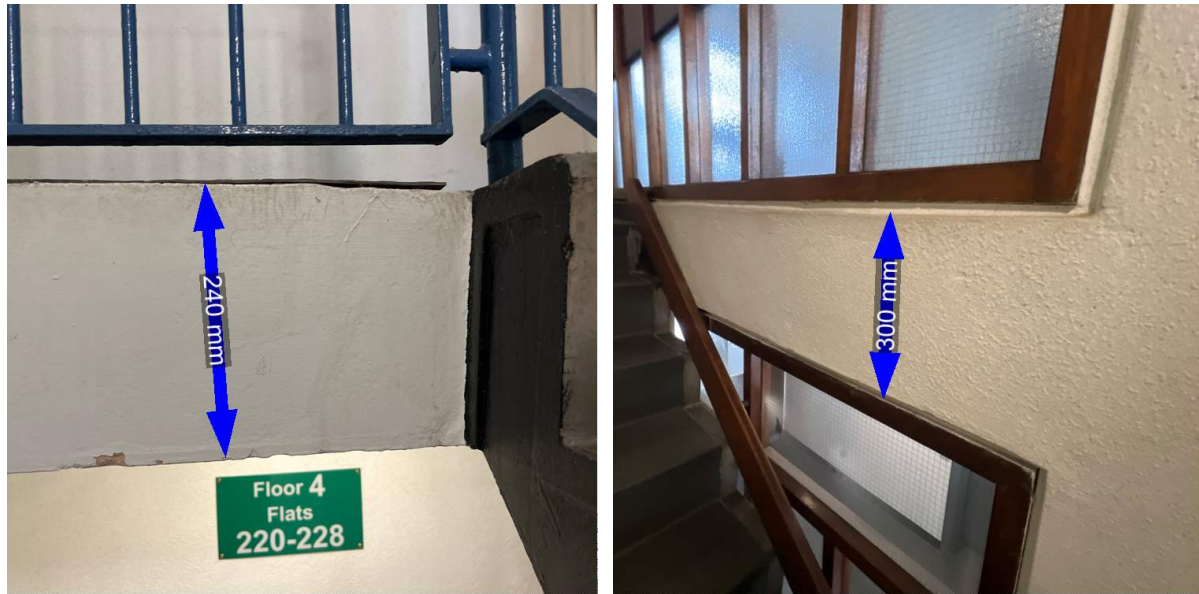
## 5th Floor Staircases

Comments: Insitu concrete stairs with steel hand railing fixed to stairs. Walls and floors appear to be fairly level.  
Stair walls covered with finishes however these would likely form the main concrete shear core walls. One side of staircase wall consists of an RC concrete beam and infill partition/glazing.

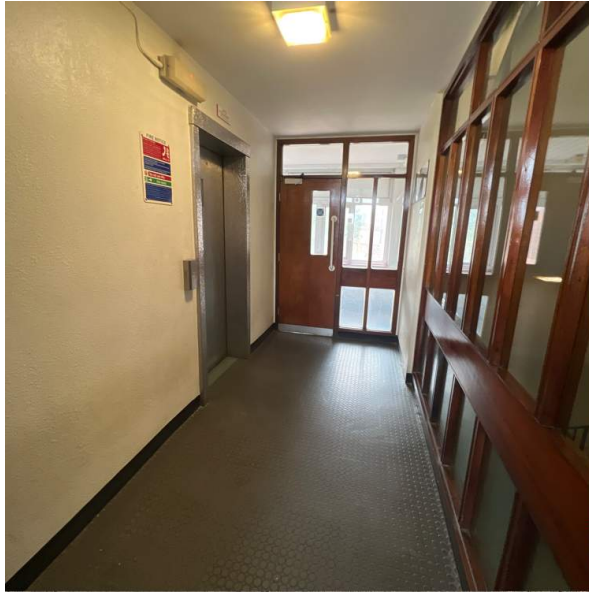
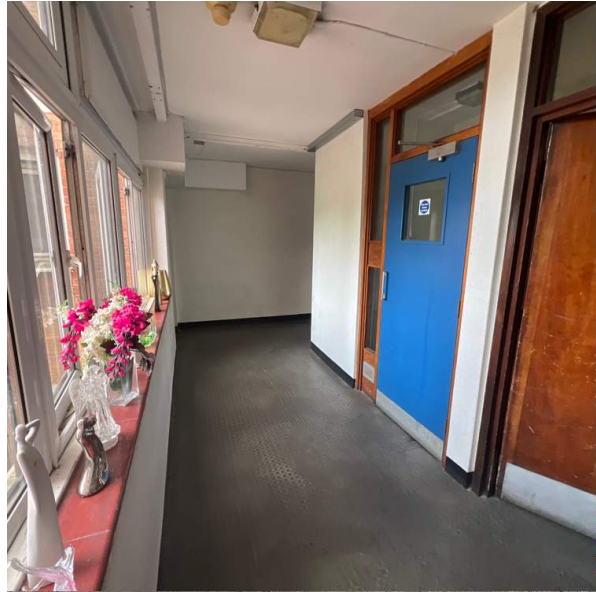
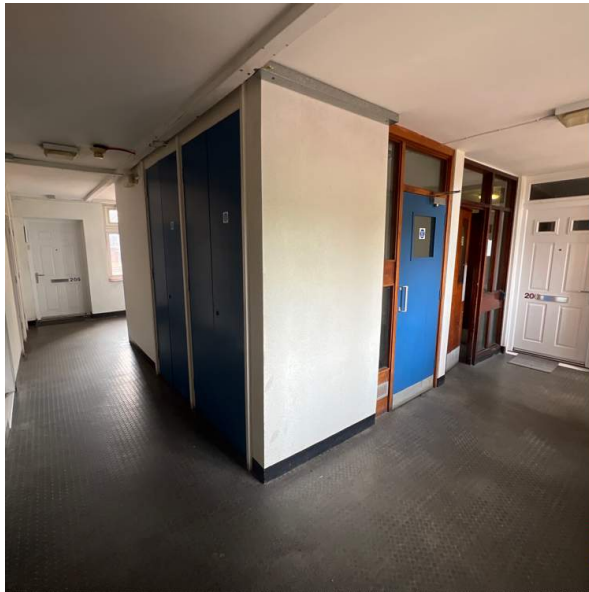
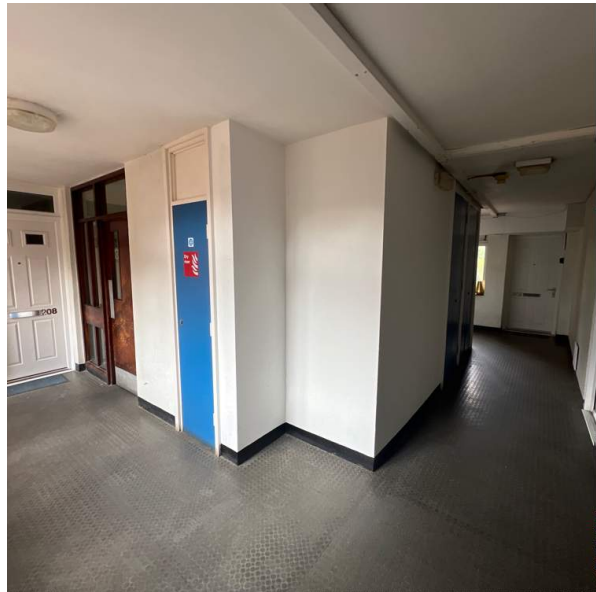
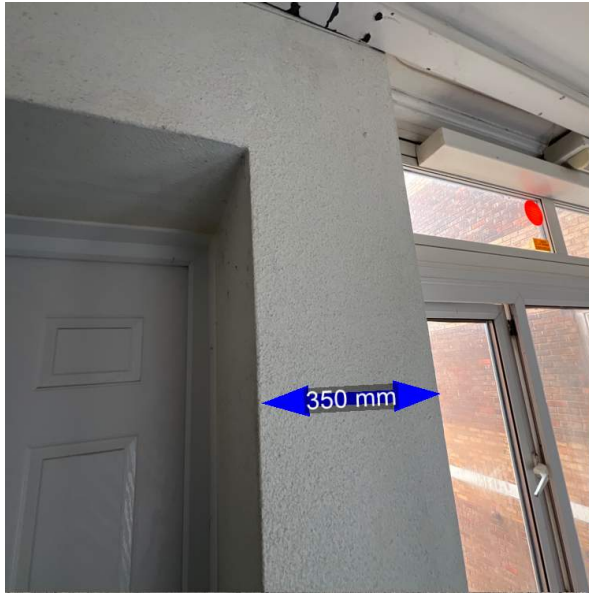
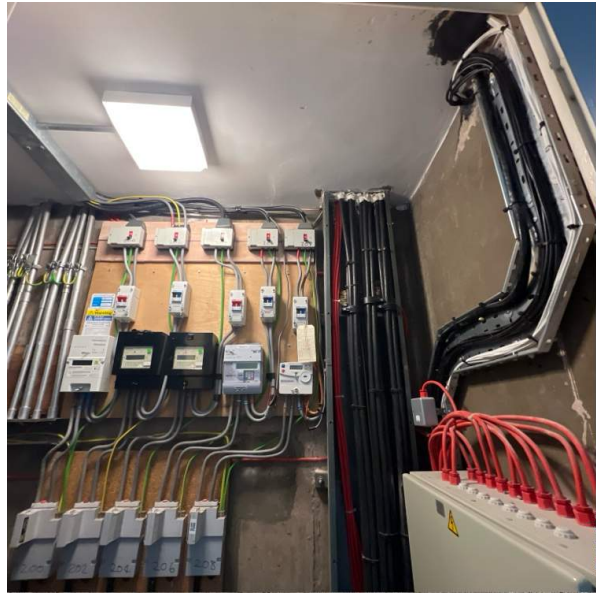
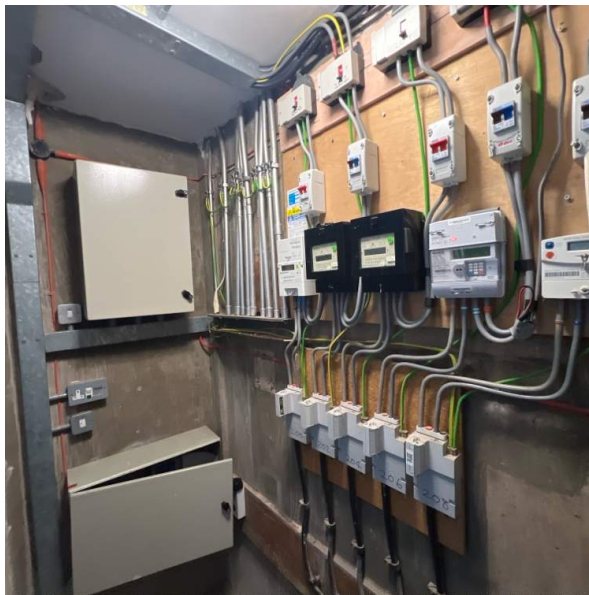
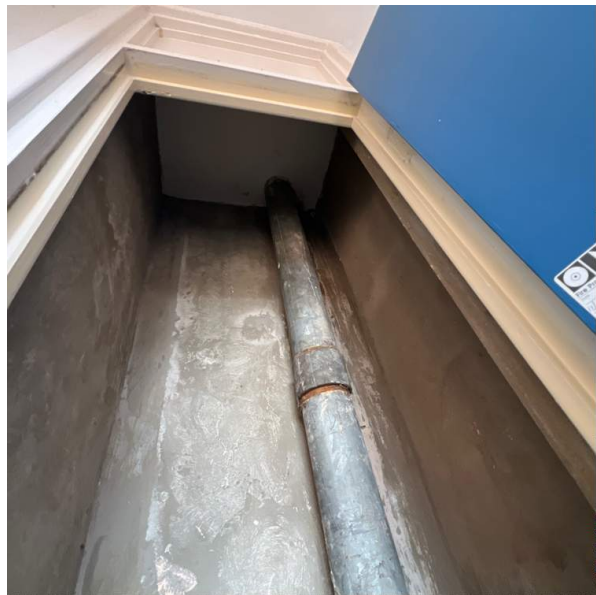
## 2nd Floor Hallway

Comments: No jams or distortions noted to hallway doors to indicate any serviceability issues. Generally walls covered with finishes in hallway, likely to consist a mixture of concrete shear walls, embedded columns and masonry infill walls. Limited structure exposed. Concrete structure and rendered infill masonry (non-load bearing) walls noted in riser cupboards.

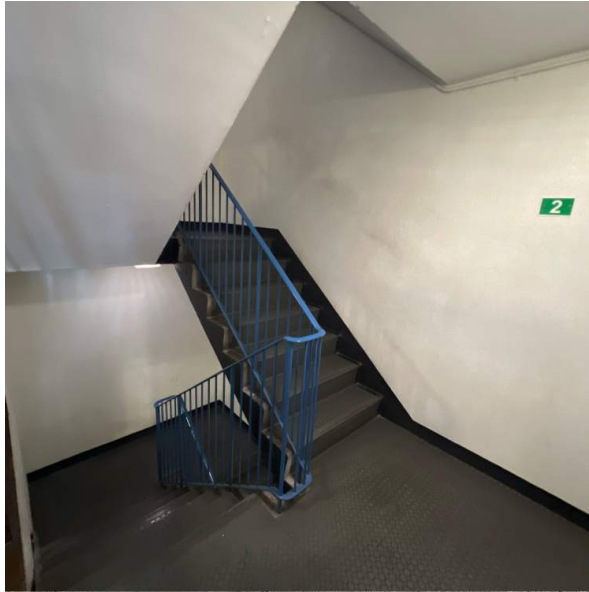
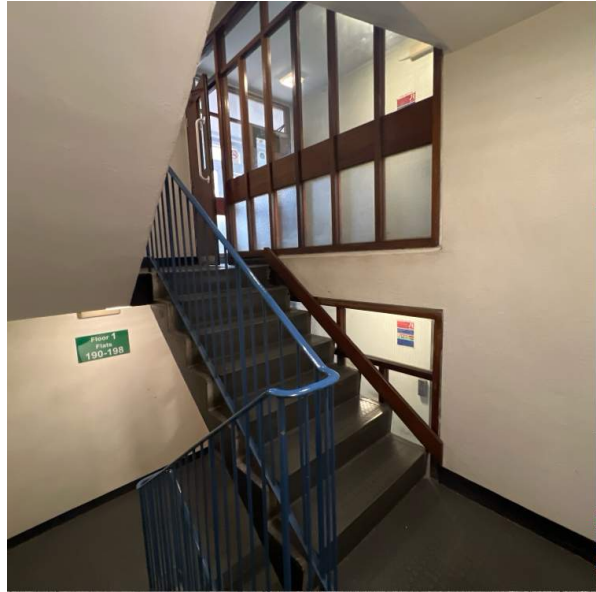
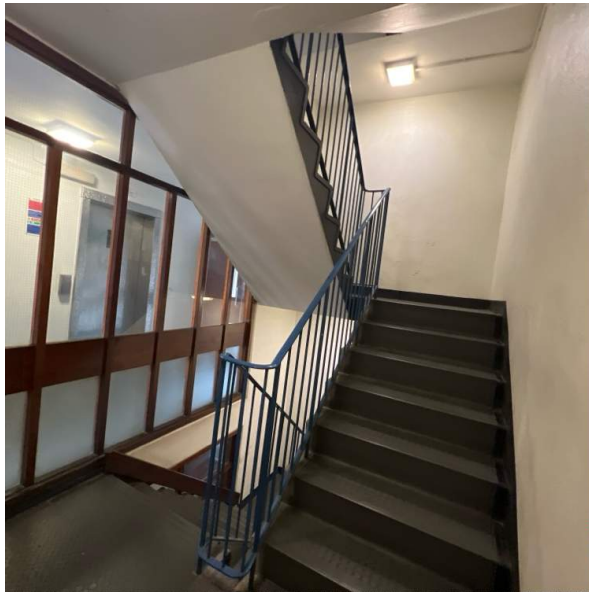
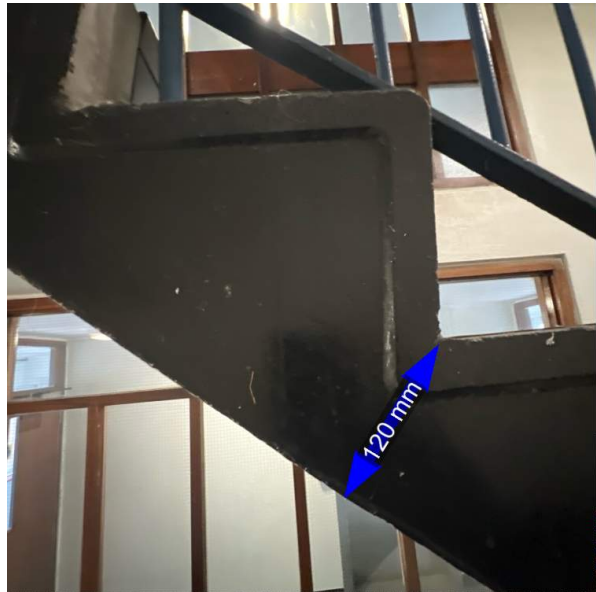
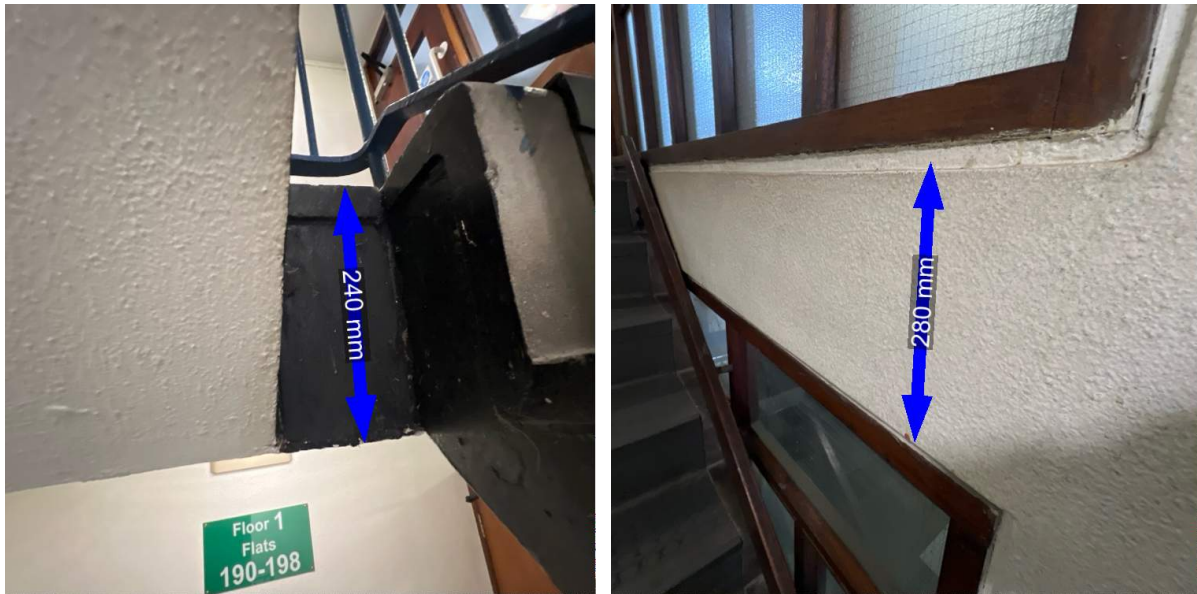
## 2nd Floor Staircases

Comments: Insitu concrete stairs with steel hand railing fixed to stairs. Walls and floors appear to be fairly level.  
Stair walls covered with finishes however these would likely form the main concrete shear core walls. One side of staircase wall consists of an RC concrete beam and infill partition/glazing.

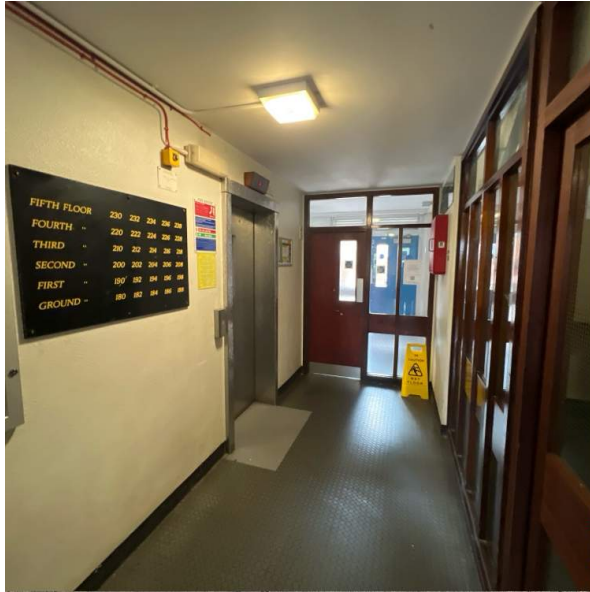
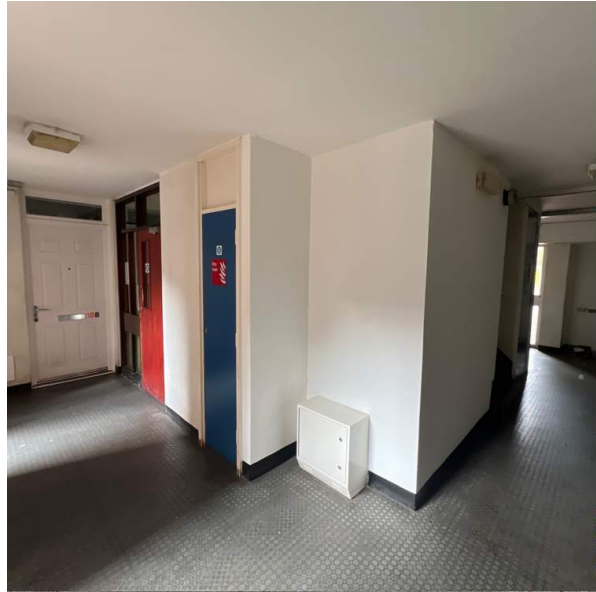
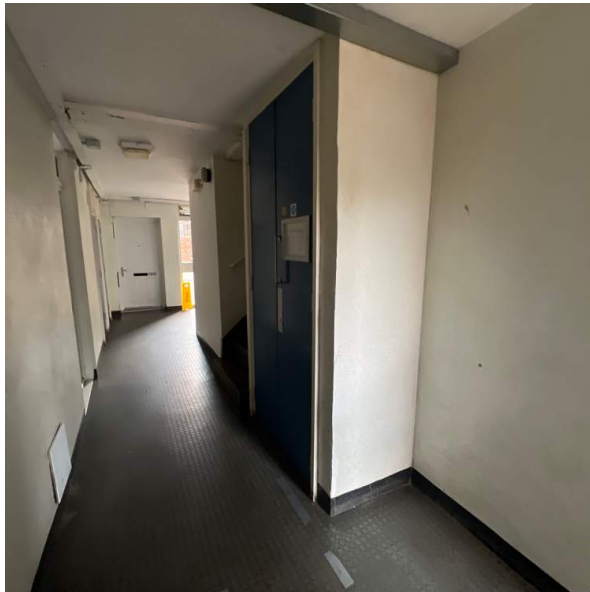
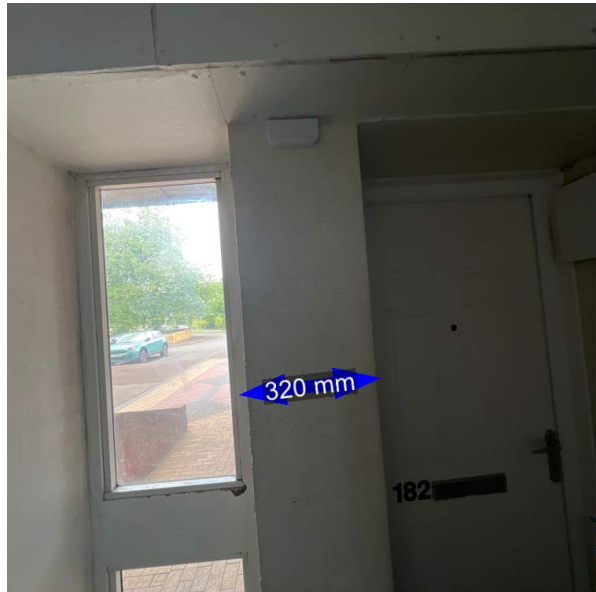
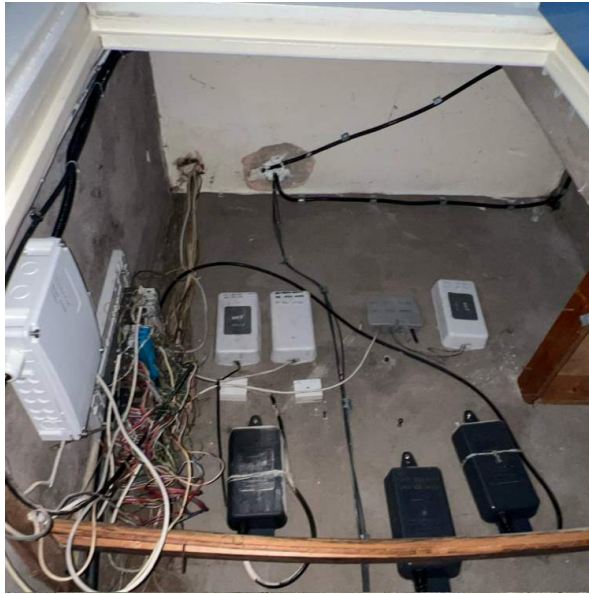
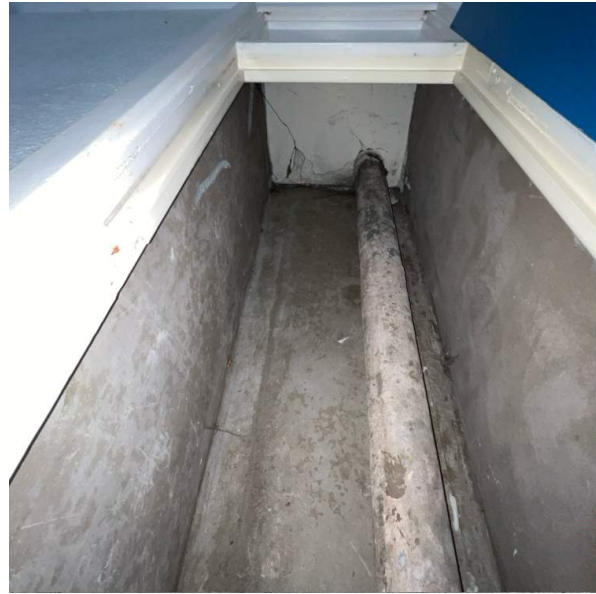
## Ground Floor Hallway

Comments: No jams or distortions noted to hallway doors to indicate any serviceability issues. Generally walls covered with finishes in hallway, likely to consist a mixture of concrete shear walls, embedded columns and masonry infill walls. Limited structure exposed. Concrete structure and rendered infill masonry (non-load bearing) walls noted in riser cupboards.

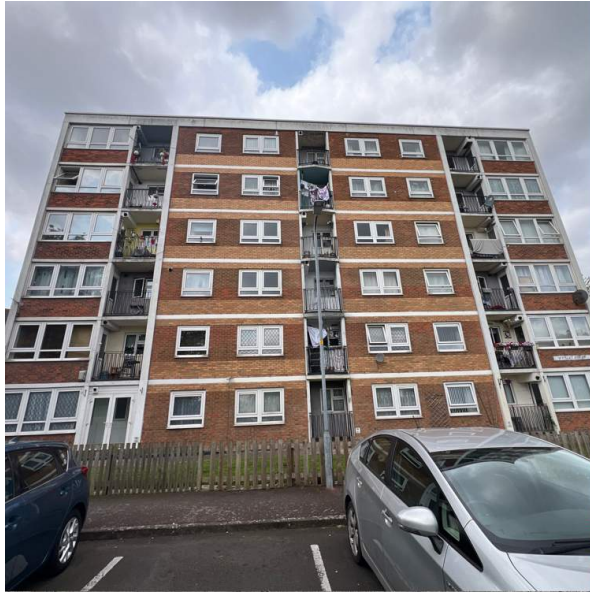
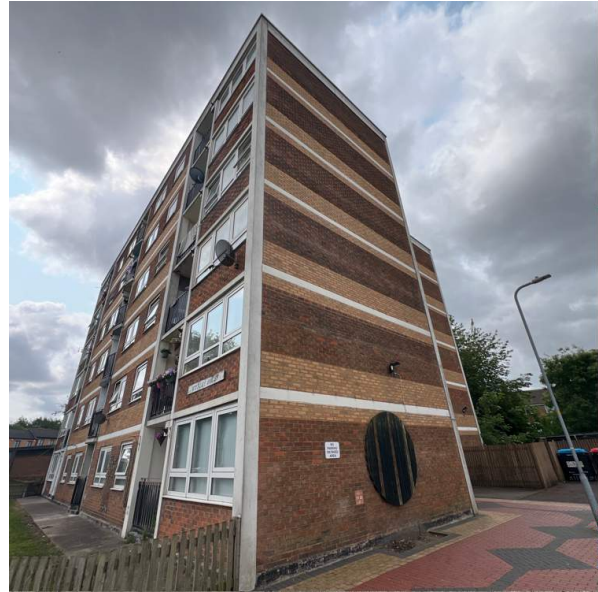
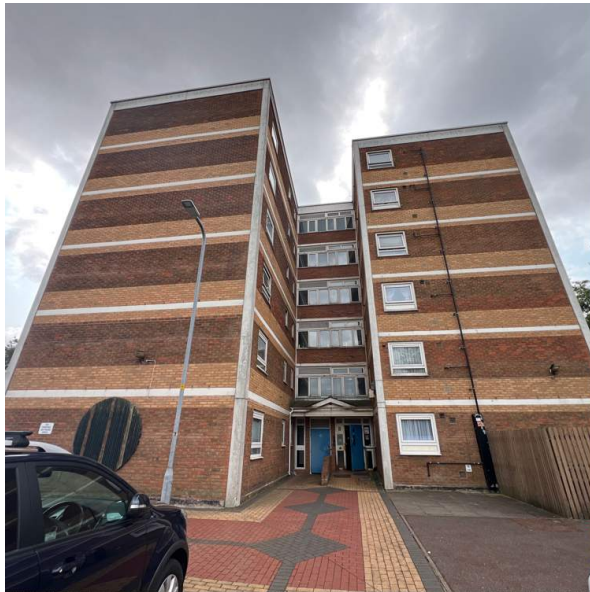
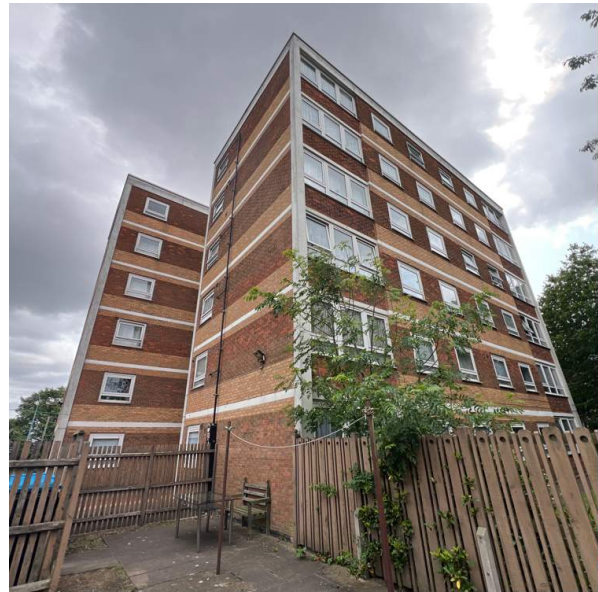
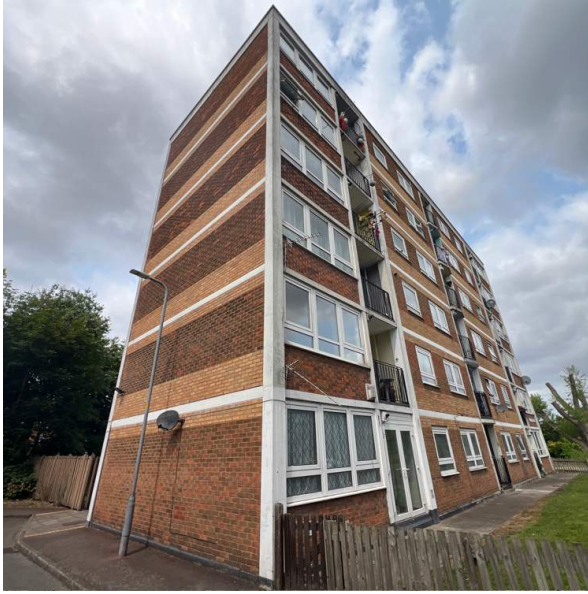
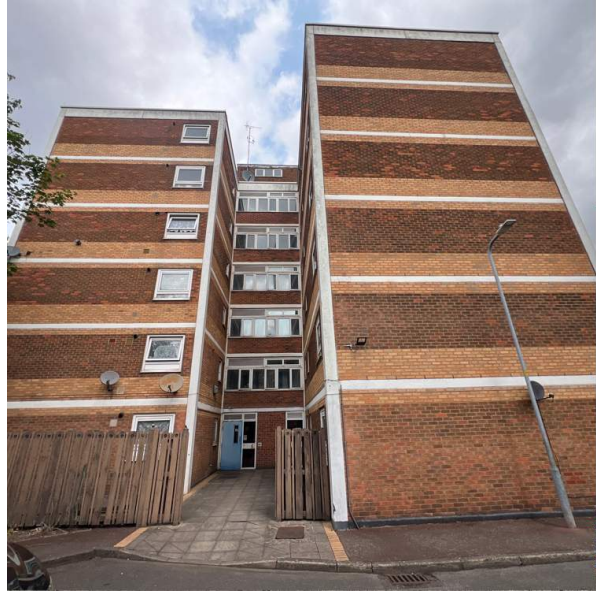
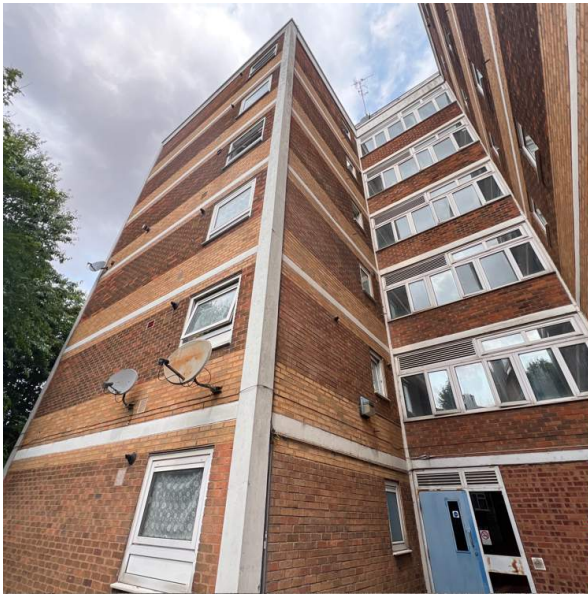
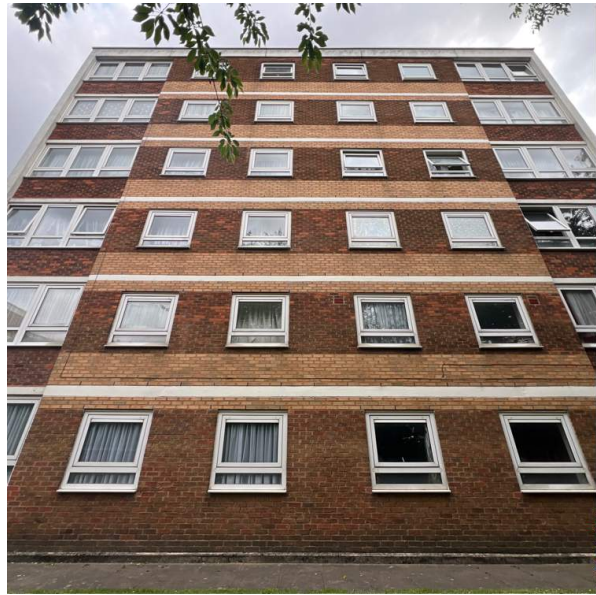
## Elevations

Comments: External facade consists of brick work to all elevations GF to top floor.  
Elevations generally in fair condition.  
RC columns forming part of main structural elements noted to perimeter of building.
