Document Version 2  
Survey Date 22/06/2025  
Suggested Review Date 22/06/2030

# EXTERNAL WALL SURVEY

## 65-96 HORTON STREET

Great Bridge  
DY4 7JW

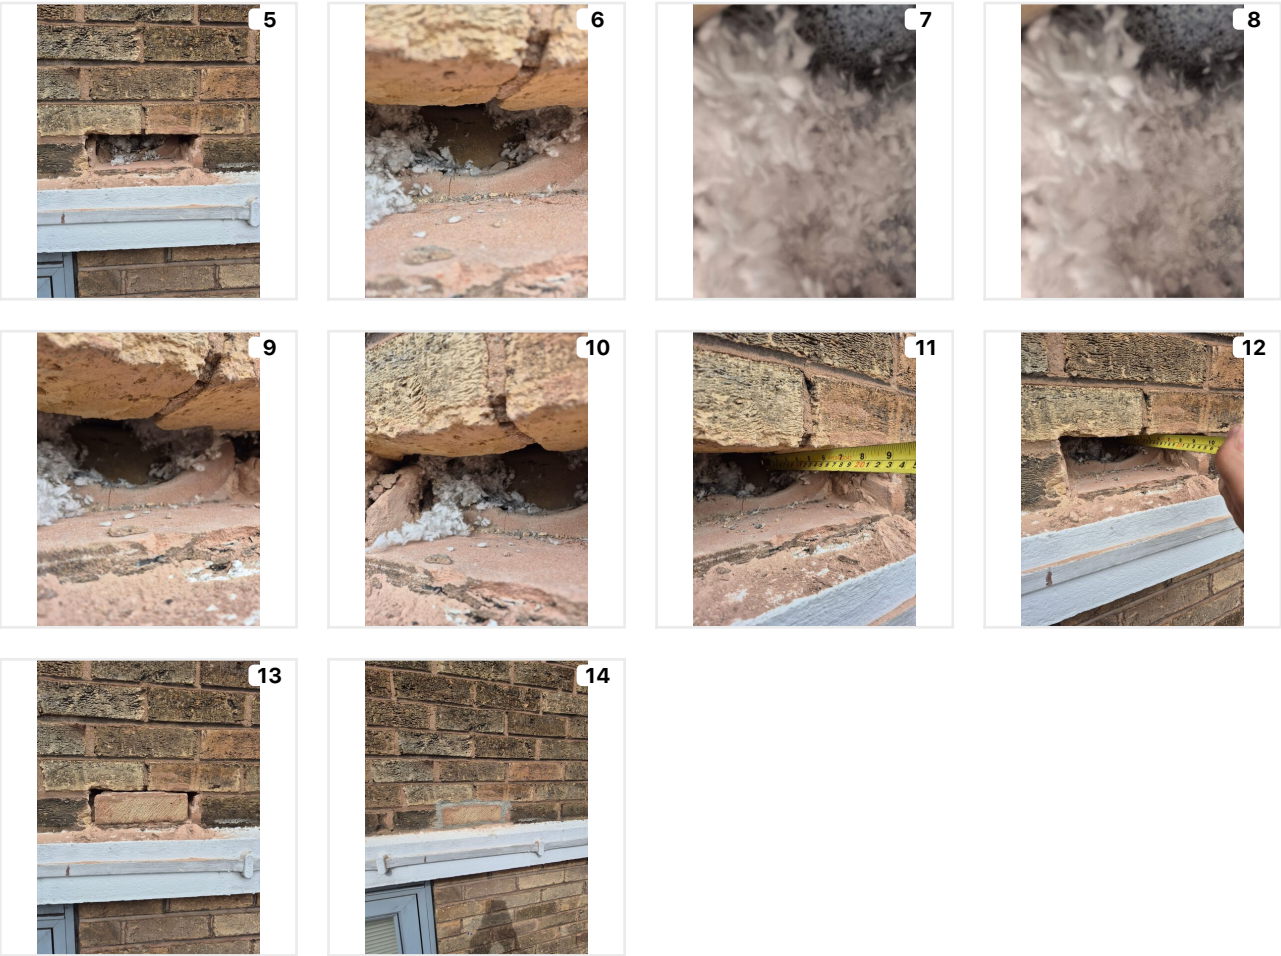
Backing Wall Sits On The Floor Slab

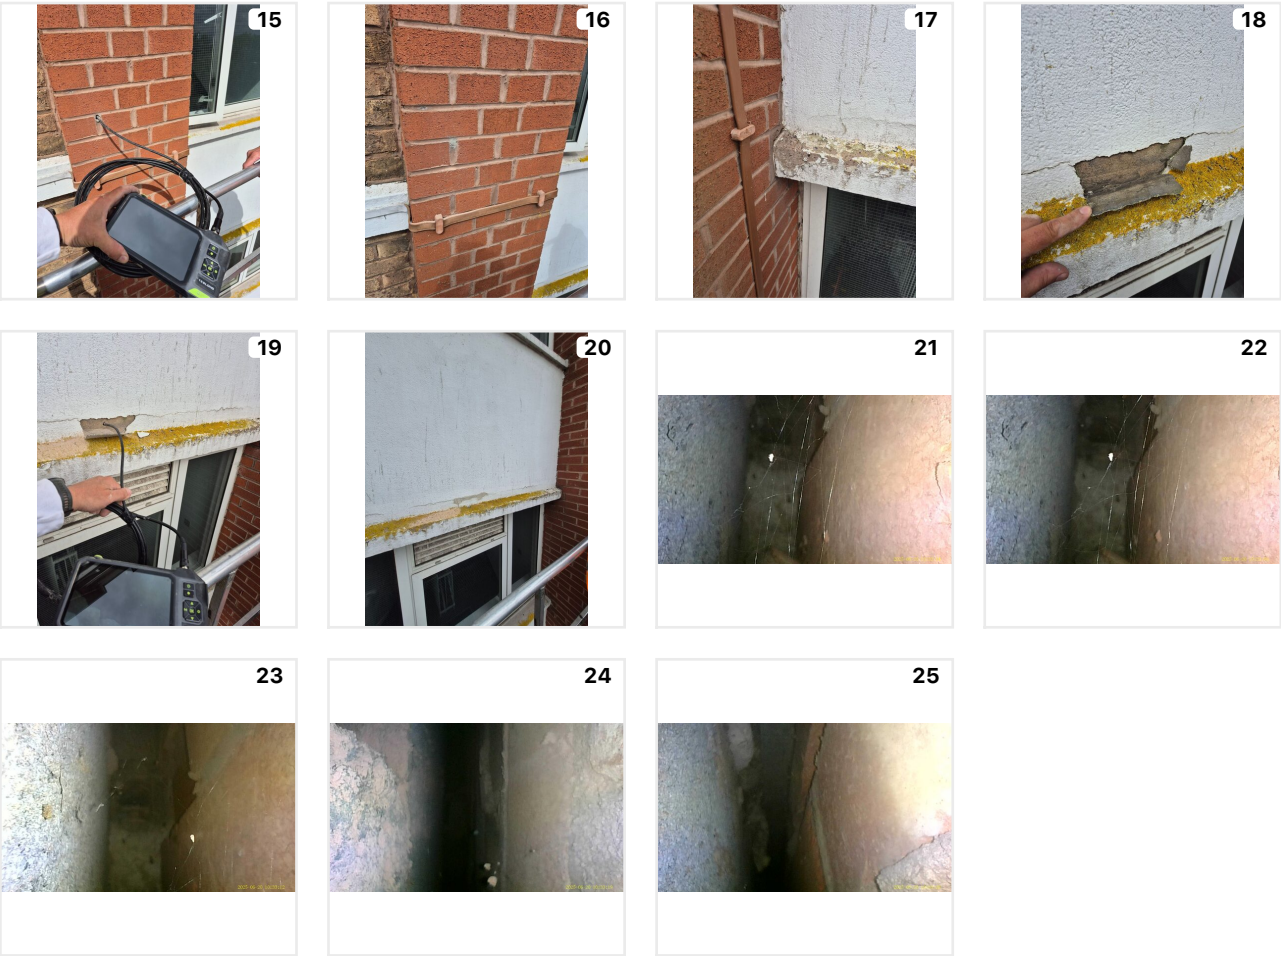
# Inspection: 5EKPBP

Elevation • Location  
West • Compartment Floor Junction

Backing Wall Sits On The Floor Slab

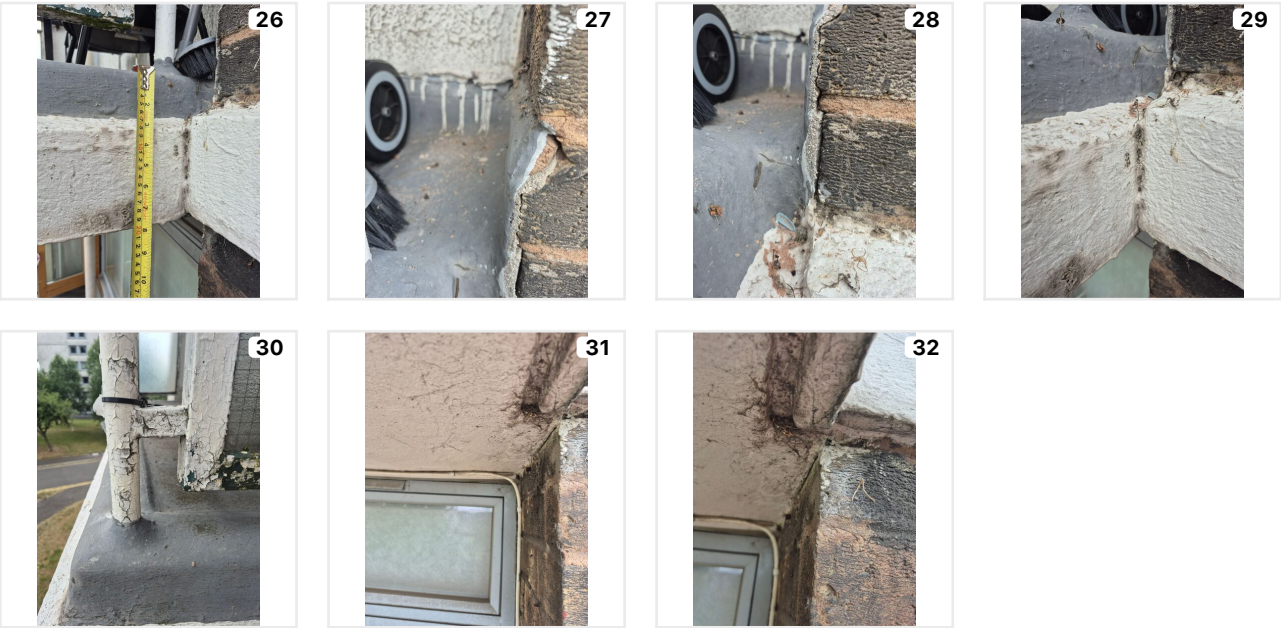
# Inspection: SA8U2Z

Elevation • Location  
West • Balcony

Reinforced concrete

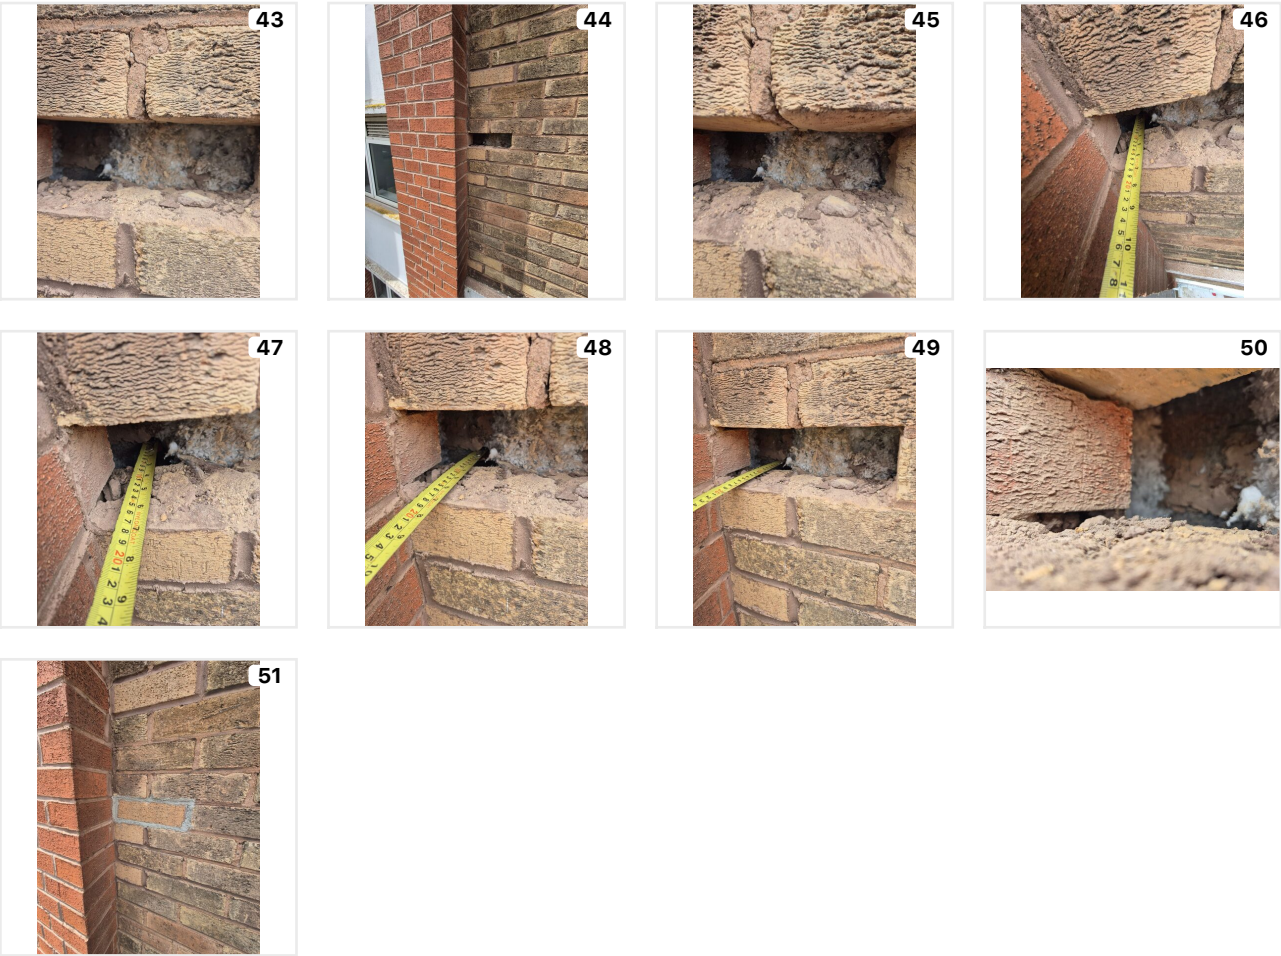
Backing Wall Sits On The Floor Slab

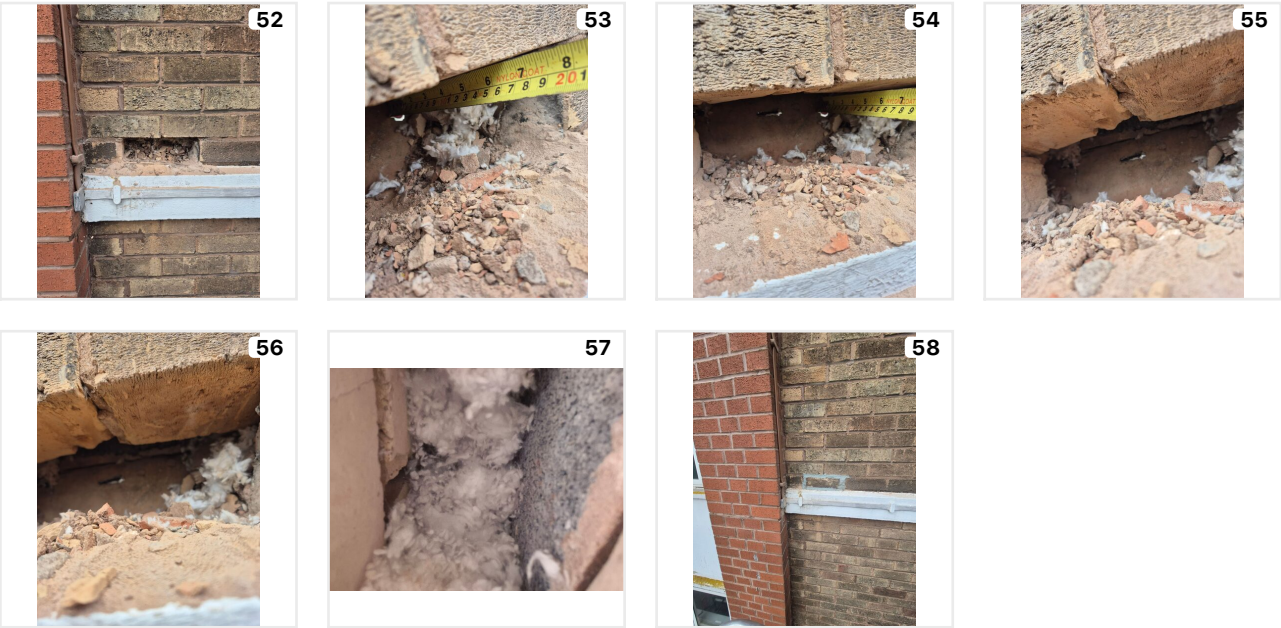
# Inspection: SEFH15

Location  
Compartment Floor and Wall Junction Interface

Backing Wall Sits On The Floor Slab
