# Fire Risk Assessment

**45-49**

**New Hope Road,  
Smethwick,  
B66 3TX**

**Date Completed: 10/07/2026**

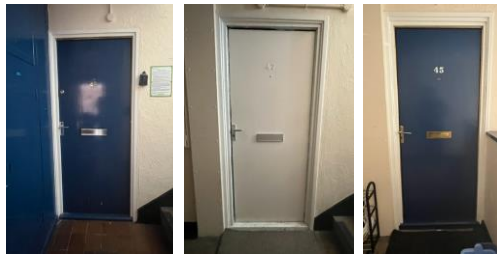
- 1) Each property is fitted with a minimum of an LD3 detection system within the flat. See Section 8
- 2) All corridors are of adequate width (at least 1050mm) and will be maintained clear to that width as a minimum
- 3) None of the corridors that form part of the means of escape are dead ends.
- 4) Flats within the block are fitted with timber notional doors.

**Flat entrance doors:** The replacement of flat entrance doors throughout the block should be considered as part of a future capital investment programme. The doors surveyed appeared to be notional fire doors and were not fitted with key fire door components, including compliant self-closing devices, intumescent strips, and smoke seals. As such, their ability to provide the required level of fire and smoke resistance cannot be confirmed.

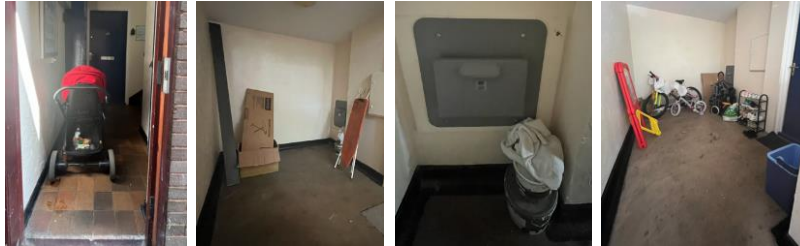
- 6) It was observed that a number of items are being stored within the communal area. The Housing Manager has been notified and asked to remind the resident that these items must be relocated, as the communal landing is required to remain sterile and free from obstruction. email sent on 22/06/2026 to housing manager

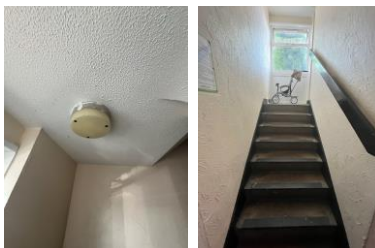
- 13) No emergency lighting is installed on the communal landings or stairways. Borrowed light is obtained through the communal windows and by the standard lights fitted. See section 9/2

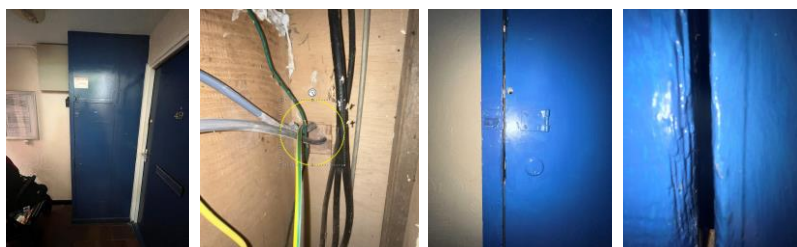
- 16) Within the communal area on the ground floor, adjacent to Flat 45, there is an electrical service cupboard constructed from a timber frame and panel. Fire-stopping is required within this cupboard (see Section 10) to address identified gaps and ensure adequate compartmentation. It is also recommended that the unit is upgraded to fire-resistant materials during future refurbishment works.

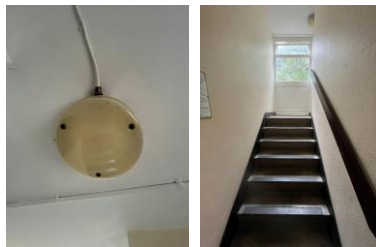
- 1) The premise is not fitted with emergency lighting
- 2) The communal landings and stairways within this three-storey block are not provided with emergency lighting. *Approved Document B, paragraph 3.41* requires that, except for two-storey blocks of flats, all escape routes must have adequate artificial lighting, with escape lighting operating in the event of a mains power failure. To meet this requirement and comply with the *Regulatory Reform (Fire Safety) Order 2005*, it is recommended that emergency lighting is installed throughout the escape routes as part of future upgrade works. At present, illumination is limited to standard luminaires and natural light from the landing window and final exit door. Added to recommendations after emailing conversation with Building and Fire Safety Team Manager.  
[Approved Document B](#) See page 35 paragraph 3.41

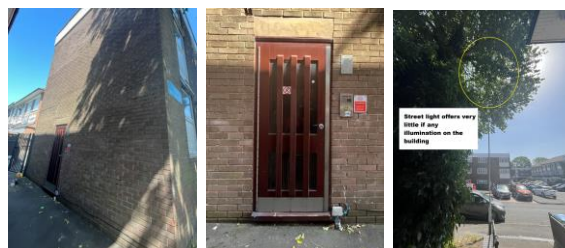
- 3) Recommend installing safety/security lighting above the external entrance doorway. Although there is street lighting in the vicinity, it does not adequately illuminate the immediate entrance area.

**Block entrance door:** Recommend installing safety/security lighting above the external entrance doorway. Although there is street lighting in the vicinity, it does not adequately illuminate the immediate entrance area.

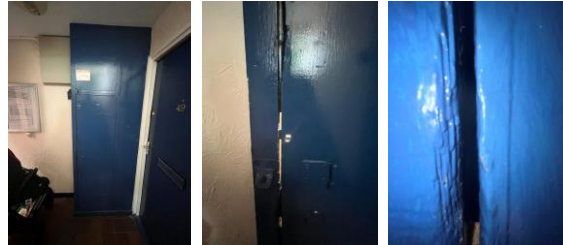
- a) **The door to the electrical service cupboard has a large gap on the slam side of the door. This requires a replacement door due to the unevenness of the gap.**

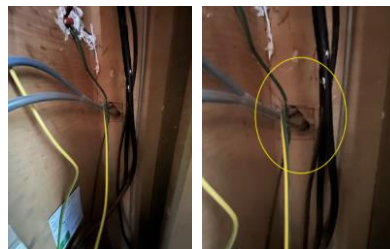
- b) **Within the electrical service cupboard on the ground floor adjacent to Flat 45, fire-stopping is required where the electrical cables pass through the wall on the right-hand side. Due to the size of the opening, this area will need to be sealed using fire batt/rockwool and fire stopping mastic around the cables to restore the required level of fire resistance.**

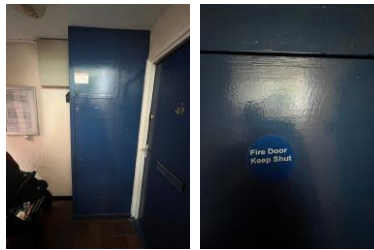
- 1) The service cupboard on the ground floor is currently fitted with *Fire Door Keep Shut* signage; however, this should be replaced with Fire Door Keep Locked signage to reflect the correct requirement for this type of cupboard. In addition, electrical hazard warning signage should be installed on the door.

**a) Replace 'Fire Door Keep Shut' signage with 'Fire Door Keep Locked' signage.**

**b) Install electrical hazard warning signage to the electrical service cupboard.**

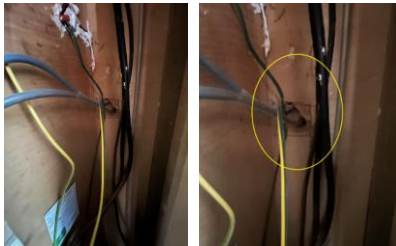
| Question/<br>Ref No | Required Action | Supporting photograph | Priority | Timescale<br>and Person<br>Responsible | Date<br>Completed |
|---|---|---|---|---|---|
| 10/7b | <b>Adjacent flat 49:</b> Within the service cupboard on the right hand side, fire stopping is required. Fill with Rockwool and a mastic seal. | | P2 | Within 1-3<br>months<br>Fire Raid<br>Response | Completed<br>14/07/2026 |
