# Fire Risk Assessment

## New Hope Road 54 - 58

**Smethwick**  
**B66 3TX.**

**Date Completed:** 13<sup>th</sup> July 2026

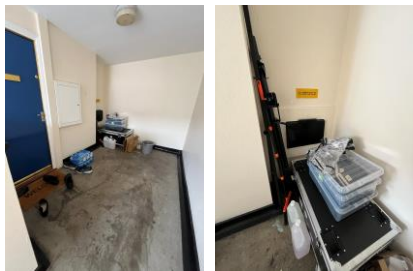
- 3) **On the second-floor landing outside Flat 54, numerous items are stored within the escape route and in front of the refuse hopper. The landing is actively being used for storage, compromising the means of escape.**

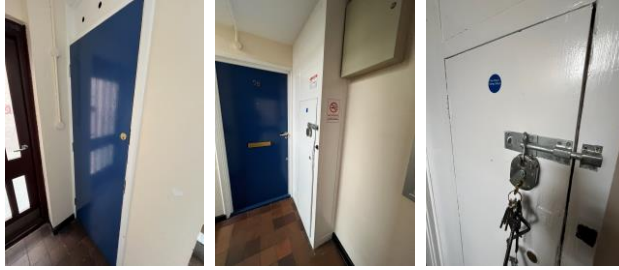
- 4) Located beneath the ground-floor concrete staircase is a storage cupboard door. This area was omitted from the internal inspection as no keys were available at the time of the assessment. Electrical intake cupboard is located on the ground floor adjacent to flat 58, this is secured behind a timber door, access was not possible due to a seized lock.

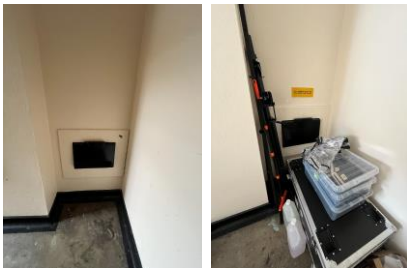
- 8) On both 1<sup>st</sup> floor and 2<sup>nd</sup> floor landings, there are bin chute hoppers within the means of escape, they do not present any obstruction in the event of safe evacuation. The 2<sup>nd</sup> floor hopper was obstructed by items that have been stored. *Noted in the section 7 (Means of escape)*

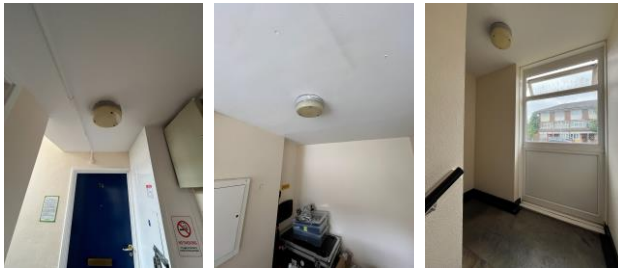
- 10) The block has no emergency lighting system installed, standard lighting units are situated throughout the communal stairwell, internal landings, these units, supplemented by borrowed street lighting, provide sufficient levels of illumination to facilitate a safe means of escape.

| Observations | |
|---|---|
| The block does not have the required emergency lighting that should be present, however there is sufficient illumination to the communal escape routes and with the block being of non-complex design, this can be seen as acceptable. <i>Recommended that on any future refurbishment of the block that these lights be upgraded.</i> | |

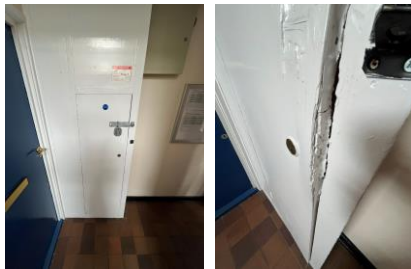
- 6) The electrical cupboard on the ground floor within the escape route could not be accessed to check sufficient compartmentation and fire stopping. There is evidence of a repair on the door with some fire mastic. *Recommended that on any future works programme to the block that this door be replaced with a certified FD30s fire door.*

Recommended that the electrical intake cupboard on the ground floor to be fitted with a fire rated FD30s enclosure on any future refurbishment of the block.

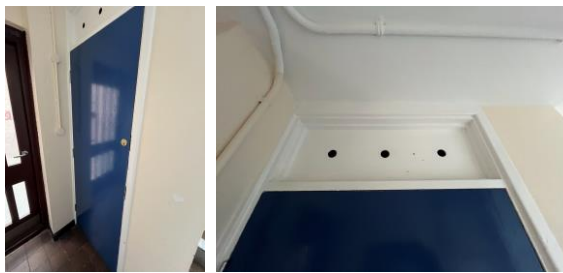
- 7) No access was gained to assess the storage cupboard door in the means of escape. There are also vent holes above the door.

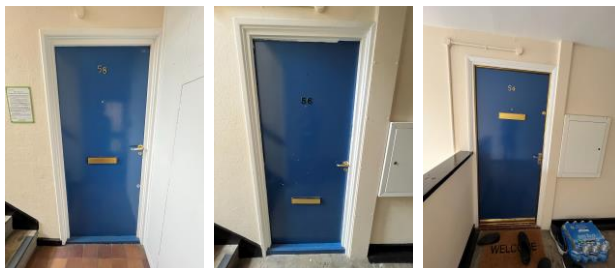
Flats 54,56,58

- 8) All individual flats are installed with timber FD30s doors. *Recommendation on any future refurbishment of the block the doors be upgraded to certified FD30s rated fire doors.*

| Observations | |
|---|---|
| Recommended that all timber FD30S flat entrance doors are to be upgraded to Composite certified FD30S fire doors on any future upgrade to the block. | |

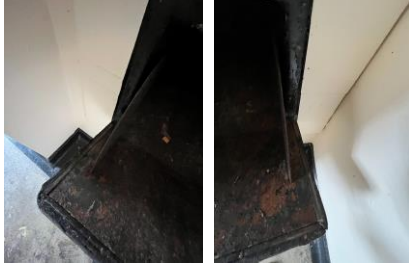
- 8) Intumescent seals have been installed within the chute hoppers on the 1<sup>st</sup> and 2<sup>nd</sup> landing

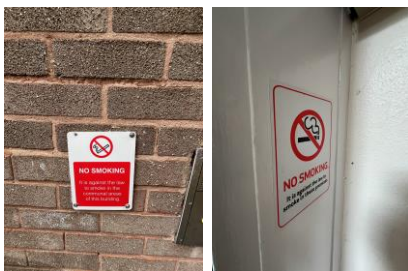
- 2) Yellow LPG warning signs are not displayed within the block. [refer to section 18](#).
- 3) Smoking is prohibited within any communal parts of the building in line with Smoke Free England legislation. Signage is also displayed in the external refuse cupboard located next to the entrance doors.

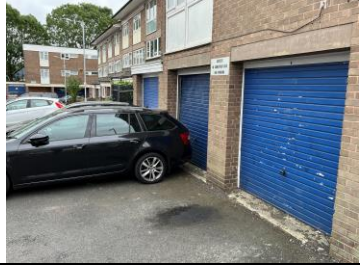
| Observations | |
|---|---|
| Vehicles are being parked close to the building's envelope and under flat windows, this will need to be factored in on any future refurbishment of the block. | |
