# Fire Risk Assessment

**New Hope Road 60-68**

**Smethwick  
B66 3TX.**

**Date Completed: 3<sup>rd</sup> July 2026**

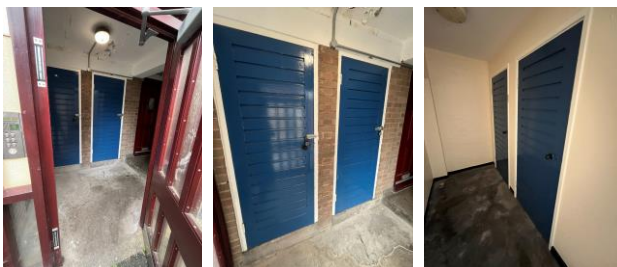
- 4) Resident storage cupboards are within the means of escape, these are made secure by residents. Has been noted in previous FRA, that these are to be upgraded to FD30S fire rated doors in any future refurbishment of the block.

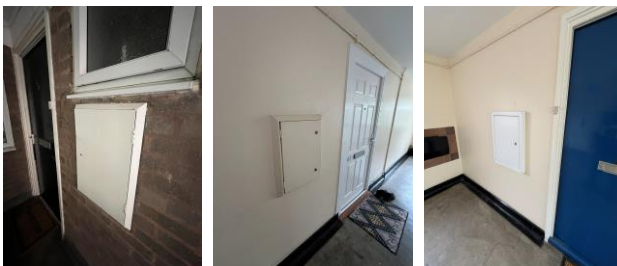
- 9) The residential electricity meters are installed within durable metal enclosures situated in the communal corridors adjacent to the flat entrance doors. Access control to these service boxes is maintained via standard budget lock mechanisms.

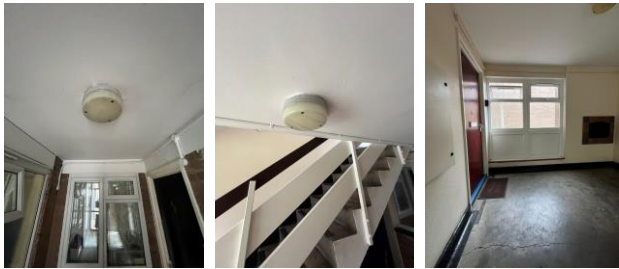
- 11) The block has no emergency lighting system installed, standard lighting units are situated throughout the communal stairwell, internal landings, these units, supplemented by borrowed street lighting, provide sufficient levels of illumination to facilitate a safe means of escape.

The block does not have the required emergency lighting that should be present, however there is sufficient illumination to the communal escape routes and with the block being of non-complex design, this can be seen as acceptable. *Recommended that on any future refurbishment of the block that these lights be upgraded.*

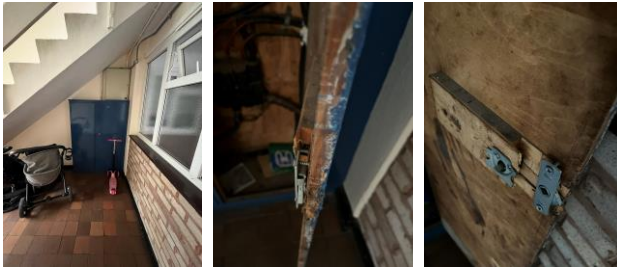
- 13) The electrical cupboard for the intake to the block is beneath the communal staircase and within the means escape.

- 6) The electrical cupboard beneath the communal staircase and within the escape route presents critical non-compliances. A damaged locking mechanism leaves electrical infrastructure unsecured. Additionally, the door assembly lacks intumescent and cold smoke seals. Located under the sole exit stairs, these defects severely compromise fire compartmentation and elevate life safety risks. *Recommended that on any future works programme to the block that this door be replaced with a certified FD30s fire door.*

| 10/6 | Electrical cupboard on the ground floor under the stairs needs securing. Fit new locking mechanism | | P2 | 1-3 Months<br>Fire Rapid Response | |

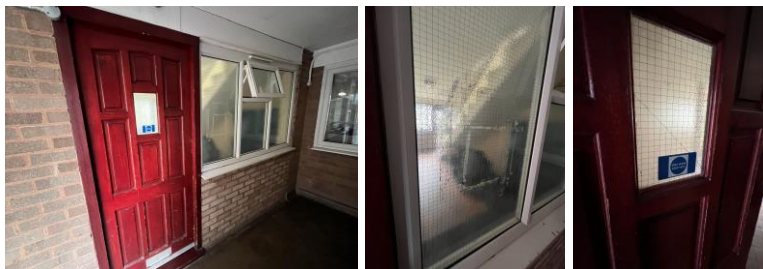
- 12) On the ground floor, there is a UPVC window unit and a timber glazed door that divide the communal area into 2, this has been noted in section 10 Compartmentation)

- 7) On the ground floor, there is a UPVC window unit and a timber glazed door that divide the communal area into 2, in the event of a fire the UPVC window unit will not provide the sufficient compartment required to resist any fire and smoke in an event of fire. *Recommendation on any future refurbishment of the block that the UPVC window unit to be removed and replaced with sufficient fire resistance and the glazed door to be upgraded to a certified FD30s fire door to maintain complete compartmentation between the 2 communal areas.*

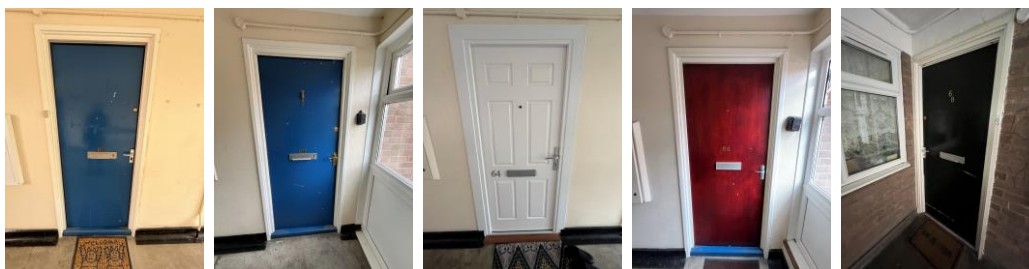
Flats 60,62,64,66,68

- 8) All individual flats are installed with combination timber and composite FD30s doors. *Recommendation on any future refurbishment of the block that flats doors to 60,62,66 and 68 to be upgraded to certified FD30s rated fire doors.*

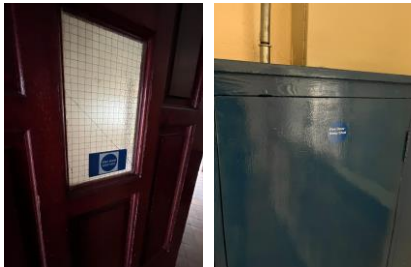
- 1) Fire door keep shut signs are displayed on external electrical cupboard and on a communal fire, however neither of the doors are fire doors and these will be required to be replaced with certified fire rated FD30s doors on any future refurbishment of the block.

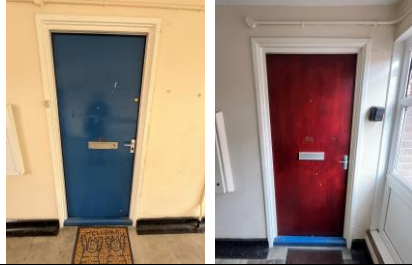
| Currently only one flat has a certified composite fire door<br><i>Recommended that all timber FD30S flat entrance doors are to be upgraded to Composite certified FD30S fire doors on any future upgrade to the block.</i> | | |

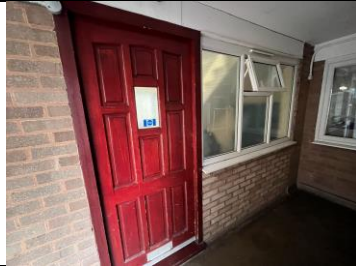
| Timber glazed door and UPVC window unit which separates the block communal area on the ground floor.<br><i>Recommended that the door to be upgraded to a certified FD30S and the UPVC window unit to be removed and the cavity to be blocked up to maintain sufficient compartmentation in the block</i> | | |

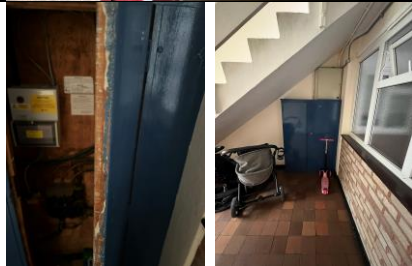
| Recommended that the electrical intake cupboard on the ground floor under the stairs to be fitted with a fire rated FD30s enclosure on any future refurbishment of the block. | | |
