# Fire Risk Assessment

**New Hope Road 75 - 83**

**Smethwick  
B66 3TX.**

**Date Completed: 3<sup>rd</sup> July 2026**

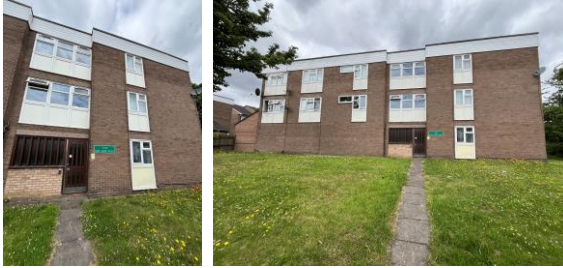
- 2) UPVC double glazed window units have been installed for each flat and communal areas within the block. Spandrel panelling is installed under each window unit.

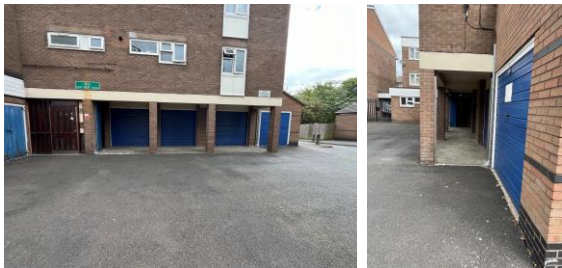
- 3) Front elevation of the building has resident garages which are slightly set back from being in line with the front elevation of the building and not directly under the flats above.

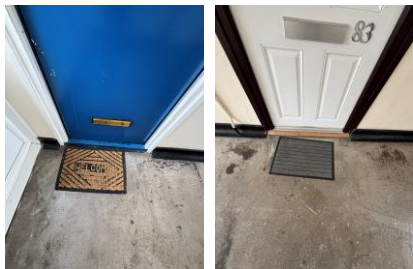
- 1) Each flat is equipped with, as a minimum LD3 fire detection to facilitate means of escape and provide sufficient response time.
- 2) Flat entrances have door mats placed within communal corridors, the fire rating is not known, however the condition and the size of these mats are acceptable

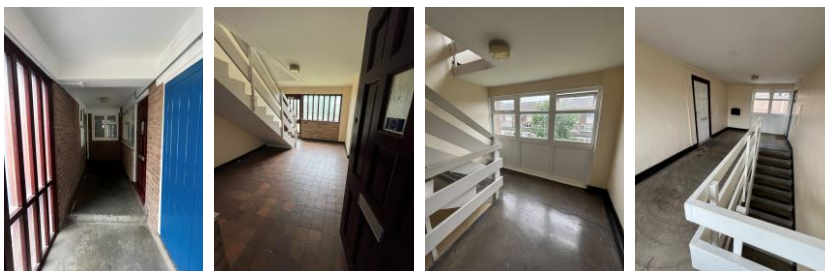
- 3) All corridors, landing and staircase are of adequate width and are kept clear to promote & maintain safe exit in an event of fire.

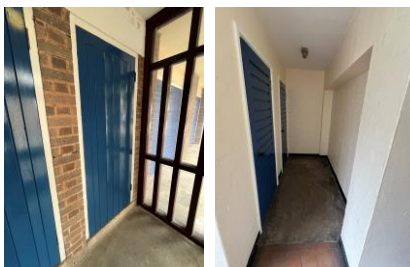
- 4) Resident storage cupboards are within the means of escape, these are made secure by residents. Has been noted in previous FRA, that these are to be upgraded to FD30S fire rated doors in any future refurbishment of the block.

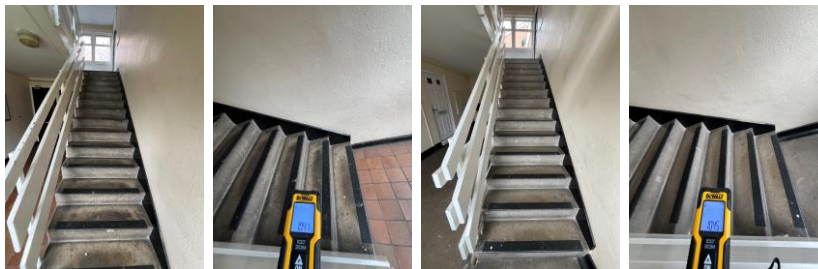
Ground to 1<sup>st</sup> and 2<sup>nd</sup> floor

- 5) 75 -83 New Hope Road consists of a single staircase that provides sufficient means of escape, this is located as you enter the block from side entrance. The width of the staircases has been measured from handrail to wall at a measurement of 1041 & 1045mm. The stairs and landings are kept clear to maintain safe means of escape.

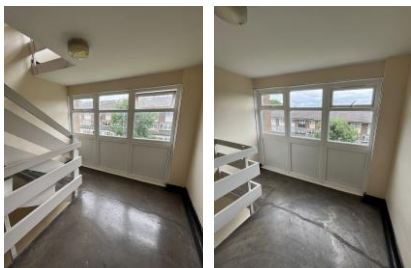
1<sup>st</sup> and 2<sup>nd</sup> floor landing

- 6) UPVC windows units have been installed on the staircase landing and within the corridors to the flats, these windows can be opened without the use of a key to allow sufficient airflow into the corridor and stairwell. There is no automatic smoke ventilation system installed in this premises.

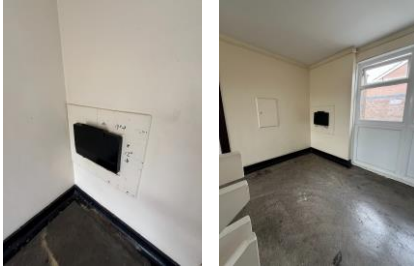
- 7) On both 1<sup>st</sup> floor and 2<sup>nd</sup> floor landings, there are bin chute hoppers within the means of escape, they do not present any obstruction in the event of safe evacuation.

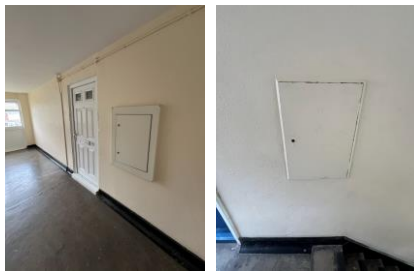
- 8) The residential electricity meters are installed within durable metal enclosures situated in the communal corridors adjacent to the flat entrance doors. Access control to these service boxes is maintained via standard budget lock mechanisms.

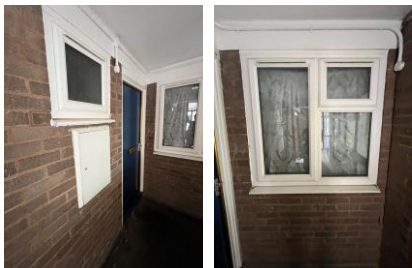
- 9) Ground floor flat 75 has UPVC window units that face into the communal hallway of the block, *Recommendation on any future refurbishment of the block these are to be removed and replaced with sufficient fire resistance to maintain complete compartmentation between the flat and of the communal area.*

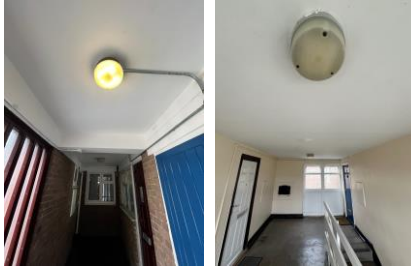
- 10) The block has no emergency lighting system installed, standard lighting units are situated throughout the communal stairwell, internal landings, these units, supplemented by borrowed street lighting, provide sufficient levels of illumination to facilitate a safe means of escape.

| Observations | | |
|---|---|--|
| The block does not have the required emergency lighting that should be present, however there is sufficient illumination to the communal escape routes and with the block being of non-complex design, this can be seen as acceptable. <i>Recommended that on any future refurbishment of the block that these lights be upgraded.</i> | | |

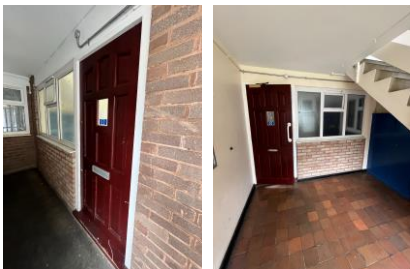
- 11) On the ground floor, there is a UPVC window unit and a timber glazed door that divide the communal area into 2, this has been noted in section 10 Compartmentation)

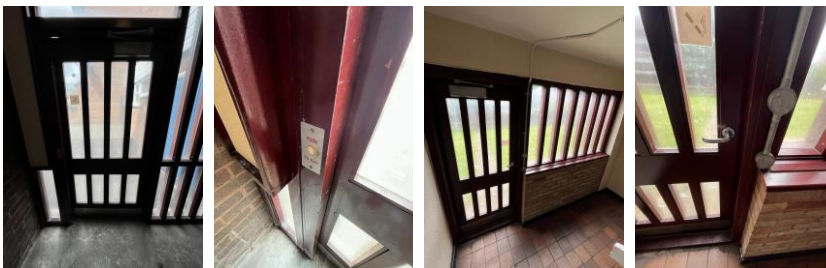
- 13) There is a clear and safe exit out of the building via the two-ground floor exits. The front final exit door is accessed using a push button, this will fail safe in an emergency, the rear final exit door accessed by a levered handled.

Final exit doors and doors exits buttons

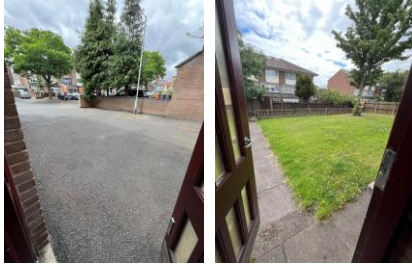
- 14) The route out the block to ultimate safety is clear from both final exit doors

Front and rear final exit routes

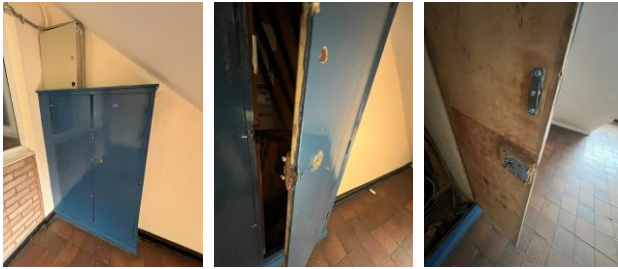
- 6) The electrical cupboard beneath the communal staircase and within the escape route presents critical non-compliances. A damaged locking mechanism leaves electrical infrastructure unsecured. Additionally, the door assembly lacks intumescent and cold smoke seals. Located under the sole exit stairs, these defects severely compromise fire compartmentation and elevate life safety risks. *Recommended that on any future works programme to the block that this door be replaced with a certified FD30s fire door.*

- 5) Electrical service cupboard on the ground floor under the stairs is not secure and enclosure is not fire rated. Noted in section 10(Compartmentation)

| Question/<br>Ref No | Required Action | Supporting photograph | Priority | Timescale<br>and Person<br>Responsible | Date<br>Completed |
|---|---|---|---|---|---|
| 10/6 | Electrical cupboard on the ground floor under the stairs needs securing. Fit new locking mechanism and make secure. | | P2 | 1-3 Months<br>Fire Rapid<br>Response | |

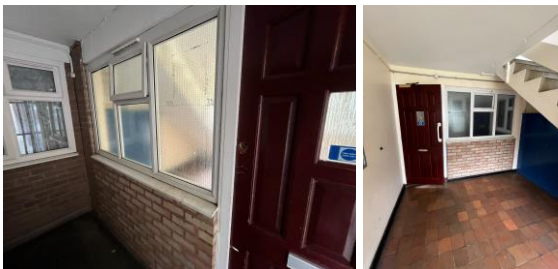
- 7) On the ground floor, there is a UPVC window unit and a timber glazed door that divide the communal area into 2, in the event of a fire the UPVC window unit will not provide the sufficient compartment required to resist any fire and smoke in an event of fire. *Recommendation on any future refurbishment of the block that the UPVC window unit to be removed and replaced with sufficient fire resistance and the glazed door to be upgraded to a certified FD30s fire door to maintain complete compartmentation between the 2 communal areas.*

| Timber glazed door and UPVC window unit separate the block communal area on the ground floor. <i>Recommended that the door to be upgraded to a certified FD30S and the UPVC window unit to be removed and cavity to be blocked up to maintain sufficient compartmentation in the block</i> | | |

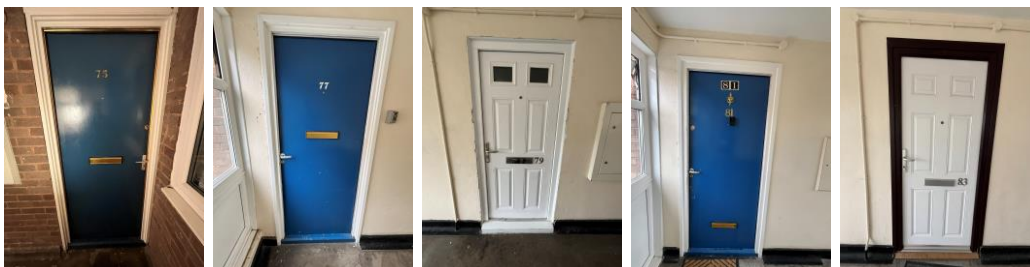
Flats 75,77,79,81,83

- 8) All individual flats are installed with a mixture of timber and composite FD30s doors. Flats 75, 77 and 81 *Recommended to be upgraded to certified FD30s rated fire doors on any future door program.*

| Observations | | |
|---|---|--|
| Recommended that all timber FD30S flat entrance doors are to be upgraded to Composite certified FD30S fire doors on any future door program. | | |

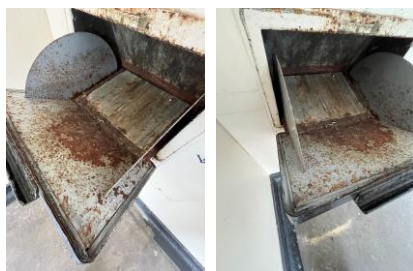
- 9)Intumescent seals have been installed within the chute hoppers on the 1<sup>st</sup> and 2<sup>nd</sup> landing

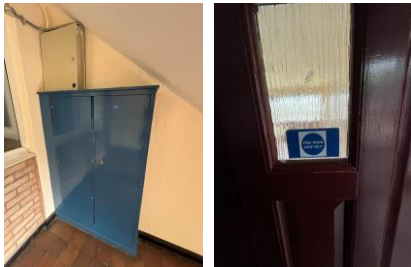
- 1) Fire door keep shut signs are displayed on external electrical cupboard and on a communal fire, however neither of the doors are fire doors and these will be required to be replaced with certified fire rated FD30s doors on any future refurbishment of the block.

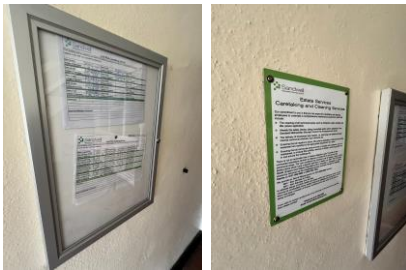
- 1) There is a regular Cleaning Service to the premises. Regular checks by Caretakers minimise risk of waste accumulation. Sandwell Council 'Out of Hours' service is in place to remove bulk items

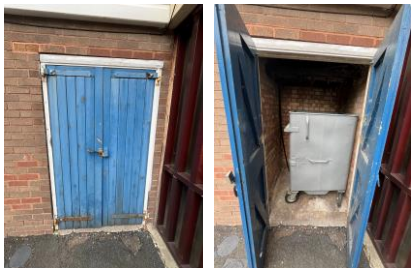
- 2) Refuse bins are stored in secured bin rooms that are located at the front of the building. This is kept secure by a means of a sliding bolt and padlock. Bins Are regularly emptied by site services.

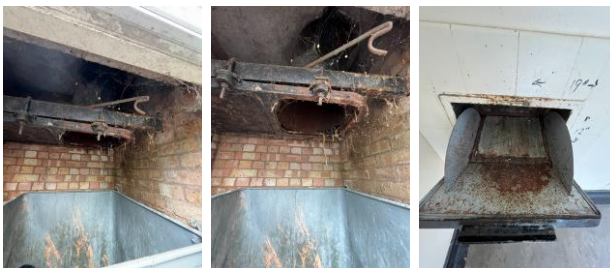
- 3) Refuse storage cupboard has a manual bin closure plate to mitigate any potential fire risk, both 1<sup>st</sup> floor internal refuse chutes are clear of any rubbish.

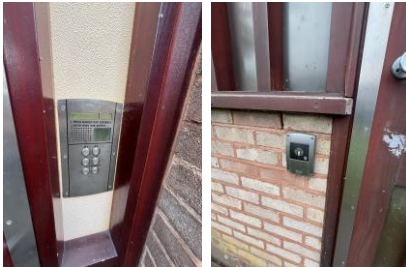
Both entrance door access systems.

- 1) Regular checks are undertaken by Caretakers / Cleaning Team(s) 365 days per year which helps reduce the risk of arson.
- 2) 75 - 83 New hope Road has restricted access, this is via door access control, each resident has their own fob to gain access. There is an intercom system that can allow visitors and contractors in.

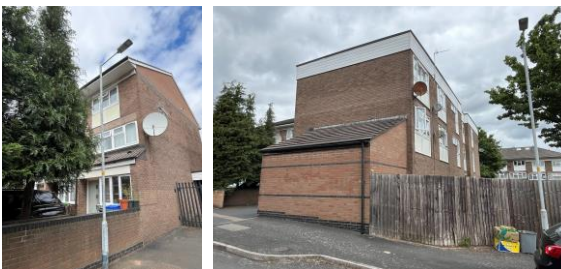
- 3) There is no current evidence of arson.
- 4) The perimeter of the premises is well illuminated. The building has no external lighting units installed, however illumination from the nearby streetlamps provide sufficient lighting

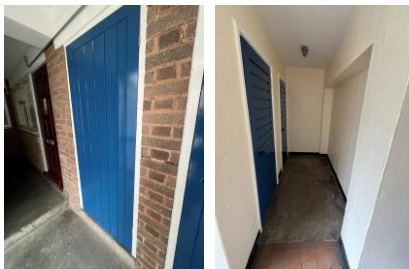
- 1) Residents instructed not to bring L.P.G cylinders into block.
- 2) The tenancy conditions, Section 7 – Condition 5.6 stipulates “If you live in a flat or maisonette, you, people living with you and any visitors to your property must not keep or use paraffin oil, petrol, bottled gas appliances or any other explosive, FLAMMABLE or dangerous material in the property. This restriction also applies to any storage facility situated in or attached to the block, which has been provided for your use.”
- 3) No Flammable liquids stored on site by Caretakers / cleaners.
- 4) There are no flammable liquids or gas cylinders stored on site.
- 5) Resident storage cupboards are located on the ground floor of the communal area; these are secured by tenants using their own keys and locks.
