# **Fire Risk Assessment**

## **Moorlands Court**

**Reservoir Road,  
Rowley Regis B65 9PB**

**Date Completed: 02/07/2026**

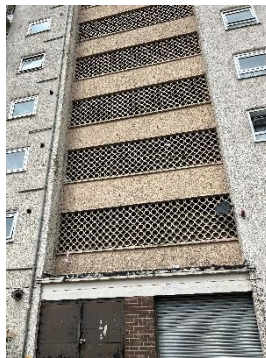
6. The ventilated block work to the chute rooms on the rear elevation have been externally covered with pest control netting. The netting will be permanently removed during significant refurbishment works that are anticipated in the future.

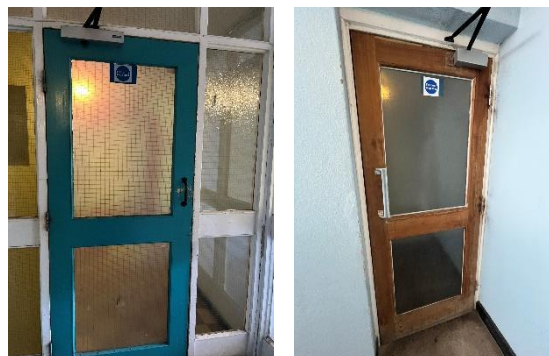
- 7) The communal landings and staircases are protected by use of notional FD30s fire doors with vision panels. It was noted that some communal doors have been replaced with nominal FD30s fire doors.

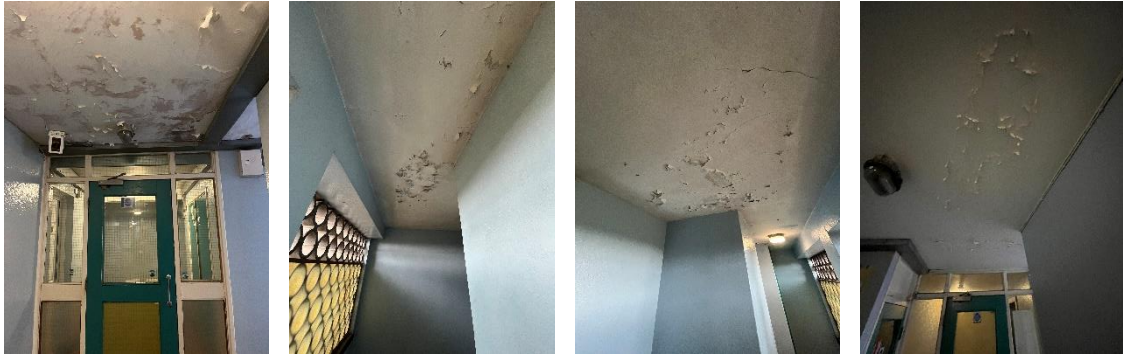
- 16) The surface coatings to the communal areas are believed to be Class 0 rating (this rating has been superseded by Euro Class B-s3, d2.) The paint in the following common areas is flacking and detached from the building fabric. Affected areas are required to be repainted with a suitable Euro Class B-s3, d2 rated product.

- a) 13<sup>th</sup> floor, near flats 83-85. See action 7/16a.
- b) 4<sup>th</sup> floor, near flats 26-28. See action 7/16b.
- c) 3<sup>rd</sup> floor bin chute corridor. See action 7/16c.
- d) 2nd floor bin chute corridor. See action 7/16d.

| 7/16a | The paint in the common area is detached from the building fabric on the 13 <sup>th</sup> floor, near flats 83-85. | | P3 | Repairs<br>3 – 6 months. | |
| 7/16b | The paint in the common area is detached from the building fabric on the 4 <sup>th</sup> floor, near flats 26-28. | | P3 | Repairs<br>3 – 6 months. | |
| 7/16c | The paint in the common area detached from the building fabric on the 3 <sup>rd</sup> floor bin chute corridor. | | P3 | Repairs<br>3 – 6 months. | |

| 7/16d | The paint in the common area is detached from the building fabric on the 2nd floor bin chute corridor. | | P3 | Repairs<br>3 – 6 months. | |

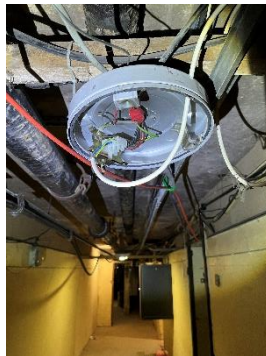
- 2) **Several emergency light fittings are damaged in the basement area, rectification is required. See action 9/2.**

| 9/2 | Several emergency light fittings are damaged in the basement area. Rectification is required. | | P3 | Electrical<br>3 – 6 months. | |

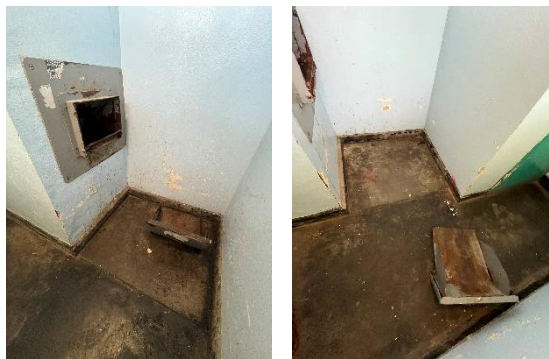
**All defective hopper intake doors should be repaired or replaced and securely refitted to ensure the refuse chute system remains fully operational and to prevent residents from removing the hopper doors. See action 15/2.**

| 15/2 | Several hopper intake doors had been removed. All defective hopper intake doors should be repaired or replaced and securely refitted to ensure the refuse chute system remains fully operational and to prevent residents from removing the hopper doors. | | P3 | Repairs<br>3 – 6 months. | |

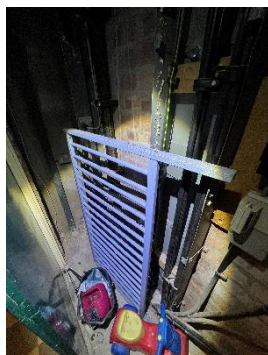
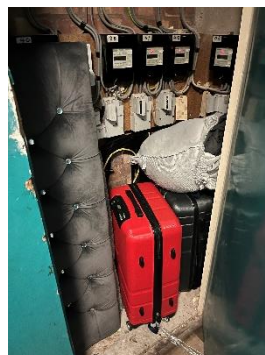
- 2) The tenancy conditions, Section 7 – Condition 5.6 stipulates “If you live in a flat or maisonette, you, people living with you and any visitors to your property must not keep or use paraffin oil, petrol, bottled gas appliances or any other explosive, FLAMMABLE, or dangerous material in the property. This restriction also applies to any storage facility situated in or attached to the block, which has been provided for your use.”
- 3) No Flammable liquids are stored on site by Caretakers / cleaners.
- 4) There are no flammable liquids or gas cylinders stored on site.
- 5) **Electrical cupboards on the 6th and 8th floors are being used for the storage of residents' belongings. All unauthorised items should be removed, and electrical cupboards maintained in a sterile condition, free from storage and combustible materials at all times. See action 18/5.**

| 18/5 | Electrical cupboards on the 6th and 8th floors are being used for the storage of residents' belongings. All unauthorised items should be removed, and electrical cupboards maintained in a sterile condition, free from storage and combustible materials. | | P2 | Caretaker<br>1 – 3 months. | |
