# Fire Risk Assessment

**2-6**

**New Hope Road,  
Smethwick,  
B66 3TX**

**Date Completed: 16/07/2026**

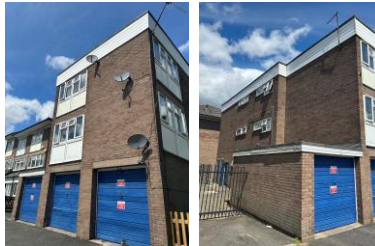
- 3) Beneath the first and second floors, and accessed from the side elevation of the building, are three garages forming part of the external envelope. These garages remain secured at all times using residents' keys. As access could not be gained at the time of the FRA, the fire-resisting compartmentation and general fire safety condition of the garages could not be confirmed.

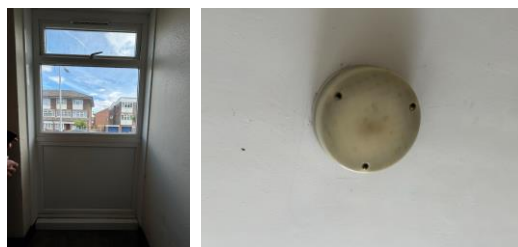
- 11) No emergency lighting is installed on the communal landings or stairways. Borrowed light is obtained through the communal windows and by the standard lights fitted. See section 9/2

**Emergency lighting:** It is recommended that compliant emergency lighting be incorporated during future refurbishment works. At present, illumination is provided only by standard lighting and natural light from nearby doors and windows.

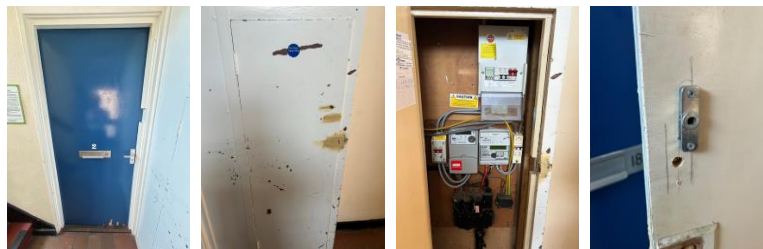
- a) **Flat 2: The electrical service cupboard adjacent to the entrance door of Flat 2, serving both Flat 2 and the building's main electrical supply, has a faulty lock and requires replacement.**

- b) The cupboard is constructed from a timber frame and panel and should be upgraded to a suitable fire-resistant/fire-retardant unit as part of future refurbishment works.

| 7/12a | Replace faulty lock to the electrical service cupboard adjacent to the entrance door of Flat 2 | | P3 | Within 3-6 months<br>Fire Rapids Response | 16/07/26 |

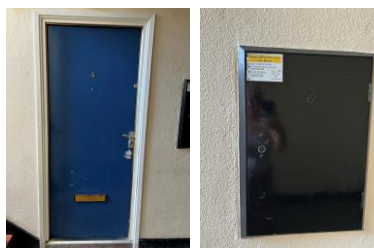
- c) Flat 4: No access was gained to the electrical over-cupboard at the time of the survey. Consequently, it was not possible to assess the condition or adequacy of any fire stopping measures within the enclosure, nor to comment on the integrity of compartmentation associated with this area.

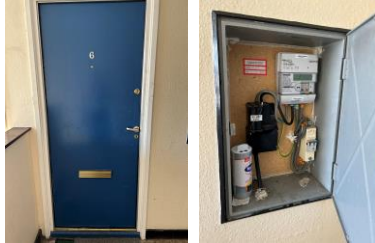
- d) Flat 6: Access was gained to the electrical over cupboard adjacent to Flat 6 entrance door. Adequate fire-stopping was observed around service penetrations, and the cupboard was found to be in satisfactory condition at the time of inspection.

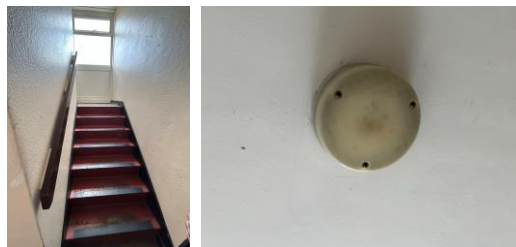
- 1) The premise is not fitted with emergency lighting
- 2) The communal landings and stairways within this three-storey block are not provided with emergency lighting. *Approved Document B, paragraph 3.41* requires that, except for two-storey blocks of flats, all escape routes must have adequate artificial lighting, with escape lighting operating in the event of a mains power failure. To meet this requirement and comply with the *Regulatory Reform (Fire Safety) Order 2005*, it is recommended that emergency lighting is installed throughout the escape routes as part of future upgrade works. At present, illumination is limited to standard luminaires and natural light from the landing window and final exit door. Added to recommendations after emailing conversation with Building and Fire Safety Team Manager.

It is recommended that emergency lighting be installed throughout the communal areas, as the building exceeds two storeys and requires adequate illumination to support safe evacuation in the event of a power failure.

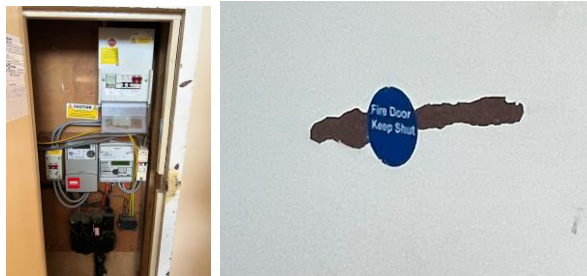
- 1) **Electrical service cupboard: Adjacent flat 2 on the ground floor, the signage displayed on the electrical mains service cupboard should be updated to display 'Fire Door Keep Locked'**
- 2) **Electrical service cupboard: Adjacent flat 2 on the ground floor a hazard warning sign should be installed on the mains electrical service cupboard to clearly notify all, of the electrical hazards contained within**

| 12/1 | Electrical service cupboard (ground floor): Replace existing signage with 'Fire Door Keep Locked' | | P3 | Within 3-6 months<br>Fire Rapid Response | 16/07/26 |

| 12/2 | Electrical service cupboard (ground floor): Fit electrical hazard warning signage | | P3 | Within 3-6 months<br>Fire Rapid Response | |

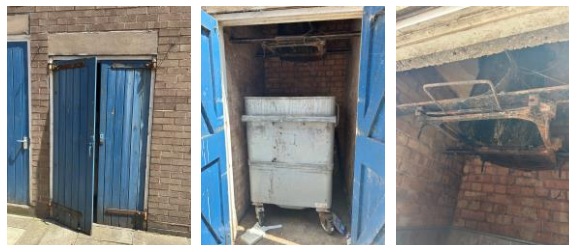
2) Refuse arrangements for 2-6 New Hope Road are provided via a dedicated bin storage area located at the rear of the premises, which also incorporates the building's bin-chute discharge point. Refuse chute hopper doors are provided on the 1st and 2nd floor landings to facilitate waste disposal by residents, with waste removed as part of the routine collection service. During the inspection, the manual damper control mechanism situated above the bin storage area was found to be seized and inoperable.

| 15/2 | Bin chute room: Repair chute closing plate, due to seized open. | | P3 | Within 3-6 months<br>Repairs<br>Metal Work | |

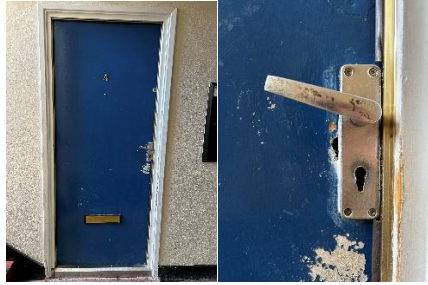
| 7/5f | Flat 4: A hole was present on the external face of the door adjacent to the handle. | | P2 | Within 1-3 months<br>Fire Rapids Response | |
