# Fire Risk Assessment

**9-14**

**Newmans Close,  
Smethwick,  
B66 4SW.**

**Date of Inspection: 6<sup>th</sup> August 2026**

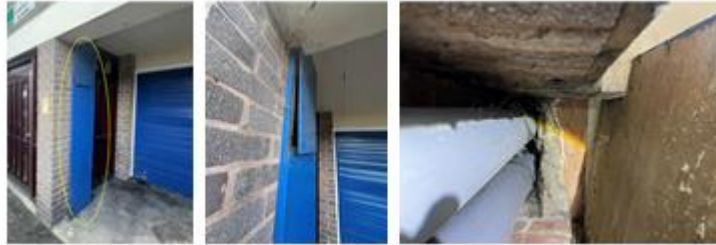
- 5) Adjacent to the garage serving Flat 6 at the front of the premises, a plywood cover was observed to be detached from its frame, exposing service risers and soil pipework serving the flats above. A visual inspection of the exposed area indicated that there appears to be an absence of suitable fire stopping around service penetrations.

This condition could compromise the integrity of the building's compartmentation and may facilitate the spread of fire and smoke between compartments. It is therefore recommended that the area is inspected by a competent contractor and that appropriate fire-stopping measures are installed around all service penetrations in accordance with relevant fire safety standards. The damaged plywood cover should also be repaired or replaced to restore the enclosure and maintain the fire-resisting construction.

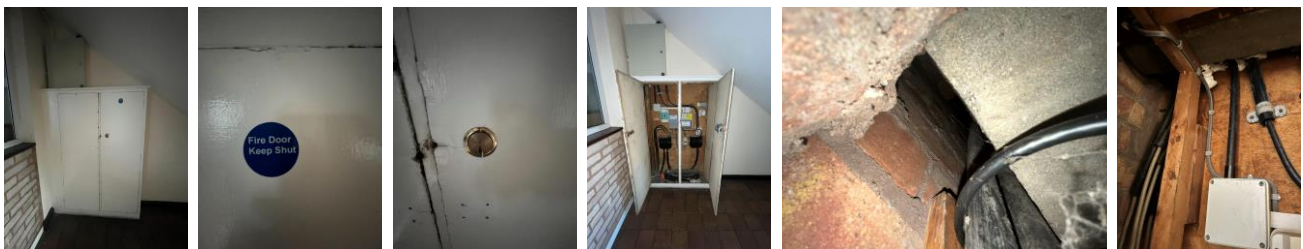
10) A plywood-constructed cupboard is located within the ground floor communal area and was found to contain the building's main electrical intake equipment. During inspection, deficiencies were identified, including the apparent absence of suitable fire stopping within the cupboard, a defective lock, and the need for replacement safety signage.

- a) **Fire Stopping: Install suitable fire-stopping measures to all service penetrations within the cupboard to maintain the integrity of the building's fire compartmentation.**
- b) **Lock Replacement: Replace the existing lock or fit a suitable new lock to the cupboard to prevent unauthorised access to the electrical intake equipment.**
- c) **Signage: Provide and install compliant electrical hazard warning signage to clearly identify the presence of electrical equipment and associated risks. See section 12**
- d) **Signage: Replace existing signage with 'fire door keep locked' See section 12**

These actions should be completed to ensure the cupboard is adequately protected, secured, and appropriately identified.

Furthermore, as part of any future planned refurbishment or capital investment programme, consideration should be given to replacing the existing plywood cupboard with a suitably constructed non-combustible metal enclosure to improve fire safety and enhance the protection of the building's electrical infrastructure.

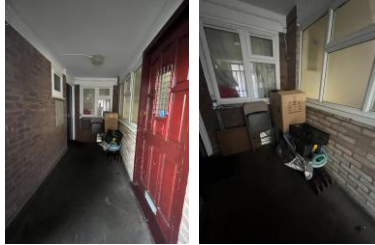
- 11) **A number of items were observed being stored within the communal area adjacent to the entrance of Flat 14. The storage of personal belongings within common escape routes has the potential to increase the fire load and may obstruct means of escape in the event of an emergency. Relocate these items from the communal area or dispose of items no longer required.**

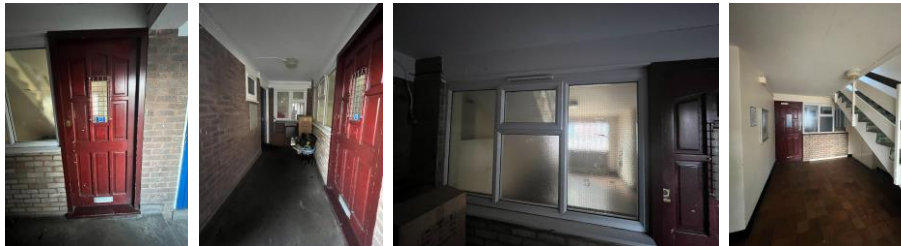
- 14) Ground Floor Dividing Wall: The ground-floor flat is located within a separate communal lobby. This area is divided from the main circulation space by a glazed screen and a self-closing timber door. Due to the flat having windows that open directly onto this lobby, would recommend that the glazed communal window unit to be upgraded to a suitable fire rated frame and to include Georgian wired safety glass, and the door replaced with a certified FD30 fire door with vision panel to maintain adequate separation. This has been raised with the head of compliance to action, and it will be reviewed in 6 months.

**Ground Floor Dividing Wall:** The ground-floor flat is located within a separate communal lobby. This area is divided from the main circulation space by a glazed screen and a self-closing timber door. Due to the flat having windows that open directly onto this lobby, would recommend that the glazed communal window unit to be upgraded to a suitable fire rated frame and to include Georgian wired safety glass, and the door replaced with a
