# Fire Risk Assessment

**15-19**

**Newmans Close,  
Smethwick,  
B66 4SW.**

**Date of Inspection: 11<sup>th</sup> August 2026**

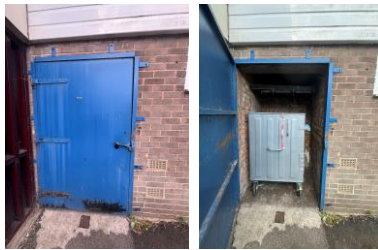
- 4) Adjacent to the front entrance of the block is a secure bin store. The store houses a large, galvanised steel bin which serves the building's bin chute system. Access to the bin store is restricted to authorised users to ensure appropriate control of waste and reduce fire loading in this area.

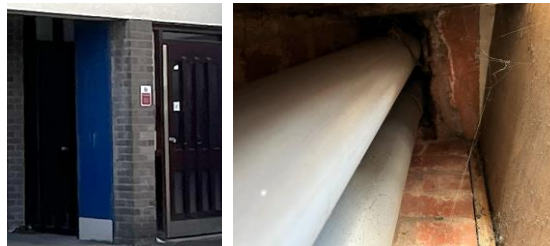
- 5) Adjacent to the entrance at the front of the premises, a plywood cover was removed by Fire Rapid Response to inspect the area behind it. This inspection was undertaken following the identification of similar fire stopping deficiencies at another property of the same construction type, which prompted Fire Rapid Response to carry out inspections of other blocks with the same build design.

A visual inspection of the exposed service shaft identified apparent deficiencies in the fire stopping around service penetrations, which could allow the passage of fire and smoke in the event of a fire.

Fire Rapid Response will replace the existing plywood cover with a Supalux board and install appropriate fire stopping within the service shaft around all service penetrations. These works will restore the required fire compartmentation and prevent the spread of fire and smoke through the service shaft, thereby improving the overall fire safety of the premises and ensuring the compartmentation is maintained as designed.

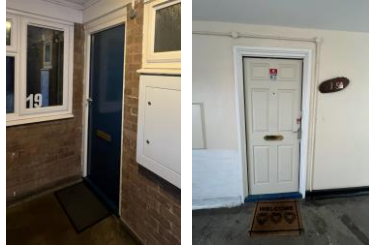
- 6) At a number of flat entrances door mats are present; the fire rating is not known on these door mats and are deemed to be low risk.

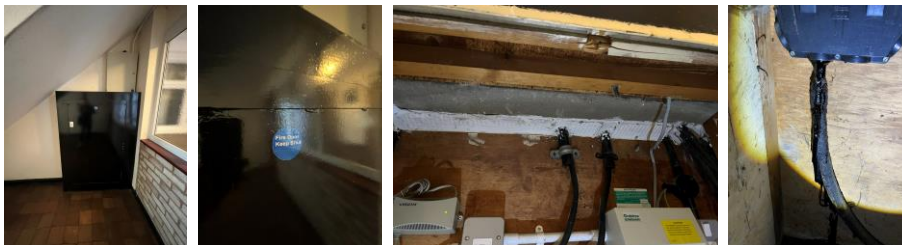
- 11) A steel cupboard is located within the ground floor communal area and was found to contain the building's main electrical intake equipment. During the inspection, a bitumen-like substance was observed leaking from the incoming mains intake equipment and accumulating on the cupboard floor. Whilst the source of the substance could not be confirmed at the time of inspection, its presence may indicate deterioration of sealing compounds or a fault within the electrical intake equipment, including possible overheating. The Electrical Department was notified on 11/08/2026 and requested to arrange for the equipment to be inspected by a competent person. 14/08/2026 Electrical department had reported this to National Grid job with reference number 6245083

- a) Signage: Provide and install compliant electrical hazard warning signage to clearly identify the presence of electrical equipment and associated risks. See section 12
- b) Signage: Replace existing signage with 'fire door keep locked' See section 12

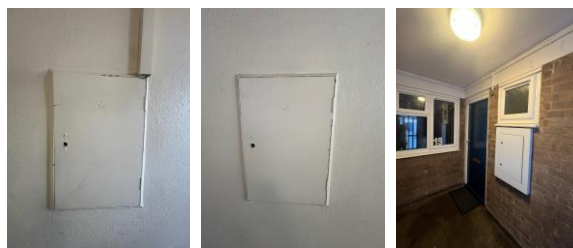
- 12) Adjacent each flat entrance there is an electrical over cupboard. One of the over cupboards requires fire stopping within it, this has been added to section 10

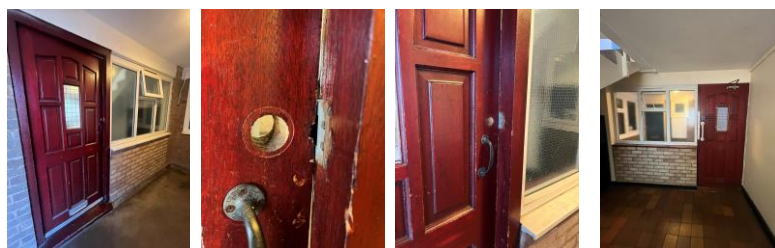
- 13) Ground Floor Dividing Wall: The ground-floor flat is located within a separate communal lobby. This area is divided from the main circulation space by a glazed screen and a self-closing timber door. Due to the flat having windows that open directly onto this lobby, would recommend that the glazed communal window unit to be upgraded to a suitable fire rated frame and to include Georgian wired safety glass, and the door replaced with a certified FD30 fire door with vision panel to maintain adequate separation. This has been raised with the head of compliance to action, and it will be reviewed in 6 months.

- a) **The door within this dividing wall does not fully close into the frame, this requires rehanging, so it closes fully in to the frame.**
- b) **Within the door in the dividing wall, there is a hole that requires fire stopping.**

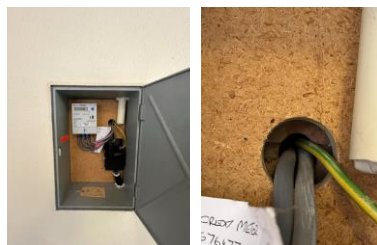
- 5) **Adjacent to the entrance of Flat 17, within the over-cupboard, deficiencies in the fire stopping were identified where electrical cables pass through the wall. Appropriate fire-stopping measures should be installed around the cable penetrations to maintain the fire-resisting construction of the compartment wall and prevent the potential spread of fire and smoke between adjoining areas.**
