# Fire Risk Assessment

## Bearwood Road 200 - 238

**Date of Inspection:** 3<sup>rd</sup> August 2026

**Current Risk Rating = Tolerable**

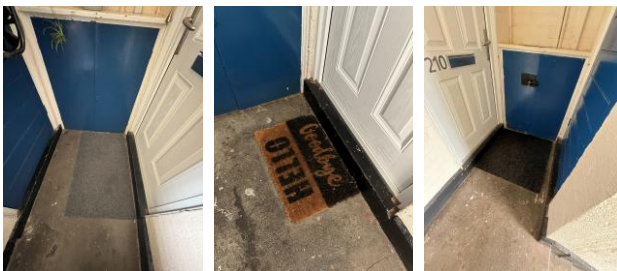
- 3) **Flat 212 has an off cut of carpet placed outside the flat entrance which extends to the foot of the stairwell.** *Email has been sent to Leaseholder Management on 03/08/2026*

| 7/4 | Flat 218 has an off cut of carpet placed outside the flat entrance which extends to the foot of the stairwell. Engage with resident on removal | | P2 | Within 1-3 Months<br>Housing Manager | 11/08/2026 |

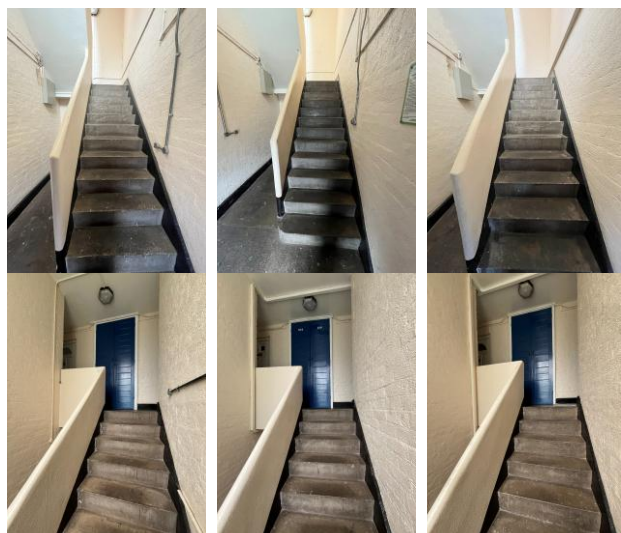
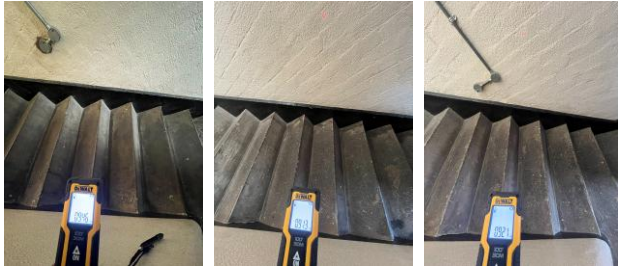
- 6) Bearwood Road 200-238 consists of a single staircase that provides sufficient means of escape to all flats on the 1<sup>st</sup> and 2<sup>nd</sup> floor, this is located as you enter each block. The width of the staircases have been measured from concrete handrail to wall at a measurement of between 913 and 946mm, each block differs in measurement slightly. These stairs and landings are kept clear to maintain safe means of escape.

Sample of stairs and measurements

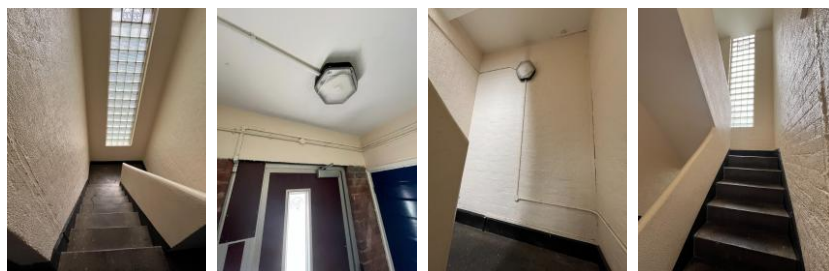
- 8) The block currently lacks a dedicated emergency lighting system; however, standard lighting units are situated throughout the communal stairwell, internal landings, on the first and second floors. These units, supplemented by borrowed street lighting through the glass panes, provide sufficient levels of illumination to facilitate a safe means of escape.

- 2) It is recommended that emergency lighting accordance with BS 5266 to be installed on any future works program.

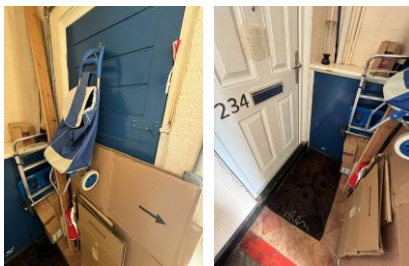
- 12) Resident of flat 234 has been advised to remove combustibles stored outside their flat entrance, resident has acknowledged the risk and has agreed to remove the items.

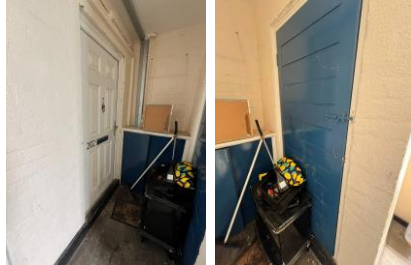
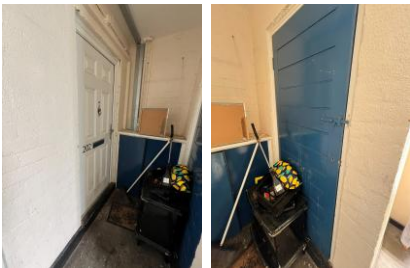
- 13) Outside Flat 202, a discarded heater near the entrance in a communal escape route. Communal areas must remain completely clear of all items to reduce potential safety risks. Email has been sent to housing on 03/08/2026**

| 7/13 | Flat 202, a discarded heater near the entrance in a communal escape route. Engage with residents on removal | | P2 | Within 1-3 Months<br>Housing Manager | 11/08/2026 |

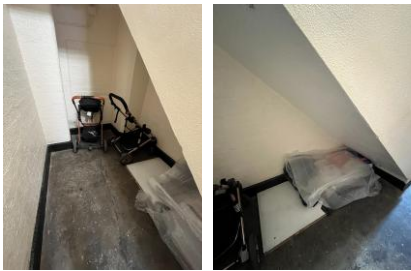
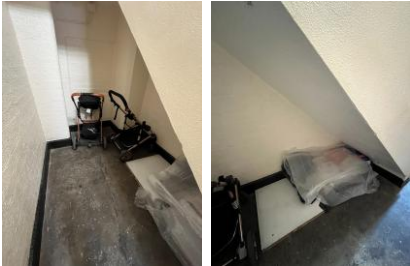
- 17) Pushchairs and building materials are currently stored under the stairs in the block serving flats 210 and 212. Email has been sent to housing on 03/08/2026**

| 7/17 | Pushchairs and building materials are currently stored under the stairs in the block serving flats 210 and 212. Engage with residents on removal | | P2 | Within 1-3 Months<br>Housing Manager | 11/08/2026 |

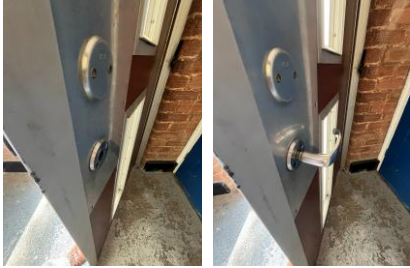
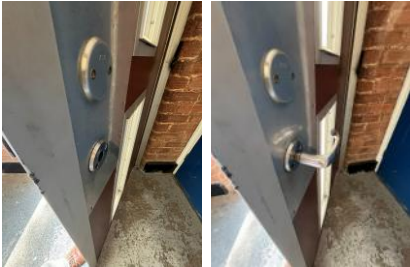
- 19) Internal door handle to block accommodating flats 226 and 228 is loose and come away from spindle making it difficult to exit the building, this is a matter of urgency to be rectified as this is the only exit for resident of flat 226 and 228 in an emergency. *Email has been sent to the Fire Rapid Team on 30/07/2026 to rectify, scheduled as a matter of urgency. This has now been repaired as of 31/07/2026*

| 7/19 | Internal door handle to block accommodating flats 226 and 228 is loose and come away from spindle | | P2 | Within 1-3 Months<br>Fire Rapid Response | 31/07/2026 |

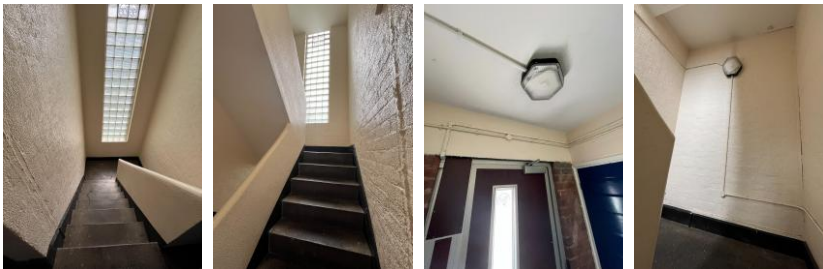
- 1) The block currently lacks a dedicated emergency lighting system; however, standard lighting units are situated throughout the communal stairwell, internal landings, on the first and second floors. These units, supplemented by borrowed street lighting through the glass panes, provide sufficient levels of illumination to facilitate a safe means of escape.

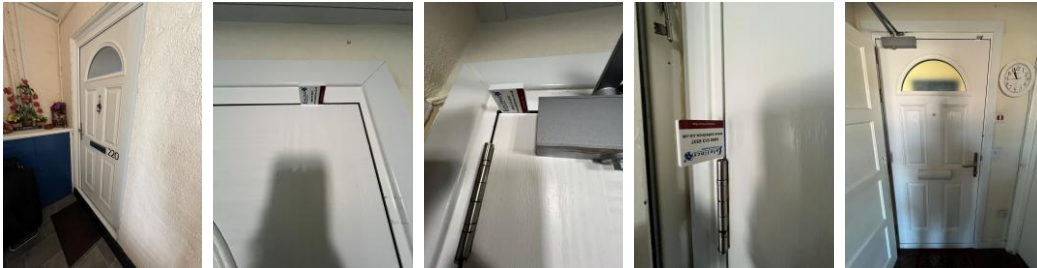
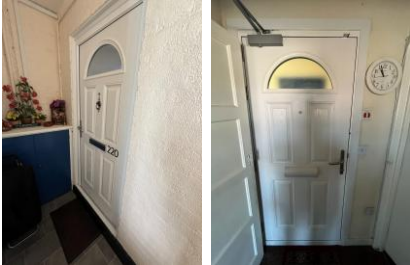
- 12) **Flat 220 self-closing device requires adjusting due to the sweep and latching speed being aggressive.** Gap on internal leaf of the doors are within the 4mm threshold.

| 10/12 | Flat 220 self-closing device requires adjusting due to the sweep and latching speed being aggressive. | | P2 | Within 1-3 Months<br>Fire Rapid Response | |

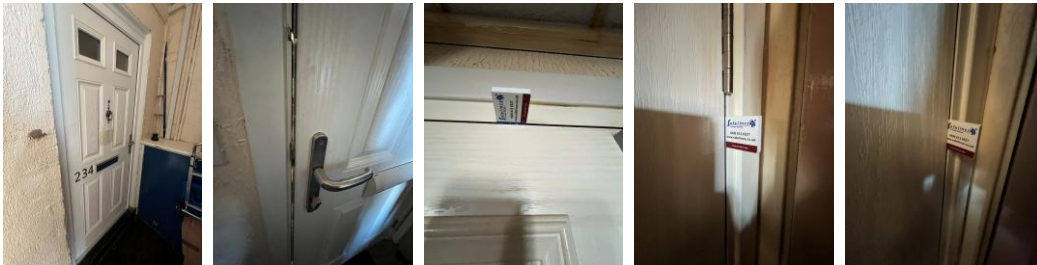
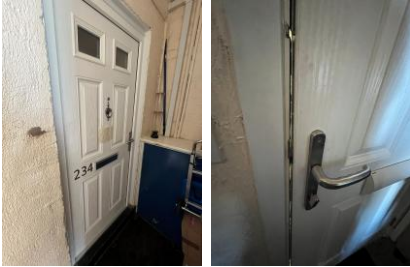
- 13) **Flat 234 self-closing device requires assessing and adjusting due not auto closing on test.** Gap on internal leaf of the doors are within the 4mm threshold.

| 10/13 | Flat 234 self-closing device requires assessing and adjusting due to the door not auto closing on test. | | P2 | Within 1-3 Months<br>Fire Rapid Response | |

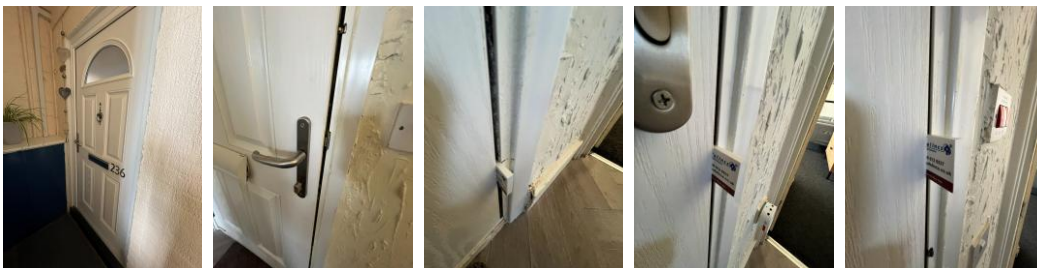
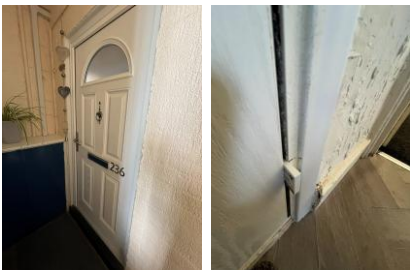
- 14) **Flat 236 self-closing device operates as it should, however internal door leaf gap exceeding the 4mm threshold on the slamming side.**

| 10/14 | Flat 236 internal door leaf gap exceeding the 4mm threshold on the slamming side. | | P2 | Within 1-3 Months<br>Fire Rapid Response | |

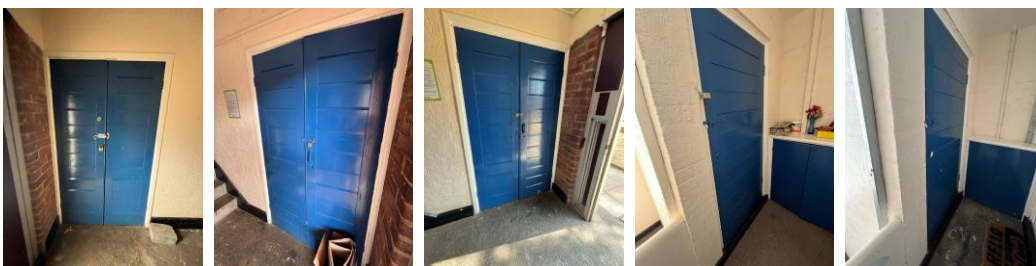
- 15) **Access was not possible to assess the resident storage cupboards located on the ground floor communal area and storage cupboards adjacent to flat entrances on the 2<sup>nd</sup> floor.**

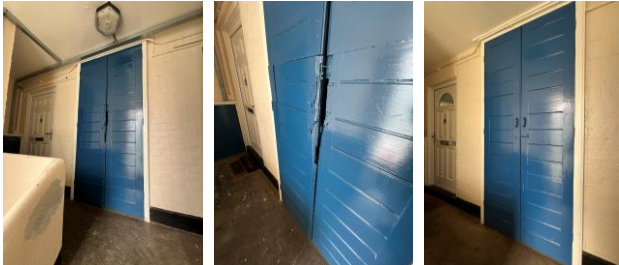
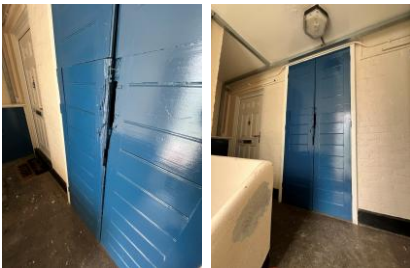
- 16) Access to the decommissioned refuse chute cupboards on the second-floor landing area for all blocks was not possible as the timber access doors were sealed shut; **however, block (serving flats 202 and 204) a visual inspection noted that while the refuse chute door itself exhibits slight frontal damage, it remains structurally secure.**

| 10/16 | block (serving flats 202 and 204) 2 <sup>nd</sup> floor refuse chute door has damage to the front. Seal and make correct. | | P2 | Within 1-3 Months<br>Fire Rapid Response | |

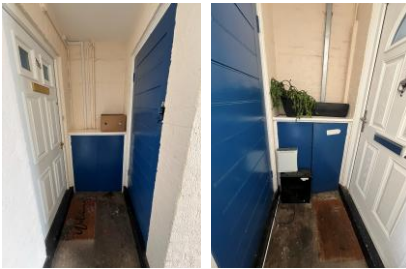
- 17) Resident electrical cupboards located adjacent to flat entrances on the 2<sup>nd</sup> floor on each block are secured by a timber door. *Recommended that these doors be upgraded to certified fire doors on any future works program for the building.*

All resident electrical cupboards to be upgraded to FD30s fire rated enclosures and appropriate signage to be attached regarding Fire Door Keep Locked on any future works program.

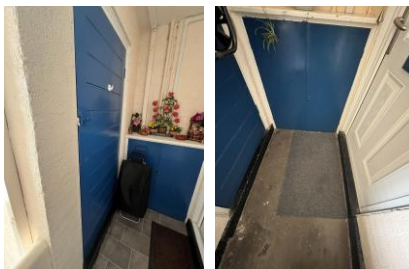
- 3) There is no signage displayed on any residential electrical cupboards adjacent to flat entrance doors.

| 12/4 | Signage to identify resident electrical cupboard is required. | | P2 | Within 1-3 Months<br>Fire Rapid Response | |

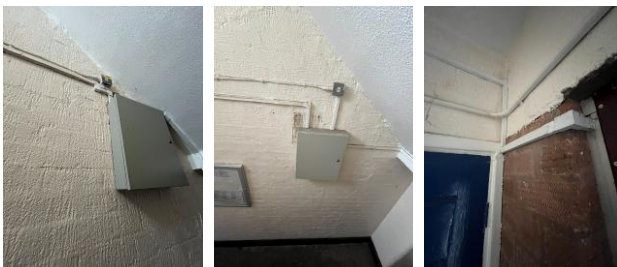
- 8) There is a run of Extra Low Voltage data cables that are fed from the door access control unit in the communal hallway to the door, these cable are housed in plastic trunking, at present the risk is low, but it is recommended that any refurbishment of the block that these cable be housed in metal trunking separate to any low voltage cables.
