Fire Risk Assessment

1-6
Park Court,
Rowley village
Rowley Regis,
B65 9ER.

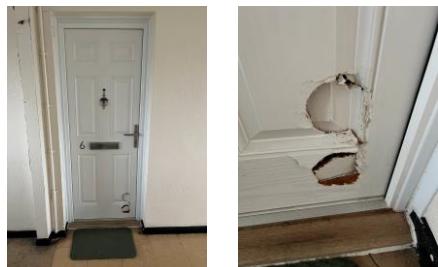
6) Some of the flats at their entrances have door mats, the fire rating is not known but deemed to be low risk.

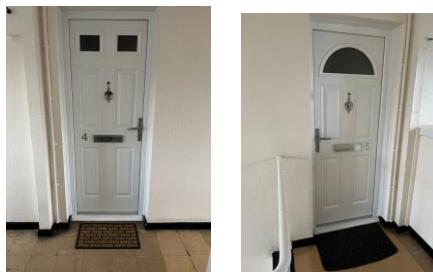
7) The cupboard housing the electrical installation is made of timber

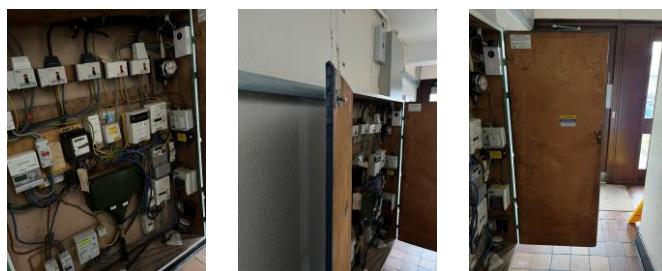
9) The means of escape is a stairs case of concrete construction.

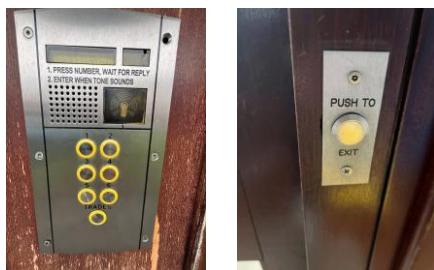
10) The rear final exit door has a handle operation internally to exit.

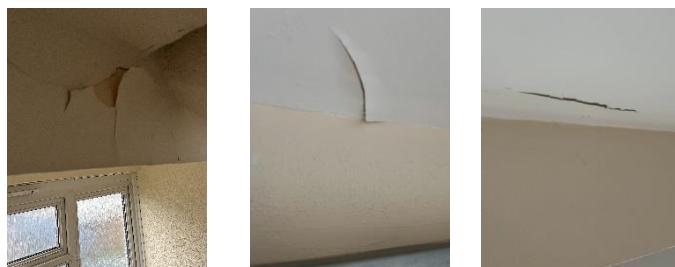
15)The building has sufficient passive controls that provide effective compartmentation to support a Stay Put Policy. Therefore, residents are advised to remain in their flat unless the fire directly affects them.

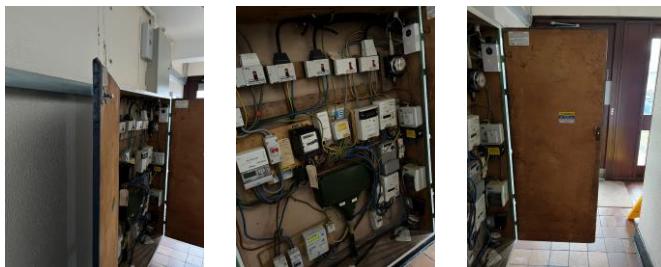
9) All flat front doors appear to be FD30s door sets.
