Fire Risk Assessment

**Park Court,
Rowley village
Rowley Regis,
B65 9ER.**

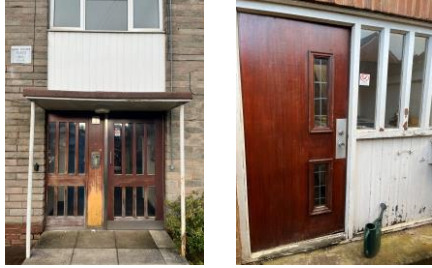
- 4) The roof is clad with concrete interlocking tiles with
- 5) The building has Crocidolite cement board soffits and UPVC guttering just below the roof line.
- 6) **Large hole in the soffit on the front of the building this requires repairing to cover the hole. See Action 6/6.**

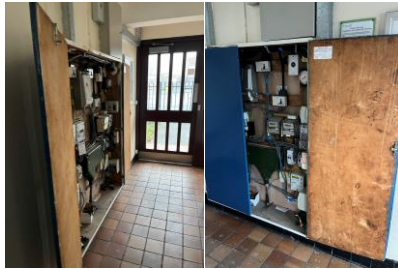
- 8) The means of escape is a stairs case of concrete construction.
- 9) The only communal doors within the block are the final exit doors. The main front door is fitted with an automatic closing device that is checked on a regular basis by Caretaking Teams as part of their daily checks. Defective closing devices are reported to an external contractor.
- 10) The front final exit door has a door entry system installed. These systems are designed to fail safe i.e., door unlocked in the event of a power failure. This prevents residents being locked in or out of the building.
