Fire Risk Assessment

Braybrook House 356-422

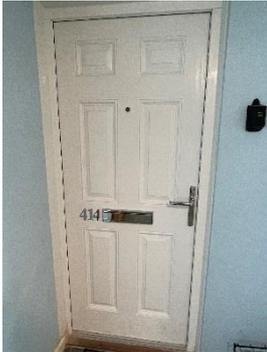
- 2) All flat entrance doors at Braybrook House are scheduled for an annual inspection in January 2026, on a best endeavour basis. The inspections and were necessary any subsequent repairs or adjustments will be carried out by SMBC inhouse fire door inspectors / Fire Safety Rapid Response Team.
- 3) A number of flat entrance doors have door mats on the communal corridor side. The fire rating of the mats is unknown but deemed to be sufficiently low risk.

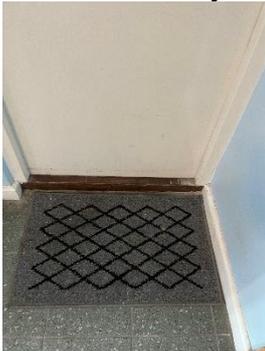
- 4) Ramps were noted outside flats 400, 376, 364. The ramps have been installed by the tenants who rely on mobility aids to assist passage over the threshold. It is deemed the ramps represent a sufficient low risk.
-

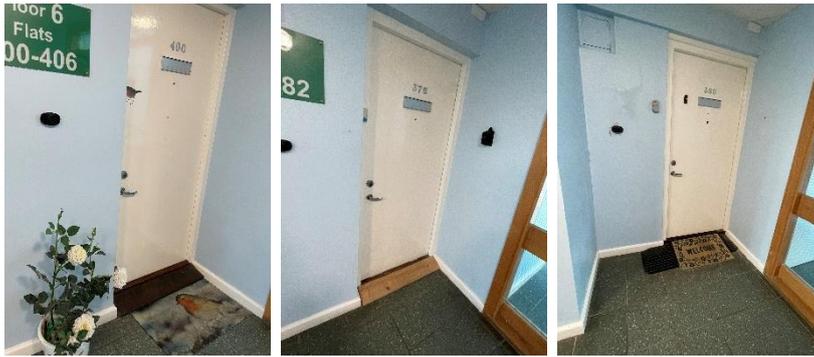
- 5) The means of escape are protected to prevent the spread of fire and smoke.
- 6) Emergency lighting is provided to the communal landings and stairs. Checks are done on a monthly basis by Sandwell MBC in house electrical team or approved contractor.
- 7) None of the corridors that form part of the means of escape are dead ends.
- 8) Surface coatings to the communal areas are presumed Class 0 rated.
- 9) All corridors are of adequate width and will be maintained clear.

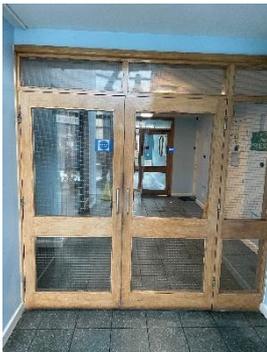
- 11) All communal doors are fitted with automatic closing devices that are checked on a regular basis by Caretaking Teams as part of their checks. Defective closing devices are replaced either by the Caretaking Team(s) or the in-house repairs team(s).
- 12) All communal fire doors are subject to a 12-week check by the Fire Safety Rapid Response Team.
- 13) There are two staircases both equipped with automatic opening vents and approximately 1000mm wide. Both provide a sufficient means of escape and facilitate two way travel.

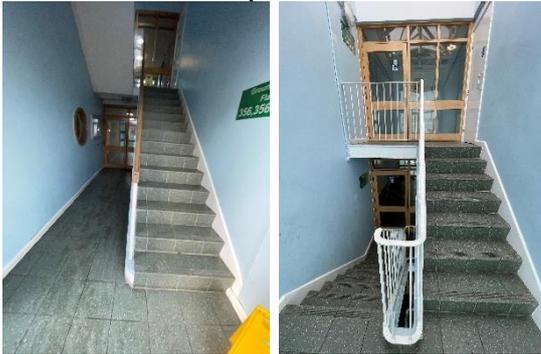
- 14) The maximum travel distance from any flat to the nearest protected stairwell is 2.5 metres.
- 15) The automatic smoke vents are located in both stairwells between the 1st / 2nd , 3rd / 4th , 5th / 6th , and 7th / 8th floors. The system status panel is located in the main entrance foyer.

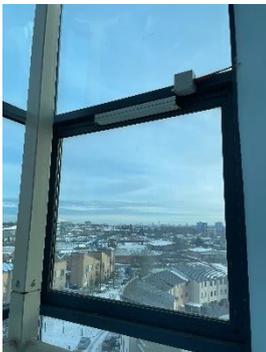
- 16) Glazing noted within 1.8m of staircase. Sprinkler roll out programme should therefore be considered as part of future refurbishments. (Recommended in section 19 Observations)

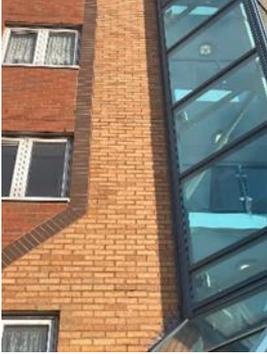
- 17) The final exit doors at the bottom of each stairwell have door entry & exit systems installed. These systems are designed to fail safe i.e., door unlocked in the event of a power failure. This prevents residents being locked in or out of the building.

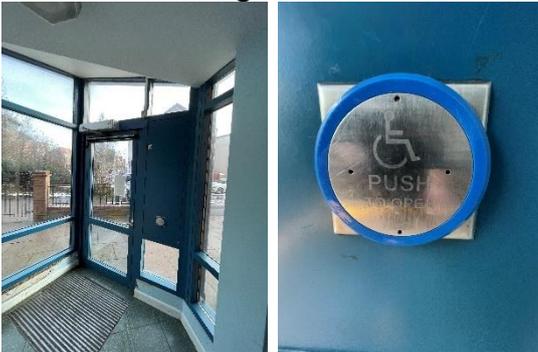
- 18) Communal areas should be kept free of flammable items. The communal areas are checked on a regular basis by Caretaking / Cleaning teams 365 days per year and all items of rubbish are immediately removed. There is also an out of hour's service that allows combustible items of furniture / rubbish to be removed.

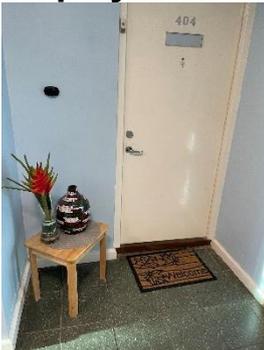
- 23) 6th floor lift lobby – Artificial plants in pot displayed outside flat 402. Also, there's a small rug which potentially could cause a trip hazard during evacuation or firefighting procedures. It is recommended that the rug should be replaced with a suitable door mat. A small Christmas wreath was also noted attached to the flat door; it presumed this item will be removed by the tenant following the festive period.

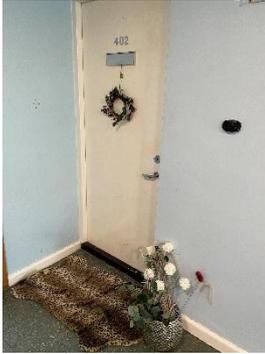
- 24) 6th floor lift lobby - Artificial plant in pot displayed outside flat 400.

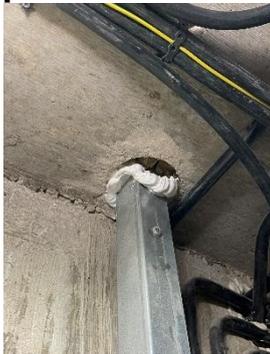
- 8) A variety of methods / materials have been used to achieve fire-stopping including intumescent mastic, intumescent sponge and mineral wool. **It is recommended that all fire stopped penetrations in service cupboards on all floors are, where possible, enhanced further with ablative batt, installed as per the manufacturer's application instructions.**

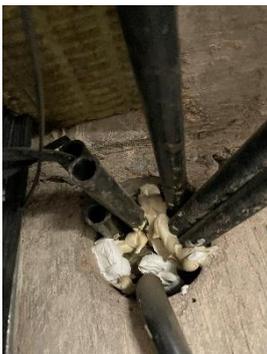
- 9) All communal doors are fitted with automatic closing devices that are checked on a regular basis by Caretaking Teams as part of their checks. Defective closing devices are replaced either by the Caretaking Team(s) or the in-house repairs team(s).
-

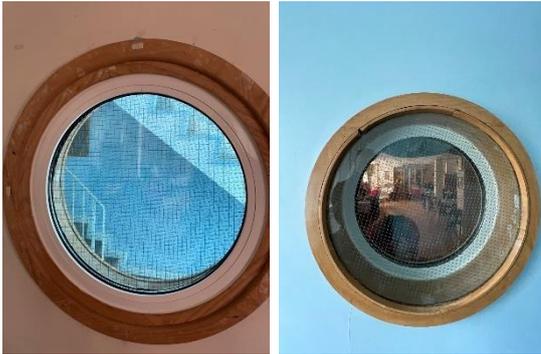
- 13) Communal fire doors within the means of escape are nominal FD30s doors with vision panels.

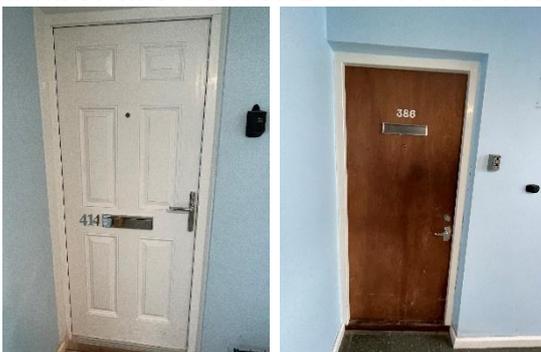
19) Individual flat entrance doors were inspected in January 2026 by SMBC's Fire Rapid Response team. A total of 18 doors passed the inspection and 8 failed. Access was gained to a total of 26 flats including the community room entrance door. The occupiers of the remaining 10 flats that require door inspections have been written to, requesting access. Repairs will be completed by the Fire Rapid Response. An approved contractor will install any replacement FD30s doors that are required.

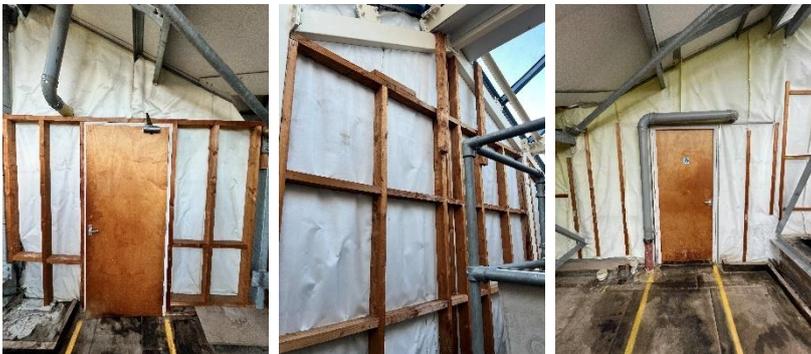
21) Nominal fire doors have been installed within the fire curtain walls to the roof void. All 6 doors fit poorly; lipping's have come away and appear to have swollen. It is likely they have been affected by fluctuations in temperature and moisture due to exposure to direct sunlight and heat from the installed solar thermal system. **Therefore, all 6 doors should be replaced with external grade FD30s timber fire doors with self-closing devices and mandatory signage. Door stops should be considered for those which foul on pipework. Update 03/02/26 This work will be completed in conjunction with the recommendation detailed in 10/20.**

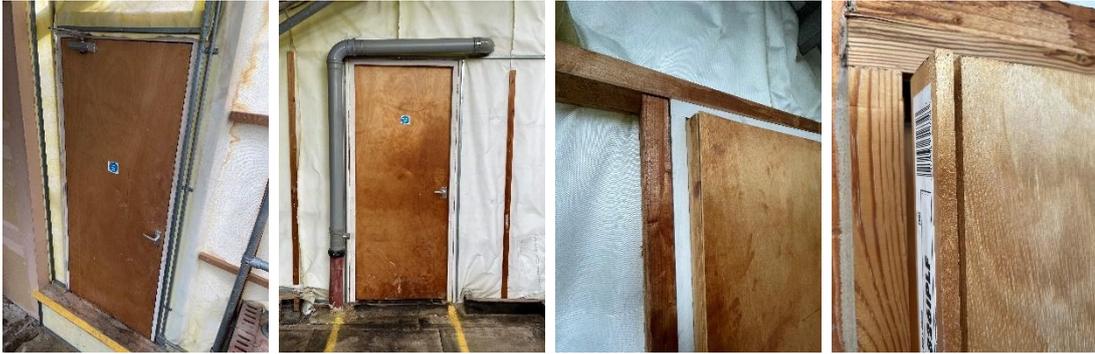
Definitions Fire Doors.

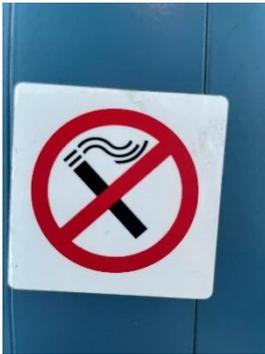
- 2) Hot working is not normally carried out. If essential maintenance requires the use of hot work processes, then corporate policies and procedures are to be followed.
- 3) Portable electrical equipment used as part of the Caretaking / Cleaning regime is subject to annual PAT Testing. This information is held by the Estate Services Manager Bryan Low.
- 4) The fixed electrical installation shall be tested every 5 years. It was noted that the last inspection was recorded as satisfactory and completed 06/06/2024.

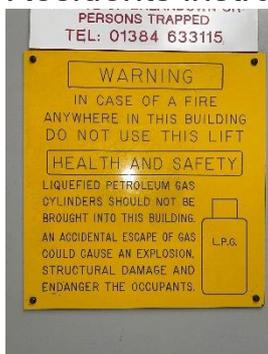
- 2) The tenancy conditions, Section 7 – Condition 5.6 stipulates “If you live in a flat or maisonette, you, people living with you and any visitors to your property must not keep or use paraffin oil, petrol, bottled gas appliances or any other explosive, FLAMMABLE or dangerous material in the property. This restriction also applies to any storage facility situated in or attached to the block, which has been provided for your use.”
- 3) No Flammable liquids stored on site by Caretakers / cleaners.
- 4) All store cupboards are kept locked.
- 5) There are no flammable liquids or gas cylinders stored on site.
- 6) Items stored within the entrance hall of the community room are restricting access to a portable fire extinguisher. **All items stored here should be removed to ensure the portable fire extinguisher is accessible and a sterile means of escape is maintained.**

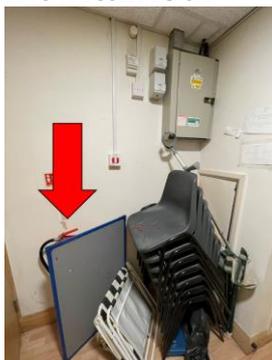
- 7) It appears a large number of personal items to include furniture; fabrics & home appliances have been introduced to the community room. Because the safety, ignitability and combustibility of such items is unknown, there's the potential for excessive fire loading.

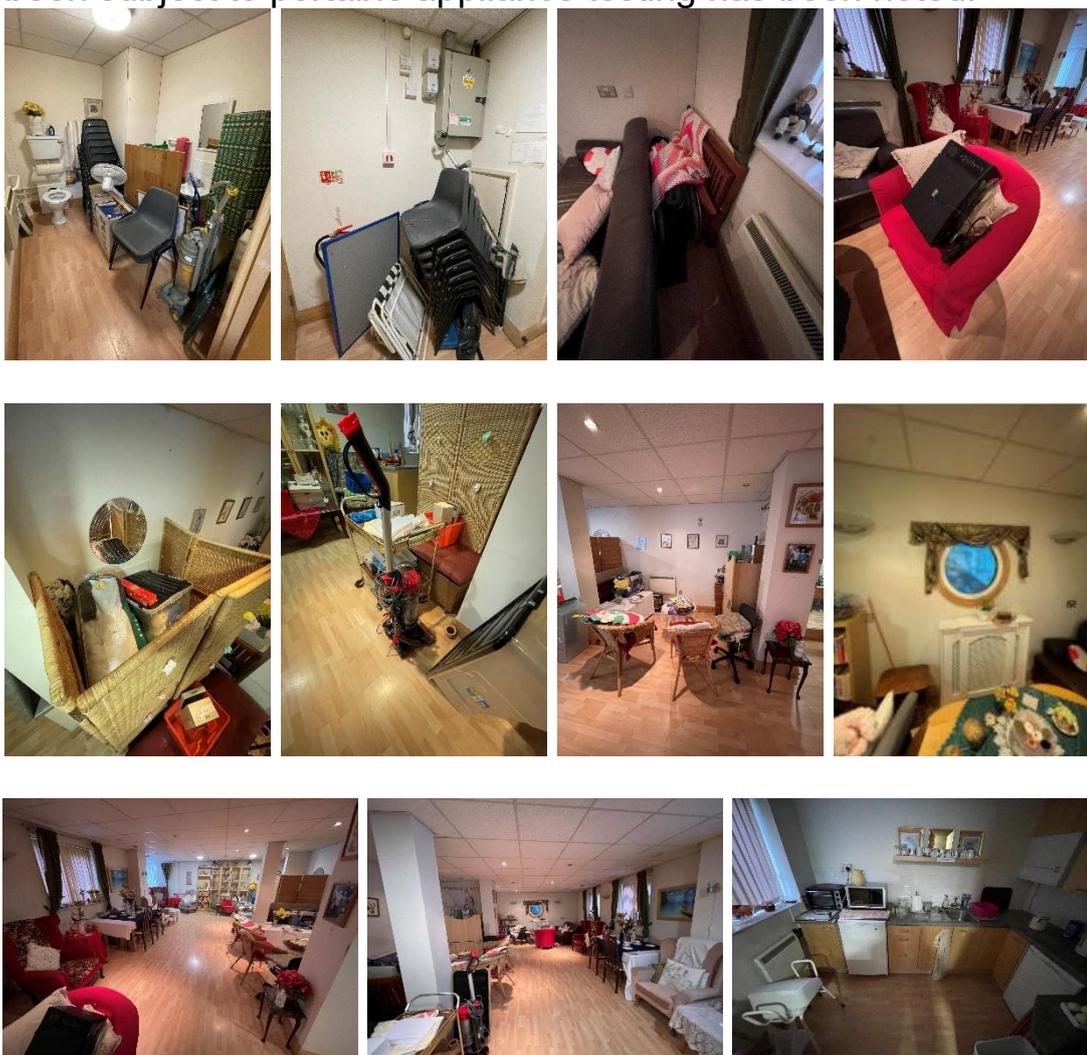
Hard wired smoke alarms and evidence some appliances have been subject to portable appliance testing has been noted.

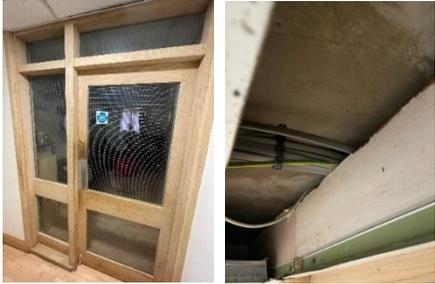
P2	Within 1-3 months Rapid Fire Team JM18694941	27/01/2026
10/7	3 rd floor service cupboard. Remove and replace intumescent mastic which has moved.

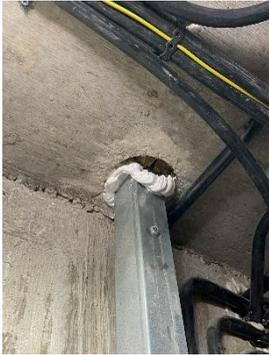
P2	Within 1-3 months Rapid Fire Team JM18695007	27/01/2026
10/8	Where possible enhance all fire stopped penetrations in all service cupboards with ablative batt or other suitable product.

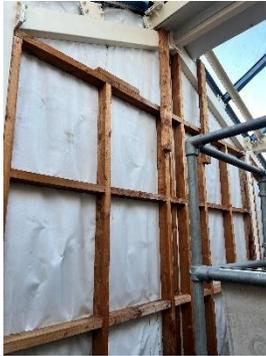
P4	Programmed Work Head of Building Safety & Compliance	
10/21	Replace all 6 fire doors installed in roof void fire curtain wall with external grade self-closing FD30s <i>(Where necessary install door stops)</i>

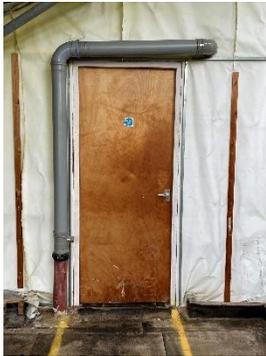
P4	Programmed Work Head of Building Safety & Compliance
