# Fire Risk Assessment Broadmede House

## 1-32, Pavillion Avenue, Smethwick, B67 6LB

Date Completed: 04/04/2025. Review Period: 12 months. Officer: A. Jones Building Safety Manager Checked By: C. Hill Building Safety Manager

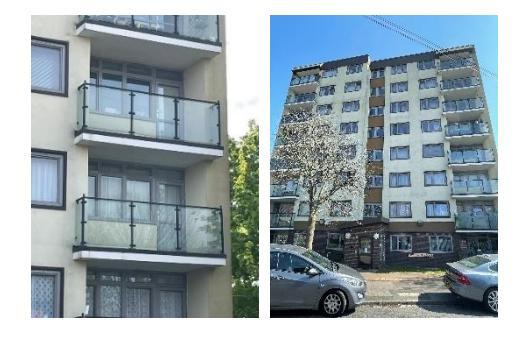
5) Screening has been installed to several flats within this building. This should be removed at the earliest opportunity in line with SMBC policy. Email sent to housing officer regarding this point.

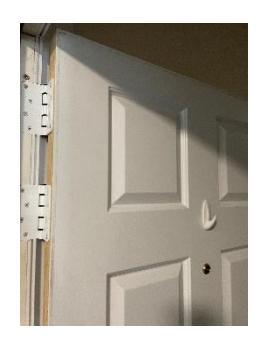
a) Flat 32 – The self-closer was missing from the flat entrance door. The resident is unable to leave the property easily due to mobility issues & uses a mobility frame to walk around. PEEP required. This has been requested through the housing manager.

| Question/<br>Ref No | Required Action | Supporting photograph | Priority | Timescale and<br>Person<br>Responsible | Date<br>Completed |
|---|---|---|---|--|---|
| 07/22a) | Flat 32 requires<br>replacement self-closing<br>device to the flat<br>entrance door. This<br>should be a cam action<br>self-closer due to mobility<br>issues of the resident and<br>her having the ability to<br>access and egress the<br>flat in an emergency. | | P2 | Rapid Response<br>team.<br>1-3 months | |

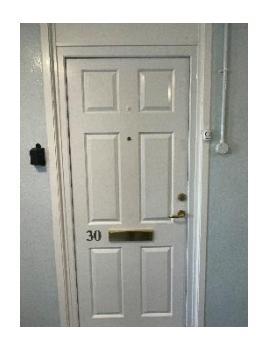
b) Flat 30 – Door was correct.

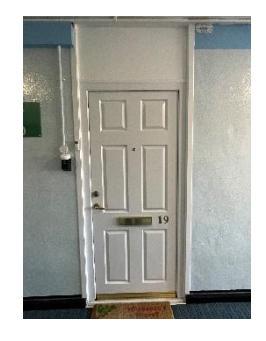
c) Flat 19 – Door was correct.

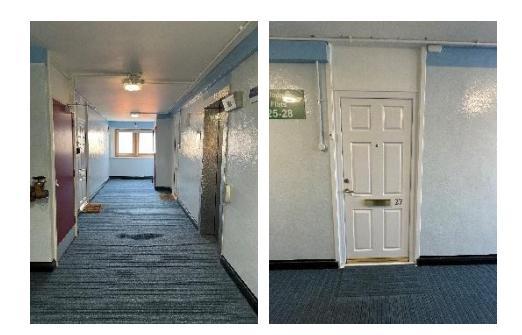
23) At the time of the assessment, it was noted that landing floors were fitted with carpet. It is understood that carpets have been procured in accordance with BS 5287: 1988 specification for assessment and labelling of textile floor coverings and & BS 4790 Fire Test to Textile Floor Coverings.

These carpets have been procured by SMBC utilising third party approved contractors. Therefore, it is understood that carpets fitted meet the approved standard.

When any refurbishment of the building takes place consideration should be given to replace existing flooring for an approved floor covering that has appropriate fire resistance.

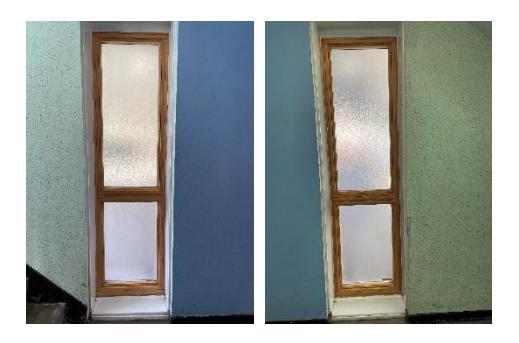
- 1) The building is designed to provide as a minimum 1-hour vertical fire resistance and 1-hour horizontal fire resistance around flats stairwells and lift shafts. All doors are a minimum 30-minute fire resistant with cold smoke seals, including those in 1-hour rated walls.
- 2) The premise has compartmentation to limit the travel and effect of smoke and flame in event of a fire. Whilst the existing fire stopping is fit for purpose, there is a cyclical programme to ensure fire stopping as not been compromised by third parties and where applicable enhance the fire stopping.
- 3) The staircase should remain a protected route. However, it was noted in the lower ground floor area that timber window frames and glazing had been used. It should be confirmed that glazing provides a minimum of 60 mins fire resistance.

| 10/03 | The staircase should<br>remain a protected route.<br>On the lower ground floor<br>area that timber window<br>frames and glazing had<br>been used.<br>It should be confirmed<br>that glazing provides a<br>minimum of 60 mins fire<br>resistance. | | P2 | Repairs<br>1-3 months. | |

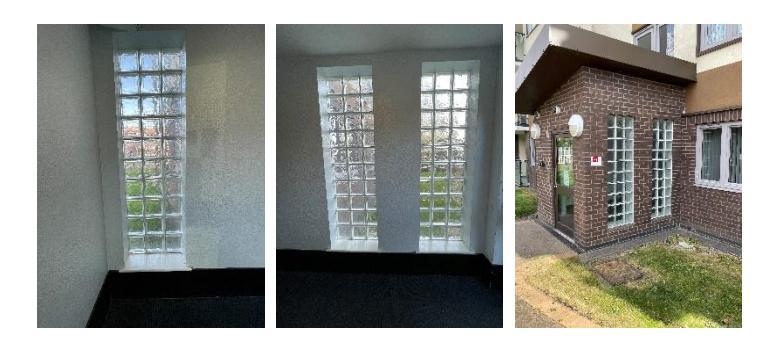
6) Following the refurbishment in 2008 glass blocks located on the front elevation are within 1.8 meters of residential window frames. It could not be confirmed that this type of glazing provides adequate protection as set out in ADB.
