Fire Risk Assessment

Lancaster House

1-120, Oldbury Rd, Rowley Regis, B65 0QF

Date Completed: 02/04/2025 Review Period: 12 months Officer: C. Hill Building Safety Manager Checked By: Adrian Jones Building Safety Manager

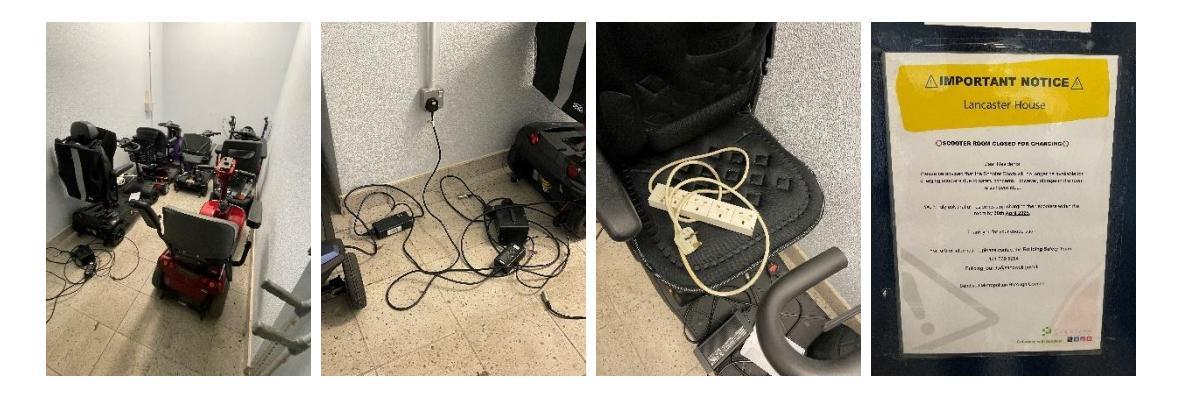
There is a storage room to the ground floor lobby which is used by residents to store and charge mobility scooters. The room is equipped with single gang socket, hardwired smoke detector and is secured with a locked nominal self-closing FD30s door with a thumb turn lock.

Evidence an extension lead has likely been used to charge multiple devices was noted. With multiple devices plugged in at once, potentially the maximum amperage of the extension lead could be exceeded and therefore lead to overheating and ignition. There is a sign on the door which informs residents to refrain from charging their devices by 30th April 2025.

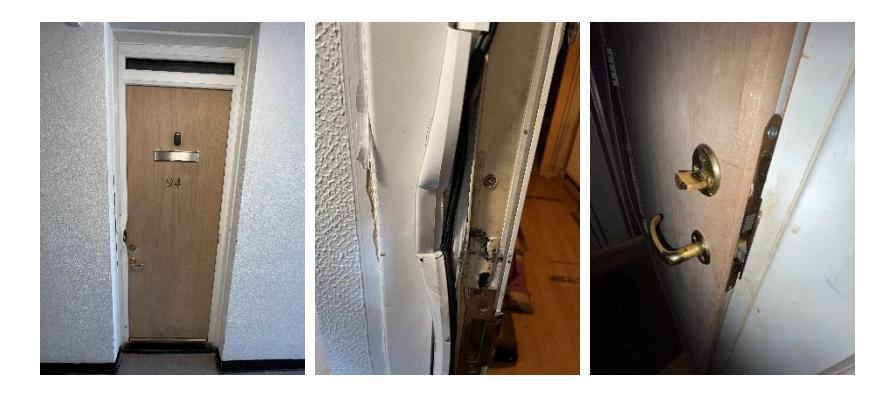
c) Flat 94 – Door is a timber FD30 temporary replacement following a forced entry. *Measurements will be taken for a replacement FD30s doors set during a survey booked for 11/04/25. SMBC contractor Lutley Windows will complete the work – Job Number 16452783*

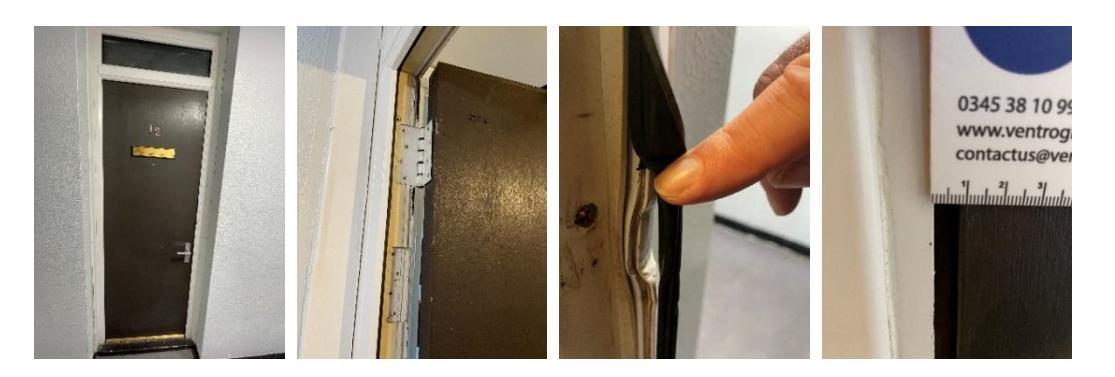
e) Flat 12 – Door leaf is timber FD30 door that has been installed as a replacement door within the previous Permadoor frame. The door has been installed with 3 hinges. There is a small area of the frame without intumescent where a 4th hinge was previously fitted. Damage is evident to the lock side of the frame where forced entry tools have previously been used. There's an 8mm gap between the door leaf and latch side of the frame. Replacement FD30s door and frame set required.

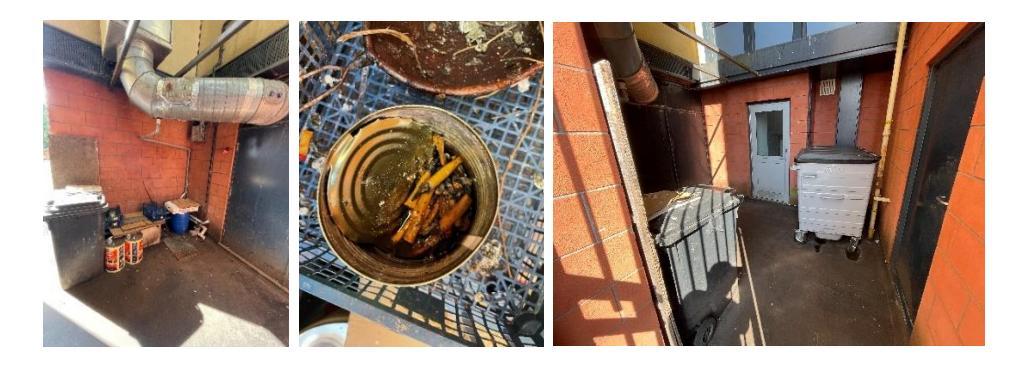
6) There is a build-up of waste products at the rear of Hans Cantonese Take-Away. Plastic crates & drum, cooking oil drums, cardboard boxes and MDF sheets have been discarded against the wall of the building. It was also noted that cigarettes are discarded in a tin can amongst the waste. The premise also stores a waste bin here which is covered in the next point.

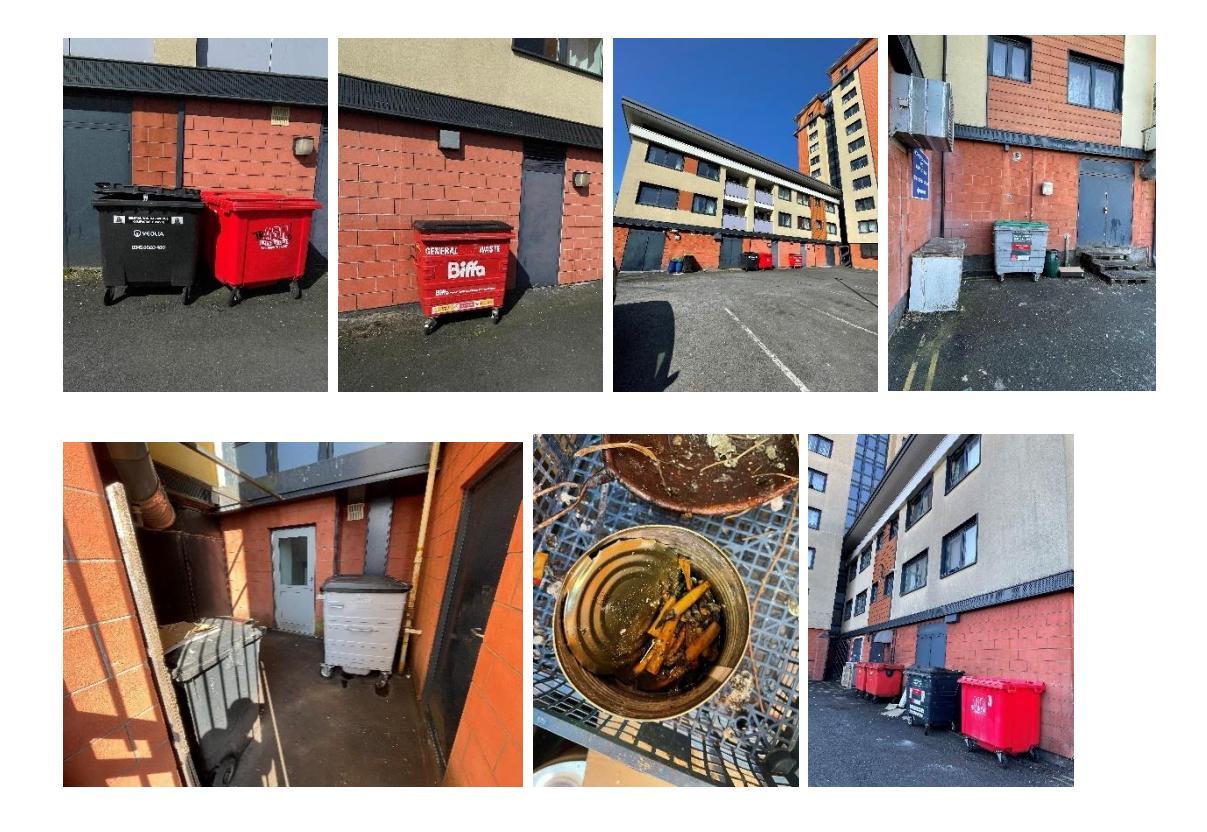
7) A mixture of 9 metal and plastic waste containers for the retail units are stored against the rear of the building with no consideration for safe distances.

A suitable area should be identified where all waste containers can be stored safely at a horizontal distance of 6 metres from the building as per the recommended guidance of the Confederation of Fire Protection Associations Europe (CFPA-E).
